**APPENDIX 11-A**  
**Surficial Geology, Permafrost,**  
**and Terrain Stability**

TETRA TECH EBA

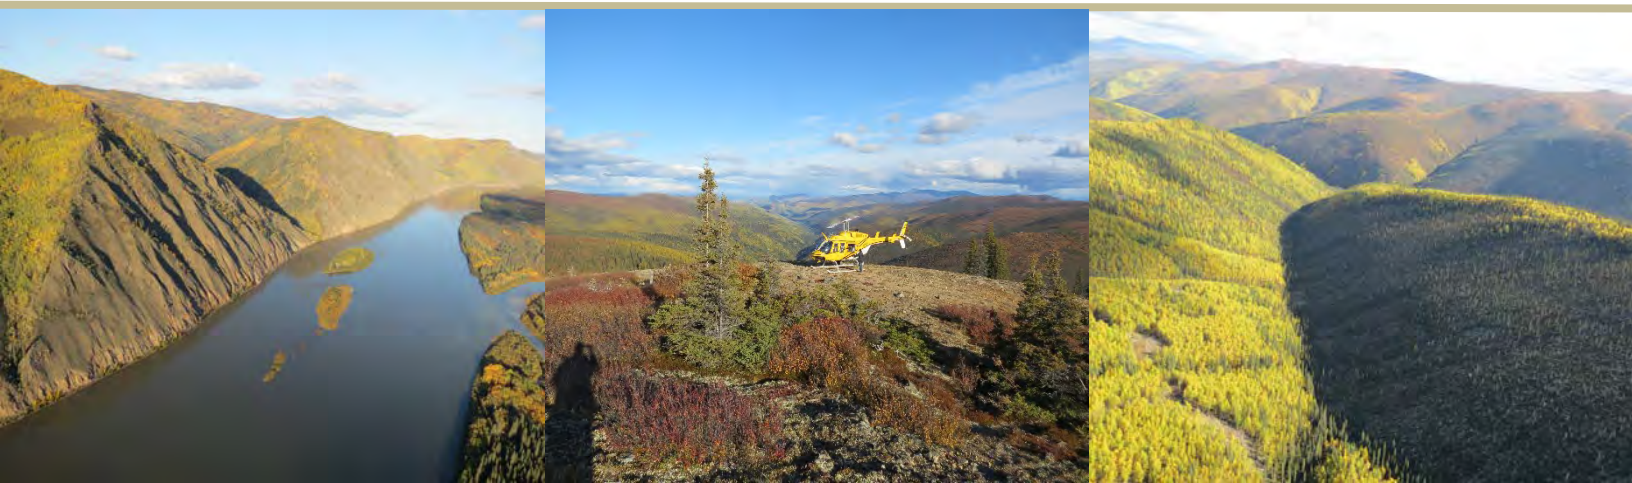
PRESENTED TO  
**Kaminak Gold Corporation**

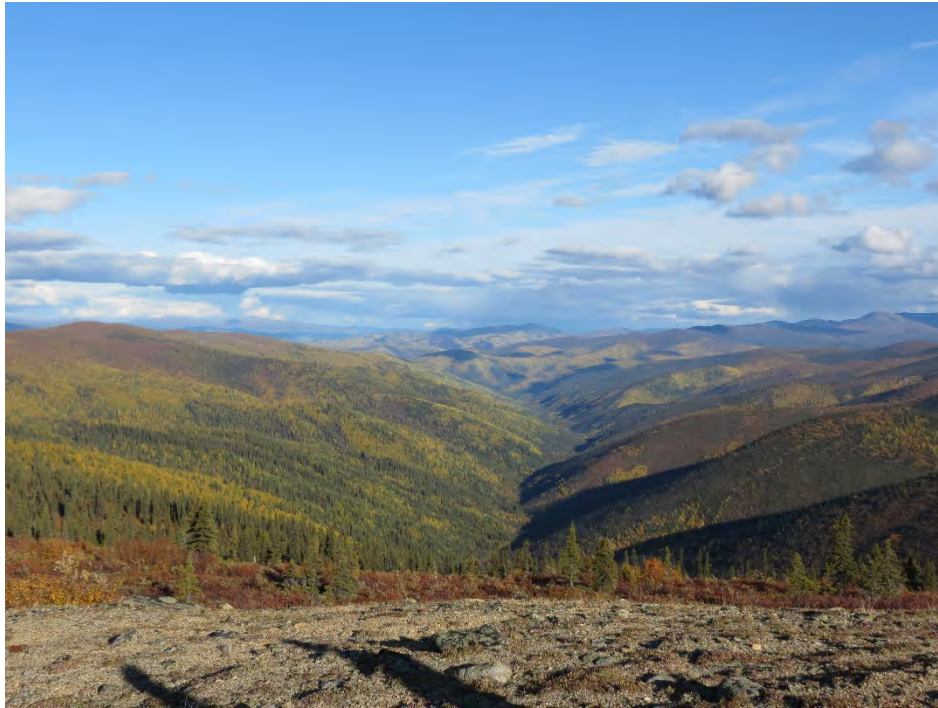
**Photo 1:** Latte Creek valley exhibiting convex valley slopes, looking east. Sparse stunted black spruce on the north-facing slope (on right side of photo) is indicative of shallow ice-rich permafrost; whereas the south-facing slope (left side), covered with moderately dense aspen and aspen/white spruce mixed forest, is predominantly permafrost-free.

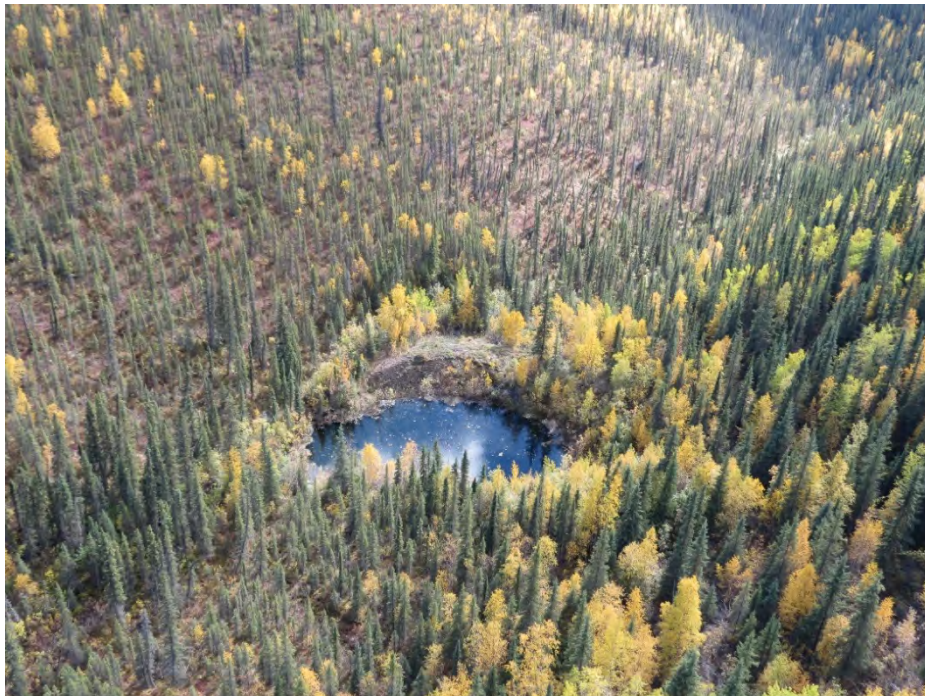
**Photo 2:** Collapsed open-system pingo in in a small tributary valley of Latte Creek, looking south.

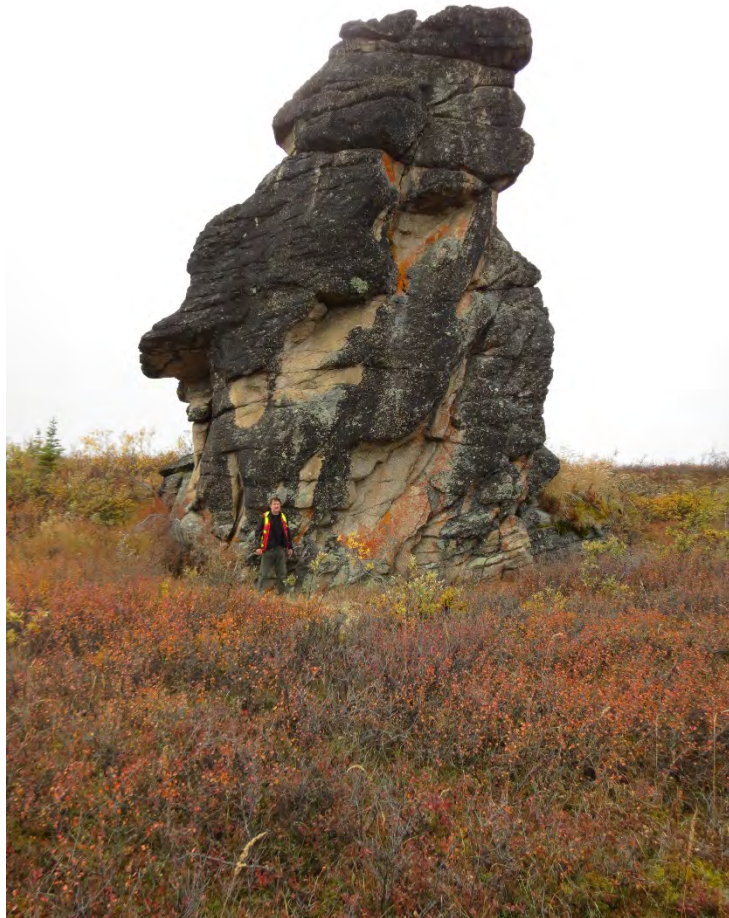
**Photo 3:** Ground view of a tor located within the HLF footprint in the western part of the mine site study area.

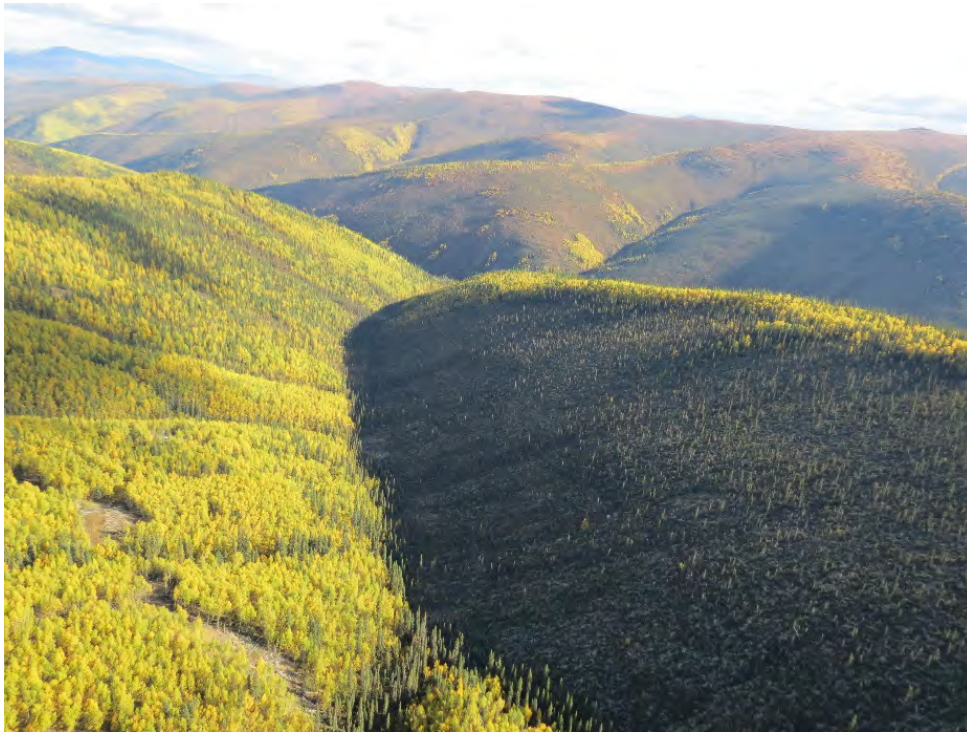
**Photo 5:** South WRSF, Perennally frozen northeast-facing slope (right) and permafrost-free southwest-facing slope (left), looking south towards the Latte Creek valley.

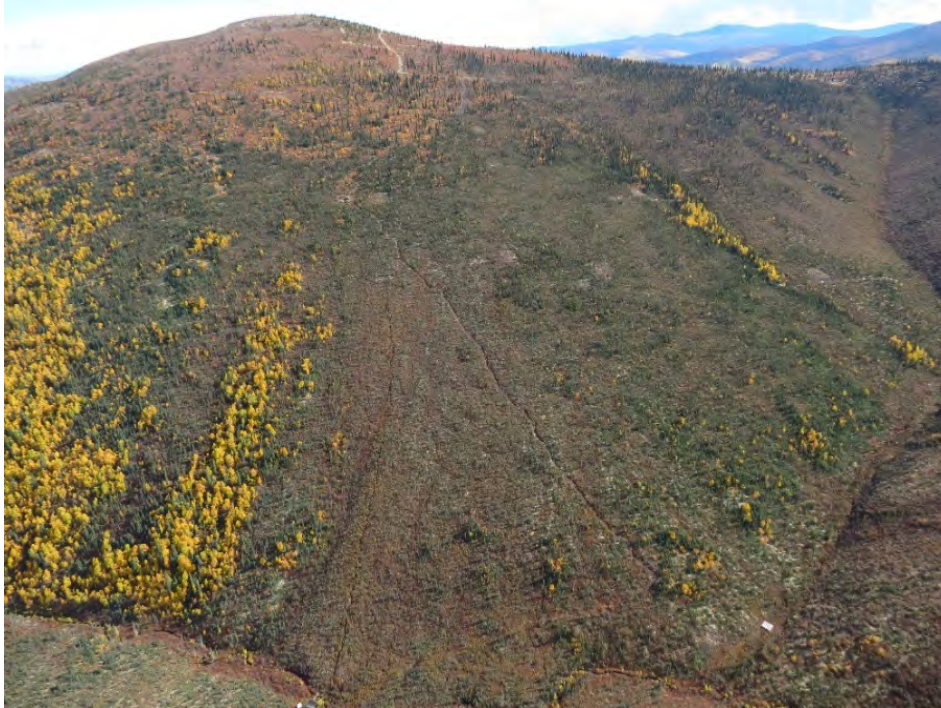
**Photo 6:** West WRSF, Recent access trail along west-northwest-facing perennially frozen slope, looking southeast. Drillers' access trail crosses photo from the hill top in the upper left to the base of the slope on the lower right.

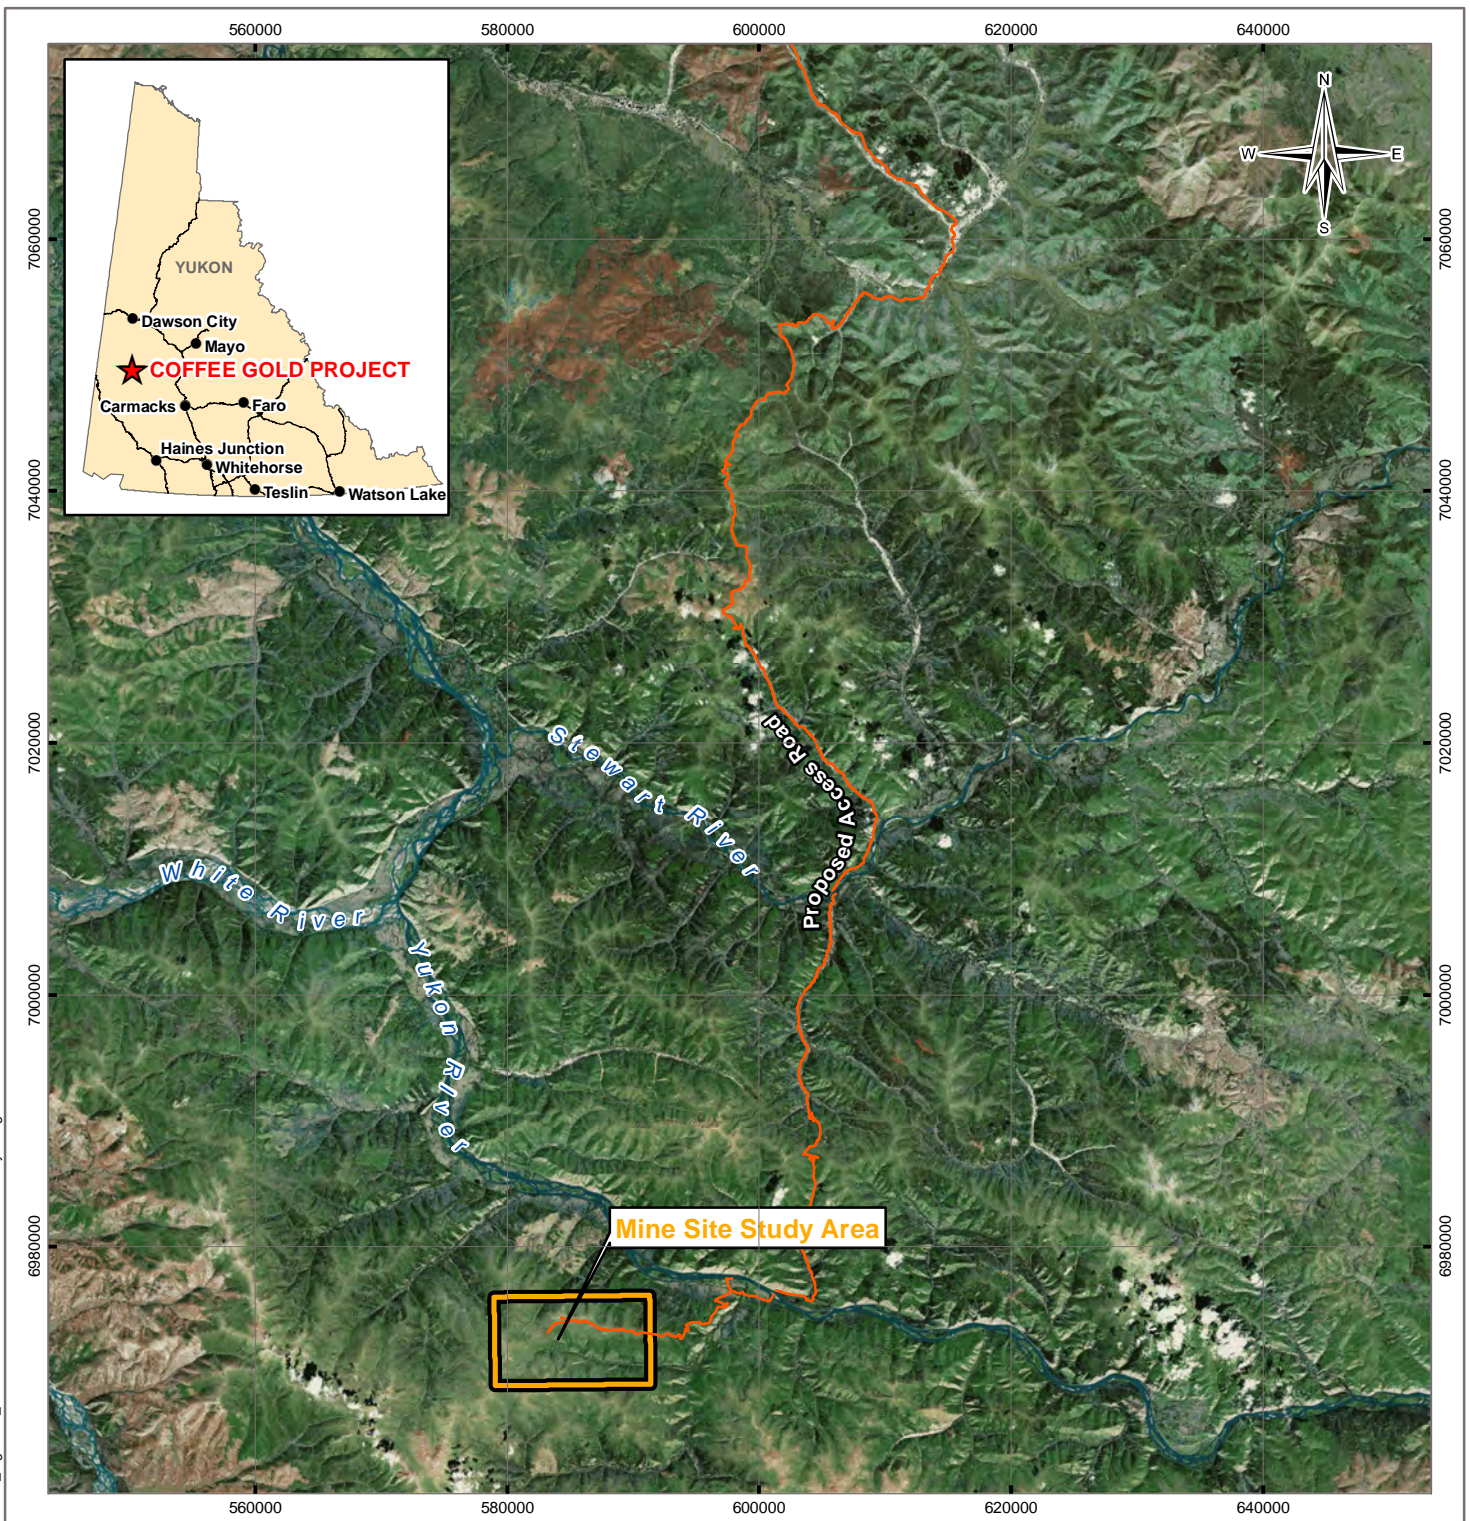
Q:\Vancouver\GIS\ENGINEERING\EARC03004-01\Figure01\_SiteLocation.mxd modified 5/2/2016 by morgana.zondervan

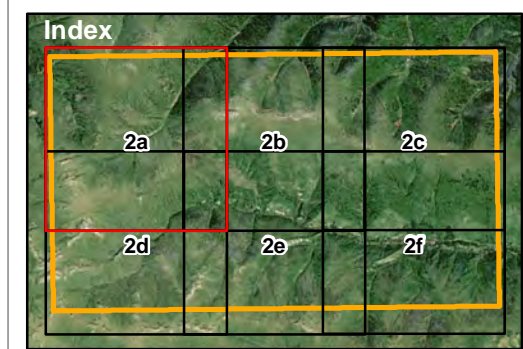
**COFFEE GOLD PROJECT ENVIRONMENTAL BASELINE REPORT**

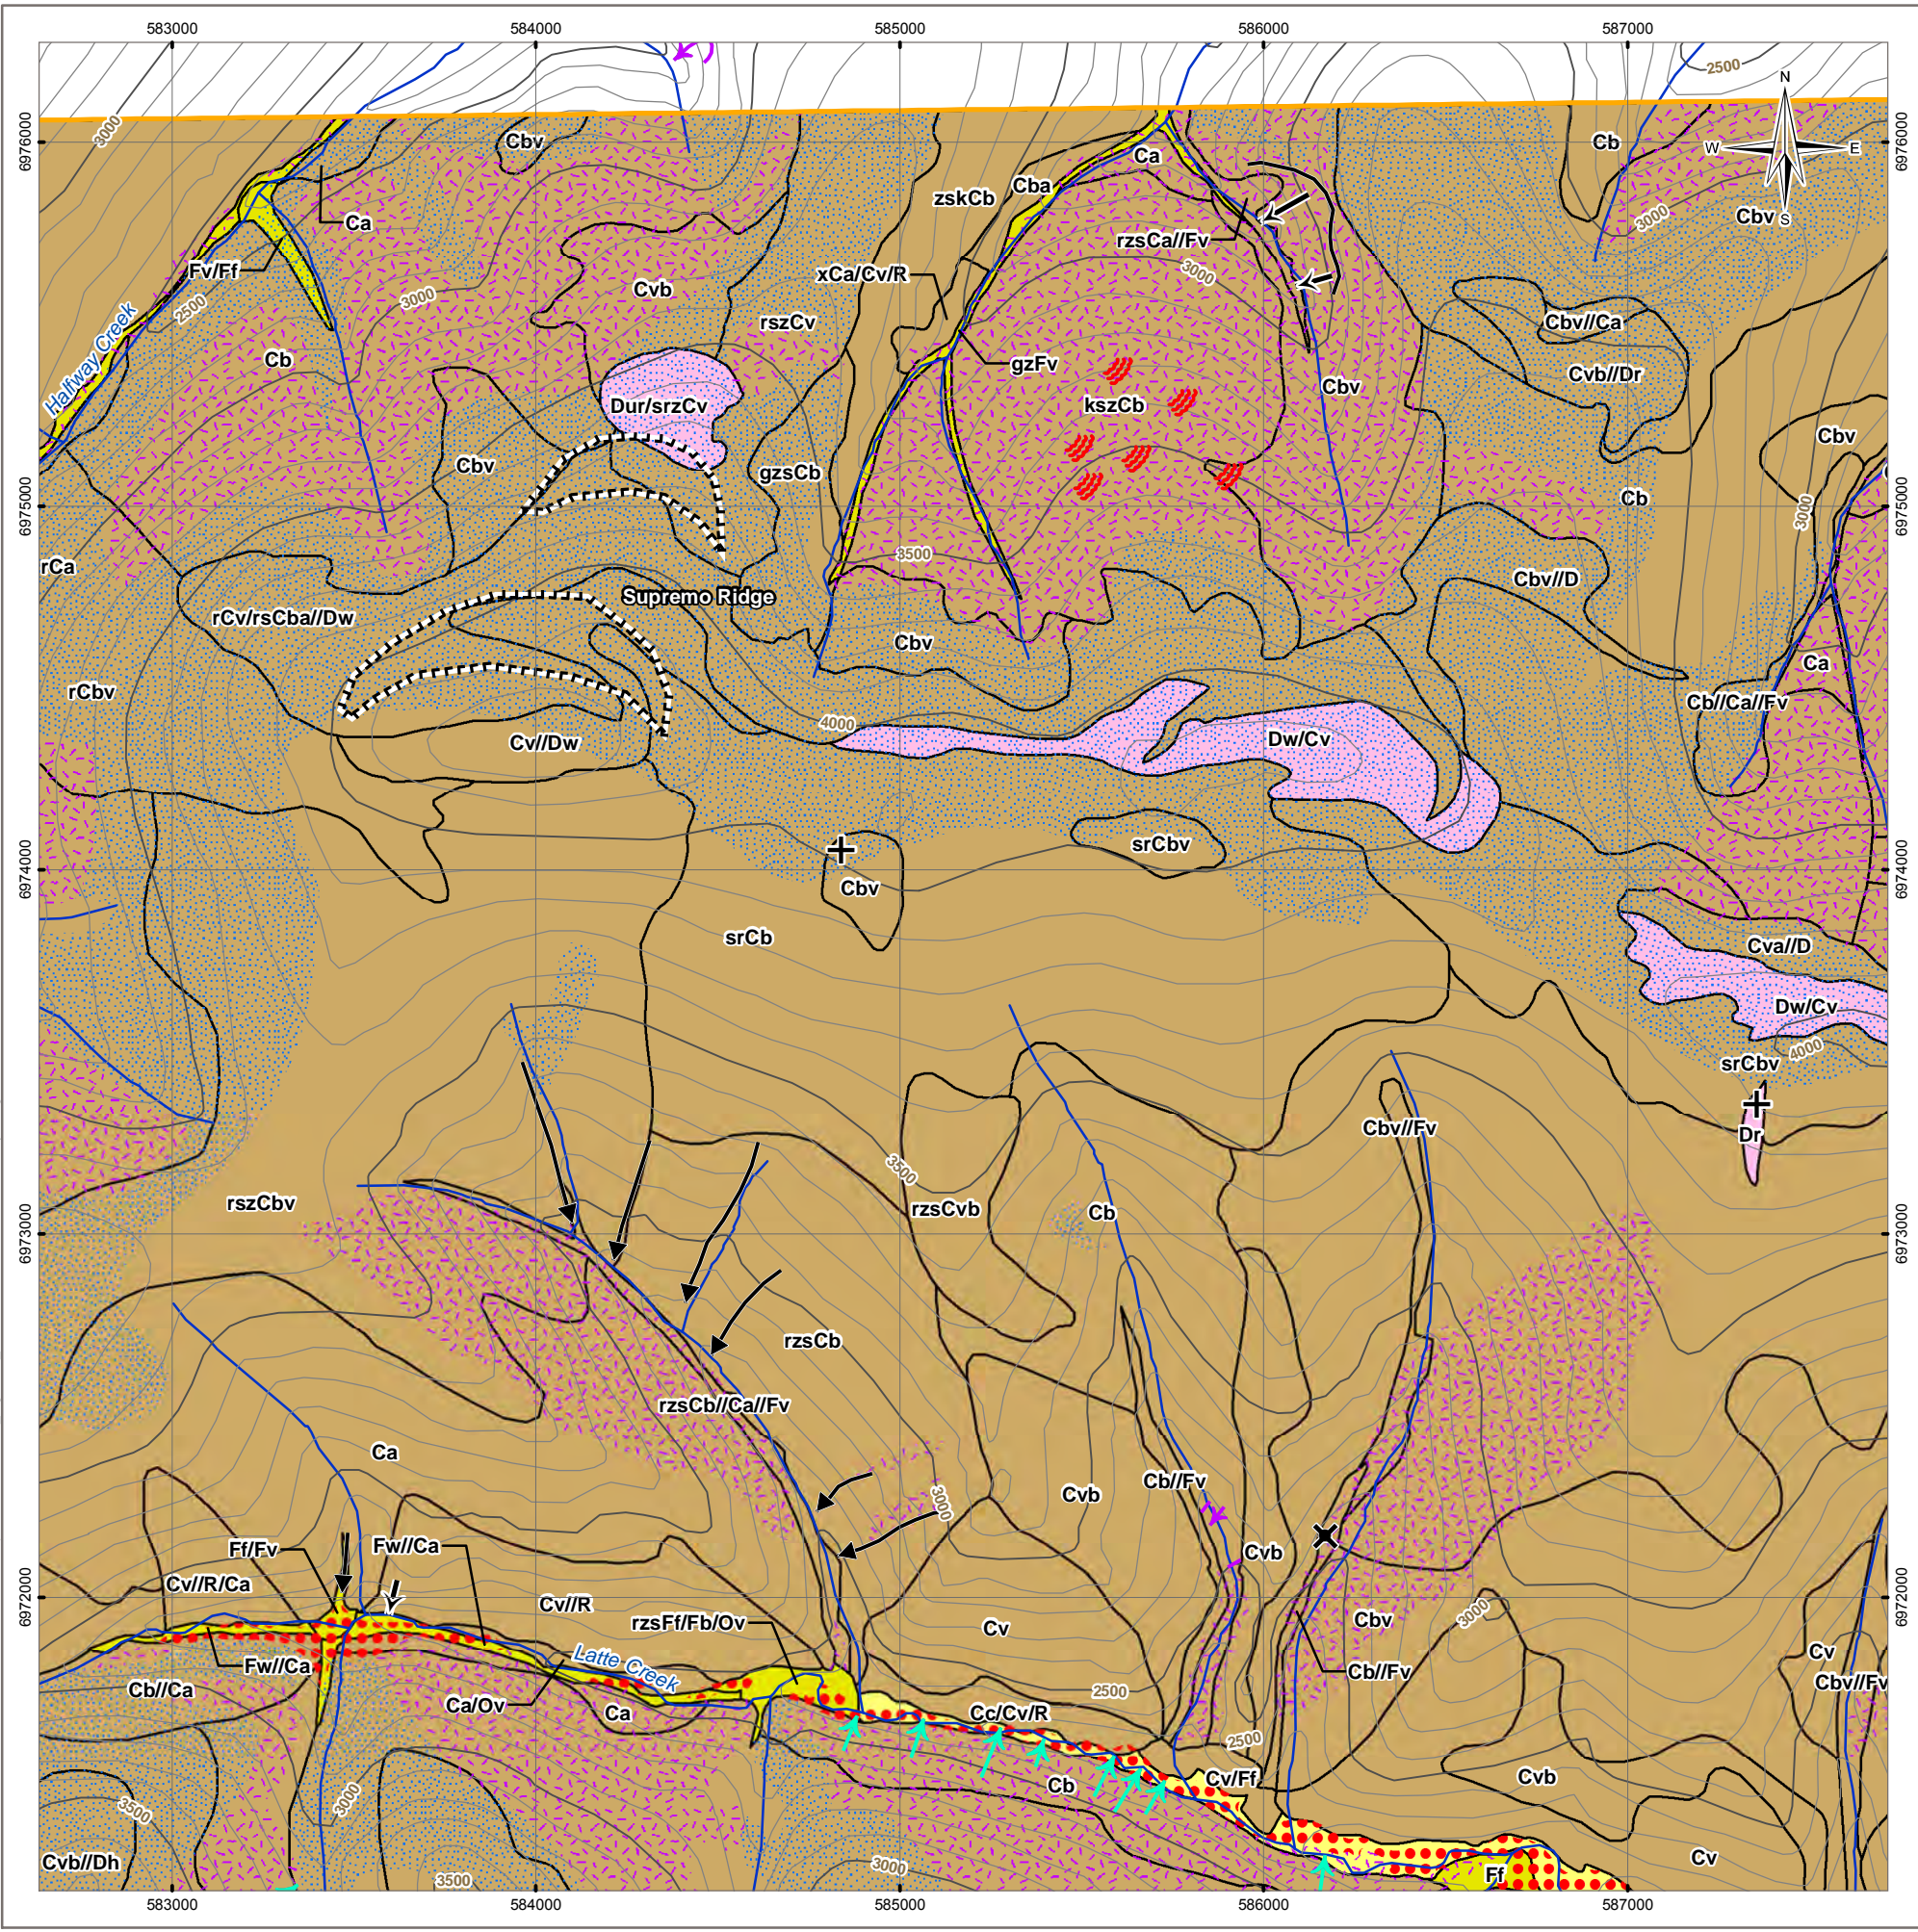
Q:\Vancouver\GIS\ENGINEERING\EARC\03004-01\Maps\EARC03004-01\_Figure02\_SurfGeo.mxd modified 5/2/2016 by morgana.zondervan

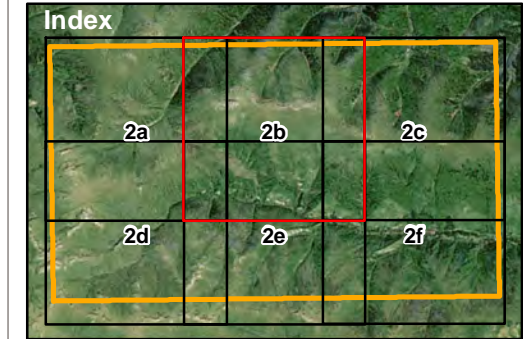
## COFFEE GOLD PROJECT ENVIRONMENTAL BASELINE REPORT

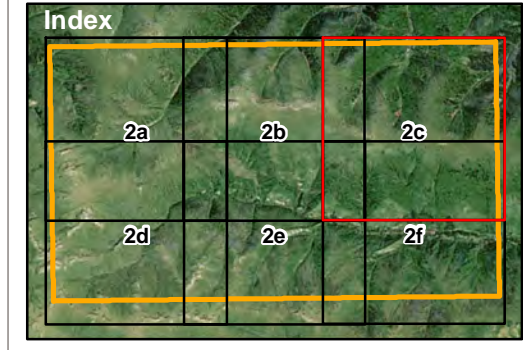
## COFFEE GOLD PROJECT ENVIRONMENTAL BASELINE REPORT

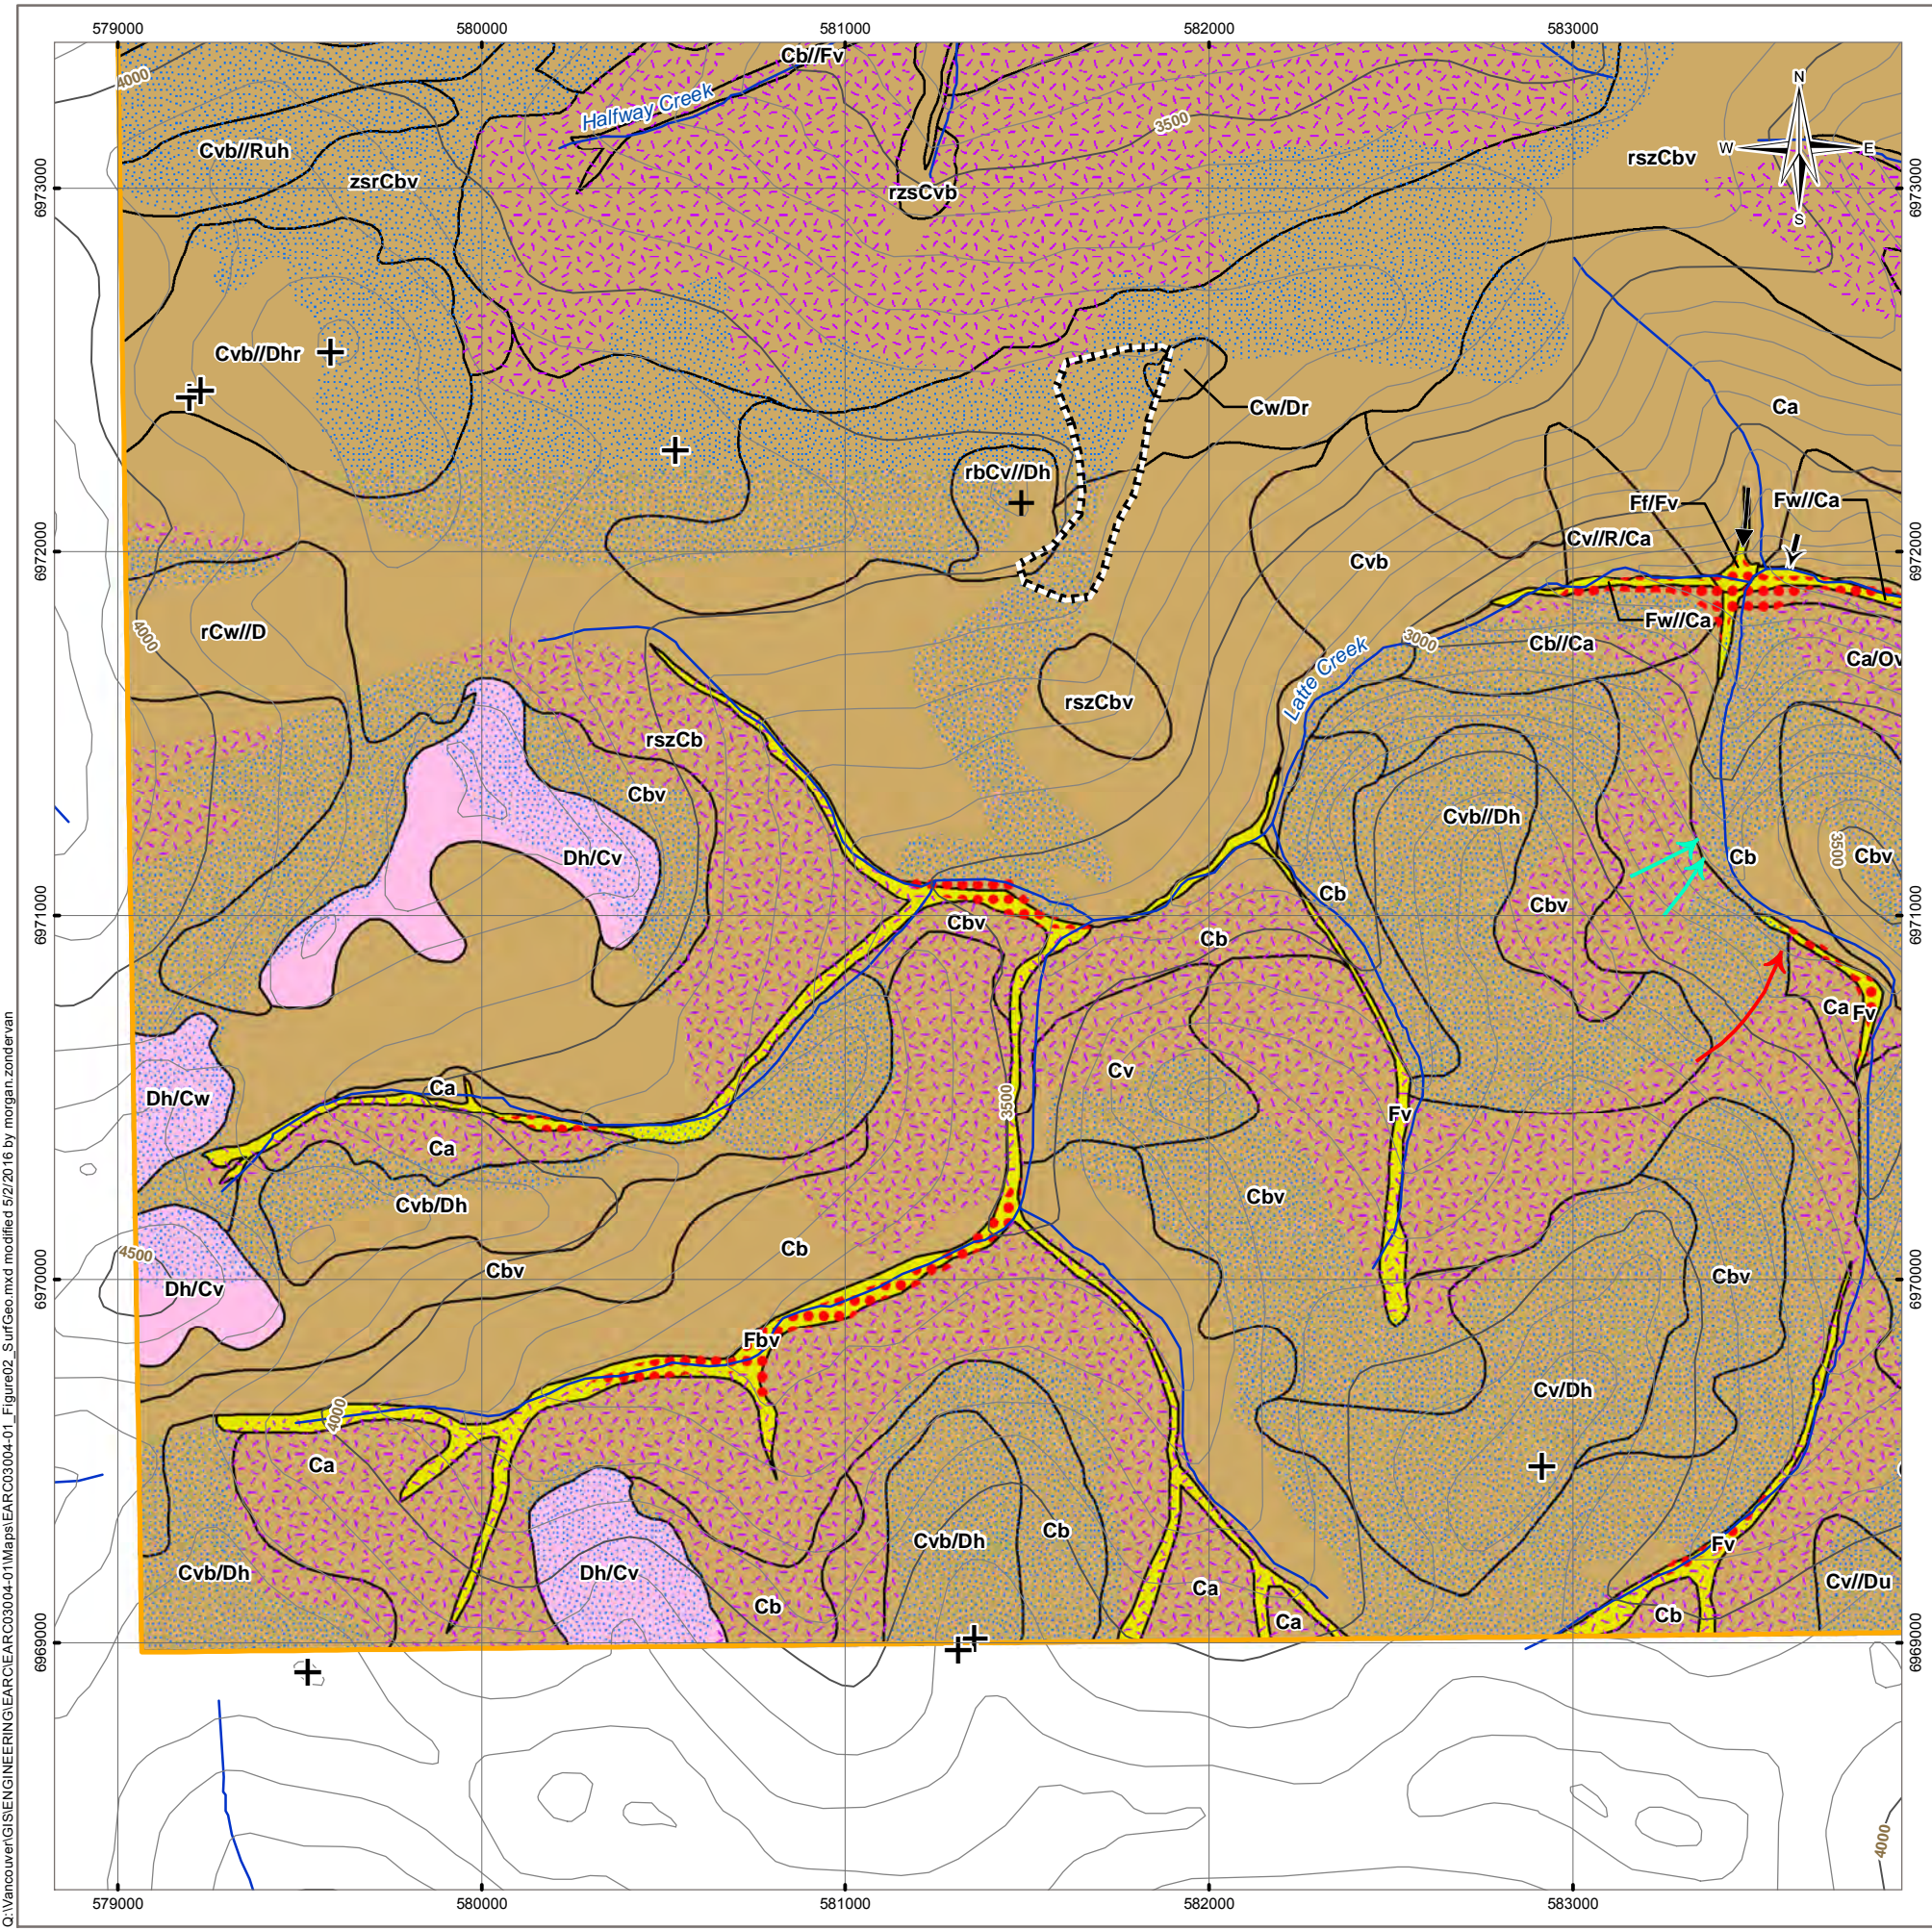
STATUS  
ISSUED FOR USE

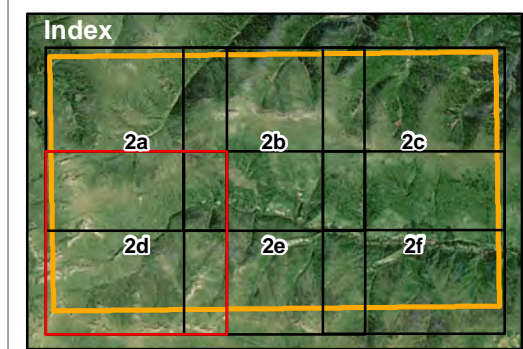
**COFFEE GOLD PROJECT ENVIRONMENTAL BASELINE REPORT**

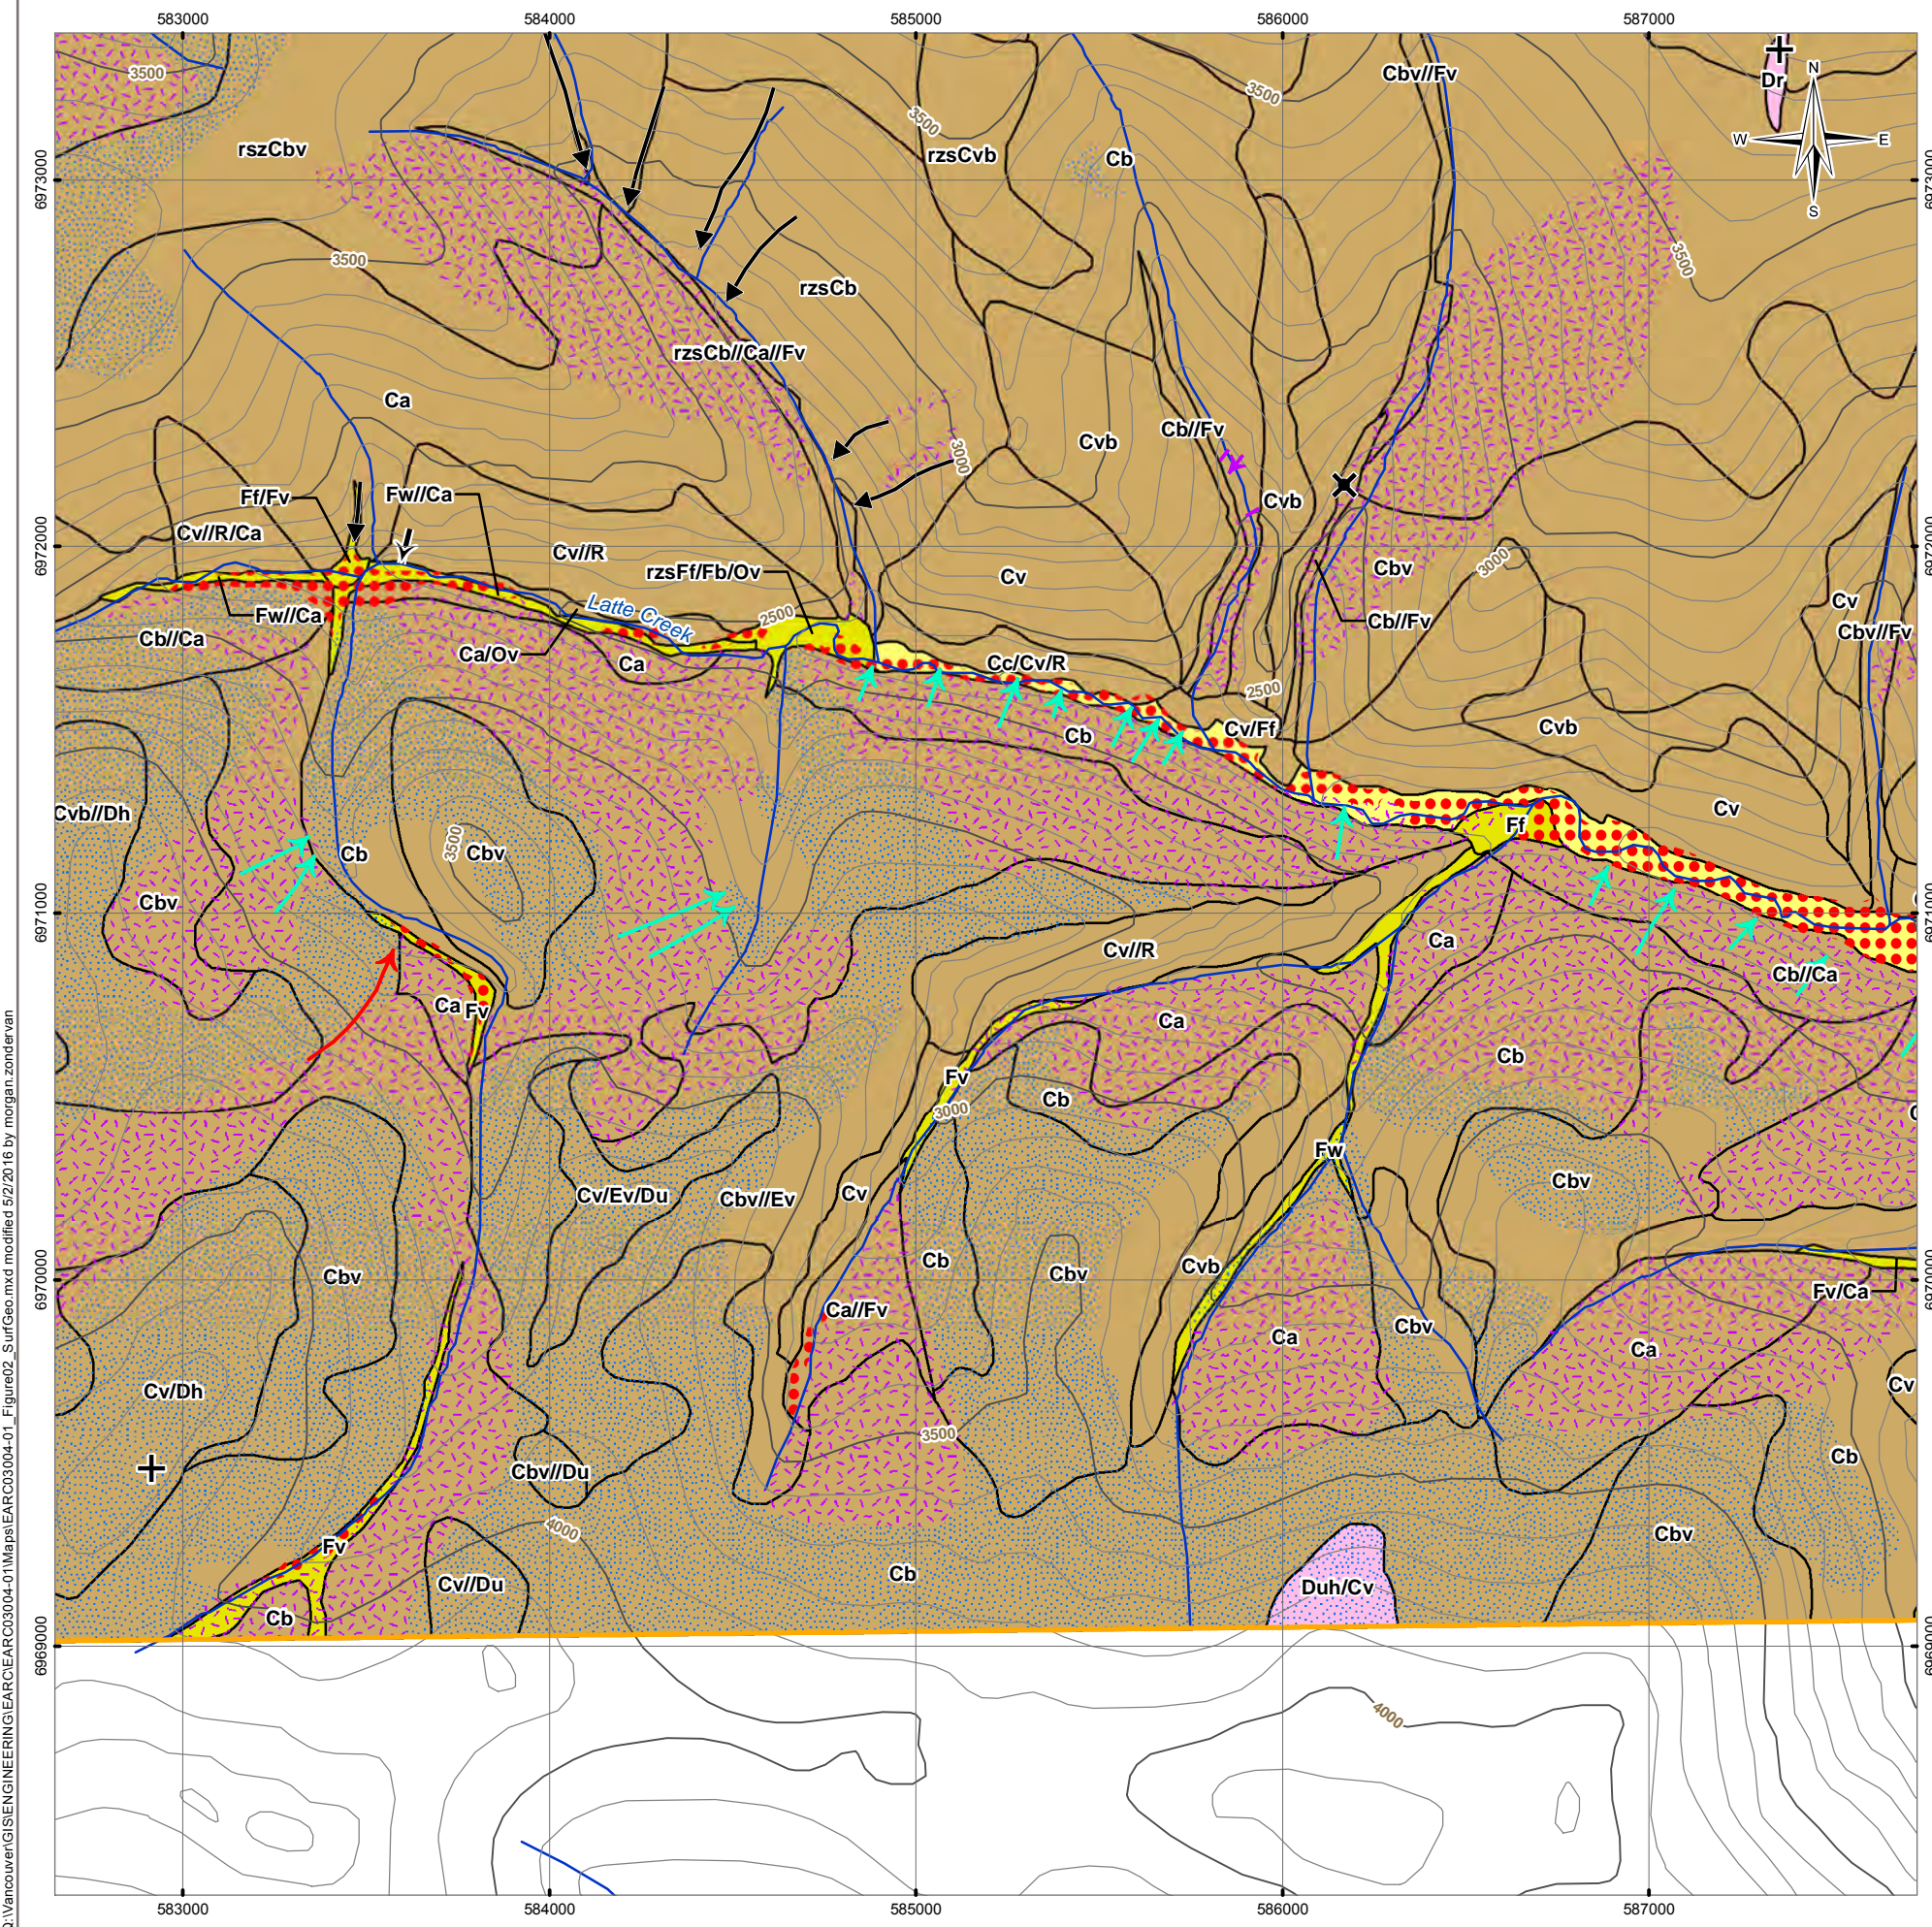
Q:\Vancouver\GIS\ENGINEERING\EARC\03004-01\Maps\EARC03004-01\_Figure02\_SurfGeo.mxd modified 5/2/2016 by morgan.zondervan

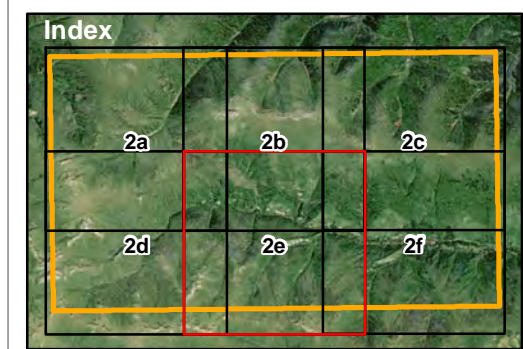
**COFFEE GOLD PROJECT ENVIRONMENTAL BASELINE REPORT**

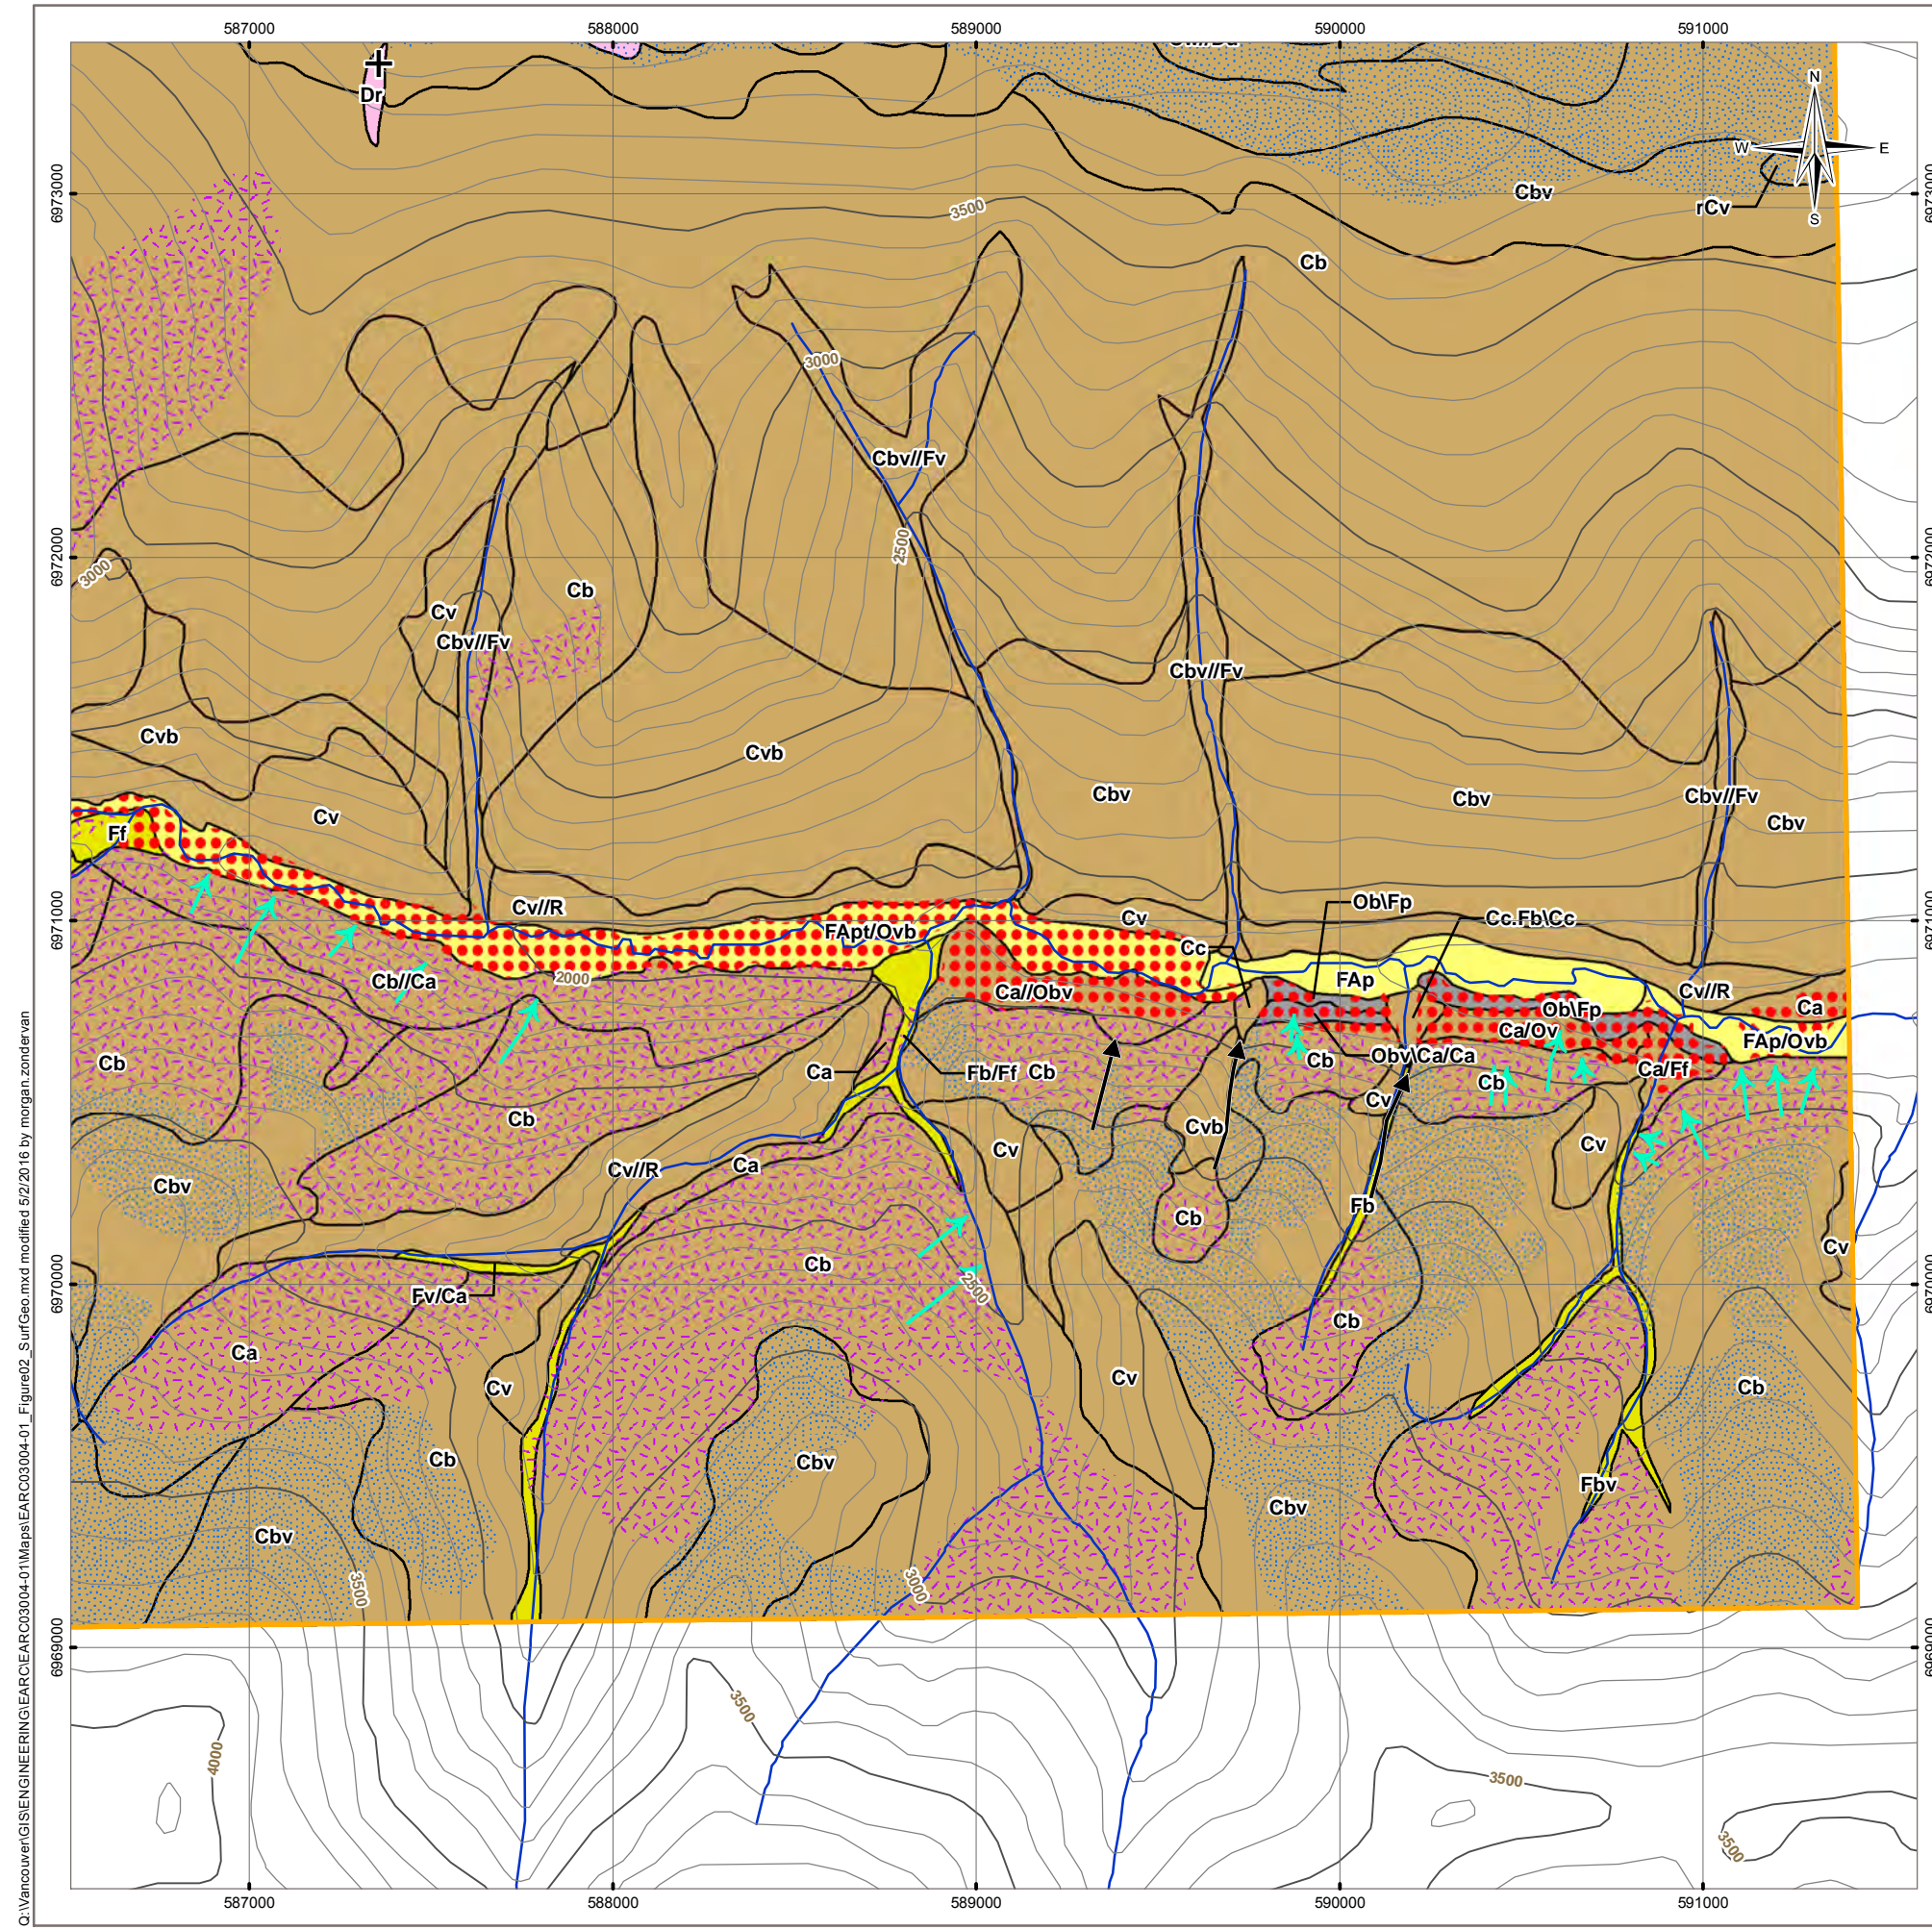
Q:\Vancouver\GIS\ENGINEERING\EARC03004-01\Mapa\EARC03004-01\_Figure02\_SurfGeo.mxd modified 5/2/2016 by morgana.zondervan

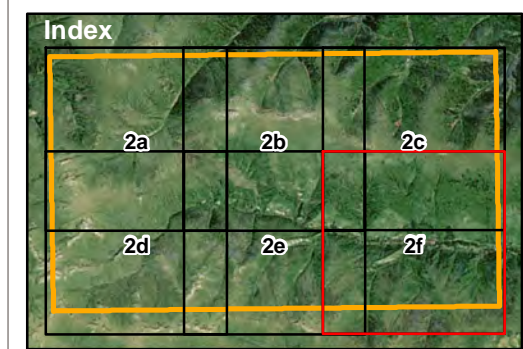
## COFFEE GOLD PROJECT ENVIRONMENTAL BASELINE REPORT
