**APPENDIX 11-A**  
**Surficial Geology, Permafrost,**  
**and Terrain Stability**

TETRA TECH EBA

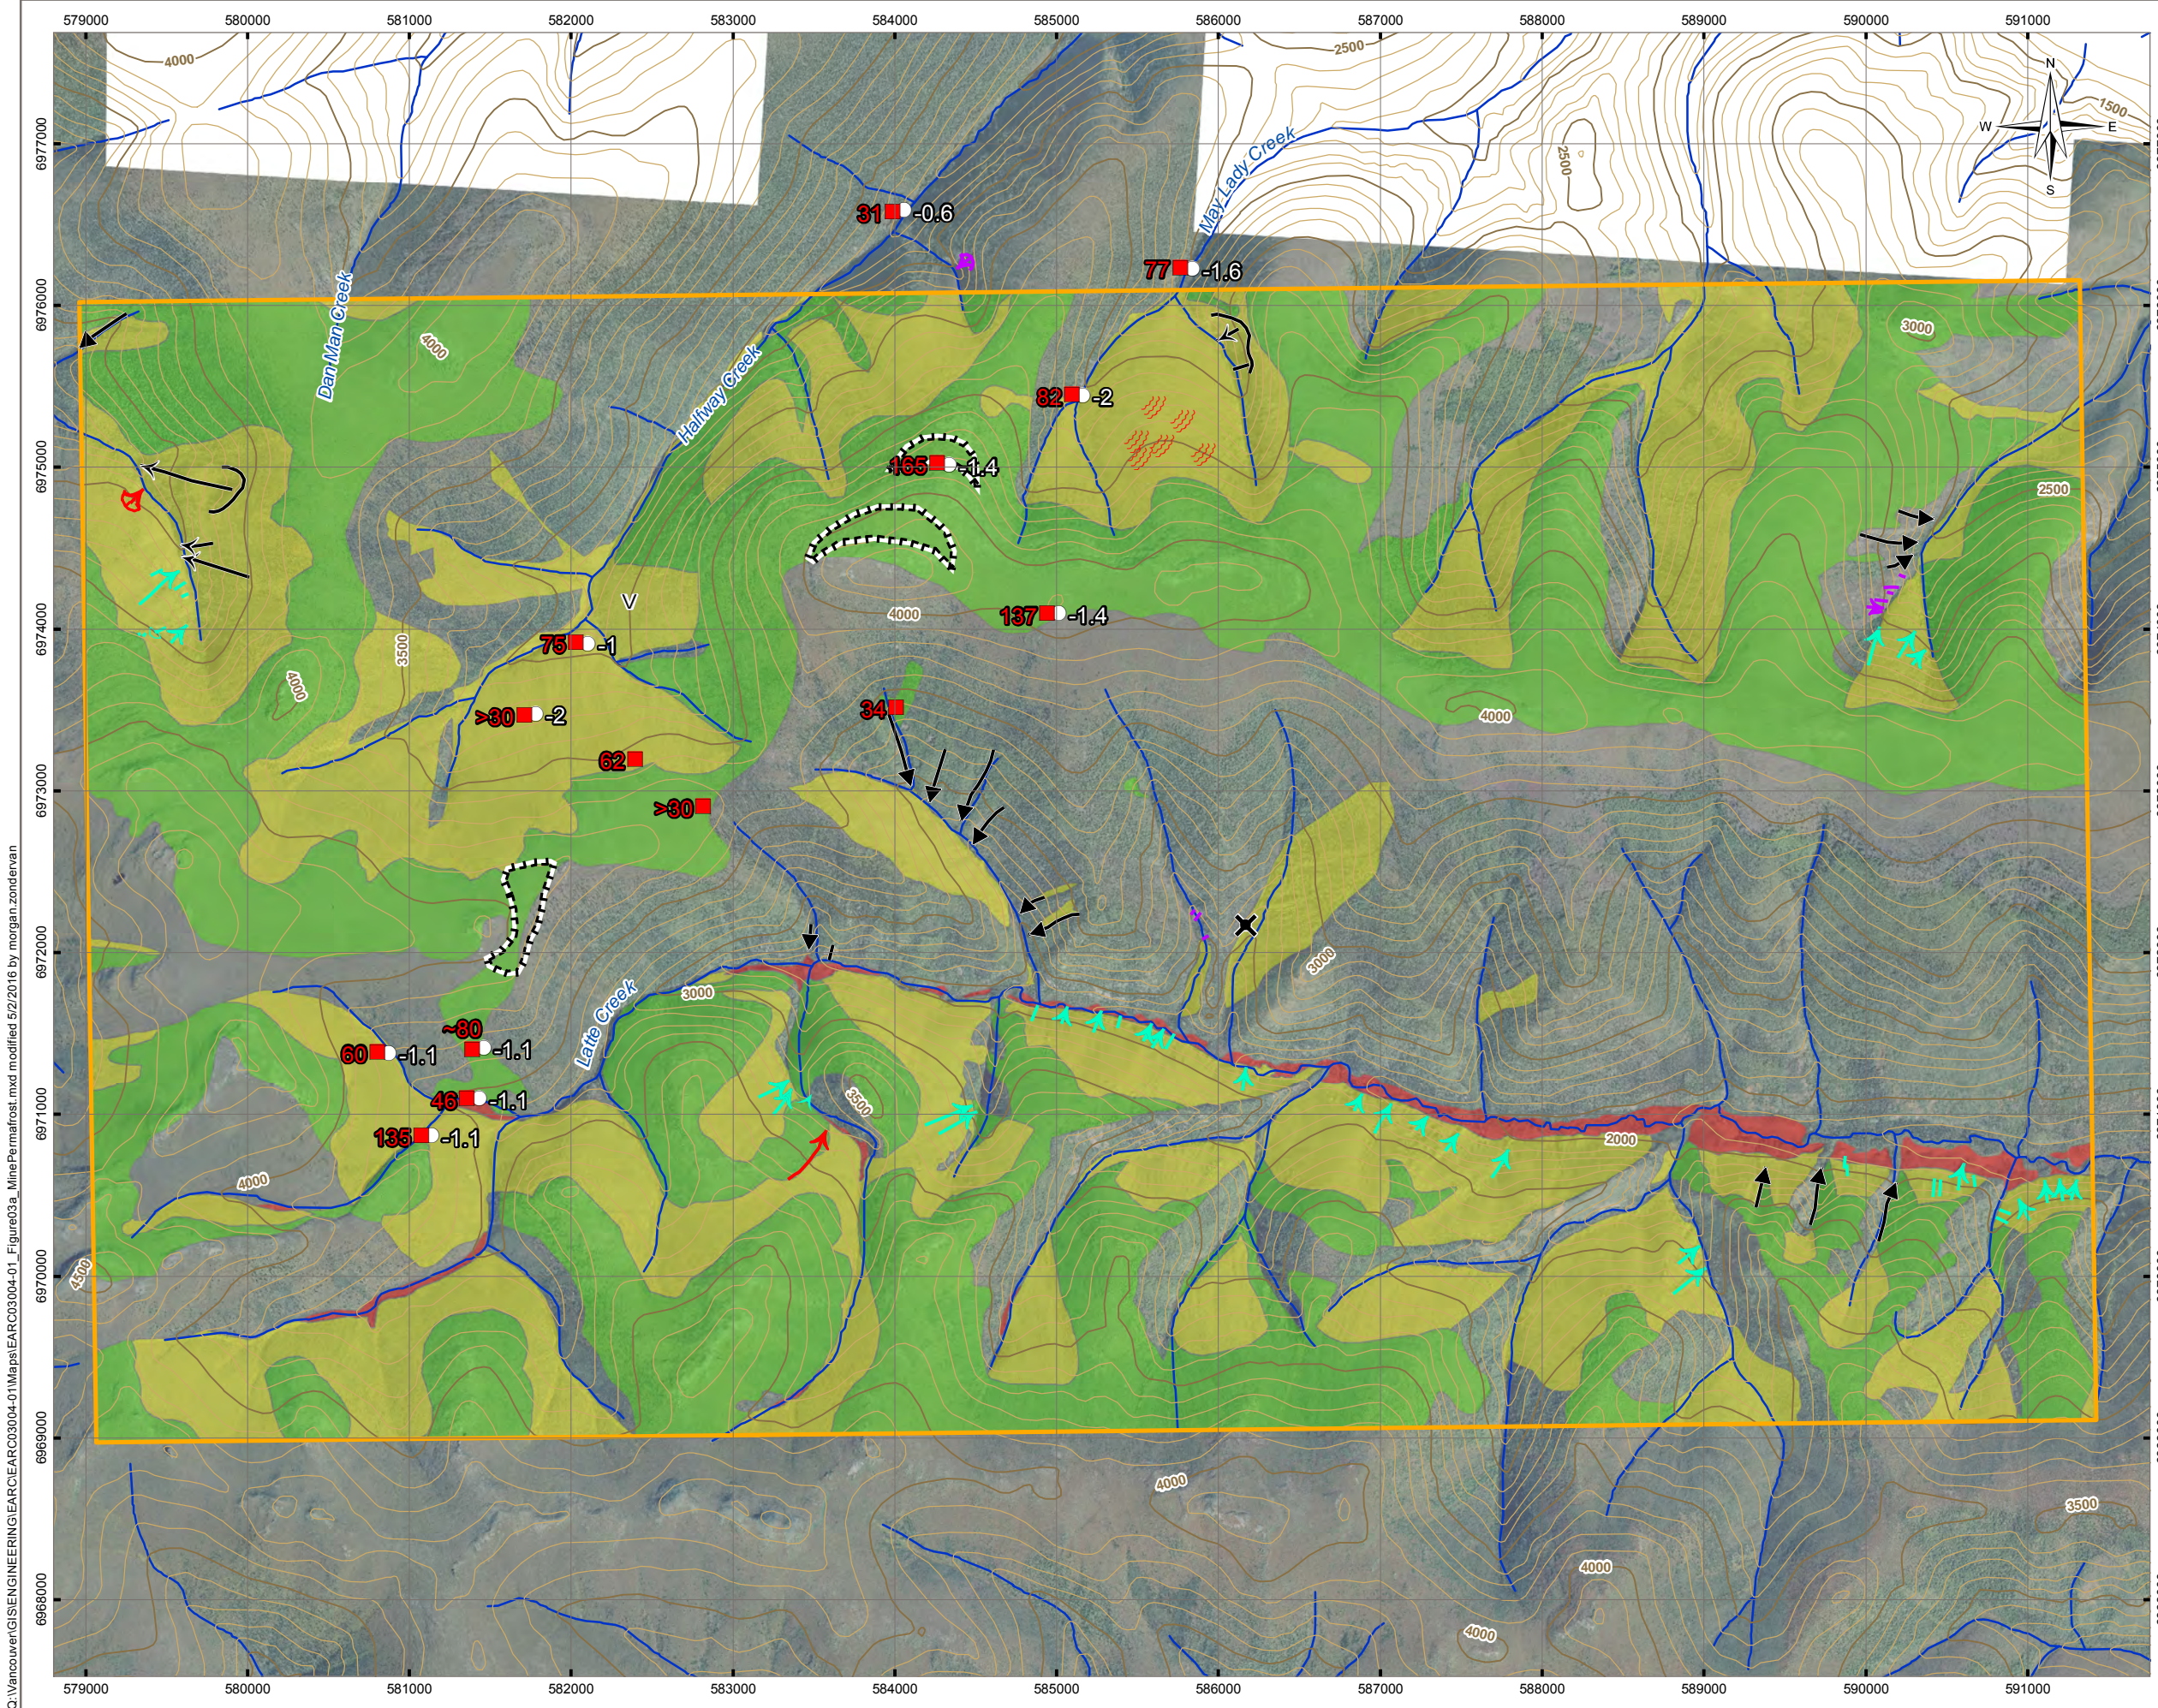
Q:\Vancouver\GIS\ENGINEERING\EARC\03004-01\Maps\EARC03004-01\_Figure02\_SurfGeo.mxd modified 5/2/2016 by morgana.zondervan

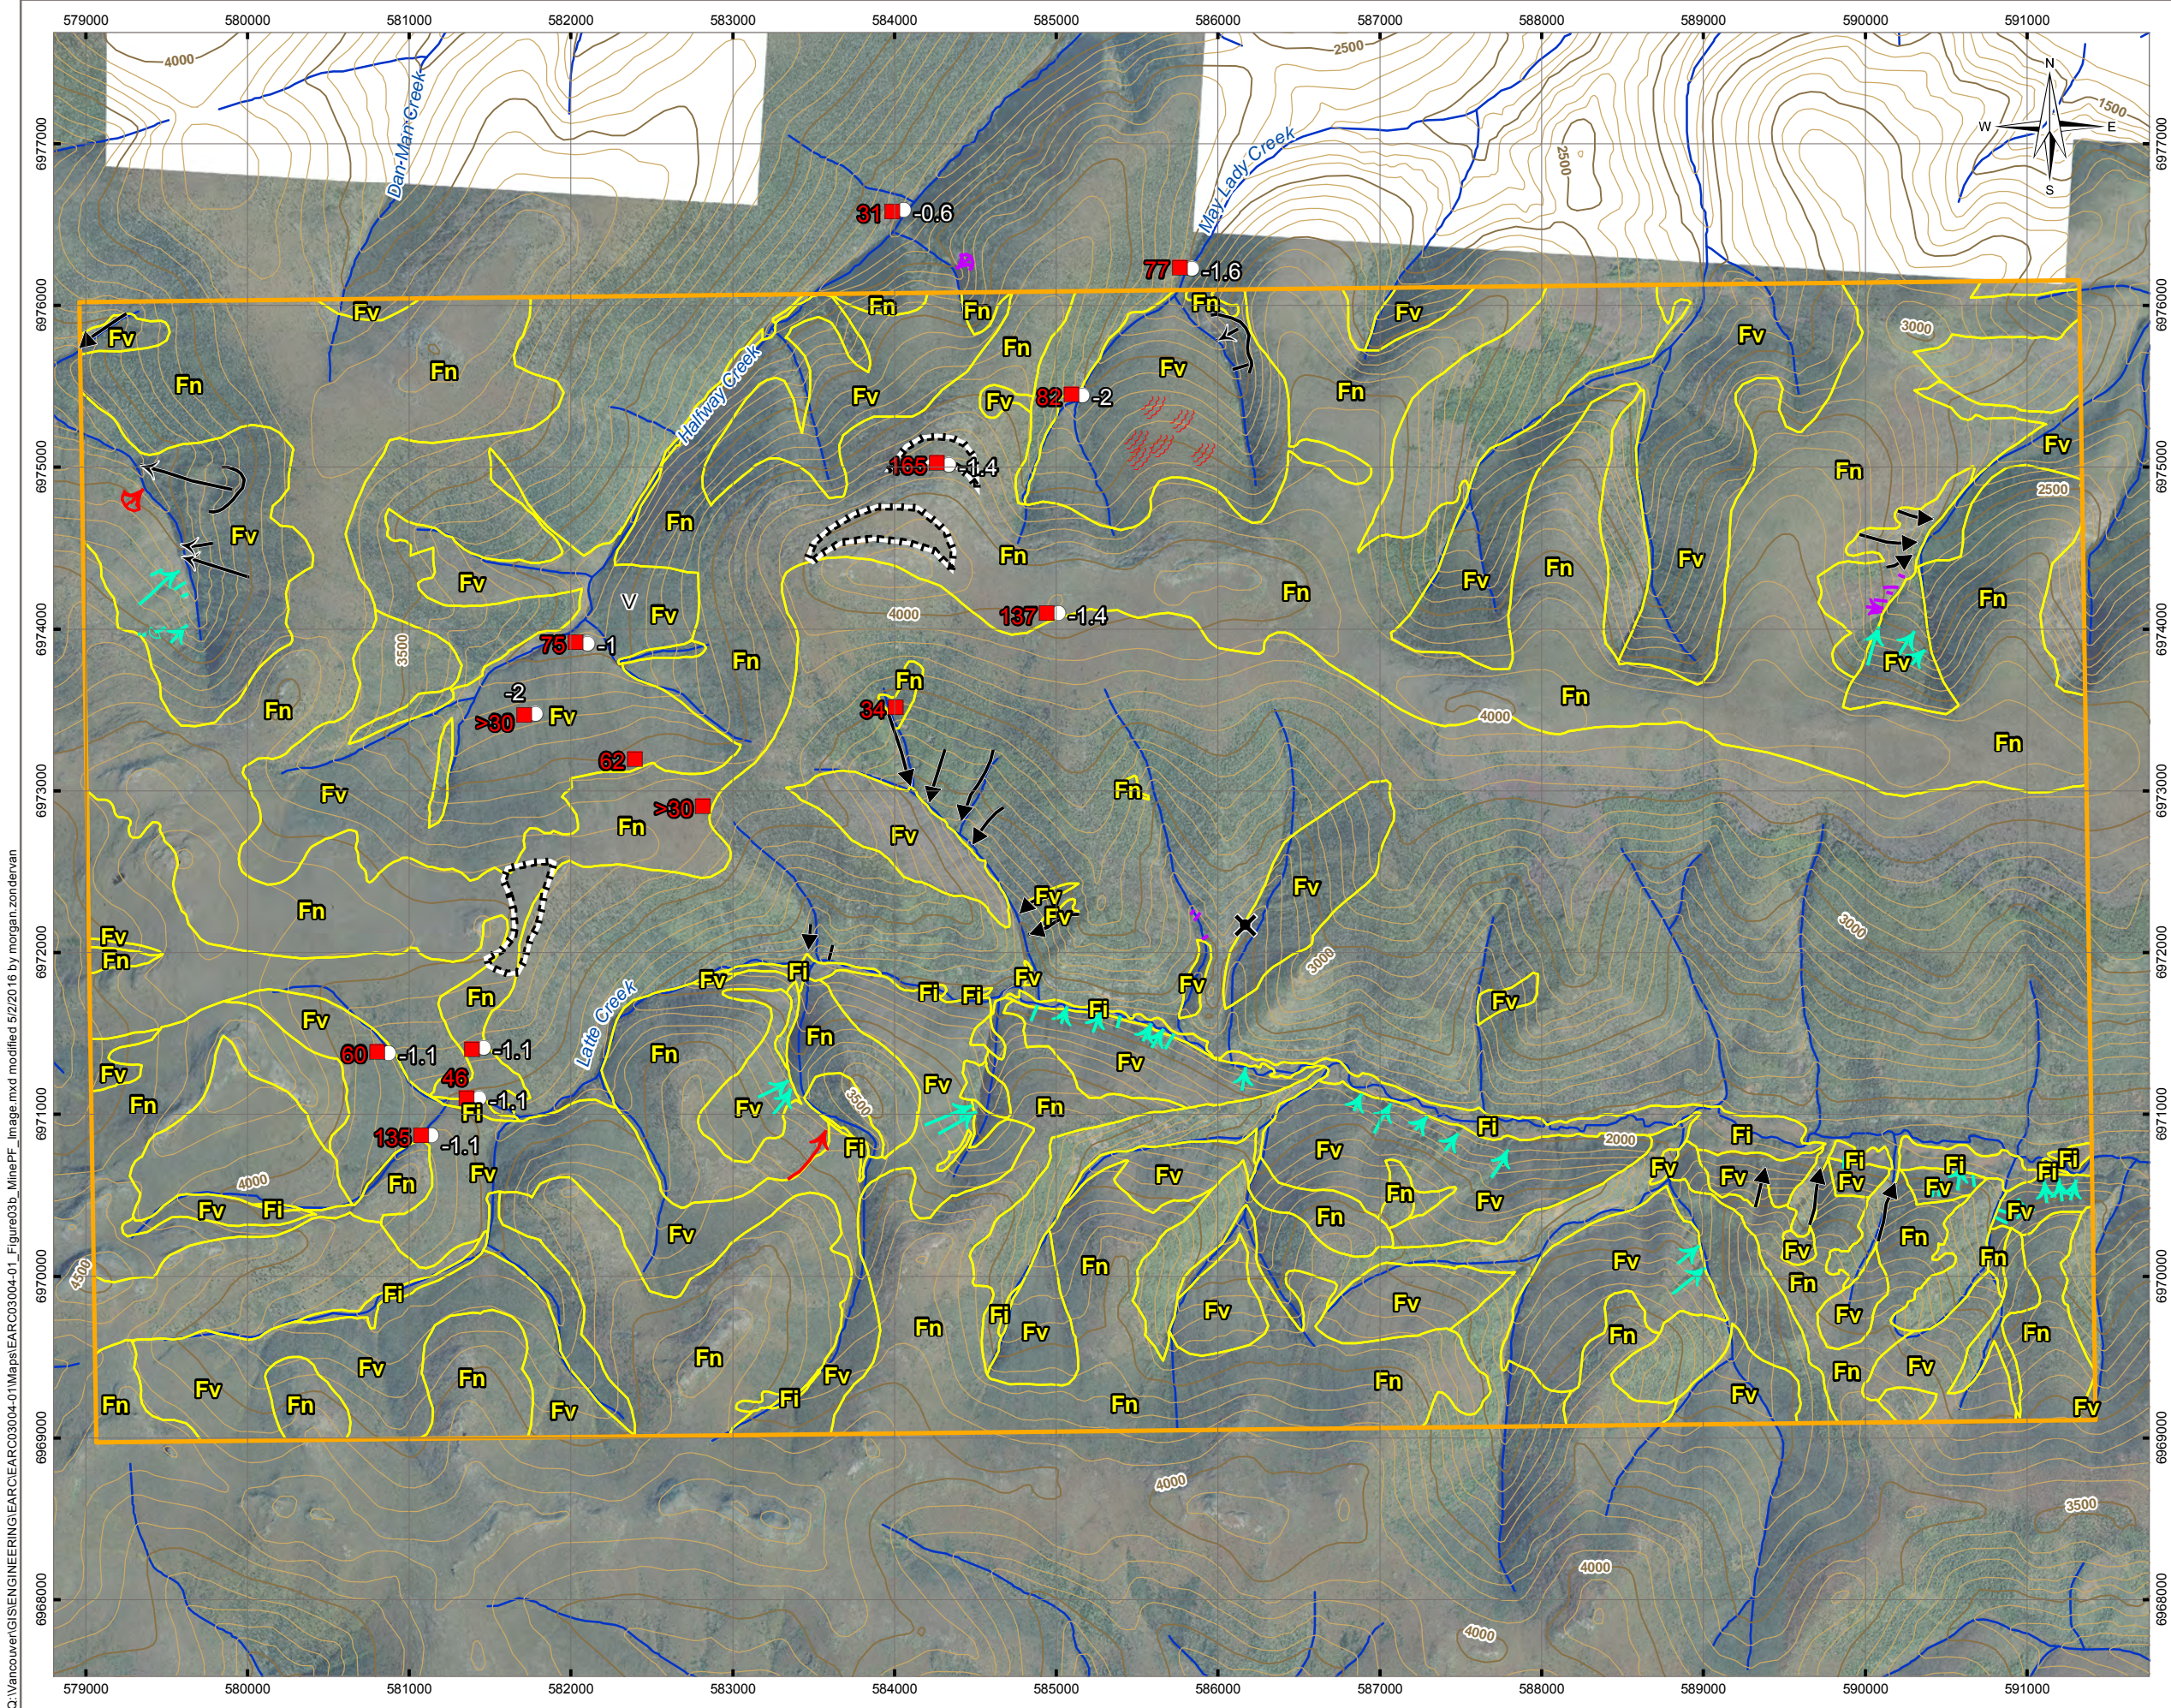
Q:\Vancouver\GIS\ENGINEERING\EARC03004-01\Mapa\EARC03004-01\_Figure03a\_MinePermafrost.mxd modified 5/2/2016 by morgah.zondervan

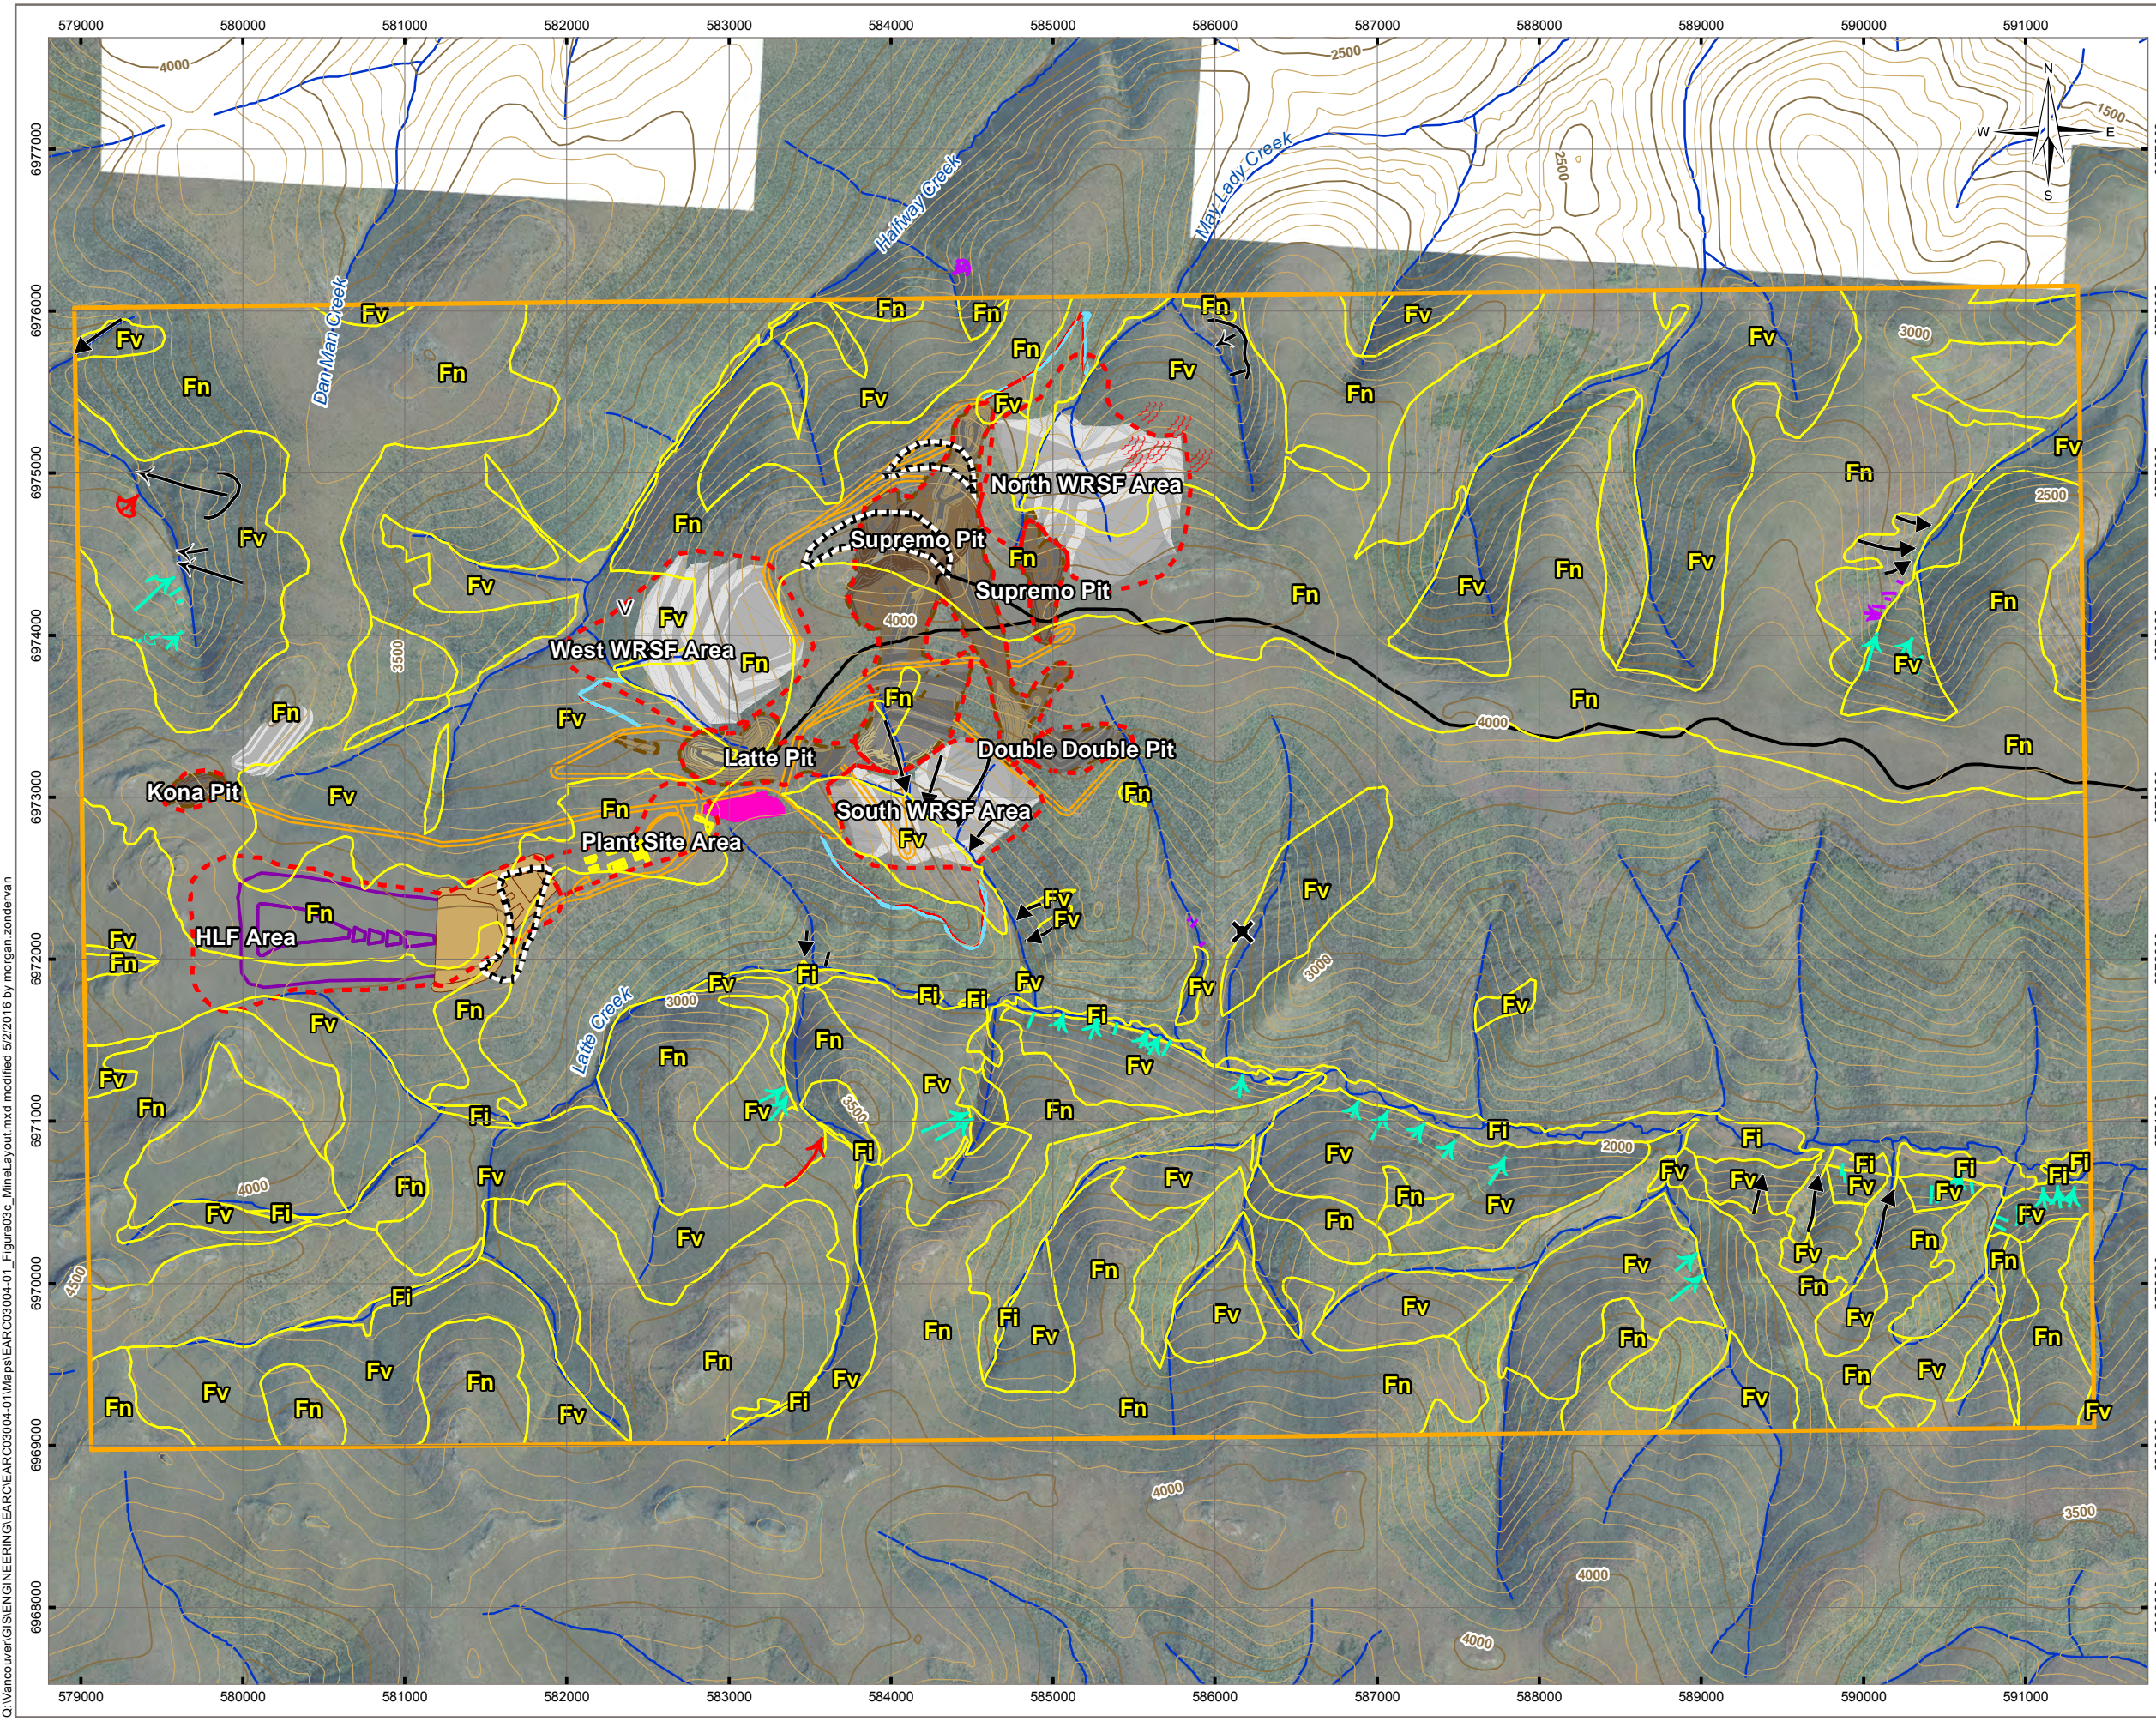
Q:\Vancouver\GIS\ENGINEERING\EARC\03004-01\Maps\EARC03004-01\_Figure03b\_MinePF\_Image.mxd modified 5/2/2016 by morgan.zondervan

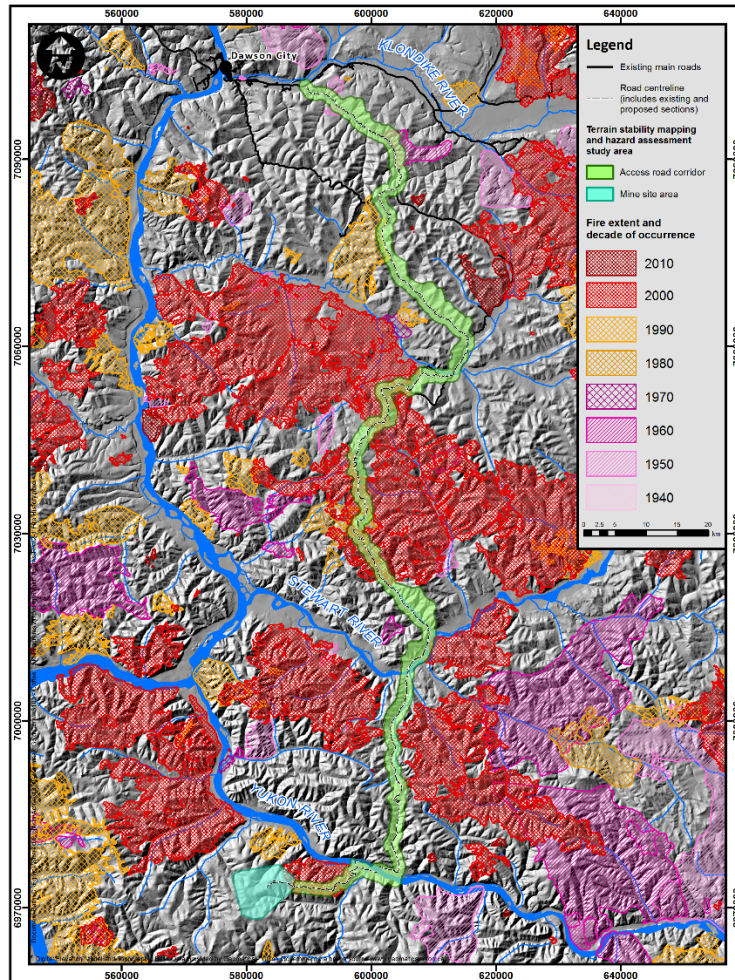
Figure 2-1. Fire history in the region encompassing the study area

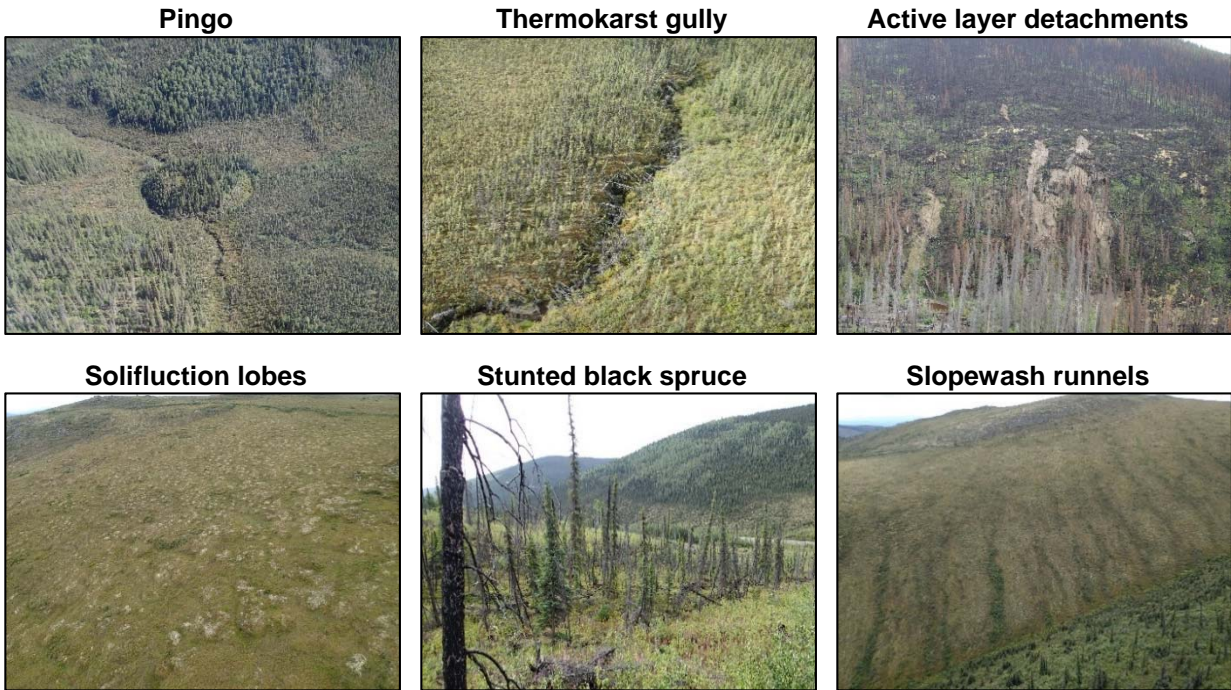
**Figure 2-4. Example of features indicative of permafrost in the study area**

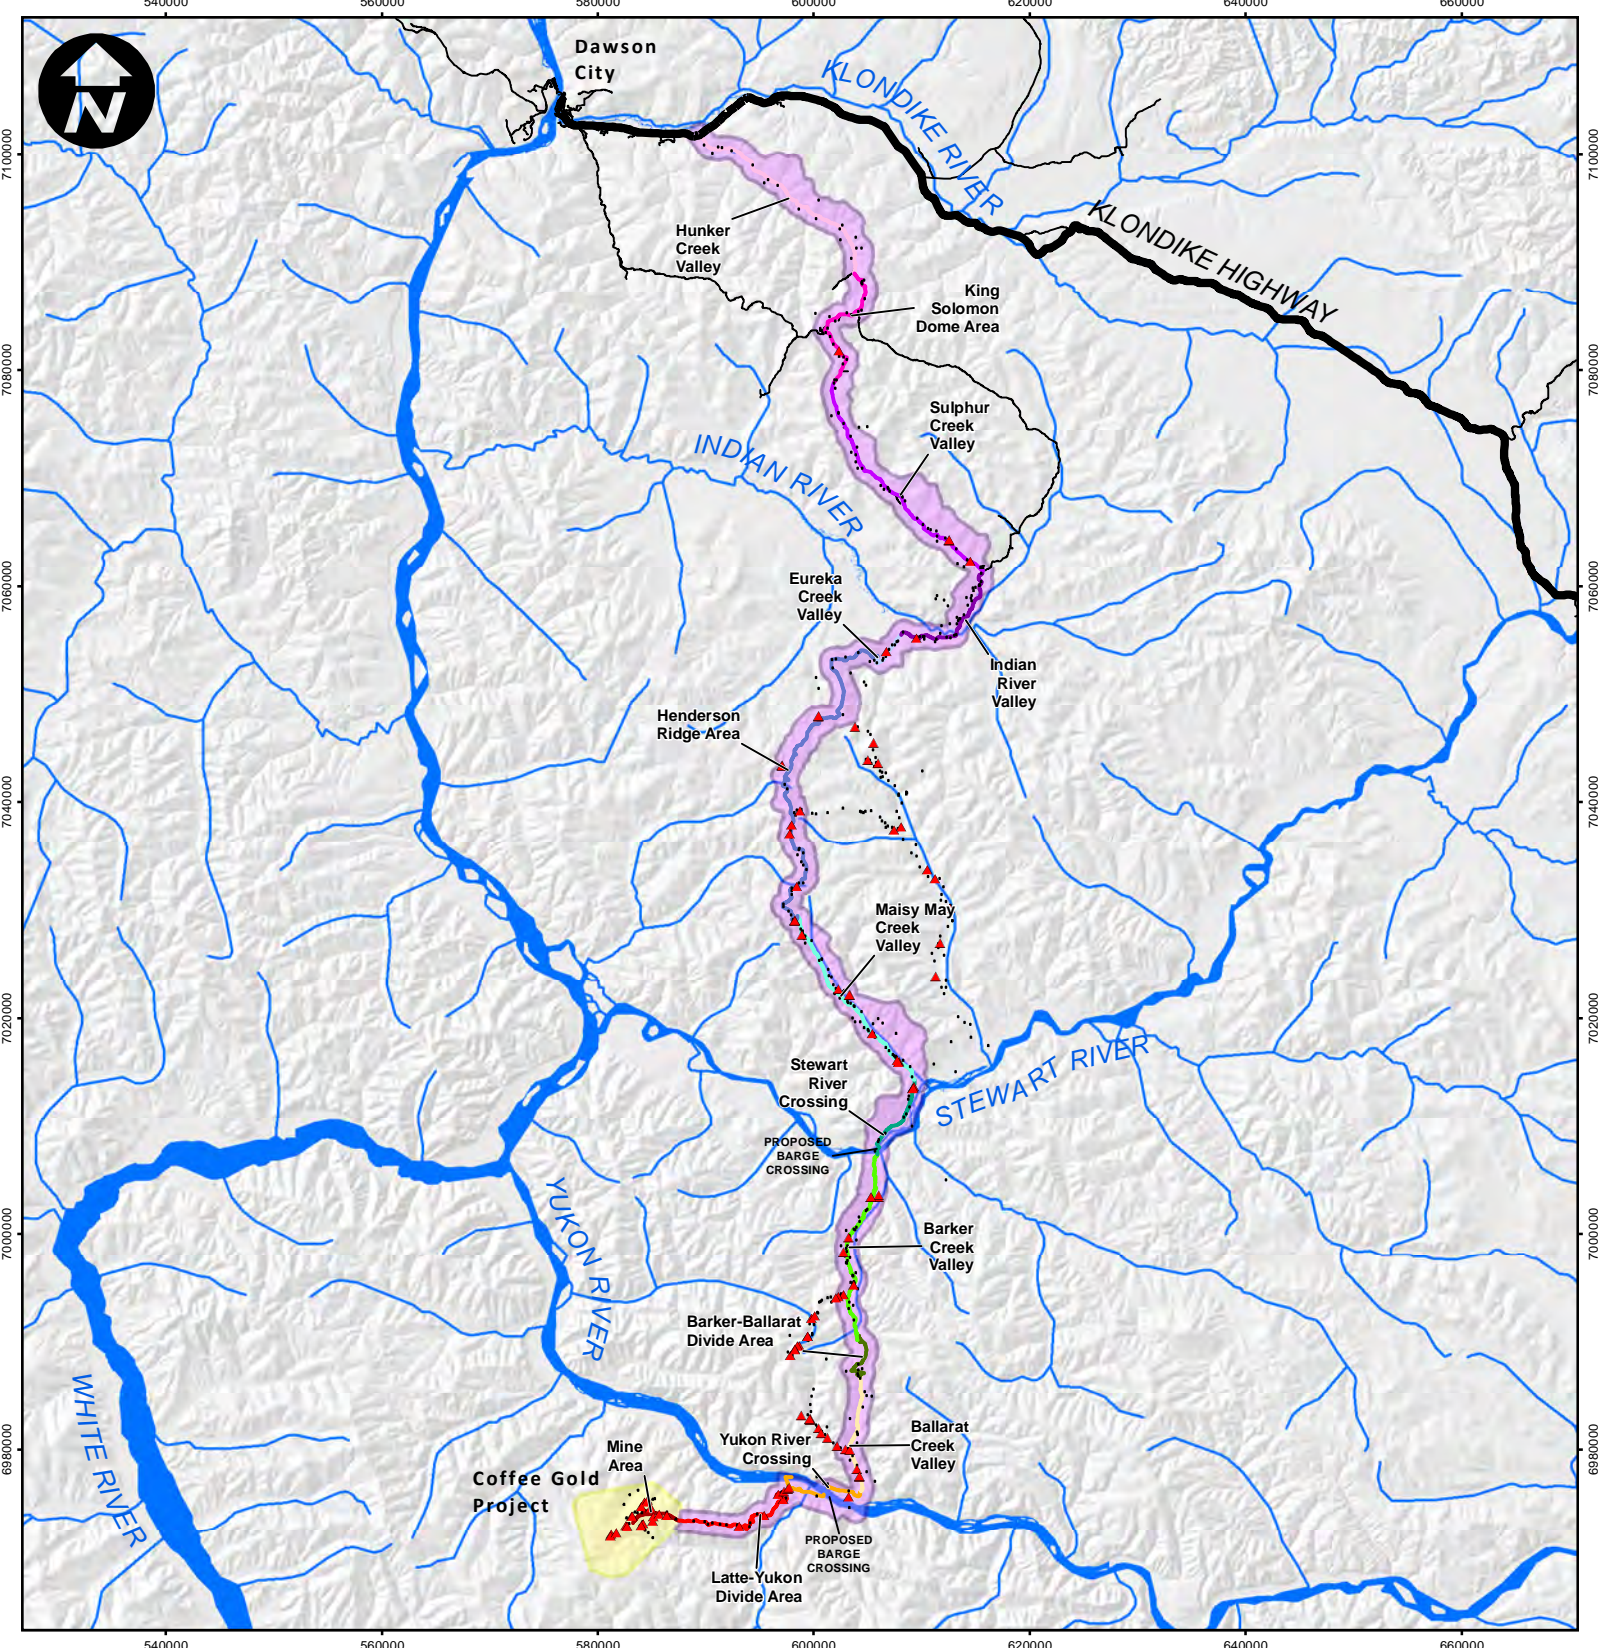
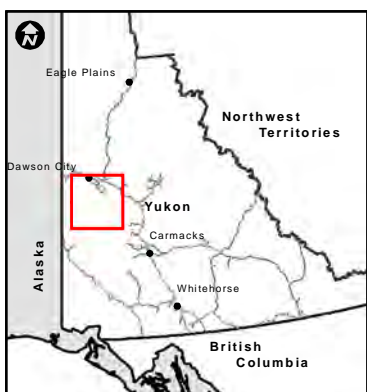
Morphology and geotechnique of active-layer detachment failures in discontinuous and continuous permafrost, northern Canada			Lewkowicz and Harris, 2005	
	Active layer detachments following the summer 2004 forest fires near Dawson City, Yukon			Lipovsky et al., 2006	
	Significant Canadian Earthquakes of the Period 1600–2006			Lamontagne et al., 2007	
	A permafrost probability model for the southern Yukon and northern British Columbia, Canada			Bonnaventure et al., 2012	
	Property-scale classification of surficial geology for soil geochemical sampling in the unglaciated Klondike Plateau, west-central Yukon			McKillop et al., 2013	
Field Data	Type	Collector	Date	Project	
	Permafrost and soil data	TT-EBA	2016	Coffee Gold Project permafrost distribution and permafrost-related geohazard mapping	
	Permafrost and soil data	AECOM	2012	Coffee Gold Project geomorphological mapping study

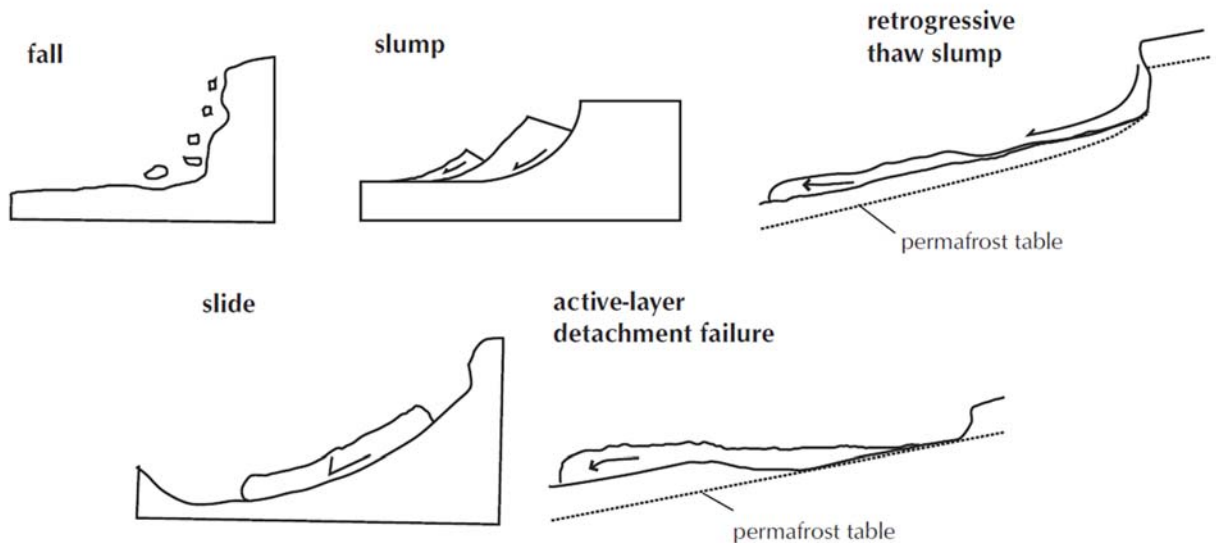
Note: Excludes rock creep, which is generally considered separately from landslides. Retrogressive thaw slump also known as retrogressive thaw flow.

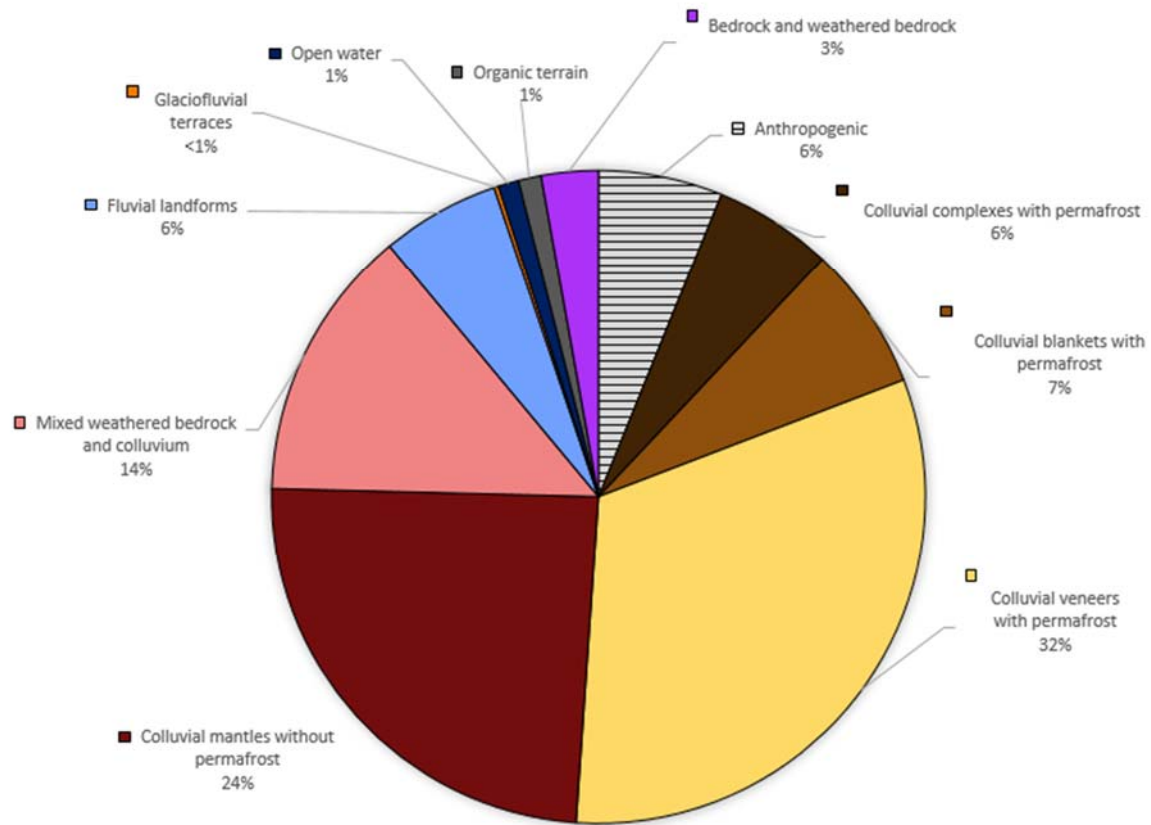
Figure 4-1. Areal proportion (%) of terrain units within the study area

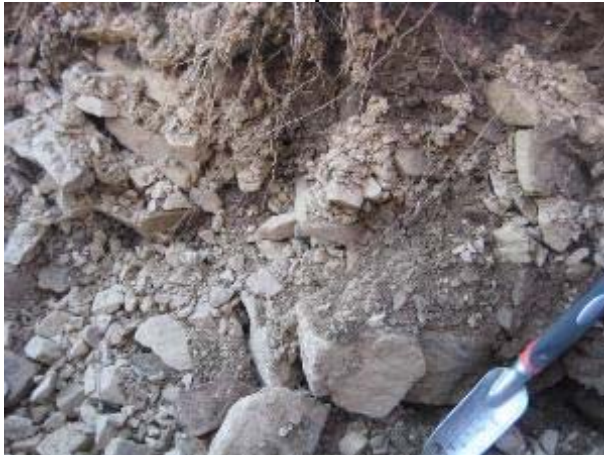
<p>General distribution</p>	<p>Summits; ridges and spurs; over-steepened valley sides</p>
	<p>Common terrain units</p>	<p>zsdV/Rh Rs/zsdV-R"bV</p>
	<p>Dominant processes</p>	<p><i>In-situ</i> weathering; rockfall; gullyng; cryoplanation; nivation</p>
	<p>Drainage range</p>	<p>Well to rapid</p>
	<p>Dominant slope range</p>	<p>Gentle to steep</p>
	<p>Permafrost</p>	<p>Deep and ice-poor on northerly aspects; ice-moderate within saddles</p>
	<p>Other characteristics</p>	<p>Tors and outcrop may be present; variable aspect and slopes</p>
	<p>Hazard considerations</p>	<p>Localized rockfall; thermokarst subsidence in saddles</p>

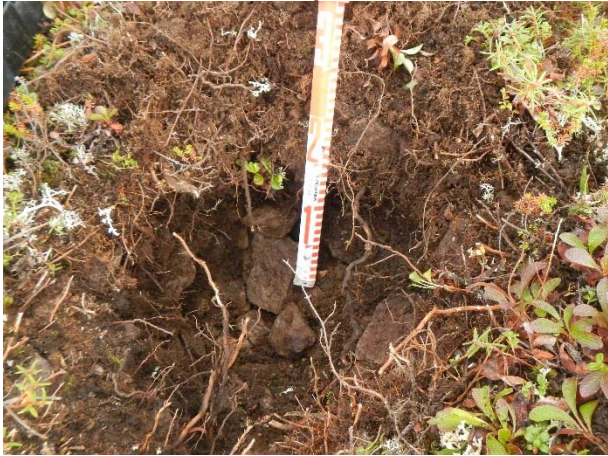
<p>General distribution</p>	<p>Heavily weathered ridgetops; ridge and spur shoulders</p>
	<p>Common terrain units</p>	<p>zxDv/szxCv szxCv/zsxDv-Fg</p>
	<p>Dominant processes</p>	<p><i>In-situ</i> weathering; soil/rock creep</p>
	<p>Drainage range</p>	<p>Imperfect to well</p>
	<p>Dominant slope range</p>	<p>Gentle to moderate</p>
	<p>Permafrost</p>	<p>Deep and ice-poor where dominantly D; shallow where dominantly C</p>
	<p>Other characteristics</p>	<p>Smooth convex slopes; scrub vegetation; may contain knickpoints</p>
	<p>Hazard considerations</p>	<p>Soil/rock creep; active layer detachments possible where silty colluvium is dominant</p>

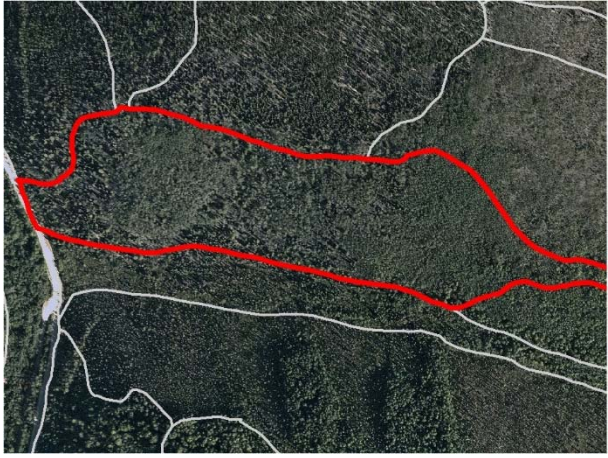
<p style="text-align: center;"><b>Oblique aerial view</b></p>

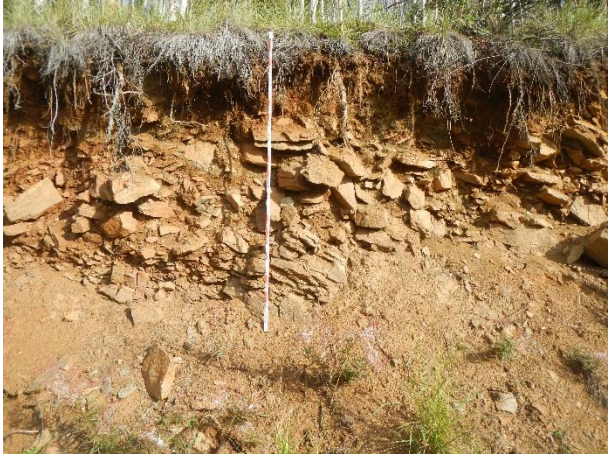
<p>General distribution</p>	<p>Slopes with southerly aspects</p>
	<p>Common terrain units</p>	<p>z<sub>sxCx</sub>; z<sub>sxCv</sub>; z<sub>sxCb</sub>; z<sub>sxCw-V</sub></p>
	<p>Dominant processes</p>	<p>Soil creep</p>
	<p>Drainage range</p>	<p>Imperfect to rapid</p>
	<p>Dominant slope range</p>	<p>Gentle to moderately steep</p>
	<p>Permafrost</p>	<p>n/a</p>
	<p>Other characteristics</p>	<p>Typically convex slopes; dominated by deciduous or mixed forest</p>
	<p>Hazard considerations</p>	<p>Soil creep; gullyng</p>

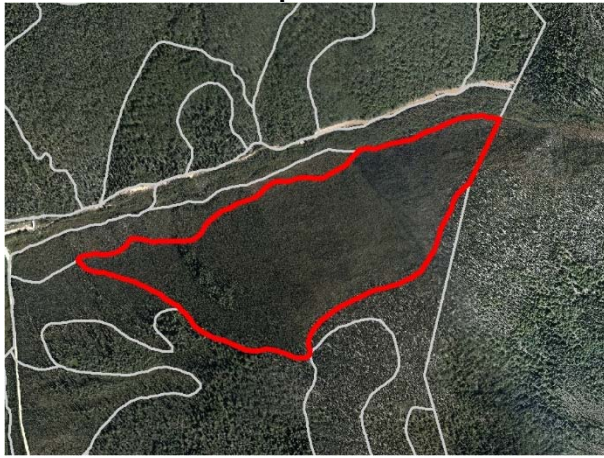
<p style="text-align: center;"><b>Oblique aerial view</b></p>

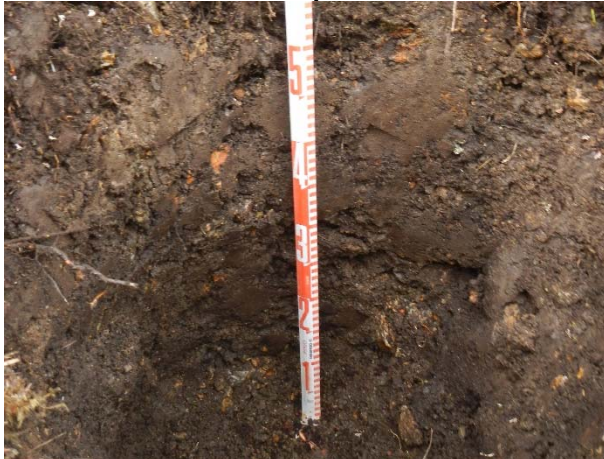
<p>General distribution</p>	<p>Upper and mid-slopes with northerly aspects</p>
	<p>Common terrain units</p>	<p>szxCv szxCv-SX<sup>f</sup></p>
	<p>Dominant processes</p>	<p>Active layer detachments; solifluction; slopewash; cryoturbation</p>
	<p>Drainage range</p>	<p>Imperfect to poor</p>
	<p>Dominant slope range</p>	<p>Gentle to moderately steep</p>
	<p>Permafrost</p>	<p>Typically ice-poor and shallow</p>
	<p>Other characteristics</p>	<p>Convex to straight slopes; dominantly stunted black spruce</p>
	<p>Hazard considerations</p>	<p>Active layer detachments; slumping; slope wash; soil creep</p>

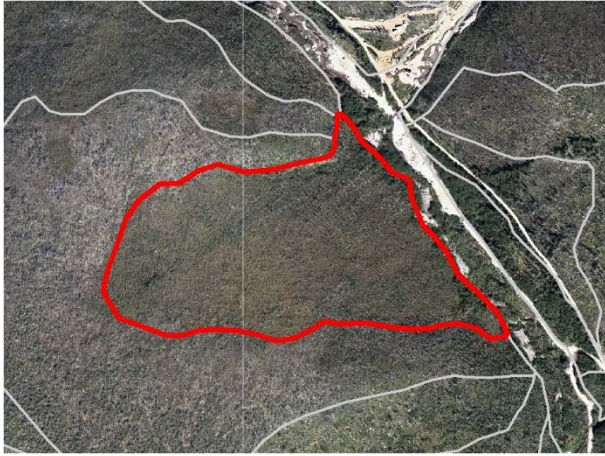
<p style="text-align: center;"><b>Oblique aerial view</b></p>

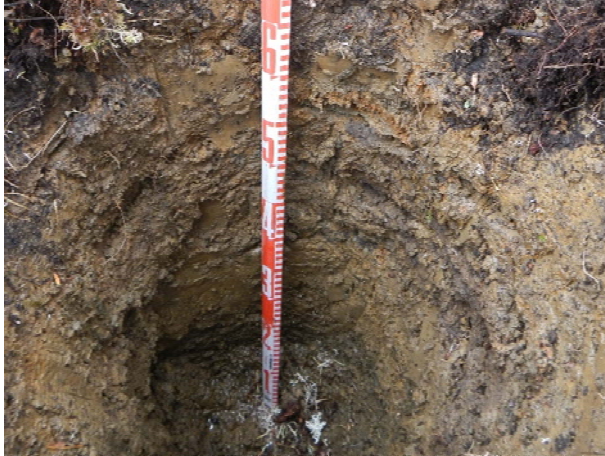
<p>General distribution</p>	<p>Mid to lower slopes and within concavities</p>
	<p>Common terrain units</p>	<p>sxzCb sxzCb-S</p>
	<p>Dominant processes</p>	<p>Slow downslope creep; thermokarst subsidence; solifluction; slopewash</p>
	<p>Drainage range</p>	<p>Imperfect to poor</p>
	<p>Dominant slope range</p>	<p>Gentle to moderate</p>
	<p>Permafrost</p>	<p>Typically ice-moderate and shallow</p>
	<p>Other characteristics</p>	<p>Smooth surface; occurs on concave slopes; dominated by stunted spruce</p>
	<p>Hazard considerations</p>	<p>Thermokarst subsidence; active layer detachments</p>

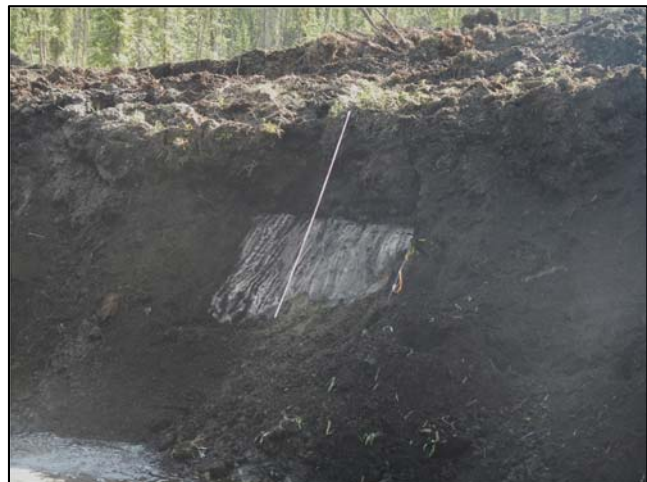
**Photo 4-1. Massive ice exposed by recent placer mining in a tributary to Maisy May Creek (2 m-long stadia rod for scale)**

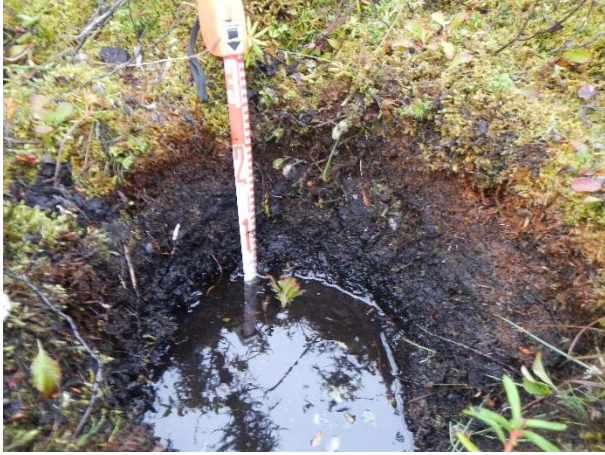
<p>General distribution</p>	<p>Toe-slope position on all aspects</p>
<p>Common terrain units</p>	<p>xszC1a-Xt xszC1b</p>	
<p>Dominant processes</p>	<p>Thermokarst subsidence and thermal erosion</p>	
<p>Drainage range</p>	<p>Imperfect to very poor</p>	
<p>Dominant slope range</p>	<p>Gentle to moderate</p>	
<p>Permafrost</p>	<p>Typically near surface and ice-rich</p>	
<p>Other characteristics</p>	<p>Dominated by stunted spruce; contain Klondike 'muck'</p>	
<p>Hazard considerations</p>	<p>Thermokarst subsidence; slumping if debuttressed</p>

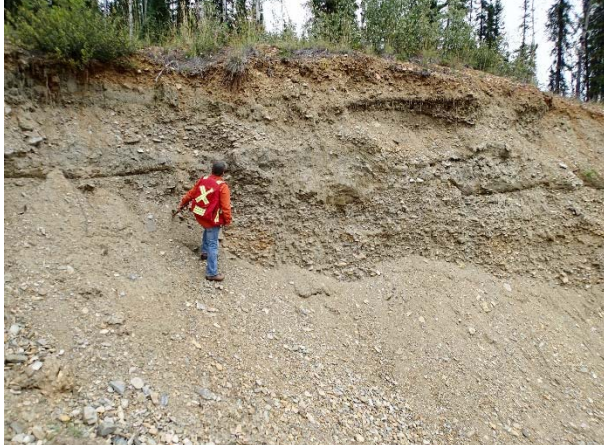
<p>General distribution</p>	<p>Valley bottoms; elevated terraces</p>
<p>Common terrain units</p>	<p>zsgFap-M zsgFt</p>	
<p>Dominant processes</p>	<p>Thermokarst subsidence; meandering</p>	
<p>Drainage range</p>	<p>Well to very poor</p>	
<p>Dominant slope range</p>	<p>Planar to gentle</p>	
<p>Permafrost</p>	<p>Presence, ice content and depth vary depending on location</p>	
<p>Other characteristics</p>	<p>May be interbedded with organic deposits on inactive floodplains</p>	
<p>Hazard considerations</p>	<p>Thermokarst subsidence; meander migration</p>

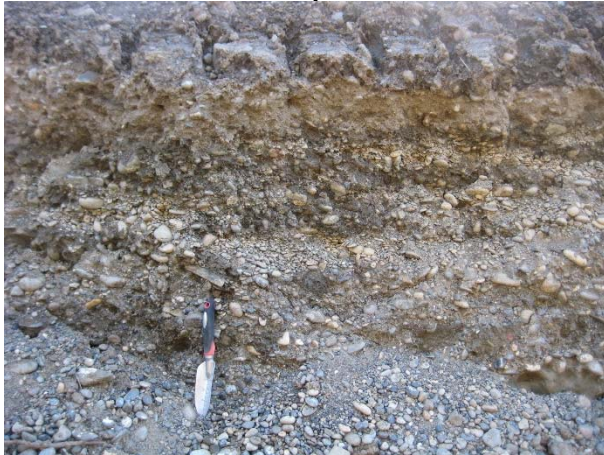
<p>General distribution</p>	<p>Elevated benches above the Yukon River</p>
	<p>Common terrain units</p>	<p>zsgFGt</p>
	<p>Dominant processes</p>	<p>Gullying</p>
	<p>Drainage range</p>	<p>Moderate to well</p>
	<p>Dominant slope range</p>	<p>Planar to gentle</p>
	<p>Permafrost</p>	<p>Deep and ice-poor</p>
	<p>Other characteristics</p>	<p>Typically contain rounded clasts of foreign lithology</p>
	<p>Hazard considerations</p>	<p>Gully processes along terrace scarps</p>

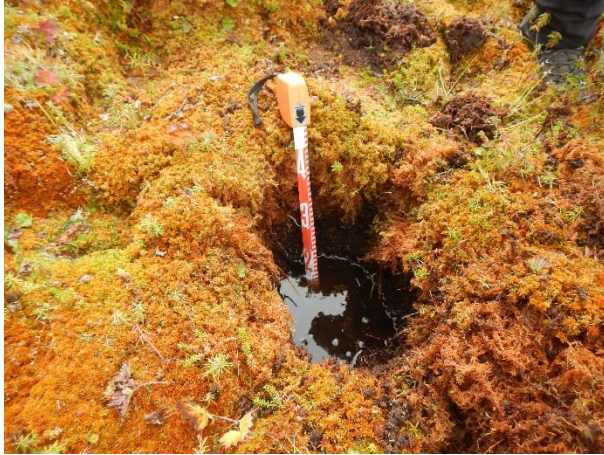
<p>General distribution</p>	<p>Floodplains and valley bottoms</p>
	<p>Common terrain units</p>	<p>eOp-Xt</p>
	<p>Dominant processes</p>	<p>Thermokarst subsidence; inundation</p>
	<p>Drainage</p>	<p>Poor to very poor</p>
	<p>Dominant slope range</p>	<p>Planar</p>
	<p>Permafrost</p>	<p>Typically shallow and ice-rich</p>
	<p>Other characteristics</p>	<p>Surface water common</p>
	<p>Hazard considerations</p>	<p>Thermokarst subsidence; flooding</p>

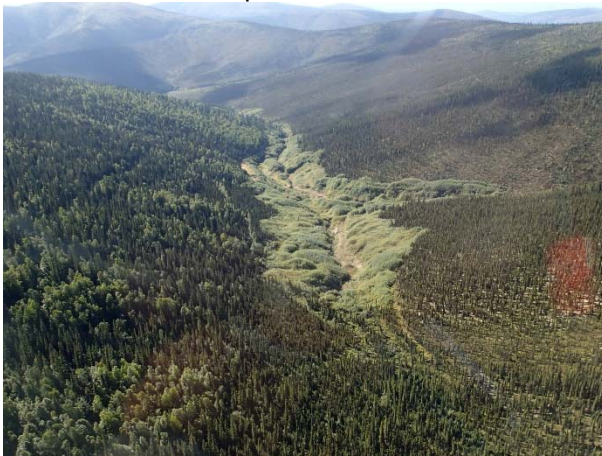
<p style="text-align: center;">Soil pit (n/a due to variability)</p>	<p>General distribution</p>	<p>Valley bottoms and terraces</p>
	<p>Common terrain units</p>	<p>A</p>
	<p>Dominant processes</p>	<p>n/a</p>
	<p>Drainage</p>	<p>n/a</p>
	<p>Dominant slope range</p>	<p>n/a</p>
	<p>Permafrost</p>	<p>Typically degraded due to disturbance; deep and potentially ice-rich where it remains</p>
	<p>Other characteristics</p>	<p>Deciduous vegetation</p>
	<p>Hazard considerations</p>	<p>Unpredictability requires site-specific investigation</p>
