**APPENDIX 11-A**  
**Surficial Geology, Permafrost,**  
**and Terrain Stability**

TETRA TECH EBA

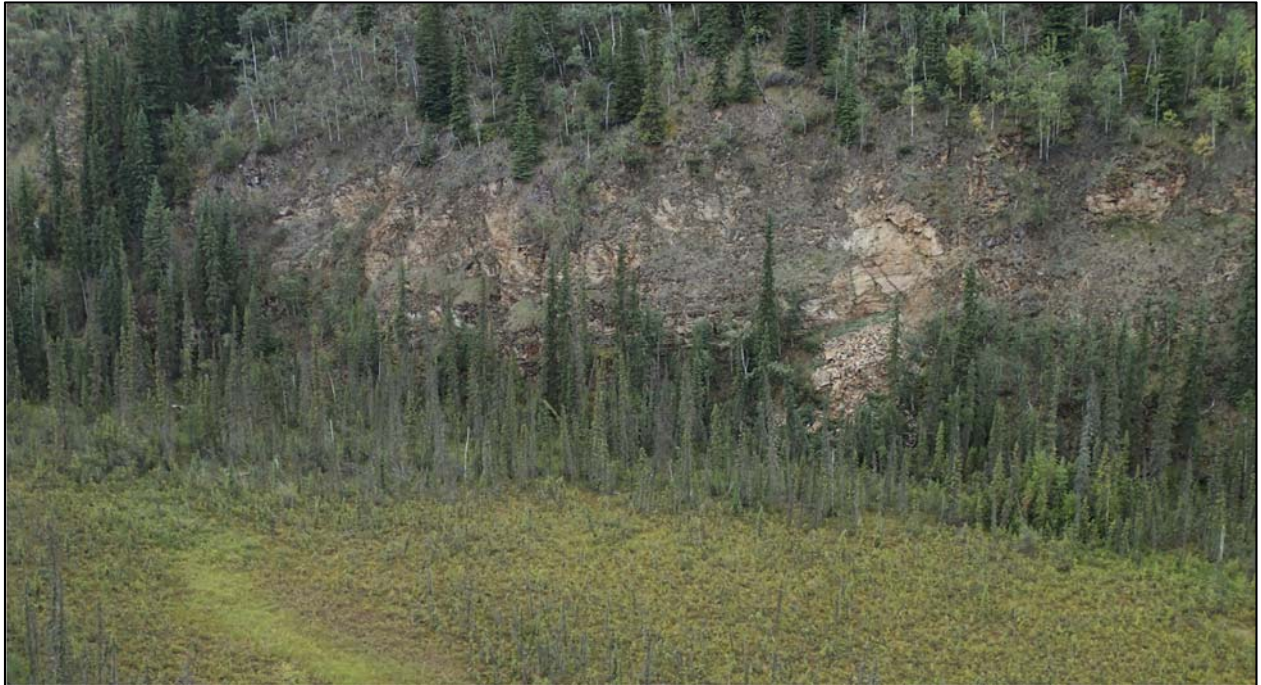
*Photo 4-2. Recent rockfall on bluff adjacent to proposed road alignment north of Stewart River*

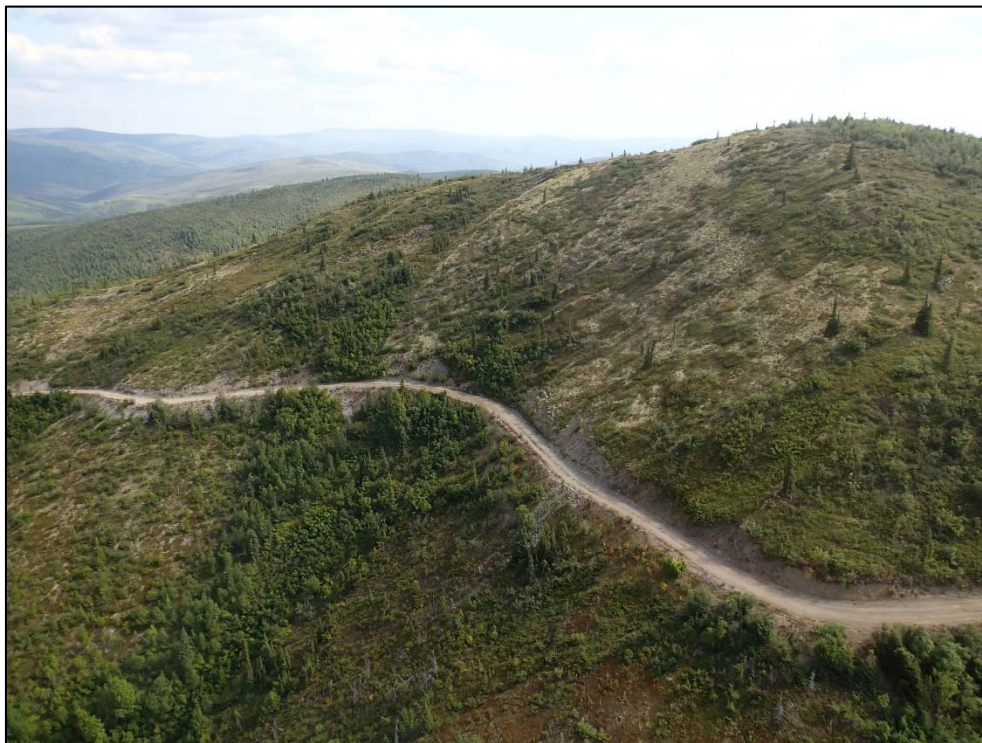
**Photo 4-3. Henderson Ridge Road traversing a slope exhibiting rock creep**

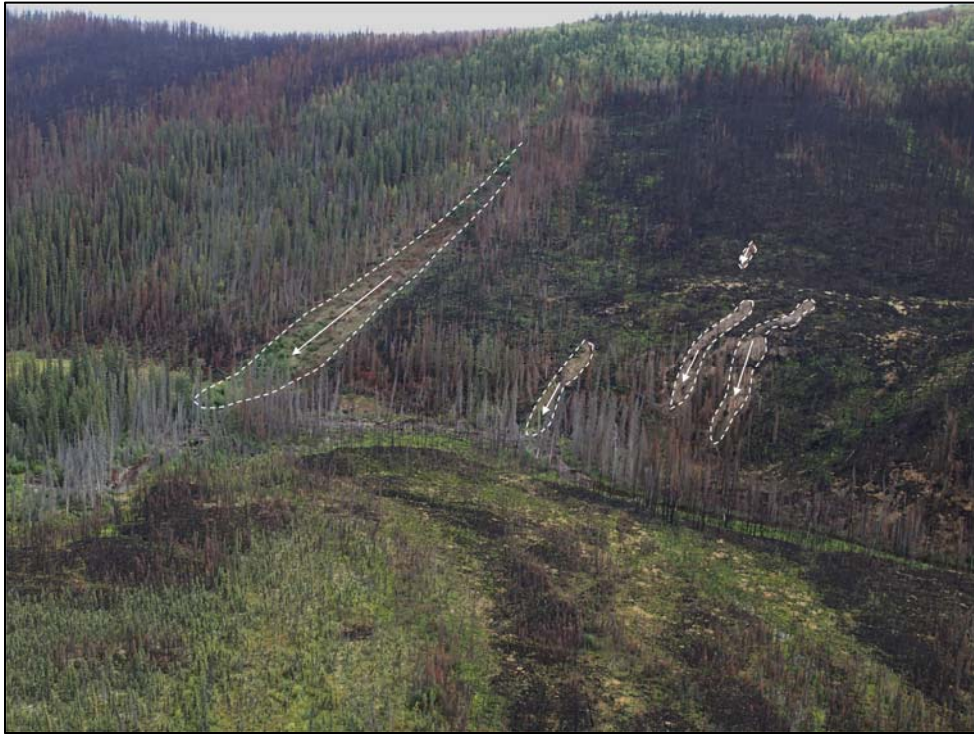
**Photo 4-4. Active layer detachments on recently burned east valley side of Barker Creek**

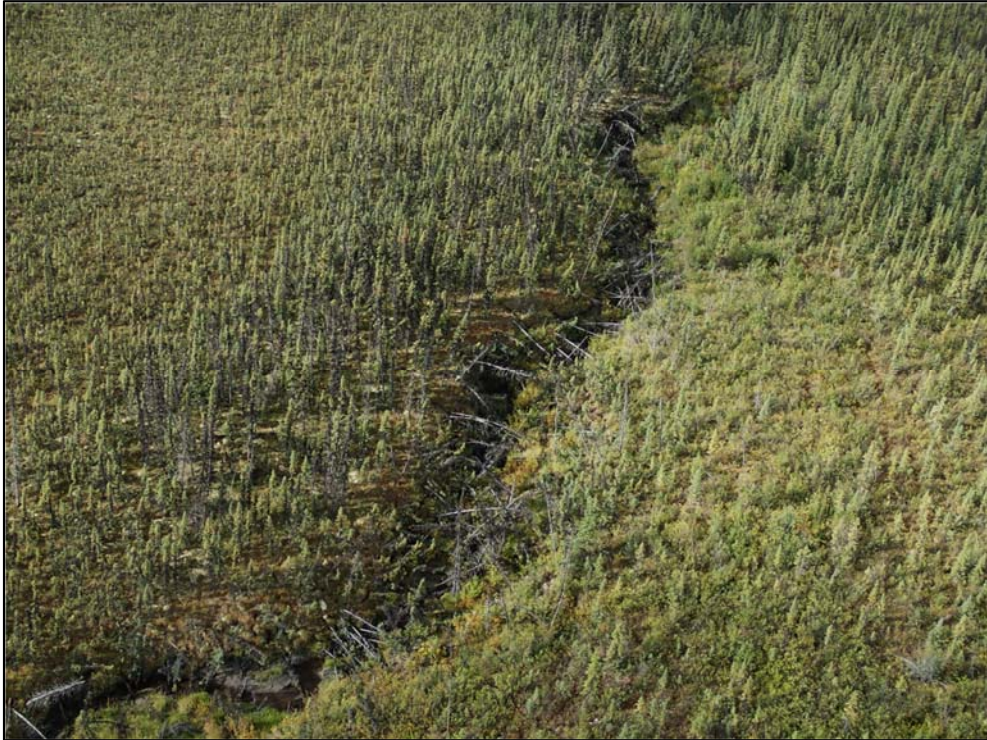
*Photo 4-5. Thermokarst gully with inward-tilting trees on collapsing sidewalls*

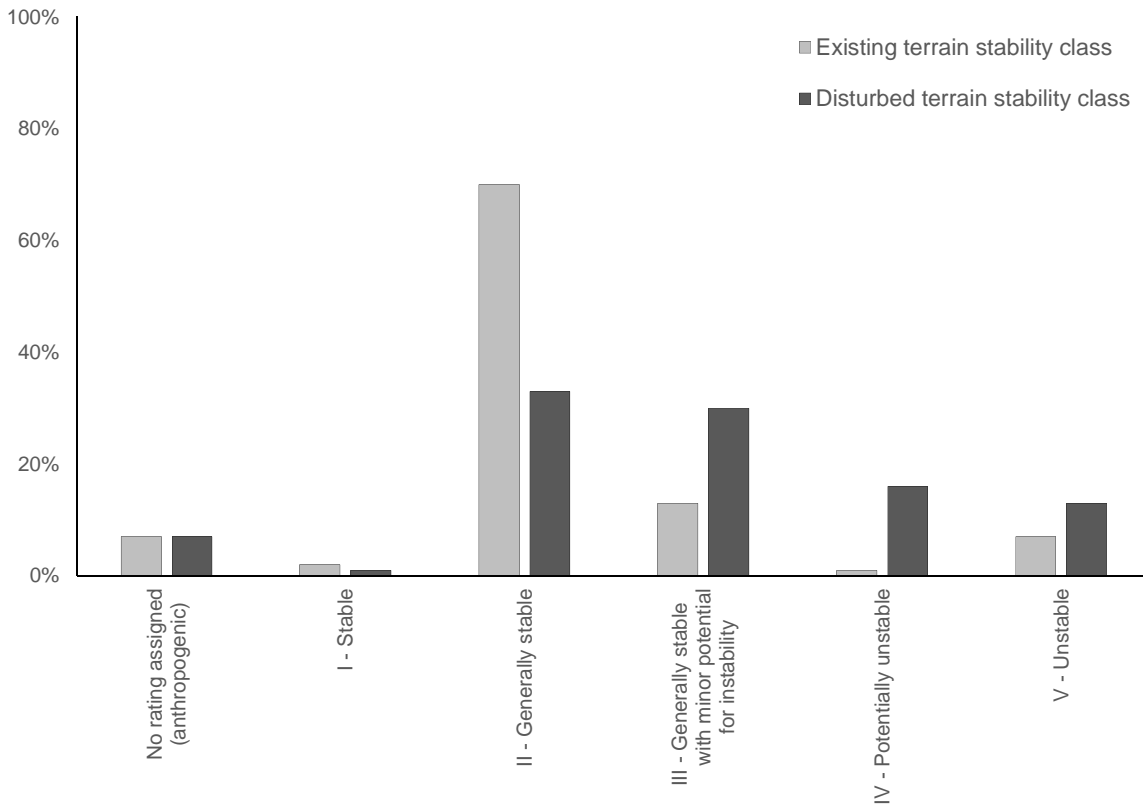
**Figure 5-1. Histogram of existing and disturbed terrain stability classification in the study area**

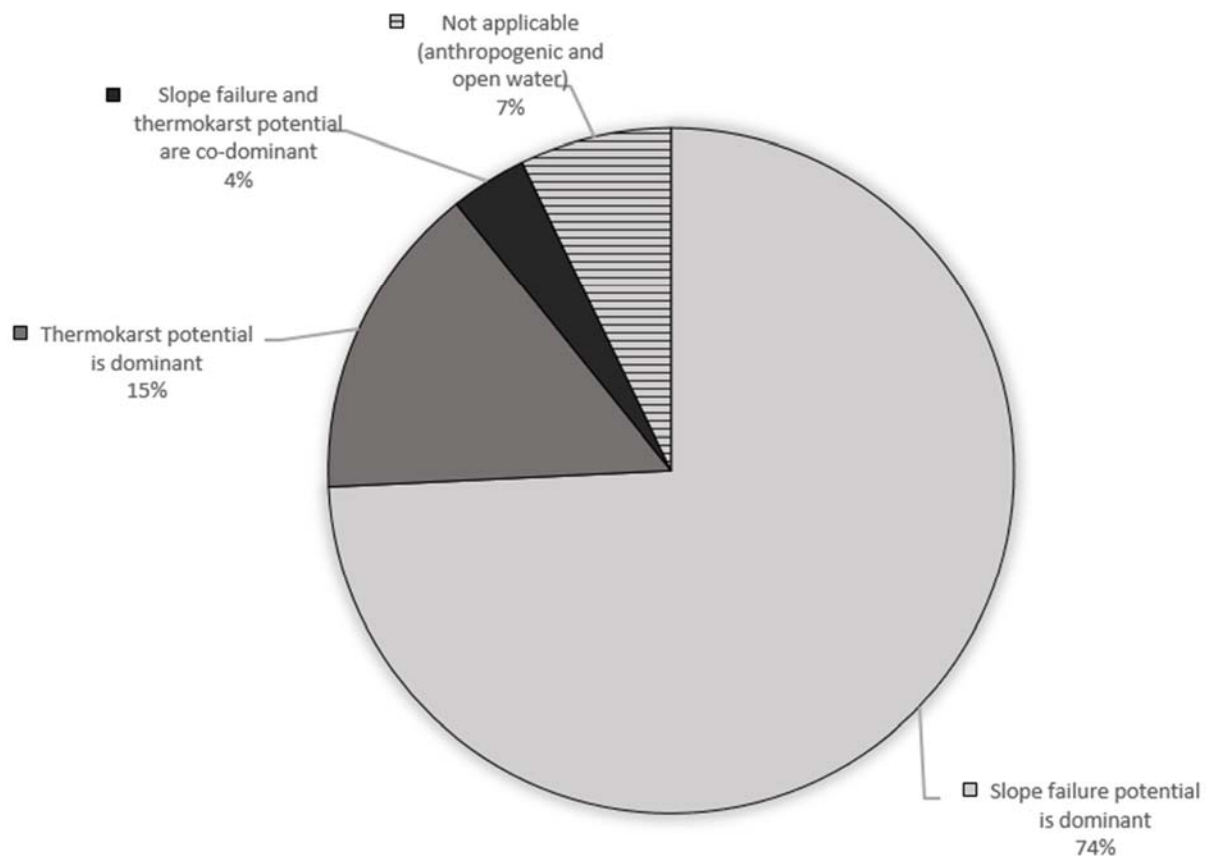
**Figure 5-2. Areal proportion (%) of applicable hazard categories in the study area**

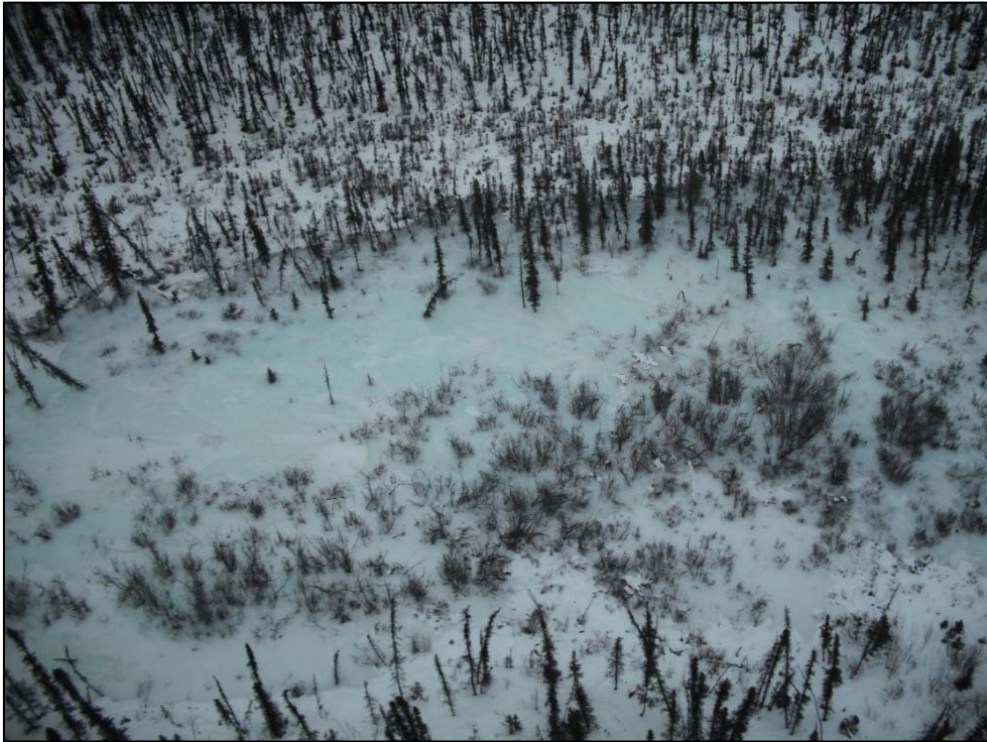
**Photo 5-1. Example of icing spanning the bottom of a headwater drainage in the Klondike Plateau**

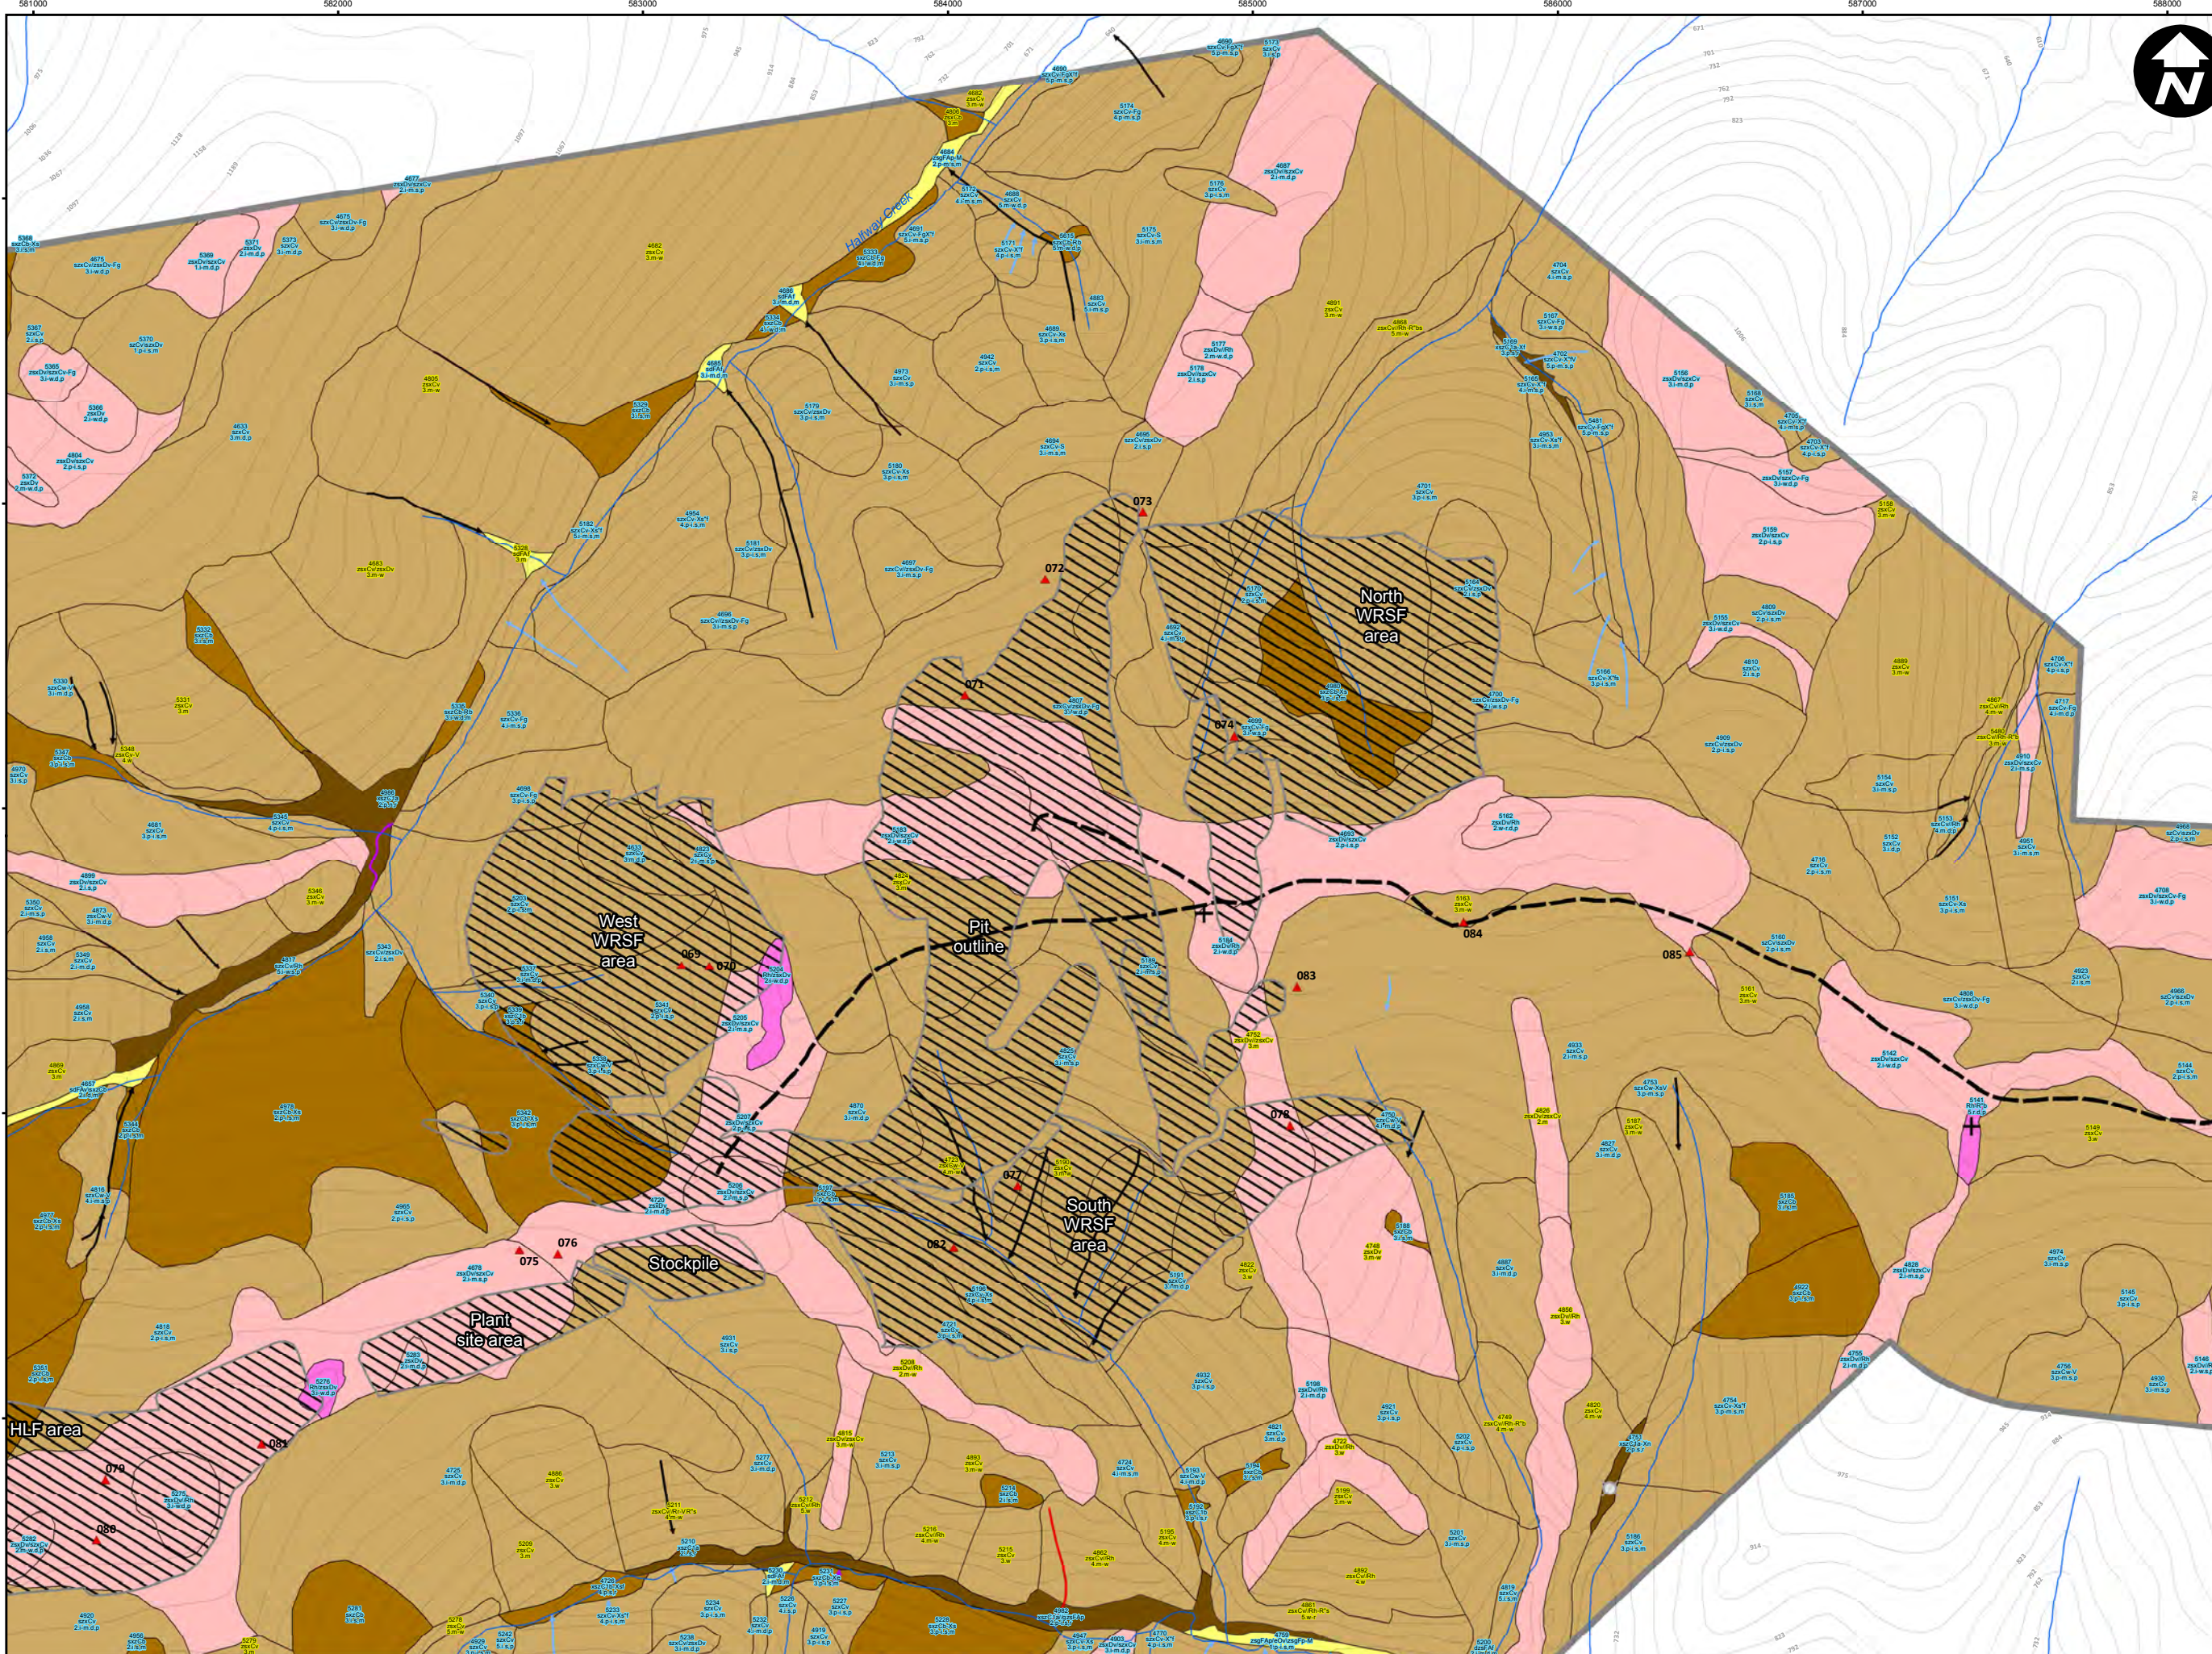
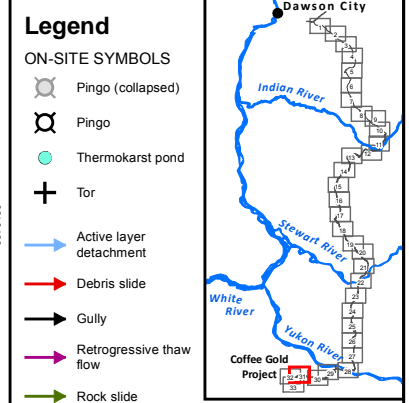
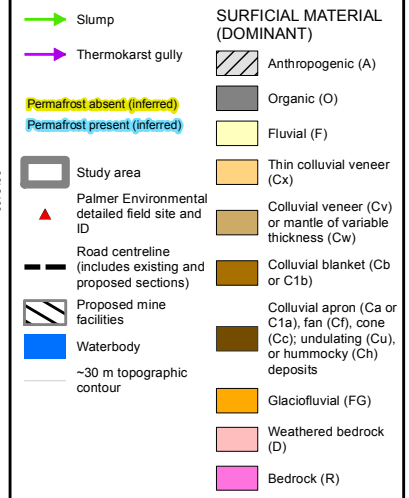
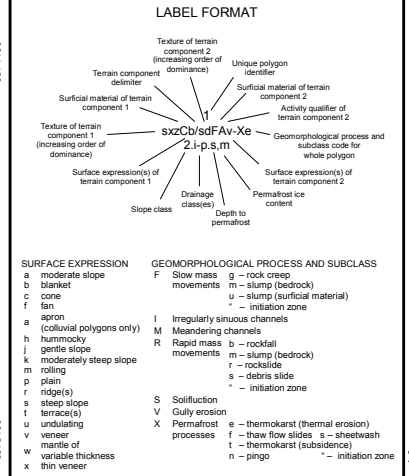
Refer to "Terrain Codes Definitions" at beginning of map book for definitions of all terminology

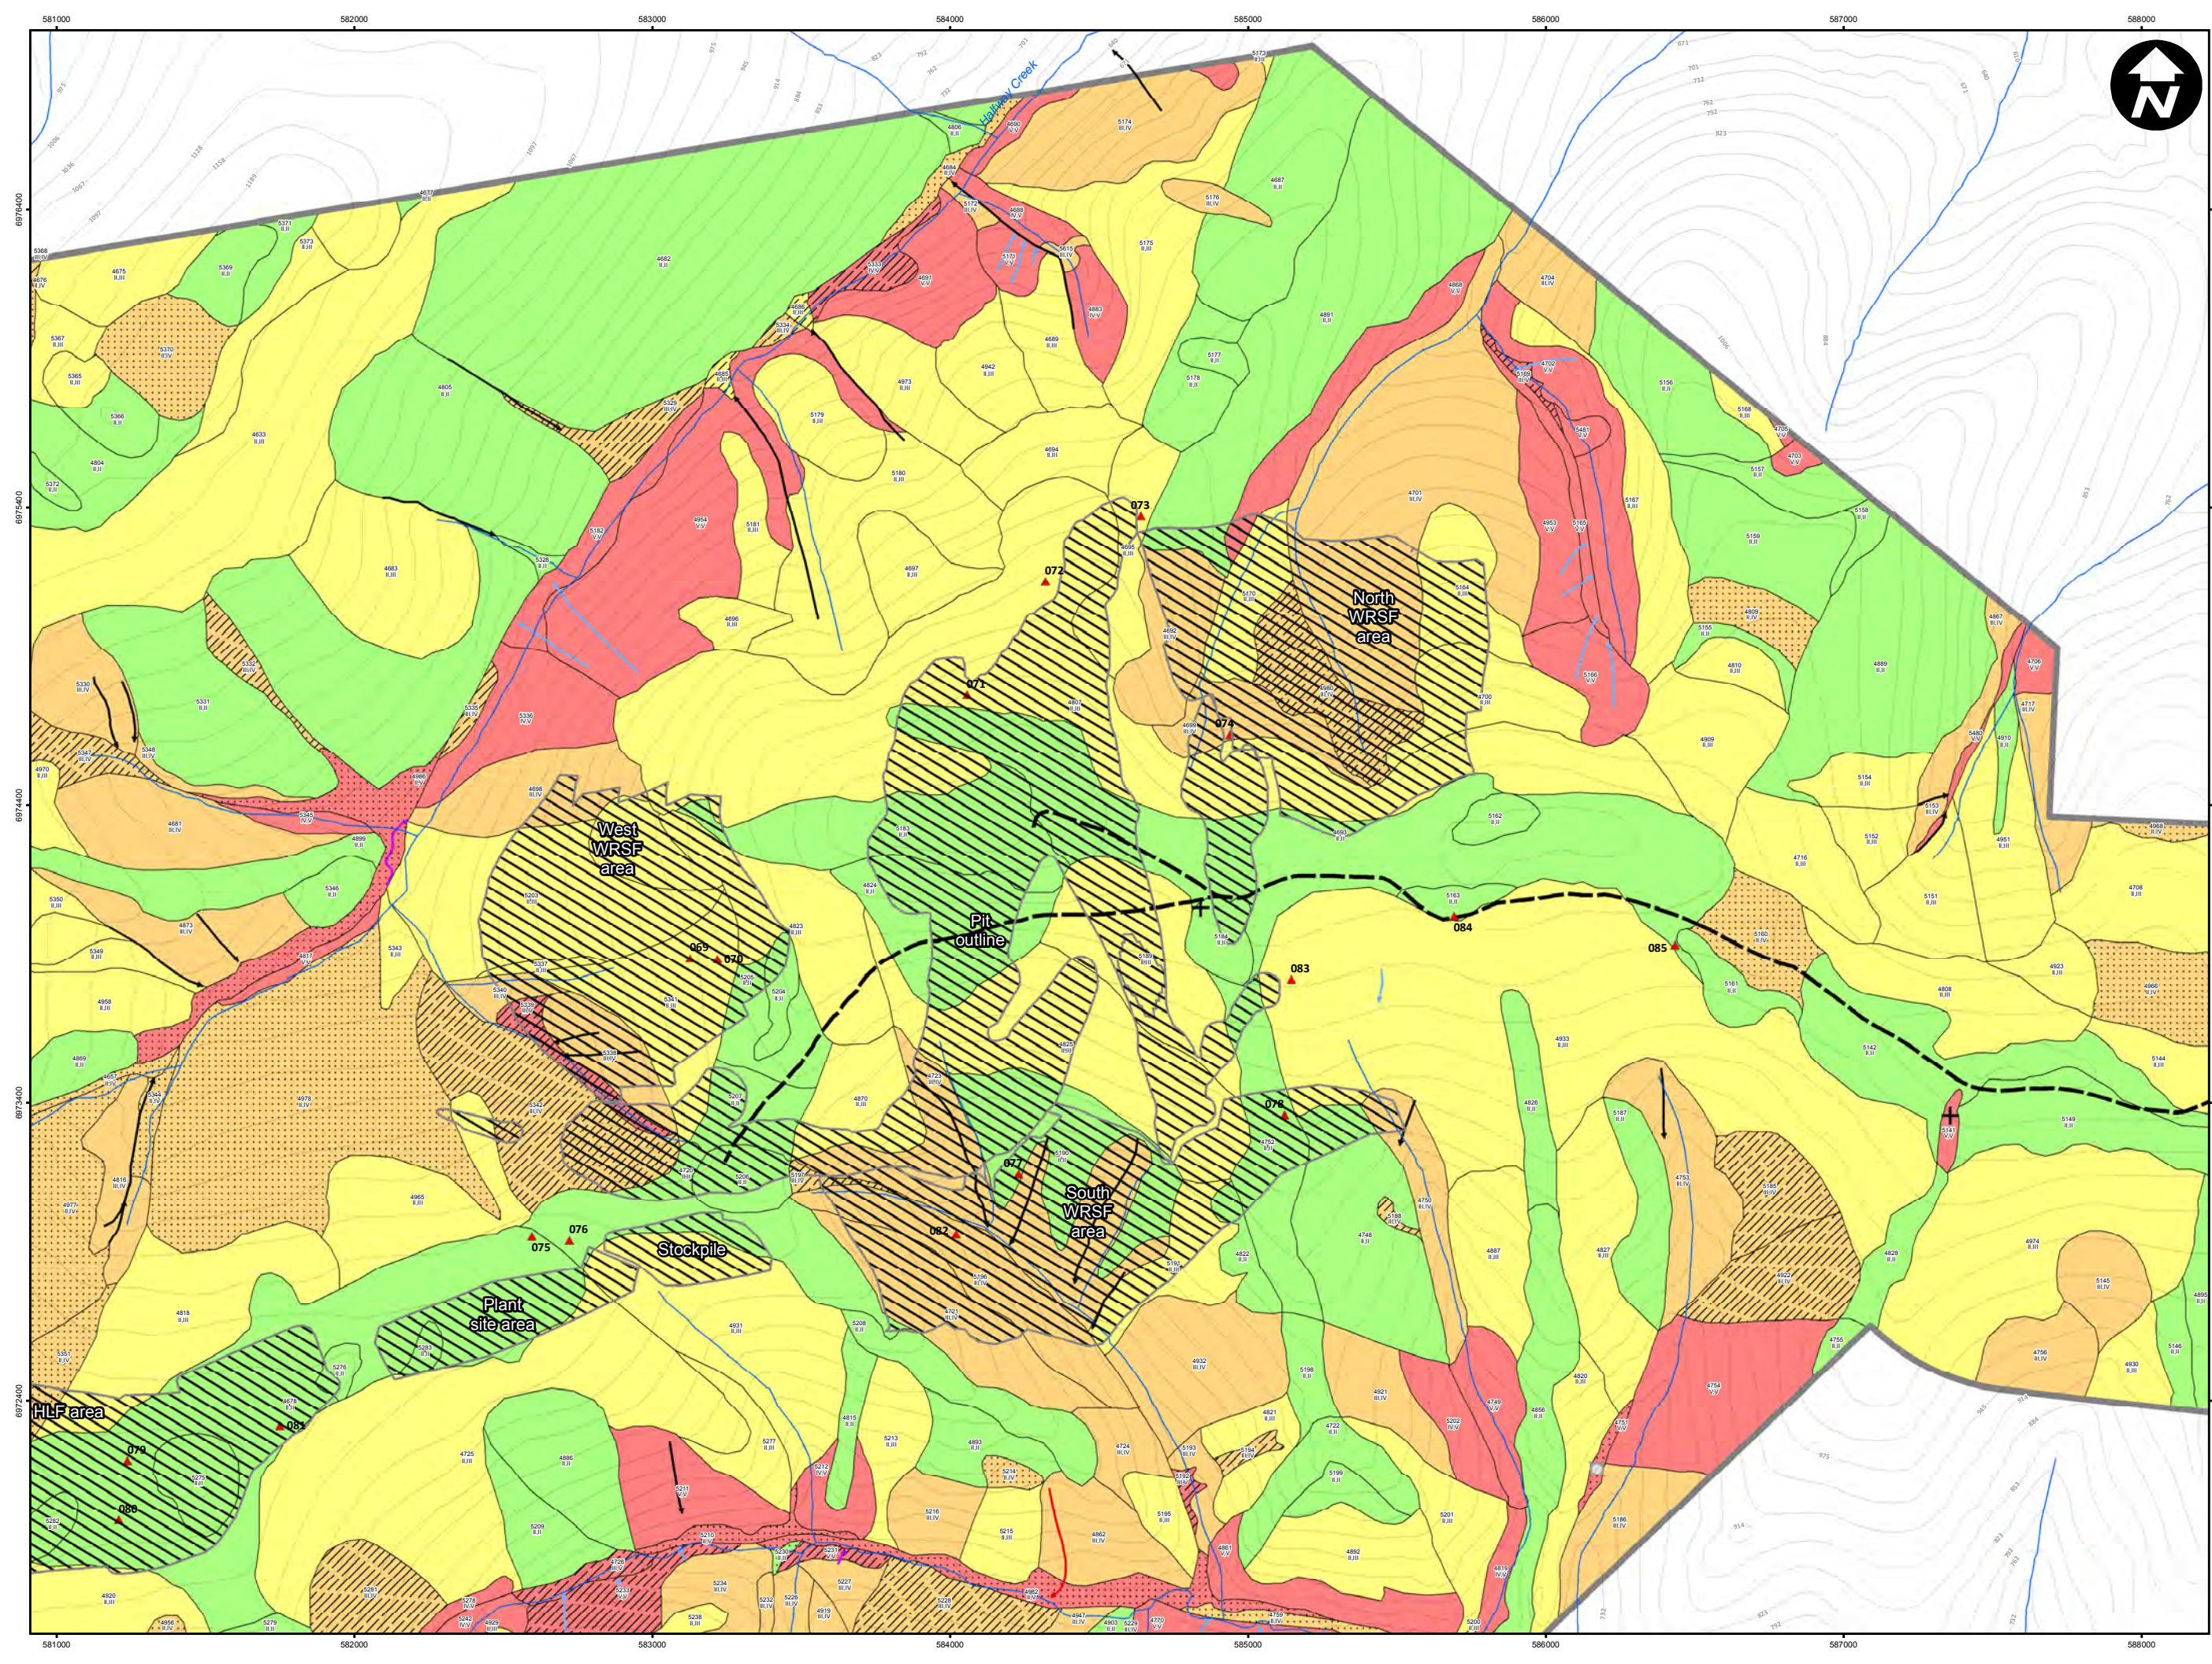
Applicable Hazard Category		
Symbol	Class	Description
s	slope failure potential is dominant	Dominant hazard potential category related to gravity induced slope failure. May or may not include existing failures. Represents default category.
t	thermokarst potential is dominant	Dominant hazard potential category related to thermokarst subsidence or erosion. May or may not include existing failures.
b	both slope failure & thermokarst potential are co-dominant	Hazard potential category related to gravity induced slope failure and thermokarst subsidence or erosion. May or may not include existing failures.

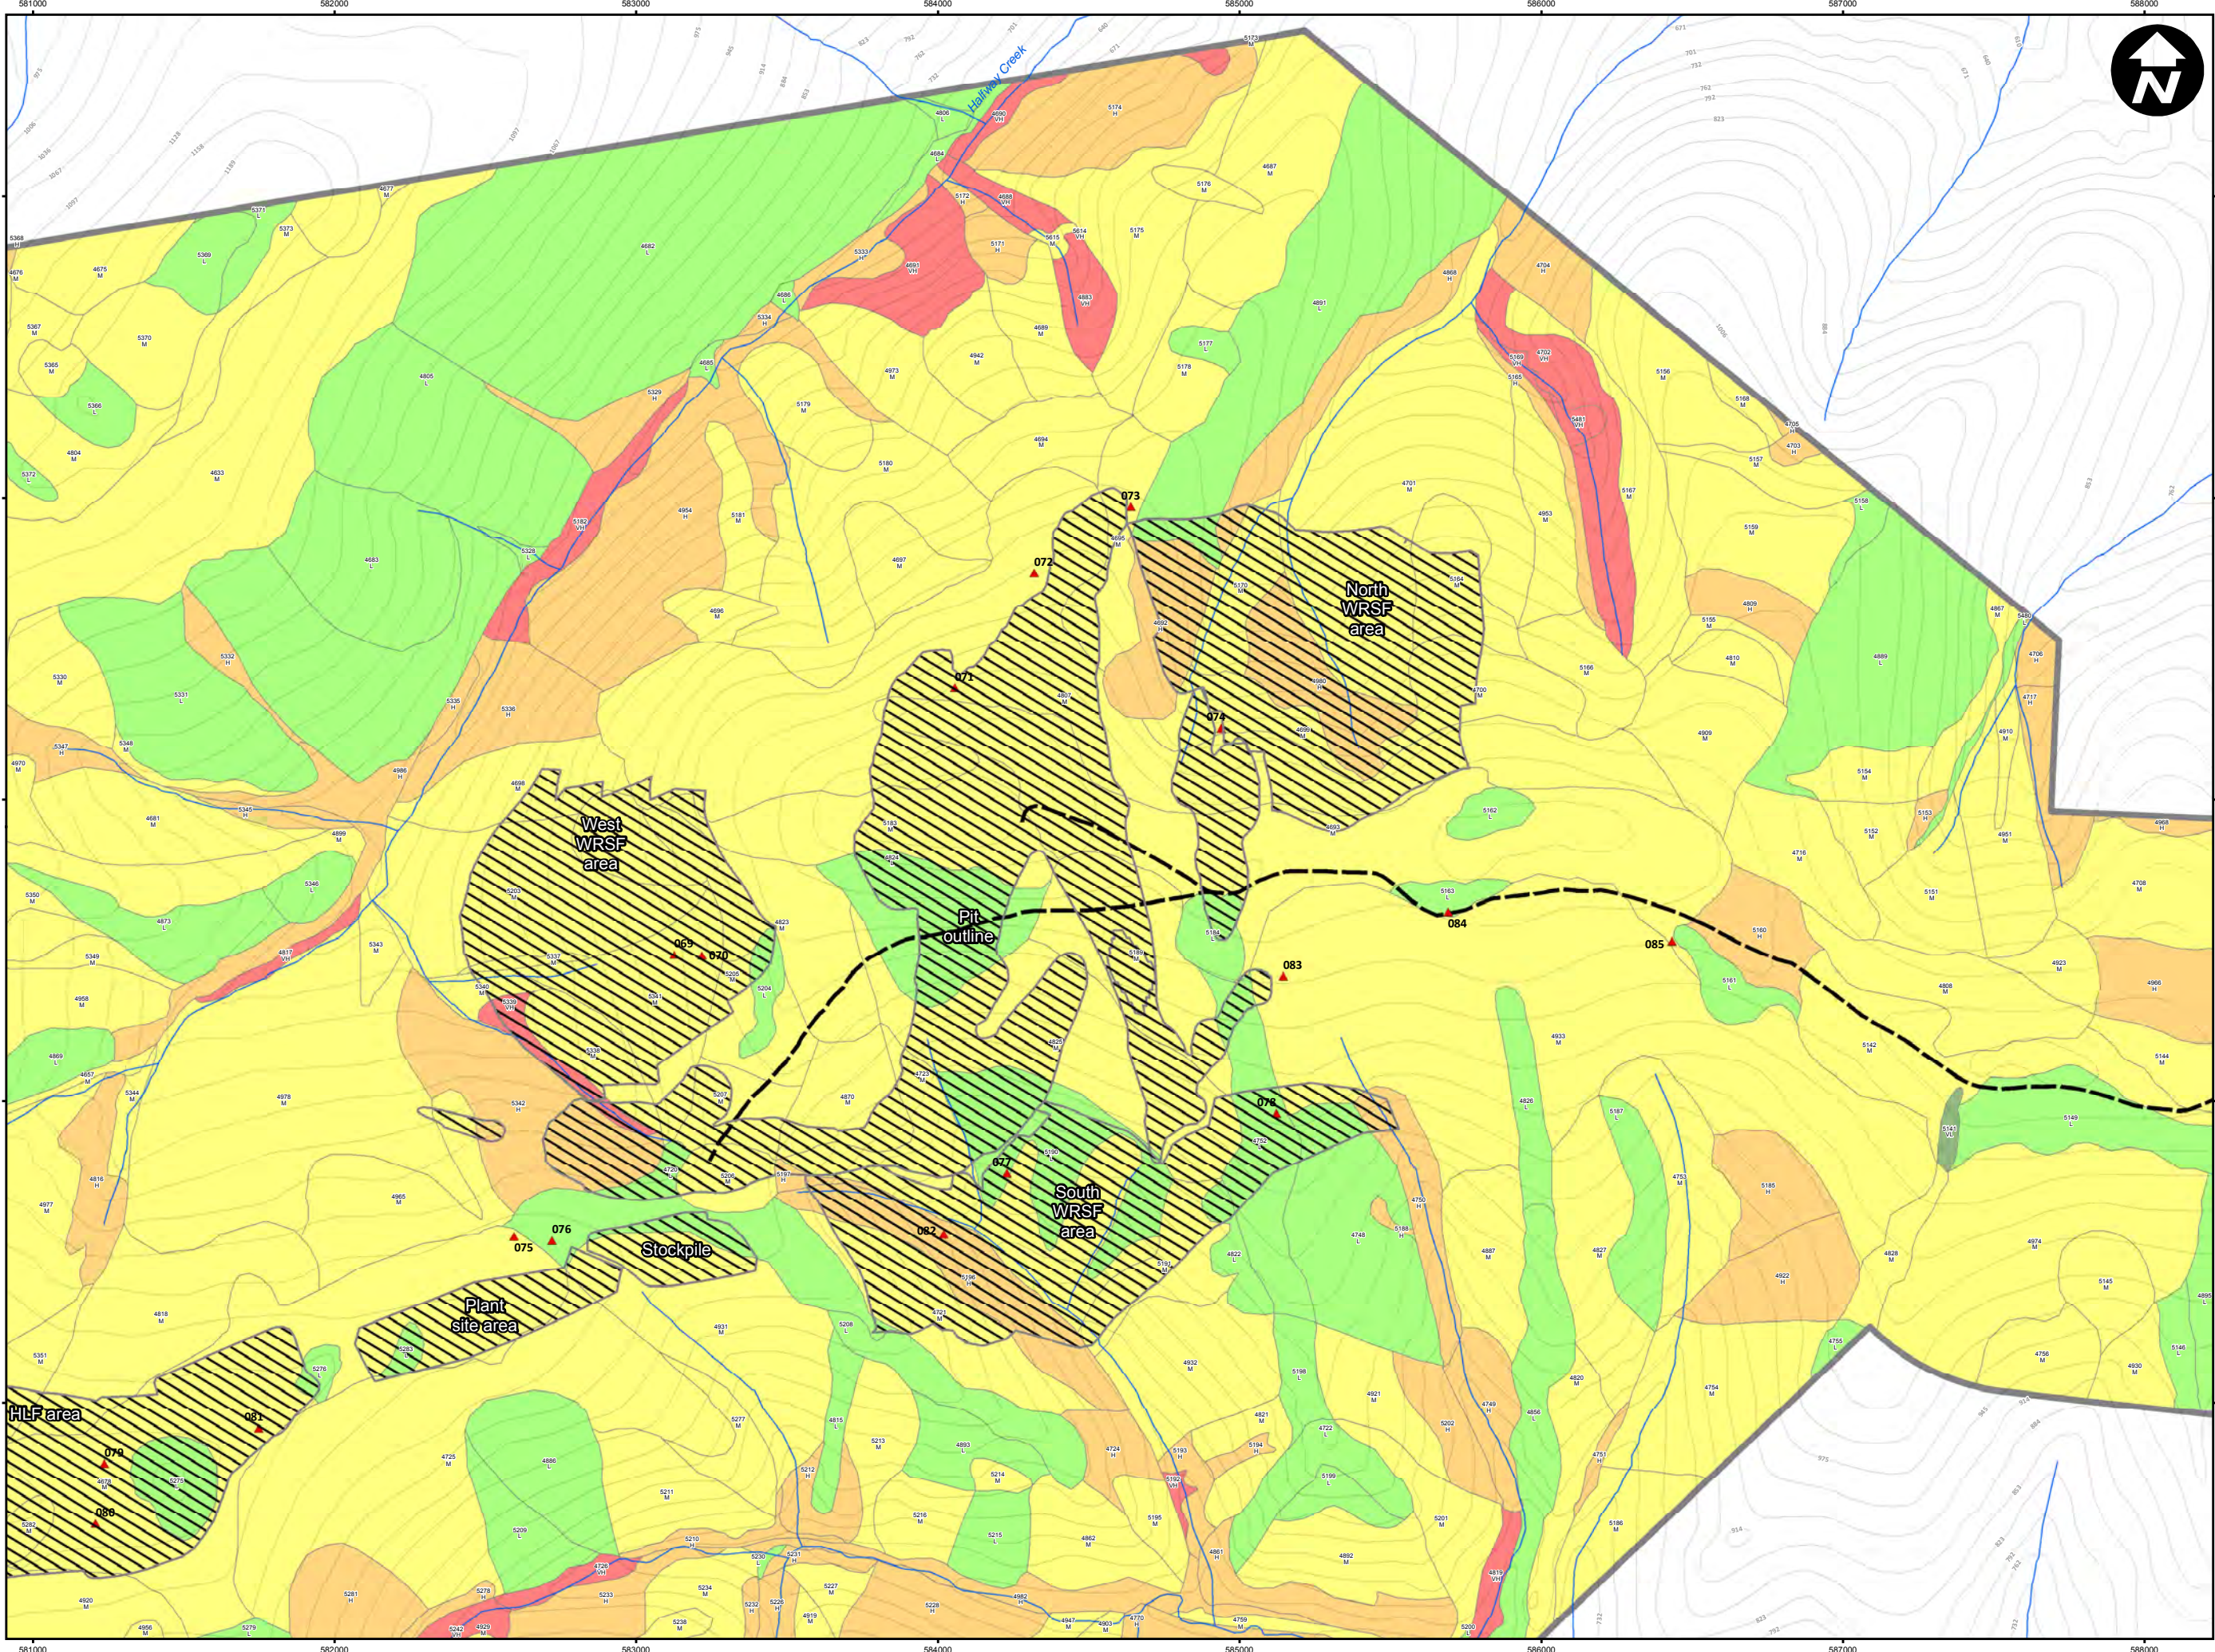
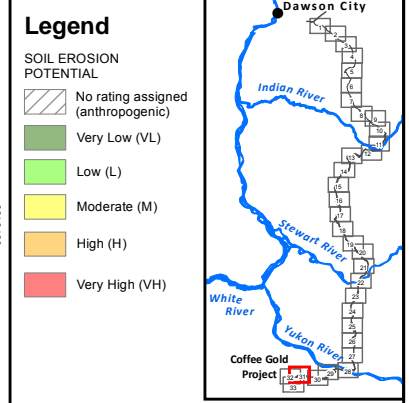
- Legend**
- SOIL EROSION POTENTIAL**
- No rating assigned (anthropogenic)
  - Very Low (VL)
  - Low (L)
  - Moderate (M)
  - High (H)
  - Very High (VH)
- LABEL FORMAT**
- Unique polygon identifier
  - Soil erosion potential
- Map Symbols**
- Study area
  - Palmer Environmental detailed field site and ID
  - Road centreline (includes existing and proposed sections)
  - Proposed mine facilities
  - Waterbody
  - ~30 m topographic contour
