**Fish and Aquatic Resources**

# Coffee Gold Project

## **Fish and Aquatic Resources Baseline Report:**

### **Mine Access Road**

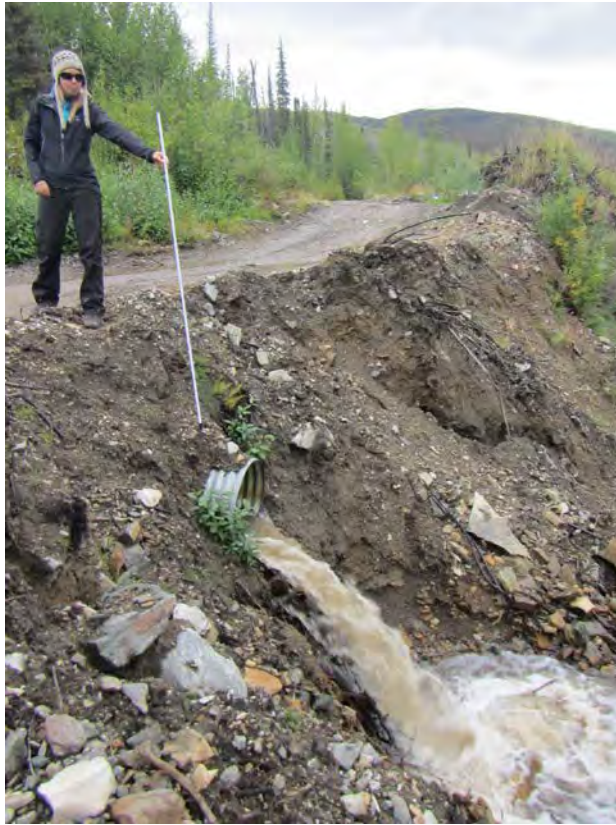
Crossing #75 was located on a side channel that drained into two other branches of upper Maisy May downstream. The crossing had a perched culvert, with a vertical drop (greater than 75 cm) that was considered a fish passage barrier (Photo 3). Channel and wetted widths upstream of the culvert were 2.4 m and 1.4 m respectively. Active placer mining was occurring upstream of the crossing site in August 2015. The crew conducted an aerial assessment upstream of the crossing site and no deep water habitat (which could provide fish overwintering) was observed. The creek valley was highly disturbed and unstable, in particular where the side channel joined upper Maisy May downstream of the crossing location. Nearby, another side channel ran adjacent to the road, and the road was eroding into the creek.

**Photo 3 – Perched culvert crossing (#75) on side channel of Maisy May Creek.**

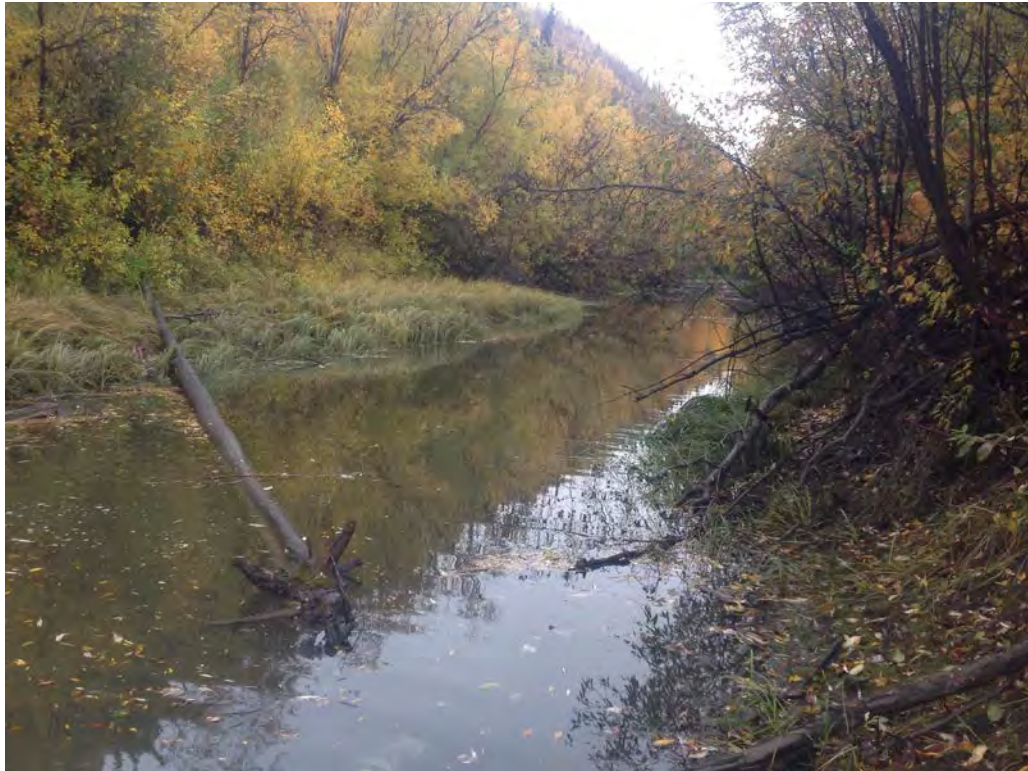
The side channel was considered fish bearing due to its seasonal connection to the Stewart River. The channel is likely to backflood and provide temporary fish habitat during spring flood conditions. However, during summer baseflow conditions, the habitat was stagnant and deemed highly unlikely to support fish throughout the majority of the channel.

**Photo 4 - Stewart River Side Channel (near confluence), on September 11, 2015.**

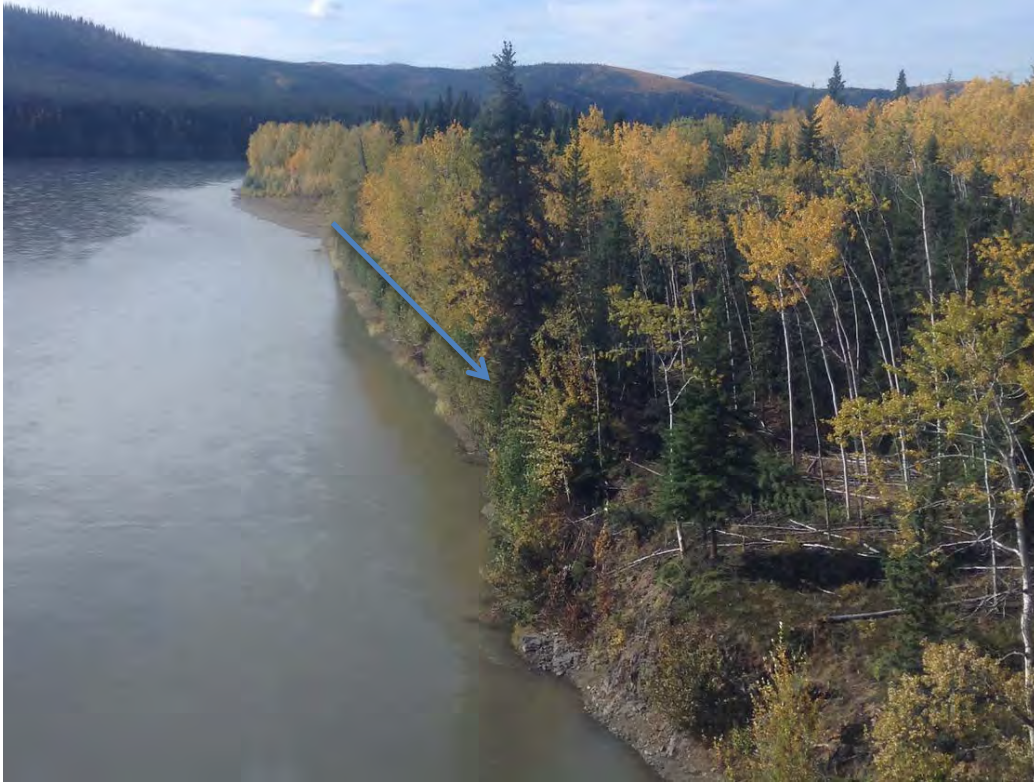
The proposed north barge landing is located west of a small rock bluff, on a gentle sloping beach with fine and cobble substrates, and grasses (Photo 5). At time of assessment (September 9), the river level was high, with poor water clarity. The riparian habitat was comprised of a mature, predominately deciduous forest. Based on substrate, water clarity and flow conditions, as well as the geographical location of barging area within the watershed, the fish habitat was identified as rearing in the immediate vicinity of the proposed landing location, and as rearing and migratory in the larger reach.

**Photo 5 – Proposed Barge Landing Location on the Stewart River (north side), on September 9, 2015. Blue arrow shows proposed landing location.**

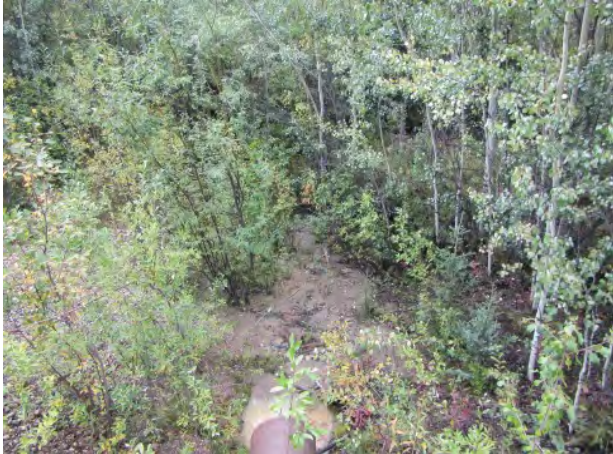
D/S (50m)	X	U/S (50m)
Coordinates:	609204	Gradient (%):	-	-
	7055294	Bankfull Width (m):	-	-
Site Visit Date:	18/08/15	Bankfull Depth (m):	-	-
Flow Conditions:	none	Wetted Widths (m):	-	-
Barrier (Y/N):	N	Wetted Depth (m):	-	-
		Substrate Bed		
Electrofishing effort:	N	(Dom/SubDom):	-	-
Gee Trapping:	N	Substrate Bank:	-	-
Fish present?:	see below	Riparian Vegetation:	-	-
Site Length:	100m	Meander Pattern:	-	-
		Cover (%/Dom):	-	-
Photo #s	29 u/s	28 x	d/s	pH:
Areas of Erosion:	-			Temperature:
Locations:				Specific Conductivity:
				Dissolved Oxygen
Comments:				
No flow; likely only flows during high snow melt.				
Very unlikely to support fish.				
Limited, poor channel definition.				
P#28 - perched culvert

Perched Culvert

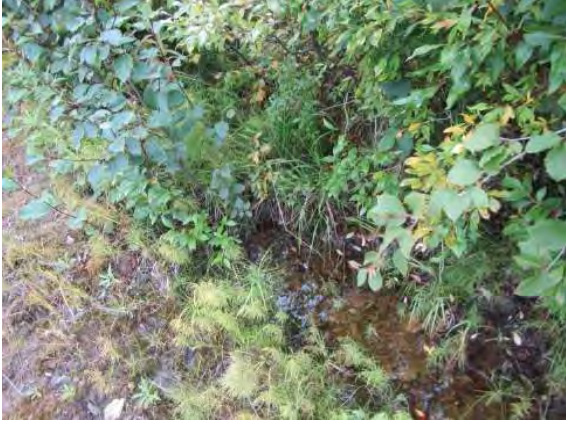
D/S (50m)	X	U/S (50m)
Coordinates:	597985	Gradient (%):	-	-
	7087893	Bankfull Width (m):	-	-
Site Visit Date:	19/08/15	Bankfull Depth (m):	-	-
Flow Conditions:	mid	Wetted Widths (m):	-	0.2
Barrier (Y/N):	Y - 38% gradient	Wetted Depth (m):	-	0.04
Electrofishing effort:	N	Substrate Bed (Dom/SubDom):	-	-
Gee Trapping:	N	Substrate Bank:	-	-
Fish present?:	N	Riparian Vegetation:	-	-
Site Length:	100m	Meander Pattern:	-	-
		Cover (%/Dom):	-	-
Photo #s	89 u/s	x	88 d/s	pH:
Areas of Erosion:	-			Temperature:
Locations:				Specific Conductivity:
				Dissolved Oxygen
Comments:				
Not fish habitat				
High gradient barrier 38% d/s of road.				
Water flows along road ditch ~ 80 m.				
No culvert.				
measurements taken where water comes in from upstream next to road (P#90)

Where water comes in u/s next to road

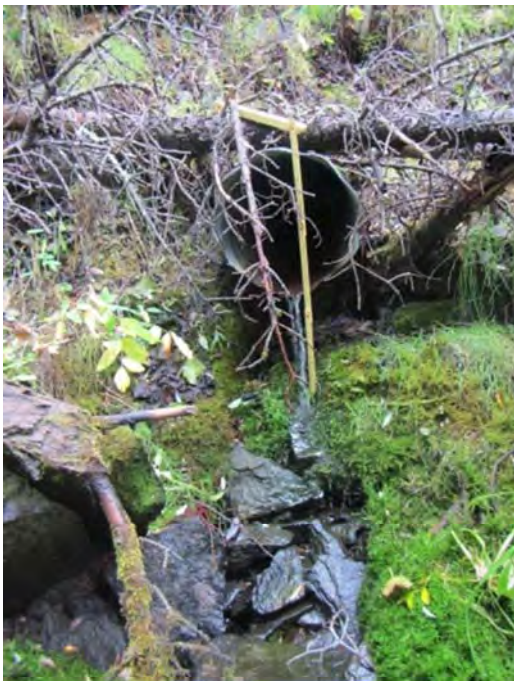
D/S (50m)	X	U/S (50m)
Coordinates:	607856	Gradient (%):	-	-
	7015989	Bankfull Width (m):	-	-
Site Visit Date:	20/08/15	Bankfull Depth (m):	-	-
Flow Conditions:	mid to high	Wetted Widths (m):	-	-
Barrier (Y/N):	Y	Wetted Depth (m):	-	-
Electrofishing effort:	N	Substrate Bed (Dom/SubDom):	-	-
	N	Substrate Bank:	-	-
Fish present?:	N	Riparian Vegetation:	-	-
Site Length:	100m	Meander Pattern:	-	-
		Cover (%/Dom):	-	-
Photo #s	145, 146 u/s	144 x	142, 143 d/s	pH:
Areas of Erosion:	-			Temperature:
Locations:				Specific Conductivity:
				Dissolved Oxygen
Comments:	Maisy May trib			
Not fish habitat, channel not well defined, and small although at mid flow conditions.				
Several natural obstructions to fish passage d/s of perched culvert.				
very perched culvert and drop to shallow stagnant pool restricts passage of fish				
downstream site: stagnant discontinuous shallow pools				
upstream site: immediately dries up above road P#146; lots of deadfall

Perched culvert

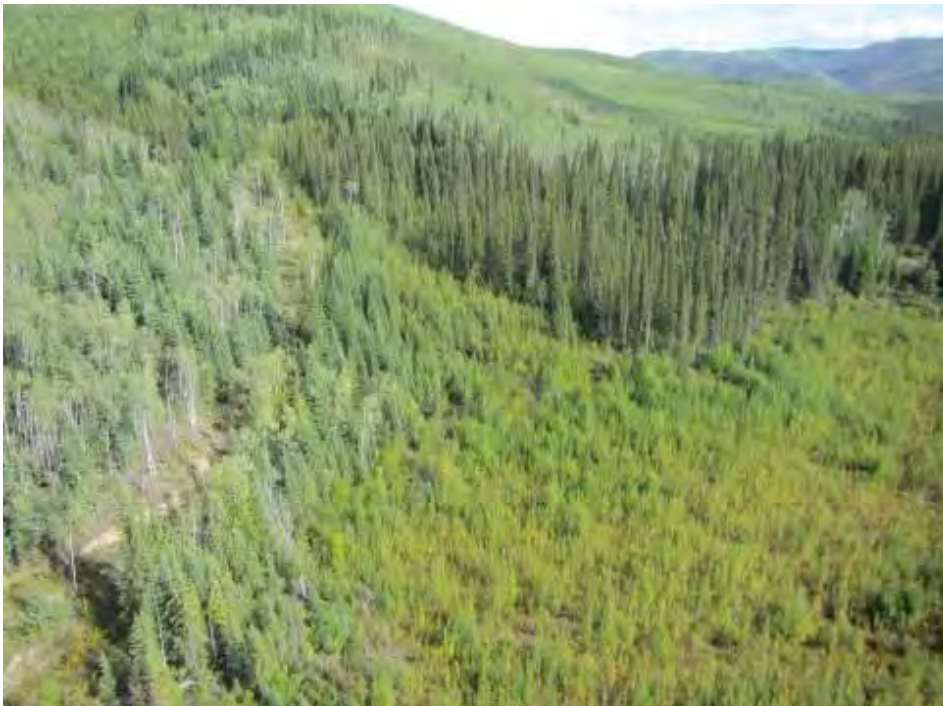
D/S (50m)	X	U/S (50m)
Coordinates:	608437	Gradient (%):	-	-
	7015678	Bankfull Width (m):	-	-
Site Visit Date:	21/08/15	Bankfull Depth (m):	-	-
Flow Conditions:	none	Wetted Widths (m):	-	-
Barrier (Y/N):	n/a	Wetted Depth (m):	-	-
Electrofishing effort:	n/a	Substrate Bed		
		(Dom/SubDom):	-	-
Gee Trapping:	n/a	Substrate Bank:	-	-
Fish present?:	N	Riparian Vegetation:	-	-
Site Length:	100m	Meander Pattern:	-	-
		Cover (%/Dom):	-	-
Photo #s	u/s	x	d/s	pH:
Areas of Erosion:	-			Temperature:
Locations:				Specific Conductivity:
				Dissolved Oxygen
Comments:				
No visible channel from air, P#148

Photo from air; no visible channel
