Eagle Gold Project

Environmental Baseline Report: Historical Resources

FINAL REPORT

March 2010

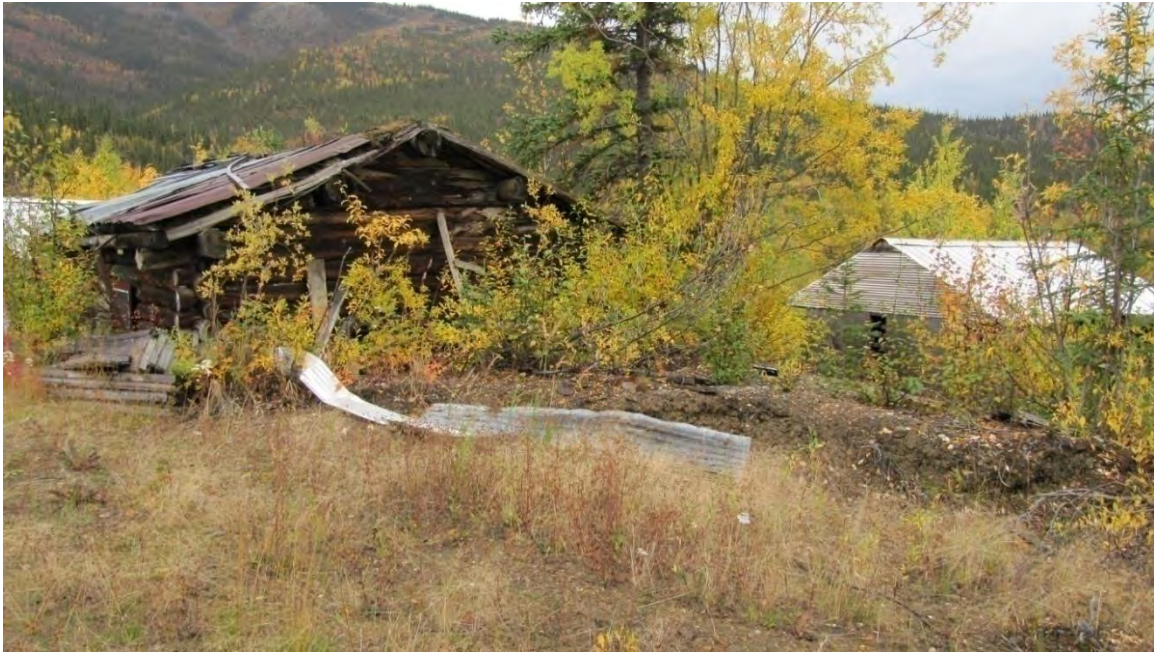
Plate 1: Site 1, back of log structure [2], view southwest, and more recent structure

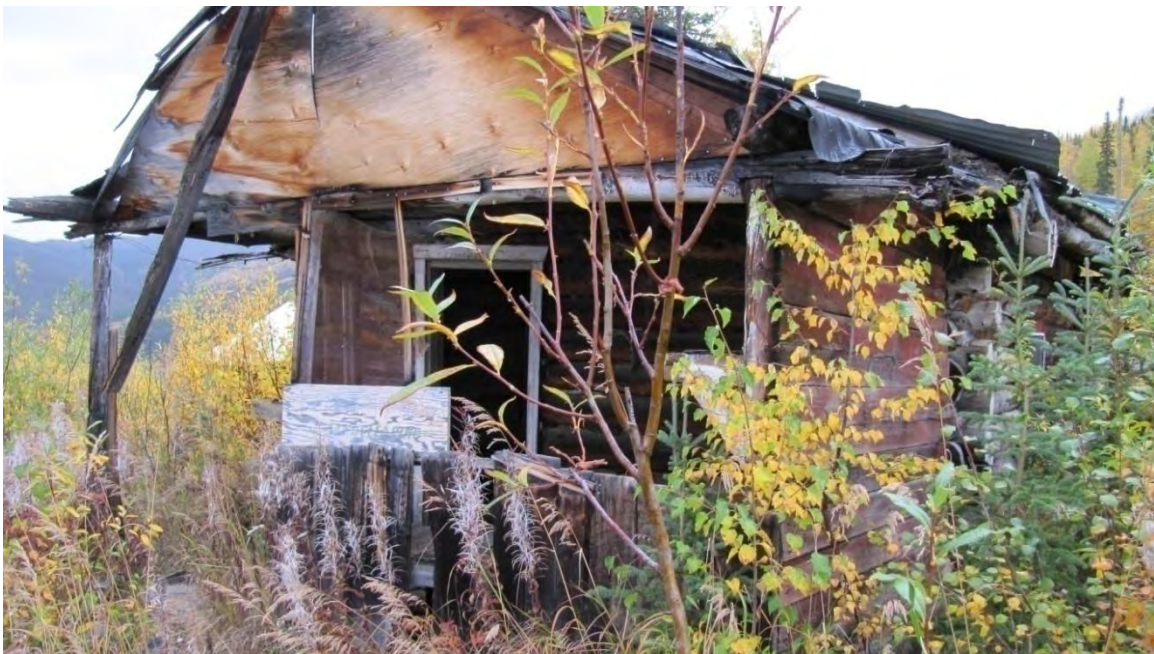
Plate 2: Site 1, front of log structure [2], view northwest

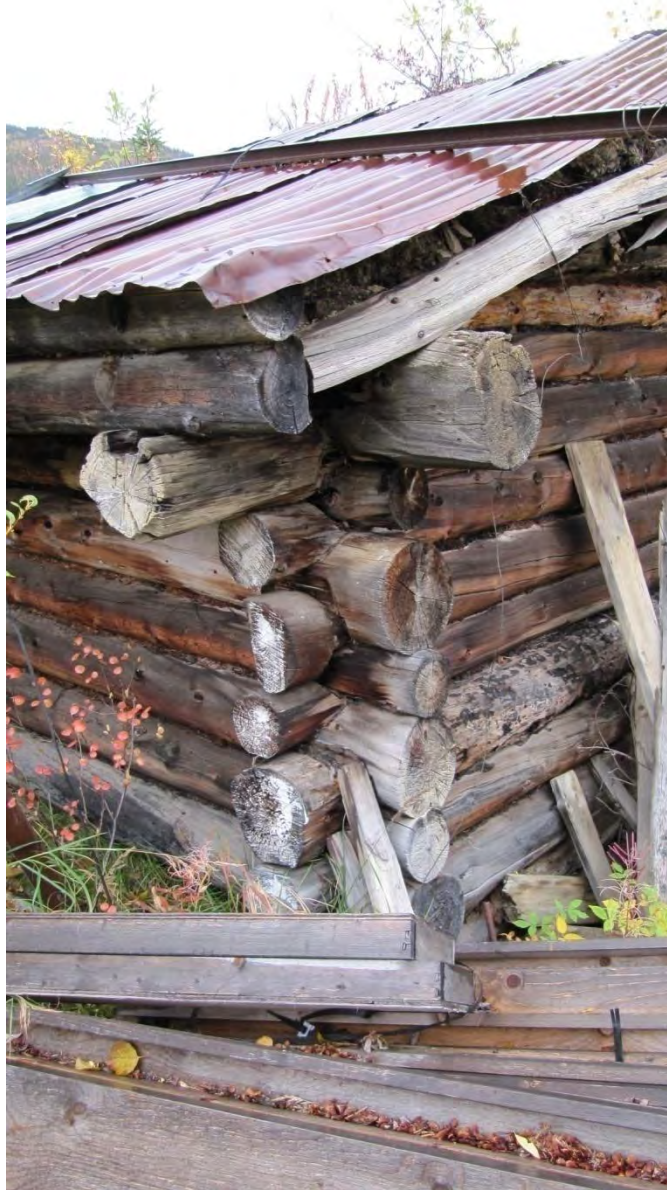
Plate 3: Site 1, close view of log structure [2] construction, view southwest of back corner

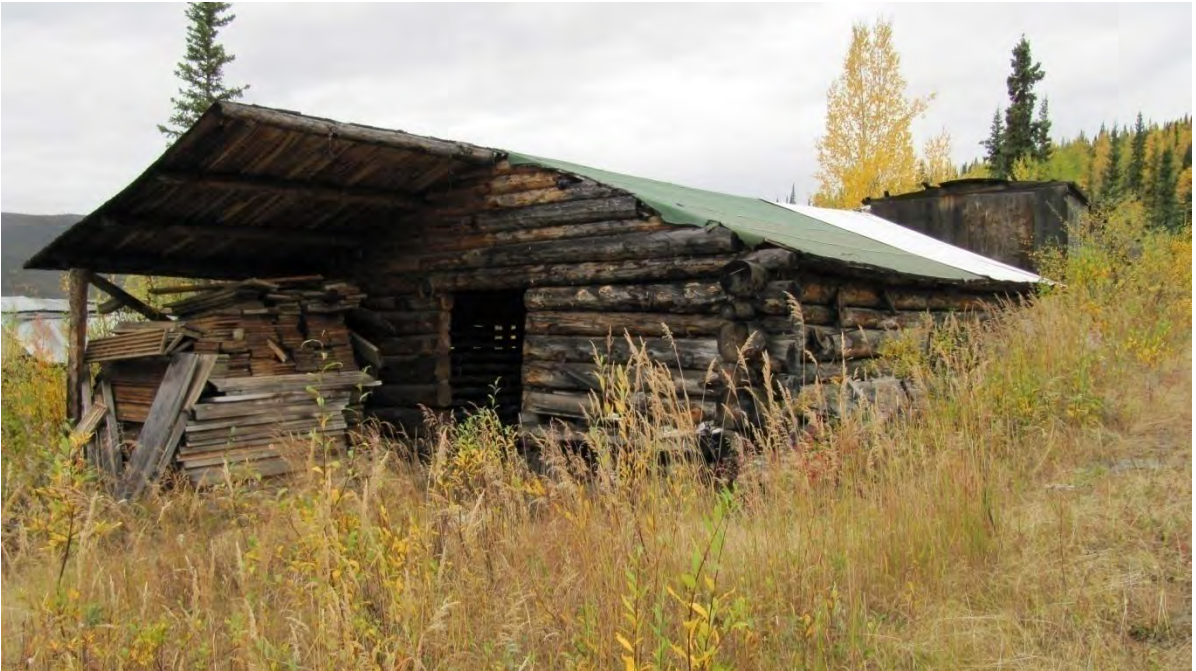
Plate 4: Site 1, view northwest of log structure [5]; note more recently constructed roof extension over front of the structure

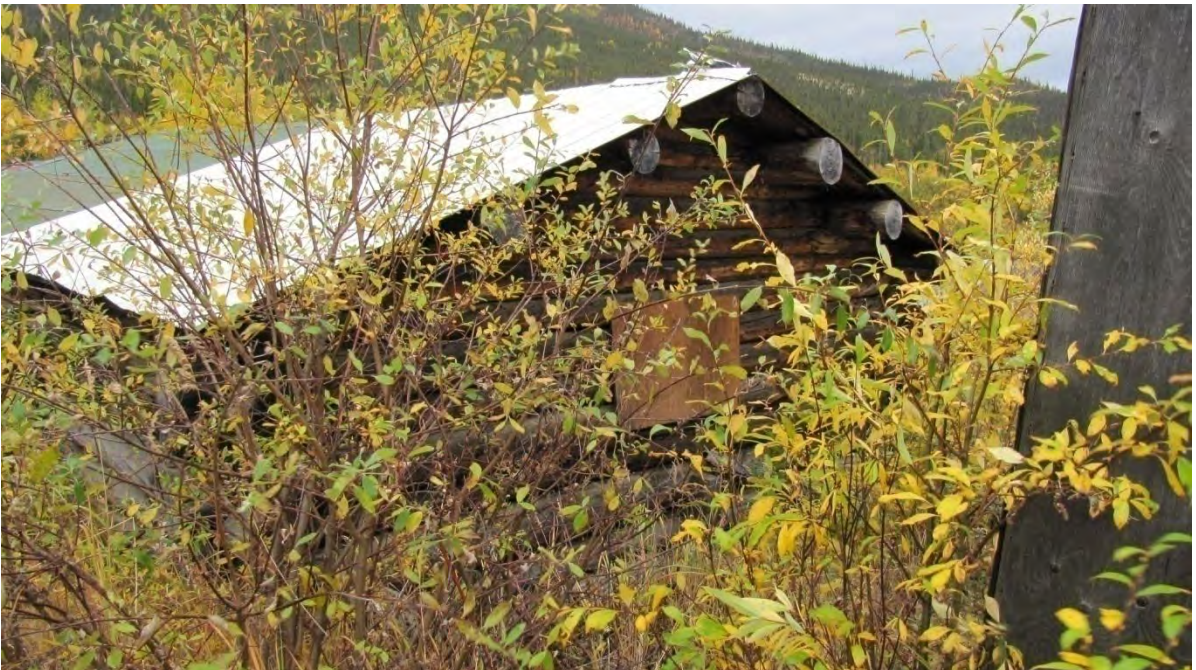
Plate 5: Site 1, back side of log structure [5], view southwest

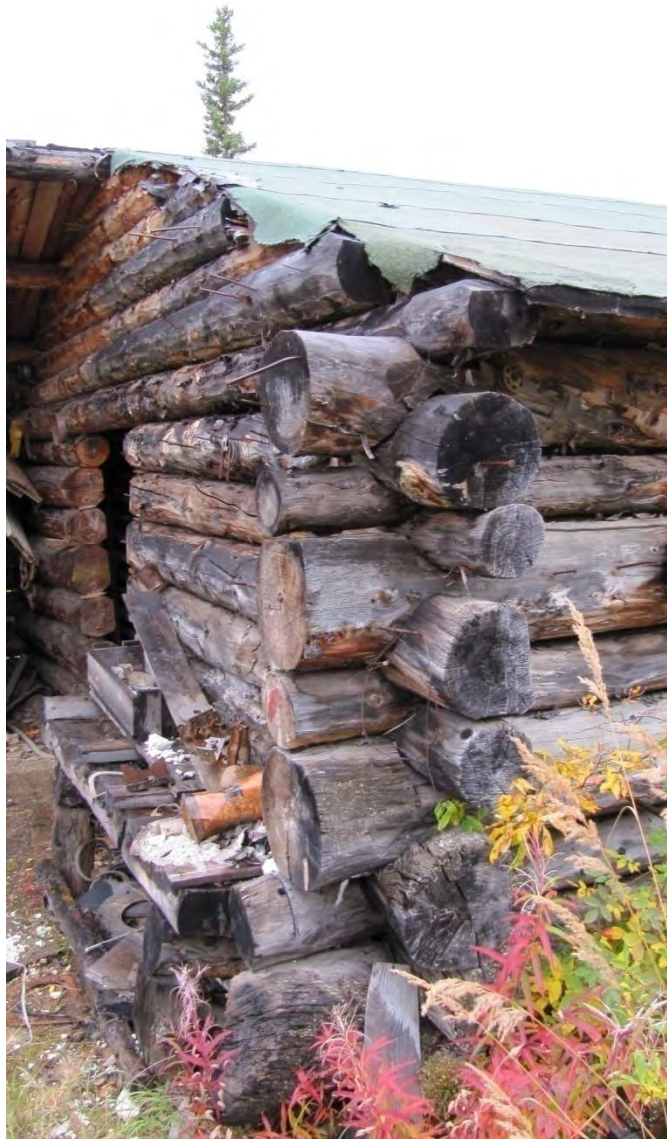
Plate 6: Site 1, log structure [5], view northwest at structure details

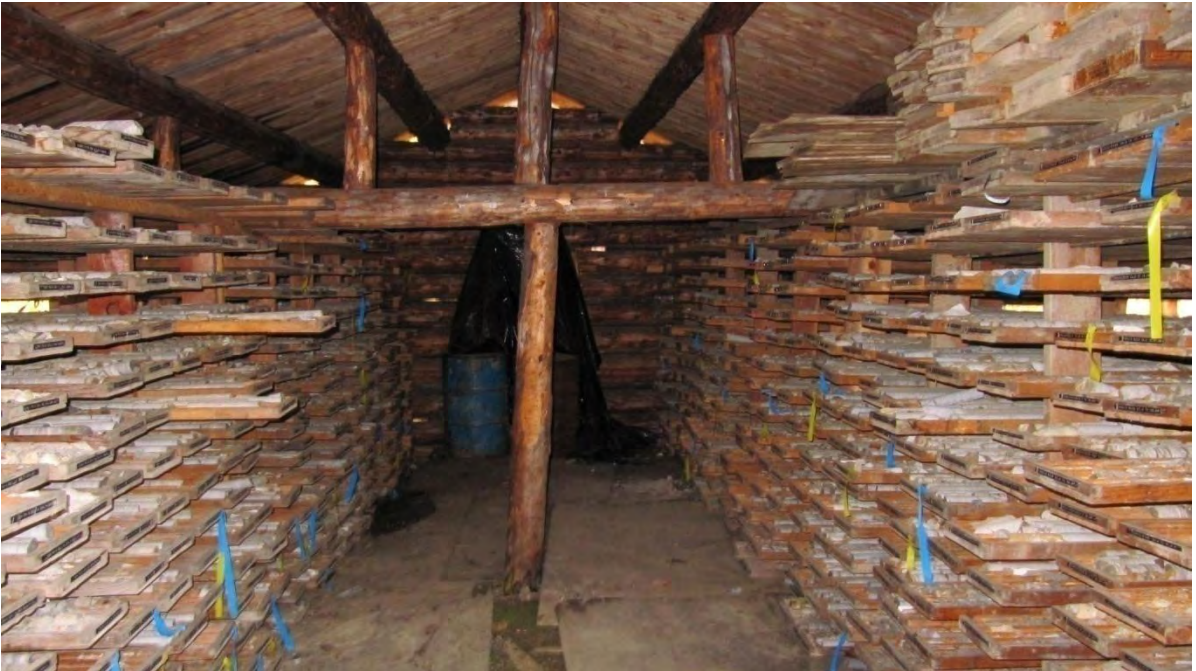
Plate 7: Site 1, interior view of log structure [5], showing recent (1970s) use of the cabin as a core shack

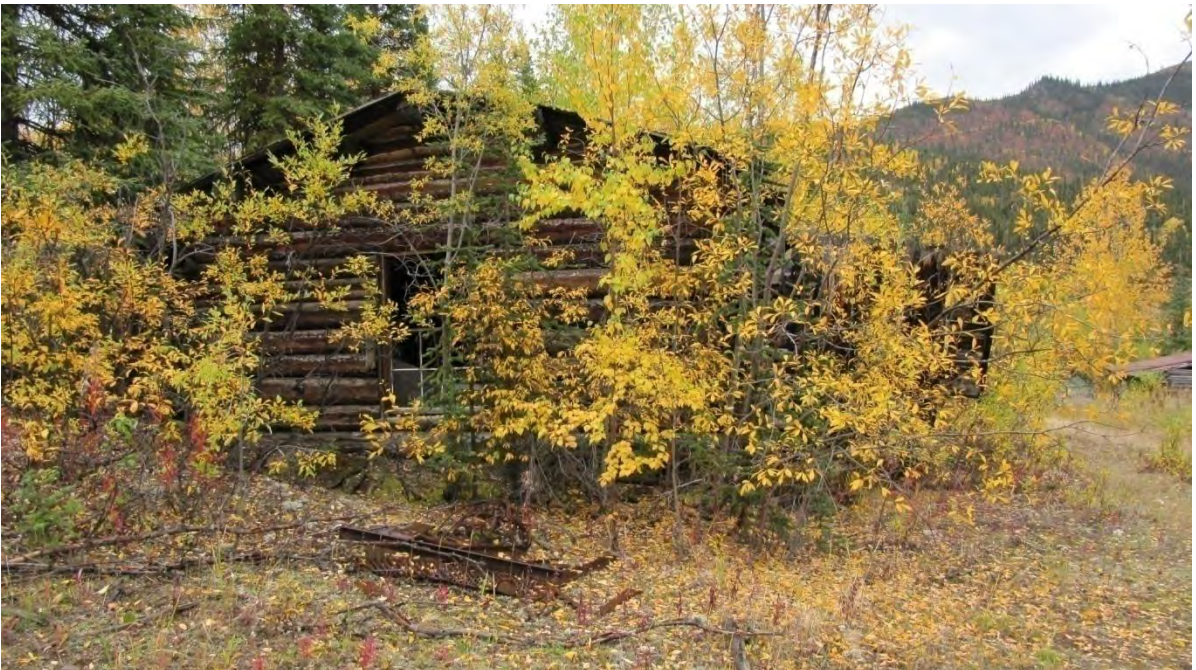
Within the “industrial” portion of the site, three log cabins or structures were identified. These log structures were used in the 1970s for storage of cores and equipment, as evidenced by the current presence of these items. However, these log structures are interpreted as being of some antiquity, clearly well over 45 years in age. The first cabin structure [2] is of some antiquity and currently contains cores and equipment (Plates 1-3). A more recent metal-roofed core shack is located adjacent to this, and cores in core boxes were observed lying around the general area. A large piece of metal equipment [1] assumed to be from the 1970s is located between the log structure and the road. The structure may be the same as that shown in *Gold and Galena* (page 324); the photo dates to 1955 and, as such, if this is the same structure, the structure predates 1955. A second log structure [5] appears to be of similar antiquity (Plates 4-7). This structure has a roof extension over the front of the building that appears to have been added subsequent to construction of the original structure, possibly in the 1970s to shelter cores/equipment (currently situated beneath this roof extension). This structure currently contains cores that date to the 1970s (there are dates on many of the core boxes), but the structure is clearly much older. The third log structure identified [7] is also of some antiquity, and again currently contains cores and various equipment (Plates 8-10). Portions of this structure's roof are partially collapsed.

Plate 8: Site 1, view south of back side of log structure [7]

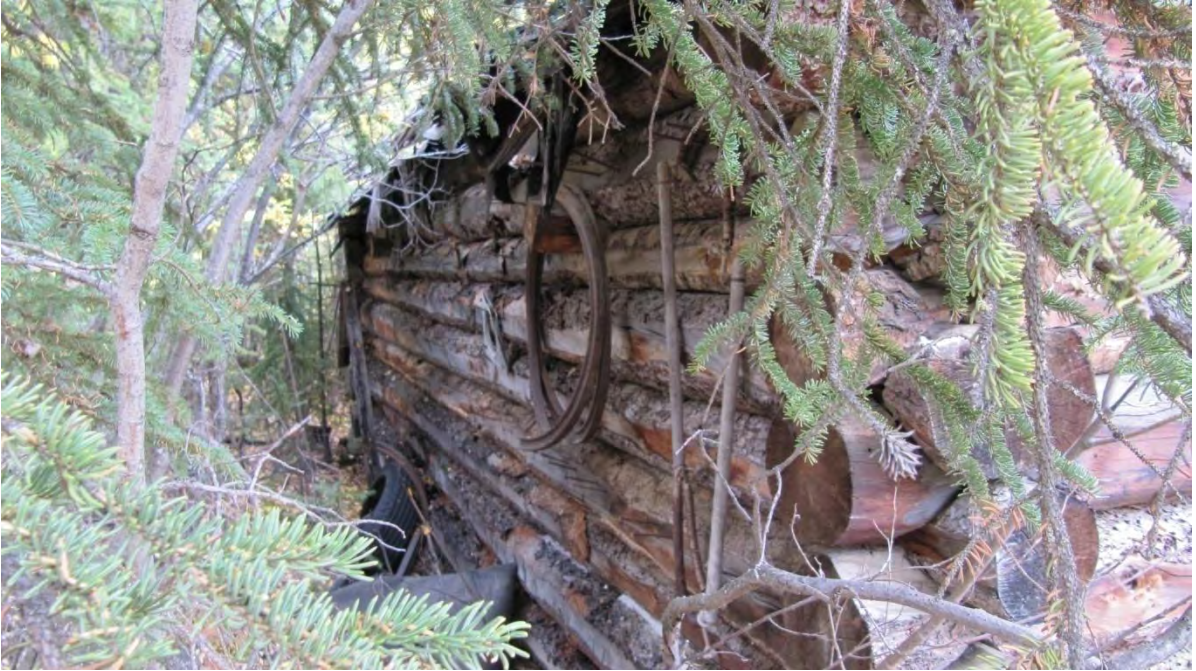
Plate 9: Site 1, view south of the east exterior wall of log structure [7] showing construction detail

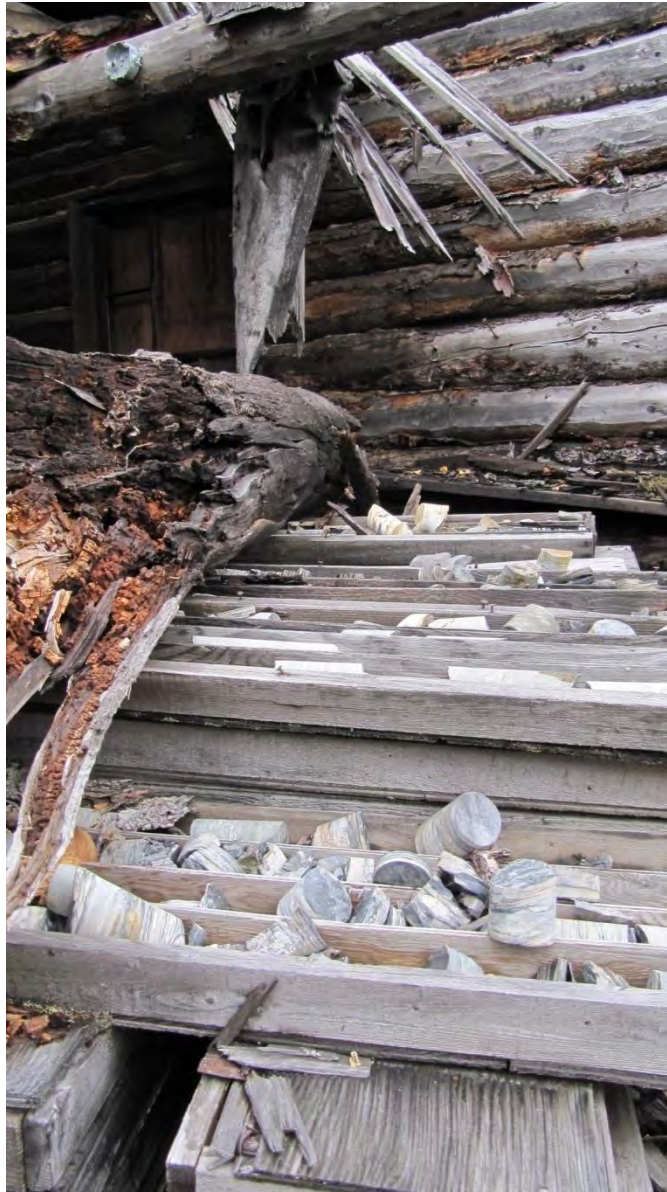
Plate 10: Site 1, view southeast of the interior of log structure [7], showing collapsed roof and recent (1970s) use of the cabin for core storage

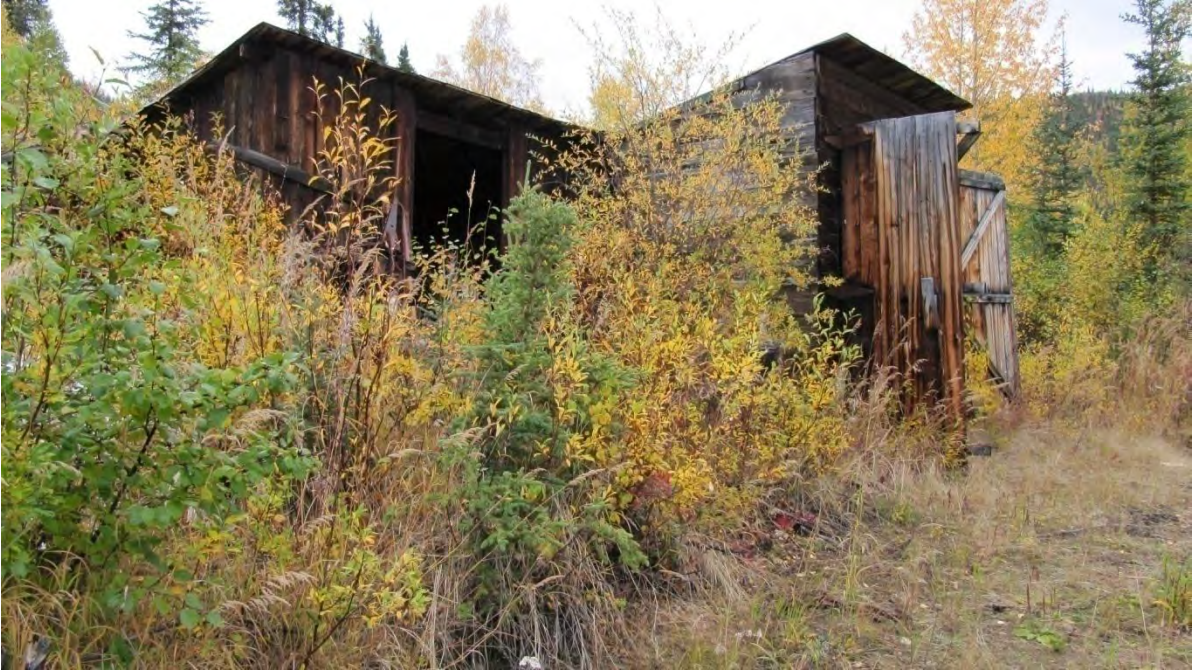
Plate 11: Site 1, view southeast of plank shacks [4]

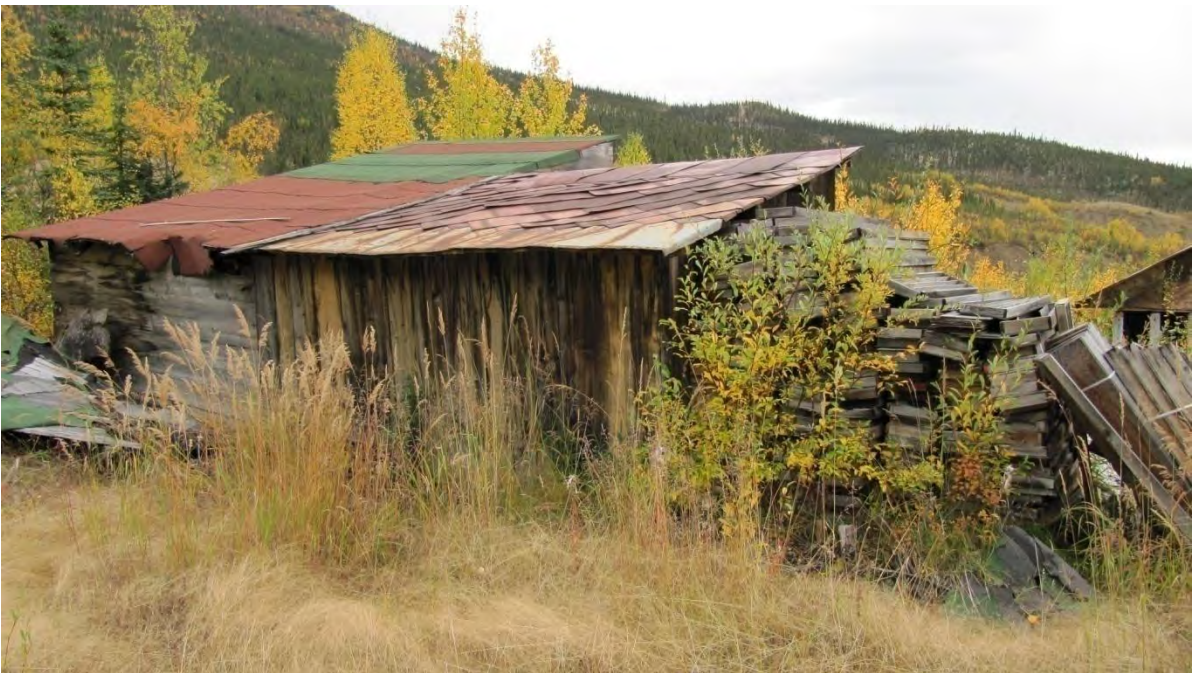
Plate 12: Site 1, view southwest showing the back side and partial metal roof of the plank structures [4]

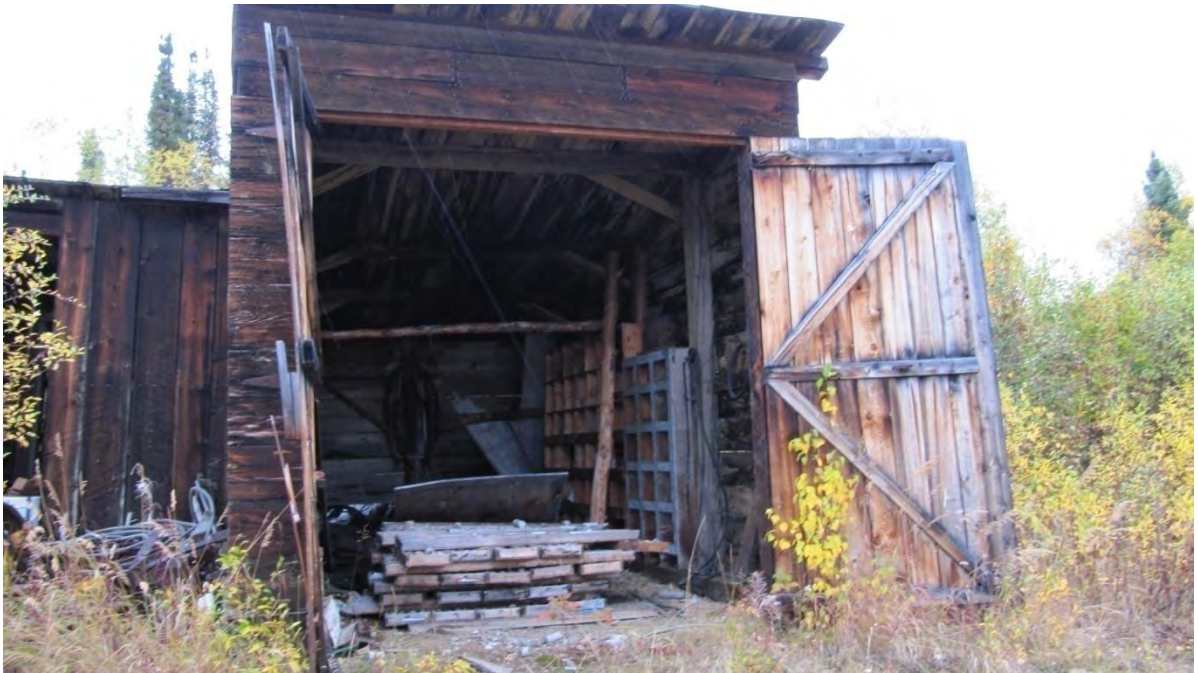
Plate 13: Site 1, view east showing interior view of the larger of two plank shacks [4]

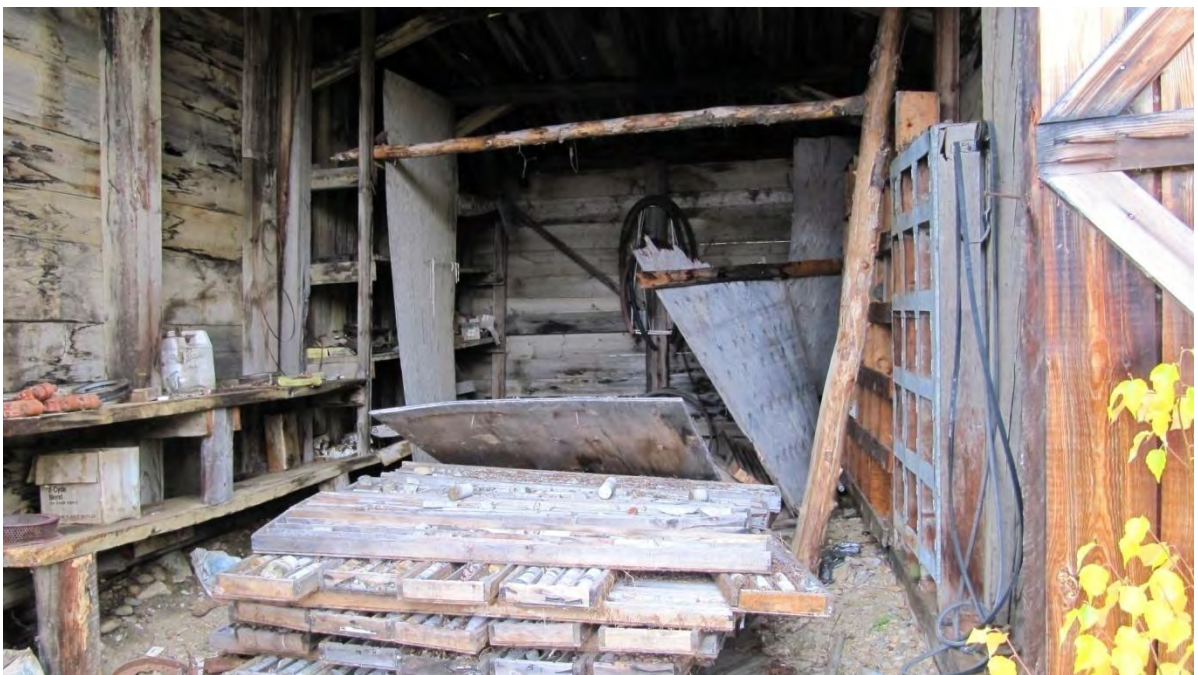
Plate 14: Site 1, view east showing detail of the interior of the larger of two plank shacks [4]

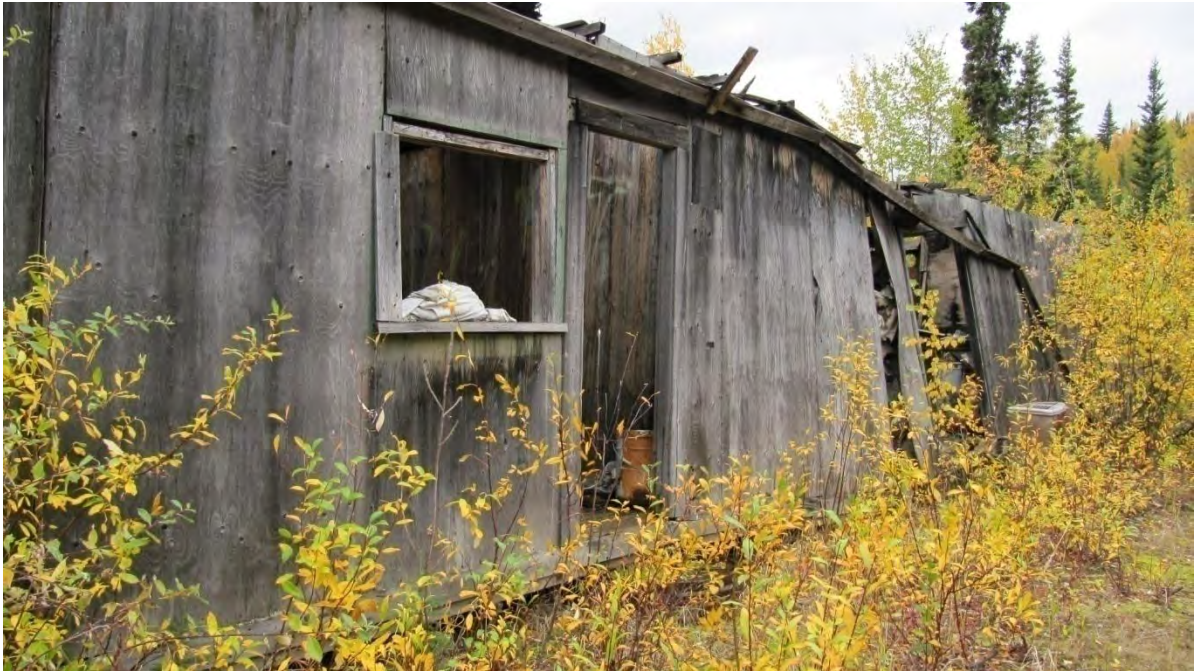
Plate 15: Site 1, plank/board/plywood structure [6], view northwest

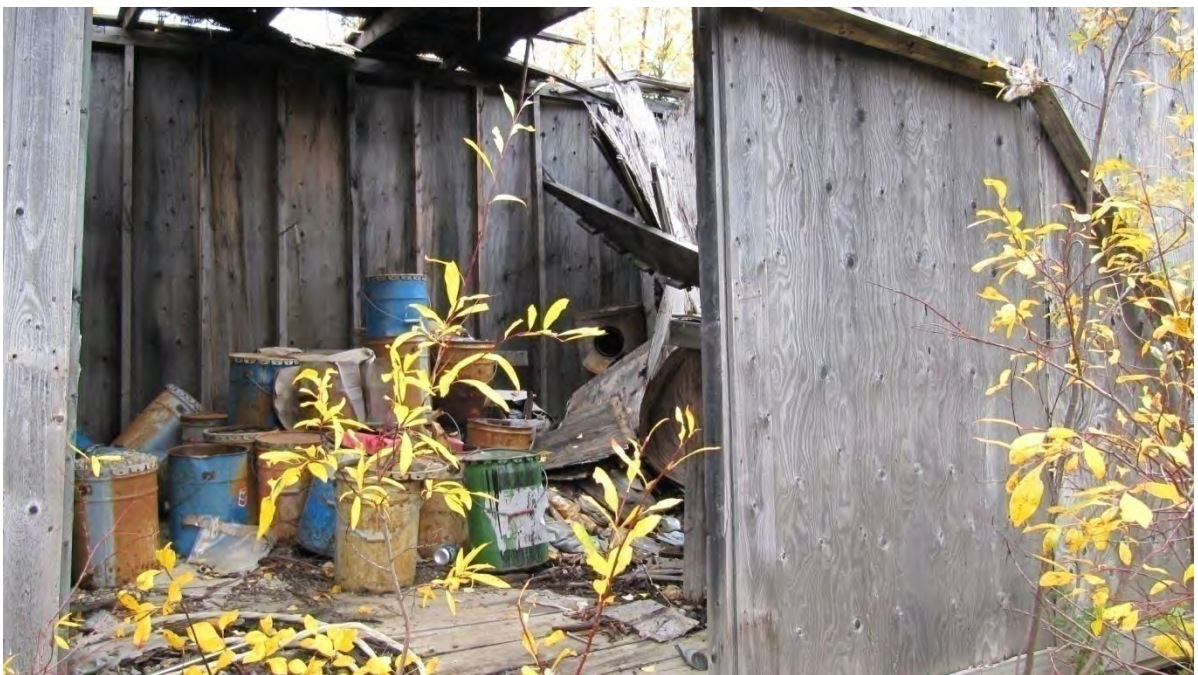
Plate 16: Site 1, interior view west of structure [6]

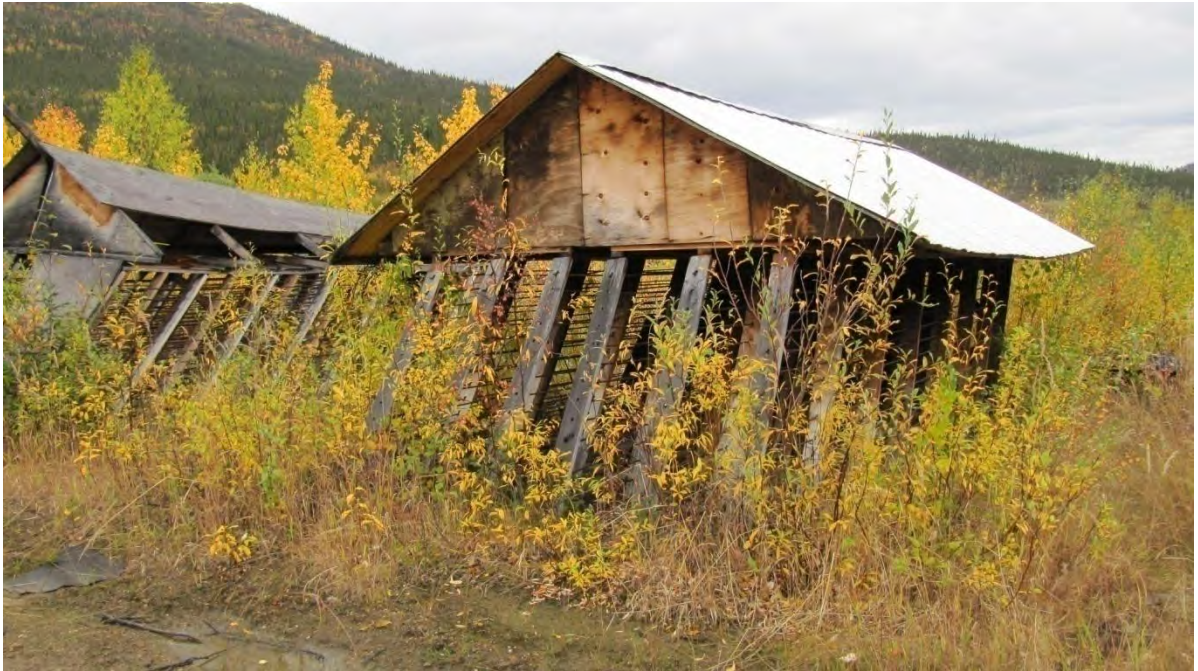
Plate 17: Site 1, view west at core structures [3]

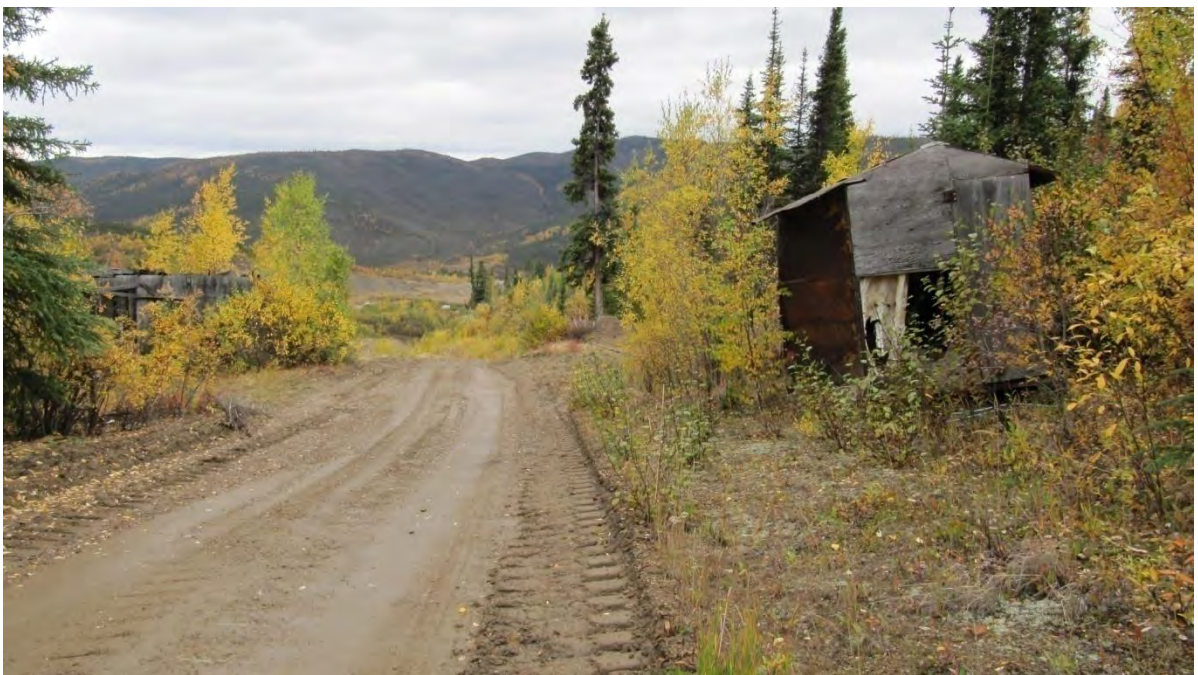
Plate 18: Site 1, small structure [11], view west

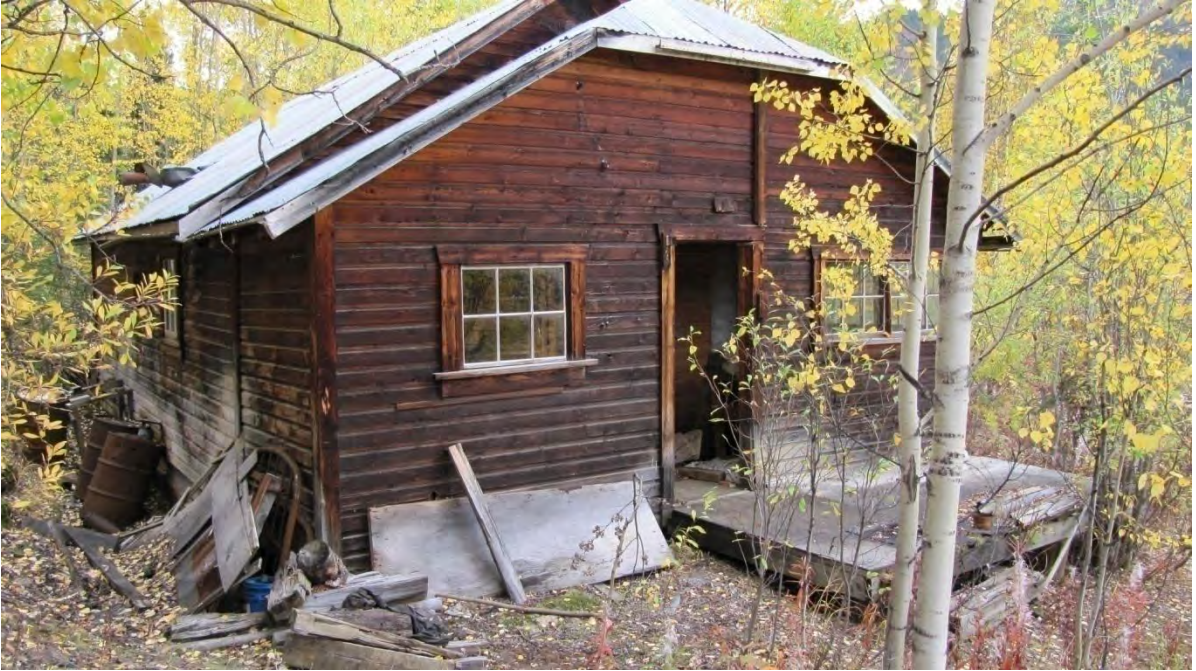
Plate 19: Site 1, house [8], view southeast

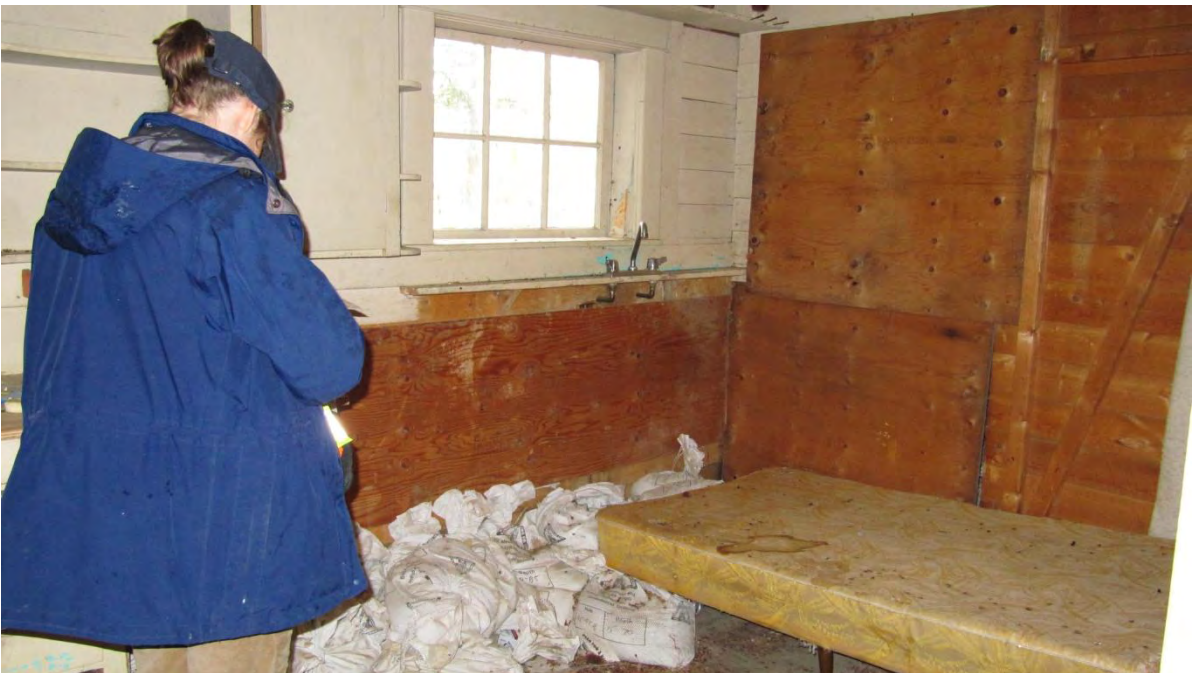
Plate 20: Site 1, house [8] interior, main floor, back room

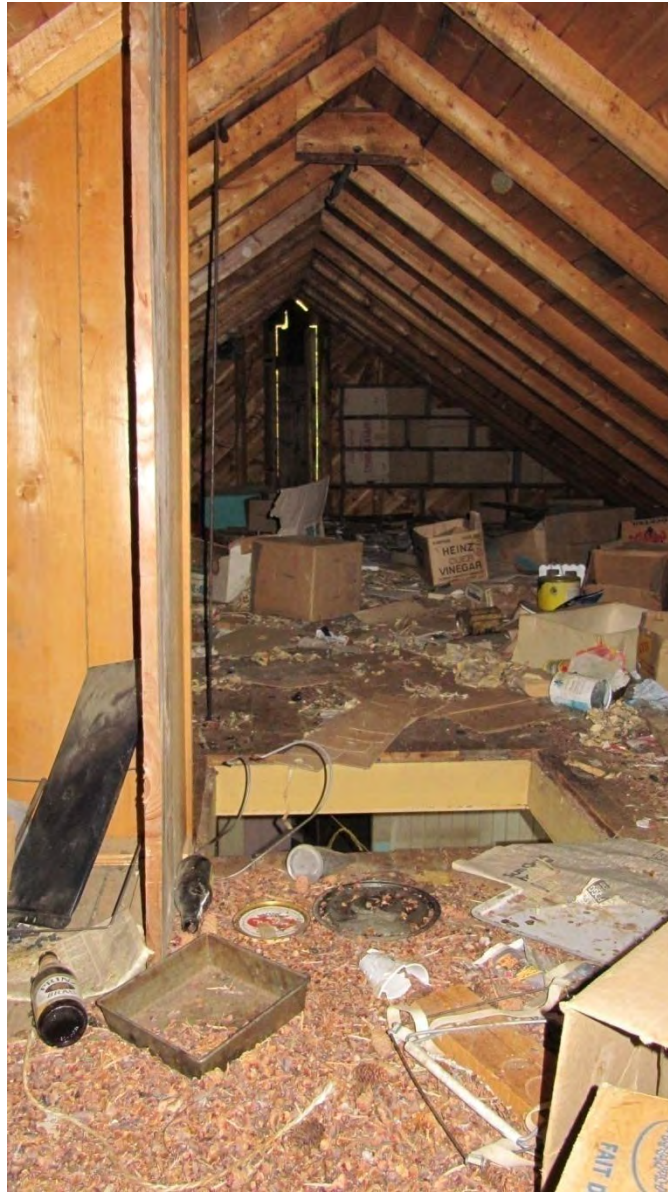
Plate 21: Site 1, house [8] interior, attic/second floor

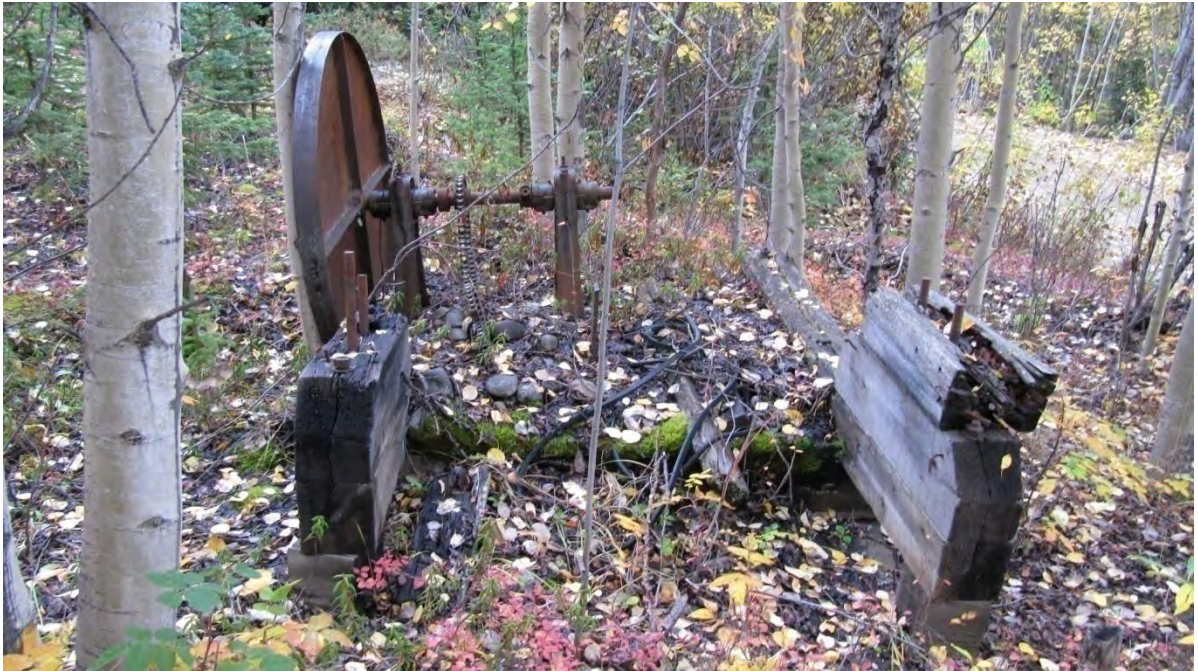
Plate 22: Site 1, equipment observed behind the house [8], view east

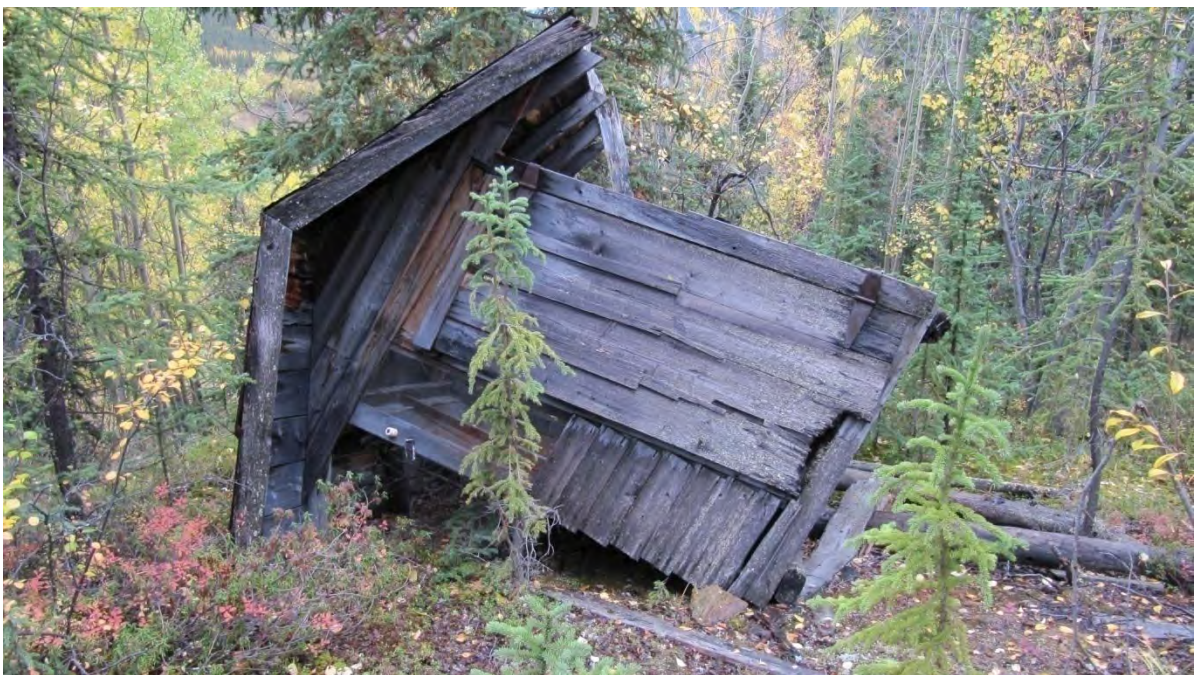
Plate 23: Site 1, small shack [10], view west

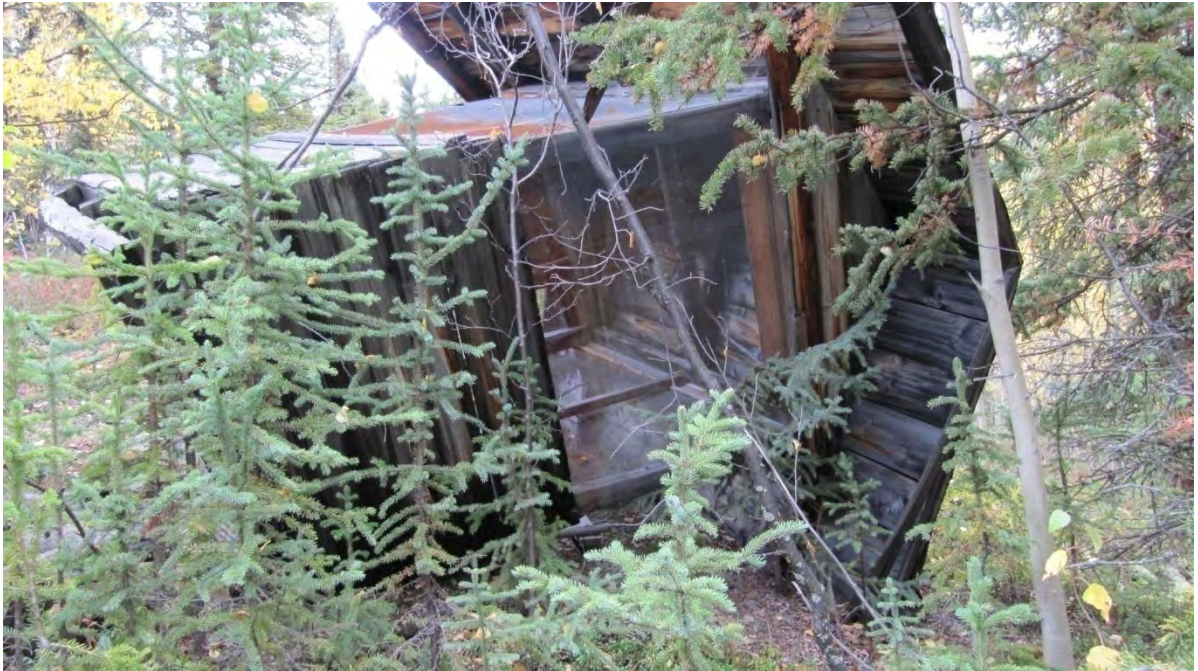
Plate 24: Site 1, small shack [10], view east

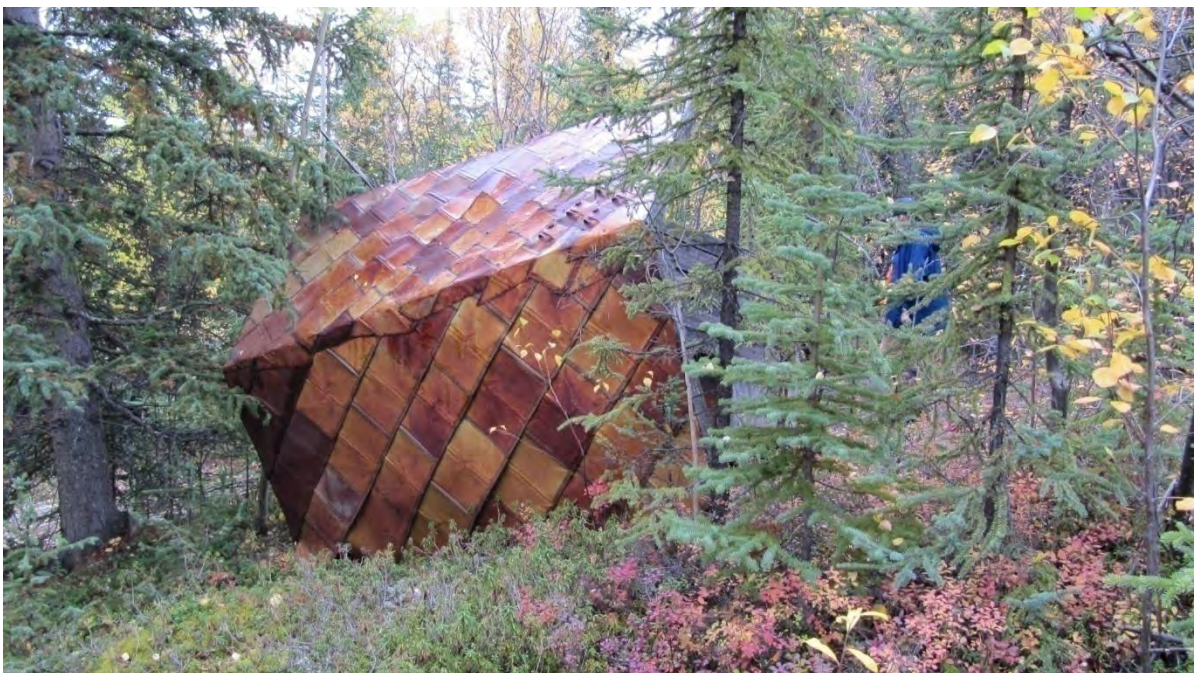
Plate 25: Site 1, metal roof of small shack [10], view north

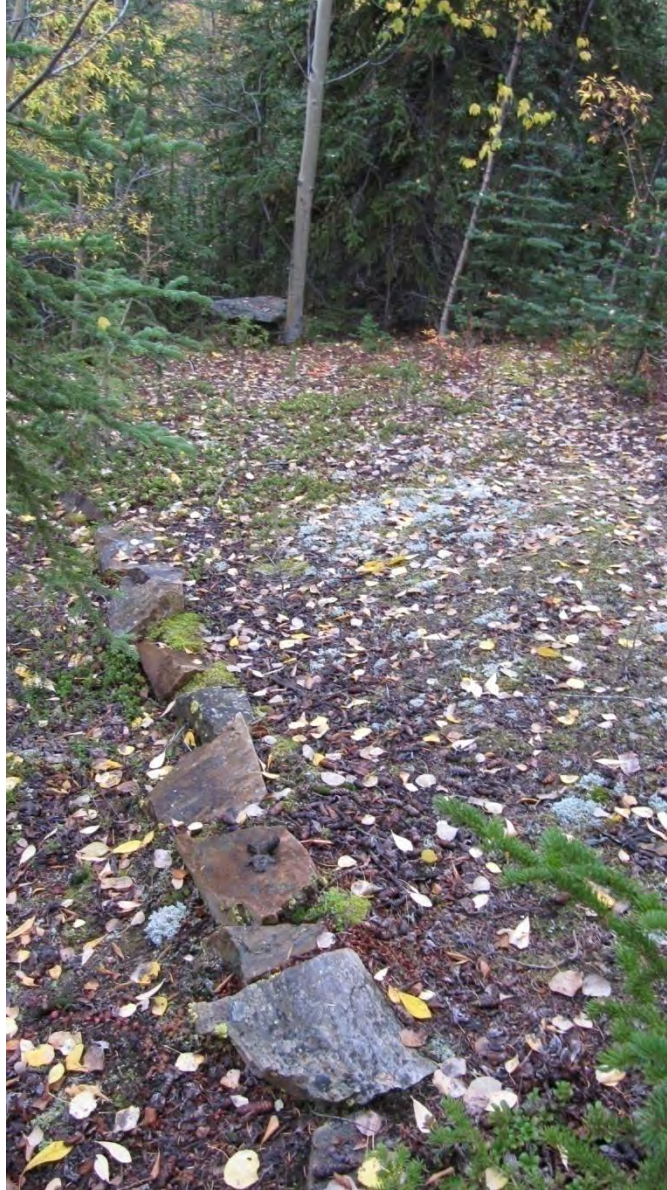
Adjacent to the small shack, a rectangular rock outline [9] was observed on the ground surface (Plate 26). The rectangular outline is somewhat sodded but rocks are still visible and the outline appears to be a complete rectangle. The rocks are tightly spaced. This feature may represent the outline of a garden. Fred Taylor mentions a garden in *Gold and Galena*, but does not describe the location. This feature does not appear to represent a foundation of a structure, and no structure is visible in the photo in *Gold and Galena*. At the west end of the rock outline a "table" made of flat stones is located just below the crest of the hill. The table is low and small (child size?), made of a flat stone slab, and three upright stones (Plate 27).

Plate 26: Site 1, stone outline [9] view west along the south wall of the stone rectangle; note stone table at west end of rock outline

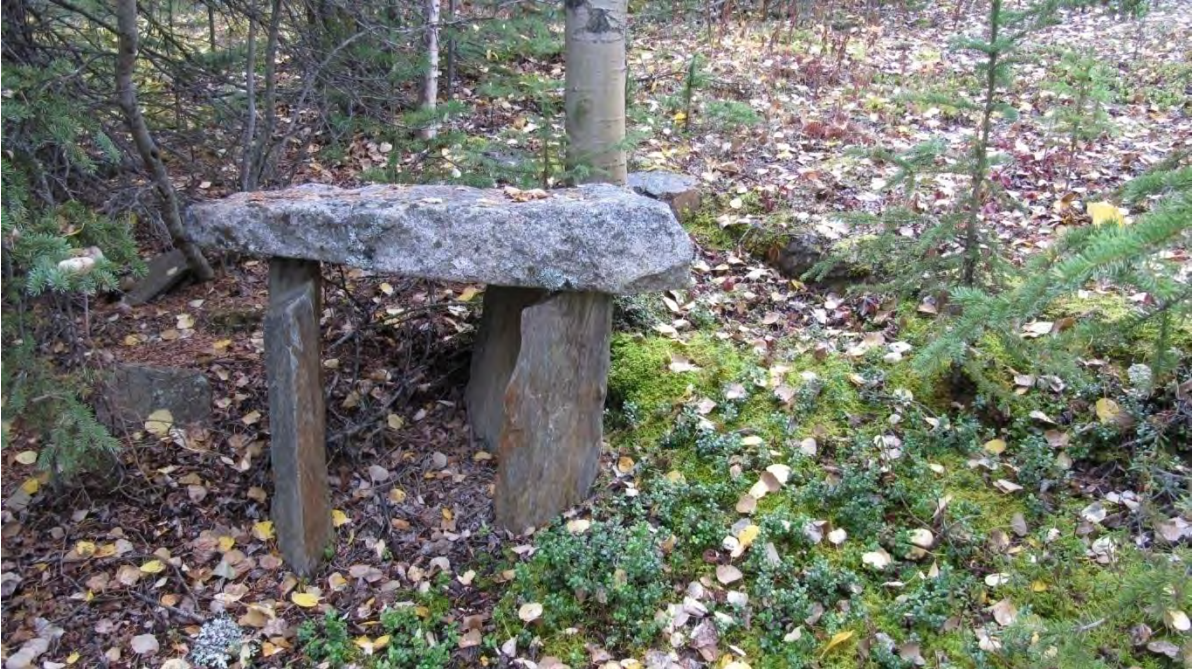
Plate 27: Site 1, stone table just west of the rock outline [9], view northeast; west side of the rectangular rock outline can be seen just to the east of the table
