Eagle Gold Project

Environmental Baseline Report: Historical Resources

FINAL REPORT

March 2010

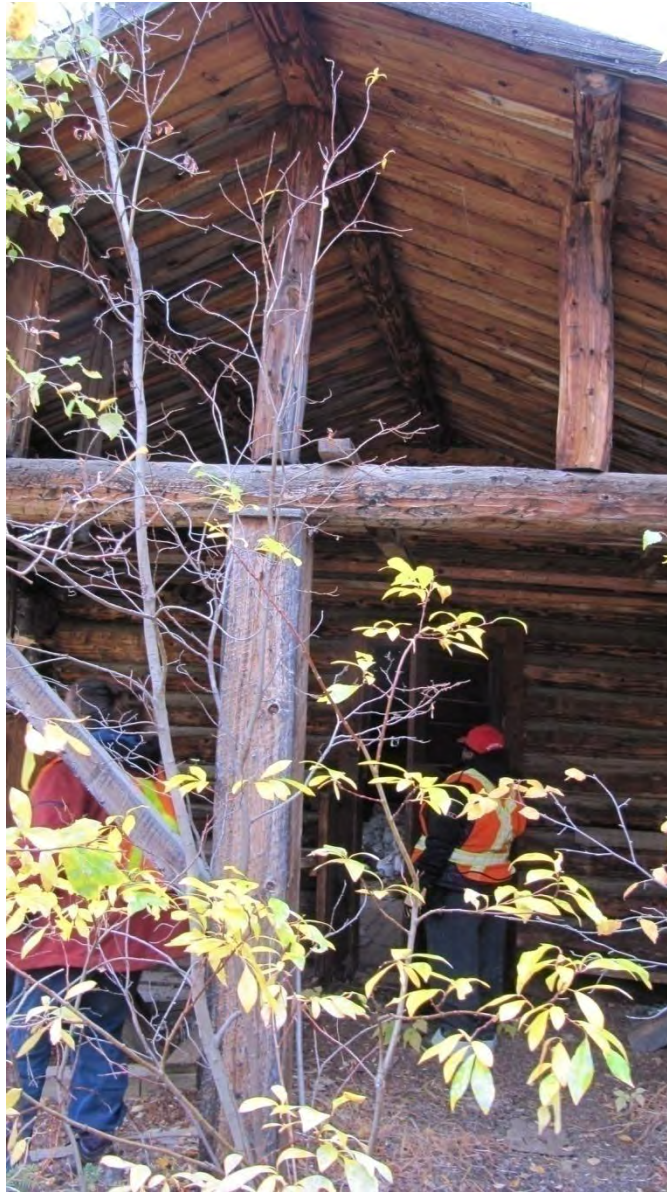
Plate 28: Site 2 structure, view west of the front of the structure; note porch with extended overhanging roof

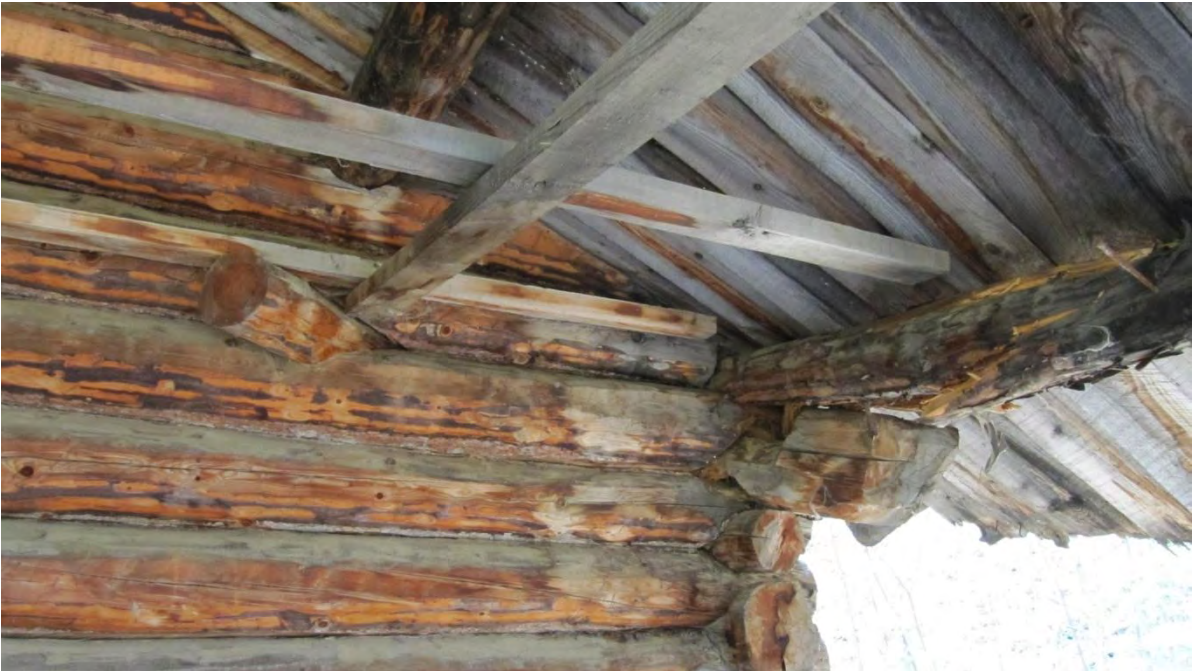
Plate 29: Site 2 structure, view northwest of roof and exterior wall detail at front of building

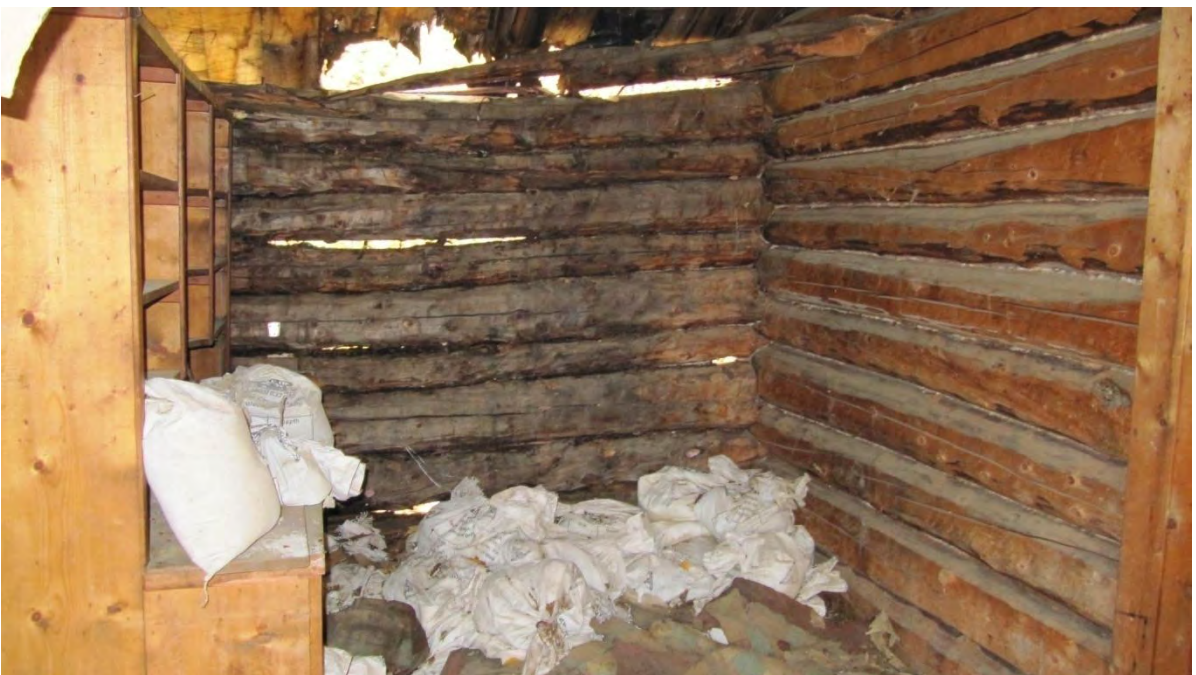
Plate 30: Site 2 structure, interior view of north wall

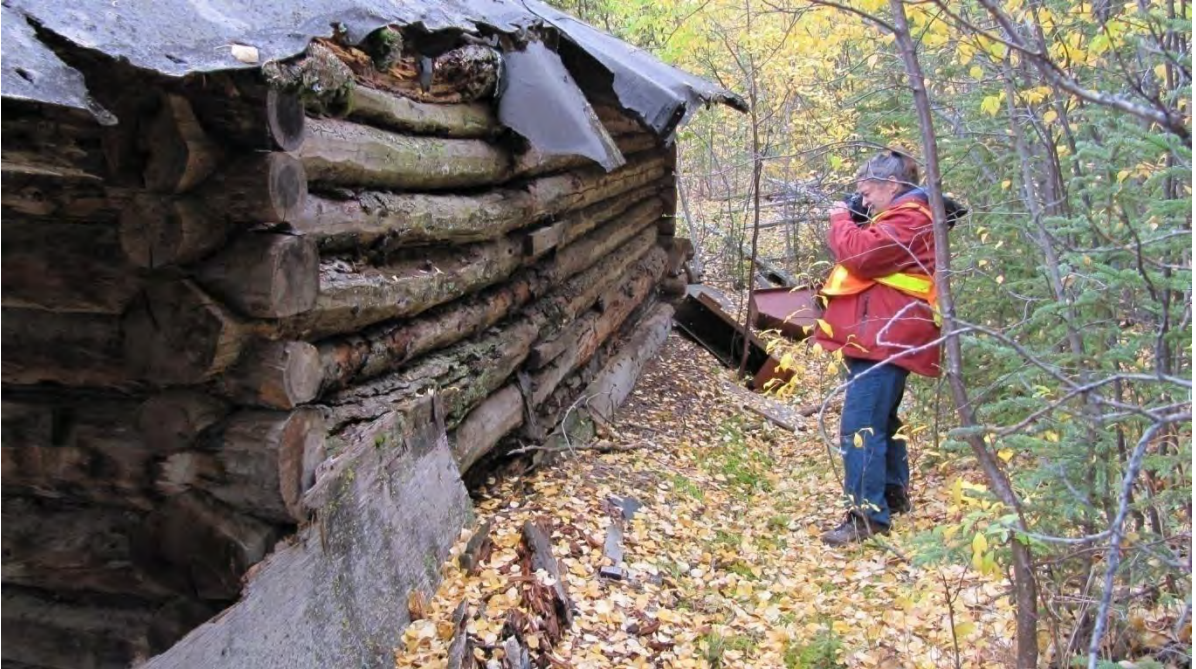
Plate 31: Site 2 structure, exterior view of north wall

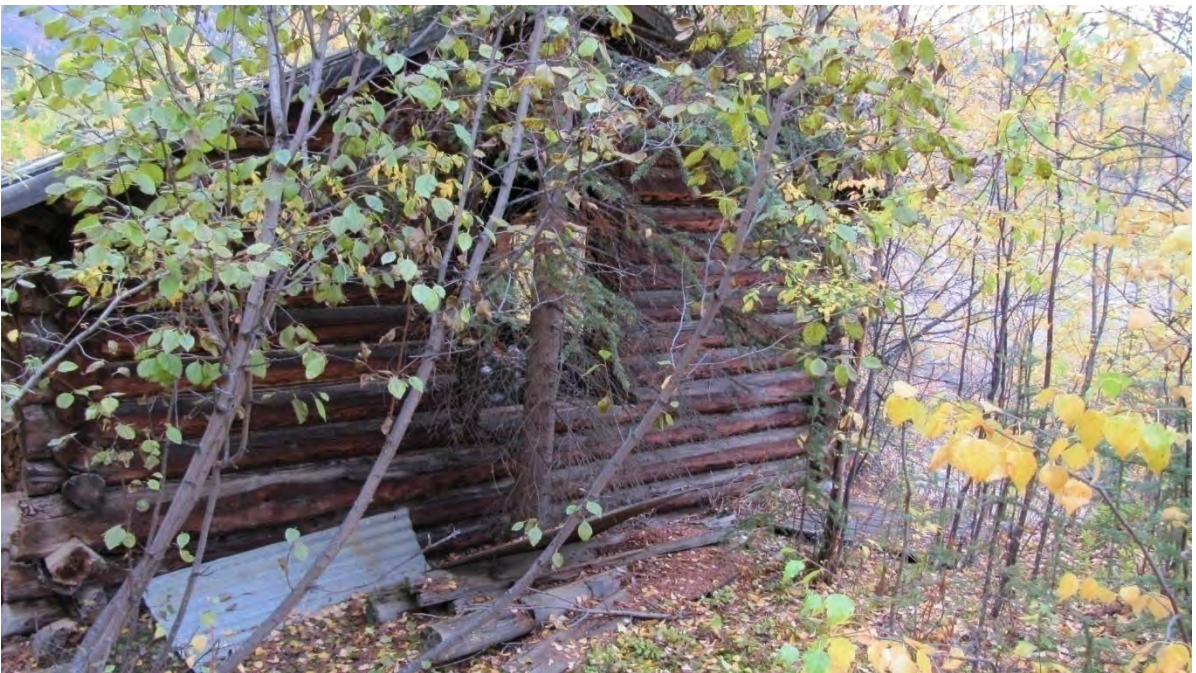
Plate 32: Site 2 structure, exterior view of back (west) wall

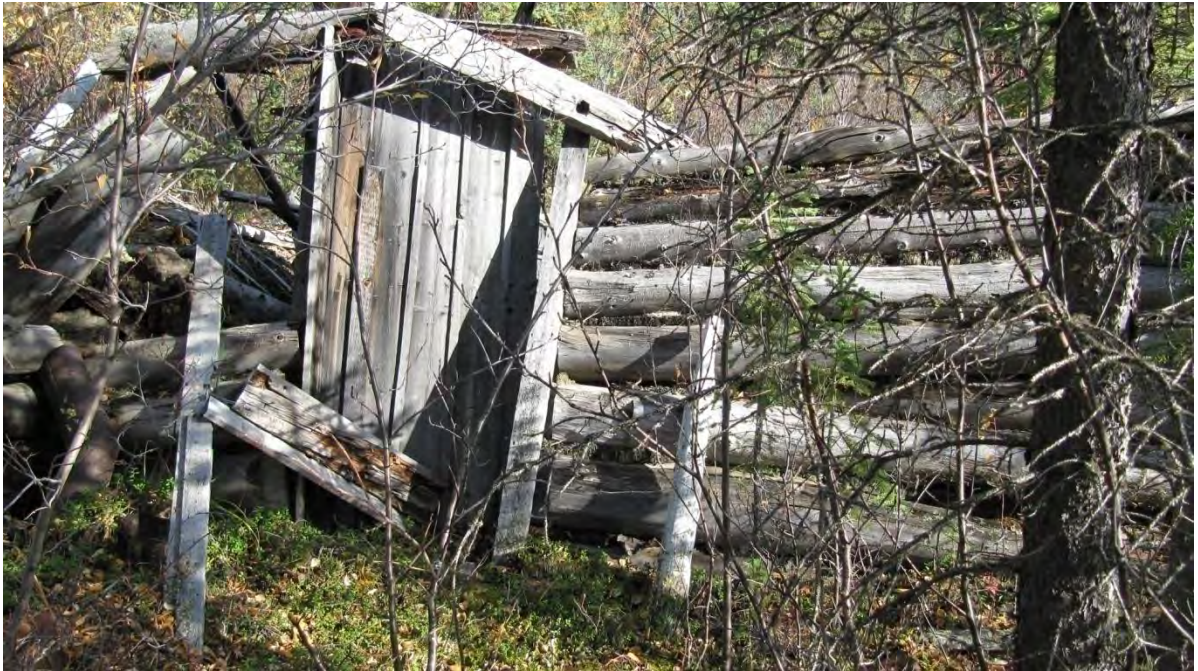
Site 3 consists of a single partially collapsed structure on a low bench just above Haggart Creek, north of the Dublin Gulch confluence (Figures 3-1 and 3-5). The building is made of sawn logs and planks that have a very weathered appearance (Plates 33 – 38). The structure has a door facing the creek (west) and a window opening (no glass observed) facing south. The structure appears to have had a sod roof. Wire drawn nails were observed on the interior walls. Some rusted cans/containers were observed around the cabin. The area around the cabin is heavily overgrown and the cabin is nearly impossible to see from the creek. No trail leading to the cabin was observed. Although the cabin is on a low bench, the area around the cabin is not very well drained, so the cabin may have been constructed in the winter. The cabin appears to be well over 45 years in age.

Plate 33: Site 3 structure, view east showing the front (door) of the cabin

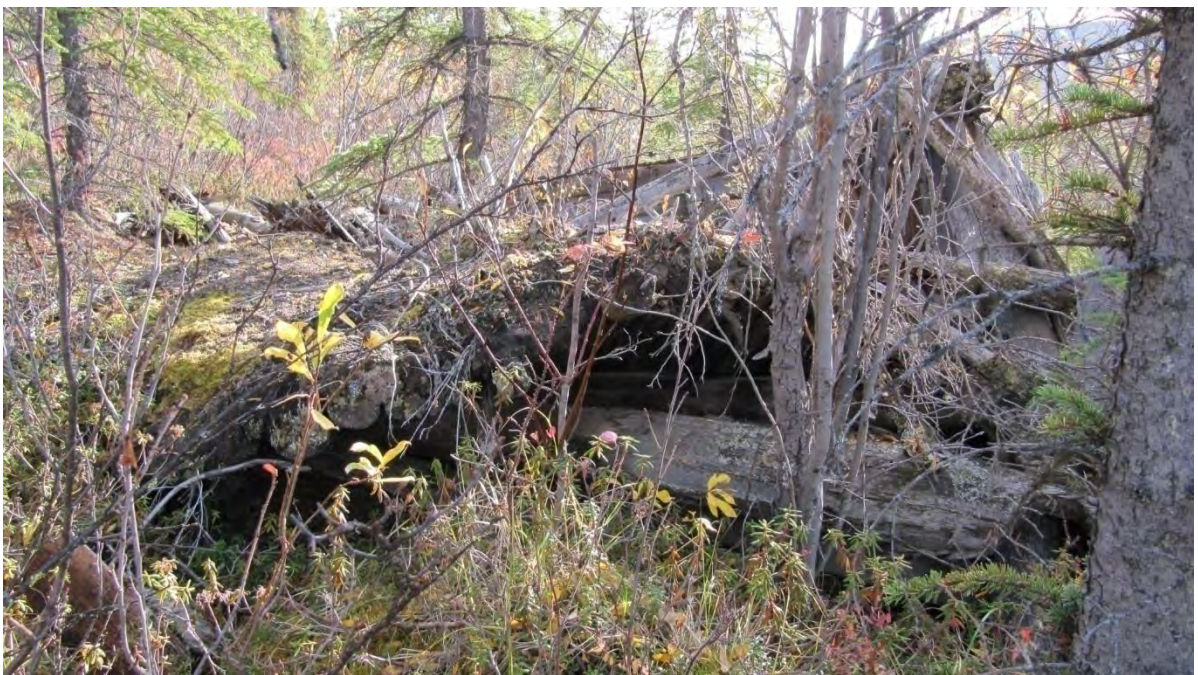
Plate 34: Site 3 structure, view south; note the sod roof

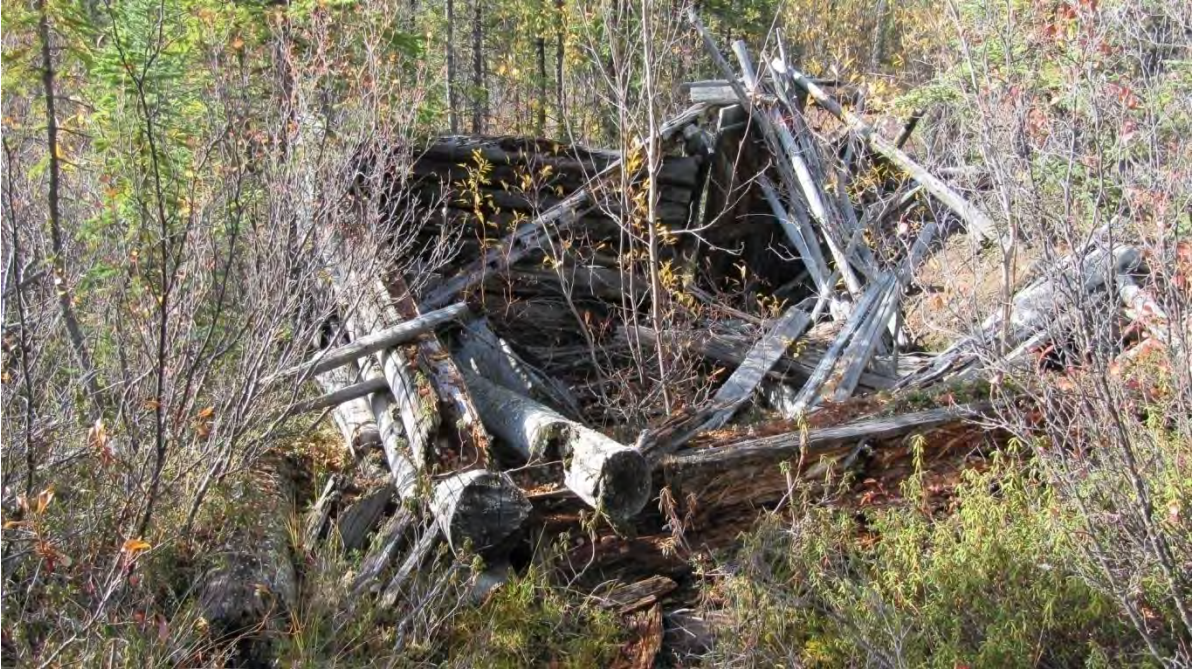
Plate 35: Site 3 structure, view west

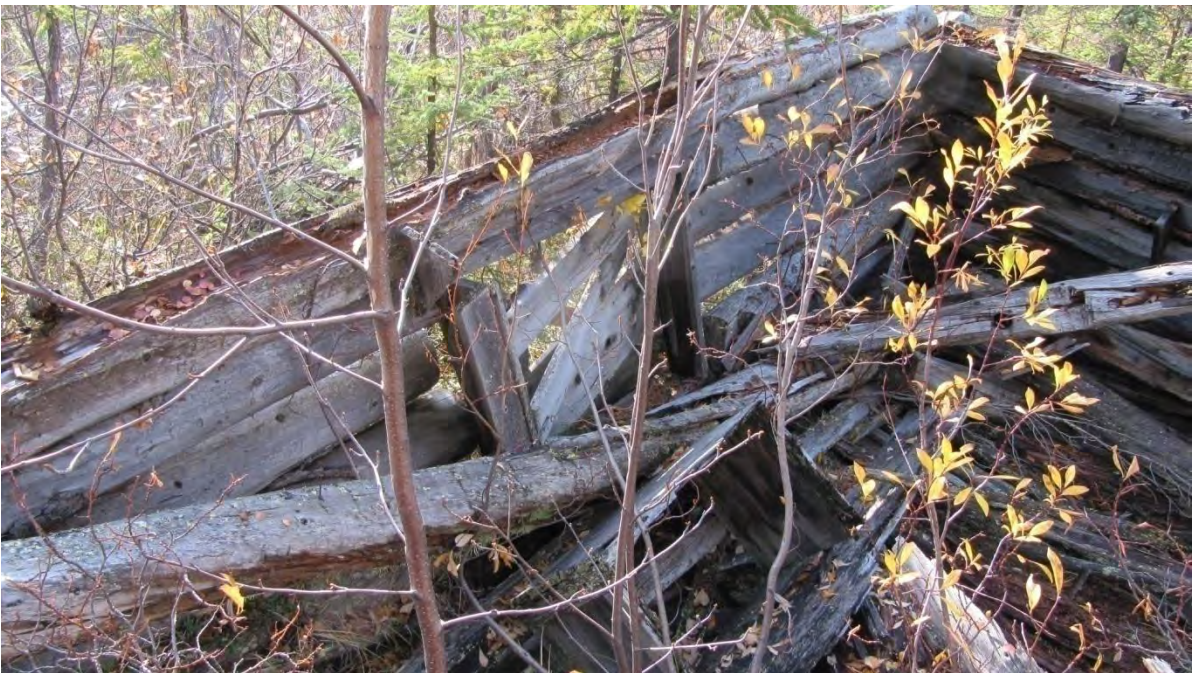
Plate 36: Site 3 structure, view southwest; note window opening on south wall

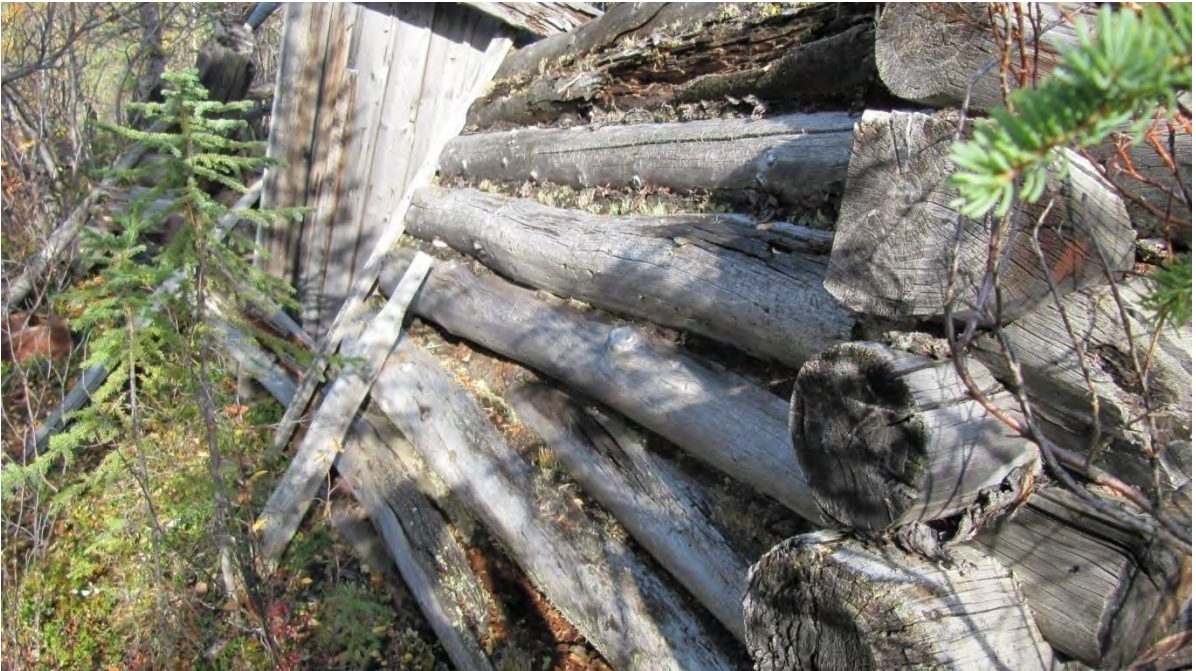
Plate 37: Site 3 structure, view northeast showing construction detail of west wall and southwest corner

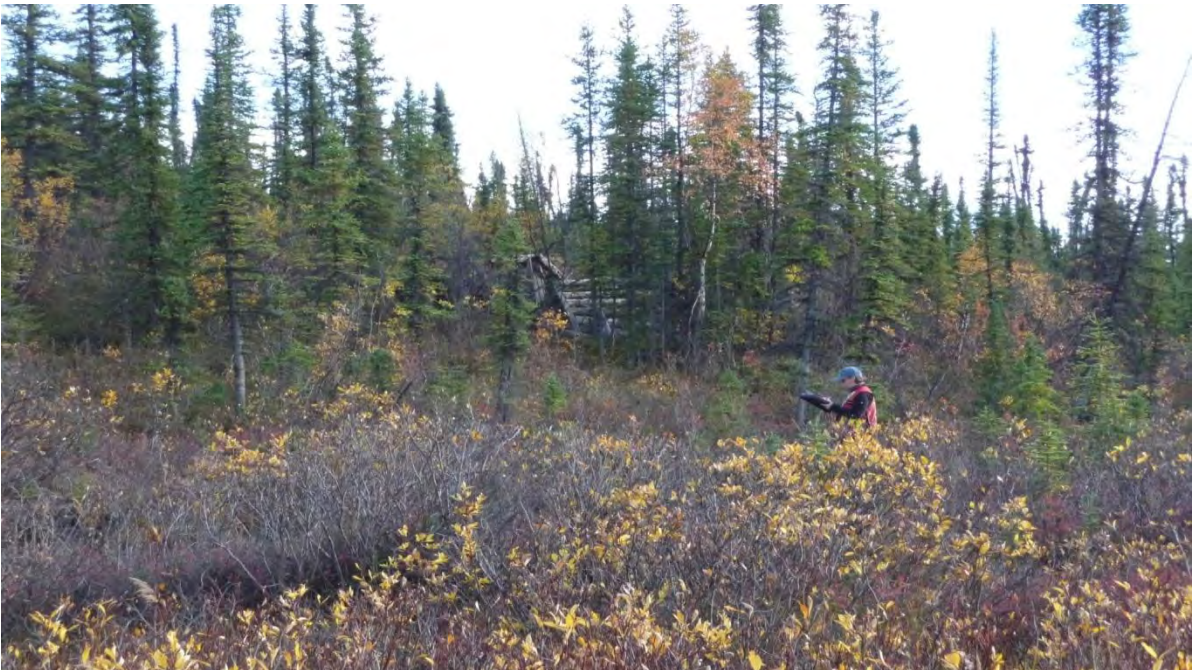
Plate 38: Site 3, view southeast from Haggart Creek to the structure located on a low bench in heavily overgrown vegetation
