Geotechnical Inspection Waste & Water Management Facilities

Ketza River Mine, Yukon Territory

Project Reference Number SRK 1CY001.003

September 2005

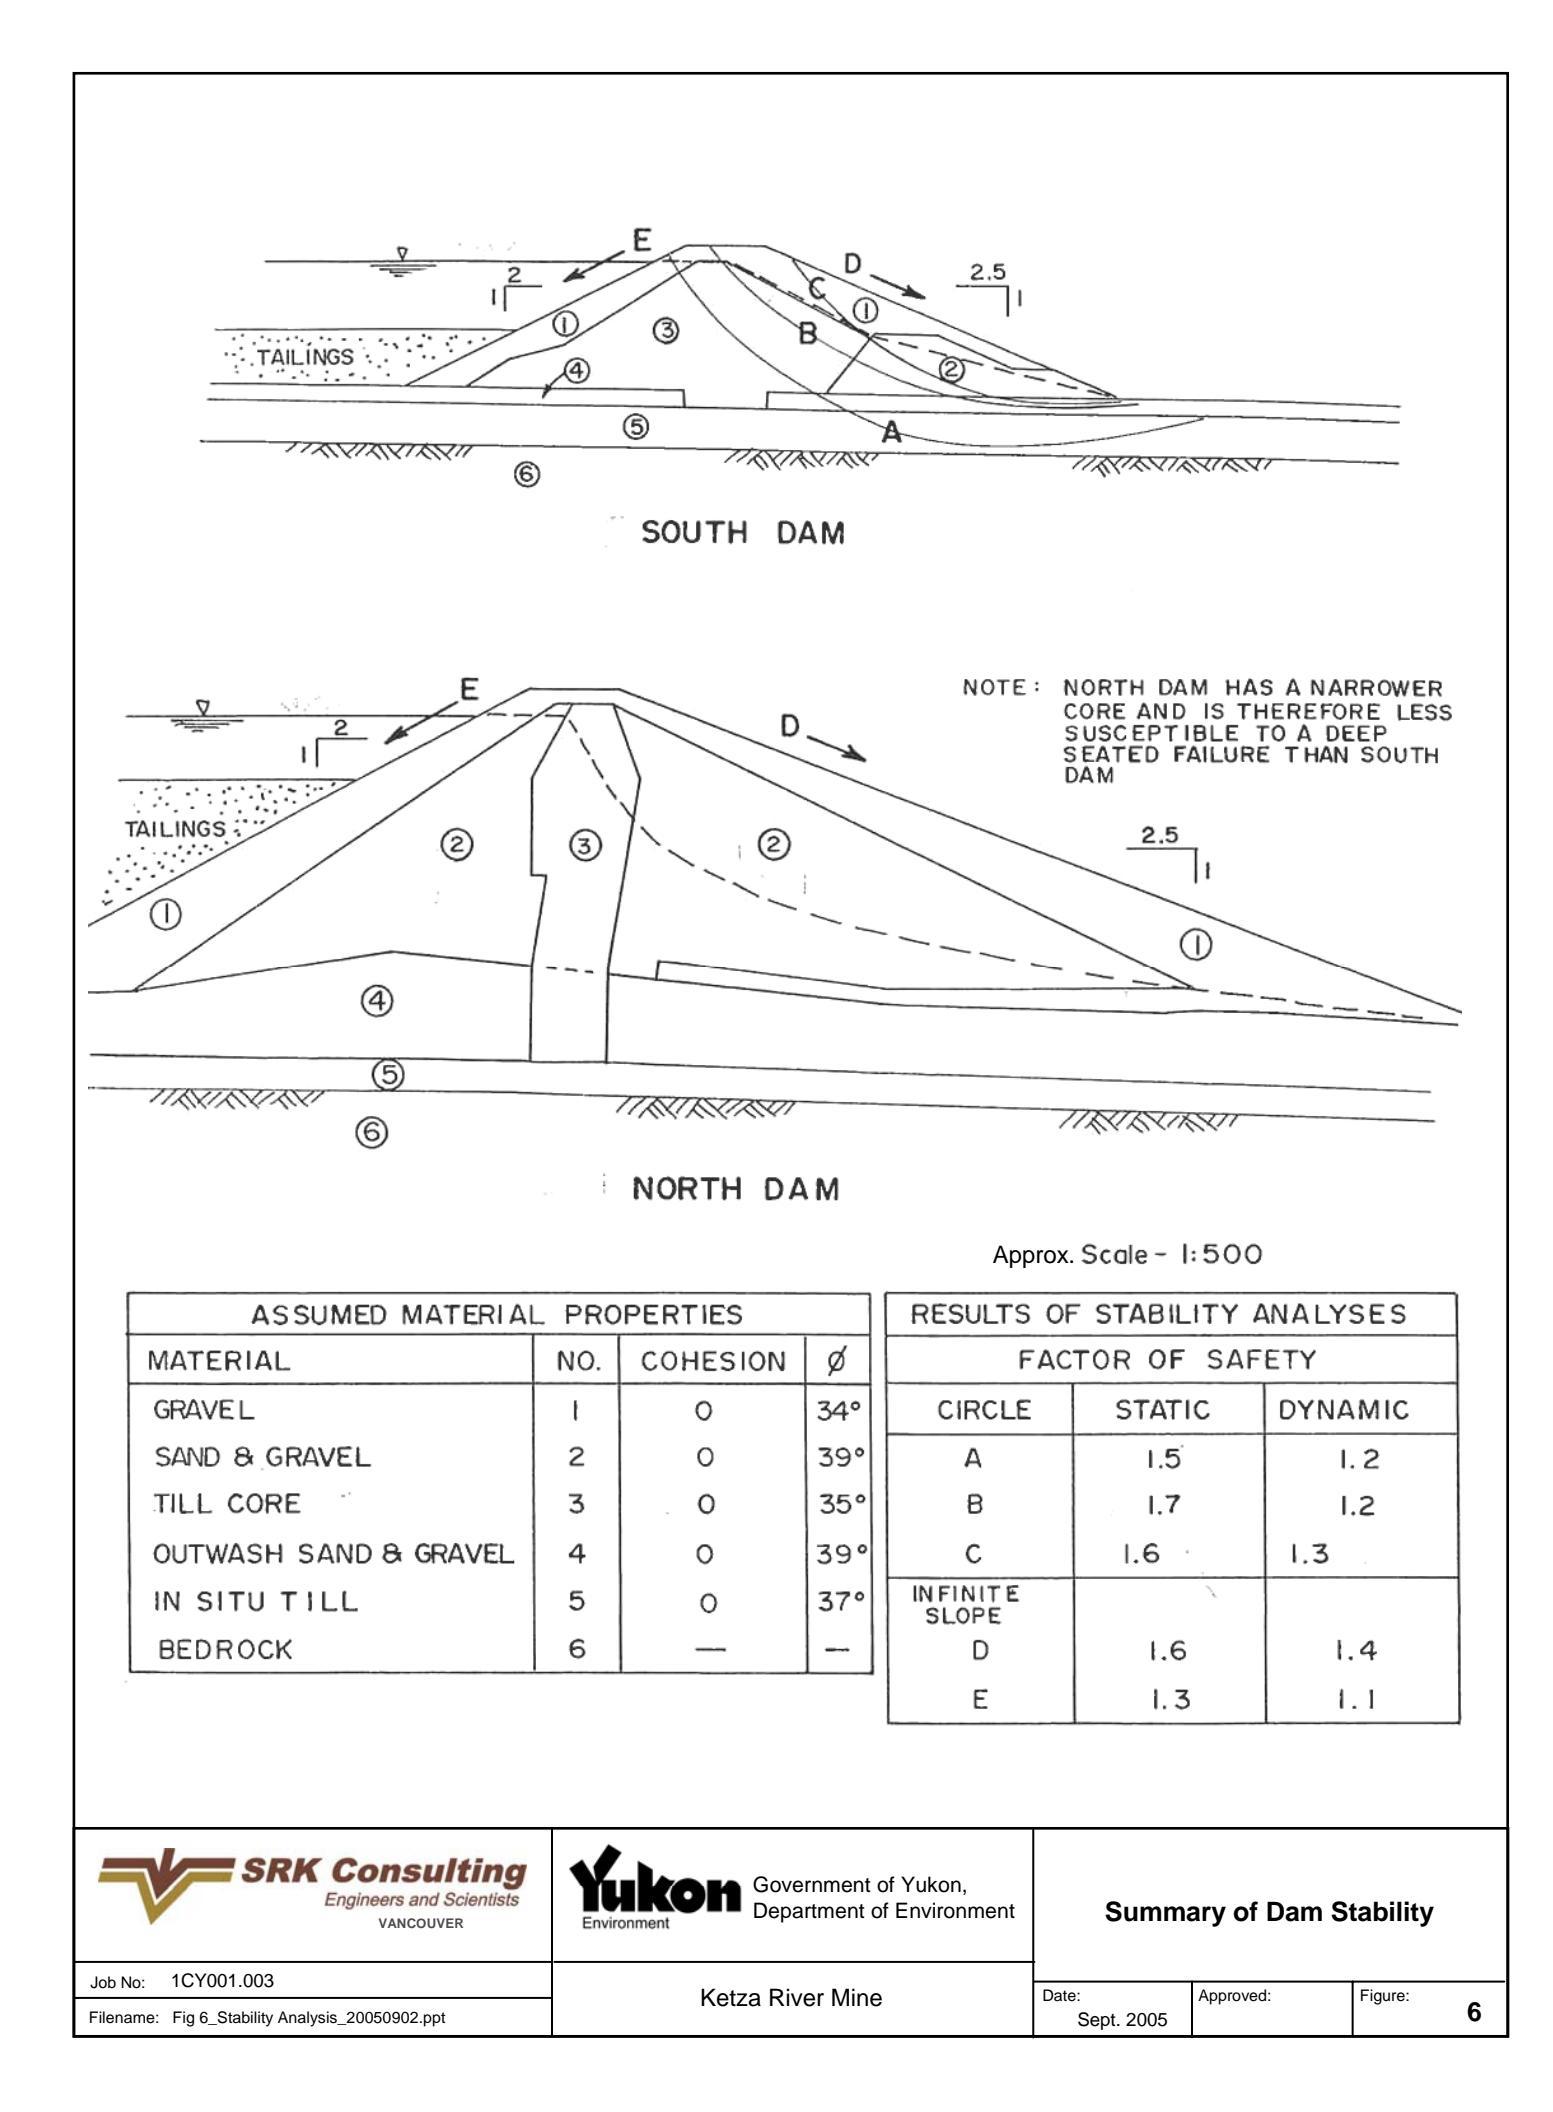
Based on the original design of the TMF, the maximum operating level of the tailings pond is El 1312.00. As shown on Figure 6, both dams under these conditions would have a theoretically acceptable factor of safety against failure under static conditions. However, leaving the water level at El 1311.6 or 0.4m below the maximum operation level is exposing the dam to unnecessary risk. Furthermore, the factor of safety against shear failure under seismic loading conditions would likely not meet current earthquake design criteria for this dam which is expected to have a high consequence category in accordance with the Canadian Dam Safety Guidelines. Therefore, SRK recommends that the current pond water level be lowered to at least 1.5 to 2m below the spillway elevation or in the elevation range of 1310.7 to 1310.2. The lowering should commence as soon as possible.

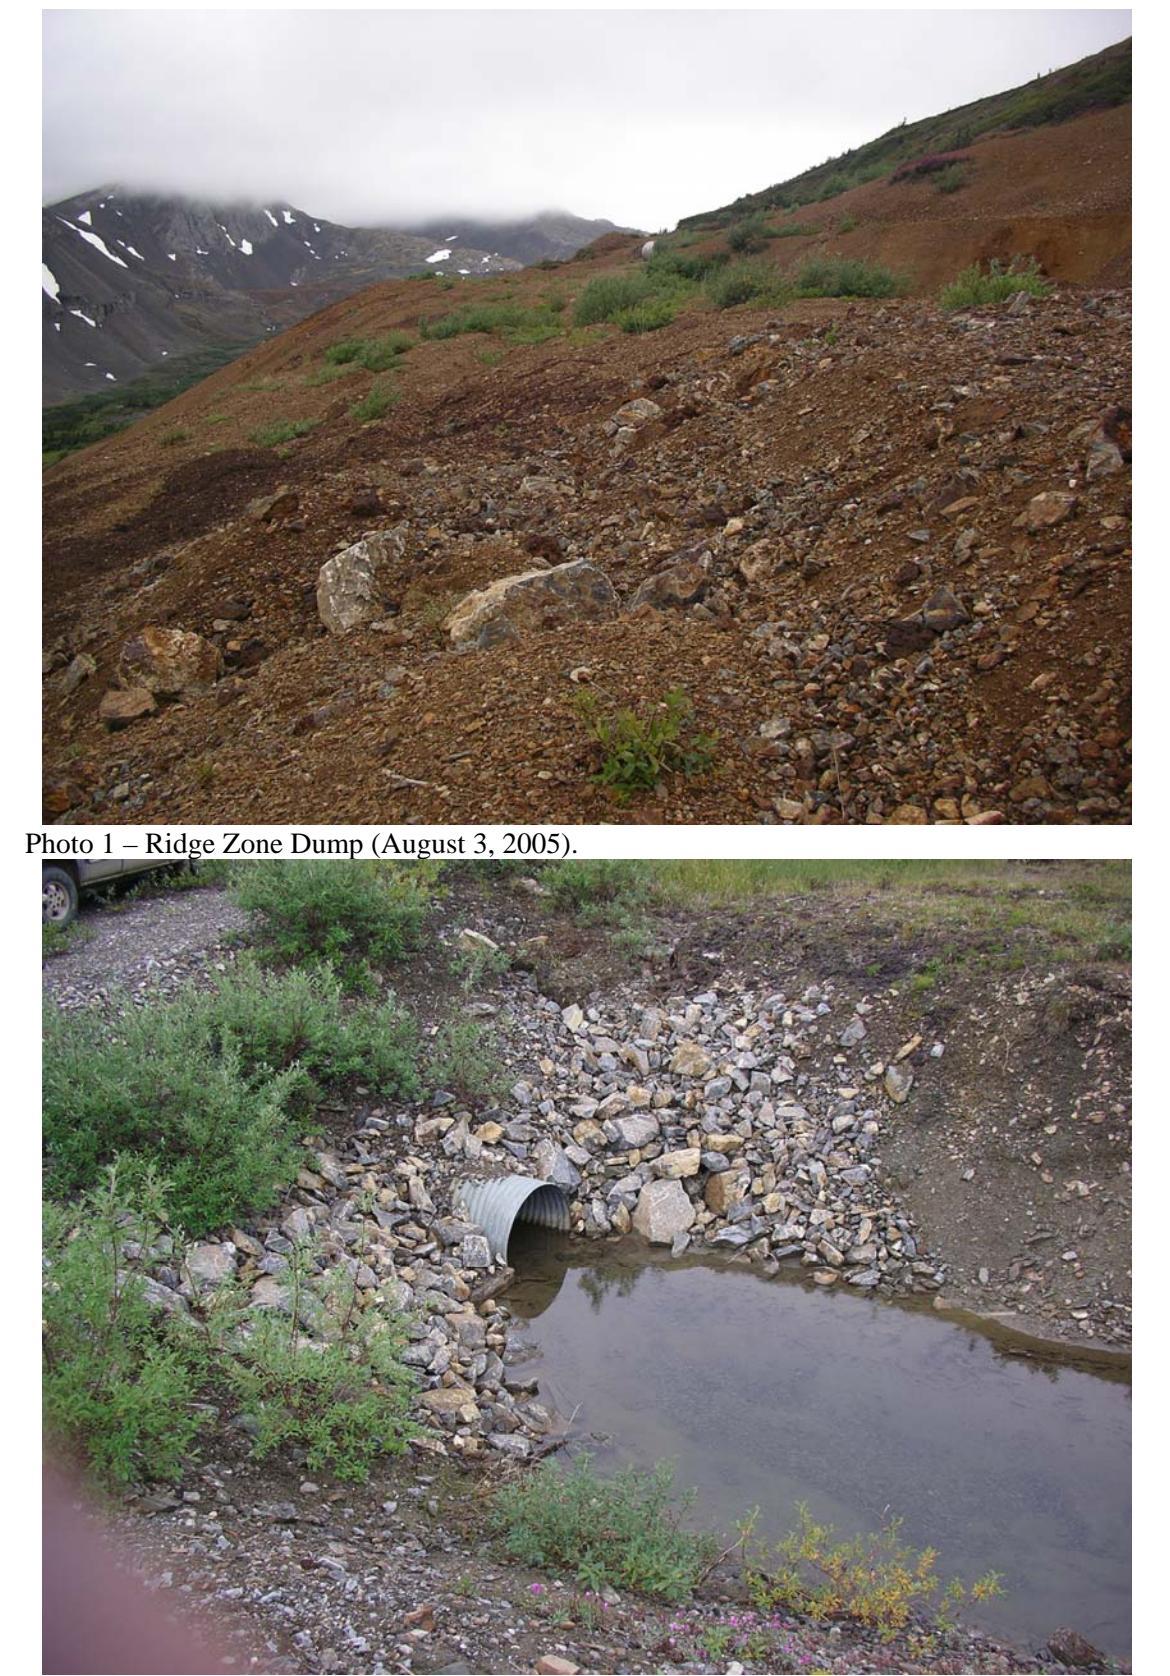
During the development of the mine, the upper reach of Subsidiary Creek (see Figure 2) was diverted into Cache Creek above the Mill site. Flow in the lower reach of Subsidiary Creek was diverted around the tailings impoundment and into Cache Creek. The upper diversion was achieved by directing the flow into an open ditch, which runs in a north-south direction at right angles to the original creek alignment. Flow in the ditch discharges through a 0.9m dia. culvert located beneath an access road which crosses over the ditch. The culvert entrance is shown in Photo 2. It was noted that water pools around the entrance of the culvert suggesting that the culvert may have settled over time or the culvert is partially silted up with debris.

Photo 2 - Subsidiary Creek Diversion above road crossing (August 3, 2005).

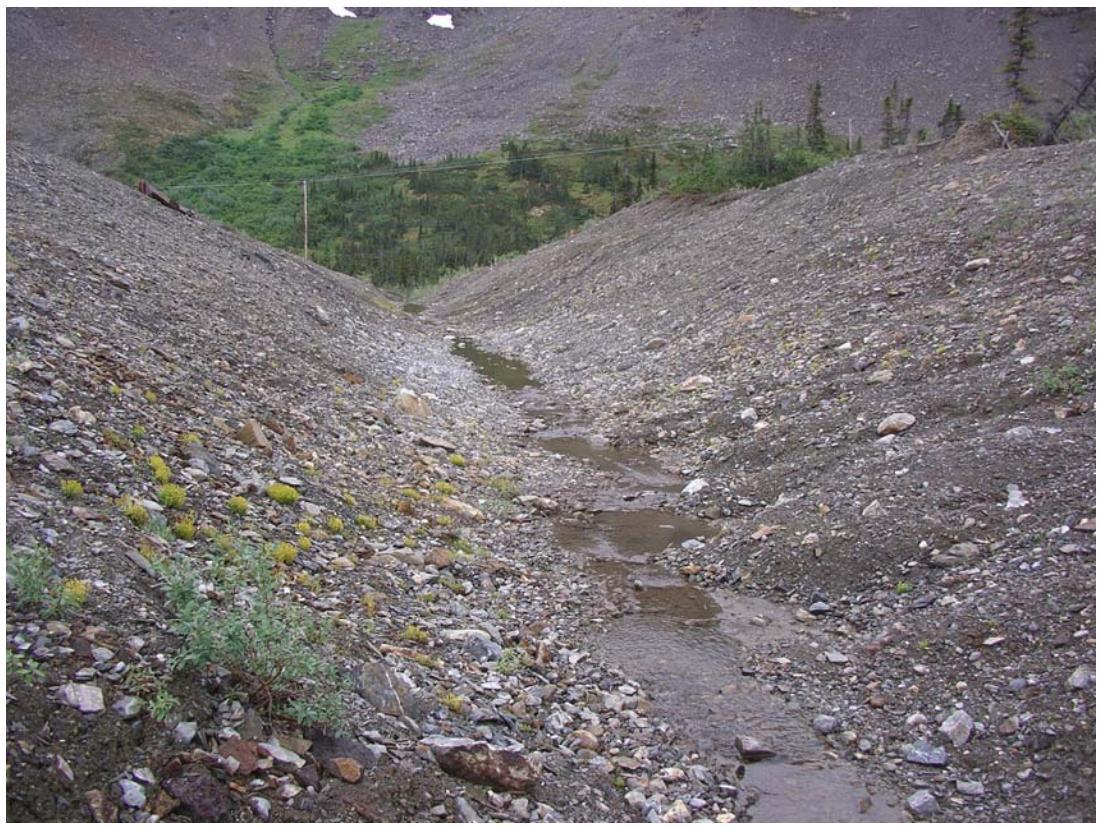
The diversion ditch is founded in a loose weathered bedrock and was apparently constructed as a cut and fill operation. The sideslopes of the channel are approximately 2:1 (Horizontal to Vertical) and the base of the channel is about 2m wide. The sideslopes are relatively stable despite the lack of any riprap or erosion protection (Photo 3).

Photo 3 - Subsidiary Creek Diversion (upper) below road crossing.

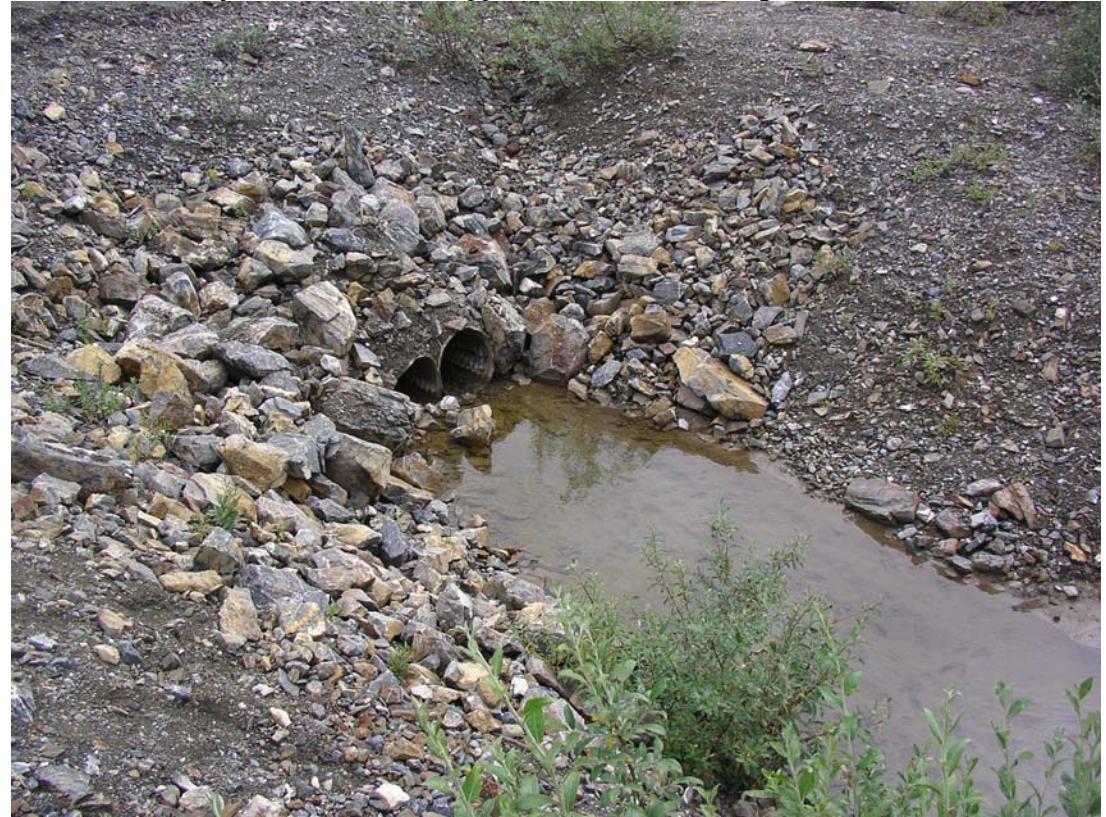
Runoff from the catchment below the upper Subsidiary Creek diversion is diverted around the southern perimeter of the tailings impoundment as shown in Figure 3. Flow in the diversion joins up with diverted runoff from Northwest Interceptor ditch (NID) (Figure 3) and passes through two 0.6 m dia. CMP culverts (Photos 4 and 5). At the southwest corner of the tailings impoundment, the flow discharges through a 0.3m dia. corrugated metal pipe (CMP) before finally entering Cache Creek (Photo 6 and 7).

The outlet at the two 0.6m dia culverts are partially silted up caused by subsidence and accumulated debris. This causes water to pool not only just upstream of the culverts but also into the Northwest Interceptor ditch.

Photo 4 - Twin culverts at confluence of Subsidiary Creek Diversion and Northwest Interceptor Ditch (August 3, 2005).

SRK recommends that all culverts be inspected regularly. Any debris or loose material that has accumulated at the entrance and outlet of the culverts should be cleaned out. It is also recommended that the twin culverts at the confluence with Subsidiary creek and NID be hosed out to remove internal debris.

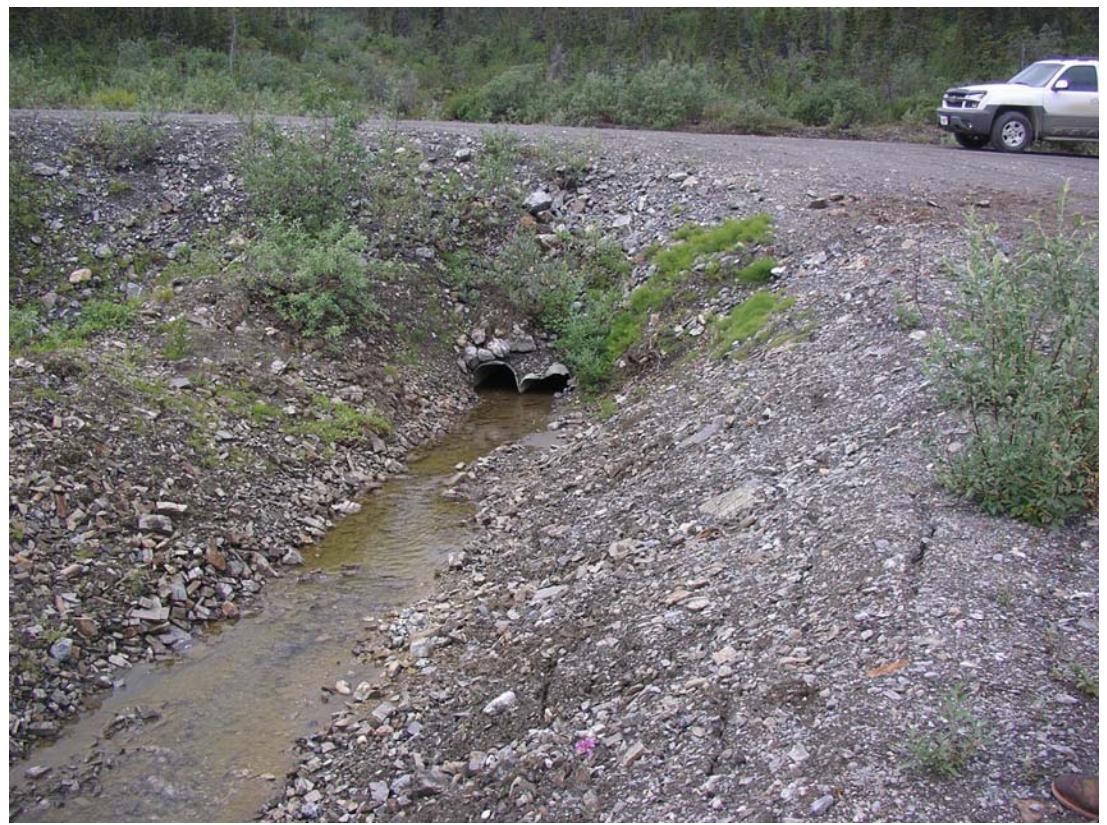
Photo 5 – Outlet of Twin Culverts at Lower Subsidiary Creek Diversion.

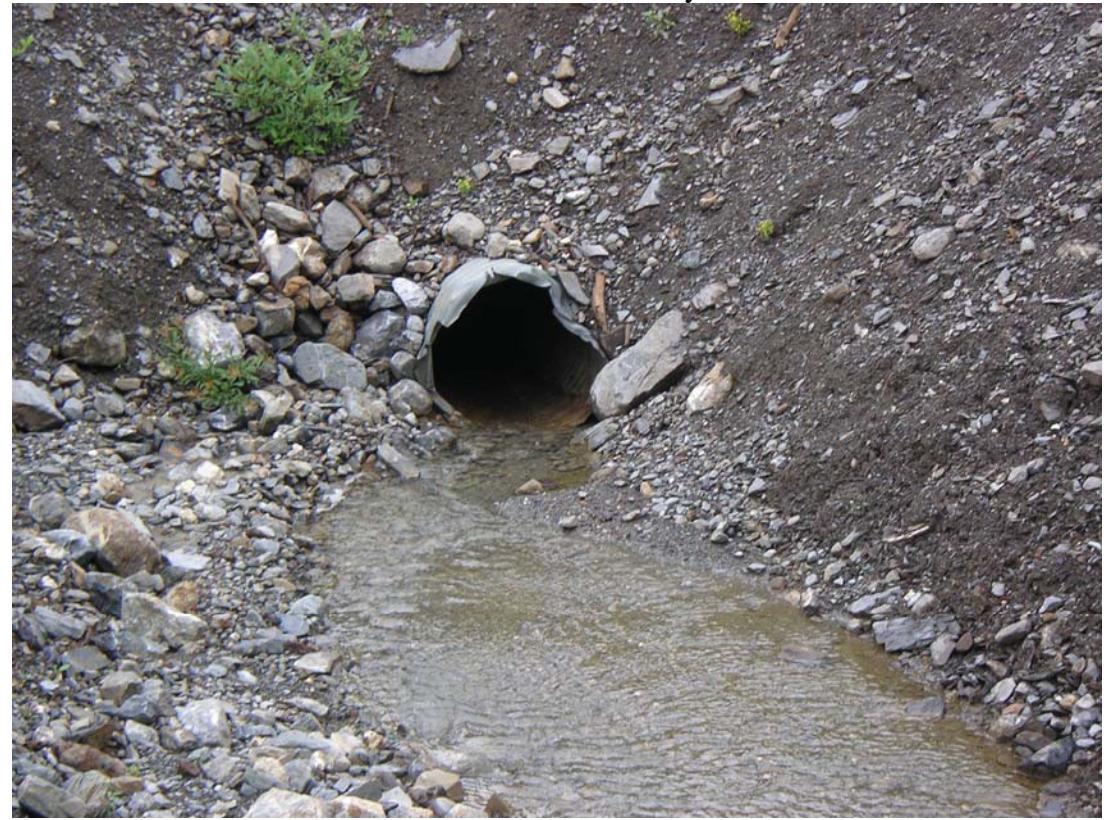
Photo 6 - Inlet of 0.3m diameter culvert which takes flow from Northwest Interceptor Ditch and Subsidiary Creek Diversion to Cache Creek.

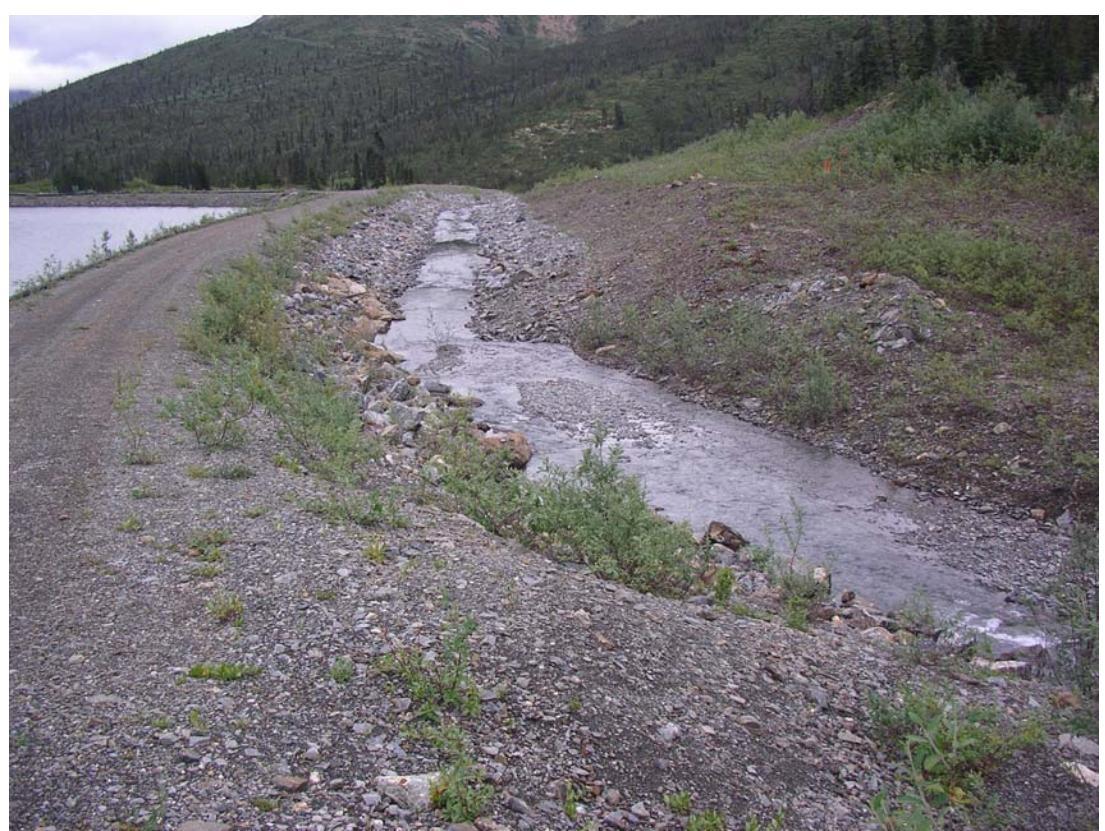
In the upper reaches of the channel (Photo 7), the base is about 5m wide, the sideslopes are about 2:1 (H:V) and the channel slope is about 1 percent. Very little erosion of the existing riprap was observed during both visits along this reach and the banks remain stable. The riprap along this section varies from about 50mm to 1.2m in diameter with a D_{50} of about 450mm.

Photo 7 - Cache Creek Diversion (August 3, 2005).

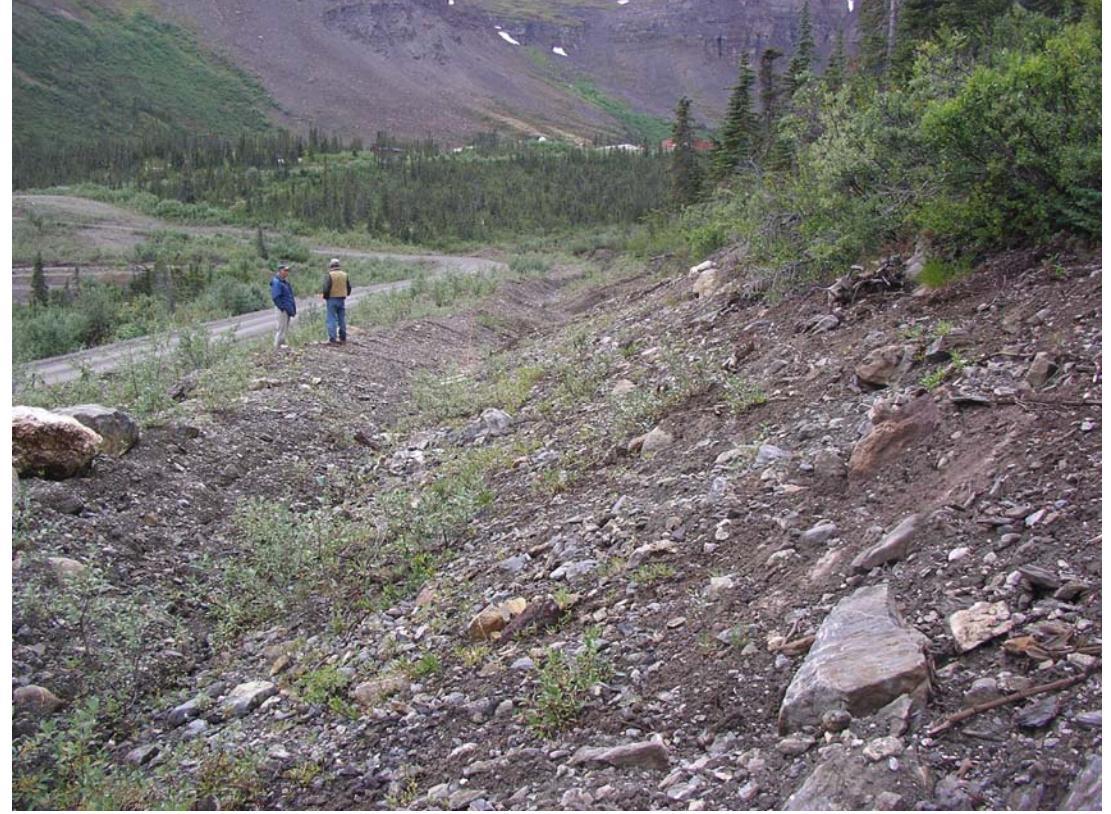
The Northwest Interceptor ditch (Photo 8) diverts runoff from the catchment north of the tailings impoundment. The ditch directs the flow partly to the west where it joins up with lower Subsidiary Creek diversion and partly to the east where it discharges into Cache Creek downstream of the tailings dam. We observed that in sections of the ditch, debris has accumulated in a number of places (Photo 9 and 10) and where the flow crossed beneath the main access road to the mine, the culvert is partially blocked (Photo 11).

Photo 8 – View East along Northwest Interceptor Ditch (August 3, 2005).

The debris that has accumulated in the NID should be removed. It is believed that the silt build-up in the NID has contributed to the increased inflow into the tailings pond causing the pond to be consistently at its current level for the last 3 to 4 years.

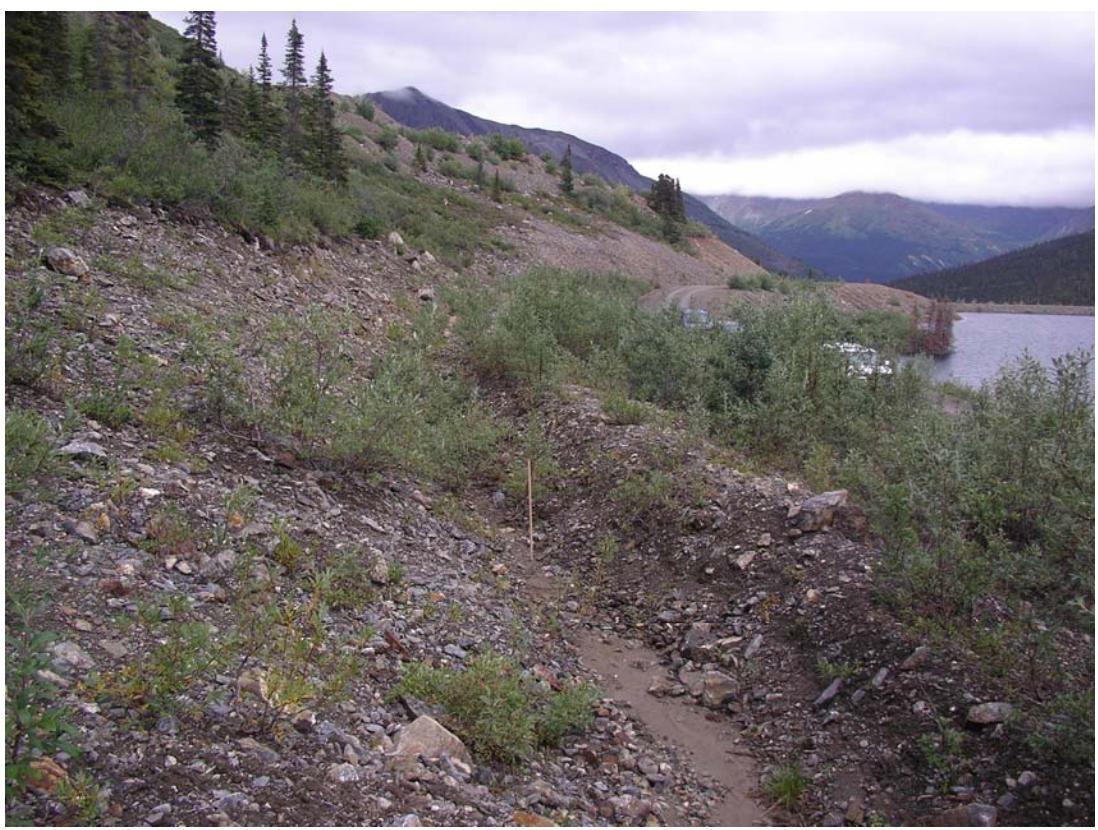
Photo 9 - View West along Northwest Interceptor Ditch

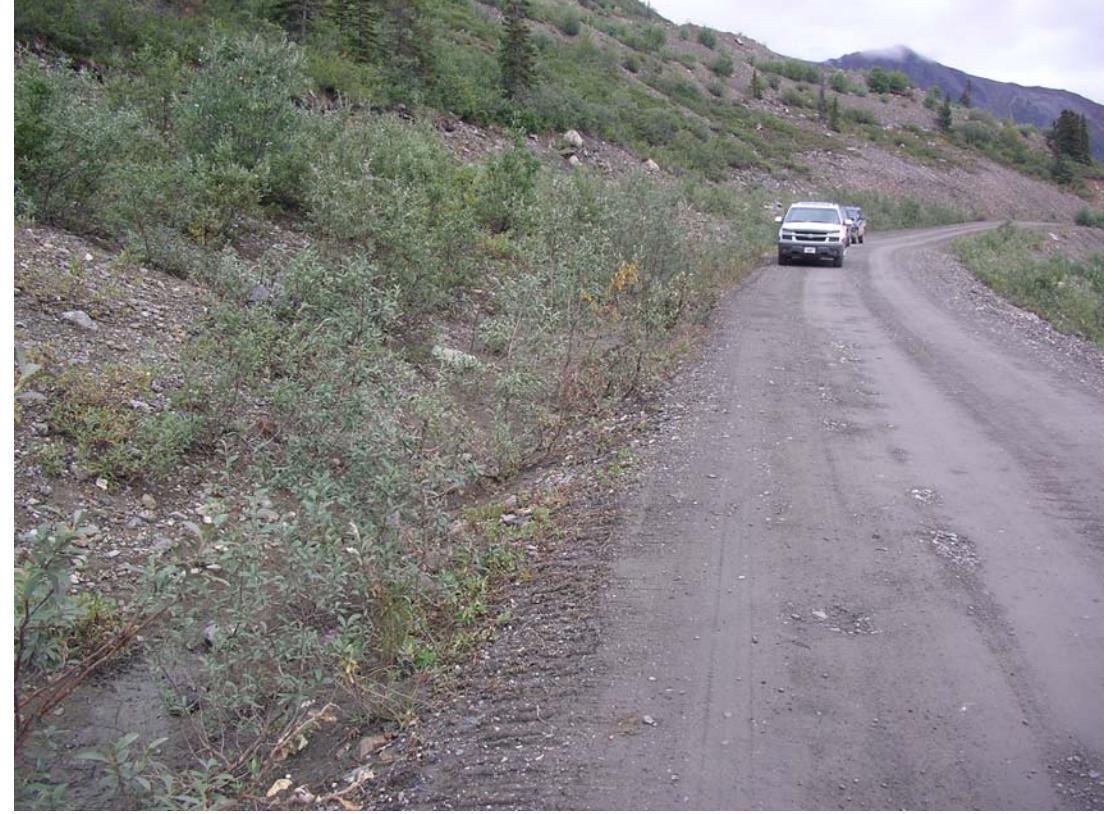
Photo 10 – Sediment buildup in Northwest Interceptor Ditch.

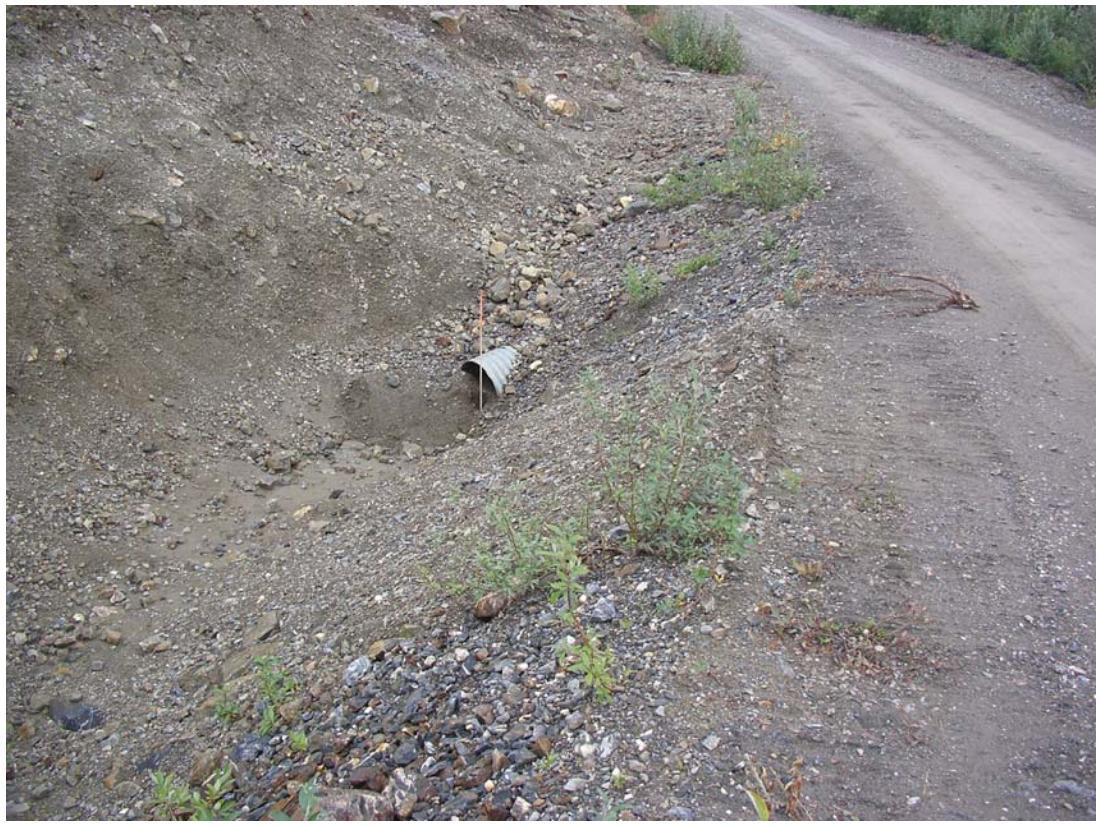
Photo 11 – Entrance of culvert which diverts flow from NID to below Tailings Dam.

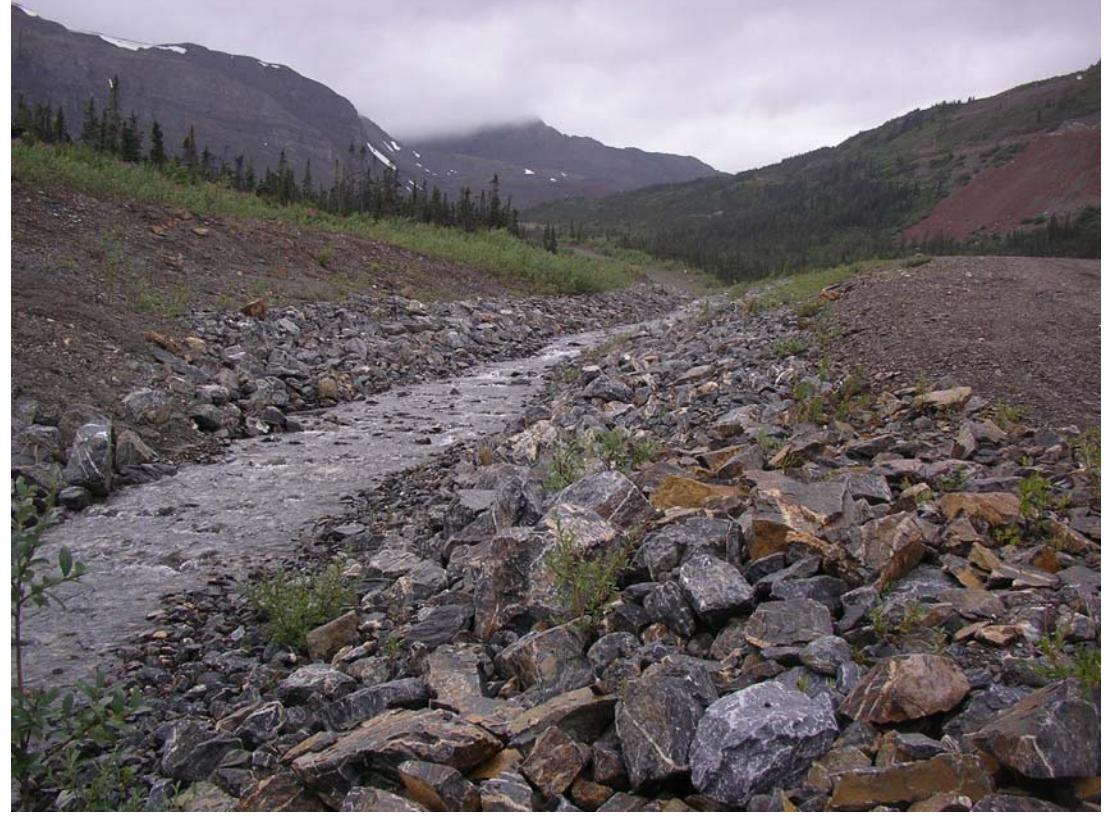
In the middle reach of the diversion (Photo 12), the riprap protection extends about 1.2m above the base of the channel. The riprap in most places has remained intact. However, there is one location on the north bank, as shown in Photo 13 where the riprap protection has been disturbed and the bank has started to erode.

Photo 12 – Middle reach of Cache Creek Diversion.

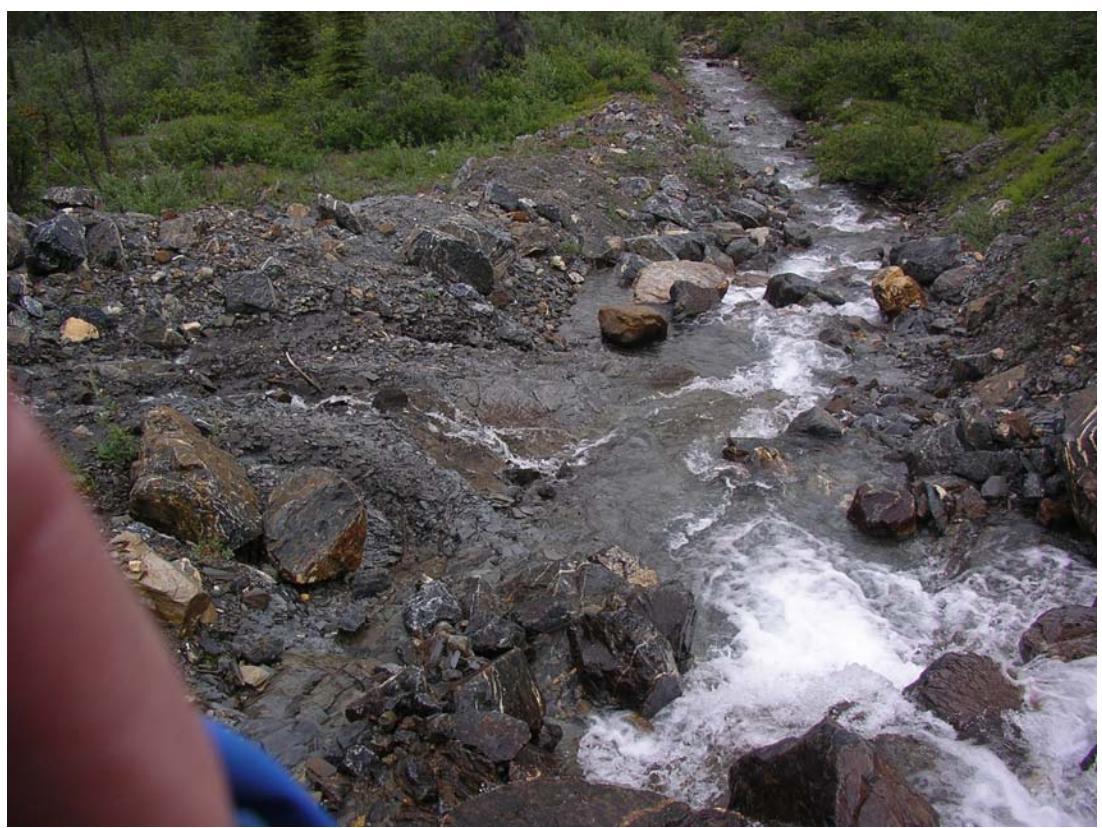
The lower reach of the diversion is relatively steep varying from 16 to 20 percent over a distance of about 60m (Photos 13). This section of the channel had previously been reconstructed by YGC to train the flow directly into Oxo Creek.

Photo 13 - Lower-reach of Cache Creek diversion

Monthly monitoring of the area on the south side of Cache Creek diversion should be initiated for movement or subsidence. The channel bank on the north side of Cache Creek Diversion where rip rap has been washed away, should be repaired.

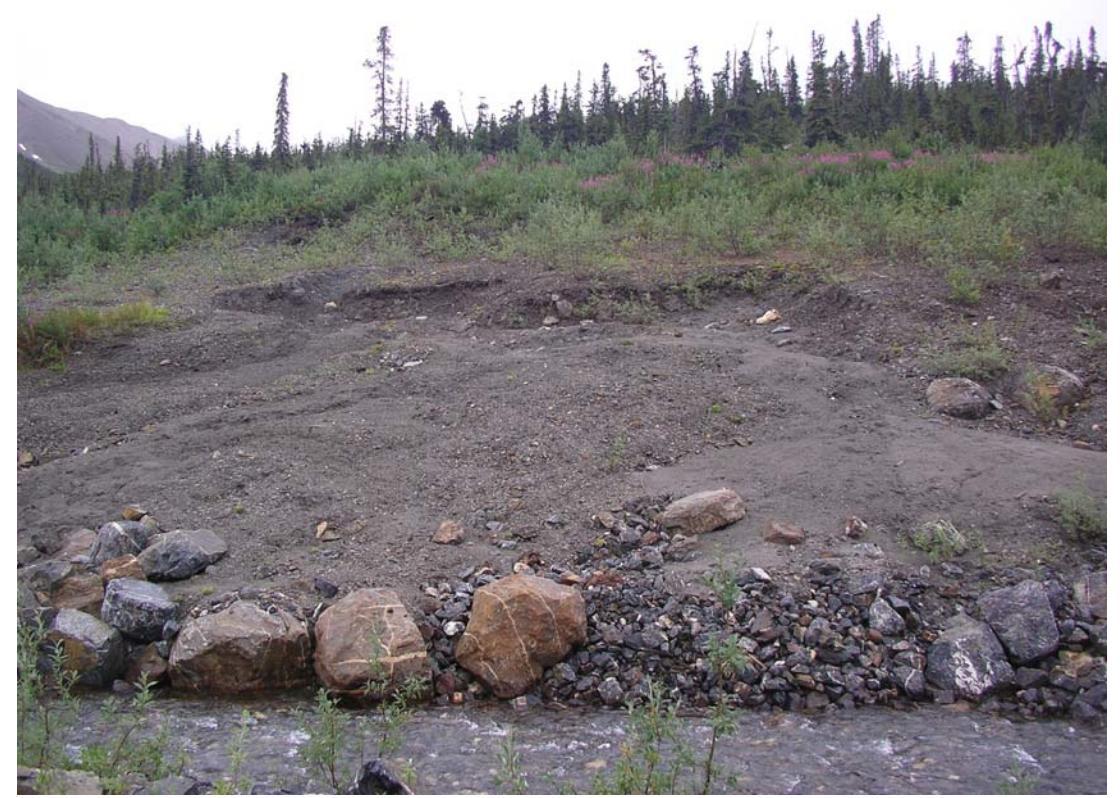
On the south side of the channel adjacent to the steep section, is an area that has previously had a history of creep and instability (Photo 14). This area is believed to be prone to permafrost. During

the 1996 inspection by SRK, it was noted that a 1m deep cavity had formed in behind the riprap at a location several metres downstream of the creep area. It was thought that this cavity had occurred during spring runoff where ice build up had forced flow in the creek to wash out the finer material. SRK recommended to YGC at the time that the saturated soil in the slide area be removed, geotextile filter fabric be placed over the exposed area and then backfilled with riprap. It was also recommended that the cavity downstream be backfilled with riprap. This work was completed in accordance with SRK's recommendations in August, 1996. During both the 1997 and 1998 inspections by SRK, further creep of the area was noted and some of the material had moved down the slope partially covering the newly placed riprap. Evidence of this previous movement was noted during this year's inspection. However, there appears to have been no significant additional creep or movement.

Photo 14 - Creep area above south side of Cache Creek Diversion (August 3, 2005).

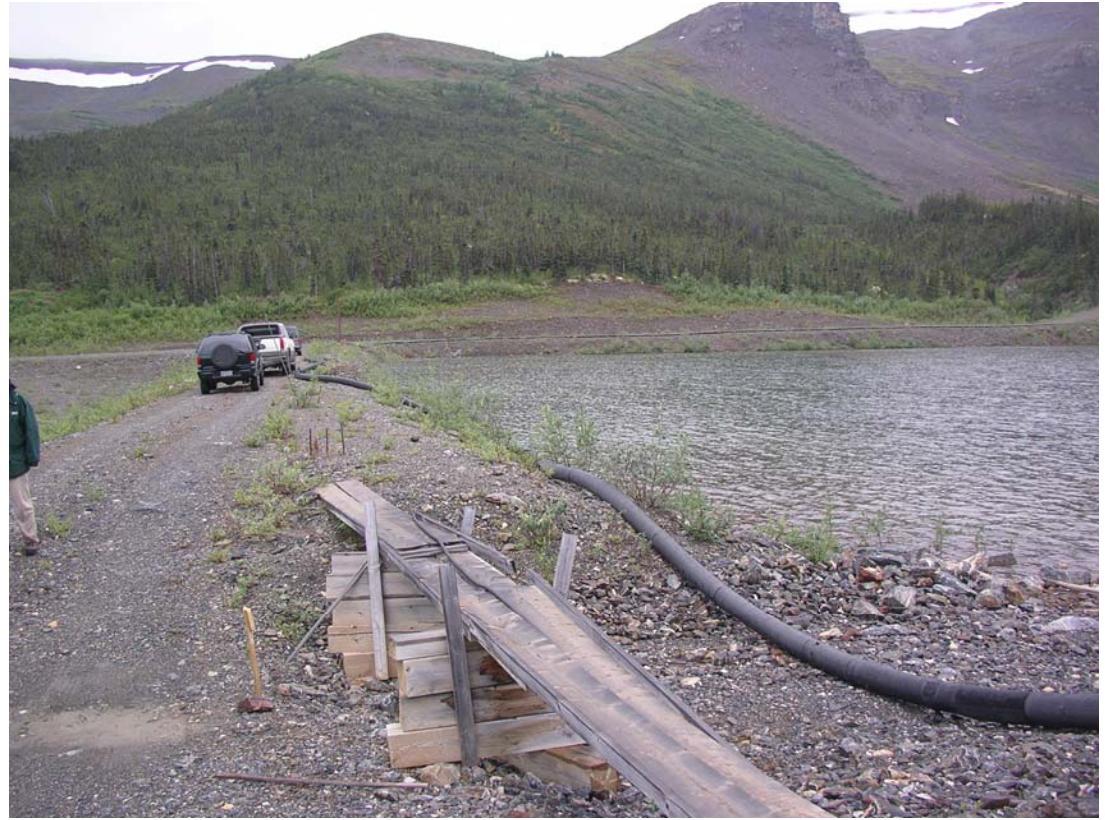
During the August 2005 visit, SRK inspected the two tailings dams at the impoundment for evidence of instability, cracking, settlement or bulging (Photos 15 and 16). The emergency spillway was also examined (Photo 17 and 18).

No cracks were observed along the crest of either dams and no visible settlement was detected. The upstream and downstream faces of the dams showed no signs of erosion or bulging.

Photo 15 – View south along crest of South Dam.

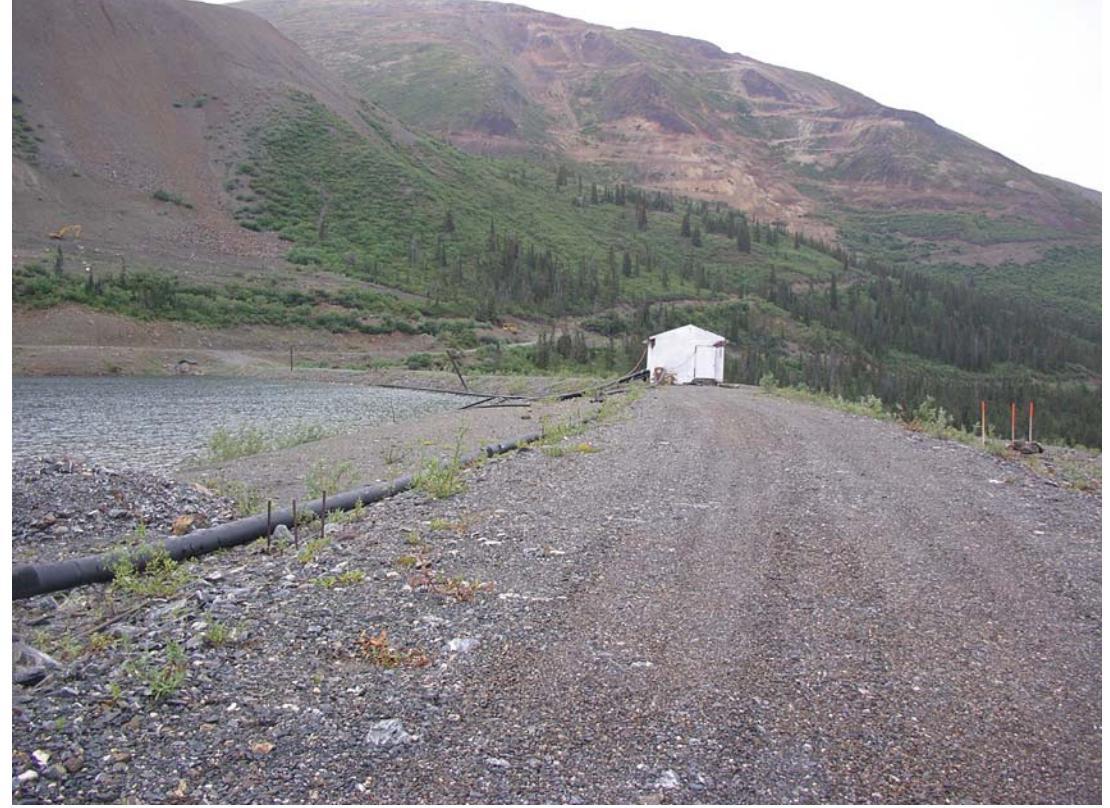
Photo 16 – View north along crest of North Dam.

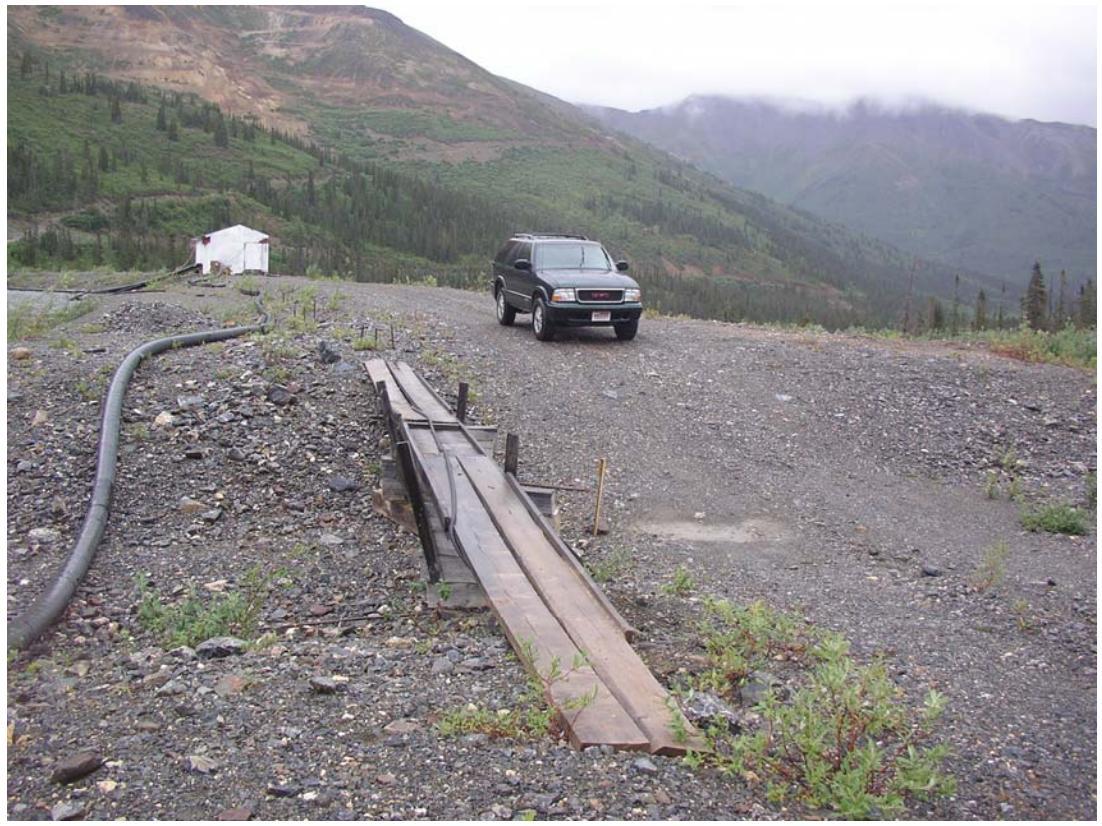
The existing emergency spillway is located in original ground between the North and South dams. The spillway was designed to handle overflow from the tailings impoundment in the event that the free storage was insufficient to accommodate a flood event. The invert of the spillway at the centreline of the dam was recently surveyed (August 2, 2005) by Yukon Engineering Services (YES) at about El 1312.20m or 1.7m below the dam crest. The spillway channel has a base width of about 4m with a relatively shallow depth of about 0.5m. The slope of channel averages about 3 percent for a distance of 54m from the invert of the spillway then steepens to about 6 percent as it approaches Cache Creek Diversion. The spillway channel is lined with broken rock with about 50 percent of the rock less than 75mm in diameter. During the life of the tailings impoundment this spillway has never been used.

Photo 17 – View looking north of the existing Emergency Spillway

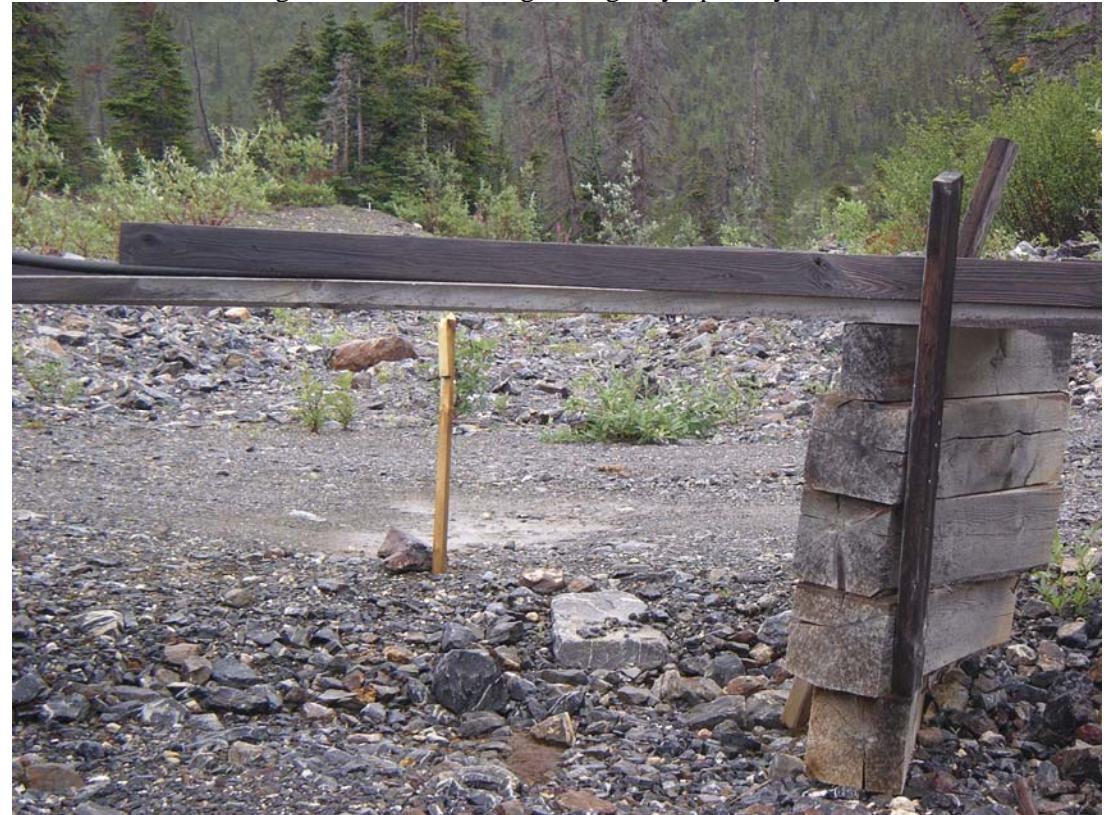
Photo 18 - View along Emergency Spillway perpendicular to Dam Crest
