# WOLVERINE MINE

# QUARTZ MINING LICENSE QML-0006

# 2013 ANNUAL REPORT

Prepared by: Yukon Zinc Corporation Vancouver, British Columbia

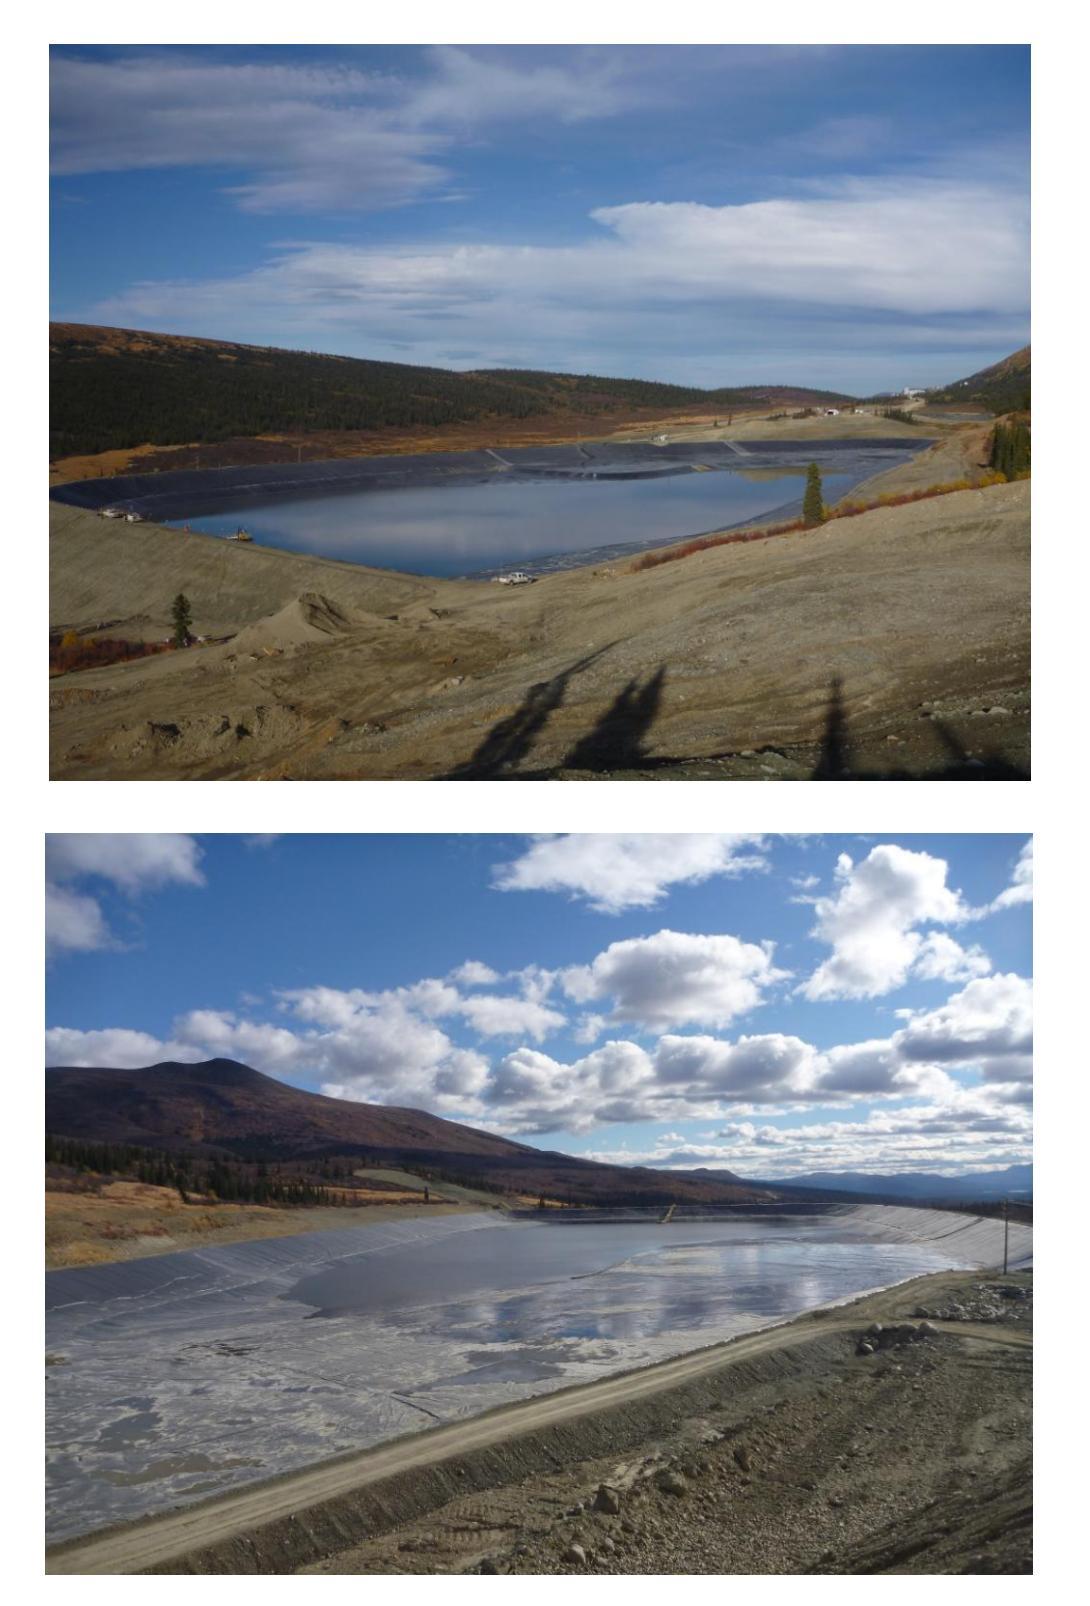
Picture 2-1: Tailings storage facility after dam lift construction project, looking east (top) and west (bottom).

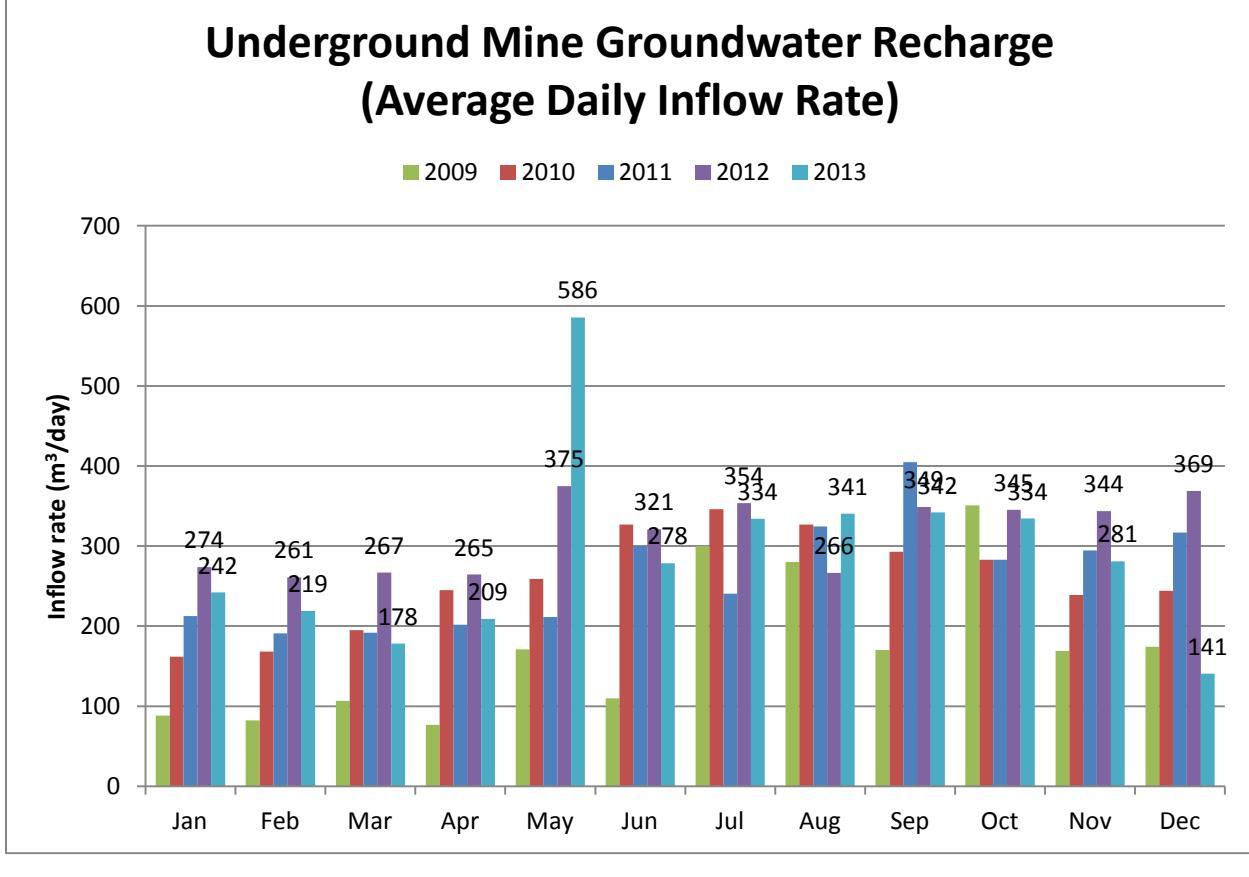
Figure 4-1: 2009-2013 Daily Average Underground Recharge Rates

Hydrological flow rates in the underground workings have been monitored since 2006; however, in 2007 – 2008 the rates were calculated based on discharge volumes from treatment sumps, whereas in 2009 -2012 the flow rates were more accurately monitored using a flow meter on the discharge pipe. These rates are presented in Figure 4-1. Flow rate increases during the summer months were evident in all four years. The average daily flow rates decreased in 2013 to 290 m<sup>3</sup>/d from 316 m<sup>3</sup>/d in 2012. In 2013 recharge rates ranged from 141 m<sup>3</sup>/day (December 2013) to 586 m<sup>3</sup>/day (May 2013) and indicate seasonal variations consistent with previous years. However, these extremes are somewhat artificial, since the May inflow included runoff water from the industrial complex (flow meter was not online during May), and the December inflow was diverted through a line that did not have a flow meter. Both issues have been rectified and will be reported accurately moving forward.

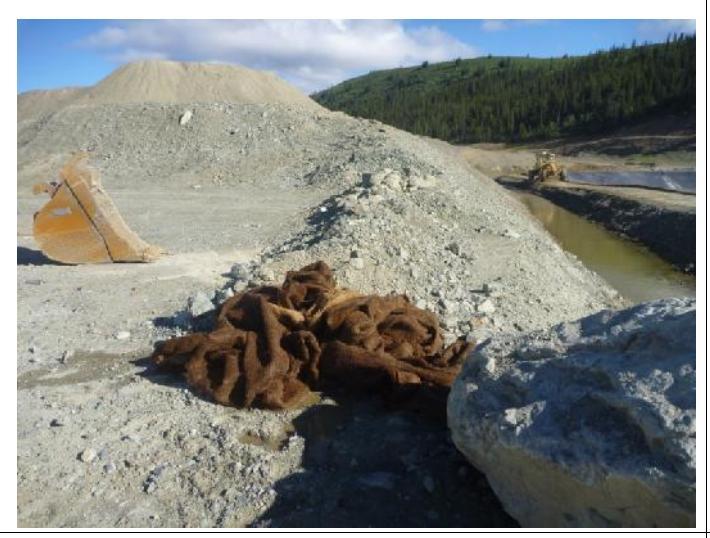
**Photo 7:** Coconut matting removed from Ditch A culvert to improve water flow.

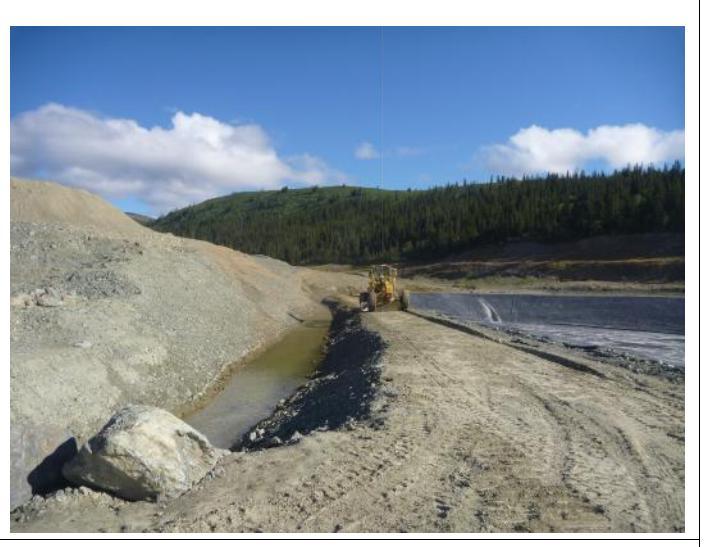
**Photo 8:** Grader re-contouring road to improve runoff into Ditch and away from liner wall.

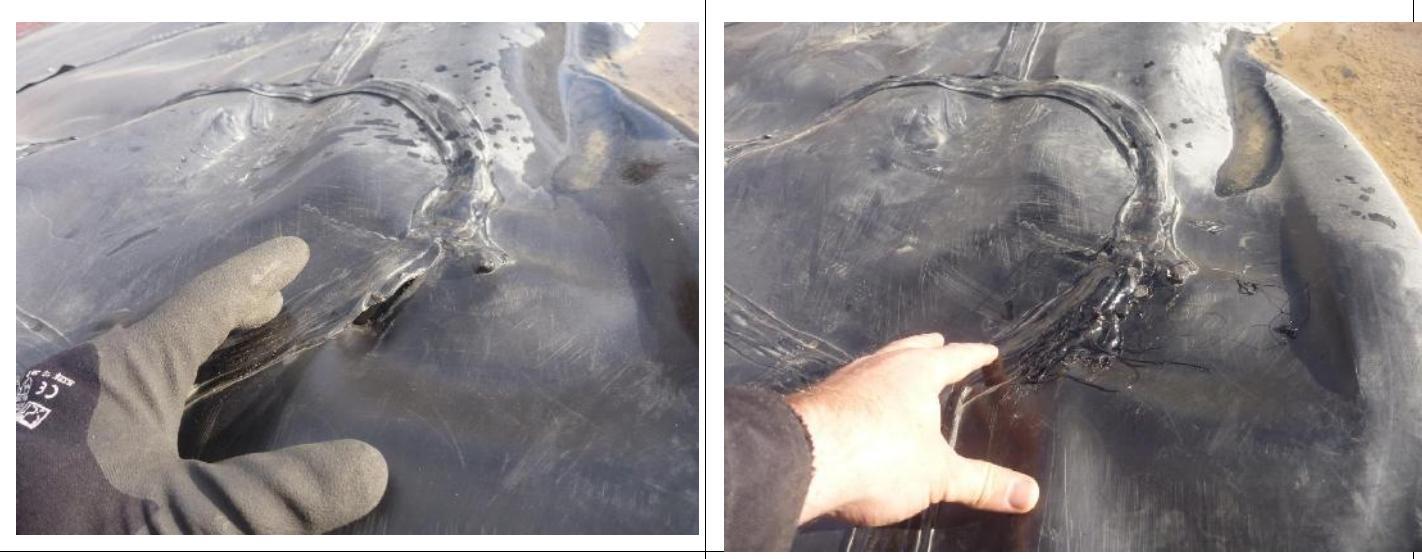
Photo 9: Hole in Tailings Liner along crease (east liner wall)

Photo 10: Hole in Tailings liner repaired (east liner wall)

- 1. Milling rates averaged 1651.4 dry tonnes per day (Total of 18 Operating Days), processing 29725.5 tonnes ore with 7491.5 dmt of tailings reported to underground for paste fill and 14692.0 dmt tailings to TSF.
- 2. Brief on any maintenance: No Maintenance Performed
- 3. The flow meter was offline from UG to Sump 2 and thus could not calculate total runoff. This value is therefore included in Total Monthly Underground Input. Monitoring of conditions continue at Ditch A after improvements were made to improve water flow and runoff from surrounding landscape (which were potentially contributing to slope failure on the South end of the Tailings Facility). Liner patches/repairs were made at 3 locations (refer to Photos 9-12).

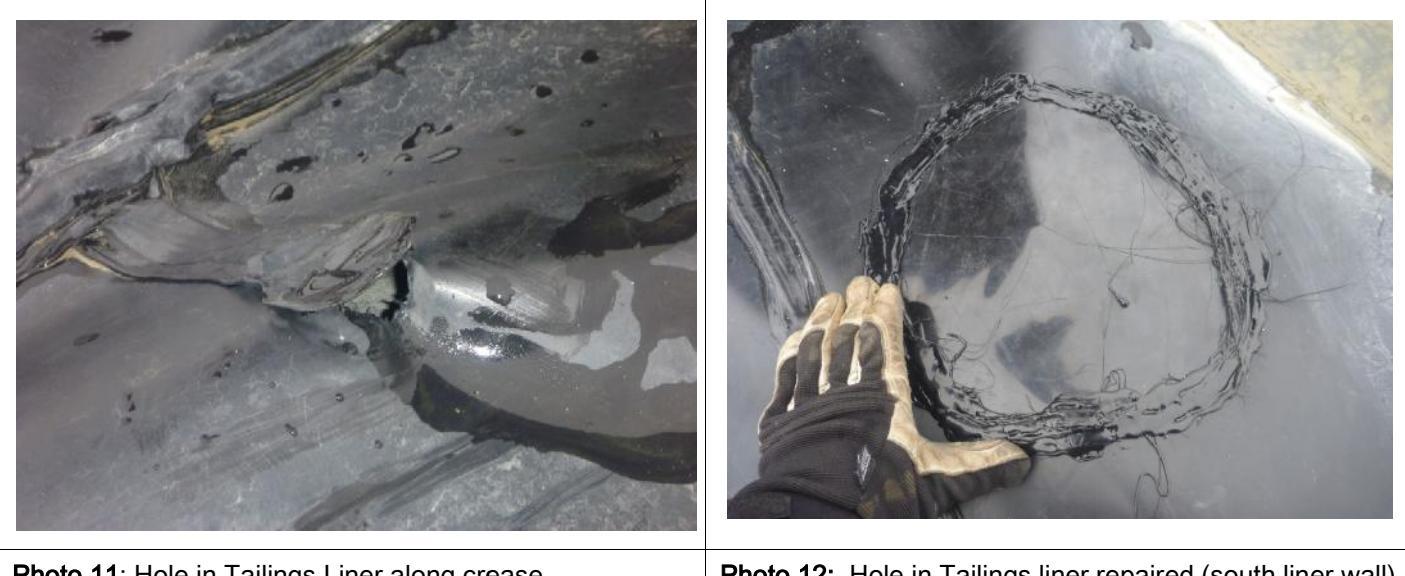
Photo 11: Hole in Tailings Liner along crease (south liner wall)

Photo 12: Hole in Tailings liner repaired (south liner wall)
