MPERG Report 2012-3

Evaluation of Yukon Live Willow Staking

February 2013

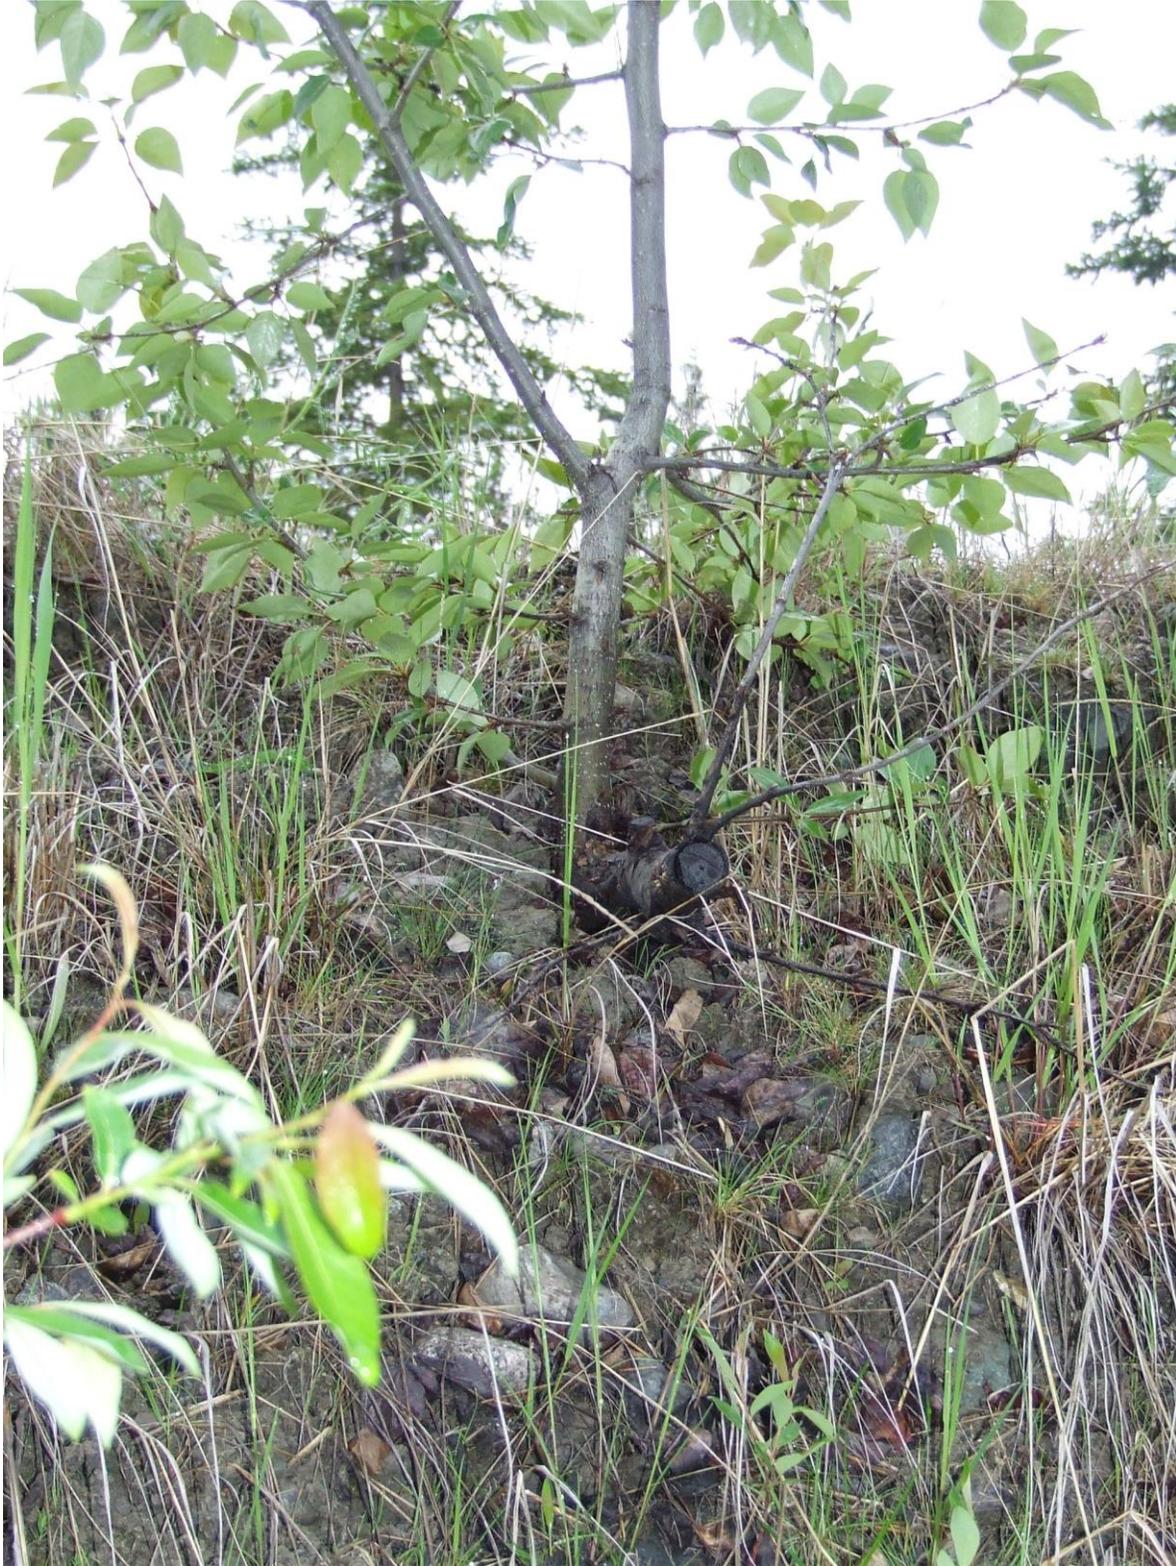
The diversion berm had been staked more-or-less horizontally on both sides of the berm with willows and balsam poplar. Near the top of the berm, on both sides, is a good growth of balsam poplar up to 2.5 meters tall, along with a few willows (1.5 meter tall *Salix pseudomonticola* and 1 meter tall *Salix niphoclada*). The *Salix pseudomonticola* had been browsed on, probably by moose. There were also a few 1 meter tall *Salix bebbiana*. These willows were probably a volunteer growth (not staked). The lower layers of staked willows on both sides of the berm were not so successful, with only a few surviving *Salix pseudomonticola* and *Salix niphoclada*.

Figure 1 Balsam poplar sprouting from horizontal stake near top of diversion berm.

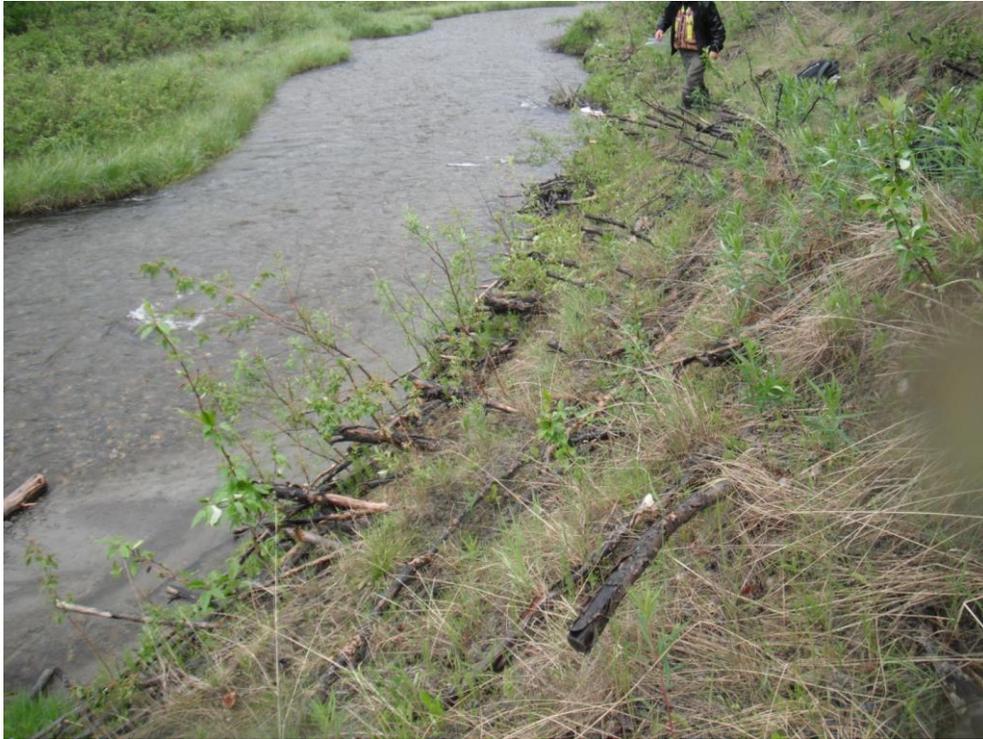
The streambank stabilization project consisted of the construction of a wattle fence along with rows of staked willows and balsam poplar. Most of the wattle fence and staked willows have failed to survive. The willows (*Salix pseudomonticola* and *Salix alaxensis*) staked closest to the water are doing the best. Most of the fence and the upper staked rows were not successful, with only a few surviving *Salix pseudomonticola* and *Populus balsamifera*. The surviving willows and balsam poplar are less than 2 meters tall.

Figure 2 A few false mountain willow and felt-leaf willow have survived near the bank of McIntyre Creek.

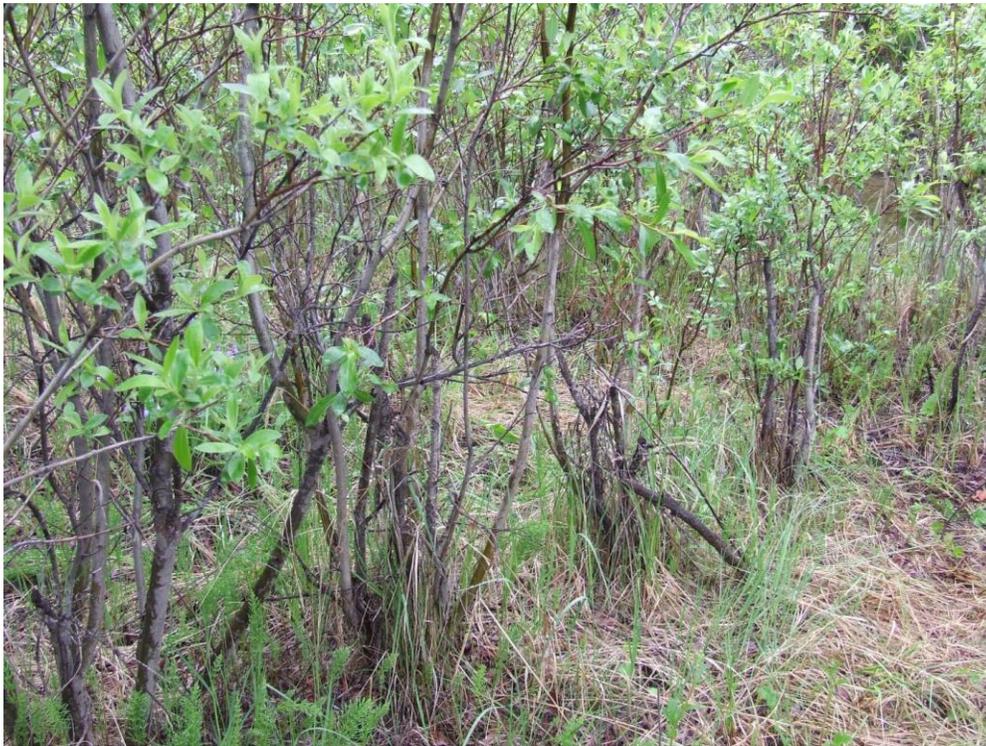
It was difficult to differentiate the three or four rows of staked willows from the naturally occurring growth of willows at this site. The staked willows all appeared to be *Salix pseudomonticola*. The volunteer willow species are *Salix planifolia*, *Salix arbusculoides* and *Salix niphoclada*. Both the staked willows and the naturally occurring willows are 2 meters tall or greater.

Figure 3 This row of false mountain willows have probably grown from stakes at Porter Creek.

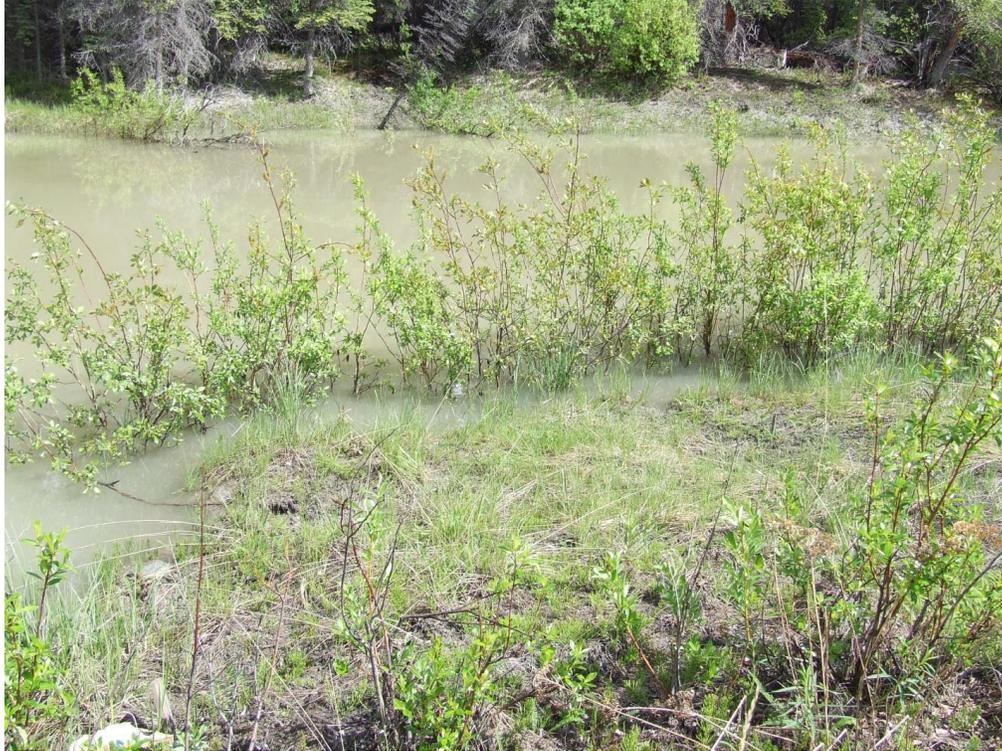
Downstream from the culvert on the right bank, near the water, is a mixed row of *Salix arbusculoides*, *Salix pulchra*, *Salix niphoclada* and *Salix pseudomonticola* (all < 1 meter tall). At the time of assessment they were partially submerged. About 30 meters back from the water is a row of clumps consisting of *Salix arbusculoides*, *Salix niphoclada* and *Salix pseudomonticola* (all about 2 meters tall). All of the willow species in this row had catkins. In between these rows are staked willows that have mostly not survived.

Figure 4 A partially submerged row of diamond-leaf willows grows from stakes at the Mendenhall River.

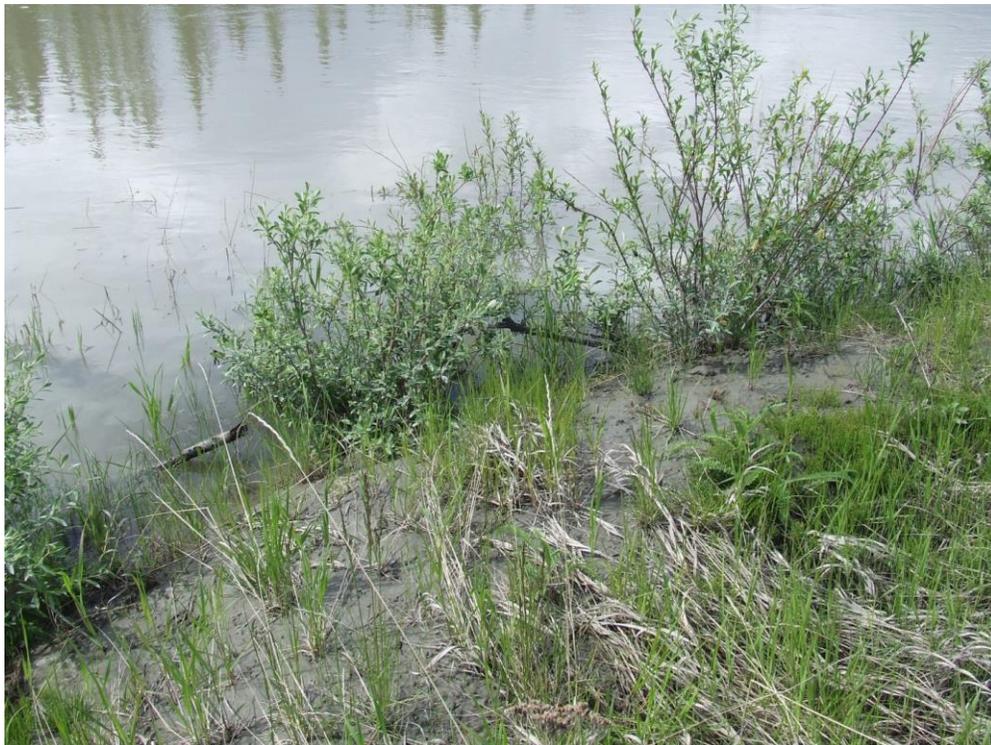
Figure 5 A row of mostly little-tree willows grows from stakes at the edge of the Mendenhall River.

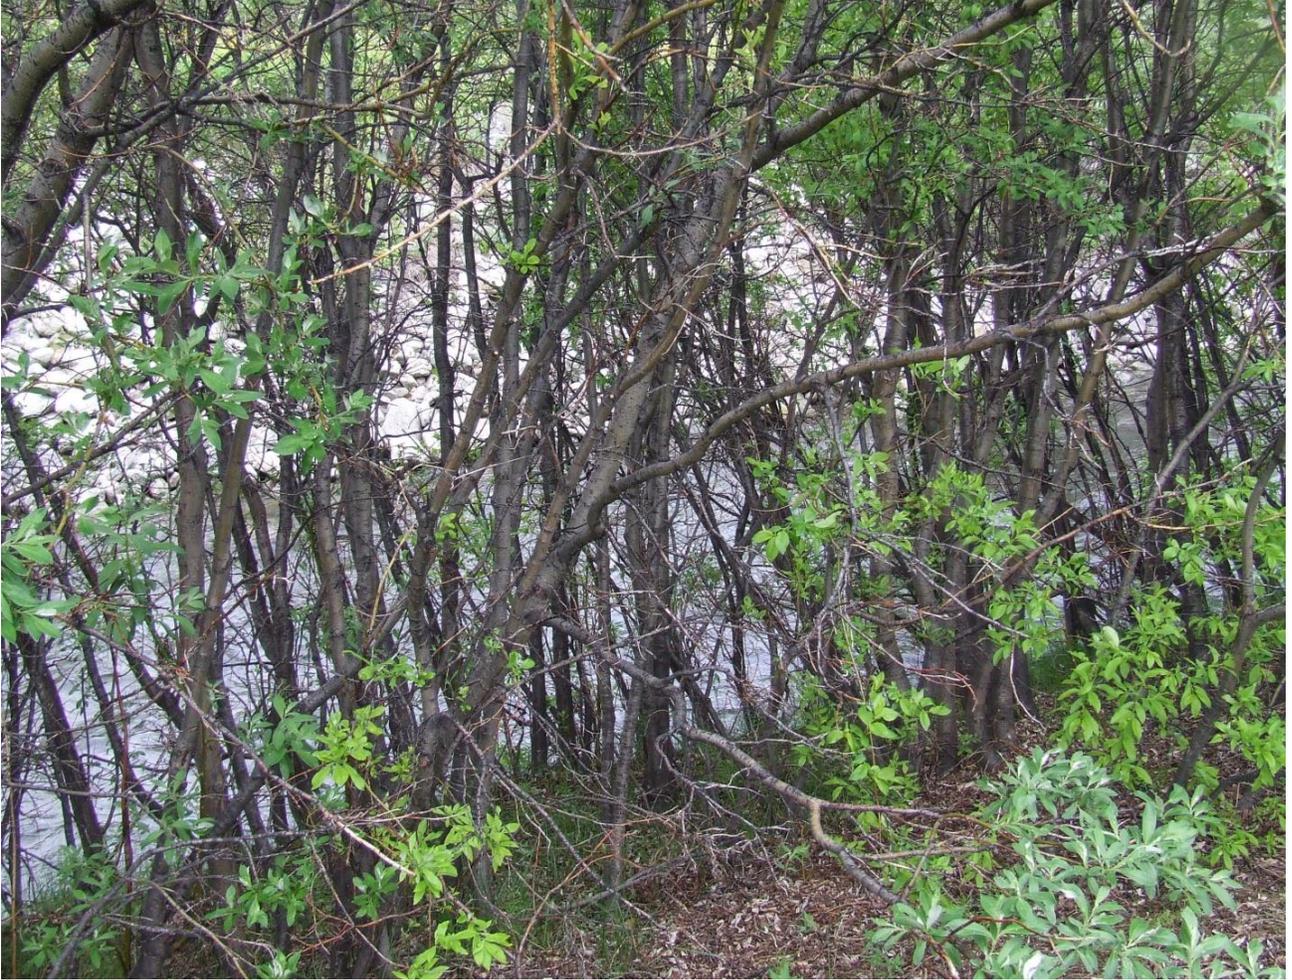
Willows were staked in rows parallel to the channel back to about 3 meters from the water's edge. A dense growth of willows now grows in rows along this bank. Closest to the water is a tall row of *Salix alaxensis*. Farther back are mixed rows of *Salix niphoclada* and *Salix barclayi*. Also growing amongst the willow are *Populus balsamifera* (probably not staked). All willows growing from stakes are greater than 2 meters tall. The tallest willows are *Salix alaxensis*, up to 6 meters tall and 15 cm diameter at the base. The most dominant species are *Salix alaxensis* and *Salix barclayi*.

Figure 6 Thick stems of felt-leaf willow have grown from stakes at the Klukshu River.

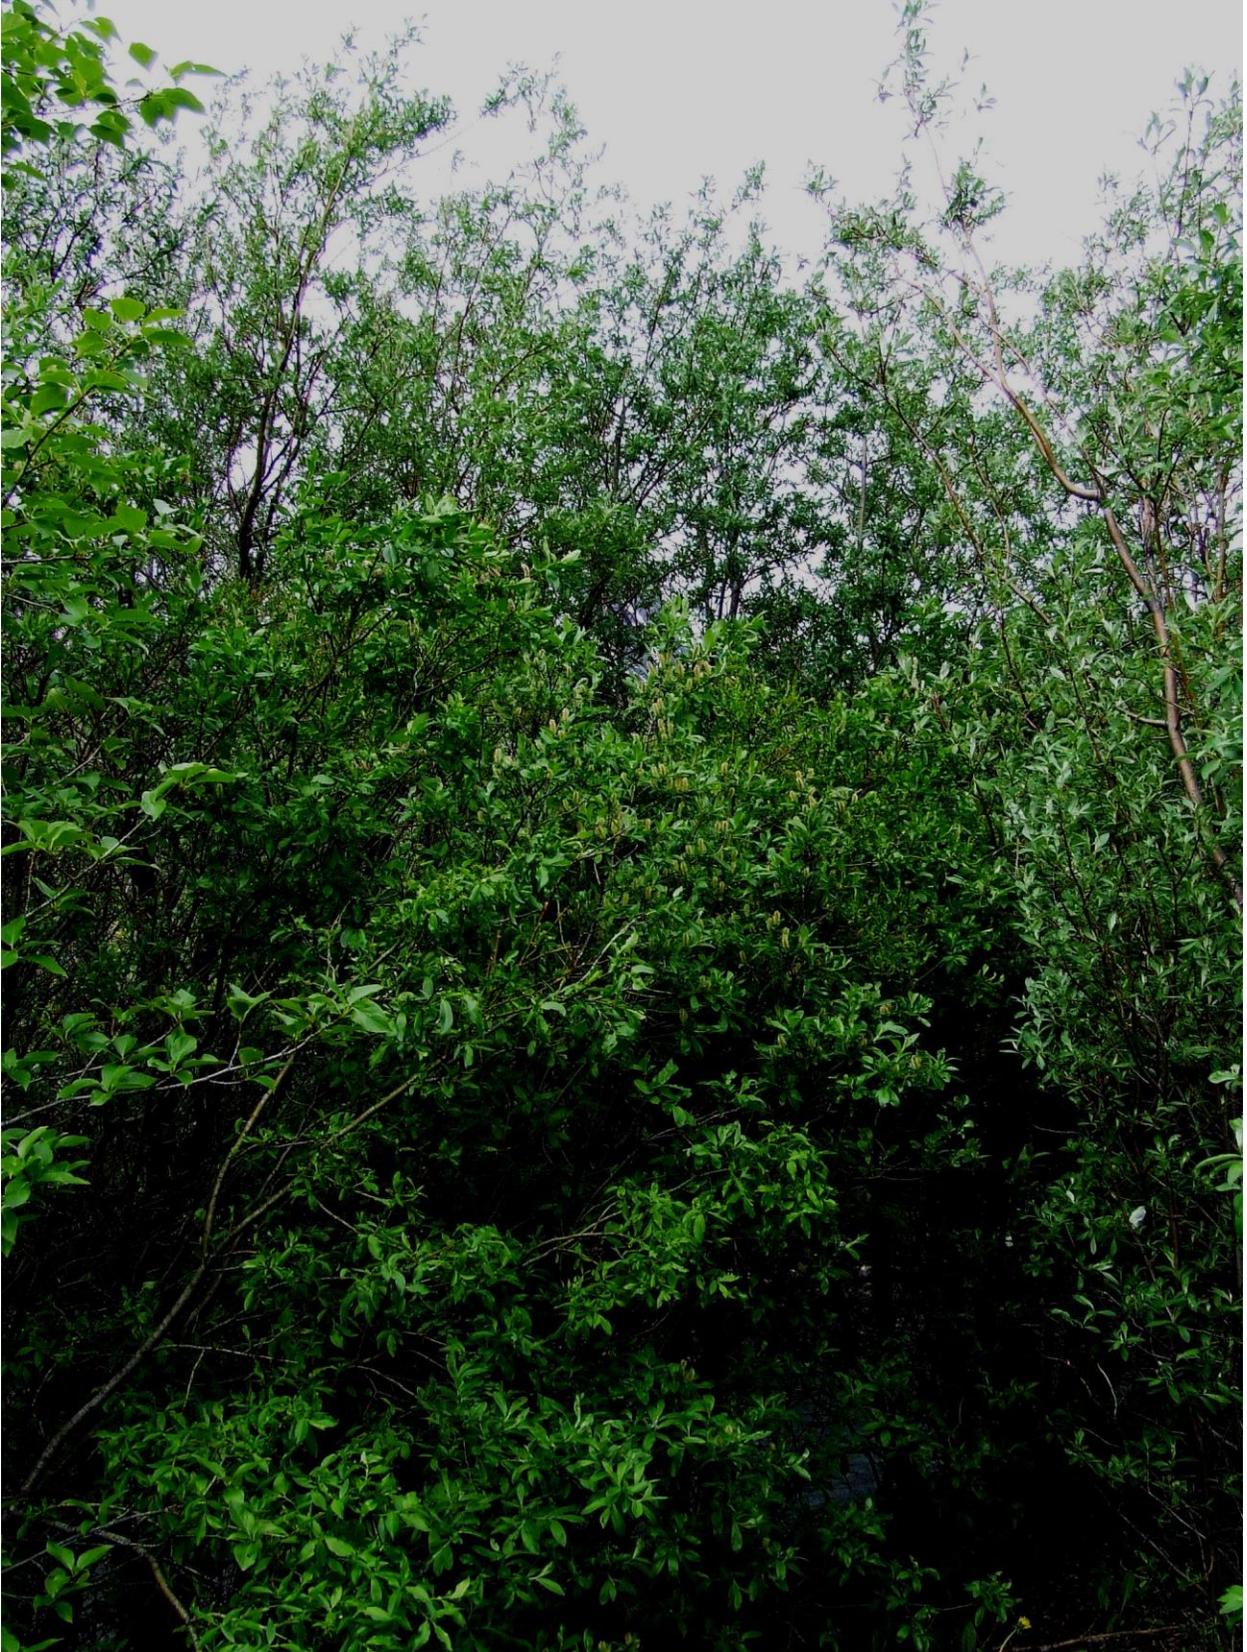
Figure 7 Tall felt-leaf willow with Barclay's willow in foreground at the Klukshu River.

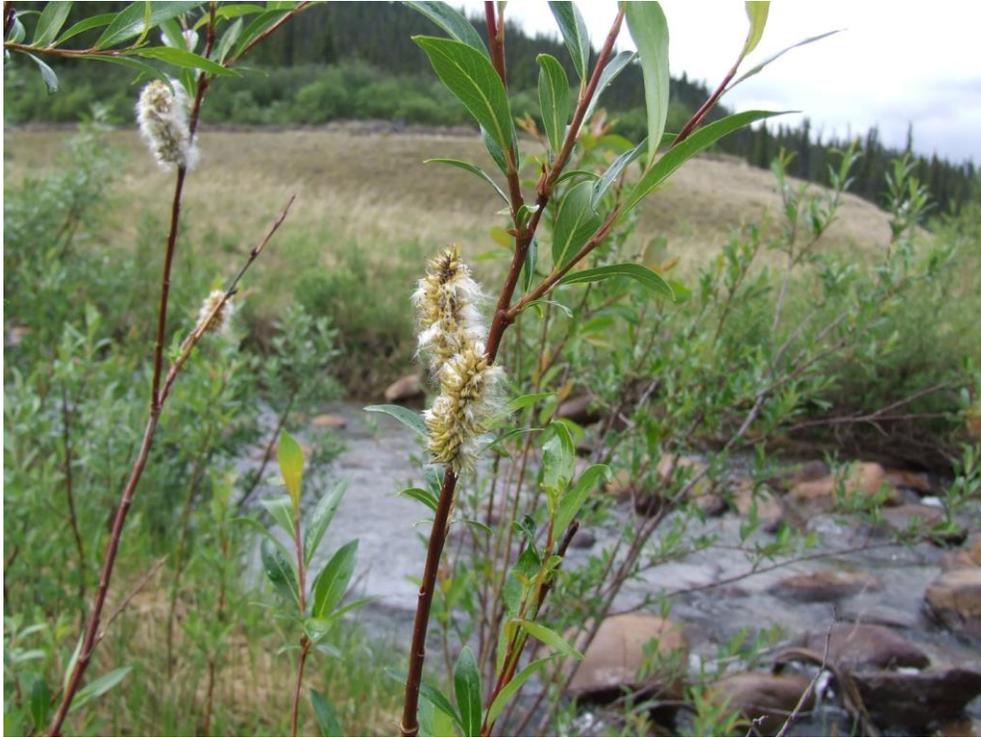
Figure 8 This diamond-leaf willow is growing from a stake along the south fork of Rose Creek.

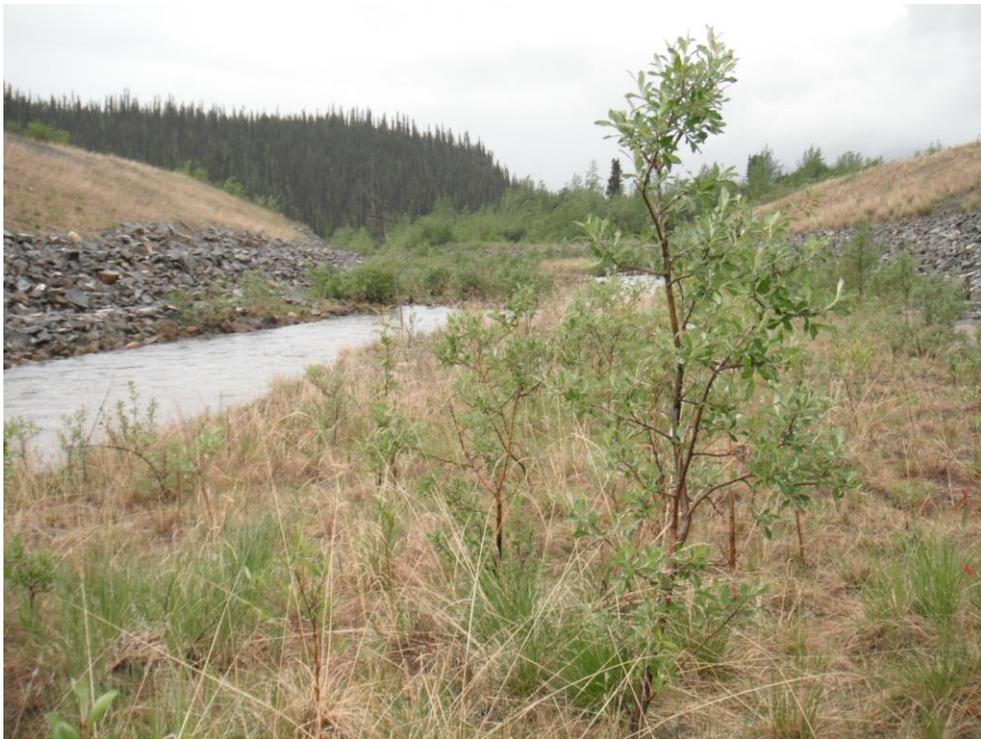
Salix alaxensis and *Salix arbusculoides* are the willow species growing from stakes at the area of the dam breach, along with *Populus balsamifera*. Although most of the willows and poplars staked in this area have survived, many appeared dead but are regrowing from near the base of individual plants.

Figure 9 These felt-leaf willows are growing from stakes near the freshwater dam breach on the south fork of Rose Creek.

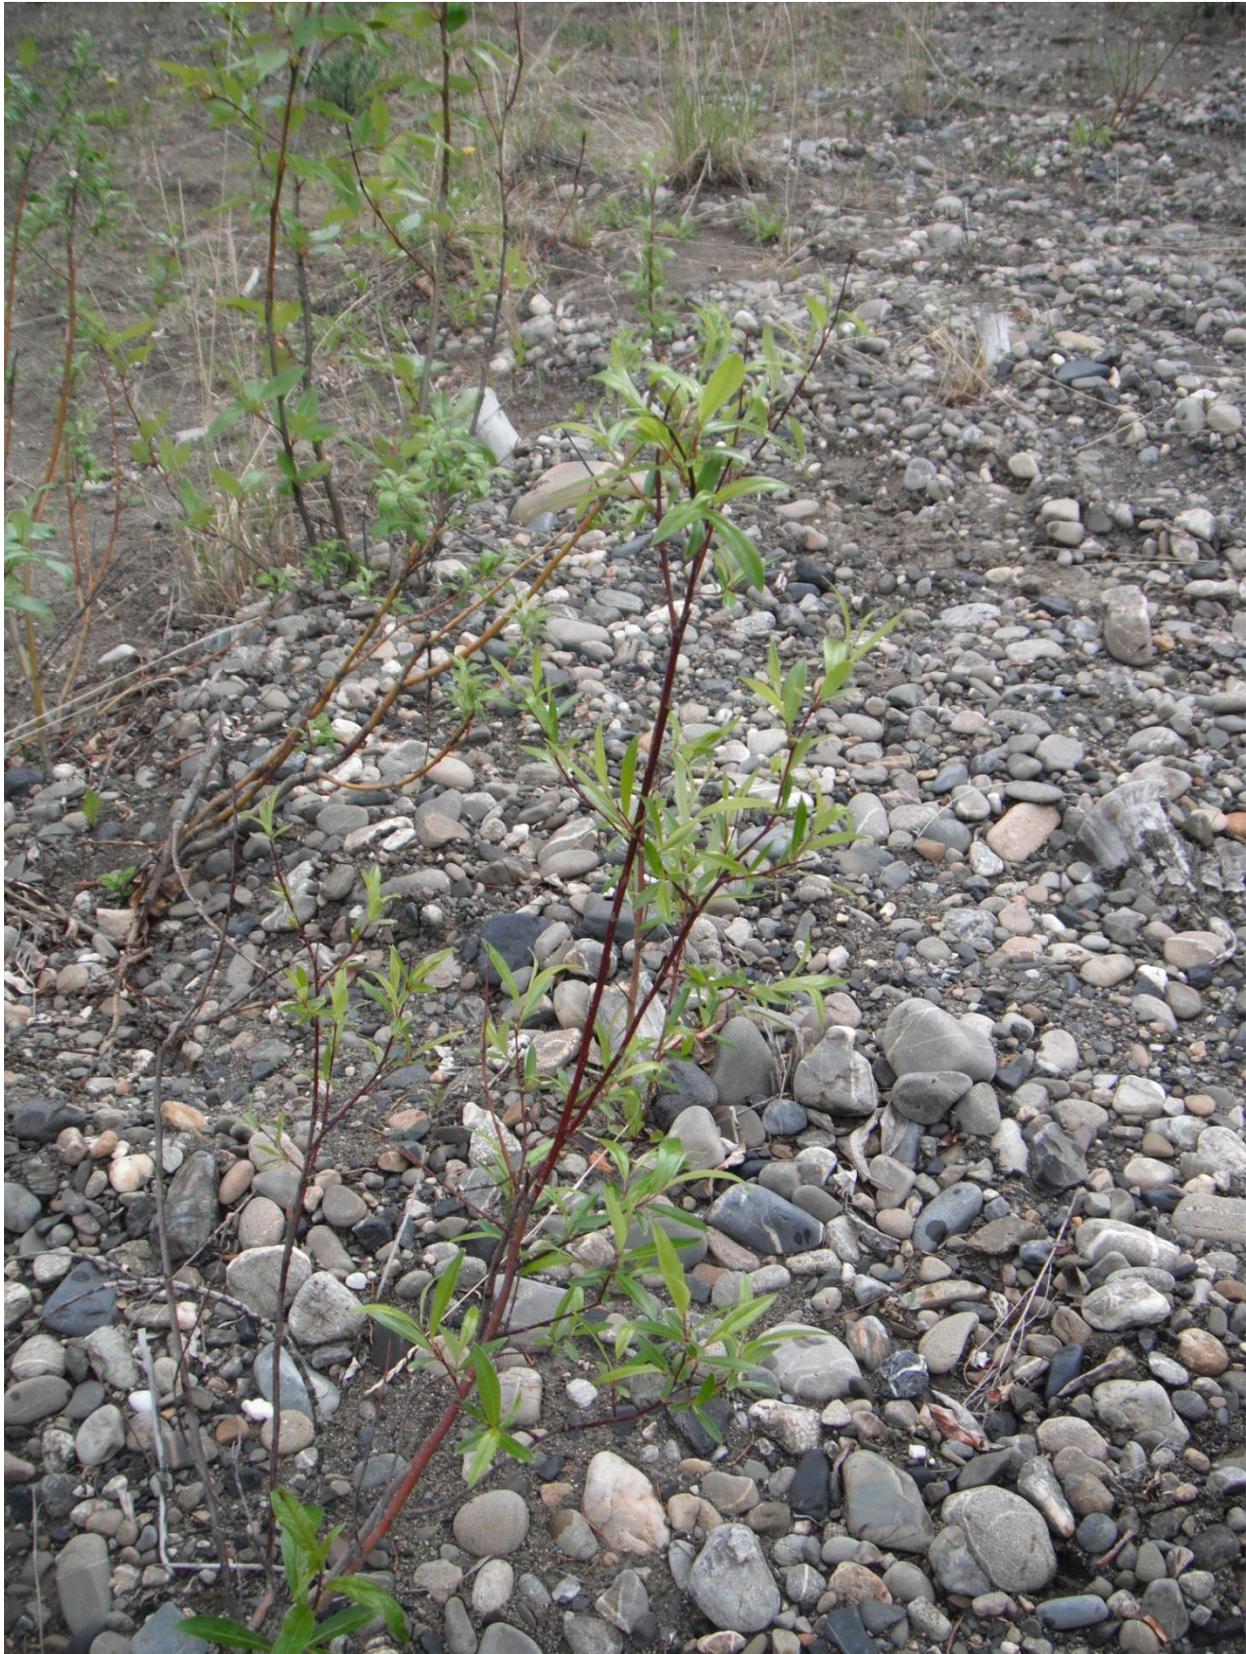
There appears to be a reasonably good success rate of the willows and poplars staked on the gravel bar in the Klondike River back channel, although many of the dead stakes could be missing because of the seasonal flooding and sediment deposition. The successful species are balsam poplar along with the willows *Salix alaxensis*, *Salix arbusculoides* and, to a lesser extent, *Salix planifolia*.

Figure 10 This little-tree willow is growing from a stake on the Germaine Creek gravel bar.

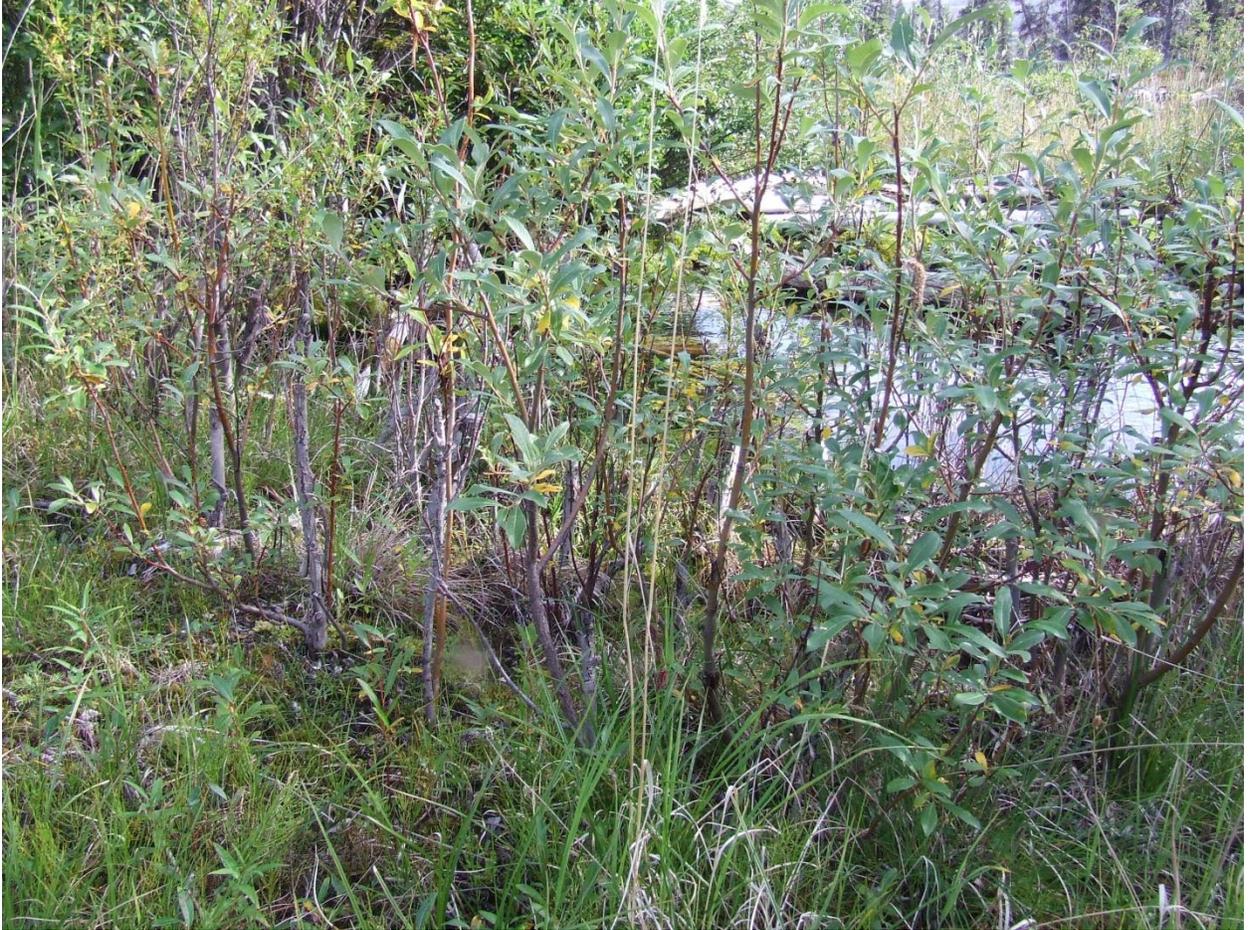
Salix arbusculoides and *Salix pulchra* stakes had been collected from the nearby riparian area and planted on both sides of the stream crossing in 2004. The 2012 survey showed a high success rate for both species.

Figure 11 Diamond-leaf willows growing from stakes at the Engineer Creek crossing.
