ABANDONED CLINTON CREEK ASBESTOS MINE

January 1998

A Water Contaminants Evaluation
File 9590-2-6
by

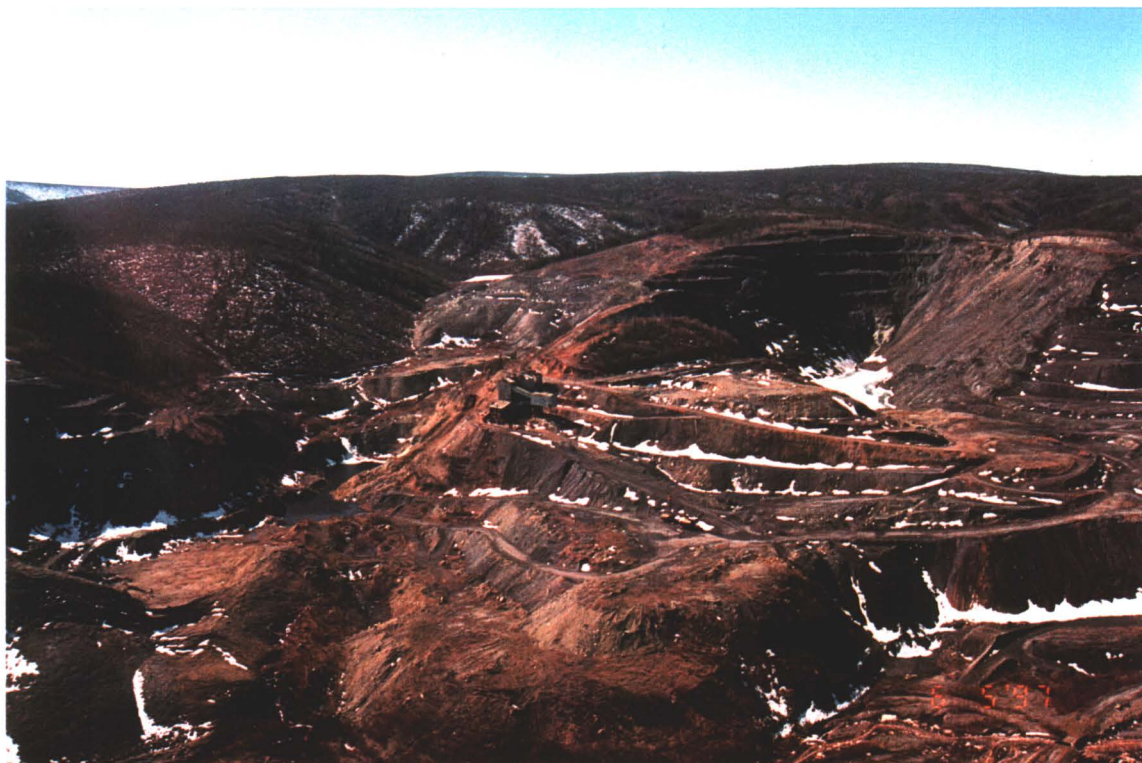
Photo A: Clinton Creek Mine Open Pits

The site is in hilly and unglaciated terrain 86 kilometres northwest of Dawson City, Yukon. The mine consists of three open pits, located on the south side of Clinton Creek (Photo A). The waste rock from these pits was dumped adjacent to the pit sites with the largest volume being located to the south of Clinton Creek. There are approximately 60 million tonnes of waste rock, the movement of which blocked the drainage of Clinton Creek. The body of water formed by this blockage is referred to as Hudgeon Lake (Photo B), and the waste rock continues to creep down slope. An additional 3 million tonnes of waste rock has formed an impoundment on Porcupine Creek.

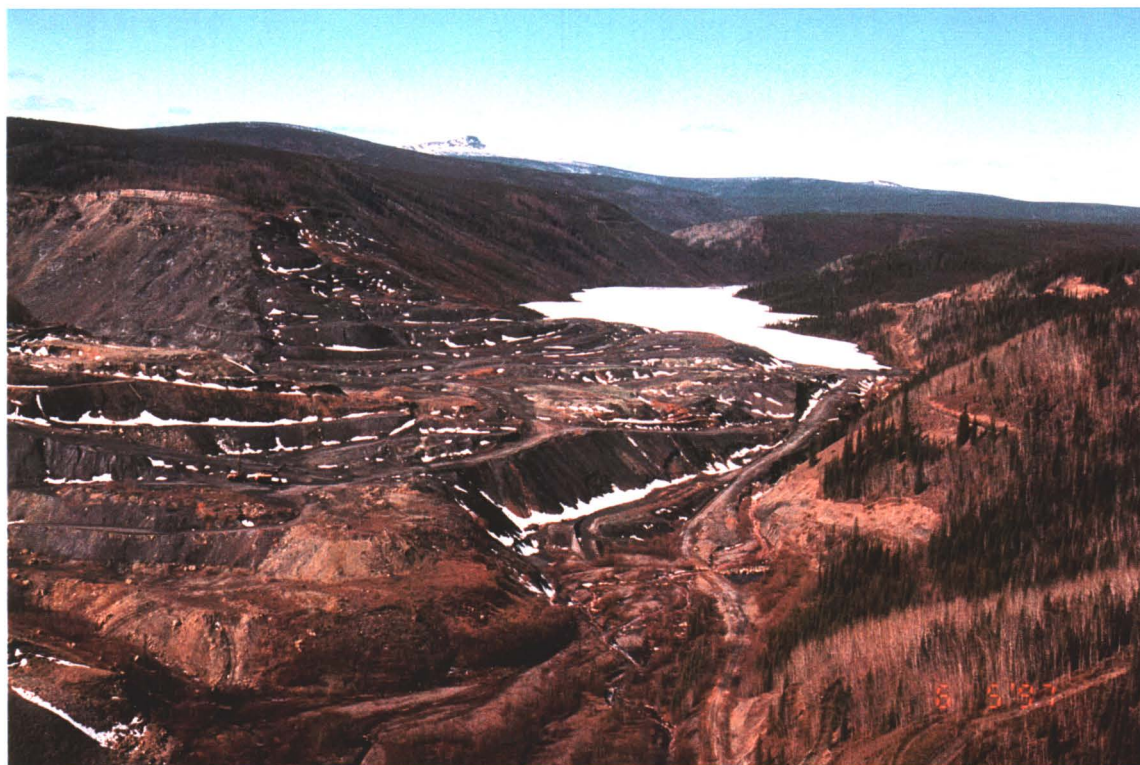
Photo B: View of Mine with waste rock forming Hudgeon Lake

There are 60 million tonnes of waste rock which have blocked the drainage of Clinton Creek and formed Hudgeon Lake. The mill produced one million tonnes of long fibre asbestos and discharged 10 million tonnes of tailings to the Wolverine Creek valley. The tailings dumps have since failed and formed two lobes, blocking the flow of Wolverine Creek. The creeks have eroded both the tailings piles and waste rock causing intermittent failure of impoundments and the aggradation of both creeks. The fish habitat of upper Clinton Creek and Wolverine Creek has been destroyed through physical deposition of material in the creeks.

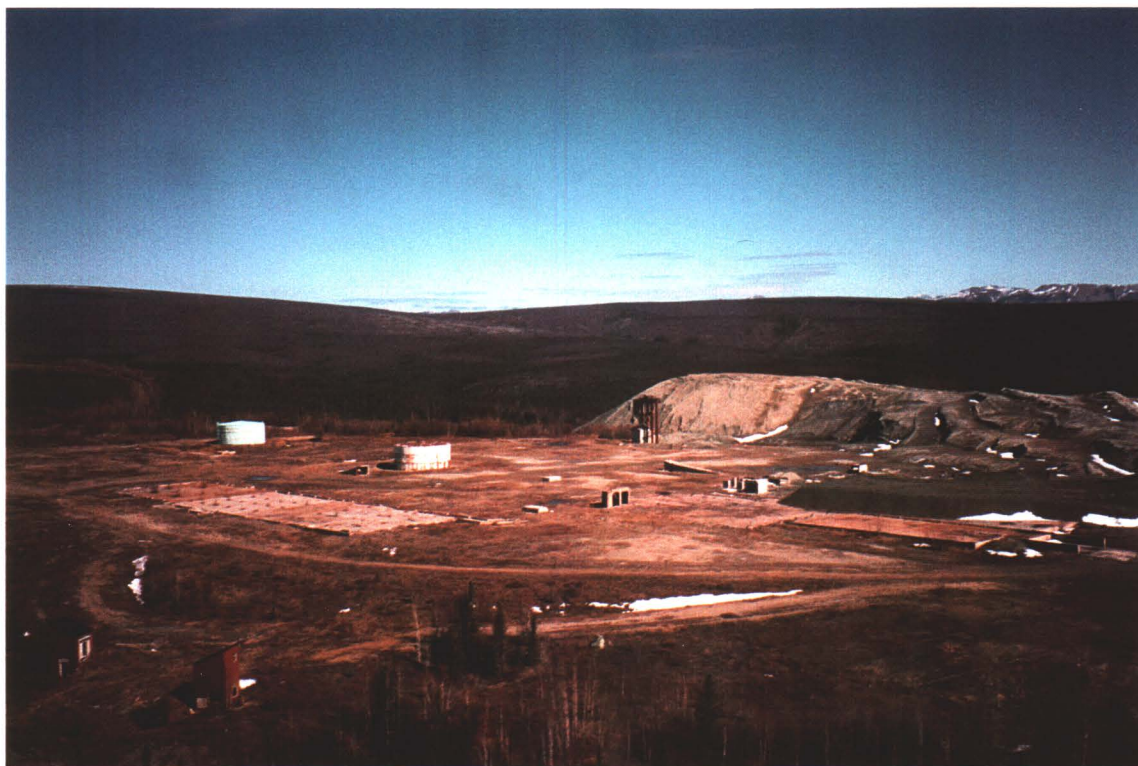
Photo C: Abandoned mill site

The mill was located on a flat ridge north of the mine site (Photo C). The mill produced one million tonnes of long fibre chrysotile asbestos and discharged 10 million tonnes of tailings with a conveyor stacker to the west slope of the Wolverine Creek valley (Photo D).

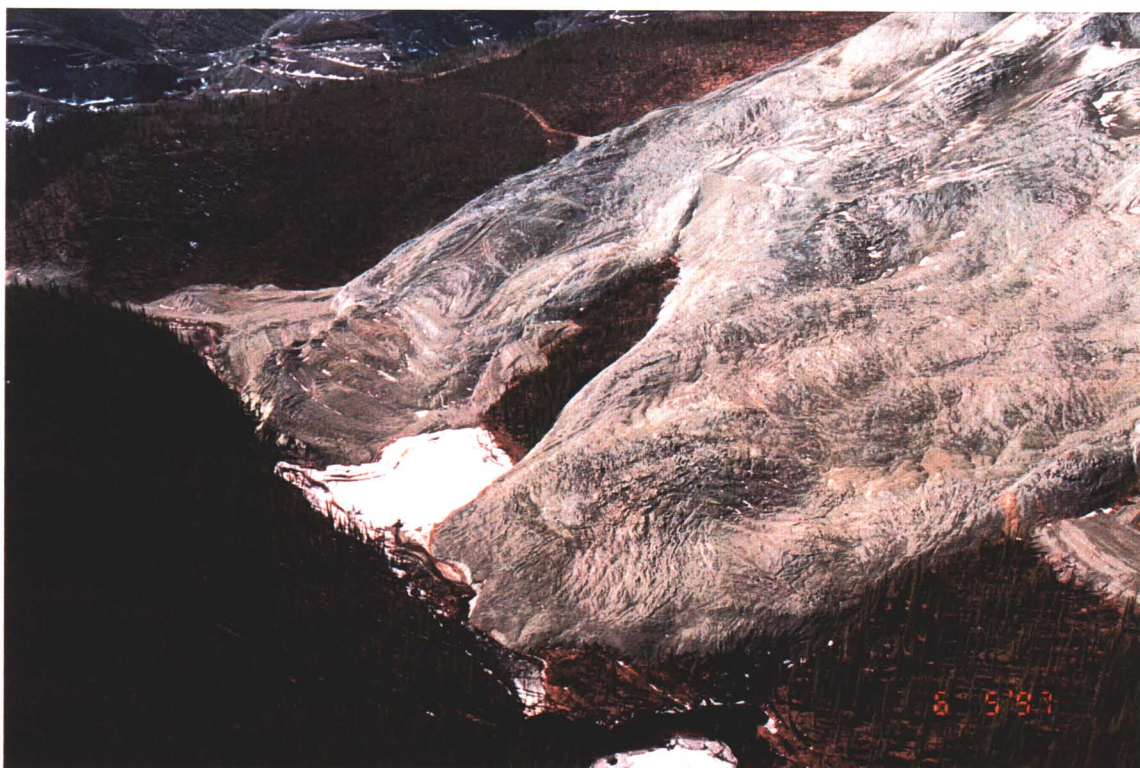
Photo E: North and South lobes of tailings with North lobe at bottom

The tailings were stacked in two piles, which have since formed two failures known as the north and south lobes (Photo E). The original tailings pile was the south lobe which failed in 1974 and blocked the flow of Wolverine Creek, creating an unnamed lake. The north site was employed following this failure and tailings were deposited there until closure. The north lobe failed in 1976 and added to the blockage of Wolverine Creek. Since that time the creek has eroded both the tailings pile and the east bank of the valley (Photo F). This combination of erosion and blockage has caused the intermittent failure of impoundment with often dramatic results downstream on Wolverine Creek. In the spring of 1997, a large flow of water discharged past the Clinton Creek impoundment and resulted in serious erosion of the mine site road access (Photo G and H). It is likely that this is typical of the area's hydrological regime (1,2,3,4,5,6).

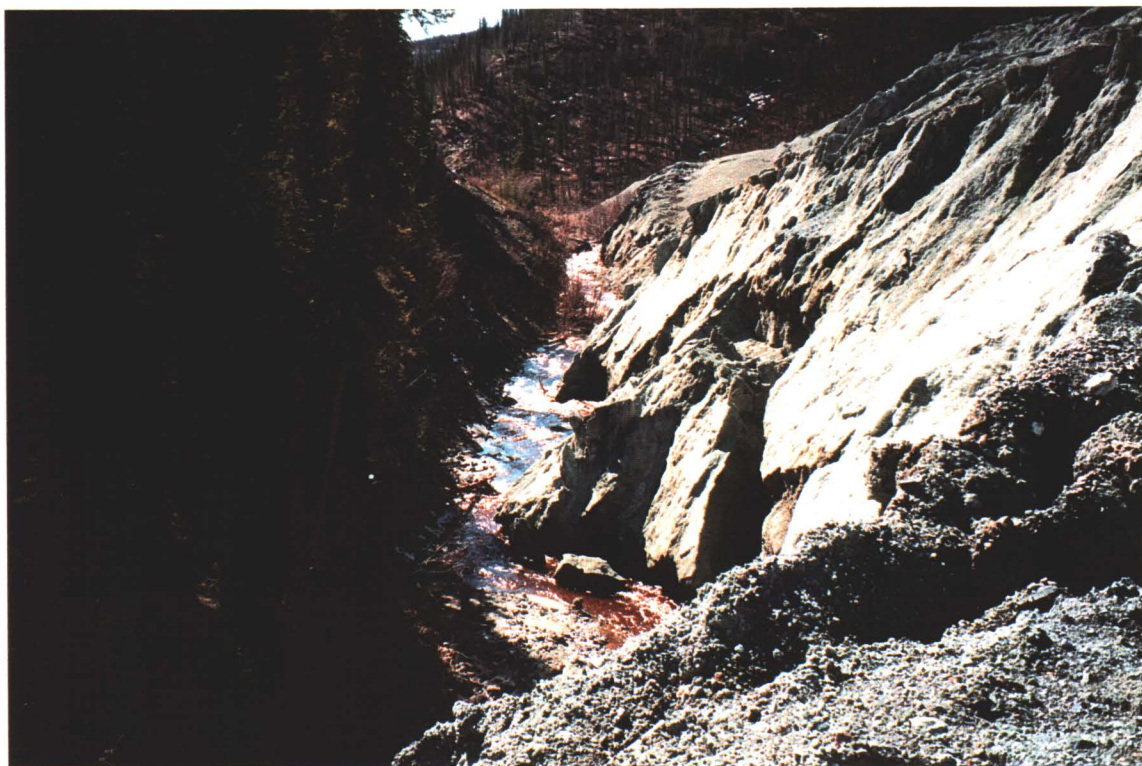
Photo F: Eroding toe of tailings and east bank of Wolverine Creek

The tailings piles have been eroding into Wolverine Creek since the failure of the south lobe in 1974. The progressive failure of the north lobe, beginning in 1978 and reaching the creek in 1985, has served to block the creek and increase erosion of the east bank since that time. The channel at Wolverine Creek has received attention similar to that at Clinton Creek over the same time frame. The armouring of the creek channel with weirs was conducted in 1979 (Photo J). The weir construction has fared better than that in Clinton Creek and has remained relatively intact, although the outfall channel is unprotected and continues to erode (4,14).

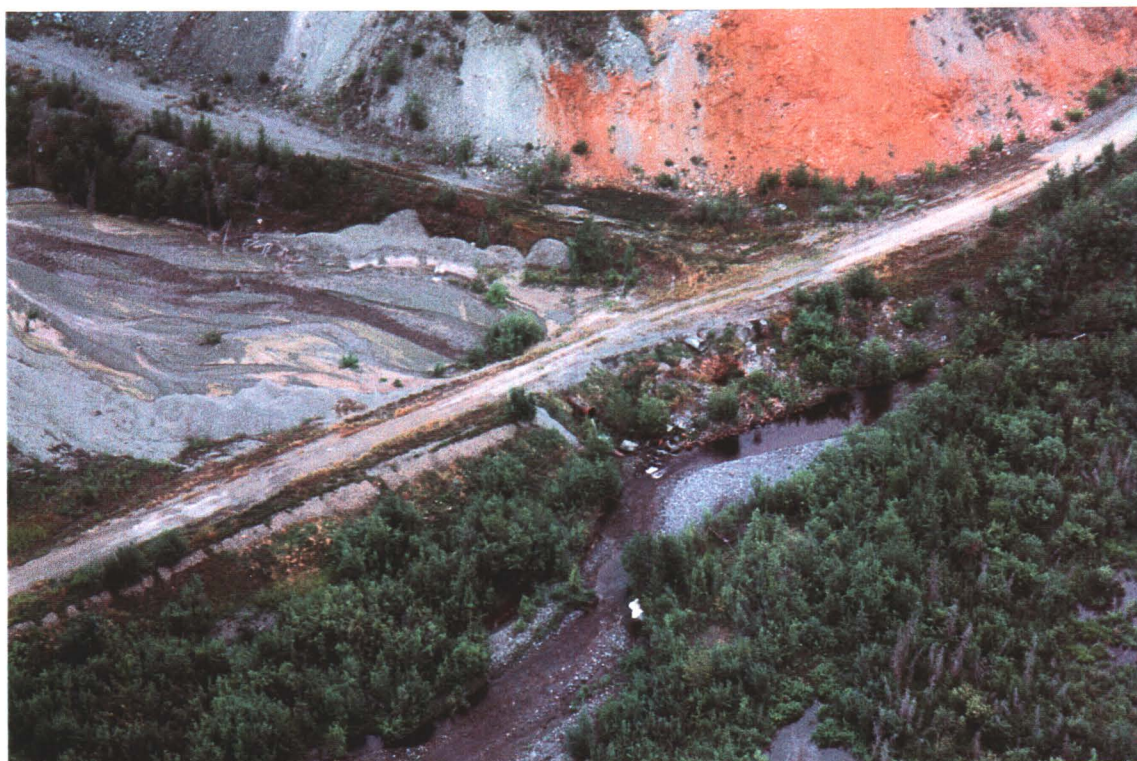
Photo K: Mouth of Wolverine Creek at Clinton Creek

The physical aspects of the site, with regard to abandonment, have received the most attention of past reports. The unstable nature of the waste rock and tailings has figured prominently in any risk evaluation for the Clinton Creek Mine property. The environmental impacts to the water quality are directly dependent on the physical deposition of material resulting from the movement of tailings and waste rock. The repeated destruction of habitat in Clinton and Wolverine creeks is tied to the input of material from the movement of waste rock and tailings down the valleys (Photo K).
