## **ABANDONED CLINTON CREEK ASBESTOS MINE**

**CONCEPTUAL DESIGN REPORT**  
**June, 2002**

**Reference: Abandoned Clinton Creek Asbestos Mine  
Conceptual Design Report**

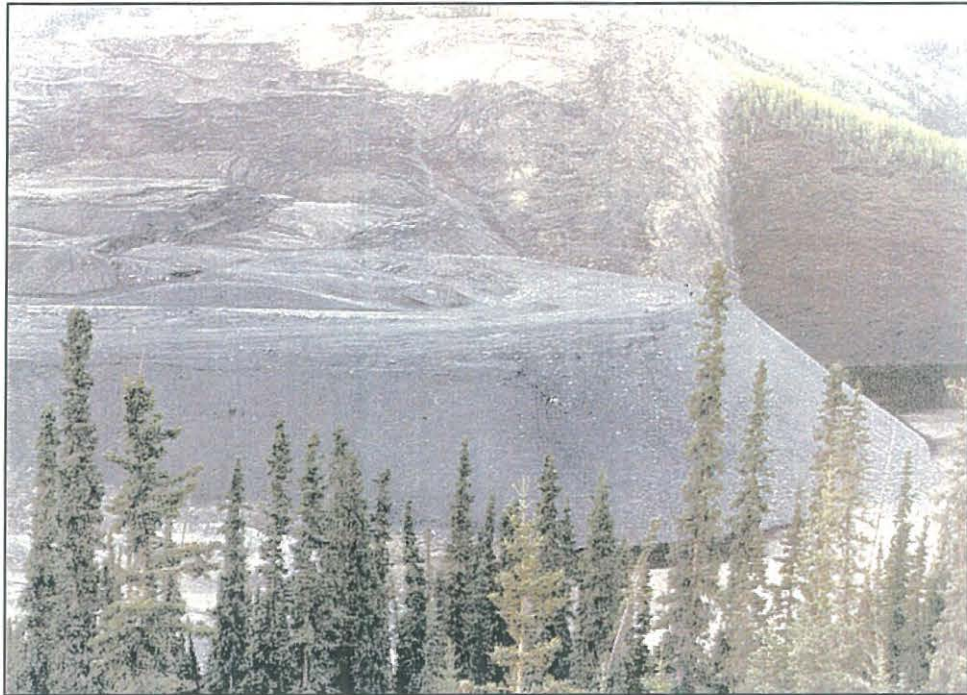
**Figure 2-5**  
**Waste Rock Dump in 1975**

- Placement of an additional 3 million tonnes of waste rock was planned over the lower regions of the dump in the summer of 1974. It was recommended that this placement could destabilize the lower portion of the waste rock dump and further elevate the creek channel, although it would improve the overall stability (Golder 1974, pg3&4). Any additional waste material (beyond the 3 million tonnes) was to be placed on the east side of the waste dump. *Concerns remained however about the shear strength and displacement of the organic mantle beneath the waste rock already placed and the planned dump extension to the east* (Golder 1974, pg5). Golder Associates proposed to evaluate the presence of permafrost and if necessary strip the organic soil, allow the active layer to freeze and place 10 feet of waste rock as an insulating layer to prevent permafrost degradation. *It is not known if this recommendation was followed.* The waste rock dump in 1975 is illustrated on Figure 2-5. *Note North South Orientation of Cracks.*

- It appears that little to no fill was placed on the active dump beyond about 1974 after which time, waste material was being dumped northwest of Snowshoe pit (Golder 1977, V77016 pg2). Large cracks believed to be a result of graben development still existed in a north-south alignment in the toe area above the road in 1976/77 (Golder 1977, V77016 pg8). Changes in the physical condition of the waste rock dump between 1975 and 1976 can be seen in Figures 2-5 and 2-6. *Note evidence of slumping of into Hudgeon Lake by 1976.*

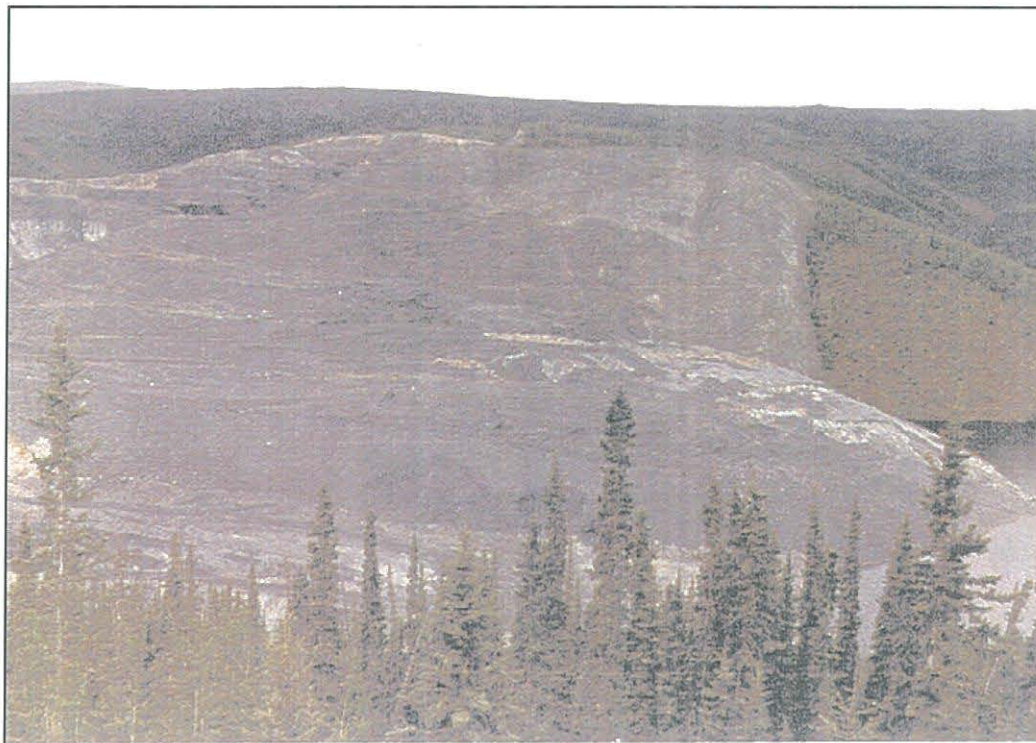
**Figure 2-9**  
**Waste Rock Dump (1982)**

- In 1982 Hardy noted that the surface characteristics of the waste rock dump demonstrated sufficiently clearly the ongoing instability and continued movement of the dump (Figure 2-9). The channel weirs constructed in the fall of 1981 were now by-passed by the stream, which was undercutting and eroding the natural side slope (Figure 2-10).

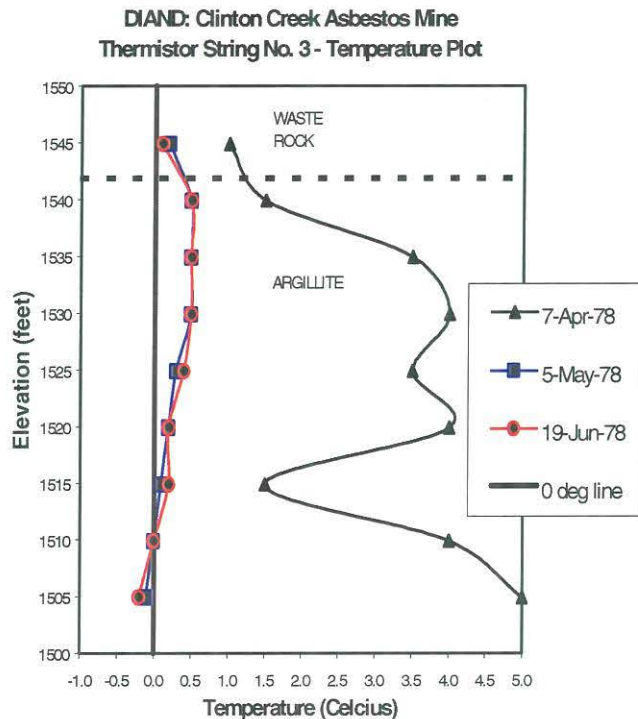
**Figure 3-5**  
**Temp. Profile – Thermistor String T3**

Thermistor T3 is located farther to the west within the waste rock dump but still some distance from the creek. The results indicate the ground temperatures are above 0 degrees (about +0.5 degrees) for a depth of 30 feet below the original ground surface. At the location of T3, the ground surface formed part of a north aspect and quite likely was underlain extensively by permafrost. It appears therefore that the permafrost may have degraded to a depth of 30 feet in this area of the waste rock dump. No ice chips were observed during installation of the Thermistor T3 (BH4).

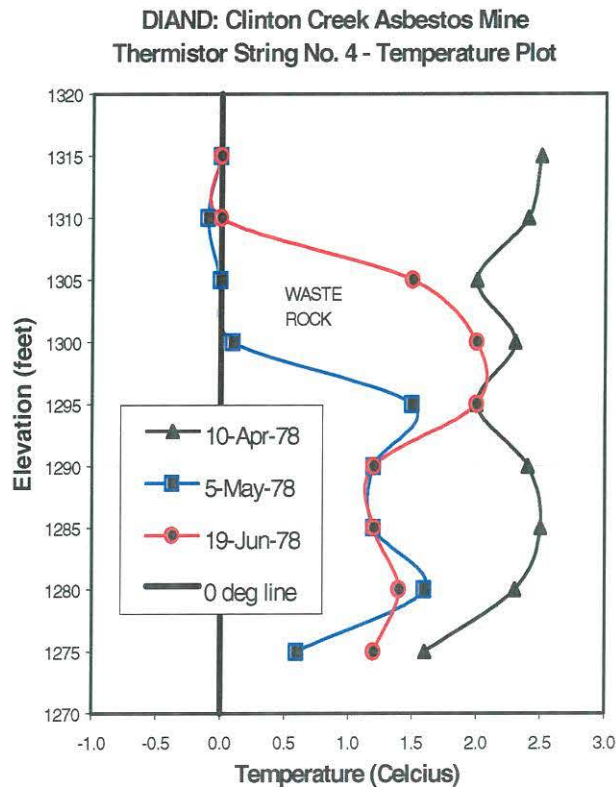
**Figure 3-7  
Temp. Profile – Thermistor String T4**

Thermistor T4 is located near the northern edge of the waste rock dump along the access road adjacent to Clinton Creek, approximately coincident with the original toe of the north valley slope. Unfortunately, the base of the waste rock dump was not reached with the borehole and sloughing prevented the installation of the string to the base of the hole. Golder Associates concluded that the measurements reflected the temperature of seepage water within the base region of the dump. Based on the temperature profile, it was speculated that the phreatic surface was at approximately elevation 396m (1300 ft).

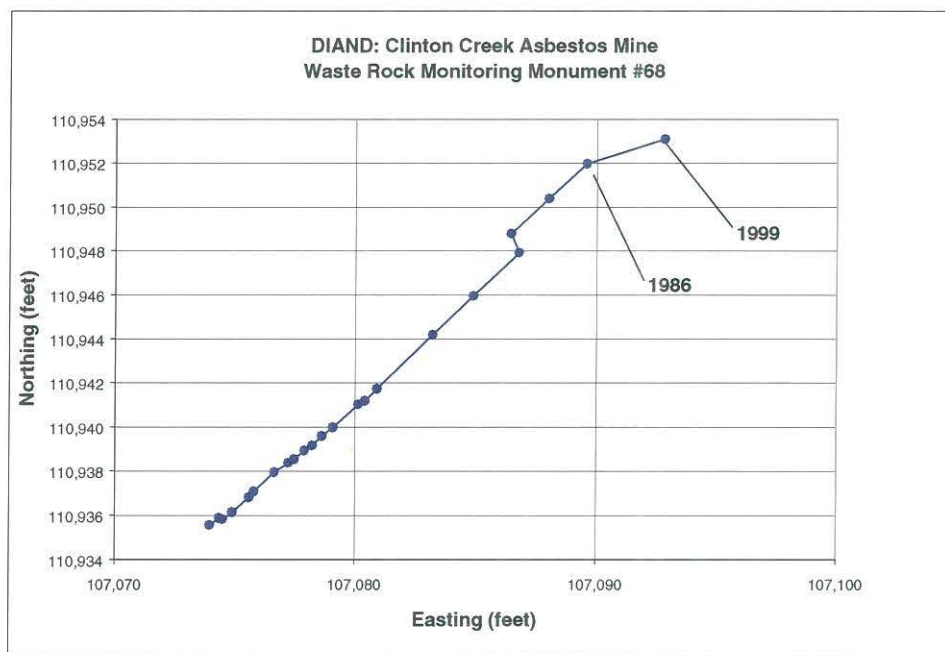
**Figure 4-1**  
**Target Coordinates**

Plots of movement data are illustrated in Figures 4-1 to 4-3 using Movement Monitor #68 as an example. Movement vectors are generally consistent throughout the observation period i.e. the direction of movement is consistent (Figure 4-1). Current (1999) horizontal movement rates appear to have reduced significantly from those observed prior to 1986 (Figure 4-2). Over the same period, however, settlement rates have remained about the same, currently at a magnitude about double that of the horizontal movement (Figure 4-3). It therefore appears that while the horizontal movement has slowed down considerably or may have ceased, settlement of the waste rock is continuing at a more or less constant rate.

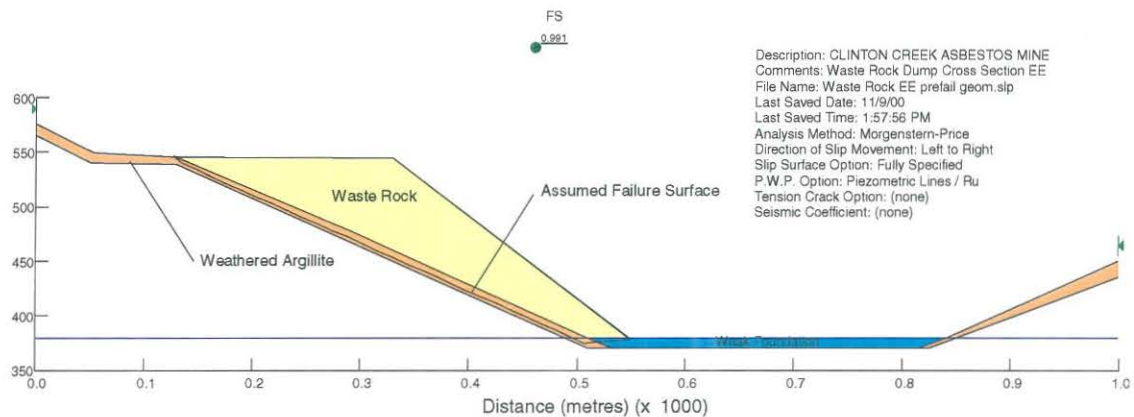
**Figure 5-1**  
**SECTION E – Initial Failure**

The failure surface was assumed to be within a weak layer of the weathered argillite at a shallow depth in the foundation soil across the valley floor. The resisting forces in the rock fill were excluded in the analysis by forcing the failure through the weathered argillite. The piezometric level within the weak foundation soil is assumed to be coincident with the top of the original creek bank (valley floor). Sensitivity analyses were then carried out to determine the influence of pore water pressures and friction angles for the argillite. A friction angle in the weathered argillite of 33.5 degrees (close to the

direct shear testing results) was then selected to determine the pore water pressures necessary to achieve a FS of 1.0, as illustrated in Figures 5-1 and 5-2.

The resistance to sliding within the frozen foundation soil at the toe of the dump and along the valley slope would be expected to decrease if the drainage of water from the thawing permafrost affected soil is restricted. To investigate the parameters necessary to cause an initial foundation failure of the waste rock, the pre-failure dump geometry was generated from historical surveys and photographs. Two representative cross sections (E and K) were chosen for the slope stability back analysis that assumes the factor of safety (FS) at the time of failure was unity (Drawing 02).
