Anvil Range, 2003 Project 18b, Assessment of Tailings Outside of Containment

Re: 40436 – Tailings Outside of Containment – Draft Report

**Anvil Range, 2003 Project 18b, Assessment of Tailings Outside
of Containment**

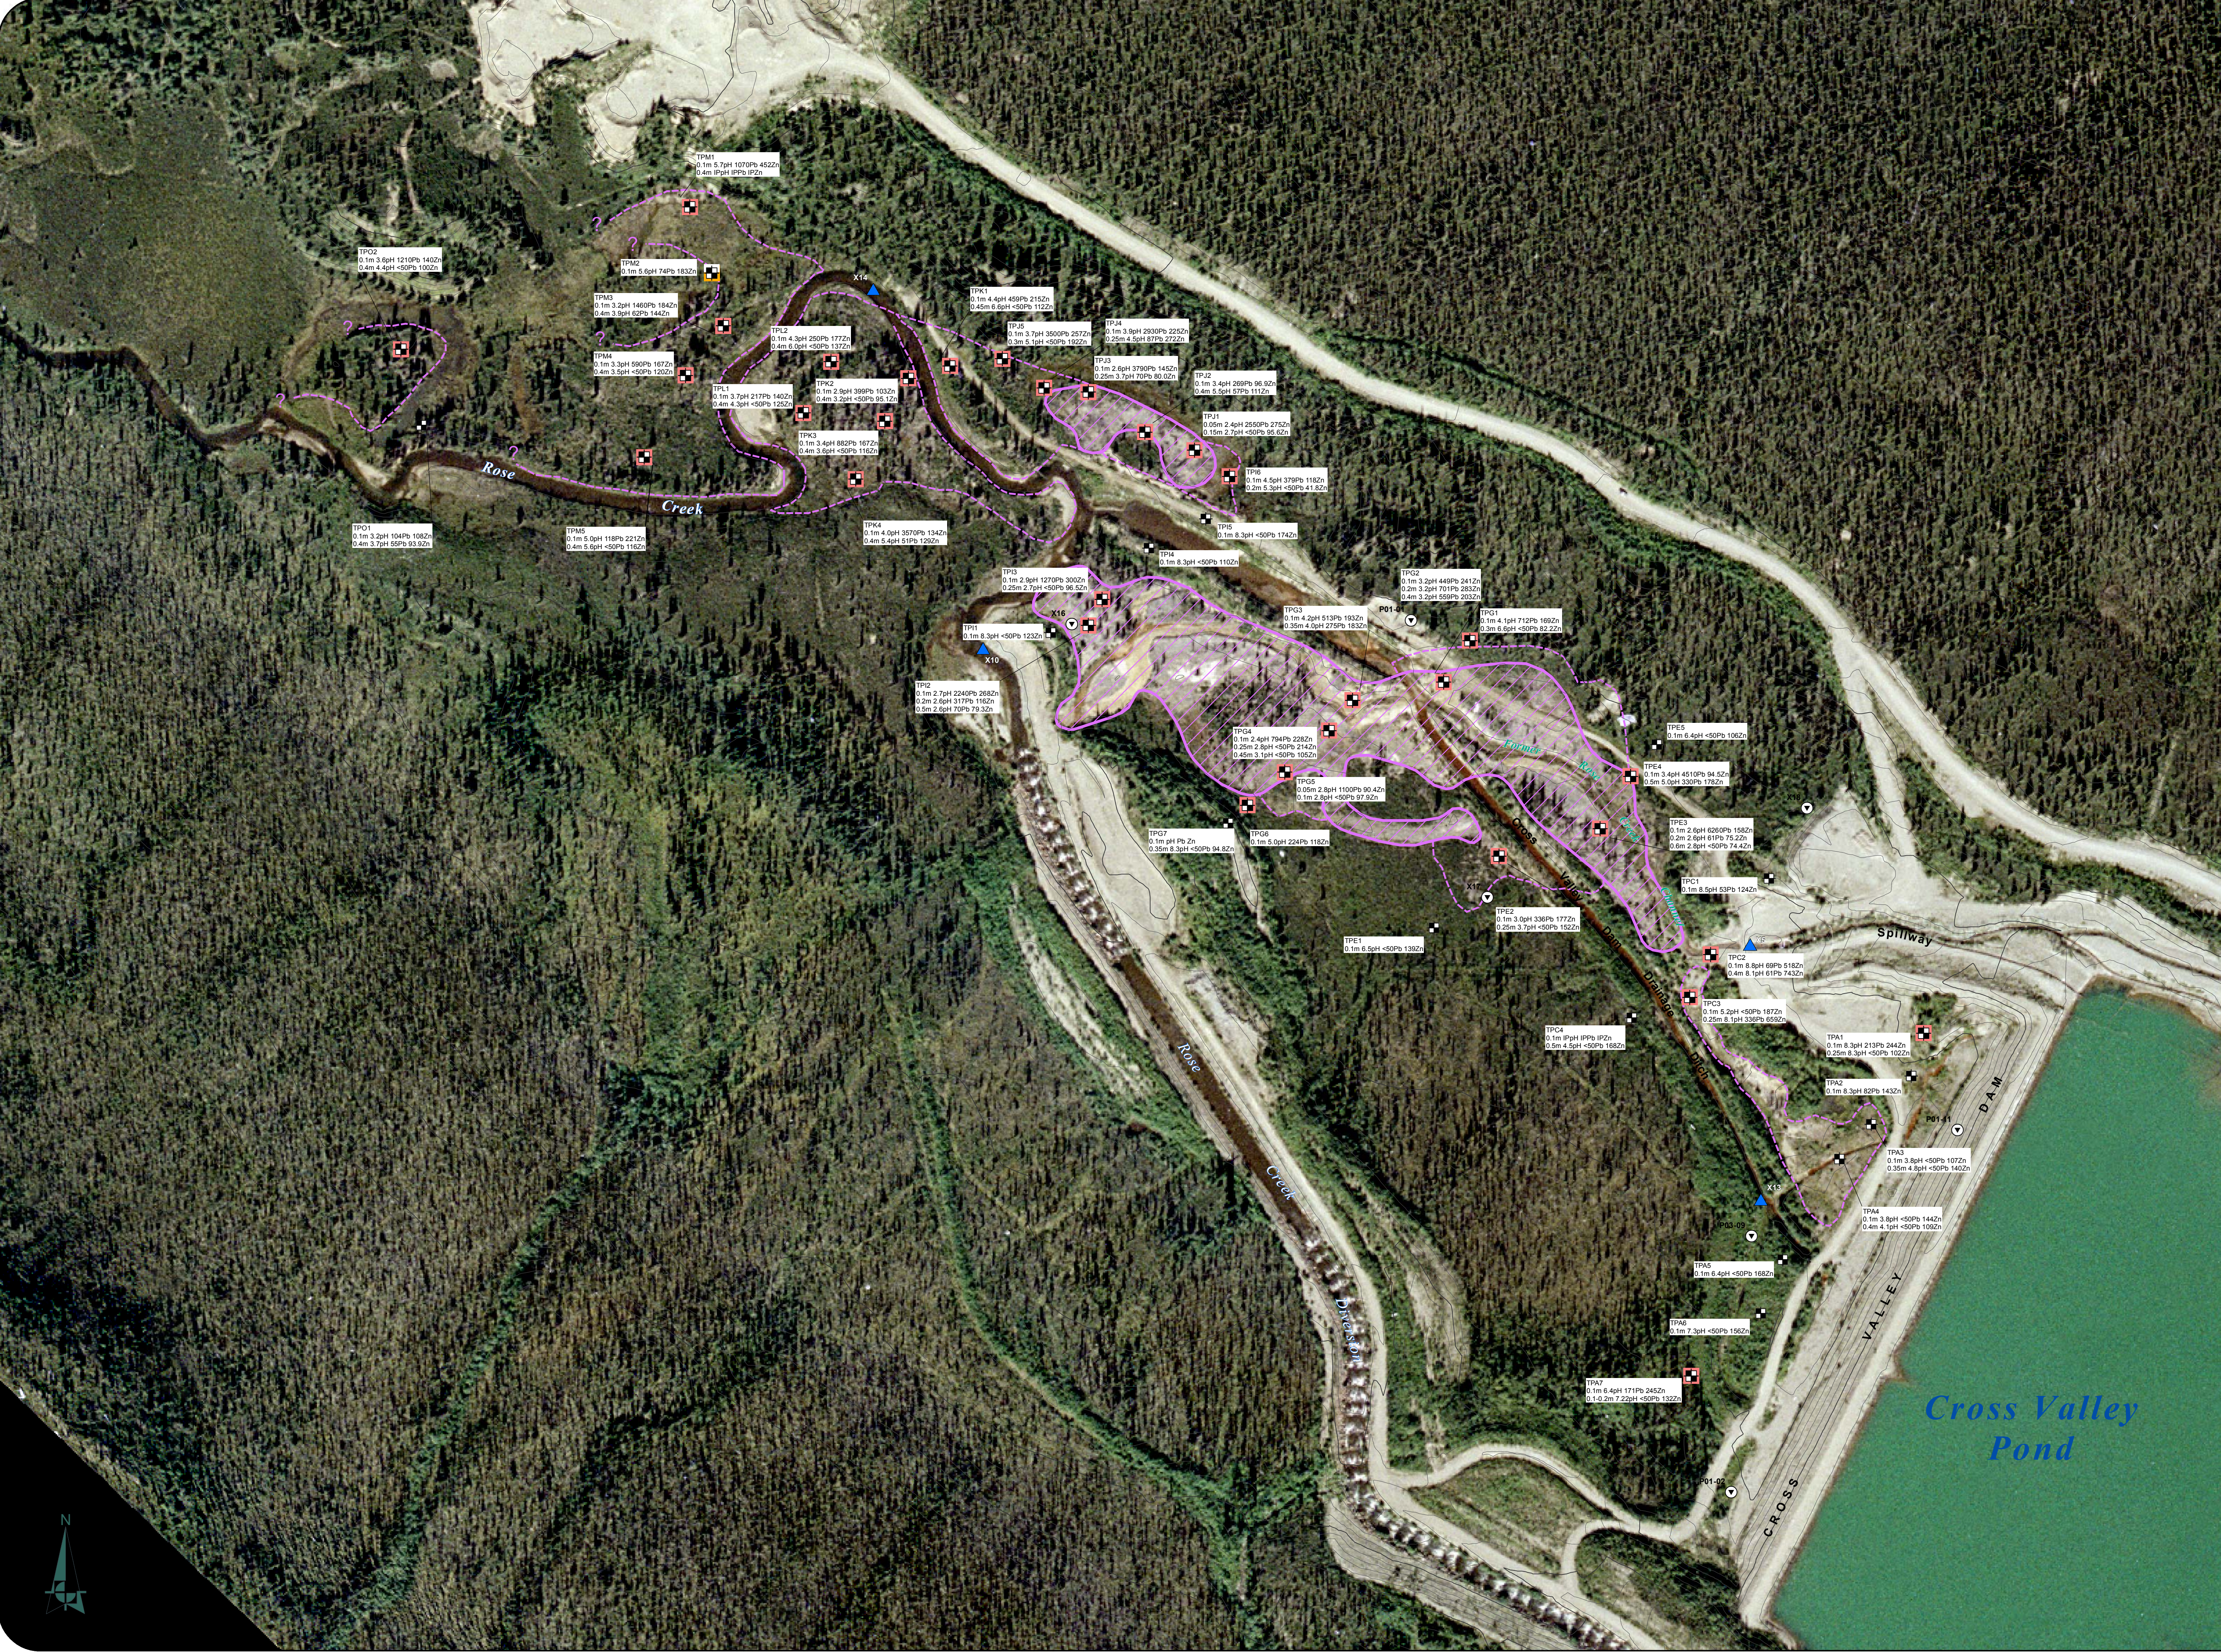
Figure No.
3

Today, there are obvious areas of killed and stressed vegetation (kill zones) in the area between the Cross Valley Dam and the end of the Rose Creek Diversion (X14). The extent of the major kill zone areas are shown on Figure 3. Further downstream of X14, there are many areas of stressed vegetation and dead trees that appear to also have been impacted by the spill. These areas are identified as “Intermittent Kill Zones” on Figure 3.

Preliminary results of soil quality testing are presented on Figure 3.

Soil Quality in Area 2
Down Valley Area

A total of 85 soils samples from this area have been analyzed to date. Of these, 34 samples exceed the Yukon Contaminated Sites Regulation (YCSR) Parkland Use Standard for Lead (31 samples exceeded the CCME Parkland guideline). Due to low soil pH, the YCSR Standards are typically more stringent than the CCME guidelines. 34 samples exceed the YCSR Parkland Use Standard for Zinc (31 samples exceeded the CCME Parkland guideline). Location of samples exceeding guidelines/Standards are highlighted on Figure 3.

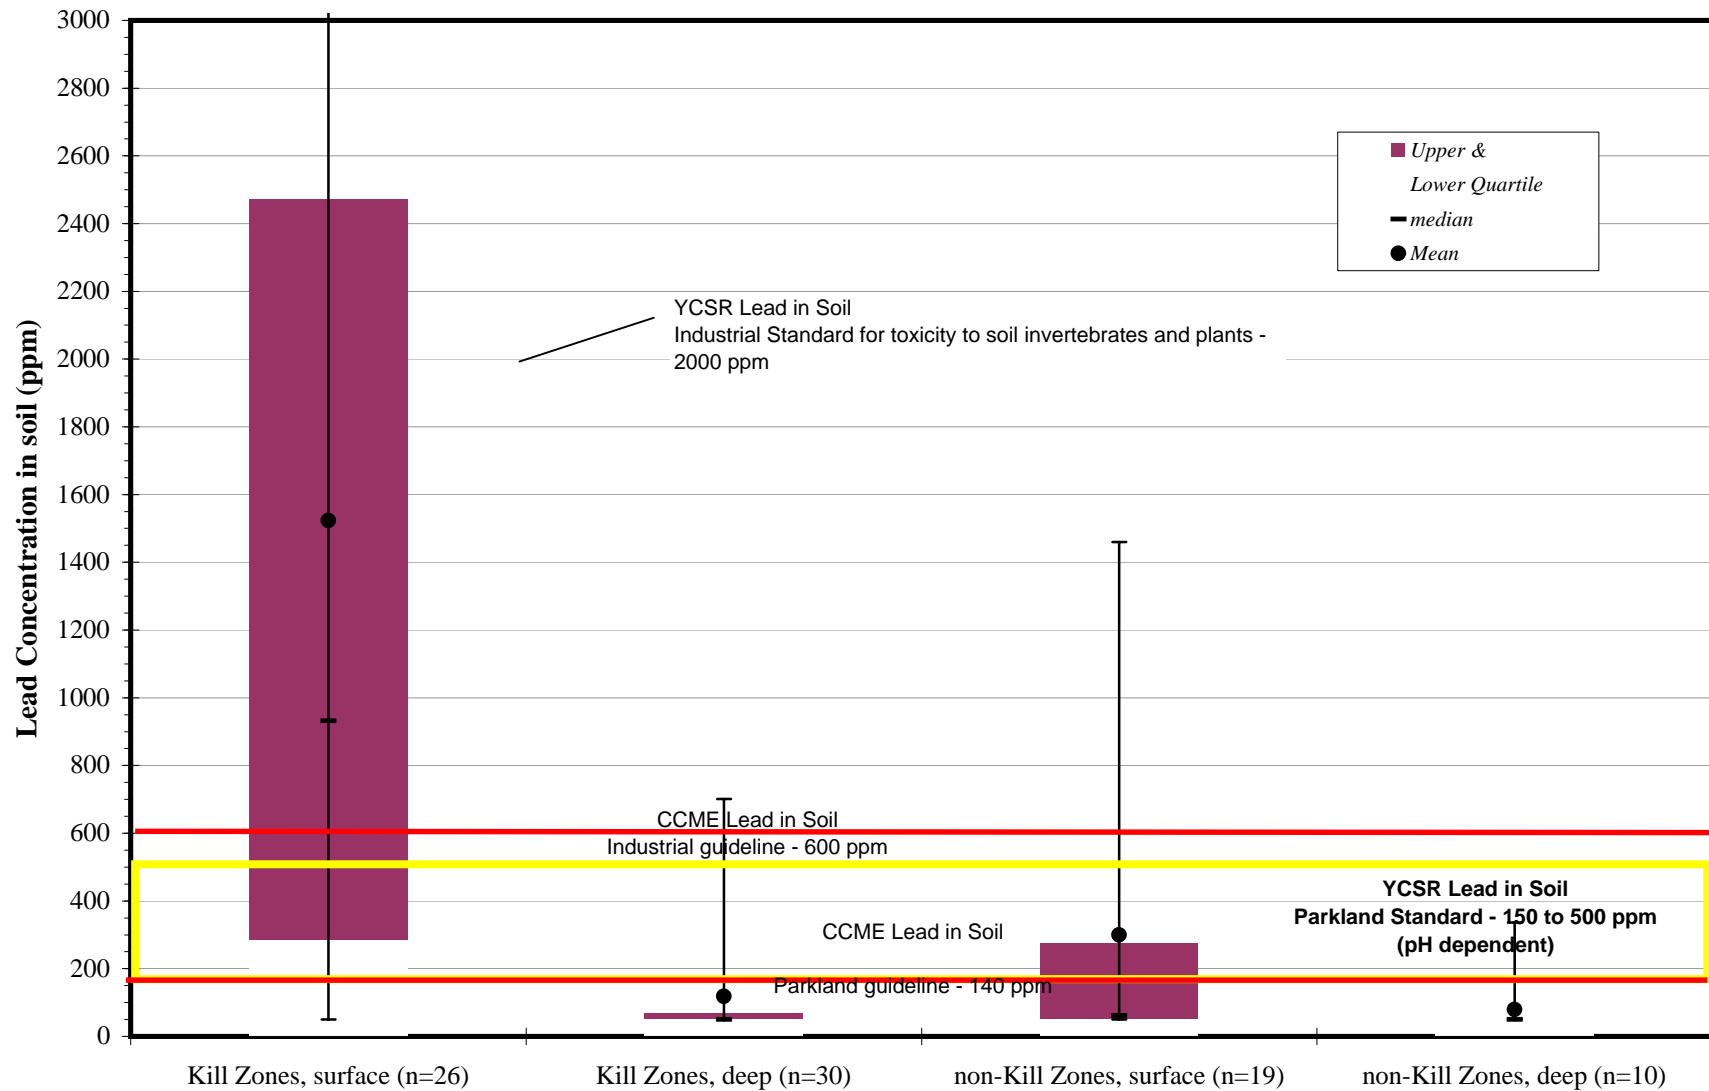
Figure 4. Lead Concentrations in Down Valley Area

The statistical distribution of lead and zinc concentrations in soils are illustrated on Figure 4 and Figure 5 respectively. Components of these statistical distribution figures are as follows:

- Metal concentrations grouped by the four main soil categories (kill zones surface, kill zones deep, non-kill zones surface and non-kill zones deep).
- The purple bars represents the upper and lower quartiles of contaminant concentrations (e.g. 50% of samples).
- The whiskers illustrate maximum and minimum concentrations observed.
- Median and mean concentrations are shown with a horizontal bar and a dot respectively.
- CCME parkland and industrial soil quality guidelines as red horizontal lines.
- The YCSR Parkland Standards are shown as a yellow shaded area as the Standard varies with soil pH.

- 75% of samples from the surface soils in kill zones contained lead concentrations in excess of the CCME parkland guideline and YCSR parkland Standards.
- 75% of deep soil samples from this kill zones did not exceed the lead guideline/Standard. This indicates that the lead deposited by the tailings spill appears to remain in the top 0.1 m of soil and has not migrated downward, impacting underlying soils.
- In the non-kill zones, 25% of samples exceeded the lead guideline/Standard.
