**AQUATIC HABITAT CHARACTERIZATION OF
THE NORTH FORK OF ROSE CREEK
AND ROSE CREEK DIVERSION CHANNEL
FARO MINE COMPLEX (2009)**

**prepared for
Assessment and Abandoned Mines Branch
Energy, Mines and Resources
Government of Yukon**

March 2010

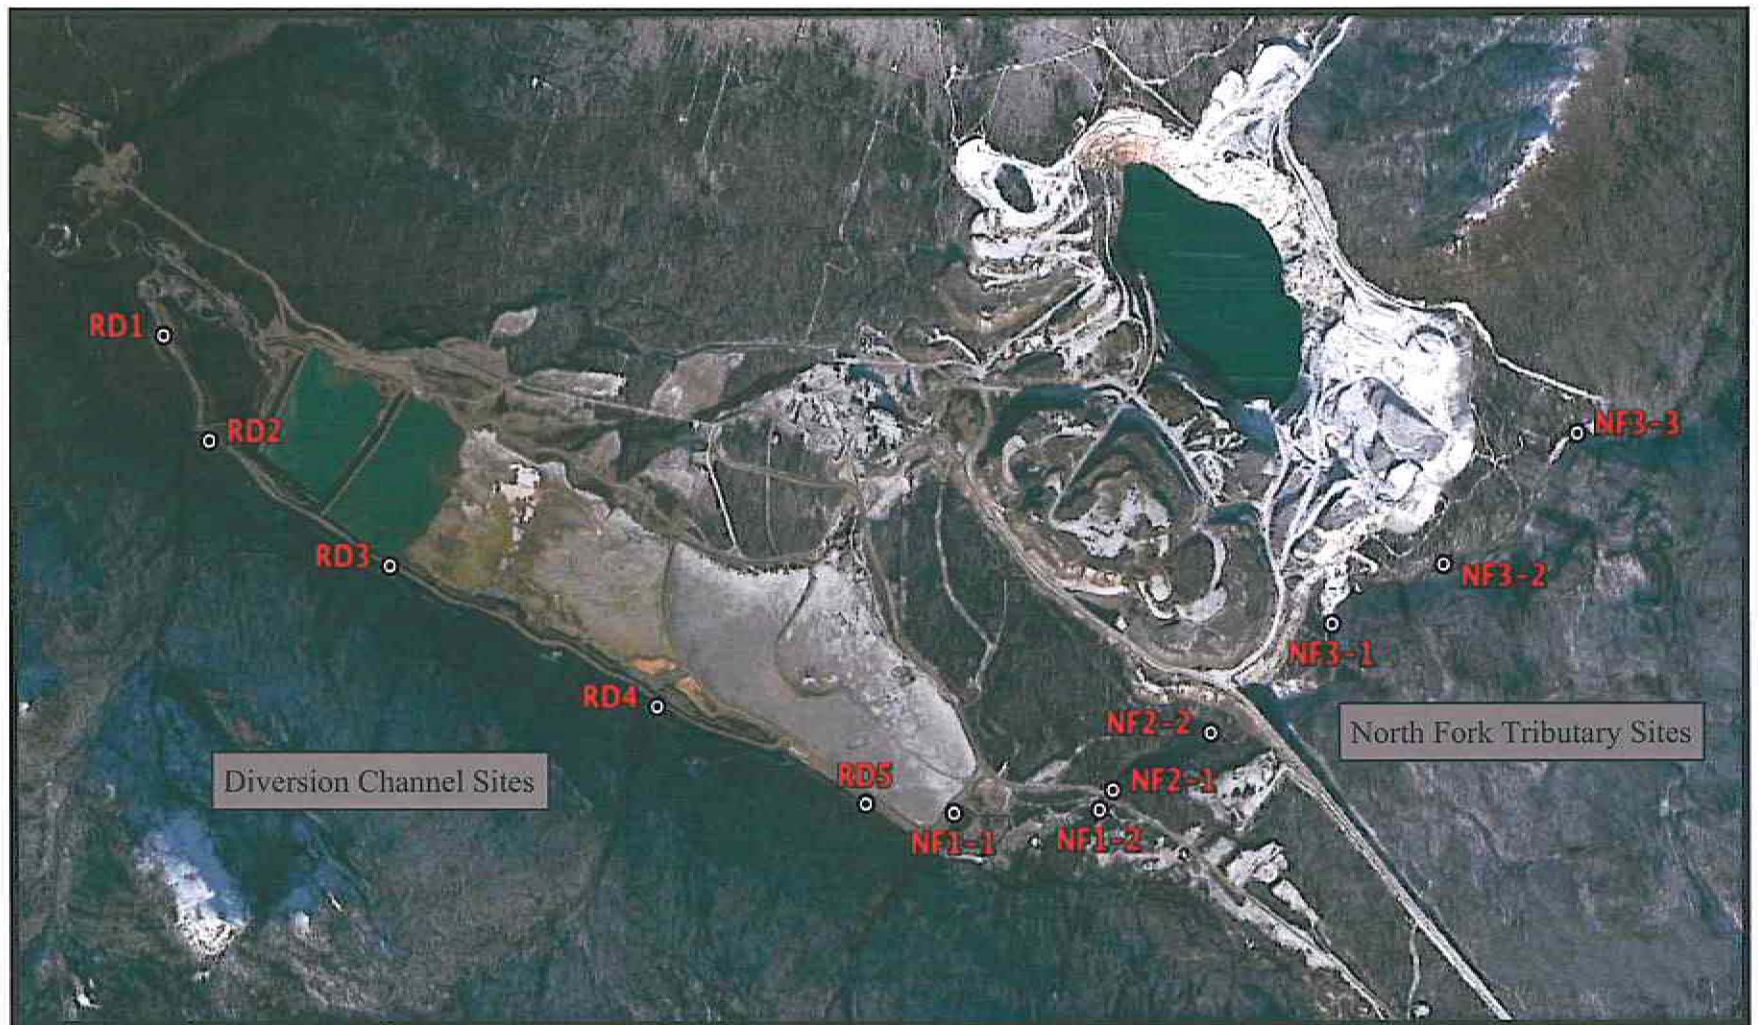
Figure 1 Study sites associated with the Rose Creek Diversion and the North Fork tributary of Rose Creek.

A total of 12 study sites, focusing on fish utilization and habitat characterization component of the study, were located within sections of upper Rose Creek that have been identified for remediation (Figure 1). Five of these study sites (RD1, RD2, RD3, RD4 and RD5) were equidistantly spaced and located in various habitats over the length of the RCDC. The RCDC is currently used to divert surface waters originating from the North and South Forks of Rose Creek around the tailings impoundment and is positioned against the valley wall on the south side of the valley. The RCDC is approximately 4.7 km in length. To characterize the two habitat types found in the channel, three sites were chosen to represent the low gradient glide-run-pool type habitat (RD3, RD4 and RD5) and 2 sites were selected to represent the steeper gradient step-pools associated with the lower reaches of the channel (RD1 and RD2). Site RD2 was also in close proximity to a verified Chinook spawning redd that was discovered earlier in the season.

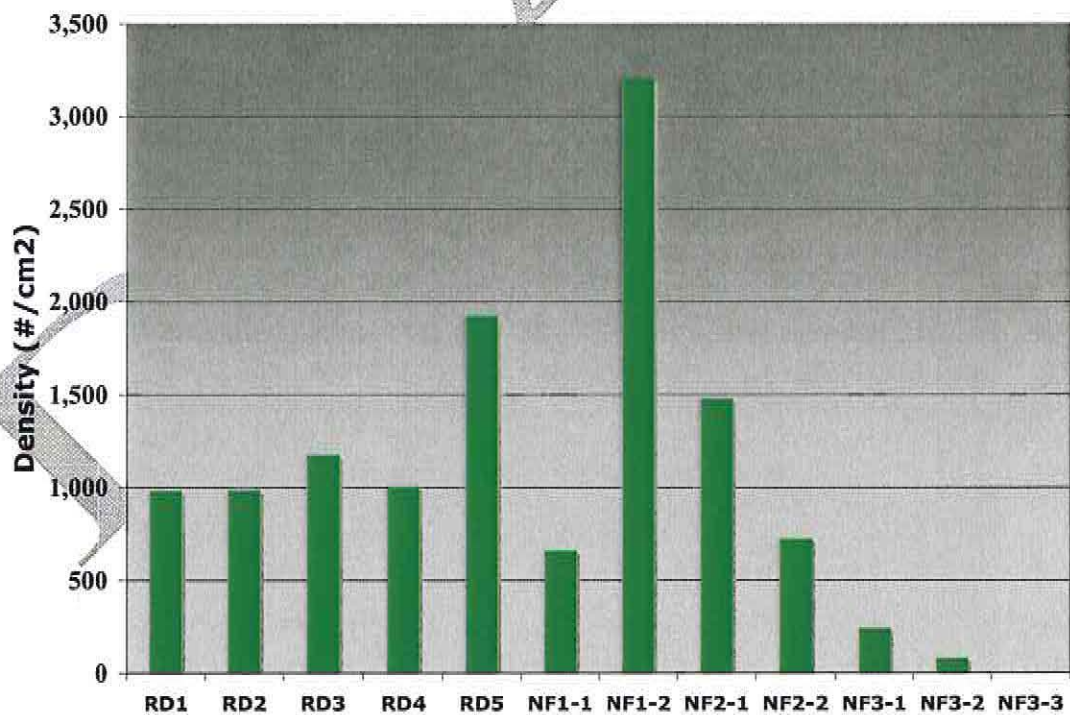
Figure 3 Comparison of densities of *Achnanthes minutissima* in periphyton samples collected at the Rose Creek study sites during August 2009.

Results show that the preponderance of periphyton and high densities of the diatom *Achnanthes minutissima* in the lower reaches of the North Fork of Rose Creek are indicative of a biotic response to heavy metal groundwater contamination. The CABIN site assessment results imply benthic communities at most sites in the Rose Creek Diversion Channel are potentially stressed and those in the lower reaches of the North Fork of Rose Creek are severely stressed. The study also confirms that Arctic grayling and slimy sculpin continue to utilize the North Fork of Rose Creek and the Rose Creek Diversion Channel. Other occasionally documented species include burbot, round whitefish and Chinook salmon. Aquatic habitat in the upper reaches of the North Fork of Rose Creek is relatively undisturbed while habitat and cover in the constructed Rose Creek Diversion Channel is constrained by the lack of natural stream processes, homogenous substrates and sparse riparian vegetation. Barriers that prevent upstream movements of fish in the upper Rose Creek drainage are believed to be exclusively associated with the road network at the Faro Mine Complex.

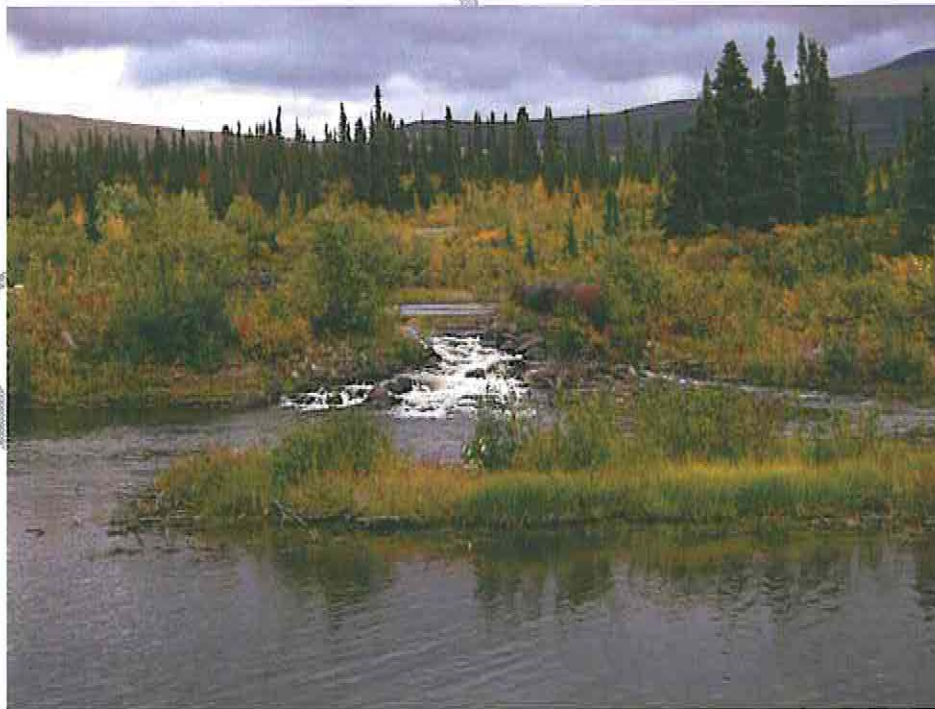
Figure 5 Connected ponds associated with the south channel in reach NF1 of the North Fork of Rose Creek, August 2009.

The upper Rose Creek barrier survey noted 4 complete and 1 partial barriers to the upstream movement of fish in the watershed portions associated with the Faro Mine Complex. All of the barriers were associated with road crossings of the North and South Forks of Rose Creek (Table 7, Figures 5 to 7).

Inspection of aquatic habitat in the lowest reach (NF1) of the North Fork of Rose Creek suggests the original stream channel has been heavily modified by past mining activities at the Faro Mine Complex. Currently, two channels convey portions of the flow of the creek. The dominant feature of the south channel is a series of connected ponds that were constructed to increase groundwater infiltration for a local well (Figure 5). Arctic grayling use the small riffles between these ponds as spawning habitat and the ponds offer suitable over-wintering habitat for fish due to their depth (Sparling pers. com. 2009). The outlet of the lowest pond reports into a several braided willow lined channels before finally discharging into the South Fork of Rose Creek. No barriers were observed that would prevent fish from accessing these ponds from the South Fork tributary. From observations at moderate and low flow periods, the north channel section accommodates

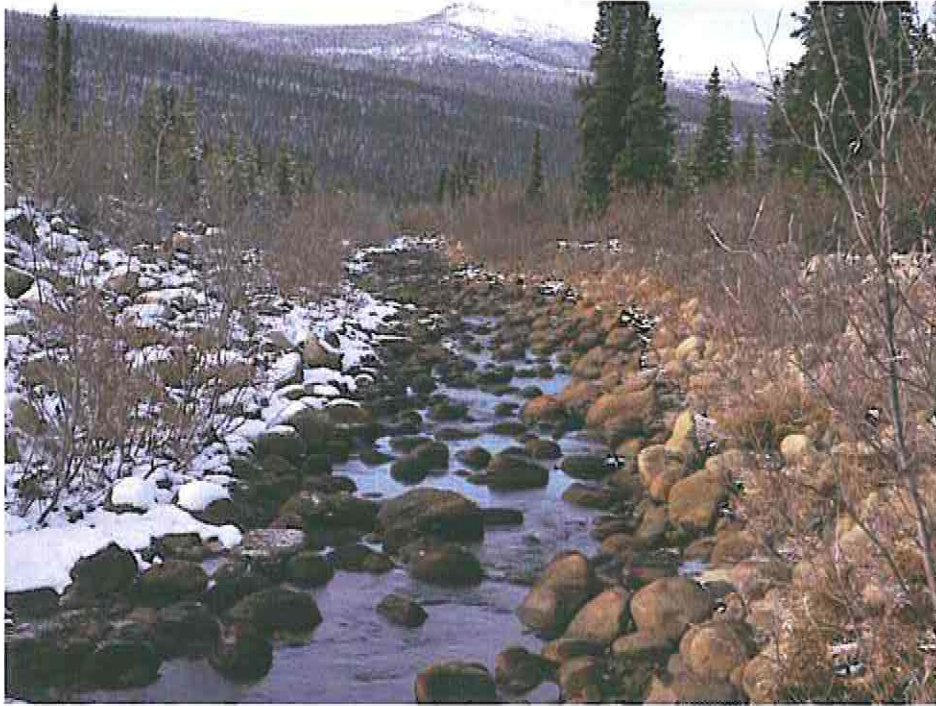
Figure 6 North channel in reach NF1 associated with the North Fork of Rose Creek downstream of the Faro Mine Access Road, October 2009.

a smaller percentage of the total flow of the creek. In this section the creek channel is boulder strewn and entrenched with a severely eroded lower reach presumably from past channel modifying flows (Figure 6). Site NF1-1 was situated in the eroded lower reaches of this channel. Catches of juvenile and adult fish at this location were few however the site was heavily utilized by Arctic grayling and slimy sculpin fry during October. Fish cover was relatively low and the CABIN assessment report concluded the site was severely stressed. Site NF1-2 was also situated in reach NF1 but just downstream of the mine Access Road culvert. This short section was just above the divergence of the two channels. Several Arctic grayling adults were observed or captured in the deeper pools located at this site during August. All life history stages of slimy sculpin were also captured at this site. This site had the highest densities of *Achnanthes minutissima*, a species that is believed to be a bioindicator of heavy metal pollution (Nakanishi *et al*). The CABIN site assessment suggests the stream is severely stressed at this location. (What reference stations were used for comparison and what metrics led you to conclude that they were appropriate reference stations.) The culverts just downstream of this site that convey flow into the south channel also represent a complete barrier to the upstream movement of fish. The large single culvert associated with the Access Road just upstream of this site is likely a partial barrier to movements of fish at higher flows.

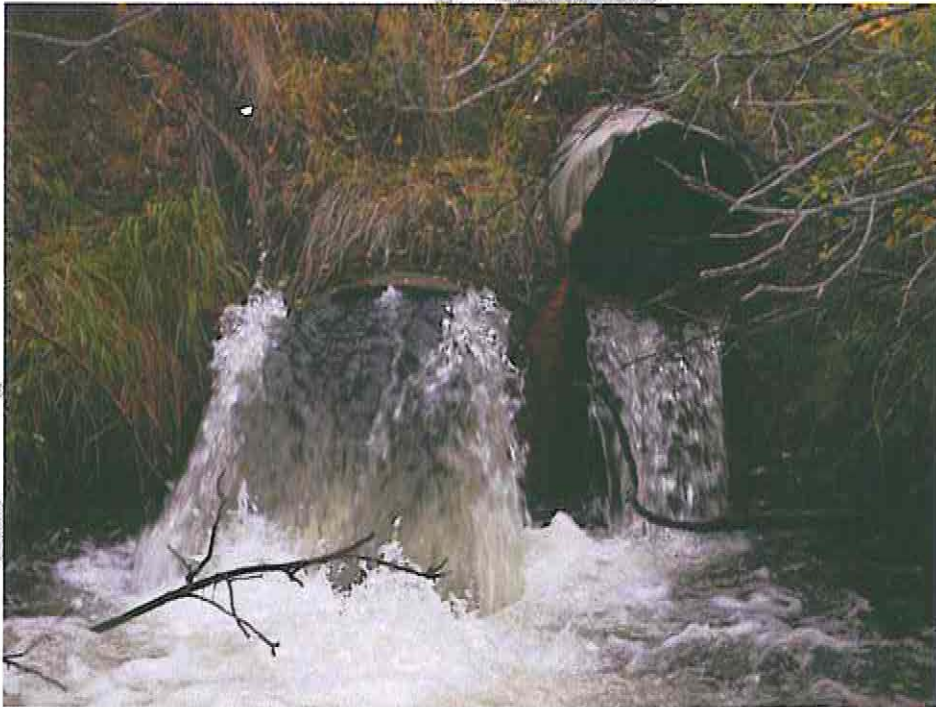
Figure 7 Culverts located upstream of the constructed ponds in reach NF1 of the North Fork of Rose Creek, August 2009.

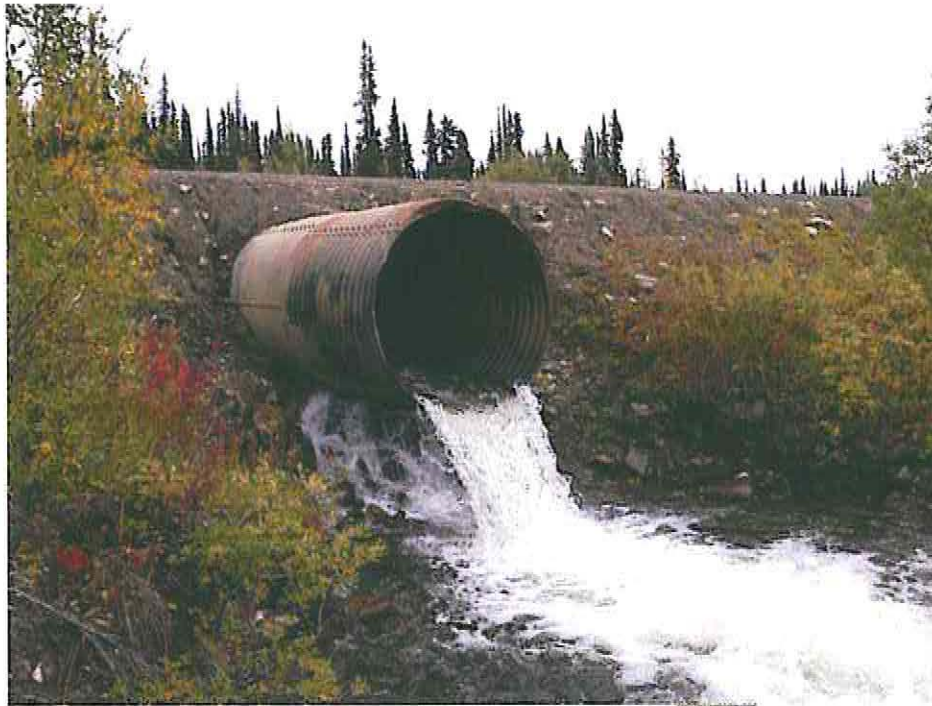
Figure 8 Culvert located at the Access Road crossing of the South Fork of Rose Creek, August 2009.

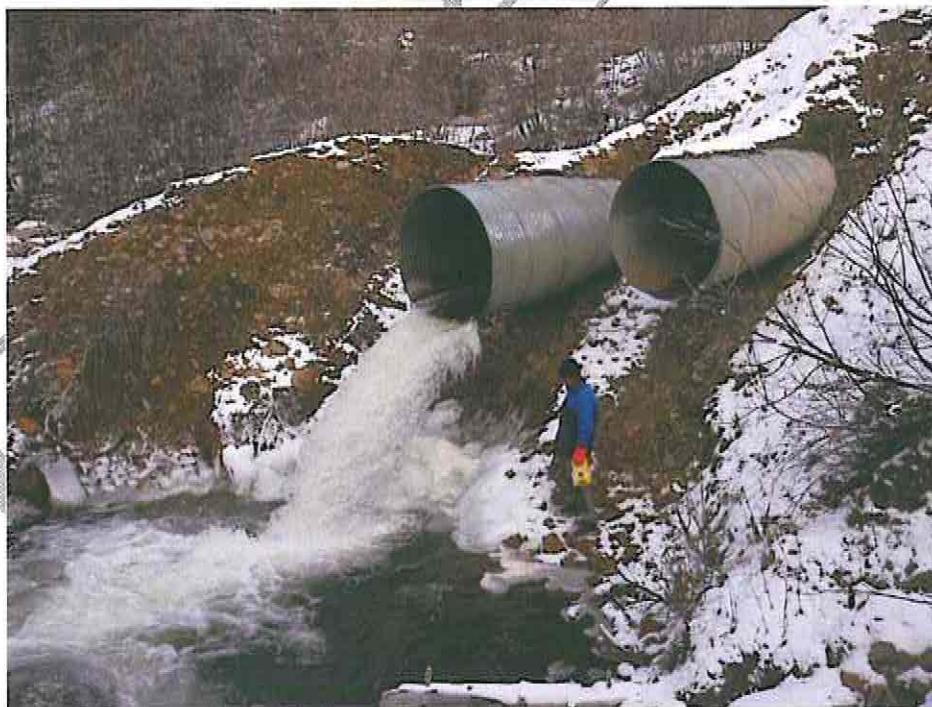
Figure 9 Culverts located at the Haul Road crossing of the South Fork of Rose Creek, October 2009.
