CASSIAR ASBESTOS CORPORATION LTD.
CLINTON CREEK MINE
MOVEMENT MONITOR DATA
TO APRIL 1979

CLINTON CREEK, YUKON TERRITORY

Re: Movement Monitor Data to April 1979 - Clinton Creek Mine

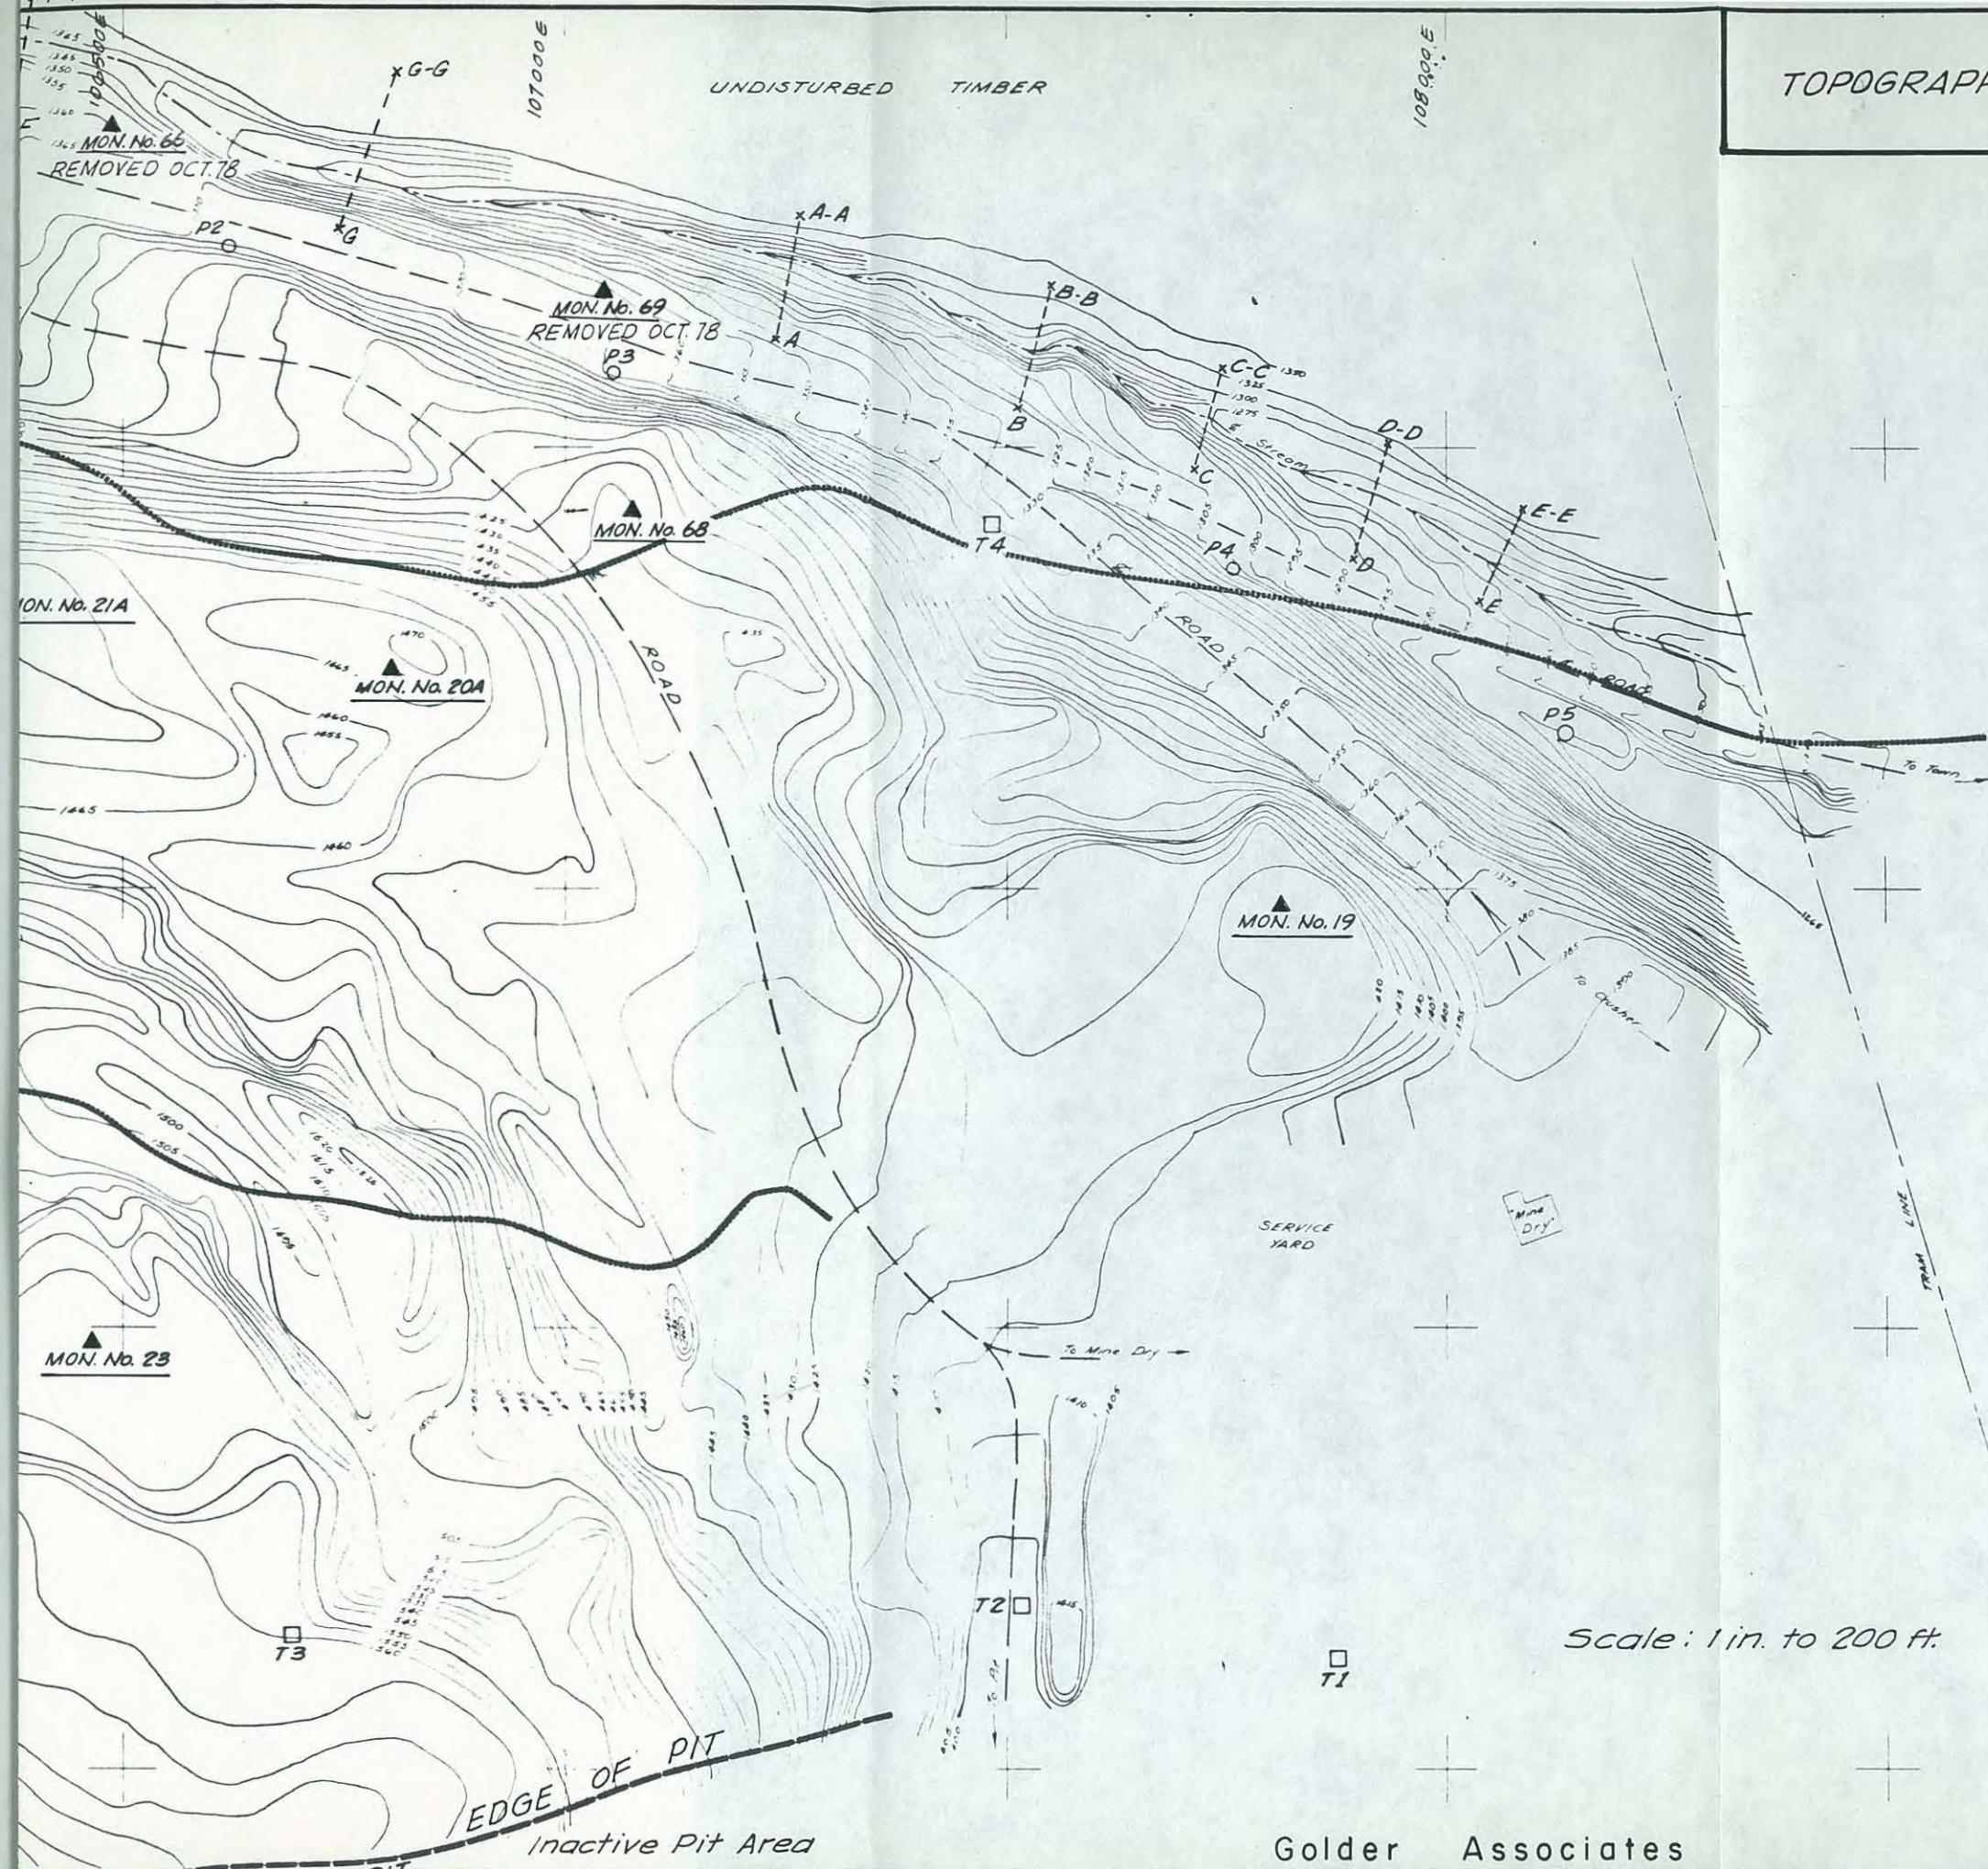
FIGURE 1

The planned work for construction of weirs in the Clinton Creek channel is not expected to be completed until late summer, 1979. Consequently, no comment on the effectiveness of the work can be made at this time. Movement monitor data for the waste pile and data for the Clinton Creek channel closure monitors are attached. The data continue to indicate a general trend toward slower rates of movement of the waste pile. A plan showing the locations of the movement monitors and channel closure monitors is included as Figure 1.

TOPOGRAPHY - CLINTON DUMP

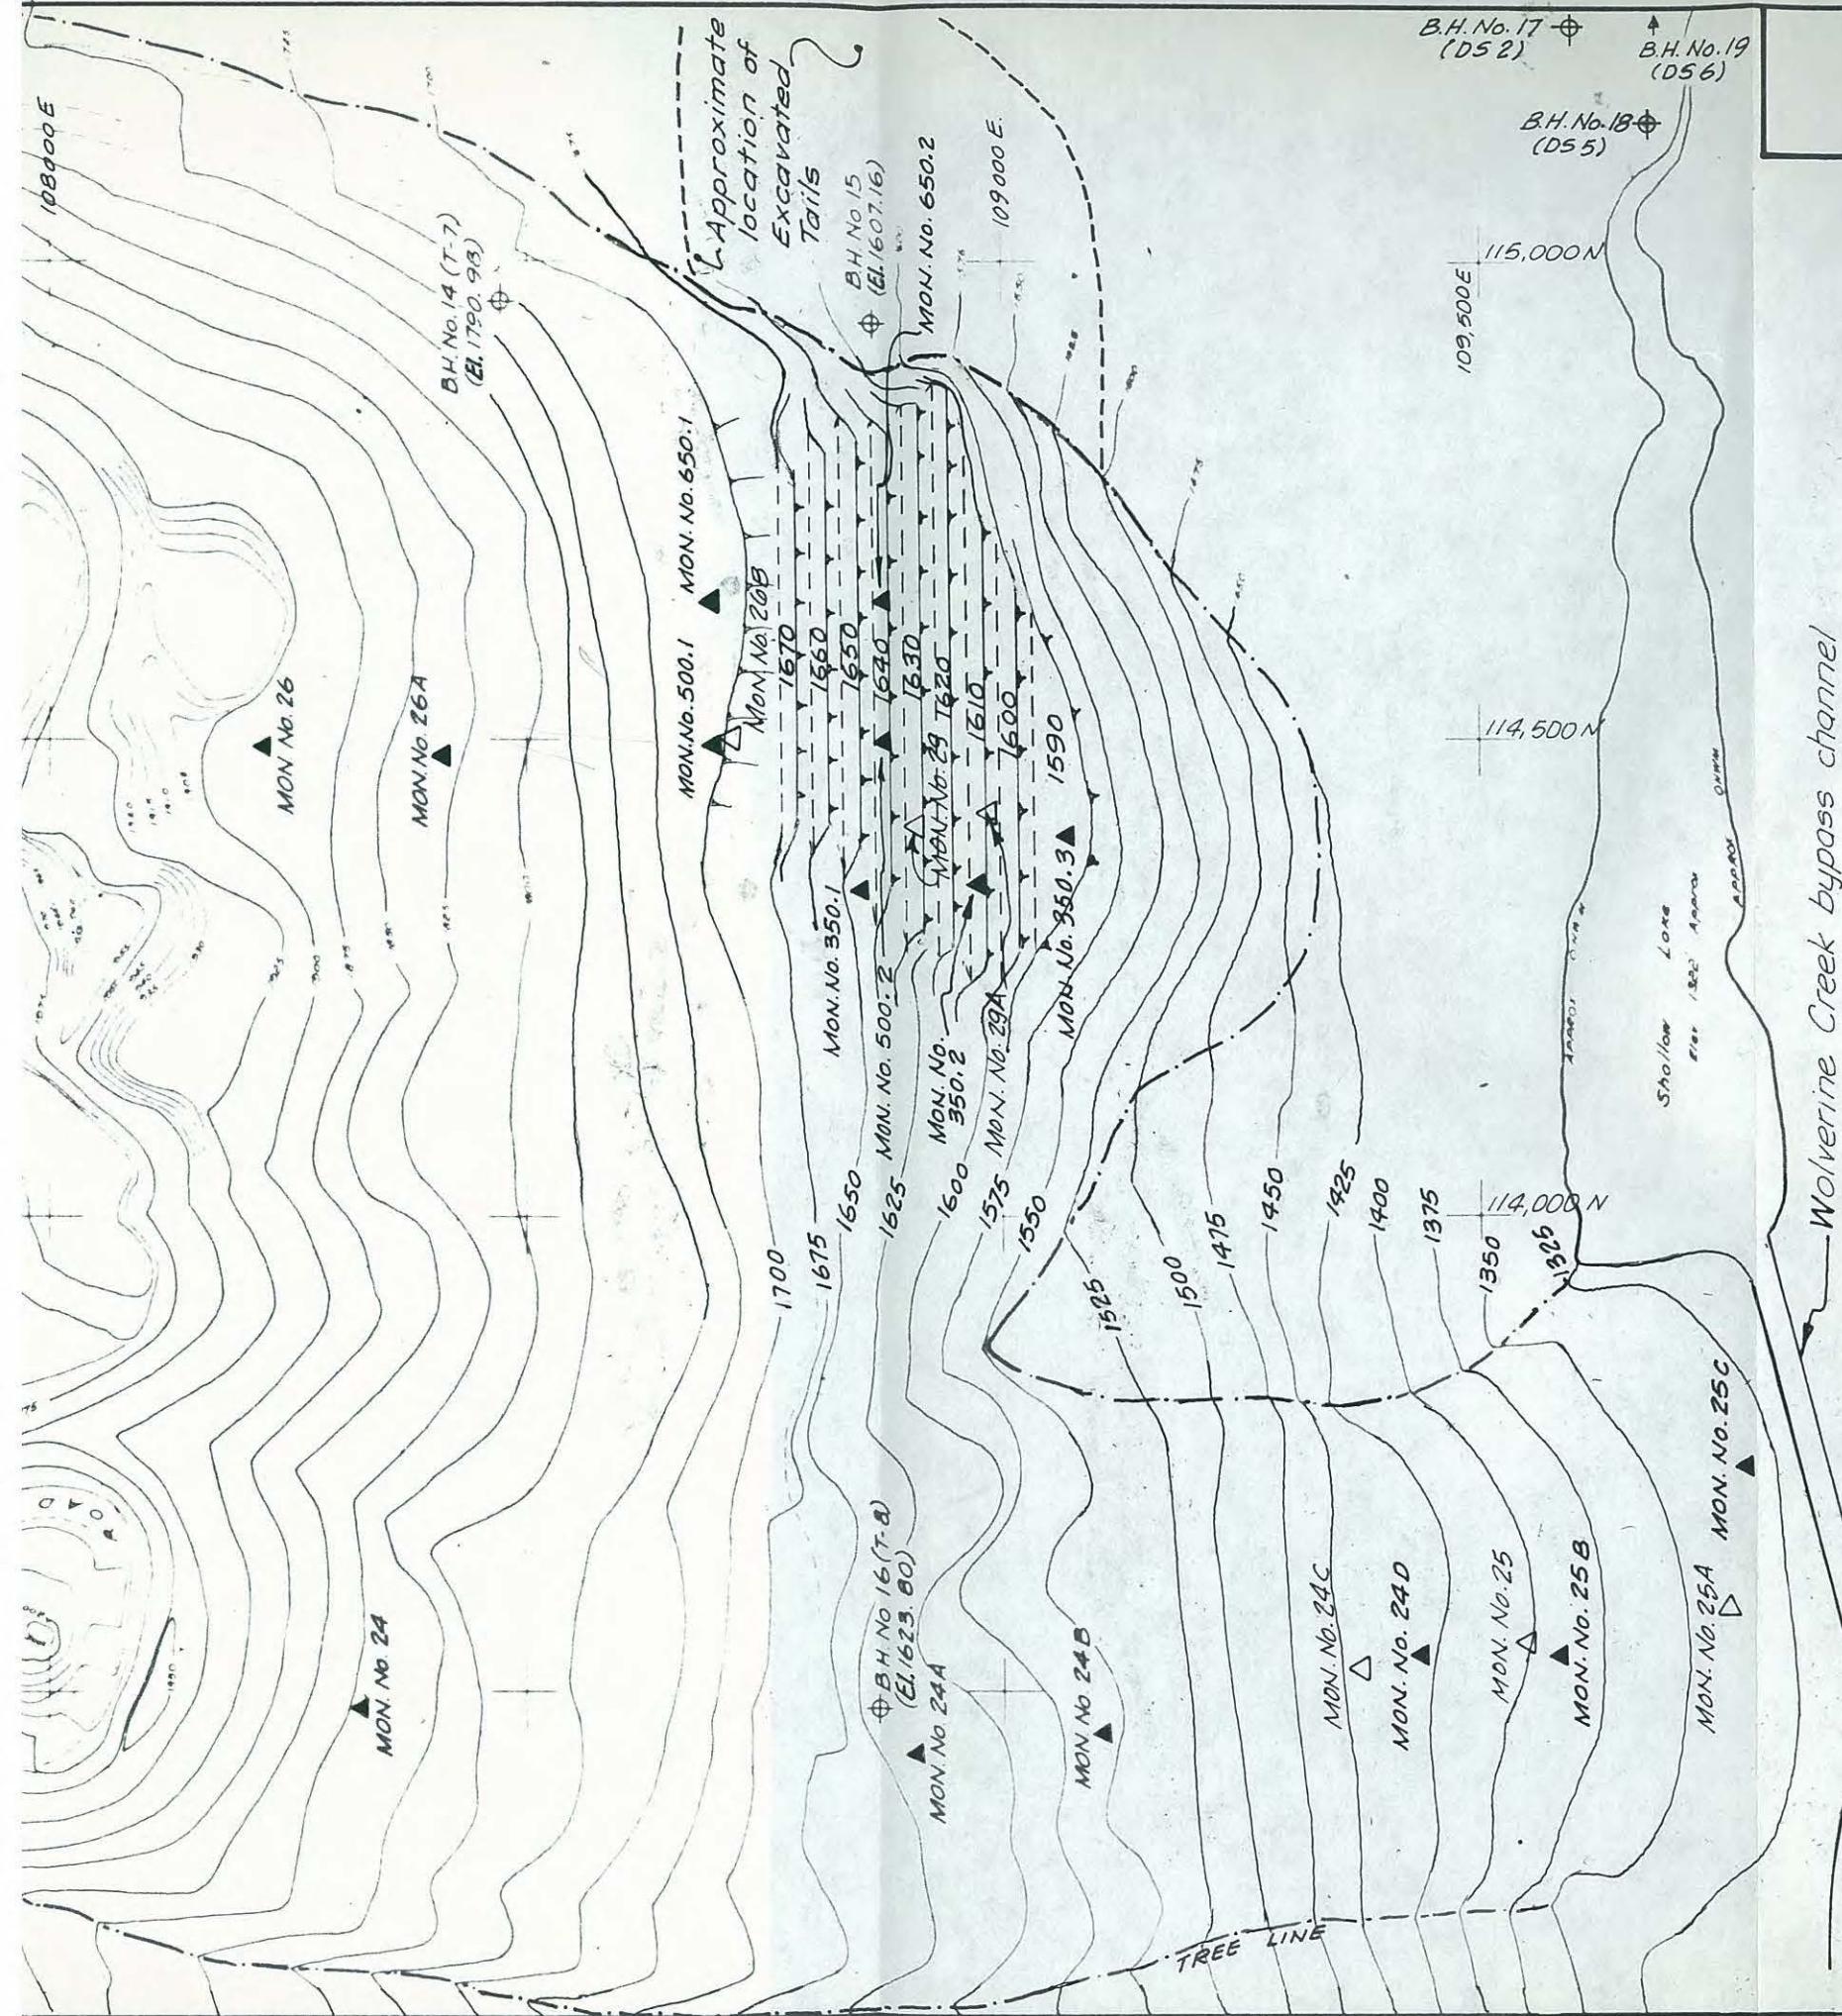
FIGURE 2

On the basis of our analyses the tailing pile has been re-contoured. A plan showing the surface contours on the reshaped pile and the locations of all of the survey monitors, including 10 new monitors installed on the recontoured pile, is included as Figure 2.

RECONTOURED
TAILING PILE.

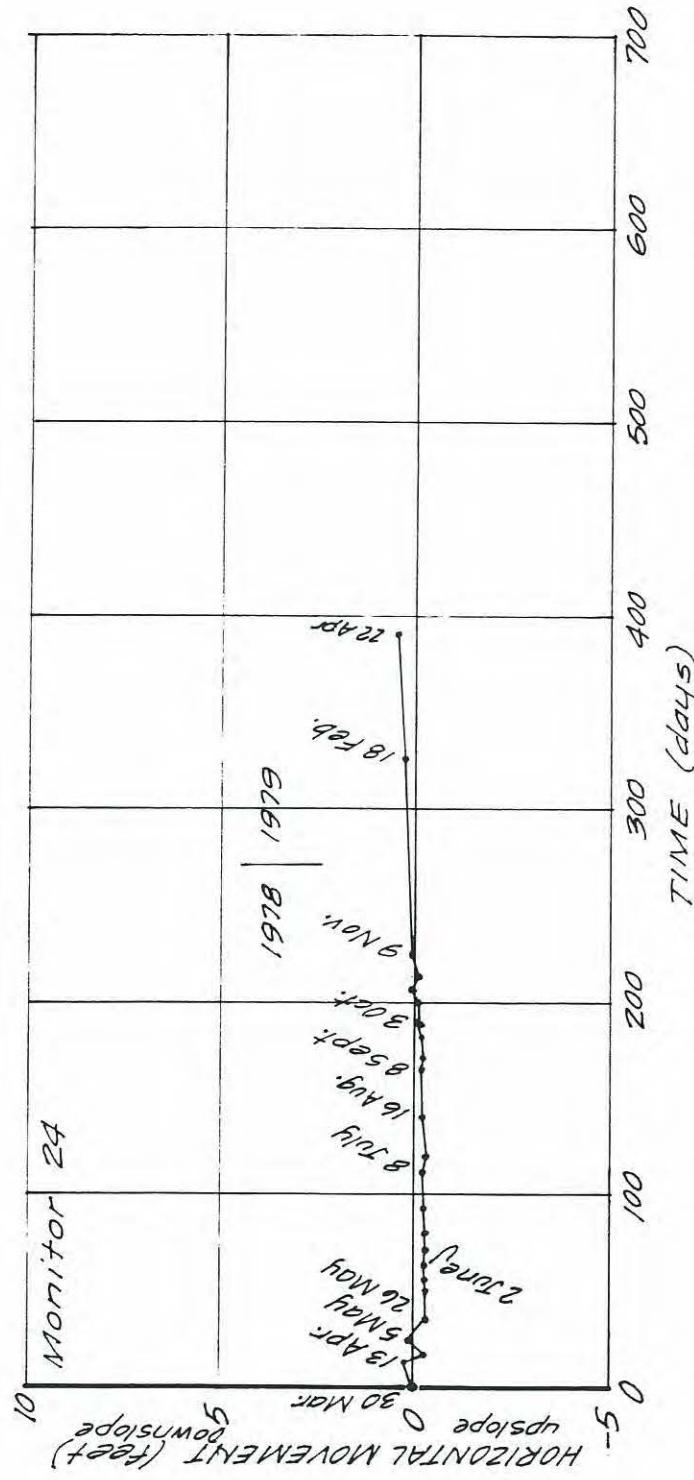
Figure 24-1

TAILING PILE - MONITOR NO. 24

NOTE: The average rate of downslope movement of Monitor 24 between May 26, 1978 and April 22, 1979 is approximately 0.44 ft./yr.
