ABANDONMENT PLAN

PROJECT: CLINTON CREEK ASBESTOS MINE

LOCATION: CLINTON CREEK, YUKON TERRITORY

CLIENT: CASSIAR MINING CORPORATION

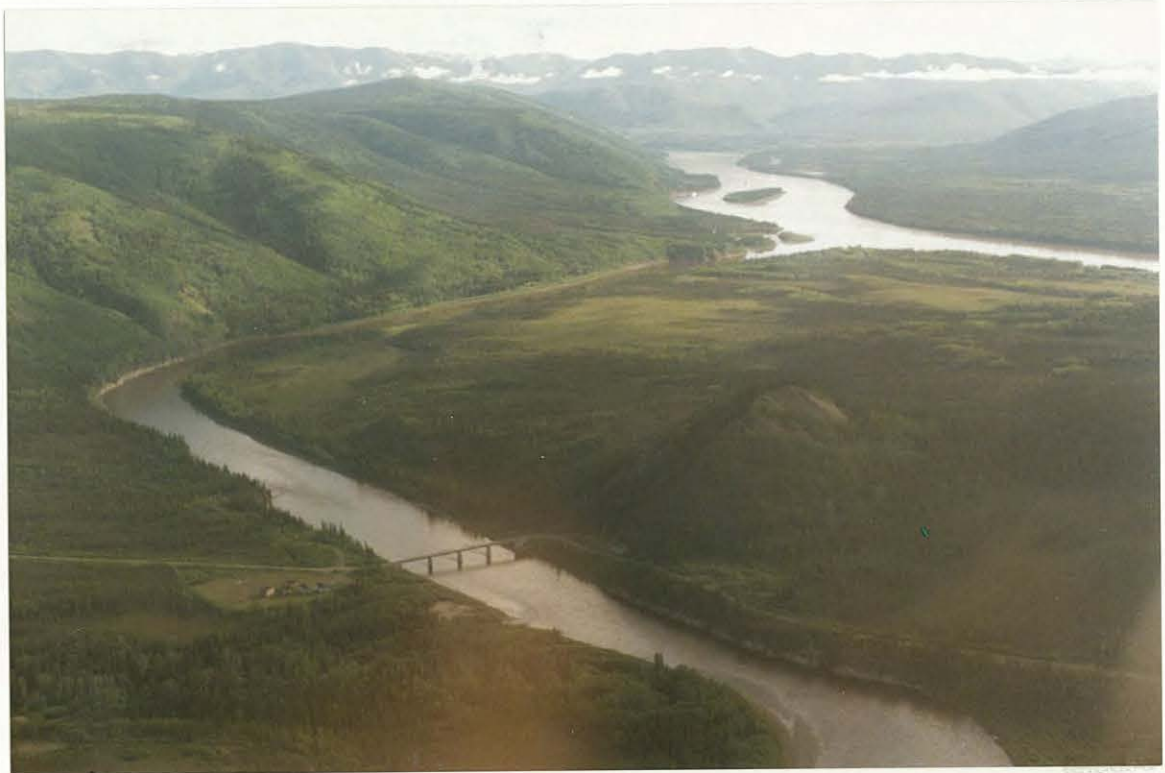
Photo 1: Forty Mile River showing confluence with Yukon River in background. Clinton Creek enters Forty Mile River just upstream of bridge. June 1985.

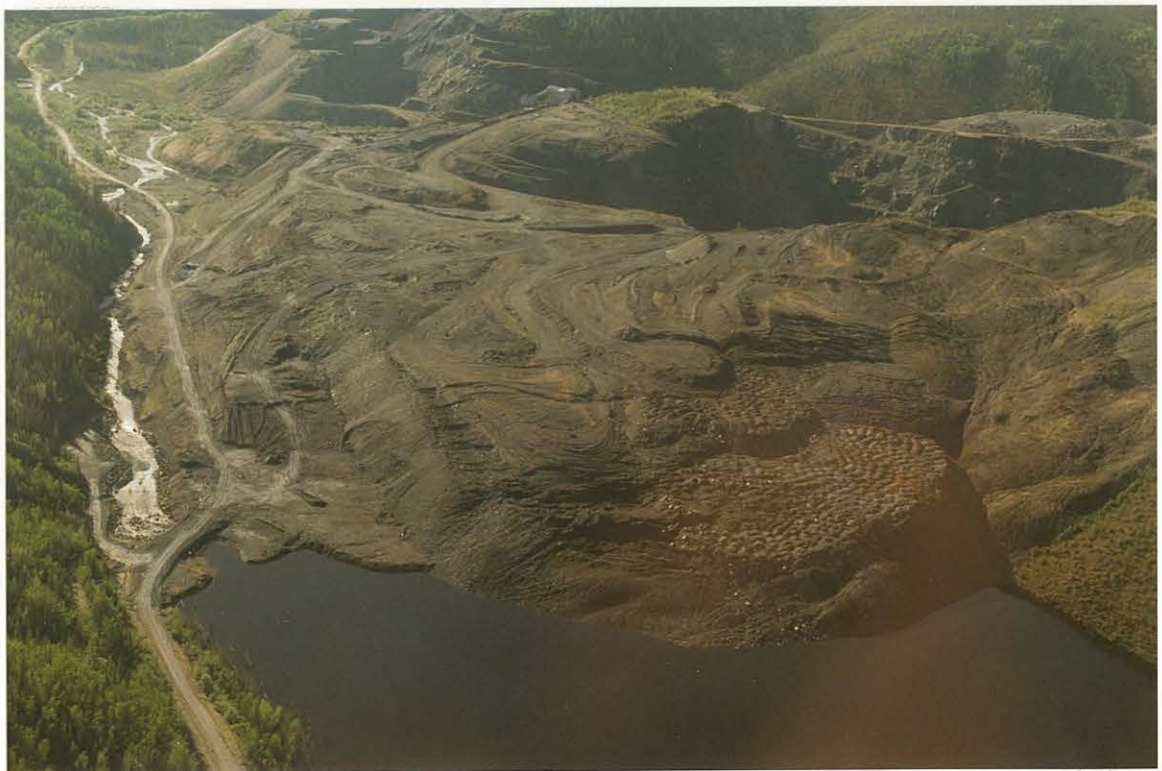
Photo 2: Clinton Creek waste dump, showing Hudgeon Lake at bottom of photo and channel of Clinton Creek over waste dump on left. June 1985.

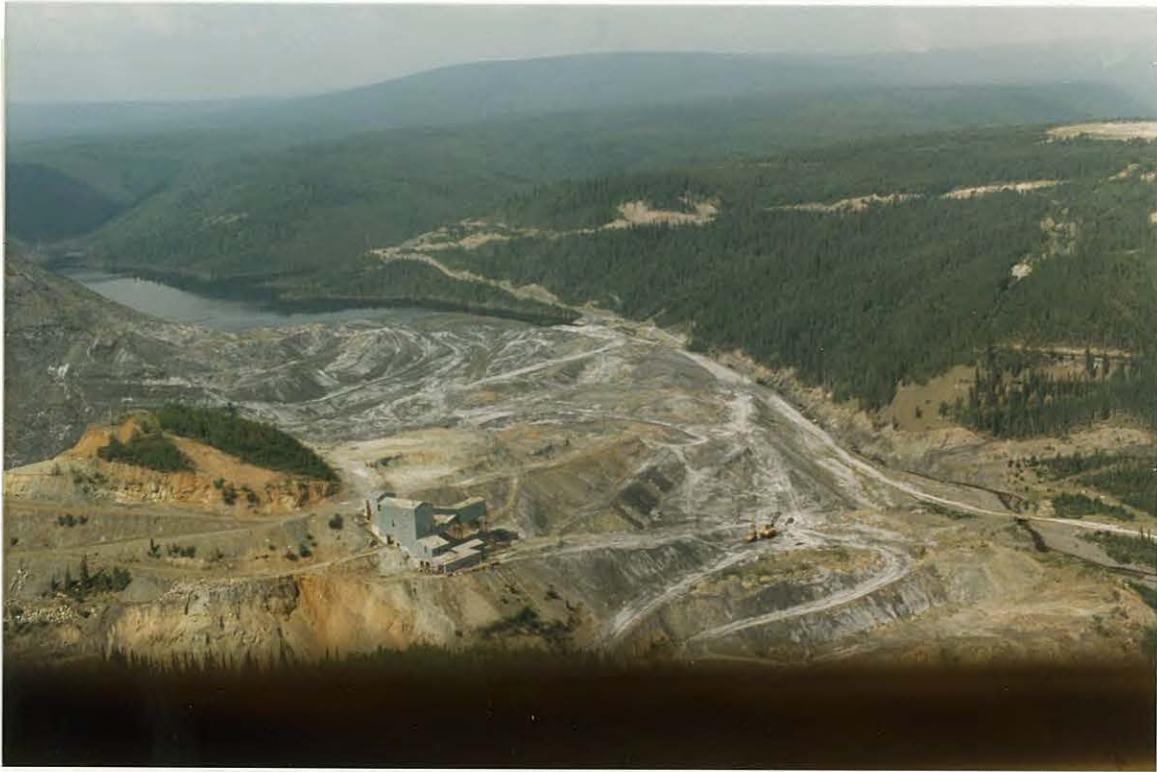
Photo 3: Clinton Creek waste dump, looking upstream toward Hudgeon Lake. Open pit is at left, crusher in foreground, and concentrator site on plateau at upper right. July 1986.

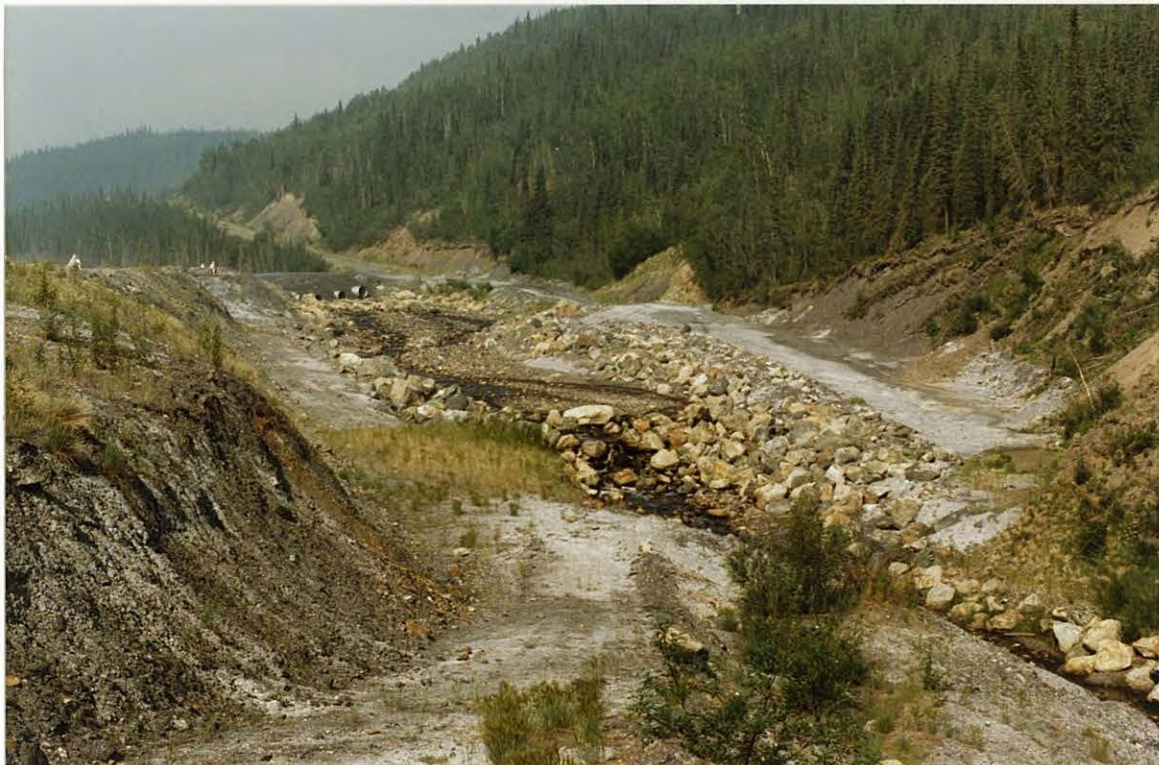
Photo 4: Rock lined section at upper end of Clinton Creek channel over waste dump. Access road culverts at upper left. July 1986.

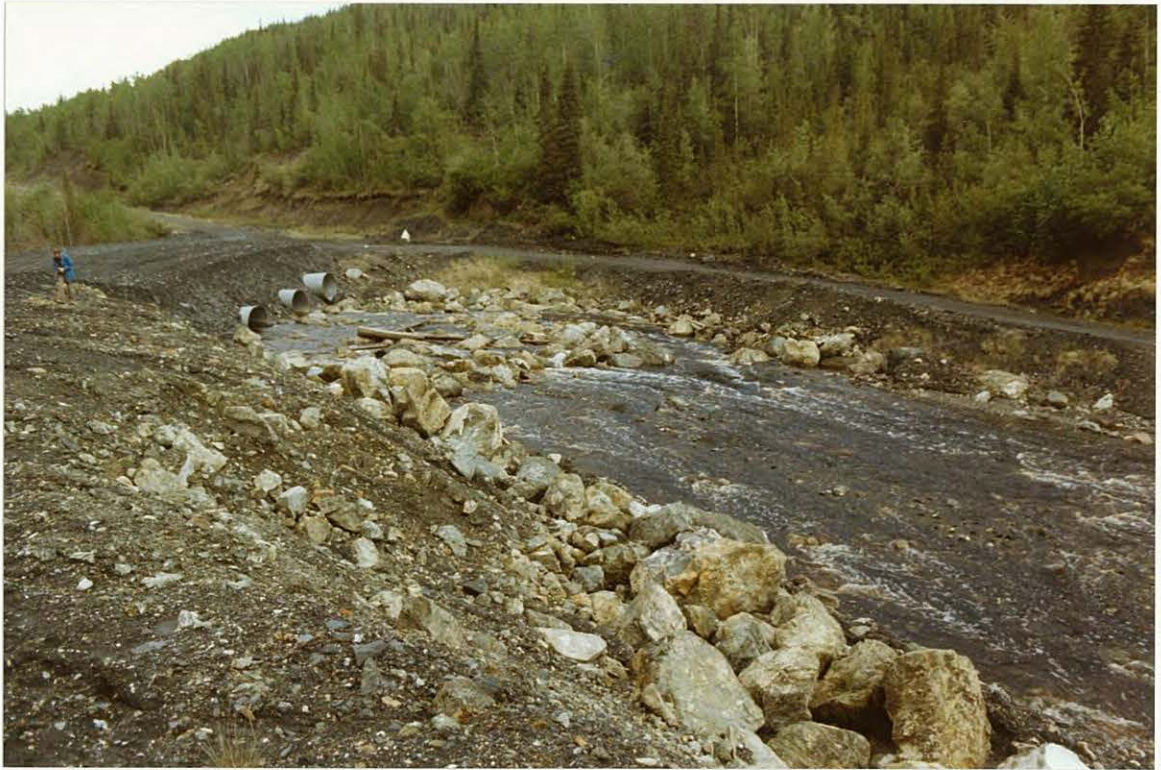
Photo 5: Access road culverts at upper end of waste dump channel. June 1985.

In summary, the Clinton Creek waste dump is considered to be in an acceptable condition for abandonment. No further remedial works or monitoring are recommended. The culverts at the outlet of Hudgeon Lake which pass flow into the Clinton Creek channel should be removed as the final stage of abandonment. Culvert removal is recommended to prevent problems resulting from possible future plugging.

It is recommended that the waste dump be abandoned in its present configuration, with the exception that the culverts should be removed from the road crossing at the upstream end of the channel of Clinton Creek across the waste dump. Culvert removal is recommended to prevent problems resulting from possible future plugging.

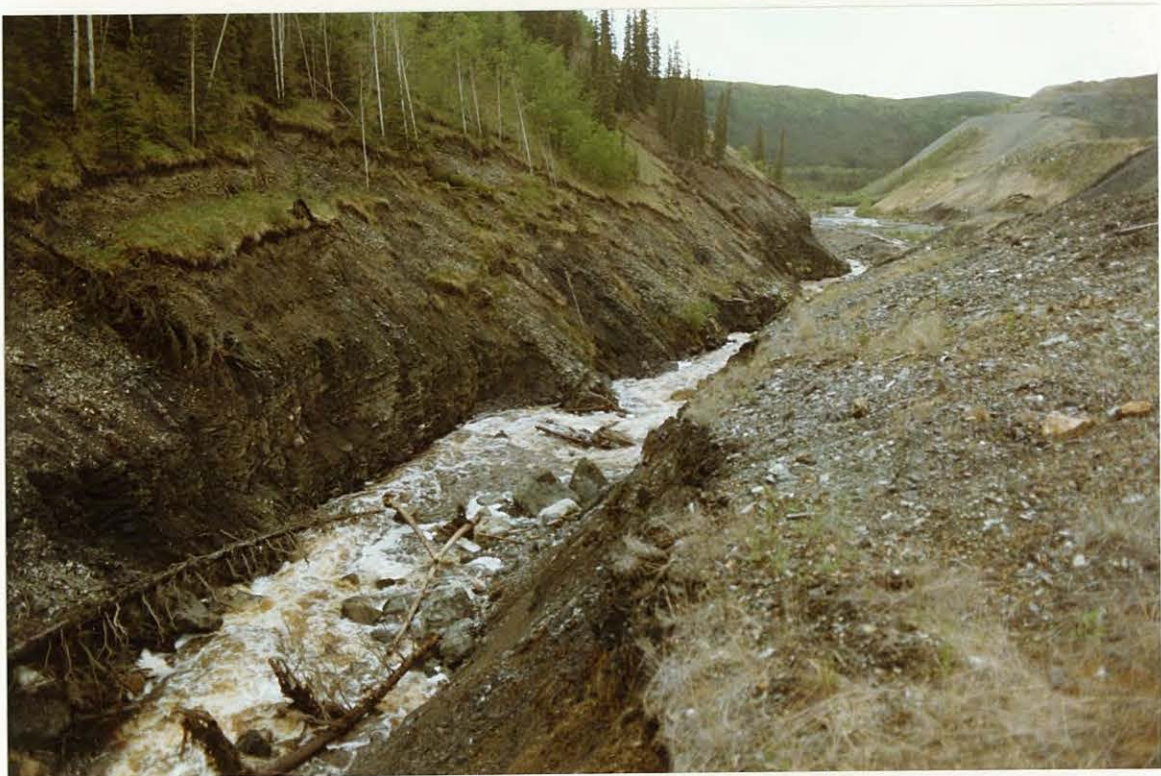
lined section and eroded a large scarp in native soil on the left bank (relative to an observer facing downstream). Klohn Leonoff (1983a) prepared a design for repair and modification of this rock-lined section. The design included backfilling of the eroded channel, which was then bypassing the weir section, and placing geotextile filter and riprap along the left bank of the channel to protect the erodible zone. Also, the revised design of the riprapped channel section provided for heavy riprap and geotextile filter along the left bank, a riprap apron at the outlet culverts from Hudgeon Lake and riprap lining without filter on the right bank. A sketch of the site prior to these remedial works, and design recommendations for the channel prepared by Klohn Leonoff are shown on Drawing No. D-1002A. Photographs of the site before and after the 1983 stabilization measures were implemented on Clinton Creek are shown in Appendix I, Photographs 5 and 6.

Photo 6: Waste dump channel looking downstream. Note left bank is protected by bedrock and stream bottom is armoured by large boulders from waste dump. June 1985.

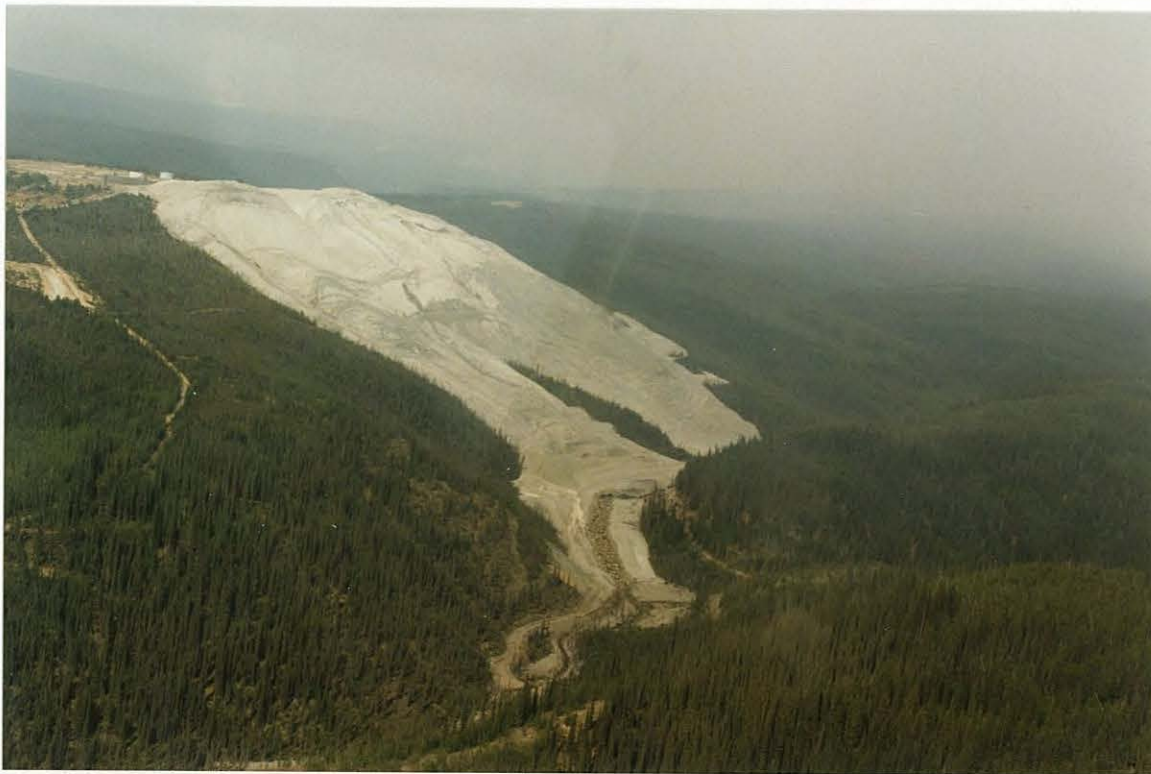
Photo 7: Wolverine Creek tailings piles looking upstream (north).
July 1986.

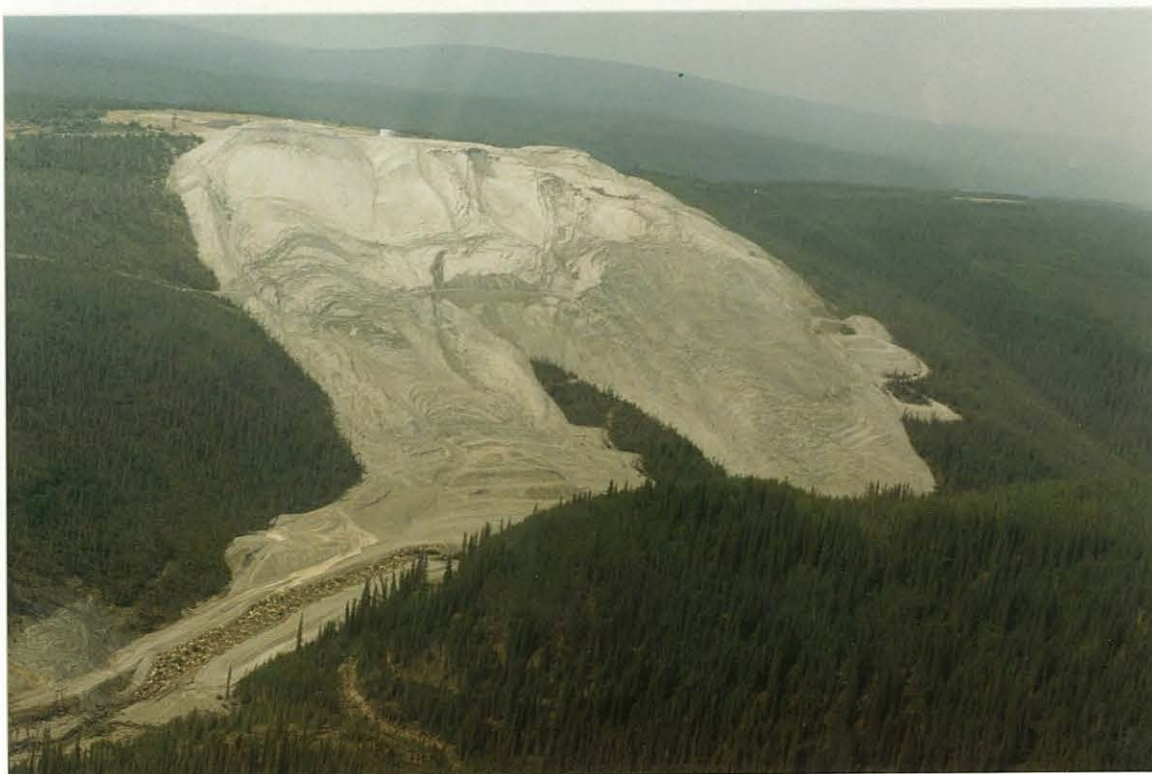
Photo 8: Wolverine Creek tailings piles looking northwest. July 1986.

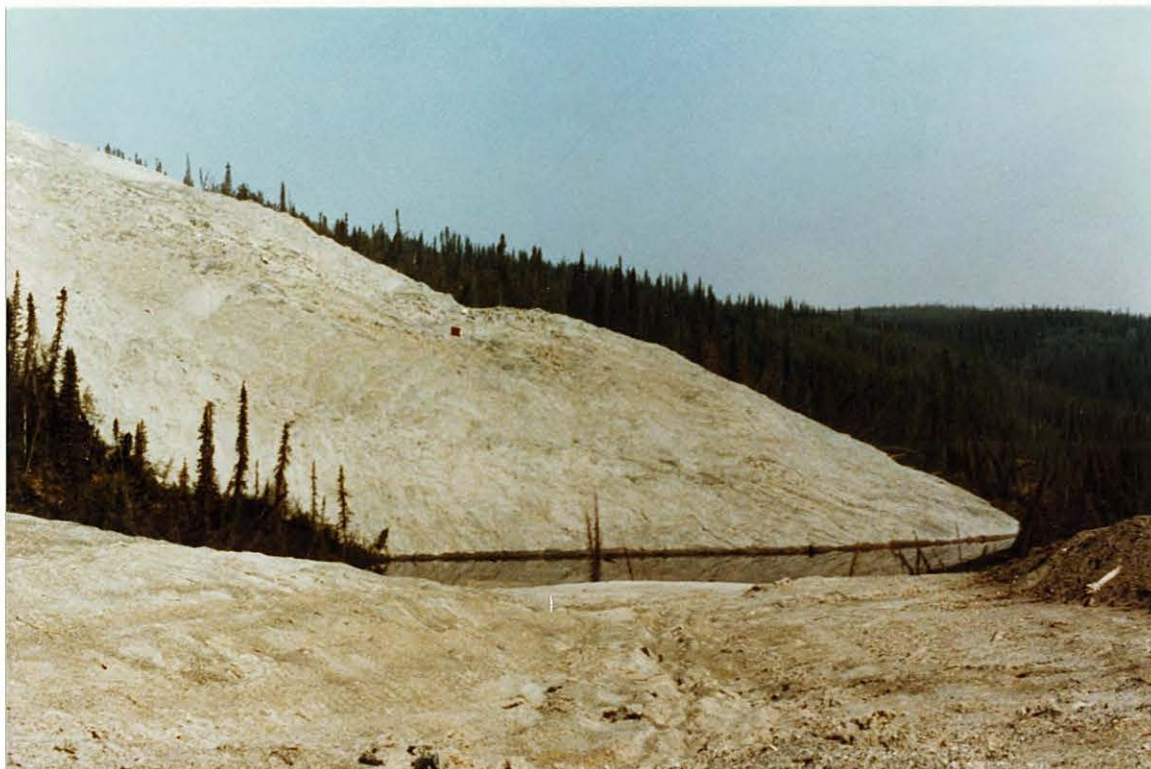
The north tailings lobe has been sliding down the valley slope at a considerable rate. The surface is highly distorted, with a continuous series of scarps from top to bottom. The toe has moved over 400 ft from its position as plotted in 1978, and the tailings have now reached the valley bottom. Movements of monitoring points on the north lobe have reached maximum horizontal rates of over 100 ft/yr on the lower part of the lobe. Movements appear to have reached a peak in 1983 and have slowed to a maximum observed rate of 62 ft/yr in July, 1986. Monitoring points near the top indicated much lower movements of less than 2 ft/yr. The monitor locations and rates of horizontal movement observed in July, 1986 are shown on Drawing D-1004C. Prior to the 1985 site visit, a high steep face existed at the toe of the north lobe. In June, 1985 this face slumped and flattened considerably, so that the potential for rapid movement of the north lobe is reduced.

Photo 9: Toe of north tailings lobe. July 1986.

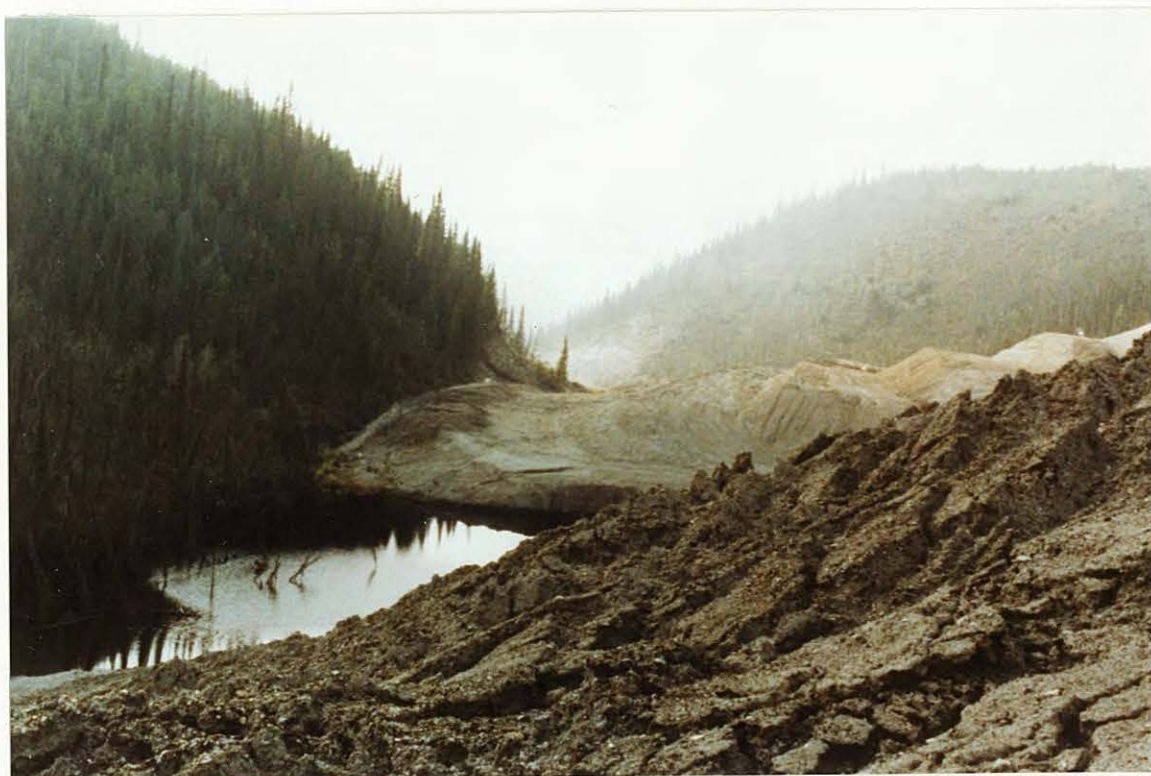
Movements of the south tailings lobe are considerably lower than the north lobe, but are still significant as the maximum movement rate observed in July, 1986 was 21.5 ft/yr on monitor point 24A. The highest rates are in the lower part of the south lobe. Movements have been increasing slightly over recent years, with the highest rates recorded in 1986. The channel conveying the stream past the toe of the south

Photo 10: Toe of south tailings lobe. July 1986.

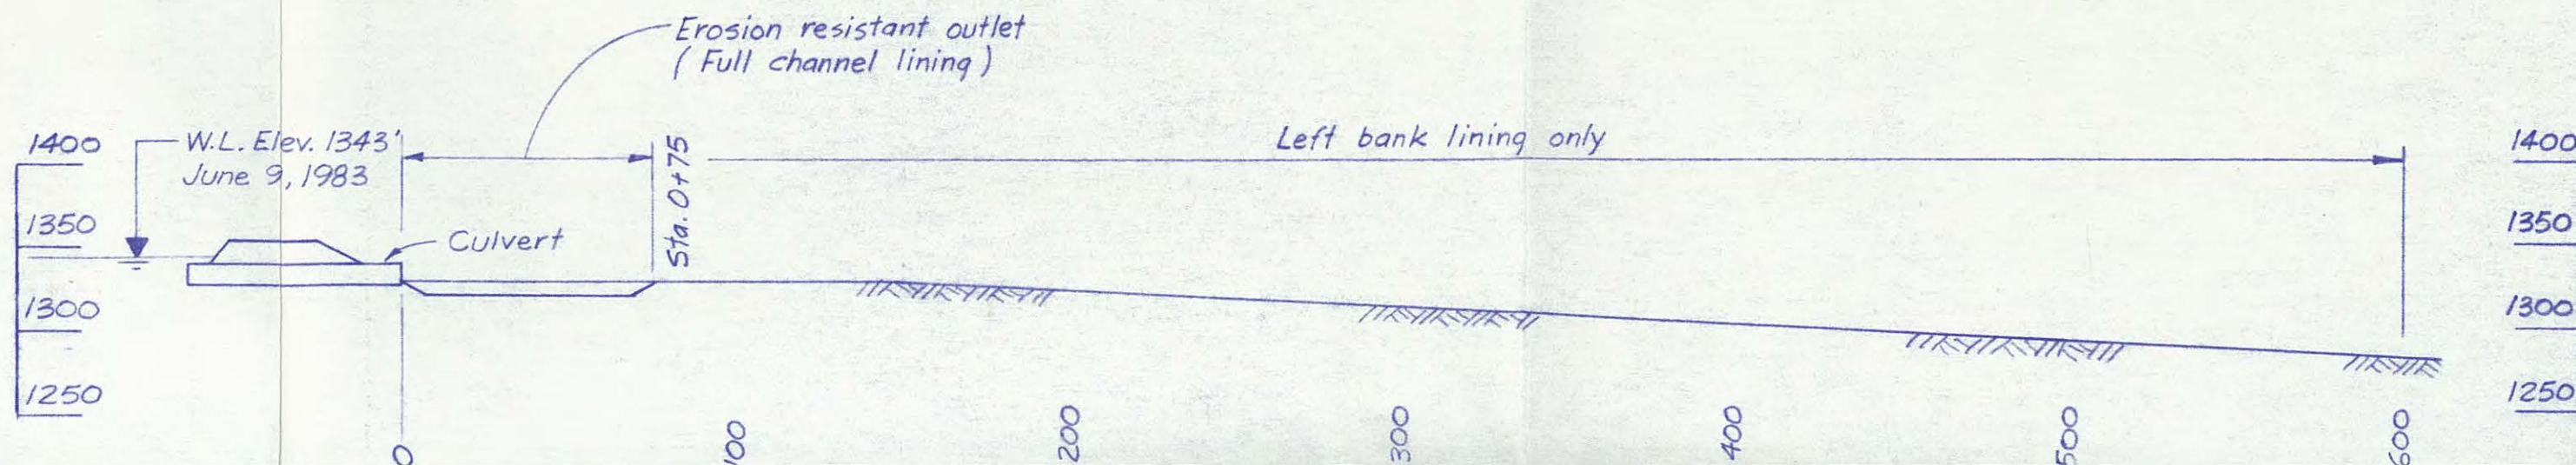
SITE PLAN SHOWING CHANNEL LINING

TYPICAL SECTION OF CHANNEL - STA. 0+75 TO 6+00

DETAILS OF CHANNEL LINING

- Plans, profile and sections are approximate, based on limited survey data, sketches of site prepared during site inspection by Klohn Leonoff and photographs of the area.
- Backfill in existing channel should be placed in maximum 1 ft. lifts and compacted by bulldozer travel.
- Geotextile filter to consist of high strength woven polymer such as Mirafi P600X or equivalent. Where two sheets are joined provide minimum 1 metre overlap.
- Riprap gradation:

% finer by wt.	rock size
100	3.0 ft.
50	1.5 ft
10	0.5 ft
- Final alignment of riprap lining and extent of riprap placement to be approved by the Engineer on site.
