Government of Yukon Energy, Mines and Resources - Assessment and Abandoned Mines

Clinton Creek Drop Structure No. 4 Repair

Construction Report

18-Dec-15

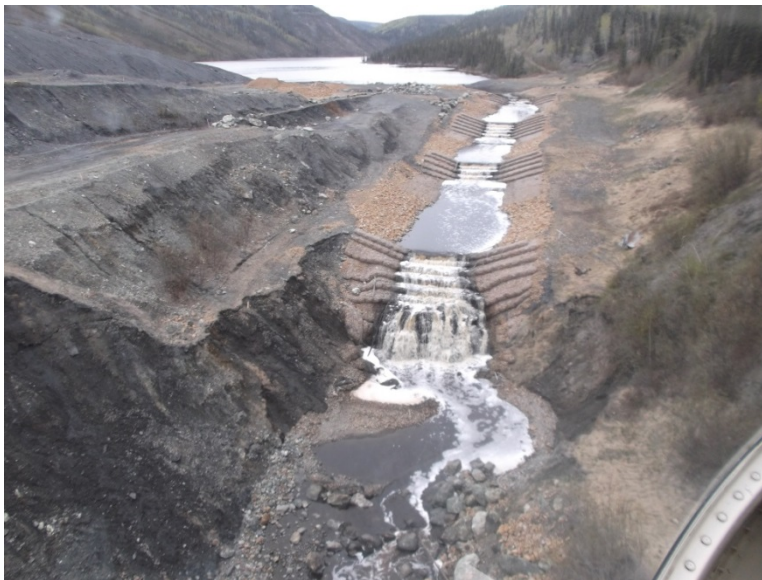
Photo A Site Overview prior to DS4 Repairs (May 21, 2014, looking west)

Prior to the repair of DS4, the potentially unstable waste rock slope to the south and east of DS4 (Photo A) was regraded to 2H:1V to allow safe working access to the site.

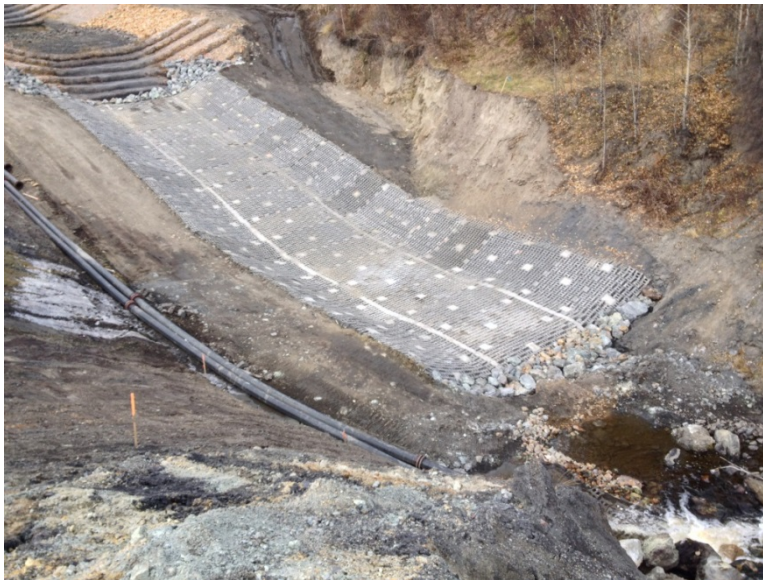
Photo B Site Overview at Substantial Completion
(September 23, 2015, looking northwest)

Engineering record drawings and construction specifications for the DS4 repairs are presented in Appendix 1 and 2, respectively. The completed work is shown in Photo B. The original design report for the DS4 repairs is in Appendix 3.

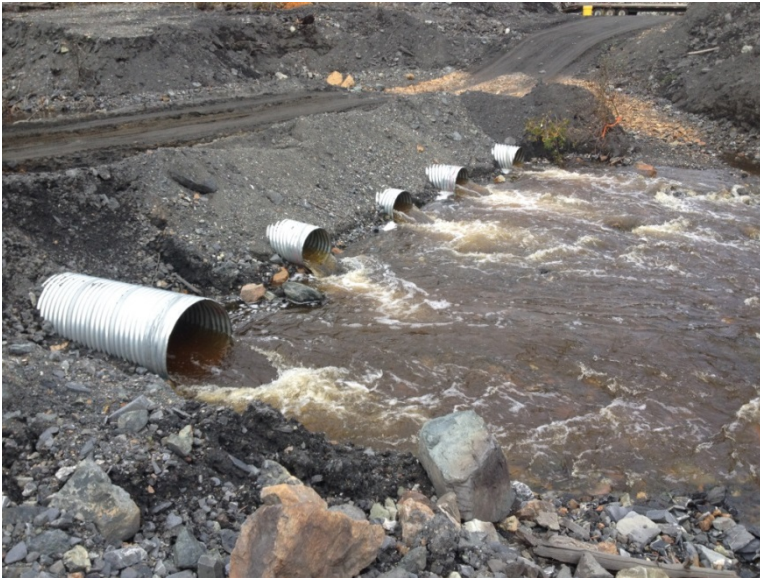
Photo C **Fording 1, Downstream Side (August 31, 2015, looking northwest)**

Fording 1 is located approximately 300 m past the site access gate and crosses Clinton Creek. To allow heavy equipment and trailers to access the site, a causeway was constructed at the fording using on-site fill material. One 1.0 m dia. CSP culvert, four 0.6 m dia. CSP culverts, and a high flow channel were constructed to maintain flows through the crossing, as shown in Photo C. This crossing was designed and constructed by the contractor.

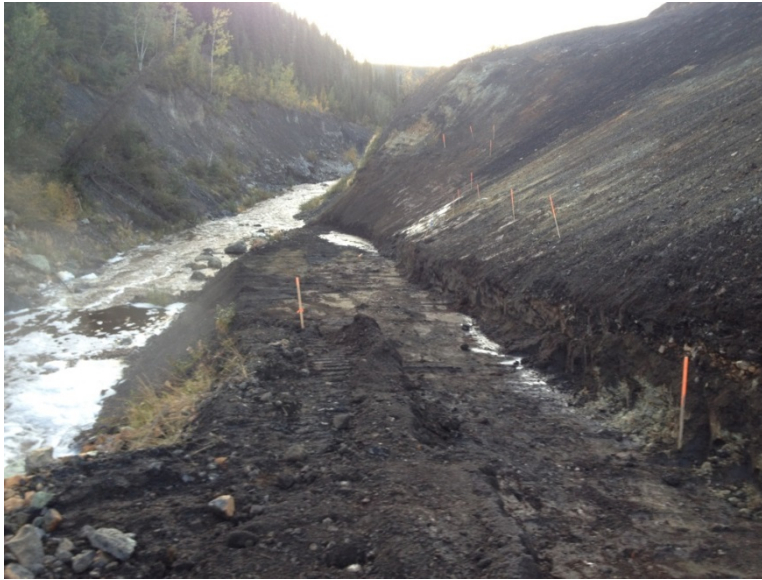
Photo D Permafrost at Toe of Waste Rock Slope (August 30, 2015, looking east)

Permafrost was encountered in the lower 2 m to 4 m of the excavated slope. The extent of permafrost on the slope, marked with survey stakes, is shown in Photo D. Groundwater seeped from a 5 m-wide section along the toe of the slope, and appeared to be discharging at the surface of the permafrost. The seepage was initially turbid but was running clear by the following day. The seepage rate was approximately 1 L/s and remained constant throughout the project. Rock and geotextile was placed at the toe of the slope on September 25, 2015 to mitigate erosion. No other work was completed. The presence of permafrost is not expected to significantly affect the stability of the slope or the DS4 repair.

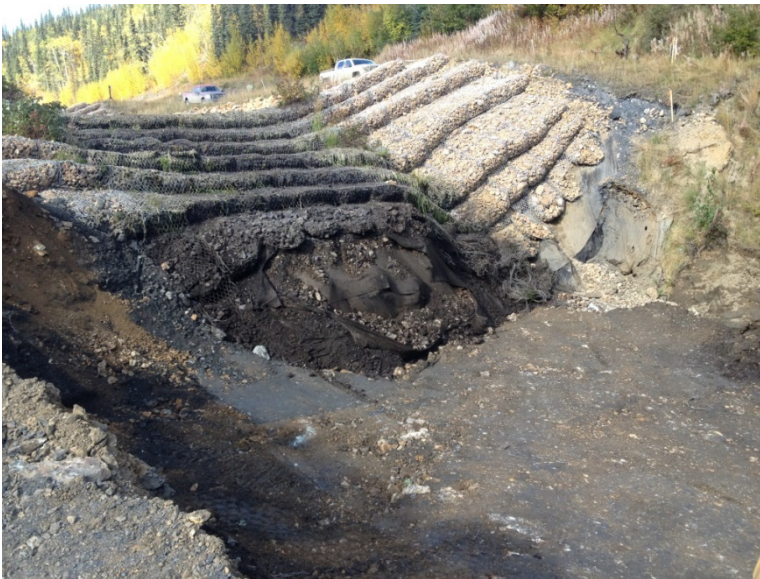
Photo J **DS4 after Removing Damaged Gabion Baskets**
(September 5, 2015, looking northwest)

Damaged gabion baskets on the sixth course (i.e. row or layer) from the top of DS4 were removed to create a hydraulically efficient transition to the Armorflex channel.

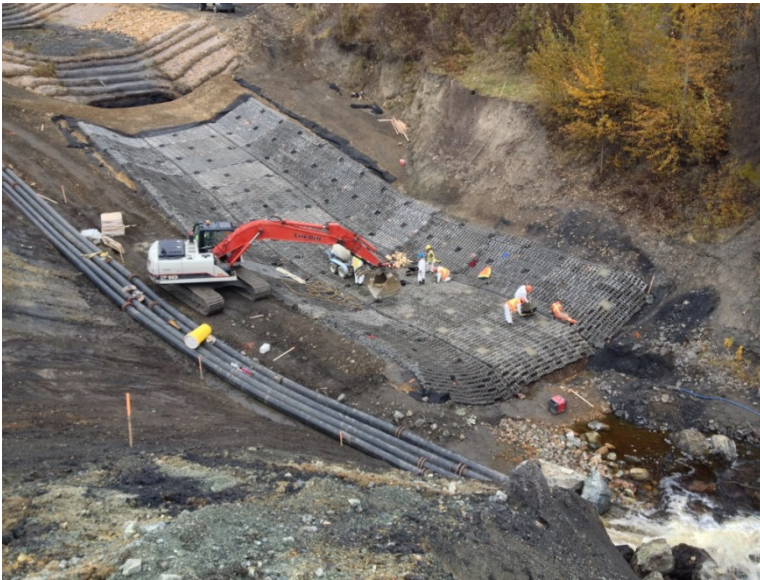
Photo N **Mixing and Placing Grout (September 17, 2015, looking northwest)**

The dry grout was mixed with water from Clinton Creek on-site using a portable concrete mixer. The grout was placed using wheelbarrows, tamping rods and finishing trowels. Fresh grout was covered with insulated blankets overnight to protect against freezing.

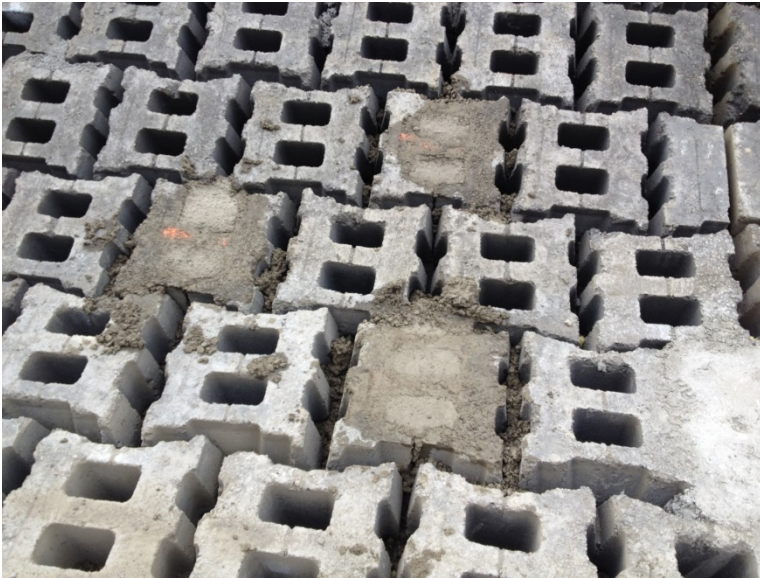
Photo O Broken concrete blocks grouted in place
(September 21, 2015)

The first shipment of Armorflex mats was found to be deficient, with the average block height approximately 16 cm to 17 cm thick. Mats were re-fabricated and shipped to site; however, to avoid delays to the project schedule Armortec shipped the replacement Armorflex mats following a relatively short curing time at their Edmonton plant. While the tested 28-day compressive strength of the Armorflex blocks (Appendix 7) met the minimum specified by Armortec, many of the blocks in the replacement mats had large cracks or spalling.

As per Armortec's direction, cracks were repaired using a primer/water mix and Portland cement. 29 blocks out of the 54 mats (3780 blocks total) were split in half during transport to site. These blocks were replaced with spares by cutting the steel cables and reconnecting them with crimp sleeves. Concrete blocks that were damaged during placement were grouted in place (Photo O).

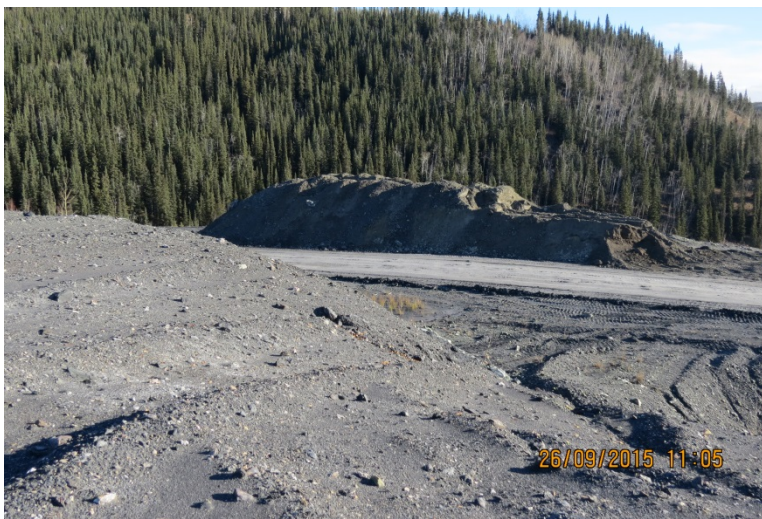
Photo R Access road waste rock stockpile (September 26, 2015)

Waste rock stockpiles along the road entering the laydown area (UTM 513,140 mE, 7,147,357 mN) and near Porcupine Pit (UTM 513,305 mE, 7,146,841 mN) were left in place. Deficient Armorflex mats (170 mm height), extra Armorflex blocks, damaged Armorflex blocks and spare gabion repair materials were also stored at the Porcupine Pit stockpile area. The stockpile areas are shown in Photo R and Photo S.

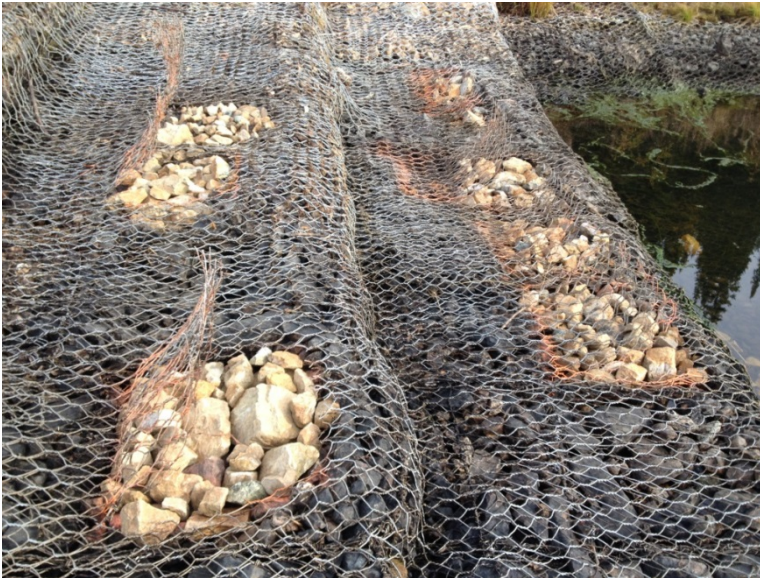
Photo T **Cutting and Filling Gabion Baskets with Rock**
(September 11, 2015, looking north at DS3)

Photo T shows gabion baskets cut along downstream edge and filled with rock (light coloured). Photo U shows a finished gabion drop structure after patches and strips of gabion mesh were placed and stapled.

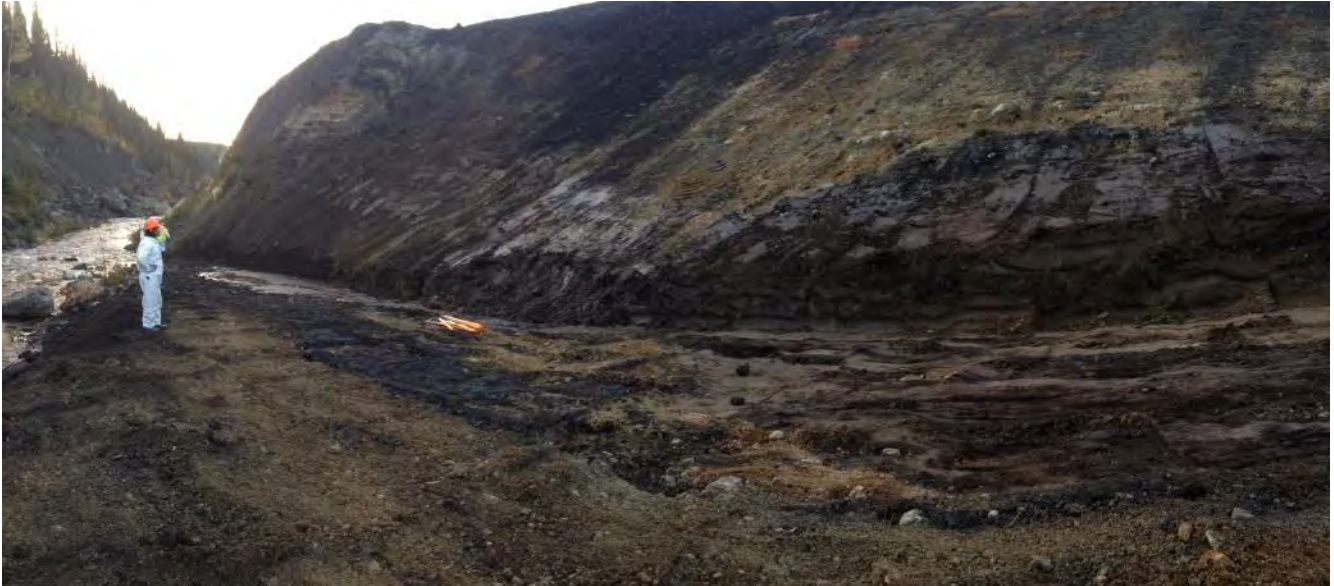
Looking east: Permafrost layer along toe of excavated slope (dark brown area). Bottom 2-4 meters approximately.

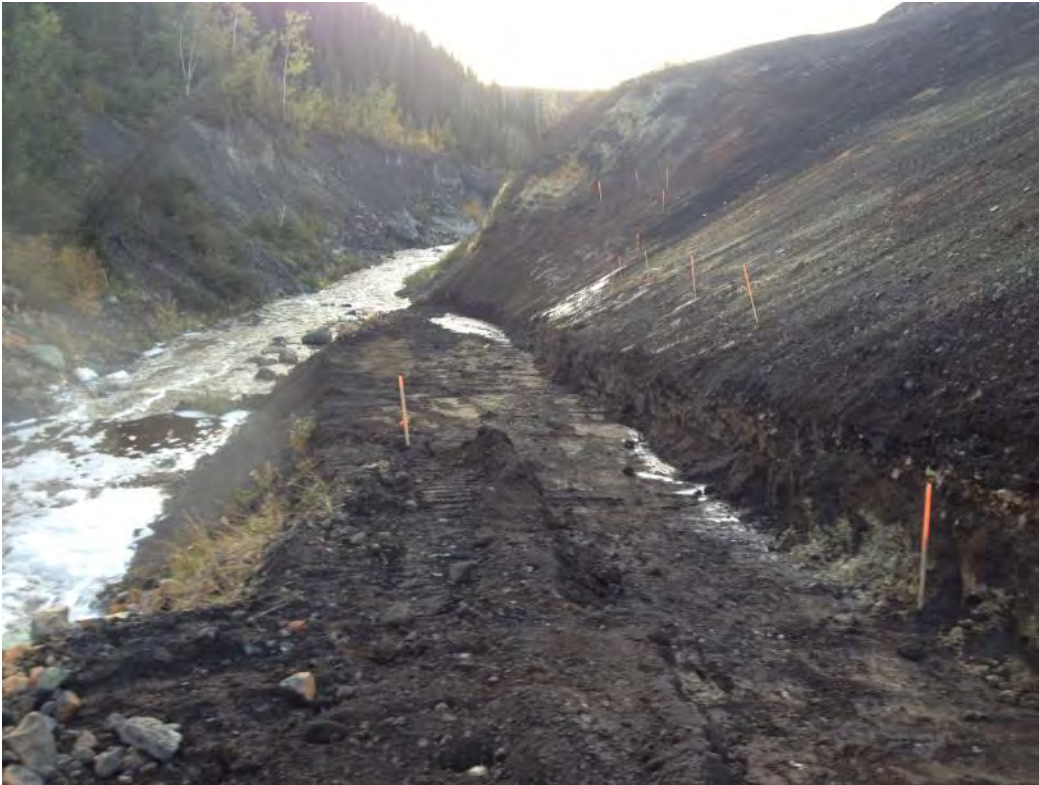
Looking east: Top of permafrost region marked with survey stakes.

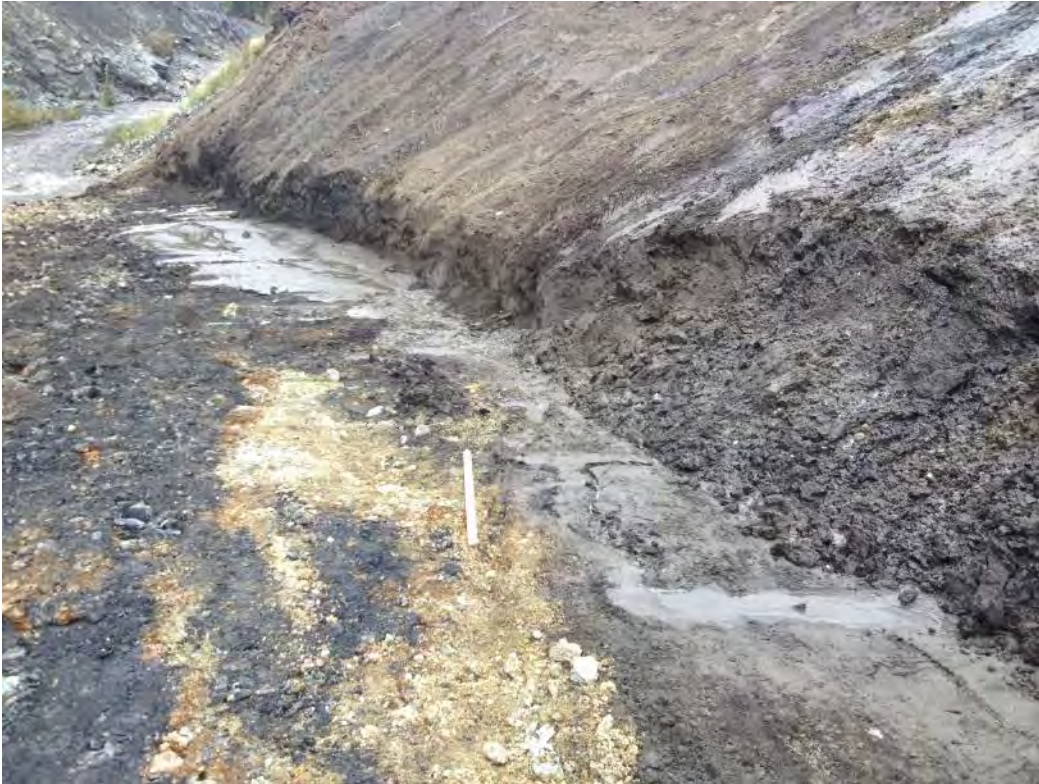
Looking east: ~1 L/s seepage of water from toe. Assumed to be rainwater running along top of permafrost. Delta of fine sediment deposited in background.

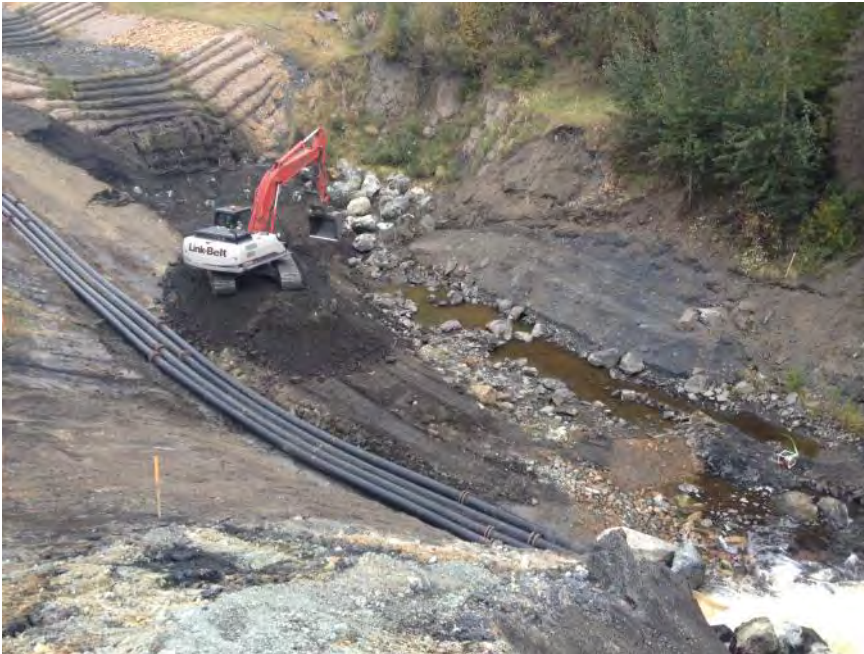
Looking northwest: Instream work area at 4pm – removing some poorly compacted fill.

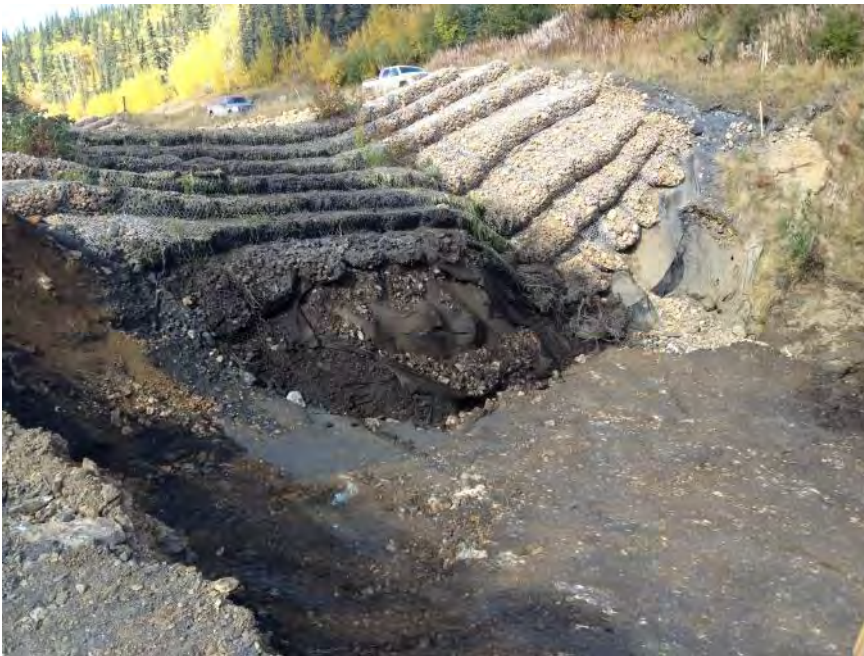
Looking northwest: Damaged gabion baskets removed. Top of Armorflex will tie into first level of intact gabions (second level shown).

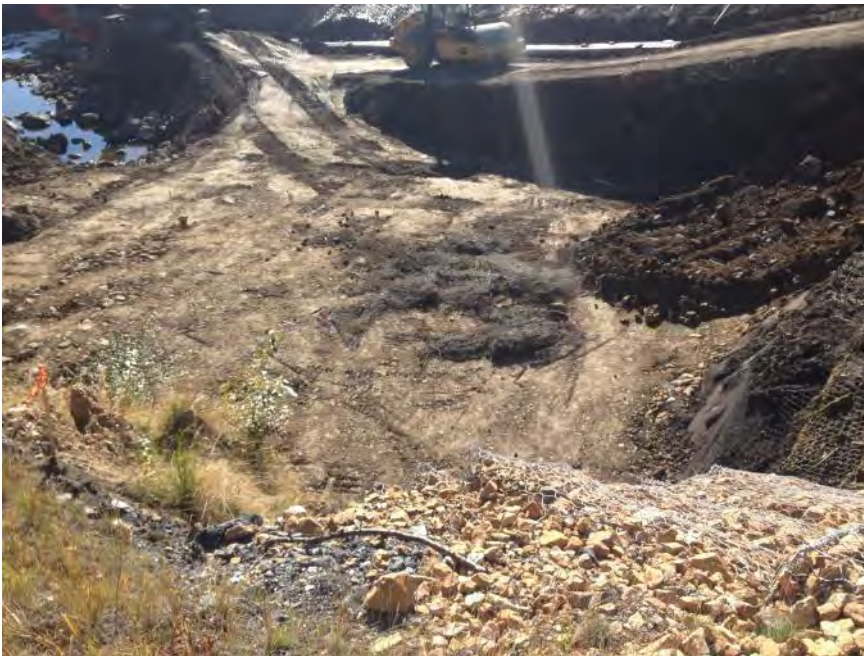
Looking southeast: Burying damaged gabion baskets in middle of channel infill.

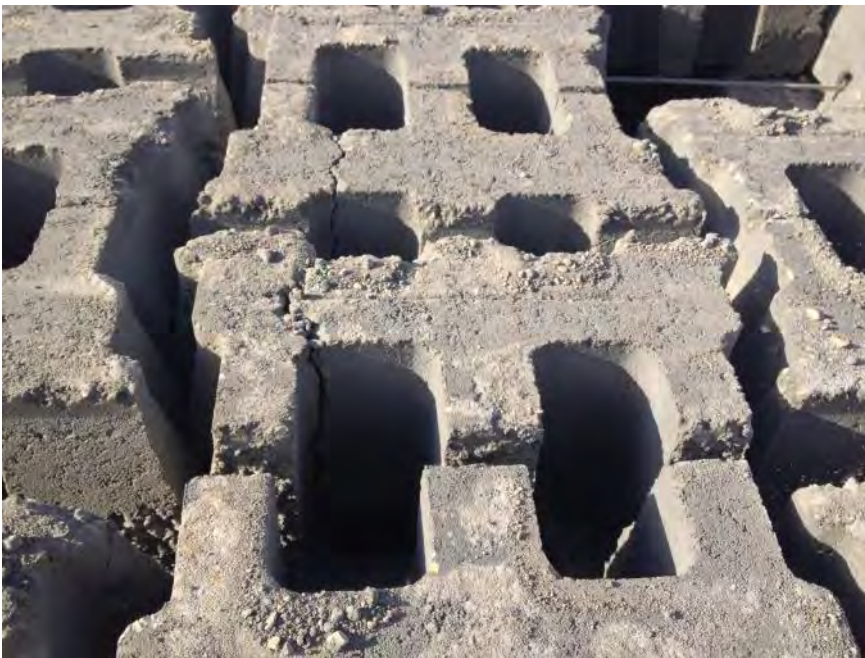
Armorflex mats: Crack through that will need repair. Only defect found in top mat on stack.

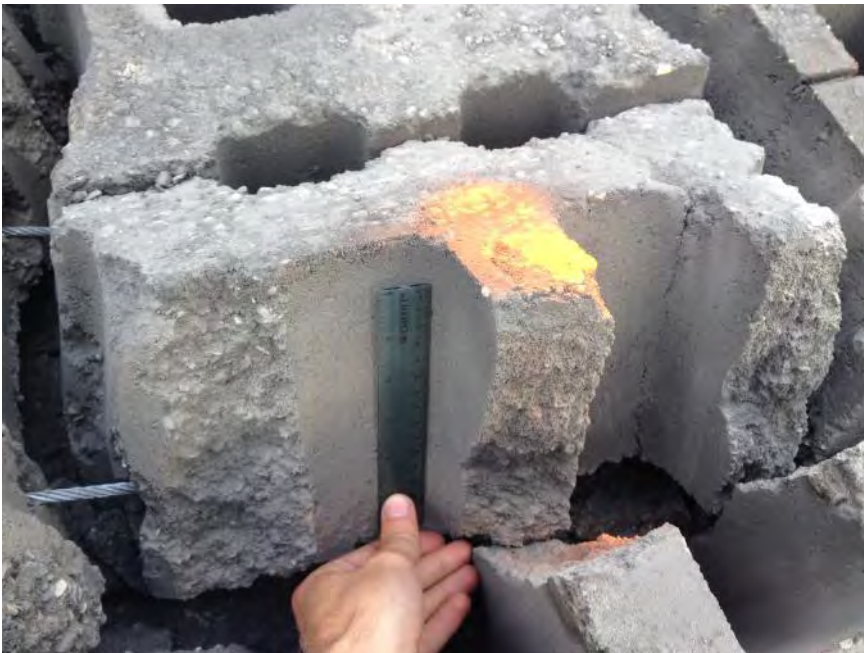
Broken Armorflex block.

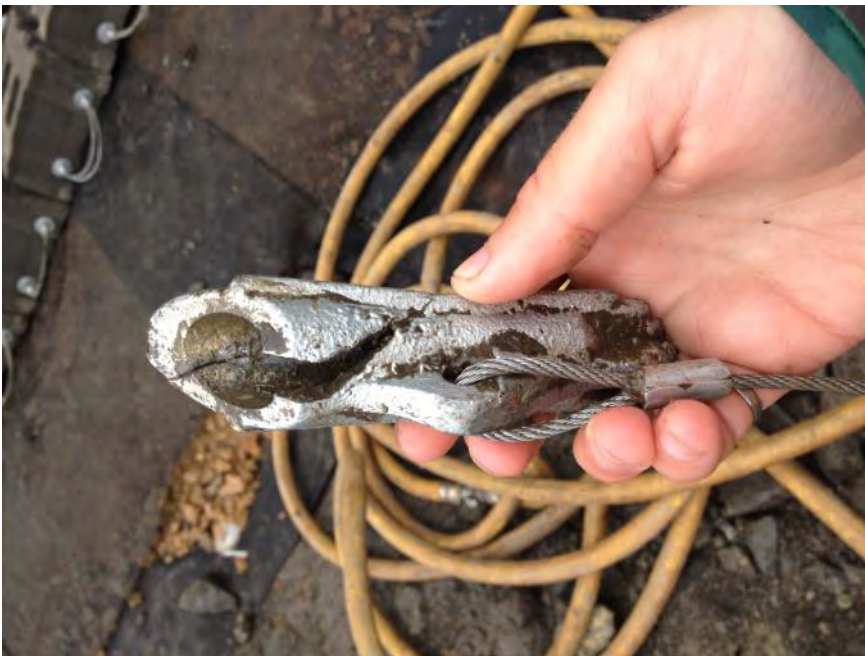
The duckbill 68-DBD anchors specified were not suitable for shale bedrock, which caused substantial damage to the anchors and the driving rod during installation. This change will have no significant impact on the performance of the Armorflex channel because these mats are located in the stilling basin section of the channel, which has a higher factor of safety against failure.

Damaged duckbill anchor

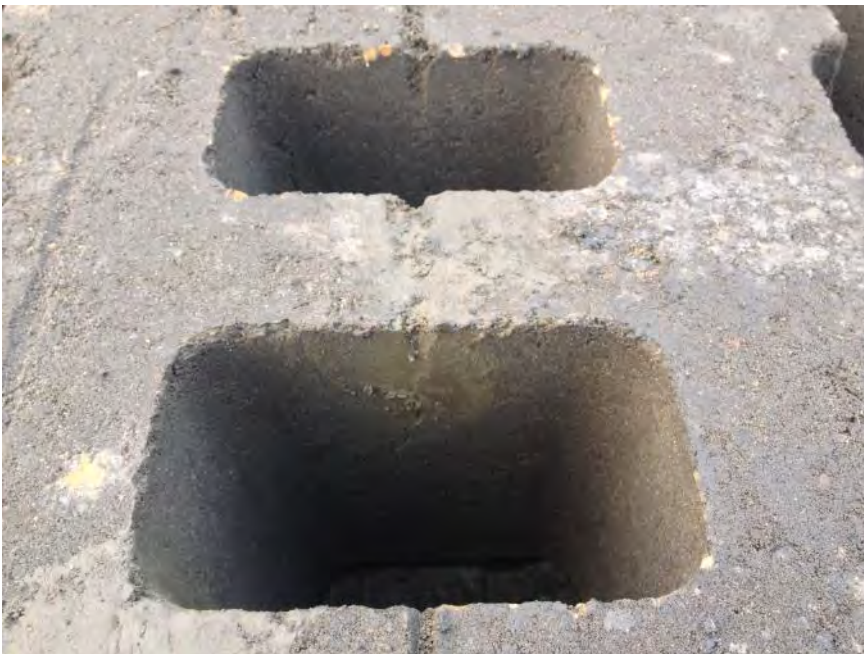
Typical repair of long crack in concrete.

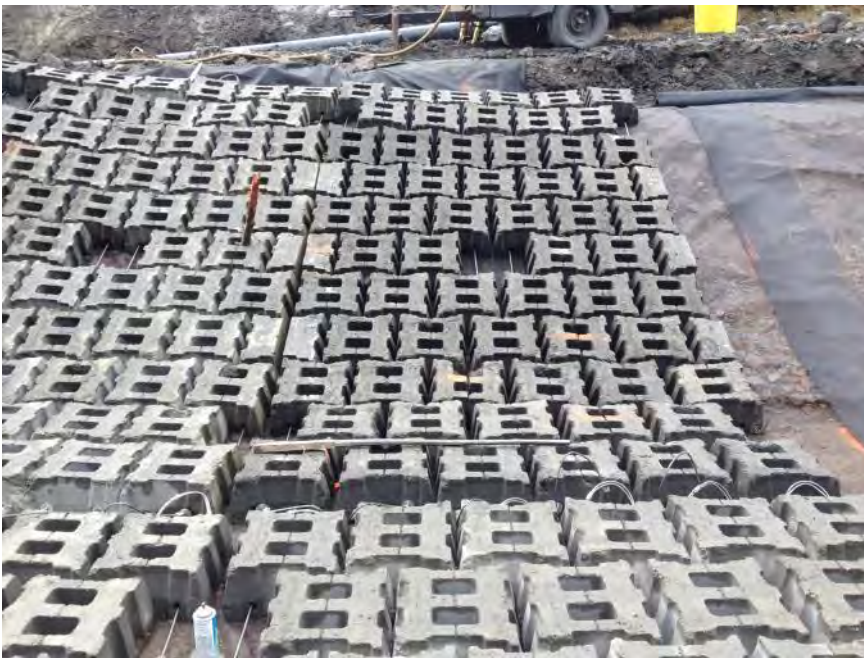
Looking south: 5th mat from end is typical of generally poor concrete. 3 blocks cracked during placement.

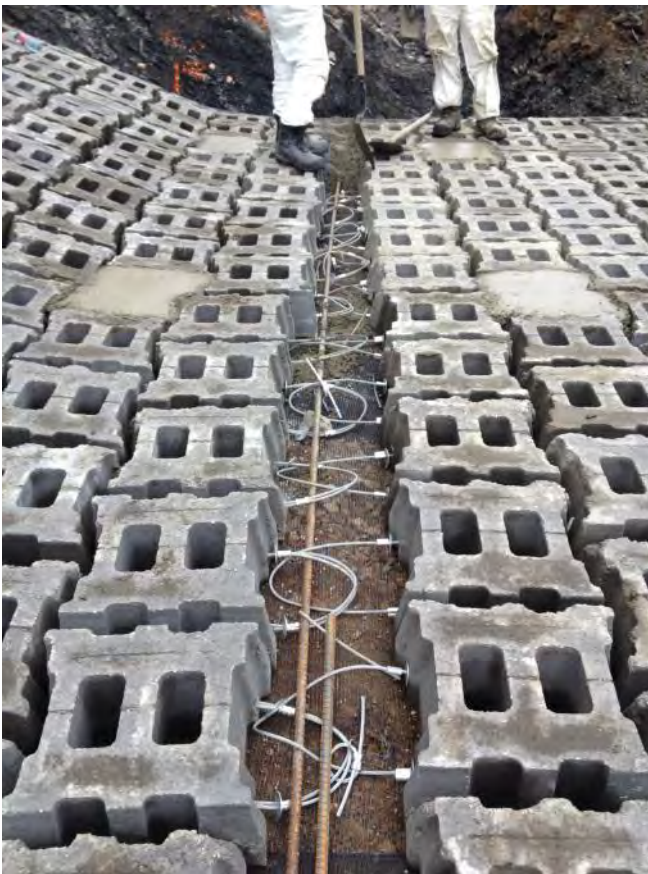
Looking east: Loose cables to be tucked in, should not stick out of grouted trench

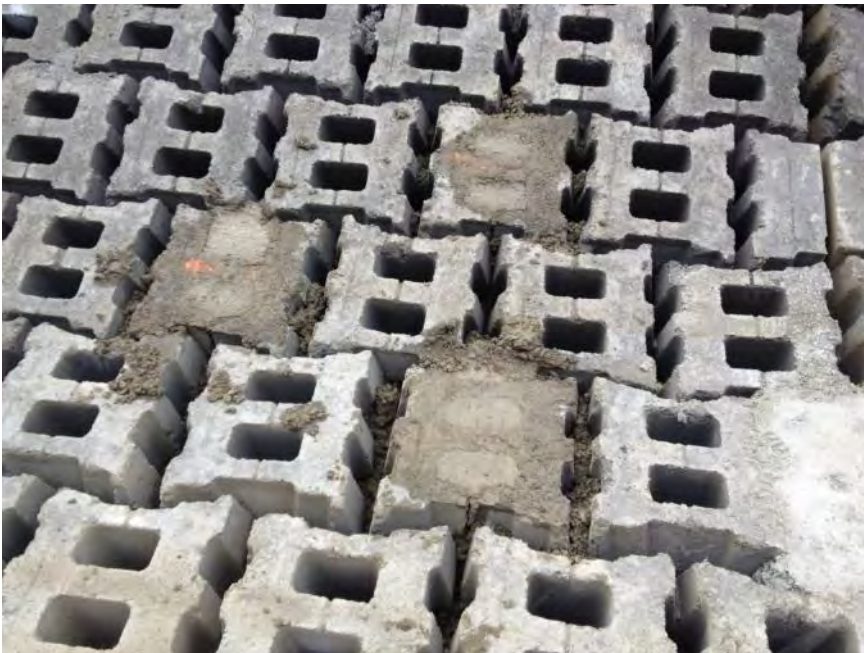
Repair of broken Armorflex blocks – fill both voids with grout
