**CLINTON CREEK MINE WASTE ROCK DUMP**  
**ASSESSMENT OF REVEGETATION POTENTIAL**  
**JULY 2008**

CC012-R26  
CLINTON CREEK MINE WASTE ROCK  
DUMP ASSESSMENT OF REVEGETATION  
POTENTIAL JULY 2008

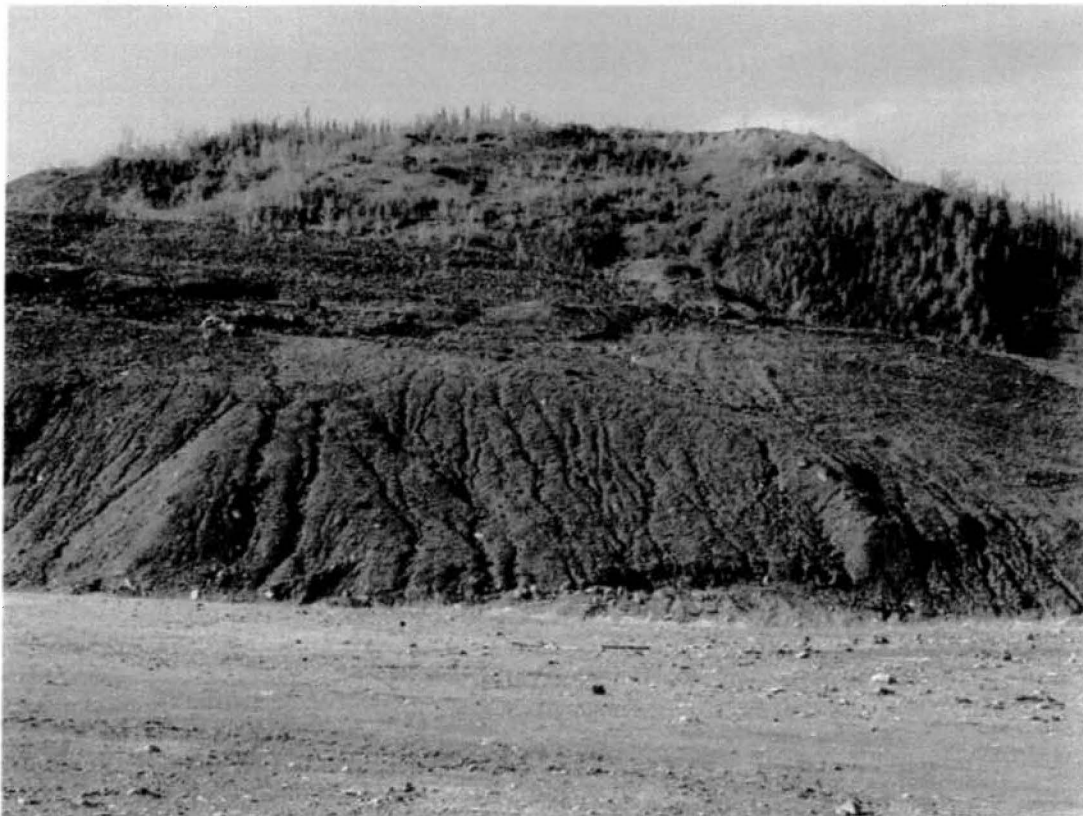
Photo #1: Toe of waste rock dump near Hudgeon Lake. The gulying evident is actually providing micro habitats allowing for the growth of forbs and shrubs, shown in Photo #2.

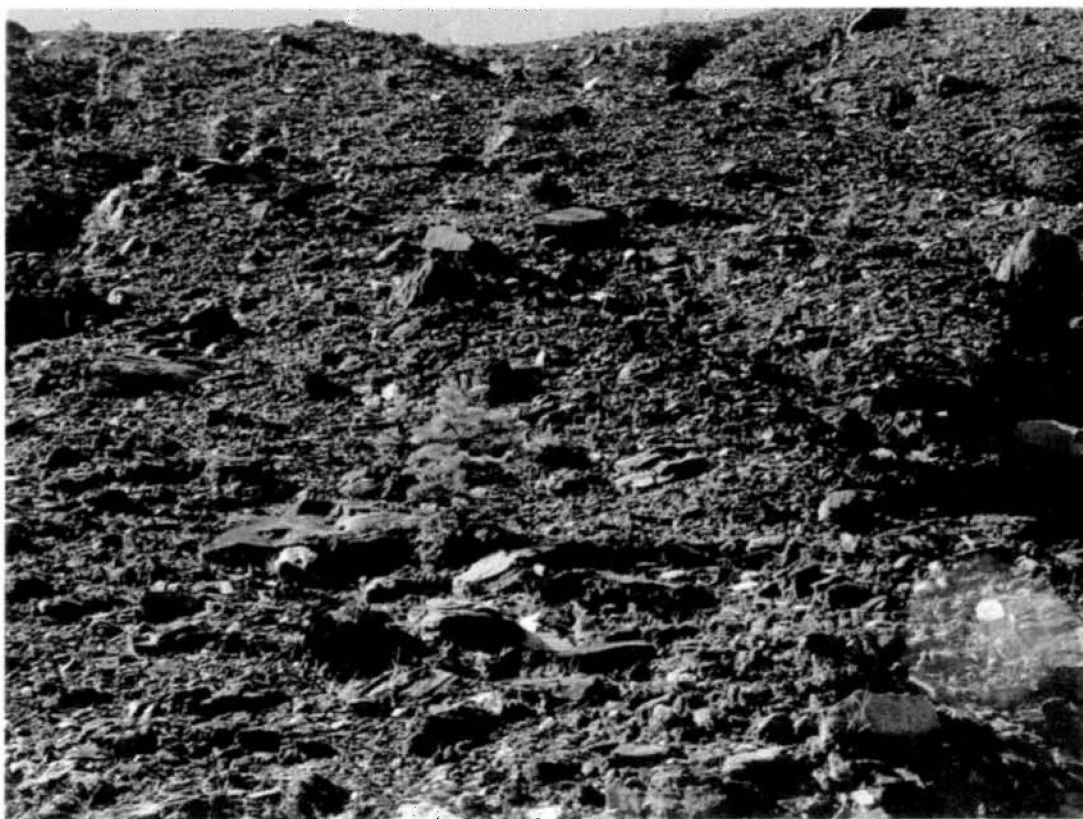
Sites CC-1 and CC-2 are located on the toe of the waste rock dump near Hudgeon Lake with a northerly aspect. Site CC-1 has a sparse growth of balsam poplar, white spruce and willows, with an occasional trembling aspen and paper birch. Nearby Site CC-2 is devoid of vegetation. Both sites have compacted soils that are classified as sandy loam.

There is little information in the soil analysis results to explain the difference in vegetative growth at the two sites. Soils at both sites are deficient in the macronutrients nitrate, phosphorous and potassium but with excess sulfate. Both sites have alkaline soils (although the in-situ pH readings show slightly acidic soils), satisfactory electrical conductivity and a low percentage of organic matter.

Photo #2: A close-up look at the slope in Photo #1. This area is near sample site CC-1.

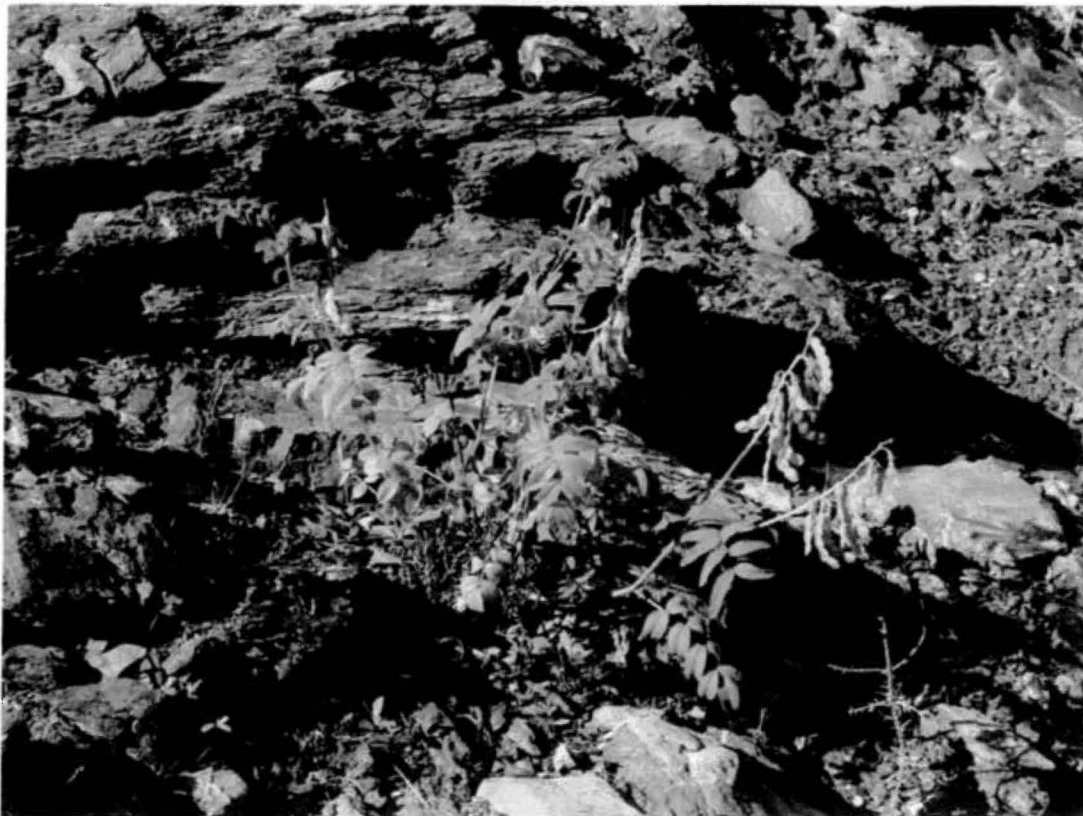
Photo #3: A *Hedysarum alpinum* plant, a nitrogen-fixer, growing on the waste rock dump.

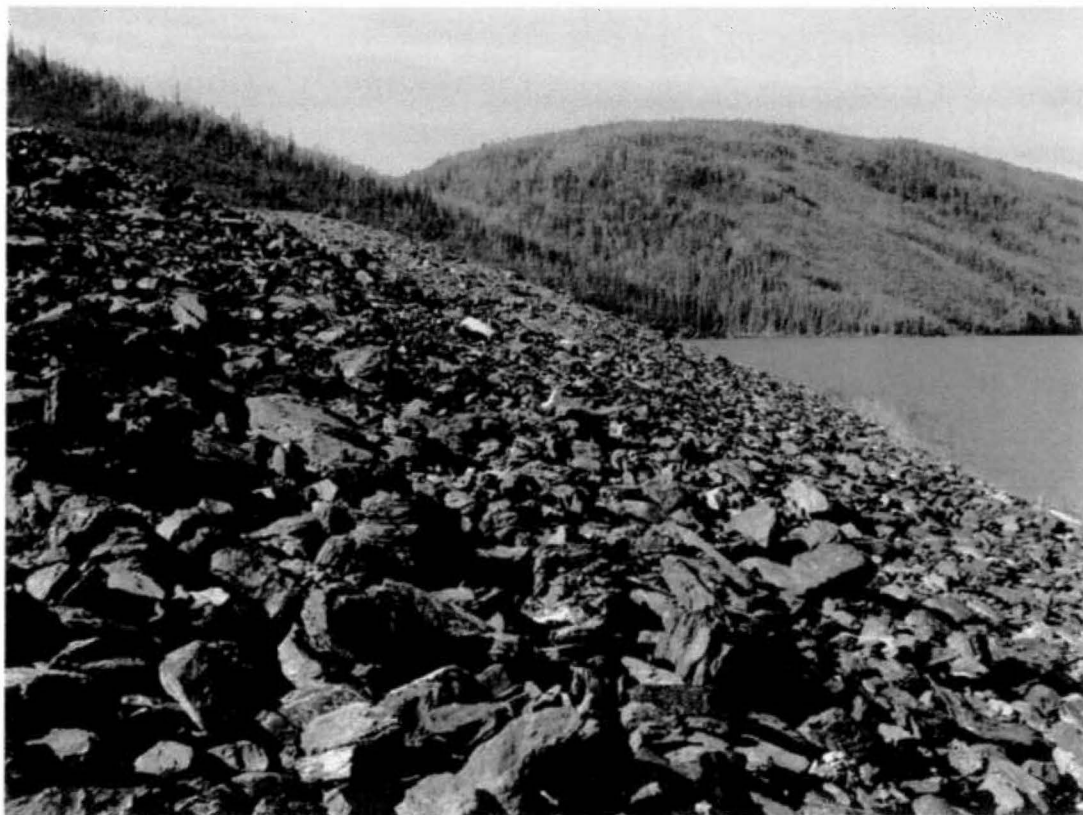
Photo #4: The bare slope devoid of any vegetation, where sample CC-2 was collected.

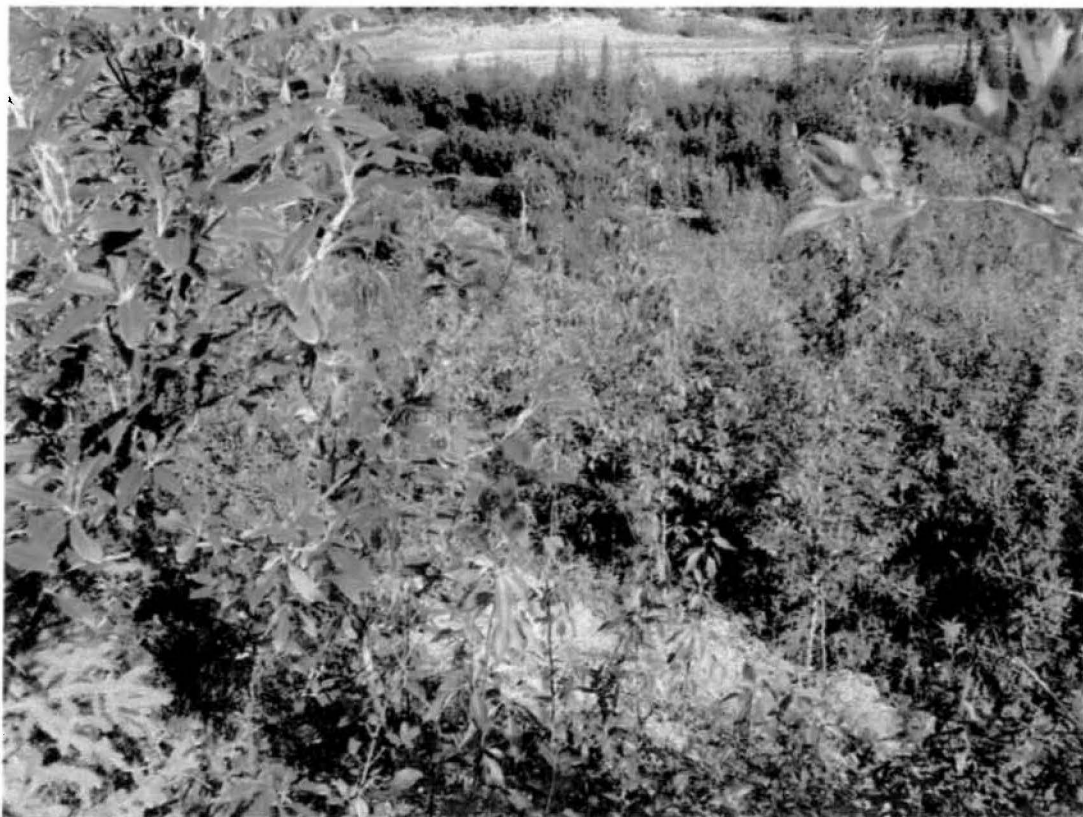
Sites CC-3 and CC-4 are located near the northeast edge of a waste rock dump overlooking Clinton Creek (not far from the abandoned shovel and drill). Site CC-3 has a fairly dense and diverse vegetative growth dominated by balsam poplar, willows (including felt-leaf willow, blueberry willow and little-tree willow) and soapberry, along with several forb and grass species

Photo #5: A well vegetated area where sample CC-3 was collected.

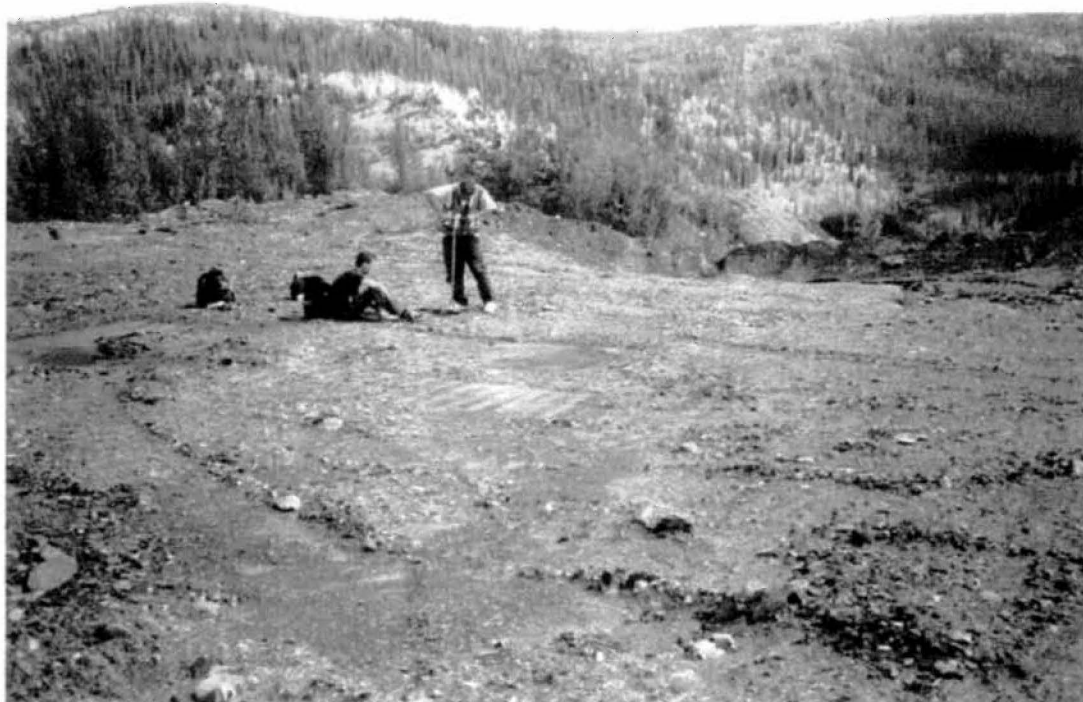
(see next section). Nearby Site CC-4 is devoid of vegetation. The soil at Site CC-4 is slightly more compacted than that at Site CC-3.

The soils at both sites are deficient in the macronutrients nitrate, phosphorous and potassium but with excess sulfate. Both sites have alkaline soils (although the in-situ pH readings show slightly acidic soils). The electrical conductivity at Site CC-3 (0.46 dS/m) is satisfactory while that at Site CC-4 (5.62 dS/m) is in the toxic range. The loamy sand at Site CC-3 has a normal percentage of organic matter (2.1 %), while the percentage of organic matter in the sandy loam at Site CC-4 (1.7 %) is considered to be low.

Photo #6: The area near the abandoned shovel and drill where no vegetation was growing, sample site CC-4.

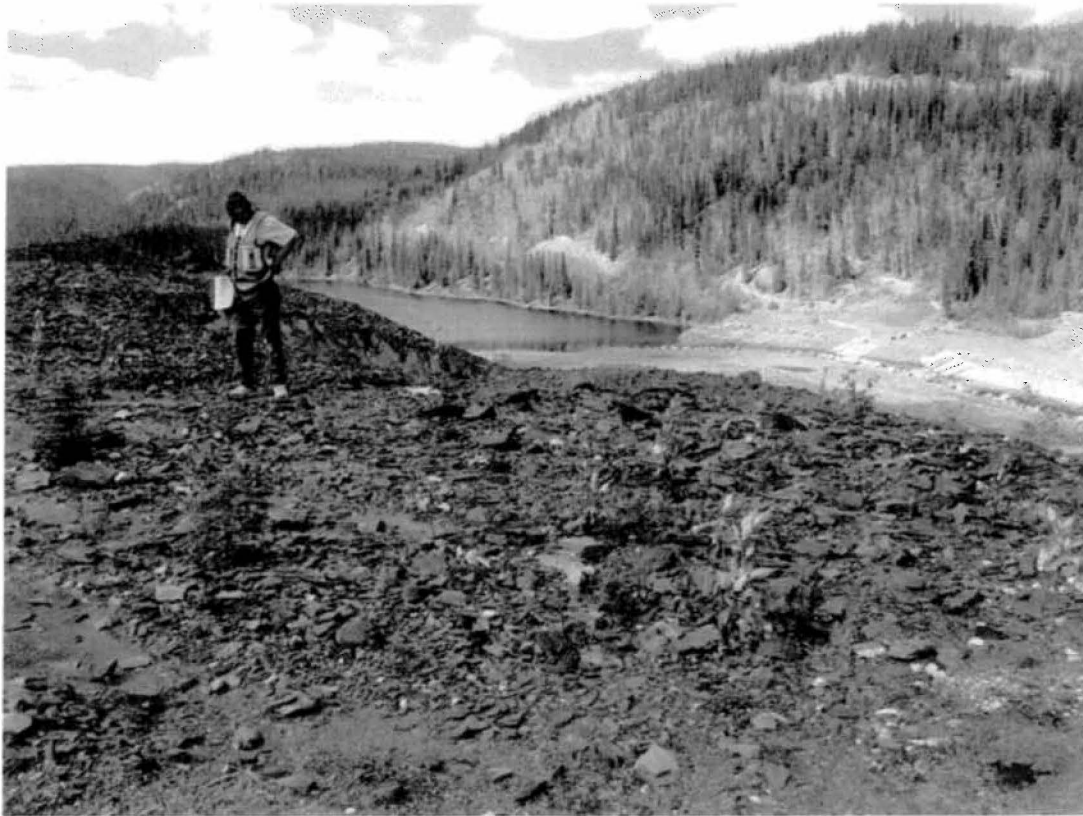
Sites CC-5 and CC-6 are located on the waste rock dump northeast of the Eagle pit and have a northeasterly aspect. The soils at both sites are compacted, with that at Site CC-5 classified as sandy loam and that at Site CC-6 classified as loamy sand. The naturally occurring revegetation at Site CC-5 includes white spruce, balsam poplar, trembling aspen, paper birch and soapberry, and almost appears as a planted plot however no documentation could be found to support this. Site CC-6 is devoid of vegetation.

Photo #7: Diverse growth of several species of shrubs and trees, where sample CC-5 was collected.

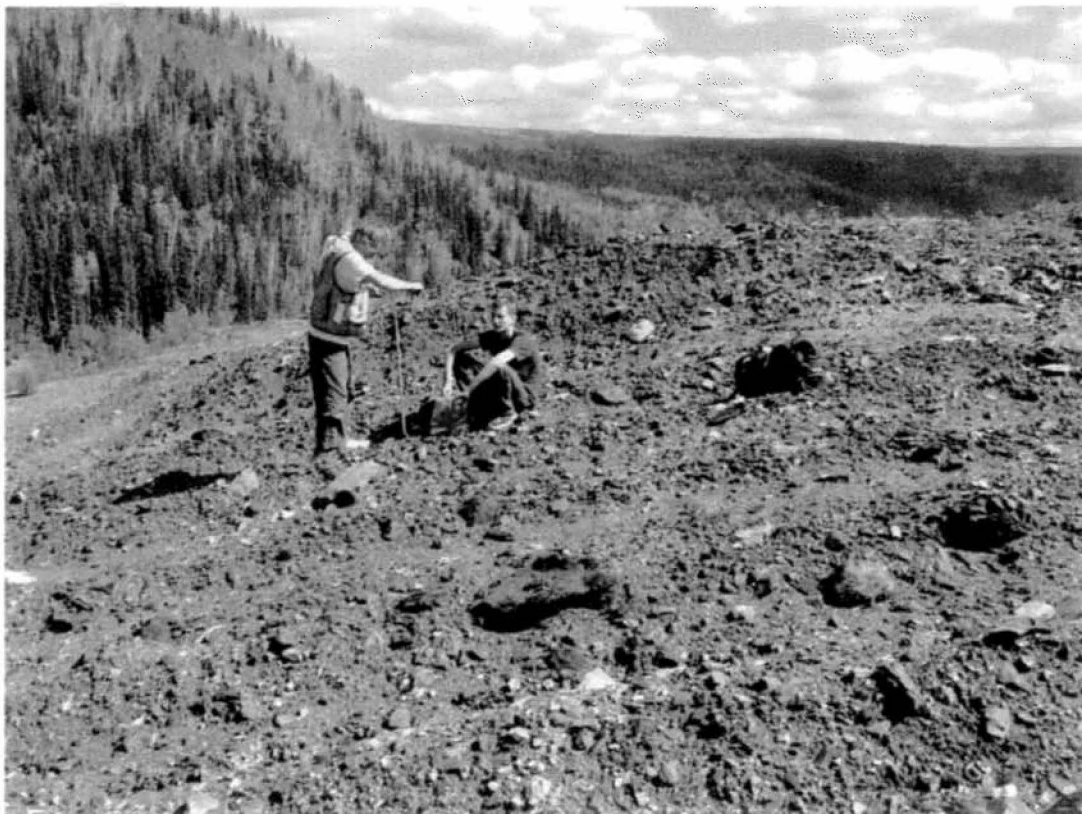
The soils at both sites are deficient in the macronutrients nitrate, phosphorous and potassium but with excess sulfate. Both sites have alkaline soils (although the in-situ pH readings show slightly acidic soils). The electrical conductivity at both sites is considered to be satisfactory. The soil at Site CC-5 has a low percentage of organic matter (1.2 %), while the percentage of organic matter in the soil at Site CC-6 (2.1 %) is considered to be normal.

Photo #8: The barren area of Site CC-6, adjacent to CC-5.

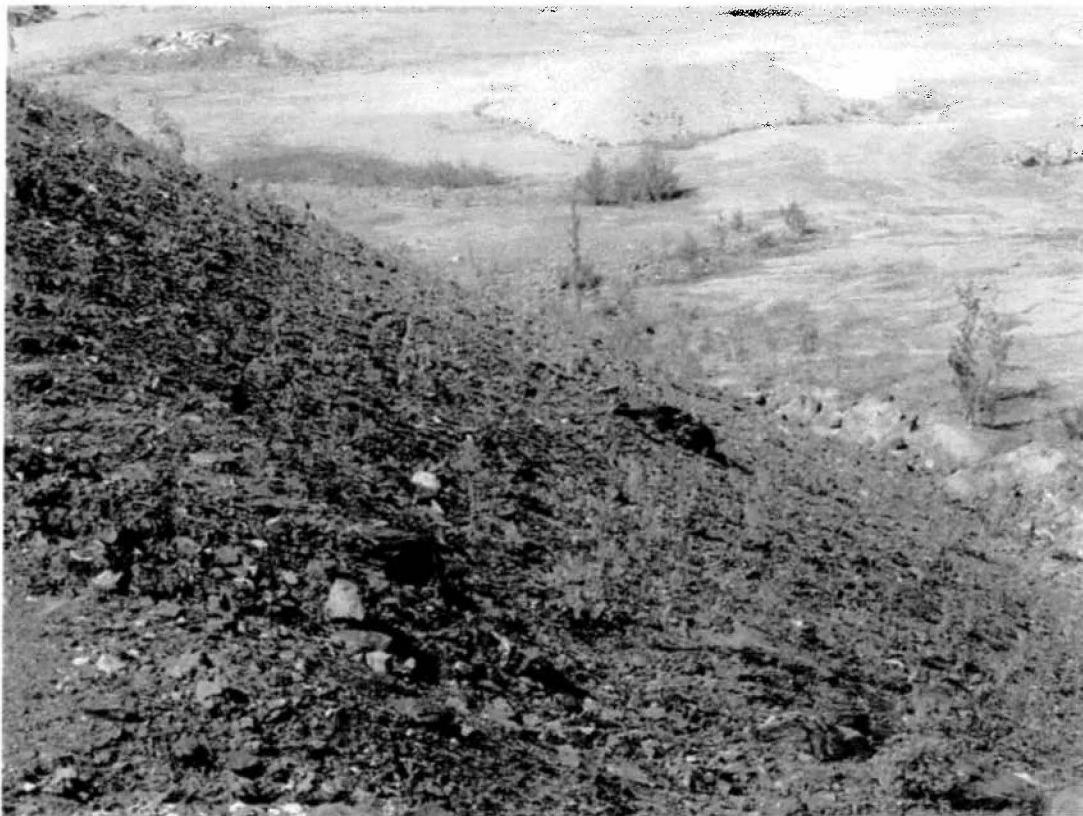
Photo #9: The slope near CC-5 and CC-6 showing good natural colonization of shrubs.

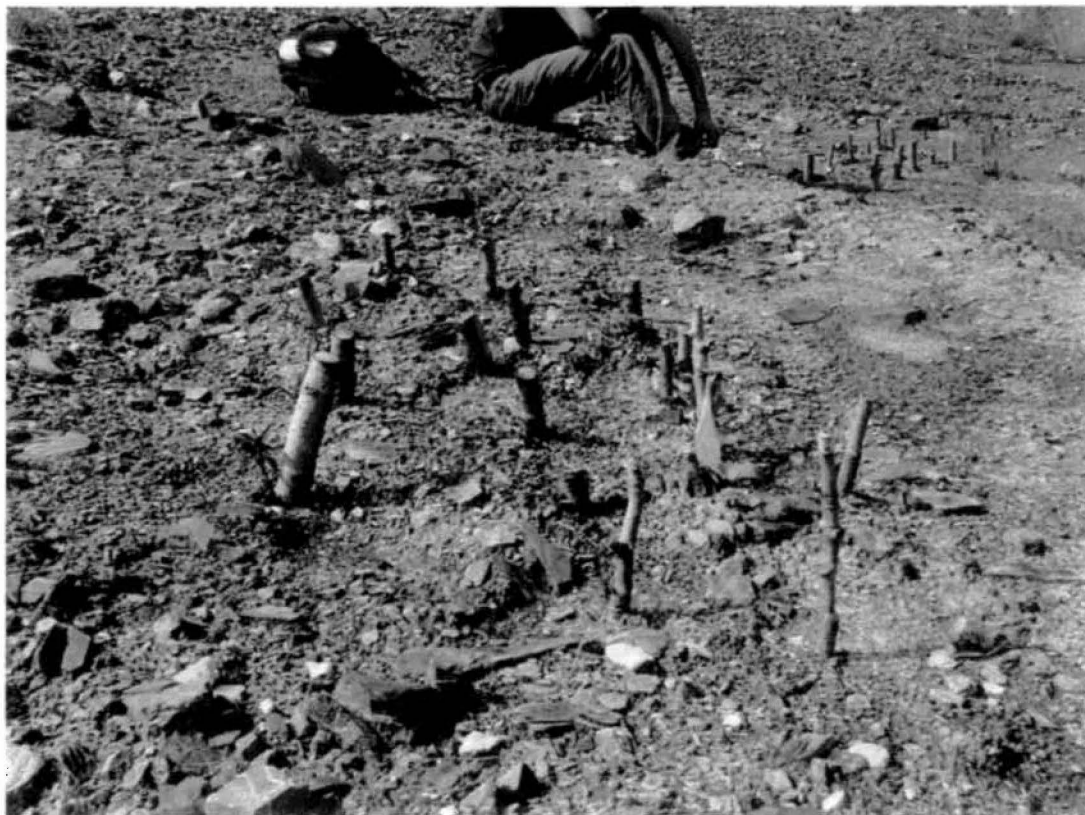
Site CC-7 is located next to one of the haul roads and is beside the shrub cutting test plot established by the Mineral Resources Branch on September 21<sup>st</sup>, 2007. Willow and balsam poplar stakes, 40 to 50 cm long were planted leaving approximately 10 cm above ground. Aspen root cuttings were about 20 to 35 cm long and were buried approximately 10 cm deep. All donor plants were collected off site, near the Carcross Road. There was some initial sprouting on the live stakes, but no growth from the root cuttings was observed on July 16<sup>th</sup>, 2008.

The soil at Sites CC-7 is deficient in the macronutrients nitrate, phosphorous and potassium but with excess sulfate. The soil is alkaline (although, as at each of the other soil sampling sites, the in-situ pH readings show slightly acidic soils). The electrical conductivity at Site CC-7 (4.55 dS/m) is considered to be toxic and has a low percentage of organic matter (1.3 %).

Photo #10: Site CC-7 showing the live staking test plot established by MRB in 2007.

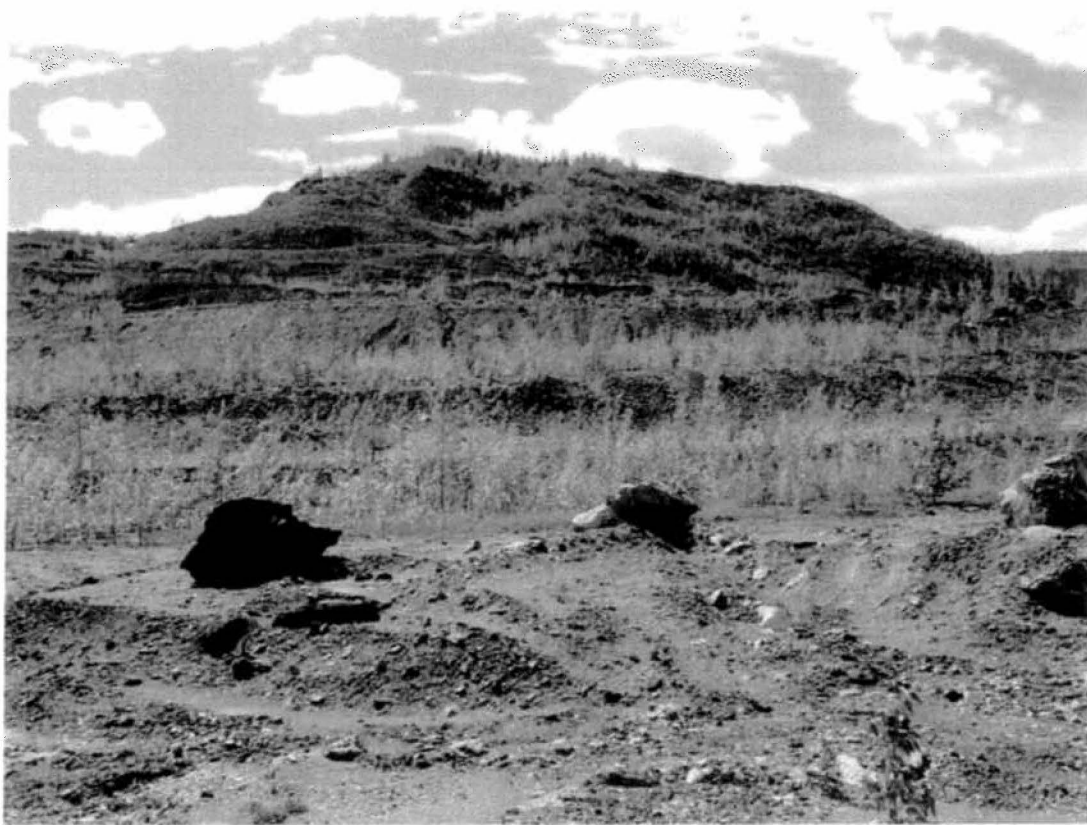
Photo #11: Well established growth of poplars on terraces and upper slope of the southern area of the waste dump.

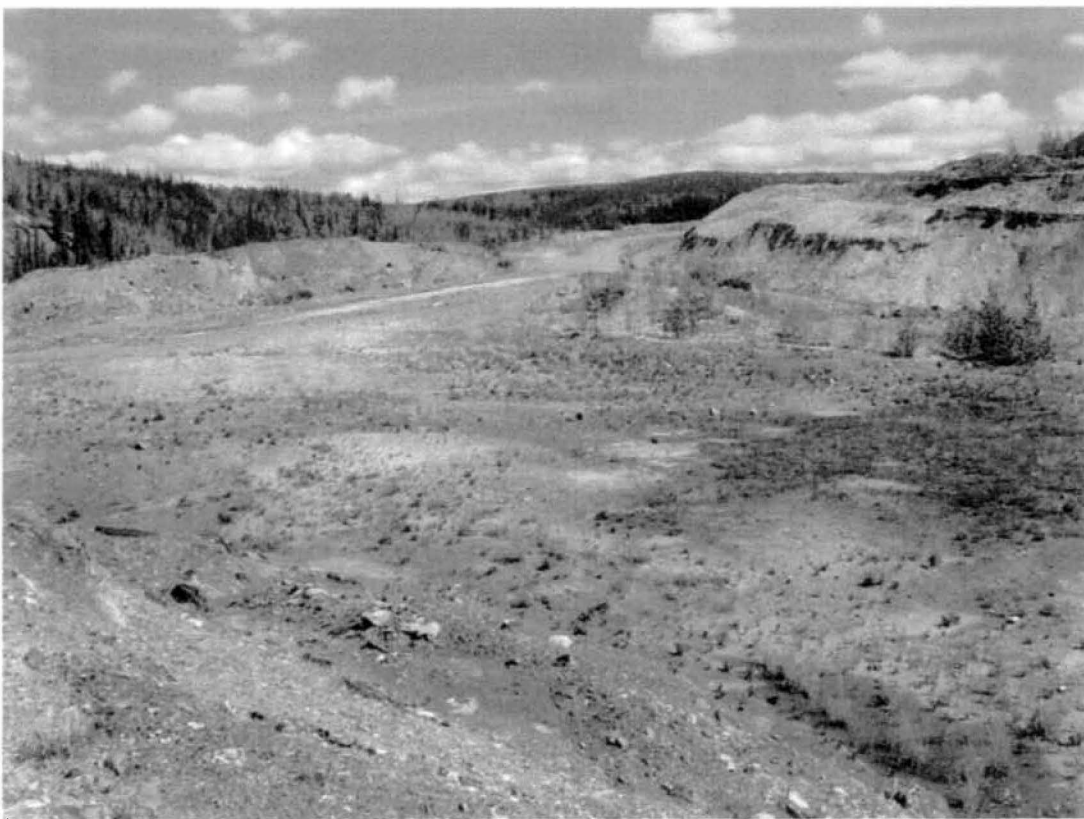
Photo #12: Natural invasion of native species on some of the level areas on the waste rock dump.
