Clinton Creek Asbestos Mine Downstream Hazard Assessment

We are pleased to submit six copies of our report entitled "Downstream Hazard Assessment for Mine Abandonment", dated December 10, 1987.

This report presents the results of a hazard assessment to determine the potential risks to human lives presented by the abandoned waste dump and tailings piles at the Clinton Creek asbestos mine, Yukon Territory.

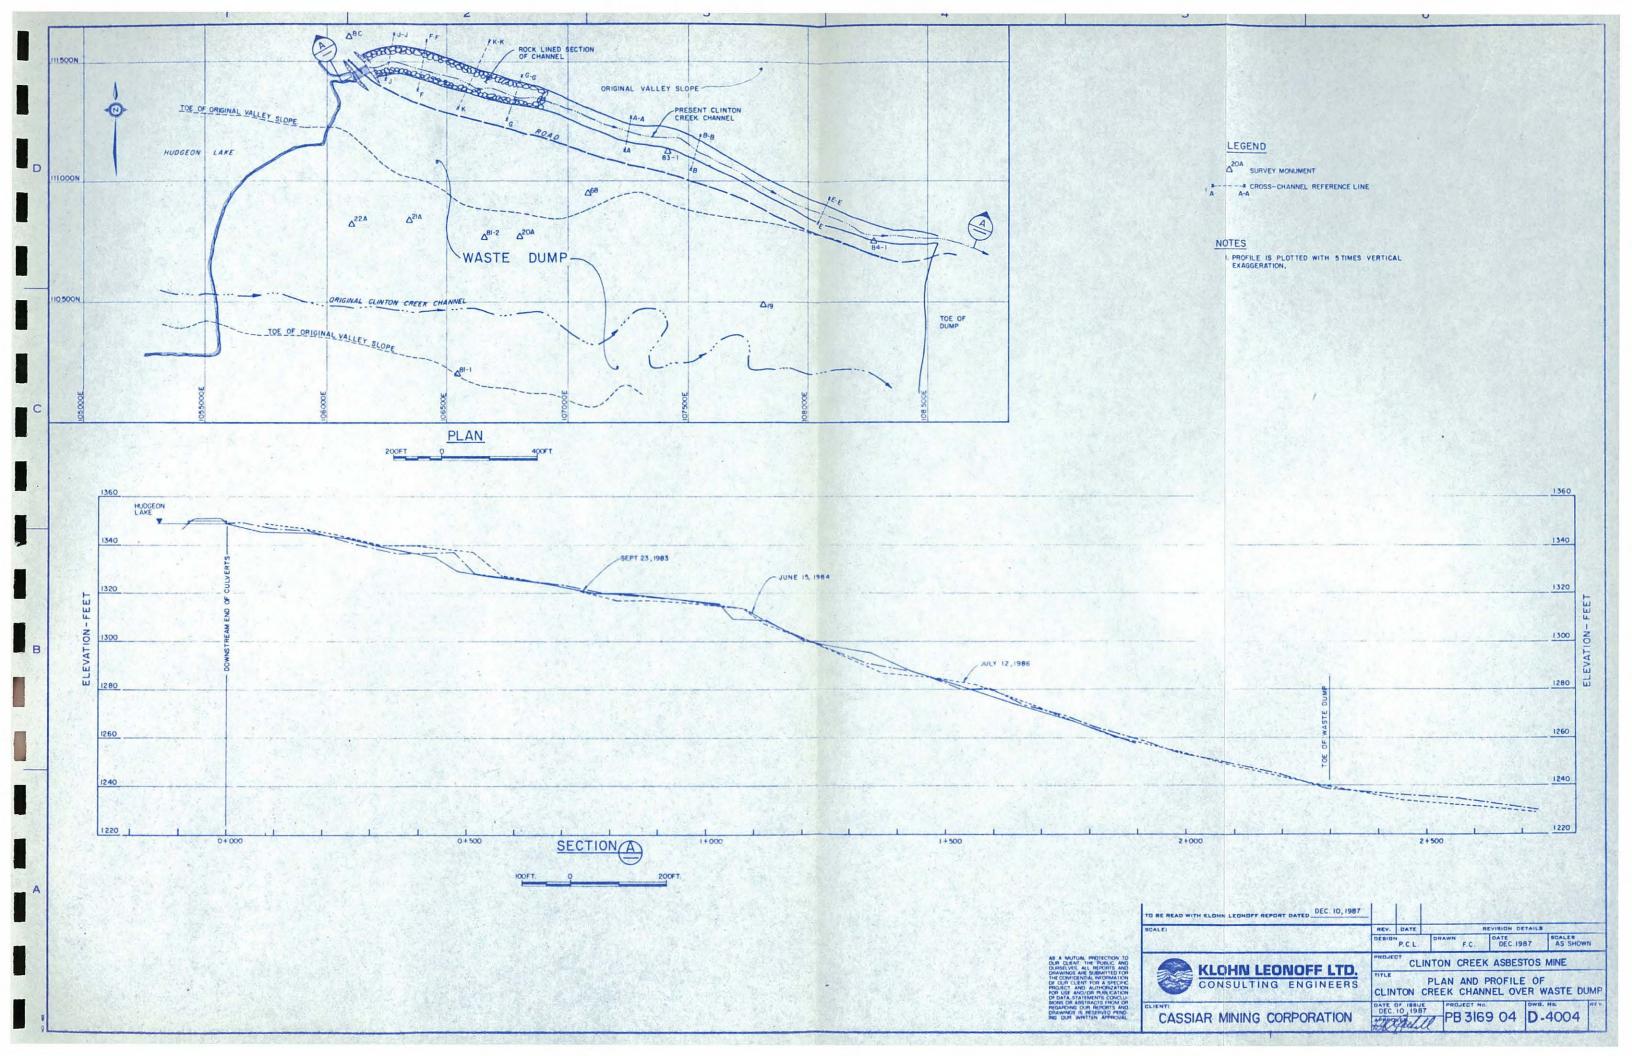
Waste rock from the Porcupine Pit was disposed by dumping on the slope which forms the valley wall on the south side of Clinton Creek. Originally, the valley floor was flat bottomed with a width of about 240 m, and Clinton Creek meandered along the valley bottom. As the toe of the dump reached the valley floor, it began to spread on the permafrost alluvial soils on the valley floor. As more waste material, primarily argillite, was placed on the dump, spreading of the dump continued until it filled the valley bottom. The cross-section of the waste dump illustrates the very flat surface profile. See Drawings D-4004 and D-4005.

Longitudinal profiles of the channel of Clinton Creek over the waste dump were surveyed in 1983, 1984 and 1986 to monitor the rate of downcutting. These profiles shown on Drawing D-4004 showed no measur-

able downcutting over the three year period, although some local bed erosion is apparent. Examination of photographs taken over a number of years also confirms the slow rate of downcutting.

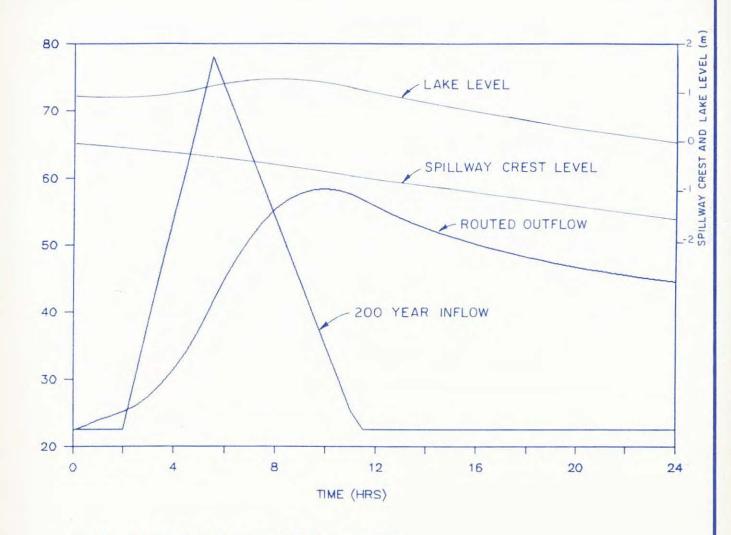
degradation was assumed to occur for a length of 340 m and 700 m, respectively.

SLOPE OF DEGRADATION CHANNEL = 0.035

LENGTH OF DEGRADATION CHANNEL = 340 m

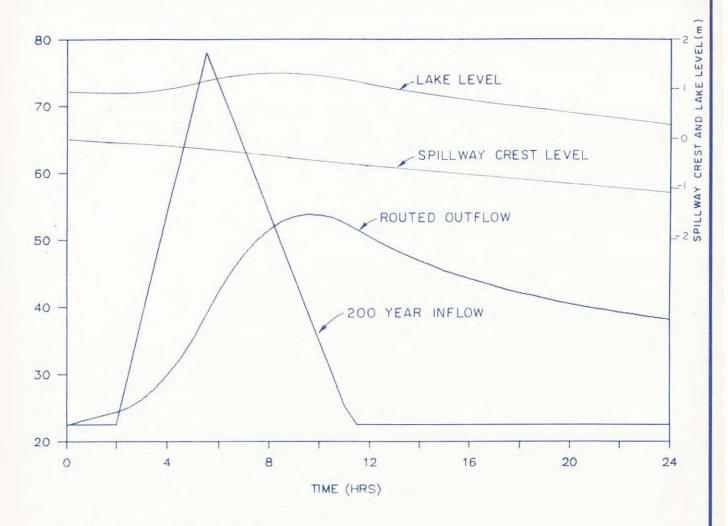
A - 4008

If the creek were to escape the bedrock channel, assuming an average slope of 0.048 over the 700 m length, 9700 m³ of material could be removed. This translates into a degradation depth of 1.1 m (shown on Drawing A-4006) over a 24-hour period. Again rapid failure would not be expected in this case. Drawing A-4008 shows the inflow/outflow hydrographs with the resulting lake levels and spillway levels.

SLOPE OF DEGRADATION CHANNEL = 0.048 LENGTH OF DEGRADATION CHANNEL = 701 m

No allowance was made in the sediment transport calculations for armouring of the channel. This armouring will reduce the sediment available for transport and result in less material being removed. Degradation would occur at a progressively slower rate until the combination of reduced flow and increased armouring would allow a new steady state to develop.

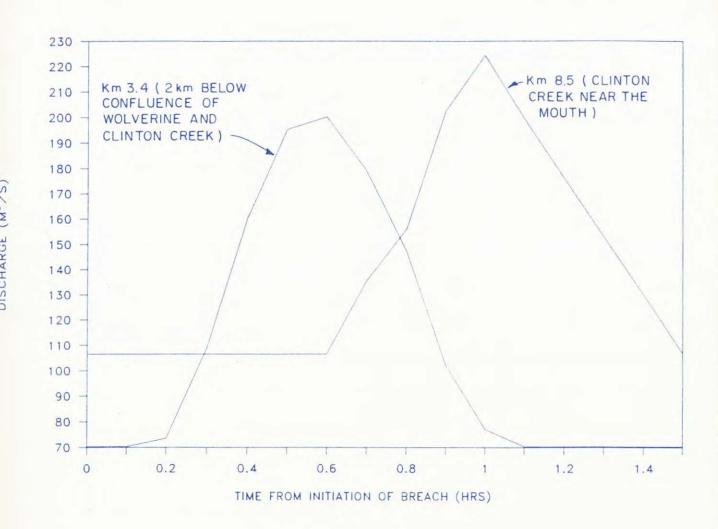
SEE DRAWING A-4012 FOR LOCATION OF HYDROGRAPHS

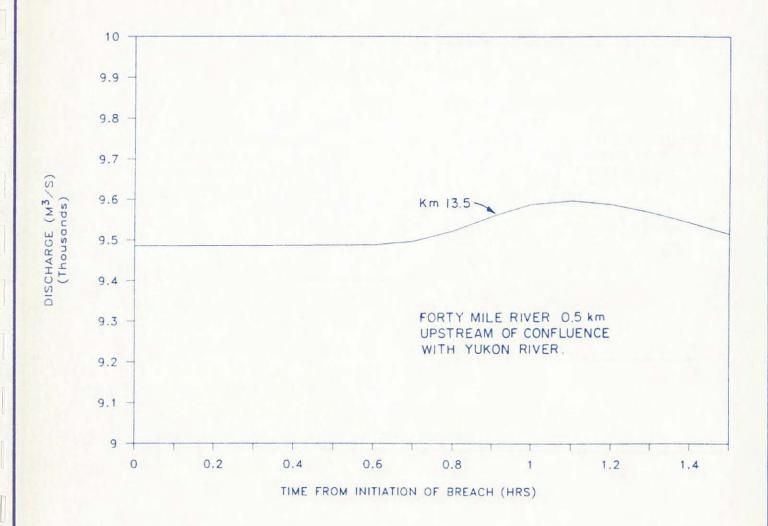
A-4014

SEE DRAWING A- 4012 FOR LOCATION OF HYDROGRAPH.
