AN ENVIRONMENTAL REVIEW OF THE CLINTON CREEK ABANDONED ASBESTOS MINE, YUKON, CANADA

Prepared for:
Indian and Northern Affairs Canada
Waste Management Program, Whitehorse, Yukon

By:
Royal Roads University - Applied Research Division

March 1999

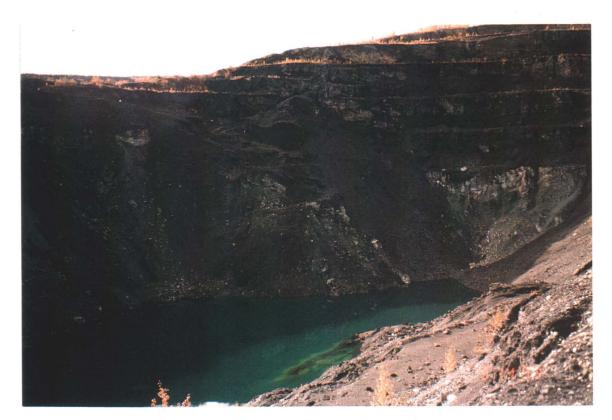
Photograph 2-3: Porcupine Open Pit, view of the southern end

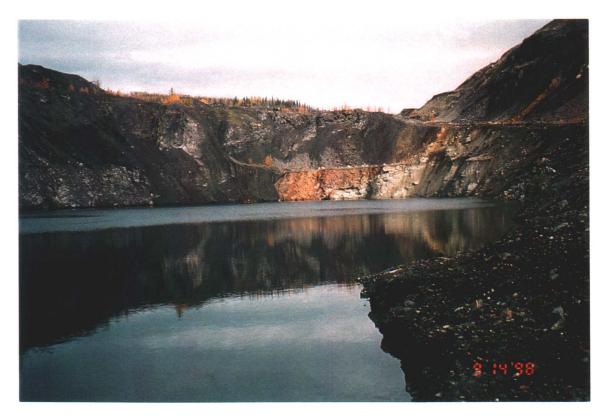
Photograph 2-4: Porcupine Open Pit, view of the northern end.

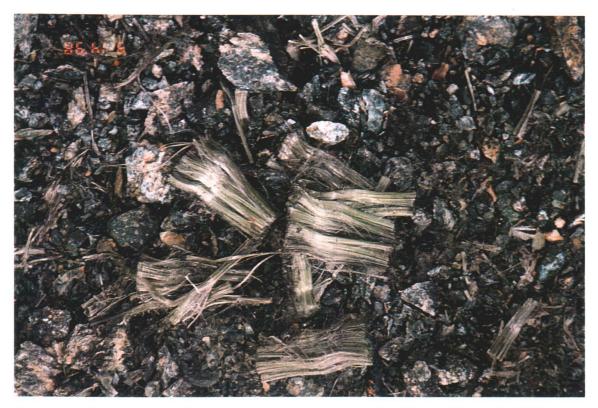
Photograph 2-5: Asbestos fibres amongst waste rocks at the Clinton Waste Rock Dump

Waste rock from the three open pits was deposited on the valley slopes adjacent to the pits. This practice created three waste rocks dumps (Clinton, Porcupine, and Snowshoe). The last of the waste rock materials was consigned to the dump sites in the summer of 1977. The waste rock predominantly consists of argillite. The volume of the waste rock piles has been estimated at 60 million tonnes (Roach, 1998). The waste rock consist mainly of argillite, phyllite, platy limestone and micaceous quartzite (Stepanek and McAlpine, 1992). Asbestos fibres are occasionally found amongst the waste rock (Photograph 2-5).

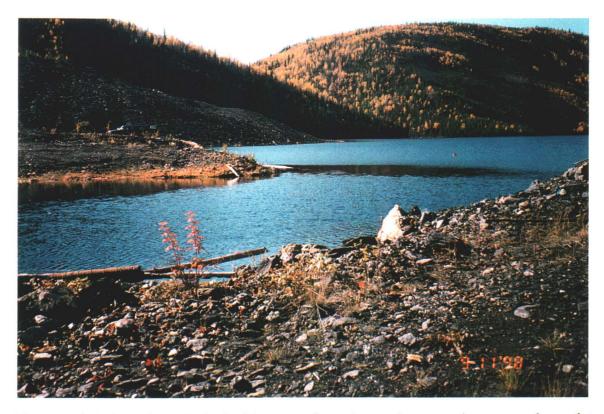
Photograph 2-6: Hudgeon Lake looking west from the northeastern shore, near the outlet into Clinton Creek

The largest dump, Clinton dump, was created by dumping overburden from the Porcupine pit near the crest of the south slope of Clinton Creek. Shortly after dumping commenced the face of the dump failed and the toe of the waste rock pile spread northward onto the Clinton Creek valley bottom. As the toe of the dump reached the valley floor it began to spread on the permafrost alluvial soil of the valley floor. Subsequent downslope movement of waste rock resulted in the blockage of Clinton Creek and the creation of Hudgeon Lake in 1974 (Photograph 2-6).

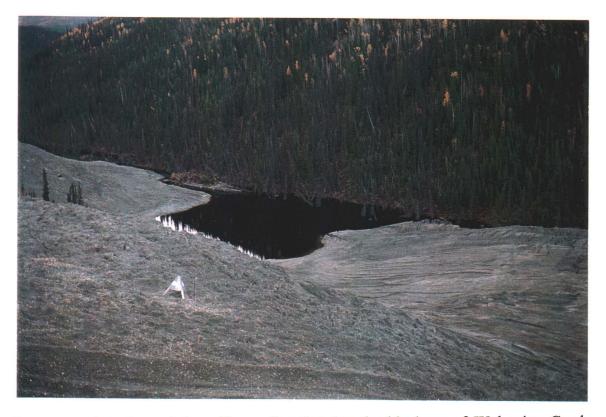
Photograph 2-8: Toe of the tailings piles showing the blockage of Wolverine Creek resulting in the formation of two ponds

Progressive failure of the north lobe began in 1978 and in 1985 the north lobe mass reached Wolverine Creek (Photograph 2-8). Both lobes were terraced in 1978 in expectation that stabilization would be achieved by 1987. Movements in both lobes have

been monitored since 1978. Mass movement of the tailings piles continues at rates as high as 19 m/yr (Roach, 1998). Wolverine creek continues to erode both the tailings piles and the east side of Wolverine Creek valley.

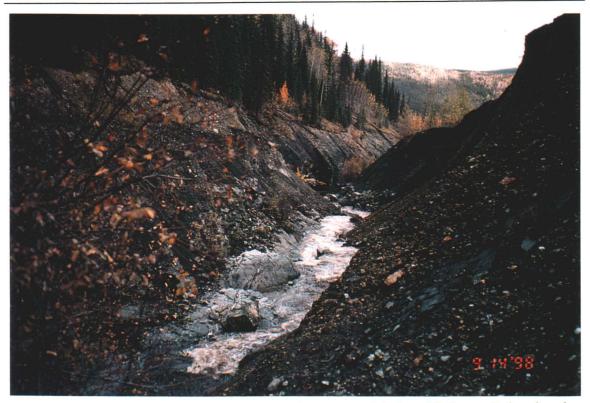
Photograph 4.1: Canyon area of Zone 1 in Clinton Creek below Hudgeon Lake showing steep scree slopes, exposed bedrock and swift currents downstream

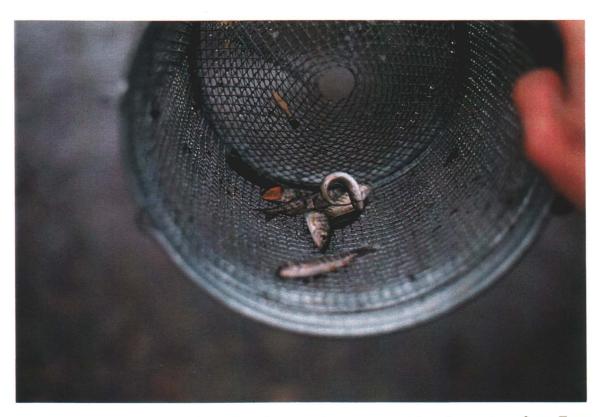
Photograph 4.4: Chinook salmon fry (0+ year class) captured in minnow trap from Zone 6.

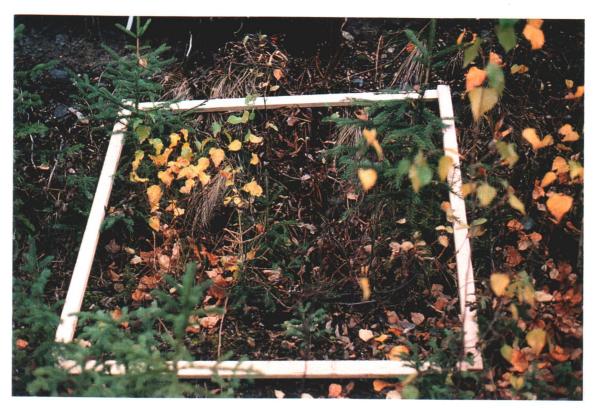
Photograph 4.5: Survey quadrat at a reference location, CLMS-13, showing naturally occurring groundcover in surrounding spruce forests.

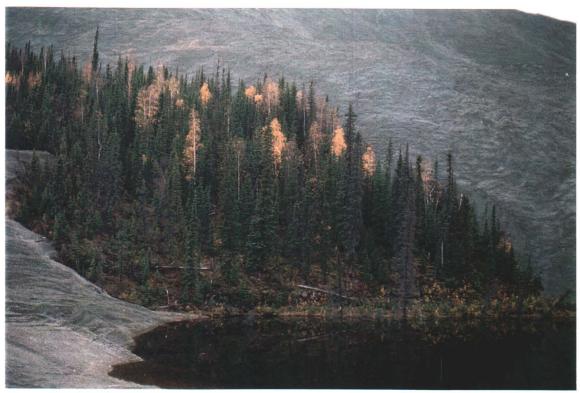
Photograph 4.6: Relic forest patch along east slope of tailings pile by Wolverine Creek.

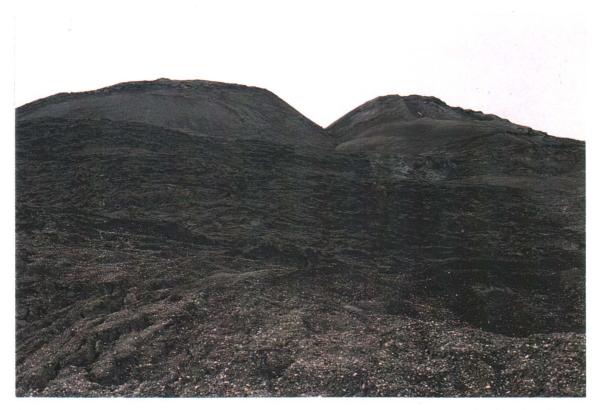
Photograph 4.7: Southeast slope of tailings pile from Wolverine Creek showing barren surfaces absent of any groundcover.

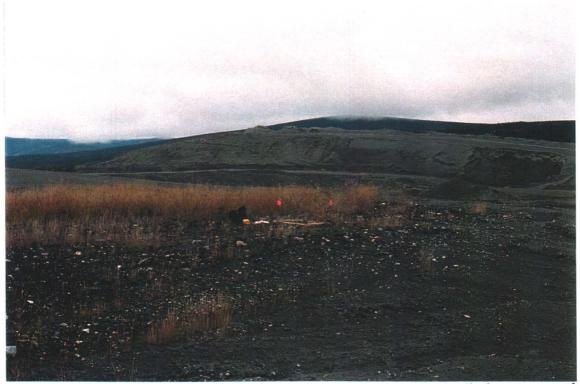
Photograph 4.8: Isolated patch of scrub vegetation at top of tailings pile between north and south peaks; the latter can be seen in the background.

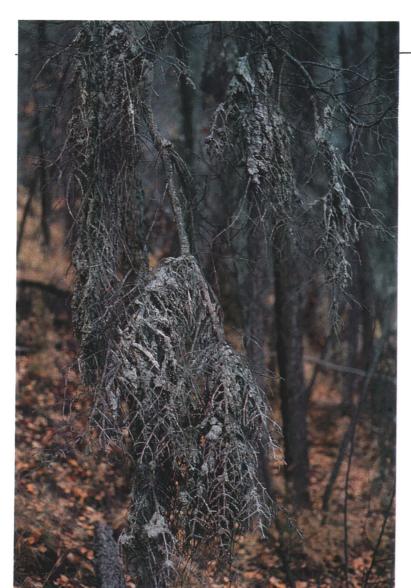
Photograph 4.9: Indirect smothering of tree leaf surfaces from wind and snow blown tailing materials along forest edge to the south of the site.

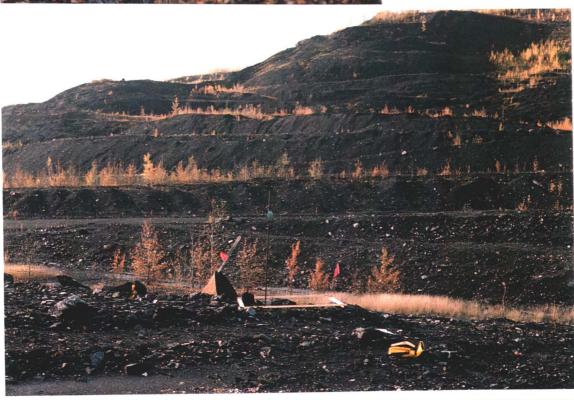
Photograph 4.10: Establishment of trees (primarily willow, birch and balsam poplar) between roadways on the Clinton Waste Rock Dump.

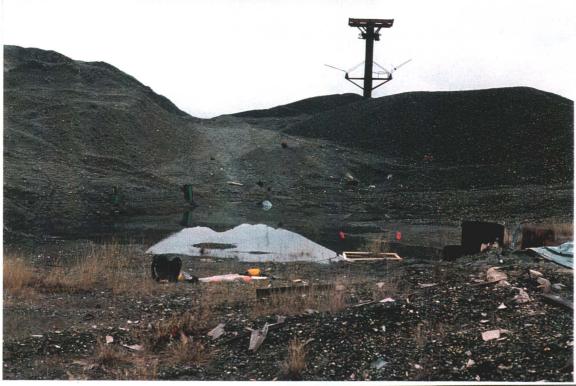
Photograph 4.14: Pool in a low-lying area at the Mill Site. Note crushed rocks and debris in the area.
