FARO MINE COMPLEX – 2009 REVEGETATION TRIALS AND MONITORING

EDI PROJECT NO.: 09-YC-0038

FEBRUARY 2010

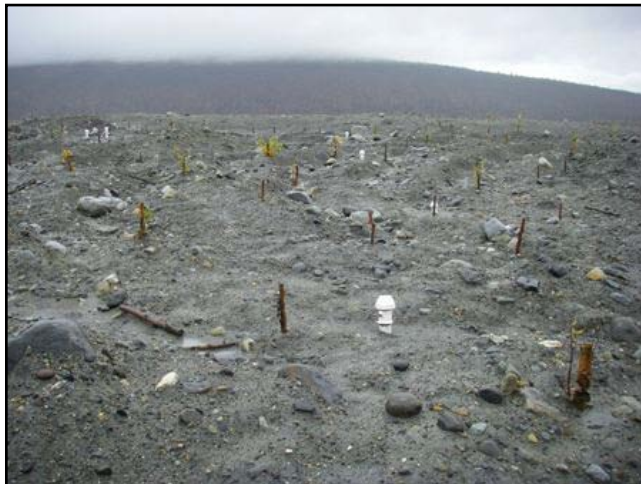
Figure 2. Lysimeter plot No. 1 in 2008, one year after planting the stakes.

Revegetation success of the live stakes was monitored by counting the stakes and identifying them as living (signs of sprouting with no signs of drying out) or dead (signs of drying out with no signs of sprouting) in 2008 (September) and 2009 (July). In 2009, 18% of the originally planted willow stakes and 67.3% the poplar stakes were still alive (Table 1). The larger diameter cuttings (>3 cm) of both species appear to be growing more successfully than smaller diameter cuttings.

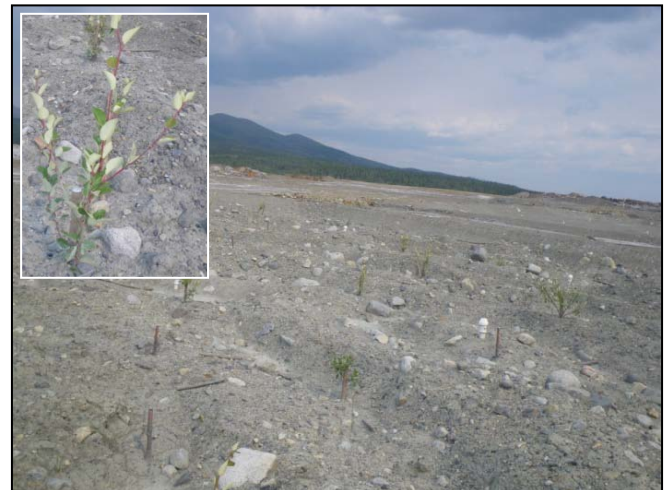
Figure 3. Lysimeter plot No. 1 in 2009. Photo insert shows willow stake with second year growth.

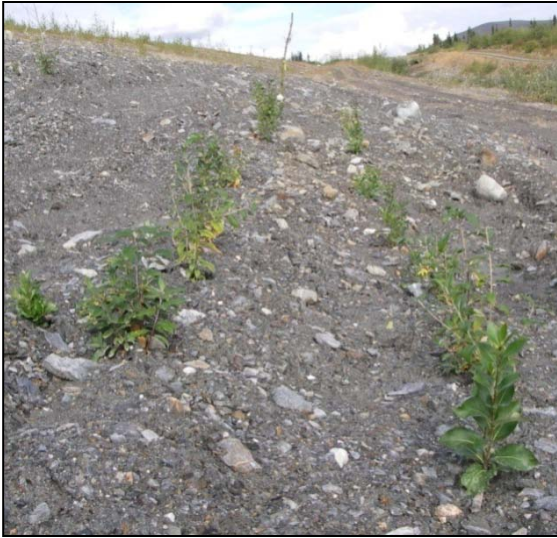
Figure 5. First-year growth on the horizontal stakes.

EDI checked the site in July 2009 and observed reasonably good growth of the live stakes: 72 % of the willows and 58 % of the poplar stakes, all planted vertically were alive. Numerous branches grew from the horizontally planted cuttings (in the trenches). Success is harder to quantify here, but based on experience, we would describe the growth to be good.

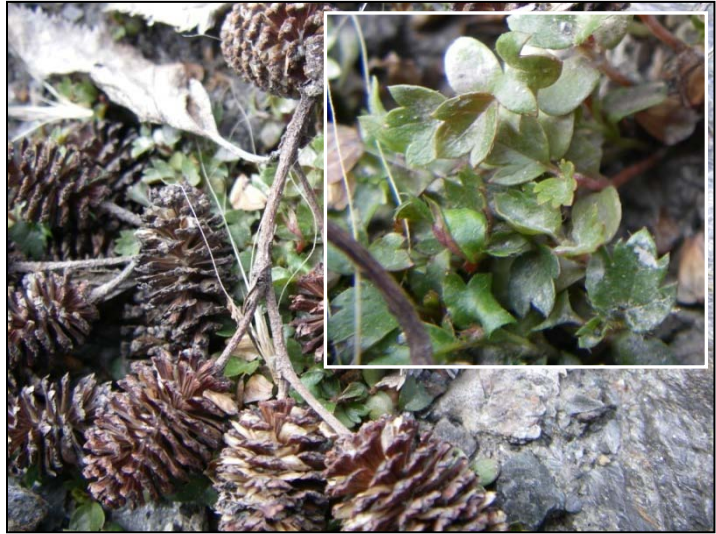
Figure 6. Alder cones surrounded by alder seedlings. Detail of seedlings shown in photo insert.

Upon return to the site in August, we found numerous alder seedlings at both areas seeded with alder (i.e., alder seed and alder organics). The plants were only in the 4- to 6-leaf stage and rather small. Future monitoring will provide further insight in shrub success.

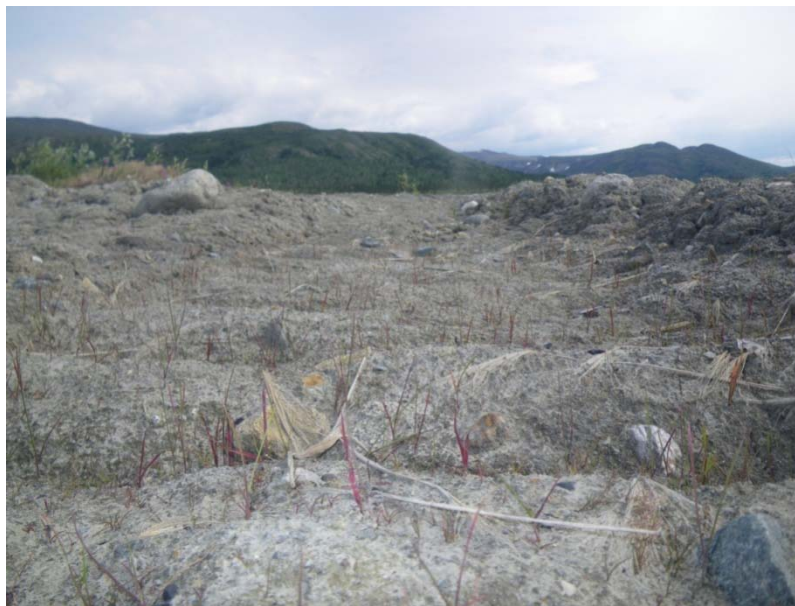
Figure 8. Trail B area. Plot 1 with small grass plants emerging.

A summary of the observations in July 2009 is included in Table 3. In general, grass emergence at all plots was sporadic and provided little cover. Willow, fireweed, and other mature plants noted at the site were likely present because of natural introduction from the surrounding area and incomplete turning of the soil last year during site preparation.

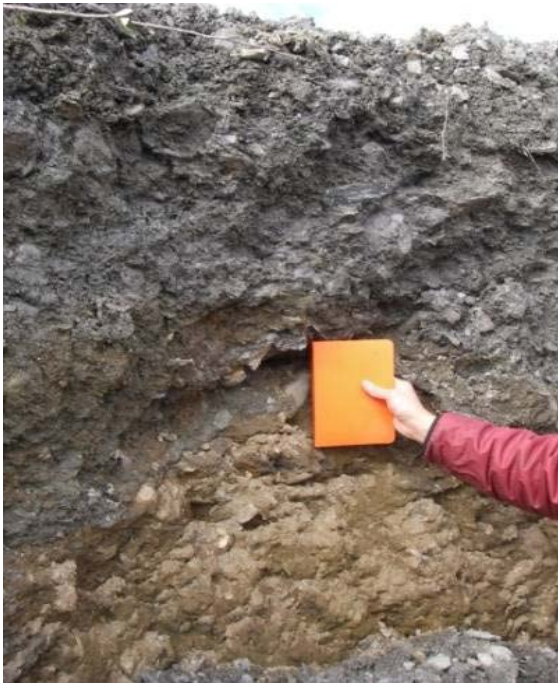
Figure 10. Detail of fill material.

The entire trial area contained many rocks, which made the site rather rough (Figures 9, 11, 13 and 17). The material would also tend to concrete up a few days after a rainfall, making it very difficult to work with hand tools or machinery. As soon as it got wet, the material turned into a wet mud, likely due to the presence of fines/clay.

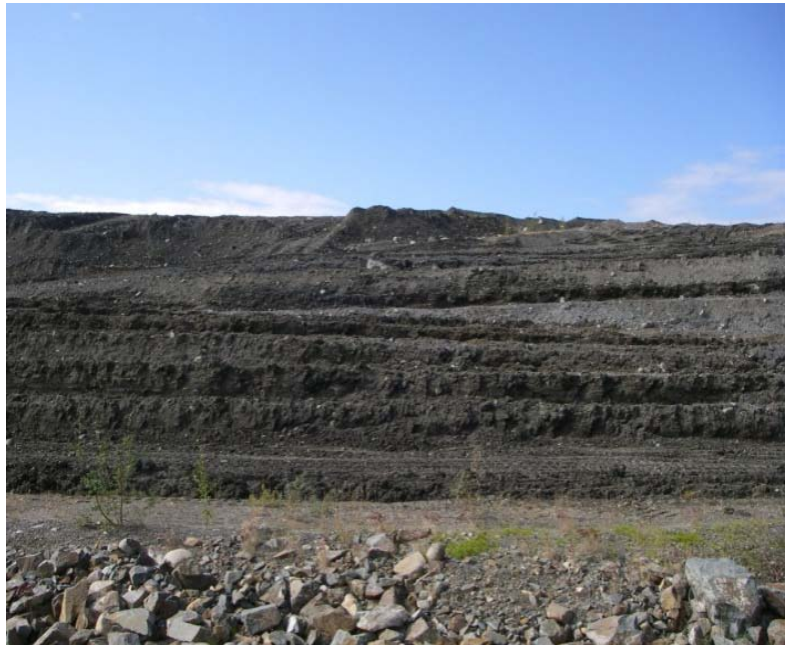
Figure 9. Reworking of slope at the Grum Overburden Dump

To get a reasonably sized trail area, part of the site had to be resloped. As a result, the site is divided into two areas: (1) an area that was resloped and reworked. For about 10 days two dozers moved the fill material around to make a gradually sloped site (Figure 10) to create a sufficiently sized trial area; (2) The second area is adjacent to it but did not require resloping. Rocky/schist-like material was lying on top of the second area. The material had a light gray color, compared to the darker resloped section (Figure 16). Because the soil particle analysis (section 6.4) shows a similar composition of sand, silt, and clay particles, we suspect the different look may be a result of washing down of fines, which exposes the grey rocks.

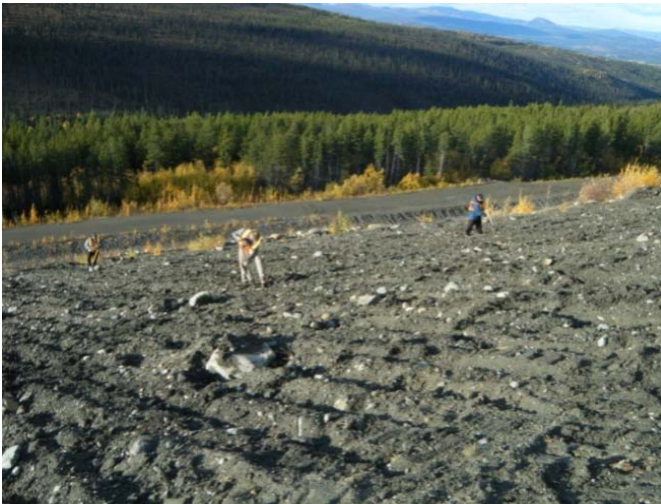
Figure 11. Planting in the micro-rills.

Site preparation: a dozer with a 5-toothed ripper attachment ran down slope creating rough rills. See Figures 11 and 12.

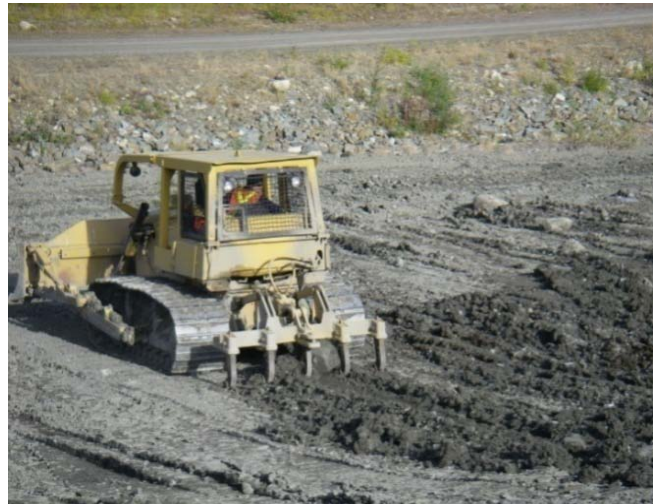
Figure 12. Creating micro-rills with dozer and ripper

2. Downslope (Micro-scale) Rills: create corrugated (downslope parallel ridge/swale patterned) features using a dozer with a special attachment creating 10 to 20 cm deep and 5 to 10 cm wide, with similarly sized ridges separating the rills.

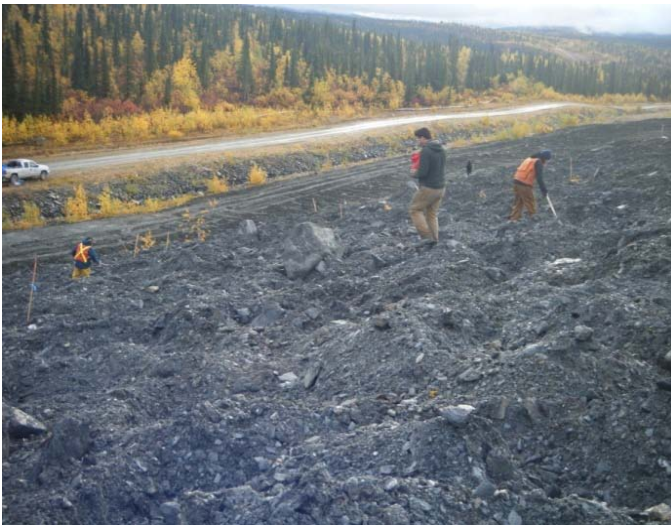
Figure 13. Planting in the rough & loose section.

3. Rough and Loose: excavator-roughened surface, potentially mixed with coarse woody debris to create loose mounds of material.

Site preparation: as an excavator walked backed up or down the slope, the bucket scooped up loads of fill and immediately dumped this again. This created a pattern of loose mounts and valleys. See Figure 13.

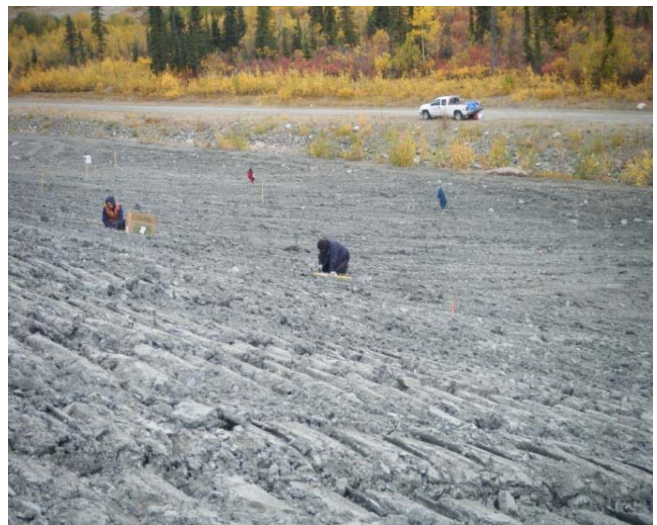
Figure 14. Planting in the planar section.

1. Planar: nominally a treatment of the slope as a planer sheet without purpose-built rills or mounds. In reality this treatment will be roughened due to the need to leave a non-compacted growth medium for revegetation.

Site preparation: after resloping the site the dozer walked up and down the site. This created track imprints perpendicular to the slope and compacting the soil. See Figures 14 and 19.

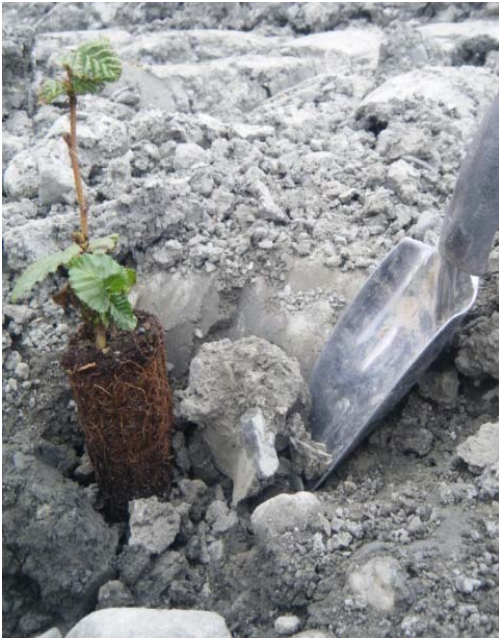
Figure 17. An alder seedling ready to be planted.

At the rough & loose and the rills treatment plots, the alder seedlings were planted by digging a small depression into the ground with a shovel and packing down loose soil around the plugs (Figure 17). Due to the compacted nature of the Planar trial area, holes had to be drilled with a hand-held 2” gas-powered auger after which the plugs were placed in the hole and packed down with loose soil.

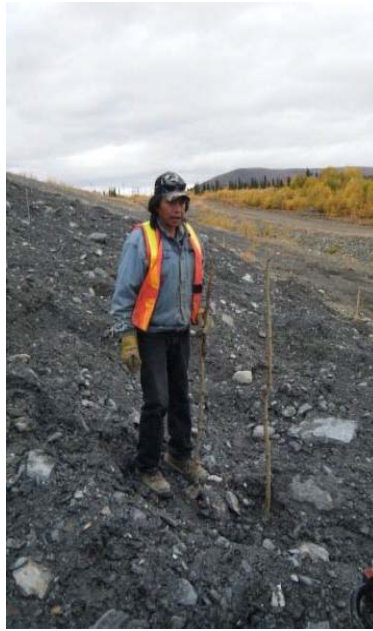
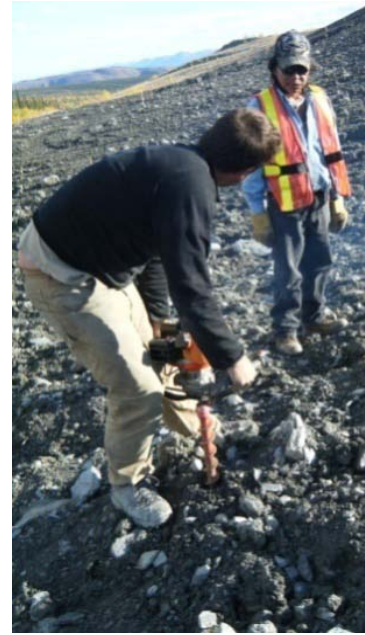
Figure 18. Planting vertical stakes.

Knowing that plant cuttings can be challenging to grow; we ensured adequate planting depth at the 2009 trials by predrilling the holes for the vertical stakes. The diameter of the cuttings was larger than 2 cm, and the soil appears to contain sufficient fines to hold moisture, which should help the survival of the stakes. Future monitoring will help determine if these measures were sufficient to ensure success.

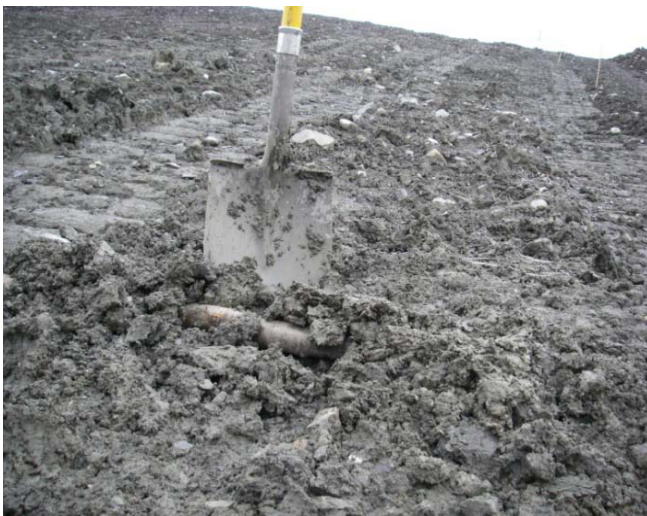
Figure 19. A horizontal stake nearly buried in planar section.
