**FARO MINE COMPLEX**  
**2011 CHINOOK SALMON SURVEYS**  
**ROSE & ANVIL CREEK**

WHITEHORSE, YUKON  
PROJECT NO. 11-115  
MARCH, 2012

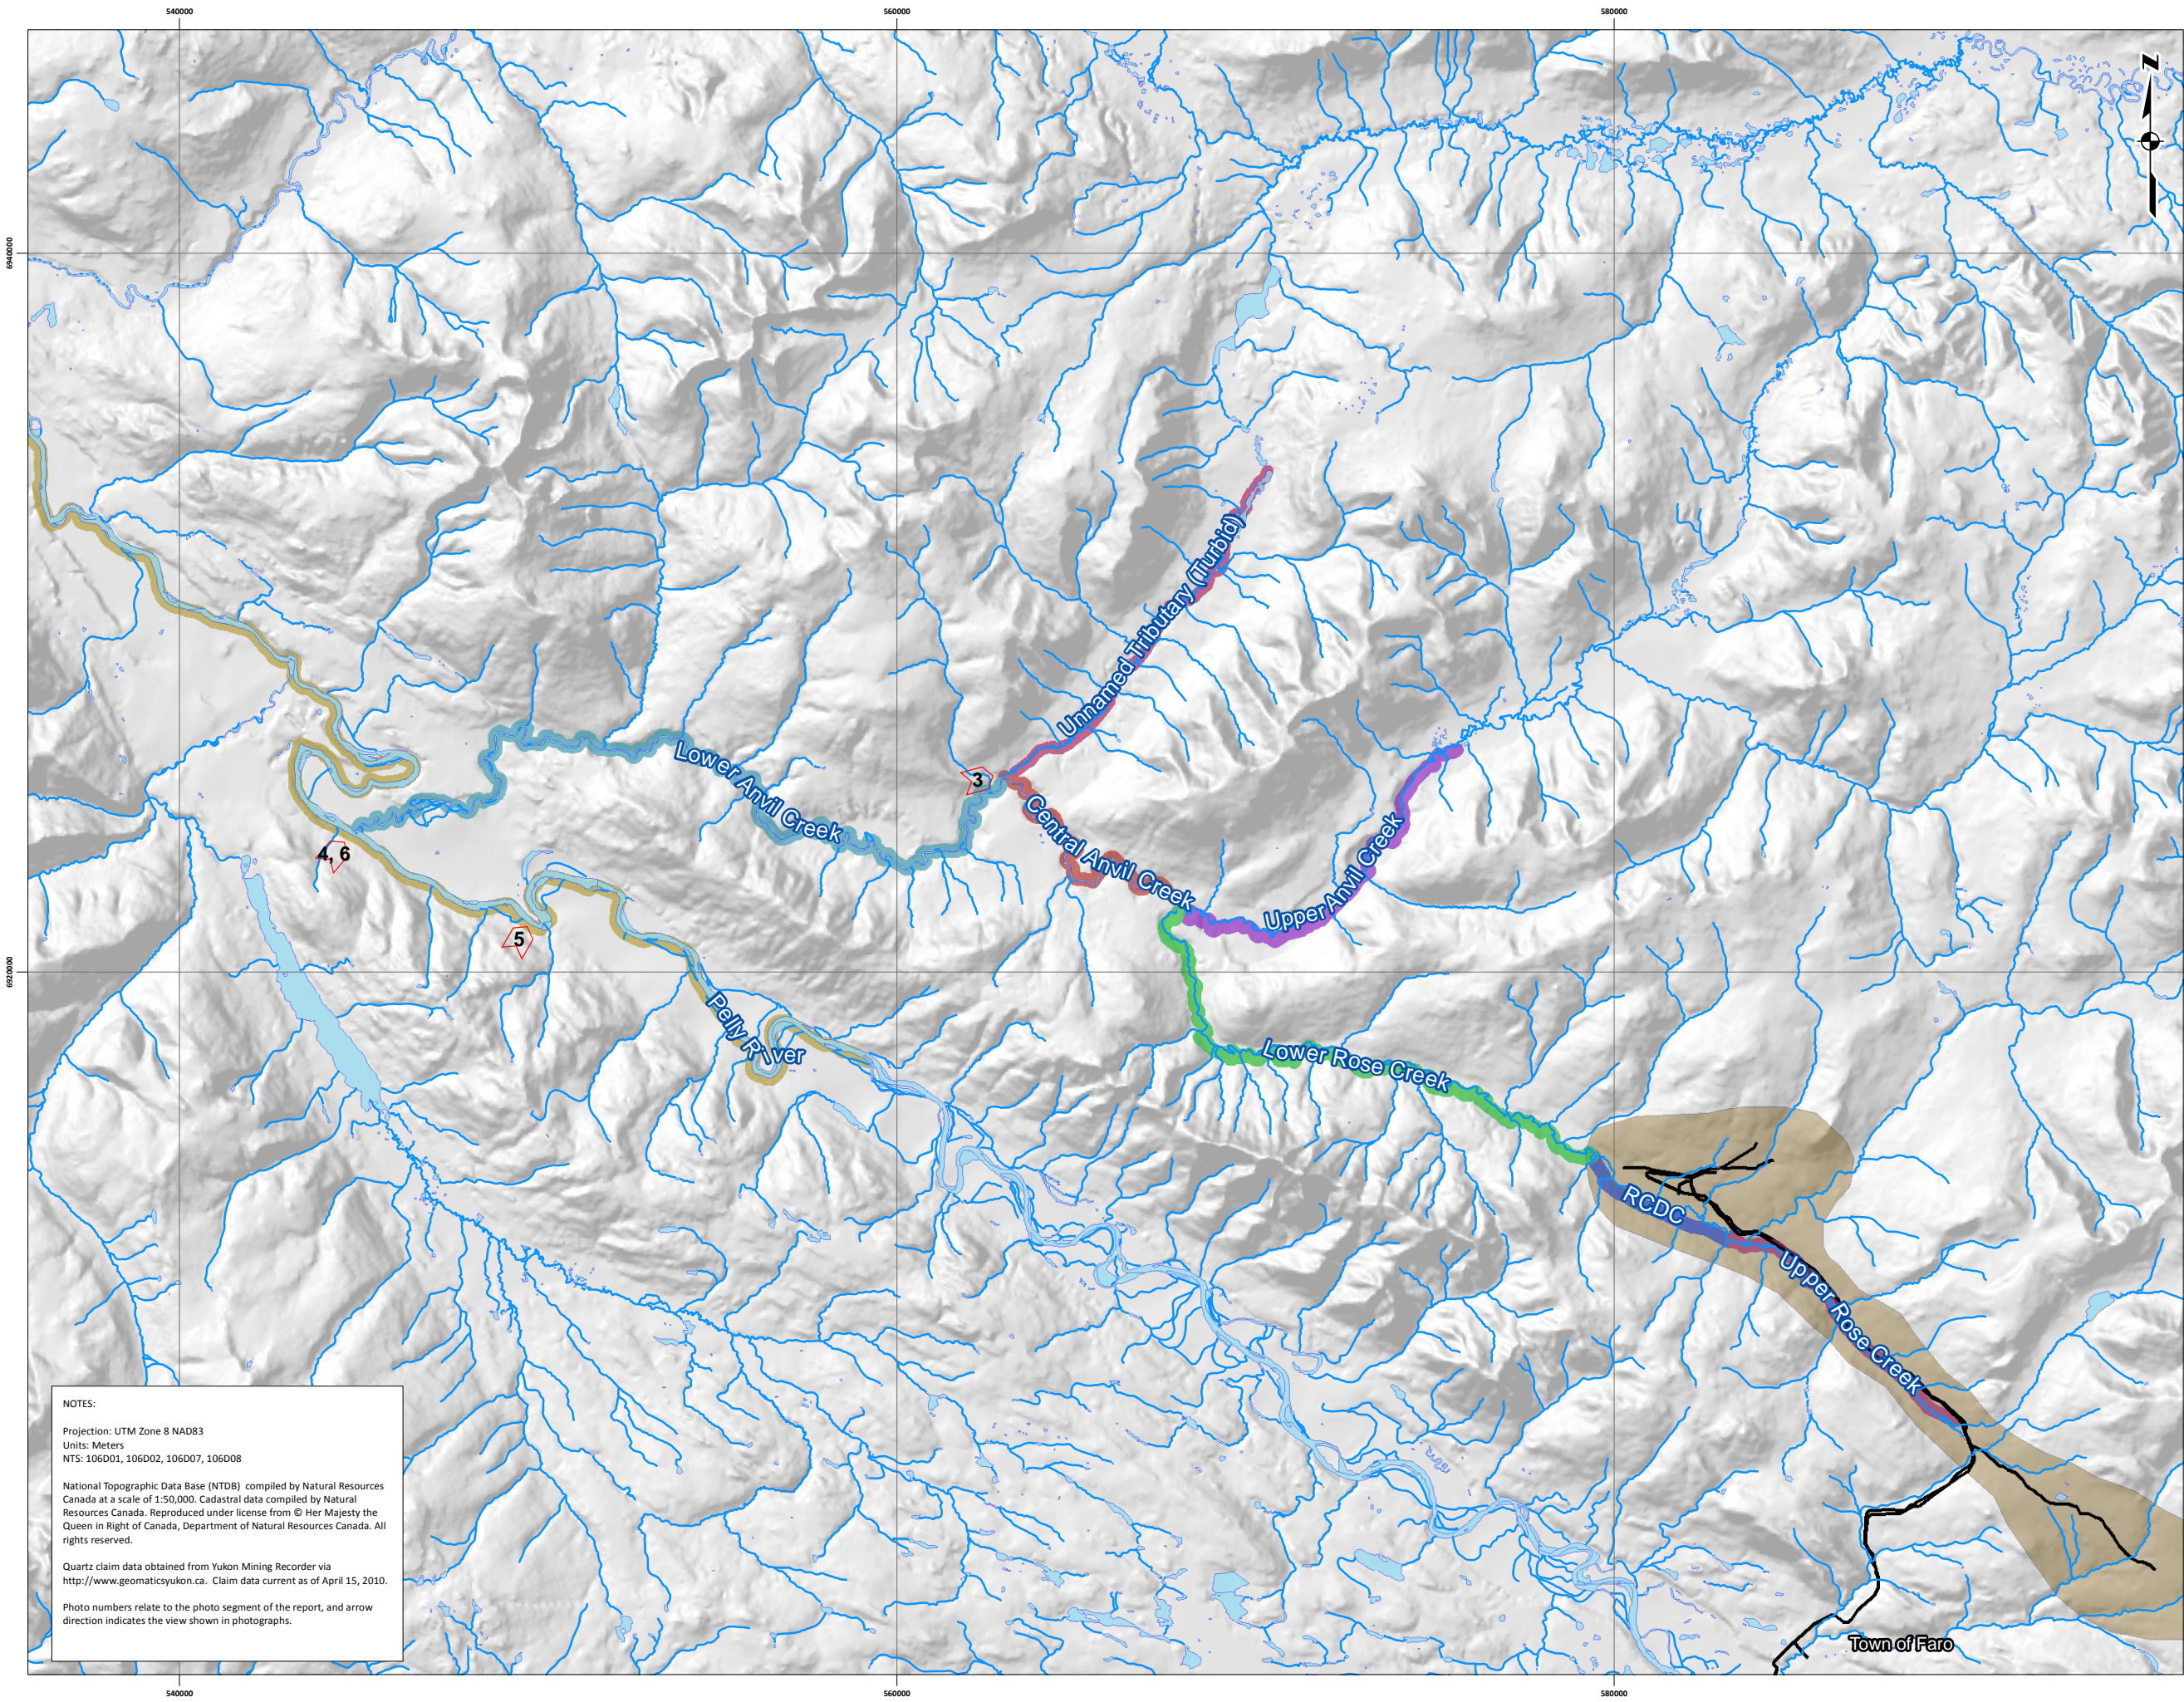
FIGURE 2

Photo numbers relate to the photo segment of the report, and arrow direction indicates the view shown in photographs.

Aerial and Ground Survey  
Areas and Photo Locations

During both surveys, the entire 4.92 km length of the RCDC was surveyed, as shown in Figure 2.

Despite turbid conditions in the lower reaches of the study area, good visibility and a high survey confidence was achieved for the entire length of Rose Creek (upper Rose Creek, RCDC, lower Rose Creek; Figure 2). A combination of low water levels, minimal surface turbulence, and clear water make Rose Creek suitable for aerial survey.

Anvil Creek (central and upper Anvil Creek; Figure 2) is not as well suited to an aerial survey, as this watercourse has lower water clarity (i.e. stained water potentially from naturally occurring tannins), a higher gradient, and numerous areas dominated by boulder substrates that create a large amount of surface turbulence. Several aerial survey attempts have been made on Anvil Creek in the past, and none have recorded many salmon. WMEC observed 7 adult Chinook salmon in the lower reaches of Anvil Creek in 2007 (during optimal conditions). However, during the same survey they were unable to see a known group of spawning Chinook salmon due to poor water clarity. The latter were barely visible from the ground in approximately 1 m of water, and were not visible from the air (P. Sparling, pers. comm.).

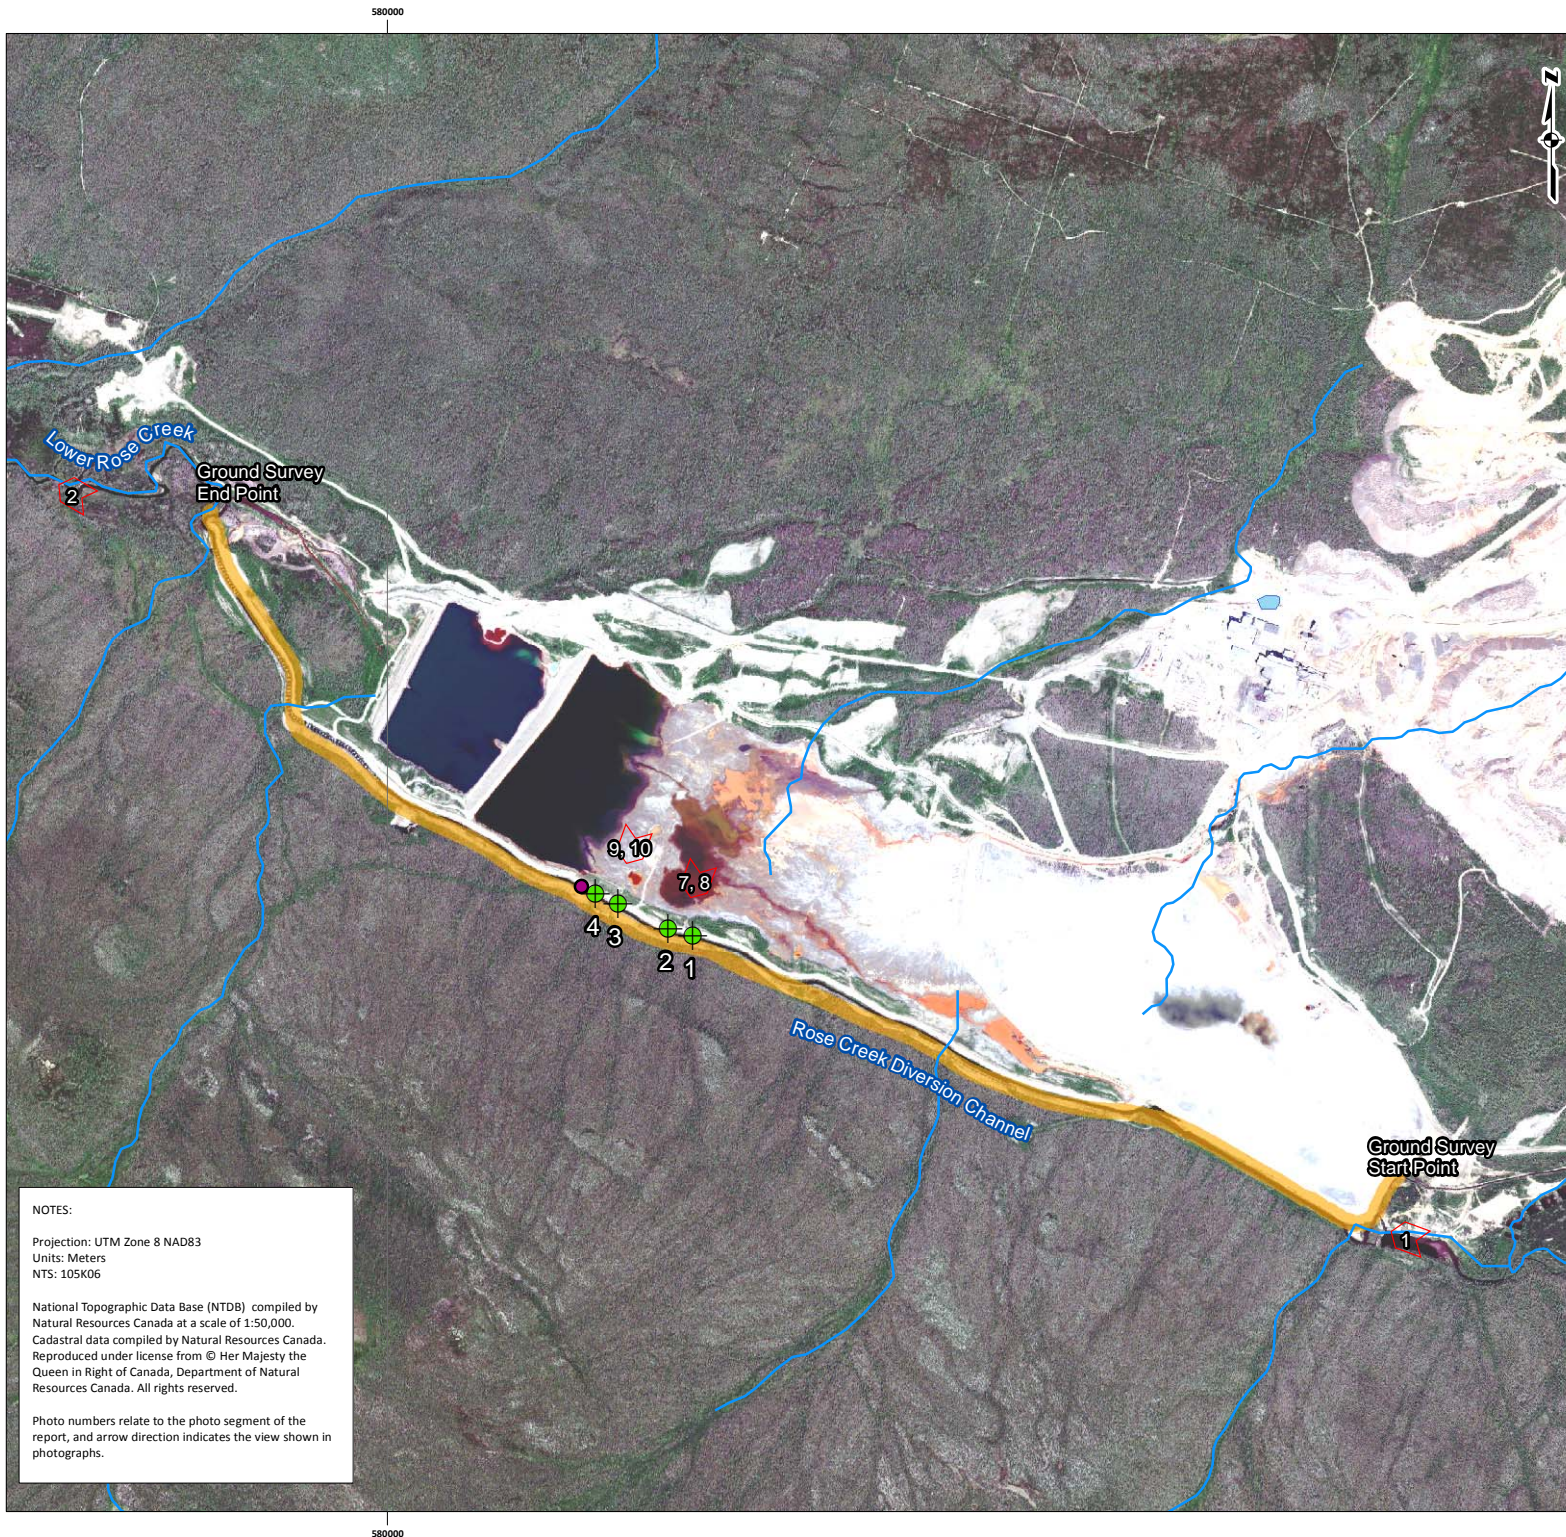
FIGURE 3

Photo numbers relate to the photo segment of the report, and arrow direction indicates the view shown in photographs.

Rose Creek Diversion Channel  
Study Area and Observations

Summary data for the Rose Creek redd observations are provided in Table 2 below, while locations are shown in Figures 3 and 4, attached.

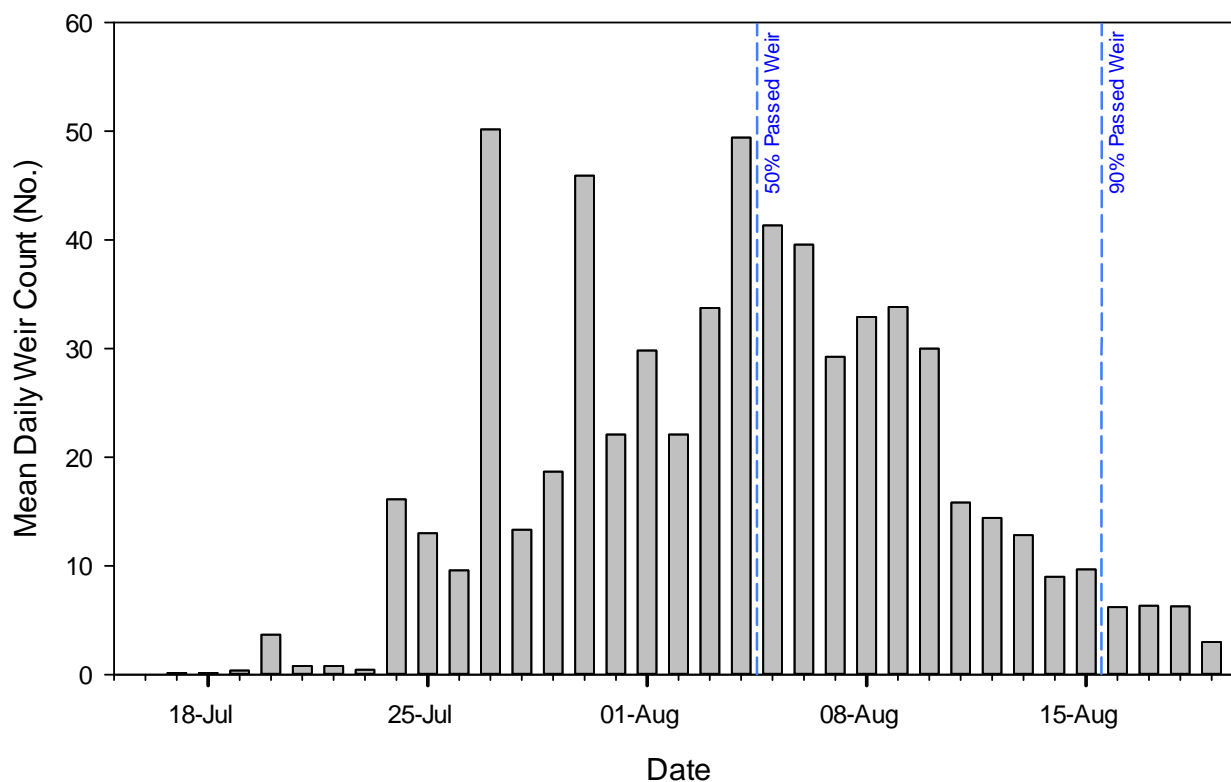
**Figure 5: Graph Showing the 12-year Mean Daily Totals of Adult Chinook Salmon Passing the Blind Creek Weir from 1997 to 2011 (based on data from Jane Wilson and Associates, 2010 and J. Wilson, pers. comm.).**

A Chinook salmon enumeration weir is located approximately 80 km upstream from Anvil Creek on the Pelly River at Blind Creek, where the run strength and timing of adult Chinook salmon has been tracked in most years since 2007. Blind Creek has one of the earliest runs in the upper Yukon River, and provides a good benchmark by which to anticipate Rose Creek spawning. The timing of adult Chinook spawning in the RCDC is thought to correspond well to the main run timing at the Blind Creek Weir (P. Sparling, pers. comm.) The 12 year average at Blind Creek saw 50 percent of fish passing by August 4, and 90 percent of fish passing by August 15 (Jane Wilson and Associates, 2010; Figure 5). Timing for 2011 was slightly later with 50 percent of the adults passing by August 10, and 90 percent passing by August 13 (J. Wilson, pers. comm.; Figure 6). The Blind Creek weir is generally closed by August 20, and at most only 1% of the annual return has been recorded beyond that date (Jane Wilson and Associates, 2010).

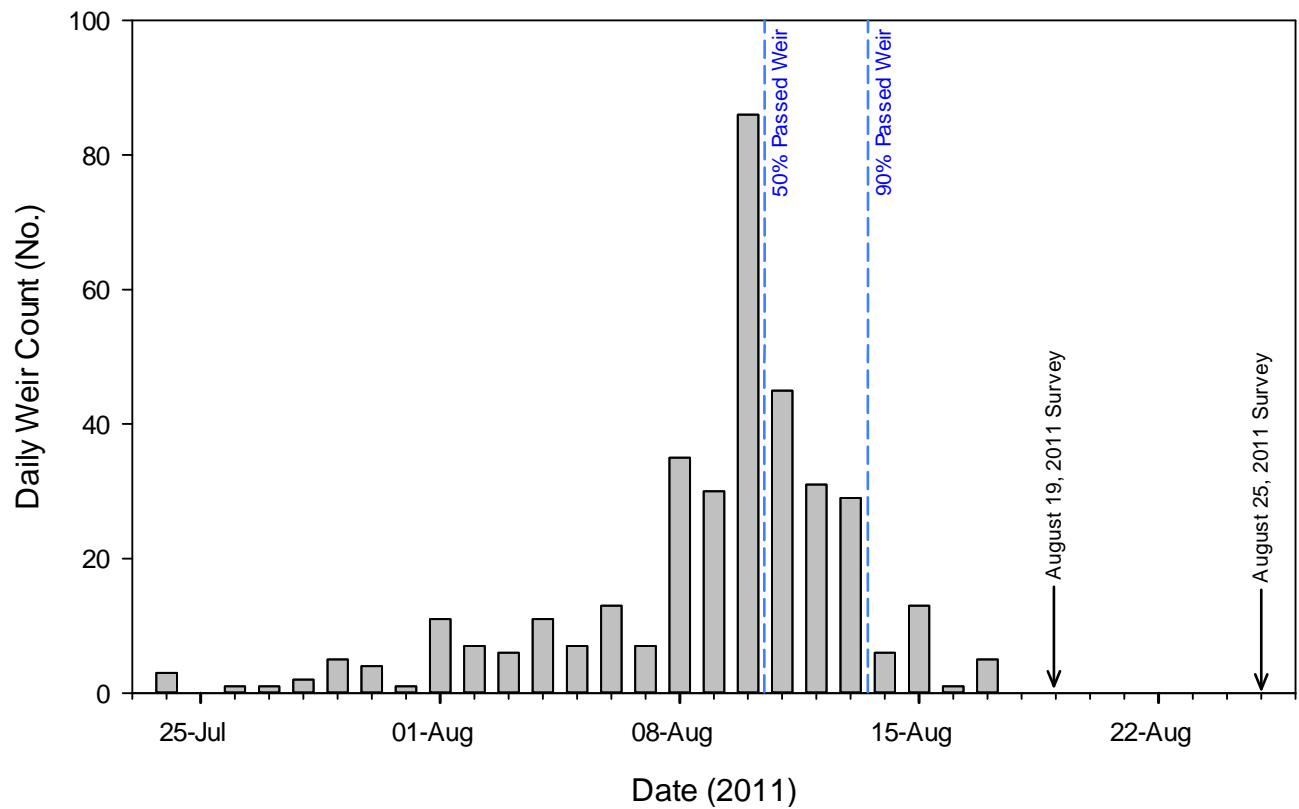
**Figure 6: Graph Showing the Daily Totals of Chinook Salmon Passing the Blind Creek Weir in 2011, in Relation to ELR 2011 Survey Dates (Based on data from J. Wilson, pers. comm.).**

Timing of the 2011 surveys was likely a factor that limited applicability of current year results (including detections of adult fish or the ability to distinguish 2011 redd activity from previous years). Based on information for the mine site and adjacent areas, early August may be more appropriate for surveys at Rose and Anvil Creeks.

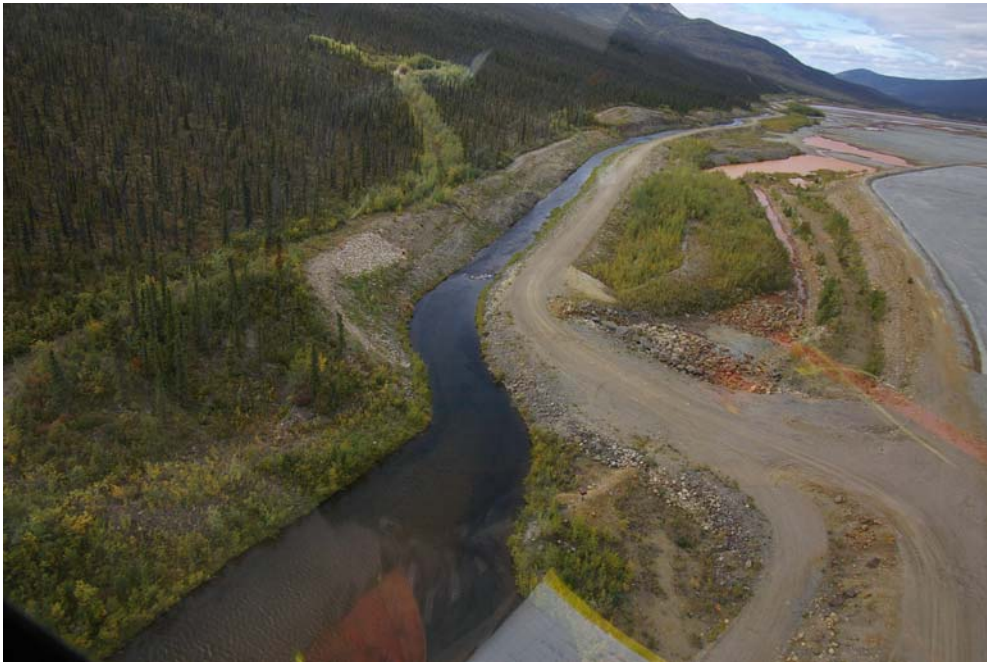
**Photo 1:** View of the RCDC looking downstream (Northwest) during the aerial survey. Photo taken August 25, 2011.

The survey began with a length of approximately 33 km of Rose Creek, including the 4.9 km RCDC and the south fork of Rose Creek (Photos 1 and 2). The survey team then proceeded downstream on Anvil Creek from the outlet of Rose Creek, however at approximately 9.4 km further downstream from that point, an unnamed tributary to Anvil Creek was introducing a heavy sediment load to the Creek making the survey below this point unfeasible (turbidity was estimated at > 30 Nephelometric Turbidity Units [NTU]; Photo 3; shown in Figure 2). Following this, 12.3 km of the upper Anvil Creek (upstream of the base of lower Rose Creek) were surveyed successfully, and the crew proceeded to the Pelly River at the base of Anvil Creek. High turbidity levels were also encountered in the Pelly River, estimated to be between 10 and 20 NTU (higher below the outlet of Anvil Creek; Photo 4). The survey was attempted at several locations along a 46 km segment of the Pelly River, however visibility was found to be very low again due to high turbidity (Photo 5). Aside from poor conditions encountered in Anvil Creek and the Pelly River, the survey confidence was high for Rose and upper Anvil Creeks.

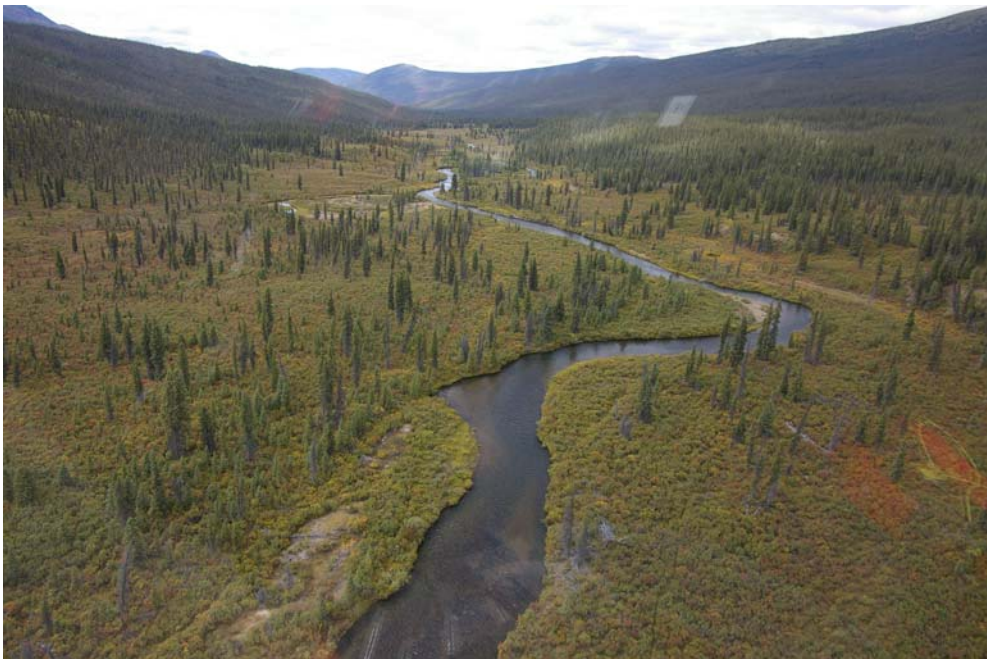
**Photo 2:** View of lower Rose Creek, downstream of the mine area. Note the irregular meandering stream with low gradient and little surface turbulence. Photo taken August 25, 2011.

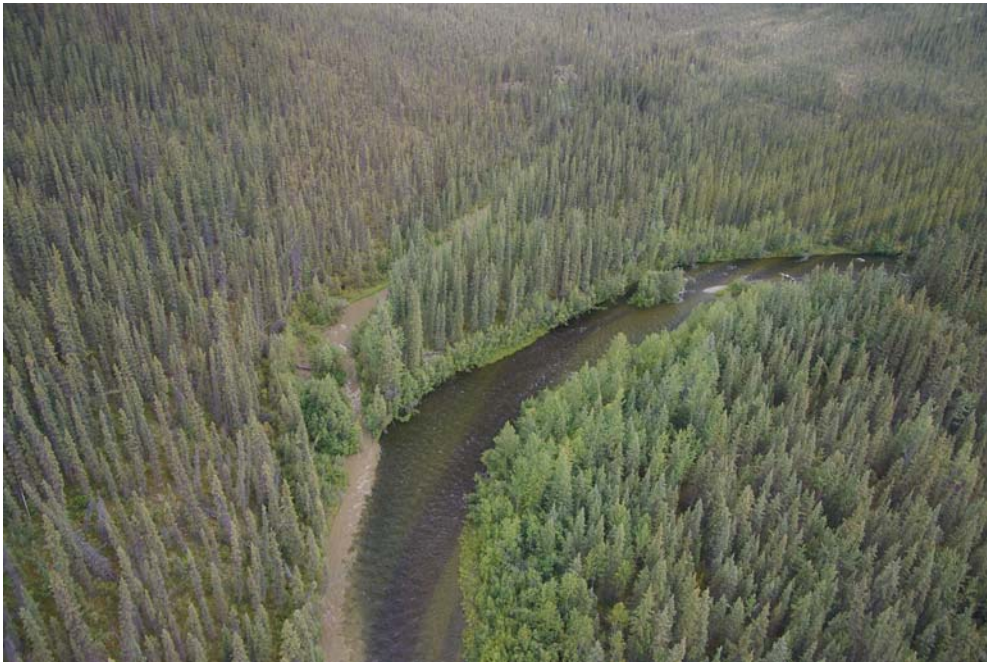
**Photo 3:** View of the heavy sediment load being washed into Anvil Creek approximately 9 km downstream of Rose Creek. Photo taken August 19, 2011.

The high turbidity observed in the lower reaches of Anvil Creek is also a factor that may make consistent aerial surveys difficult. During the 2011 surveys, the high turbidity was tracked to apparent melting permafrost ice lenses near the alpine headwaters of the unnamed tributary to Anvil Creek (Figure 2), and communications with WMEC, who have performed monitoring on Anvil Creek previously, confirmed that this melting has previously been observed in this tributary (and therefore is likely to be encountered in future years; P. Sparling, pers. comm.).

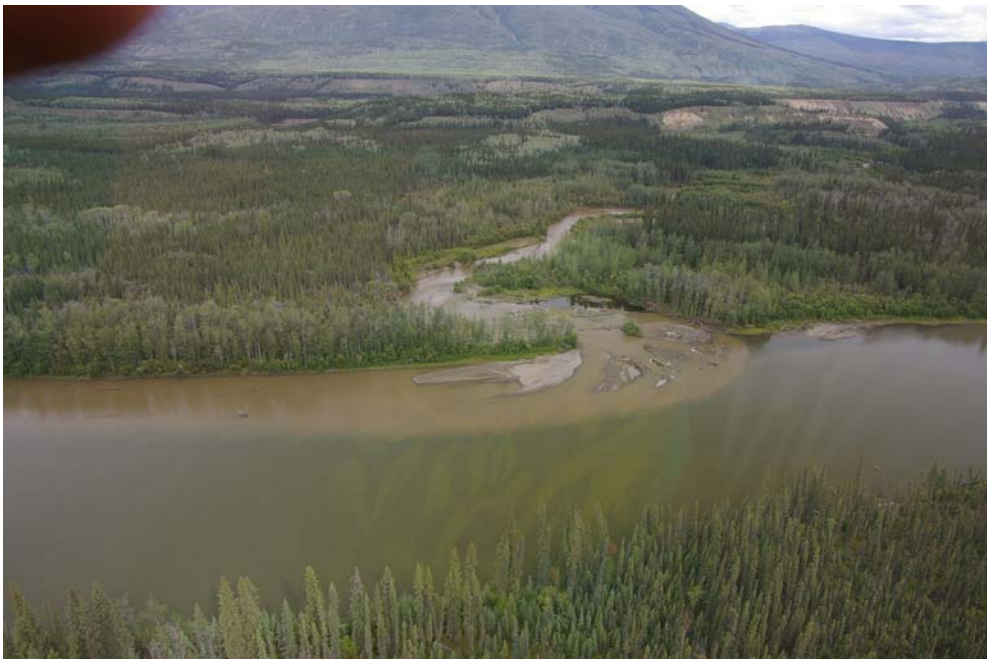
**Photo 4:** View of the heavy sediment load in Anvil Creek on August 19, 2011, shown from its outlet at the Pelly River (shown in the foreground).

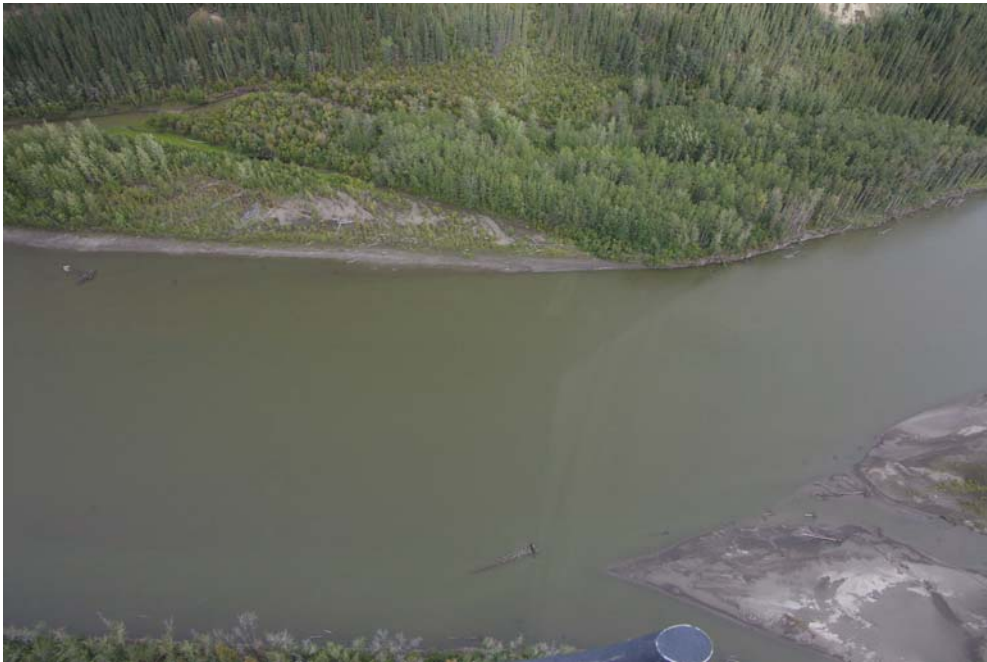
**Photo 5:** A representative view of conditions encountered in the Pelly River on August 19, 2011. Turbidity was high enough that an effective aerial survey of the Pelly River was not possible.

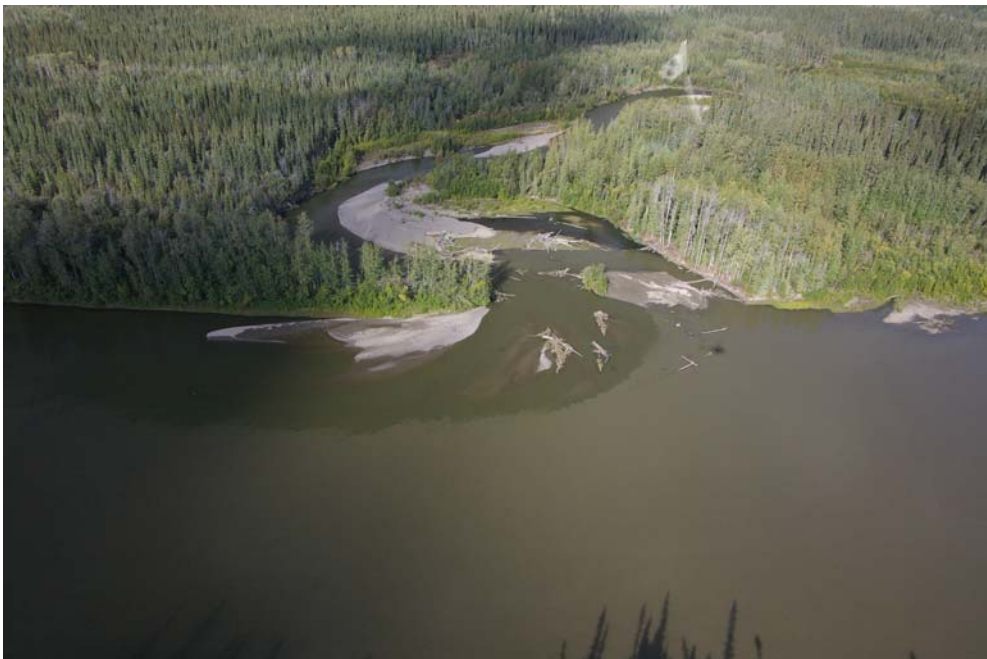
**Photo 6:** View of the relatively sediment loads of Anvil Creek and the Pelly River on August 25, 2011. Note how the relative sediment loads had reversed since the August 19th observation. Turbidity in Anvil Creek was measured at 6.75 NTU, and the Pelly River was measured at 17.5 NTU.

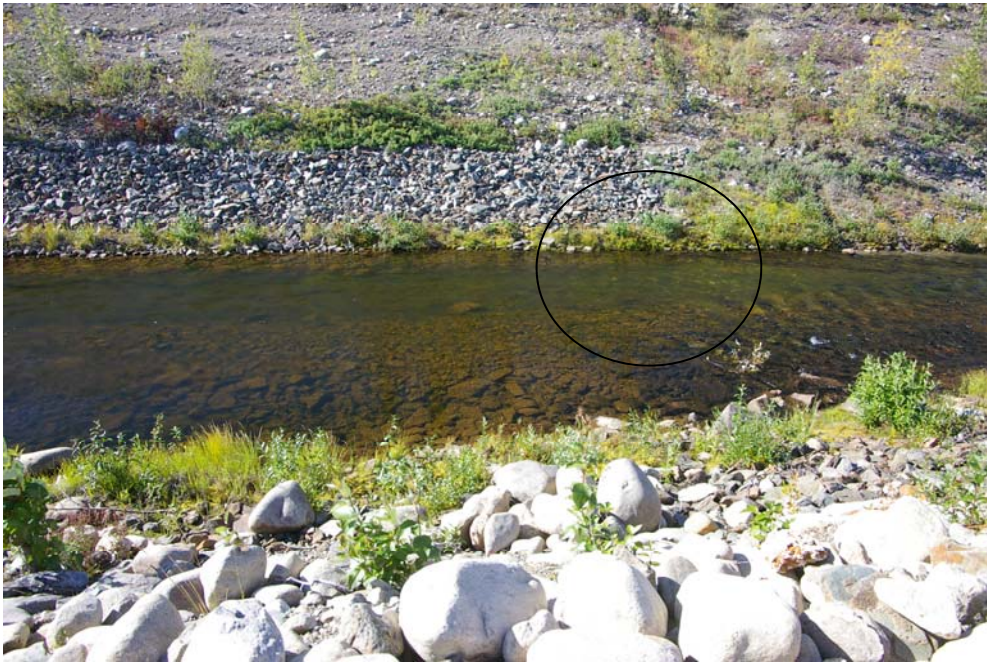
**Photo 7:** View of a redd site in the RCDC as observed from the ground. Photo taken August 25, 2011.

In the RCDC, six potential redd sites were identified; four from the ground survey and two from the aerial survey. Following the survey, the details of aerial and ground observations were compared (i.e. multiple photo angles, depth, substrate, and location with respect to stream morphology) and reviewed by an independent reviewer (P. Sparling, pers. comm.). Based on this comparison, two of the six sites identified in the RCDC were considered to be natural features, and not redd sites. No signs of recent activity were noted at the four confirmed redd sites (Photos 7 to 10).

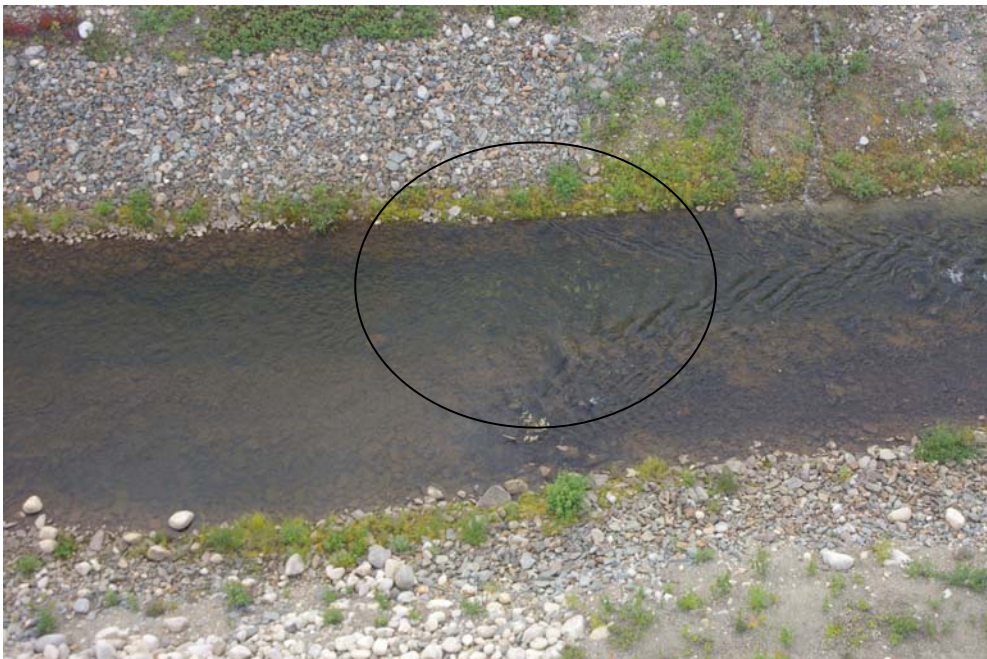
**Photo 8:** View of a redd site in the RCDC as observed during the aerial survey. Photo taken August 25, 2011.

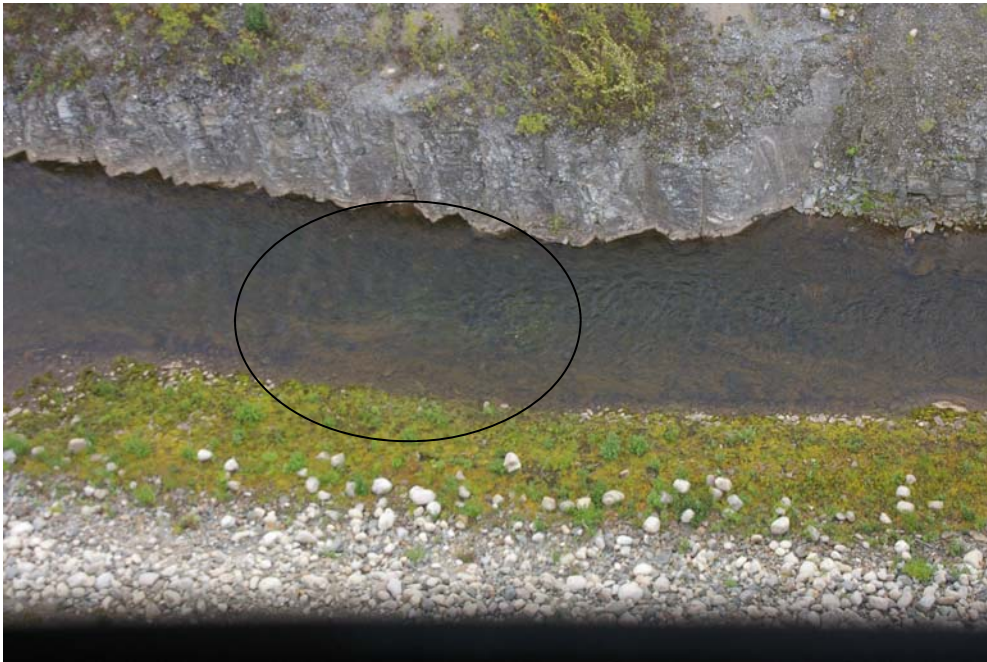
**Photo 9:** View of a redd site in the RCDC as observed during the aerial survey. Photo taken August 25, 2011.

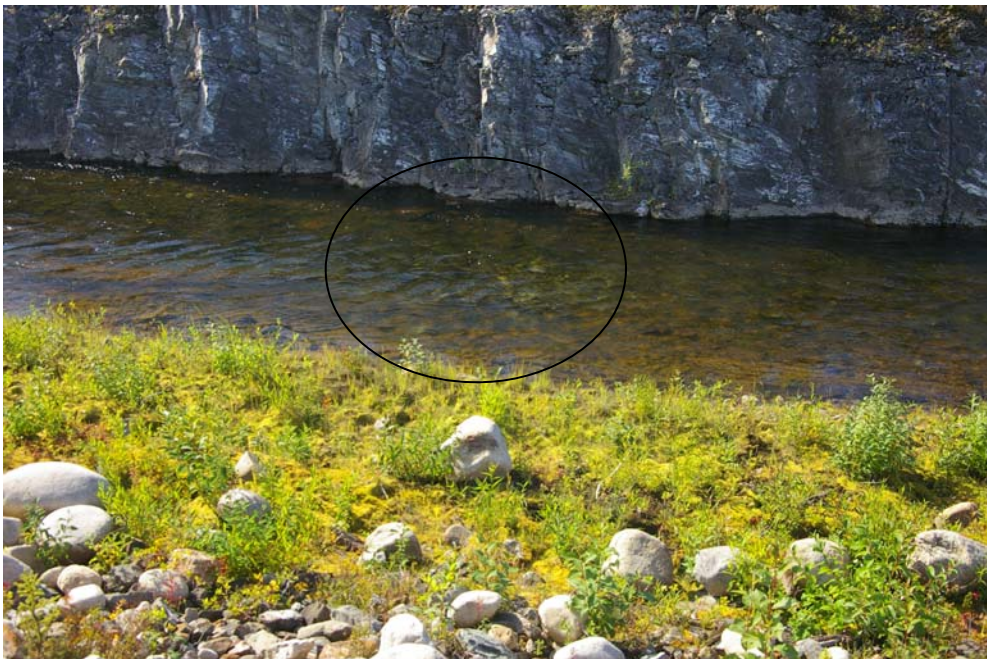
**Photo 10:** View of a redd site in the RCDC as observed from the ground. Photo taken August 25, 2011.
