Faro Mine Fish and Fish Habitat Overwintering Study

EDI Environmental Dynamics Inc.
#3-478 Range Road
Whitehorse, Yukon
Y1A 3A2

11-Y-0335
July, 2012

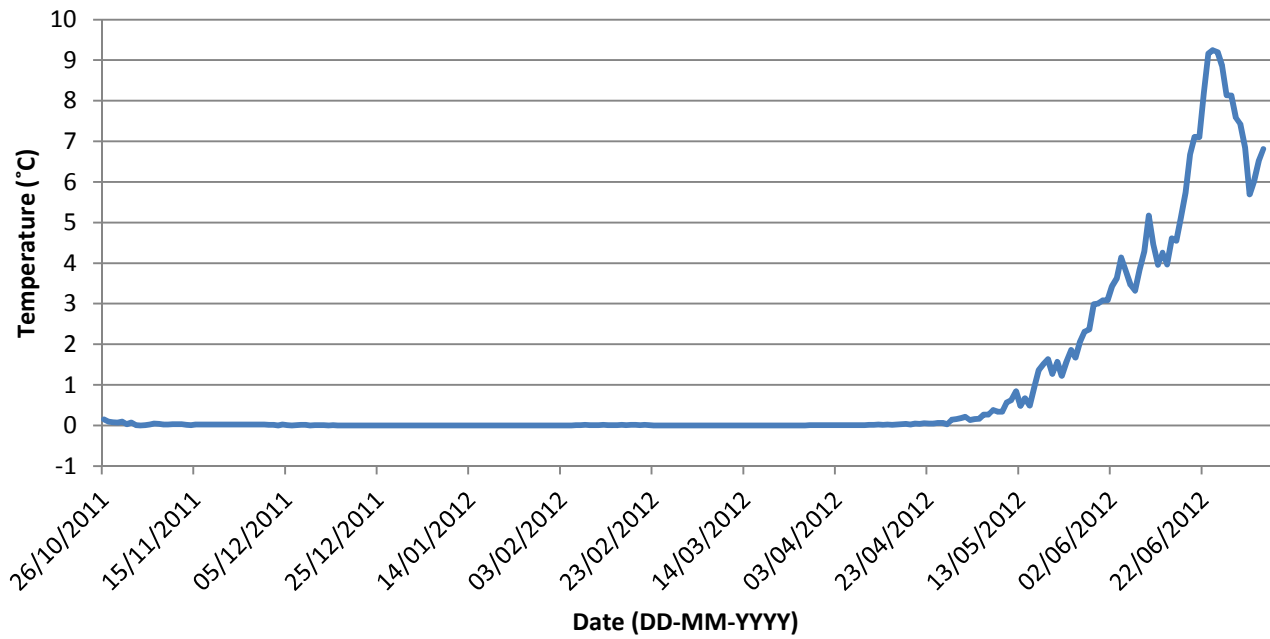
Figure 4. Mean daily water temperature, Rose Creek Diversion (RD-03).

At the Rose Creek Diversion site (RD-03), a minimum recorded temperature of 0.00°C occurred throughout December to March. The maximum temperature recorded was 10.71°C on June 25, 2012.

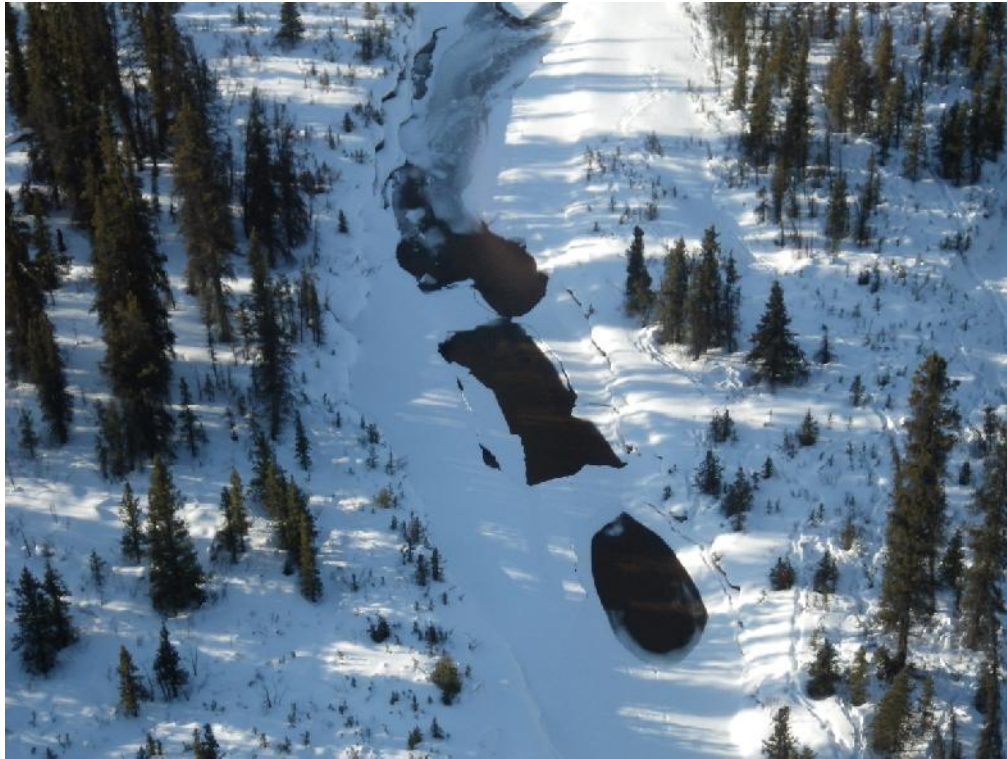
Aerial observations during the mid-winter survey noted the presence of open-water areas throughout the study area. Open-water indicates the stream does not freeze through to the bottom substrate, could have groundwater influence and has dissolved oxygen inputs from the surface. An aerial flight of lower Rose Creek downstream from the mine site to its confluence revealed many open-water areas (Photo 2). Open-water was also noted in the Rose Creek Diversion (Photo 3), North Fork (Photo 4), South Fork and Vangorda Creek while accessing sites by helicopter.

Photo 2. Open water observed in lower Rose Creek, February 14, 2012.

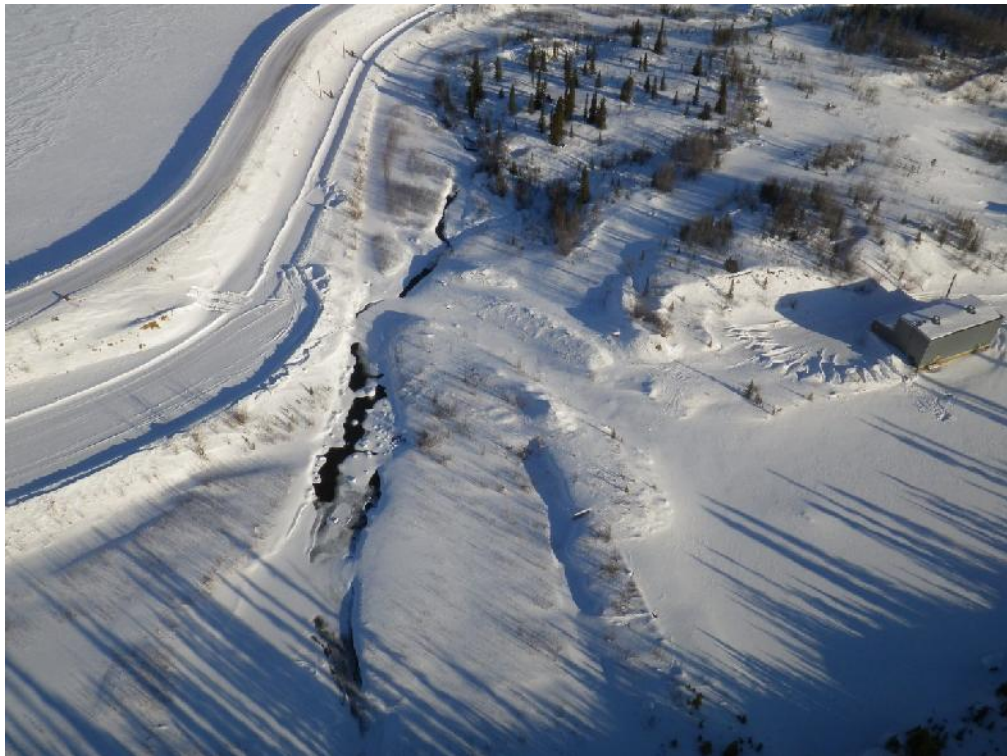
Photo 3. Open water observed in the Rose Creek and North Fork diversions downstream from Pumphouse Pond, February 14, 2012.

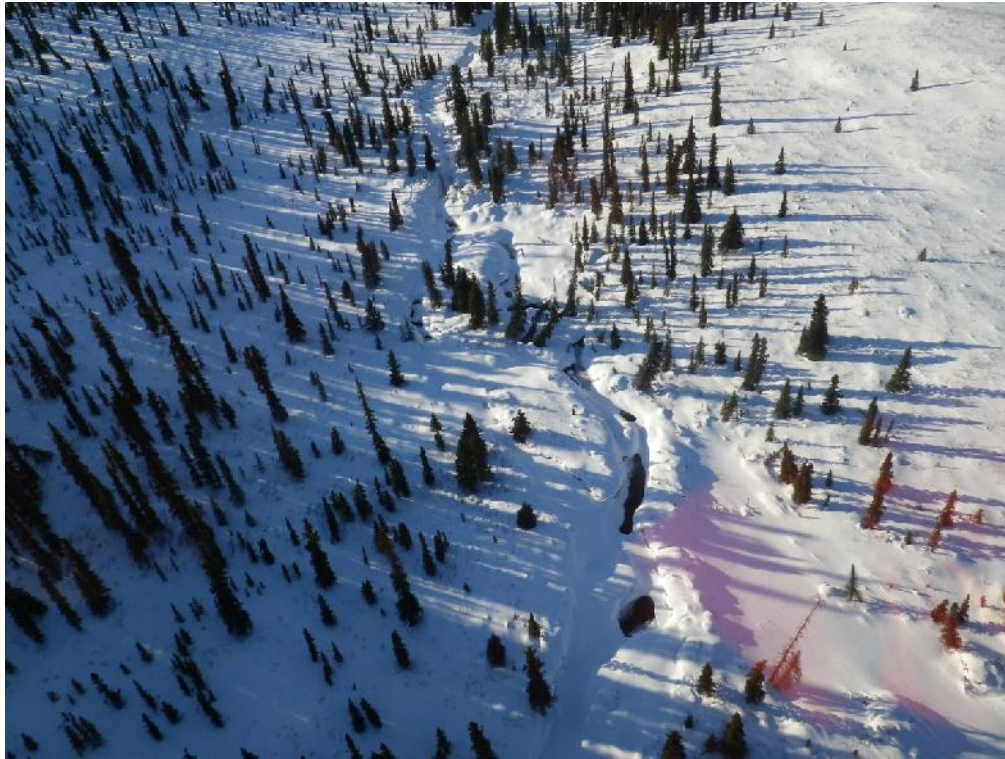
Photo 4. Open water noted in the upper North Fork, February 14, 2012.

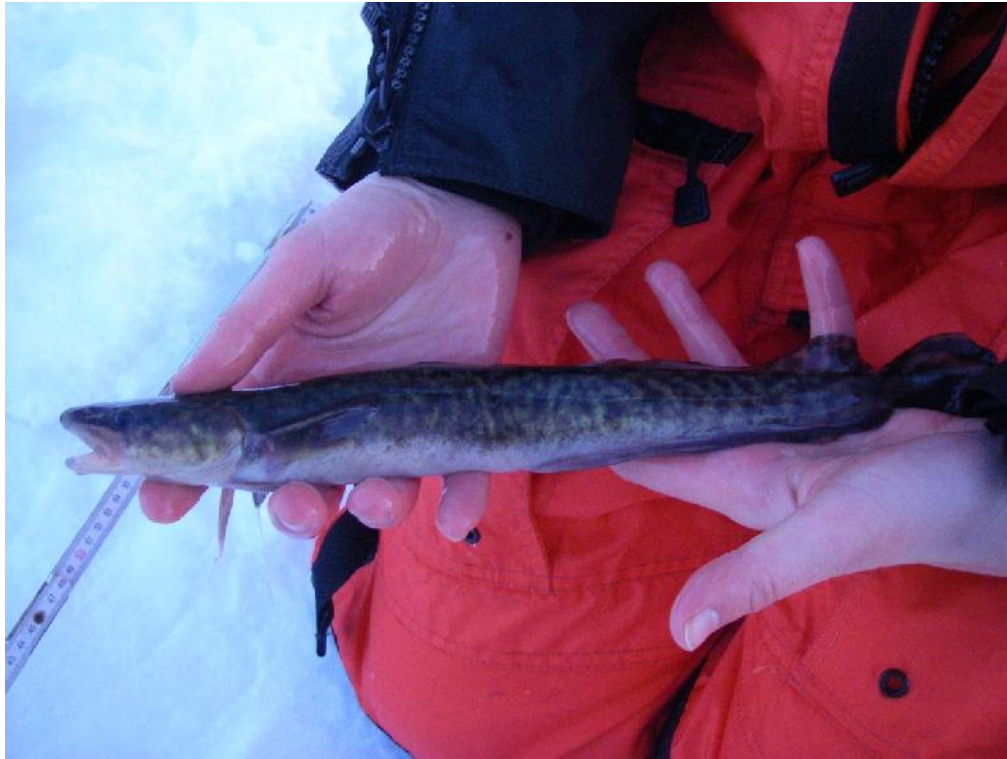
Photo 5. Burbot captured in Pumphouse Pond (RP-01), February 14, 2012.

Pumphouse Pond water quality was suitable for fish but may be limited by depth. The small burbot captured demonstrates its use but no additional fish were captured or observed. Temperature data shows this site was not at risk to freeze through to the bottom. Comparatively, the North Fork pond is similar but may be additionally limited in its capacity due to access (steep cascades between each pond).

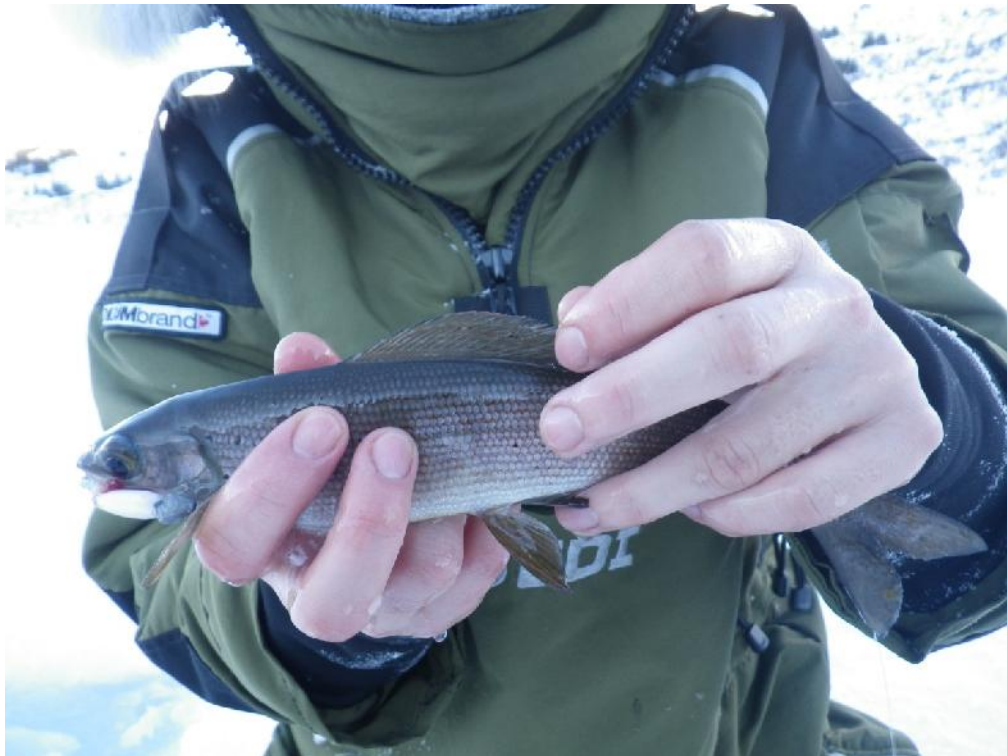
Photo 6. Arctic grayling captured in Dixon Lake (DL-01), February 15, 2012.

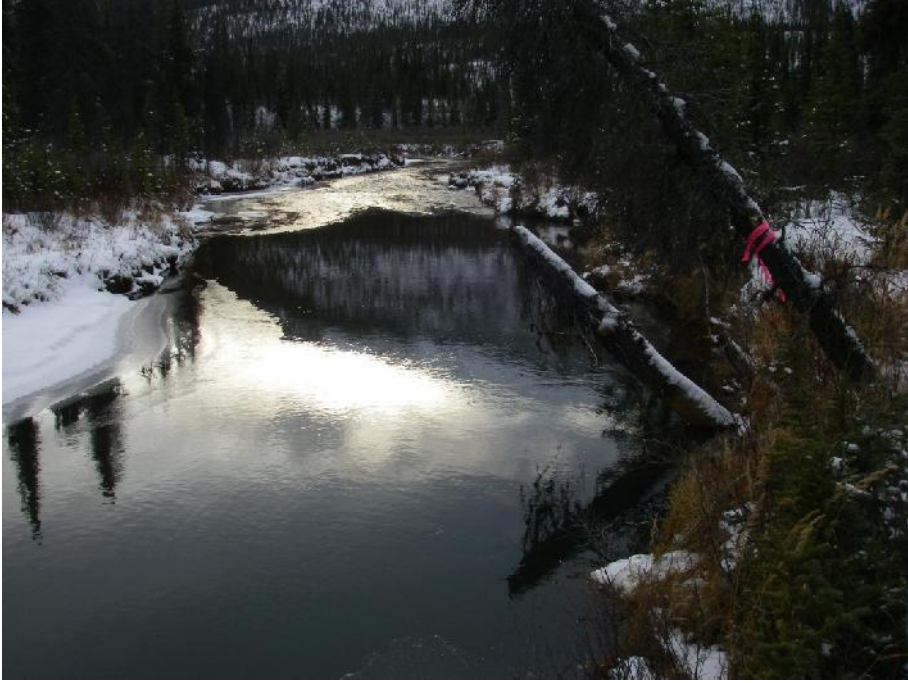
RC-01 – Rose Creek	Site Description

<ul style="list-style-type: none"> - Rose Creek, Reach 3 - Located just downstream from mine discharge in the natural channel - Vehicle accessible with short walk - Deep run habitat - Cover provided in large woody debris and cobble - Max depth 1.20 m (Oct 2011)
RD-01 – Rose Creek Diversion	Site Description

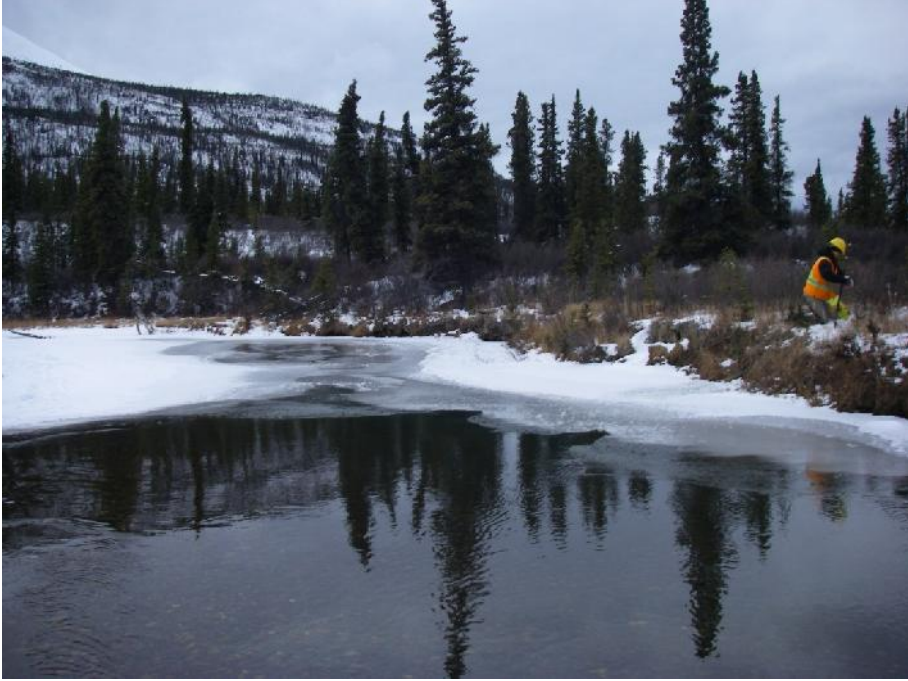
<ul style="list-style-type: none"> - Rose Creek, Reach 3 - Located in the downstream end of the diversion channel - Vehicle accessible - Natural stream characteristics - Pool habitat - Gravel/cobble substrate - Maximum depth 1.04 m (Oct 2011)

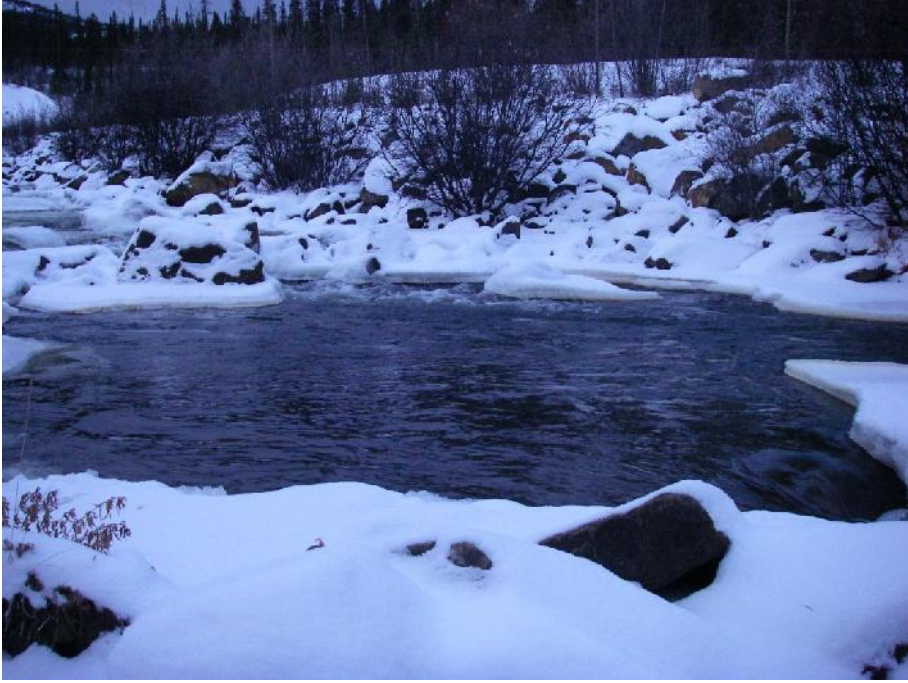
RD-02 – Rose Creek Diversion	Site Description

<ul style="list-style-type: none"> - Rose Creek, Reach 3 - Located in diversion channel midway through series of engineered step-pools - Pool habitat - Cover provided in cobble/boulder substrate - Maximum depth 0.64 m (Oct 2011)
RD-03 – Rose Creek Diversion	Site Description

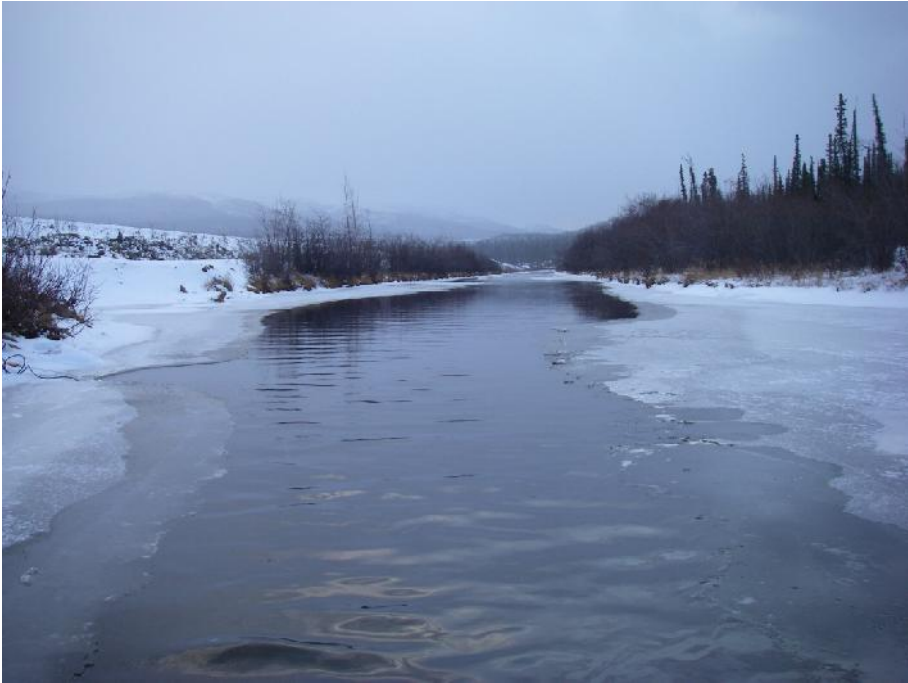
<ul style="list-style-type: none"> - Rose Creek, Reach 3 - Located in the upper end of the diversion channel - Vehicle accessible - Run habitat - Cover provided in a few cobble - Substrate mainly gravel/sand - Maximum depth 0.71 m (Oct 2011)

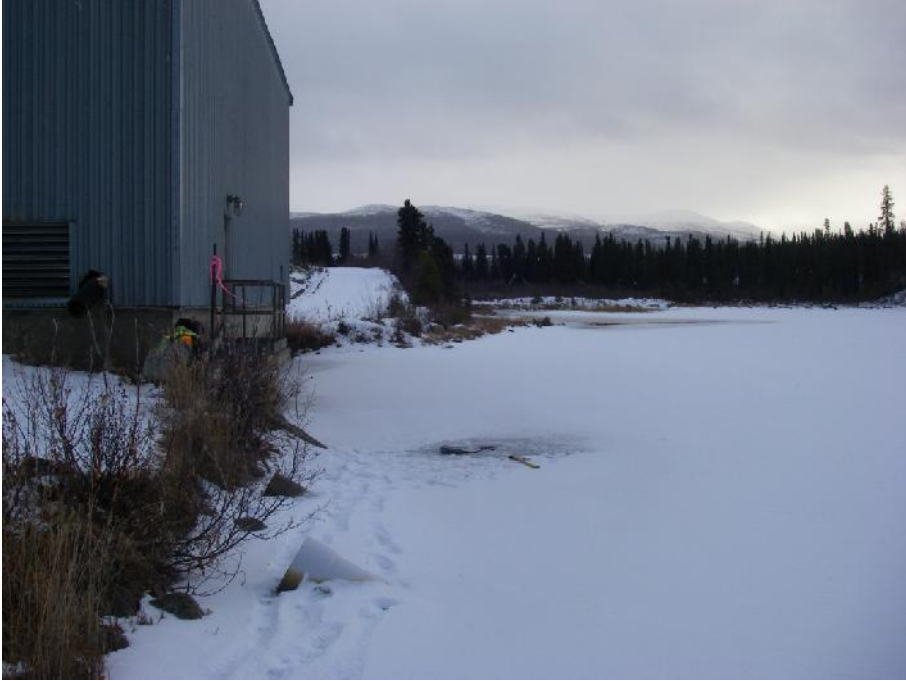
RP-01 – Pumphouse Pond	Site Description

<ul style="list-style-type: none"> - Immediately upstream from the Rose Creek Diversion and North Fork Diversion confluence - Receives inflow from North Fork ponds and South Fork - Vehicle accessible - Substrate mainly fine sediments - Maximum depth 2.10 m; ice depth 0.10 m (Oct 2011; temperature logger station)
RP-02 – North Fork pond	Site Description

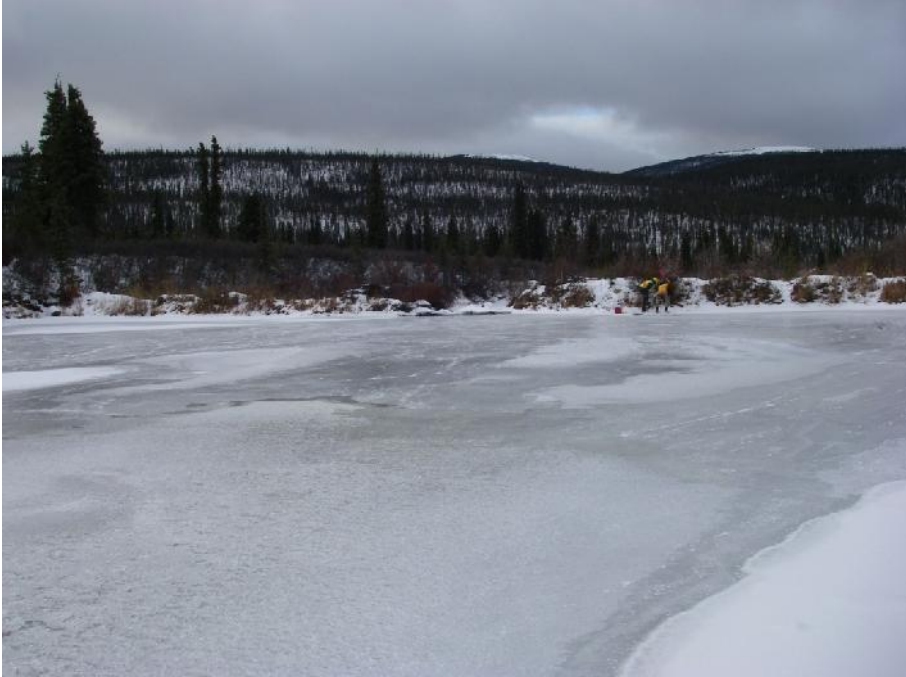
<ul style="list-style-type: none"> - Constructed series of ponds receiving water from the North Fork - Located in a pond mid-way in the series of ponds - Vehicle accessible - Substrate mainly fine sediments - Cover provided by overhanging vegetation and small woody debris - Maximum depth 1.50 m; ice depth 0.08 m (Oct 2011; temperature logger station)

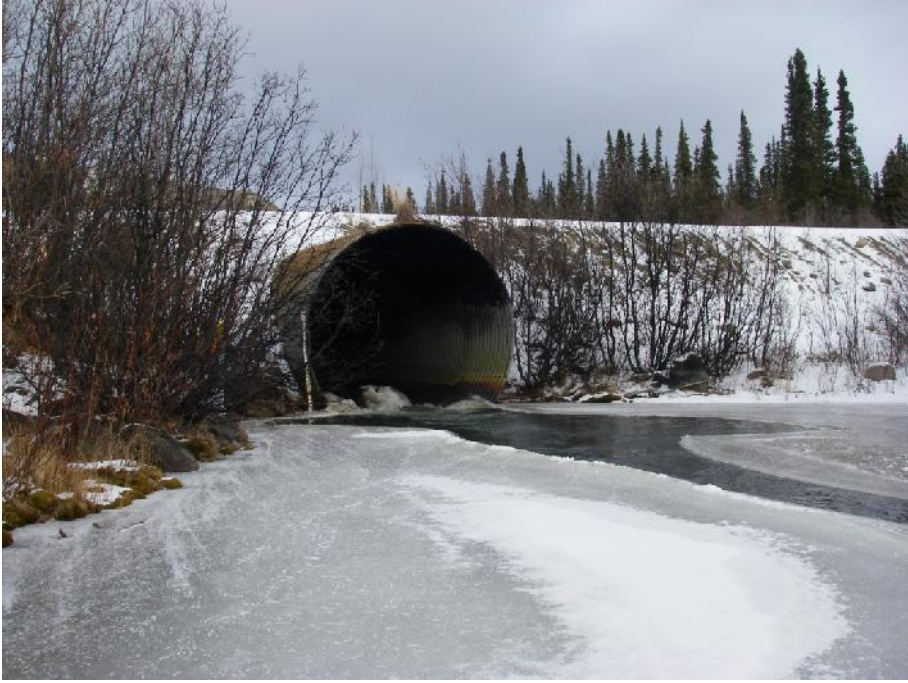
RN-01 – North Fork	Site Description

<ul style="list-style-type: none"> - North Fork, Reach 1 - Located on the downstream side of the mine access road crossing - Vehicle accessible - Culvert plunge pool habitat - Cover in cobble and overhanging vegetation - Maximum depth 1.14 m (Oct 2011)
RN-02 – North Fork	Site Description

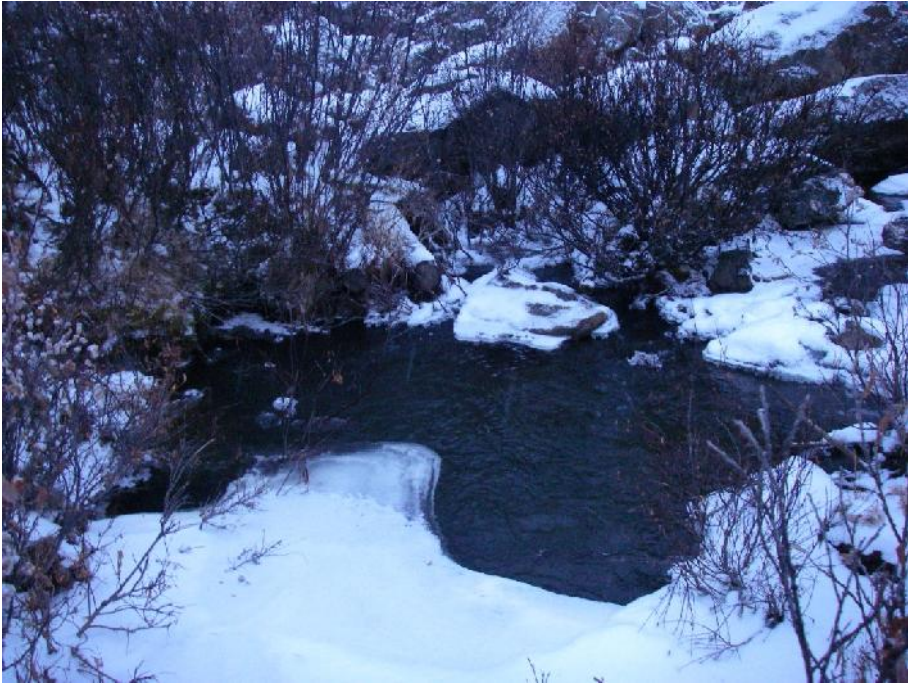
<ul style="list-style-type: none"> - North Fork, Reach 1 - Downstream side of the Haul Road rock drain; upper end of reach - Vehicle access with walk - Site located in side channel flowing out of rock drain rubble - Pool habitat - Cover provided in banks, small woody debris, vegetation - Maximum depth 1.38 m (Oct 2011)

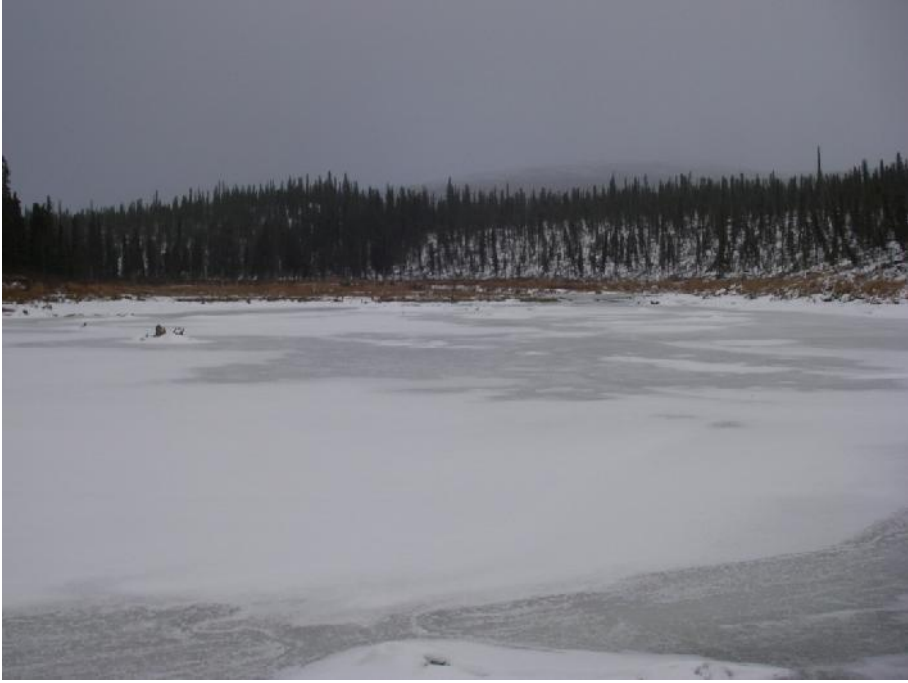
RN-03 – North Fork	Site Description

<ul style="list-style-type: none"> - North Fork, Reach 2 - Upstream side of the Haul Road rock drain; lower end of reach - All-terrain vehicle access seasonally - Site located at the rock drain end of the pond - Cover provided in small woody debris and large angular rock drain rubble - Maximum depth 0.62 m ice depth 0.03 m (Oct 2011; temperature logger station)
RN-04 – North Fork	Site Description

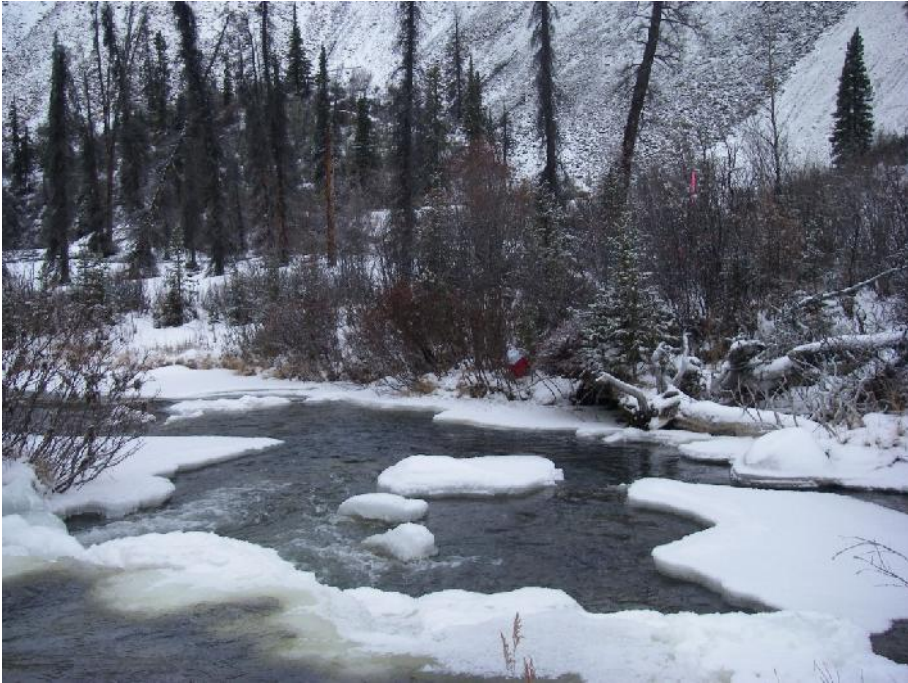
<ul style="list-style-type: none"> - North Fork, Reach 2 - All-terrain or vehicle access seasonally - Pool habitat - Anchor ice observed upstream and downstream of site and along banks - Cover provided by cobble and overhanging vegetation - Maximum depth 1.02 m (Oct 2011)

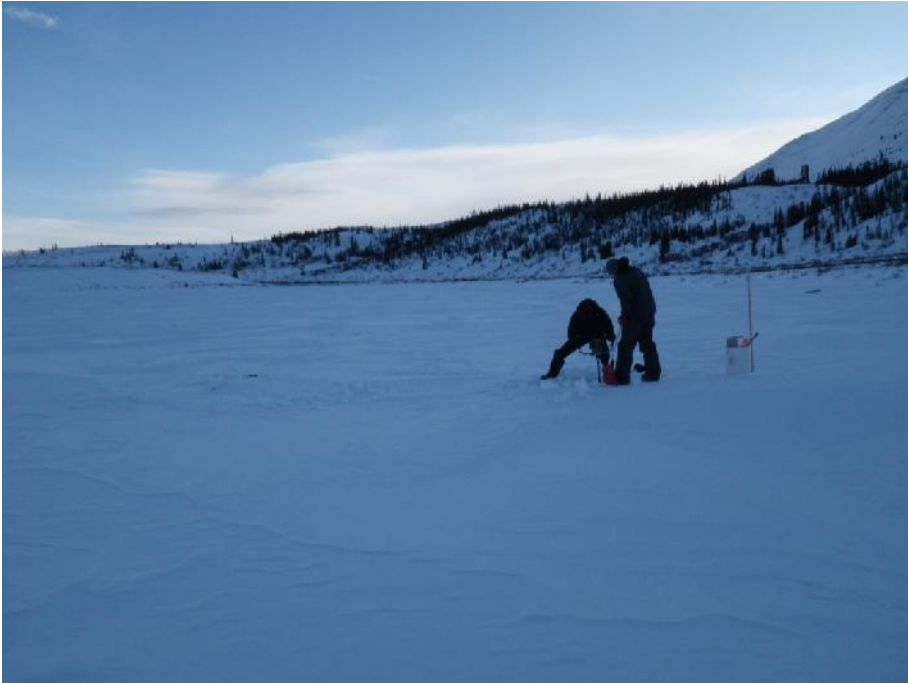
<ul style="list-style-type: none"> - North Fork, Reach 4 - Helicopter access - Large headwater pond - Fine substrate with aquatic vegetation - Not suitable for overwintering habitat - Water depth 0.05 m, ice depth 0.60 m (Feb 2012)

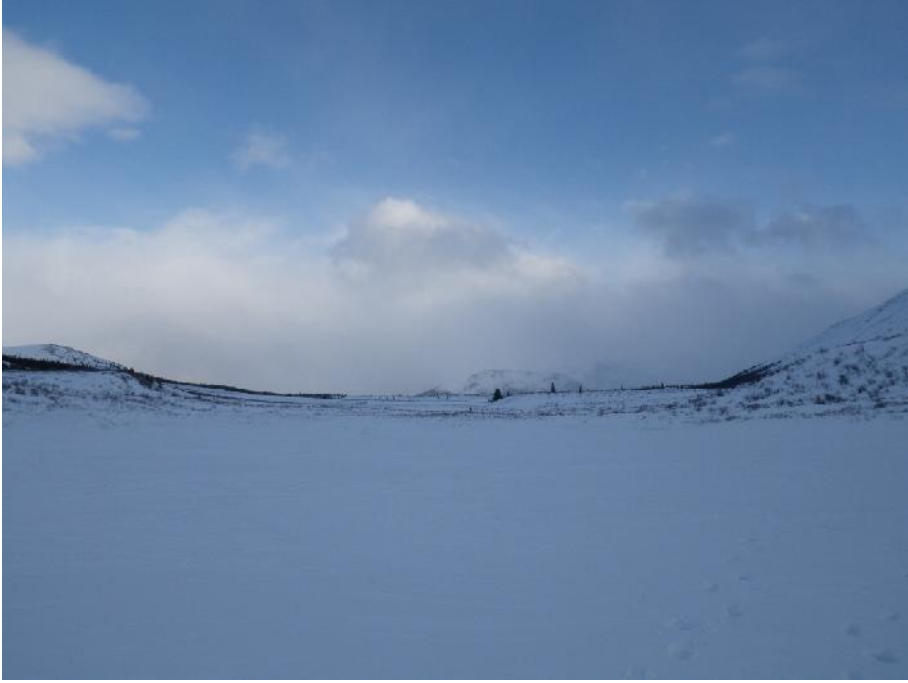
RN-07 – North Fork	Site Description

<ul style="list-style-type: none"> - North Fork, Reach 3 - Helicopter access - Beaver pond - Fine substrate with aquatic vegetation - Low overwintering habitat potential - Water depth 0.17 m, ice depth 0.99 m (Feb 2012)
RN-08 – North Fork	Site Description

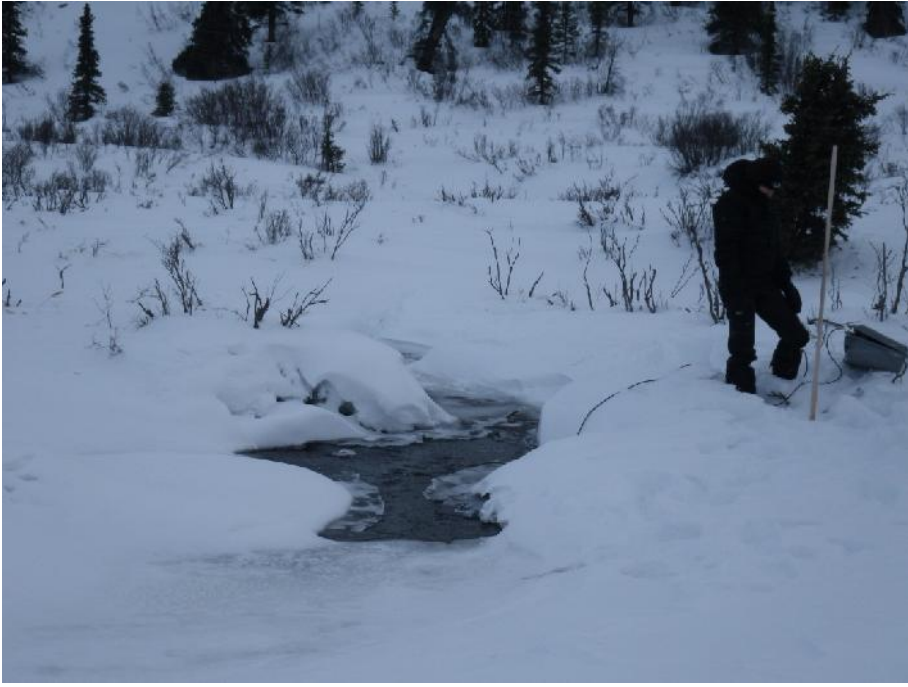
<ul style="list-style-type: none"> - North Fork, Reach 3 - Helicopter access - Open-water in riffle/ run habitat - Fine substrate with aquatic vegetation - Low overwintering habitat potential - Water depth 0.25 m, (Feb 2012)

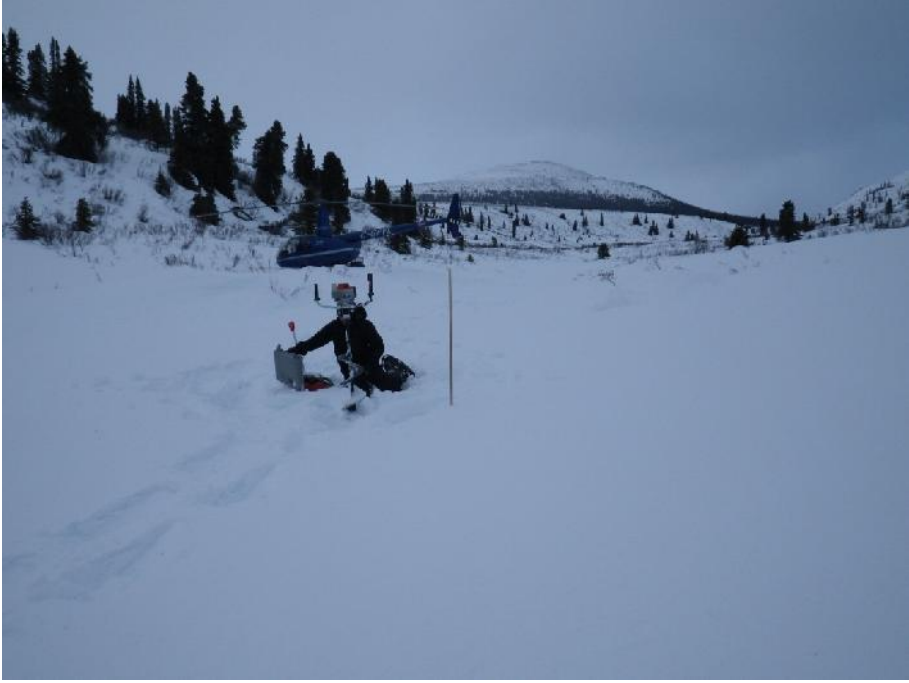
RN-09 – North Fork	Site Description

<ul style="list-style-type: none"> - North Fork, Reach 3 - Helicopter access - Site located at old deactivated road / trail crossing - Run habitat - Gravel / small cobble substrate - Water depth 0.10 m, ice depth 0.30 m (Feb 2012)
RS-01 – South Fork	Site Description

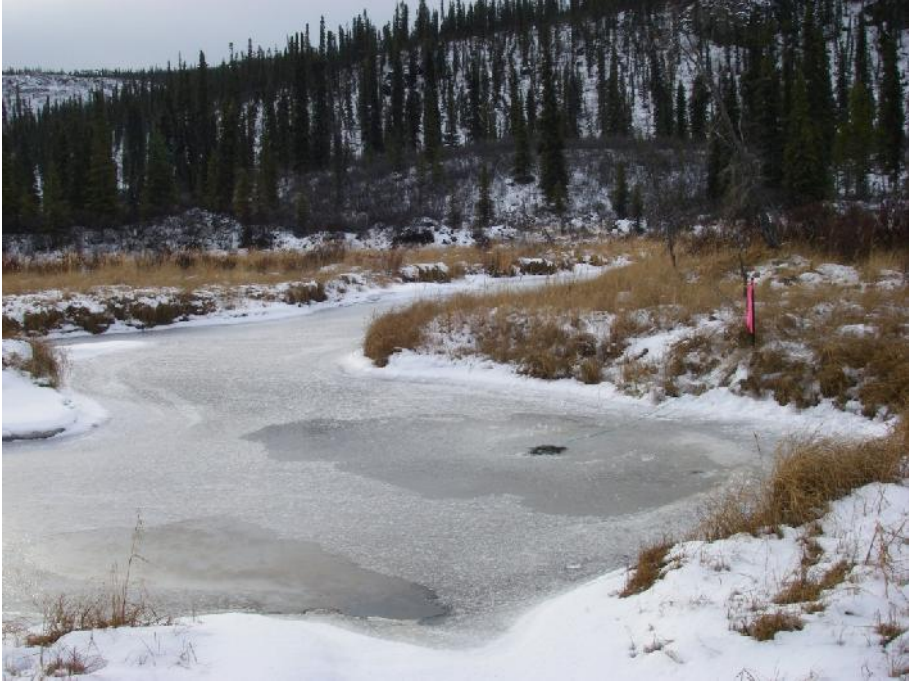
<ul style="list-style-type: none"> - South Fork, Reach 2 - Access by foot - Site located in side channel - Pool habitat - Fines/ sand dominated substrate - Maximum depth 1.30 m ice depth 0.10 m (Oct 2011)

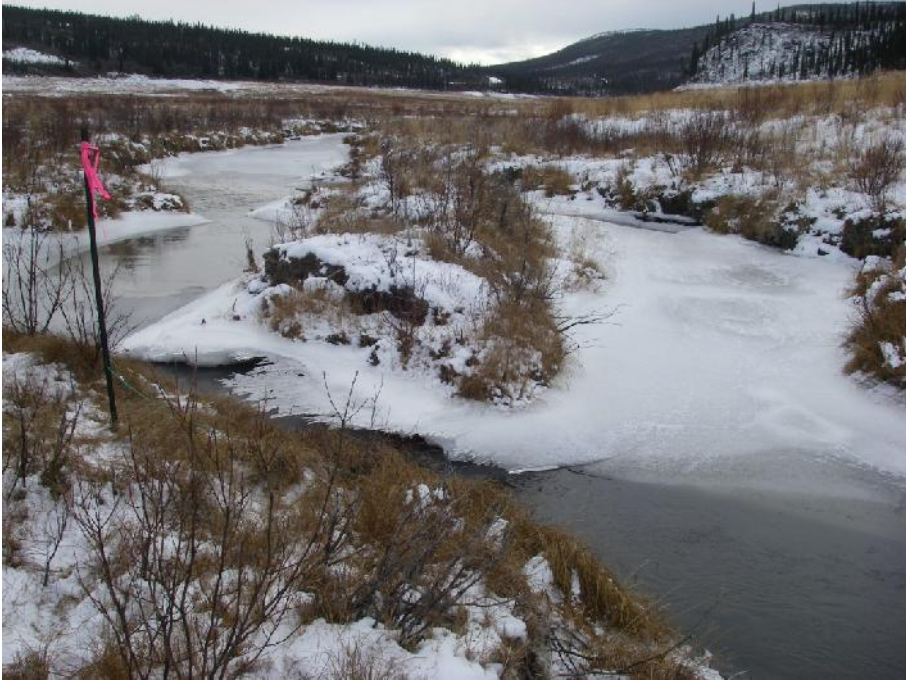
RS-02 – South Fork	Site Description

<ul style="list-style-type: none"> - South Fork, Reach 3 - Site located just upstream of the former dam, within the former Fresh Water Reservoir - Access by foot - Pool habitat within main channel - Cover available in overhanging banks, cobble and small woody debris - Maximum depth 1.22 m (Oct 2011)
RS-03 – South Fork	Site Description
 	<ul style="list-style-type: none"> - South Fork, Reach 5 - Site located in culvert plunge pool at mine access road crossing - Access by vehicle - Culvert is a barrier to upstream fish passage - Cover provided by cobble - Maximum depth 1.12 m (Oct 2011)

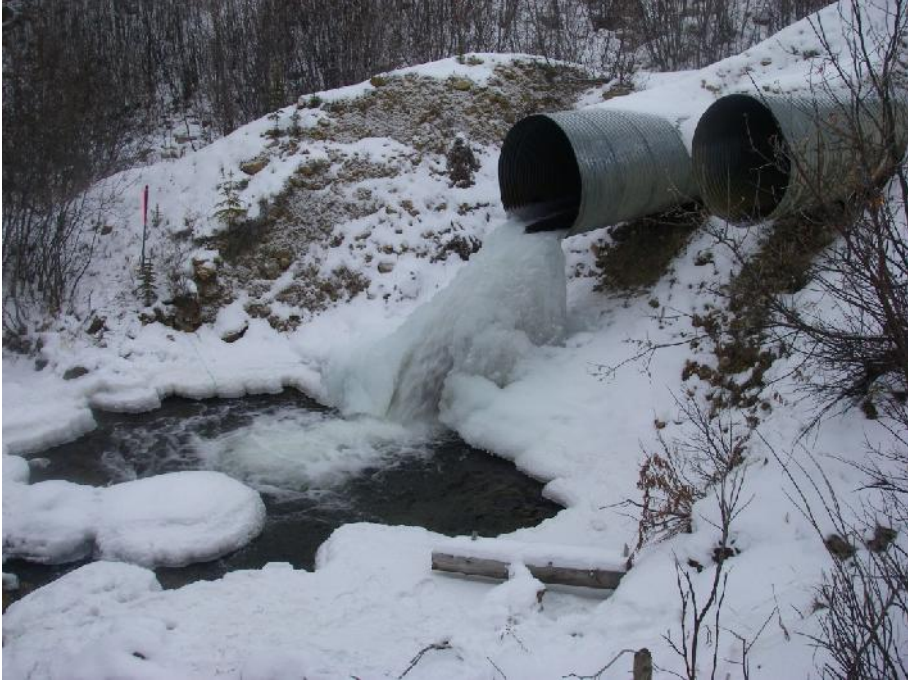
RS-04 – South Fork	Site Description

<ul style="list-style-type: none"> - South Fork, Reach 5 - Site located in culvert plunge pool at Haul Road crossing - Vehicle access - Culvert is a barrier to upstream fish passage - Site is between two fish barriers - Established site for temperature logging - Maximum depth 1.09 m (Oct 2011)
DL-01 – Dixon Lake	Site Description

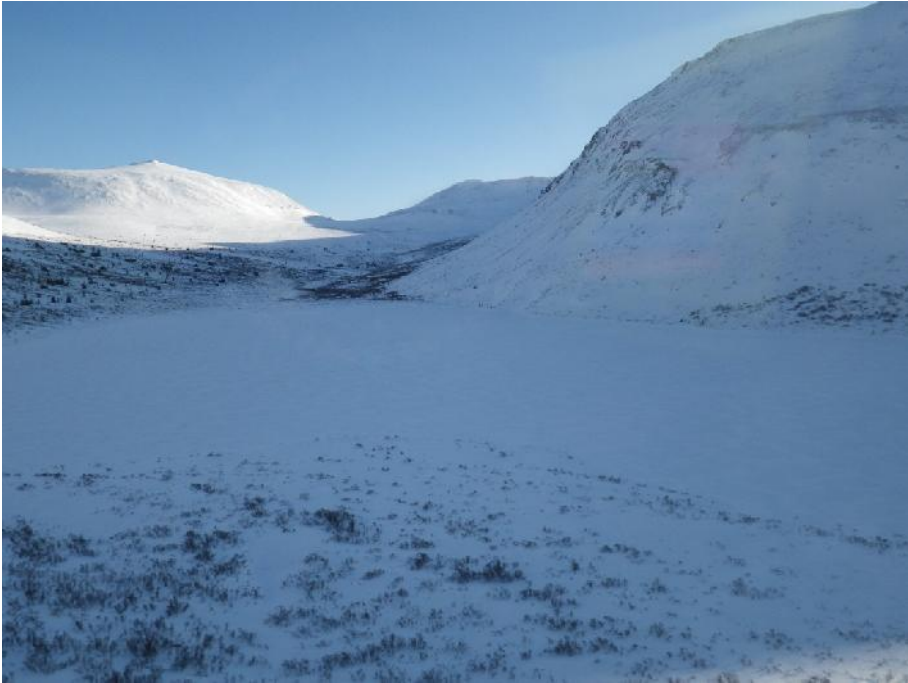
<ul style="list-style-type: none"> - Dixon Lake - Headwaters of the South Fork - Helicopter access - Substrate dominated by fines - Max depth near the inlet 6.05 m with ice depth 1.15 m

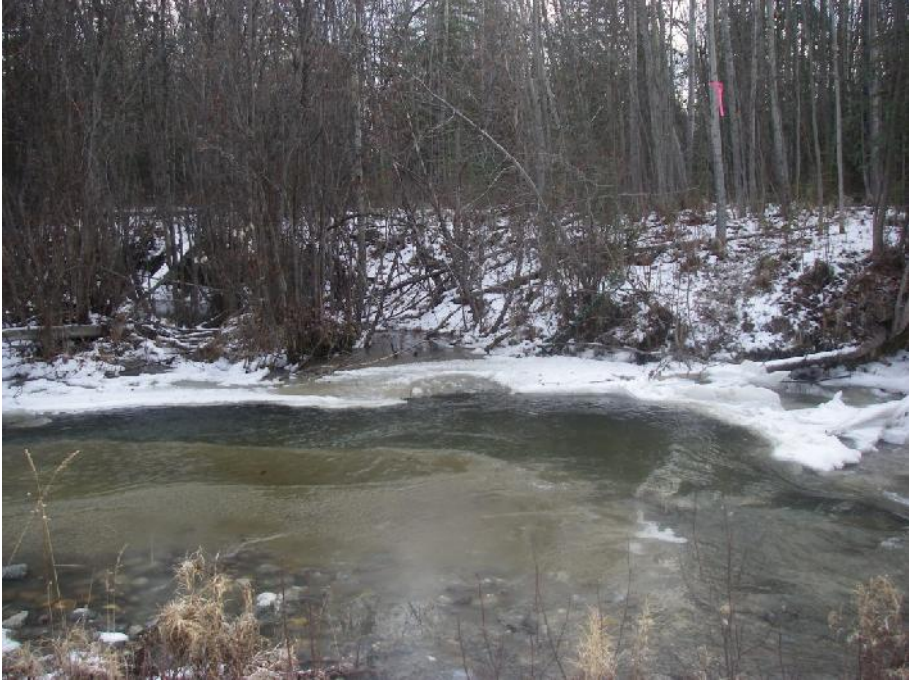
VC-01 – Vangorda Creek	Site Description

<ul style="list-style-type: none"> - Vangorda Creek, Reach 1 - Site located upstream from deactivated road crossing - Vehicle access with short walk - Cover available in cobble, overhanging vegetation and small woody debris - Pool habitat - Maximum depth 0.94 m Oct (2011)
VC-02 – Vangorda Creek	Site Description

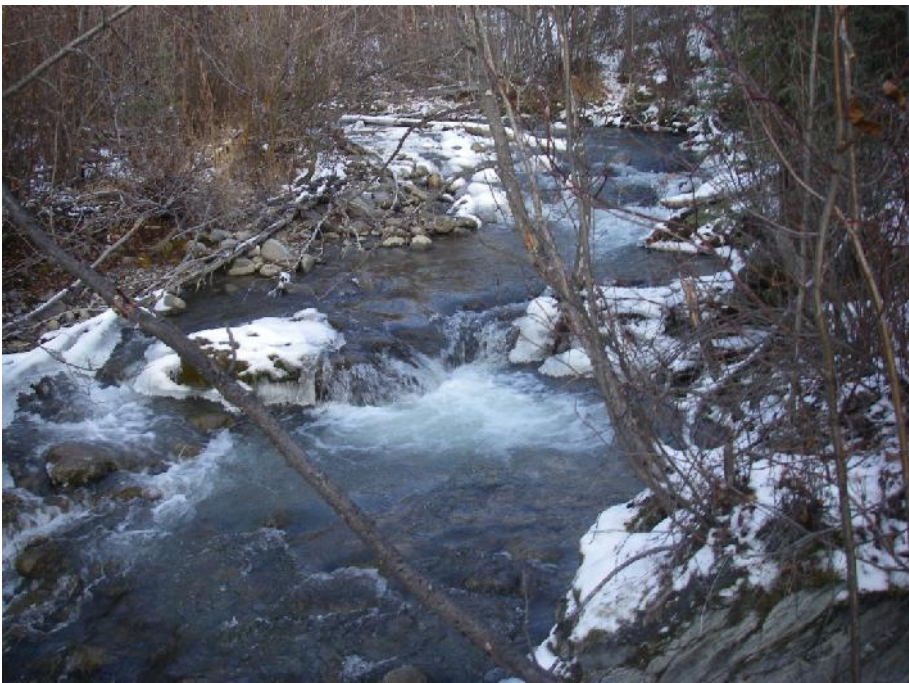
<ul style="list-style-type: none"> - Vangorda Creek, Reach 3 - Access by foot - Established site for temperature logging - Step-pool habitat - Maximum depth 0.68 m (Oct 2011)
