**Faro Mine Slimy Sculpin  
Reconnaissance Survey,  
May 2008**

**Assessment and Abandoned Mines  
Yukon Government  
Whitehorse, YT  
Y1A 2C6**

**Minnow Environmental Inc.  
Georgetown, Ontario**

**March 2009**

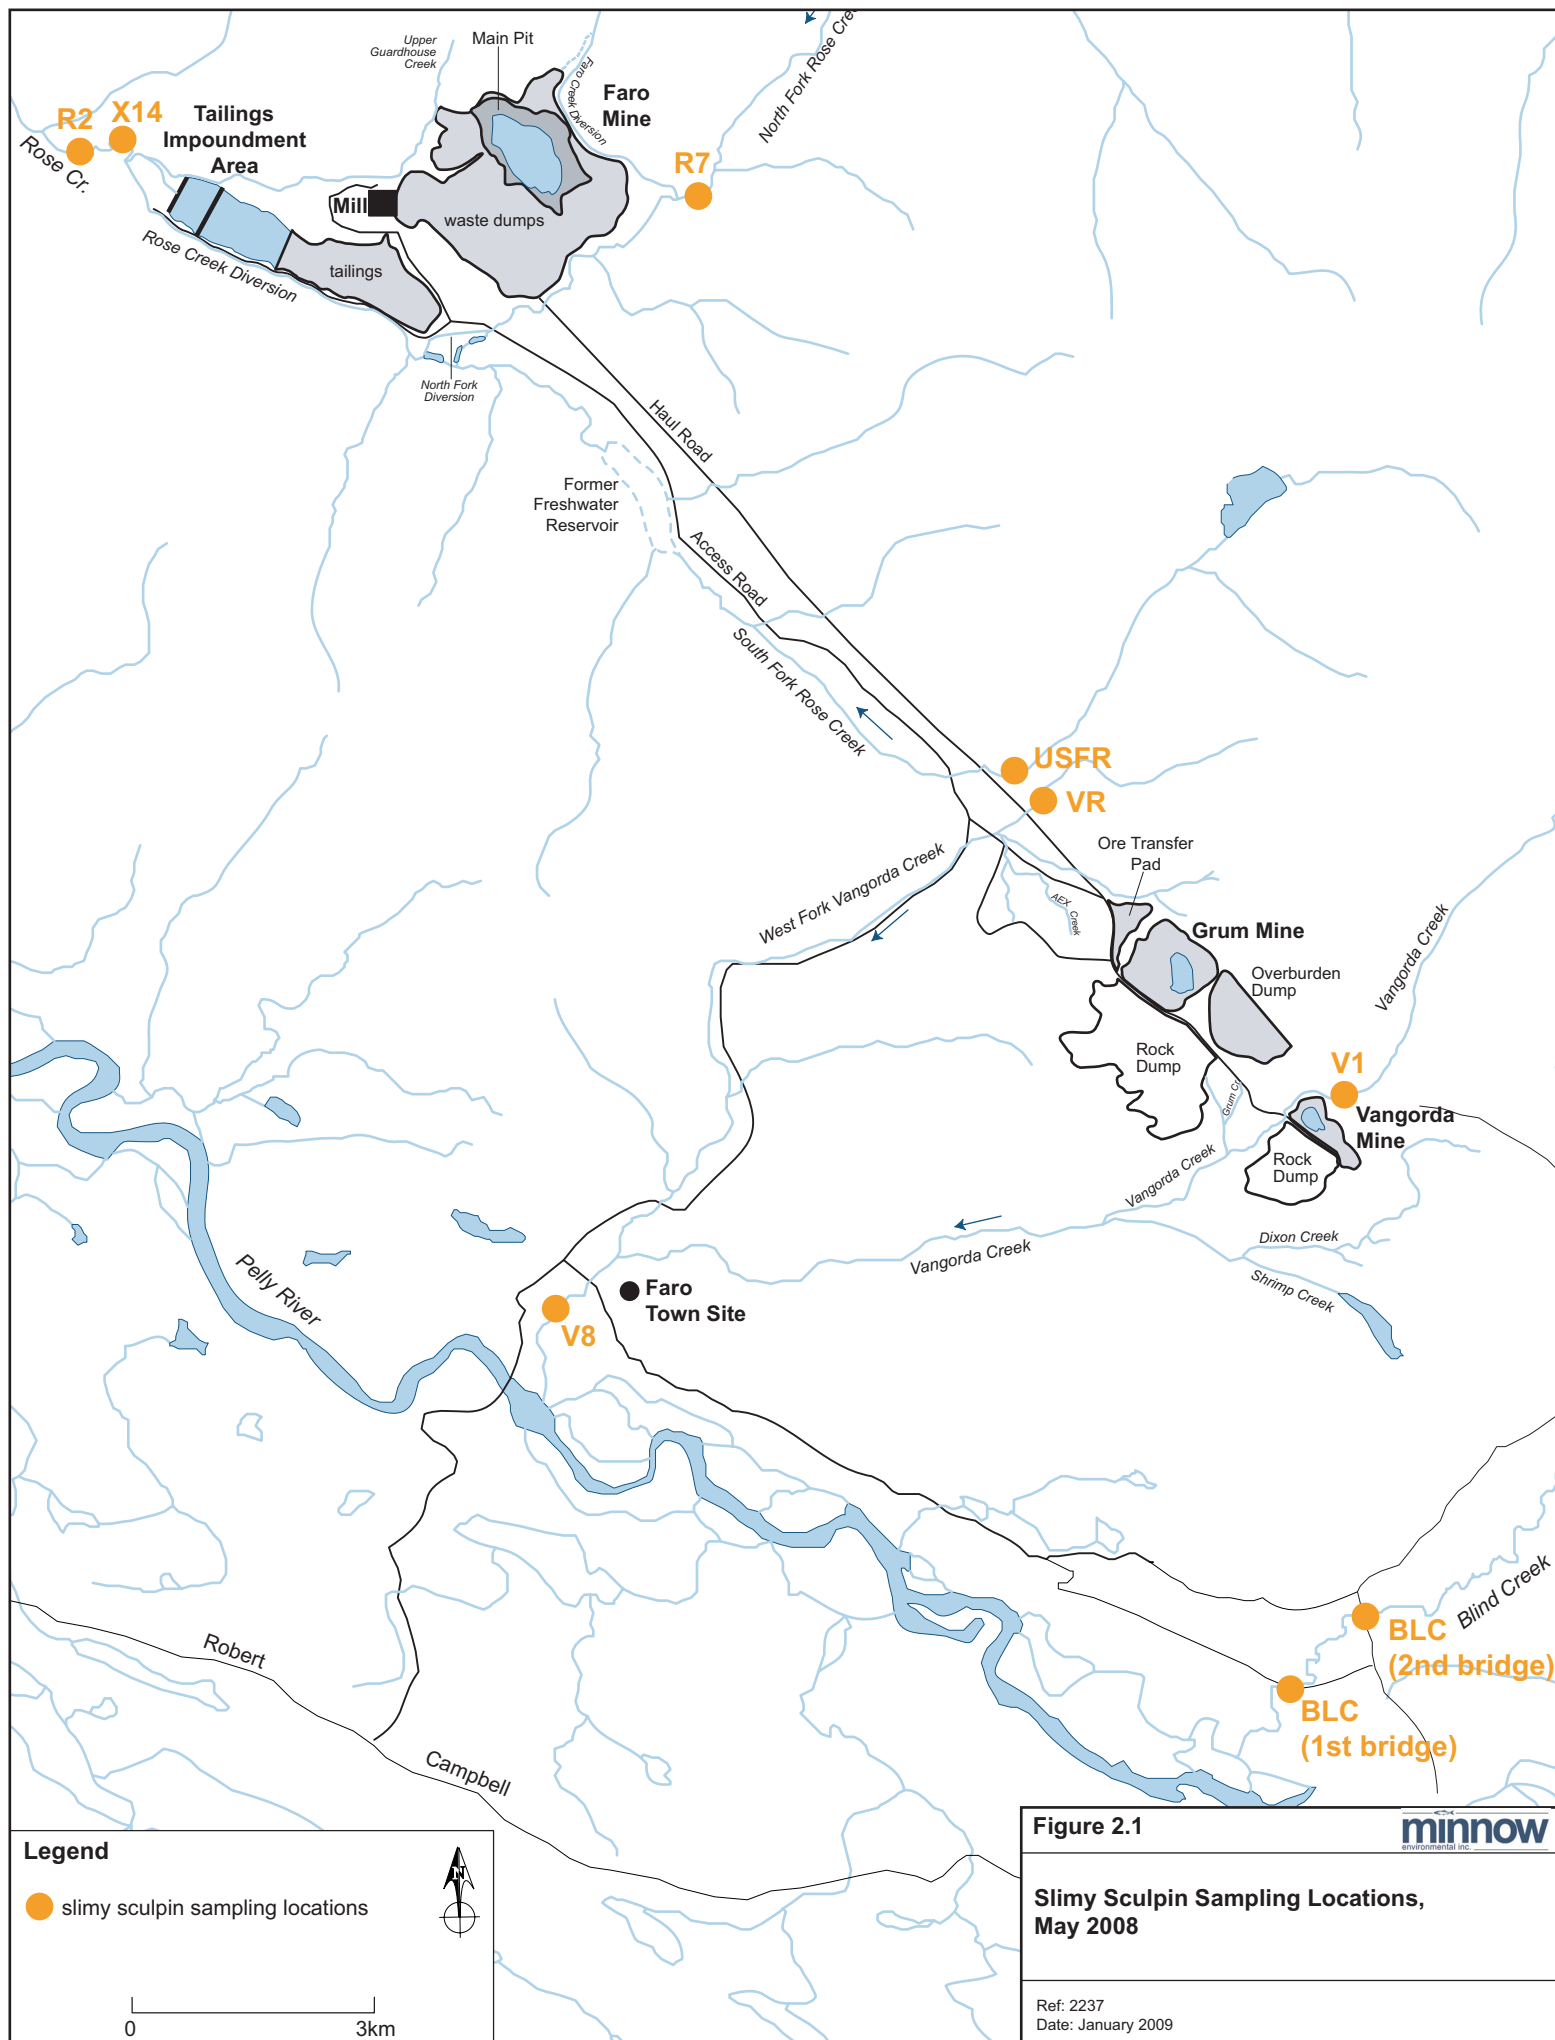
Figure 2.1

**Slimy Sculpin Sampling Locations,  
May 2008**

Backpack electrofishing and minnow traps were used to capture fish from reference and mine-exposed creeks near the Faro mine (Figure 2.1). The areas were chosen to include near-field mine-exposed areas (V8, X14) and potential reference areas (R7, USFR, VR, V1, BLC). Electrofishing was conducted using a battery powered Smith-Root LR-12 backpack electrofisher (Smith Root Inc., Vancouver, WA). Wadable areas of creeks were fished by an operator and a netter, starting at the downstream end of the reach and moving upstream. Depending on the depth and flow of the creek, the area fished ranged from immediately next to the bank (in larger creeks), to the breadth of the creek. All types of habitat were covered when possible. Stop nets were not used due to high flow and rocky habitat conditions and because they were not required to satisfy the study objectives. Fish collected were identified and enumerated on field sheets, and fish other than slimy sculpin were released. For each area, electrofishing settings and effort in seconds were recorded.

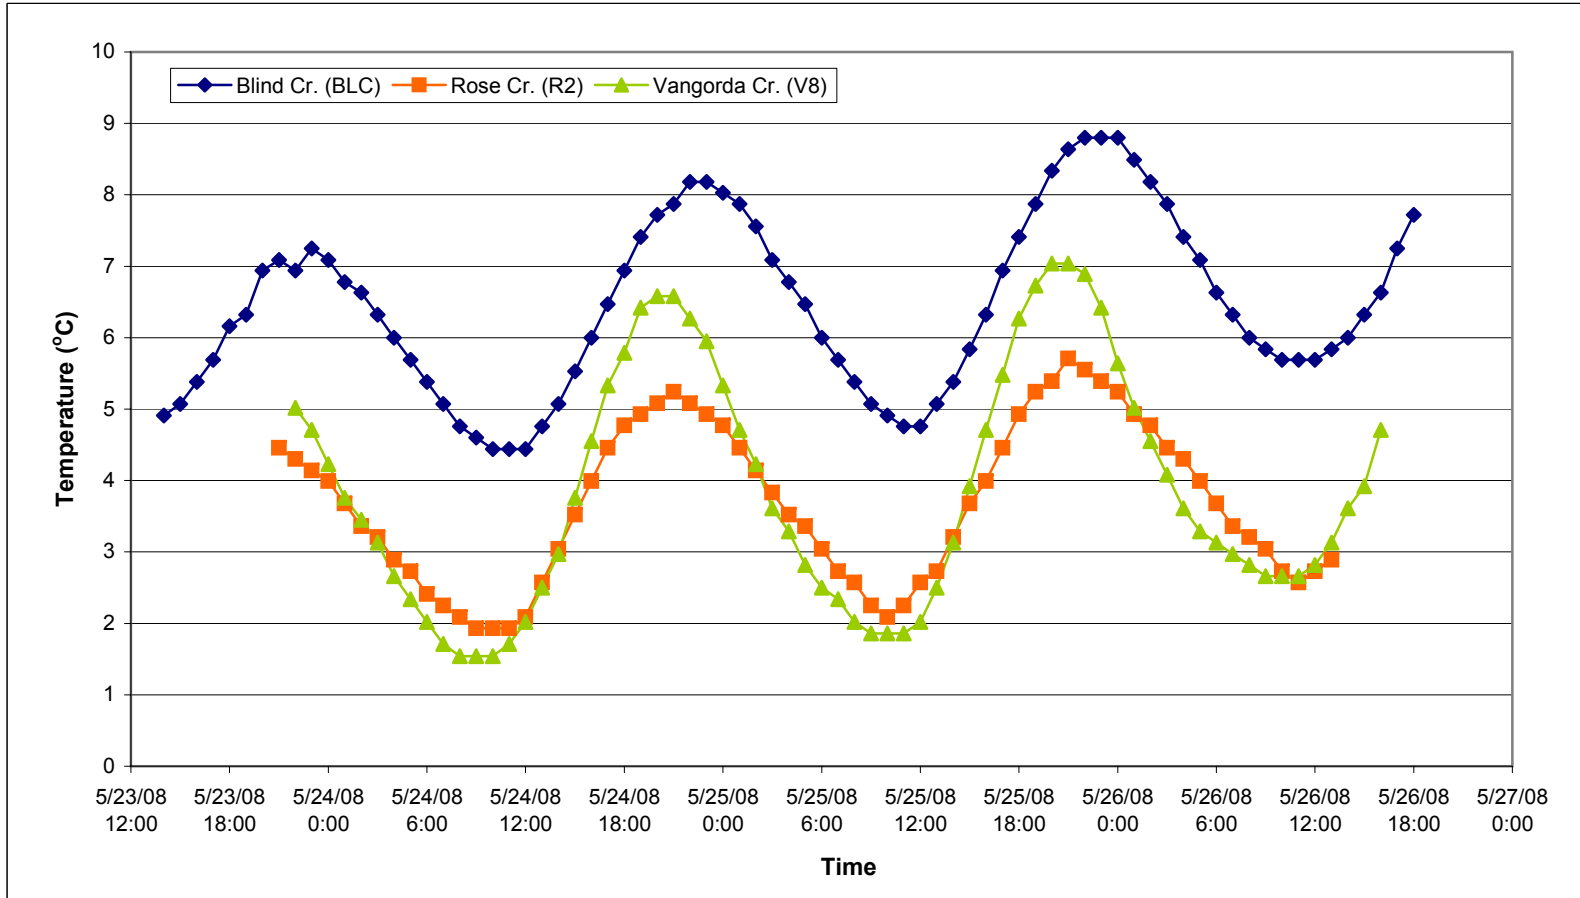
**Figure 3.1: Hourly water temperatures as recorded by temperature loggers**

Water temperatures at the time of the survey ranged from just above freezing to approximately 5°C (Table 3.2). Temperature loggers showed diurnal fluctuations of 2 to 5°C, with greatest fluctuations observed in lower Vangorda Creek (V8) relative to Blind and Rose Creeks (Figure 3.1). A slight rising trend was evident in increasing maximum and minimum temperatures recorded at each location over the 3-day survey period.

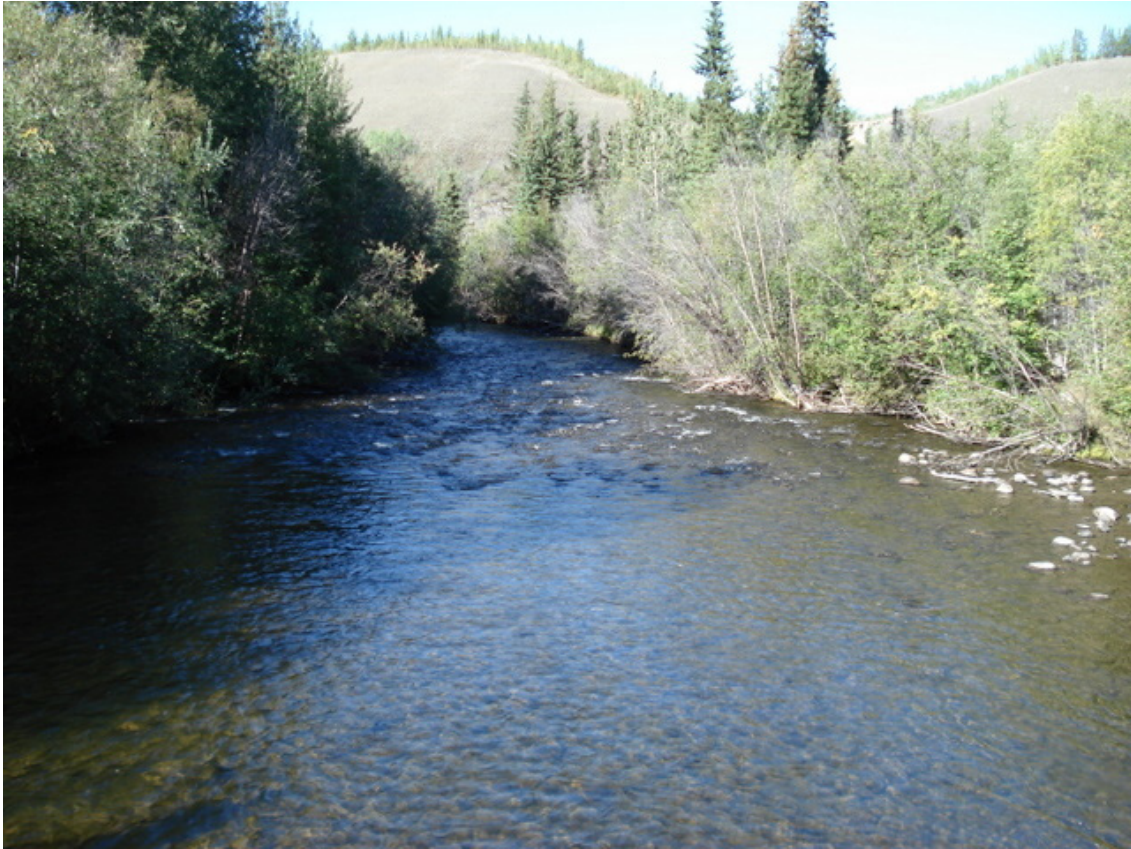
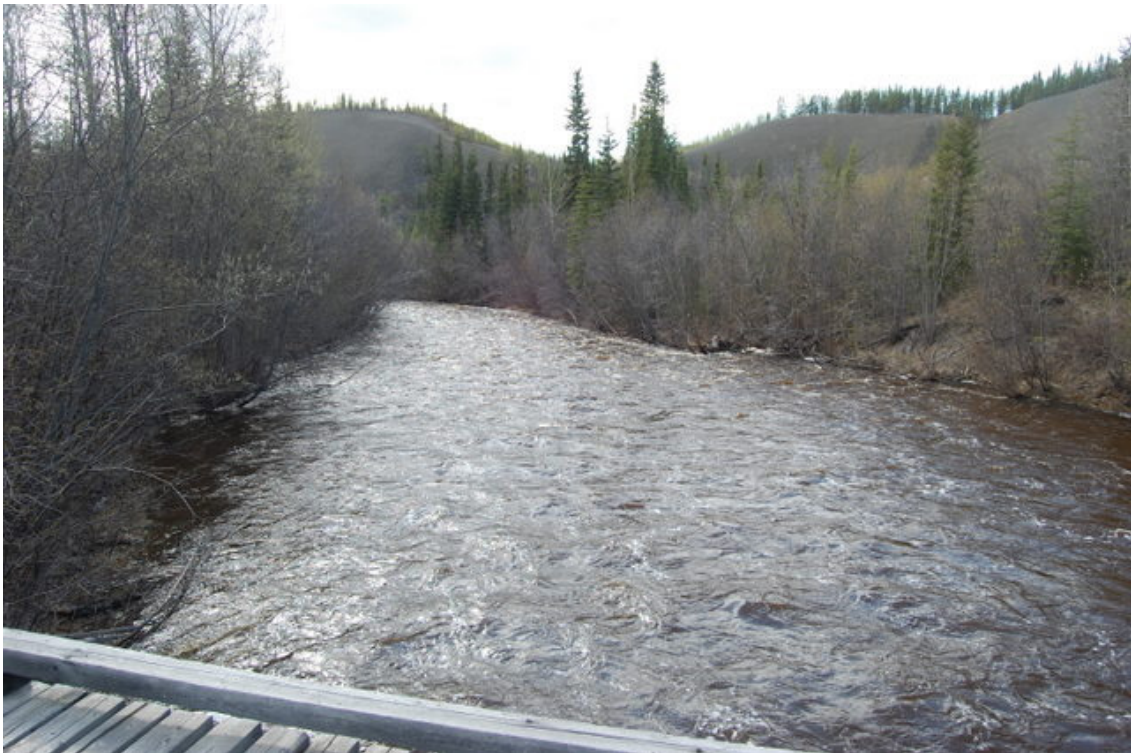
**Figure A.1: Blind Creek (BLC) in August 2007 (top) and May 2008 (bottom)**

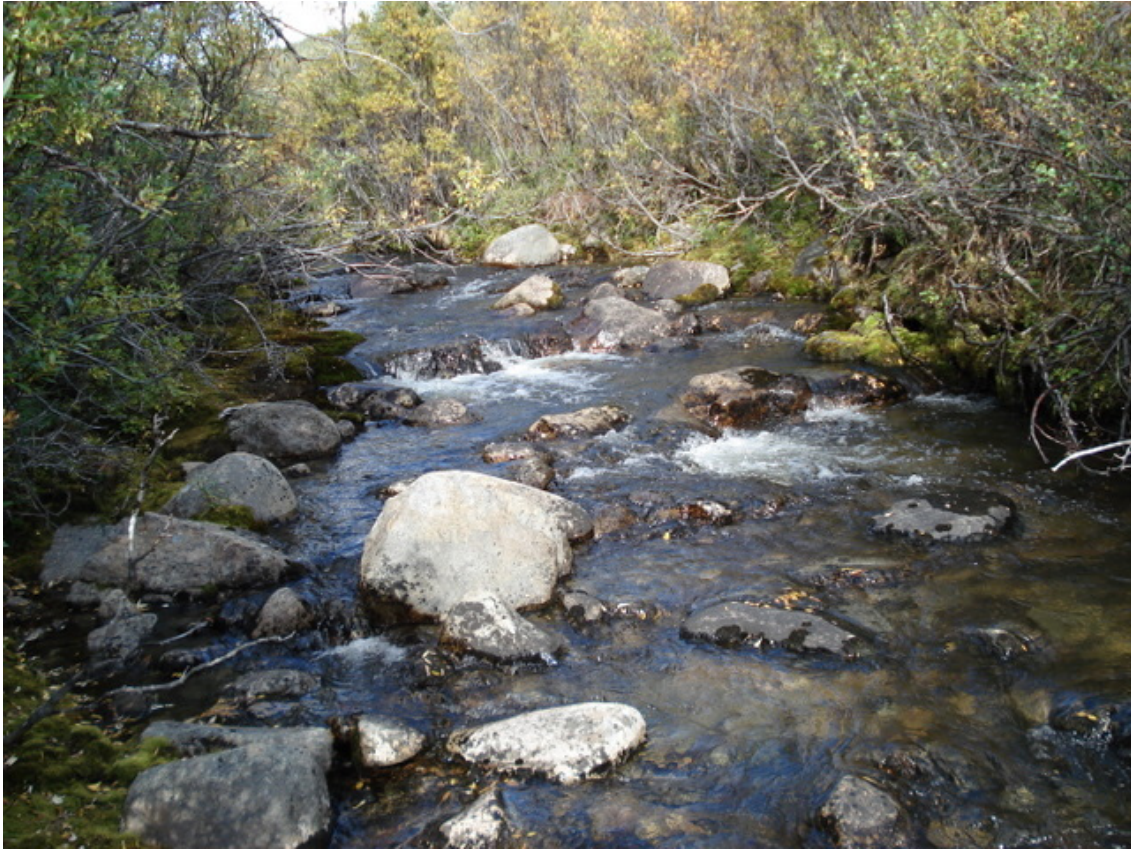
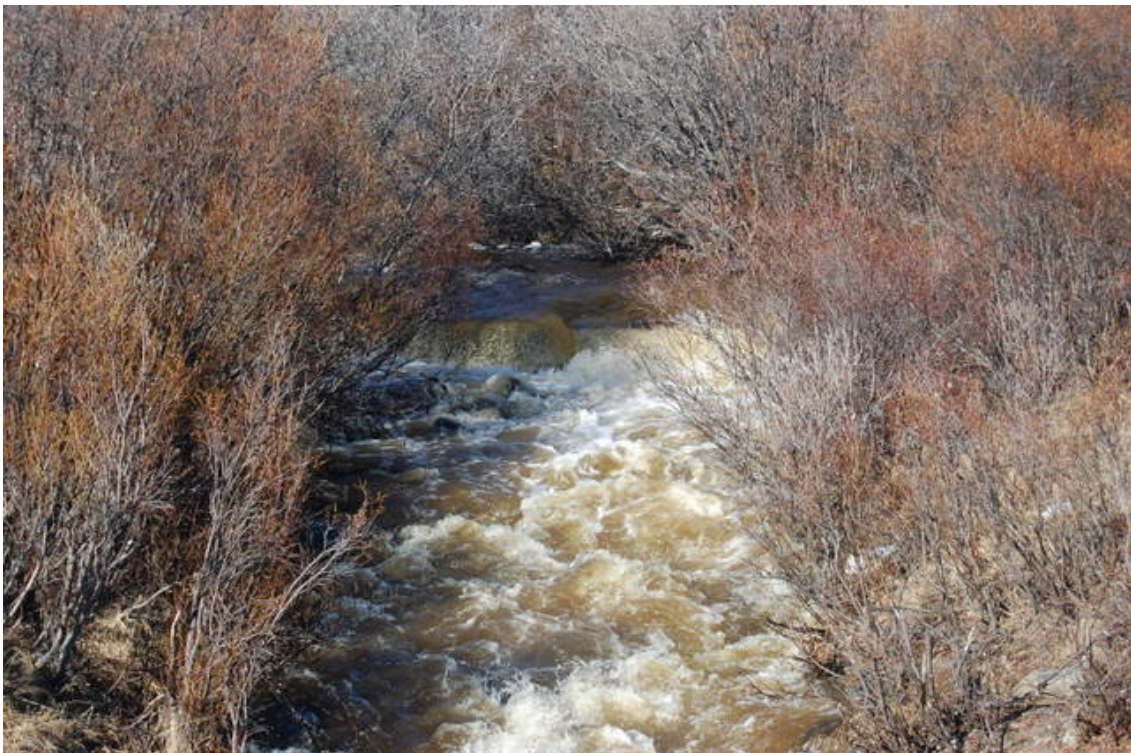
**Figure A.2: Faro Creek (FC) in August 2007 (top) and May 2008 (bottom)**

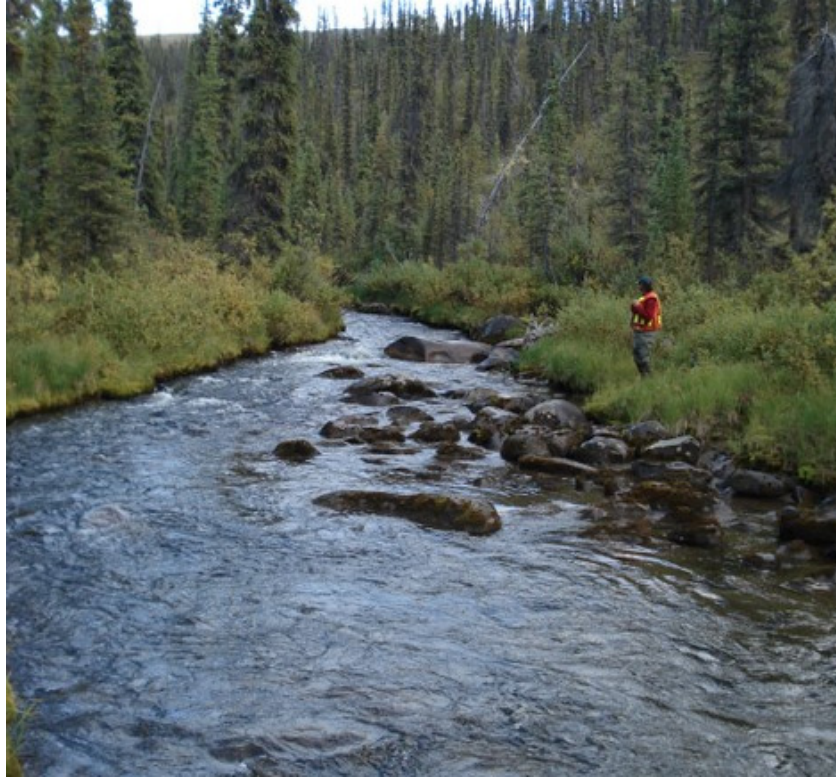
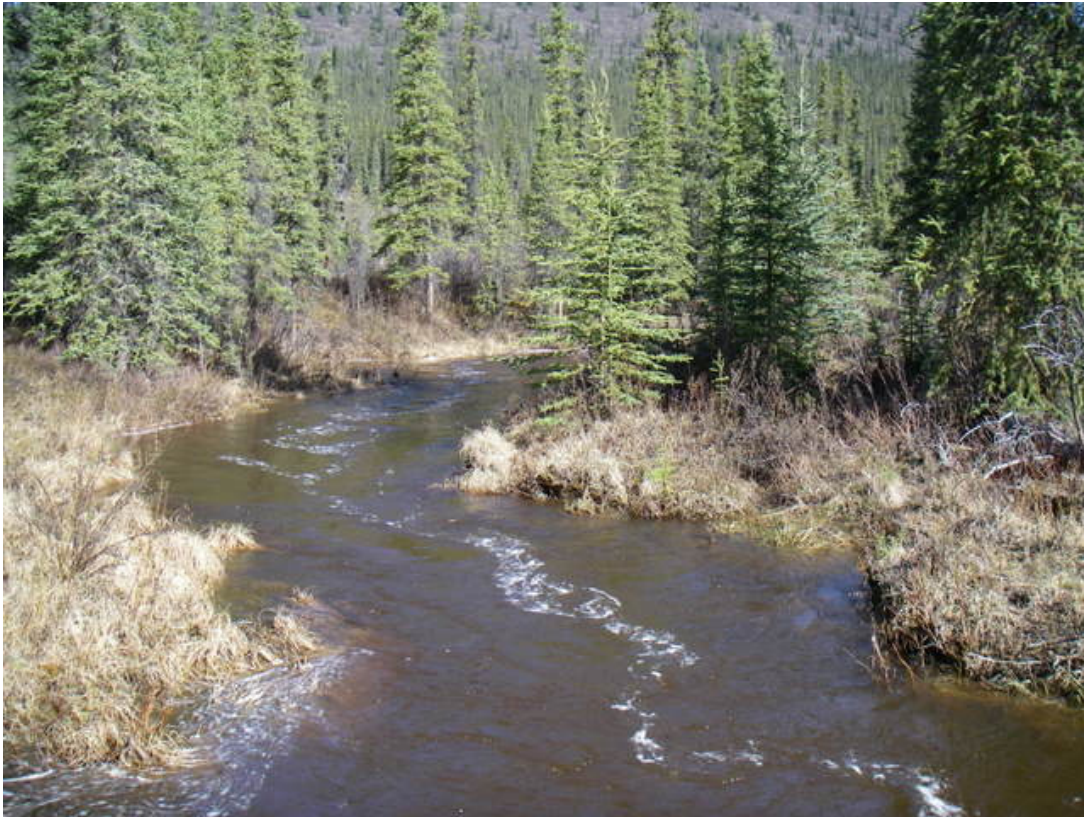
**Figure A.3: North Fork Rose Creek (R7) in August 2007 (top) and May 2008 (bottom)**

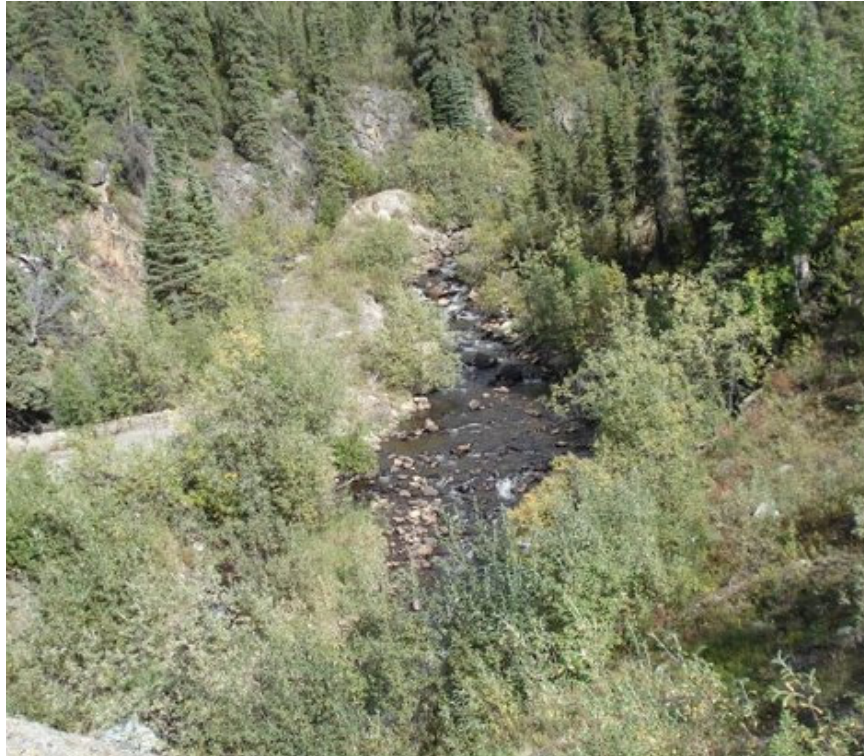
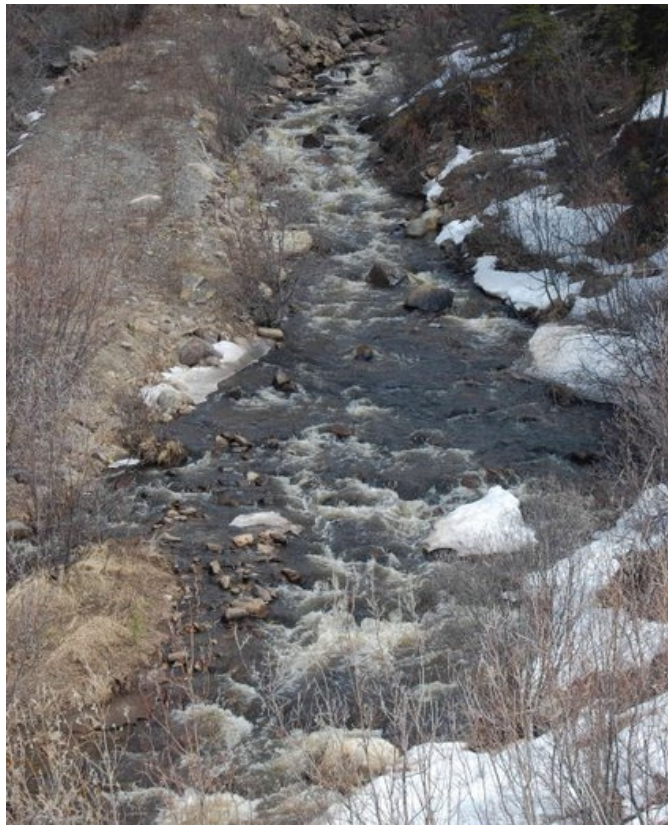
**Figure A.4: South Fork Rose Creek (USFR) in August 2007 (top) and May 2008 (bottom)**

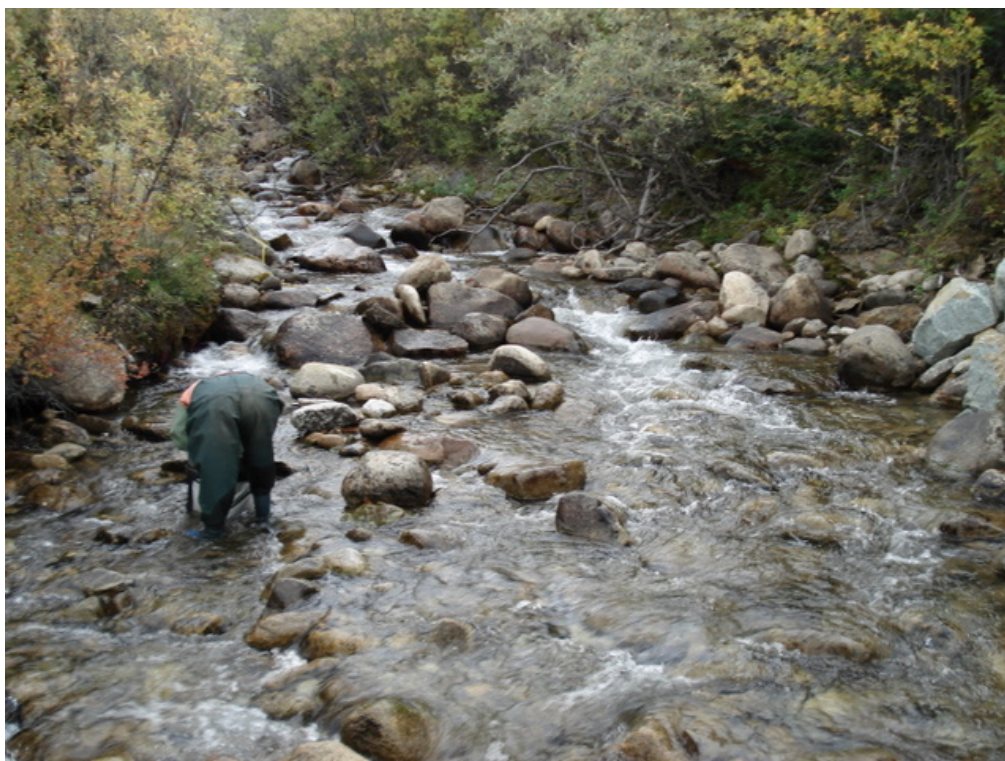
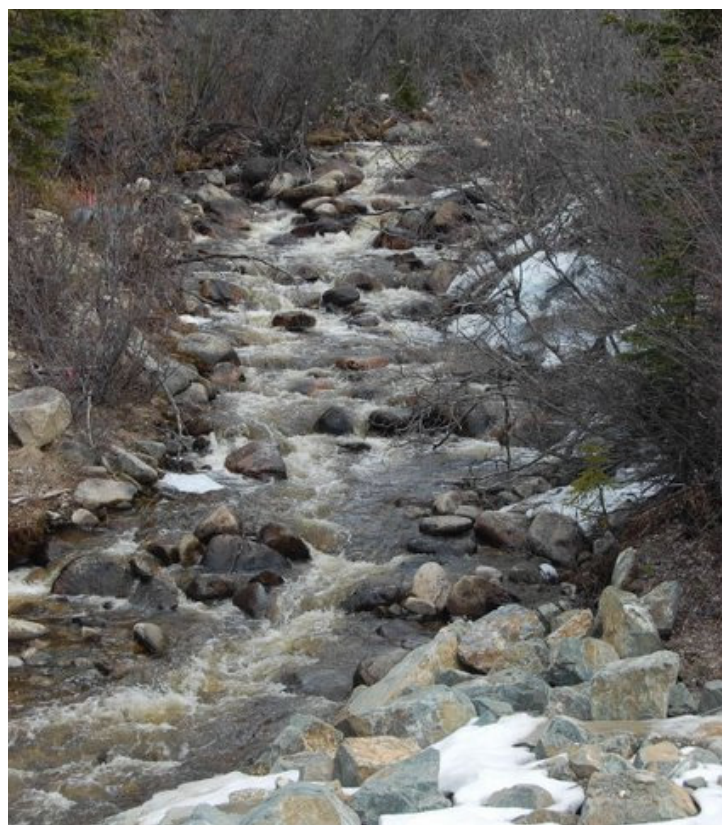
**Figure A.5: Upper Vangorda Creek (V1) in August 2007 (top) and May 2008 (bottom)**

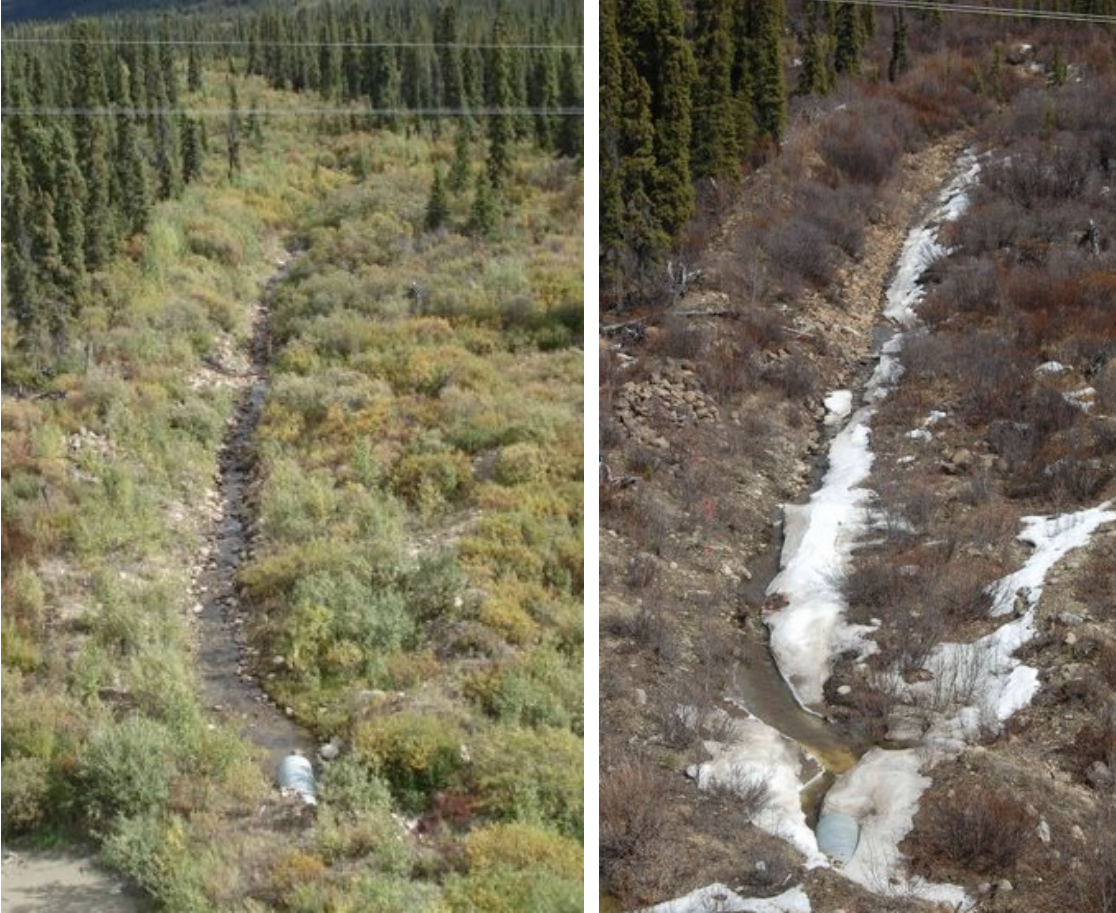
**Figure A.6: Upper West Vangorda Creek (VR) in August 2007 (left) and May 2008 (right)**

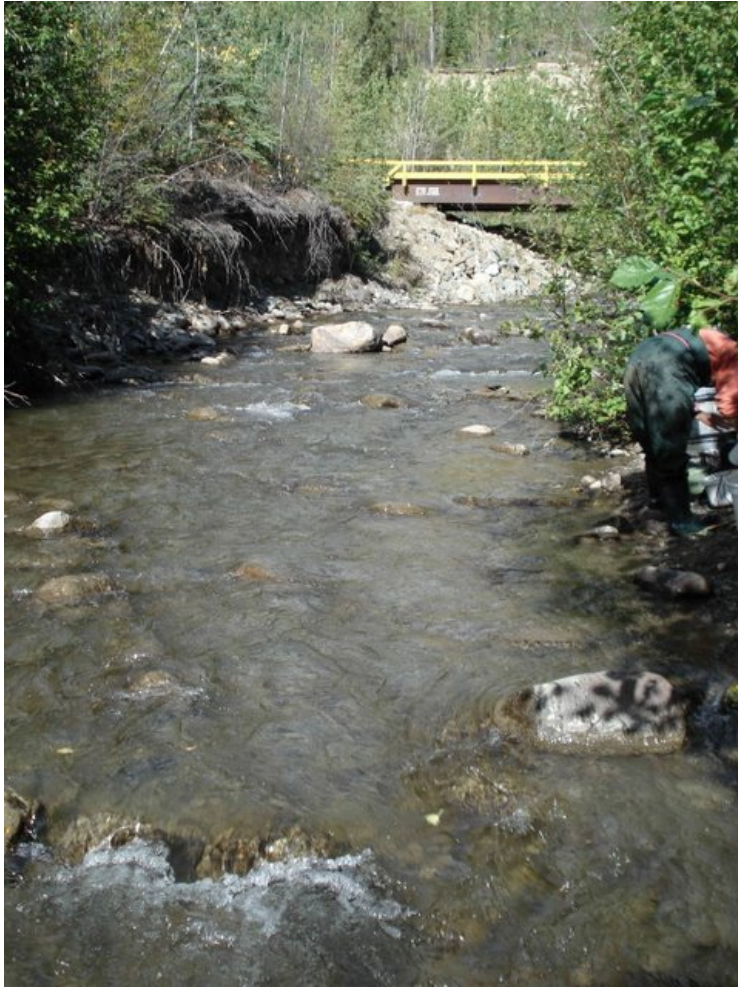
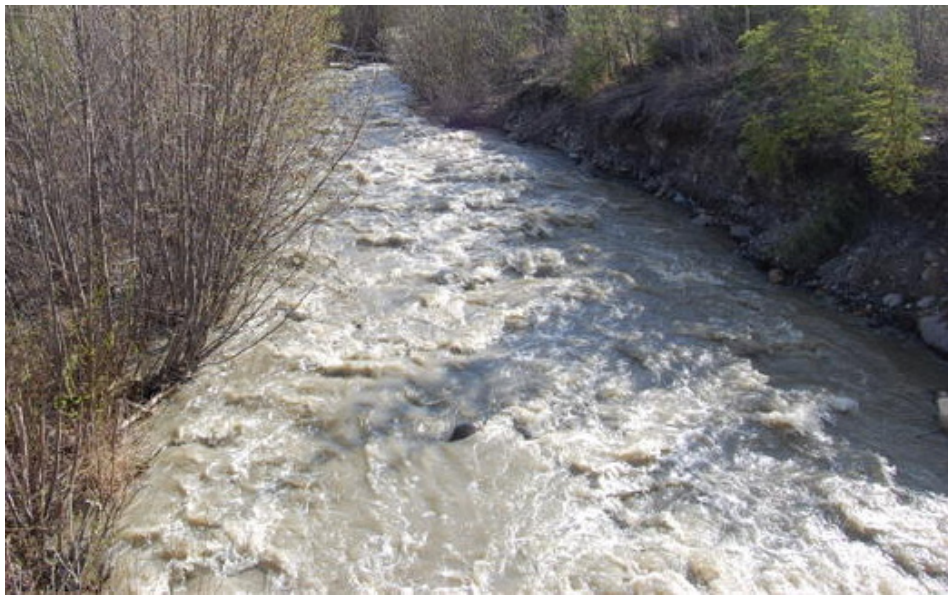
**Figure A.7: Vangorda Creek (V8, upper bridge) in August 2007 (top) and May 2008 (bottom)**

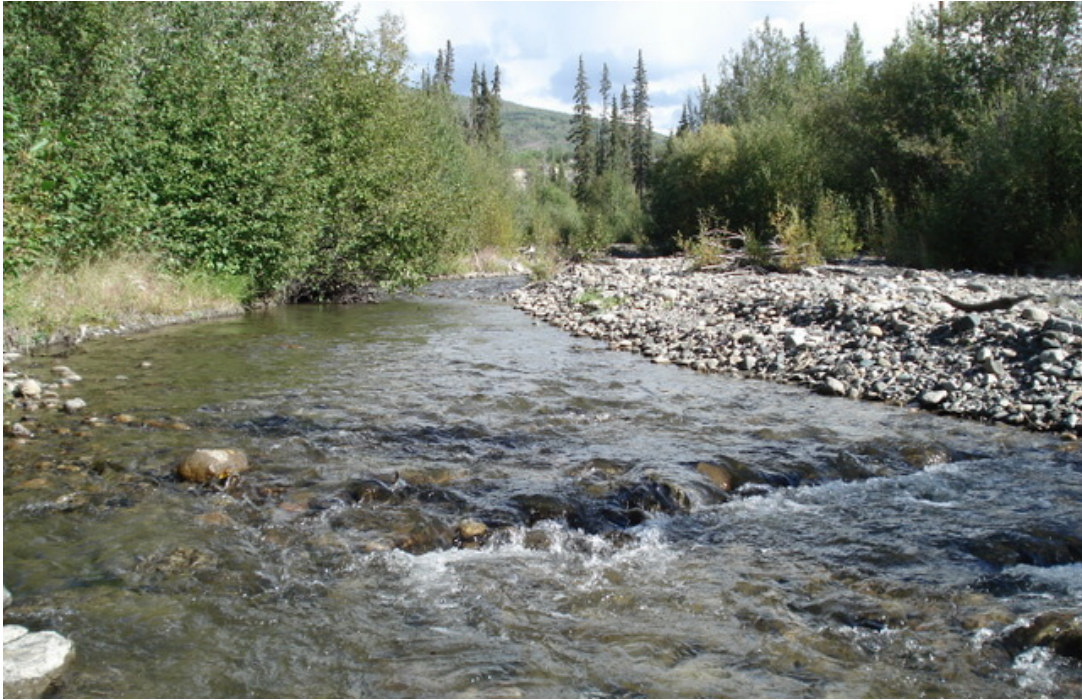
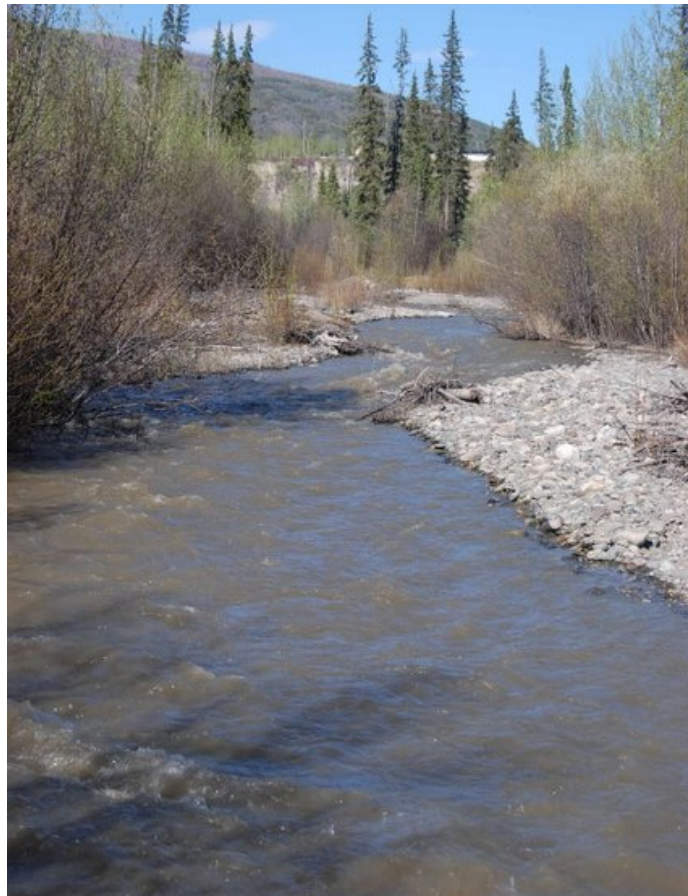
**Figure A.8: Vangorda Creek (V8, lower crossing) in August 2007 (top) and May 2008 (bottom)**

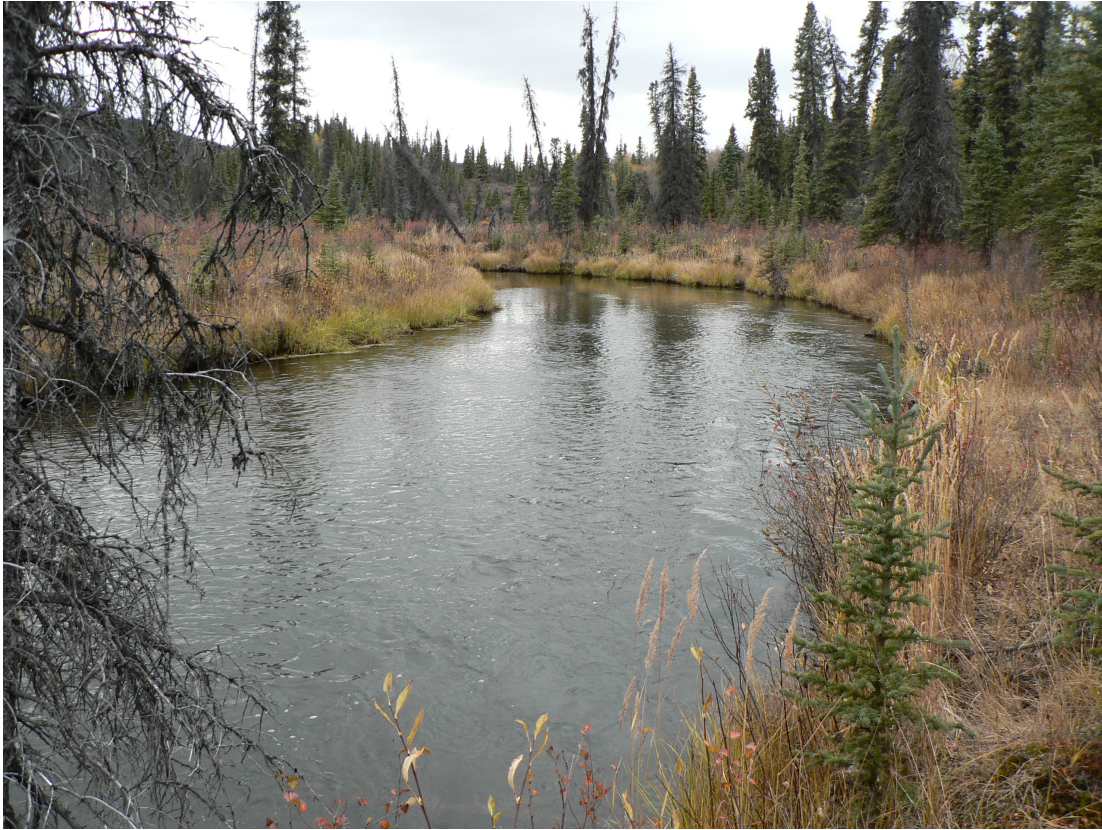
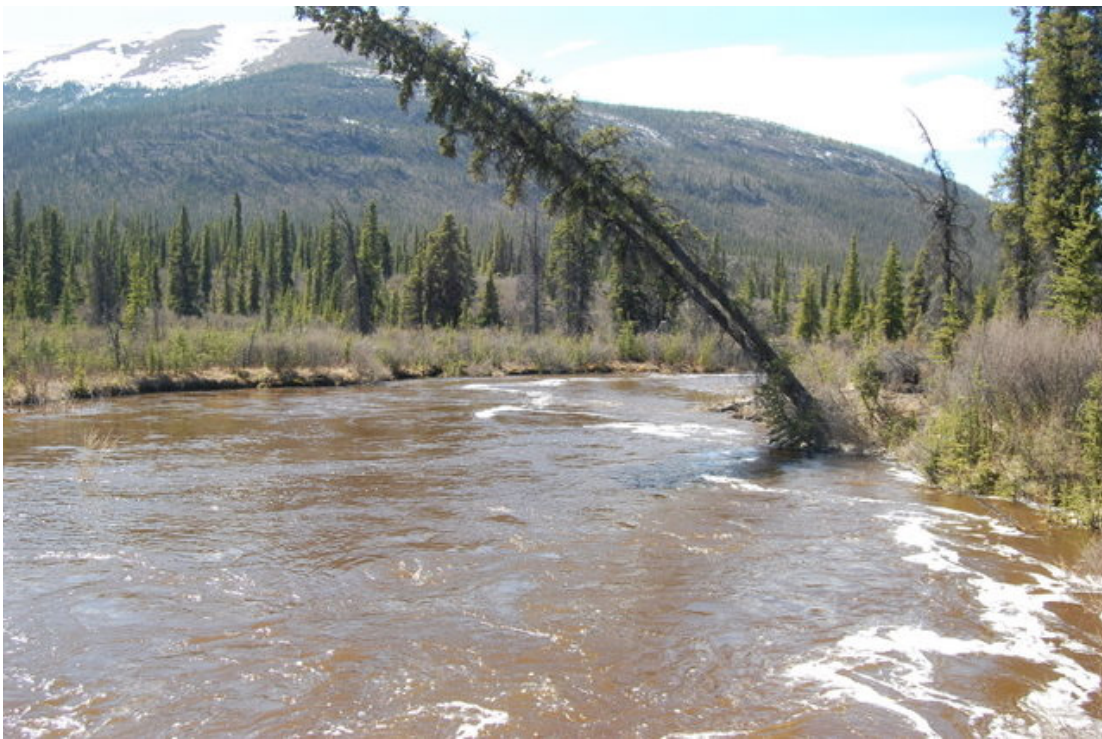
**Figure A.9: Rose Creek near X14 in September 2006 (top) and May 2008 (bottom)**
