**GOVERNMENT OF YUKON  
FORMER CLINTON CREEK ASBESTOS MINE -  
Long Term Performance Monitoring - 2006**

UMA Project No. 6029 008 00 (4.6.1)

April 2007

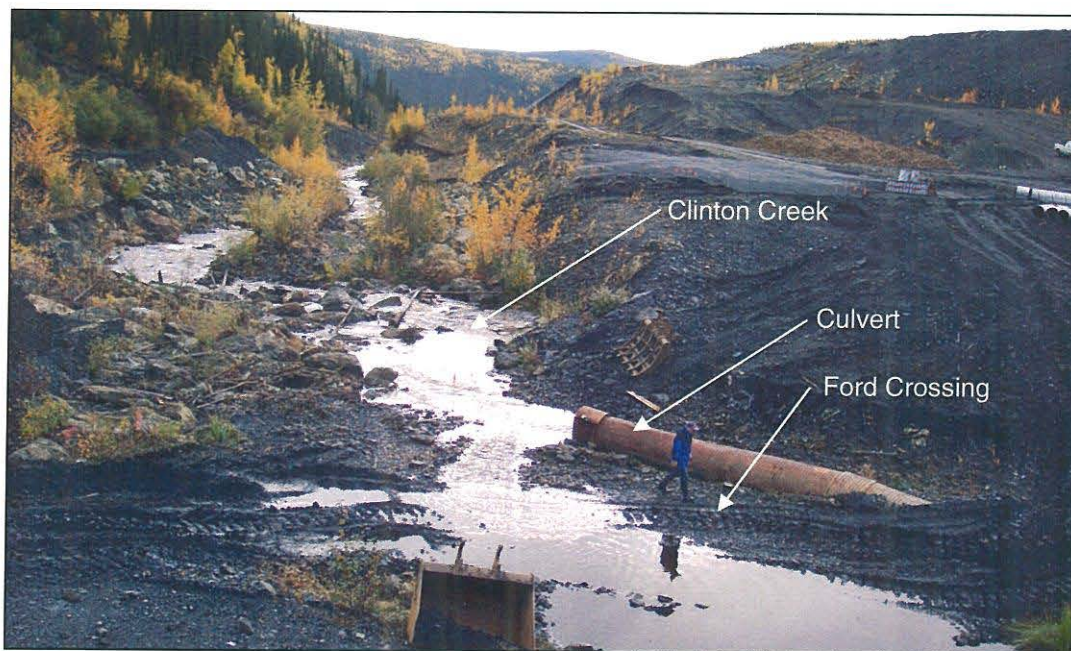
Prior to construction of the four gabion drop structures in the Clinton Creek channel immediately downstream of the Hudgeon lake outlet, the water level in the lake was controlled by two culverts at the ford crossing (Figure 2-1). On July 24, 2002, a meeting was held in Dawson City, Yukon with Al von Finster of DFO, Brett Hartshorne of Indian and Northern Affairs Canada (INAC) and UMA to discuss the proposed creek stabilization work at the former Clinton Creek mine. As reported in a letter from INAC to DFO which summarizes the meeting (Appendix A), it was agreed to design the stabilization works with an outlet control that would increase the water level in Hudgeon Lake by about 300 mm (to about elevation 411.15 m).

Figure 2-1 Hudgeon Lake Outlet Prior to Construction of Channel Stabilization Work

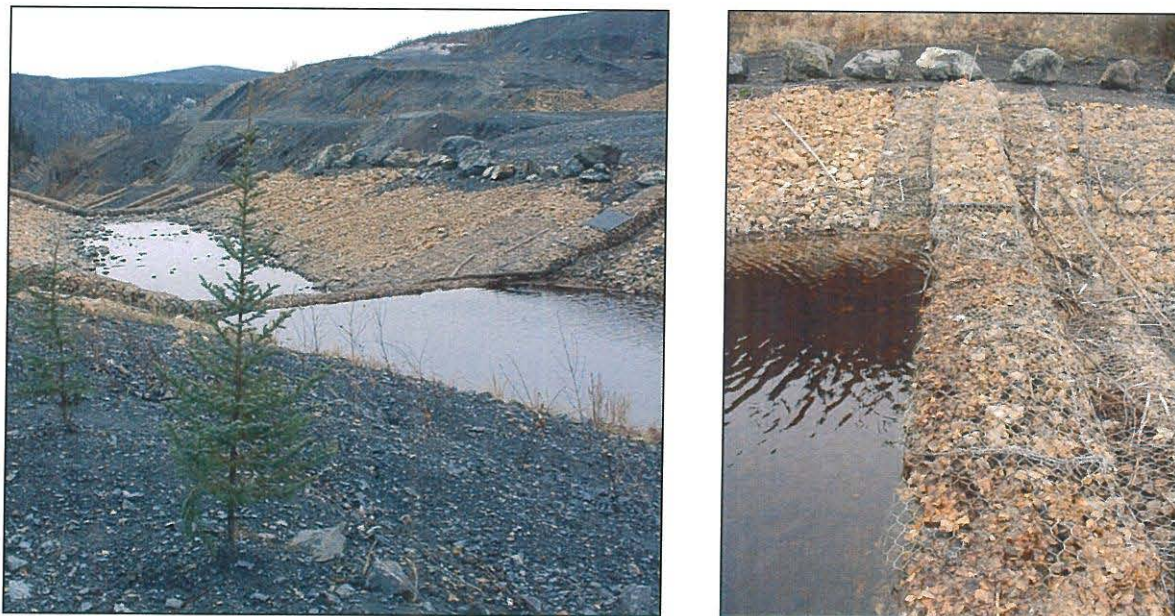
The drop structures and drawdown weir were constructed of rock filled gabion baskets that are permeable enough to allow some flow through the baskets. The first drop structure functioned in this manner for the first two to three years maintaining lake levels at about elevation 411.15 m during dryer periods. However, as illustrated on Figure 2-3, floating organic debris (e.g. dead leaves and spruce needles that were washed into the lake after the forest fires in 2004) has settled into the baskets. This debris has partially blocked flow through the drawdown weir and the underlying row of gabions resulting in lake levels near 411.5 m for extended periods of time. This condition does not significantly impact the flow capacity of the drop structures during high flow events as the water mainly flows over the gabions (Figure 2-4).

Figure 2-3 Organic Debris on Upstream Side of Drop Structure #1

The opening will result in a small reduction in upstream water levels during periods of high runoff (e.g. spring freshet). During low flow periods, the flow will be centered in the structure at the first drop step and the lake levels should be maintained at levels between 411.0 to 411.2 m. Blockage of the opening in the drawdown weir may still occur if larger floating debris (e.g. drift wood) accumulates in front of the opening. Beavers may also attempt to block the opening. Once the opening is partially blocked, debris may again accumulate and further reduce flow through the opening. The presence of debris should be checked for during every site visit and if necessary, blockages should be removed from the opening.

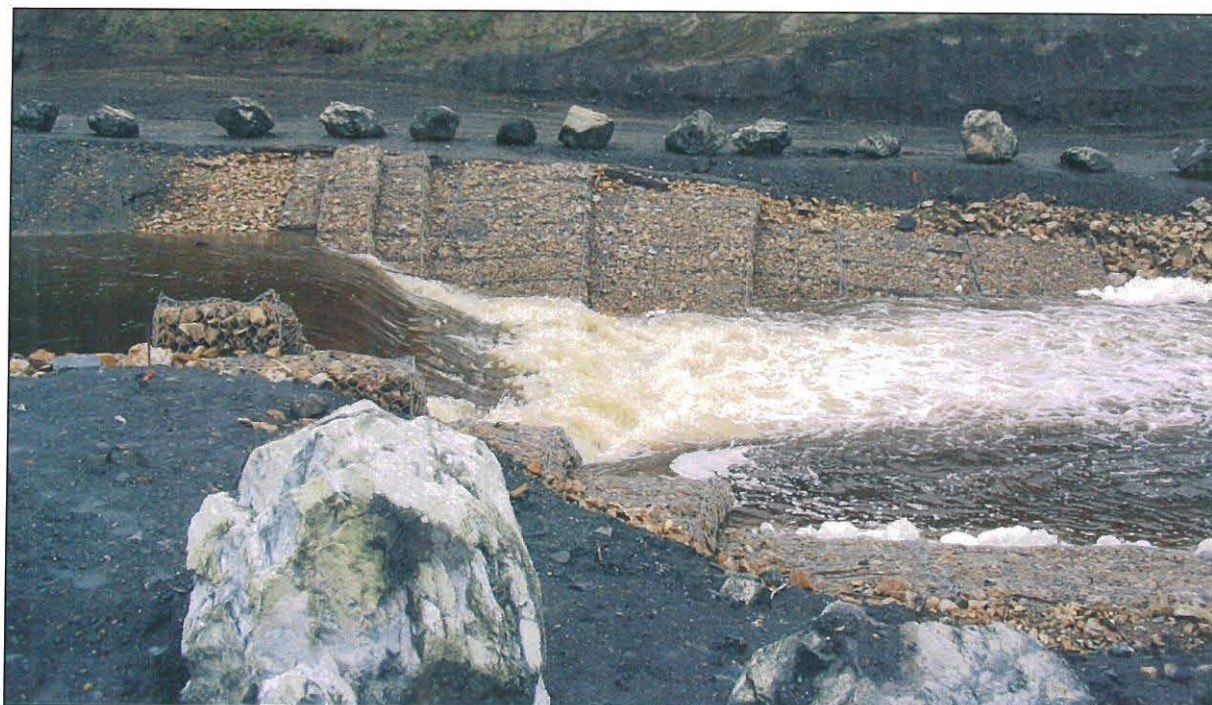
Figure 2-4 High Flow Rate Over Drawdown Weir

During low flow periods, this condition results in lake levels that are about 500 to 600 mm higher than the lake levels before construction of the channel stabilization works. To reduce the impact of debris blockage and achieve lower lake levels during periods of low flow, a larger opening in the first draw down weir is required. UMA has reviewed the hydraulics of the drop structure design and determined that this could be accomplished by removing one compartment (0.5 x 1.0 x 1.0 m) in the draw-down reduction weir. Because of the rotation of the drop structure (i.e. channel bend), the compartment to be removed should be located immediately to the right of the channel centreline (when facing downstream) so that the increased flow rate through this opening will occur on the inside of the channel bend. The horizontal bend and flow concentration to the outside of the bend are visible in Figure 2-4. Having the new opening located to the right of the channel centerline will result in the water flow discharging toward the centre of the structure.

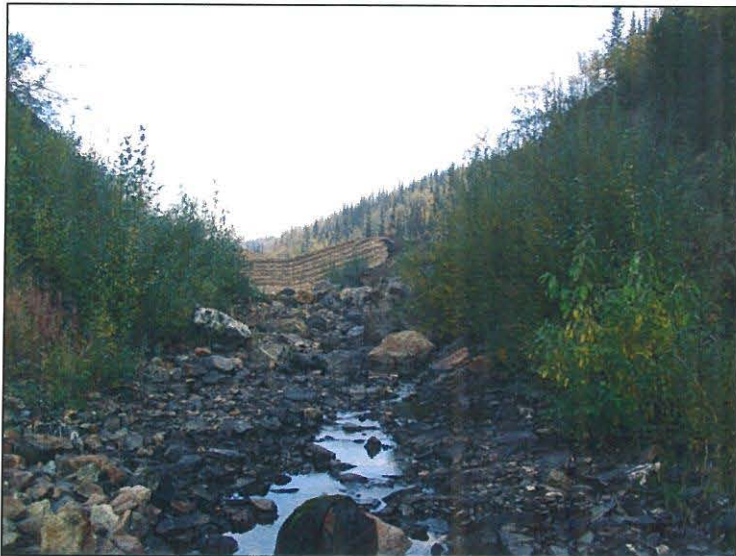
No channel down-cutting is evident for the first 20 m downstream of the end sill on Drop Structure #4. In this section of the channel, the gabion drop structure was constructed just upstream of a area where the channel is relatively well covered with boulders (Figure 3-1) from the former rock weir (Drawing 09). Immediately downstream of the end sill of Drop Structure 4, some additional gabion baskets were installed as a transition between the stabilized creek and the existing creek channel. The transition is 9 m long and consists of two full rows of gabion baskets (6 m long) covering the channel sides and bottom followed by a single row of baskets (3 m long) along the channel bottom (UMA 2005). Beyond this point, the channel is relatively well protected with boulders to about Station 0+195 m near the area where bedrock is exposed in the channel bottom. From about Station 0+195 m (i.e. just downstream of the boulders) to 0+225, about 0.2 to 0.3 m of localized down-cutting is evident in the 2006 survey. Downstream of Station 0+225, there is some evidence of minor and localized down-cutting with some stretches showing as much as 1 m of aggradation (deposition). These results are not unexpected as localized slumps routinely cause small blockages until the material is washed and deposited farther downstream (Figure 3-2).

Figure 3-1 Channel Downstream of Drop Structure #4

The 2006 survey suggests about 0.2 to 0.3 m of channel degradation has occurred around Station 0+200 m, which is significant enough to trigger planning for channel revetment work. However, because the length of channel where this has occurred is less than 10 m long it is recommended that the channel between Drop Structure #4 and Station 0+225 m be re-surveyed and visually examined in 2007 to determine if this action is necessary. Given the irregular channel bottom amongst the boulders, it is

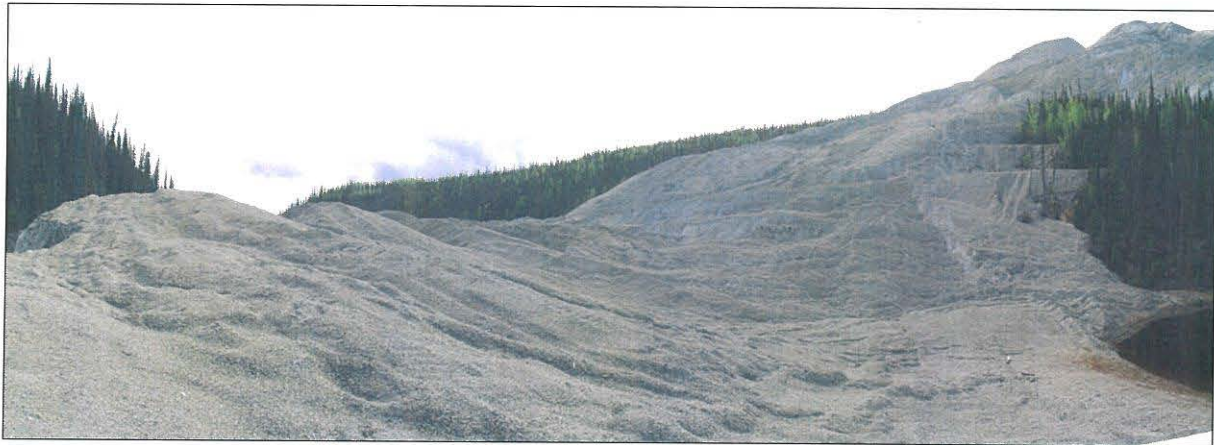
The upper and mid slope areas are moving down slope in an easterly direction. Near the mid and lower slope boundary, the movement vectors tend toward a north easterly direction indicating some lateral spreading is occurring, which is more pronounced by the lower slope movement vectors. This general direction of movement is indicated on Drawing 13. The movement vectors for the monitors in the center of the lower slope area along the creek (e.g. 25B, SL-1 and SL-2) are moving eastward and the movement monitors along the south edge of the lower slope area (2005-04, 2005-05 and 80-9) are moving in a south easterly direction. These movements show that lateral spreading of the tailings is occurring and will likely continue until sufficient toe resistance (e.g. mounding) is developed across the lower slope area. Figure 3-2 illustrates the mounding and lateral spreading along the north edge of the lower slope area

Figure 3-2) Mounding at Toe of South Lobe Near Monitor 2005-01 (view South)
