Historical Review

Of
Selected Mining Sites
In The Silver Trail Region

Prepared for
Waste Management Program
Indian and Northern Affairs Canada

March 2005

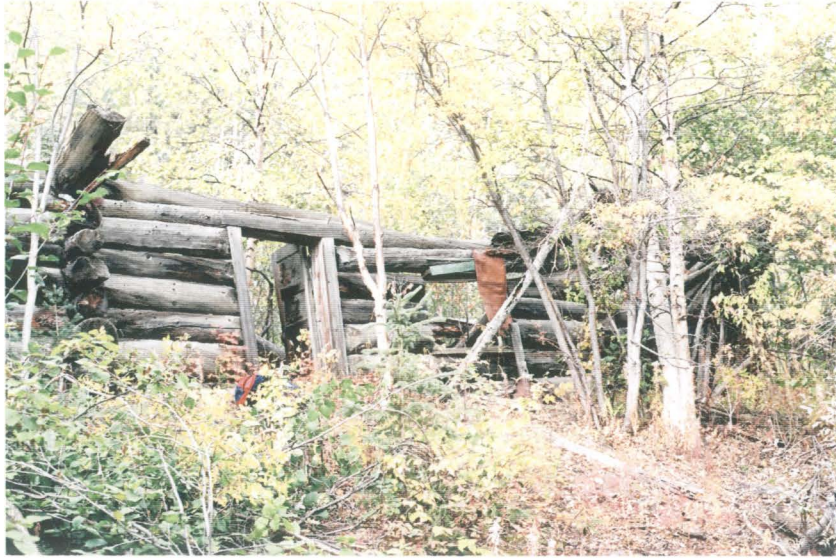
As stated in previous reports there is one shaft, an adit, and an old log cabin at this site. The cabin is three meters to the west of the dirt access road, and easily visible.

The log cabin's dimensions are 5.19m by 4.67m with a 2.45 pole shed extension having been built on the north end.

The log building is of the 1920 to 1930 era. All the log work has been done by hand with an axe and the bottom layer of logs have been placed directly on the ground.

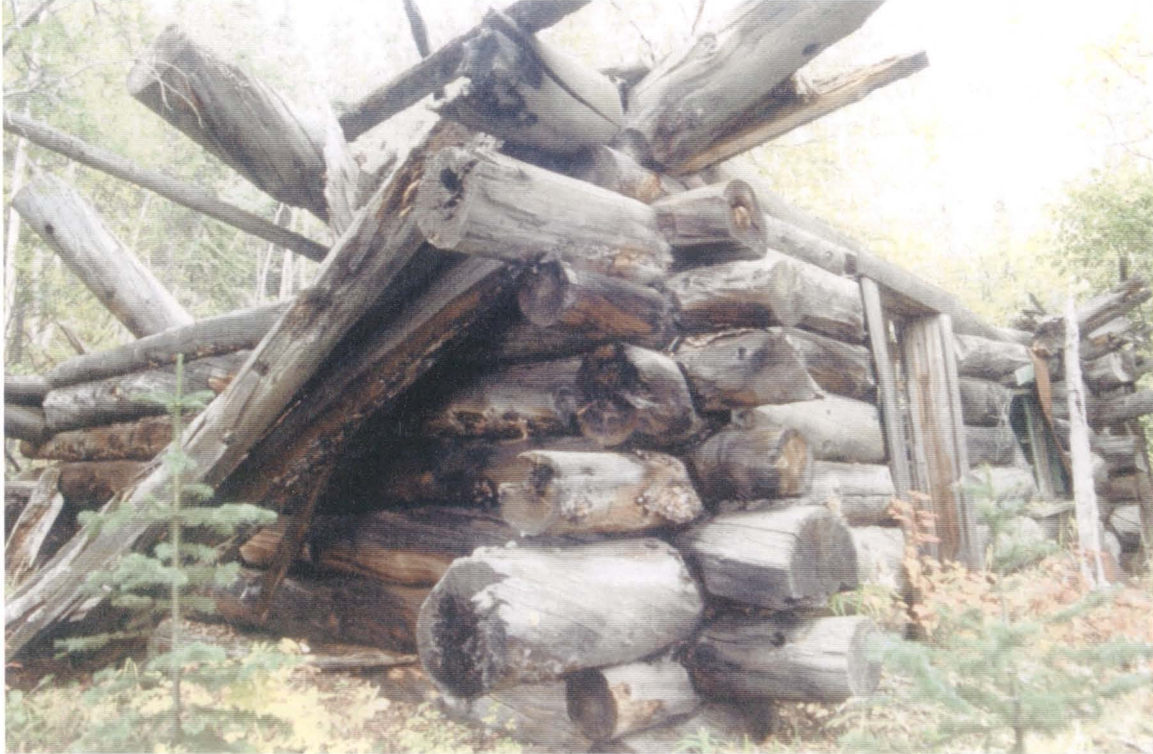
The corners of the building are all saddle notched, with moss and burlap being used for chinking material. The logs were hand hewn flat on the inside of the building.

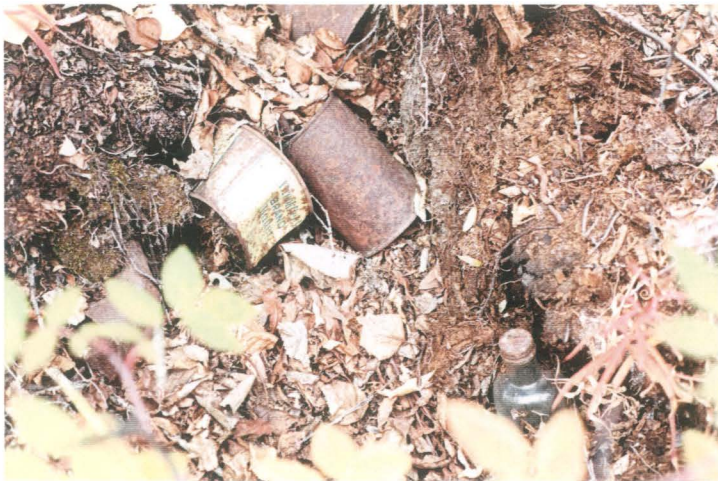
There is a small domestic waste dump just below the cabin on the edge of the access road.

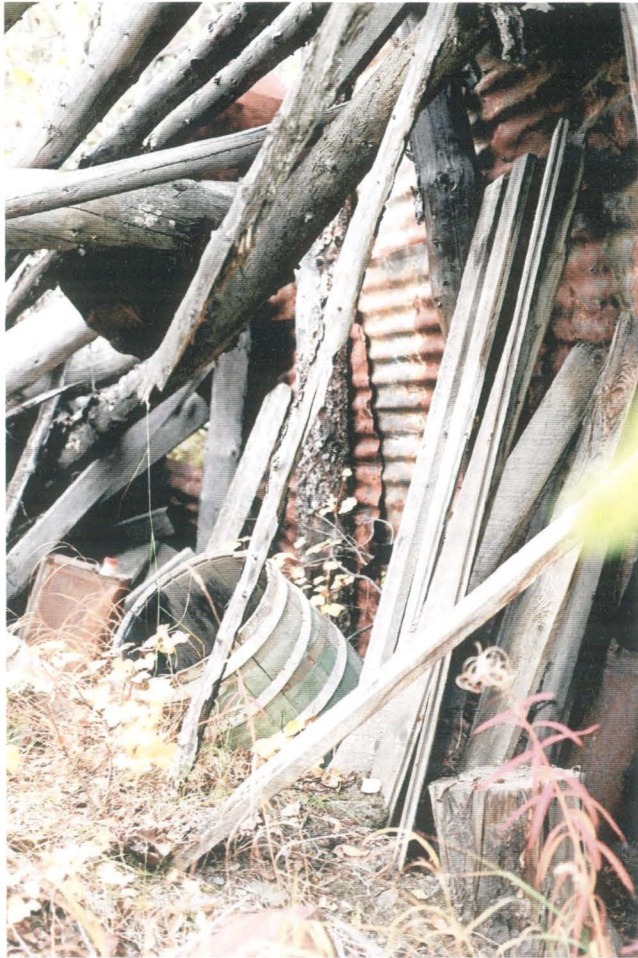
Under the collapsed sod roof we found numerous opened five gallon oil pails which were used for roofing material or as stove pipe safeties.

The building had a gable style roof with a pole shed extension. This shed extends at the same roof pitch as the main building.

The siding for the shed was heavy corrugated tin. The roof was also collapsed on the shed.

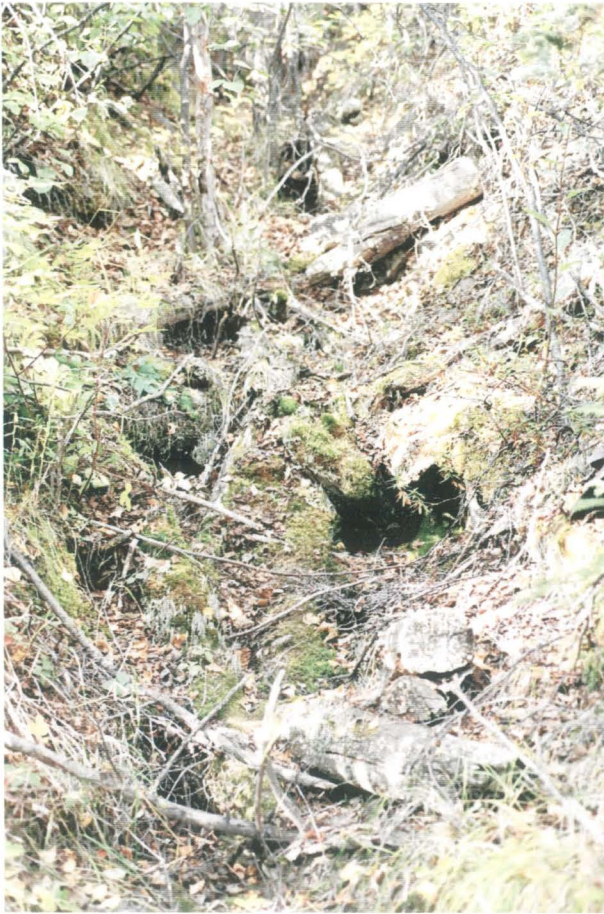
Moving north, down the dirt road 26.95m and up slope approximately 4m, are the remains of the collapsed adit. The portal has fully collapsed with only some old timbers sticking out through the waste material.

There is a small 1 meter by 1 meter plank platform to the left of the adit, possibly the remains of a storage facility.

There is a small gully that extends off the top side of the collapsed portal. It's possible that this shows the collapsed workings from the adit.

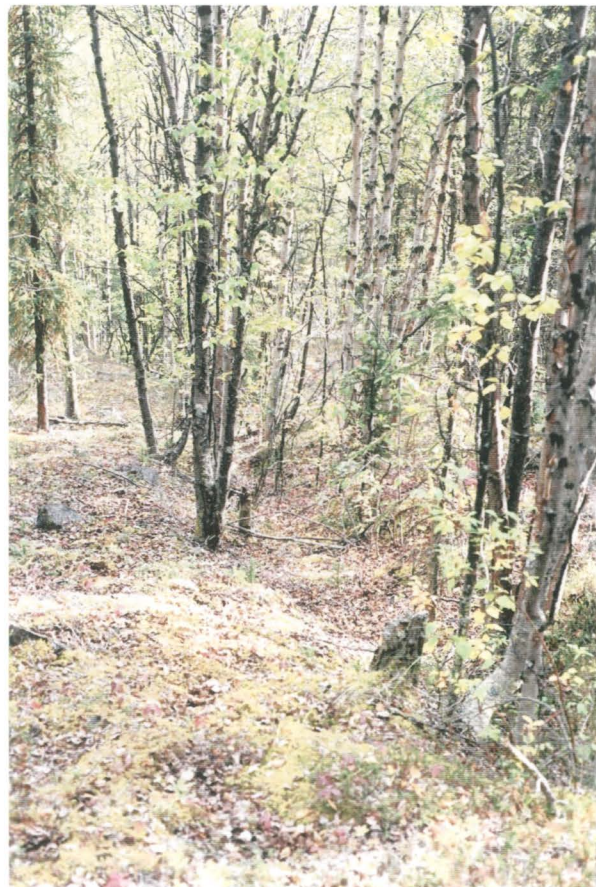
Following the gully upslope for approximately 30 meters you will find the shaft and windless.

The shaft cribbing extends .89 meters above the ground on the east side (down slope). Depth from the top of the cribbing to the water surface in the shaft is 2.79 meters. The old wooden windless is .9 meters above the top of the cribbing.

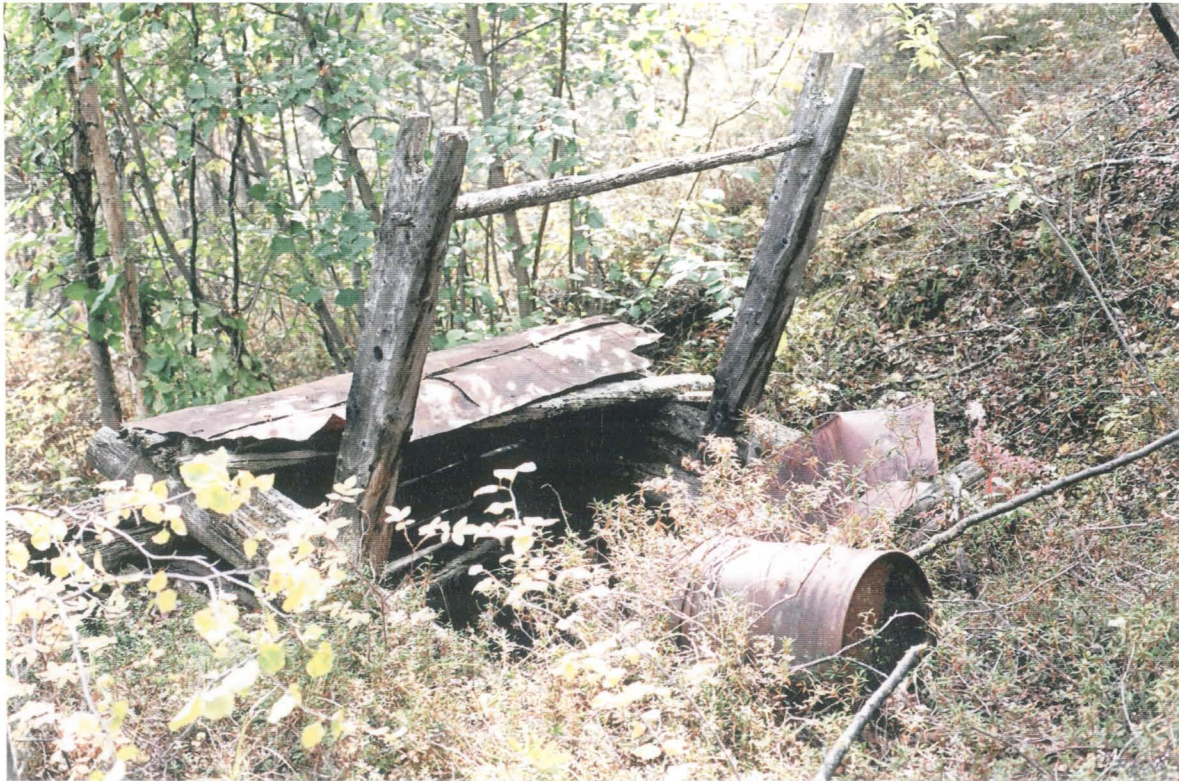
There was a tin cover made from old 5 gallon pails that covered the opening to the shaft. This has since collapsed.

In our opinion the shaft and windless structure should be preserved. This would also entail the re-establishment of the tin cover that closed the top of the shaft. A small amount of brushing could be done around the shaft and cabin to help preserve the structures.

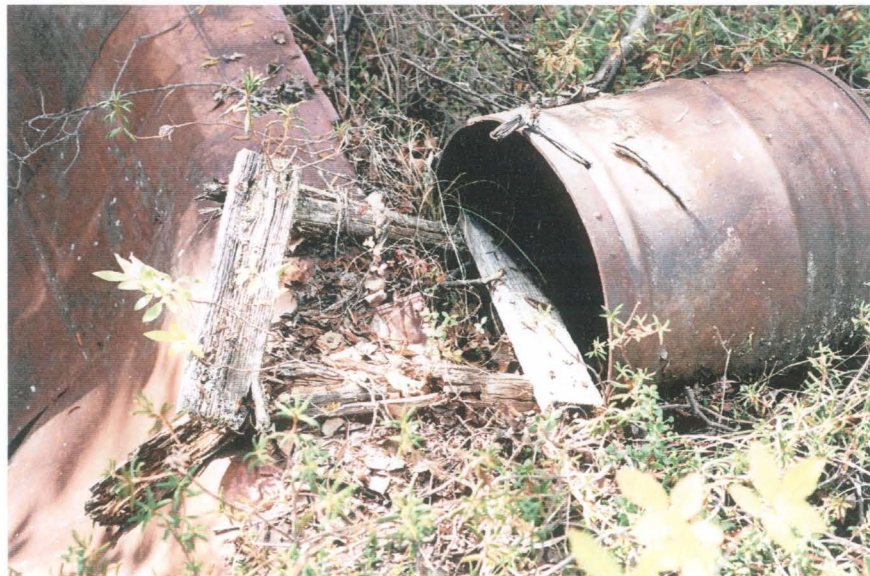
The windless bucket is laying just up slope of the shaft.

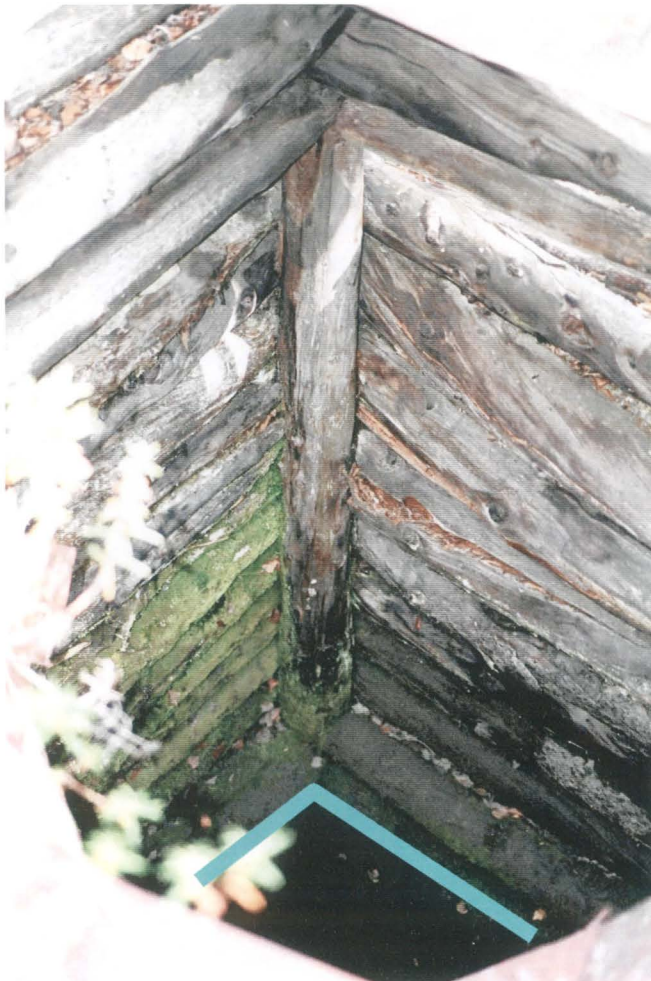
The major public concern with this site would be the exposed shaft located above the cabin. It's approximately eight feet from the top of the cribbing to the surface of the water. We determined the water to be half a foot in depth, to a soft bottom. A second concern would be the contents of the small containers that are stored in the log pole addition to the cabin.

*Photo shows the inside of the shaft.
Blue lines indicate the water level in
the shaft*

We recommend that the shaft be filled in to the surface level to remove liability. Because this shaft is in fair condition we feel that the remediation should be done by hand to preserve the integrity of the site. The shaft could be filled by hand using local surface rock found up slope of the shaft. Any materials or liquids stored in the shed should be removed. The contents should be determined and then disposed of appropriately.

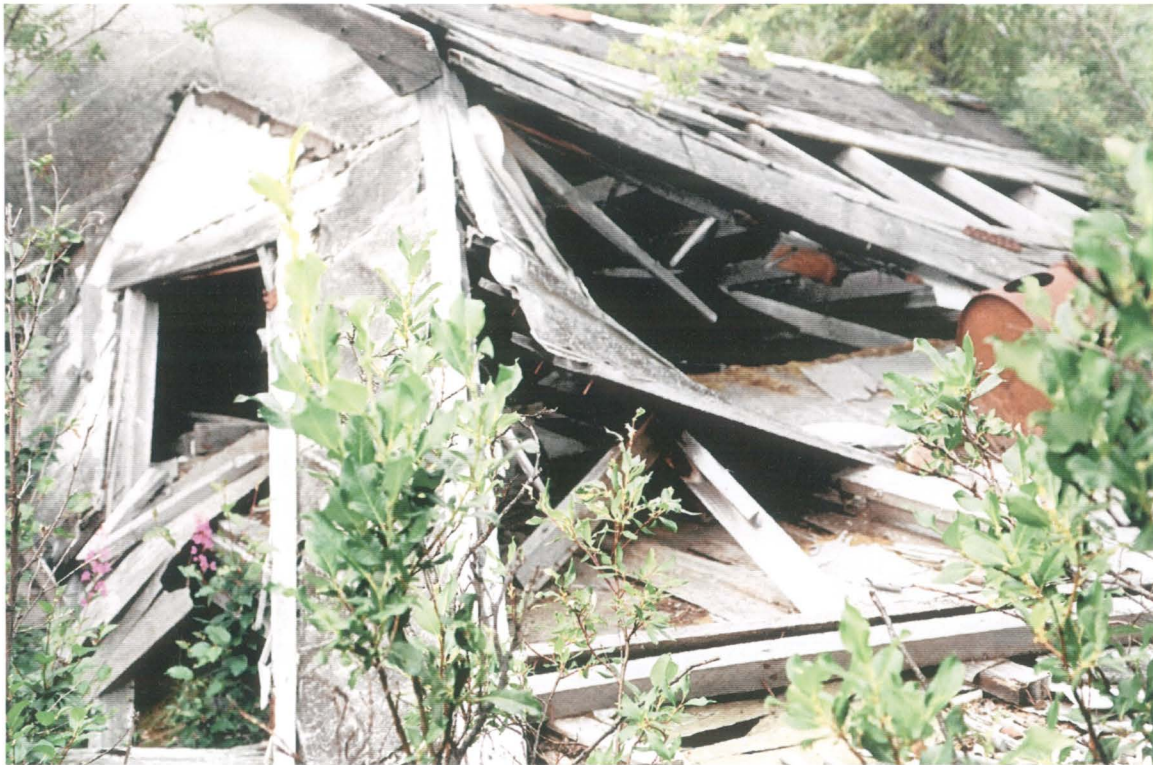
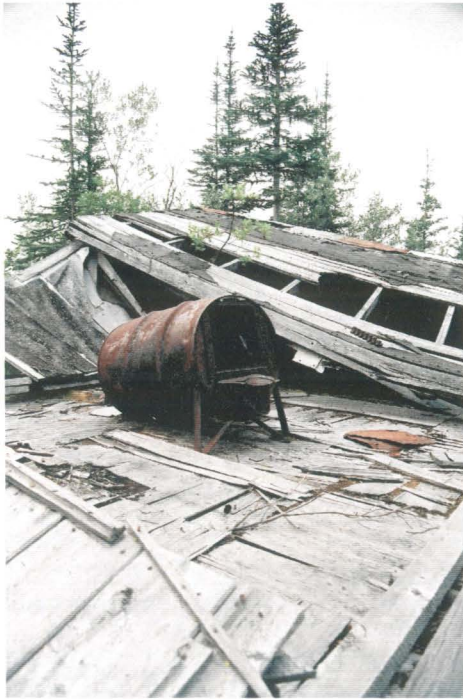
Building # 1 is the core shack. The walls of the building have collapsed down slope with the gable roof being suspended a few meters from the ground. The floor is intact with a large amount of drill core scattered over one corner.

The building is frame construction. The roof rafters are of 2 x 4s, with 1 x 8 board planking used for the exterior cover. White asbestos / tar paper was used as exterior wall covering, with rolled tar paper being used for the roof.

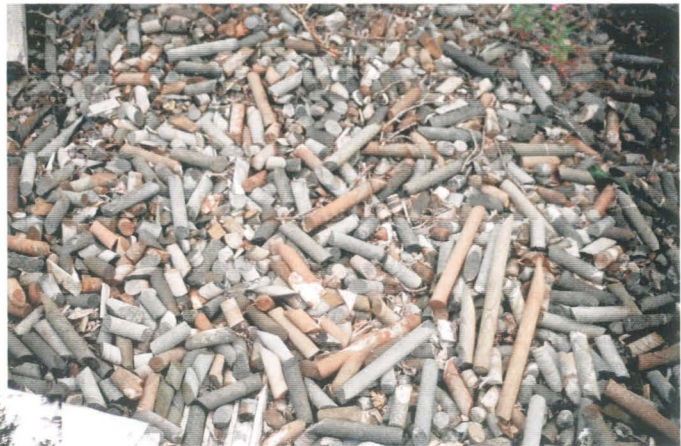
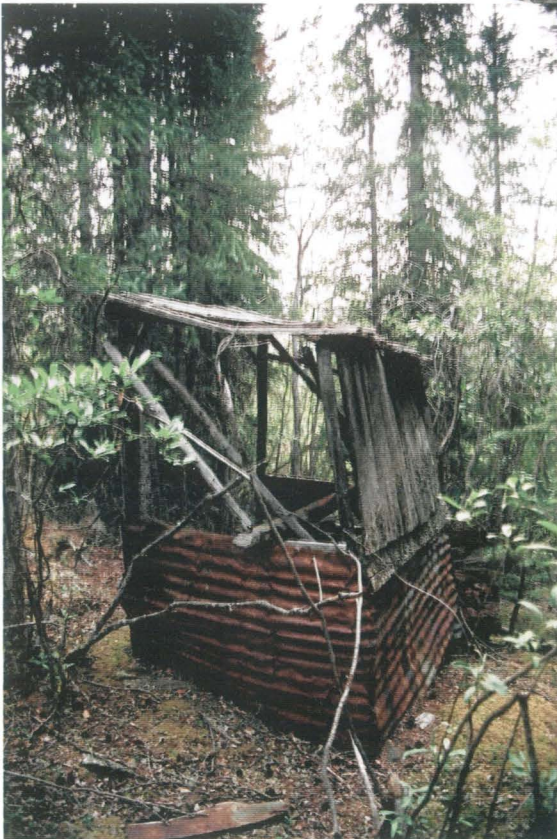
A substantial pile of drill core (below) is at the northwest corner of the building

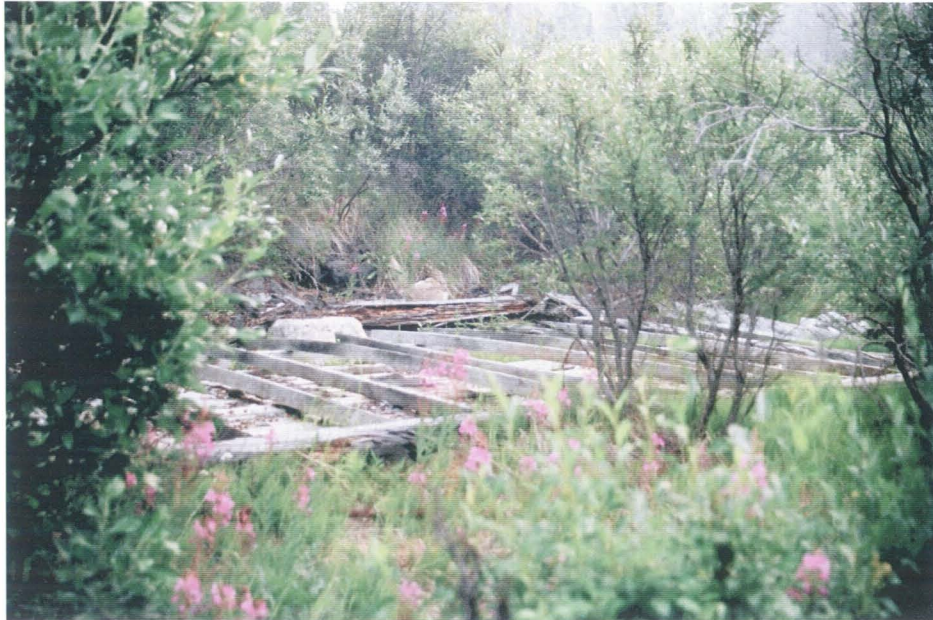
The upper adit is located approximately 37 meters due north of the core shack. The adit has fully collapsed leaving only some two inch pipe extruding from the collapsed trench. There is some evidence of old cribbing, and a loading platform to the east side of the adit.

UTM coordinates for the upper Adit are East 0485691, North 7090765

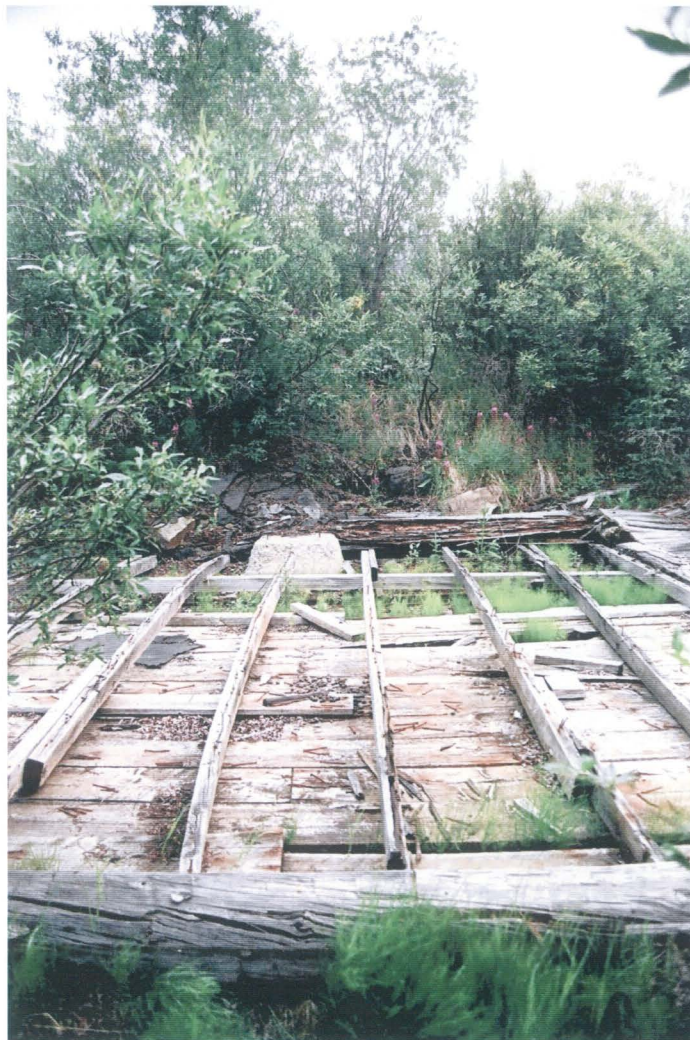
Building # 2 and the lower adit are within 5 meters of one another. The lower adit and the dump shed are approximately 20 meters directly west of Building #1.

The dump shed has two rounds of hand hewn logs. Part of the floor is still intact, and it looks as if the north wall has collapsed over the floor.

The floor is made of 1 x 10 planks over 4 x 4 joists and there is a concrete footing located in the middle of the north wall. Rails run east / west from the adit, through the building, stopping 1 meter short of the west wall.

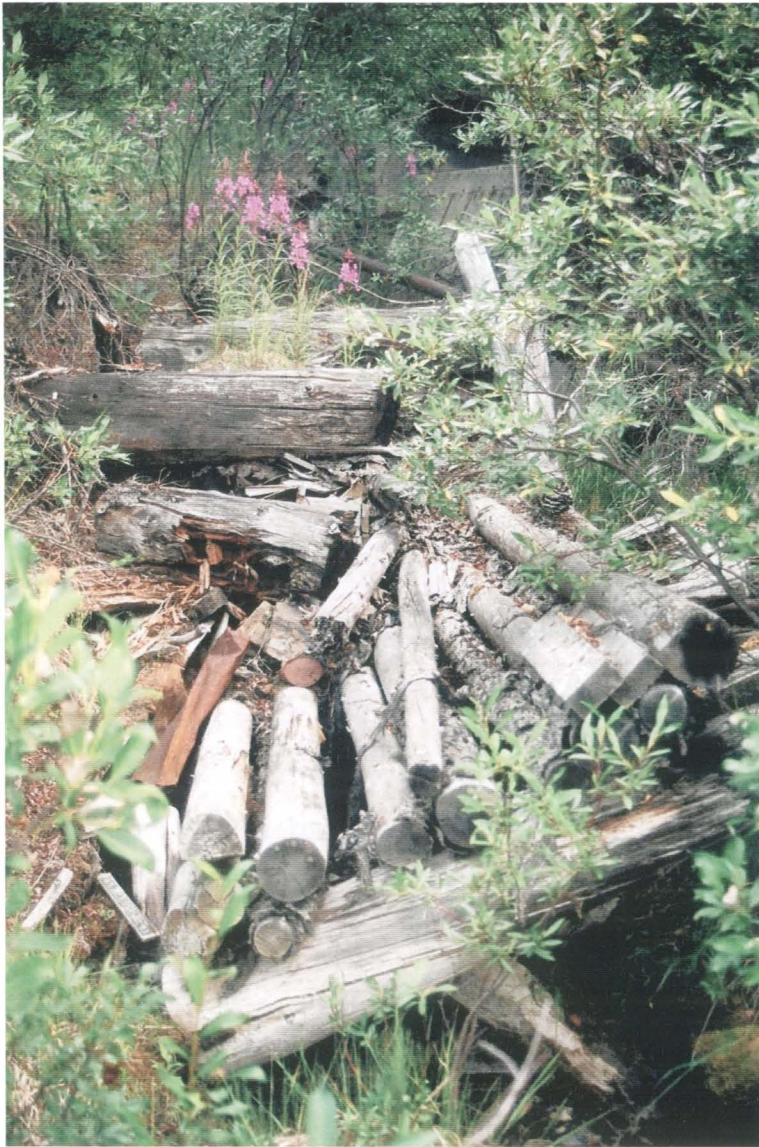
The lower adit (*left*) has completely collapsed and is inaccessible. The entrance door is still standing but the drift has collapsed behind it. Timber was used to support the adit with the approximate size being 2m x 2m.

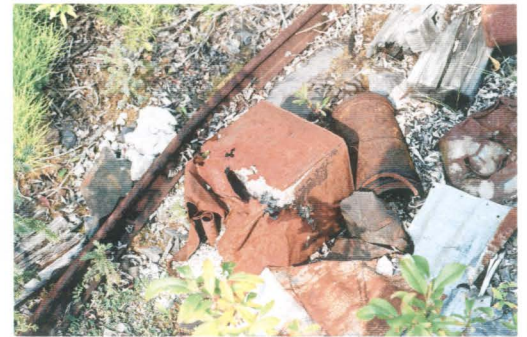
The cleared area located in front of the lower adit was the dumpsite. There is approximately 10 meters of narrow gauge rail extending to the dump edge.

There are 11 empty drums located over the steep bank of the dump on the east side. Heading southeast from the lower adit dump, we found another set of waste piles containing a couple of empty drums. Continuing in the same direction we found five 4 meter x 4 meter wooden platforms that were in line with one another. Nine drums were stockpiled at the second of these platforms.

From an environmental perspective all that needs to be done would be to remove the 45 gallon drums that are scattered about the site. There was no fuel storage, electrical equipment or potential contaminants observed at the site.

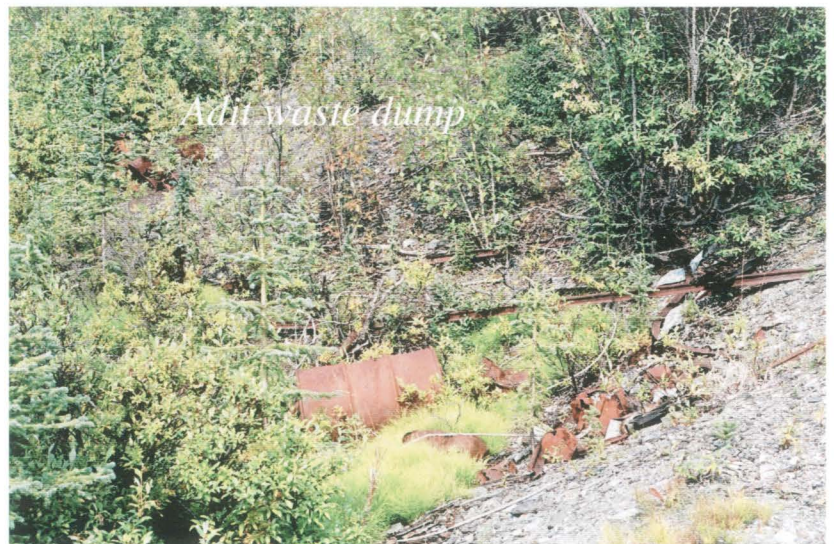
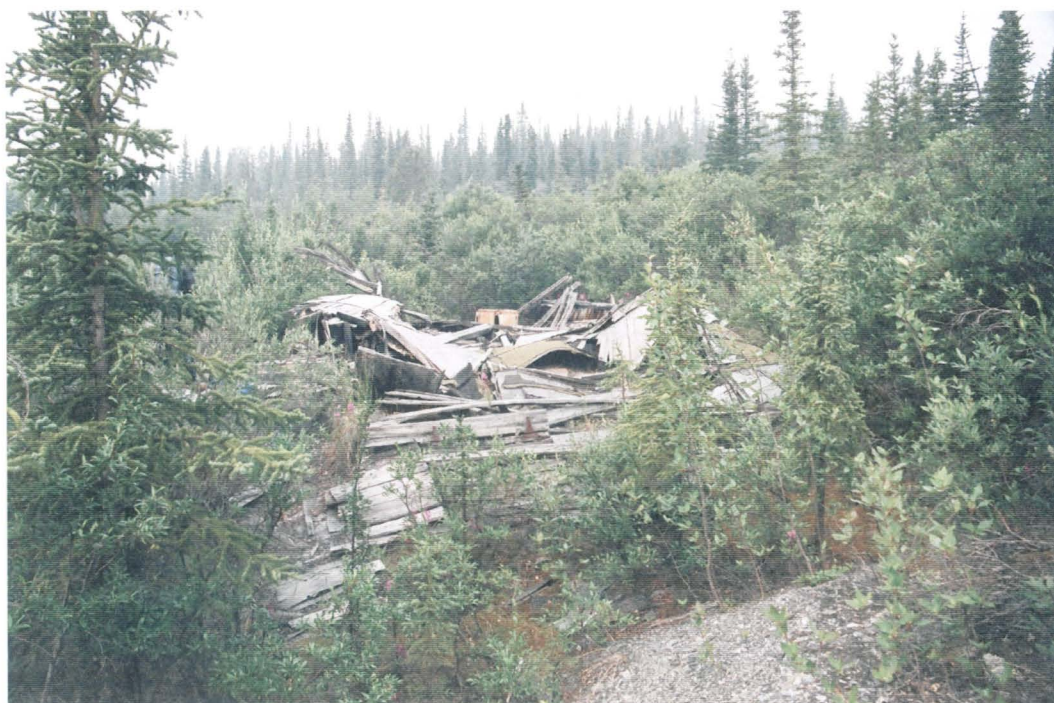
Building #3 is of frame construction and situated 28 meters west of building #2.

Pony walls are constructed of 2 x 4s with 1 x 8 rough siding, which is again covered with 1 x 8 vertical shiplap boards.

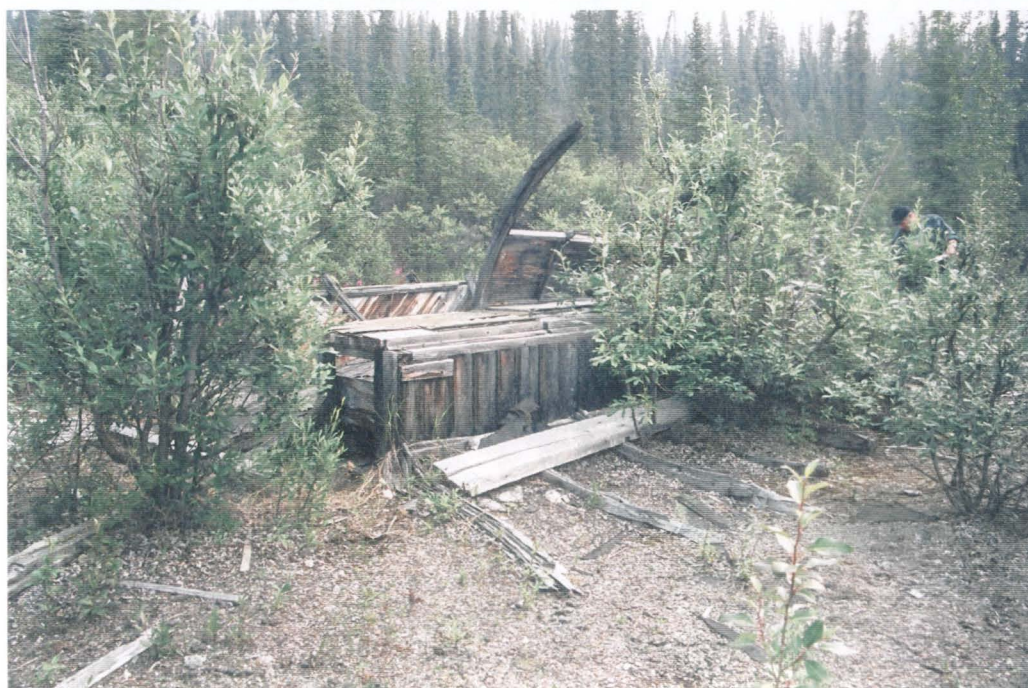
The southern third of the building has been excavated down approximately 1 meter. The lower level floor is missing, while the upper two thirds are covered with 2 x10 planks.

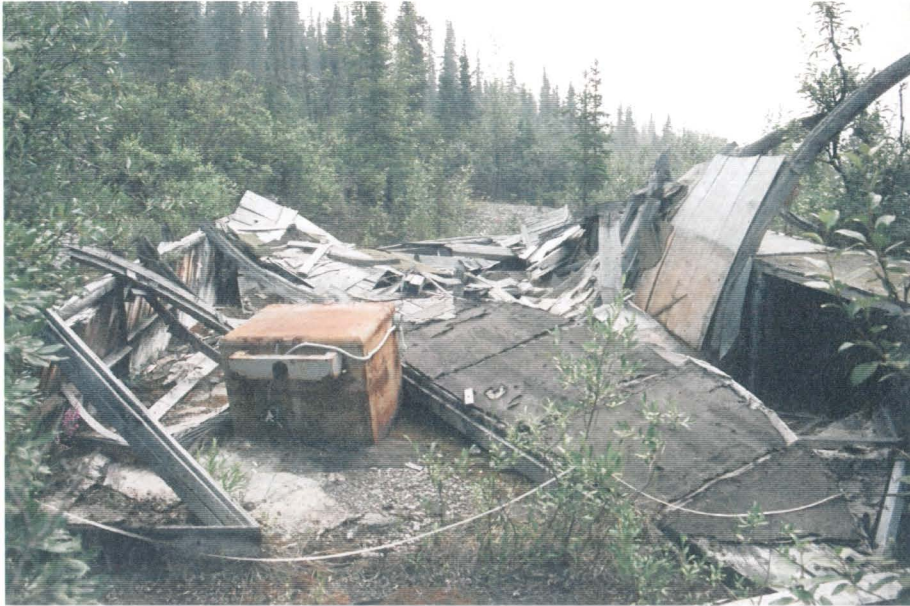
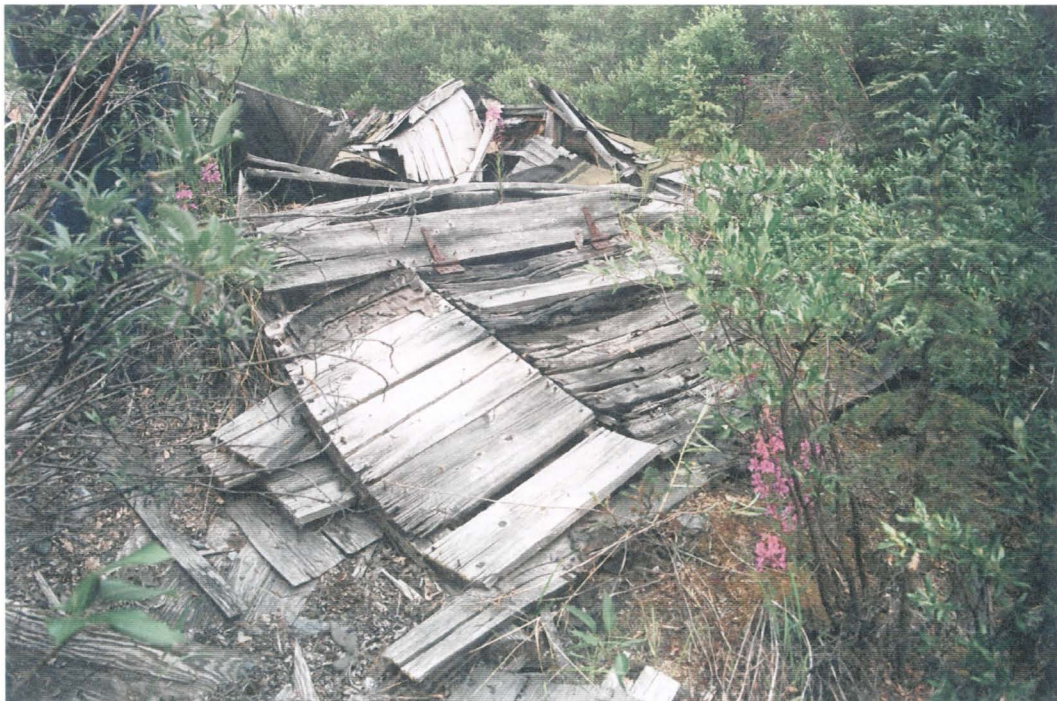
There was an arch roof on the building made from laminated plywood which had been nailed and also bolted together. This was then covered with asphalt rolled roofing. The back two third of the building had a large shelf running along the west wall. Near this was a Denver Lab Drier used for removing moisture from samples before assaying. This possibly indicates that part of this building was an assay lab.

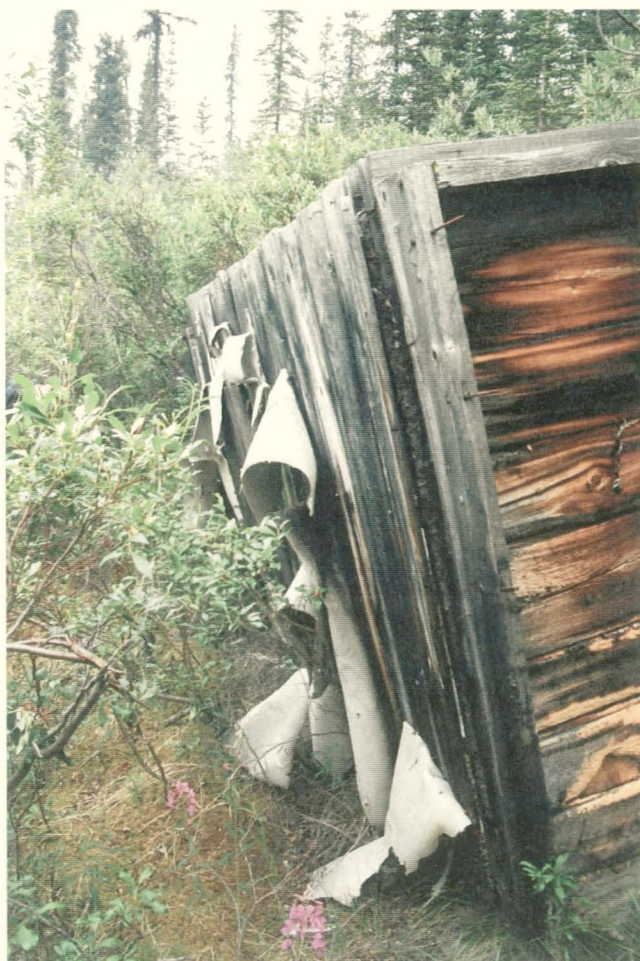
Building # 4 is 58 meters east of building #3. The building is constructed of 2 x 6s for the floor joists and roof truss, with the wall studding being 2 x 4s on two foot centers.

The outside covering is of 1 x 8 shiplap boards. The building has a shed style roof with asphalt rolled roofing.

White asbestos tar paper was used to cover the exterior of the building. There is one window in the west wall and one in the north. The building is 1.4 meters by 1.55 meters and has been tipped on its side.

There is a rotten walkway that leads from this building to what looks like the main group of living quarters. This building was possibly a chemical storage shed as we found discarded hydrochloric acid boxes near by.

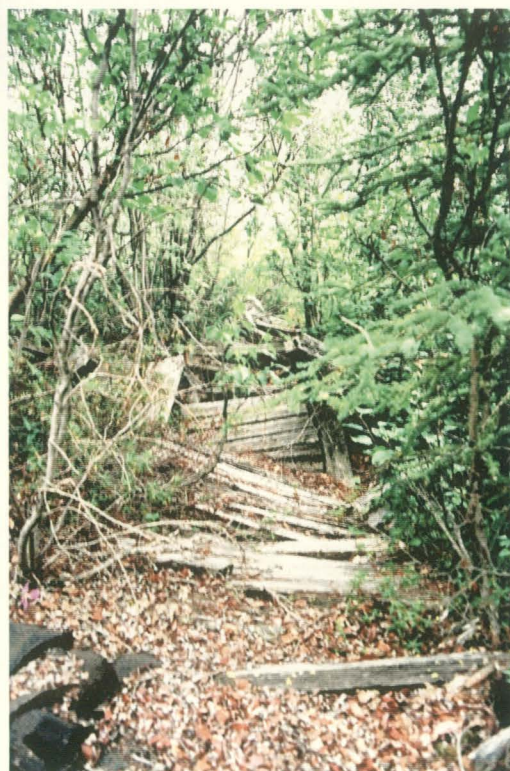
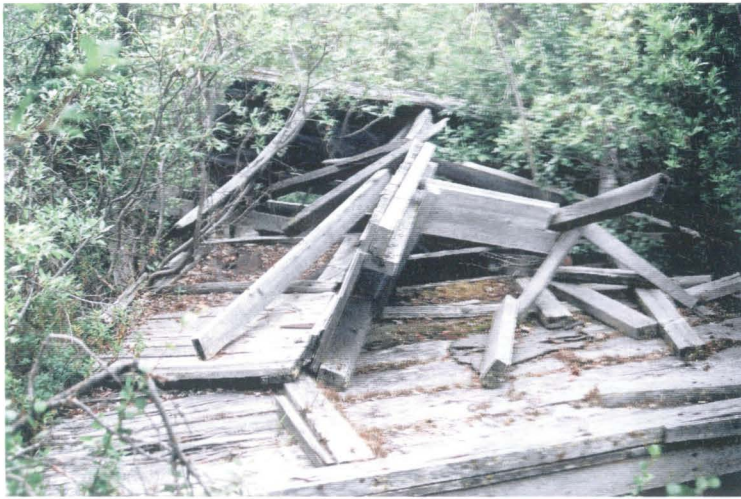
Building # 5 is 3m x 3m and of frame construction with a log foundation. The floor is covered with 1 x 12 planking. The 2 x 4 walls and gable roof have collapsed down slope. This building may have been used as water or fuel supply to the buildings.

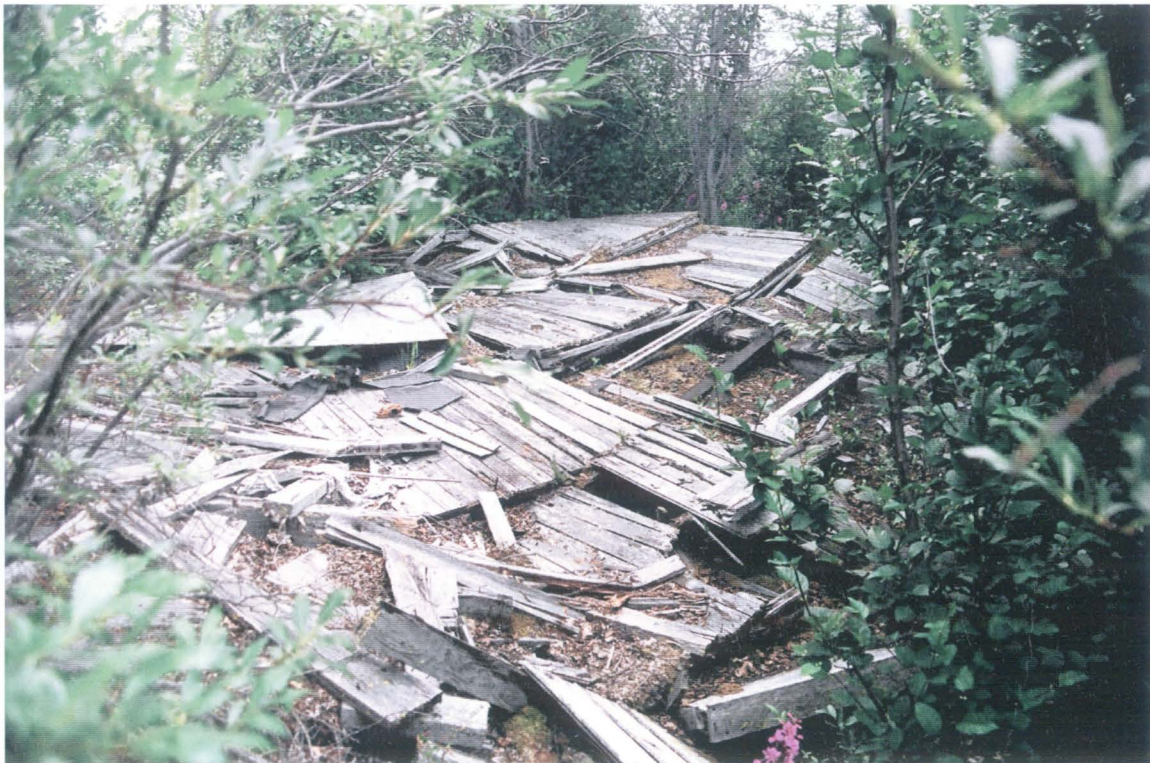
Building # 6 was a one storey frame building, it has now totally collapsed and the floor is in pieces. It had 6 x 6 timbers for a foundation with 2 inch oil lines and 3 inch water or sewer line running under them. There were no walls or roof present. Three inch stripped flooring covered over the 1 x 12 floor planking.

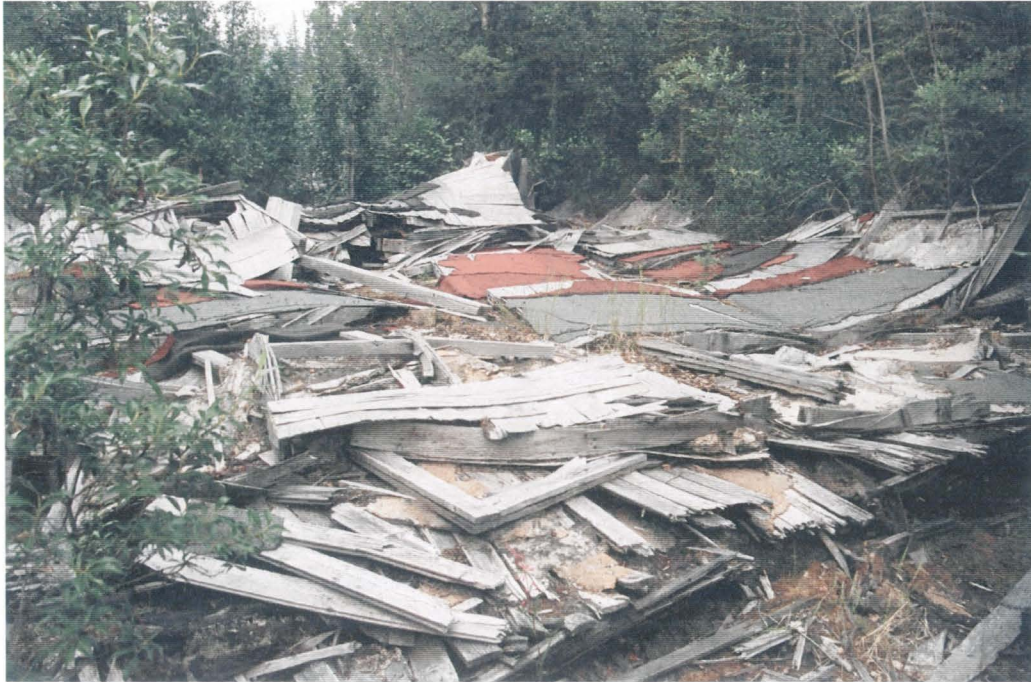
Building # 7 was also of frame construction with the floor foundation made of 6 x 6 timbers placed directly on the ground. The sub-floor over the joists are 1 x 8 shiplap boards with 1 x 3 floor stripping being place over the sub-floor.

Thin plywood sheeting was used as interior and exterior sheeting. This building also had a arched roof similar to building three. Arched rafters were made from laminated plywood with rolled roofing for exterior weather protection. The building was electrically wired and had fiberglass insulation in the walls.

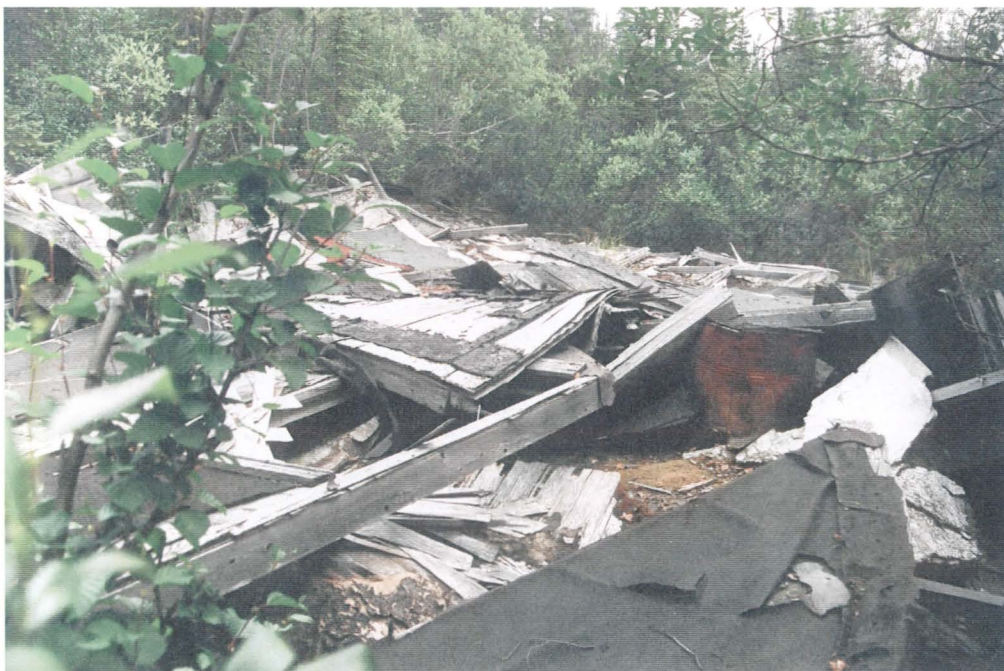
Building # 8 is of frame construction with exterior dimensions of 9 meters by 5.6 meters. All that remains is the floor which is supported on the southwest side by one meter high, 10 x 10 pillars. These are capped with 8 x 8s which then support the floor joists. The floor was then sheeted with 1 x 8 boards and then re-sheeted with 1 x 3 tongue and groove boards.

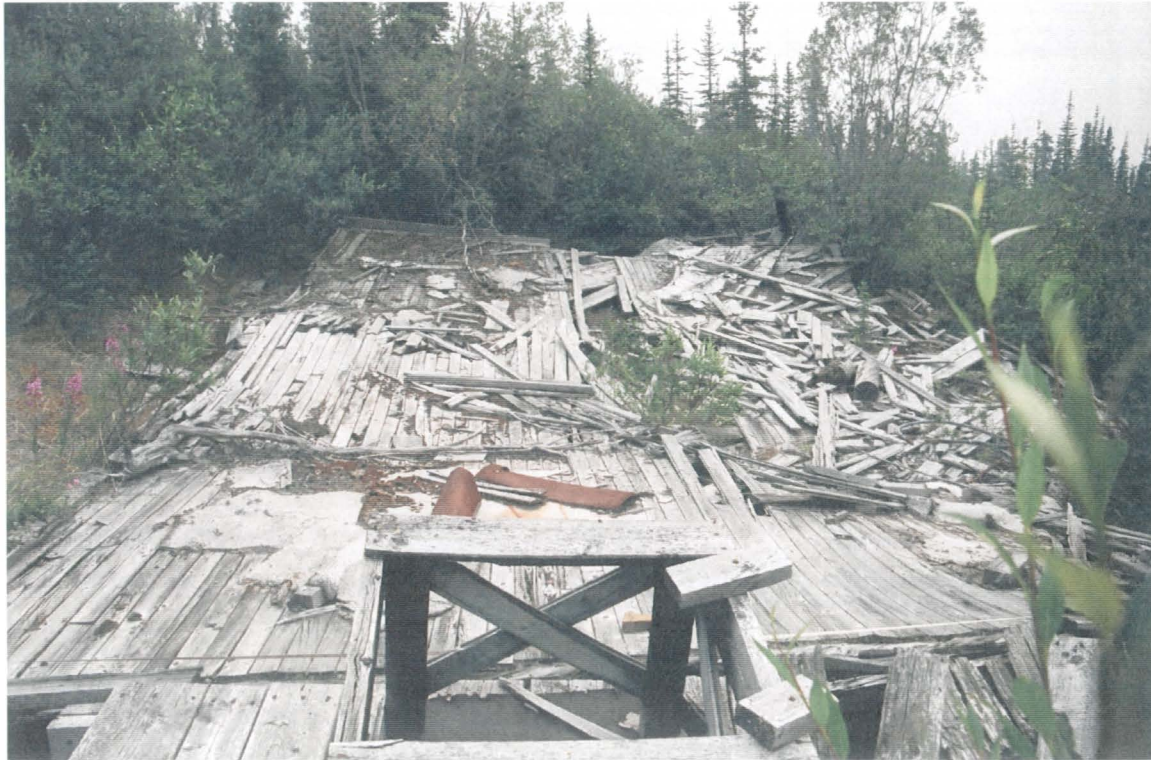
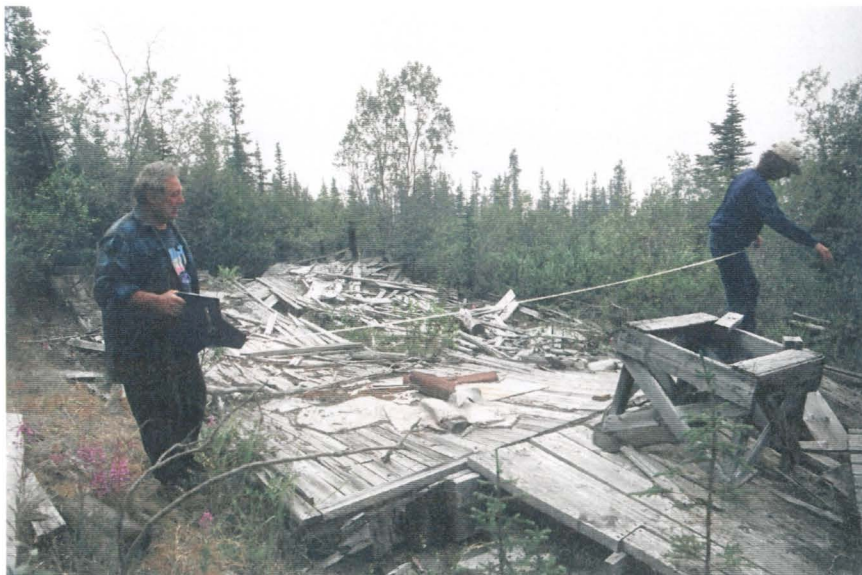
There is a one meter by one meter asbestos sheet nailed to the floor where the heater stood.

Down slope of building # 8 were old bed frames and some hydraulic hoses. Between buildings #5 to #8, following the wooden walkway there is 2 and 3 inch steel pipe. This piping entered all four buildings in this group and presumably was used for the movement of fuel and water.

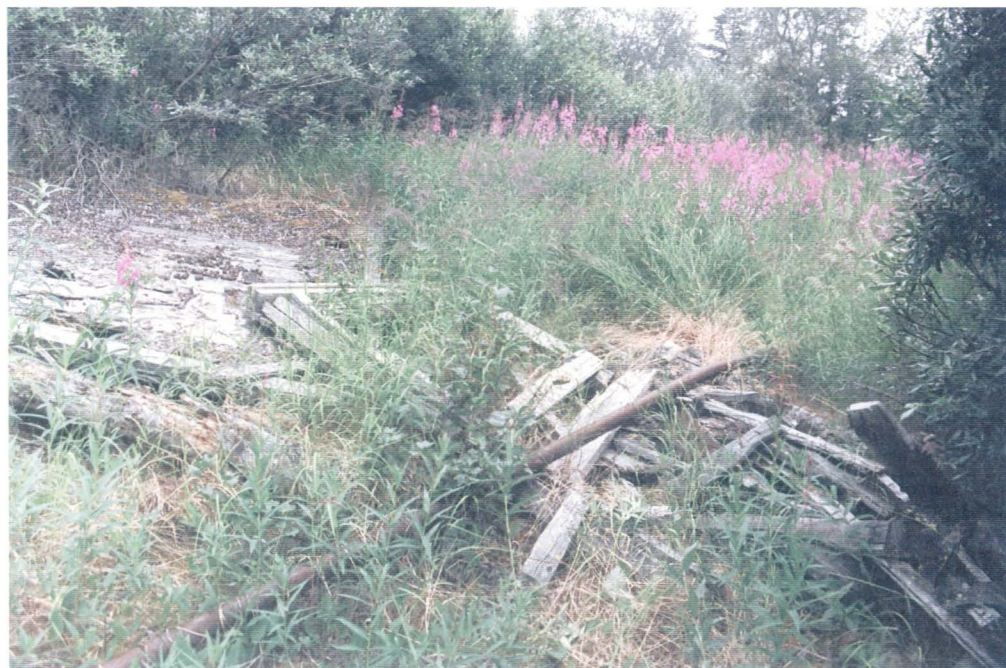
Down slope of the walkway there is a series of heavy 2 x 6 boards scattered in a parallel line to the walkway. These possibly supported further piping.

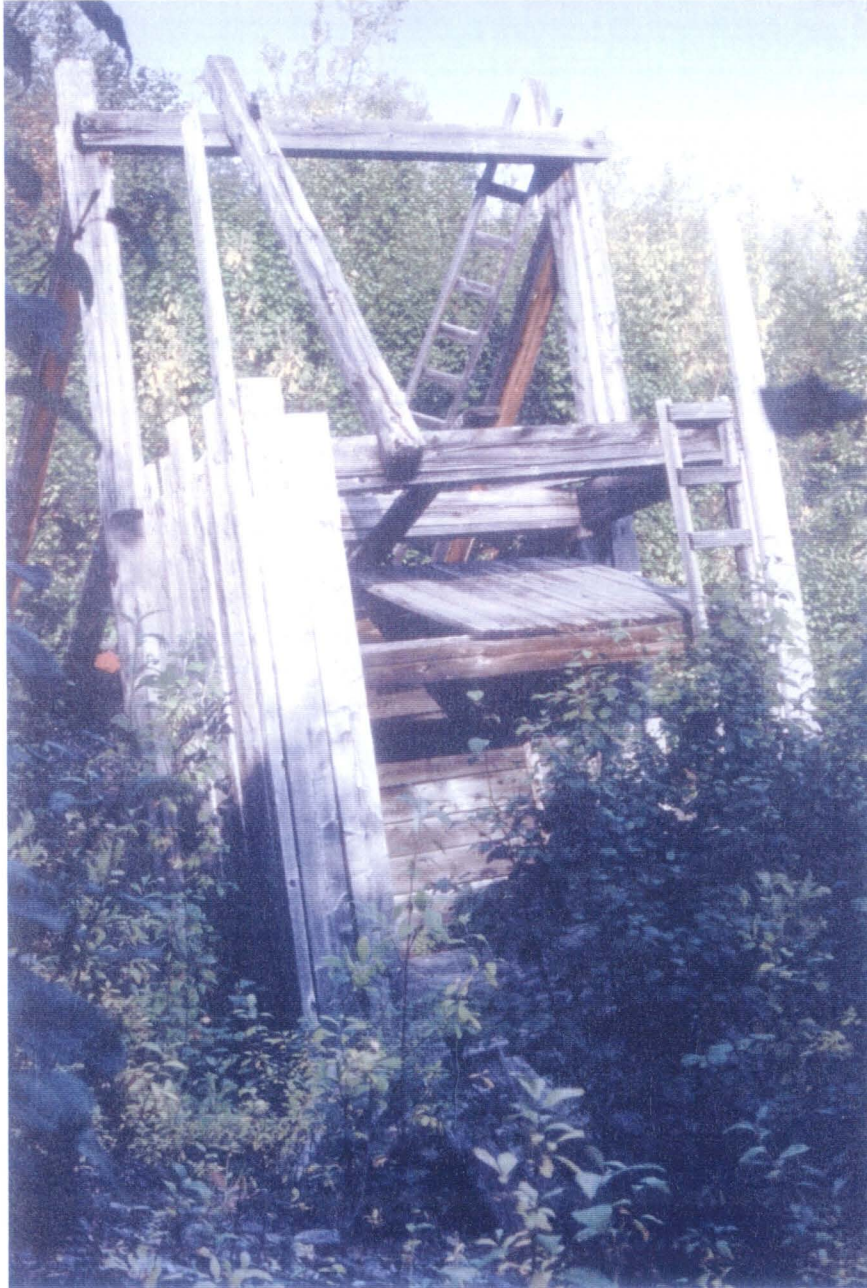
The Main Head frame is an inclined shaft structure constructed of heavy 6 x 8 and 8 x 8 frame material that has been sheeted in with 2 x 10 planking. The head frame is in fair to good condition.

The shaft door is still bolted shut as noted in the previous inspection report.

We feel the shafts pose a considerable danger to the general public at this time. We would recommend that the upper shaft be completely filled using equipment while leaving the top round exposed if possible.
