Historical Review

Of
Selected Mining Sites
In The Silver Trail Region

Prepared for
Waste Management Program
Indian and Northern Affairs Canada

March 2005

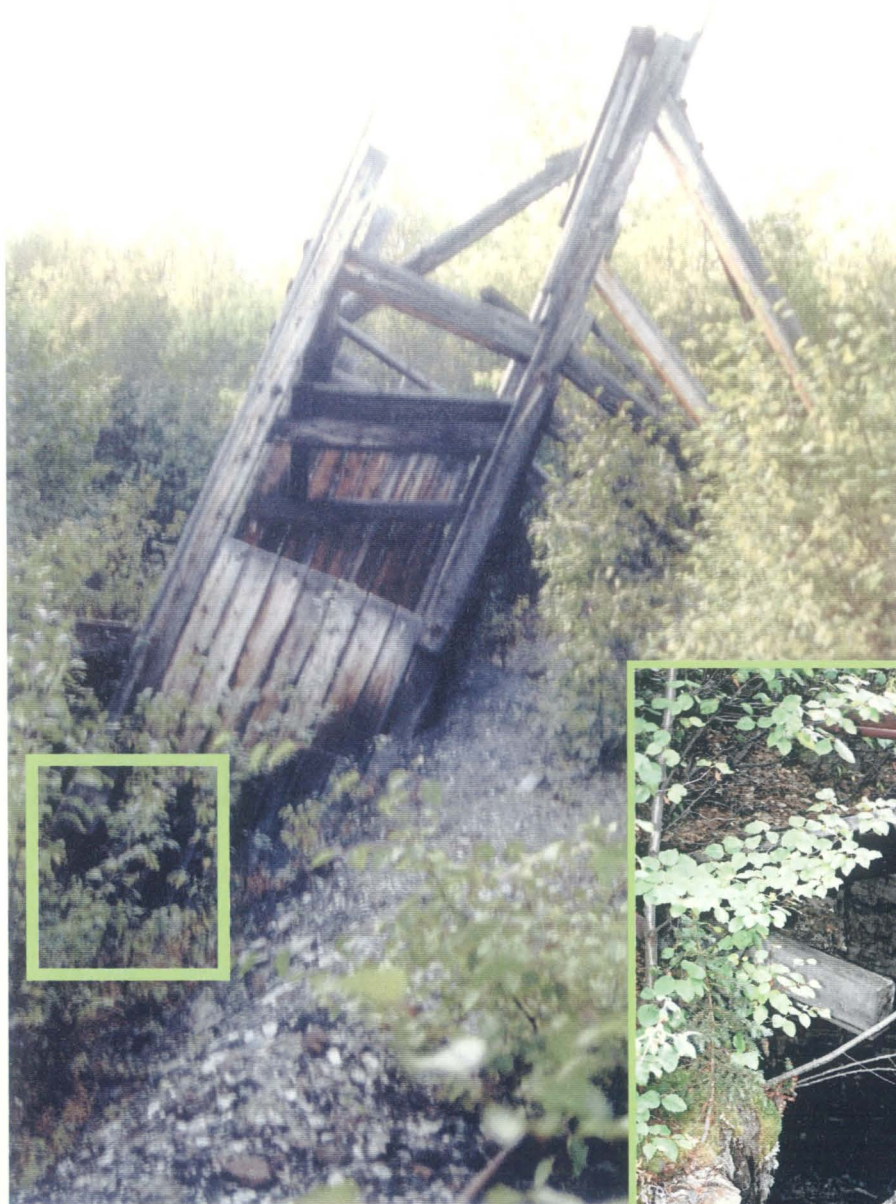
*Photo right shows collapsed shaft.
There is still entry to the inside at the N.E.
corner.*

We feel the shafts pose a considerable danger to the general public at this time. We would recommend that the upper shaft be completely filled using equipment while leaving the top round exposed if possible.

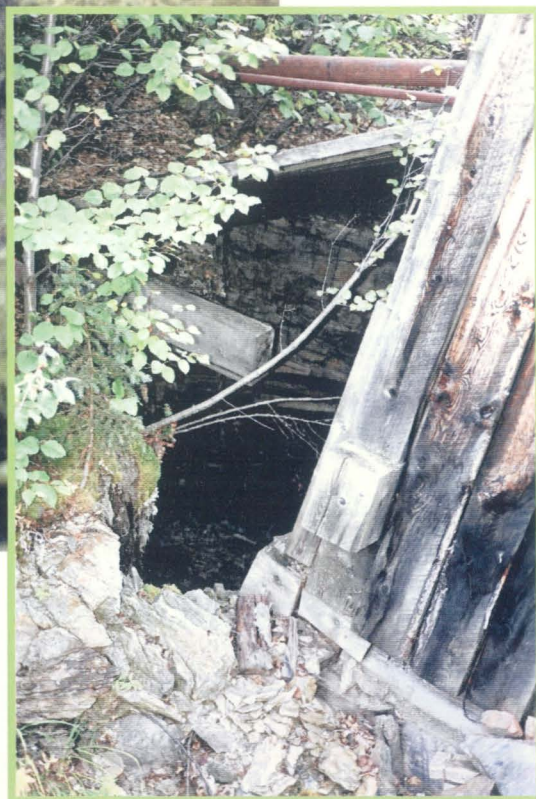
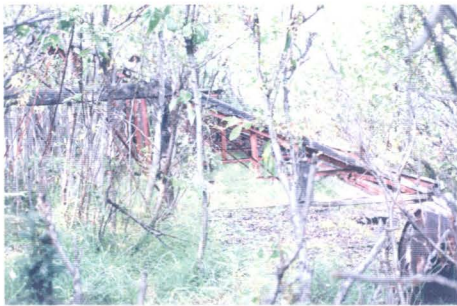
About 30m due east of the main shaft are the remains of a metal storage shed.

The foundation of the building were 8 x 8 timbers, while the walls were constructed of 2 x 4 studs with thin plywood as outside sheeting.

The roof was gable style and made of light gauge I-Beam metal rails, bolted together. The top of the I-beam stringers were capped with 1 x 3 wood strips on to which tin could then be nailed.

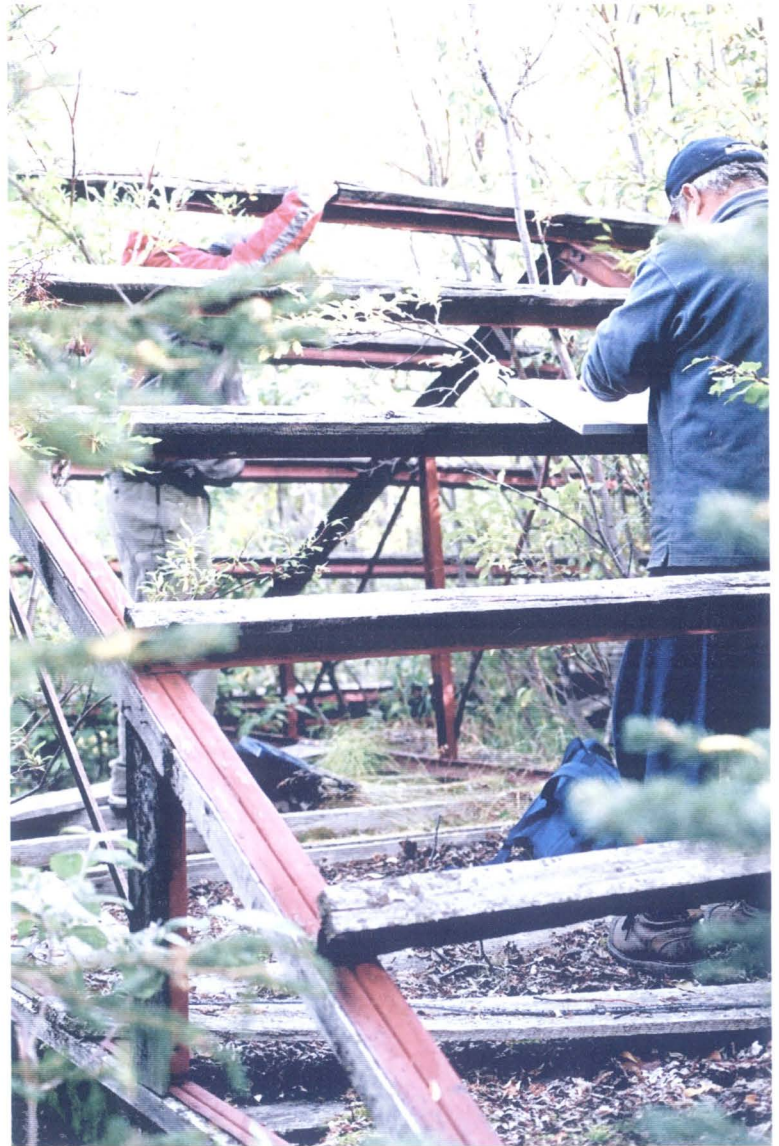
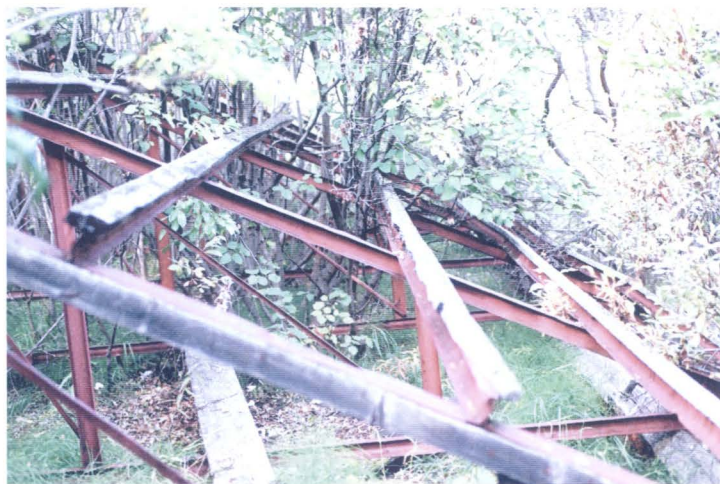
The walls of the structure have totally collapsed leaving the gable roof sitting directly on the ground. The building is 15.67 meters long by 6.8 meters wide.

Further to the east, behind the building are located three old mine cars along with a fair amount of heavy metal mining debris and more empty 45 gal drums.

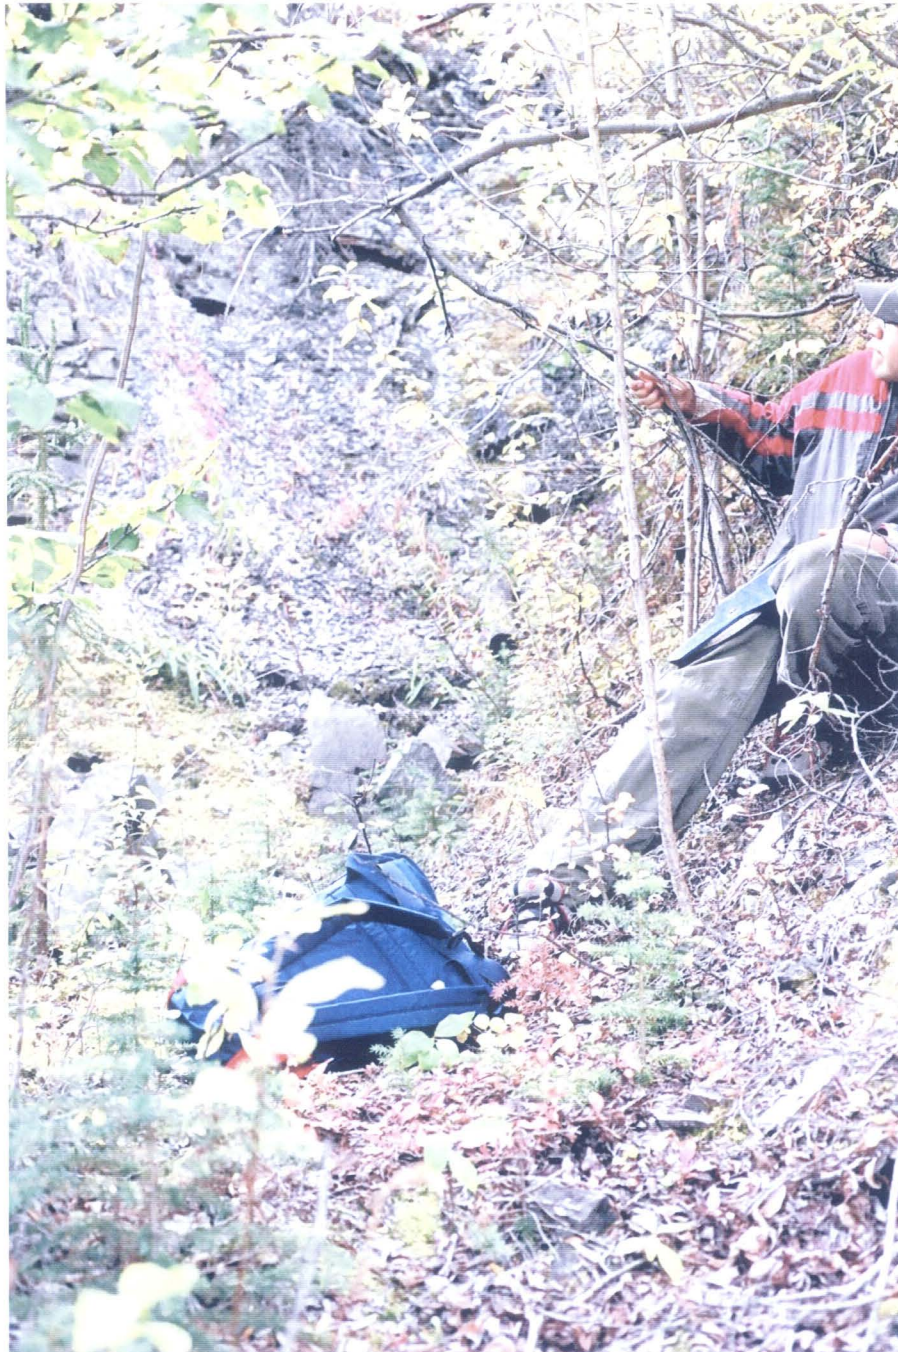
The lower adit was very difficult to find as the vegetation is well established. We only found it by noticing a small waste dump and then moving uphill from that point.

The adit is fully collapsed and there are only a few pieces of timber to actually identify the portal site. We did not find any rail or metal debris at this lower adit.

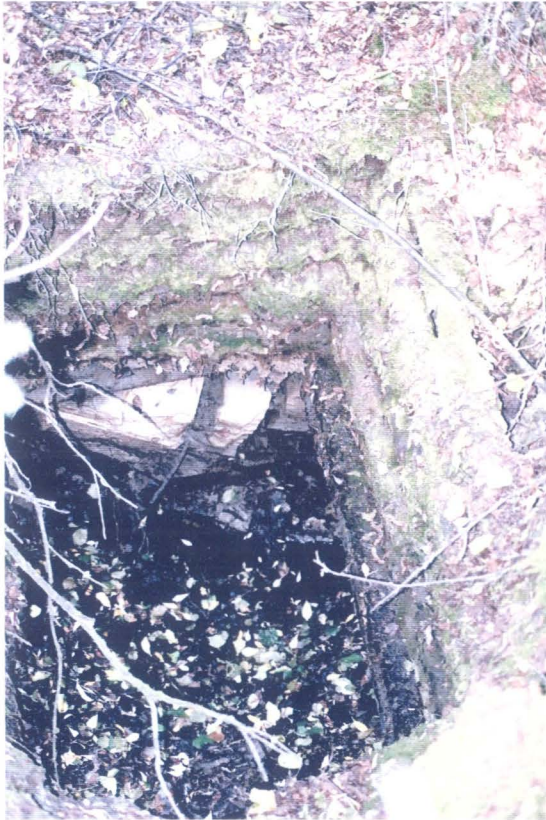
The first major safety issue that needs to be addressed at this site is the exposed upper shaft that is located near the lower Faro Gulch Trail.

Although there is flagging marking the shaft, there is no cribbing to define the upper edge which could easily slough with the added weight of a curious onlooker.

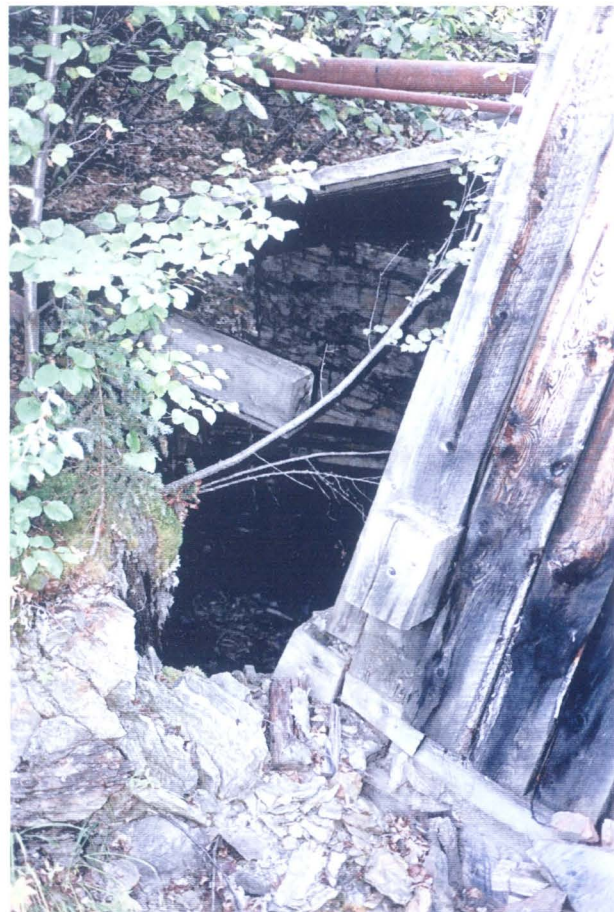
The second major safety issue is associated with the main shaft head frame.

The entrance to the shaft has been secured and is inaccessible via the main entrance, but the ground around the shaft building has sloughed to the point where there is a second access hole which leads into the shaft interior.

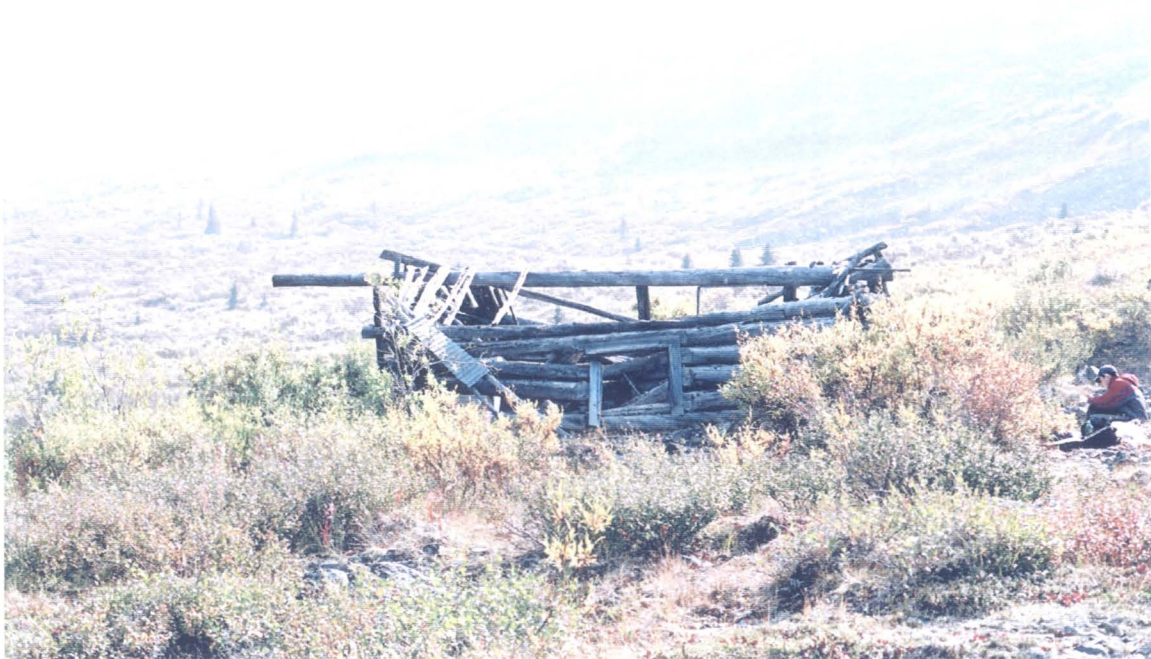
This is a log structure, indicating it to be one of the original buildings associated with the Highlander Site. The bottom rounds of the cabin are placed directly on the moss, with no evidence of a stone foundation being established prior to building. The floor is constructed of rough sawn 2 x 4 joists, sheeted with 1 x 8 rough planking. The logs are saddle notched at the corners with the work being primarily done with an axe and Swede saw.

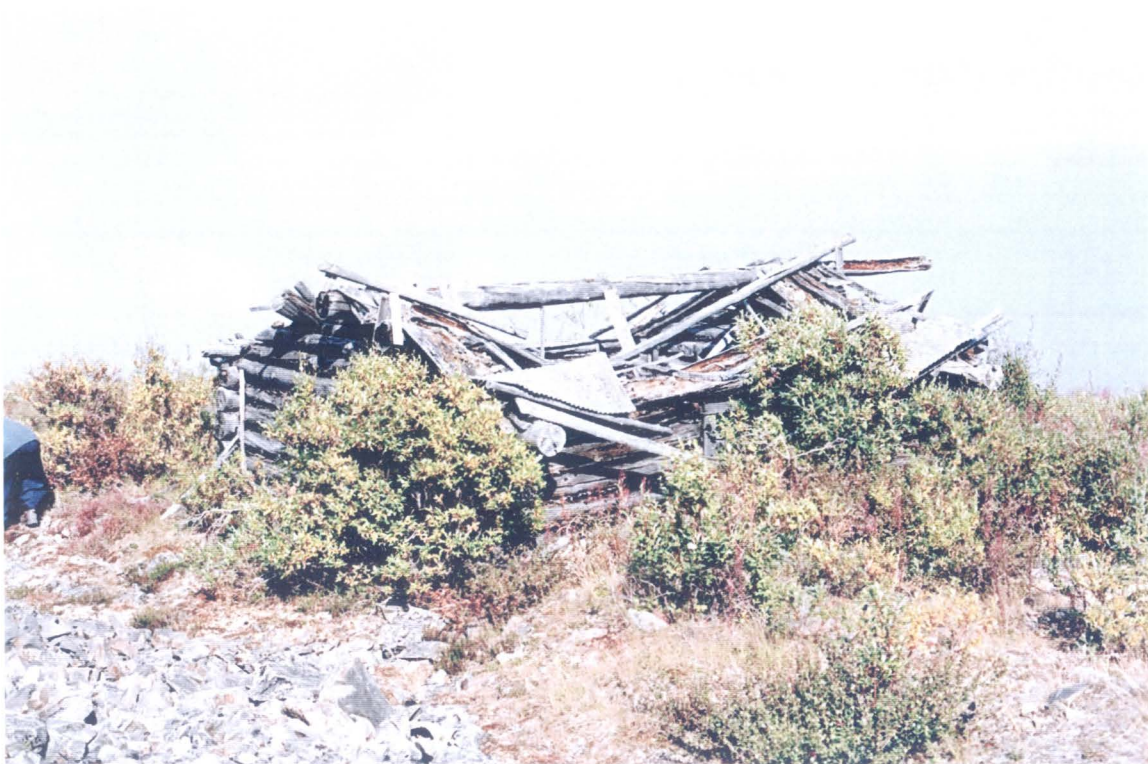
The roof has since collapsed onto the floor with only a couple pieces of tin still clinging to the outside wall. Twenty meters to the east of the old cabin is the remnants of the outhouse.

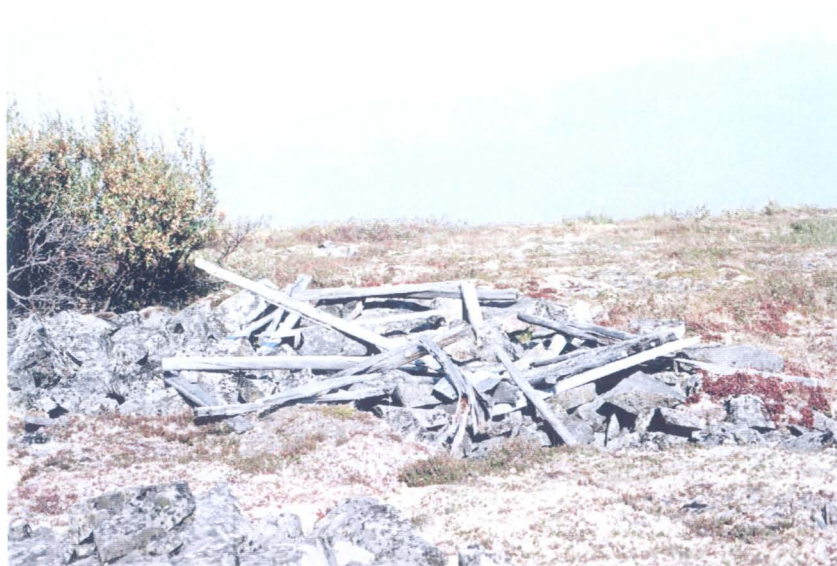
It was also of log and pole construction and as though it had a sheet of canvas as a door. For identification purposes we will call this outhouse # 1.

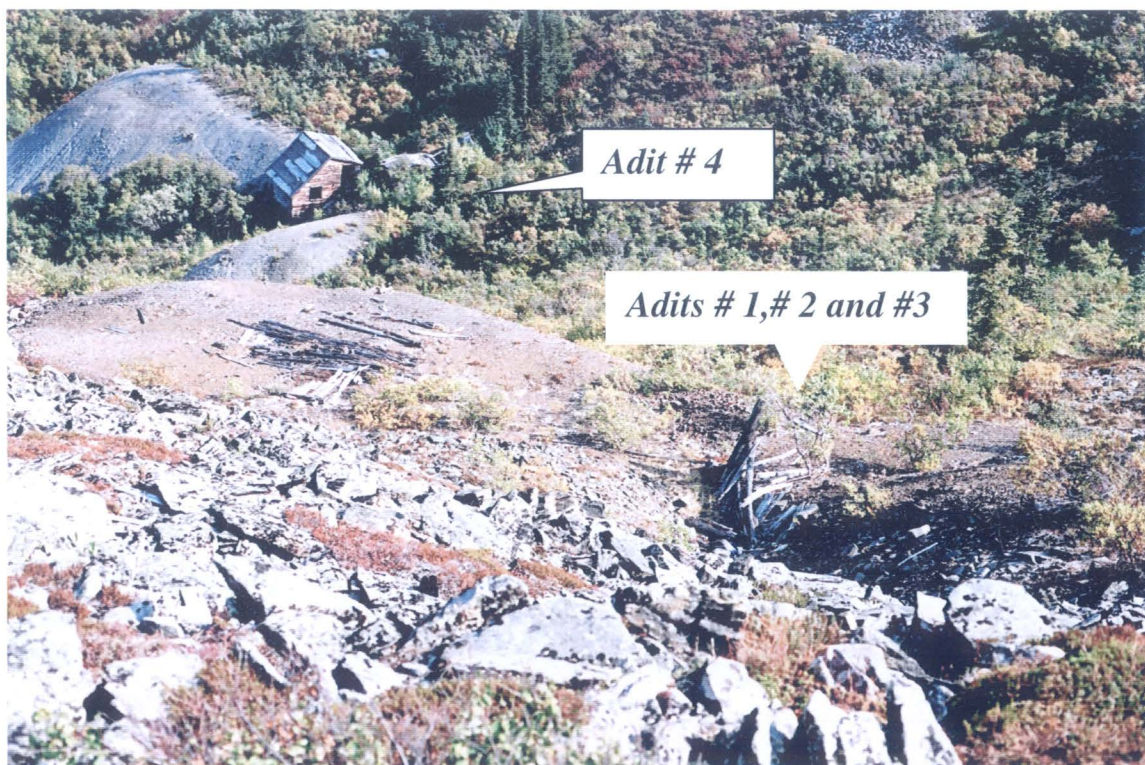
Overview of adits

All the adits have collapsed though there remains a small opening in adit # 1

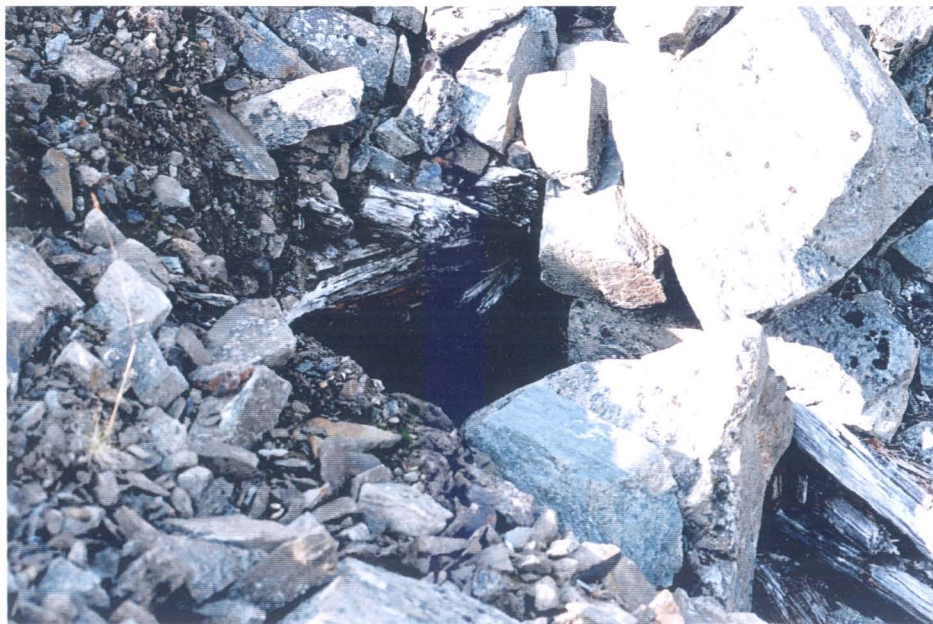
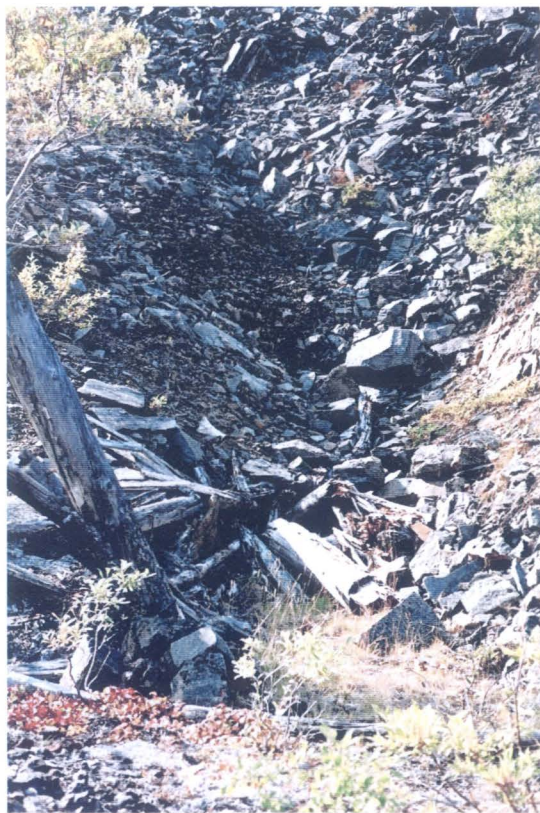
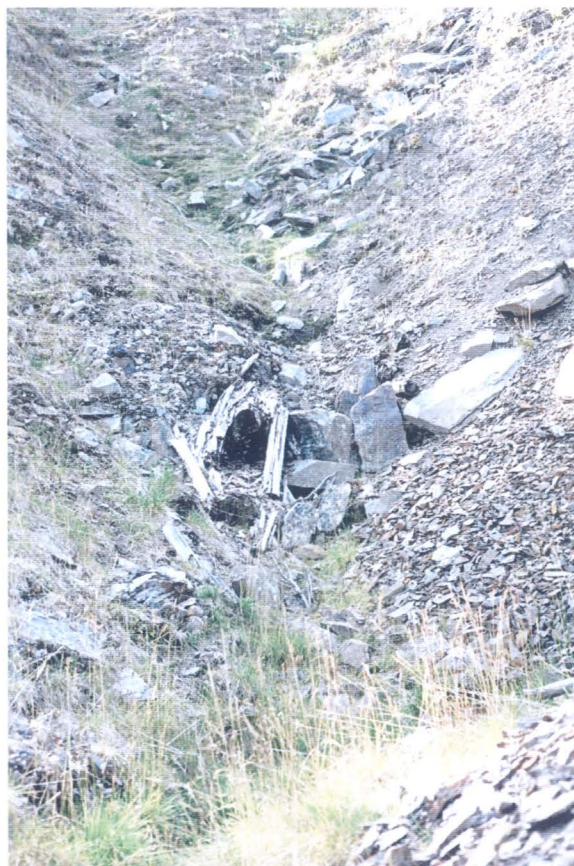
Above: adit # 2, right: adit # 3.

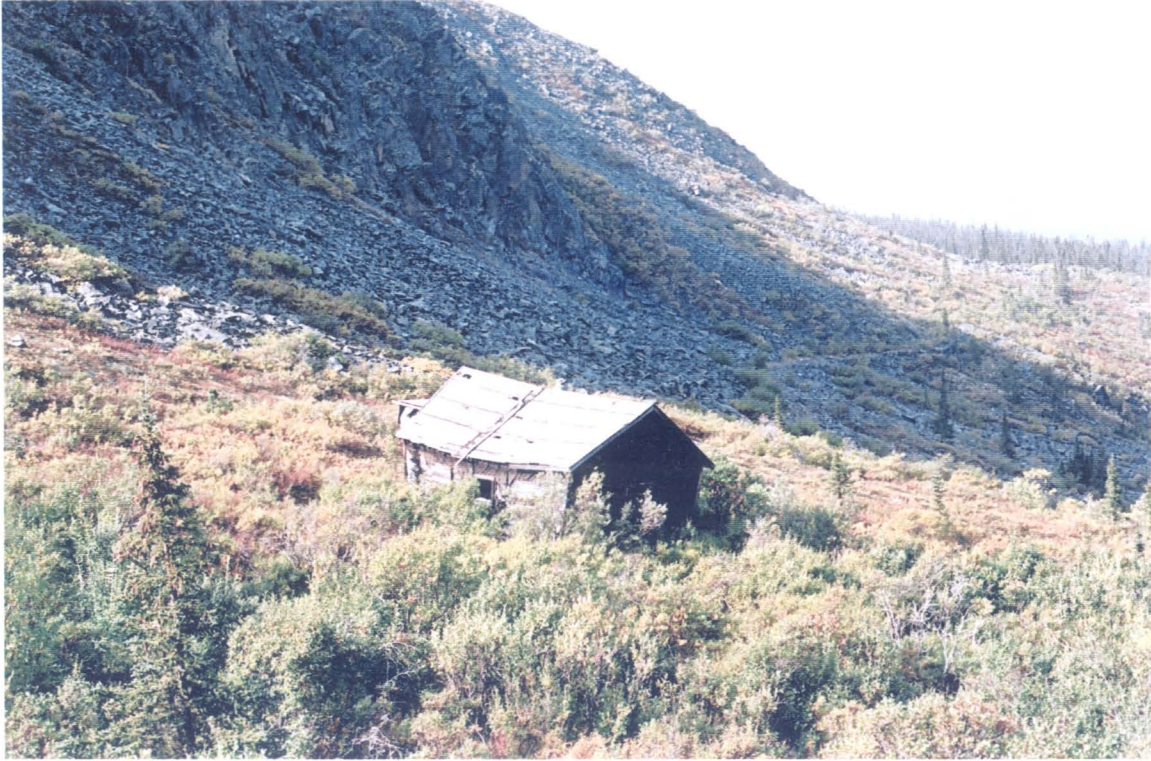
This is the first building one meets as you ascend Gambler Gulch. The building is of frame construction and probably was a bunkhouse for the miners.

The building is 9.24 meters long by 5.59 meters wide and sits on a foundation built of assorted large rocks. The 2 x 6 floor joists are placed directly on these rocks on 16 inch centers.

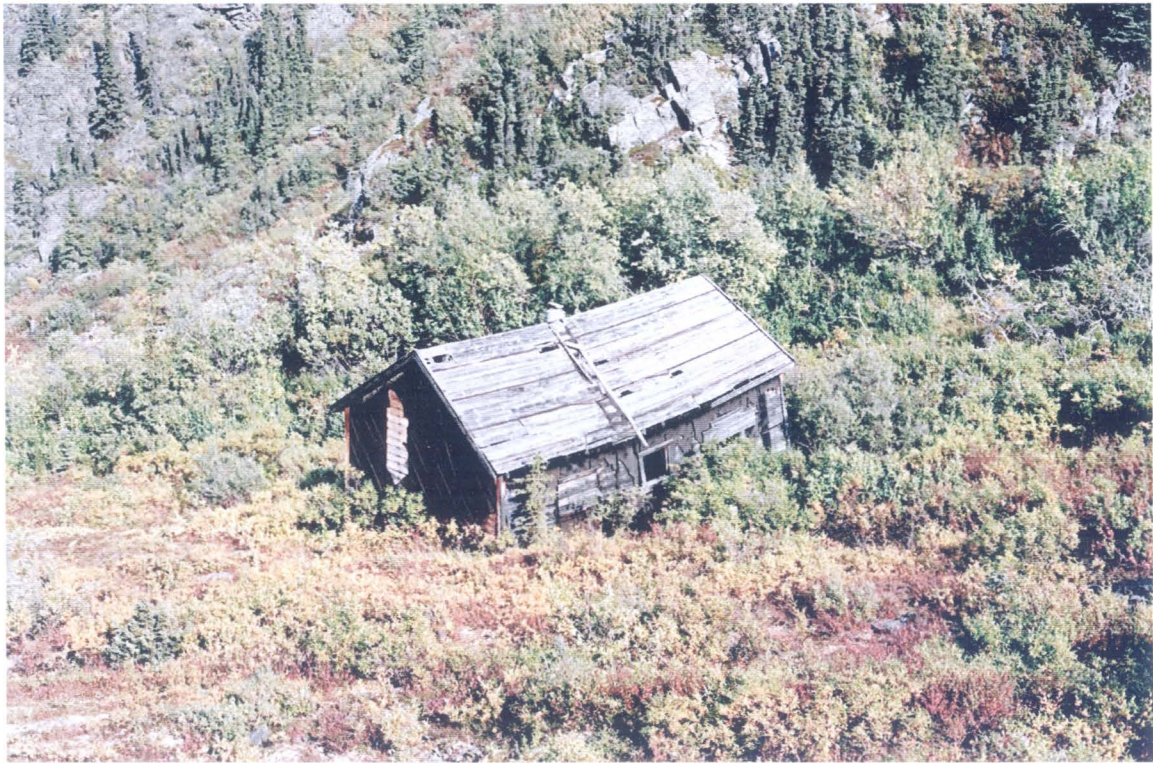
The building has sagged substantially in the middle which has caused the east and west walls to angle down slope to the west. There is a large Yukon safety in the middle of the roof along with the remnants of an old ladder.

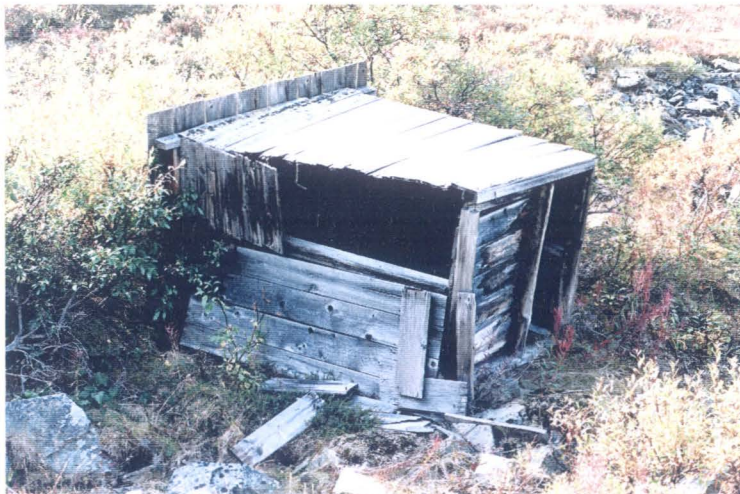
Approximately 8m from the southwest corner of building #2 is the outhouse. Number two outhouse has a log/pole foundation, with the walls being made of 2 x 4 frame construction; this was then sheeted in with 1 x 8 boards.

The outhouse had a flat shed style roof which was weather proofed with black tar paper rolled roofing.

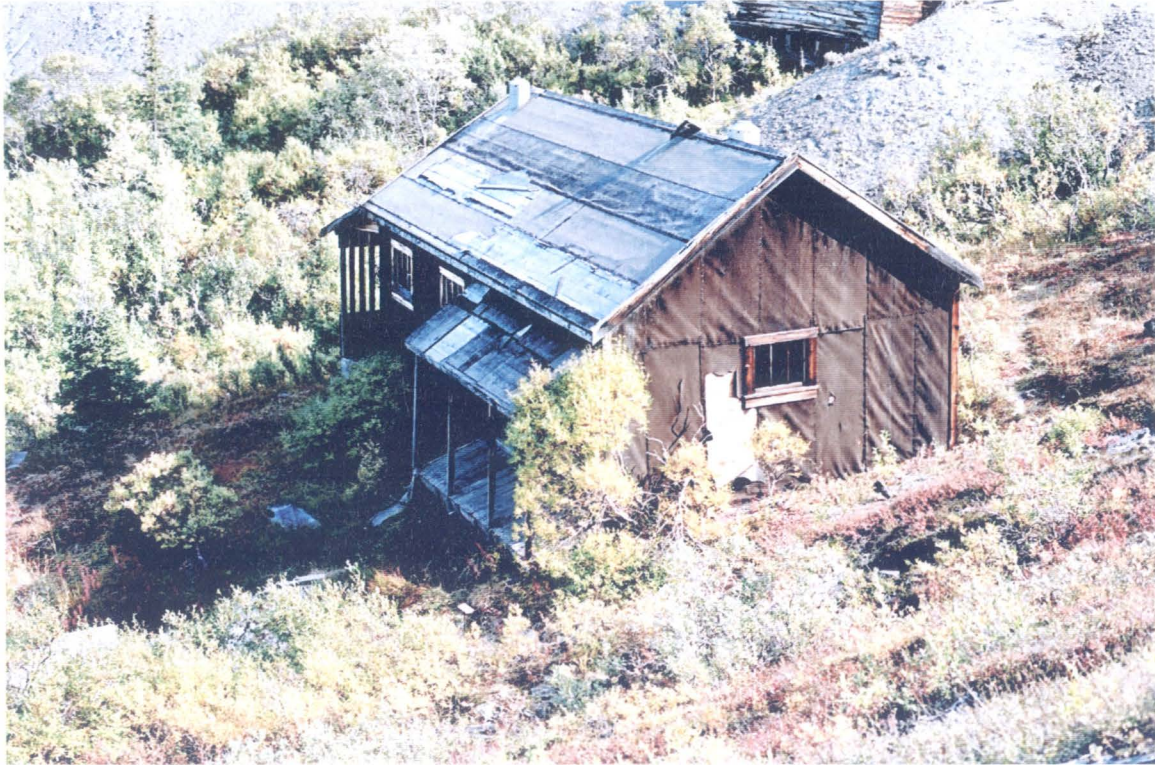
Building #3

This building is located 32 meters east of building #2 and was probably the cookhouse for the Highlander site.

The building is of frame construction, with beams being used for a foundation. These were placed directly on the ground and then sheeted in with 1 x 8 shiplap boards. Rough 2 x 6s were used for floor joists, over which 1 x 6 shiplap boards were laid for flooring.

The walls are made of 2 x 4 studs on 2 foot centers. This was then sheeted with 1 x 6 shiplap boards, and then covered with tar paper. The roof is a gable style, with 2 x 4 truss construction which has been sheeted in with 1 x 8 shiplap boards. Again black rolled tar paper roofing was used for exterior weather protection, this has deteriorated over time and only half the roof still has this covering.

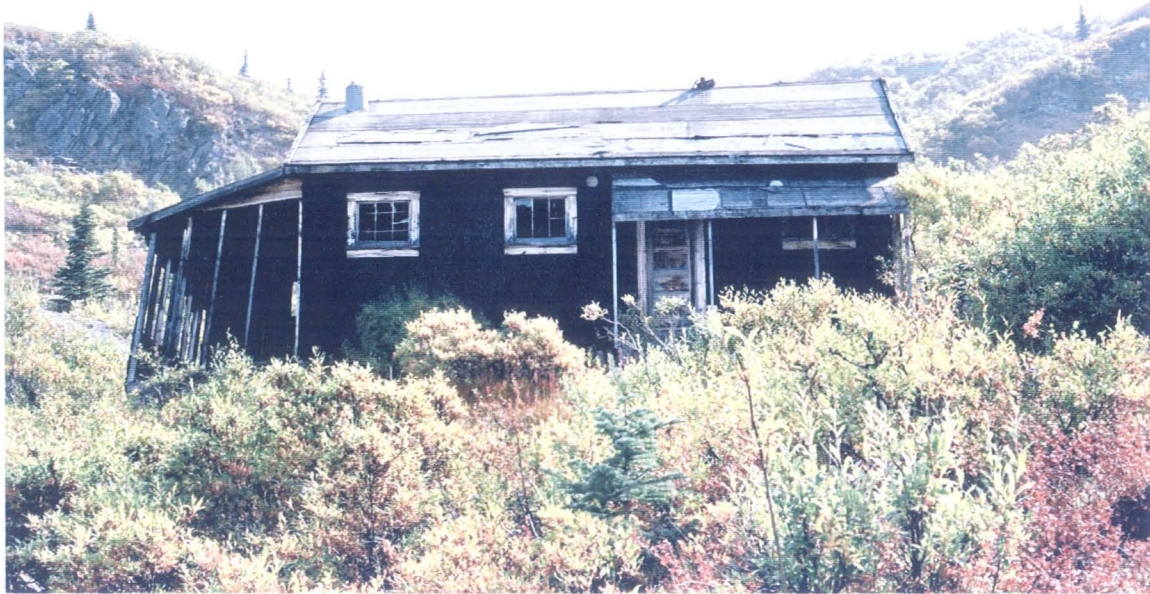
There are two other shanty style roof additions that have been added to the main frame structure. One is on the southwest corner of the building with the second being on the north east side just back from the porch.

These snow roofs are both being undermined by the rotting of the support 2 x 4s that hold them. There is a door and two windows (.84m x .72m) on the west wall, one (.86m x .72m) window on the south wall, and two more windows (.84m x .72m) on the east wall.

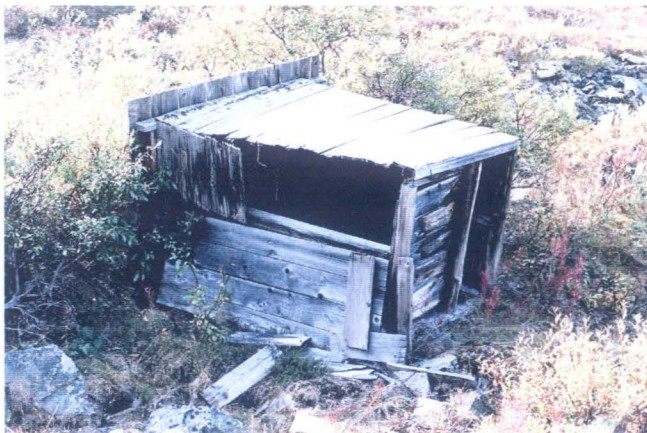
There is a tipped over outhouse approximately 8 meters west of the southwest corner of the cook-shack.

Number 3 outhouse building is made of 2 x 4 frame materials with 1 x 6 boards mixed with 1 x 8 boards used as flooring and wall material. The roof is a shanty style, with 2 x 4 construction, 1 x 6 sheeting, and no evidence of any exterior weather proofing.

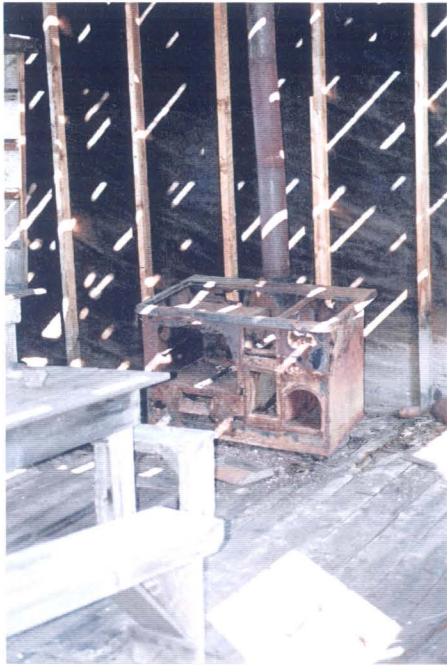
Inside the building against the north wall are the remains of a large wood cooking stove, a large table with benches, and wooden bed frames.

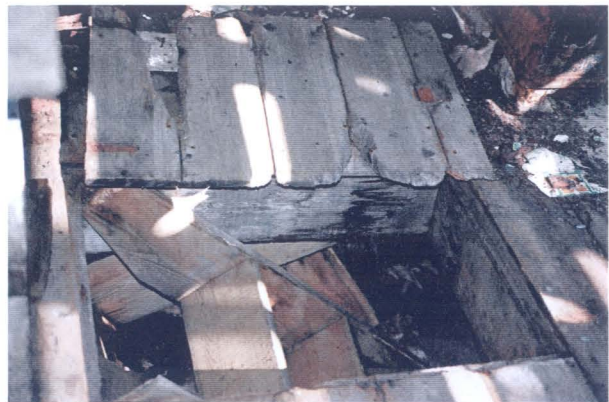
In the northwest corner there is an entrance to a root cellar.

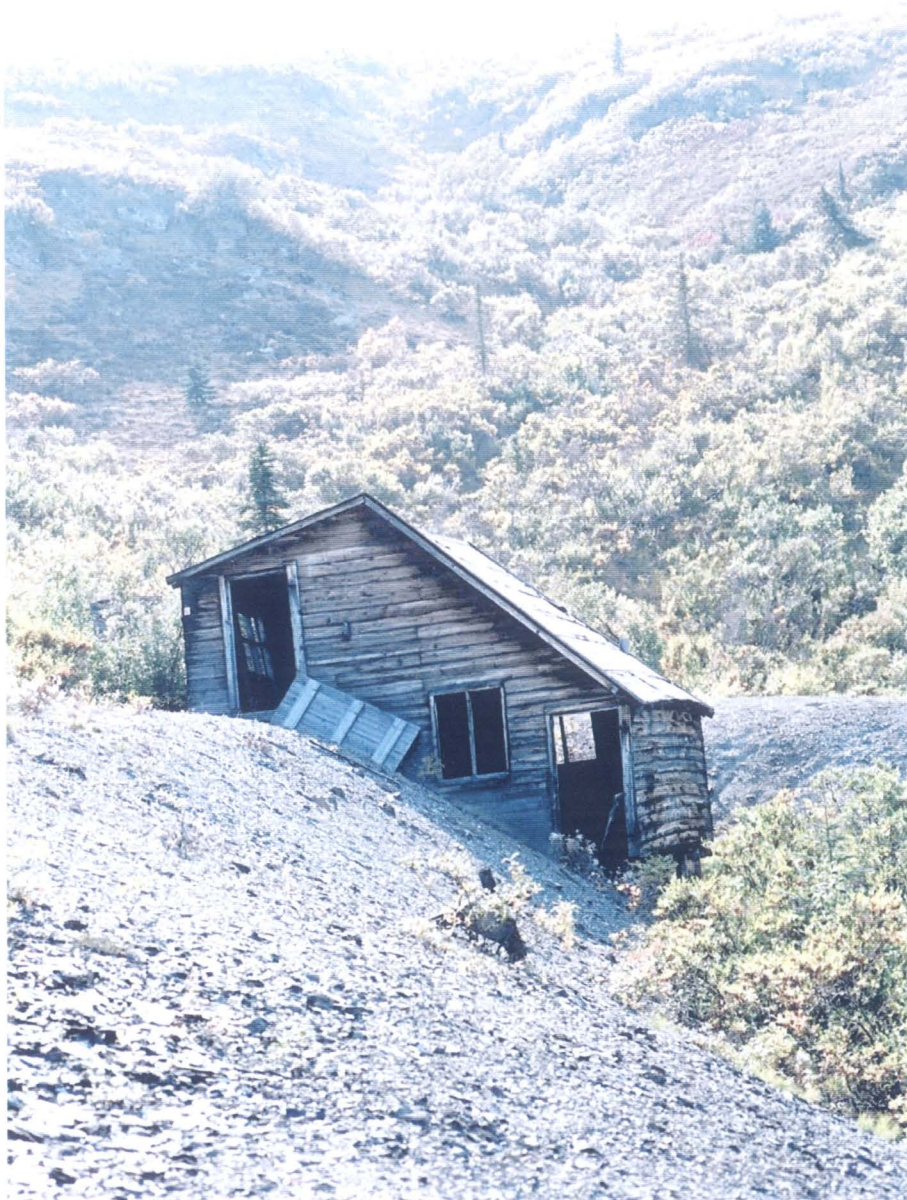
Building #4

This building is a three level wood frame structure that was probably used for the processing of ore.

The foundation of the west wall consists of one meter high, log pillar uprights. These are capped with a sill log; on top of which are placed the first of the lower joists of the three levels of floor structures in the building.

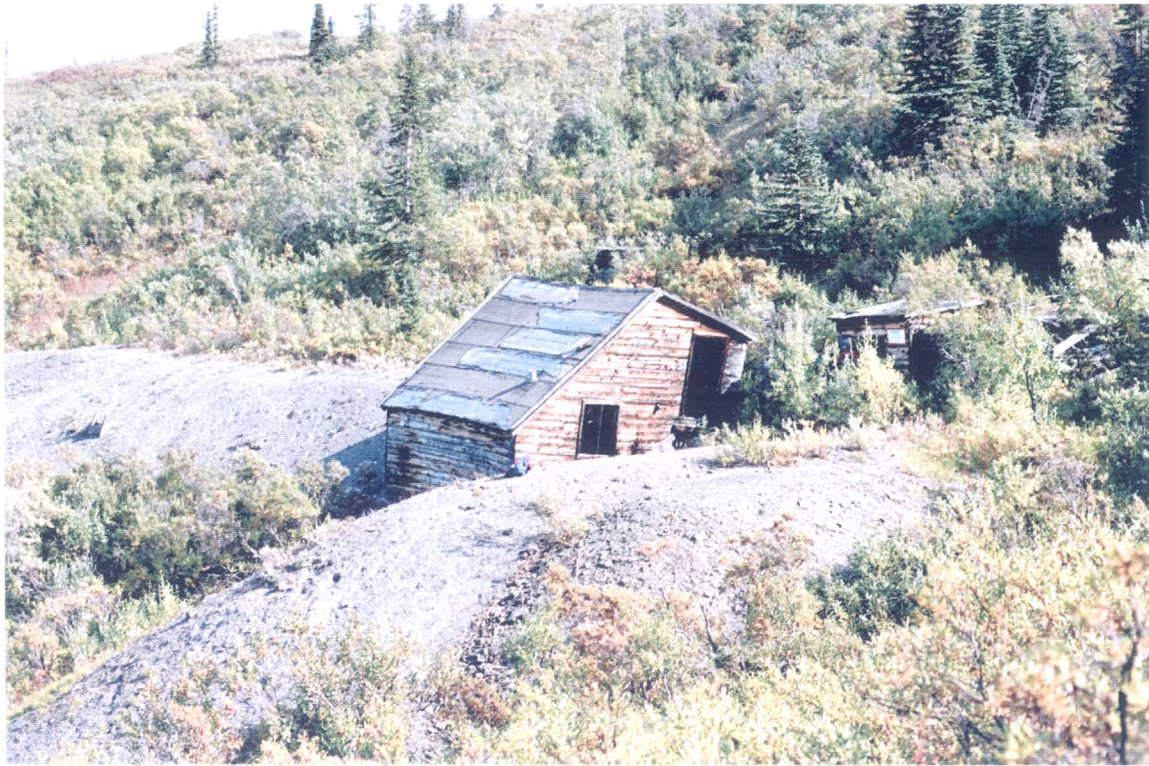
The floor joists which are 2 x 6 planks have been sheeted with 1 x 8 planking, and extend inward 1.8m. The next vertical support wall for the second floor is made of 2 x 6s along with the joists for that level. Again they are sheeted with 1 x 4 sheeting for the vertical support wall and 1 x 8 sheeting for the second level flooring material.

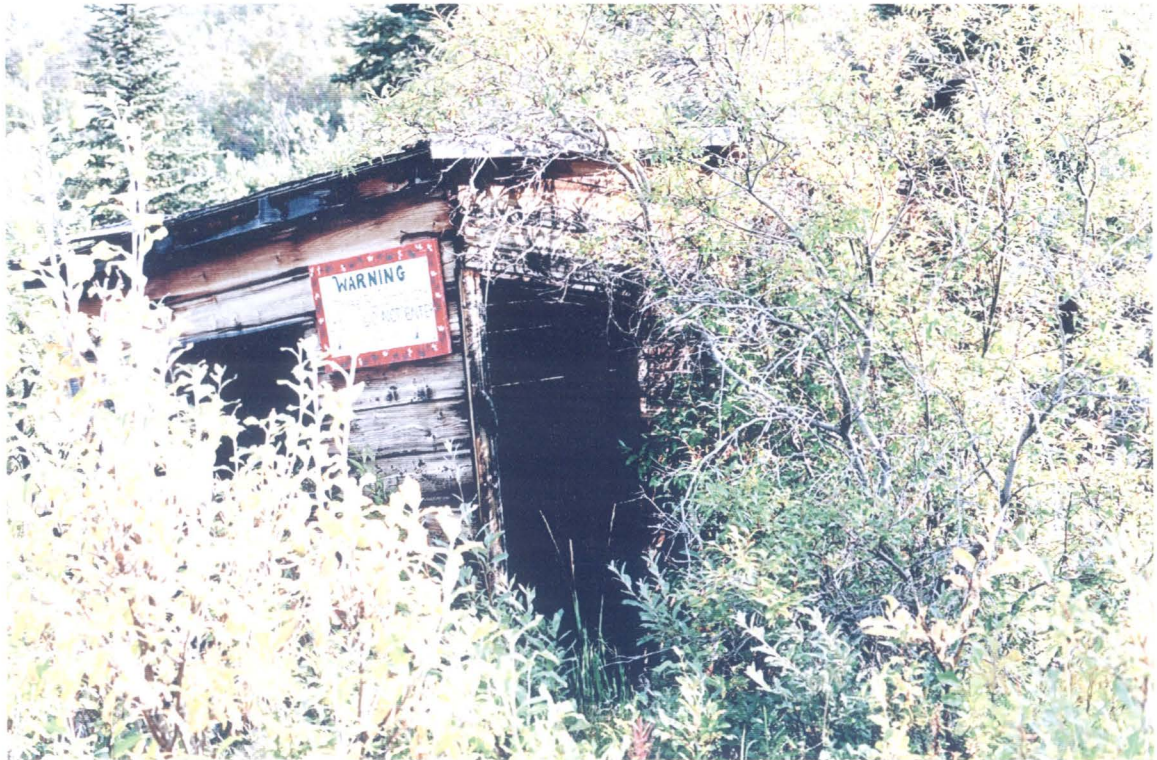
Building #5

This structure is located 2 meters southeast of building #4; it is a relatively small building compared to the rest of the other buildings, with the dimensions being 2.77m for the east wall and 4.31 meters for the south wall.

There is no floor structure in this shed, with the walls being built of 2 x 6s and placed directly on the ground.

The walls are sheathed in with 1 x 8 boards, with the shallow gable style roof being constructed of 2 x 4 joists.

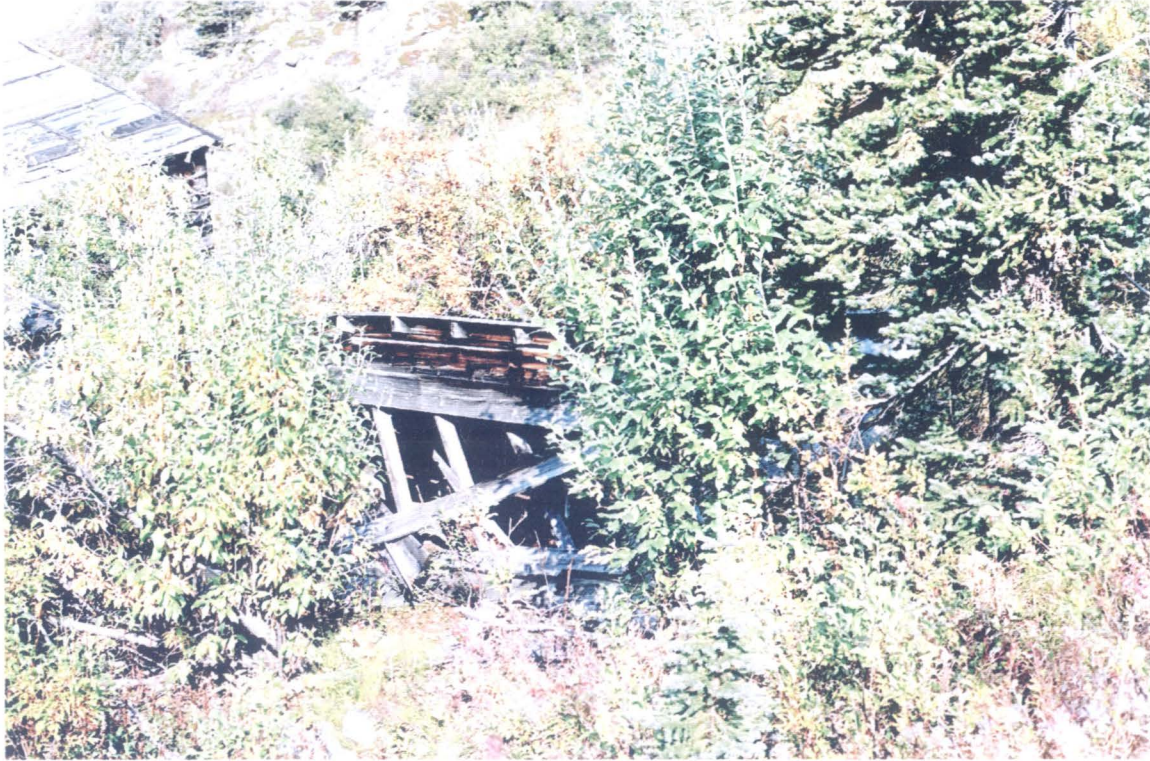
Building #6

This building is located directly adjacent to building #5, but has collapsed to the north. The shed size is similar to Building # 5, with the dimensions being 4.3m x 2.5m. This building also had a gable roof with 1 x 8 planks for exterior sheathing.

There is evidence of black rolled roofing still attached to the collapsed roof.

The walls were constructed with 2 x 4 studs, on which 1 x 10 planks were used for exterior sheathing.

This shed had a door in the middle of the south wall and like the other building, no floor. Possibly used as storage shed, it seems likely that it was a work/ repair shop for the underground workers and their equipment.

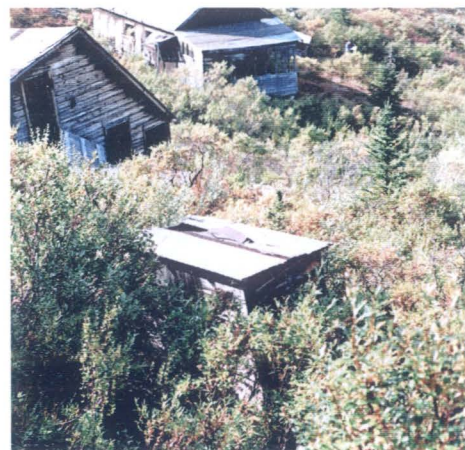
Outhouse #4 is located 14 meters north by 17 meters to the east of building #6. Its dimensions are 2.03 meters x 1.4 meters.

The walls are of 2 x 4 construction. These walls have been placed directly on the ground, with no foundation work being done.

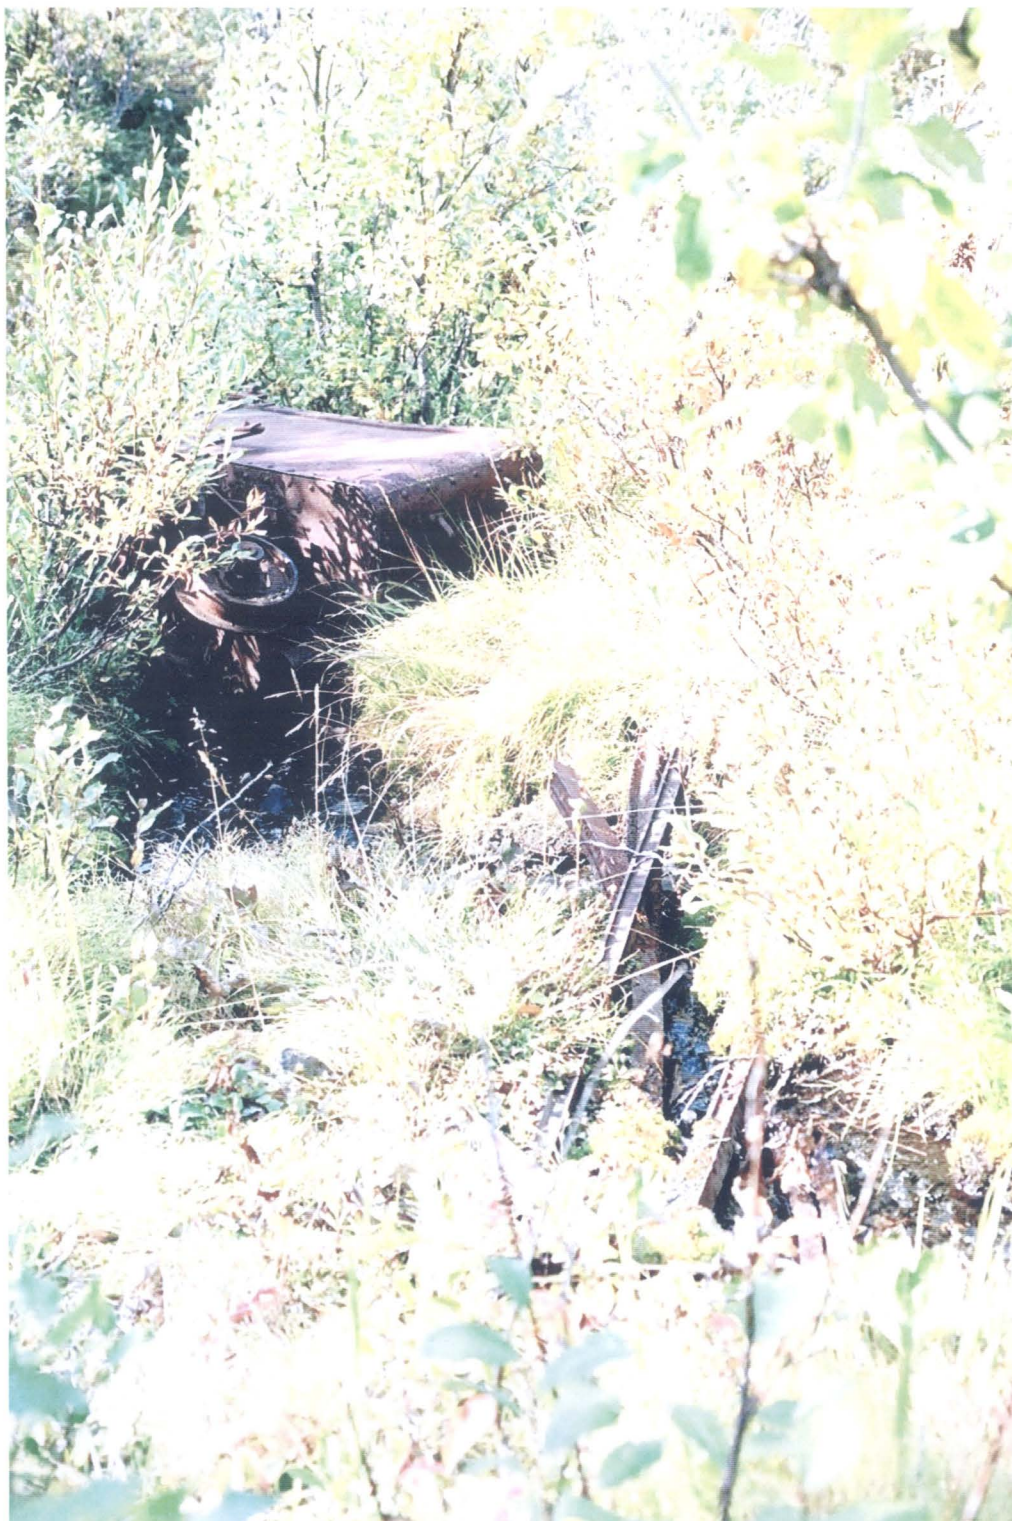
The lower adit is located beside buildings # 5 and # 6.

Rail and a small ore car lay in front of the collapsed adit.

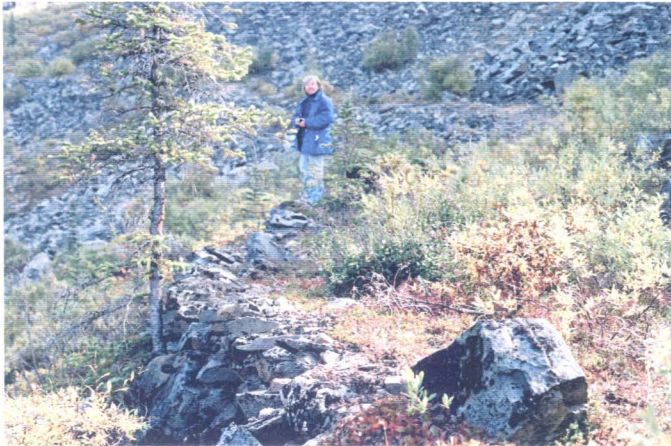
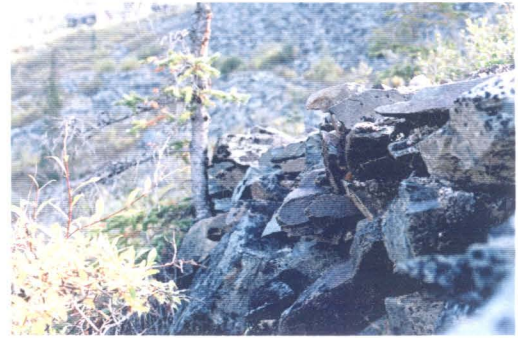
An exceptional feature of the site is the stone access road branching off the lower Faro Gulch trail uphill to the site. On many of the corners the stone has been hand placed to keep the dirt from sloughing.

There was an amazing amount of work involved by the laborers who helped construct this road
