Historical Review

Of
Selected Mining Sites
In The Silver Trail Region

Prepared for
Waste Management Program
Indian and Northern Affairs Canada

March 2005

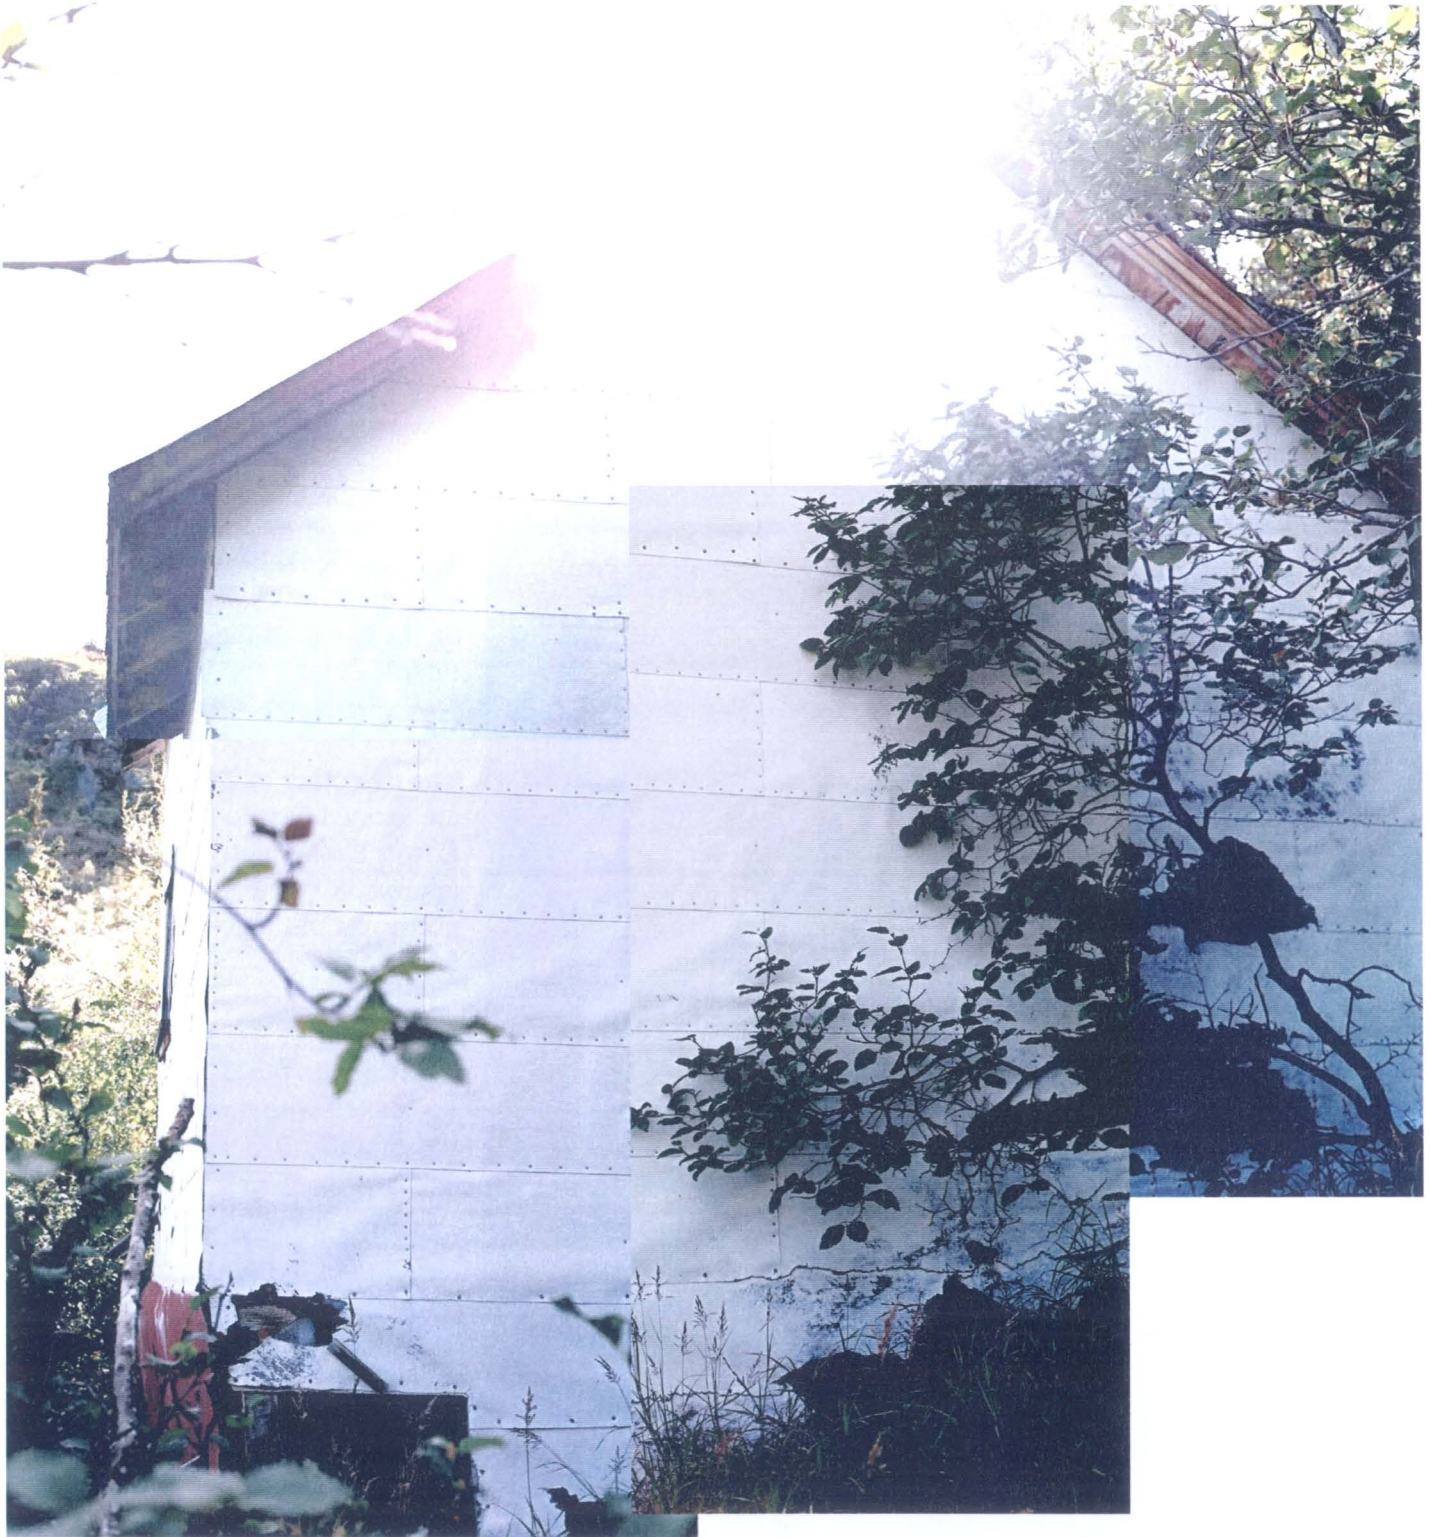
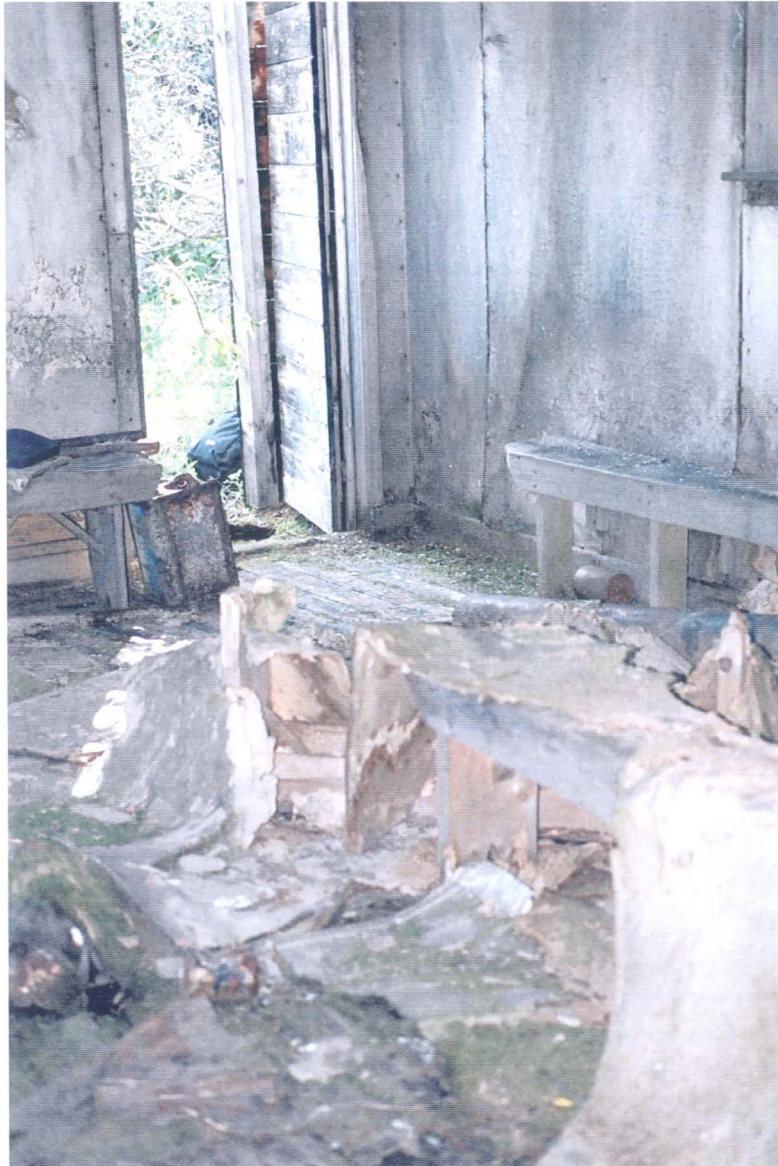
Building #1

The Dry building is the largest of the buildings, 7.28 meters x 4.36 meters.

The building location is 75m northwest of the middle adit and is at the same elevation as the adit (which is 1265m).

The foundation of the Dry is constructed out of logs that are laid directly on the ground. From the foundation there are a series of upright logs which support the actual floor framing. The upright logs are 2 meters tall on the down slope side of the building.

The building itself is in fair condition, debris and the ladder inside should be removed.

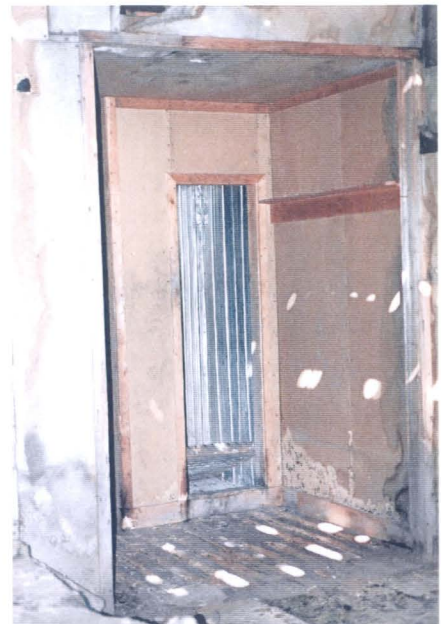
There is a shower stall (*right*) in the northwest corner of the building with a 2.5 meter x 2.5 meter sauna in the southwest corner.

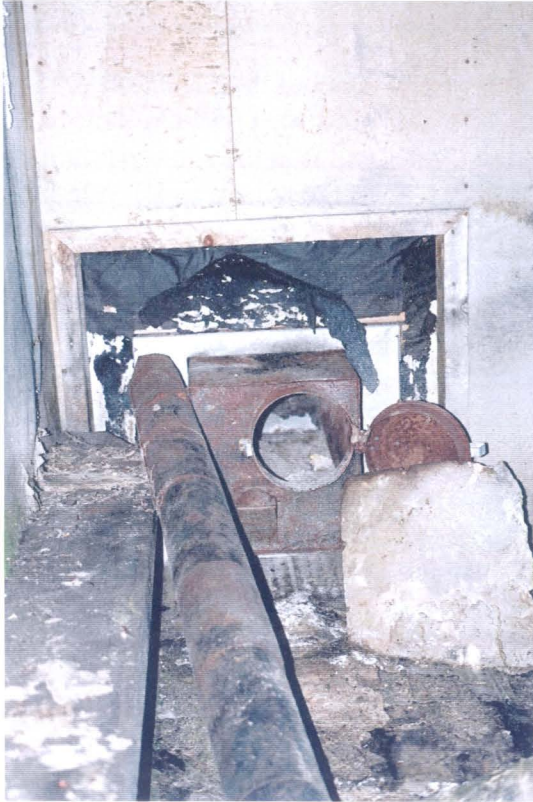
Photo right shows the front half of a wood heater and stove pipe. The back half of the heater extends into the sauna and is covered with rocks.

Above the sauna and shower is a loft that holds three 45 gal barrels. These are all connected and served as a storage facility for the water system.

There is a small line that exits the roof and continues upslope to a spring; this gravity feed system kept the water tanks full. The roof is of gable style construction, with 2 x 6 and 2 x 4 material used to build the trusses.

The roof was then sheeted in with 1 x 10 planks and tin was used for the exterior weather cladding. The tin from the roof has all been removed due to the elements and is scattered down slope of the Dry. The building remains in fair condition.

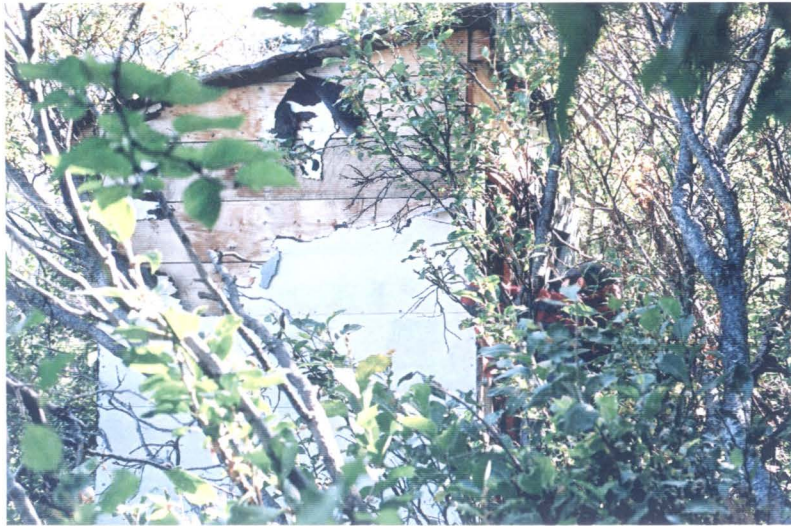
There is an outhouse associated with the Dry; it is located 6.67 meters to the east of the building. The foundation of the outhouse is built directly on the ground and consists of timbers and poles.

The floor and walls are of frame 2 x 4 construction with the floor covering being 1 x 6 planks. The outside of the outhouse is sheeted with white asbestos paper.

The outhouse has a shanty style roof constructed with 2 x 4s, and is covered with exterior rolled roofing. The seating area is a two seated type, with the construction material being 1 x 8 and 1 x 4 boards. The outhouse remains in fair condition.

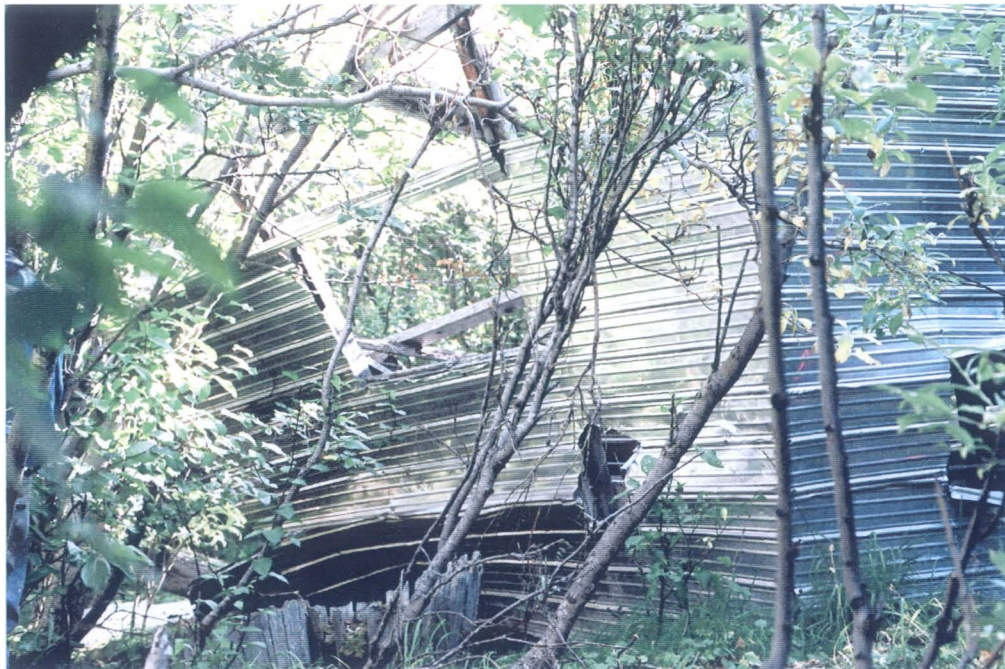
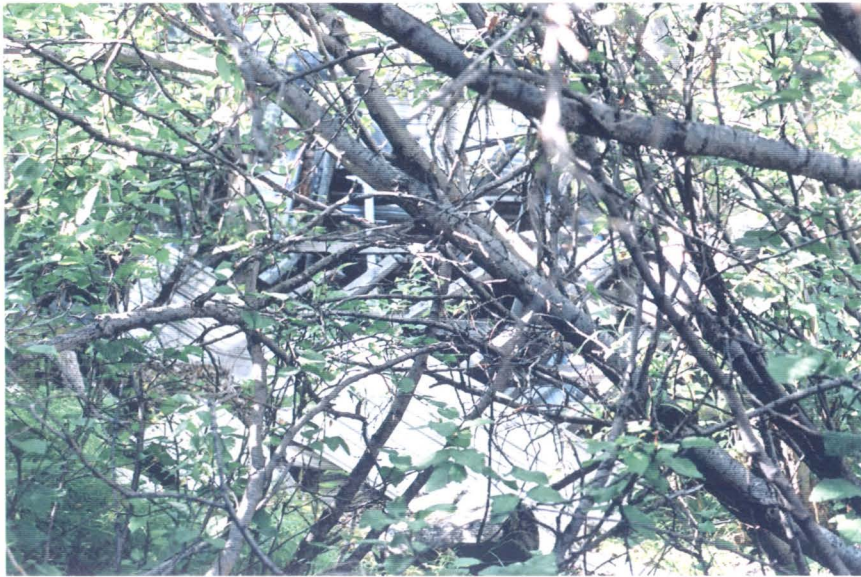
Building #2 Tool shed

This building is located 75m to the east of the Dry and is directly adjacent to the adit on the middle dump. The outside dimensions are 2.2 meters x 3.5 meters.

The foundation is frame material placed directly on the dump surface and the walls are constructed of 2 x 4s with 1 x 6 boards for sheeting.

The building had a shed style roof, with tin roofing.

The roof and two walls have collapsed.

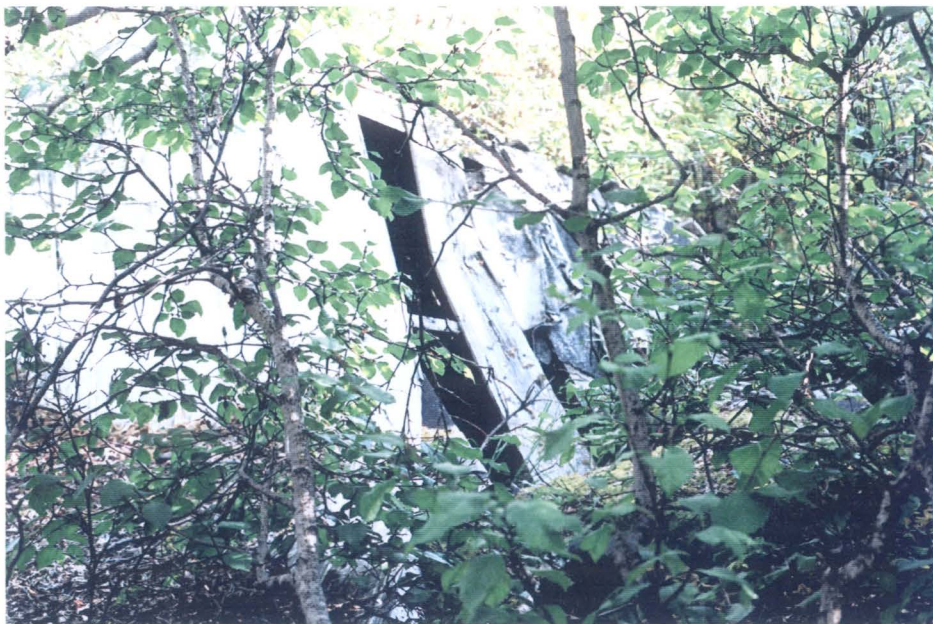
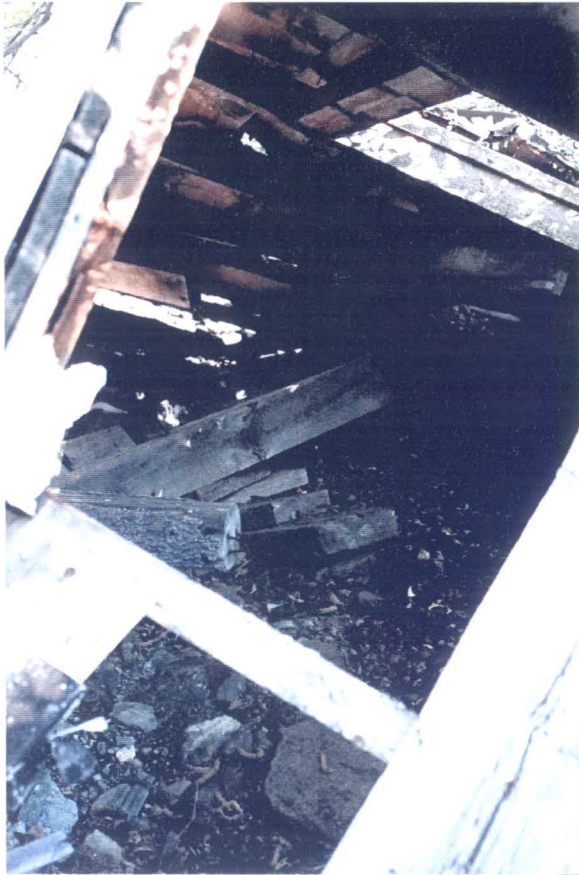
Building #3

This building is fully collapsed and is located approximately 10 meters northeast of the Tool shed. This building did not have a floor structure and could possibly have been used as the compressor house since there are a couple of venting holes in the roof.

The walls were of 2 x 4 construction sheeted in with 1 x 10 planking.

The exterior was sheeted with tar paper and the typical white asbestos covering. There are remnants of tin roofing scattered over the area.

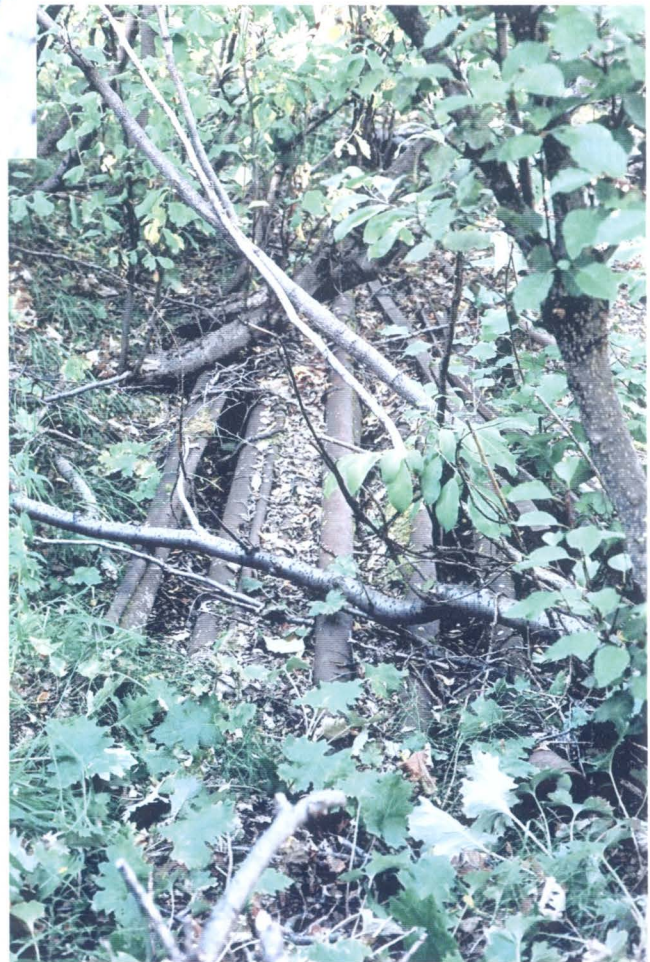
There is mining debris scattered between the Dry and the middle dump. This consists of eight lengths of 3 inch pipe, twenty feet long.

There are also twenty-two, twenty foot lengths of narrow gauge track, a pile of cribbing material, and forty feet of 2 inch pipe.

Recommendations for this site would be to remove all of the loose fuel drums, piping, and debris scattered over the site. Waste piles could be sampled.

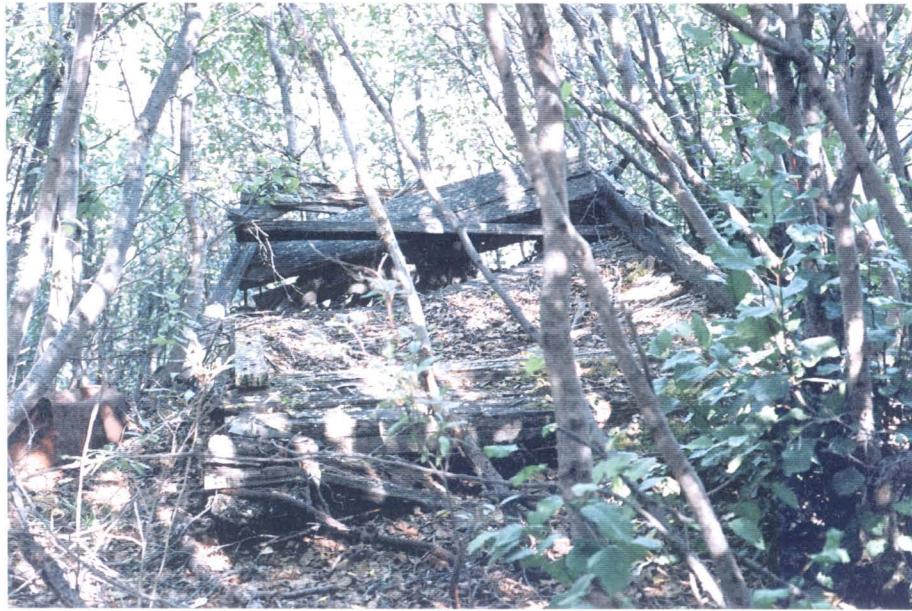
On the waste dump of the middle adit are the remnants of an old stone boat sleigh. (left)

The sleigh is in poor condition and would fall apart if moved.

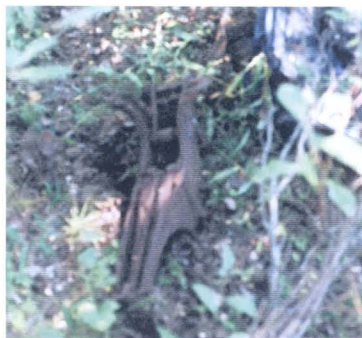
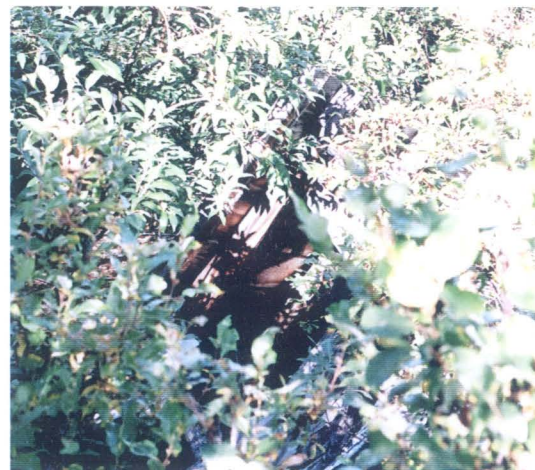
The upper adit is fully collapsed and does not pose a concern.

There is some mining debris at the dump consisting of some air hose, two inch pipe, and a Taylor's Rock Fine Crusher used for sampling core or rock. (Below)

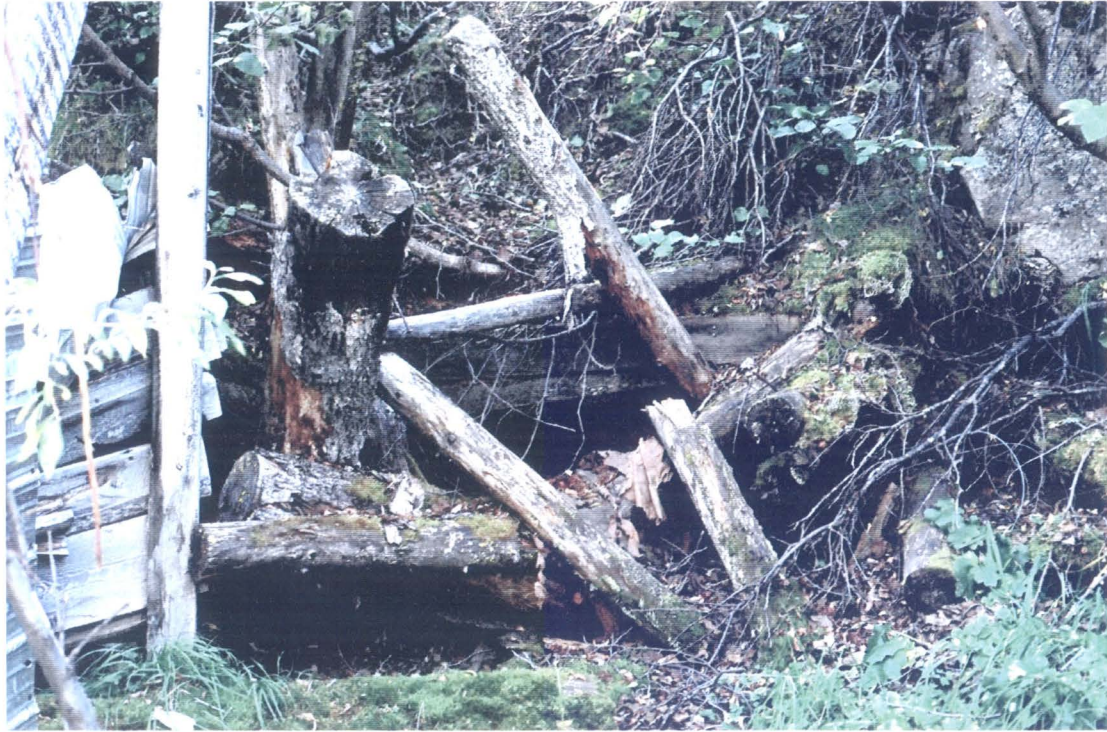
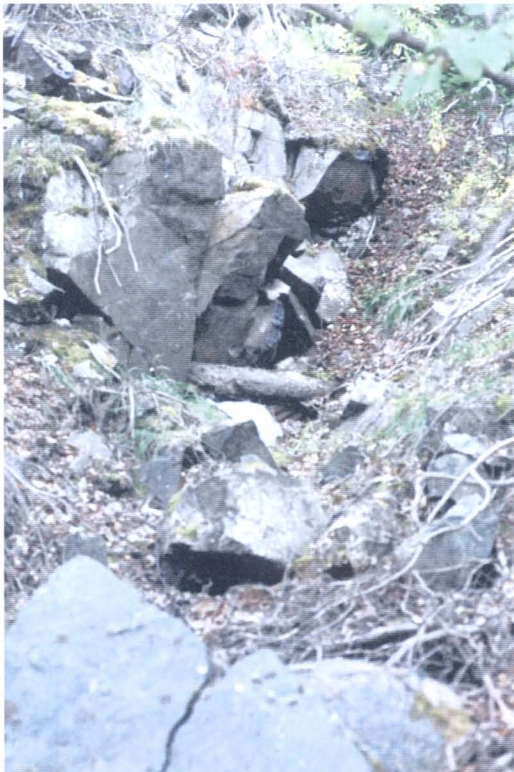
The portal at the middle adit at is only partly collapsed and does pose concern. Co-ordinates for the adit are 488835 meters E and 7092386 meters N at an elevation of 1321 meters.

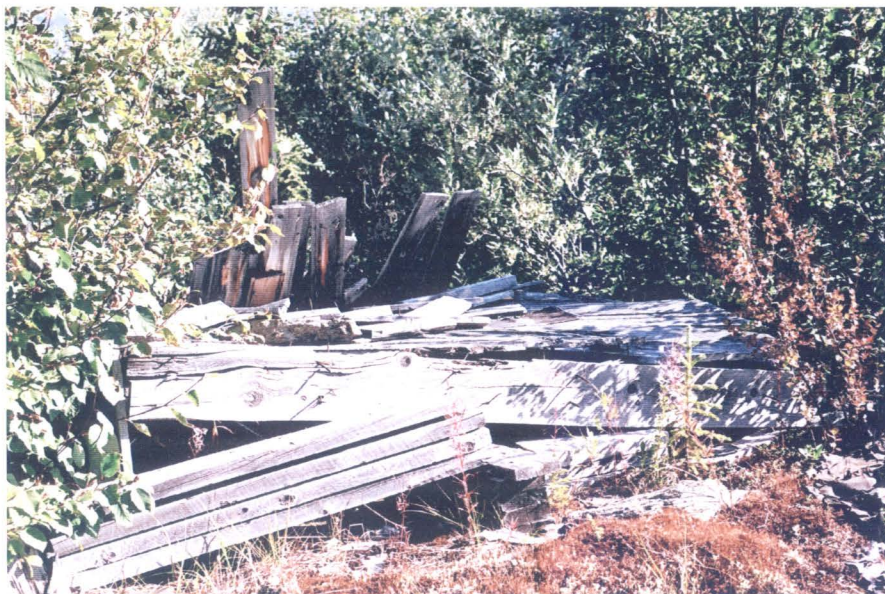
Building #4

This building is located directly above the Lower Faro Gulch Trail, 380 meters north west of the lower adit. All that remains of the building is the foundation and loose boards.

The dimensions of the building are 11m x 4.5m and were of frame construction.

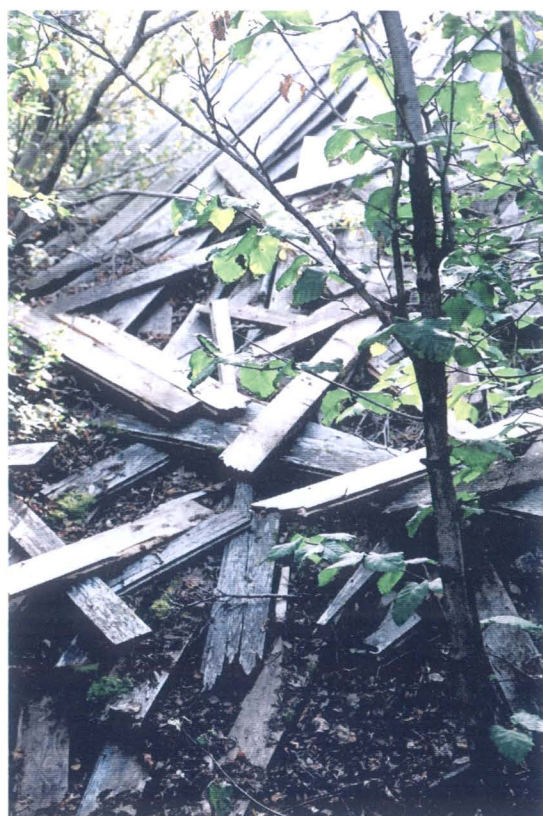
There is a lot of debris scattered over a 15 x 20 meter square area, with the concentration of material next to the main trail.

The boards have been slid over the bank, and are resting on the edge of the Lower Faro Gulch Trail.

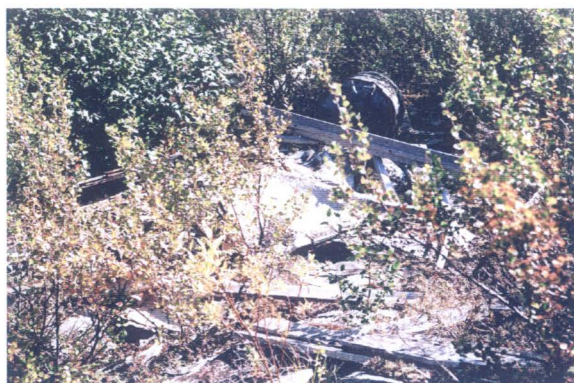
There is metal roofing scattered throughout the area. A bed frame, old heater, asbestos siding and tar paper are scattered near the building. (Above)

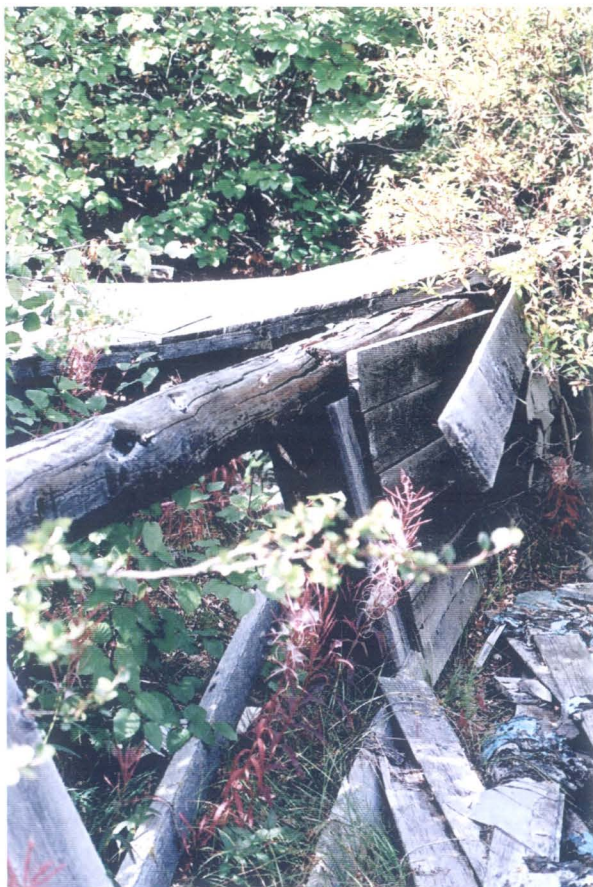
Building # 5

This building is located 7 meters below the Faro Gulch Trail and approximately 360 meters from the lower adit. (*Below*)

This building is in the same condition as building # 4 with most of the material having been salvaged.

The size of this building was 9 meters by 5 meters, with the frame foundation being the only part that is intact.

There was a 2 meter porch attached to the west end of the building. The base round of the structure was originally made of hand hewn round logs that were placed on 8 x 8 blocking. There is no evidence of the floor or walls, but we did find one frame gable end that was sheeted with 1 x 10 boards.

The sod roof has collapsed over the floor material and now supports a healthy mix of grasses and moss.

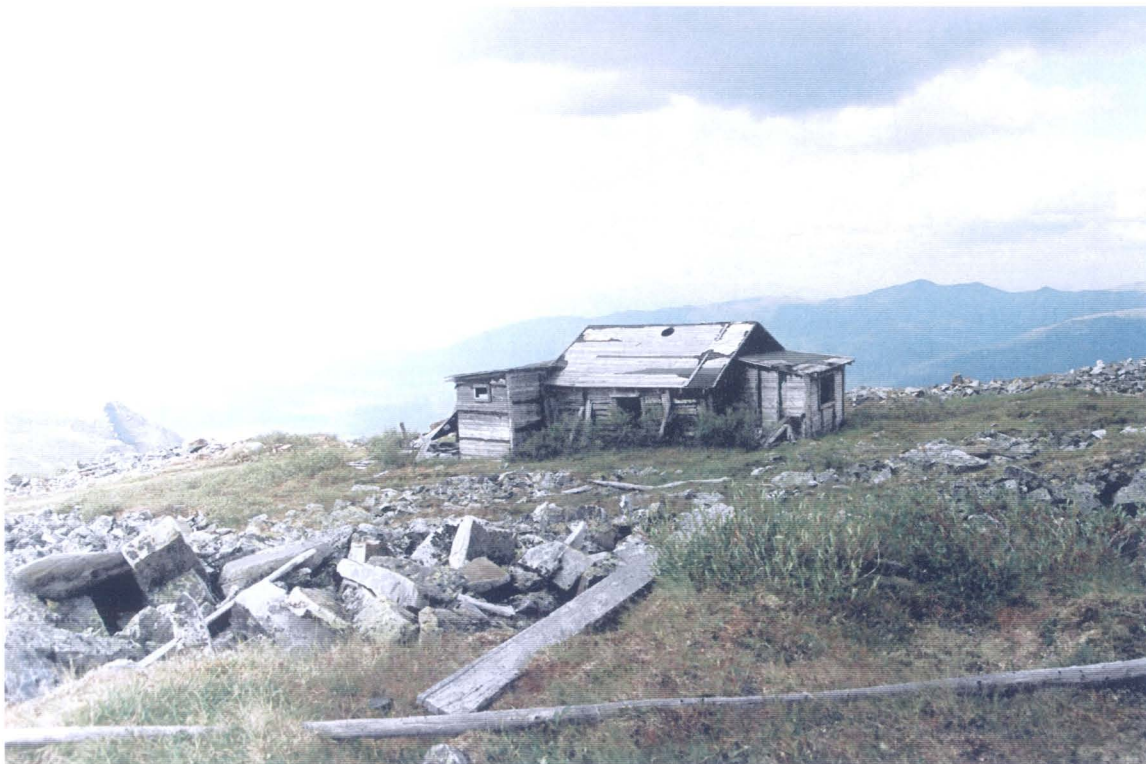
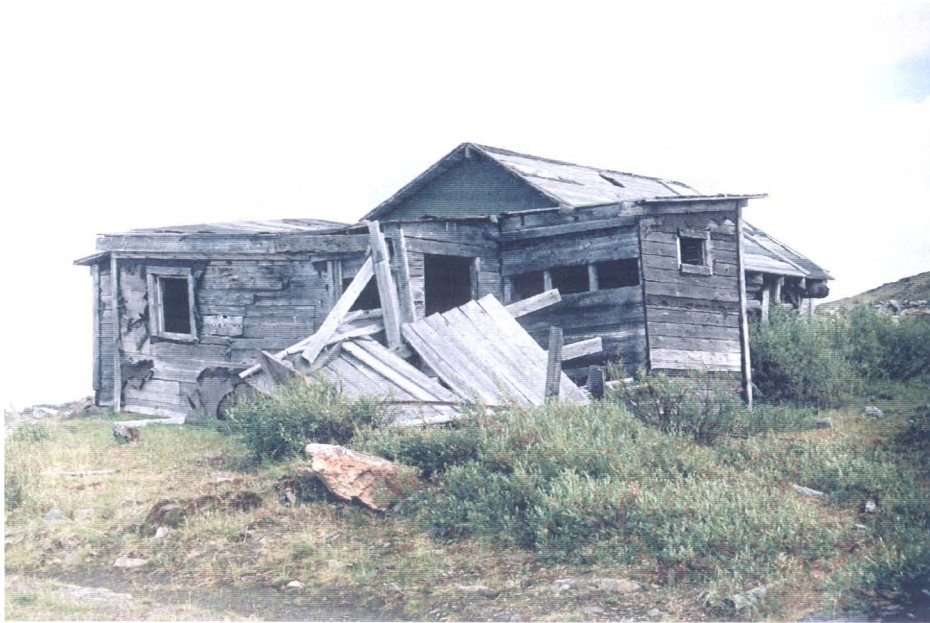
Keno Hill Summit Cabin was constructed of 8 to 10 inch logs, chinked with burlap and moss. The cabin was built using Yukon corner style assembly with 2 x 8 planking to cap the ends of the logs. The logs, as far as we could tell were placed directly on the moss and rock; this has caused the bottom rounds to be highly deteriorated.

Two log poles have been placed on the south side of the log structure to help brace the wall from collapsing. The low gable style roof is constructed of rough 2 x 6 boards, which are then sheeted with 1 x 6 boards and covered with green rolled roofing.

The frame and log cabin that is located near the hiking trails is also in a fragile state with exterior wall bracing already being used to support the integrity of the structure.

The porch addition has collapsed further since the last inspection. Since this building is highly visible from the end of the Sign Post Parking area, and is in a highly accessible area for public investigation, stabilization of the building of the building would be recommended.

Sheep camp is one of the original buildings on Keno Hill. In our opinion this site is of historical significance and should be preserved. At a minimum stabilization of the main log structure is recommended.

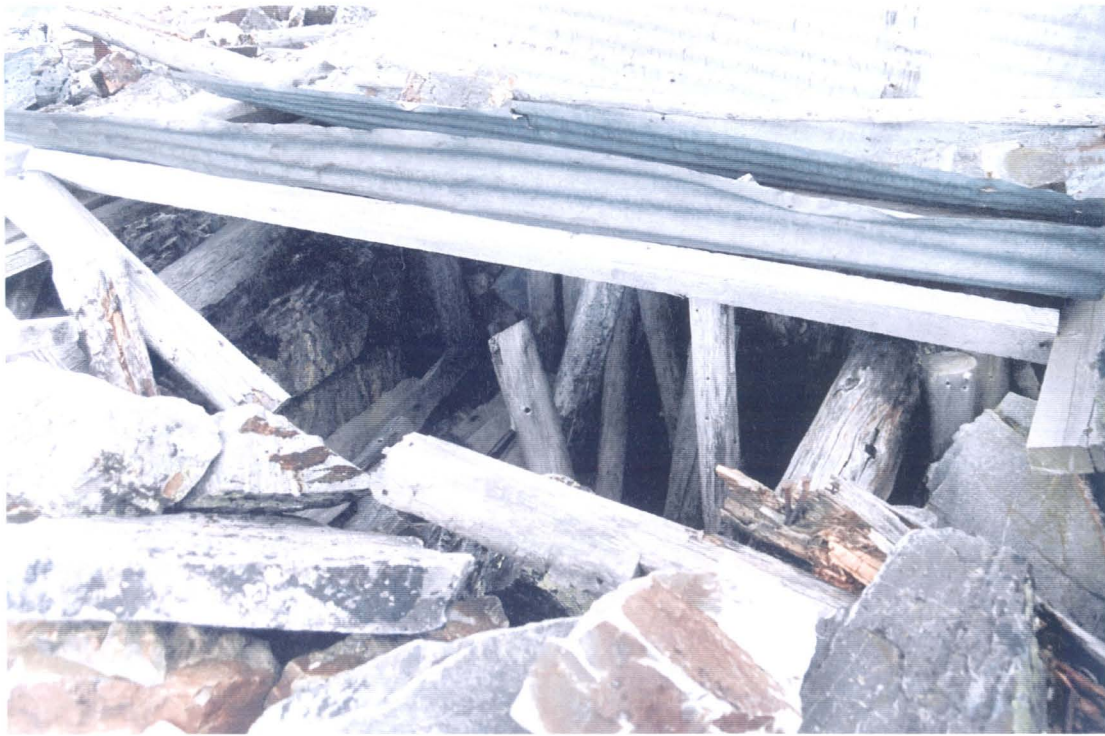
There is one shaft located south of the main camp by about 75 meters and above the road by about the same.

The shaft is 2 meters x 2 meters square and has collapsed 2.5 meters from the surface. The shaft was built with a combination of log and frame material with a shaft covering made of 2 x 4s and corrugated tin.

The major public consideration at this site is the open shaft that is exposed near the road. There has been an attempt to cover the shaft with corrugated tin, which is held in place with rocks. The top round of square timber framing and log work are severely deteriorated.

Closure of the shaft would be recommended.

From a safety perspective we would certainly recommend the closure of the open shaft.

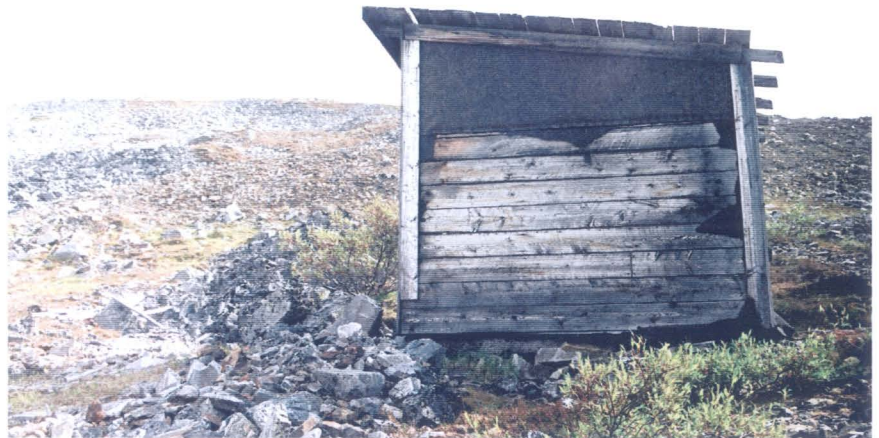
Building #2 Adit shed

The shed is 2.9 meters x 2.6 meters and of frame construction.

The foundation of the shed on the up hill side is built on 6 x 6 timbers that have been placed on flat stone. The lower side of the structure has been built directly off the existing rock. The floor is made of 1 x 8 boards, sheeted over 2 x 6 joists that are on 1 meter centers.

The walls are constructed of 2 x 4 studs that have been sheeted in again with 1 x 8 boards. The roof is shanty style with 2 x 4 roof trusses that are sheeted with 1 x 8 boards; this was partly covered with the remnants of black tar paper.

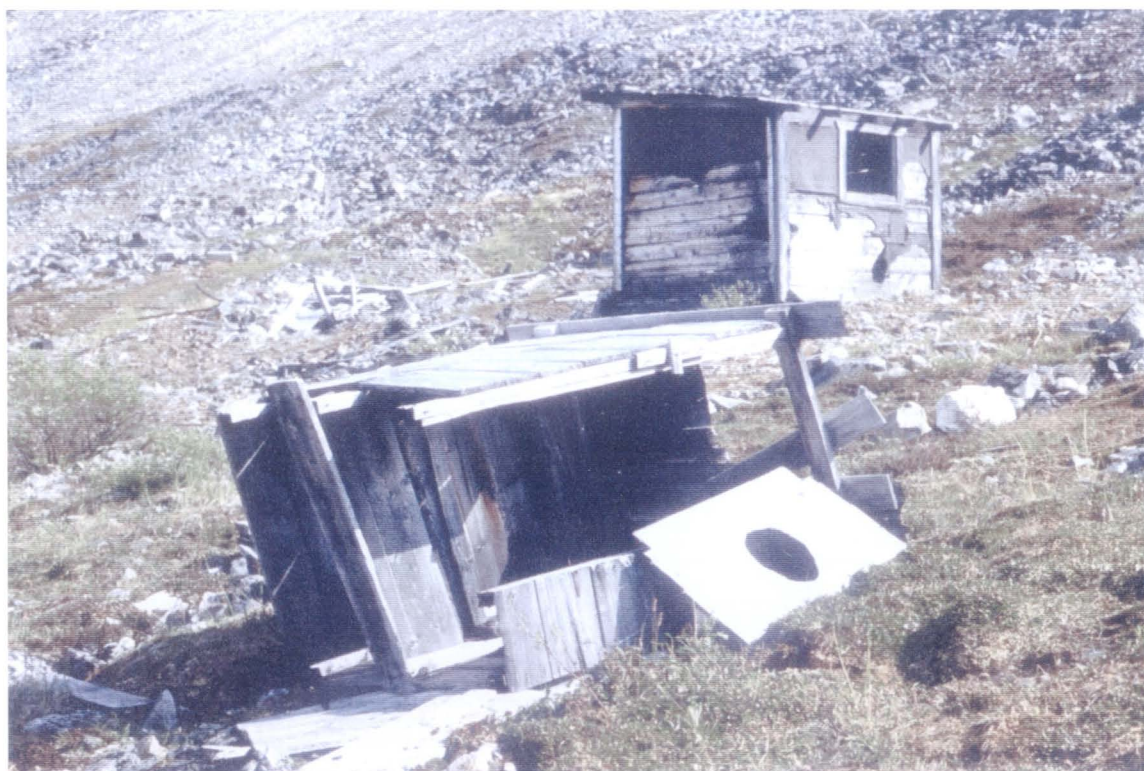
Building #3 outhouse.

The remains of a log and frame outhouse are located 10m southwest of the adit shed.

The top part of the structure has been blown off and lies nearby. The foundation was of log construction with the floor and walls being made of frame material. The outhouse had a shanty style roof that was covered with corrugated tin. The outer sheeting of the structure was rough cut 1 x 10 boards.

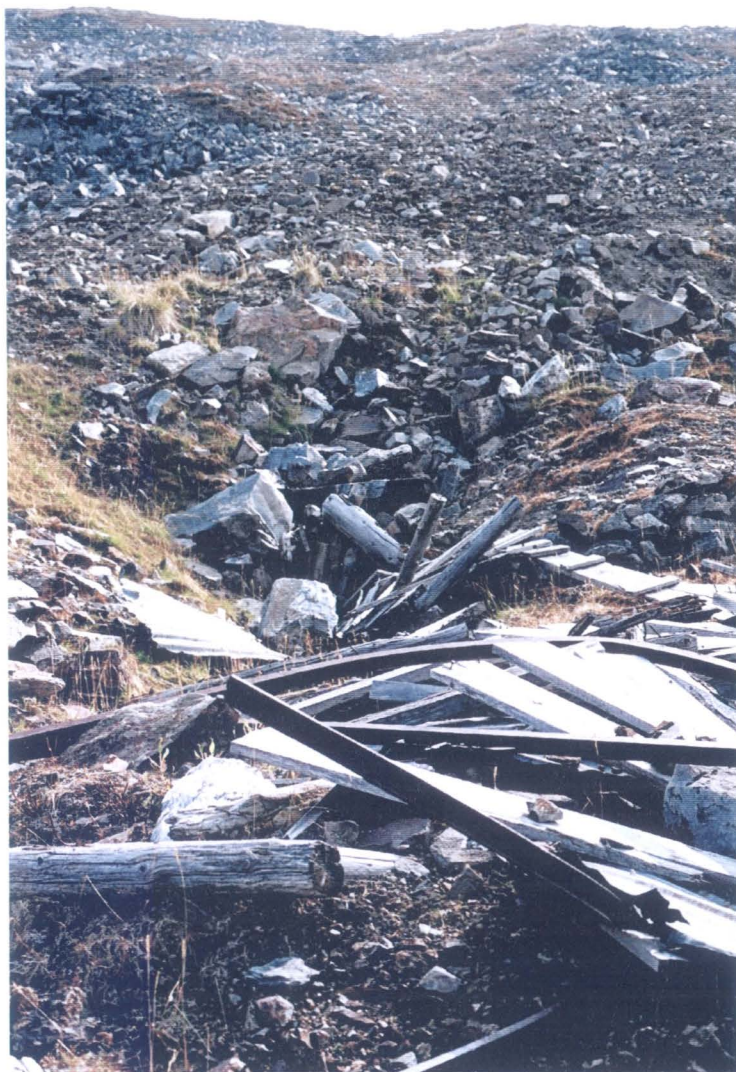
The adit is fully collapsed and is located directly below the road approximately 252 meters from the main cabin. There are numerous boards and steel rail scattered in front of the collapsed portal and extending out towards the dump site.

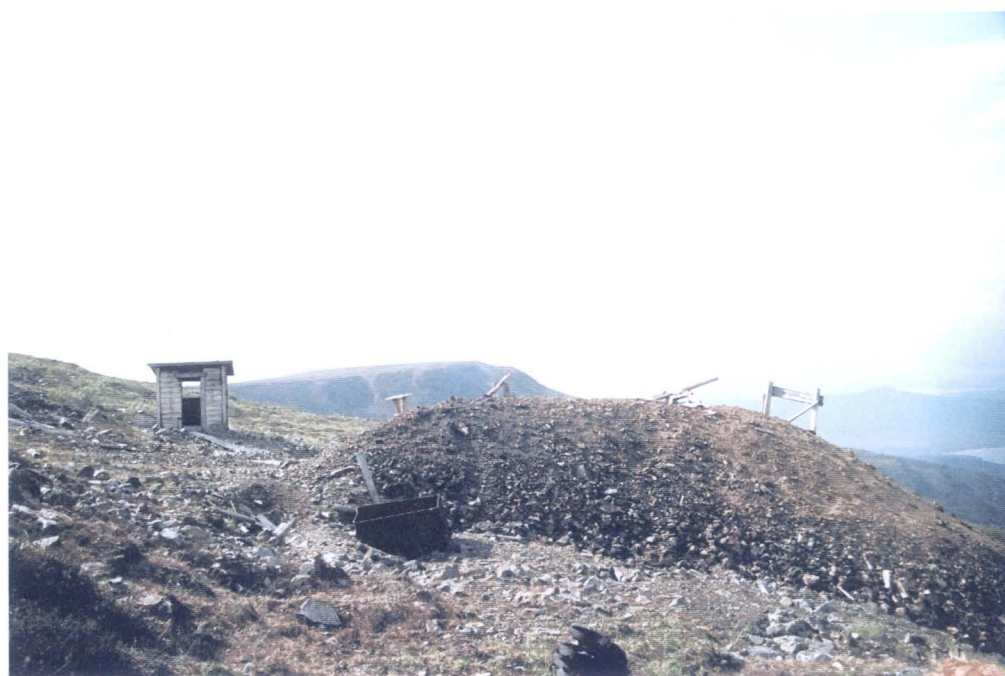
At the dump site there are a number of heavy gauge steel tanks and an old mining car, along with more wooden debris imbedded over the dump itself.

As noted in the previous 1999 Keno Hill/Dublin Gulch Baseline Assessment study, the leaching of the waste dump would be the only concern although we do not feel it is significant as there is no water discharge from the collapsed adit.

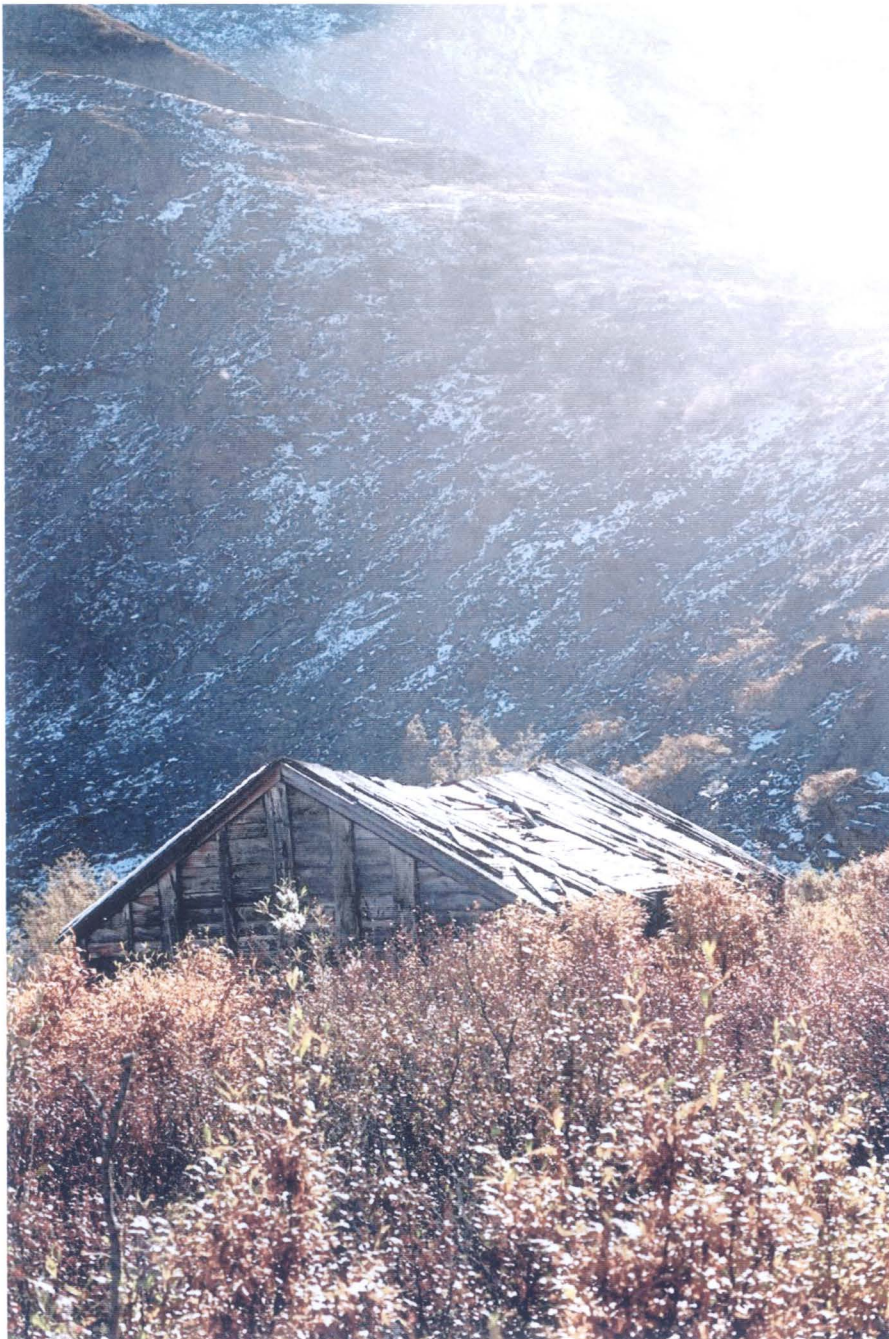
There is one cabin and outhouse associated with the Lakeview site.
The cabin is frame construction, with the foundation being placed directly on the ground.

The floor joists are made of 2 x 4s, which have then been sheeted in with 1 x 3 boards to form the floor.

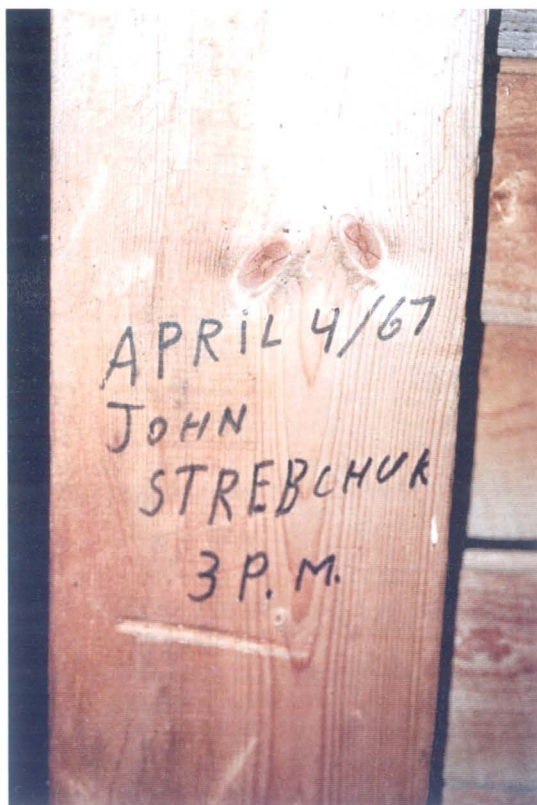
The walls are also of 2 x 4 composition, with the interior walls being partly sheeted one meter up from the floor up from the floor with 1 x 6 and 1 x 8 planks.

There is a partial interior wall, which extends off of the southwest wall, two thirds of the way into the building. This interior partition is not a bearing wall and was probably used to provide privacy for sleeping quarters.

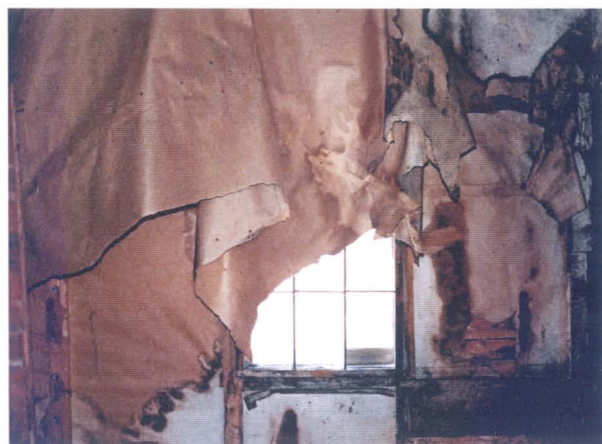
Paper that used to line the walls and ceiling dangles inside the cabin. (Below)

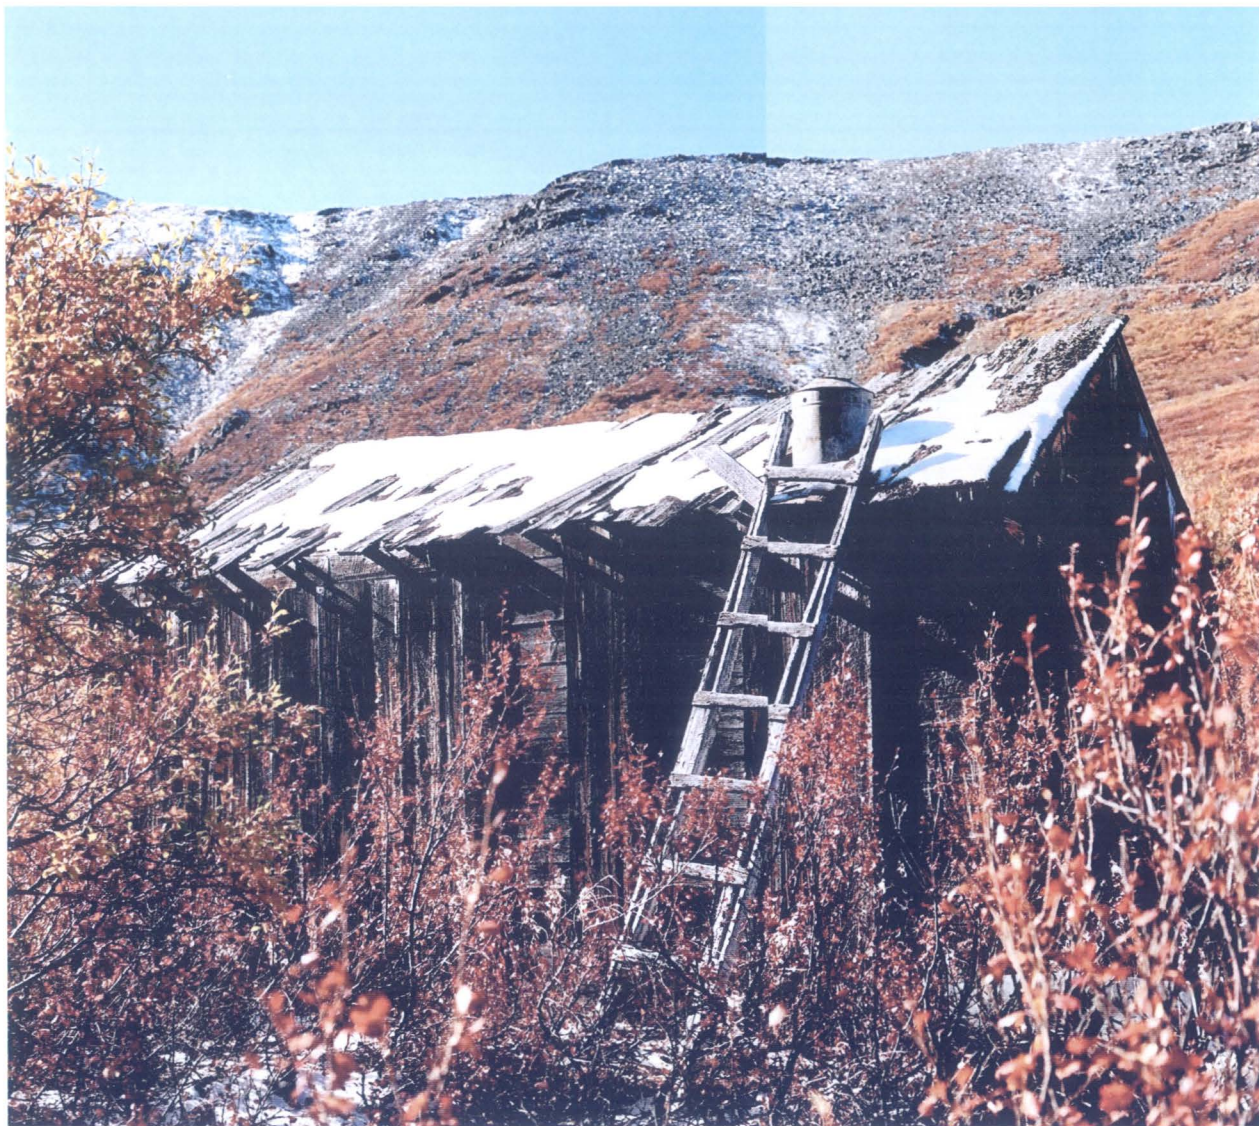
The exterior of the walls are sheathed in with 1 x 4 shiplap boards which have been placed horizontally.

The northeast wall has been partly re-covered with vertical 1 x 8 and 1 x 10 boards. The roof is of gable construction with 2 x 4 trusses sheathed in with 1 x 8 boards. This then forms the exterior roof covering.

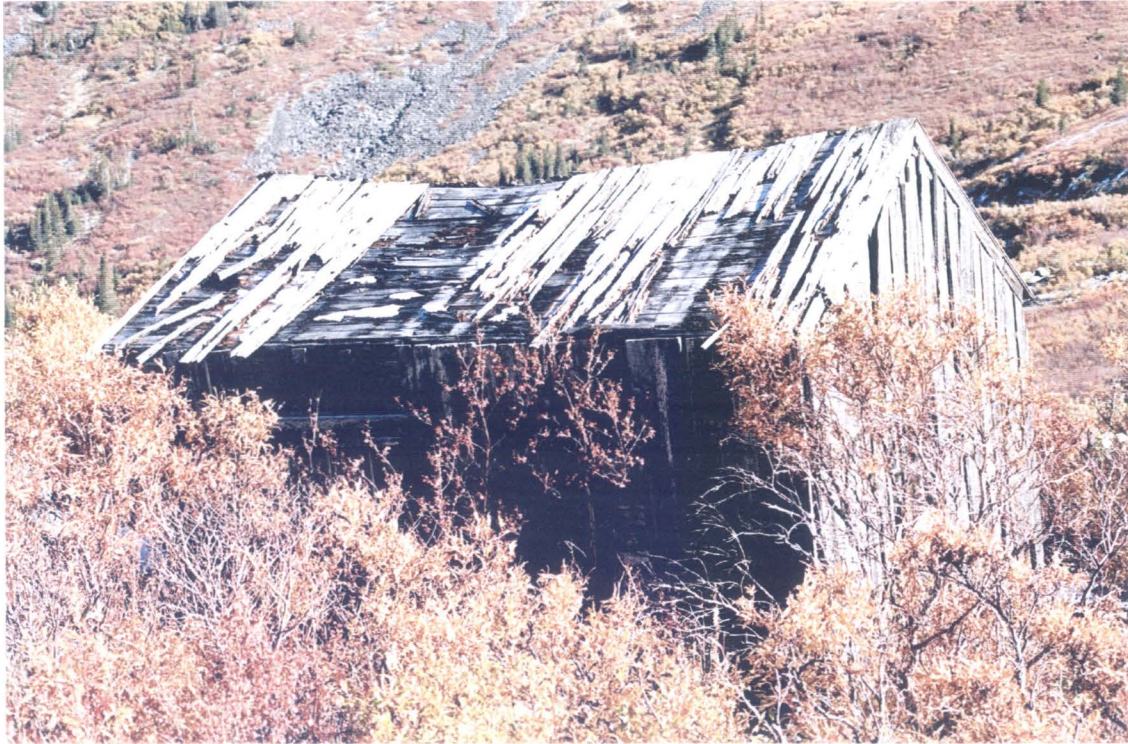
There is no exterior roof cladding remaining on the roof, although in previous report (Keno Hill 1999 Baseline Assessment) it's stated that there was tin cladding. We only found evidence of the roof being cross sheeted with more 1 x 6 boards running vertically from the gable edge to the peak of the building.
