Historical Review

Of
Selected Mining Sites
In The Silver Trail Region

Prepared for
Waste Management Program
Indian and Northern Affairs Canada

March 2005

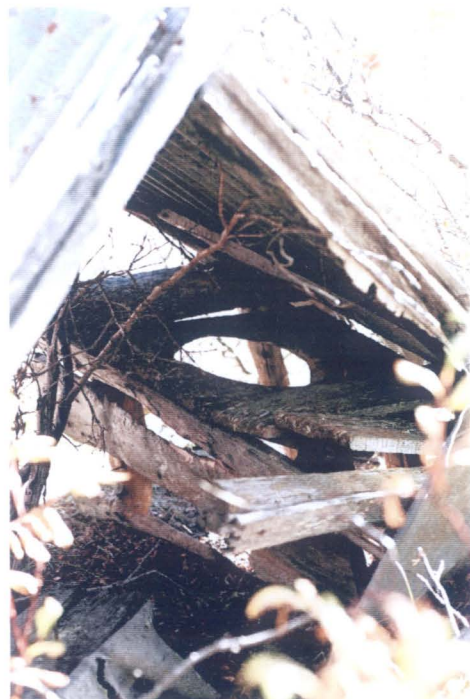
The outhouse is located 5.5 meters southeast of the southeast corner of the main cabin. It is of pole and frame construction with the frame being placed directly on the ground.

There was tin siding over the 1 x 8 exterior board walls and on the shanty style roof, which has now collapsed over the seating portion of the outhouse.

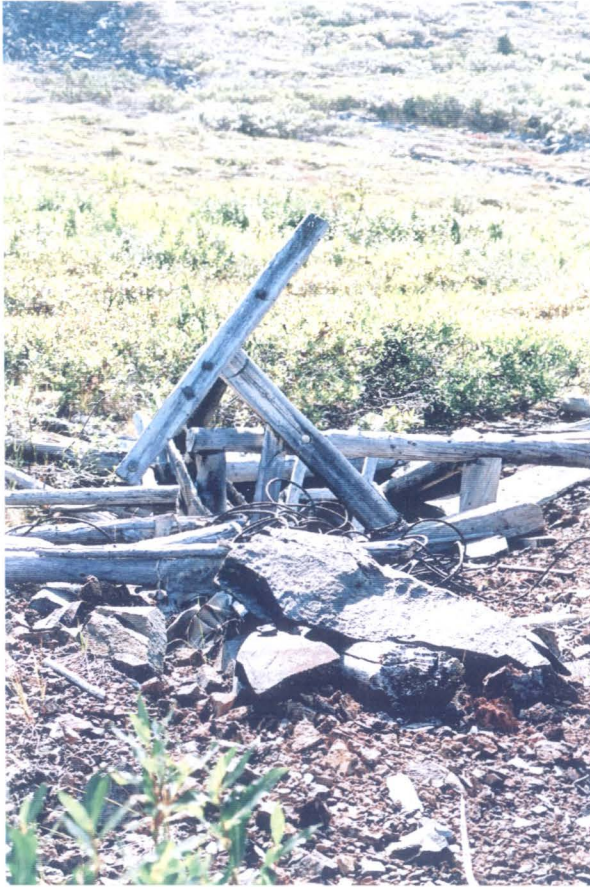
There is one tent frame structure and one shaft associated with this site.

The shaft has collapsed approximately 1.5 meters from the surface.

From an environmental perspective, we would recommend the fuel barrels and heater be removed from the site along with a general clean up of the site. The shaft could be hand filled, so as to preserve the original site location.

The shaft and windless at the site are an interesting feature. If the shaft was to be filled for safety reasons we would recommend that the top round be left in place.

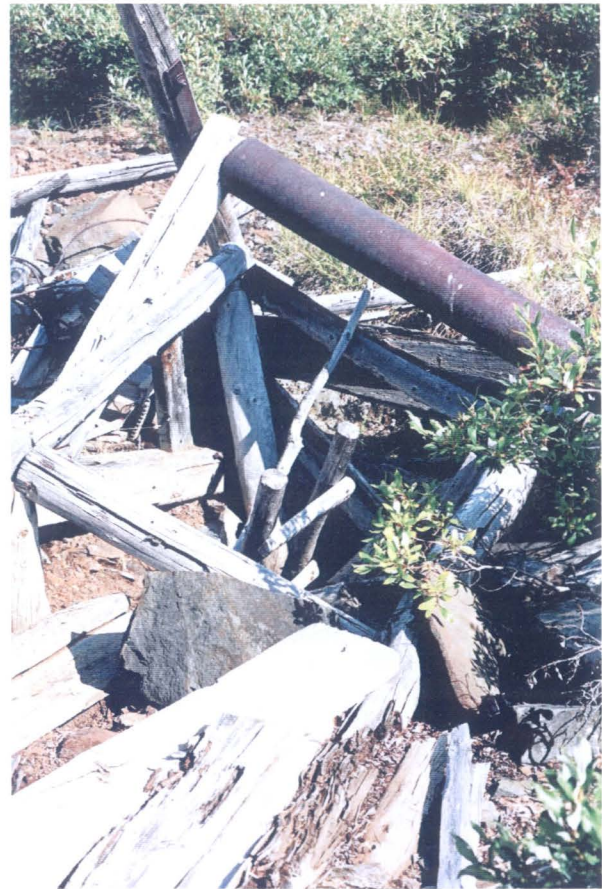
All that is left of the shaft house is the remnants of the bottom round of logs and the roof, which has been blown off and lies approximately thirty two meters north of the shaft. There is scattered wooden debris near the shaft, along with the hand winch and cable still partly in place over the shaft.

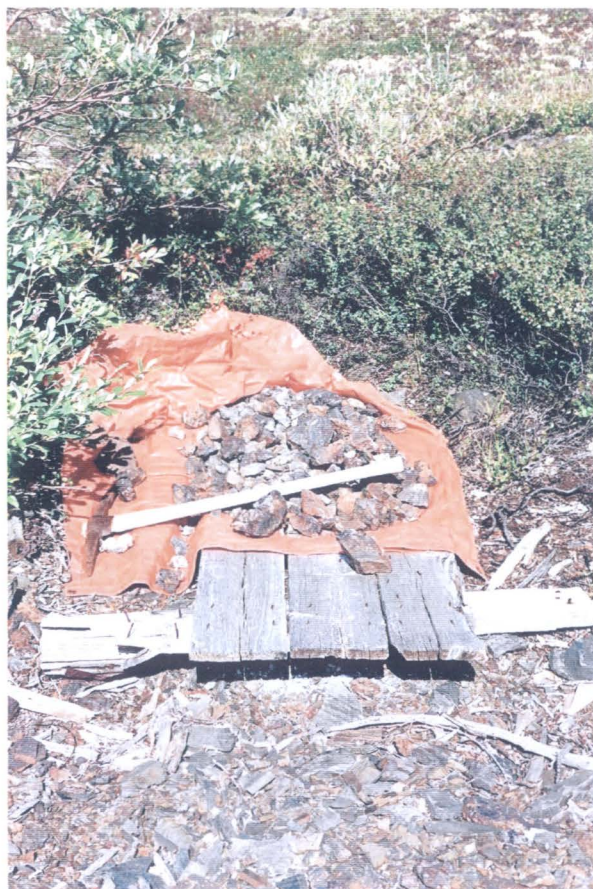
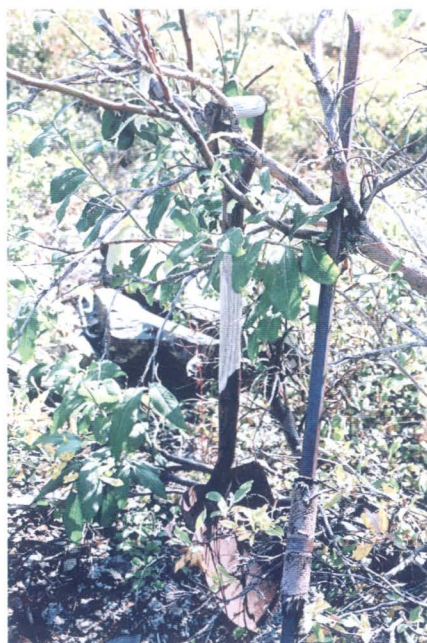
The tent frame is frame construction with the foundation being made of 6 x 6 timbers laid on three foot centers.

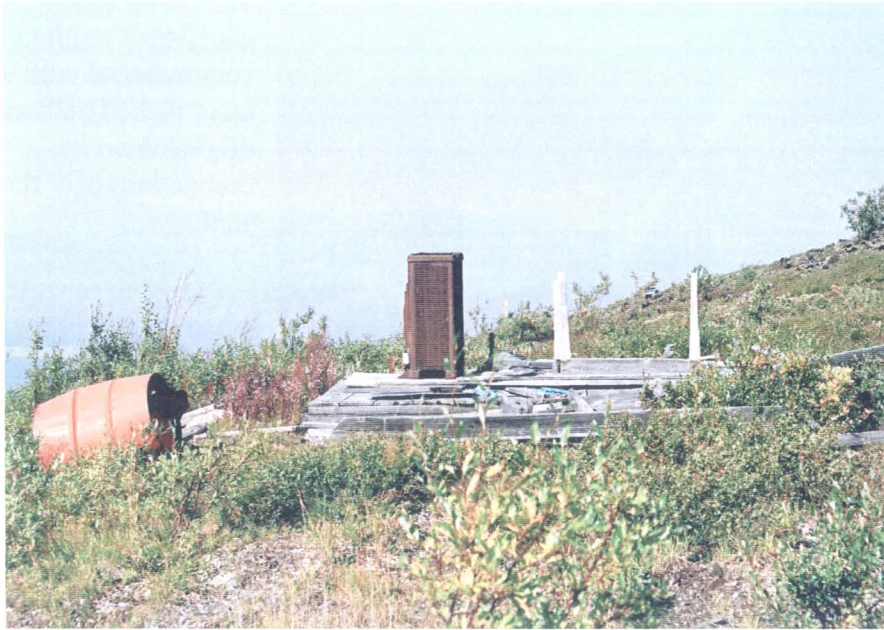
The 6 x 6 timbers were then sheeted in with 1 x 8 shiplap boards. The walls were of standard 2 x 4 construction, and have fallen on to the floor; there is no evidence of a roof structure.

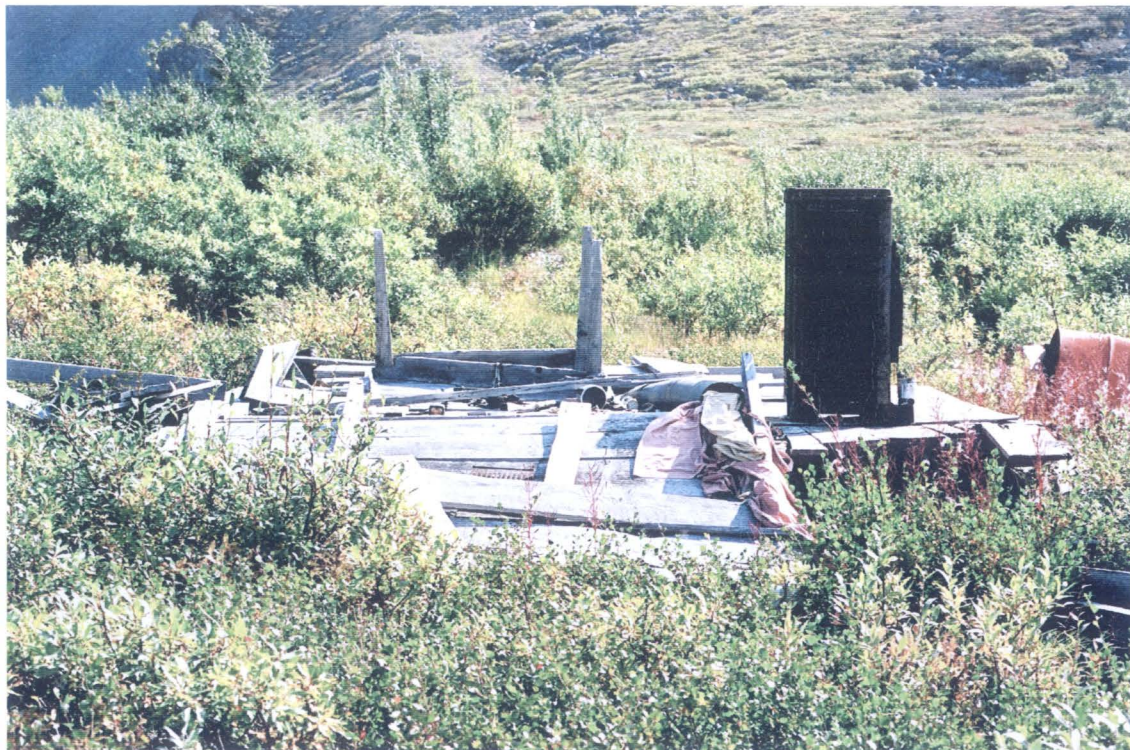
There is a small amount of heavy metal debris scattered around the foundation, such as an old oil stove, empty forty five gallon drum, Air Rock Drill, some stove pipe, and household debris.

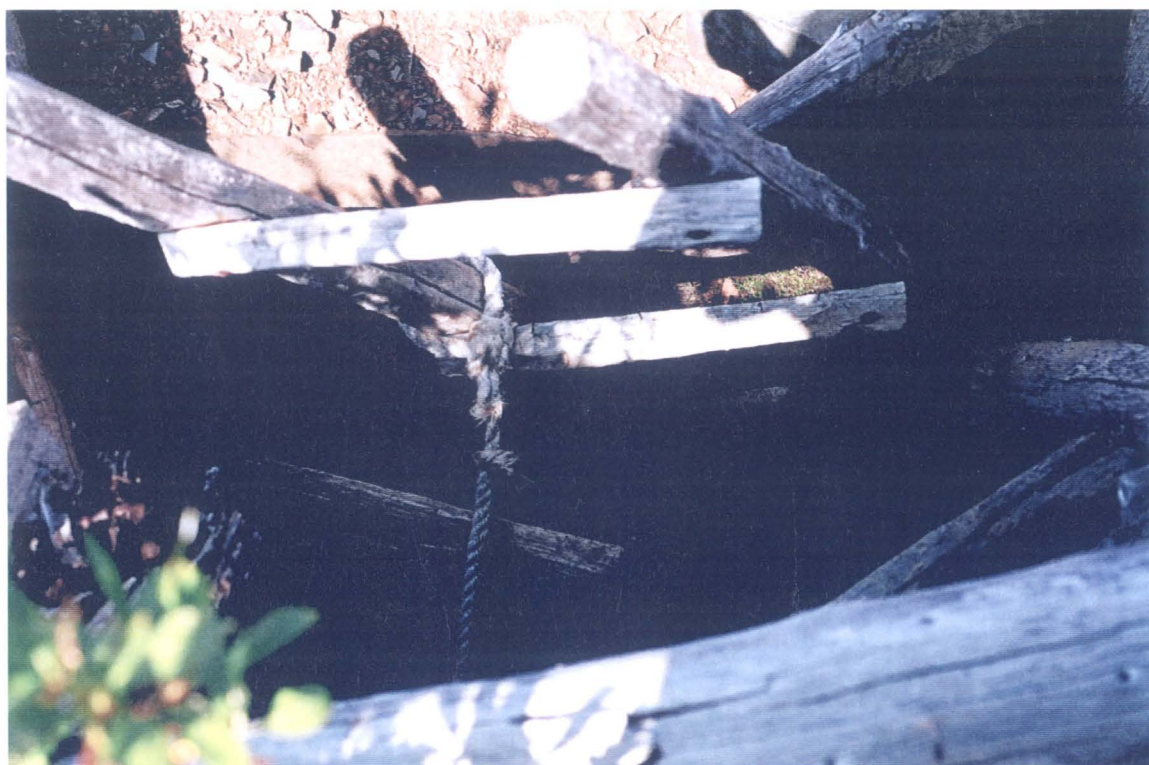
The shaft has collapsed to a depth of 1.5 meters from the surface. The top round of the cribbing is sloughed in to the shaft, with the windless assembly lying near the shaft.

This shaft opening does pose a moderate public safety concern. We did not find any other major public safety issues. The trenching has revegetated well and the sides are at a shallow grade.

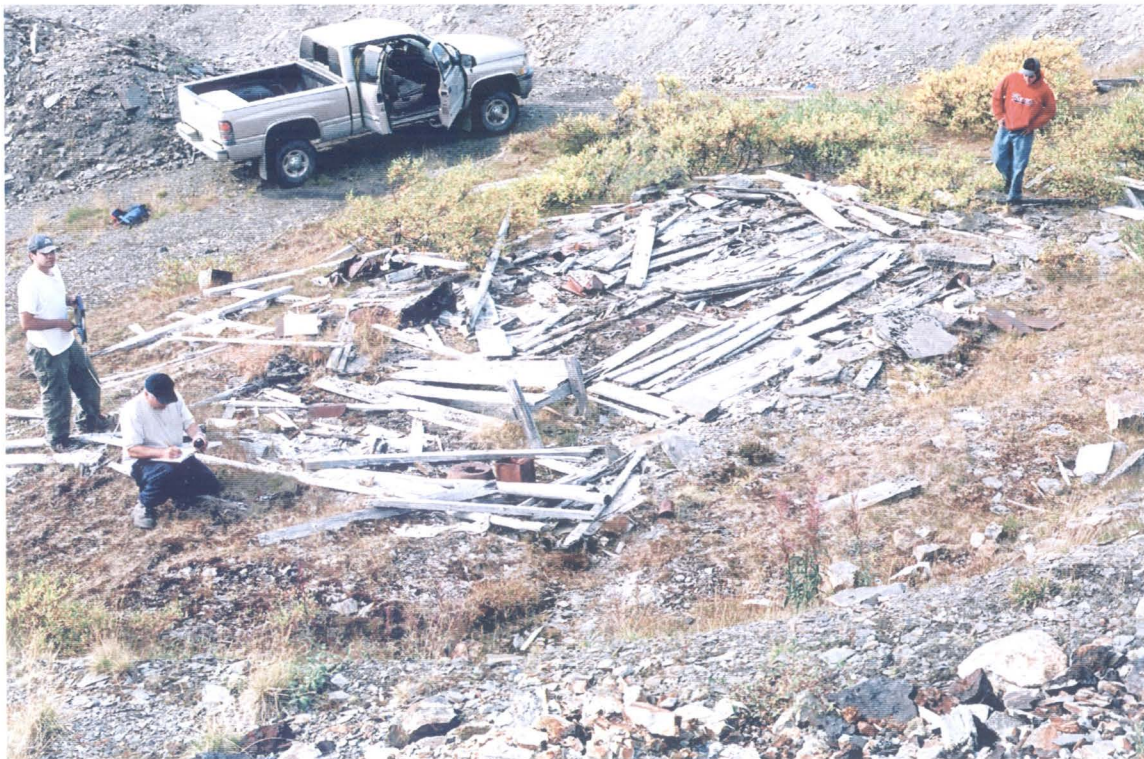
All that remains is the bottom round of logs, which formed the foundation of the structure. Logs were used as floor joists and were placed every 1.5 meters.

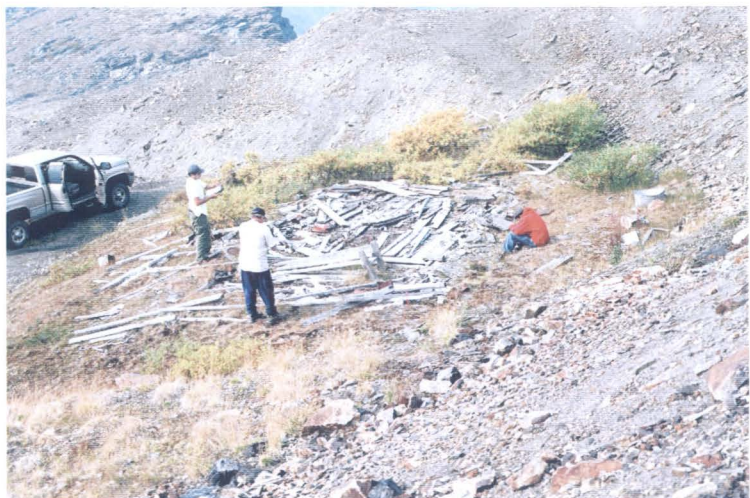
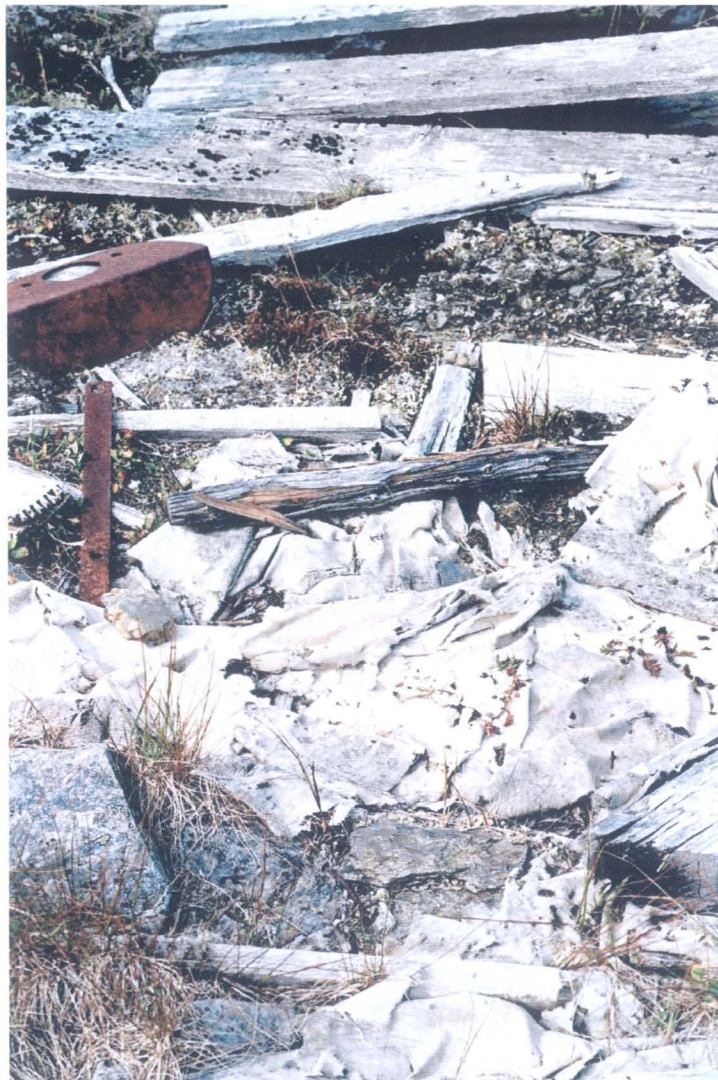
These floor joists were then sheeted with 1 x 8 plank flooring, which extended to the porch area.

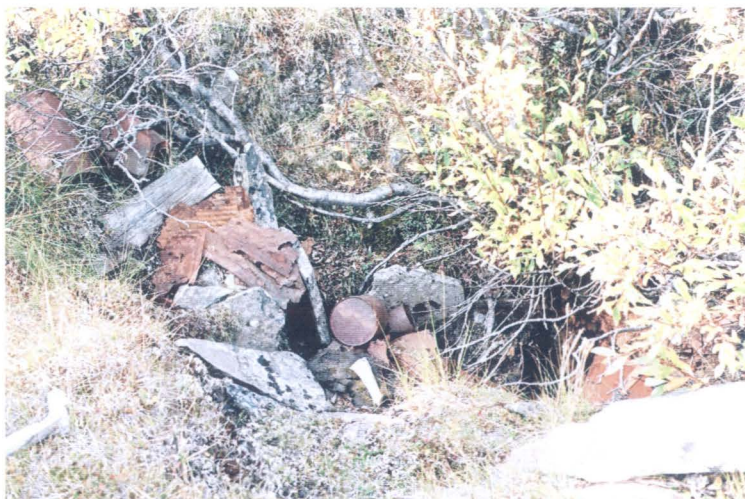
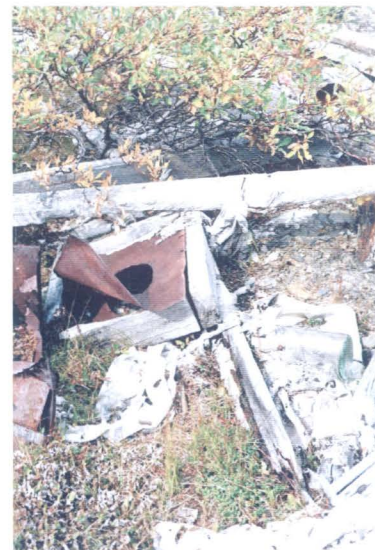
There was no wall or roof structure evident, but there was a considerable amount of old canvas and burlap indicating this was probably a tent frame structure.

There was a large amount of rock stacked around the base of the building holding down what remains of the canvas tent.

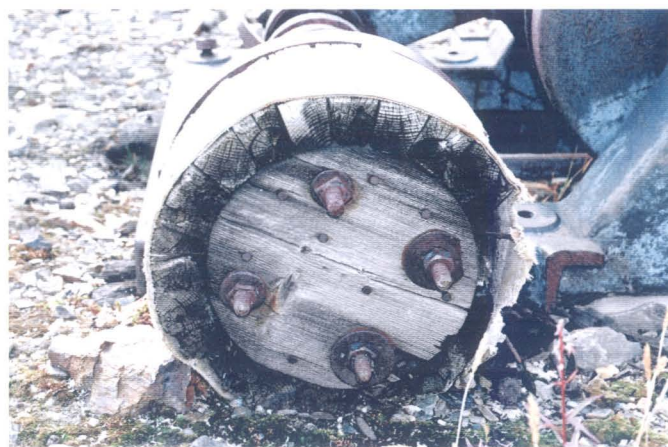
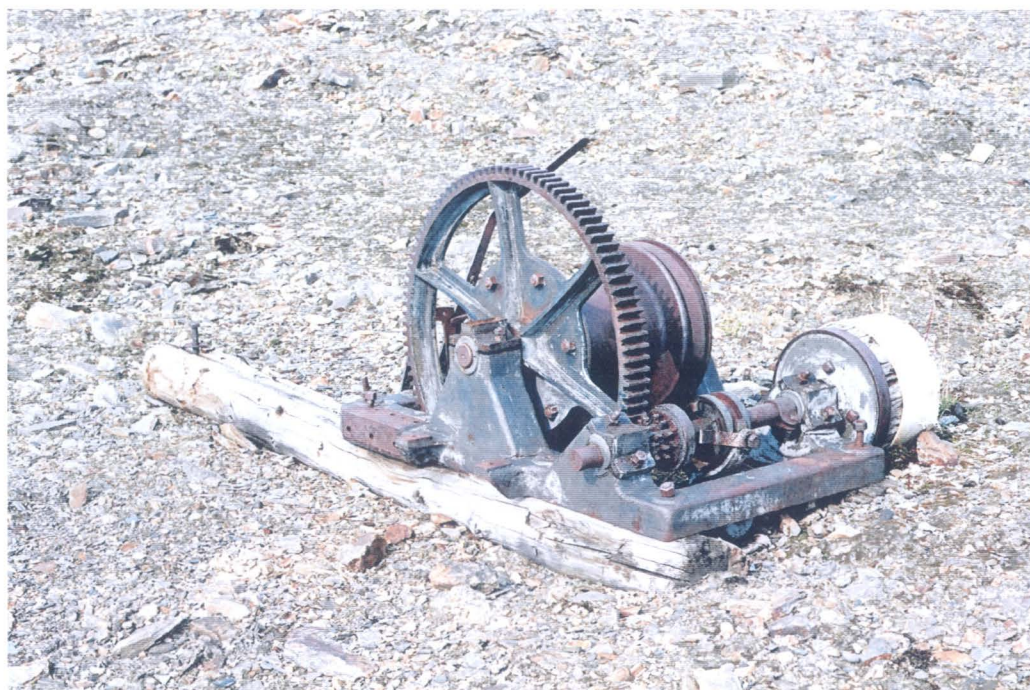
There is an old cable winch located approximately 150 meters southwest of the tent frame, on the other side of the main trench.

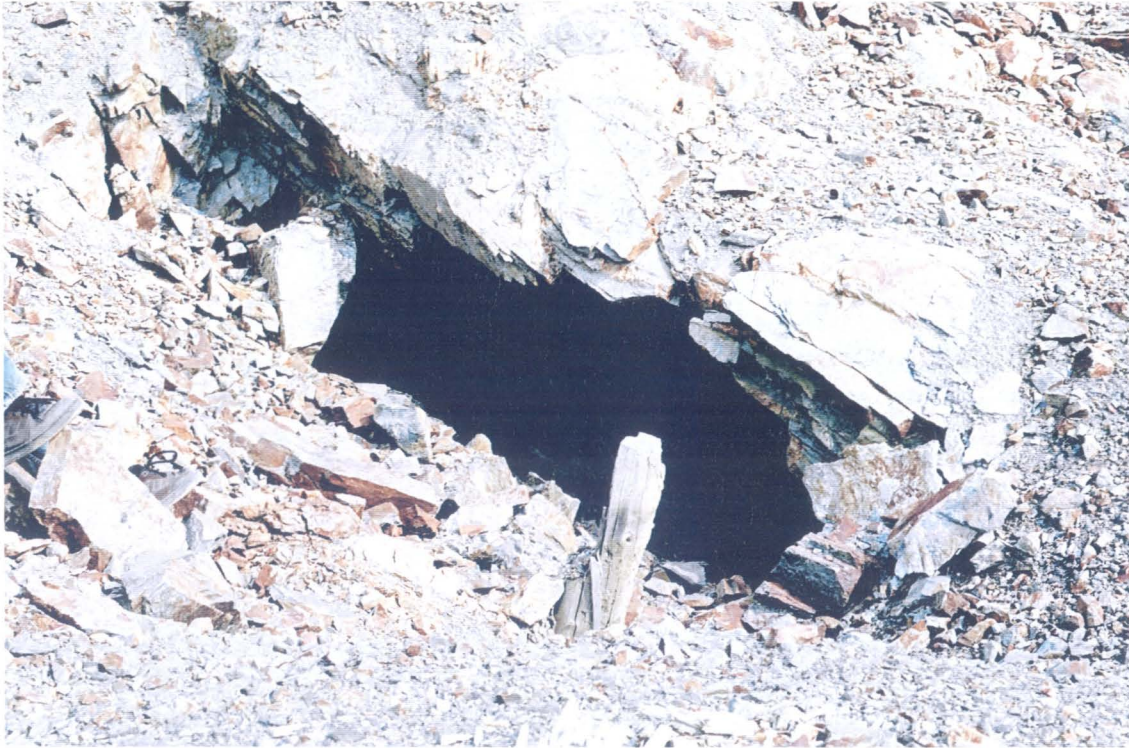
The entrance to the Caribou adit is located approximately 50 meters northwest of the tent frame foundation. The area has been extensively trenched since the last inspection and has exposed the underground workings of the Caribou Adit.

The portal itself has been demolished but the underground workings have been exposed approximately 30 meters from what used to be the adit entrance. The opening to the adit is approximately 2 meters in height by 3 meters in width, with the depth being at least 10 meters or more as we could not see any further into the adit than that. There were numerous other hillside cuts and contouring of the ground as we approached the Caribou adit.

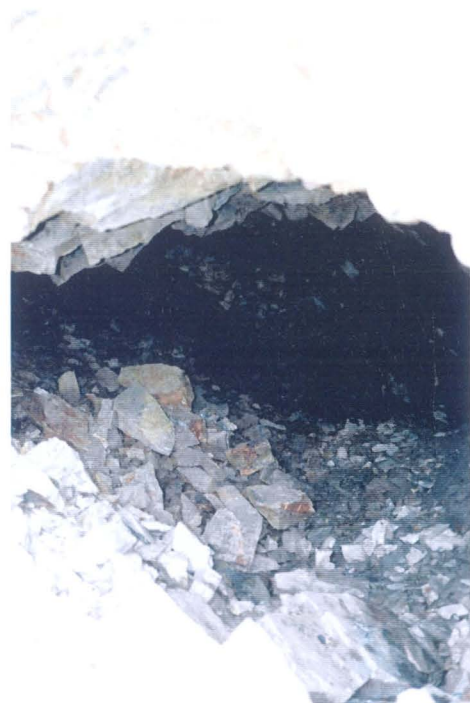
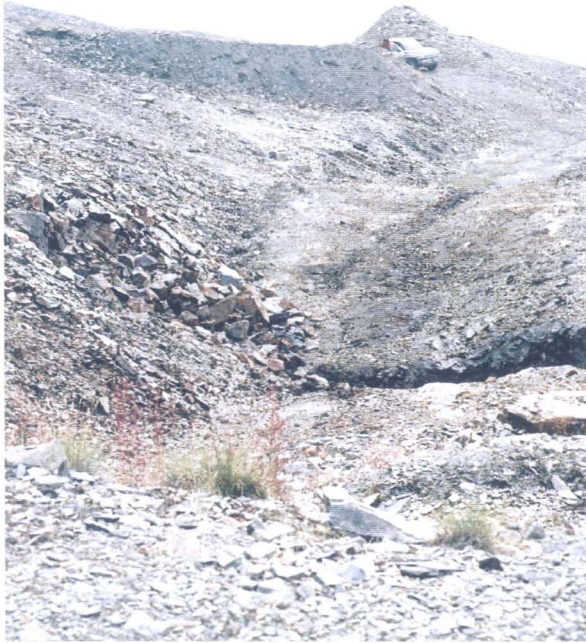
The U.T. M coordinates for the Caribou adit are 7090861m N by 492895m E.

The first priority would be the closure of the Caribou adit underground workings, this could be done by filling or collapsing the opening so access was not possible. Placing a raised berm to prevent any vehicles from entering the main trench would be advisable.

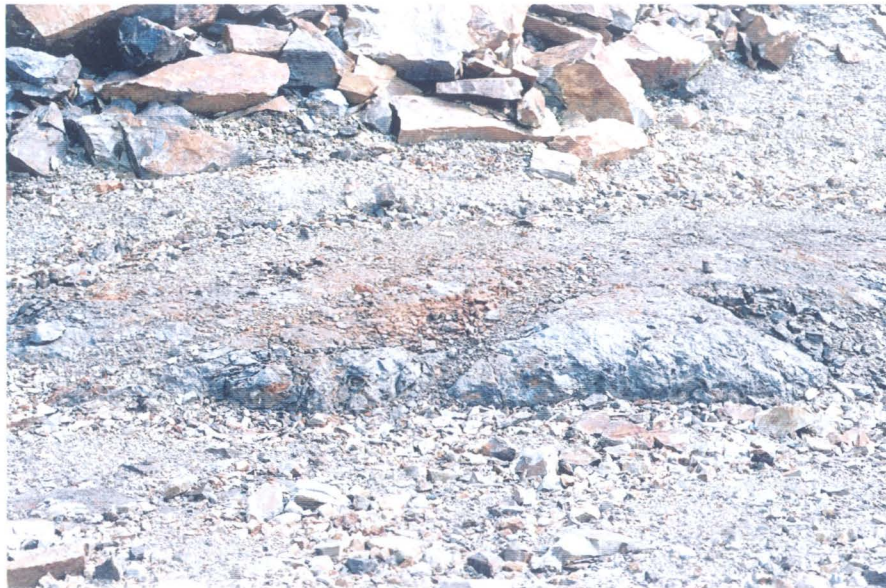
At the time of inspection there was one main trench that extended for approximately 150 meters in a north south direction about 50 meters to the east of the tent frame base.

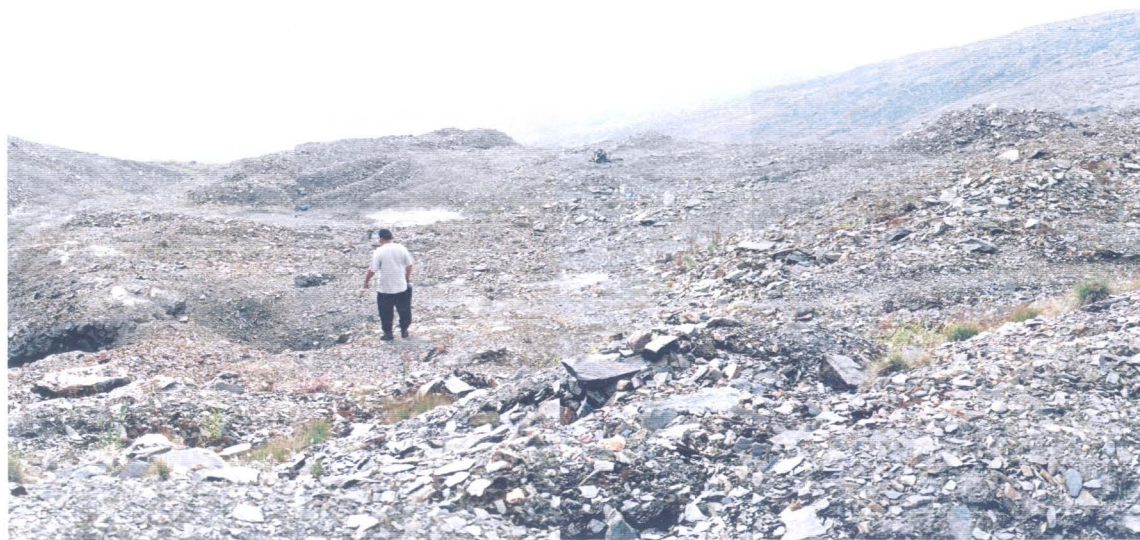
Approximately 100 meters north of the Caribou opening there is an area of bulldozer clearing that is directly on the edge of Caribou Hill cirque. The material from this clearing has been pushed into the cirque and the area size is approximately 50 x 100 meters square.

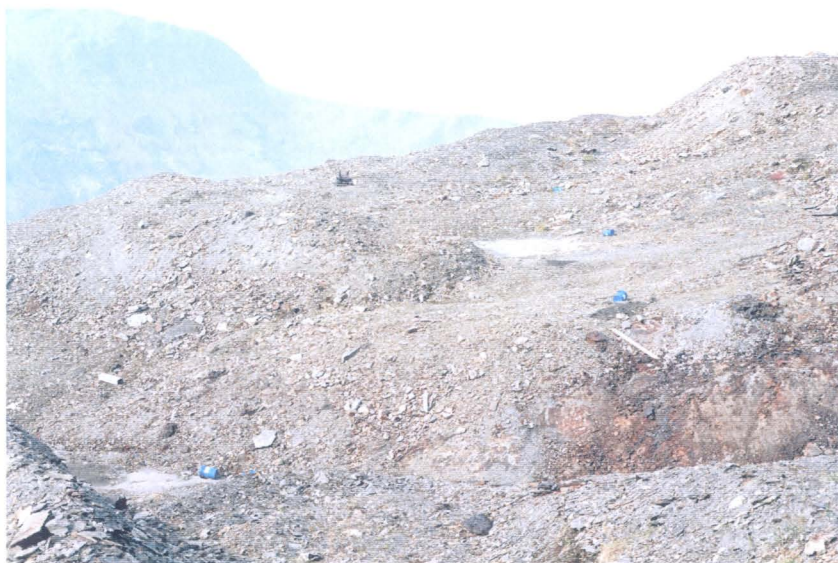
There was a number of five gallon oil pails scattered about, along with a small oil spill on the edge of this clearing.

The Alice adit is probably located half way down this talus slope face as there is some heavy timber sticking through the overburden. Also there is sloughing of the surface material causing a sink hole where the adit portal was.

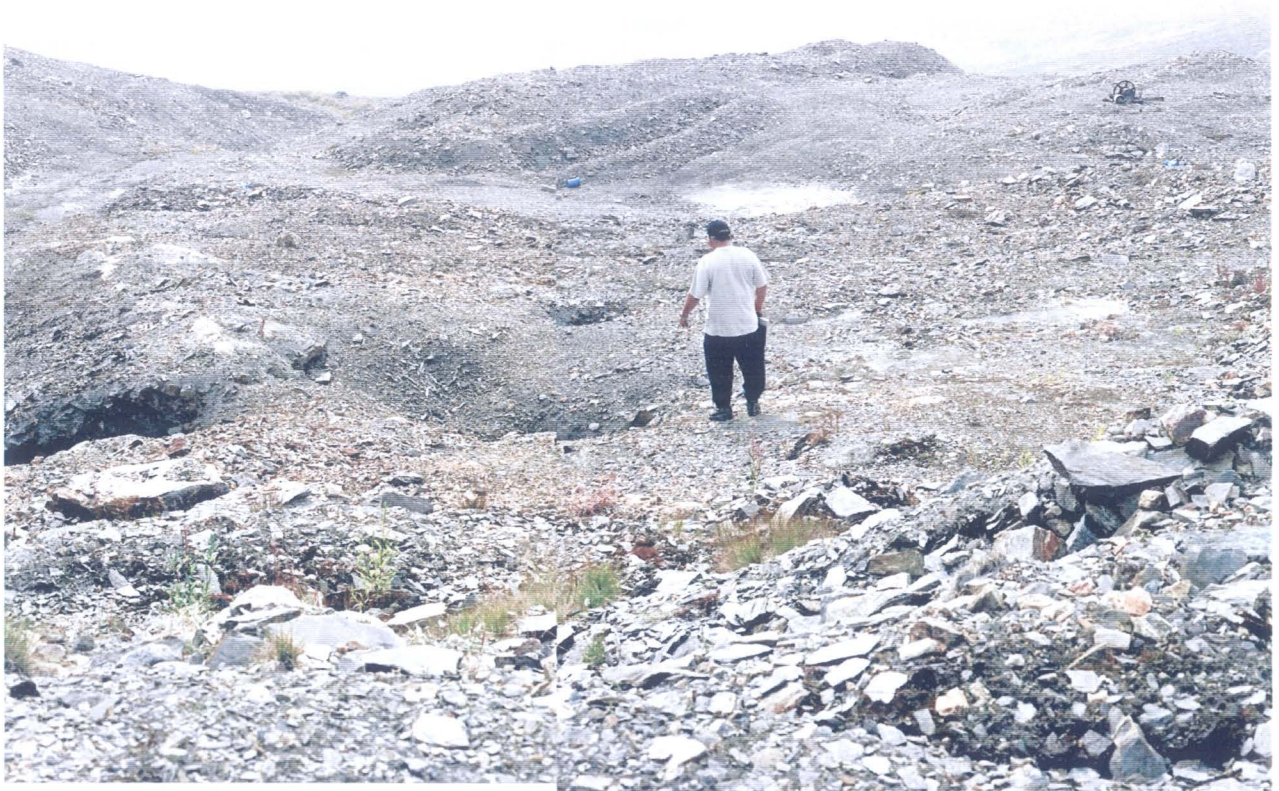
As in previous studies we did not encounter any hazardous waste at this site, previous studies indicated there may be some concern for the potential of metals leaching from the trench walls and the small oil spill on the edge of the clearing. We did not encounter any mine water discharge from the adit, but there was a small pond of water near the edge of the area that had been excavated.

This was sampled during the 1999 Keno Hill/ Dublin Gulch baseline assessment study. Site sample #39 sample #1 had a field pH. of 6.2 and a conductivity of 50uS/cm.

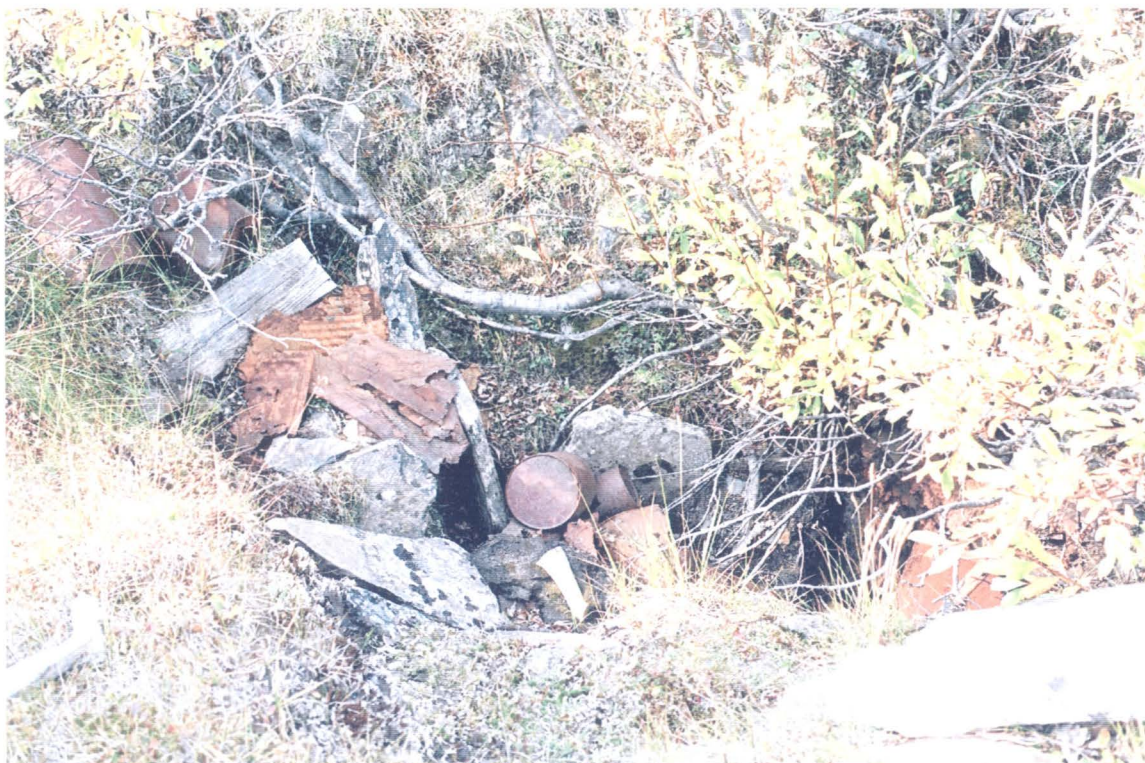
We did find a small domestic solid waste dump 3 meters from the southeast corner of the tent frame structure. This contained mainly household refuse and bottles.

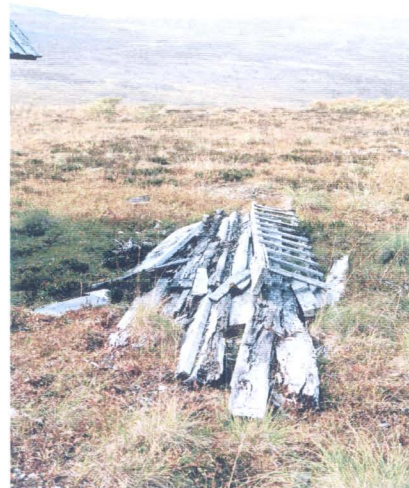
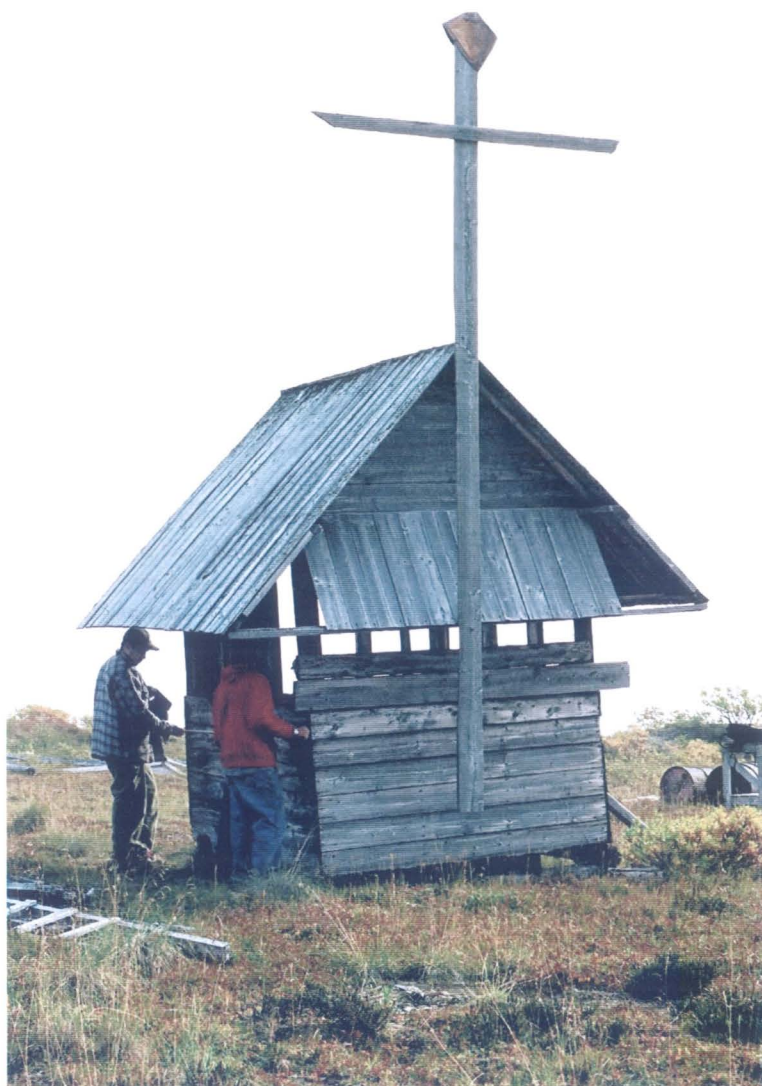
The walls have 2 x 4 boards for studs which have been sheeted in, horizontally one meter up from the floor on the outside.

The south, west, and east walls were screened to the top with fine wire mesh. The roof frame and trusses are also constructed with 2 x 4s and then sheeted with vertical 1 x 8 shiplap.

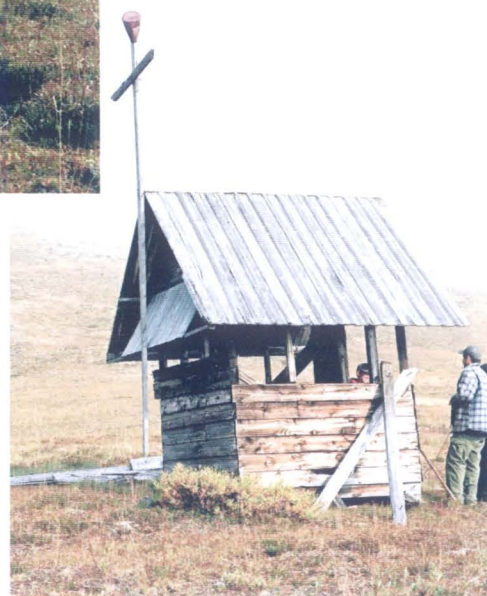
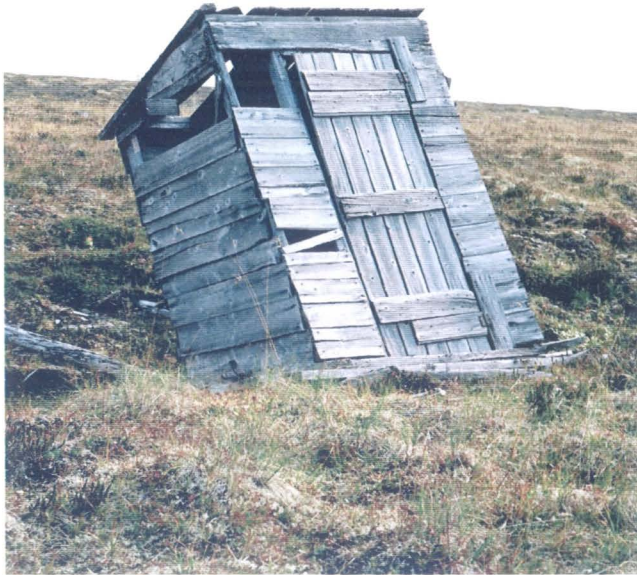
The south wall has a small board overhang which extends from the top of the wall on the outside of the building and down two feet at a sharp angle. It was probably used to shelter the interior from the wind or rain.

The outhouse, which is located approximately 38 meters north of the building, is constructed primarily of frame material except for two foundation logs that run under the floor assembly.

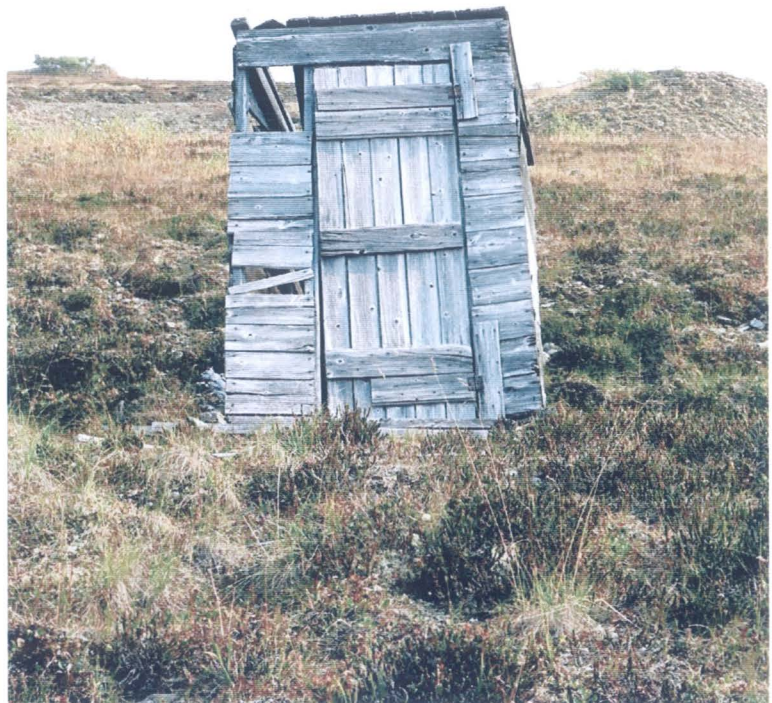
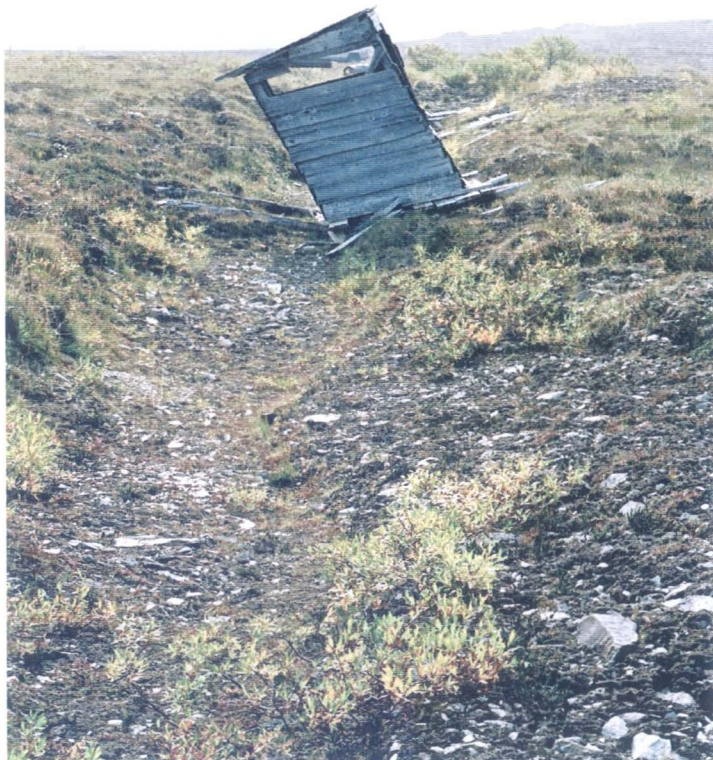
A view of the outhouse from west to east. The outhouse is sitting in a long trench that is approximately 38 meters to the north of the main building.

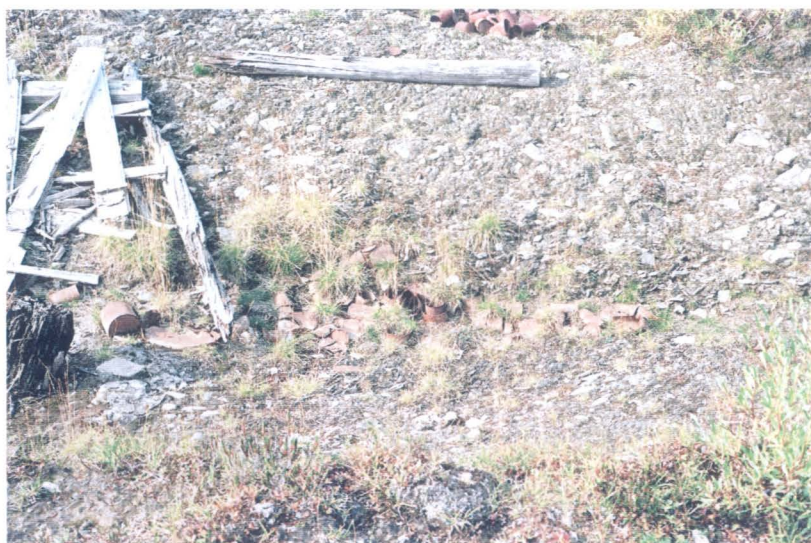
There is a small refuse dump located beside the outhouse foundation. The dump is partly situated in the long trench that runs east to west.

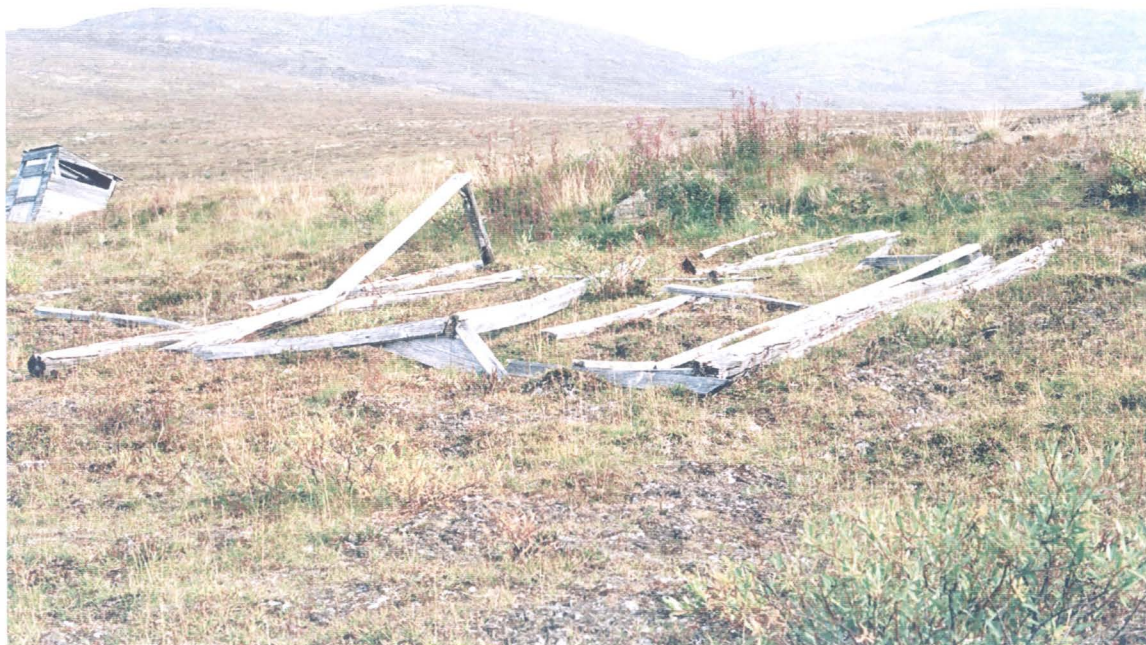
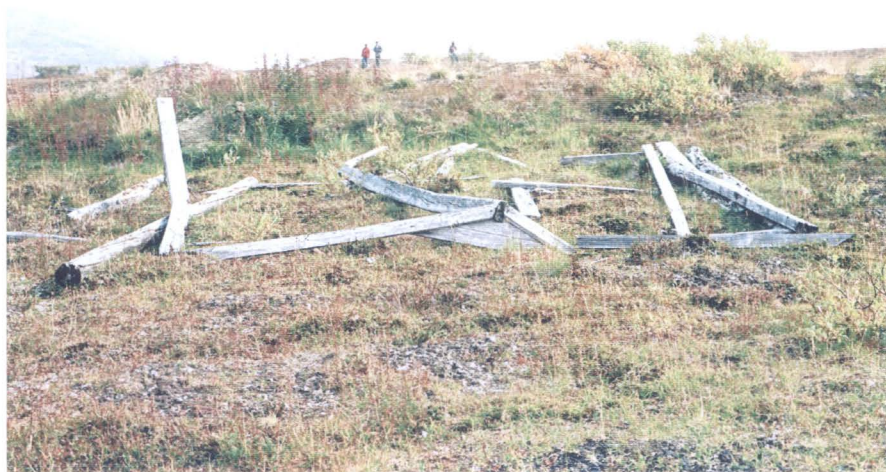
The remains of the tent frame are located 32 meters north of the main cabin and approximately 26 meters southeast of the outhouse. The foundation was constructed of small poles with 2 x 4 frame material used for the framing of the tent structure.

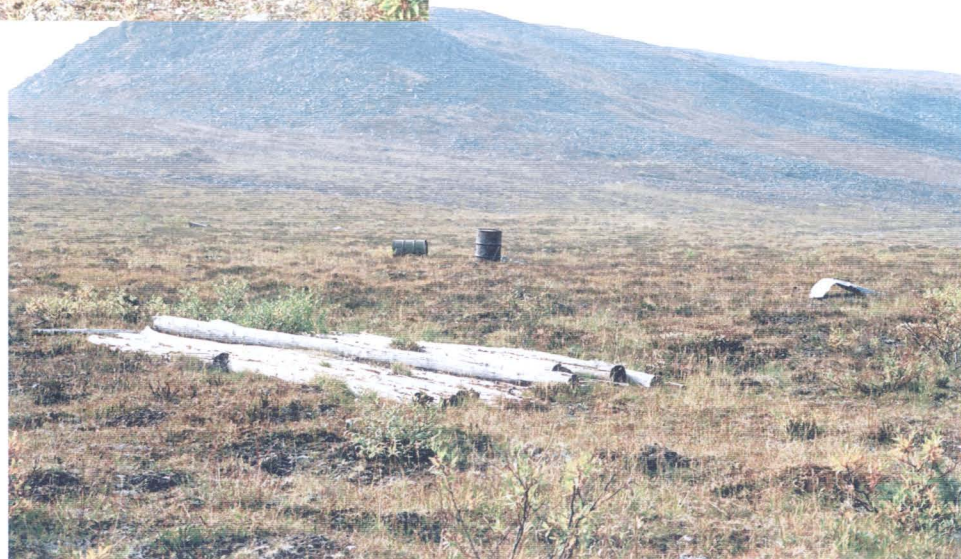
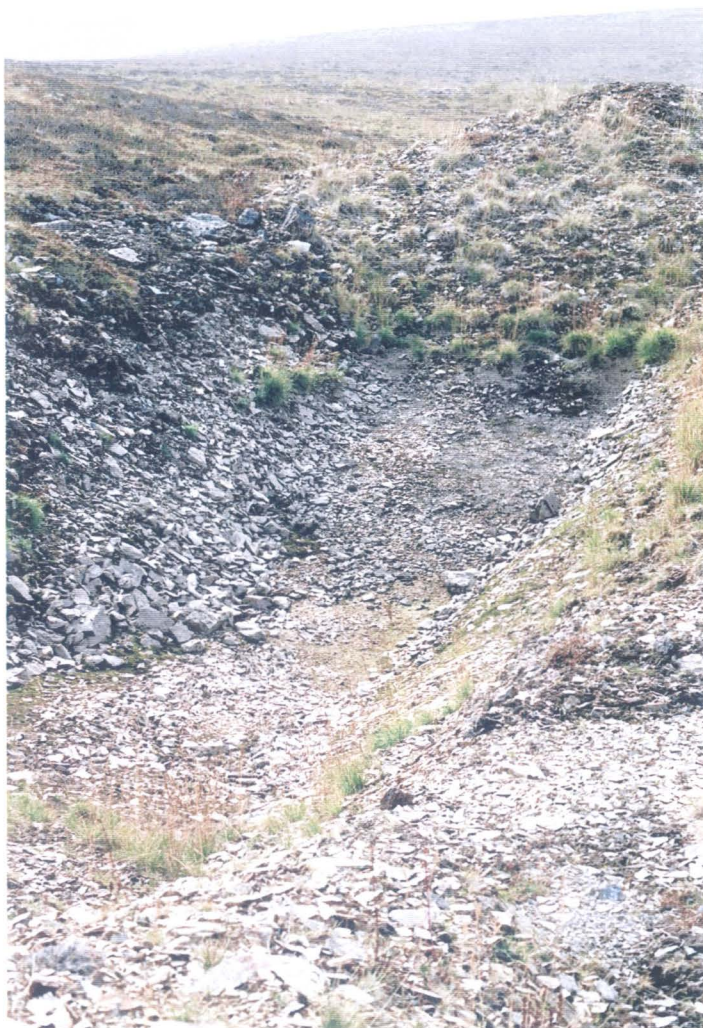
We did not find any major environmental issues at the Divide site, other than five empty fuel drums and a small refuse dump.

The small refuse pit consists of old domestic cans and bottles.

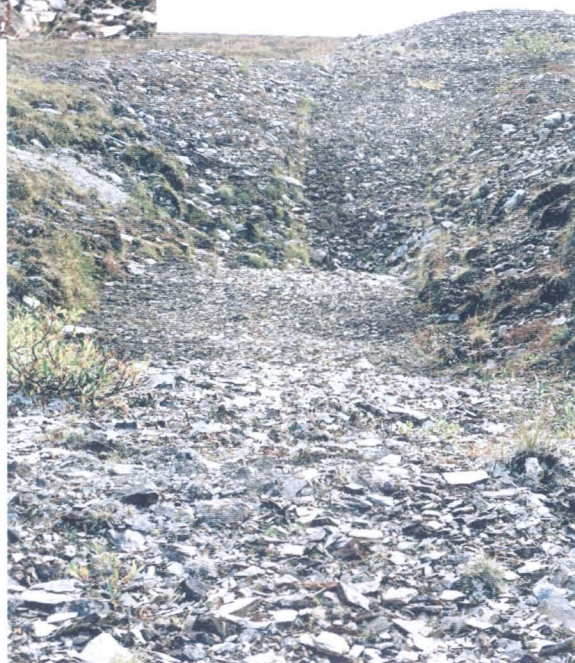
The trenching has started to re-vegetate with grass and moss. The sides of the trenches are shallow in slope.

Previous reports indicate potential contaminants of concern could include metals washing from the trench wall or waste rock piles.

From an environmental perspective, the only recommendations would be the sampling of the run off water that enters Hope Gulch and Faith Gulch from the many trenches that have been cut to the mineralized vein material. There is some ponded water in the lower ends of the trenches that could also be sampled.

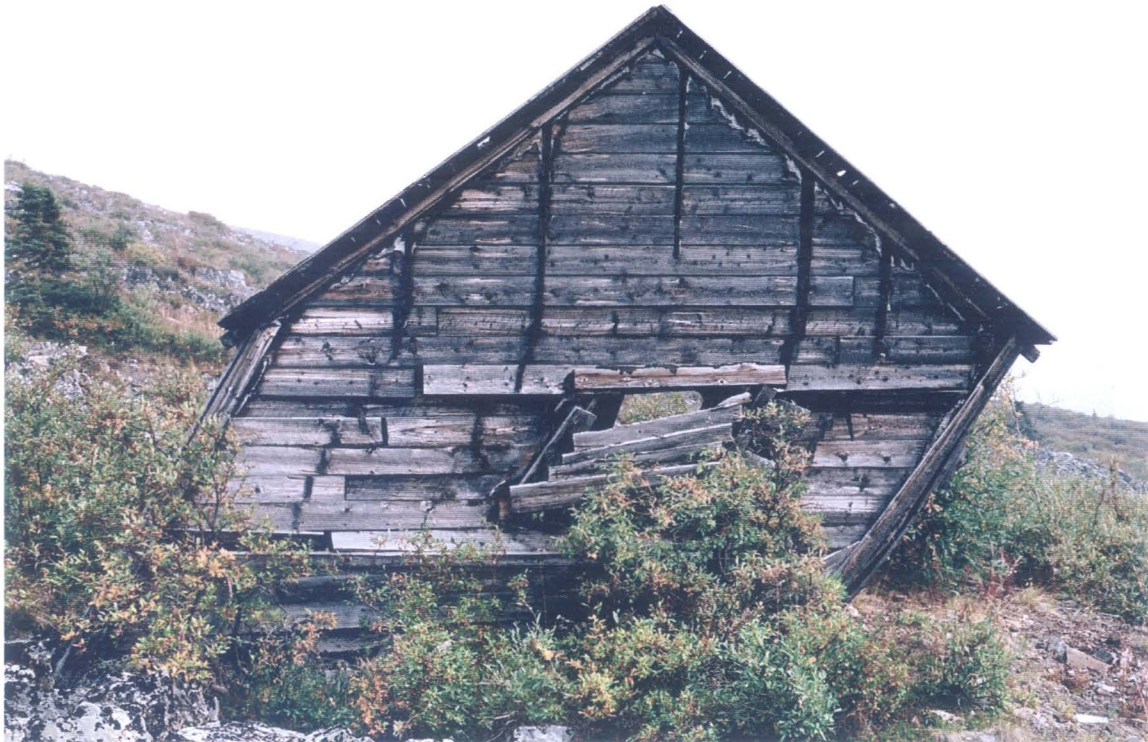
There is only one building associated with this site, and it is located directly in front of the adit. The foundation of the building is made of 6 x 6 beams placed directly on the ground. The floor joists are 2 x 4s that have been placed on two foot centers, and then cross sheeted with 1 x 8 boards.

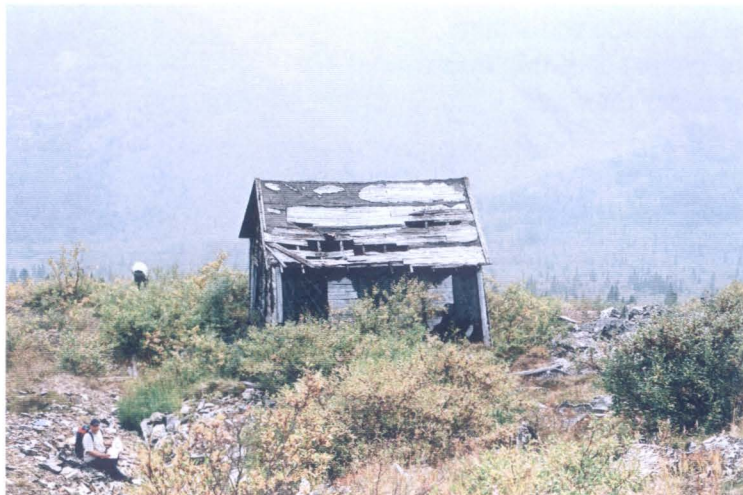
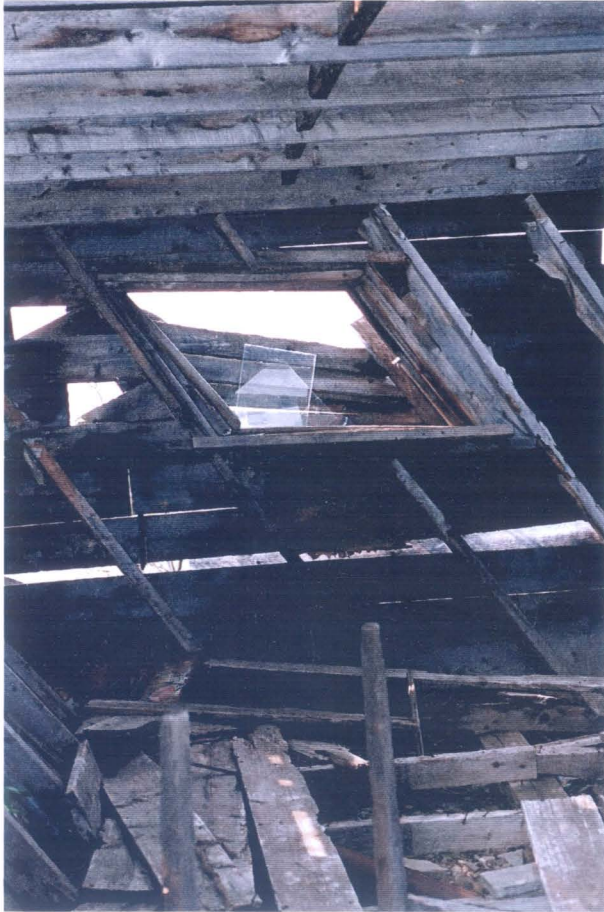
The building has a gable style roof with the trusses being made of 2 x 6 planks.

The wall studs are 2 x 4s on two foot centers, with the exterior sheeting being 1 x 8 shiplap boards.
