Historical Review

Of
Selected Mining Sites
In The Silver Trail Region

Prepared for
Waste Management Program
Indian and Northern Affairs Canada

March 2005

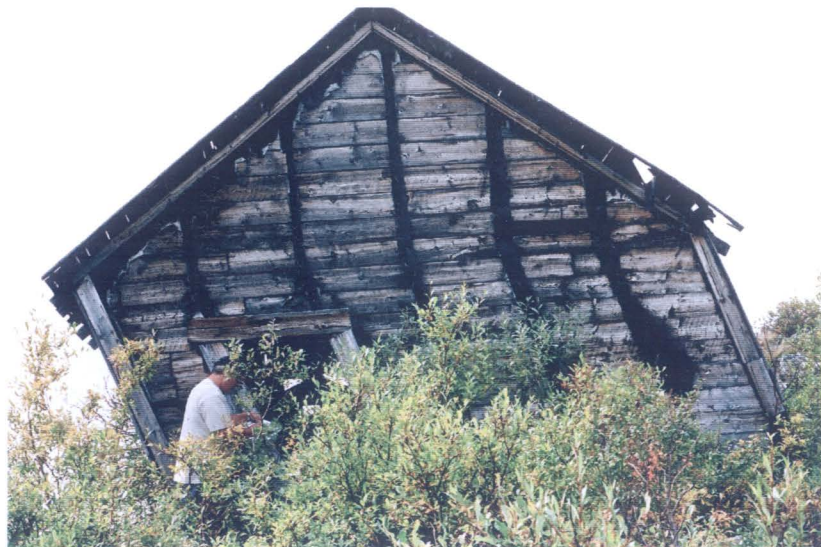
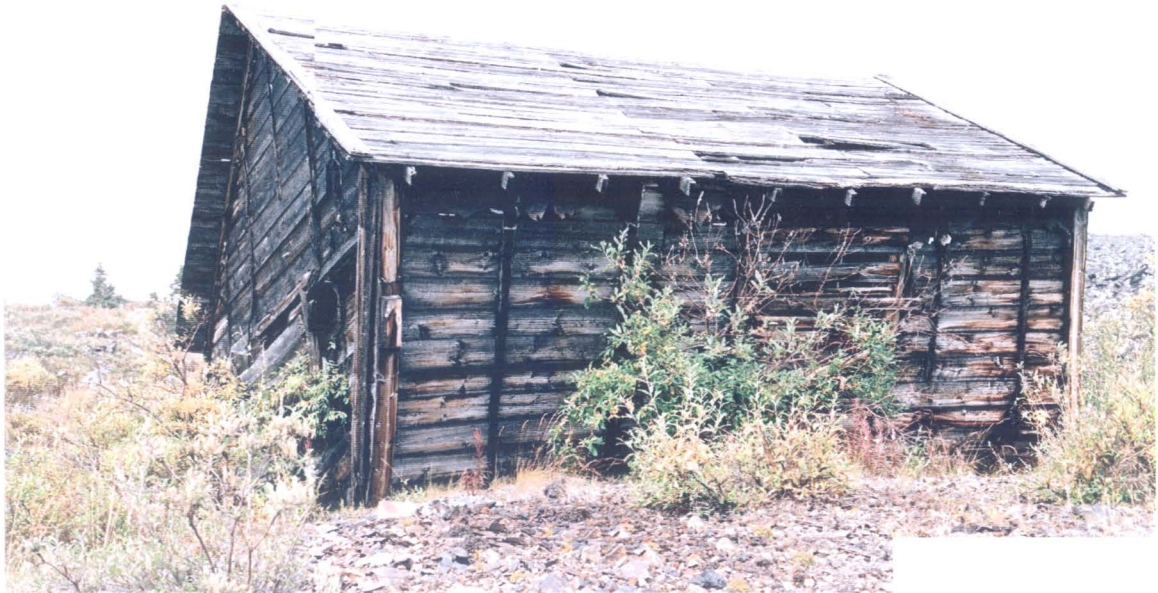
There is a 2 foot by 3 foot window in the south wall with a 2 x 2 foot window in the east wall.

There is some evidence of tar paper rolled roofing used for the roof, while on the inside walls there are remnants of thin black tar paper for wind proofing.

There is a table, old heater, and bed frame remaining inside of the building.

In our opinion the work done at this site in regards to the hand trenching is an excellent example of the ingenuity and hard work of the early pioneers. The building is certainly beyond repair, is quite dangerous and needs to be addressed, although it may be fully collapsed after this years snow load.

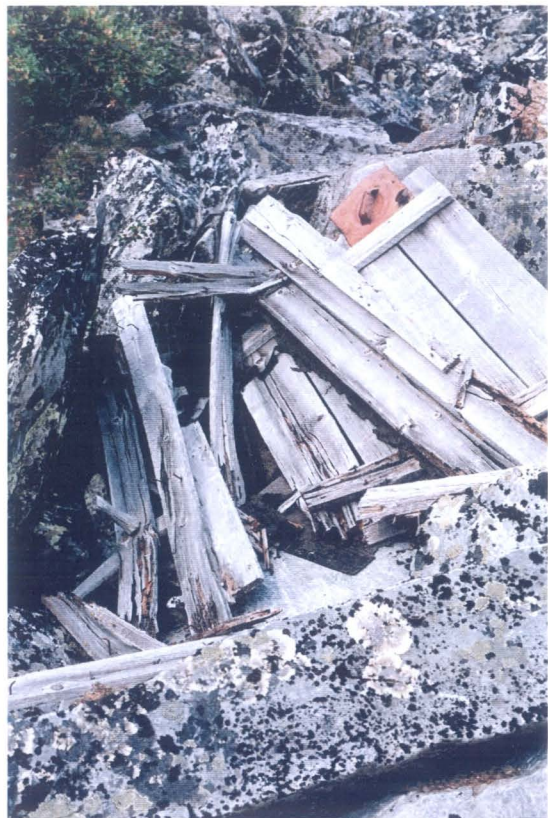
Ten meters to the west of the west wall of the building is the remnants of the outhouse.

This structure is scattered over the rocky talus slope and was built over a natural crevasse in the rocky slope.

It was constructed primarily of 2 x 4s and 1 x 8 planks.

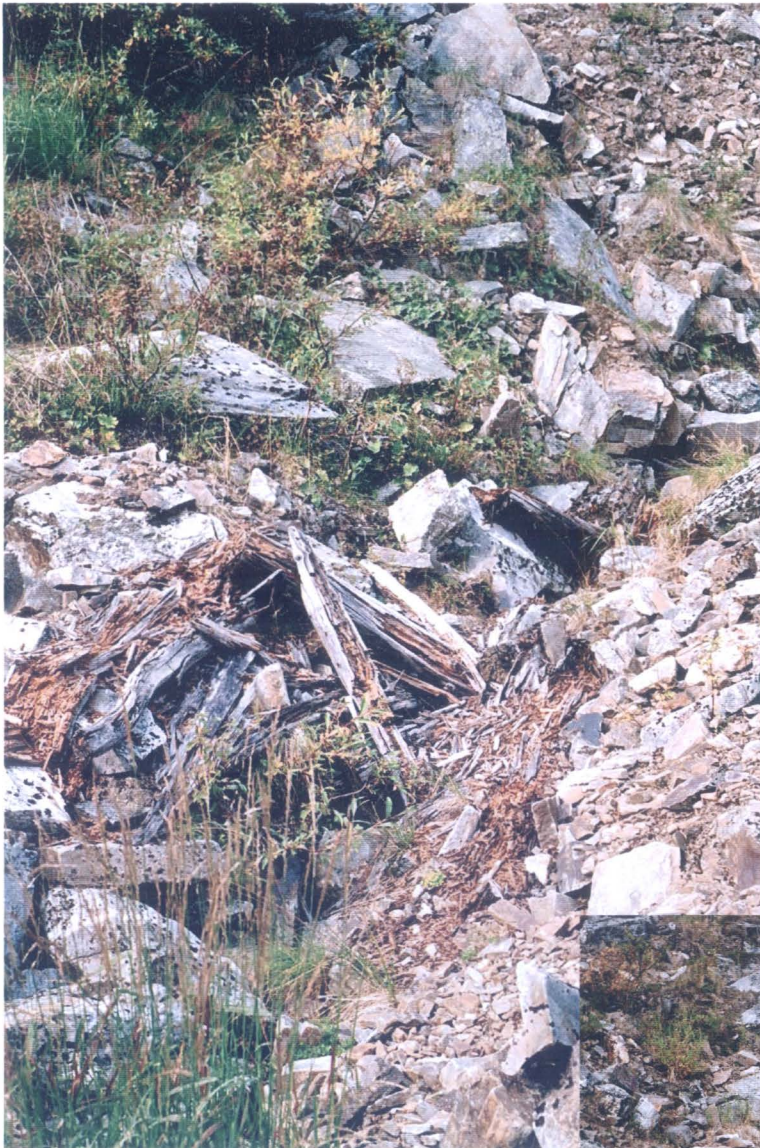
Pictures show the collapsed adit upslope of the building.

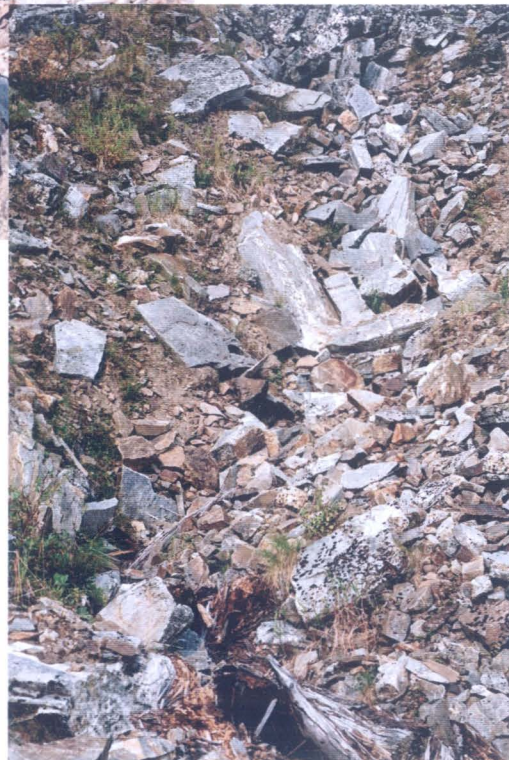
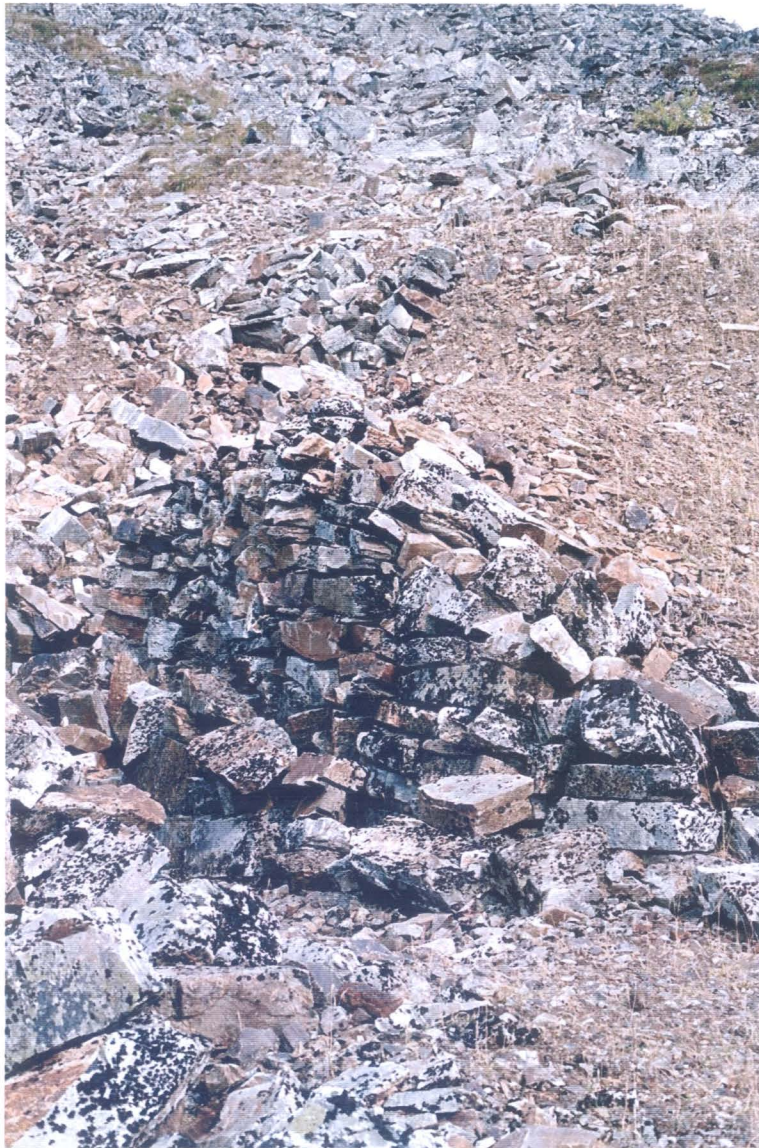
There was no discharge observed from the adit or workings above.

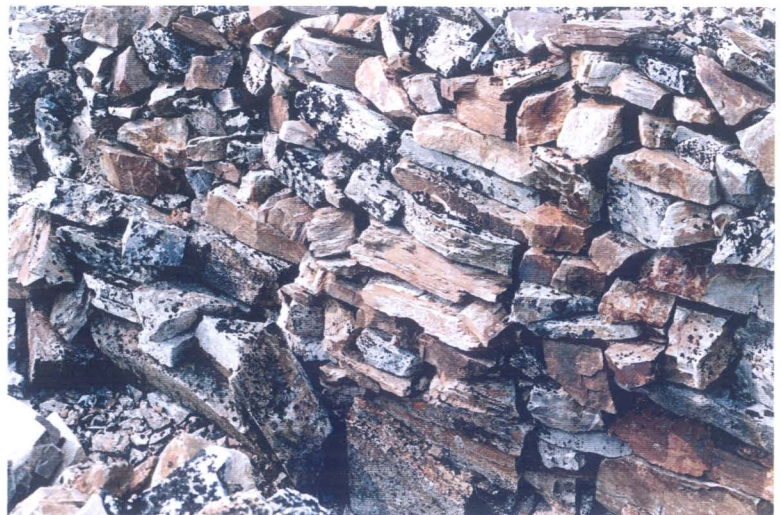
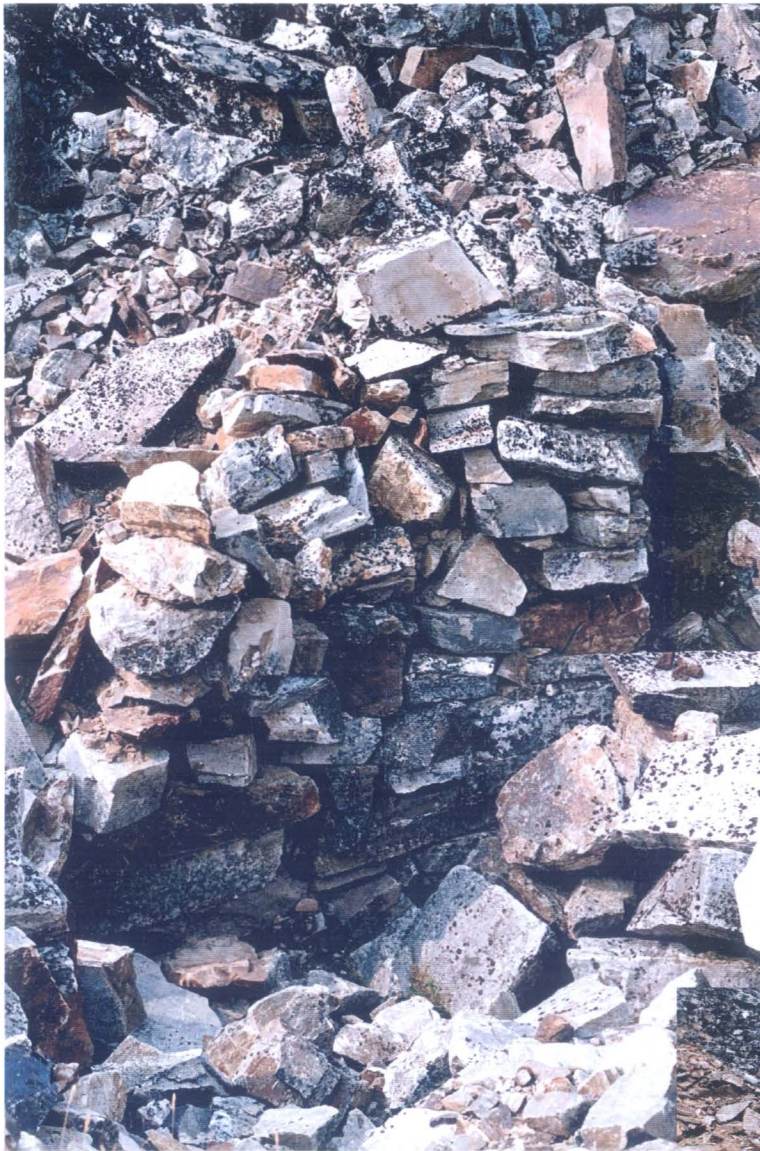
A feature of the Devon site is the stone and rock work that was used by the early miners in their method of hand trenching into the hill side.

Flat stones were hand stacked at the sides of the trenching to hold back the loose material from sloughing into the trench as they worked their way into the hard bedrock surface.

Some of the stone walls extend for ten or more meters and reach an elevation of two to three meters.

The space between the two vertical stone walls varied depending on the natural grade of the terrain, but on average maintained a one meter width. This was adequate room for the removal of the waste material by wheelbarrow to the dump site.

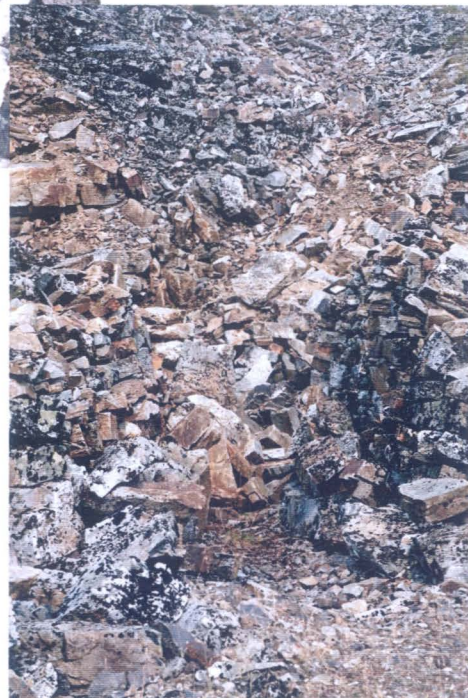
There were only a couple of artifacts at this site, such as an old steel wheeled wheelbarrow and some shovels.

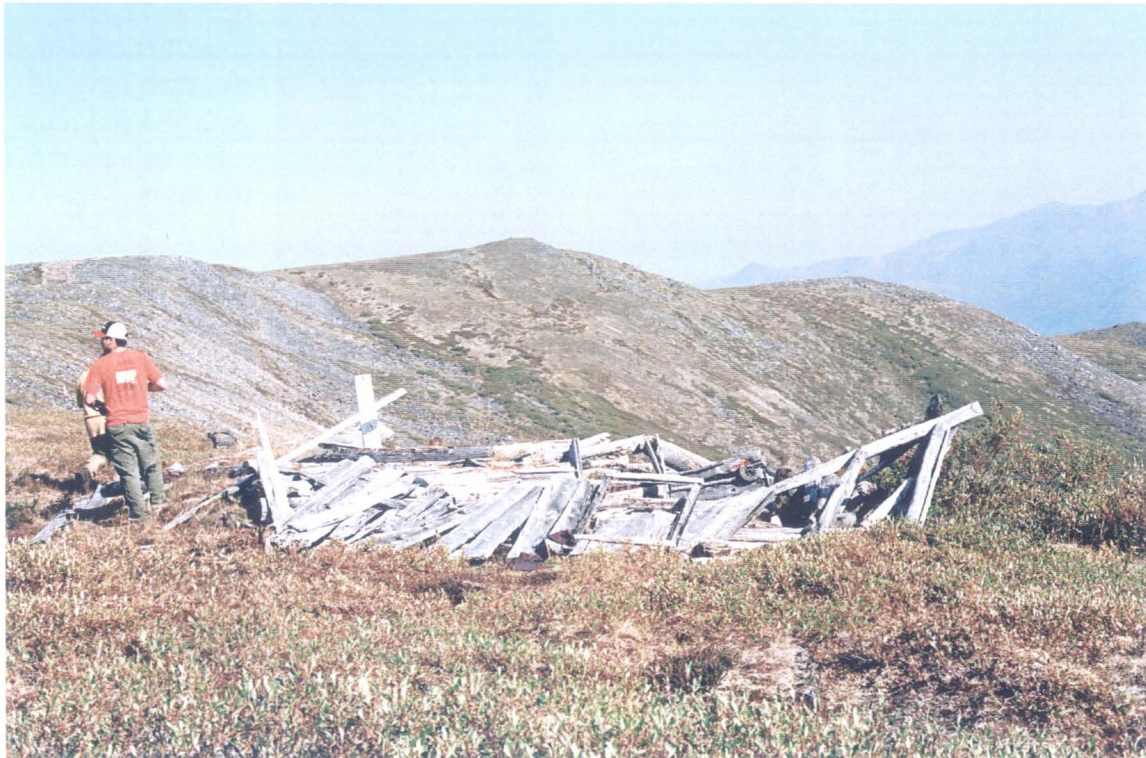
There are remnants of an old log cabin two hundred meters west of the Silver Basin Trail. The building has fully collapsed with all the exterior walls having fallen outwards.

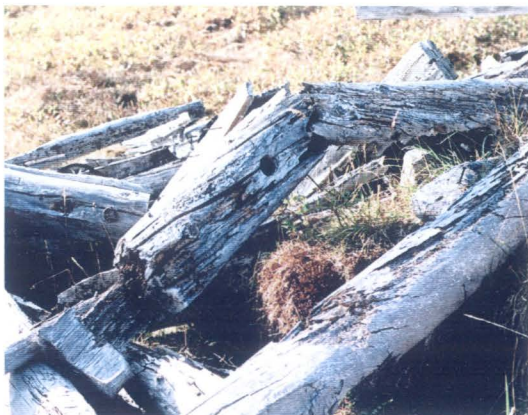
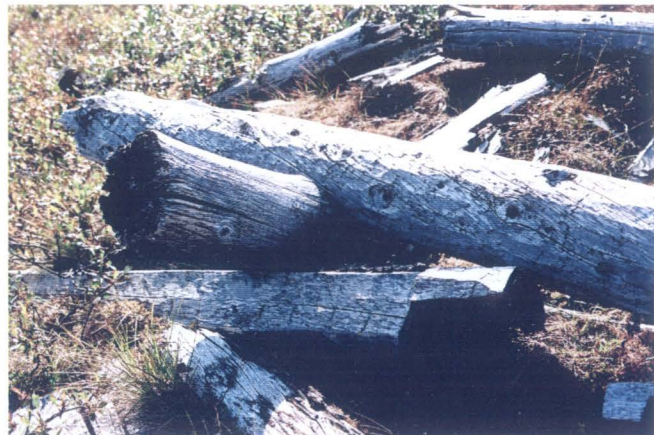
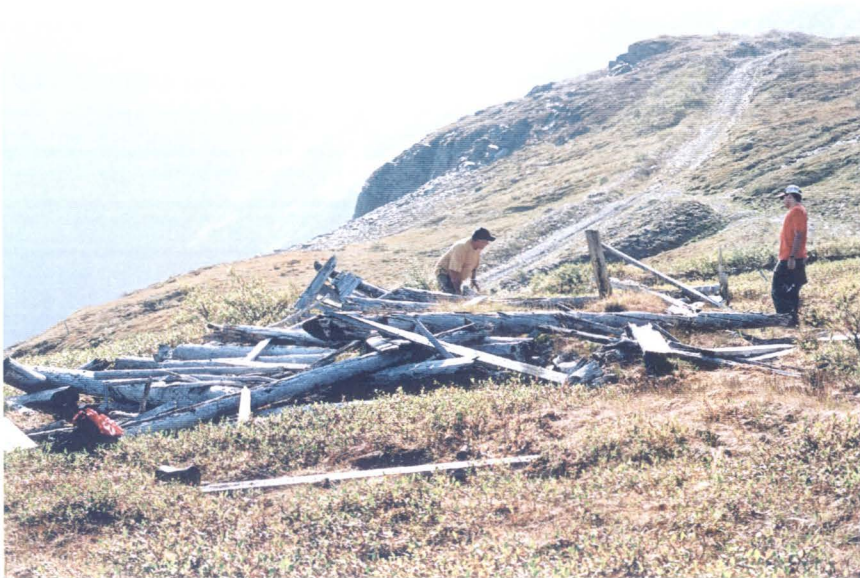
The walls were hand doweled and the corners were saddle notched with an axe.

The roof was of pole and board construction that was then covered with sod and moss. It has collapsed over the floor.

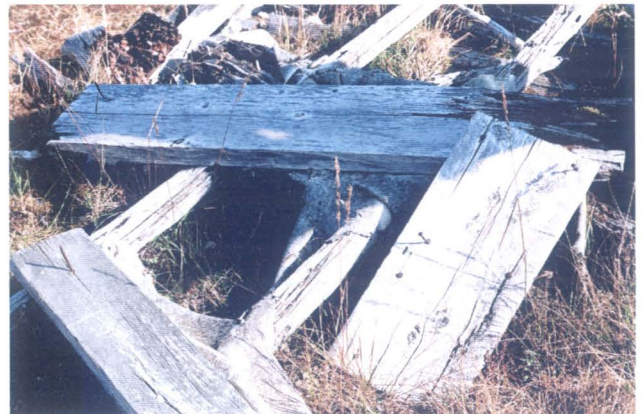
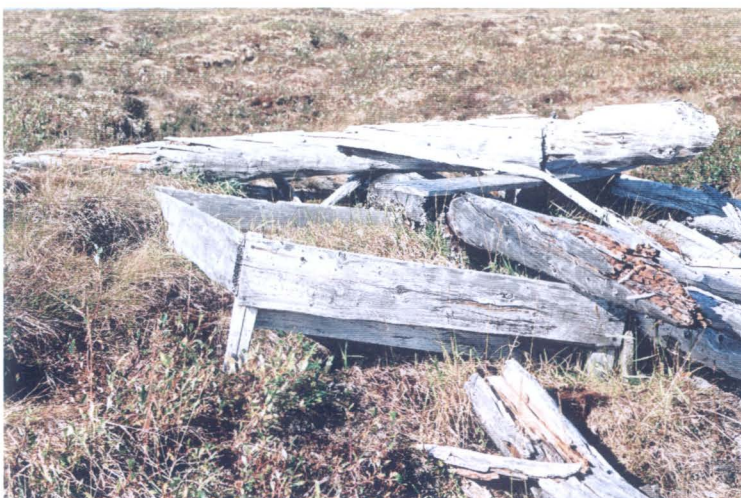
There are some remains of canvas that covered the inside of the cabin walls. (*Right*)

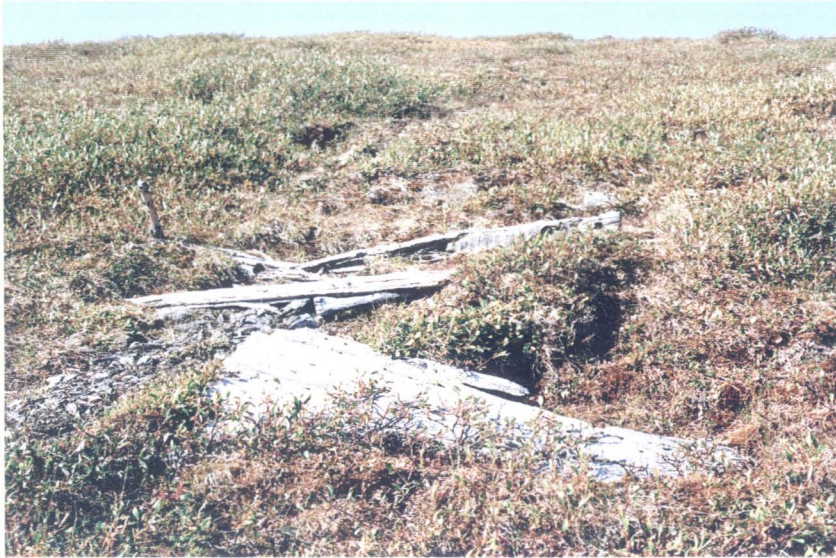
In the east corner of the building is a hand made wooden bed frame.

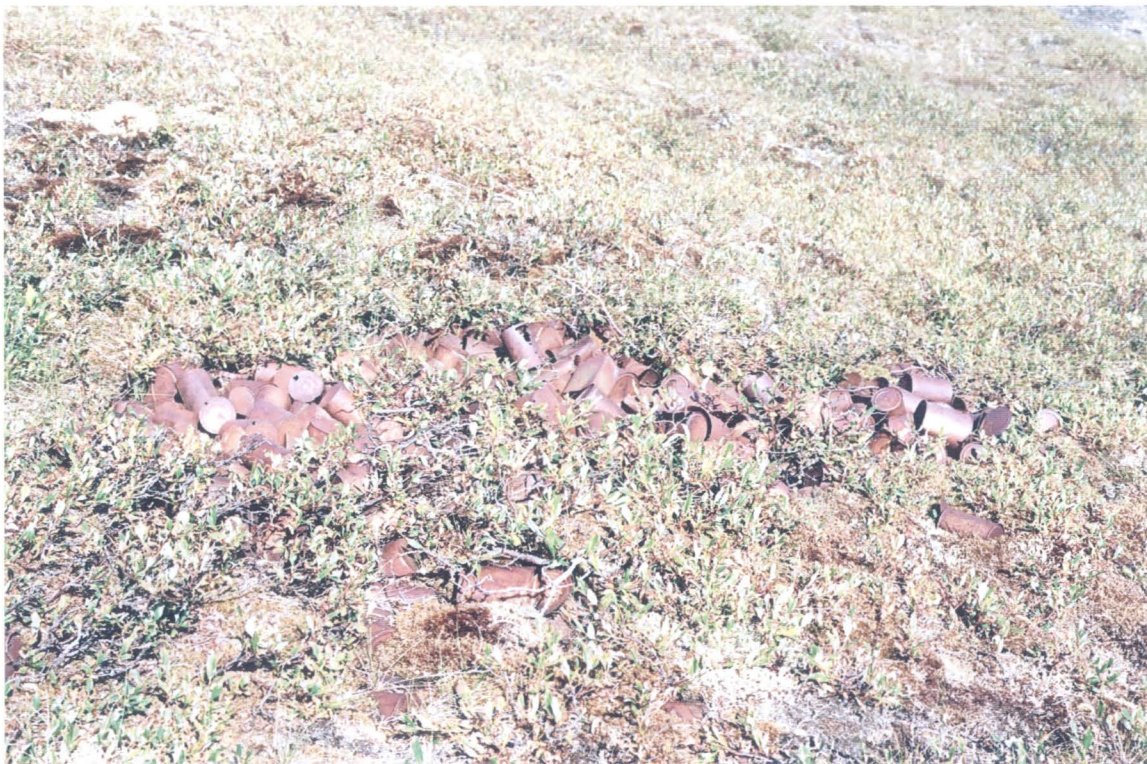
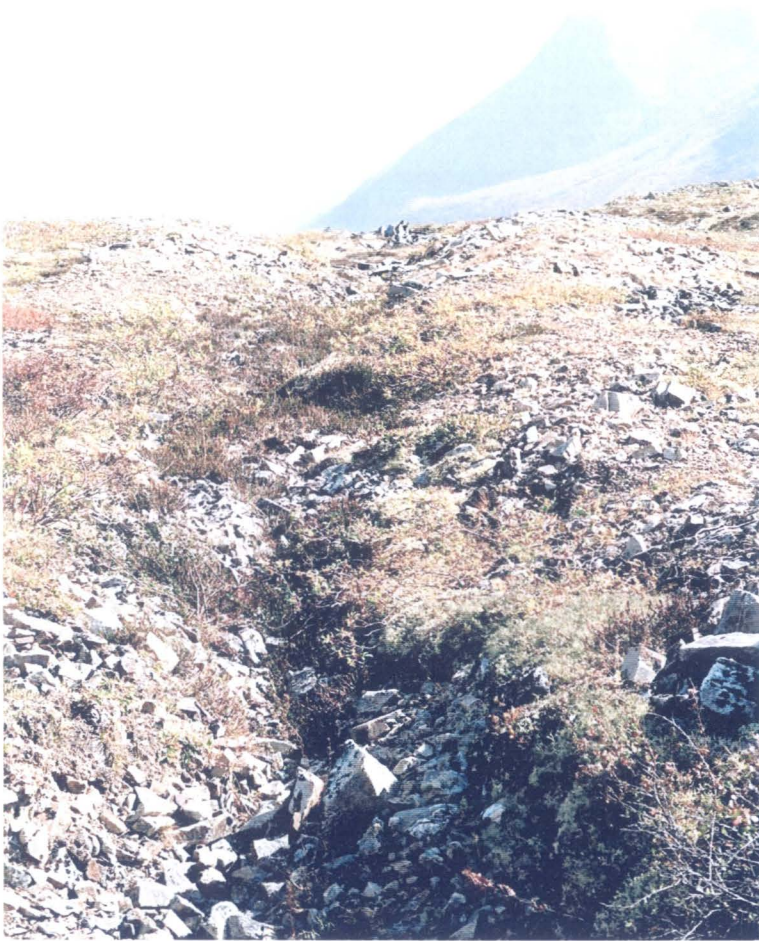
Seven meters to the east of the building is the scattered remains of the outhouse, which was built with small log poles and rough timber.

There is a refuse dump approximately 19 meters to the north of the building. It was comprised mainly of rusted cans and glass bottles, with no evidence of any contaminants.

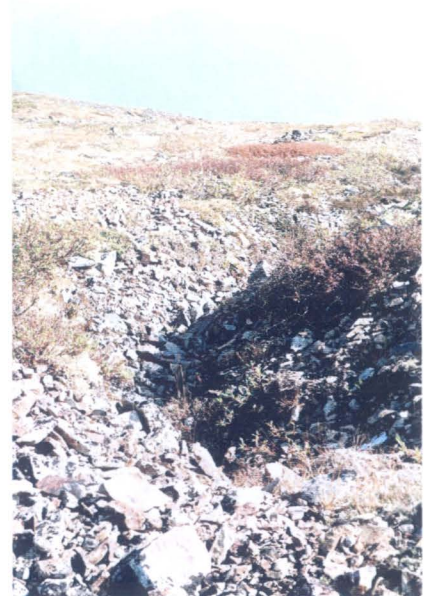
There are three trenches and one shaft associated with this site. The shaft is located 200 meters east of the Silver Basin Trial.

All that remains of the shaft at this time is a pile of timber and logs that cover a small depression in the hillside.

From the amount of waste that was near the shaft, there must not have been much depth to the excavation of the shaft. The shaft can not be accessed and does not pose any concerns.

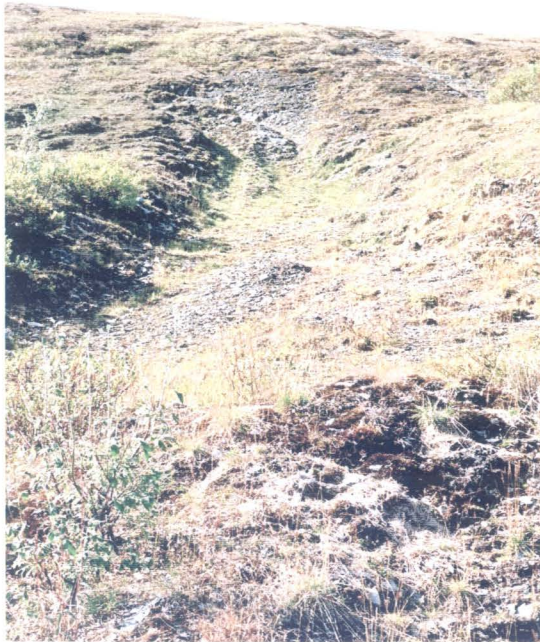
Trench #1 is located approximately 150 meters south of the cabin, and is still in the relatively flat area above the edge of the slope that drops down into the Silver Basin Gulch.

Trench #2 cuts the vein that is reported in the Yukon Minfile as being the 2.4 meter wide vein. It was traced for thirty meters, with minor galena, tetrahedrite, and arsenopyrite in a quartz-siderite gangue. Trench #2 is approximately 350 meters northeast of the remains of the shaft.

Future monitoring of the metal leaching from the trenching and waste dumps sites would be a possible consideration along with general clean up of scattered boards with rusty nails and broken glass.

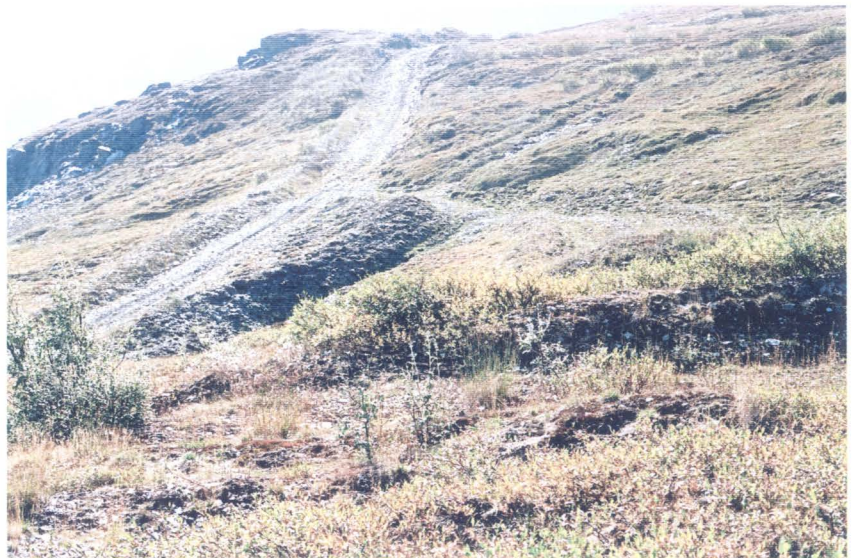
There is evidence of some small hand trenching approximately 35 meters to the east of the cabin foundation. This hand trench has started to re-vegetate with moss and grass.

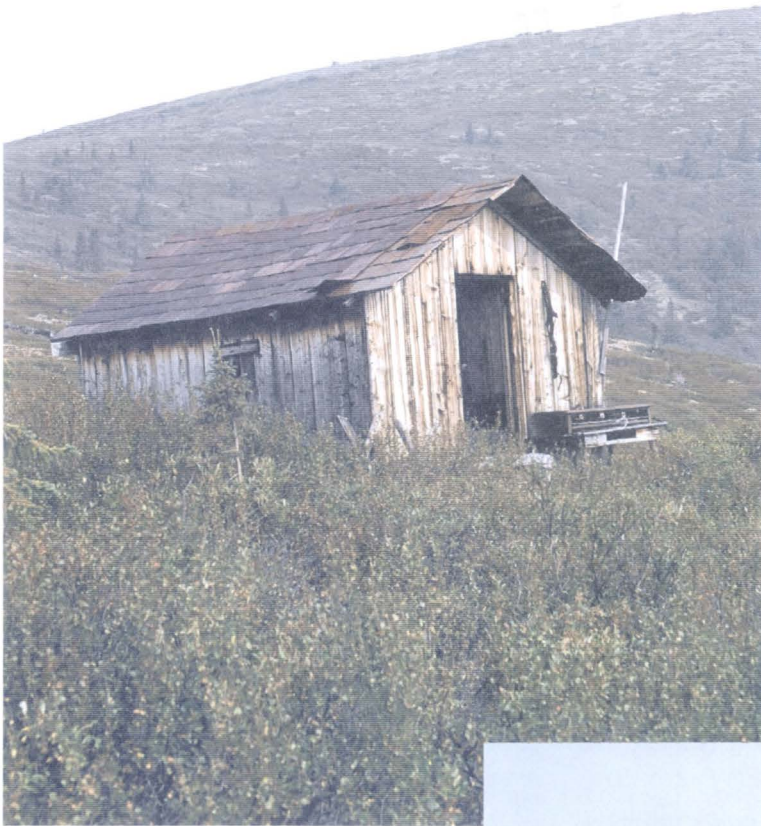
This building is of frame construction and in fair to good condition. The outside dimensions are 4.31m x 3.12 m.

The foundation of the building is built of flat stone, on top of which the 2 x 8 floor joists have been placed.

The floor joists have then been sheeted in with 1 x 8 boards to form the floor.

The walls are made of 2 x 4 studding, with the exterior being sheeted in vertically with 1 x 8 boards. The edges are battened over with small 1 x 3 strips of wood.

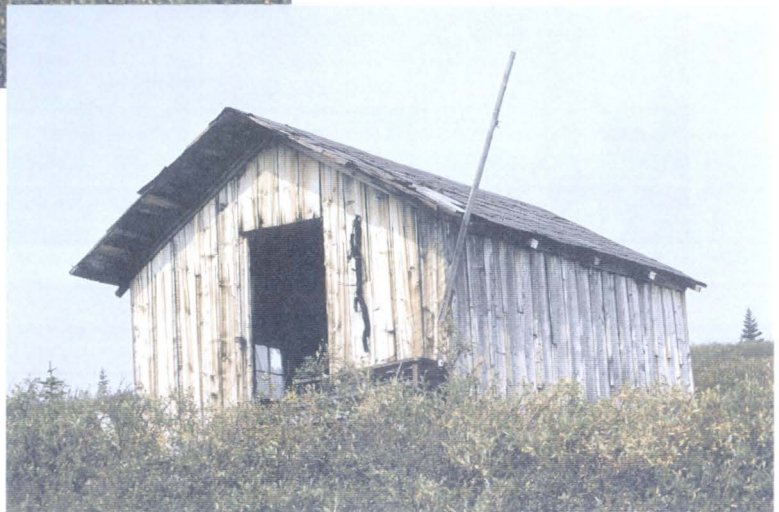
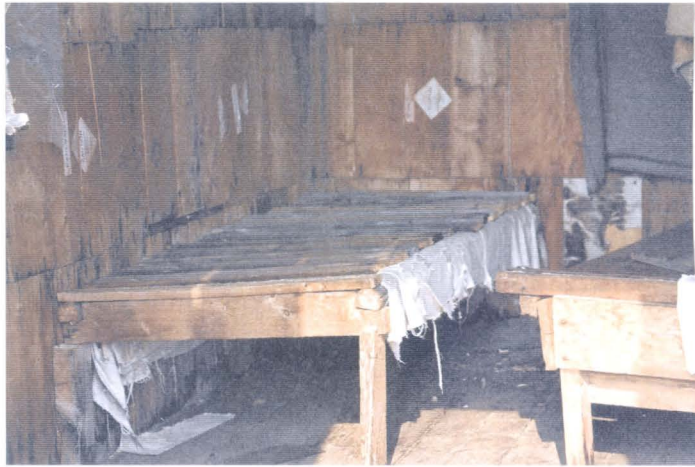
For exterior roof cladding, they spread open old five gallon square oil containers and nailed them to the roof in a shingle fashion.

The interior of walls are sheathed with pieces of old explosive boxes.

The roof trusses are constructed with 2 x 4s and are gable style. The roof was then sheathed in with 1 x 8 boards.

In our opinion the structures on the site should remain in tact. The building is in good condition and represents our early pioneer's resourcefulness. Tin pails were opened and used as roofing, the interior of walls are sheeted with pieces of old explosive boxes.

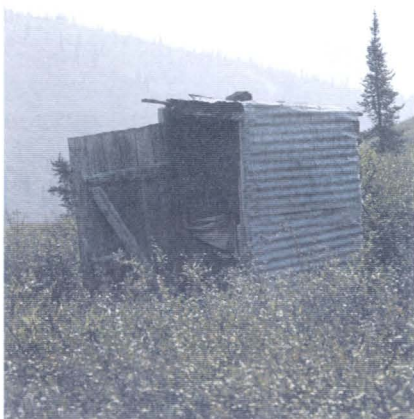
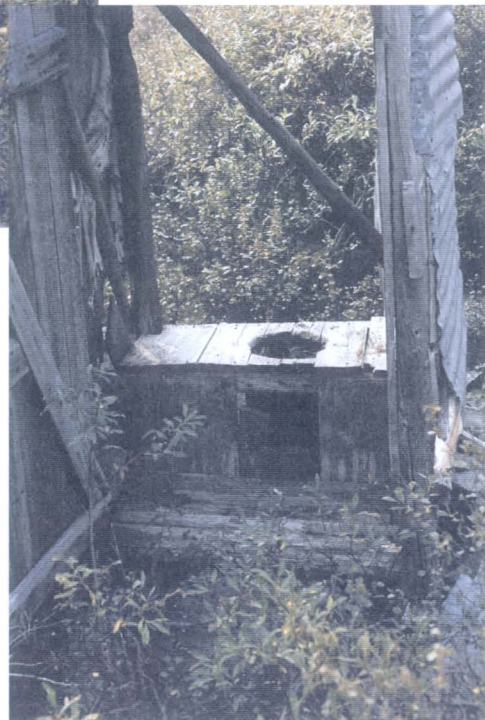
The foundation of the outhouse was built on stacked rocks, with the floor and walls being built on the log foundation cribbing.

The walls and shanty style roof were framed in using log poles, which was then sheeted in with corrugated tin. The door and the seating bench were built using rough cut 1 x 8 boards.

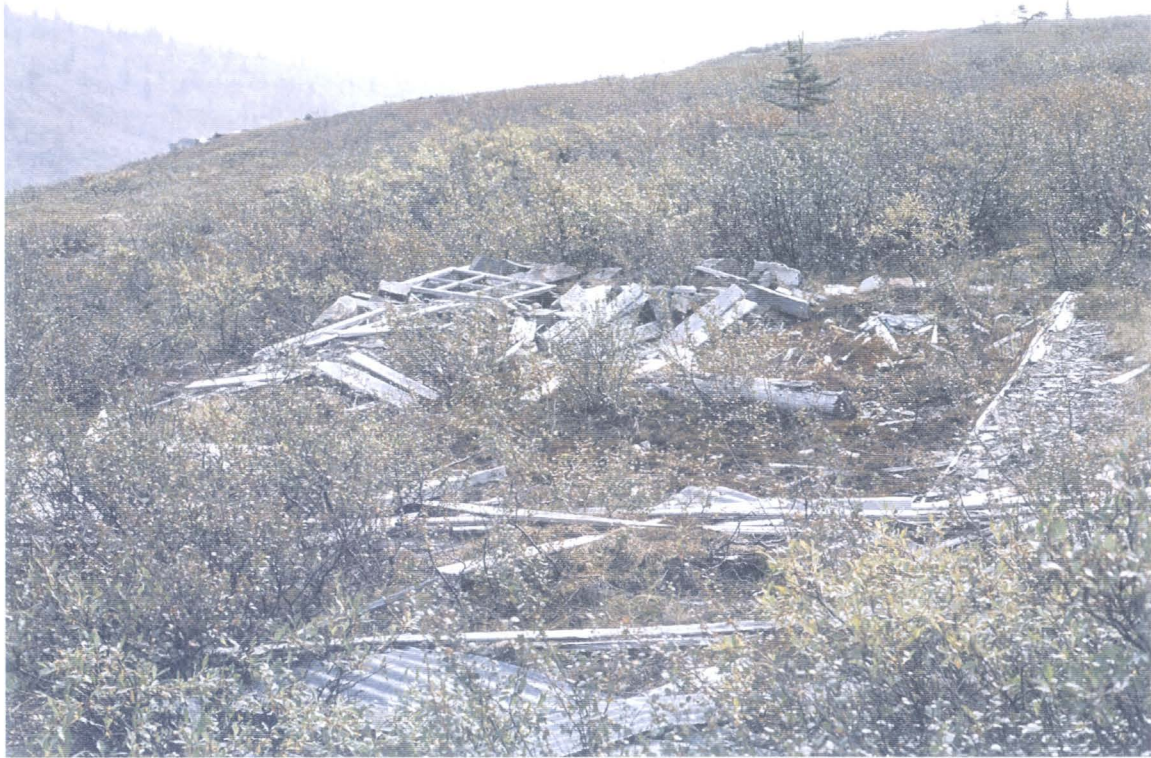
This building is located a further 72 meters down slope to the east of Building #1. The outside dimensions of this cabin are 3.8m by 4.7m. All that remains is the outline of the foundation along with some scattered boards and tin.

Given the style of construction and the condition, we would estimate this to be the original building on the Apex site.

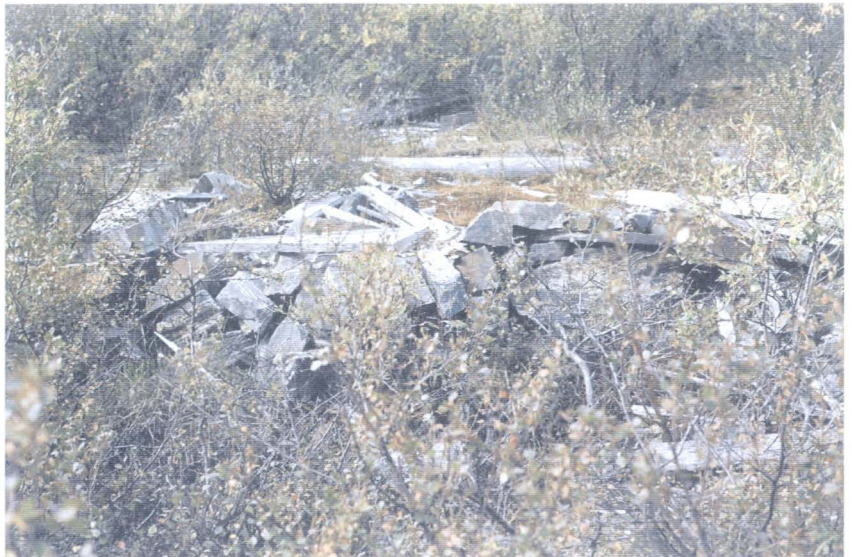
The foundation was well established by the stacking of flat stone around the perimeter of the building. The first round of the building was of log construction.

The roof was covered with sod which now has collapsed and lies outlined against the foundation perimeter. There is an old refuse pit 10 meters to the east of the old cabin. The dump consists of old cans and a few pieces of stove pipe.

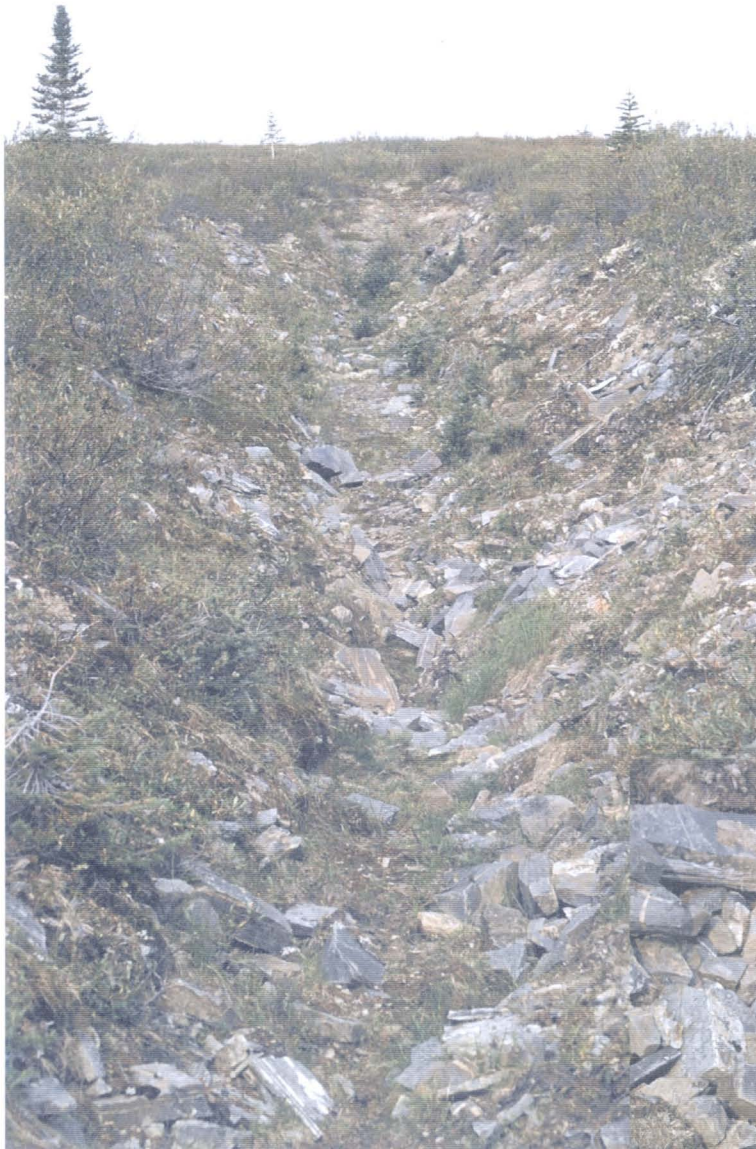
There are six trenches, two shafts, and two buildings associated with the Apex site. These trenches are located to the southwest of the building structures.

The first trench to the west is approximately 36 meters from the log remains of building number two.

One can easily access trench # 1 by climbing over the pushed up overburden at the lower end of the trench.

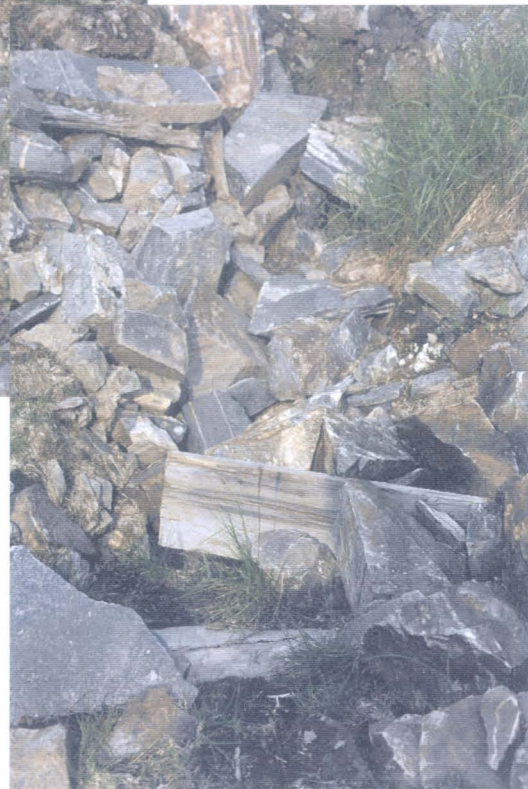
Following the three to five meter wide trench up slope approximately 27 meters, we found the remains of a collapsed shaft. All that remains is some of the log and frame cribbing sticking out of the base of the trench.

The shaft is not accessible and does not pose a safety concern.

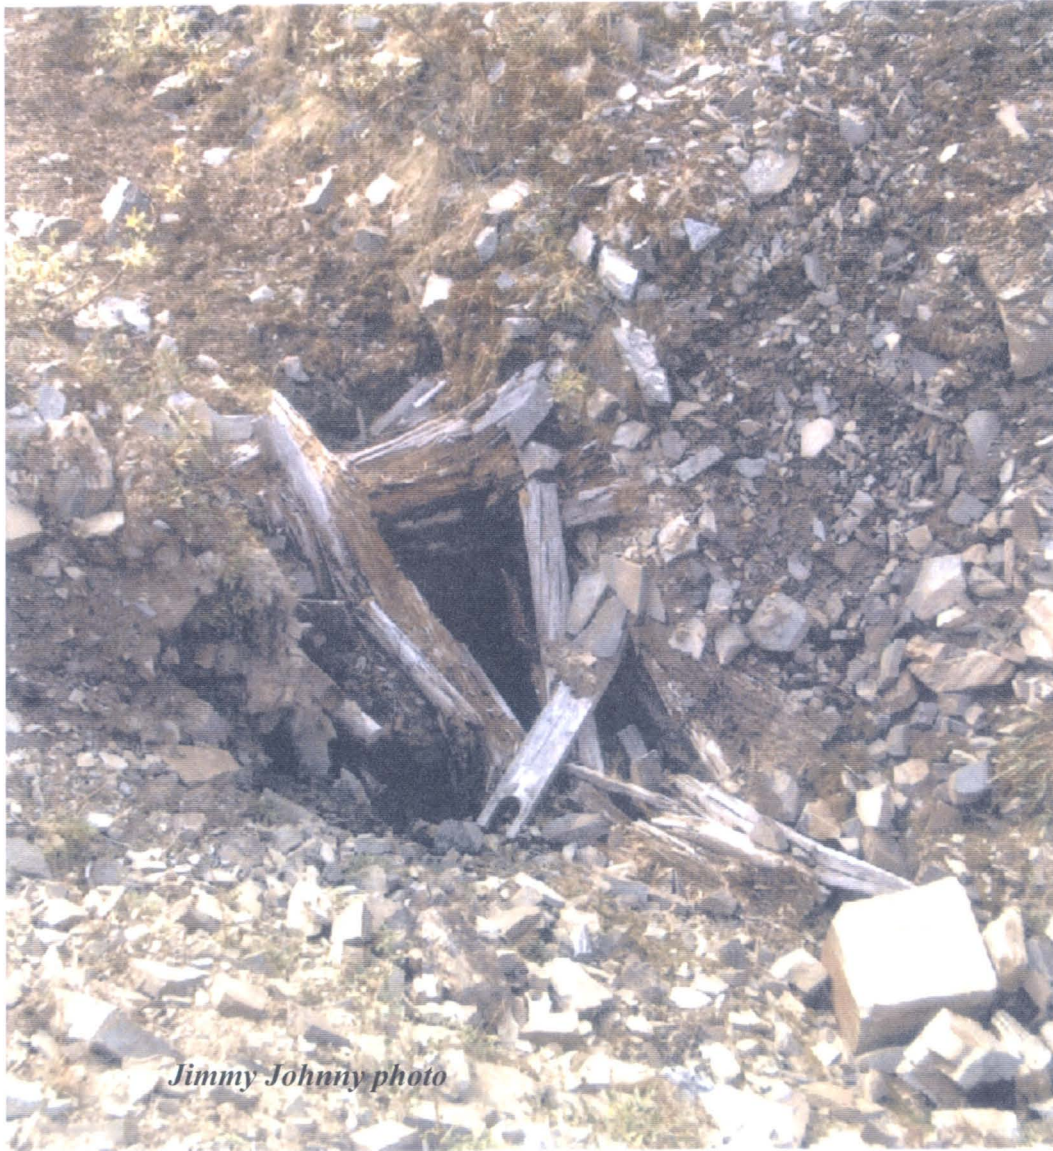
Continuing 28 southwest from trench # 1 is the second trench, which is approximately 65 meters in length.

Trench # 3 is another 22 meters further to the southwest from trench # 2, and is the longest of all the trenches with a distance of approximately 120 meters, a depth of one to two meters, and a width of five to eight meters.

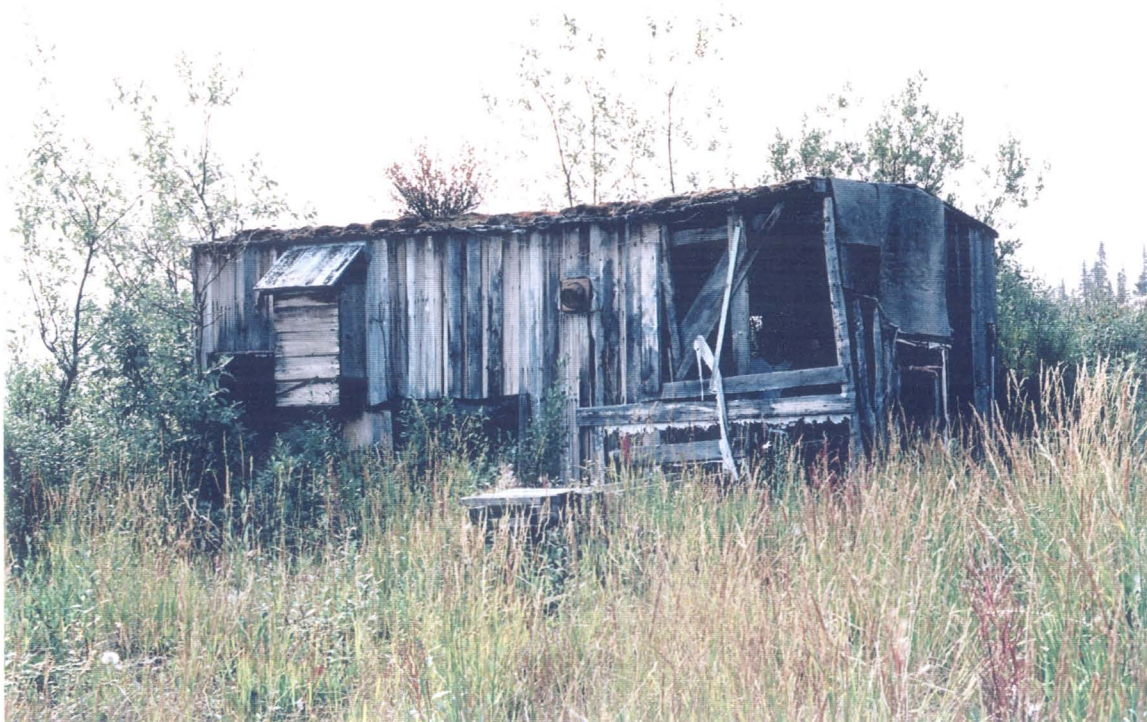
The cabin foundation has been built on top of flat stones, with the floor joists being 2 x 6s that have been sheathed in with 1 x 6 boards for the front half and 1 x 3 boards for the rest.

The exterior of the walls have been sheathed vertically with 1 x 10 planks, except for the back wall which is covered with mixed diameter planks that have been battened over with 1 x 4s.

The east wall has also been re-sheeted with heavy gauge corrugated tin. On top of the front and back walls, a six inch log pole has been used as a ridge pole, which has left the cabin with a shallow pitch gable roof.

The cabin itself is in a relatively stable state at this time, but as with all sod roof type cabins, moisture is weakening the roof structure. Someone has reinforced the ridge pole by placing an upright pole in the centre for support.

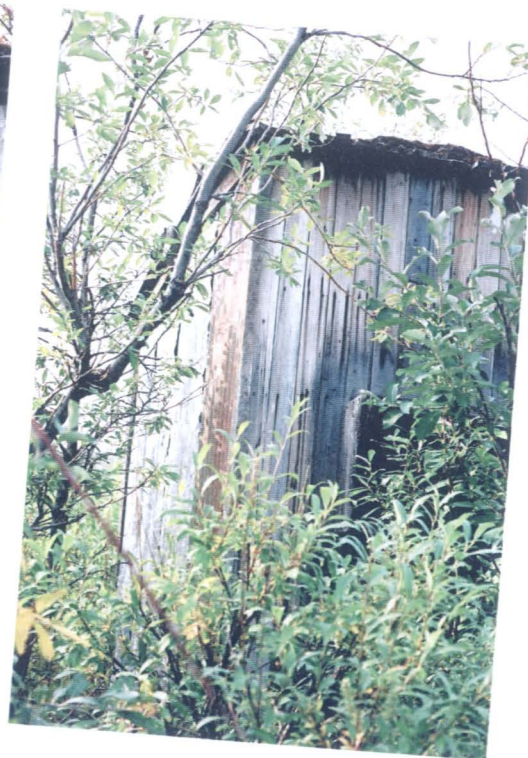
Photo left, cold storage box accessed from inside the cabin.

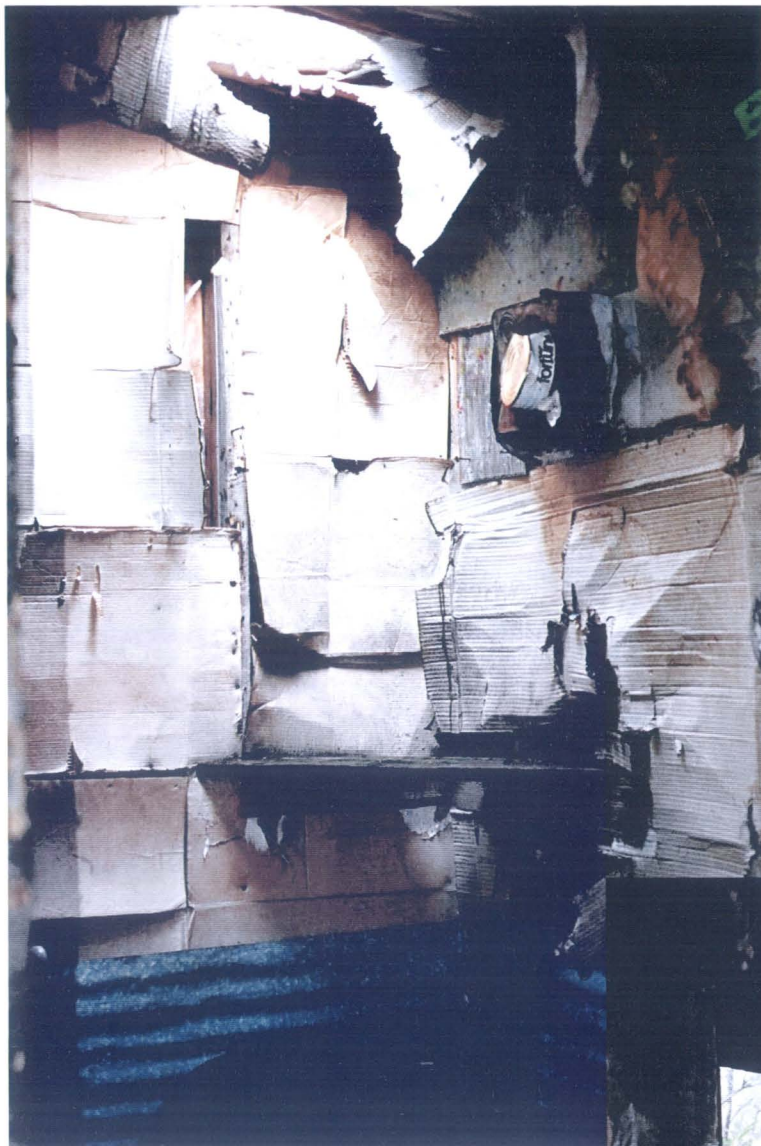
The walls are of 2 X4 construction, with one sixteenth plywood sheathing on the interior. Cardboard boxes have been used as wall sheathing and insulation material.

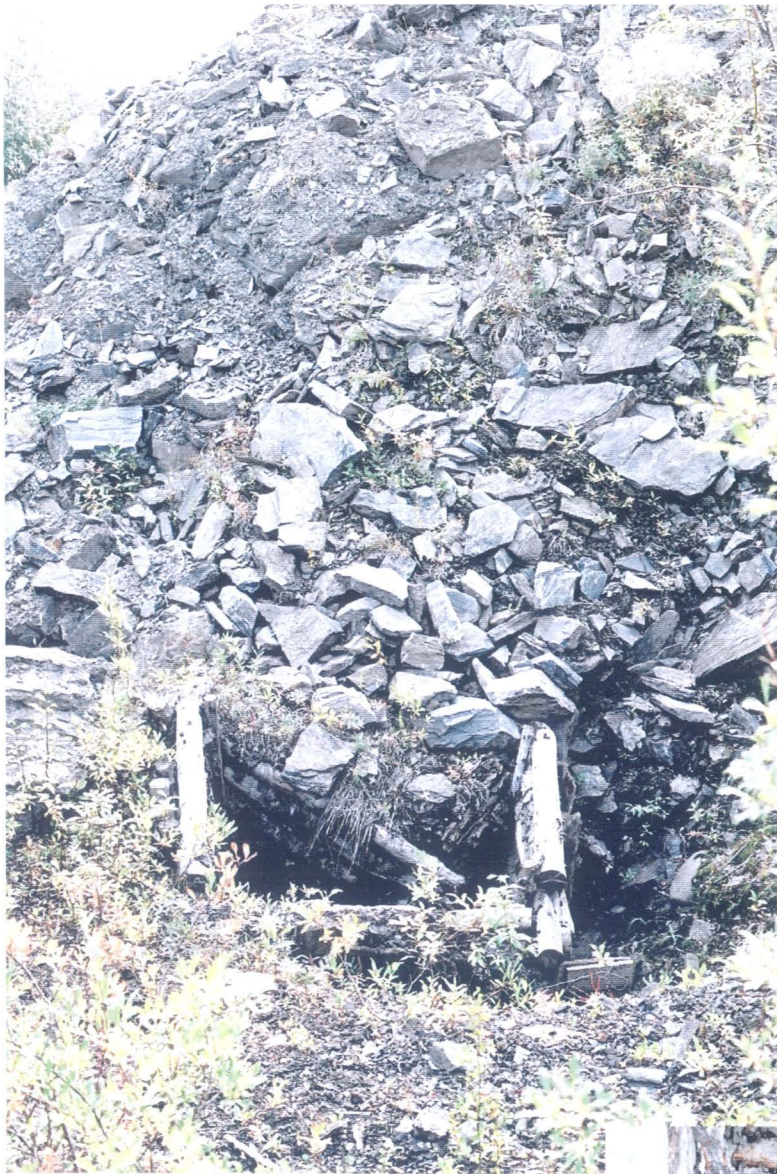
This shaft is in a very unstable state.

The east wall has sloughed, and is ready to collapse due to the movement of the waste rock pile above it.

Photo right; inside of shaft # 1

From a safety perspective we feel the two shafts should be filled as soon as possible. The shafts could easily be filled with the loose waste material that is located near the shafts.

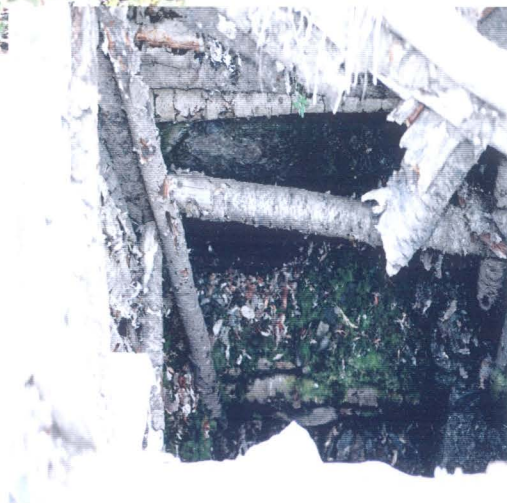
Shaft number 2 is a two compartment shaft with an incline adit which extends at a forty-five degree angle for approximately four meters before it collapses.

The vertical shaft's cribbing has deteriorated since the last inspection. Only the top two rounds of the cribbing are intact along with some diagonal cross bracing that is a meter below the top round of logs.

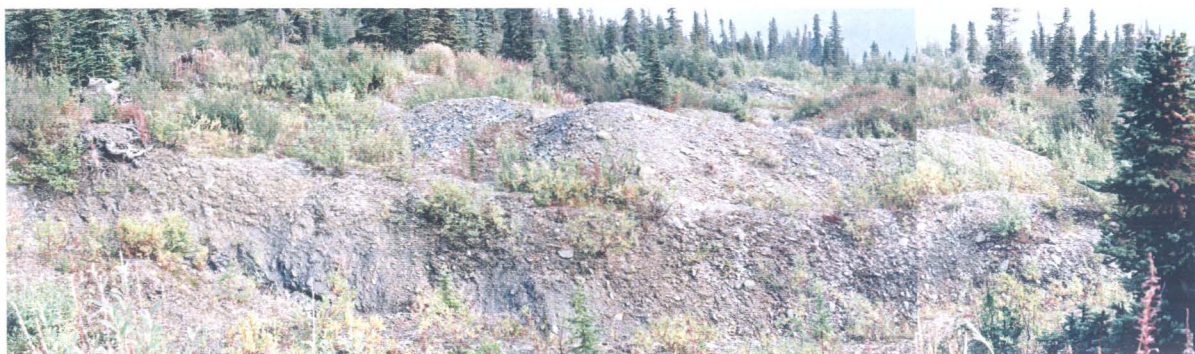
Photo above: workings directly to the north of the cabin.
