Historical Review

Of
Selected Mining Sites
In The Silver Trail Region

Prepared for
Waste Management Program
Indian and Northern Affairs Canada

March 2005

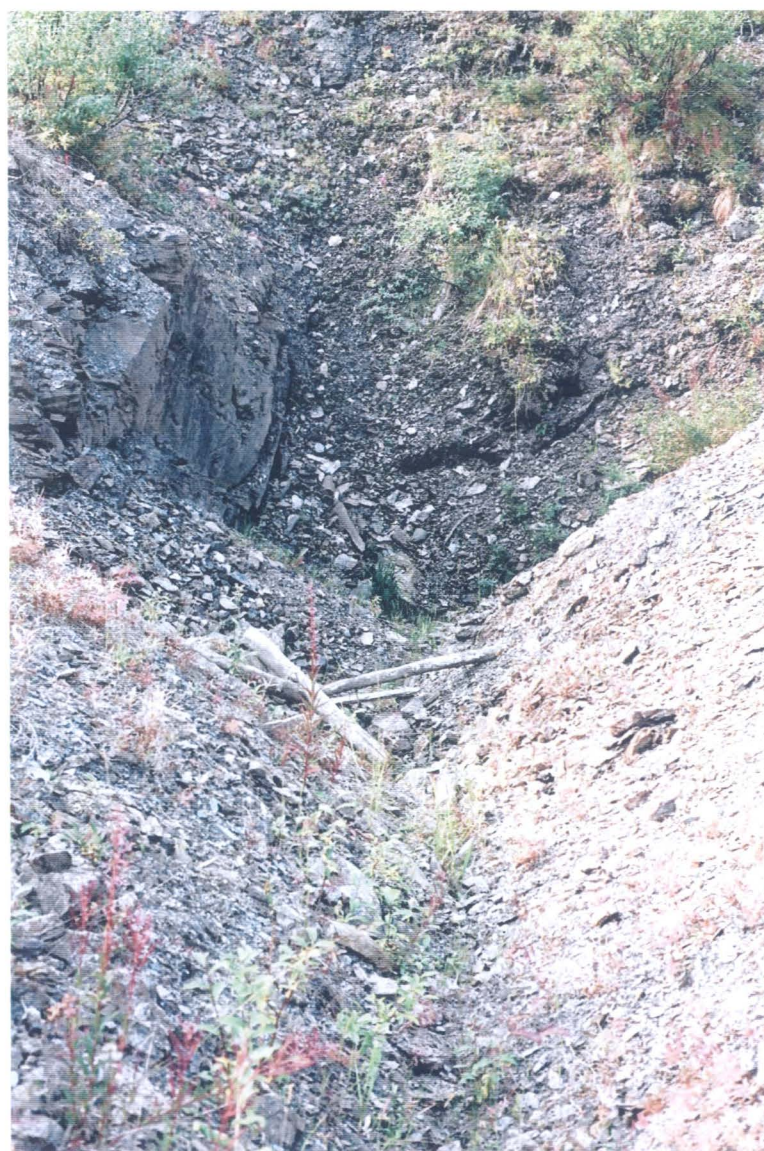
Photo left: workings directly to the south of the cabin.

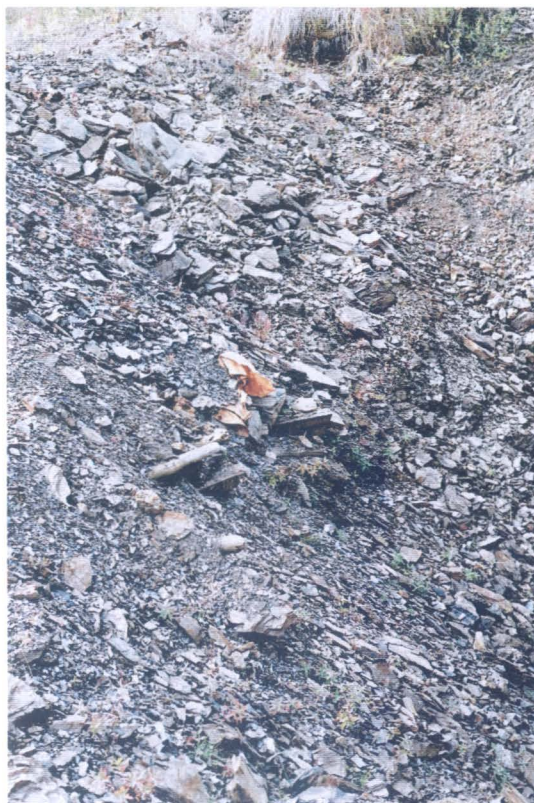
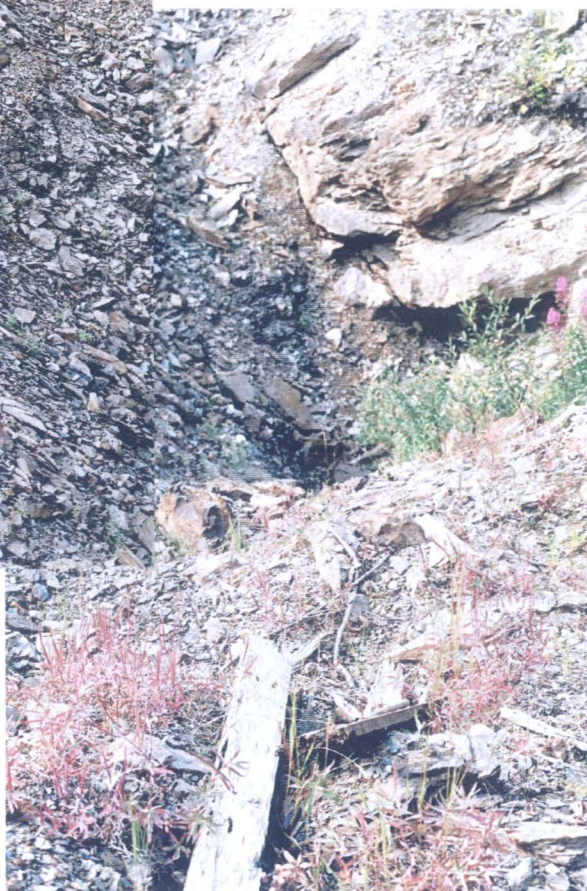
West of shaft number two by approximately 150 meters, is a deep pit with old cribbing and wood at the bottom.

There was a lot of wooden debris around the edge of the pit. This led us to believe this was the possible remains of a third shaft.

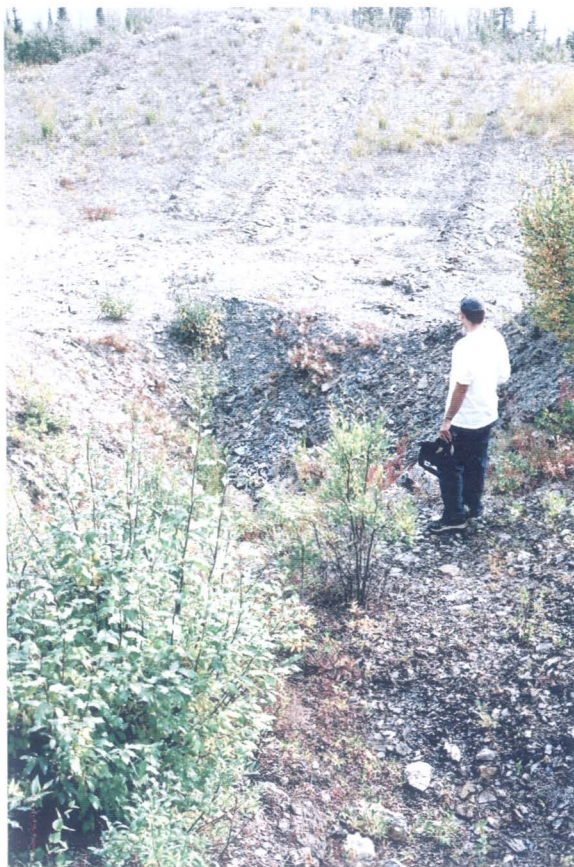
Returning to the Sourdough Trail, turning left and continuing on for .432 km, is the Boogla claim (right). The U.T.M coordinates are 486957m E by 7085145m N.

This trenched and stripped area is west of the cabin and drains into Lightening Creek. It is at an elevation of 1413 meters.

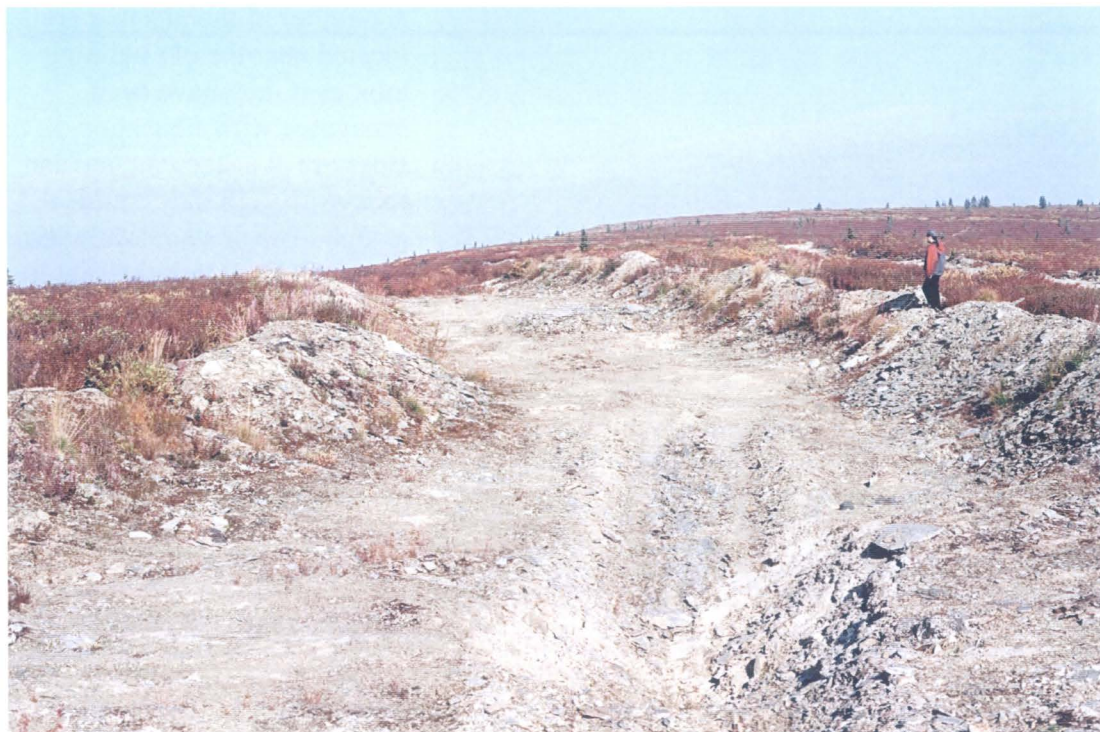
Continuing on the trail for another .732 of a km you will come upon the Bob trench (below). The coordinates are 486772m E by 7084418m N, at an elevation of 1438m.

The trench is located on the right hand side of the road and approximately 20 meters from the road. The trench is approximately 9 meters wide, 75 meters long and has an average depth 2 meters.

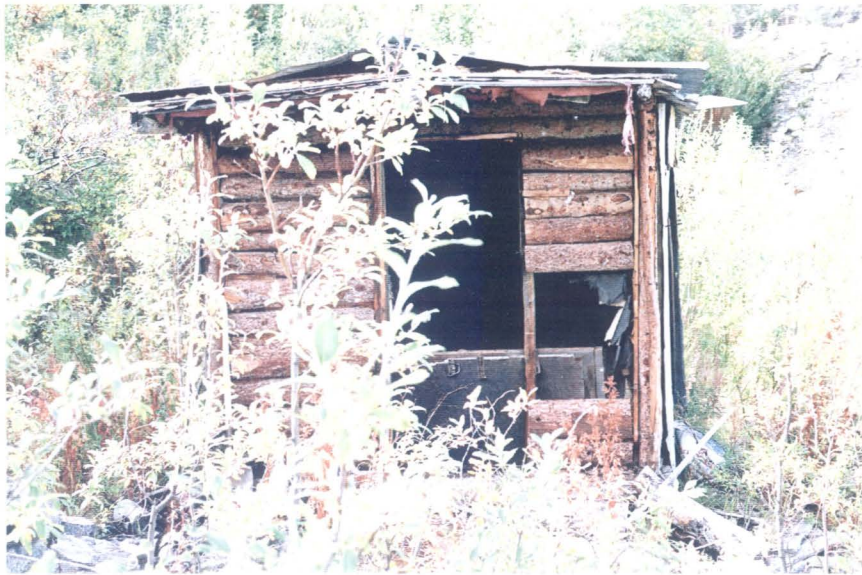
There are two buildings an outhouse, one shaft, and an adit associated with the Maybrun site. Cabin #1 is 3.21m by 4.3m in size, and situated directly behind the large piles of placer tailings.

The foundation of the cabin is built on two large log skids, which would allow the building to be moved if necessary.

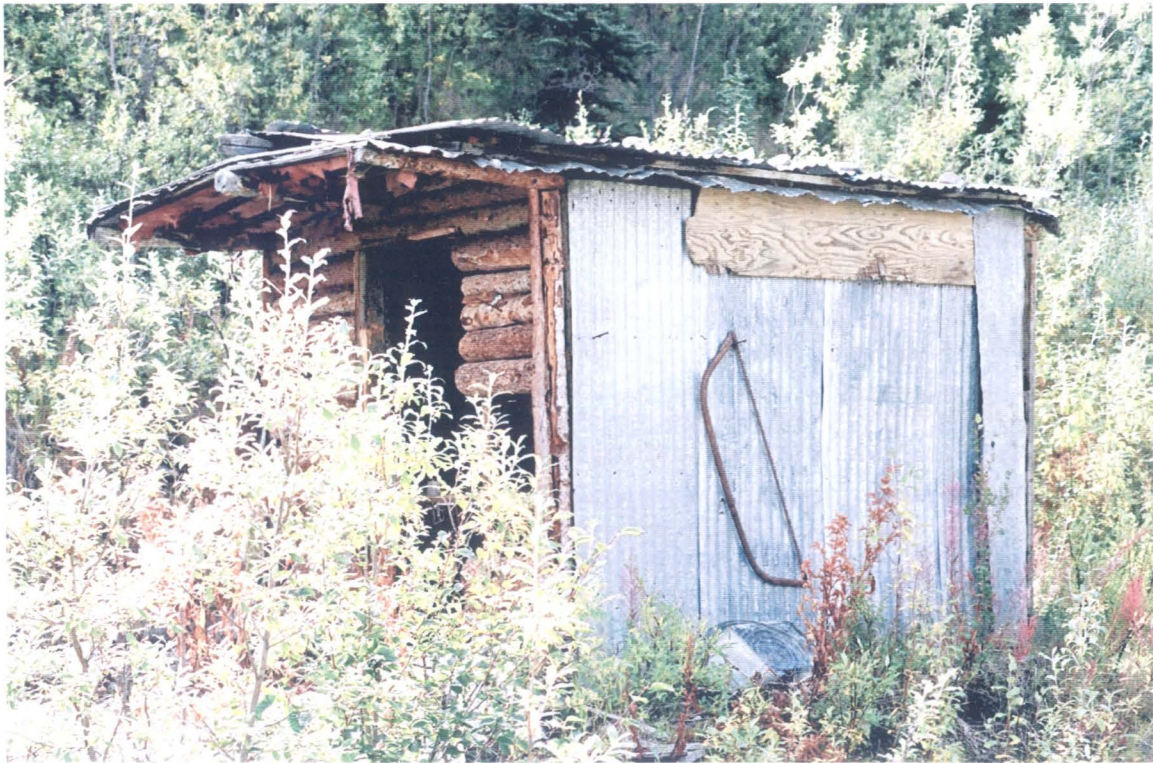
The building has a shallow gable roof which was constructed by placing a log ridge pole down the length of the building. The roof was sheeted in with rough 1 x 4 planks that were spaced eight to ten inches apart.

The roof was then covered with sheets of corrugated tin. On top of the roof, sod and moss were then used for insulation, and on top of that, a second layer of tin was then applied for further weather proofing.

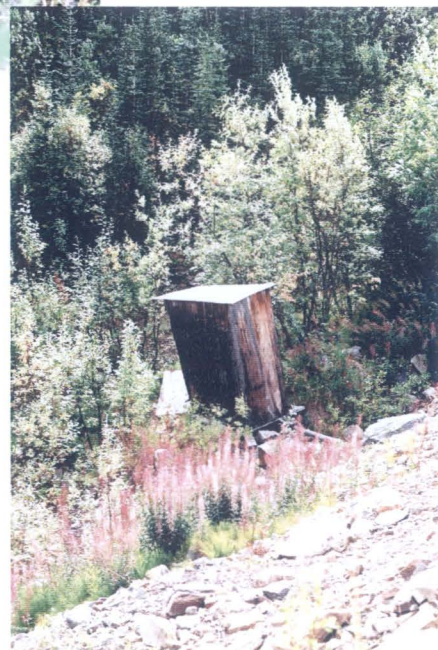
The outhouse associated with this cabin is located approximately 10 meters to the southeast of the cabin and is of frame construction.

The foundation has been built of 2 x 4 materials and placed directly on the ground. The floor and walls are sheeted with thin one quarter inch plywood.

There are only corner studs to establish the wall frame, while the roof is a half sheet of plywood laid flat on the top of the wall corner studs.

Two 2 x 6 boards were used as the door frame, while the door itself, which the wind had torn off, was built from 1 x 8 boards.

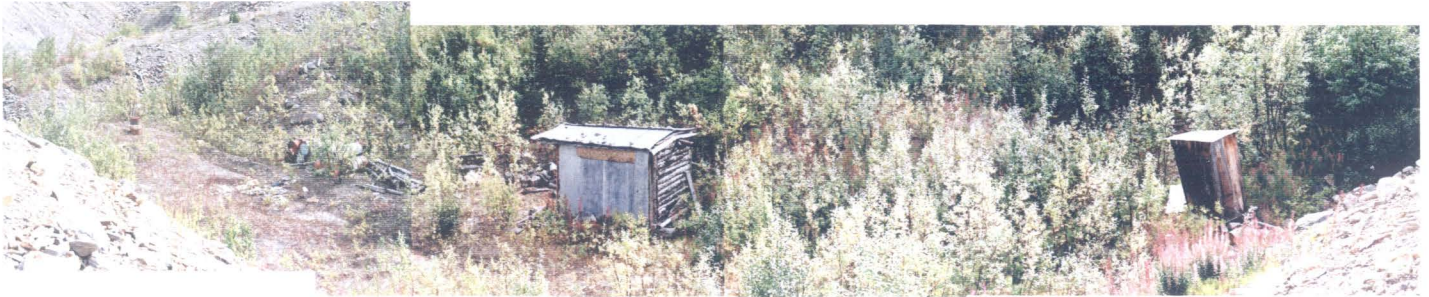
Photo below shows an overview of the lower portion of the site.

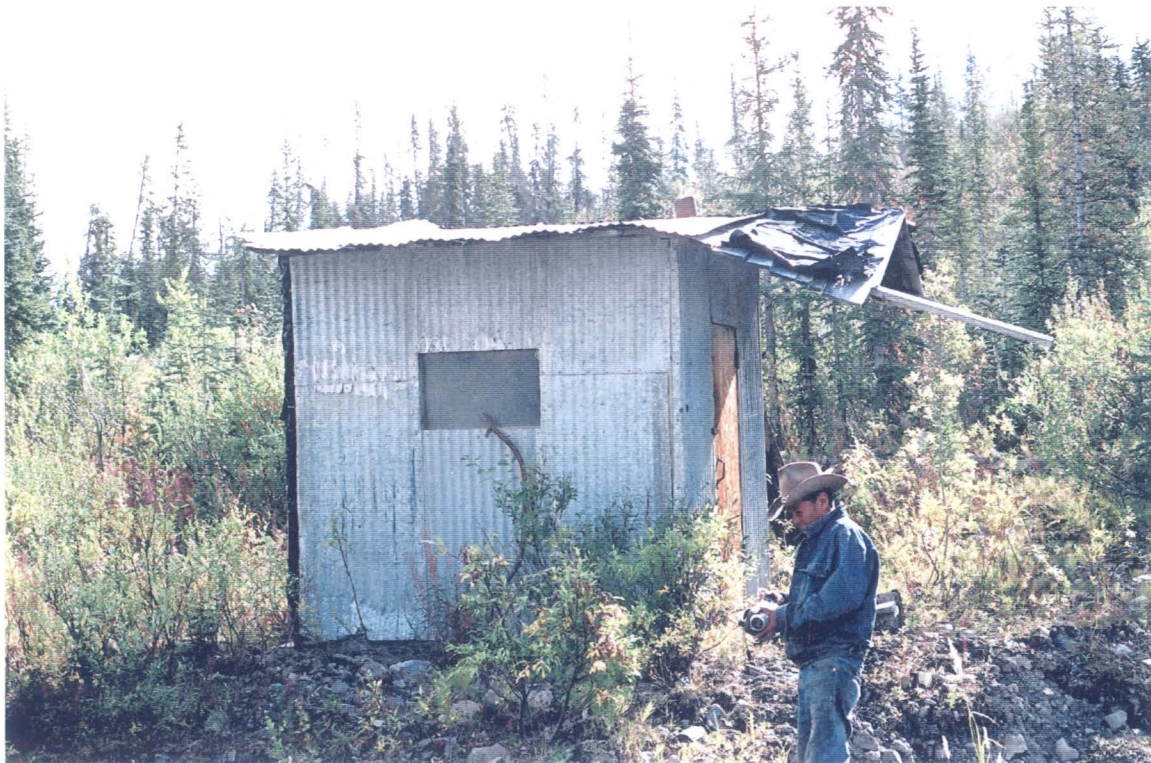
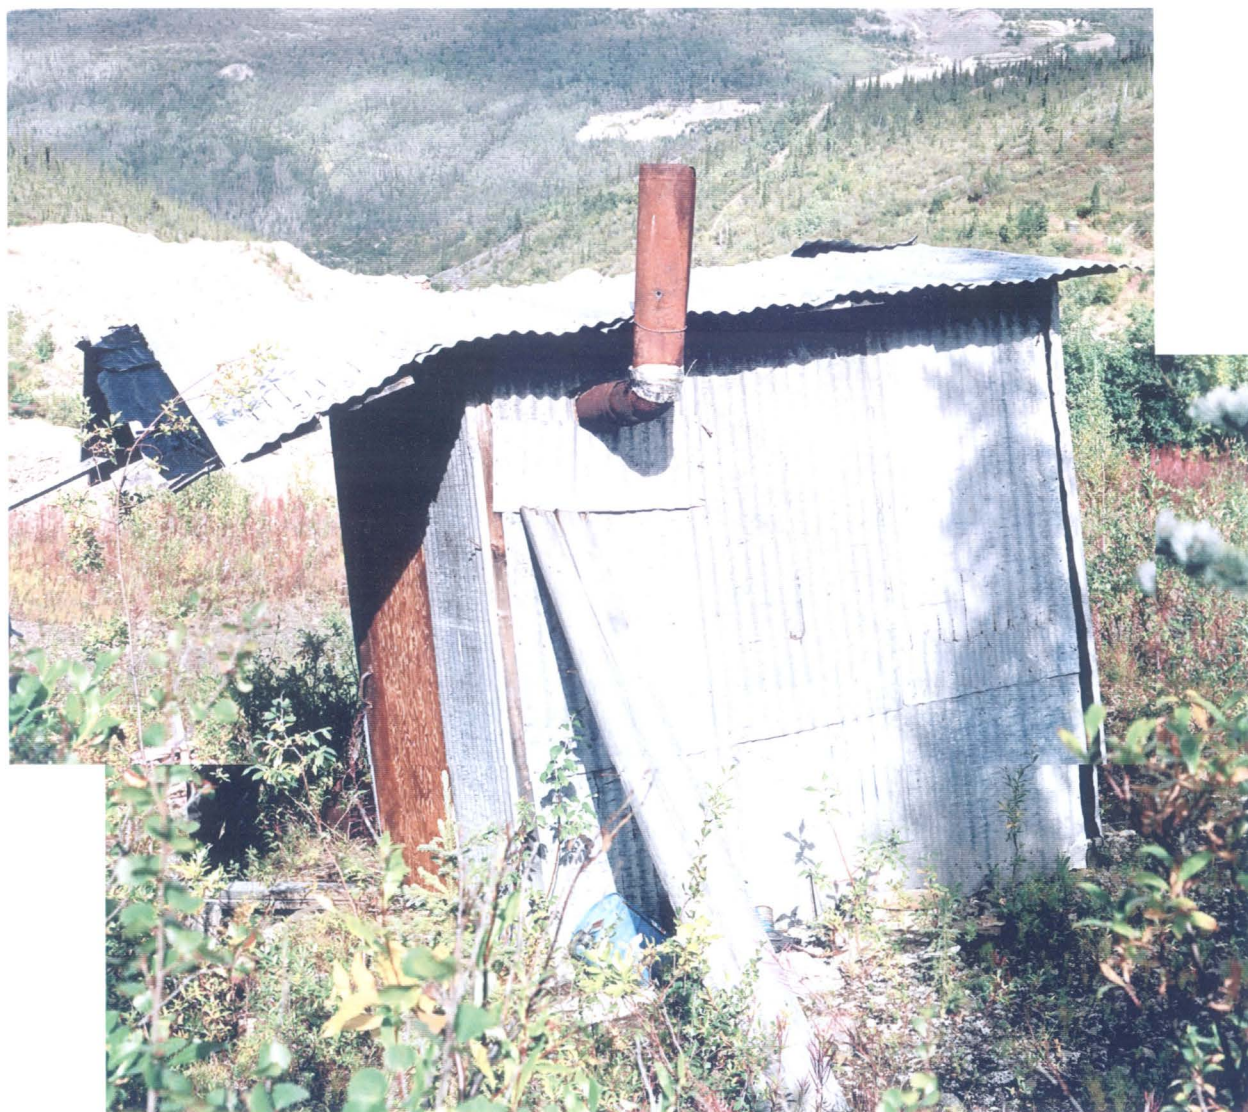
Building # 2

This is a tin shed that is located above and to the east of the adit and shaft. It is also frame construction.

The rough 2 x 4 floor joists are placed on two foot centers, with the whole foundation being supported by flat stones.

The walls are constructed of 2 x 4s with the interior being covered with a modern veneer paneling. The exterior of the walls are sheeted with quarter inch plywood which has then been re-sheeted with heavy gauge roofing tin.

The gable roof is built by placing 2 x 6 boards down the center of the building and then sheeting out to the top of the support walls with assorted 1 x 6 and 1 x 8 boards. There is a three foot overhang of the roof which extends over the door opening to the shed.

The roof and all but the southwest wall are sheeted in with heavy tin roofing material with the roof having additional layers of plastic under the tin covering. There are two windows, one in the north wall and one in the east. These windows are both sheeted in with Plexiglas, and are .83m by 1m.

The roof on building # 2 could be braced or removed.

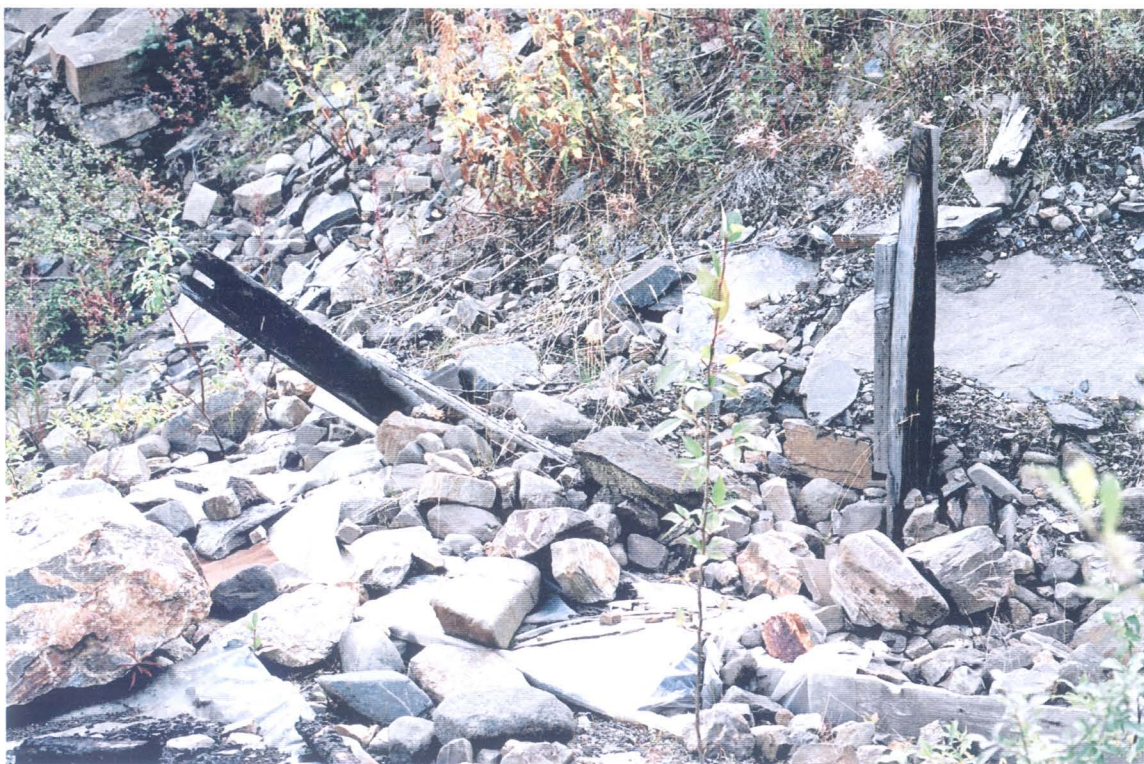
The shaft is located above the portal access point. The shaft is approximately 4m x 4m square at the surface. This size was determined by the heavy timber material used to cover the access to the shaft.

It appears that 2 x 8s and a ladder were first laid down and then covered with heavy gauge tin sheeting. This was again covered with plastic sheeting, with large boulders and rocks being placed on top to hold the materials in place.

With the shaft we would recommend that it be further investigated to determine if the covering is suspended over the shaft or if the shaft is filled with waste to the surface. The claim owner may wish to access the adit and shaft in the future. Consultation with the owner would determine what action should be taken at the site.

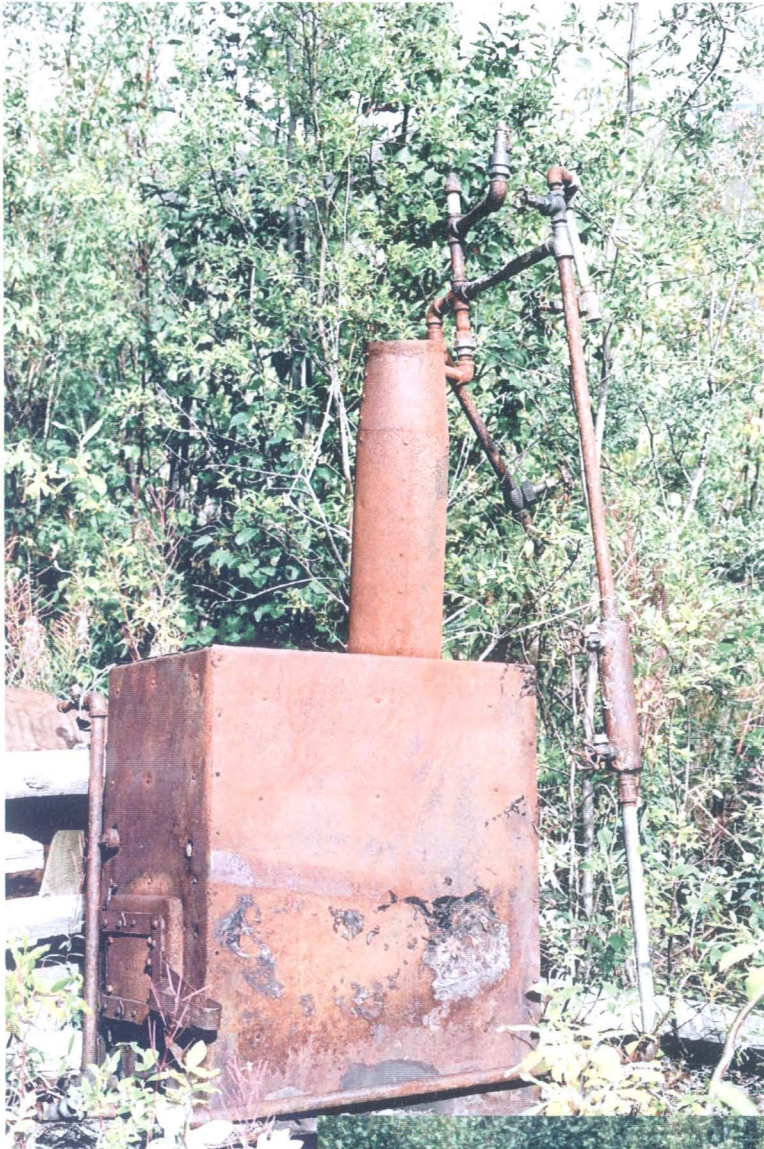
There is one significant artifact located near the shaft. This is an old home made boiler that was used for steaming purposes.

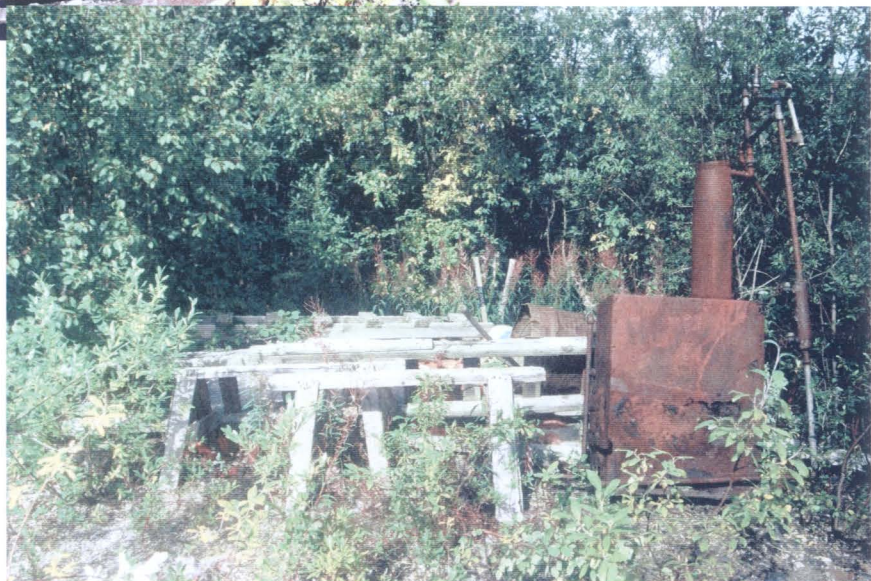
The boiler (right and below)

The height of the boiler is 33 inches by 25 inches long, with a width of 21 inches. There is a riveted 6 inch chimney near one end.

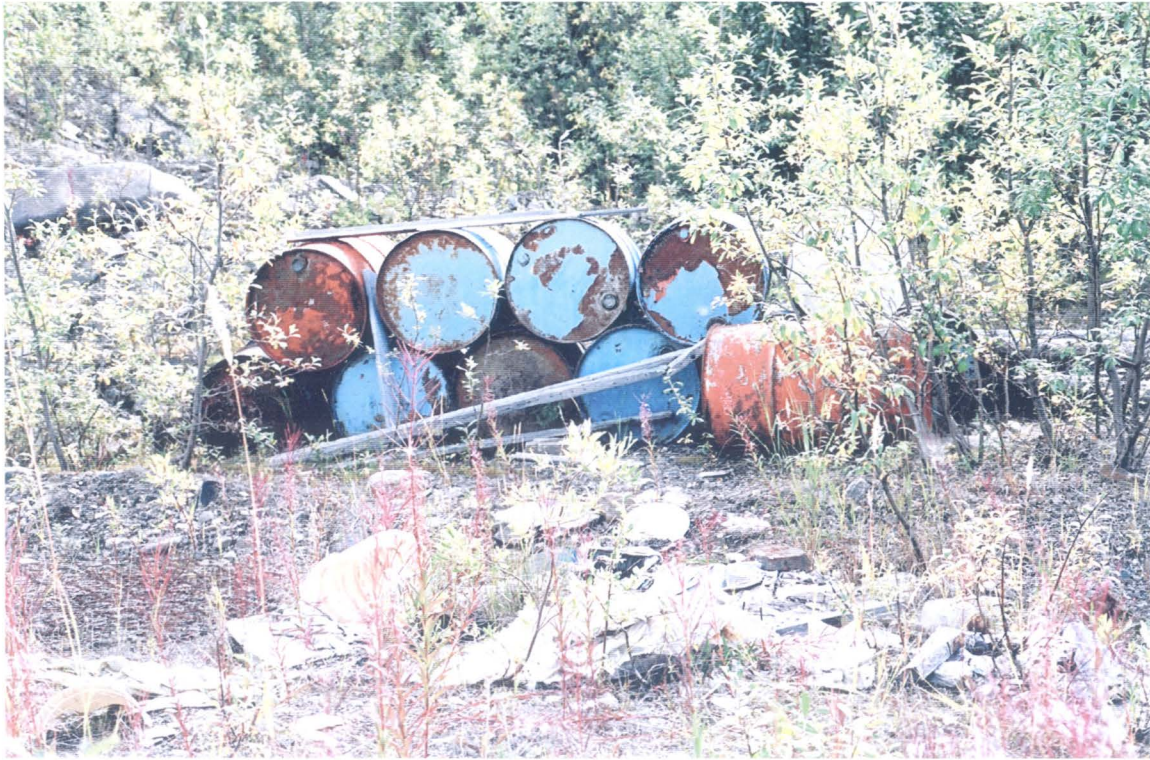
At cabin number two, there was a discarded vehicle battery. At the shaft there are one gallon and five gallon pails containing antifreeze and oils. These were the only chemical contaminants observed at the Mayburn site.

The removal of the fuel barrels, lead acid battery and containers of oil and antifreeze would be recommended along with any deteriorating rubber hose and air lines.

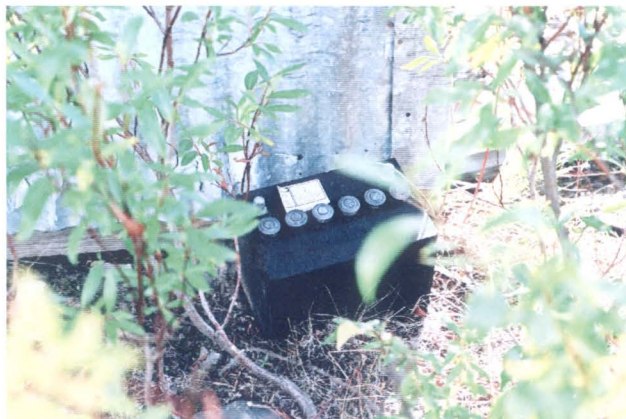
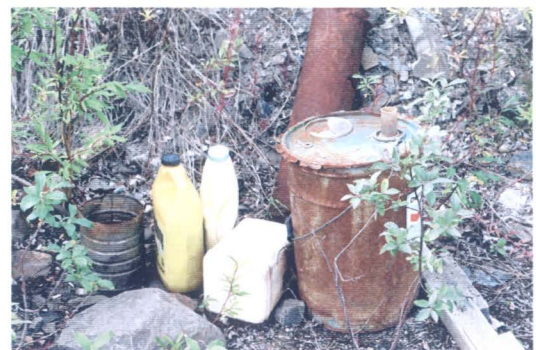
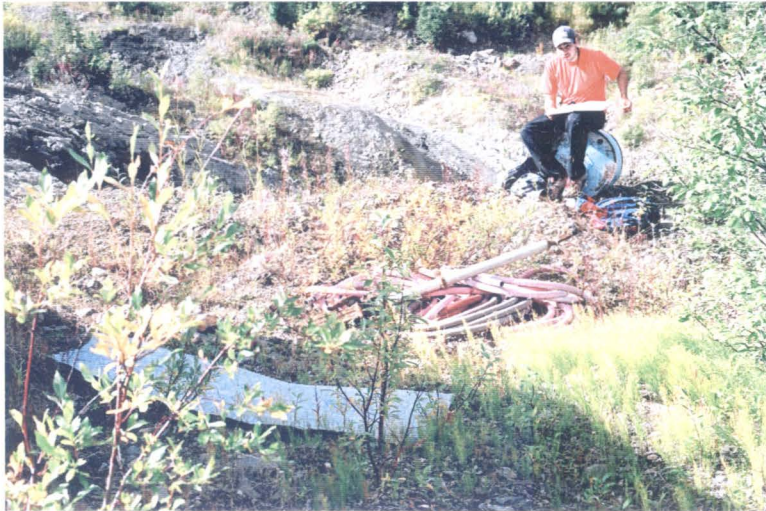
There is some heavy metal debris at the site, a winch bucket, forty feet of one inch pipe with fittings, some heavy cable, hand picks, coils of rubber air and water line, and various pieces of scrap metal.

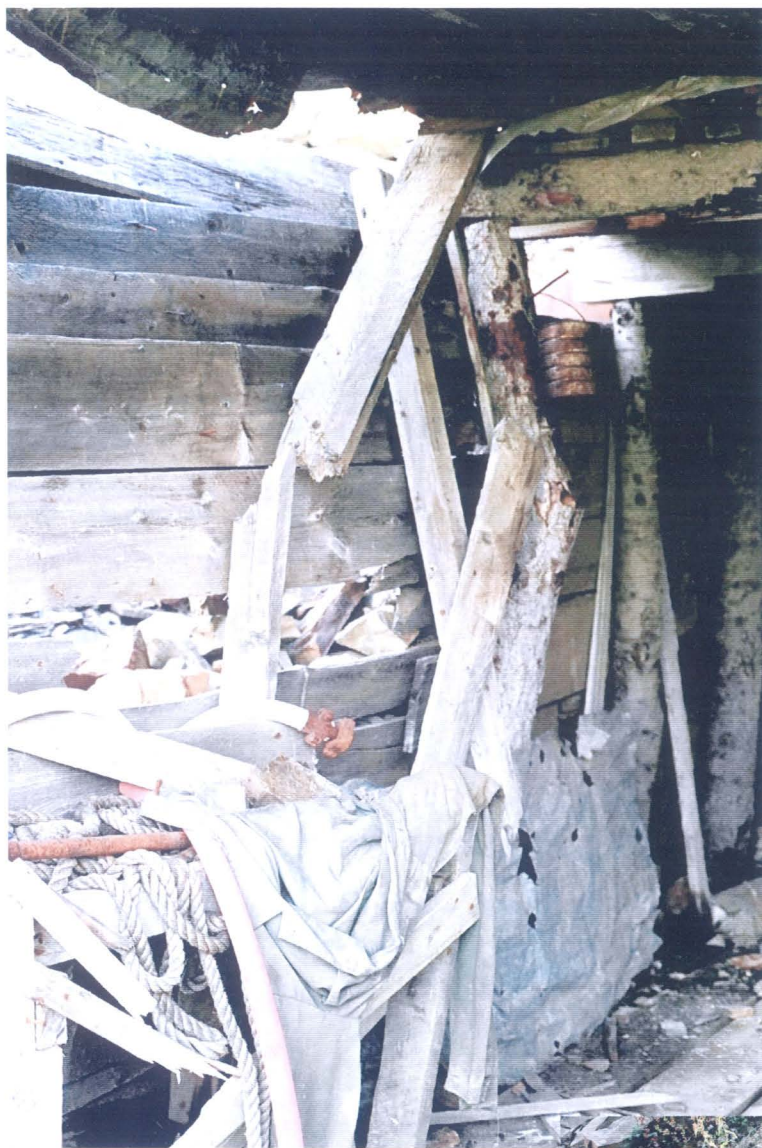
Public safety concerns at the Mayburn site are the open adit and the shaft that is 30 meters north east of the adit.

The adit support timbers are in a weakened state and are collapsing. Some of the interior uprights are broken and starting to slough into the adit portal.
