Anvil Range Mining Complex Investigations in Support of Progressive Reclamation of the Emergency Tailings Area

2005/06 Task 35

Investigations in Support of Progressive Reclamation of the Emergency Tailings Area

SRK Project Number 1CD003.081

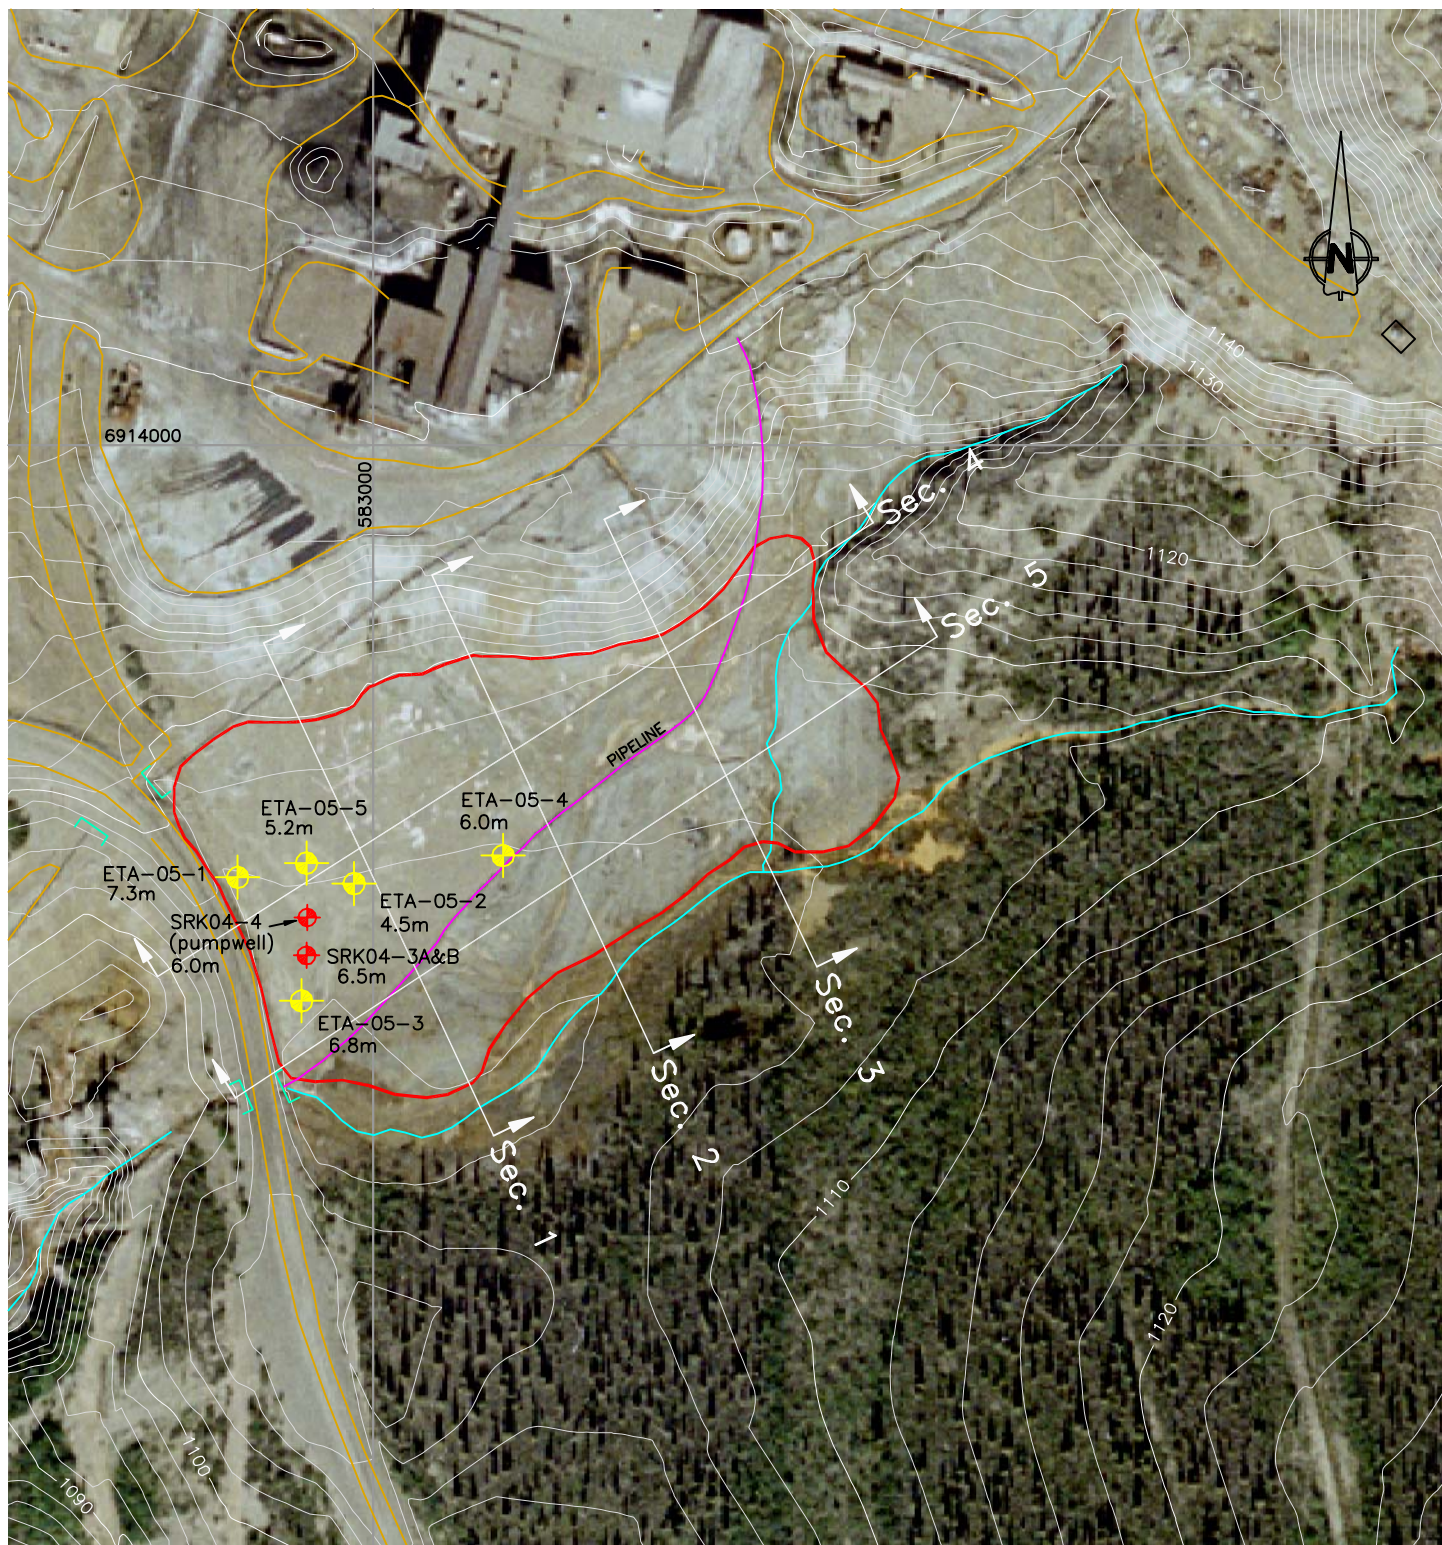
2

Five drill holes (ETA-05-1 through ETA-05-5) were completed at the ETA on August 15, 2005 using a track-mounted sonic drill operated by SDS Drilling (Figure 2). The coordinates and the depth to original ground at each of these drill holes are provided in Table 3.1. Piezometers were installed in all five holes. An SRK inspector was present to log and photograph the holes as they were drilled and to direct the installation of the piezometers. The logs and corresponding sample photographs from each of the five drill holes are provided in Appendix B.

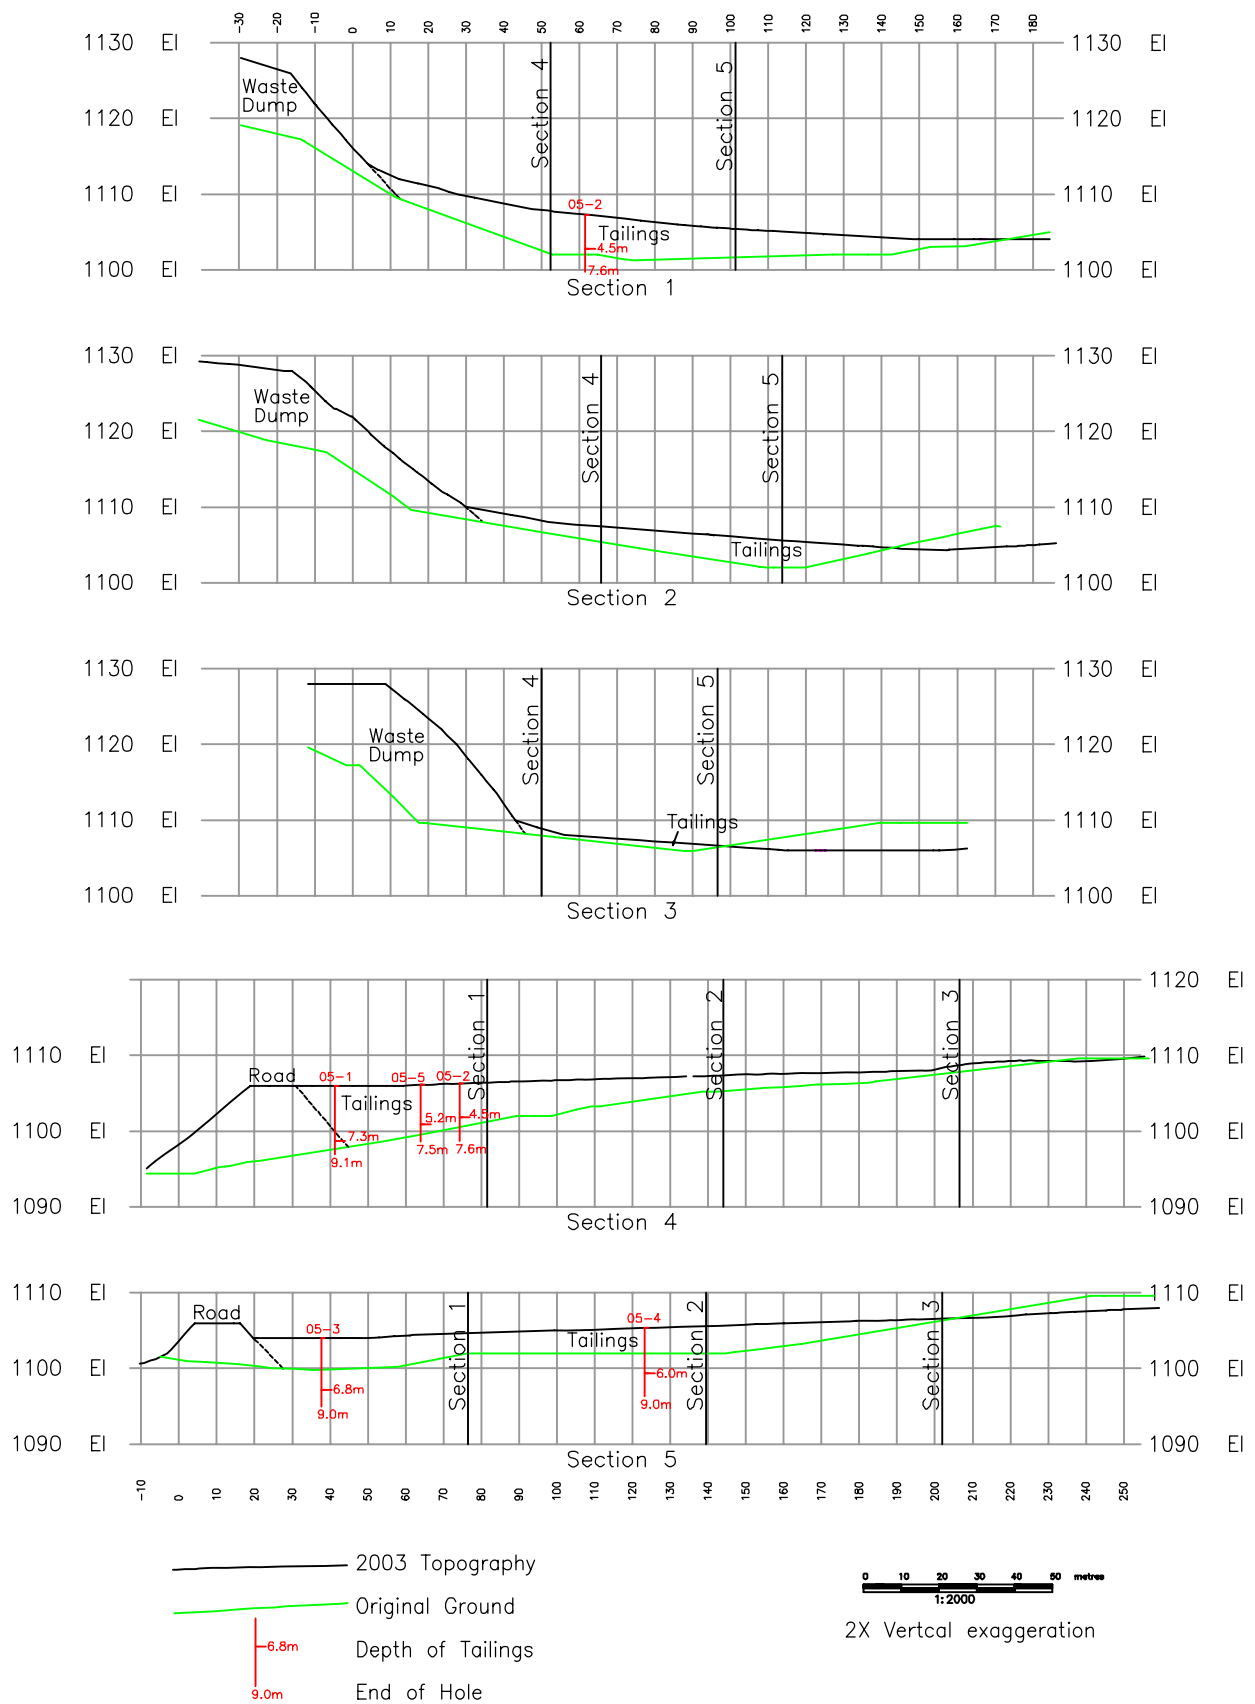
Five sections (1 to 5) through the ETA are shown on Figure 3. The sections are based on a comparison of the pre-mining topography (7.6-m contour interval) and the 2003 topography (2-m contour interval) obtained from aerial photogrammetry. The 2005 drillhole data related to tailings thickness, which indicates the maximum thickness is about 7 ½ m, has been added to Sections 4 and 5. The drilling results do not match the pre-mining profiles perfectly but, given the apparent changes in the pre-mining topography between Sections 4 and 5 and the offsets of the drill holes relative to these sections, the original ground profiles on Sections 4 and 5 seem reasonable.

The volume of tailings in the ETA was computed using Sections 1, 2 and 3, and then computed a second time using Sections 4 and 5. In the first case, the computed volume was 52,340 m³. In the second case, the computed volume of tailings was 49,220 m³. Given the similarity of these results, the mean of these two results (about 51,000 m³) is assumed to be representative of the volume of tailings in the ETA. It is possible, however, that the actual tailings volume could be greater than 51,000 m³, although it is likely that a contingency of 5 to 10% (about 2,550 to 5,100 m³) would cover the potential for the actual volume to exceed the estimated volume.

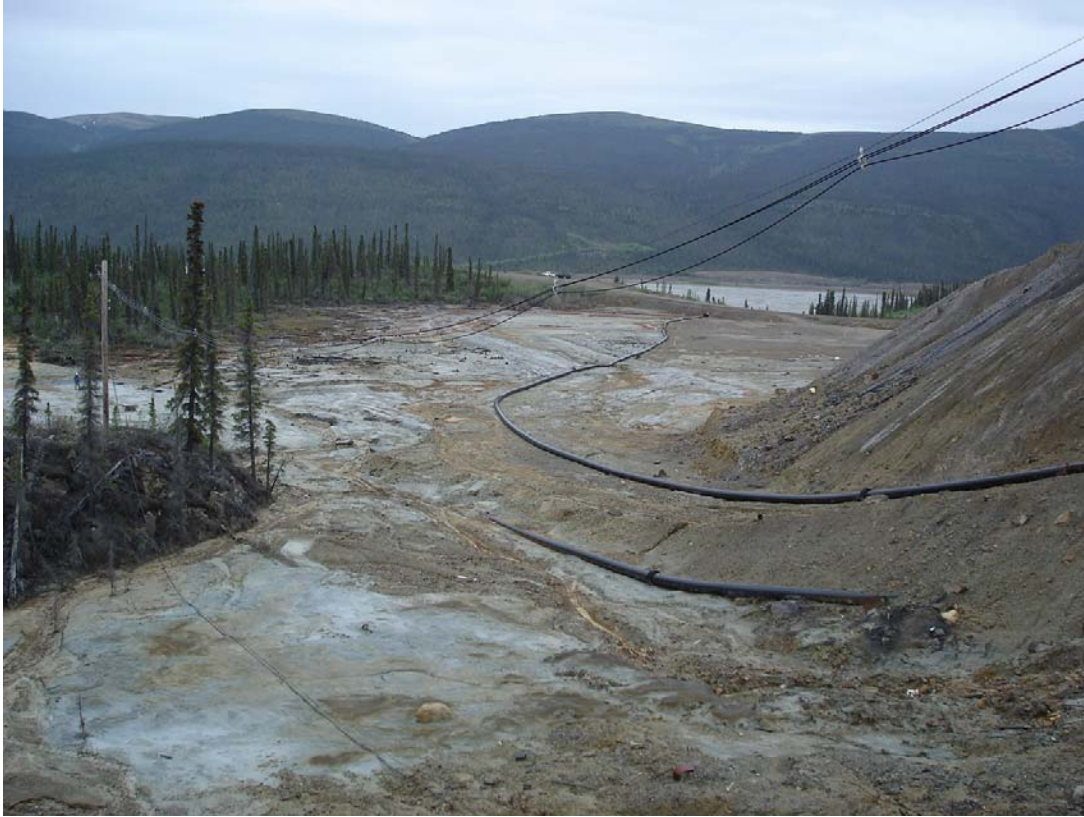
Photo 1: Southeastward view across the ETA from the general vicinity of the plant site. The mine access road is visible in the background. June 2006.

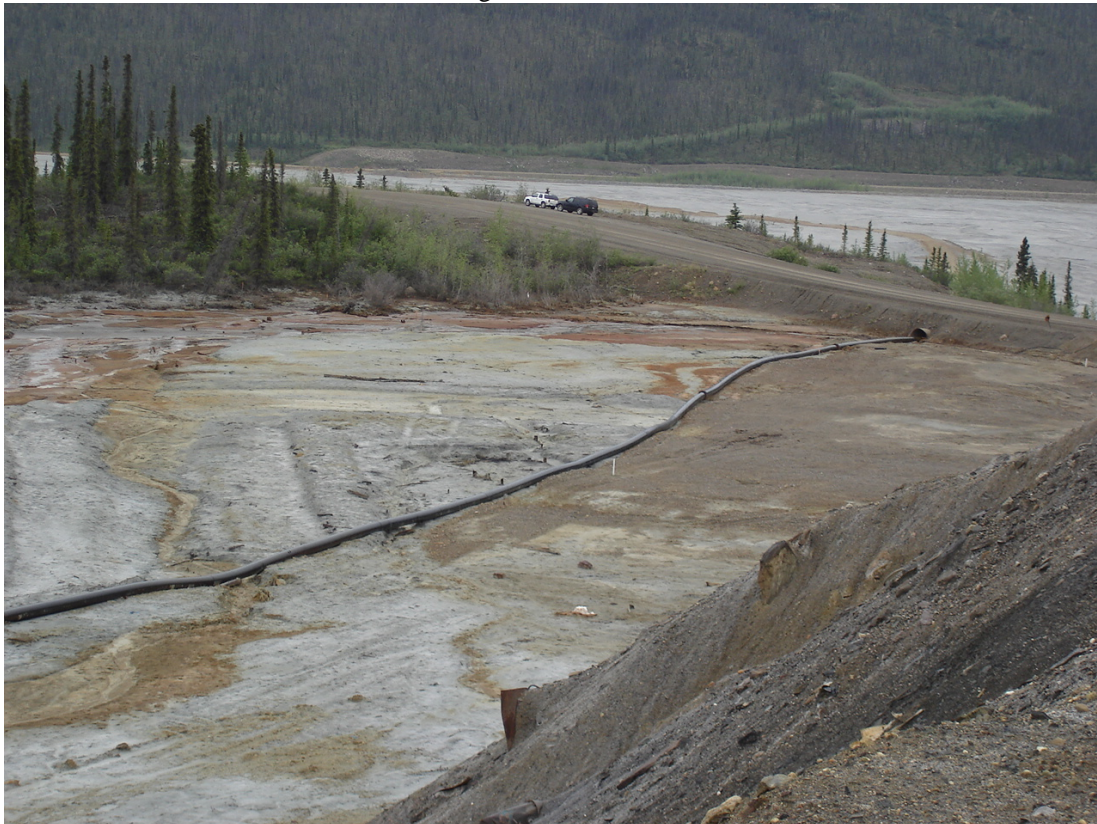
Photo 2: View similar to Photo 1, with the access road in the background (with trucks). June 2006.

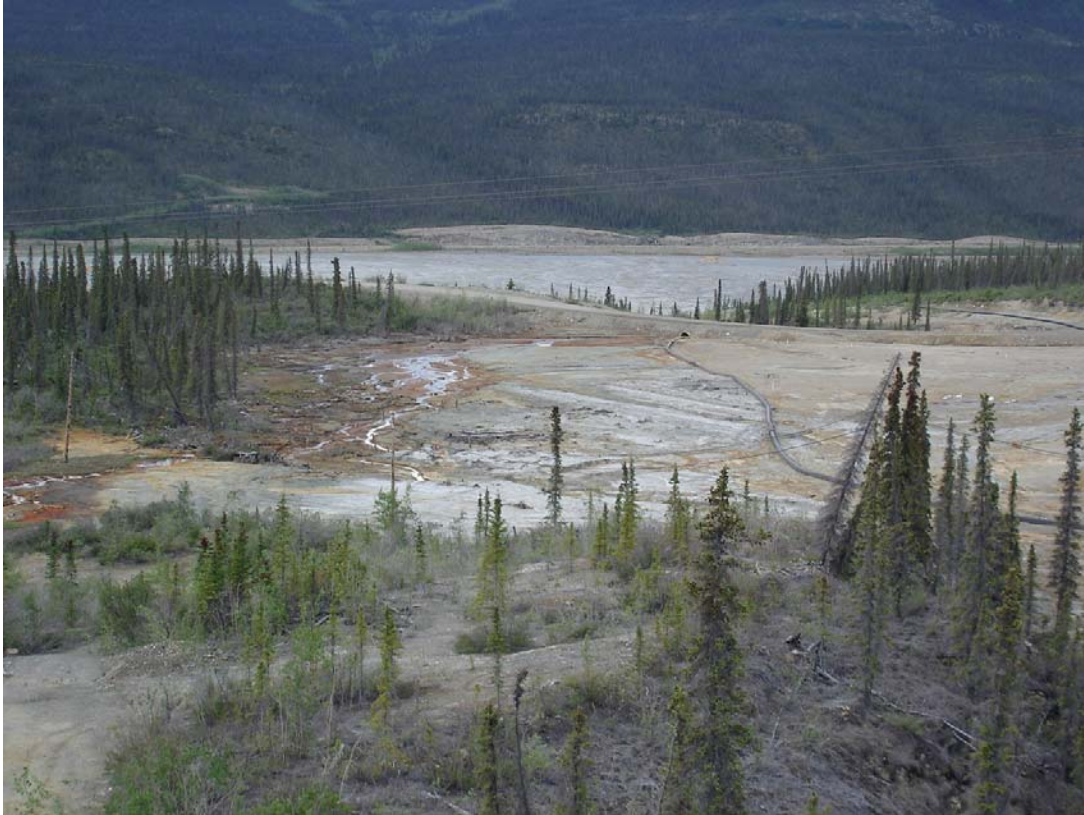
Photo 3: Southwestward view across the east edge of the ETA. The Rose Creek Tailings Impoundment is visible in the background. June 2006.

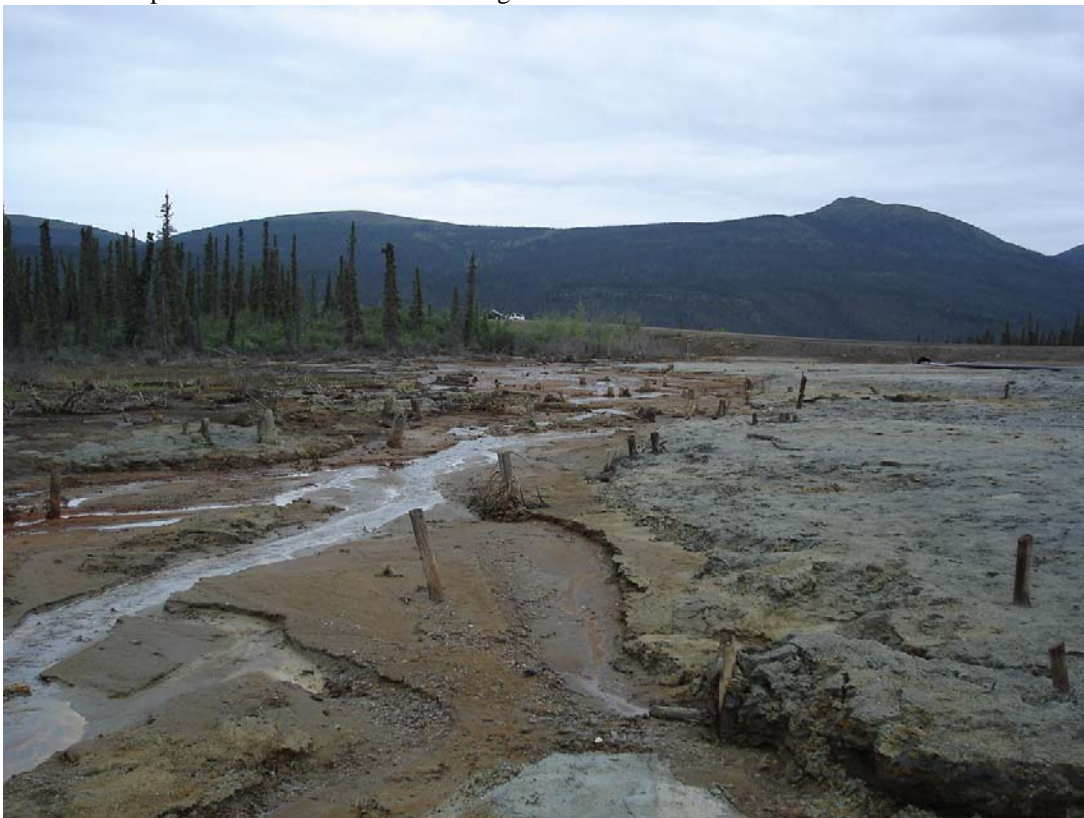
Photo 4: Ground level view, looking southwestward, of the ETA. The trees were cut down leaving the stumps that are evident above the surface of the tailings. June 2006.

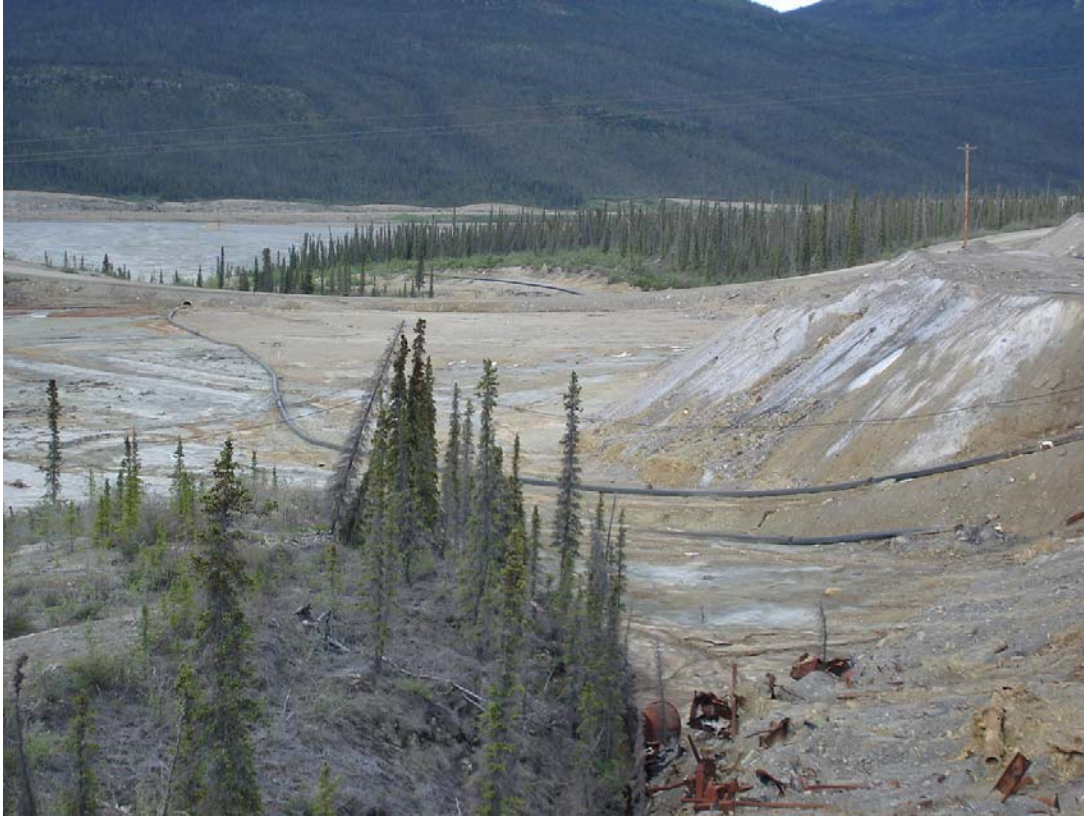
Photo 5: Southward view along the west side of the ETA. June 2006.

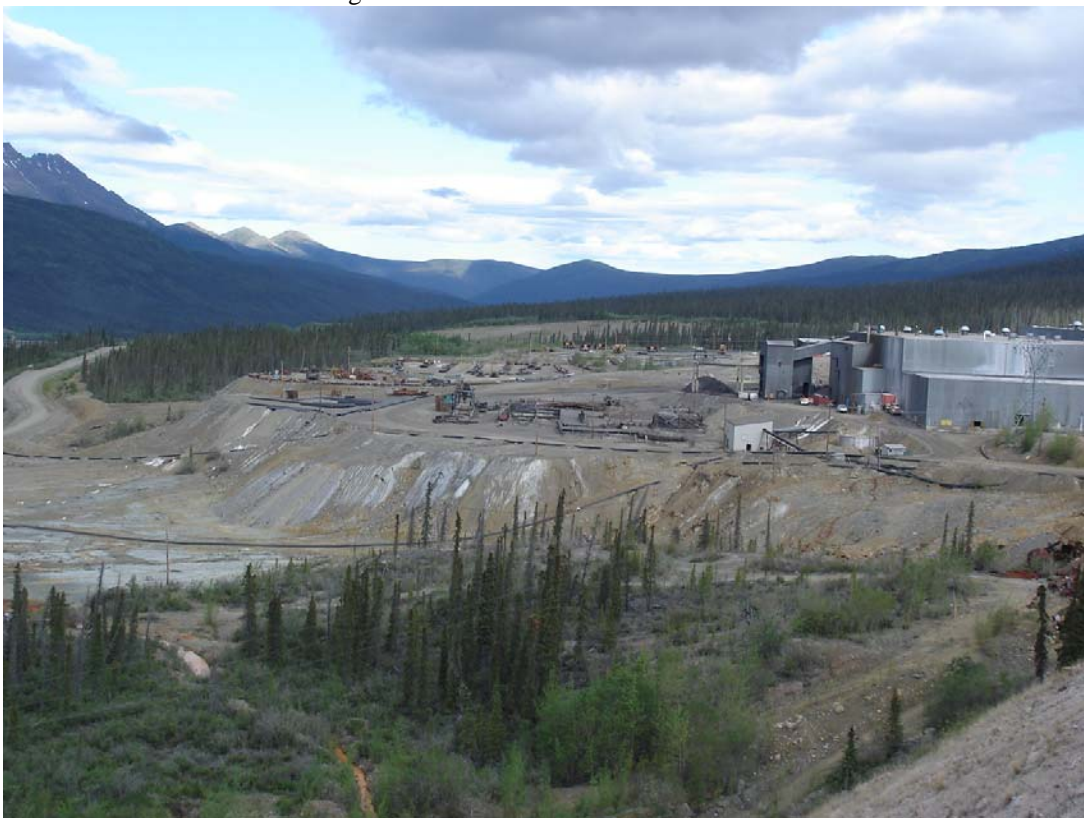
Photo 6: Westward view across the ETA (lower left foreground), with the plant site situated to the right (north) of the waste rock. June 2006.

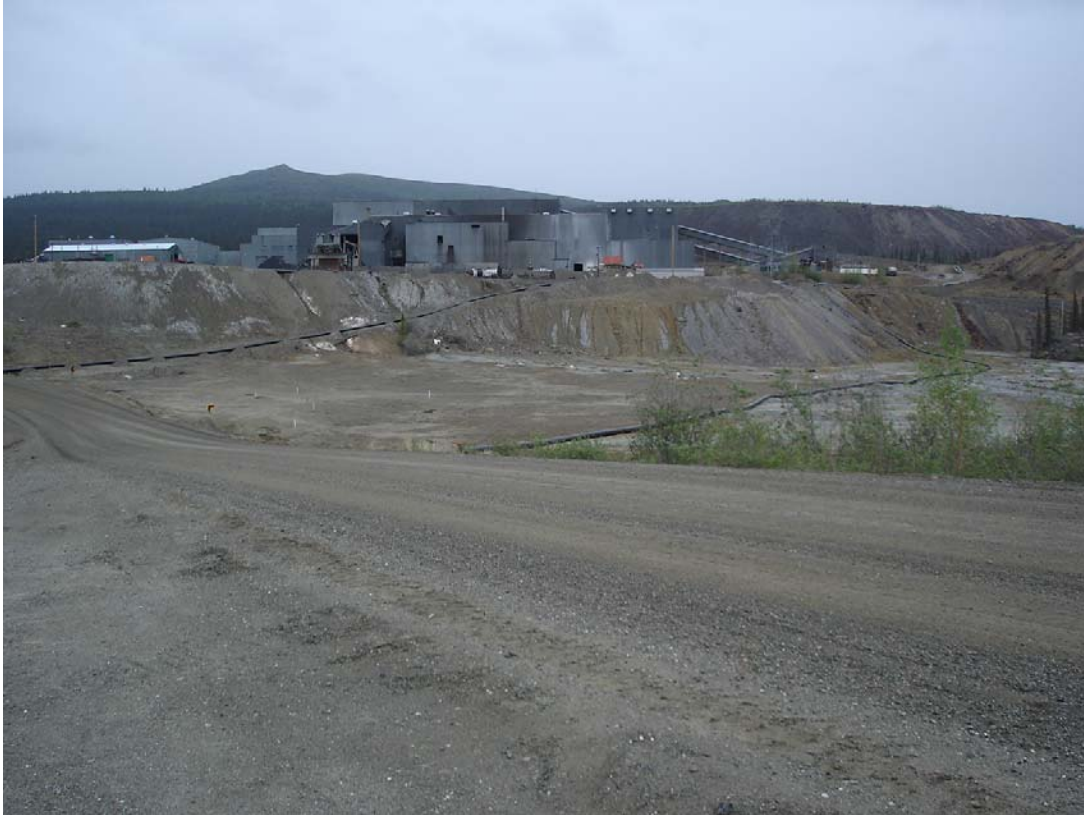
Photo 7: Northwestward view from the access road. The pipes on the surface of the ETA are piezometers installed during the drilling campaigns. June 2006.

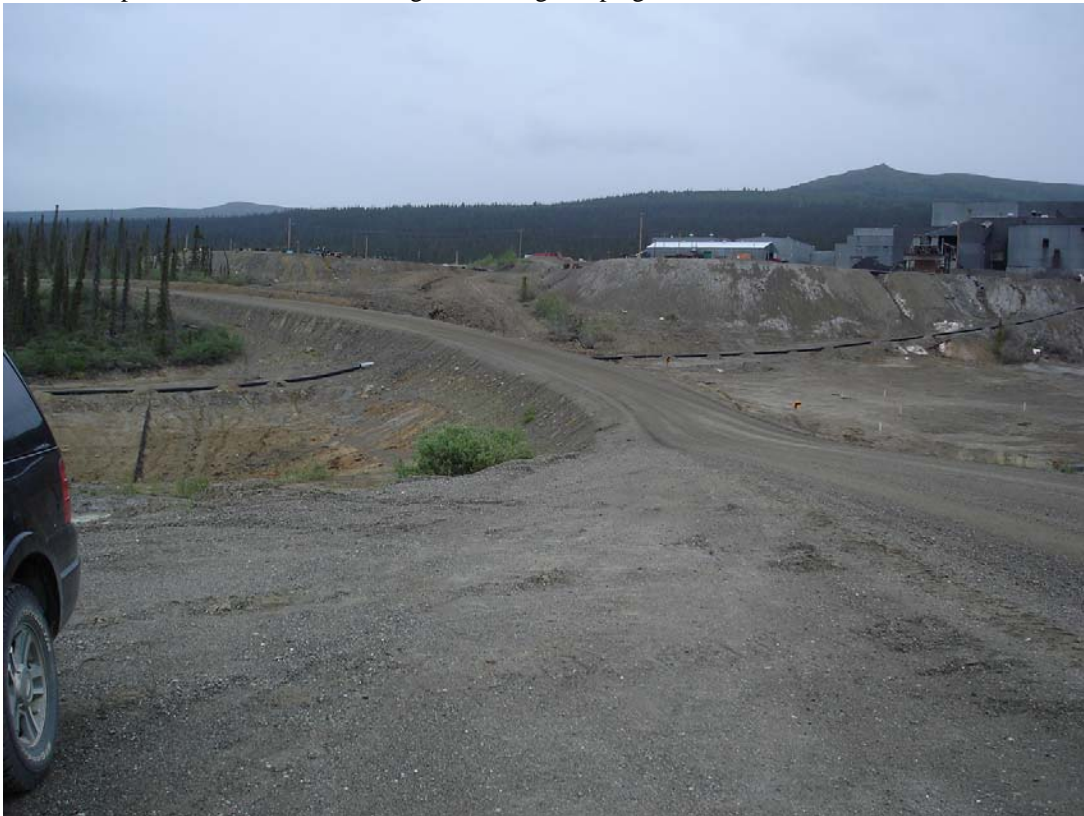
Photo 8: Westward view from the access road. The gully to the left (south) of the access road is part of the original channel for Faro Creek. June 2006.

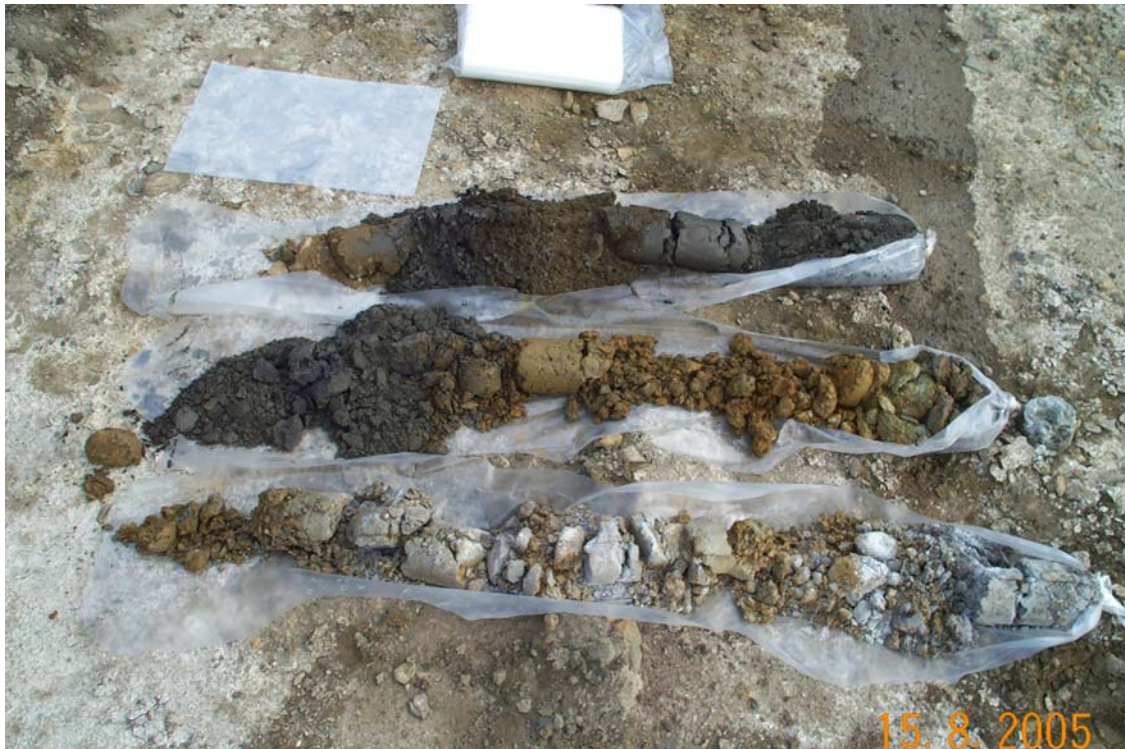
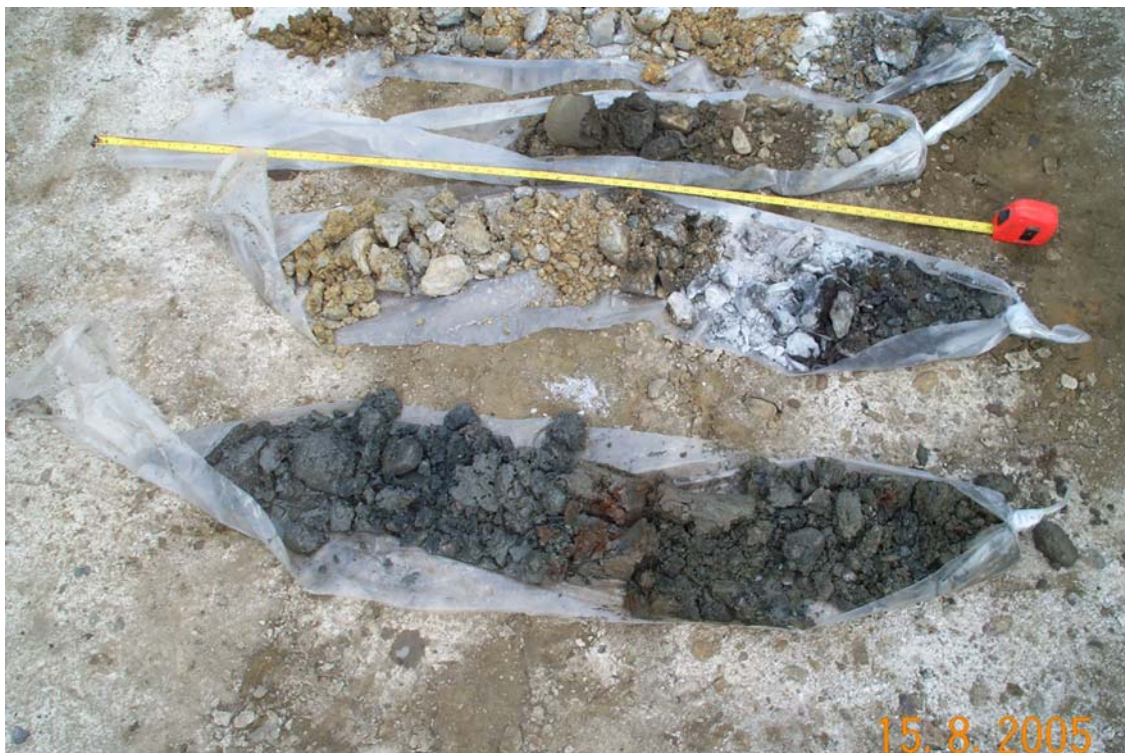
From (m)	To (m)	Description
0.00	0.15	Light brown, slightly moist SAND mixed with dark grey discrete pods. Subang gravel at surface.
0.15	0.30	Dark grey to black, fresh sulphides (sand), no oxidation, slightly moist.

0.30	0.61	Light yellowish, brown gravelly sand, slightly moist, angular gravel up to 2cm diameter.
0.61	2.13	Dark grey sulphide sand, some lenses up to 20cm with more fines, fresh slightly moist pyrite (sand). Bottom of unit has more pyritic sand, less fines.

2.13	2.90	Brownish orange, gravelly sand silt, moist to very moist. Angular gravel (20%) up to 3cm. No fresh sulphides observed.
2.90	7.32	Mottled white/orange/grey/brown zone, dry to slightly moist, silty sandy gravel (angular, up to full core diameter (10cm)). Lenses of visible pyrite up to 20cm.

7.32	7.60	Original ground. Peat layer 5cm thick, coarse, fibrous. Smells like diesel.
7.62	9.14	Dark chlorite green to olive green, gravelly, silty sand, moist to wet, mottled rusty zone @ 8.53m (diesel smell from 7.62 - 8.53m)

Photo of sample obtained with Sonic Drill from hole ETA-05-1. Material from top of hole is at left rear. Sample at depth is laid out sequentially left to right, back to front.

Photo of sample from ETA-05-1. Sample order is as indicated by upper photo, so the material from the bottom of the hole is at front right.

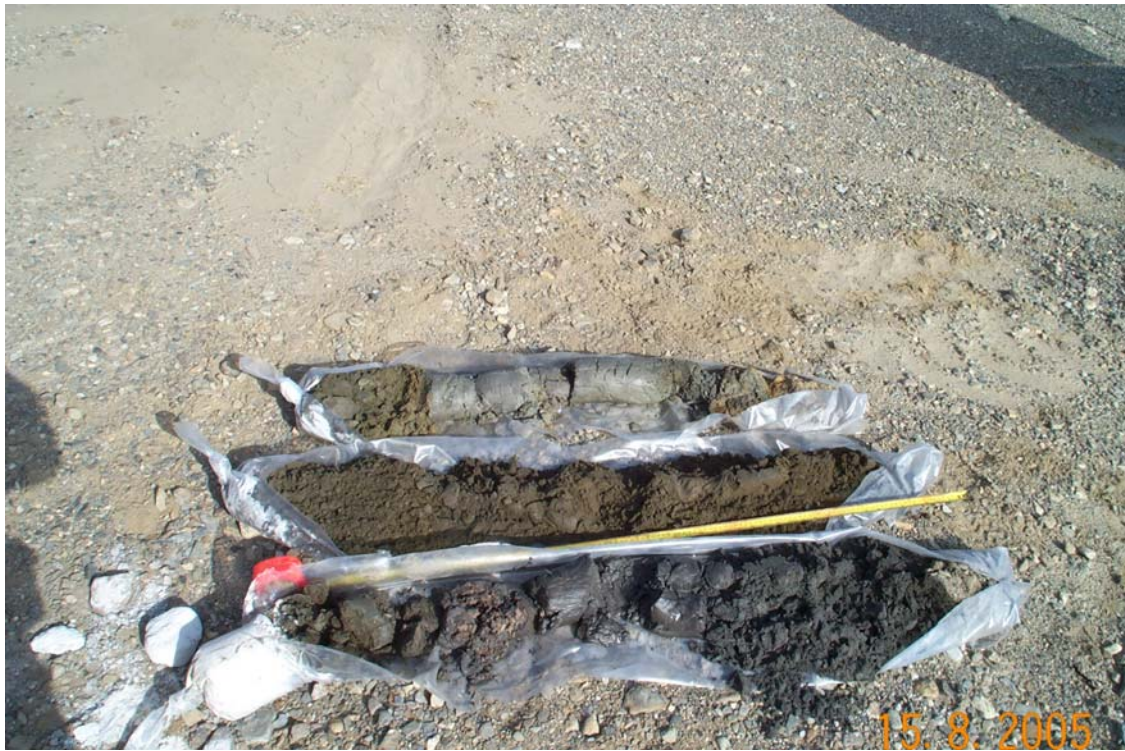
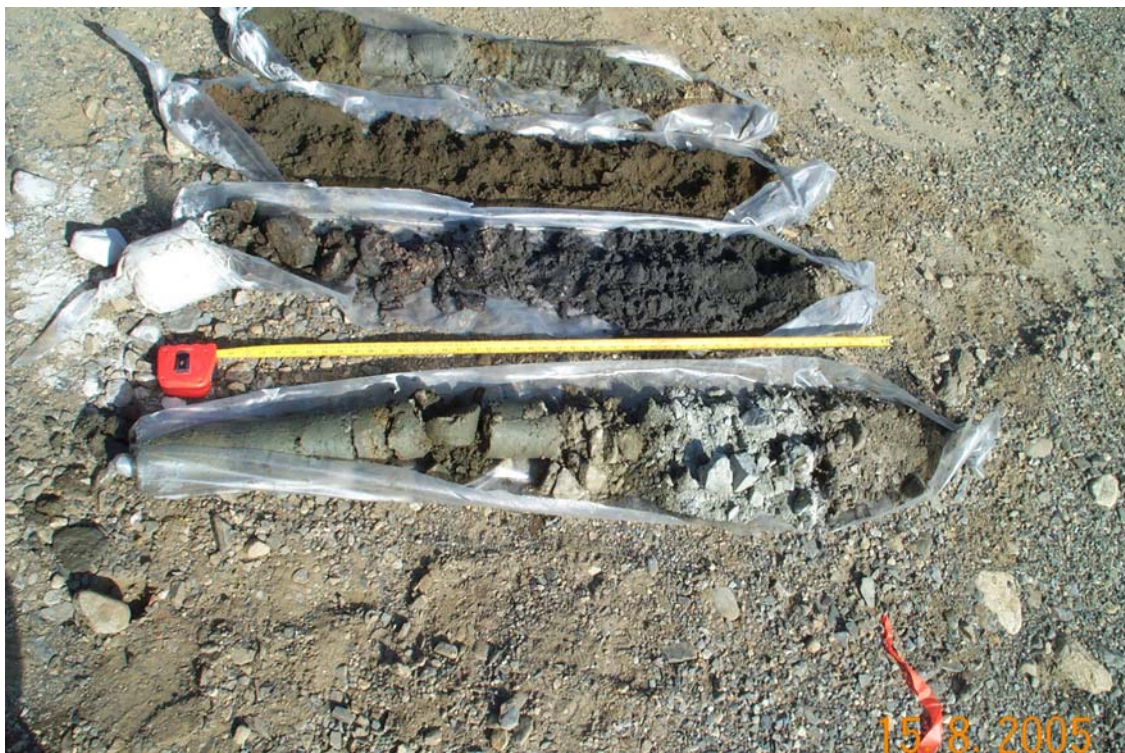
From (m)	To (m)	Description
0.00	0.30	Light brown, gravelly sand, dry, ang - subang gravel. ETA surface material.
0.30	1.20	Yellowish grey moist tailings, 95% fresh, sandy silt, vertical black and orange laminations
1.20	3.00	Yellowish brown tailings sand, very slightly moist, 5% loosely cemented no silt
3.00	4.30	Dark grey tailings sand, little to no silt, moist. Water level appeared to be at 4.0m
4.30	4.50	Mixed tailings and organics
4.50	5.50	Sandy gravel, subang - subround, light brown, moist
5.50	6.50	Olive green till, silty sandy gravel, moist. Diesel smell.
6.50	6.70	Coarse sand with gravel, no silt
6.70	7.60	Wet till, silty sandy gravel, light orangey brown

Photo of sample obtained with Sonic Drill from hole ETA-05-2. Material from top of hole is at left rear. Sample at depth is laid out sequentially left to right, back to front.

Photo of sample from ETA-05-2. Sample order is as indicated by upper photo, so the material from the bottom of the hole is at front right.

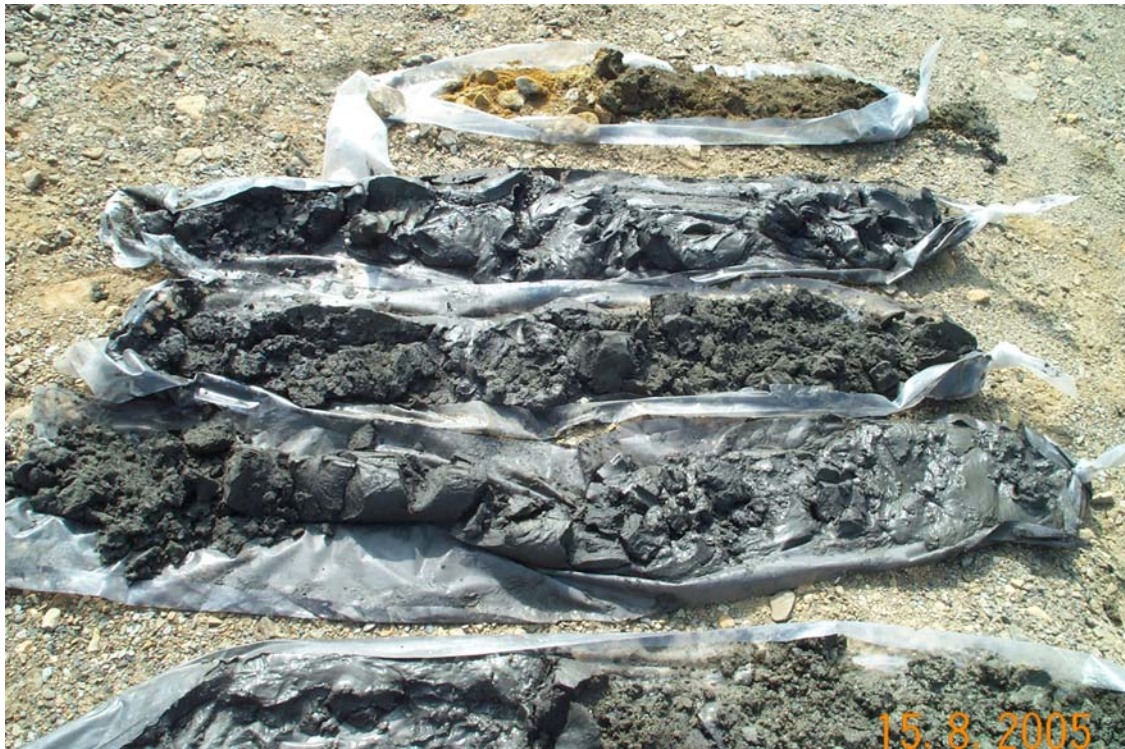
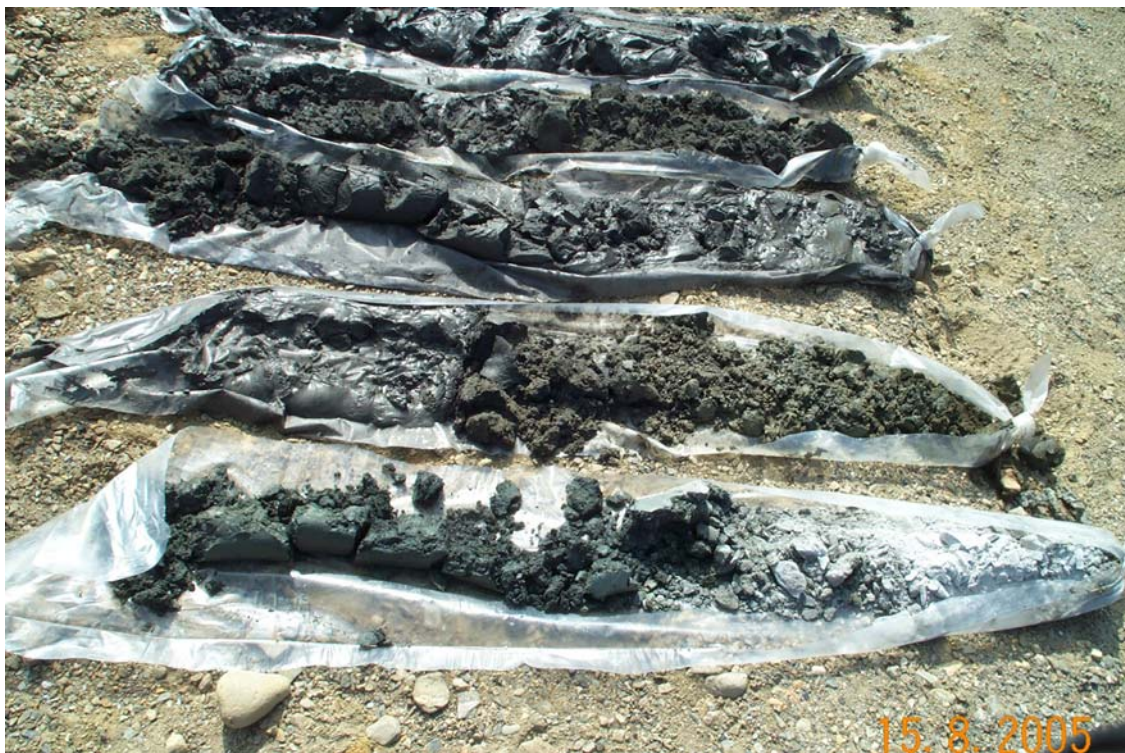
From (m)	To (m)	Description
0.00	0.40	Gravel, subangular, 40% sand, orange, dry.
0.40	1.50	Yellowish brown coarse tailings, <5% angular gravel mixed in, dry to slightly moist.
1.50	3.00	Dark grey fresh tailings, silt with 5% sand, wet.
3.00	5.25	Yellowish grey tailings sand, fresh, wet, very little silt.
5.25	6.75	Wet silt (tailings - fresh) as from 1.5 - 3m.
6.75	6.78	Fibrous peat.
6.78	7.50	Coarse sandy gravel with silt, light brown, wet. Angular to sub-rounded gravel.
7.50	8.40	Dark chlorite green, gravelly sandy silt (till), moist, angular gravel chips to 3cm diameter.
8.40	9.00	Probable bedrock: powder rock flour and chips that look like quartzite - siliceous (EOH).

Photo of sample obtained with Sonic Drill from hole ETA-05-3. Material from top of hole is at left rear. Sample at depth is laid out sequentially left to right, back to front.

Photo of sample from ETA-05-3. Sample order is as indicated by upper photo, so the material from the bottom of the hole is at front right.

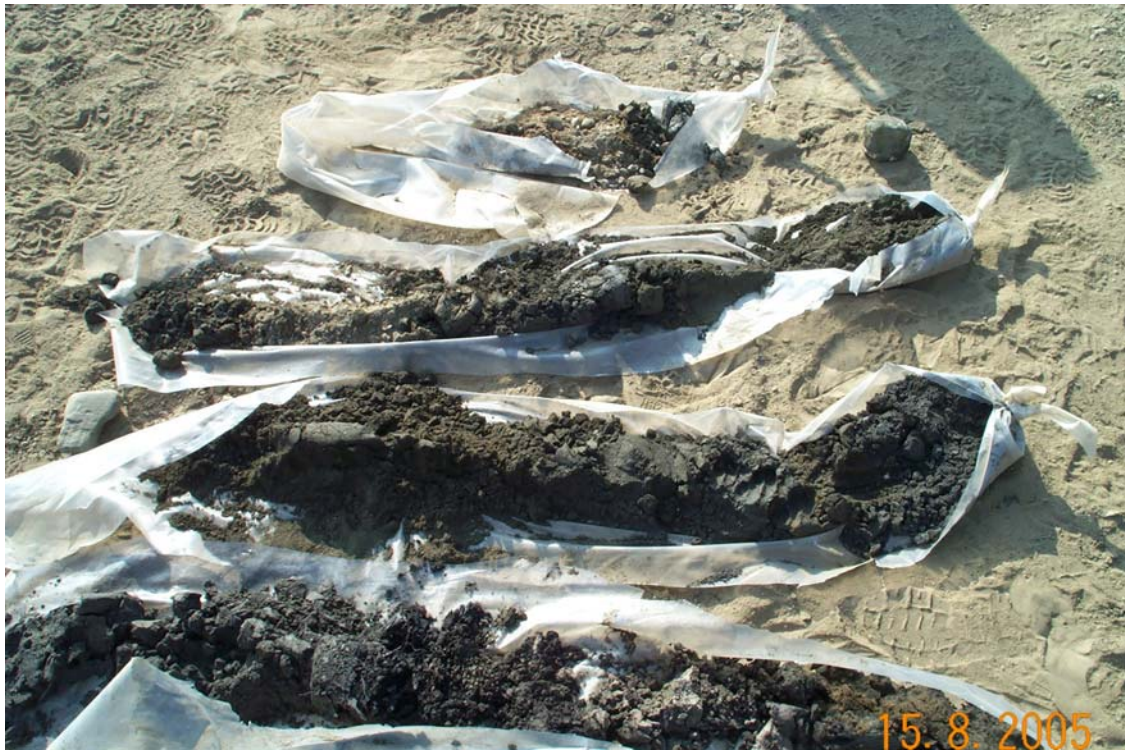
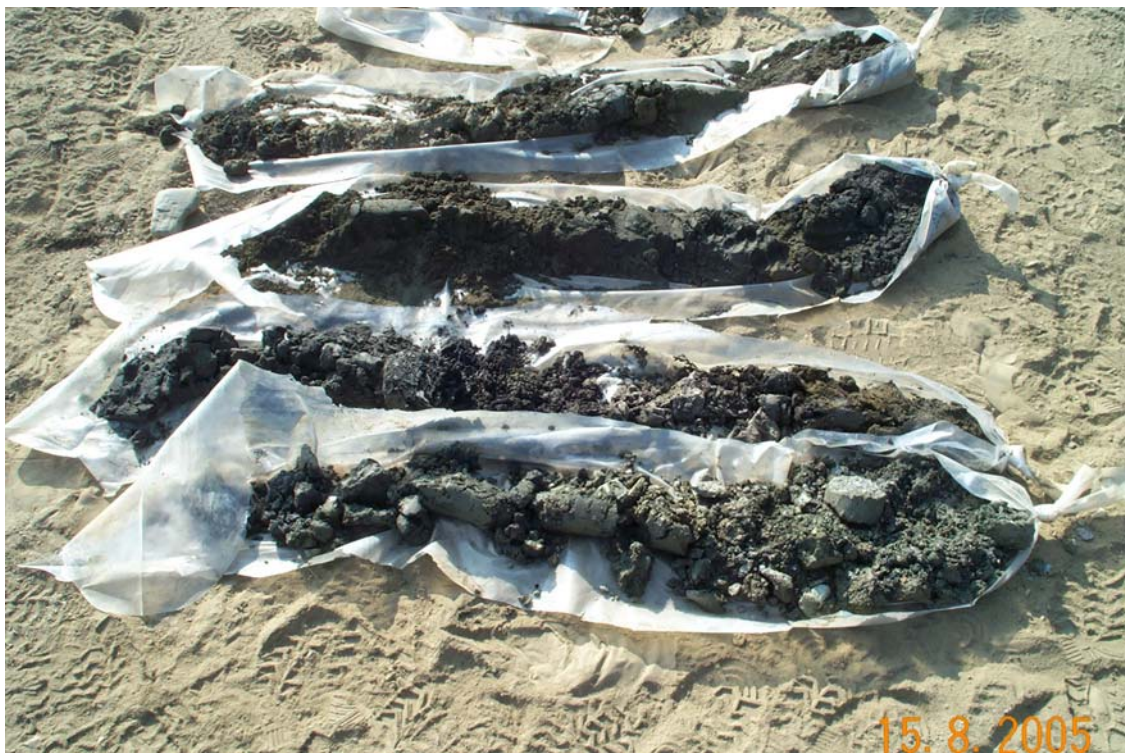
From (m)	To (m)	Description
0.00	0.50	Tan sandy gravel, subangular to subrounded, dry to slightly moist.
0.50	0.70	Yellowish brown tailings, fine sand with silt, moist. Isolated orangey-brown clasts
0.70	1.50	Moist tailings, based on drill response. Granite cobble stuck in bit at 0.7m; no sample recovery from 0.7m - 1.5m.
1.50	1.70	Moist silty fine sand tailings, yellowish brown
1.70	2.00	Tan sandy gravel as from 0m to 0.5m
2.00	3.80	Yellowish brown fine to medium sand tailings, slightly moist, little to no fines
3.80	5.20	Tailings as above - transition to yellowish grey color
5.20	5.40	Dark grey to black organics, silt, moist
5.40	6.20	Tan to light brown fine to medium sand with silt, moist
6.20	7.50	Pale green silty sandy gravel, moist (till). Particles subrounded to subang. Becomes sandier towards EOH

Photo of sample obtained with Sonic Drill from hole ETA-05-5. Material from top of hole is at left rear. Sample at depth is laid out sequentially left to right, back to front.

Photo of sample from ETA-05-5. Sample order is as indicated by upper photo, so the material from the bottom of the hole is at front right.
