Keno Hill Silver District  
Closure Planning  
Stakeholder Presentation  
Whitehorse, Yukon  
August 26, 2008

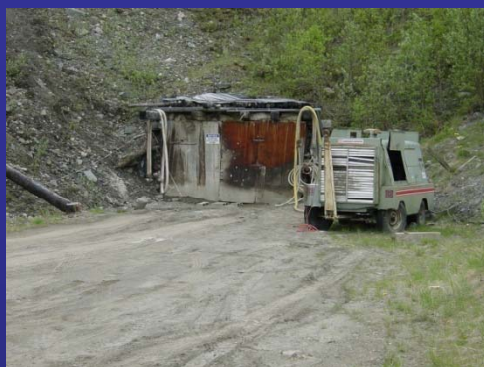
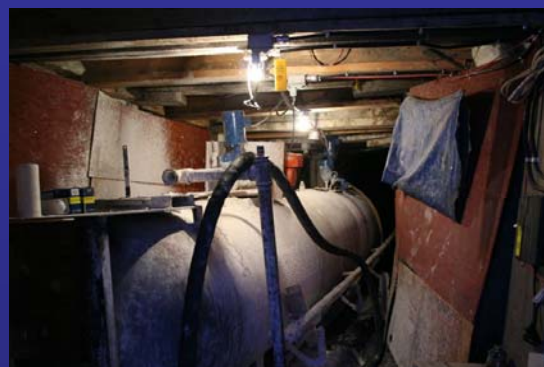
Galkeno 900 adit treatment system before improvements

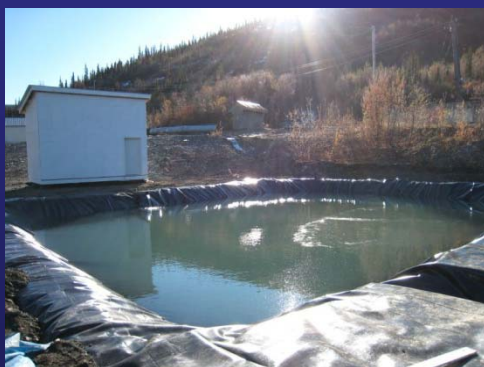
Bellekeno 600 Lined Treatment Pond and lime storage and RMT building

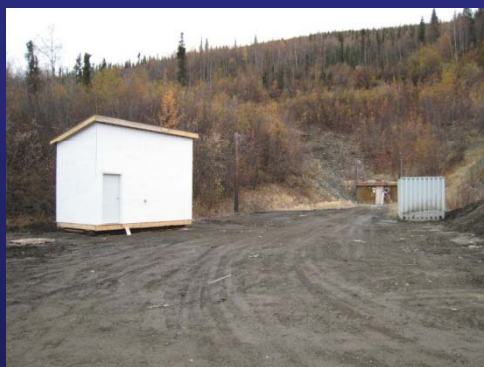
Galkeno 900 Lime storage and RMT building relocated outside of adit

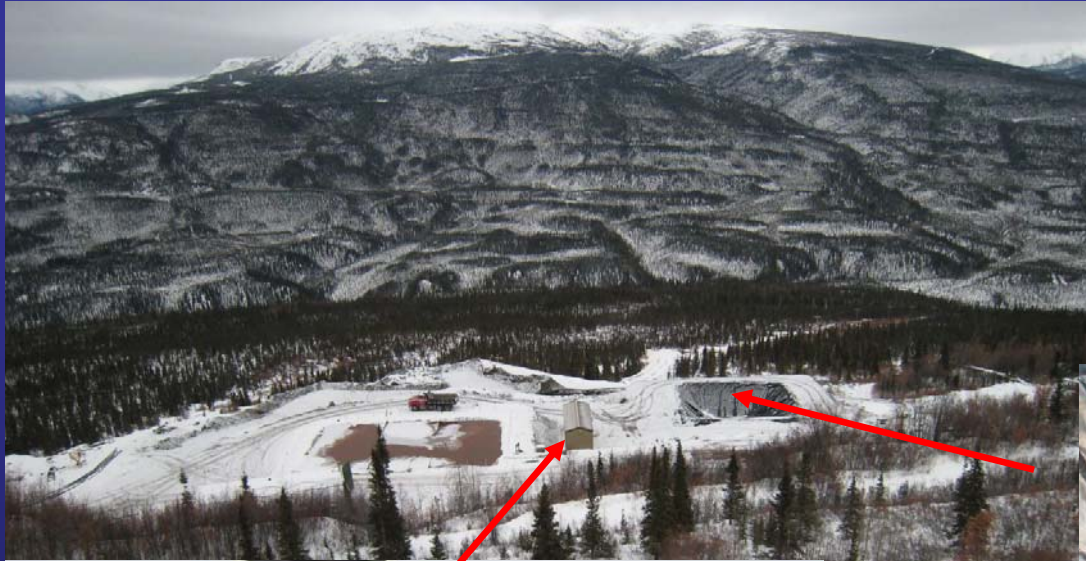
New sludge settling and holding pond

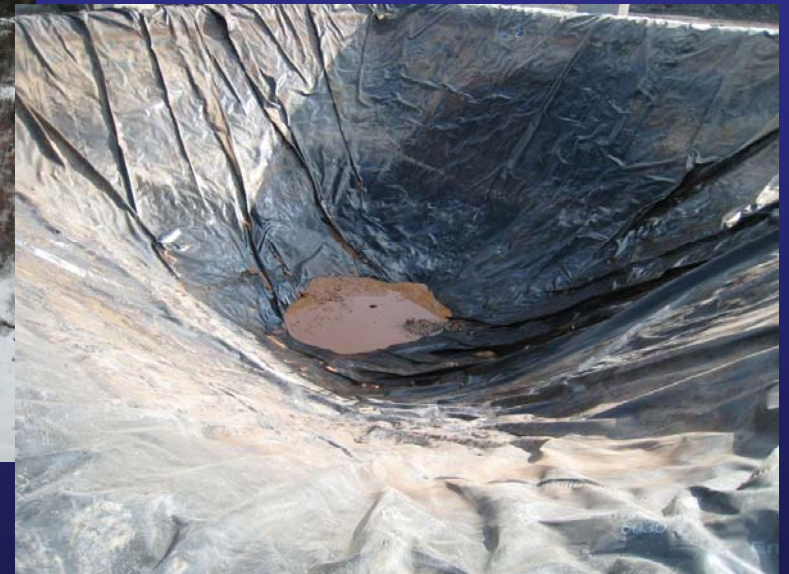
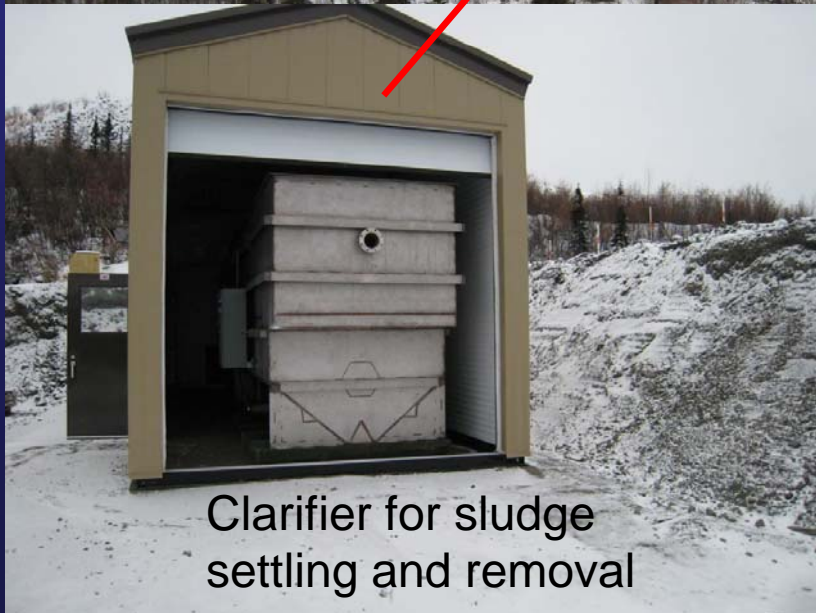
Clarifier for sludge settling and removal

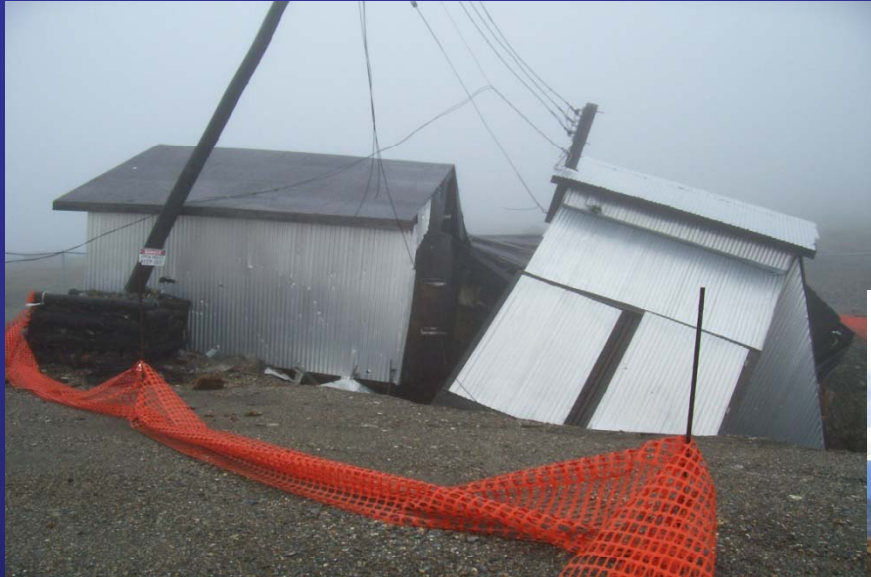
Shamrock J Raise Before

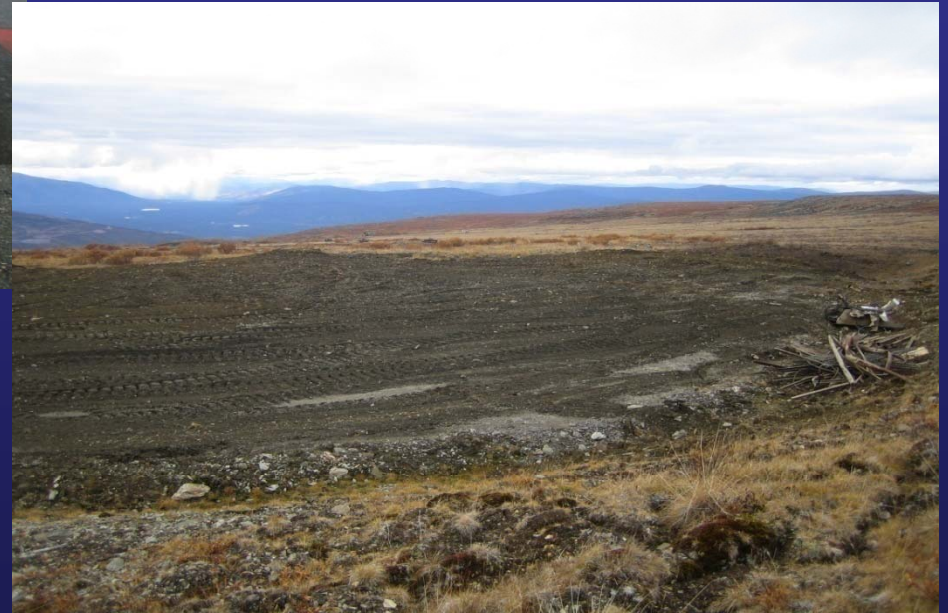
After

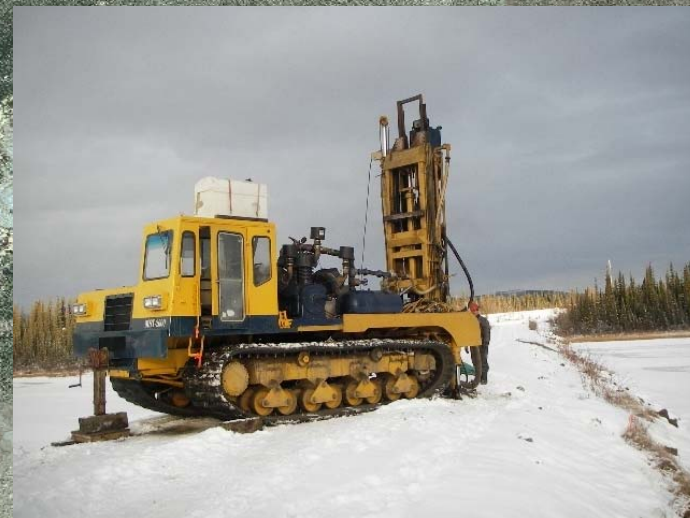
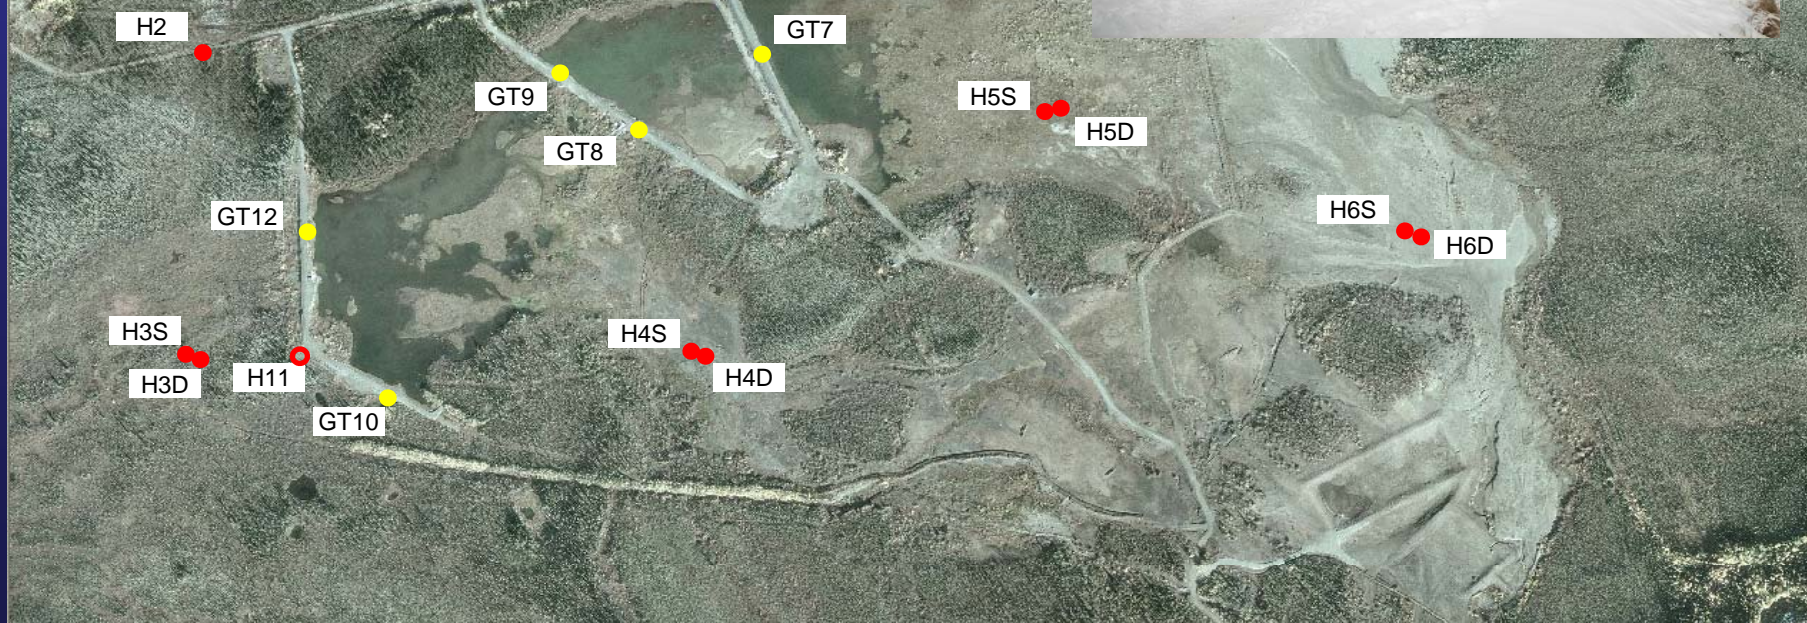
- Groundwater monitoring wells with piezometers- Oct. 2007
- Stratigraphic borehole with no installation- Oct. 2007
- Geotechnical boreholes with piezometers and thermistors- Oct. 2007

- 14 monitoring wells installed October 2007
- Water quality samples collected October 2007, May and July 2008. Sampling in September planned
- Results at Dam #3:
  - GT10 (south limb): 0.005 mg/L Zn, 327 mg/L sulphate
  - GT12 (north limb): 0.006 mg/L Zn, 250 mg/L sulphate
- Wells in tailings areas show up to 0.044 mg/L Zn in sediments below tailings, up to 900 mg/l sulphate
- Hydrogeological assessment: flux of 18 m<sup>3</sup>/day out of the VTF via groundwater flow under Dam #3
- Suggests zinc loading via groundwater is around 40 kg/yr
- Compare: surface water discharge via Dam #3 decant estimated to be about 96 m<sup>3</sup>/day (annualized)
  - At 0.1 mg/L Zn, surface discharge loading would be 3500 kg/yr
