**LIMITED PHASE 2 ENVIRONMENTAL SITE ASSESSMENT
MOUNT NANSEN MINE SITE
YUKON TERRITORY**

DRAFT REPORT (REV. 2)

File No.: K1013-002-08

July 2008

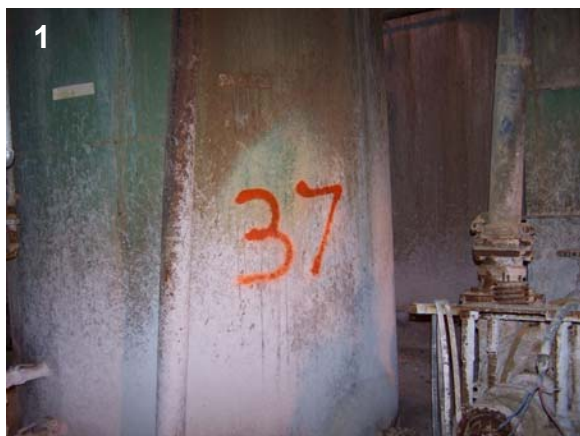
Sample location 37

45.	Mixture containing high level of cyanide	✓			1			✓	MN37	37	✓			 Cyanide mix tank (green) with 1000mm of material consisting of white powder in the tank. Sample was obtained from the top through the hopper. This sample contained the highest concentration of cyanide. Size of tank is unknown. Parameters exceeding Yukon CSR soil standards: SAD cyanide (3340/500), Ag (45/40) Parameters exceeding CCME soil quality guidelines: pH (10/8), Cyanide (3340/8.0), As (301/12), Cu (135/91), Ag (45/40) Considered a hazardous waste because the mixture is a substance containing cyanide in a concentration >100mg/kg.

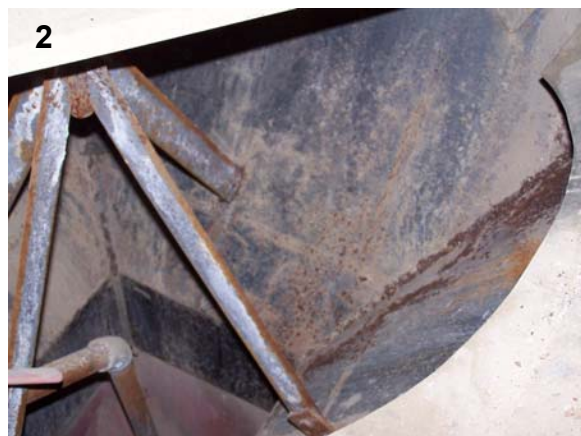
Hopper typical of some storage tanks

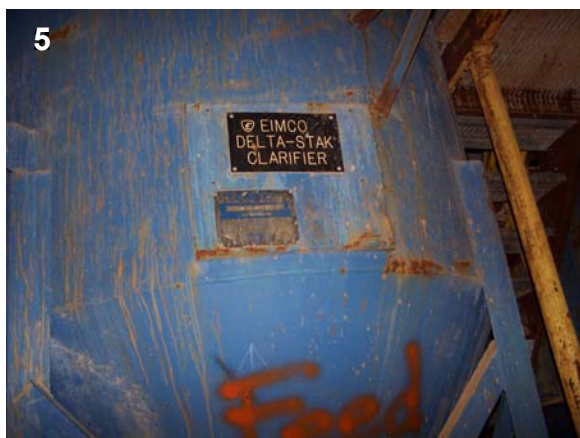
51.	Mixture containing high level of cyanide	✓			1	15	m ³	✓		MN DELTA CLARI P	42	✓		6	m ³	Blue, hopper-style, delta clarifier tank (2400mmØ narrowing to 100mmØ; cone shape had a height of 1500mm; tank height was 4000mm). 1500mm of material in the tank. Sample consisted of rusty granular material. Parameters exceeding Yukon CSR soil standards: SAD cyanide (1170/500), Sb (367/40), Mo (40.1/40), Se (14.4/10), Ag (71.7/40) Parameters exceeding CCME soil quality guidelines: Cyanide (1170/8.0), Sb (316/40), As (1660/12), Cd (44.6/22), Cu (53600/91), Mo (40.1/40), Ni (103/50), Se (14.4/3.9), Ag (71.7/40), Zn (1820/360) Considered a hazardous waste because the mixture is a substance containing cyanide in a concentration >100mg/kg.

Delta clarifier tank

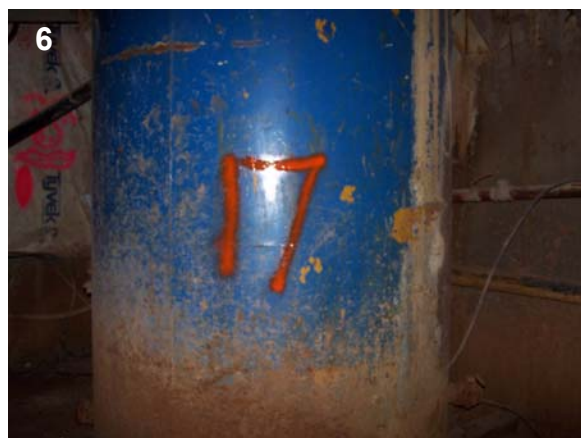
Sample location 17

20.	<i>Mixture containing high level of cyanide</i>	✓			1	5	m ³	✓		M17	17	✓	1	m ³	Parameters exceeding CCME soil quality guidelines: pH (1.85/6), Cyanide (18/8.0), As (88.3/12), Cu (216/91) Blue tank (1800mmØ x 2000mm) of unknown function. 200-450mm of white and rusty granular powder along tank bottom. Parameters exceeding Yukon CSR soil standards: Sb (414/40), Ag (98/40) Parameters exceeding CCME soil quality guidelines: Cyanide (212/8.0), Sb (414/40), As (3090/12), Cd (35.4/22), Cu (5180/91), Pb (2140/600), Ag (98/40), Zn (2640/360)

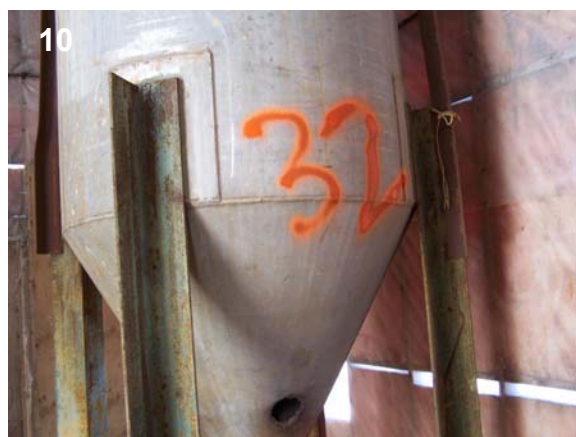
Sample location 32

37.	Mixture containing high level of cyanide	✓			1	5.4	m ³	✓	MN32	32	✓		1	m ³ Carbon column tank (1200mmØ x 4800mm) with hopper similar to tank 31. 1200mm of material in hopper; sample obtained from bottom of hopper. Parameters exceeding Yukon CSR soil standards: Mo (70.8/40), Ag (55/40) Parameters exceeding CCME soil quality guidelines: Cyanide (295/8.0), As (50.6/12), Cr (350/87), Cu (2940/91), Mo (70.8/40), Ni (281/50), Ag (55/40), Zn (440/360) Considered a hazardous waste because the mixture is a substance containing cyanide in a concentration >100mg/kg.

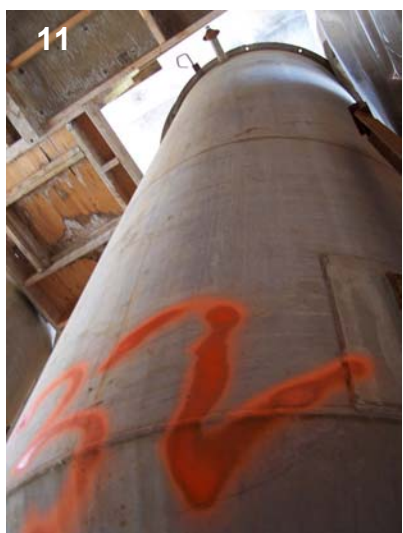
Another view of sample location 32

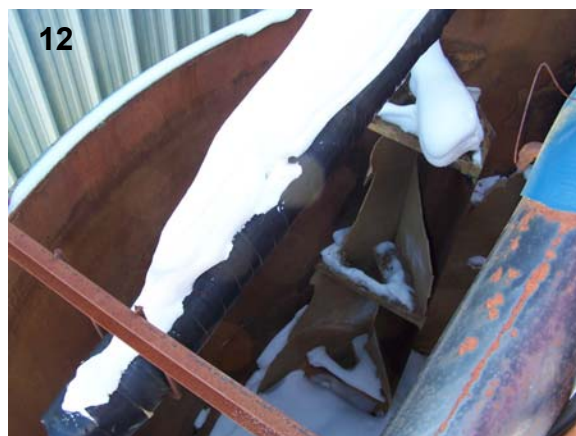
Example of sediment/scale in storage tank

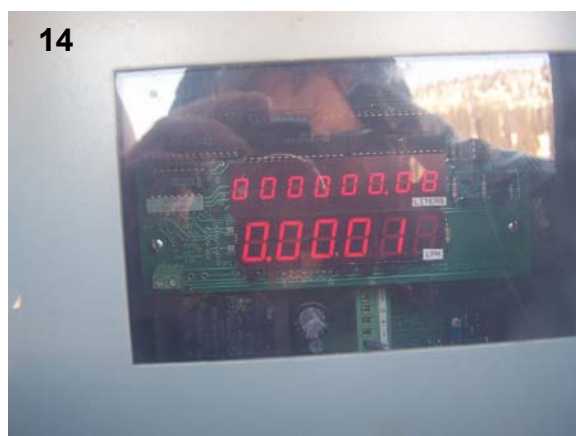
10. The sulphur dioxide (SO₂) tank at the mine site was investigated by the site assessor. The tank was in good condition, still pressurized and contained a nominal amount of gas (0.08L according to the digital display of the volume gauge). Information provided by the Client indicates that the SO₂ was used as part of the cyanide destruction system. Perhaps it is possible that the tank can still be utilized for on-site cyanide treatment, if feasible.

Volume gauge on SO₂ tank

Alternatively, if the Client intends to remove the tank from the site, it is recommended that a qualified mechanical tradesperson is retained to determine the volume of gas in the tank and to reclaim the contents of the tank in a responsible manner. The mechanical professional may also be able to evaluate the tank for potential resale. If the Yukon Government intends to decommission the tank, a qualified contractor should be retained to responsibly dispose of the tank. Tanks are generally disposed at a licensed metal salvage facility.

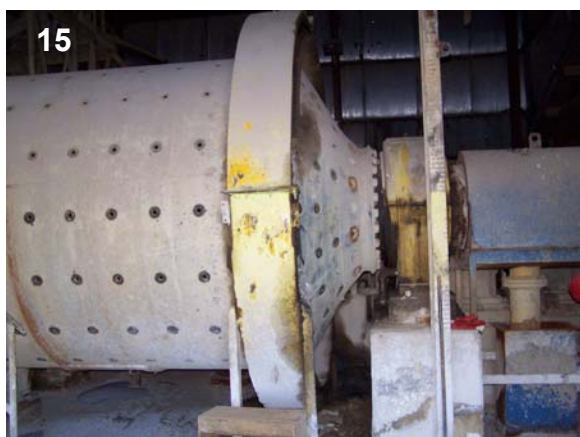
Chipping and flaking interior paint was observed in the mill complex. Paint chip samples were obtained from sampling locations 44, 45, 46, 47 & 48. Four of the samples (obtained from locations 45, 46, 47 & 48) were tested on site with a field test kit, which is a reliable indicator of the presence or absence of lead, with each result being negative for lead content. Since the site assessors did not have an additional test unit to field test the paint chip sample obtained from the ball mill, this paint chip sample was submitted to an accredited laboratory to be tested for lead. The analytical analysis concluded that the sample obtained from the ball mill had a lead concentration (6820ppm) that exceeded the recommended United States Environmental Protection Agency (EPA) lead-based paint guideline (747-K-00-001, 2000) of 5000ppm or 0.5% by weight. Therefore, based upon the guideline established by the EPA, the sample submitted for laboratory analysis did contain lead-based paint.

The results of the laboratory analysis also confirmed the presence of lead-based paint in the area of the ball mill. Lead dust in lead-based paints is released when it is disturbed or when it is chipping and flaking. The lead that is released during disturbance facilitates the ingestion of this toxic metal into the body and can cause serious health conditions. Lead poisoning can cause anemia and it can also damage the brain and nervous system, resulting in learning disabilities. The risks are greater for children than for adults, because children's growing bodies are able to absorb lead more easily. Even small amounts of dust containing lead are dangerous to infants and children. Lead taken in by mothers-to-be can also pose a danger to the health of unborn children.

Sampling of paint chips from ball mill

Lead-based paint in buildings is a serious health hazard when it is chipping or flaking, or if it is within the reach of children who might chew on it. The Client has confirmed that the ball mills are intended for salvage and sale. Therefore, it is recommended that the lead-based paint in the area of the ball mill is removed following very specific guidelines, as detailed in the following:

- Seal the work area(s)
- Workers should wear protective clothing and shoes as well as respirators designed to avoid inhaling (high efficiency particulate absorption (HEPA) respirators)
- Workers are not allowed to eat, drink or smoke in the work area
- Standard dry sanding and dry scraping methods create airborne dust and are not acceptable. Remove loose and flaking paint by wet methods such as spraying the surface with water, gently scraping off the loose paint, and collecting debris (on a disposable drop cloth).

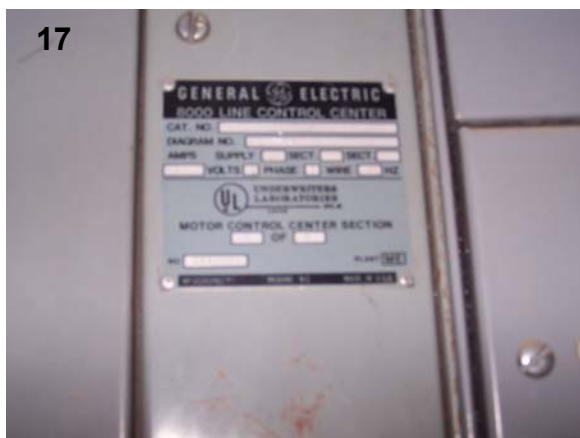
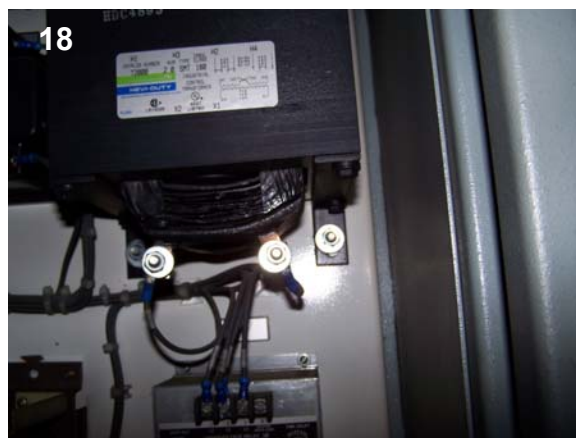
The care and maintenance supervisor, Mr. Bruce Wheeler, confirmed that the new electrical equipment was installed at the mine site in the mid-1990s, which included the sodium lighting that replaced the fluorescent light fixtures. He also indicated that transformers were removed by an environmental contractor in 2007 on behalf of the Yukon Government. Fluorescent lighting was found in the 2nd floor bathroom and shop; however, this lighting is not likely to contain PCBs since it was installed in the late 1980s; PCB use in ballasts was phased out circa 1980.

Electrical manufacturer's data panel

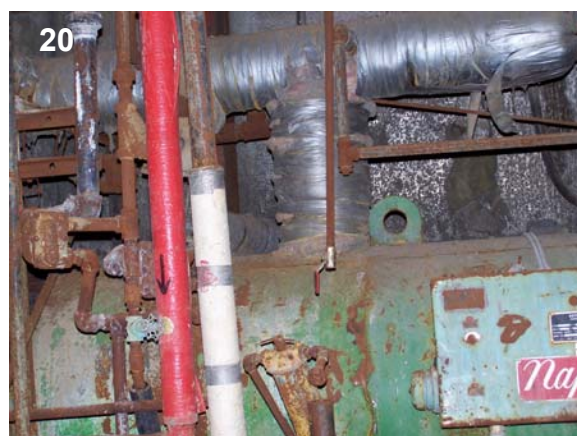
Piping insulation tested for asbestos fibres

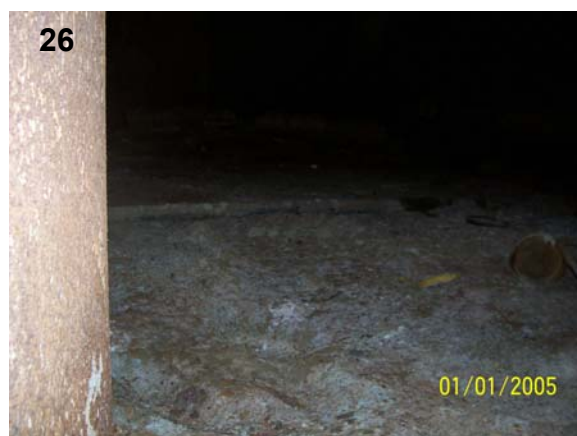
Example of sediment on floor of mill complex
