Memo

Subject: Mine Safety Issues

While researching Mayo District mine safety concerns I found that several serious areas were identified in the spring of 1999 in a report for our Department. The information was contained in the Minfiles.

BELLEKENO (#22)
(MINFILE# 105M 001y)

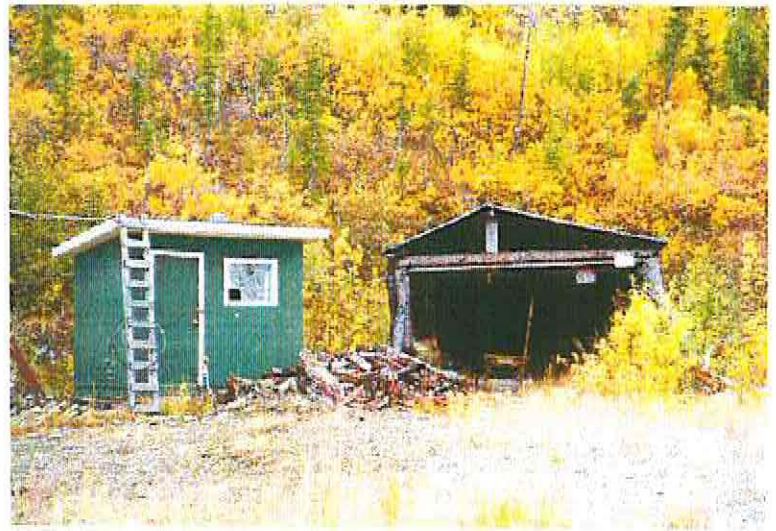
Bellekeno 200 level adit (photo 22-7)

Condition: The portal is constructed of logs and planks. It has no foundation or roofing material other than the planks. It is in fair condition and continues to be maintained by UKH Mine.

Accessibility: The adit entrance is left open to allow ventilation and provide an escape route.

Photo 22-7: View of Bellekeno 200 level adit entrance and green wooden electrical shed. (Azimuth 190°)

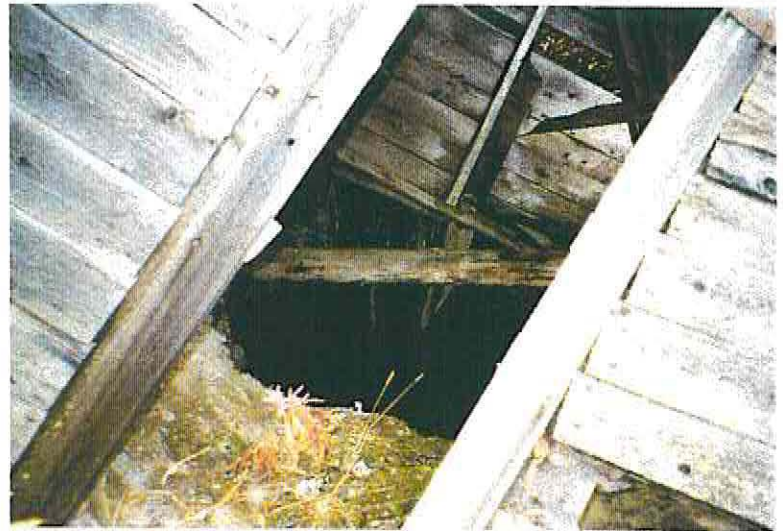
Condition: Both the adit portal and the shaft house have collapsed.

Photo 22-11: Collapsed structure enclosing shaft across Sourdough Hill Road from Bellekeno 100 level adit

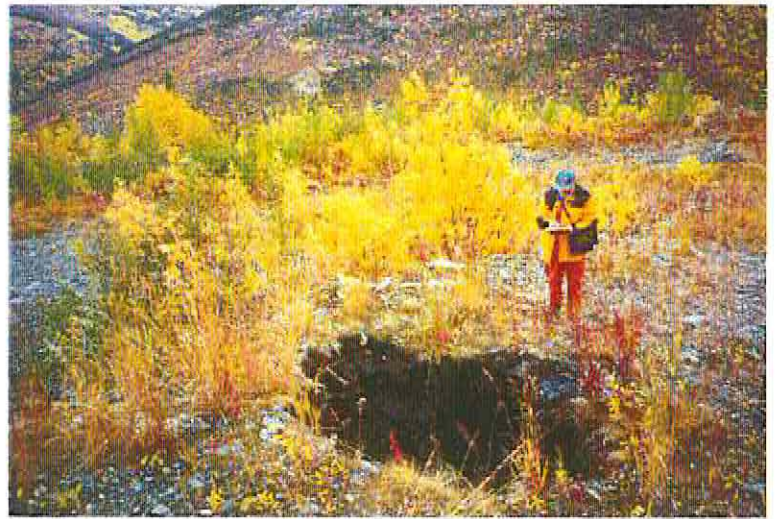
Eureka Shaft I (photo 22-15 and 22-16)

Shaft I is the most obvious because it lies in the middle of a trail leading off of Sourdough Hill Road. It is connected to an adjacent open stope that has broken through to the surface (see Figure 5).

Condition: The shaft and stope remain unstable and could be prone to continued collapse.

Photo 22-15: Eureka Shaft 1 located in the middle of a trail off of Sourdough Hill Road.

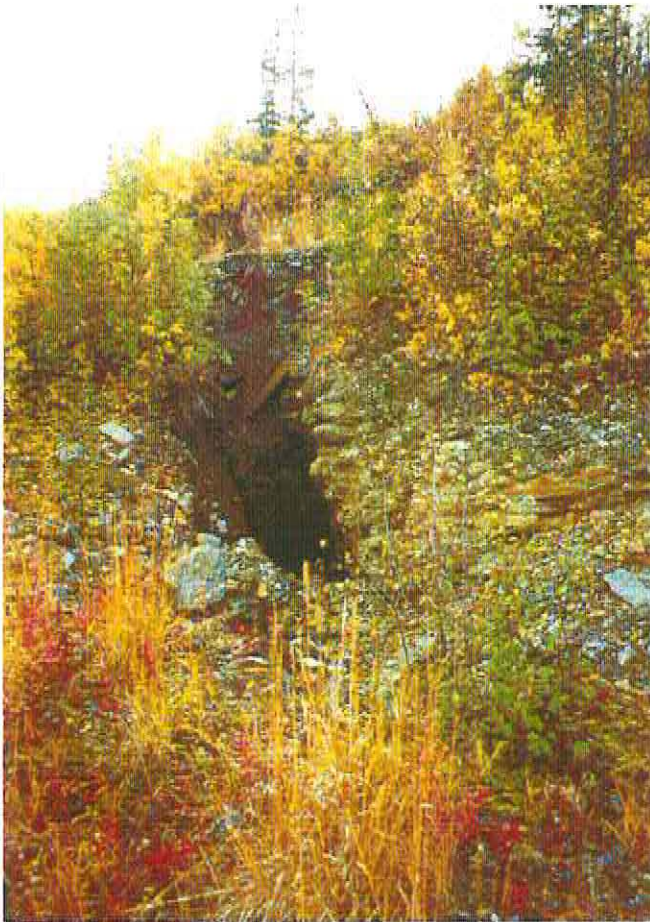
Photo 22-16: Stope broken through to surface just below Eureka Shaft 1.

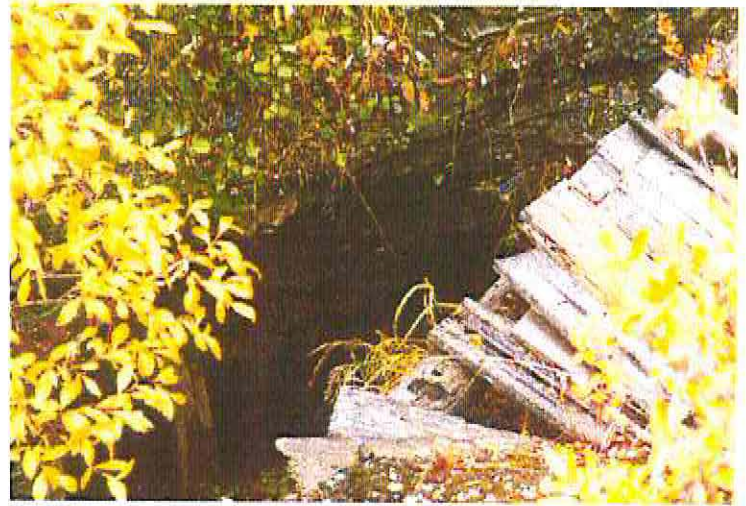
Photo 22-18: Partially collapsed shaft (Eureka Shaft 3) located about 37 m south of Eureka Shaft 1.

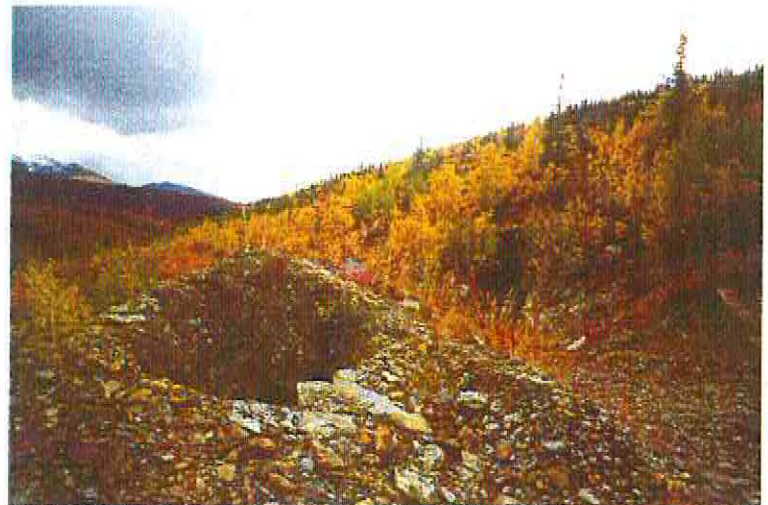
Photo 22-17: Timbered raise (Eureka Raise 1). Open stope can be seen in background.

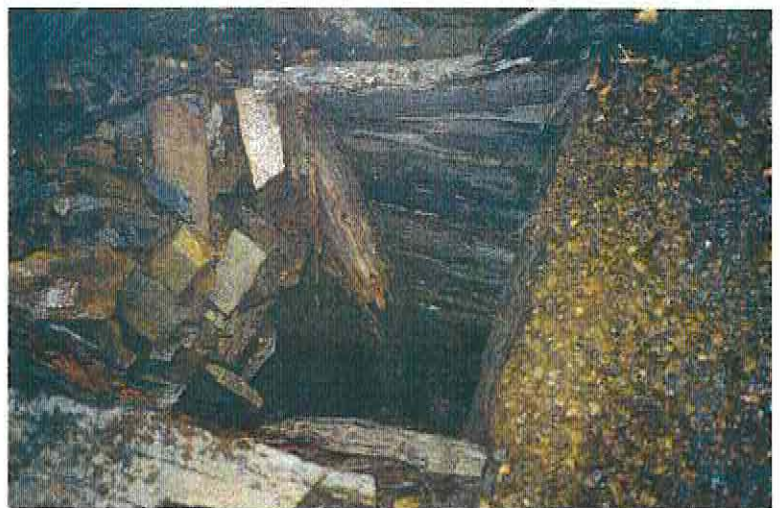
Shaft #4 (photo 49-3)

Shaft #4 is located 80m northwest of Shaft #3, 70m northeast of the adit. The shaft measures 1.5m² and is still open to about 3m down. The walls are supported with log cribbing. Three sides of the walls are still in good repair, the fourth wall is beginning to rot at the top and has partially collapsed.

Photo 49-3 : Vanguard. Shaft #4 is still open and in fairly good condition.

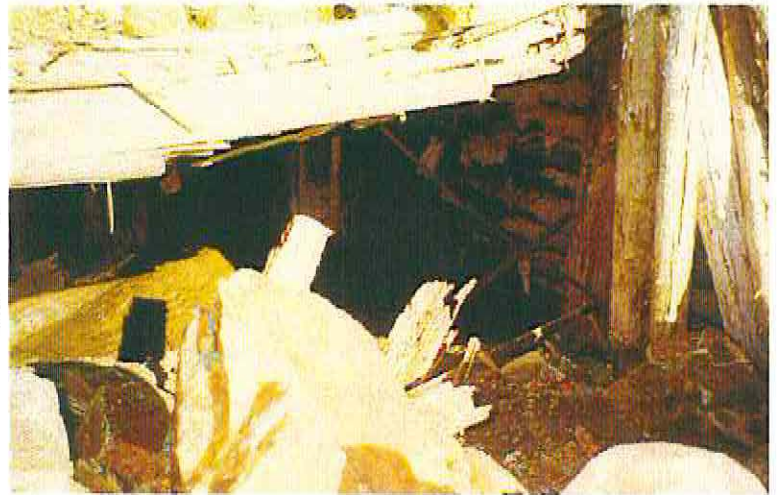
Condition : Partially collapsed, mostly blocked by open pit waste and debris

Accessibility : Access is possible but difficult, risk of collapse is evident.

Photo 28-3: Partially open adit entrance.

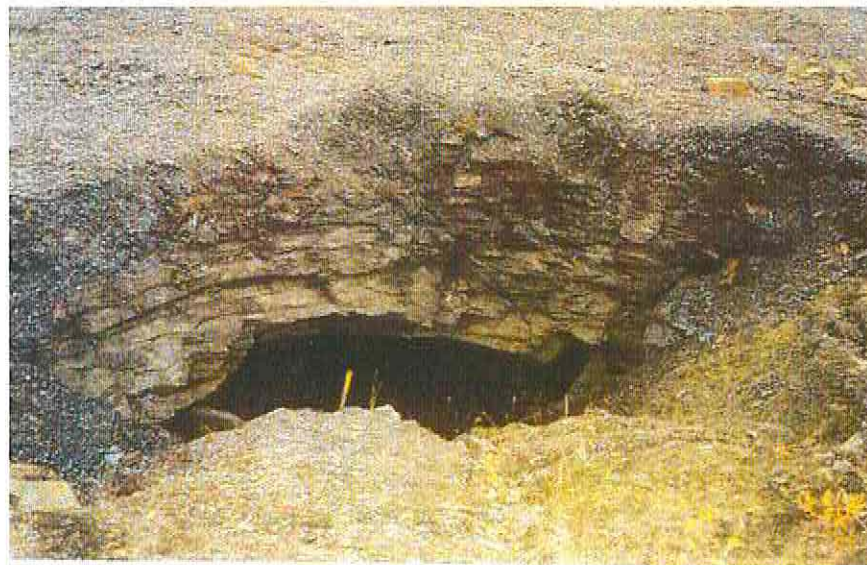
Condition: The site geology consists of near flat lying quartzites with phyllitic partings that have fallen off in slabs into the abandoned workings below, forming the cavity. Slabs of rock up to 50kg are loose in the opening and pose a serious risk to persons entering. No signs have been posted identifying the hazard.

Photo 21-3: Open decline from recent (late 1980's) work. Note hazard from loose slabs in the roof resulting from horizontal foliation structures. (Azimuth 170°)

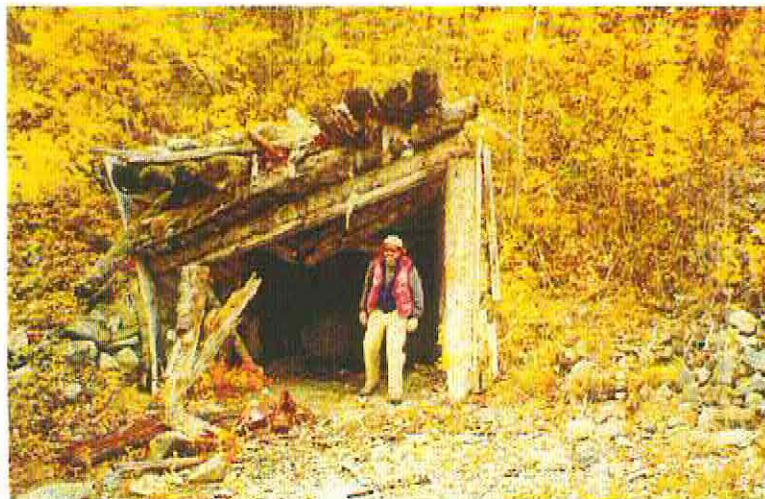
Condition: Poor condition, could collapse at any time.

Photo 58-2: Open adit.

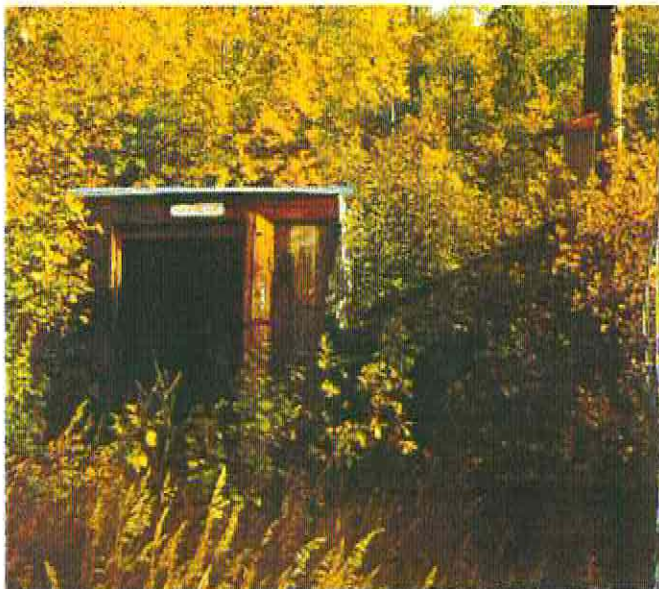
Photo 7-10: Adit to the No Cash 100 level. Note the tramway in the background,

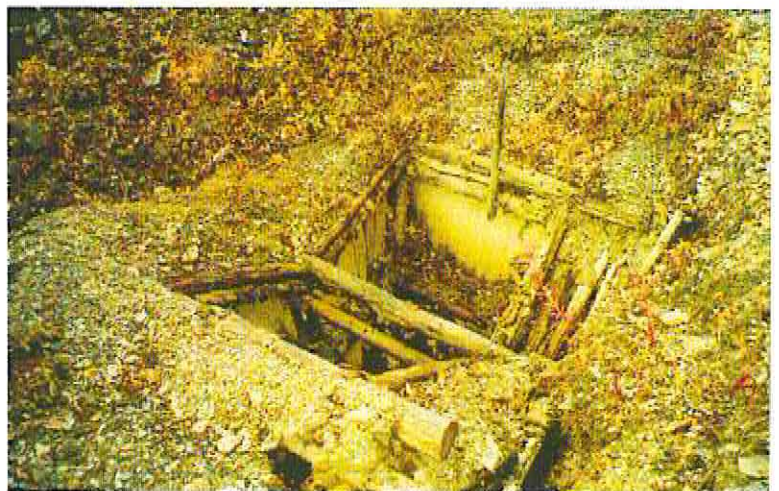
Dimensions: 2.5 m x 2.5 m - filled to within 2 metres of trench floor

Condition: the shaft has either been filled or it has collapsed

Photo 52-3: View of Shaft 1 at Windy and Casy workings.

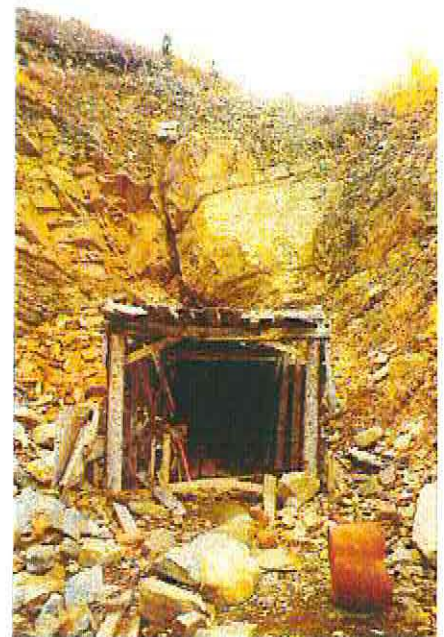
Condition: appears stable

Photo 53-1: View of Adit 1 at Maybrun site. (AZ 234)

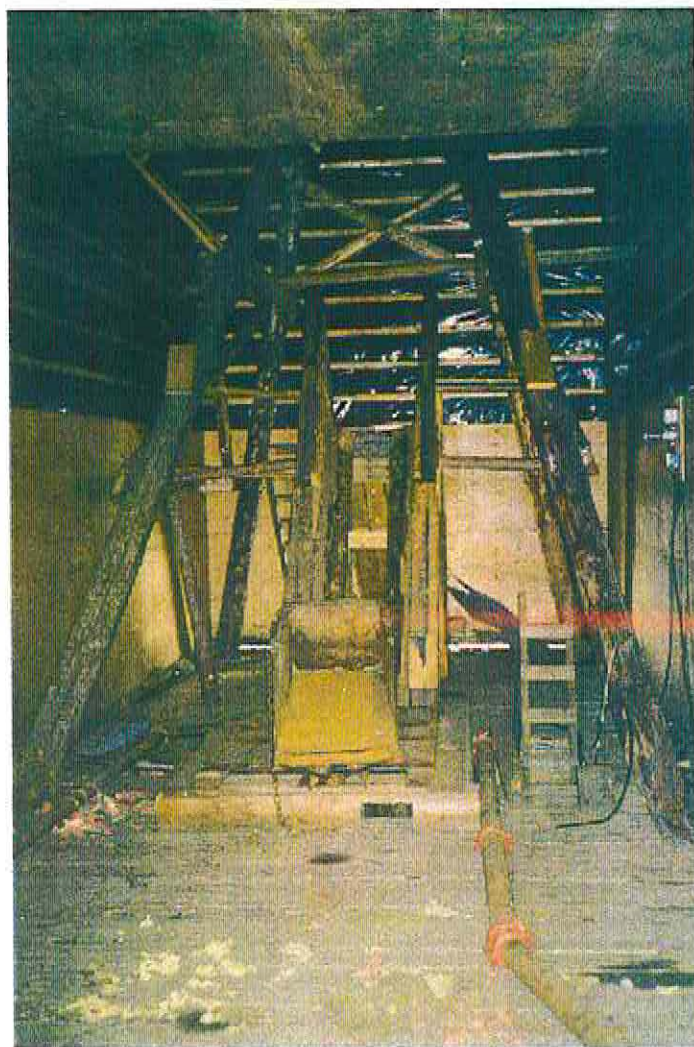
Condition: Sound, safe.

Accessibility: The shaft is enclosed in building 26-A, although access is easily gained through the unsealed ore dump. Inside, the manway and ladders are open and easily accessed.

Photo 26-7: Interior of Lucky Queen headframe building (Bldg. 26-A) showing open manway and boarded shaft opening.

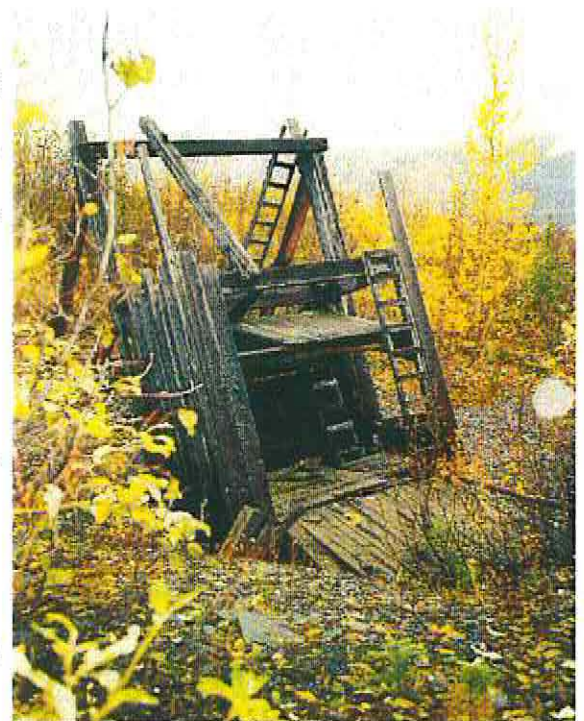
2"x 4" timbers supports the walls at the entrance to the shaft.

Condition: The headframe and the retaining walls are weathered but are still in fair condition.

Photo 27-1: Shaft headframe (Bldg. 27-1), (Azimuth 340°)

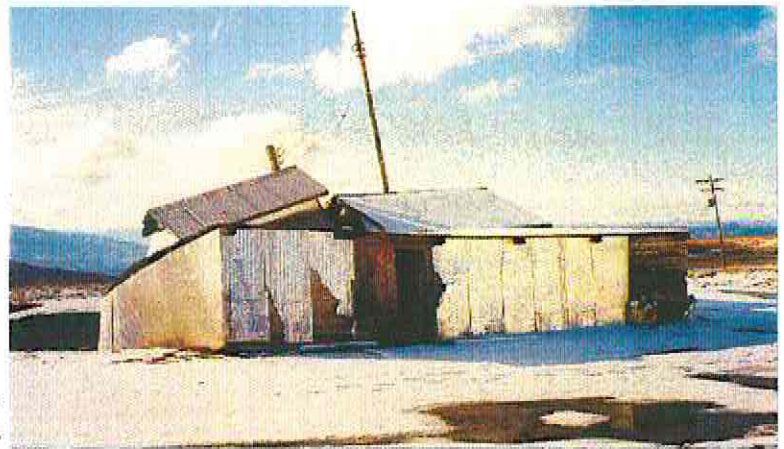
Condition: The ground around the raise and building covering it are unstable and collapsing. An area of approximately 7m by 10 m has collapsed.

Condition: Half the building is unstable and has partially collapsed into the underground workings below. Non-

Photo 36-2 : Keno No.9 Shamrock J18 Vein Raise Building (36-A). Note collapse of building into falling underground workings and fencing around opening. Also, transformer on power pole in background. (Azimuth 290o).

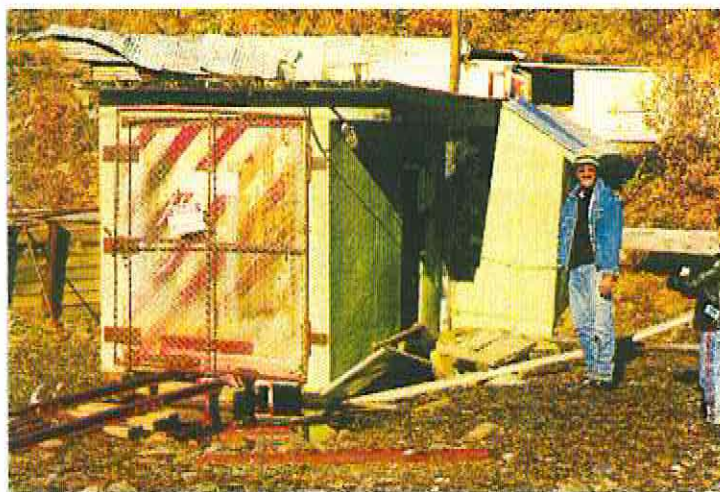
Support: railway tie wood supports along inner portal walls in relatively good condition, but beginning to rot.

Condition: structure appears to be stable

Accessibility: Inaccessible. A locked fence blocks the main adit entrance, but entry can be gained from a open side door. A large ice plug blocks a majority of the portal opening.

Photo 32-2 : Keno 700, Mine adit shed (building 7) looking N.W.

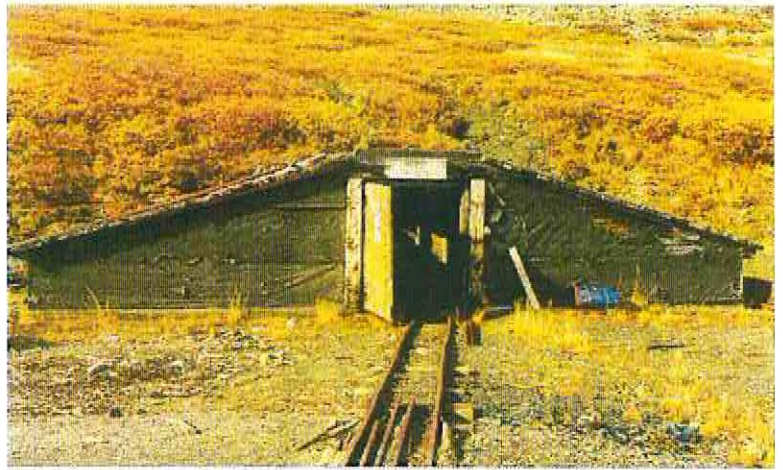
Keno 200 Adit (Photo 32-3)

Description: Portal is enclosed in plywood housing with tar paper siding and roofing, a portion of which has blown off the top. A rail car was found on the track within the shack in front of the portal opening. Some equipment, mostly ties and metal parts, was also stored along the inside of the shack.

Condition: stable near portal entrance; however, some wall collapse observed 3 m into adit (see Photo 32-4)

Photo 32.3 : Keno 200. Adit shack looking W.

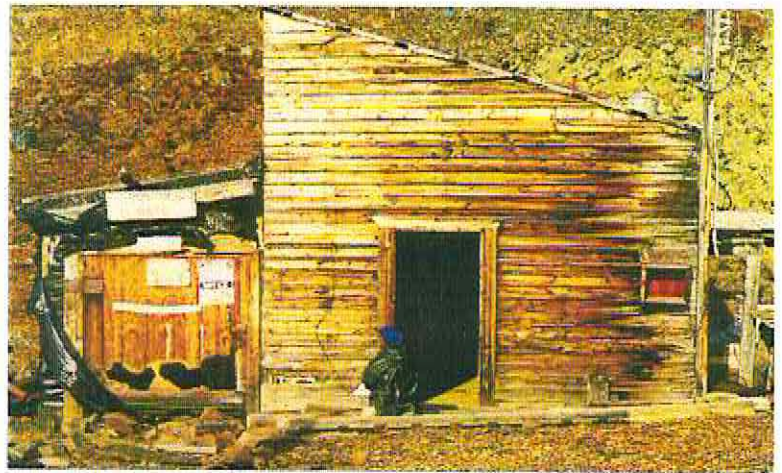
Comstock 150 Adit (Photos 32-5, 32-6)

Condition: appears to be stable near portal entrance, shack is shifting but solid

Accessibiliy: Access door to the adit has been sealed but partially damaged (see Photo 32-5).

Photo 32-5 : Comstock-Keno 150. Adit Shack (looking N.).

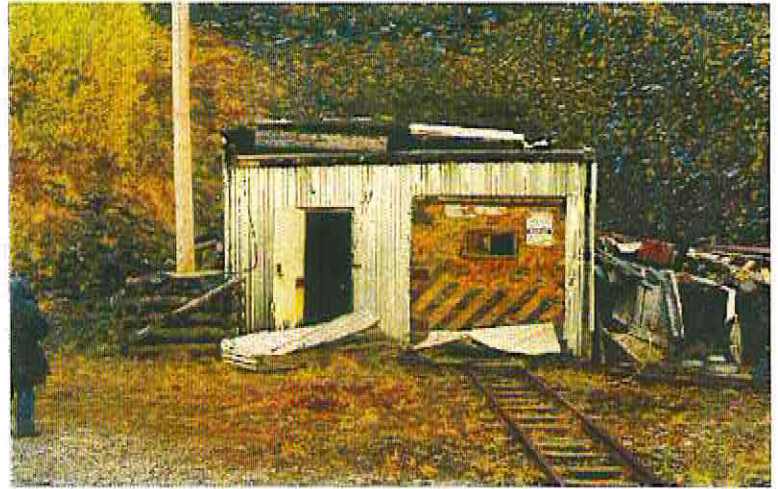
Comstock 200 Adit - (Photo 32-7)

Support : plywood and log reinforced walls at portal entrance, still in good condition

Condition: appears to be stable near portal entrance, shack is shifting but solid

Accessibility: The main access door to the adit has been locked; however, access can be gained through a second smaller door on the west side of the adit shack.

Photo 32-7 : Comstock-Keno 200. Adit entrance (looking N.E.)

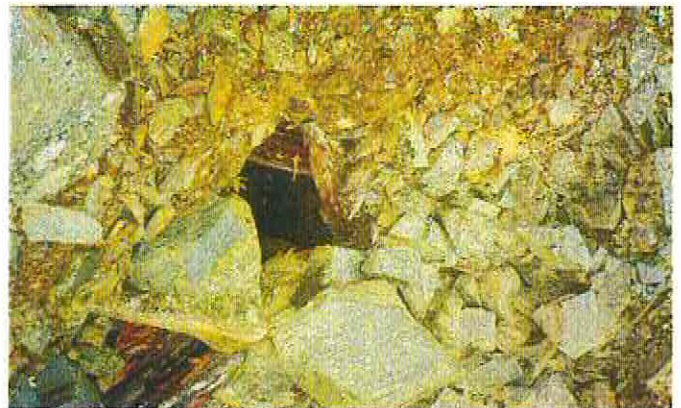
Condition: Adits are collapsed.

Accessibility: Northernmost adit is partially blocked but still accessible. Other adits are blocked with waste rock.

Photo 29-2: Northern partly collapsed adit, upper workings.

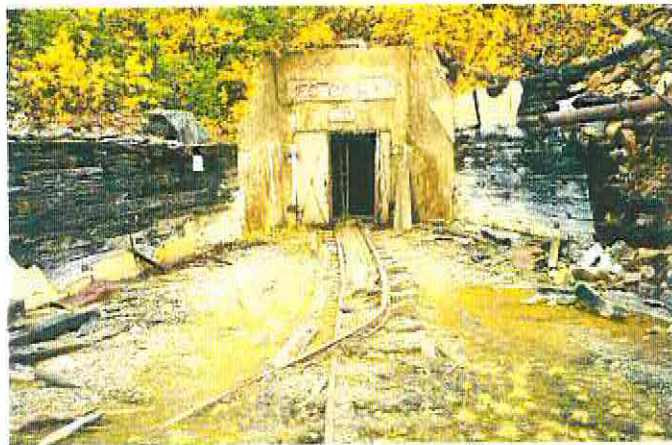
Condition: The adit appears to be stable but could only see to about 5 m.

Supports: Cement portal with wood retaining walls and metal doors. Adit entrance is constructed with wooden beams. There is a metal column has been placed about 1 m into adit, in the center, to support the beams.

Accessibility: The lock is off the doors. Approximately 3 m into the adit, most of the adit is blocked with rock debris to about 0.5 m of the roof.

Photo 9-1. Hector Adit, showing the buttressing, old rails and debris.

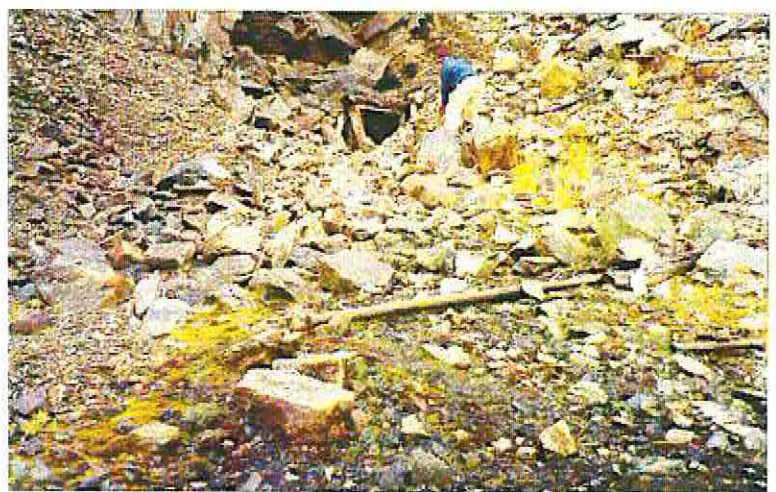
Condition: The adit is in fair condition.

Photo 44-1 : Gold Queen. Entrance to the Gold Queen Adit. (Azimuth 190 °)

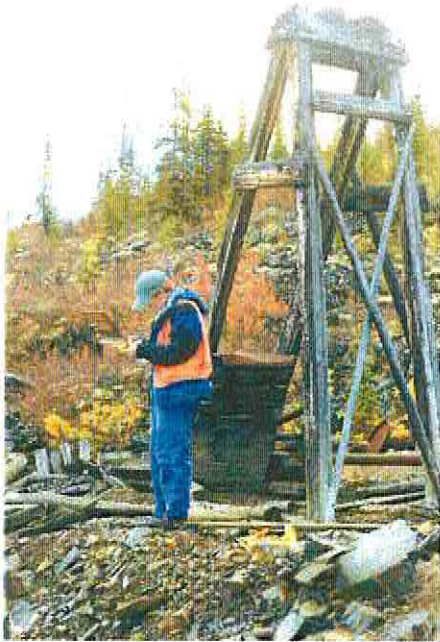
Condition: The wood of which the shaft is constructed is rotting.

Support: There is a wooden A-frame above the shaft that likely once held a pulley. The wooden supports around the shaft are in poor condition, and the ground to the NNE of the shaft is subsiding due to collapsing workings below (Photo 11-2).

Photo 11-1. McLeod Shaft, looking southeast.

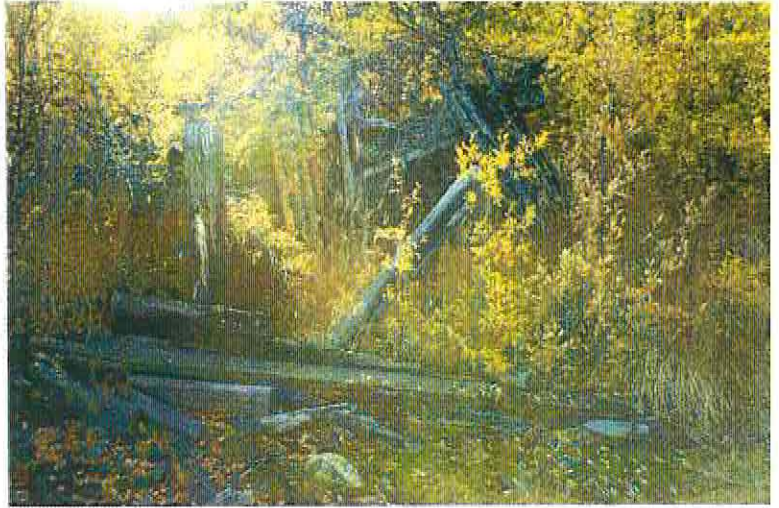
Condition: The portal is in poor condition.

Support : The wooden supports of the portal have mostly fallen.

Accessibility : The portal is accessible but appears unsafe. It was not entered to determine the depth.

Photo 11-5. Galkeno 200 level adit. Portal is open but is unsafe. The timbers of the portal are collapsing.

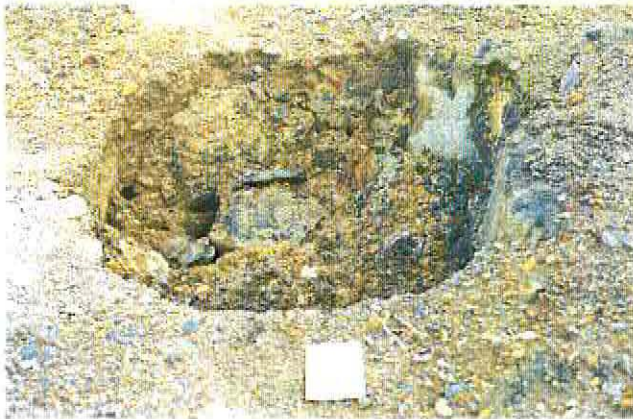
Photo 11-2. Subsidence over adit workings, near the McLeod Shaft. The collapsed area measures approximately one meter across.

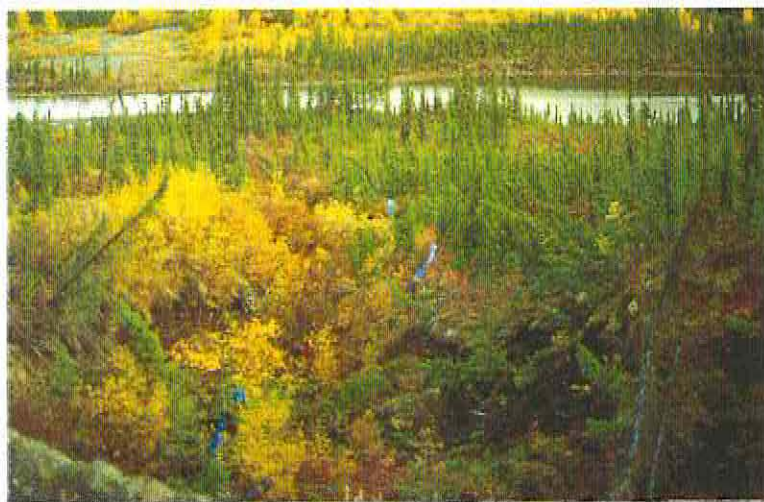
Piping : A steel pipe 5m in length connects the two settling ponds. A collapsible, blue plastic pipe had been installed to direct the outflow of the water from settling pond number #2 to Christal Lake; however, only the **first** 10m of this pipe is currently in use, directing water flow to the creek gully. The remainder of the piping has been disconnected but remains in place.

Photo 12-10: Blue piping heading to Christal Lake, stream gully roughly follows piping route. (Azimuth 100°)

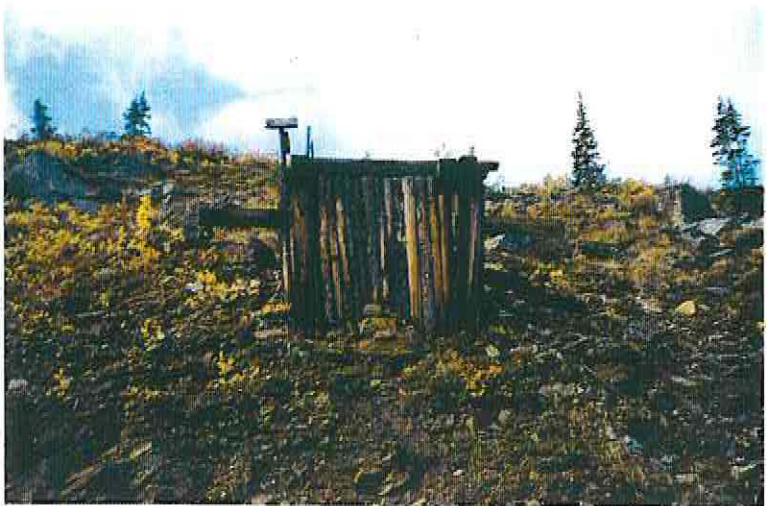
Condition: The ground around the shaft appears stable.

Accessibility: The shaft is blocked 3m below the collar by collapsed rock and cannot be accessed beyond that point.

Photo 42-1 : Faith. Faith timber shaft cover building (Building 42-B). (Azimuth 200°)

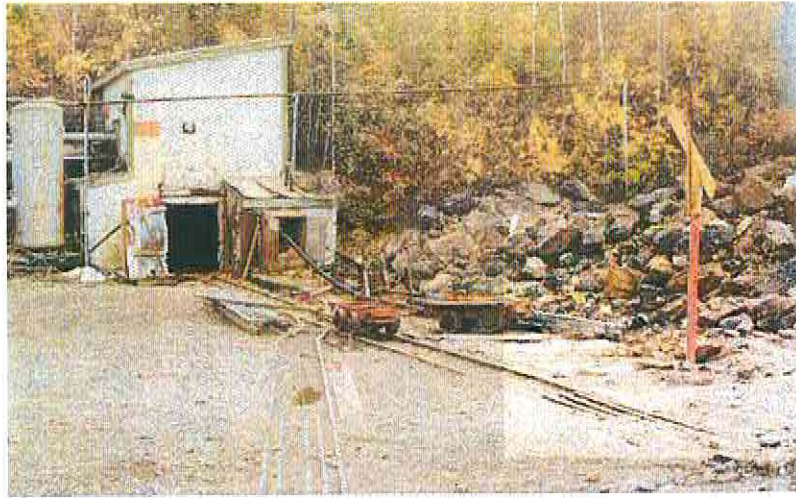
Photo 3-1 : Elsa Mine. Elsa 400 Level Portal. Looking southeast. Low grade open pit ore pile to the right of the tracks.

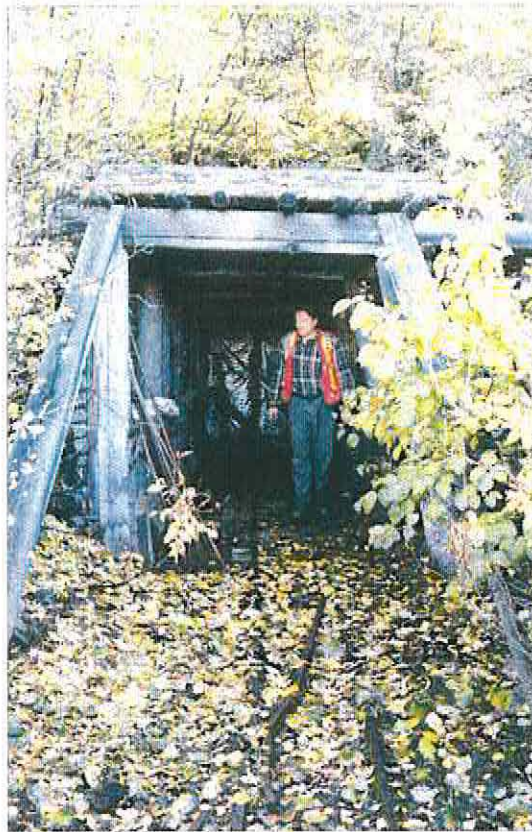
Photo 3-4 : Elsa Mine. Elsa 200 Level Portal. Looking south.

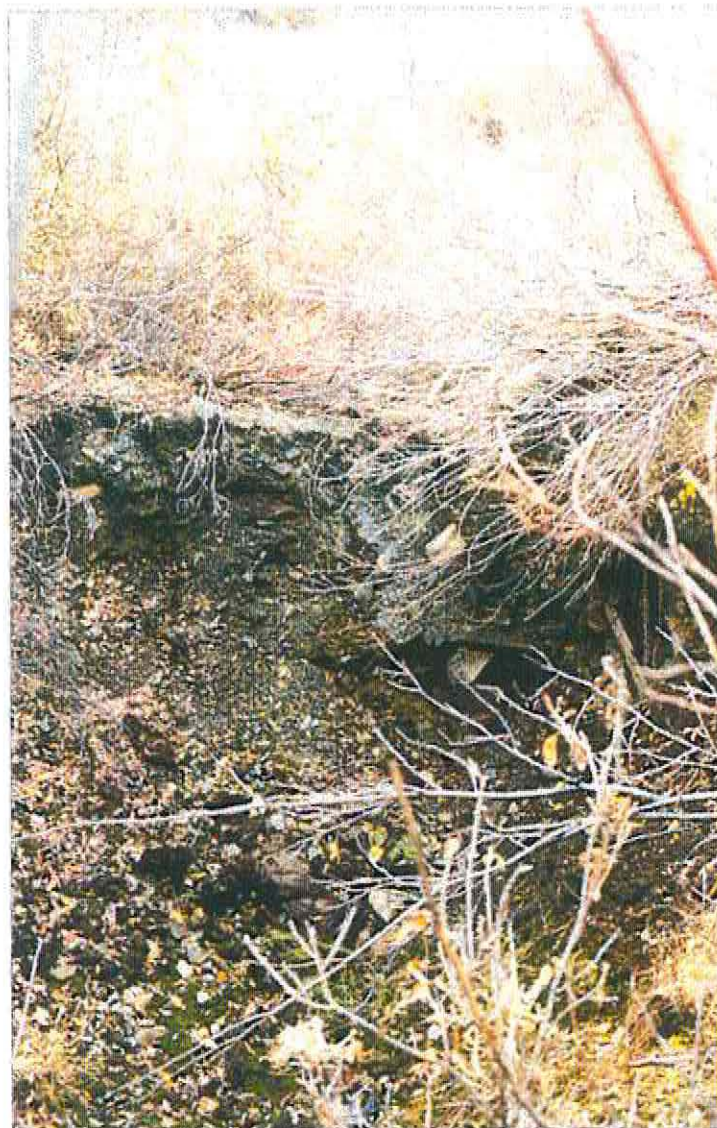
Powderhouse Corner Vent Raise

Condition: Appears to be unstable.

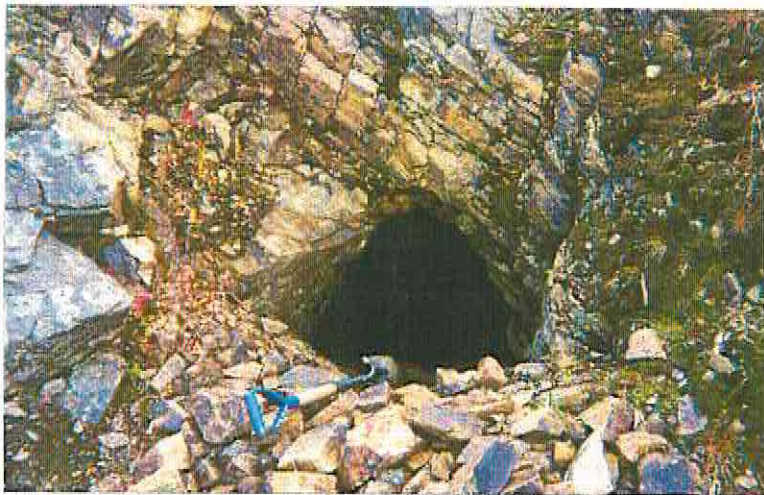
One of the old adits developed between 1908 and 1914, "Victoria" was discovered along the upper access road winding up the northeast-facing slope of Olive Gulch. The opening was located 200m upslope and due southeast from the bottom of the gulch and approximately 80 m down from the top of the ridge. The adit opening was exposed and partially filled with rocks (Photo 91-4). Two drill-casing pipes were also noted sticking out of the ground above the adit at a 45 degree angle, possibly from old drilling activities or for shaft-venting.

Condition: Appears to be stable.

Photo 91-4 : Stewart-Catto. Old 1914 mine adit along old access road to top of hill.

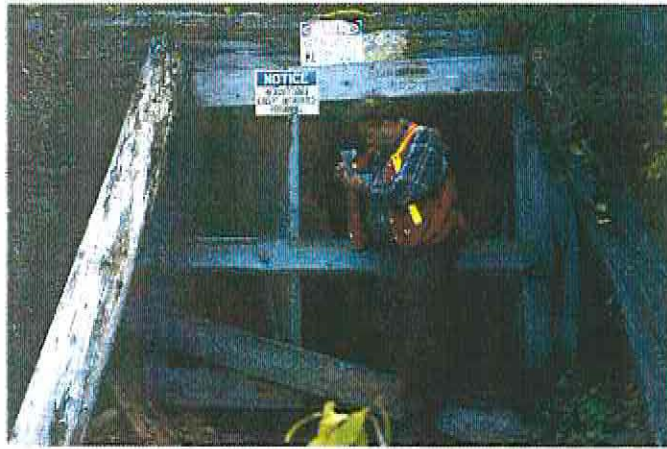
The UN portal is 2 m high and constructed with wood beams (Photo 10-2). The adit has a wooden door to the adit was open at the time of the site visit. The adit is blocked by ice that extends to the sides of the adit, and comes to within 20 cm of the roof. The ice block is reportedly present year round, but has never fully blocked the water flow.

Photo 10-2. UN portal showing wooden debris and open door.

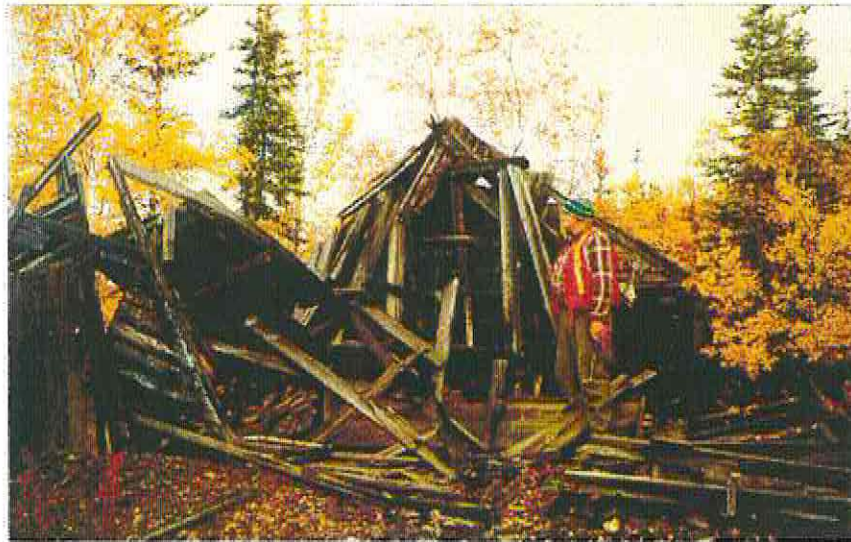
Photo 4-2: Collapsed structure above raise. The raise is located at the intersection of the powerline and roadway approximately 500m above the main Dixie site. (Azimuth 95⁰)

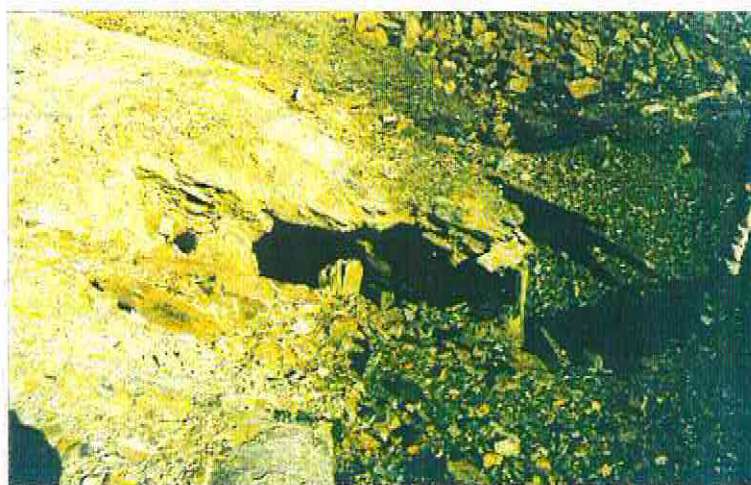
Caribou Adit (photo 39-1)

Surface stripping has exposed part of the adit, at least 10m from the portal. The support structure at the portal of the adit has likely been buried by the bulldozer trenching. The dimensions of the adit could not be determined. There is no evidence of the adit collapsing, however it is difficult to determine since the area around the adit has been extensively worked. The adit cannot be accessed.

Photo 39-1 : Caribou. Caribou adit; portal exposed by bedrock stripping. (Azimuth 080 °)

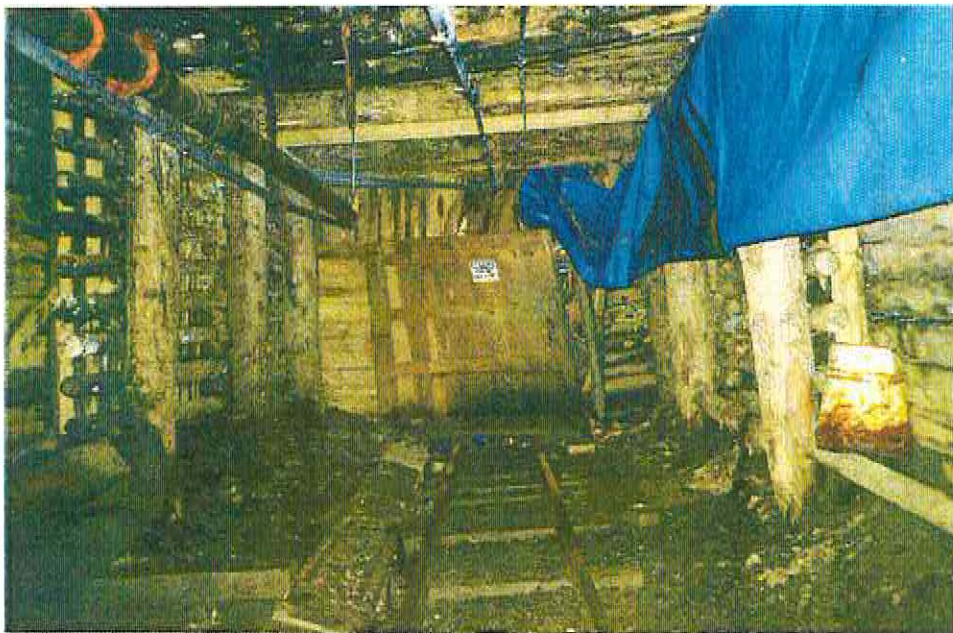
The entrance to the adit is located roughly 100m south of the south end of the North Black Cap Pit. The opening measures about 2m high by 2.5m wide and is supported by timbers. No collapses were visible in the first 50m. The adit is filled with approximately 40cm of standing water making further investigation of the adit impractical. A gravel berm located outside of the portal was built to damn mine drainage; however, water is seeping through the berm and a large puddle has formed on the other side. Water flowing from the puddle continues down the road for at least 50m before seeping back into the ground.

Photo 25-8: Interior of portal. Note drainage ditch to bottom left and partially collapsed door. Azimuth 060°)

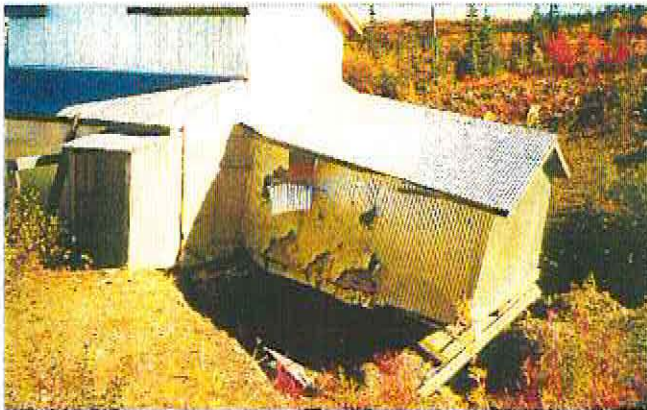
Building 6A - Ruby Shafthouse (photo 6-2)

Photo 6-2 : Ruby Shaft. South portion of shaft house over opening has collapsed.

Hazardous Contents: There were two barrels with lubricant labels, however, it is not known if the barrels contained any product **AS THE BUILDING HAS BECOME A SAFETY HAZARD AND WAS NOT ENTERED DURING THE SITE 'INVESTIGATION.** Some rags stored in pails appeared to be stained with hydrocarbon product.

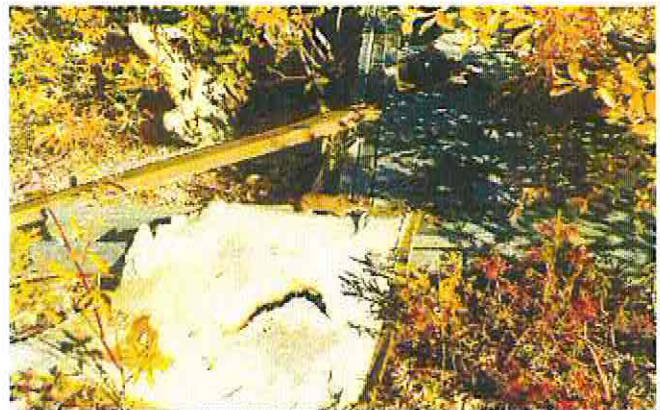
Photo 6-5 : Bermingham Adit.

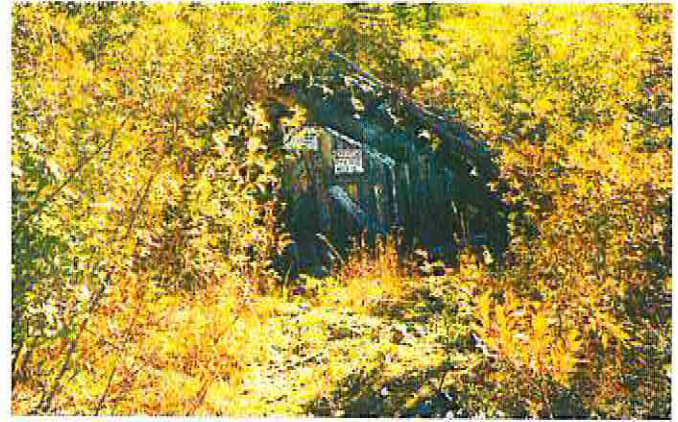
Photo 6-9 : Birmingham Adit, Portal at Birmingham Adit. (Azimuth 170 °)

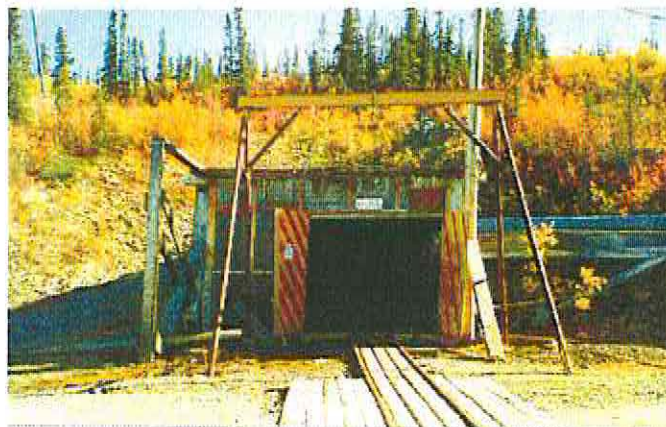
NOTE:THE STRUCTURE HAS DETERIORATED TO THE POINT THAT IT HAS BECOME A SAFETY HAZARD. IT APPEARS THAT THE SHAFT HAS COLLAPSED INTO ITSELF AND THERE ARE DANGER SIGNS POSTED ON THE WOODEN DOORS.

Photo 6-15 : Ruby 400. Adit structure with rail tracks extending from the structure and utilidor on right..

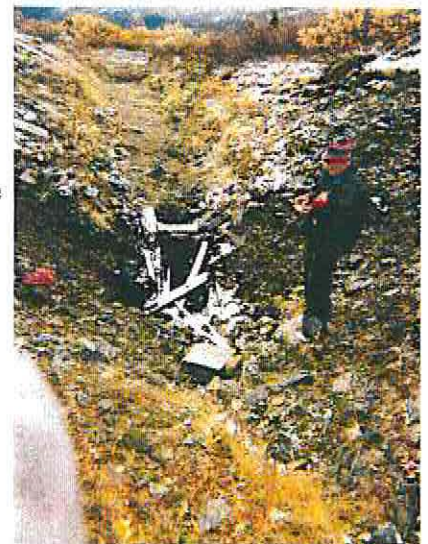
Condition: poor - caved in 5 m below surface

Accessibility: open

Photo 48-2: View of Shaft 1 in Trench 3 at Apex site. (AZ 132)
