To: Alistair Kent, AECOM  
Cc: Mount Nansen Closure Analysis Team (via Sharepoint posting)  
From: Diane Lister  
Date: December 22, 2009  
RE: **Mount Nansen Mine Closure: Mine to Mill Haul Road – Summary of Rock Characterization Studies**

The purpose of this summary is to present the characteristics of rock placed in the 'Mine to Mill Haul Road' at the Mount Nansen Mine site. The main focus areas of this summary are the rock's geochemical characteristics, general physical characteristics as they apply to use in closure activities, and estimated volume potentially available for use during closure.

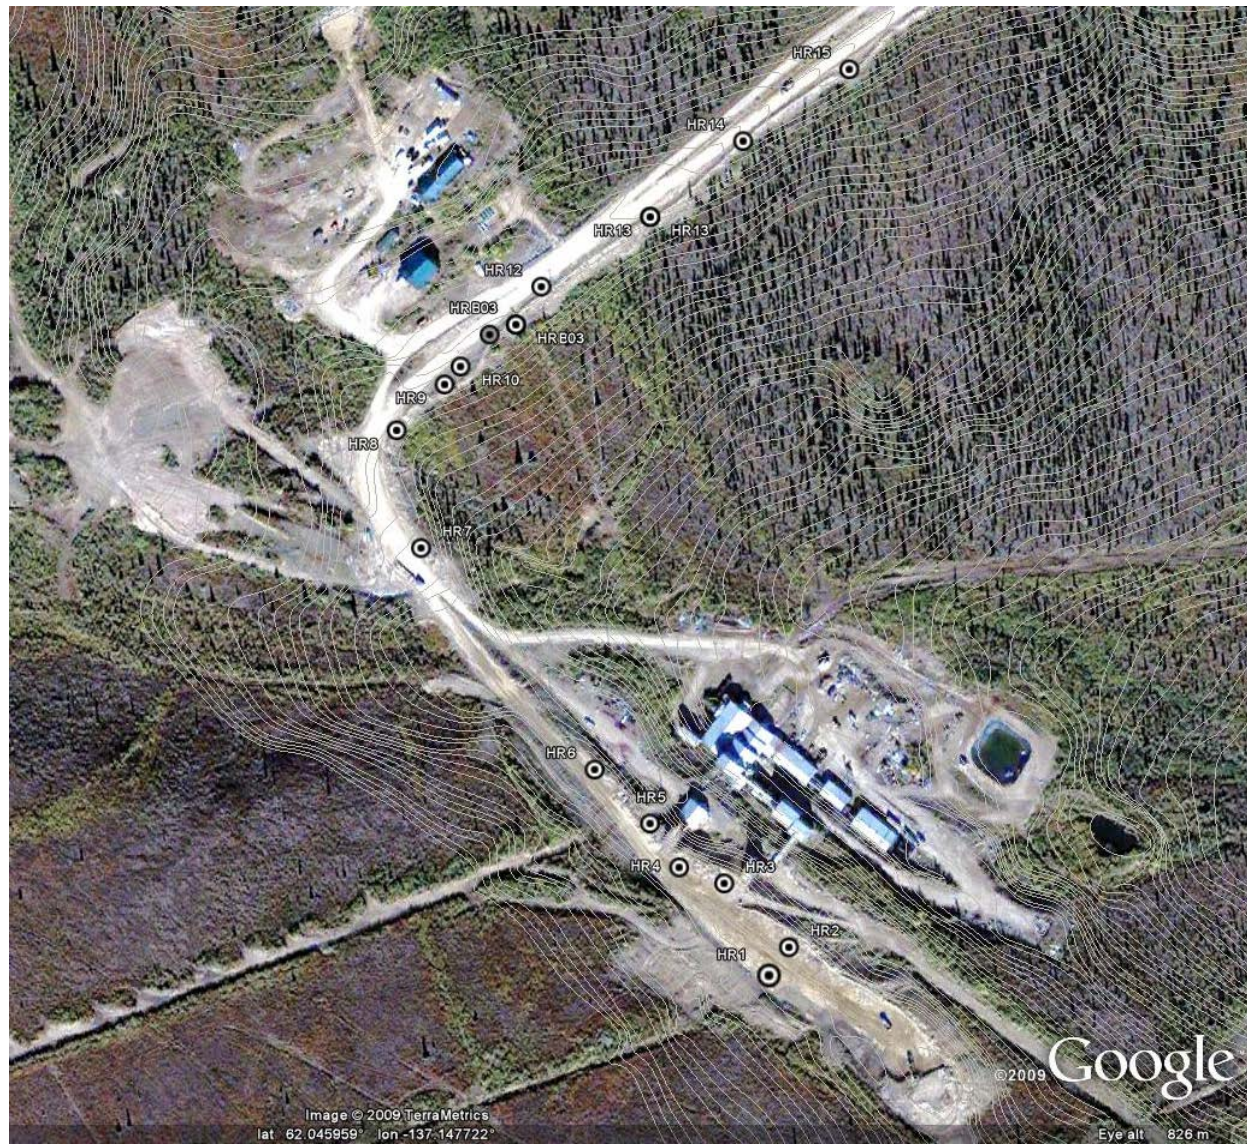
Figure 2. West section of haul road showing location of test pits (HR series) and cuts through berms (HRB series).

A total of 22 test pits were excavated in the road bed of the haul road in 2009, starting at mill area near the crusher feeder and stockpile area and terminating adjacent to the mine shop. Excavations were also cut through the road berm material at nine locations in order to augment the two samples taken in 2008. A John Deere excavator (model 350?) was used to conduct the 2009 work. Figures 2 and 3 show the locations of all test pits and berm samples.

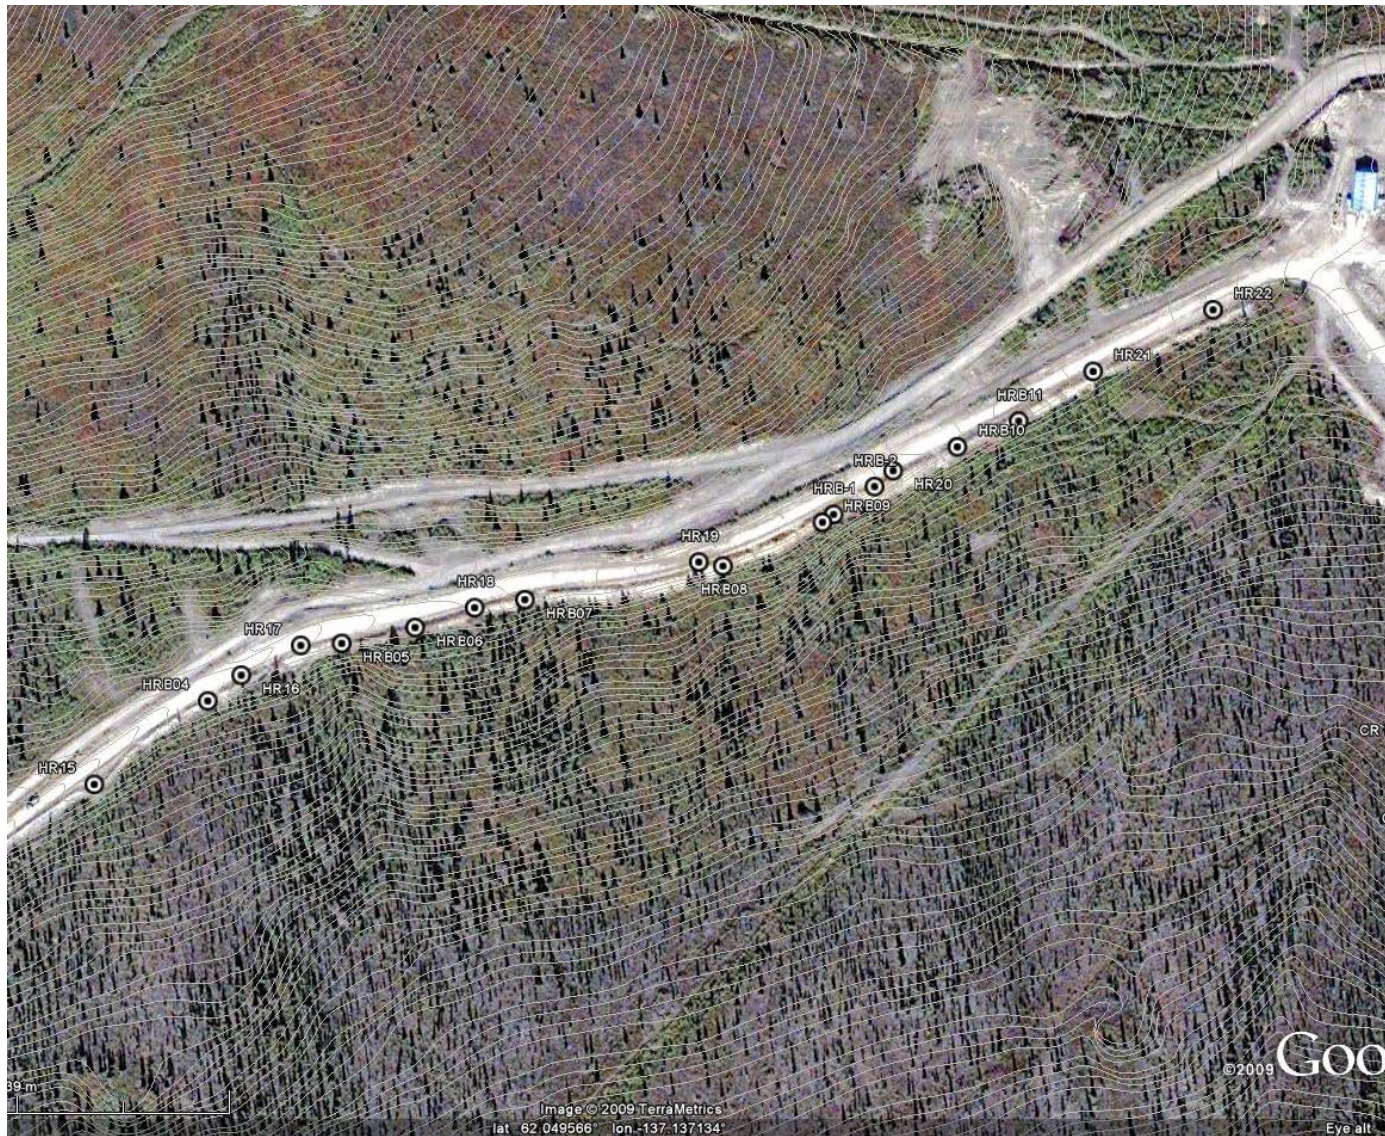
Figure 3. East section of haul road showing location of test pits (HR series) and cuts through berms (HRB series).

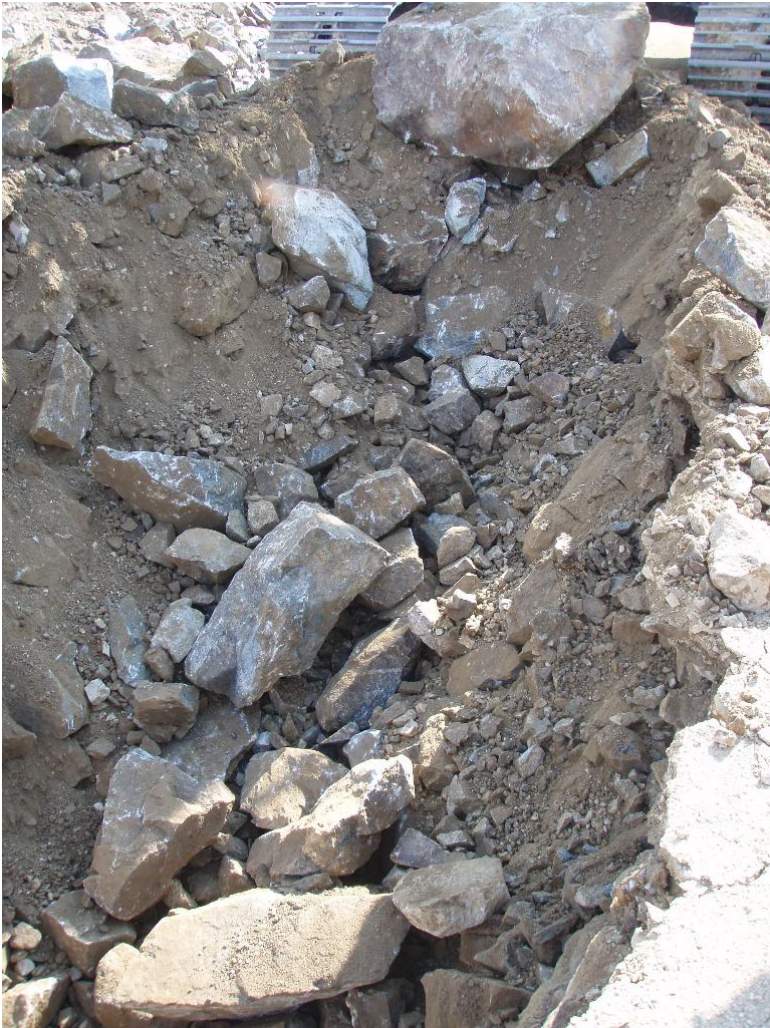
*Photo 1. Test pit HR13, very blocky digging with minor amount of fines.*

Most of the fifteen test pits into the bed of the haul road encountered material predominantly composed of intrusive of granodioritic to dioritic composition typical of Brown McDade footwall rock, consistent with historical information. Rock tended to be variably altered and thus exhibited a range of competency. Other reported rock types include fine-grained intrusives, some with porphyritic texture, and silicic/phyllic altered fragments of unknown protolith. In several pits, a road surface veneer in the order of 0.1 m thick appears to be comprised of a more clay-altered material. The backfilled material encountered in the test pits has a median of 60 percent fragments of greater than 5 cm size (visually estimated). Test pits HR 21 and 22 completed in the 150 metre stretch immediately west of the mine shop encountered a markedly greater degree of clay alteration and visible pyrite than the pits HR8 through HR20. Photos 1 through 2 demonstrate the range of material characteristics in the test pits.

Samples of both fine (-1/4") and coarse (5 cm and above) fragments were analysed from one test pit, HR13, and slightly less favorable acid base accounting, metal leaching and metal content properties were observed in the fine fraction.

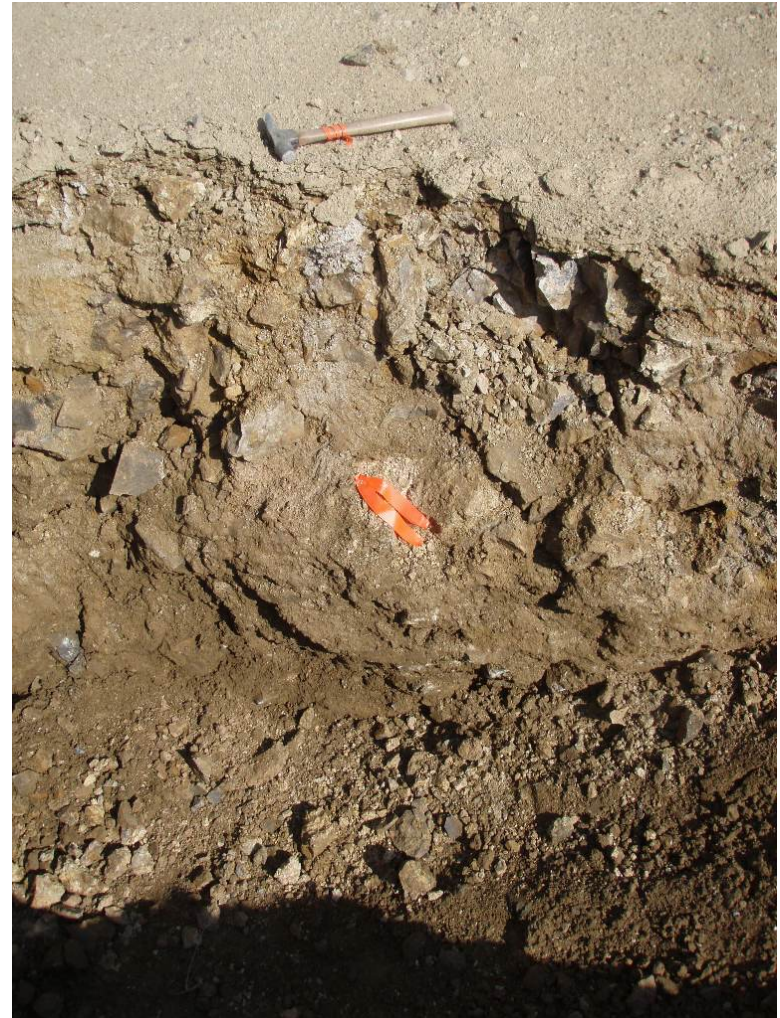
*Photo2. Test pit HR20, typical of material backfilled in road bed.*

Utilizing the Brown McDade waste rock screening criteria proposed in Altura (2009b) of no visible sulphides and paste pH greater than or equal to 6.5, four of the fifteen samples (from pits HR9, HR16, HR17 and HR20) are classified as 'Low-Reactivity'. Due to its moderately acidic paste pH, the anomalous sample HR12 discussed in the above paragraphs is appropriately designated as 'Marginal'. On the other hand, three of the eleven samples also deemed 'Marginal', have low sulphide contents ( $<0.03\%$  or less), laboratory paste pH of greater than 6.5, high NP : AP ratios of greater than 5, and low extractable metals in shake flask testing. This may indicate that there is some room for additional refinement of the field criteria for the haul road material, possibly allowing for trace amounts of visible sulphides in the material.
