# **Mount Nansen Project Pony Creek Biomonitoring Assessment**

EDI Environmental Dynamics Inc.  
#3-478 Range Road  
Whitehorse, Yukon  
Y1A 3A2

11-Y-0352  
March 2012

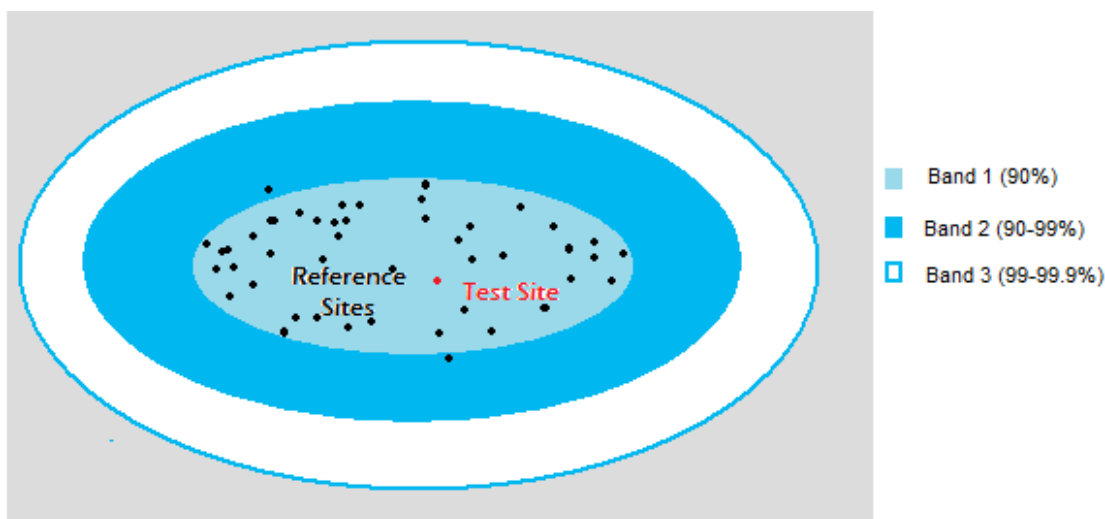
Figure 2. One dimension of ordination space between a test site (red) and its reference site group. Each ellipse is equivalent to a probability or confidence interval around the reference condition.

Ordination is in three dimensional space and results are interpreted based on where the test site falls within three ellipses around the reference condition. The distance of the test site from the reference space indicates the level of impairment. Figure 2 illustrates one dimension of ordination space in a test site assessment. The three ellipses in ordination space are equivalent to the probability the test site is divergent from the reference condition. If the test site falls within the first ellipse, this means the community is not significantly different than what is expected at the 90% confidence interval. In other words, 90% of reference sites would fall within this range. Table 1 shows how results are interpreted for a test site falling within each ellipse, also called a band or a confidence ellipse. Three comparisons are made, Axis 1 versus 2, Axis 1 versus 3, and Axis 2 versus 3. If the test site is stressed in any comparison, impairment is indicated.
