Mount Nansen – Tailings Dam Pest Control

Luca Poloni, *Summer Student*
Assessment and Abandoned Mines
August 25st, 2014
Josee.Perron@gov.yk.ca

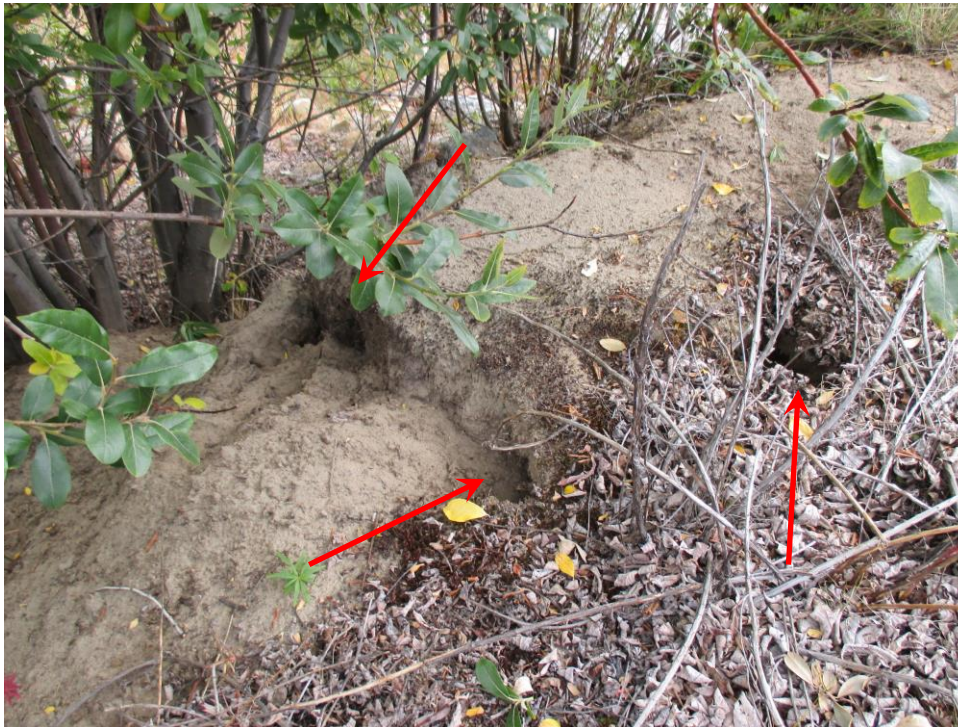
During the June site inspection at Mount Nansen, conducted by Richard Trimble of EBA, it was observed that there was an increase in the number of ground squirrel holes and burrows along the dam crest of the tailings dam facility. As a result of this, recommendations were made to remove/relocate the ground squirrels from the dam crest and have their burrows backfilled. Failure to remove the ground squirrels could potentially result in damage to the buried liner, as well as create seepage paths for water if the level of the pond was to increase.

Photo 1. Several burrows located within the Seepage Pond Area – Looking East.

Following the completion of the program, all holes and burrows within the tailings dam that were created by the ground squirrels will be filled and compacted with earth in order to increase its stability. This process will likely occur following May, 2015's monitoring program, which will be critical in determining the effectiveness of the administered Rozol to control the ground squirrel population at Mount Nansen.

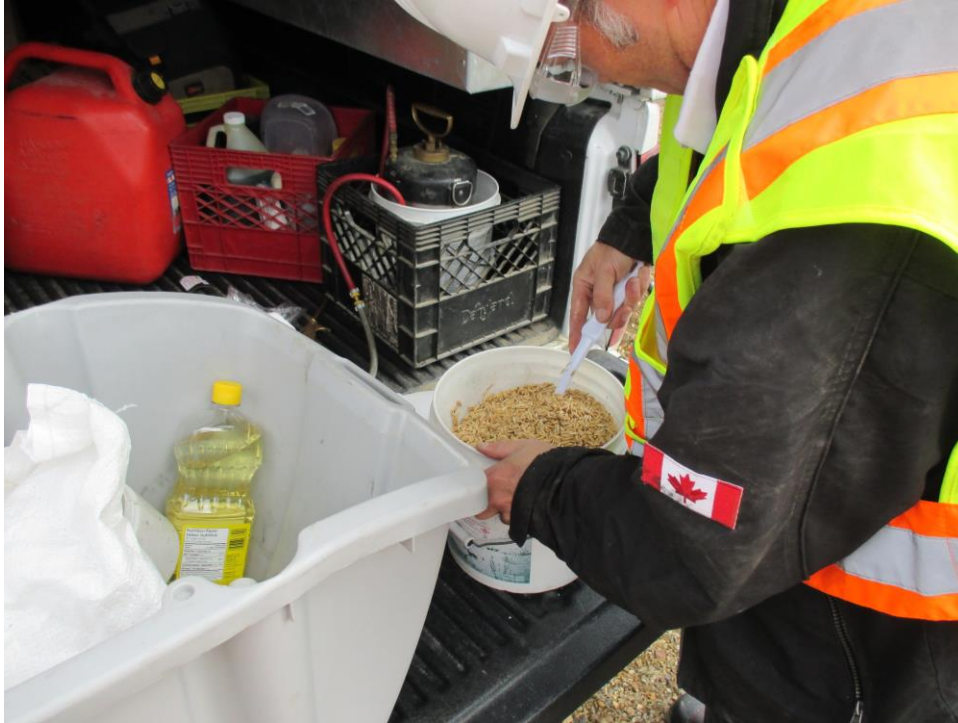
Preparing the rodenticide used at Mount Nansen consisted the mixing of 190 ml of Liquid Rozol and 260 ml adjuvant (peanut oil) into 6 kg of rough oats and mixing well (Photo 2). The peanut oil mixed with the Rozol aids in coverage of the grain during mixing and also provides a smell and taste favorable to the ground squirrel.

Photo 2. Leith, of Orkin Canada, preparing the bait prior to its application.

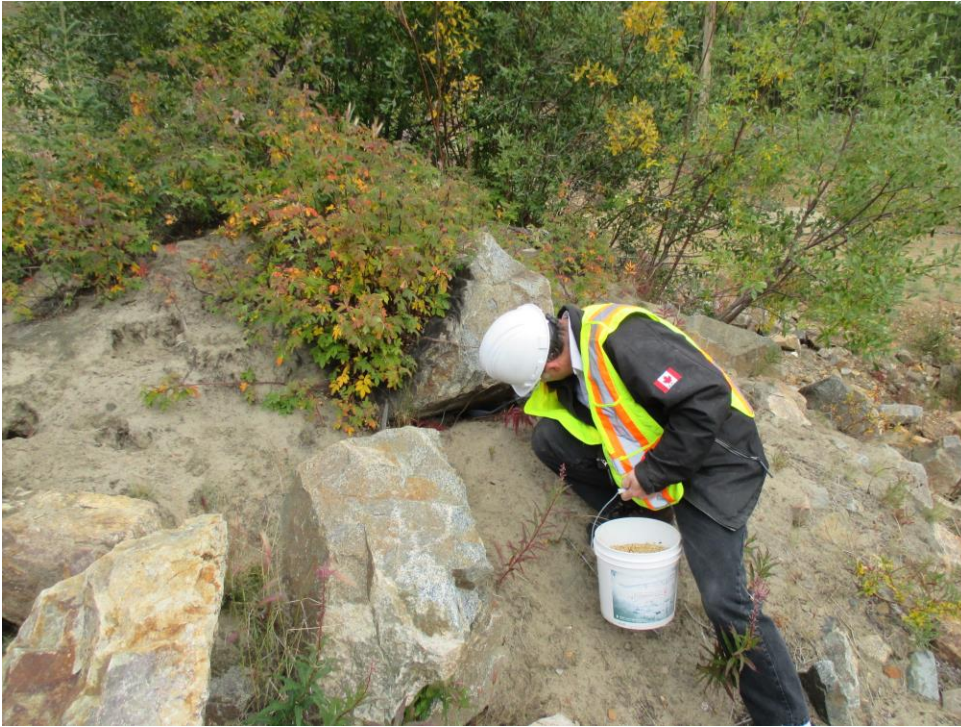
After preparing the bait, approximately 1.5 hrs. of reconnaissance took place throughout the site in order to locate burrows and apply the rodenticide. Within each burrow, one scoop (57 grams) of treated grain was placed 8 to 12 inches into the hole, working out to approximately 1.81 ml of Rozol per burrow (Photo 3 and 4). Placing the grain approximately a foot within the hole eliminates some potential of primary poisoning of any non-target animals that are also located on site. A total number of 85 burrows were treated with one scoop of Rozol baited grain. This included:

Photo 3. Leith, of Orkin Canada, administering the bait within burrows located at the Seepage Pond.

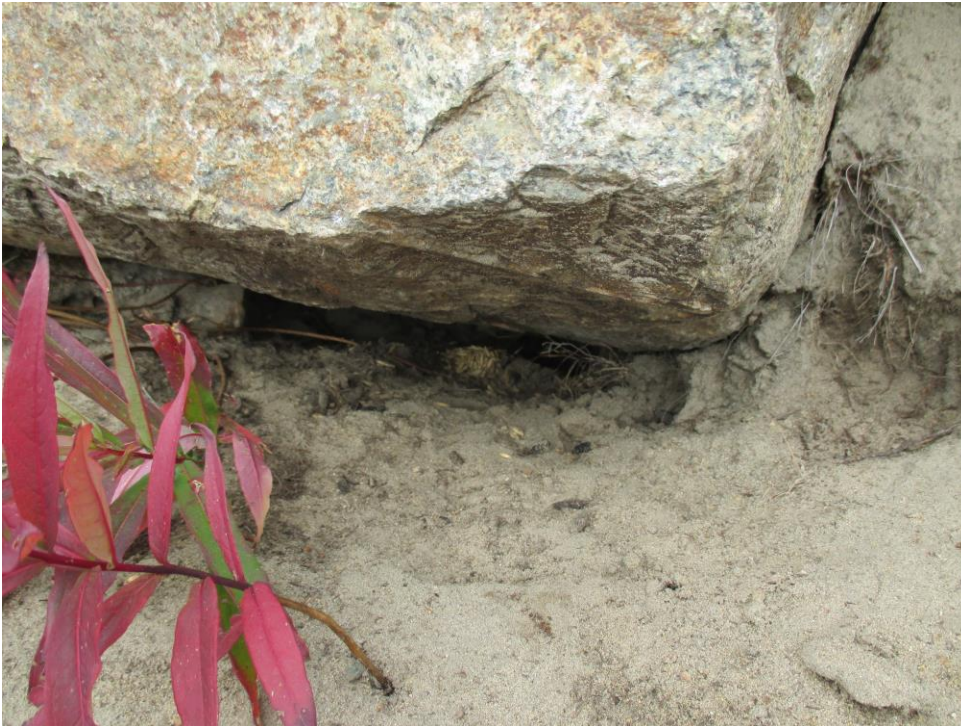
Photo 4. Baited grain placed approximately 8 to 12 inches within the burrow to avoid primary poisoning of non-targeted animals located on site.

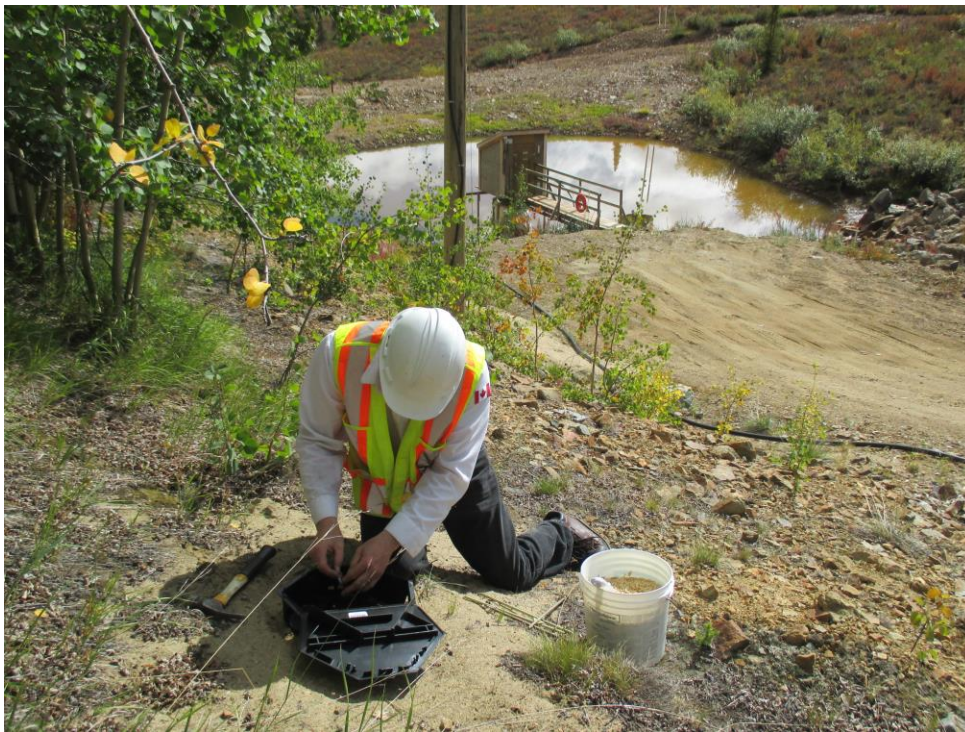
As well as baiting 85 burrows, exterior bait stations were set up in high traffic areas where ground squirrels were in abundance (Photo 5-8). Two Scoops (114 grams) of treated grain was placed within these sealed black boxes that were secured to the surface via a metal pin; this works out to approximately 3.62 ml of Rozol is placed within each bait station. There were a total of 10 black boxes placed throughout the areas mentioned above. This included:

Photo 5. Preparing the exterior bait boxes – Showing the metal pin that is hammered into the ground in order to secure the box.

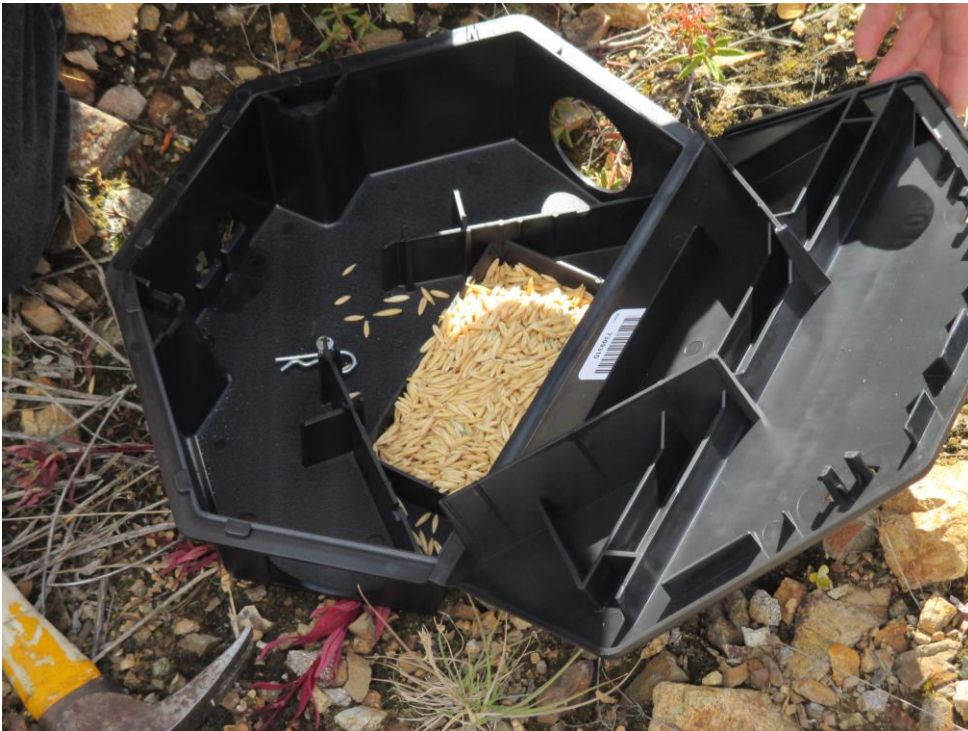
Photo 6. Preparing the exterior bait boxes – Two scoops of baited grain placed within the box and the lid is securely fastened.

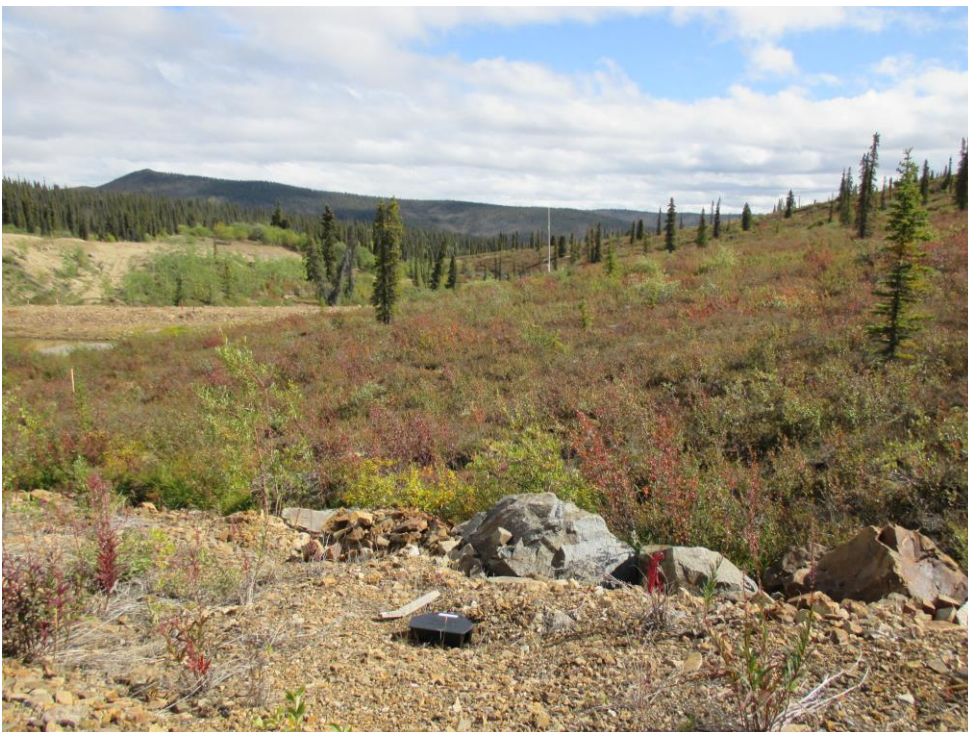
Photo 7. Exterior bait box installed on south side of the Seepage Pond – Looking East.

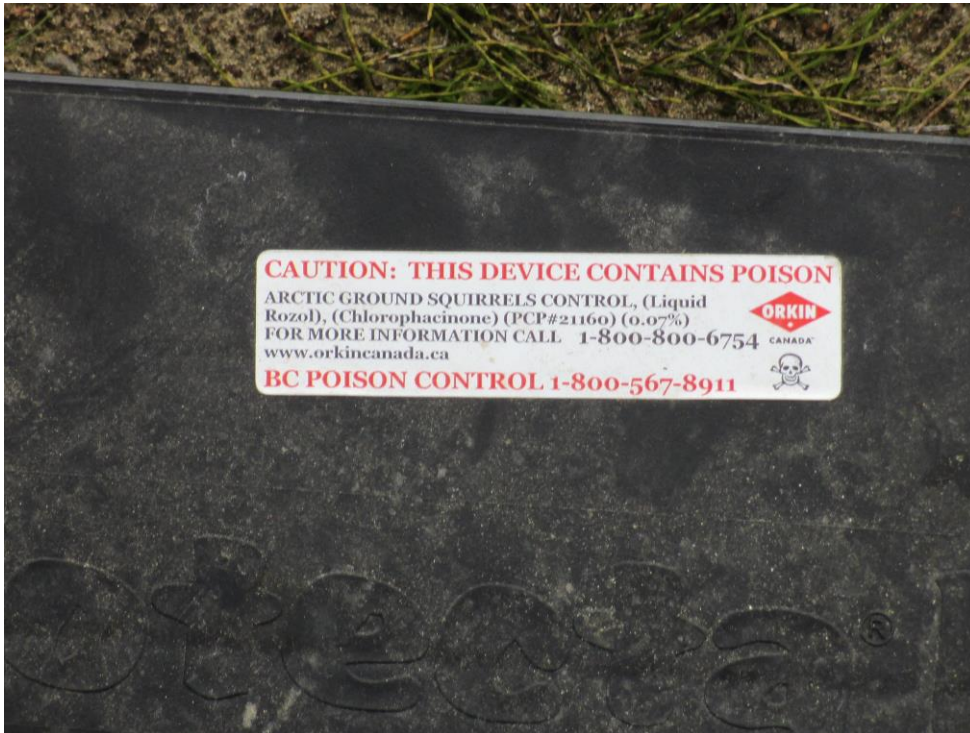
Photo 8. Label located on bait box.

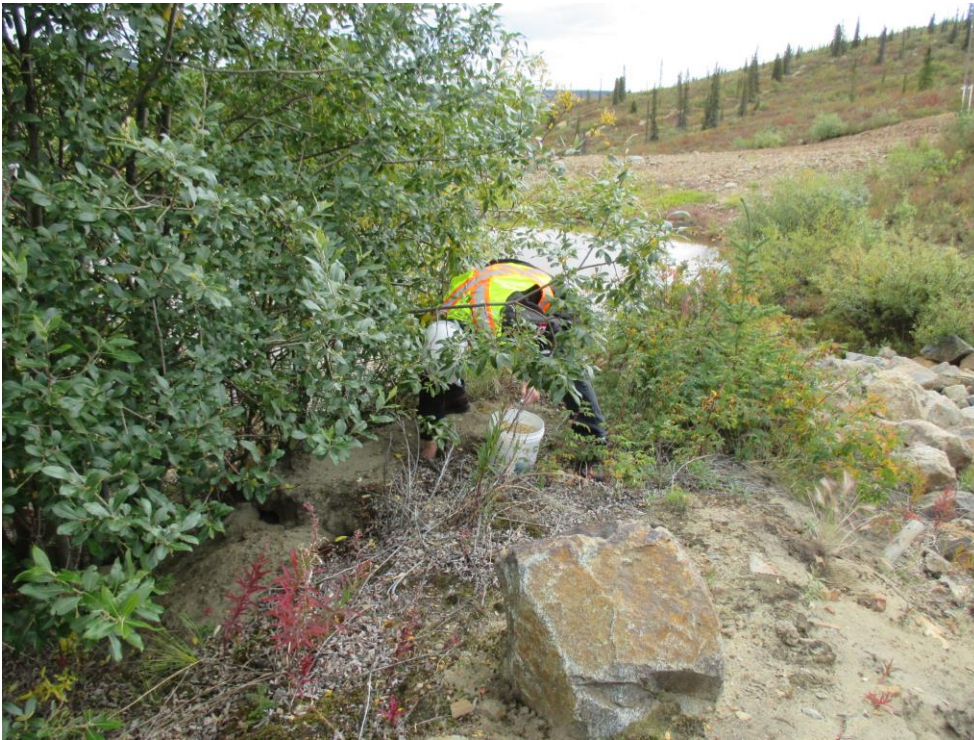
Photo 9. Placement of baited grain within the Seepage Pond Areas – Looking East.

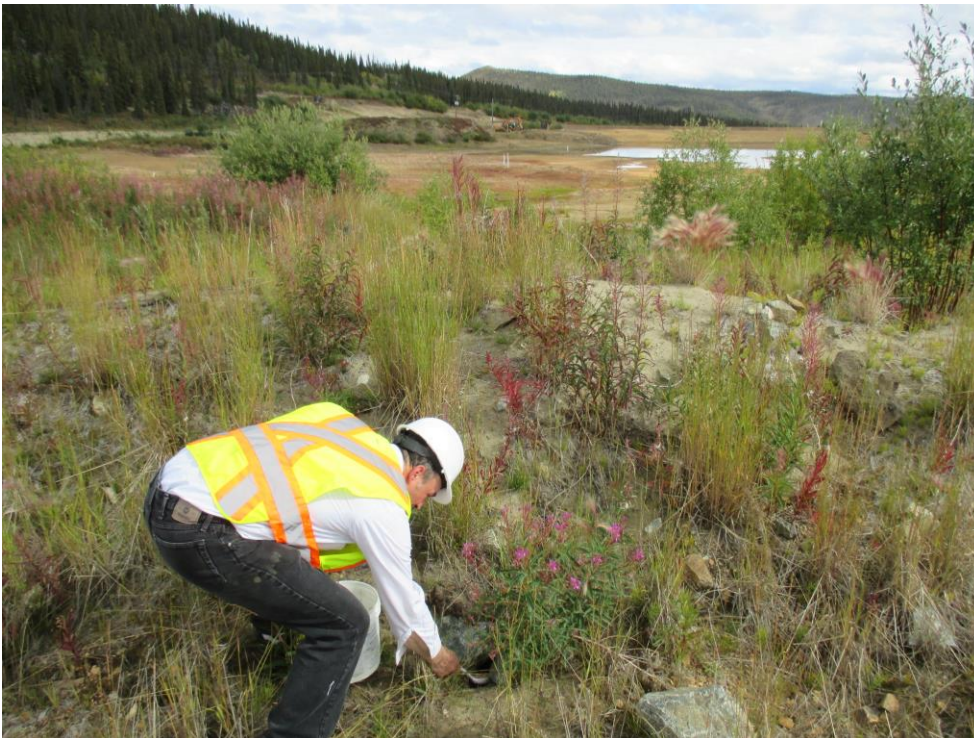
Photo 10. Placement of baited grain on the west side of the Tailings Pond – Looking East.

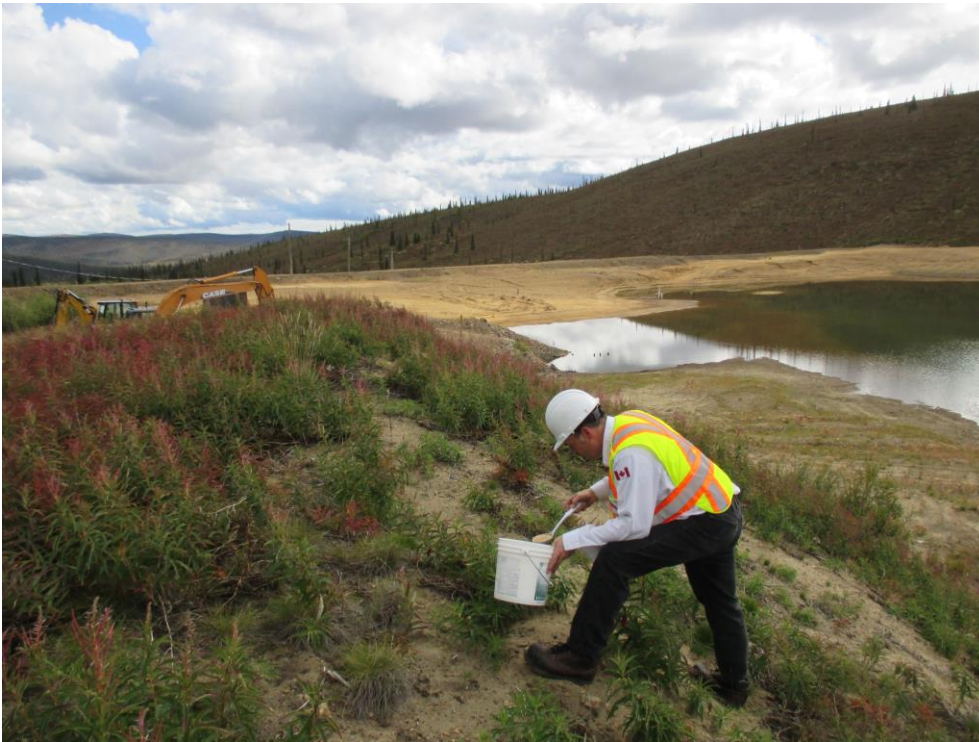
Photo 11. Placement of baited grain on north side of Tailings Pond – Looking East
