A Preliminary Environmental Impact
Assessment of Abandoned Hard Rock Mines,
Yukon Territory

Ann P. Duffy and Debbie Mahoney

August, 1982

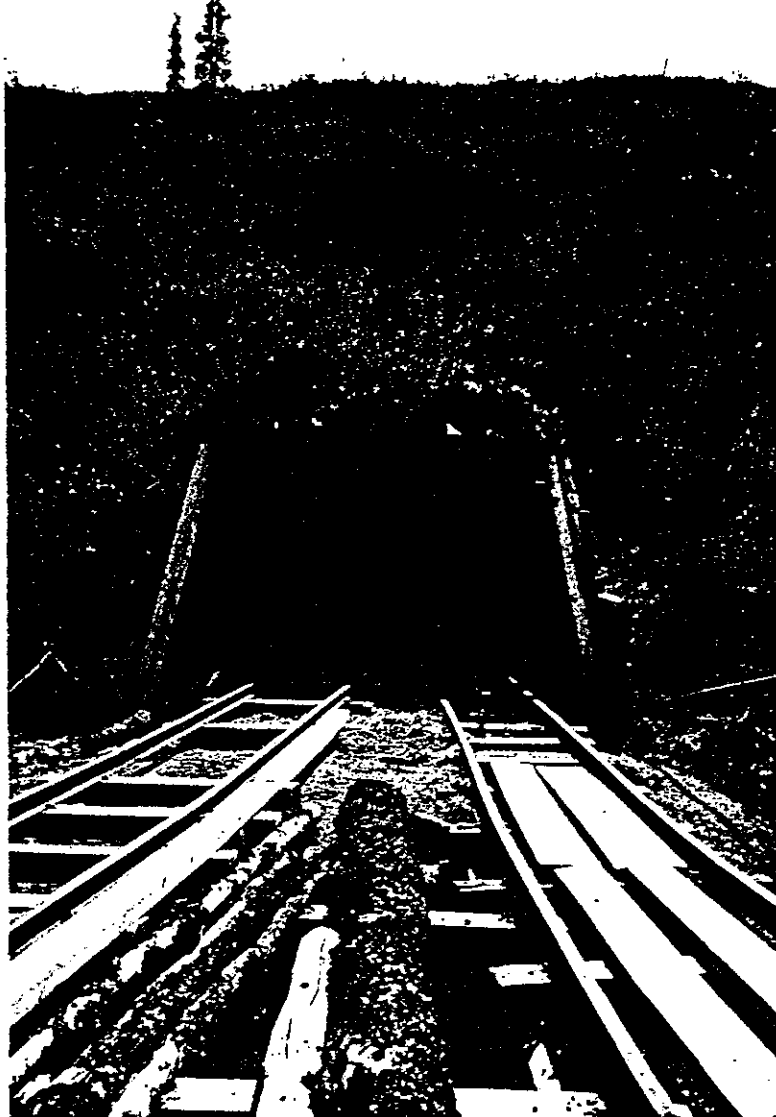
FIGURE 3 BROWN MCDADE ADIT. NOTE PROMINENT REVEGETATION OF SLOPE.

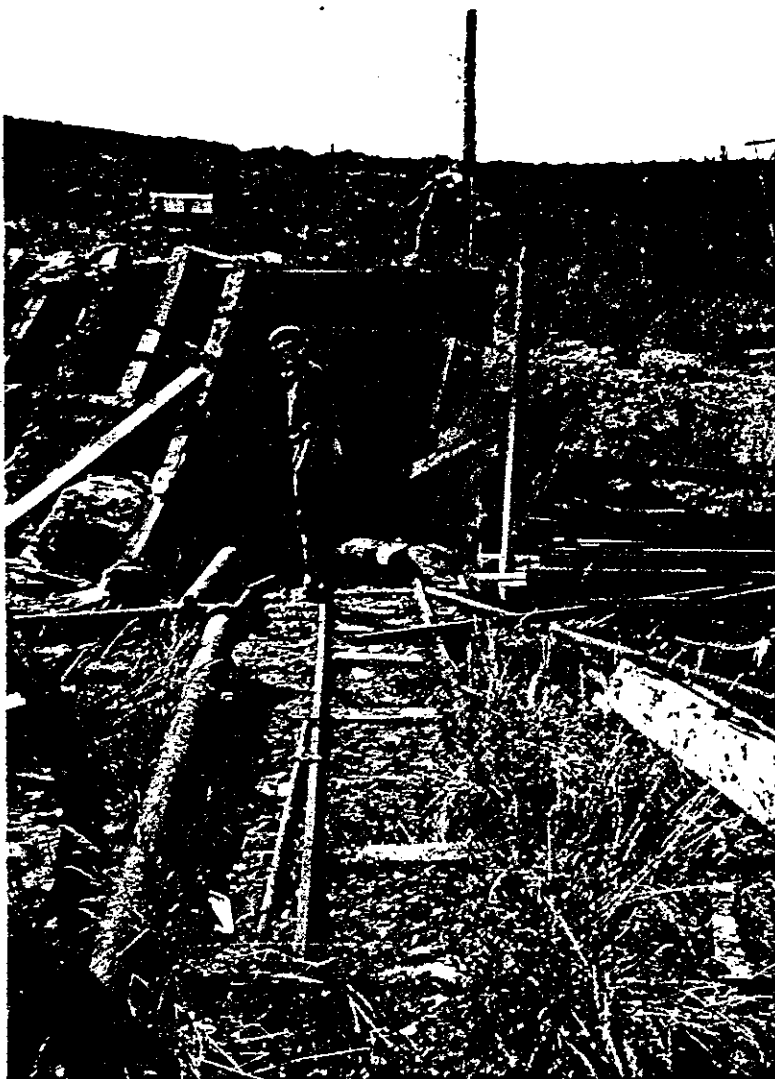
FIGURE 6 MT. NANSEN ADIT. NOTE REVEGETATIVE SUCCESS.

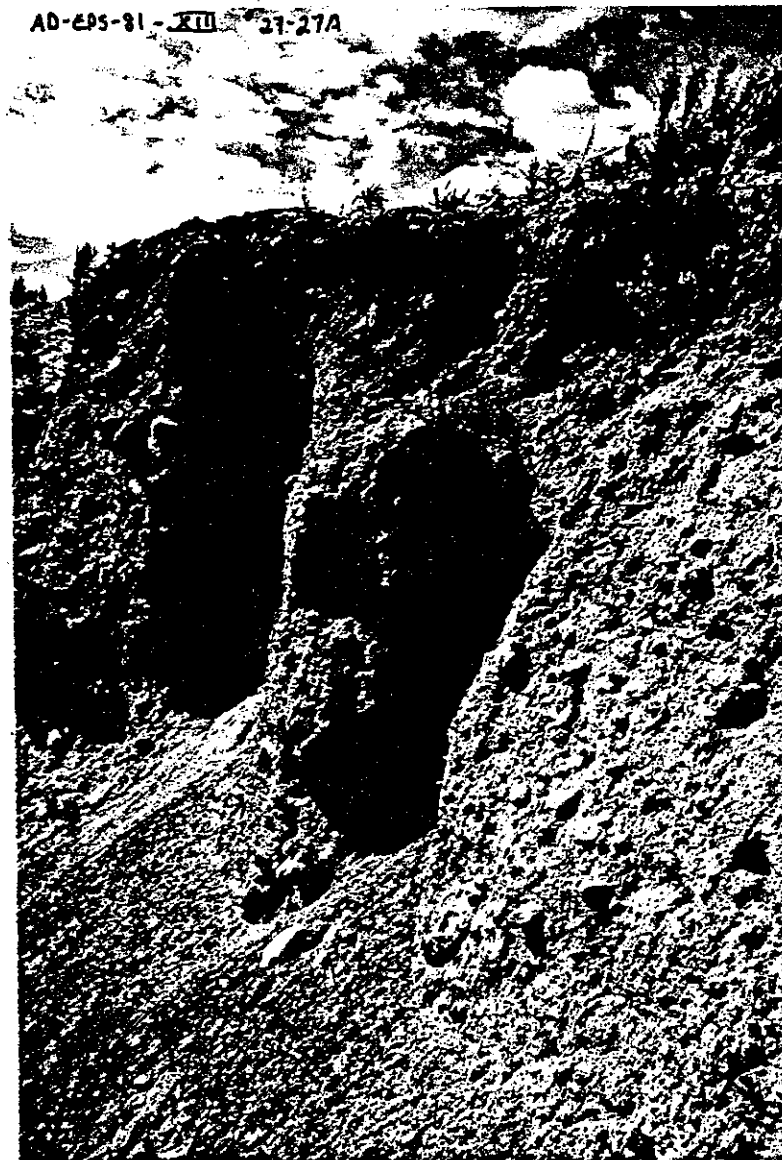
About nine meters of unconsolidated glaciofluvial till make up the walls of the Black Cub South pit. This is extremely prone to erosion (see Figure 7). Build-up of eroded particles at the base of the pit is evident. An extreme slope gradient has impeded revegetation. (The angle of repose has been exceeded.) Vegetative roots cannot become established under such adverse conditions.

FIGURE 7 GLACIOFLUVIAL TILL IS EXTREMELY PRONE TO EROSION AS SEEN OF
PIT WALLS AT WHITEHORSE COPPER MINE.

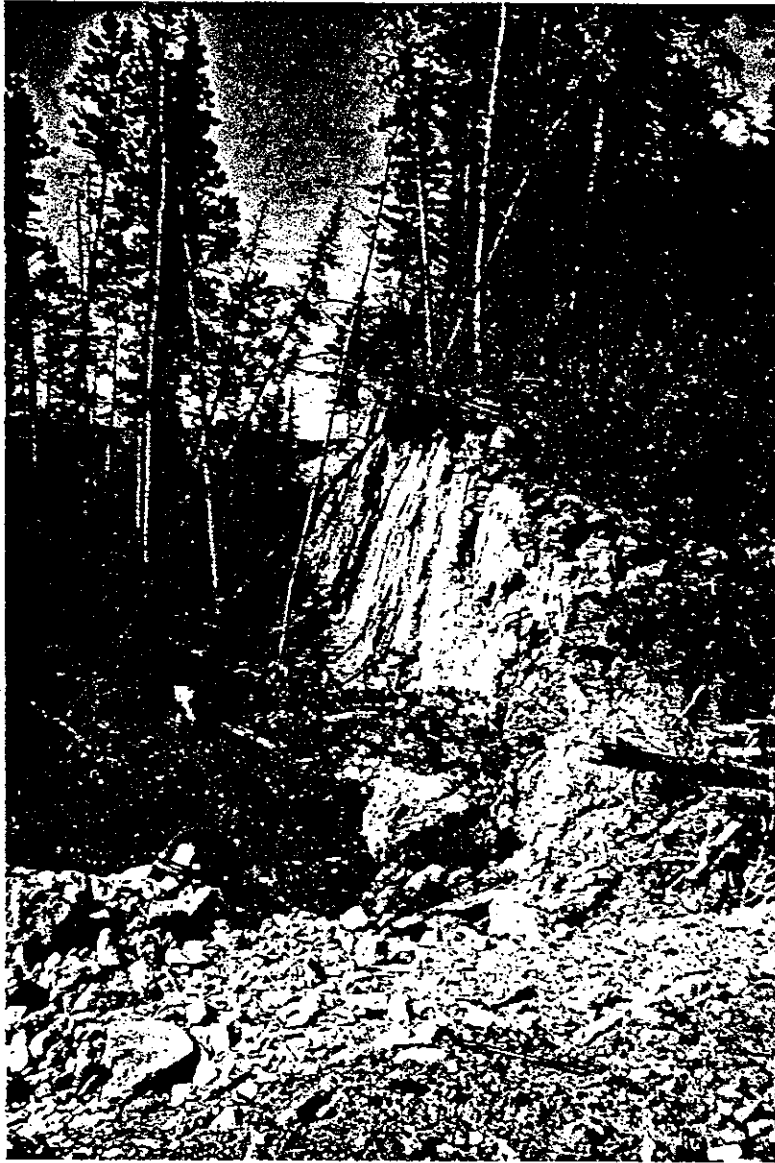
A combination of shear zones and a phenomenon known as the "Little Chief North Fault" at the Little Chief pit results in slope instability. The southeast bank of the pit is moving downslope at a faster rate than the north-facing slope. Figure 8 shows the difference in altitude of the land on either side of the fault. Activity at the Little Chief pit involved both open pit and underground mining. Original surface elevation of the pit was 2700 feet above sea level, and underground mining occurred at 2360 feet above sea level. As a result of the combination of both types of mine workings, slope instability has increased. Cracks and relatively high scarps are seen along the perimeter of the Little Chief Pit (Figure 9). Poor ground conditions at the Black Cub South Pit in combination with abundant groundwater, led to its premature closure in 1971, before the small bottom level had been mined. (Tenney, D., 1981)

FIGURE 8 THE "NORTH FAULT" ZONE AT THE LITTLE CHIEF PIT OF WHITEHORSE COPPER MINE SITE.

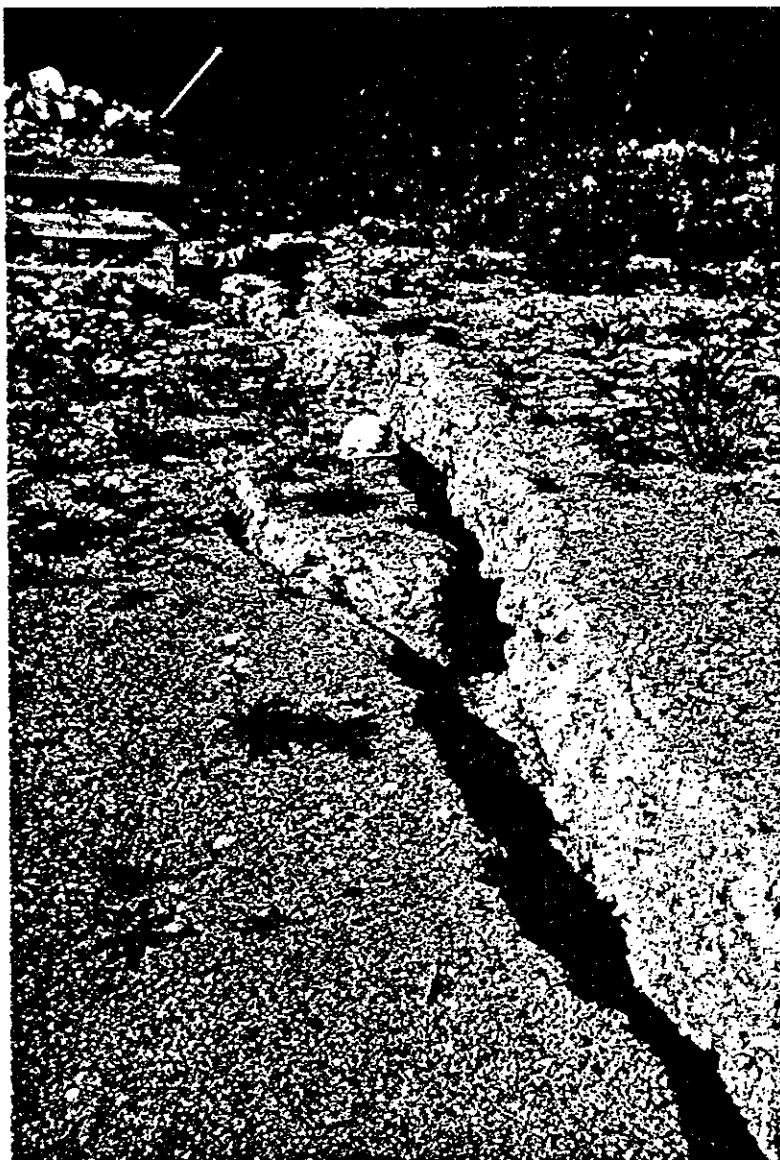
FIGURE 9 CRACKS ARE EVIDENT ALONG THE PERIMETER OF THE LITTLE CHIEF
PIT.

Often with man-made pits, severe cracking develops, where this would not occur with a natural rock cliff. To avoid soil creep and slope instability, rehabilitative measures should be taken.

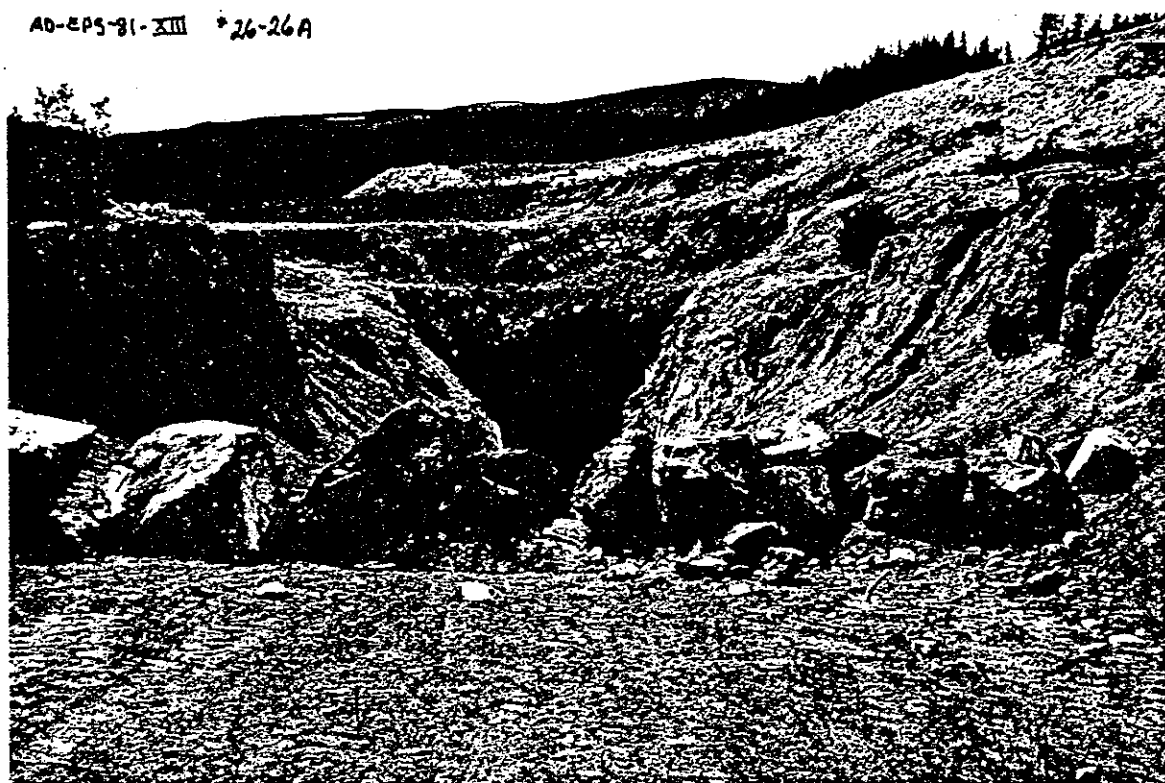
Open pit design includes establishment of "safety berms" - providing a bench for interception of material eroding from high angle pit walls, thus protecting the bottom of the pit from falling rock. The Keewenaw pit, which has only a few benches, reveals a talus slope, as does the Arctic Chief pit. (Figure 10)

FIGURE 10 ABANDONED PIT ON WHITEHORSE COPPER PROPERTY SHOWS BENCHES.
NOTE TALUS SLOPE.

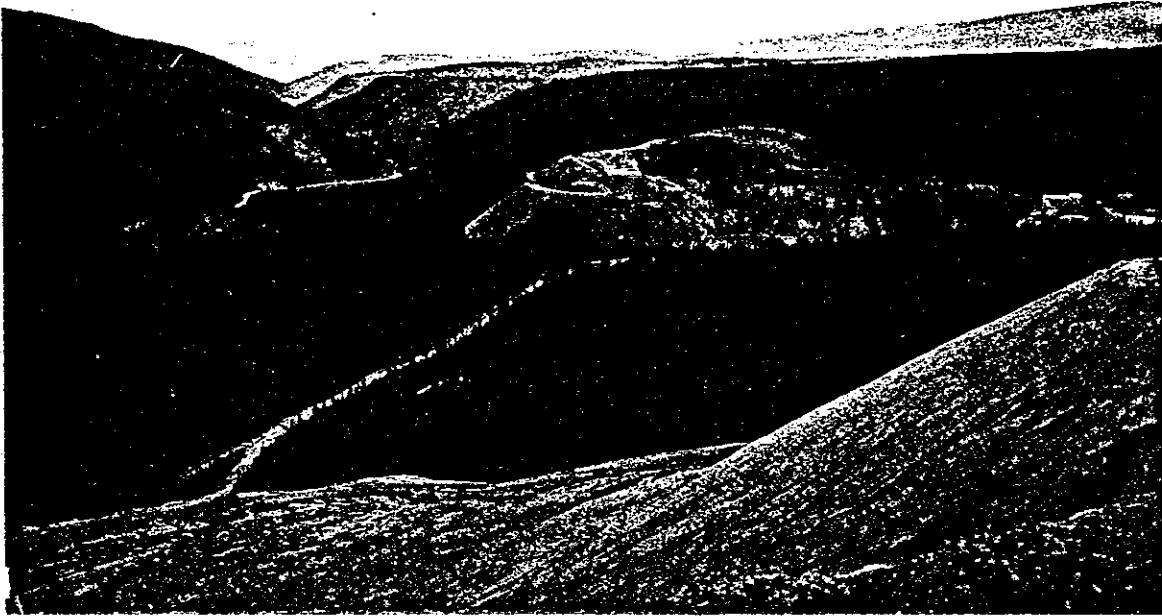
In 1981, a study performed at the Clinton Creek waste dump showed fresh tension cracks in the waste rock pile. The slope near the creek was then moving at a rate of 1.7 to 5 feet per year horizontally, and vertical movement was greater (Hardy Associates Ltd., 1981). The Wolverine Creek tailings pile exhibits wide open cracks and almost vertical scarps through its north lobe. Some of the benches cut into the pile in 1978, show numerous cracks and scarps (Figures 13 and 14). The tailings pile and waste rock pile have not reached equilibrium yet; they are still unstable.

FIGURE 13 CLINTON CREEK TAILINGS IN FOREGROUND AND WASTE ROCK PILE IN MIDGROUND. BOTH EMBANKMENTS ARE UNSTABLE. NOTE CRACKING IN LOWER LEFT HAND CORNER.

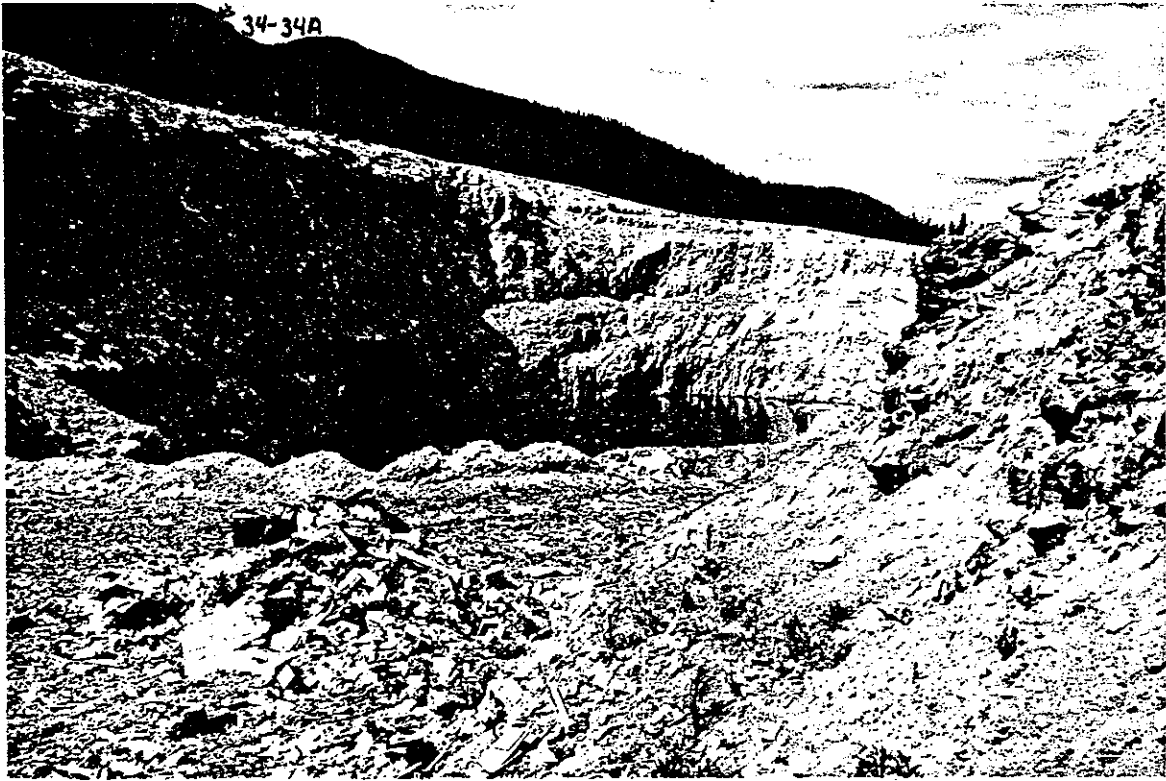
FIGURE 20 ABANDONED "WAR EAGLE" PIT ON WHITEHORSE COPPER IS BEING USED FOR THE WHITEHORSE CITY DUMP.

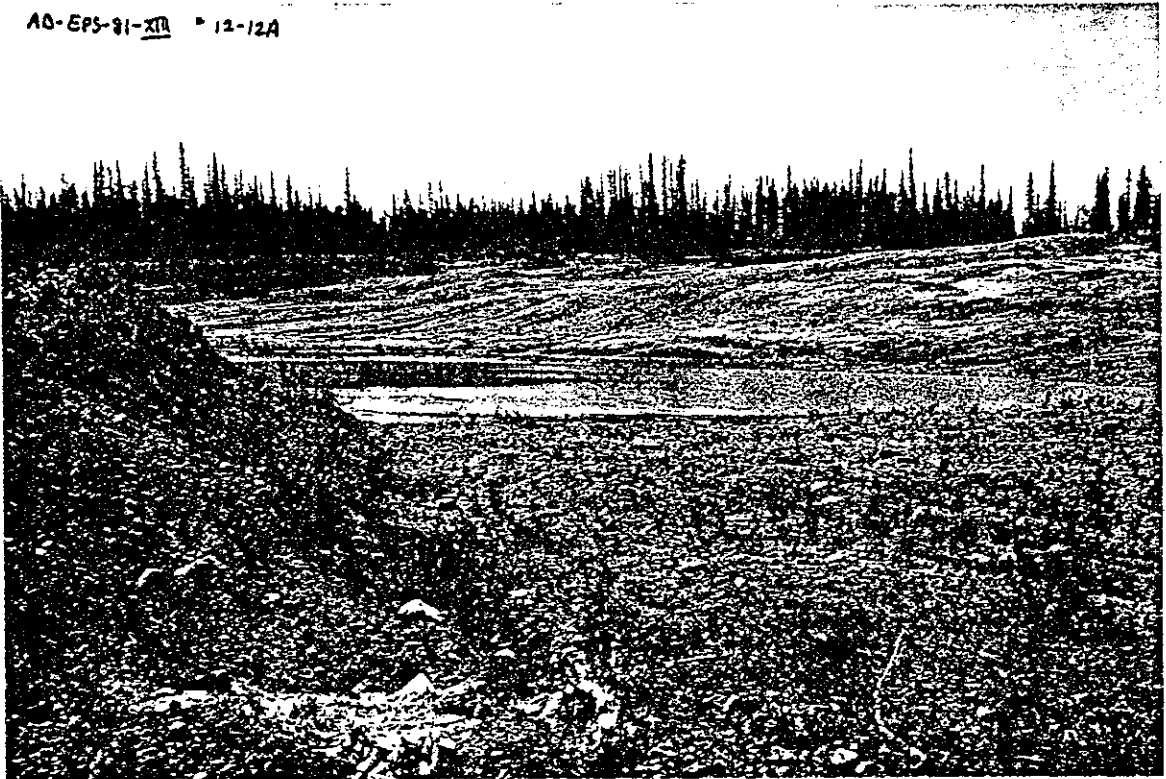
FIGURE 21 GEM PIT OF THE WHITEHORSE COPPER PROPERTY. NOTE ACCUMULATION OF GROUNDWATER. AREA COULD BE COVERED WITH OVERBURDEN AND RESEED, AS A MITIGATIVE MEASURE.

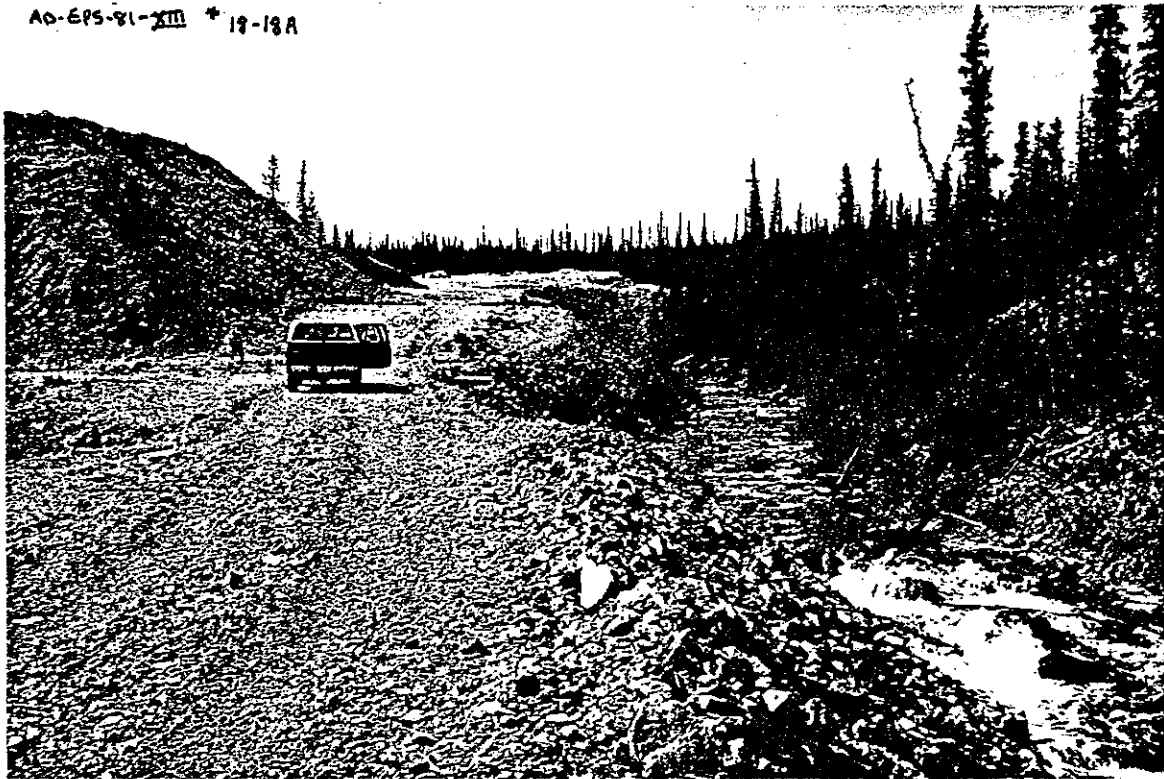
Figure 22 shows use of waste rock for a roadbed on the Whitehorse Copper property. Figure 23 allows for a comparison of vegetation on the waste rock pile side of the roadway and the natural bank on the opposite side of Wolf Creek. Waste rock particle size and lack of adequate substrate does not lend itself to revegetation of the area.

FIGURE 22 WASTE ROCK PILE USED AS A ROADBED ON THE WHITEHORSE COPPER PROPERTY.

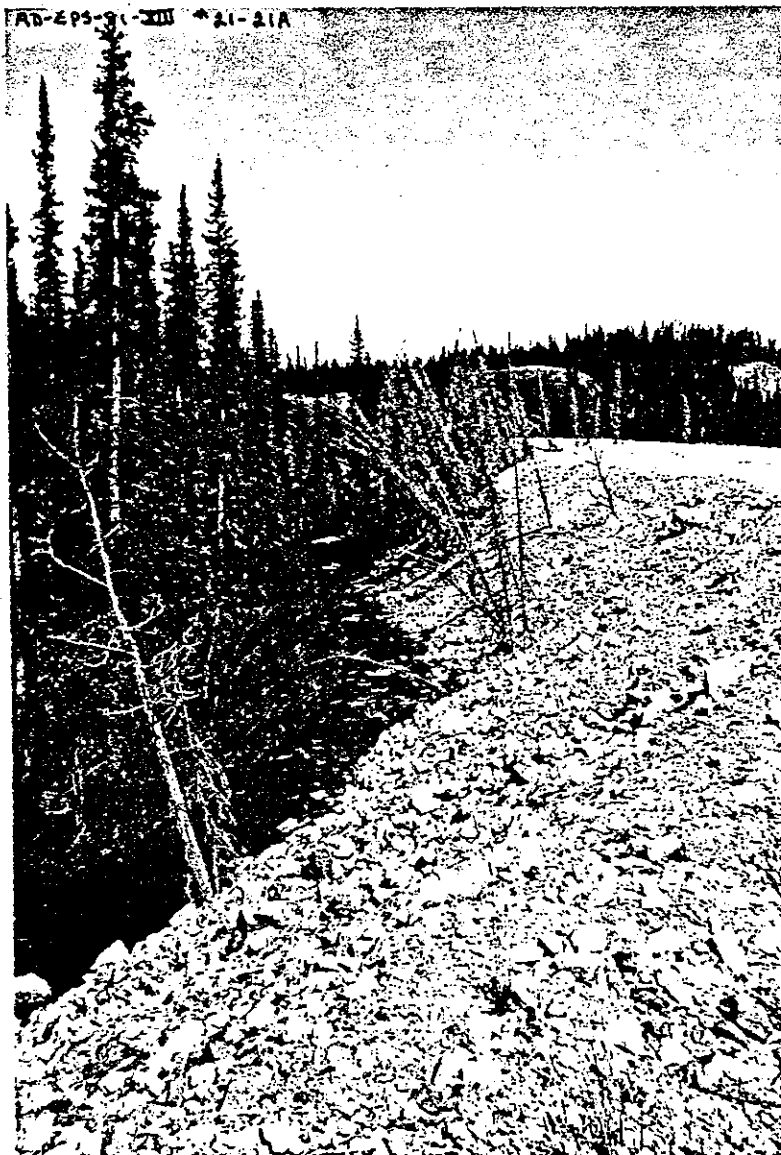
FIGURE 23. COMPARE STREAM BANKS OF WOLF CREEK ON WHITEHORSE COPPER PROPERTY IN TERMS OF VEGETATION.

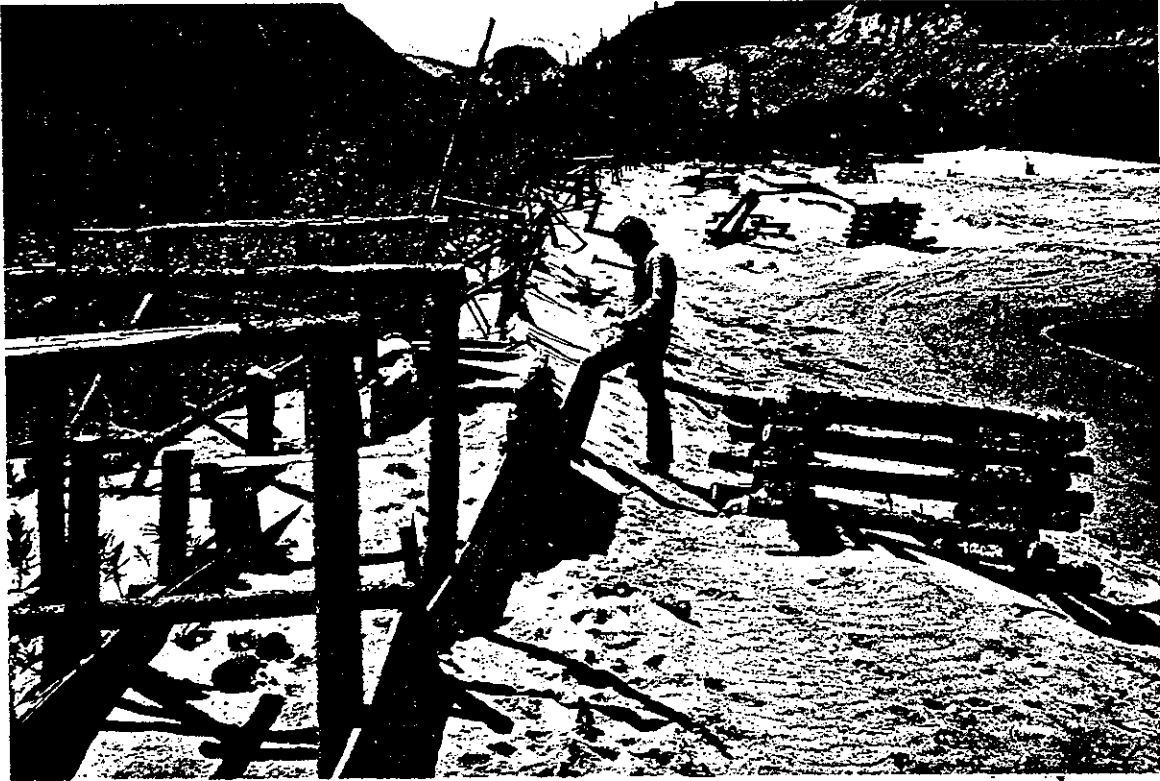
FIGURE 24 BERM OF THE TAILINGS POND AT VENUS MINE HAS COLLAPSED.

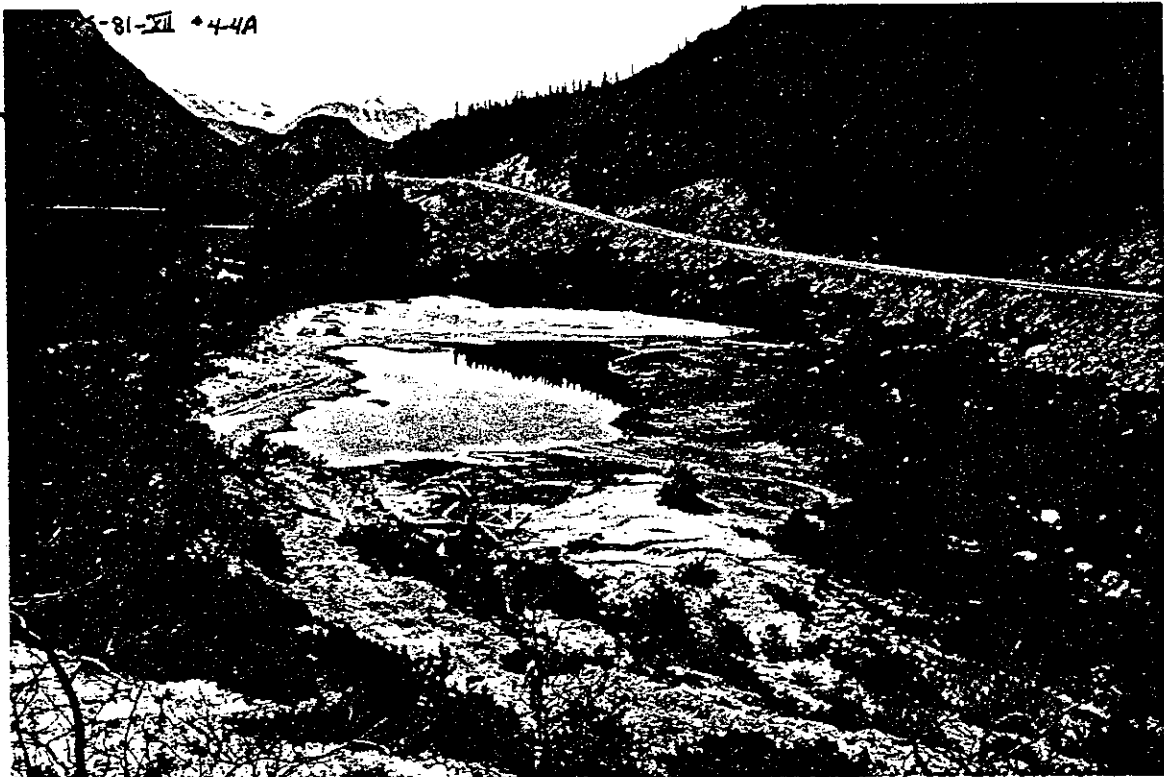
FIGURE 25 TAILINGS POND OF VENUS PROPERTY. WHILE IT HAS DRIED UP CONSIDERABLY SINCE TIME OF ABANDONMENT, HIGH WATER LEVELS IN THE POND (DURING SPRING MELT) MAY FLOW OVER THE BREACHED BERM (IN UPPER LEFT-HAND CORNER OF POND).

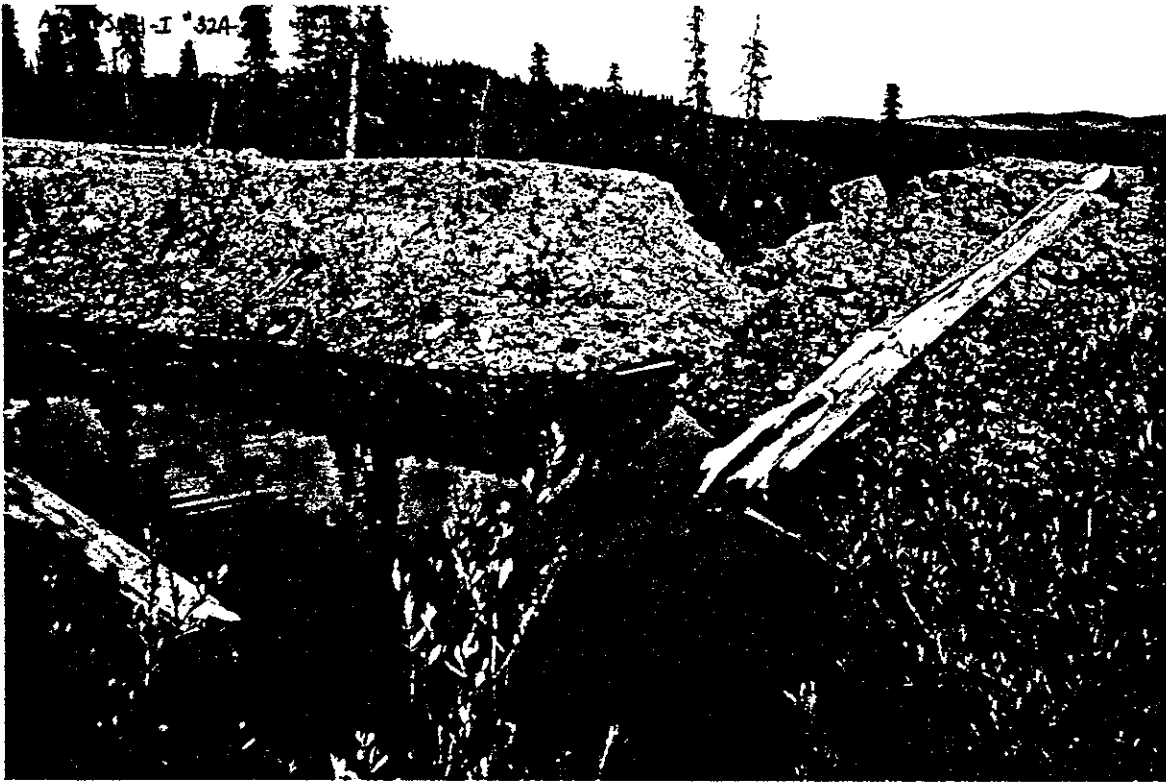
FIGURE 26 SECOND TAILINGS POND AT MOUNT NANSEN SHOWS A BREACHED EMBANKMENT.

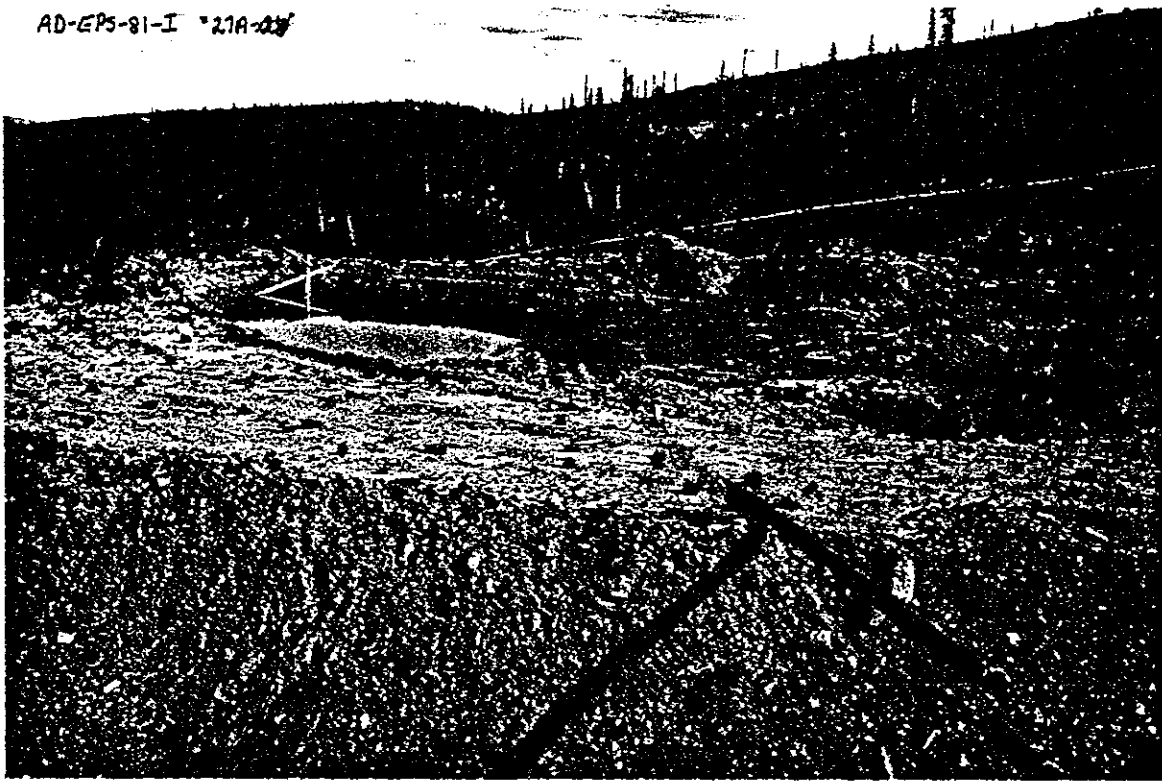
FIGURE 27 A SEVERED PIPE CONNECTING TAILINGS PONDS 2 AND 3 AT THE MOUNT NANSEN PROPERTY IS EVIDENT. (LOWER RIGHT HAND CORNER).

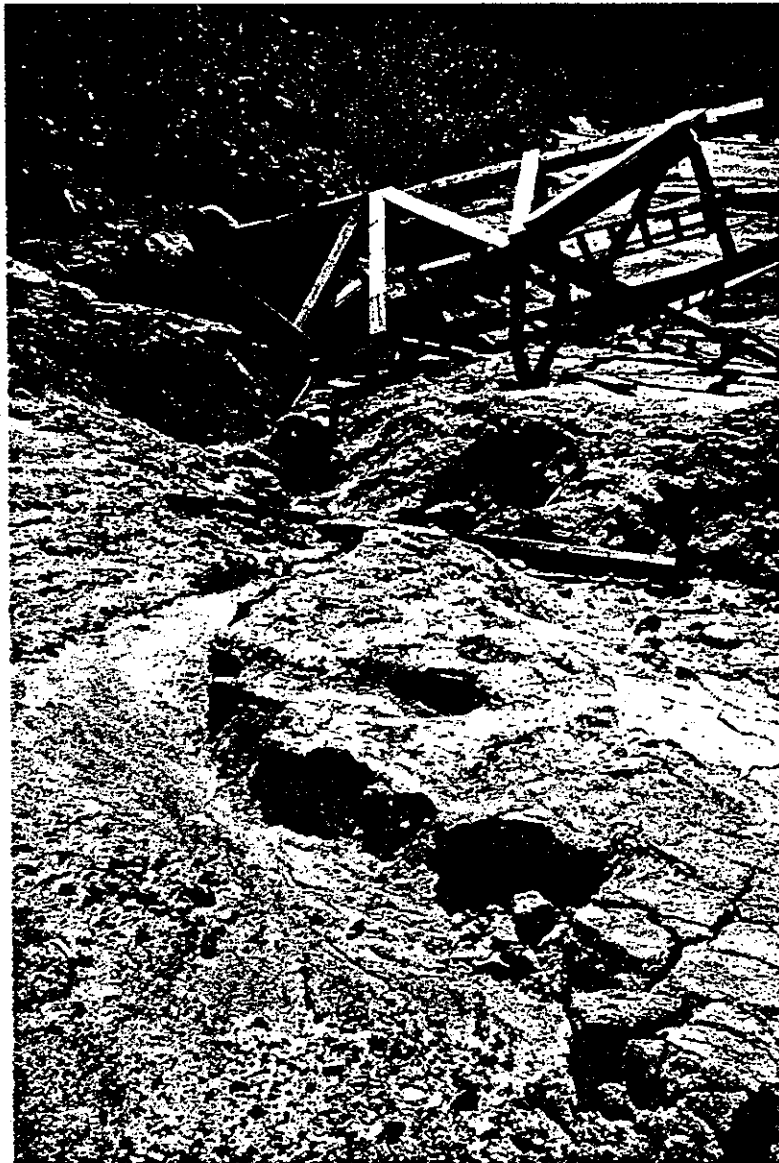
FIGURE 28 EROSION ON THE MOST EASTERLY SIDE OF TAILINGS POND ON THE VENUS MINE PROPERTY. NOTE THAT ZONE IS NOT MAINTENANCE FREE.

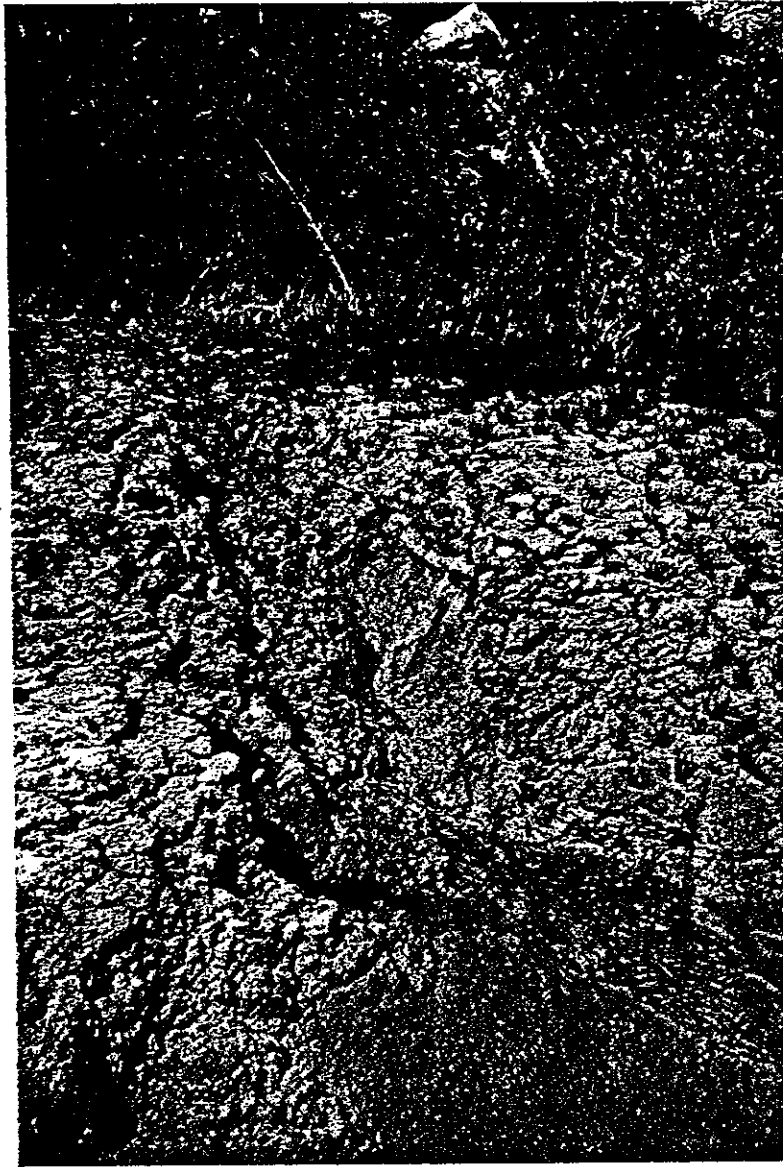
FIGURE 29 NATURAL BREACH UPSLOPE OF THE VENUS MINE TAILINGS. SEVERE GULLY EROSION IS EVIDENT.

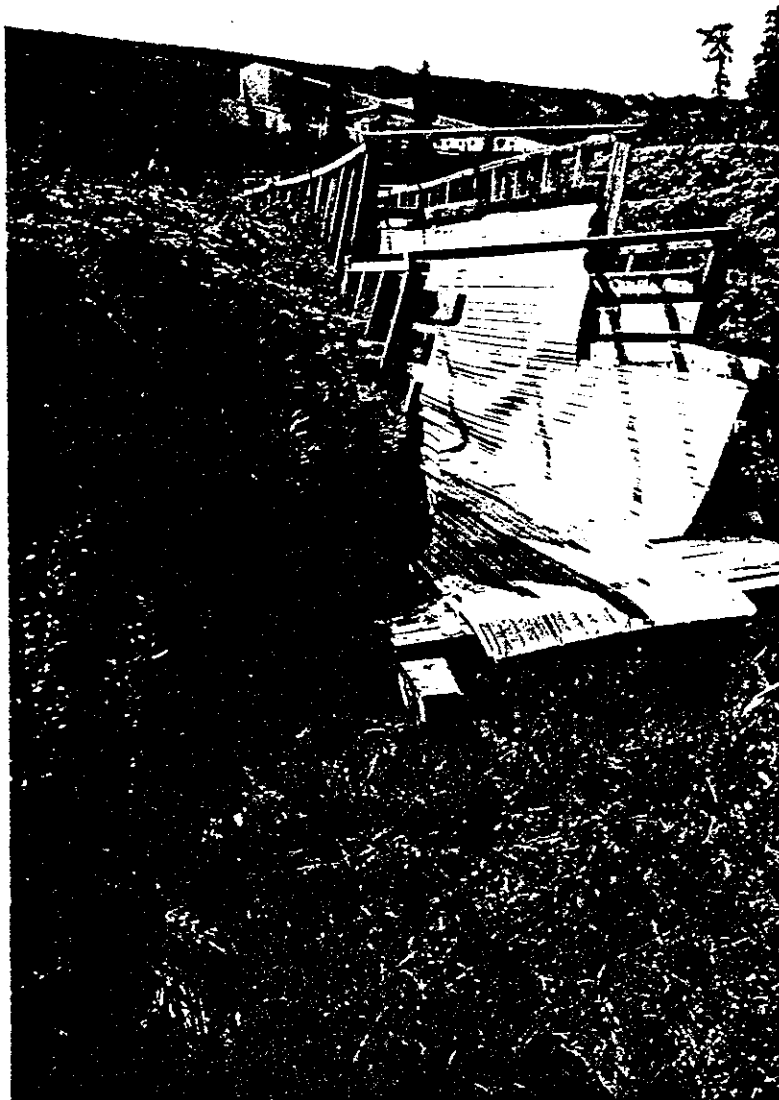
FIGURE 30 MOUNT NANSEN OVERFLOW SYSTEM MINIMIZES EFFECTS OF HIGH WATER BUILD-UP IN THE IMPOUNDMENT AREA. BANK STABILITY IS MAINTAINED.

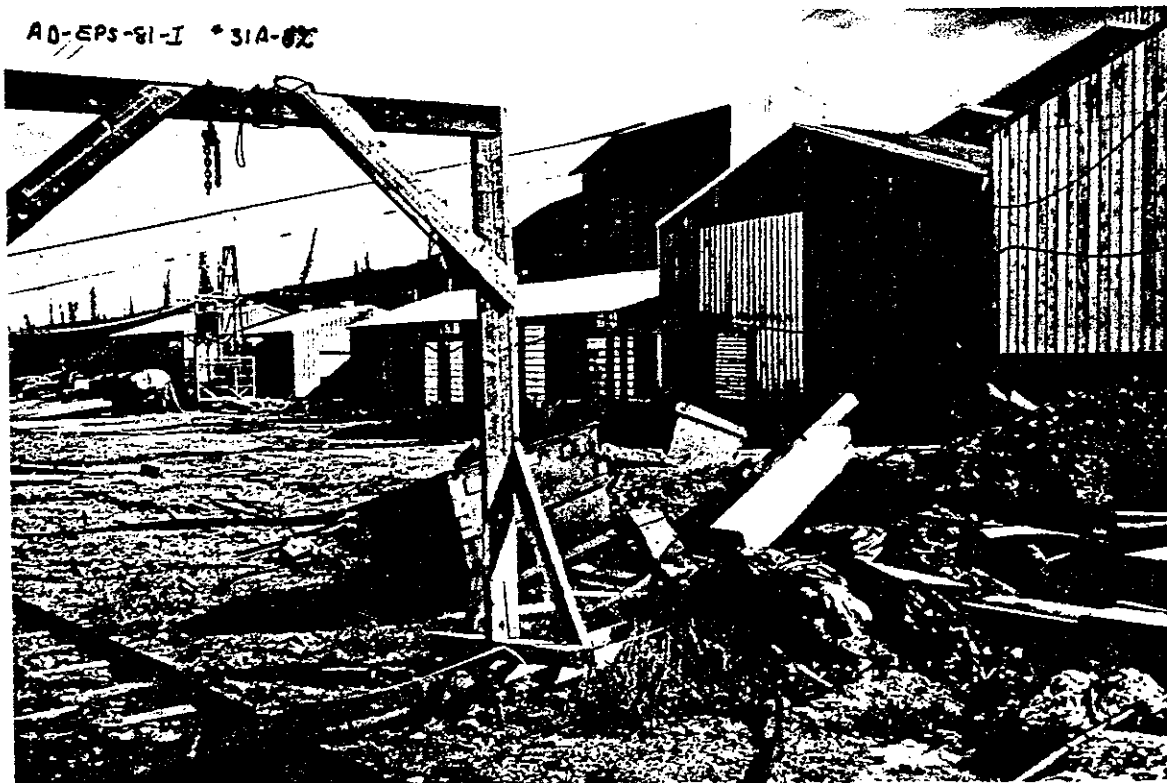
FIGURE 33 ABANDONED MILL SITE ON THE MOUNT NANSEN PROPERTY. NOTE:
OPEN ACCESS TO BUILDINGS.

4.4.2 Mitigation of Intensive Land Use Disturbances. All buildings, machinery and equipment should be removed, when a mine is shut down and the mine plant removed, (upon permanent abandonment) as is required in British Columbia (Ministry of Energy, Mines and Petroleum Resources for the Province of British Columbia, 1979). In B.C. all scrap material
