REPORT ON 1983 REMEDIAL WORKS

PROJECT: MINE WASTE DUMPS
CLINTON CREEK ASBESTOS MINES

LOCATION: CLINTON CREEK, YUKON TERRITORY

CLIENT: BRINCO MINING LIMITED
CASSIAR DIVISION

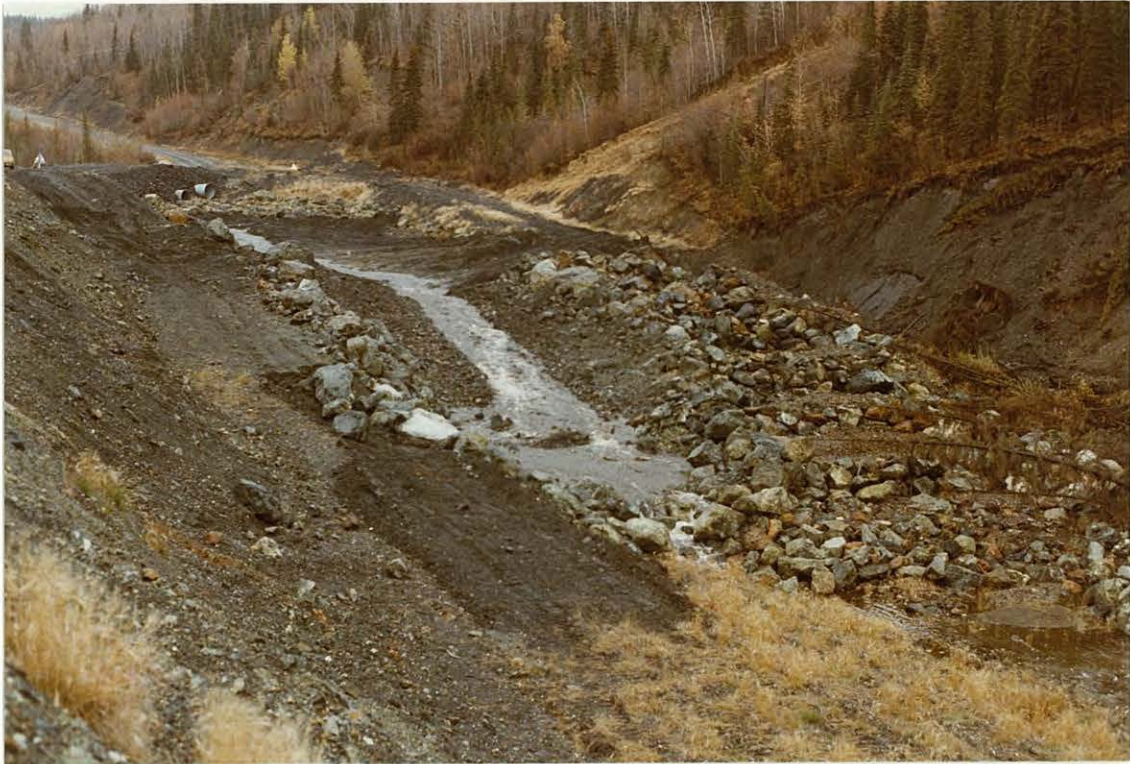
Photograph 1: Channel diverted to right hand side of creek. Ends of rock weirs removed.

Initially, the creek was diverted to the right hand side by using a D6 Cat to remove the right-hand ends of the rock weirs. The upstream end of the erosion gully was then backfilled with mine waste to the former road level to form a plug. The mine waste was obtained from the toe of the waste dump on the right hand side of the creek. The plug was then constructed to full height, about 11 feet above the creek bed level and geotextile filter fabric was placed on the sloping face. A further 12 inches of mine waste was placed on top of the geotextile and

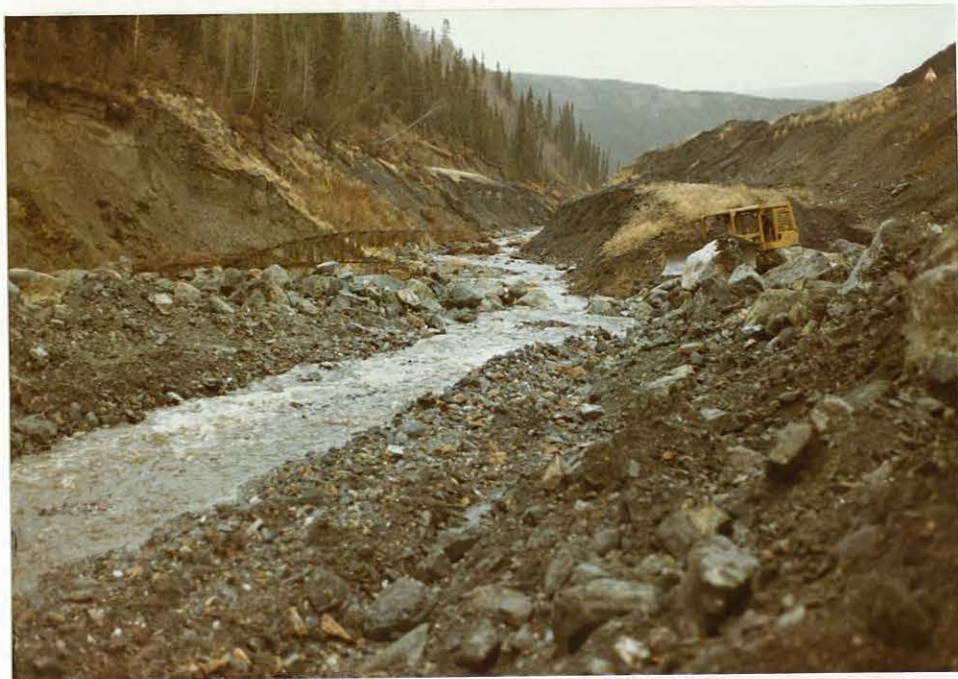
Photograph 2: Looking downstream - rock weirs removed at right hand side.

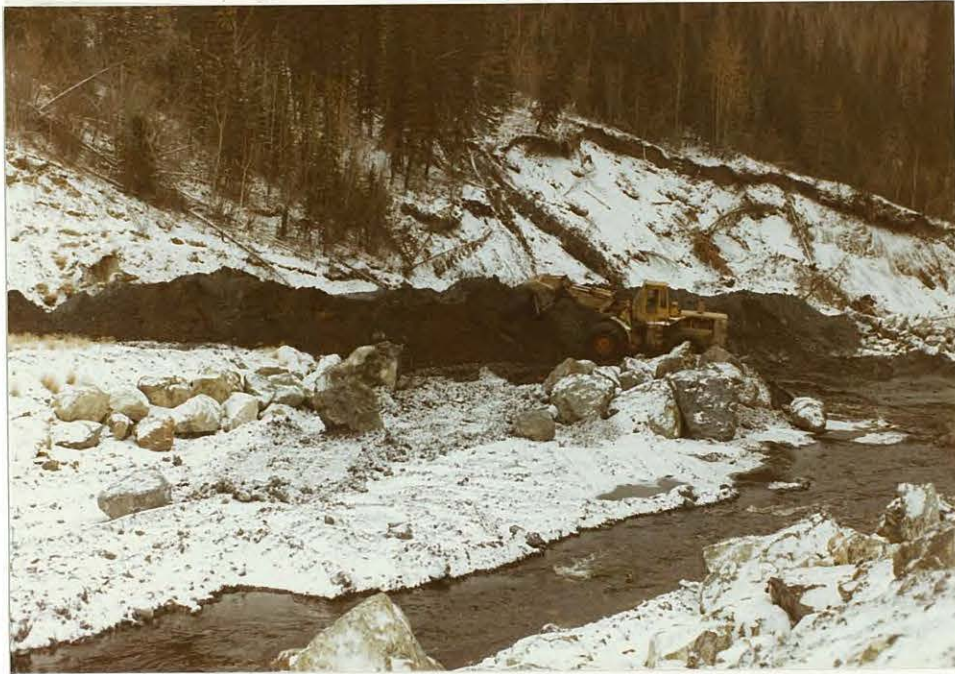
Photograph 3: Constructing plug at upstream end of left bank erosion channel.

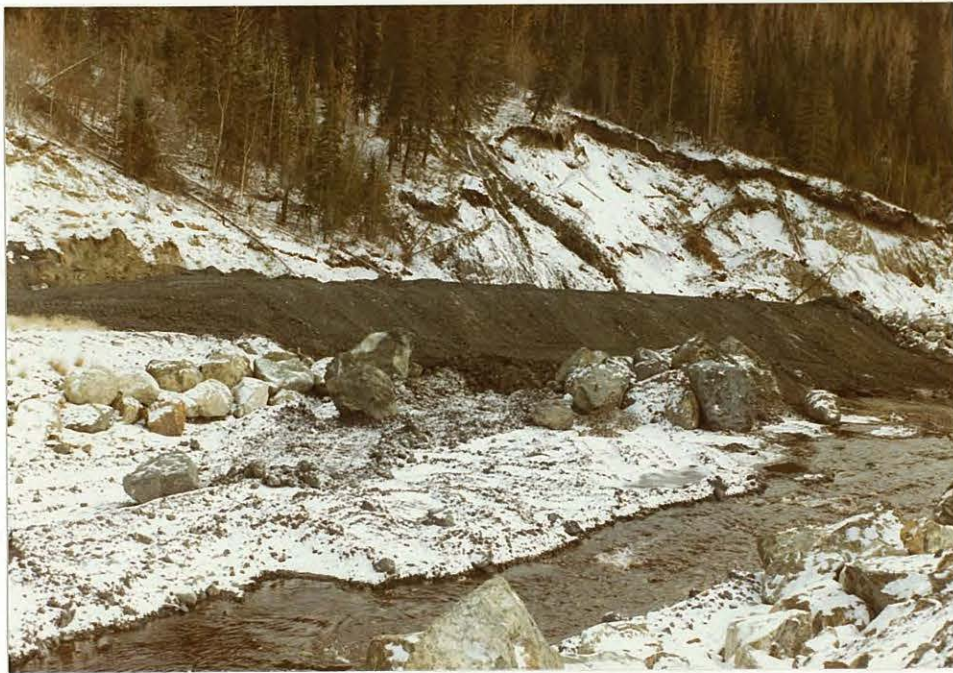
Photograph 4: Plug formed - ready for geotextile.

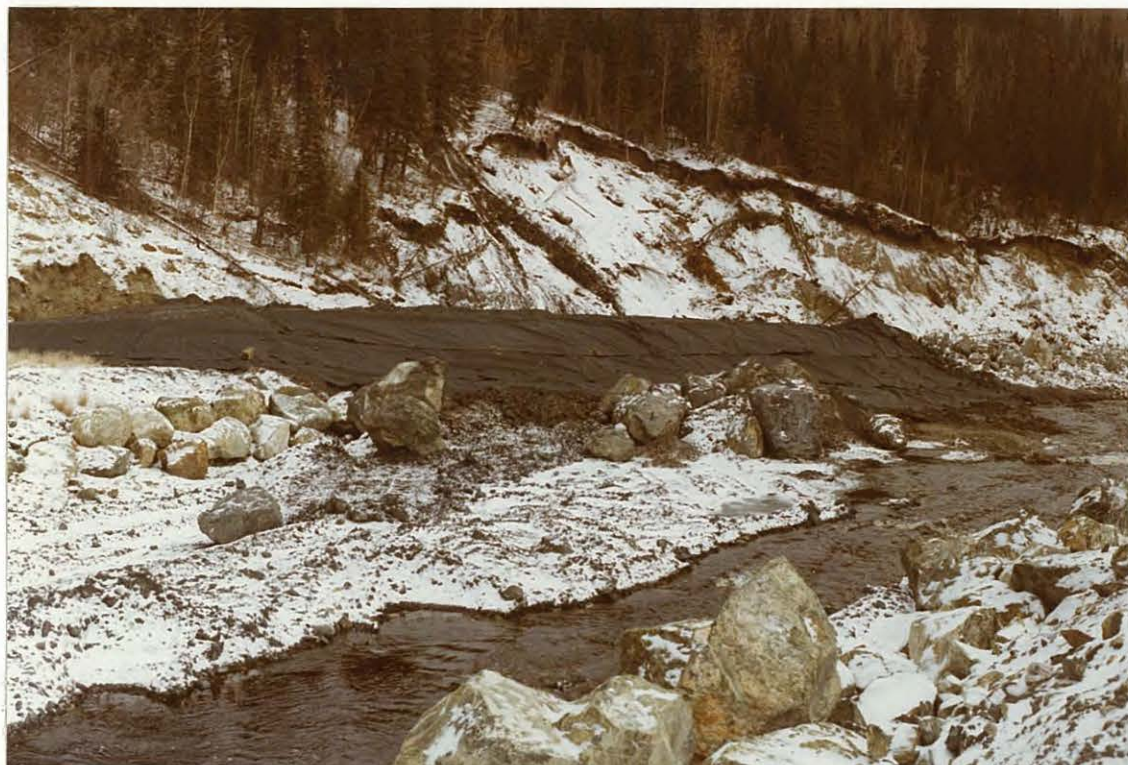
Photograph 5: Geotextile placed on slope of plug.

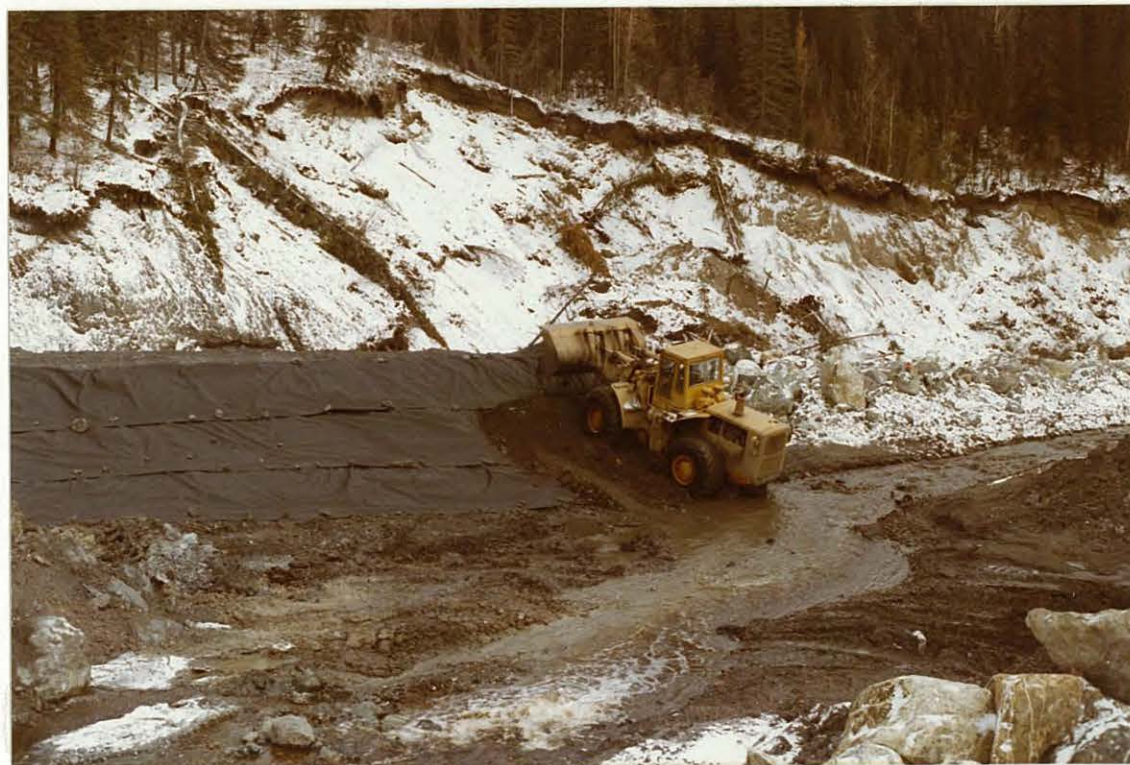
Photograph 6: Placing 12 inch of Mine Waste over geotextile.

riprap slope protection was installed. The filter fabric (Mirafi P-600X) was obtained from Canada Nylex. The riprap was borrowed from the remains of the rock weirs. The channel as it is now formed has riprap rock placed along each side of the creek to the toe of the original rock weirs, but does not have riprap lining across the creek bed. The previously installed rock ribs, which may have caused overtopping of the channel banks during the 1982 freshet, have been removed.

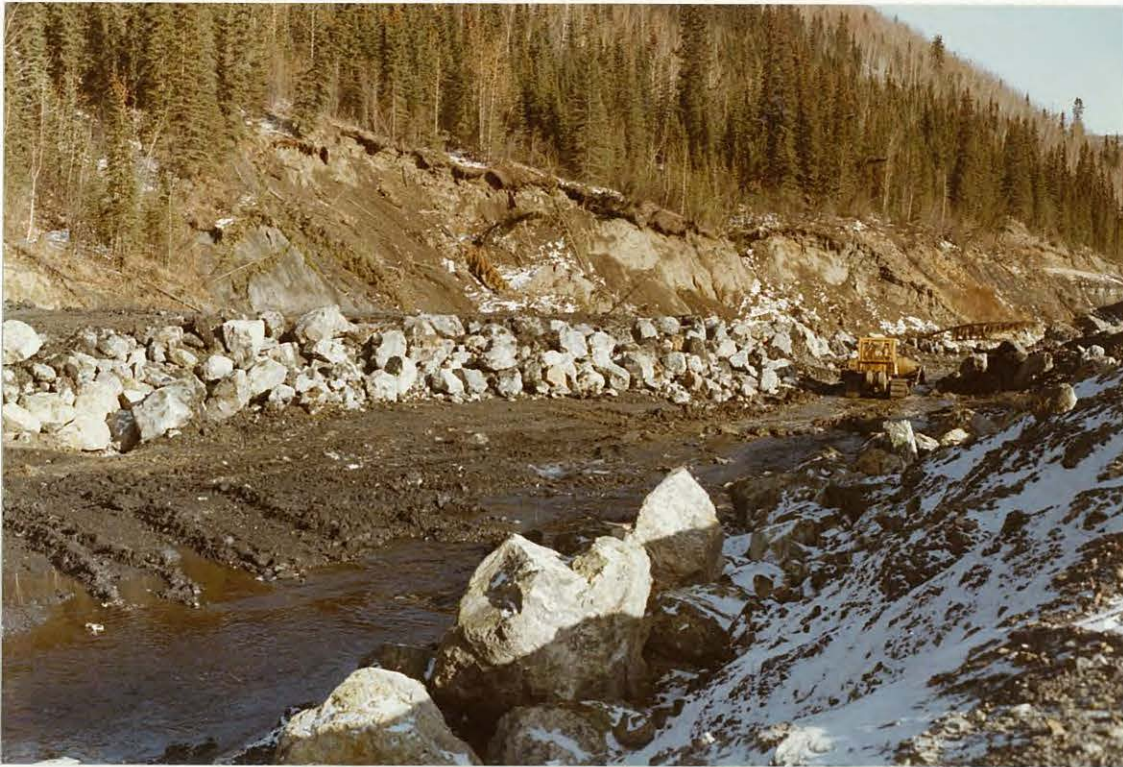
Photograph 7: Left bank protection with riprap in place.

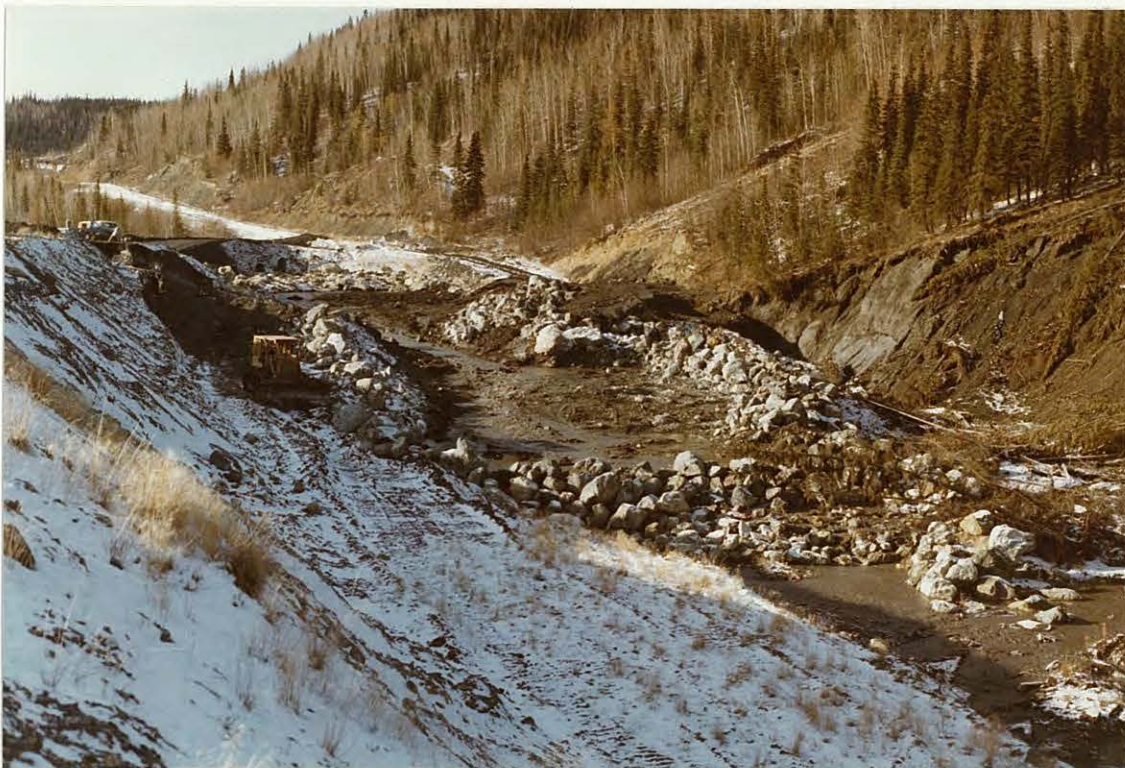
Photograph 8: Finished left bank protection. Note bottom weir left intact.

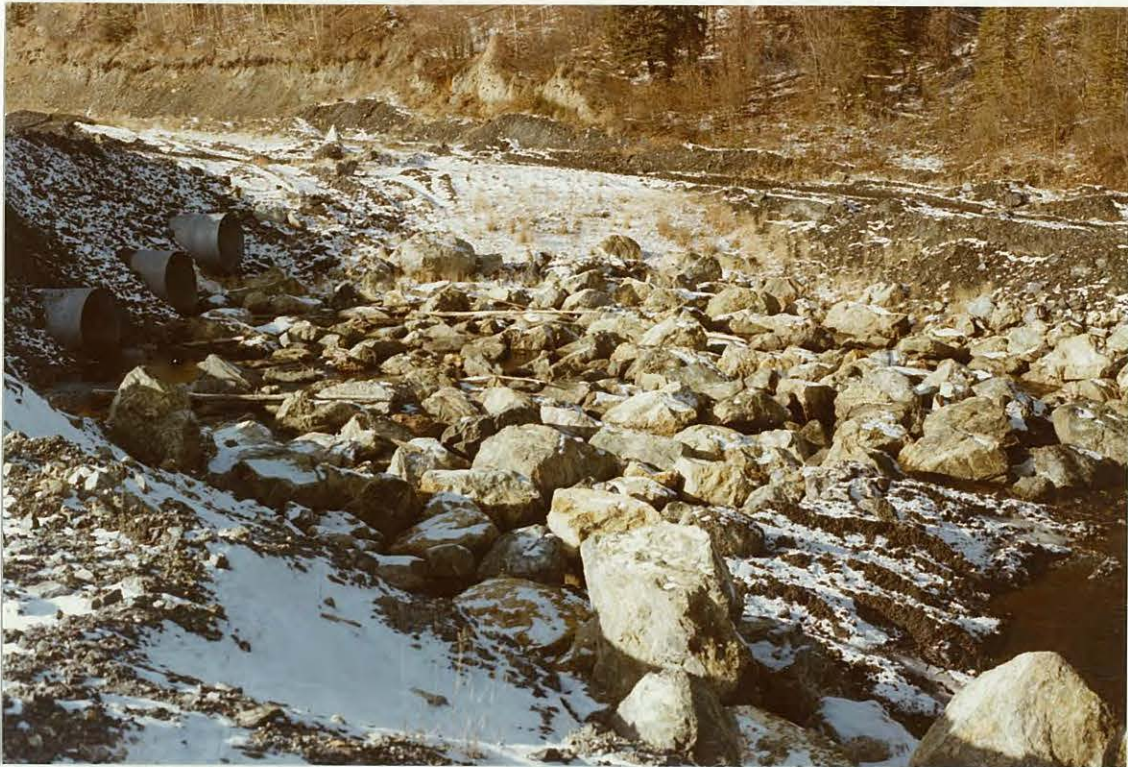
Photograph 9: Riprap at outlet of culverts.

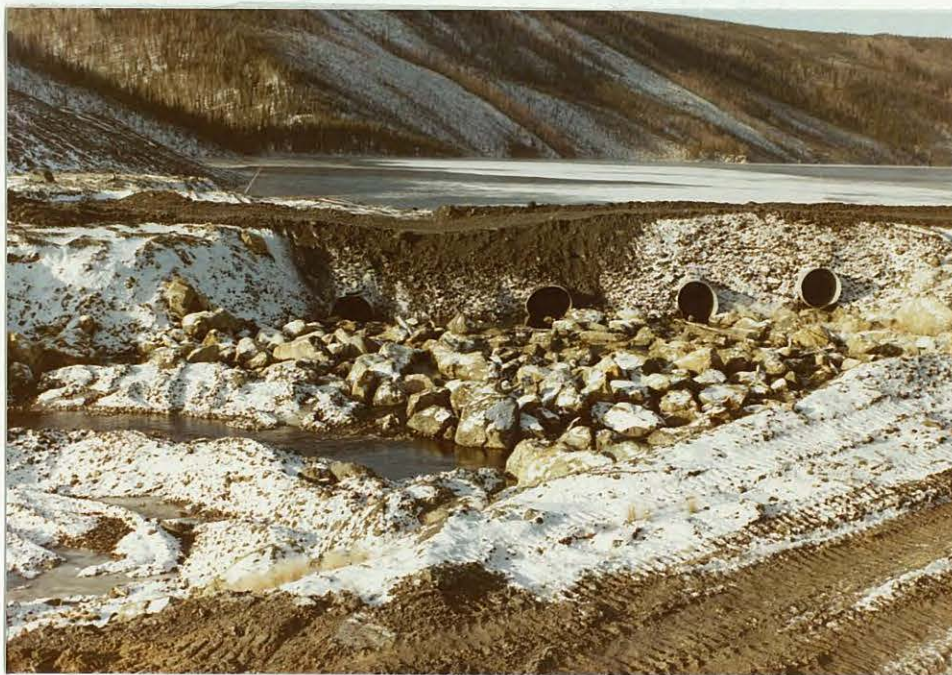
Photograph 10: Low point over culverts forming emergency overflow channel.

A low point was formed in the road embankment over the culverts to ensure that the lake would spill into the creek channel in the event that the culverts become blocked. Mr. Bob Clarke from Cassiar Division performed survey work during the construction period. This included survey of closure points at the toe of the waste dump, establishment of a new survey reference pin near the culverts and a longitudinal profile down the creek. Survey cross-sections were not obtained due to the inclement weather conditions.

A low, emergency overflow area has been constructed in the road embankment across Clinton Creek to provide protection against a sudden release of water from Hudgeon Lake that might bypass the protected area, should plugging of the culverts occur.
