REPORT ON MINE WASTE DUMPS

PROJECT: CLINTON CREEK ASBESTOS MINE  
LOCATION: CLINTON CREEK, YUKON TERRITORY  
CLIENT: BRINCO MINING LIMITED

OUR FILE: PB 3169-0101 AUGUST 16, 1983

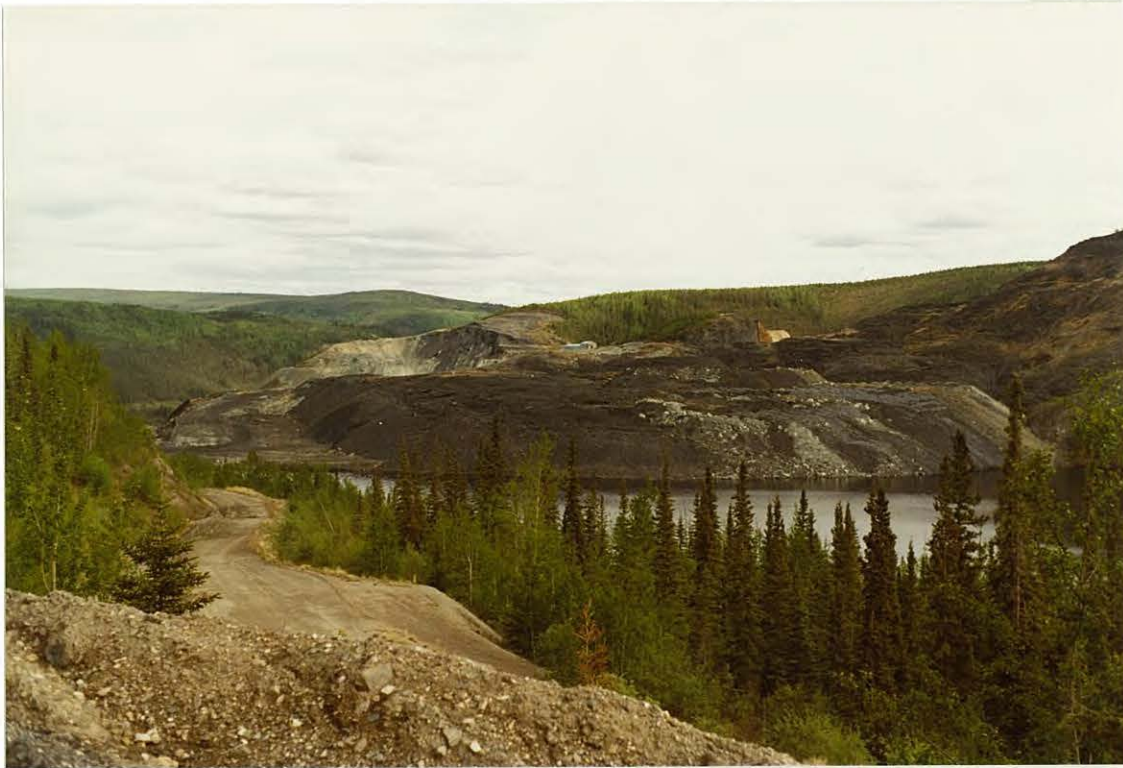
Photo 1

water up to about 85 ft deep known as Hudgeon Lake. Photograph 1 shows a view of Hudgeon Lake and the waste dump.

The waste dump and Hudgeon Lake, looking southeast. The outlet to Clinton Creek is at the left of the photo.

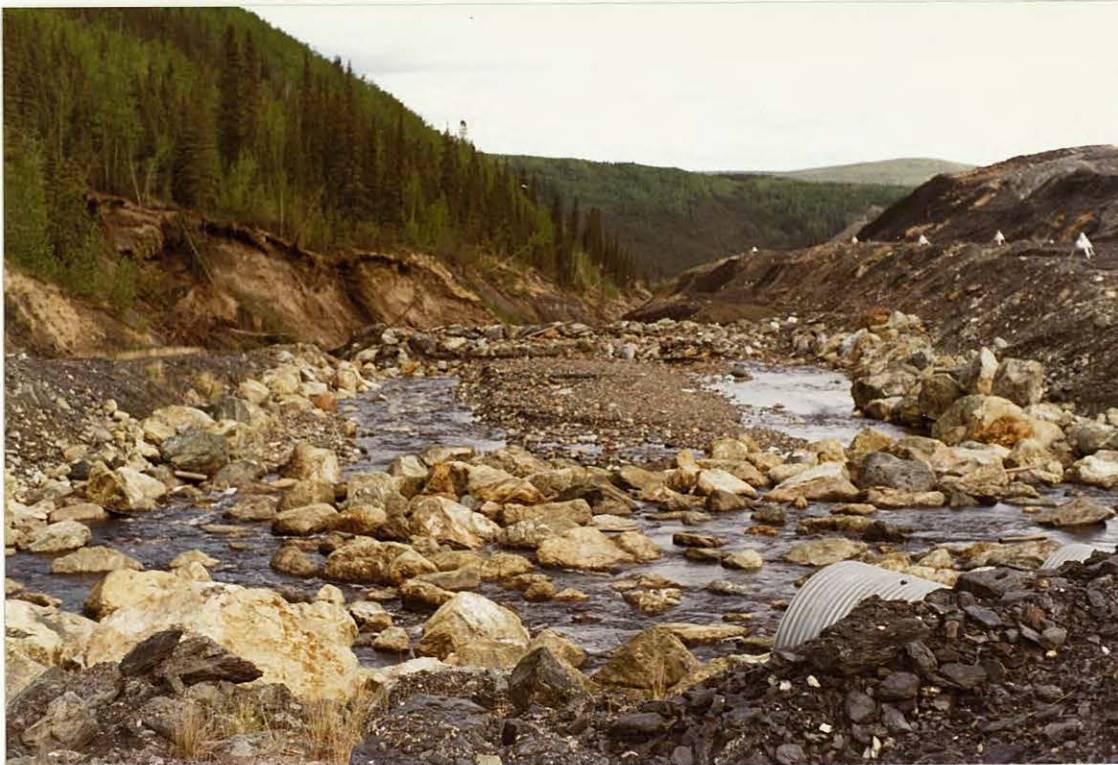
Photo 2

The level of Hudgeon Lake, at the upstream end of the waste dump channel, is controlled by four 6-ft diameter culverts which are set in the stream crossing of the access road to the Clinton millsite. The four culverts are set at different elevations. On June 8 and 9, 1983, the lowest culvert was nearly submerged at its upstream end and a second culvert was running partially full.

Downstream of the culverts is an apron of coarse rock, followed by a low gradient section of channel with a bed of cobbles and small boulders. A view downstream of the culverts is shown on Plate 2.

The apron at the outlet of the culverts, looking east.

Cassiar anticipates completing reclamation and abandonment of the mill facilities in 1985, so that the access road across Clinton Creek will no longer be required. We recommend that the four culverts at the outlet of Hudgeon Lake be removed at that time and the outlet channel be cut down to the existing level of the rock apron downstream of the culverts.

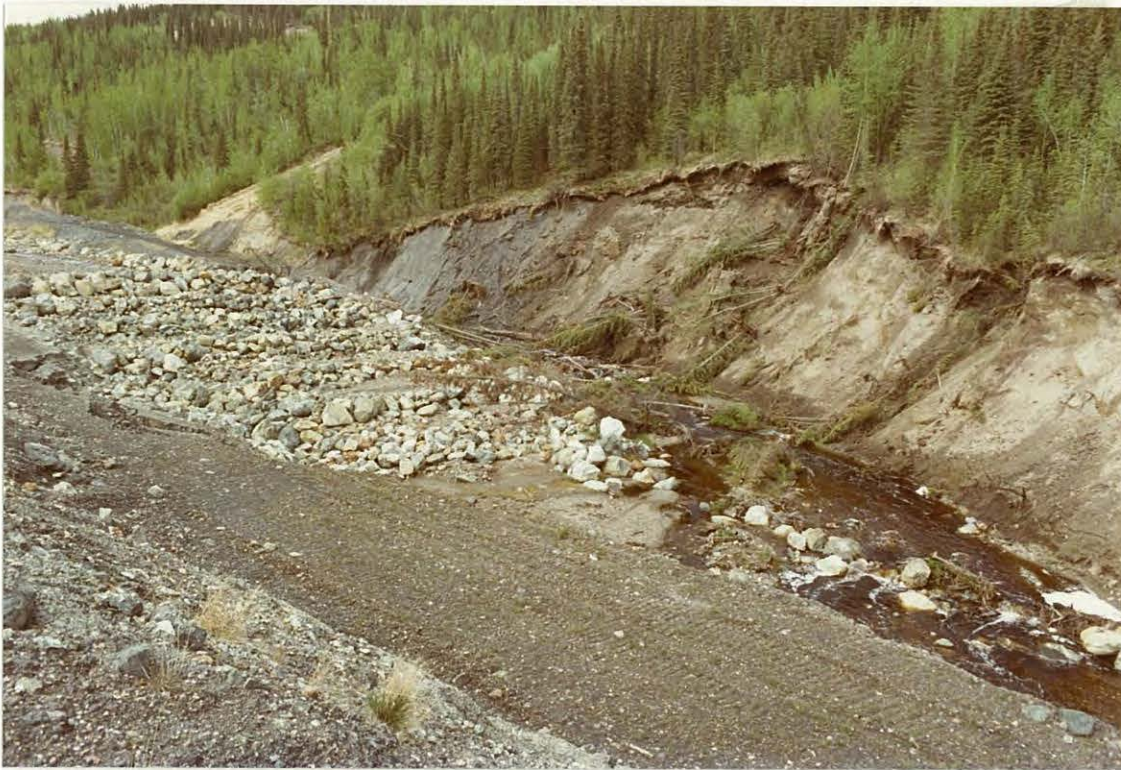
Photo 3

The present upstream end of the rock-lined section consists of a rock-fill rib of height about 6 ft, which serves to deflect the stream to the left. There deep downcutting into soft original ground has carved a channel some 8 ft lower than the rock channel level. That first rib appears to have been constructed to an elevation nearly equal to the top of the channel lining upstream, possibly causing failure by over-  
topping of the channel sides. *look at elev. on drawing*

*#20 B # 9*  
The erosion of the natural left bank materials has created an erosion scarp up to about 50 ft in height. At the upstream end of the eroded channel, bedrock appears on the left bank so that a control against further rapid erosion in that area is in place. Further downstream, soil is exposed over the entire slope adjacent to the rock-lined section. The soil appears to be a fan-shaped deposit of colluvial material which has infilled a notch in the bedrock topography (see Photograph 3).

View of the eroded left bank and the ribbed channel structure, looking northwest.

We therefore recommend that the left bank scour channel be backfilled and protected by riprap obtained mainly from the rock-ribbed channel section. A suitable riprap filter layer should be provided, probably obtainable from the supply of mill overs at the plantsite. The lining of the left bank should extend upstream to the outlet of the culverts and downstream beyond the eroded portion of the bank. The rock armouring on the low gradient portion of the channel just downstream of the culverts should be upgraded to control erosion at the outlet of Hudgeon Lake. The work should be carried out during the summer of 1983 to prevent further scour during the 1984 freshet. We recommend that the work be carried out under the supervision of an experienced field engineer.

- a) Remove the waste dump ends of the existing rock ribs and divert the stream into that area.
- b) Backfill the scour channel on the left.
- c) Place filters and riprap protection on left bank backfill material and in the apron on the left side of the channel bed. Improve the riprap lining of the stream channel at the outlet of the culverts.

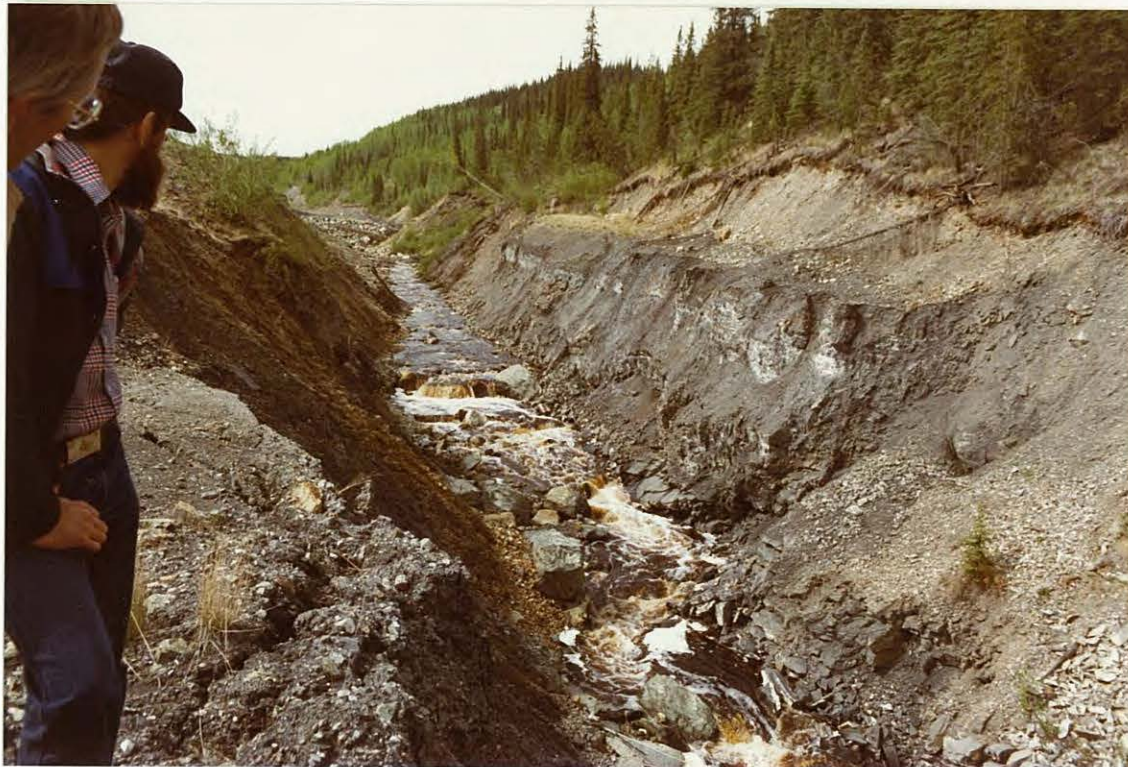
Photo 4

Downstream of the rock-ribbed section, the stream has exposed bedrock in the left bank and the channel has an estimated slope of about 4.5%. A number of large rock fragments have accumulated in the channel bottom.

The right bank is bounded by waste dump material, which is oversteepened and undergoing continual minor erosion. The channel appears stable against rapid downcutting. A typical view of the channel is shown on Photograph 4. A survey profile of the channel bottom and a number of survey cross-sections of the channel should be established so that changes can be monitored over the next few years prior to abandonment.

Typical view of the Clinton Creek channel over the waste dump, looking upstream. Failed rock channel in the distance.

Dump movement monitoring should be continued on an annual basis up to 1985, in an attempt to improve forecasting of long term movement rates. In addition, a number of survey cross-sections of the channel should be carried out in 1983 and repeated annually through 1985 to monitor the rate of downcutting of the channel.
