REVIEW REPORT  
ON  
ABANDONMENT PLAN FOR  
CLINTON CREEK ASBESTOS MINE

Prepared for:  
Northern Affairs Program  
Whitehorse, Y.T.

December, 1986

G 052-2

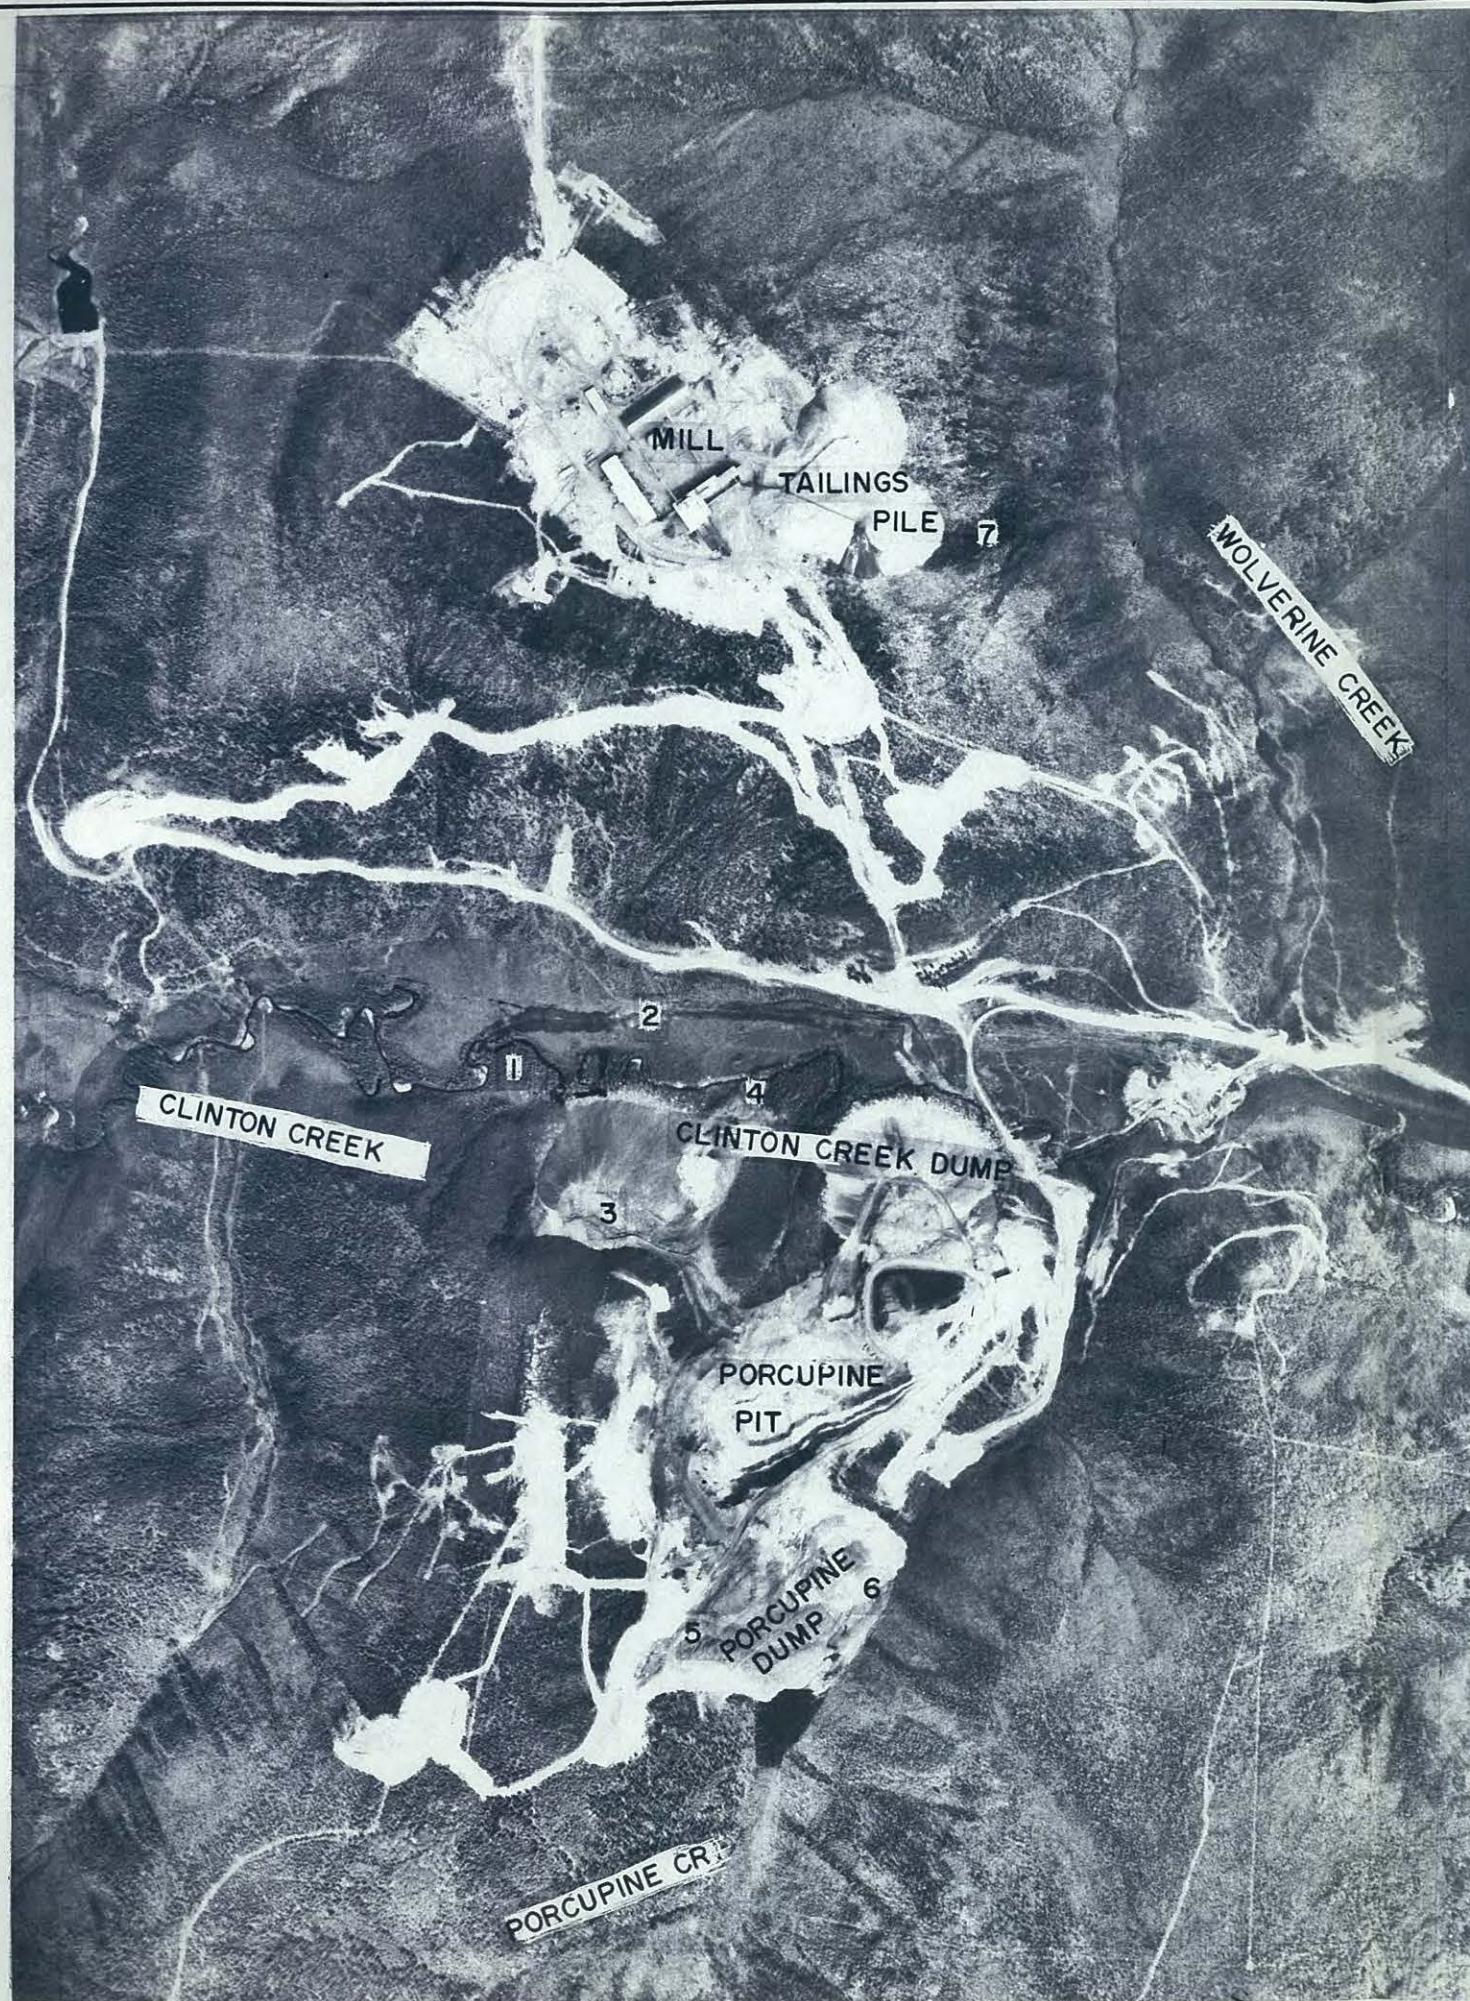
BOTH CLINTON CREEK AND PORCUPINE CREEK DUMPS WERE UNSTABLE ALREADY IN 1970.  
MAIN INSTABILITY FEATURES SHOWN ON AIRPHOTO :

3- FISSURES ON TOP OF THE DUMP

5- FISSURES ON TOP OF THE DUMP

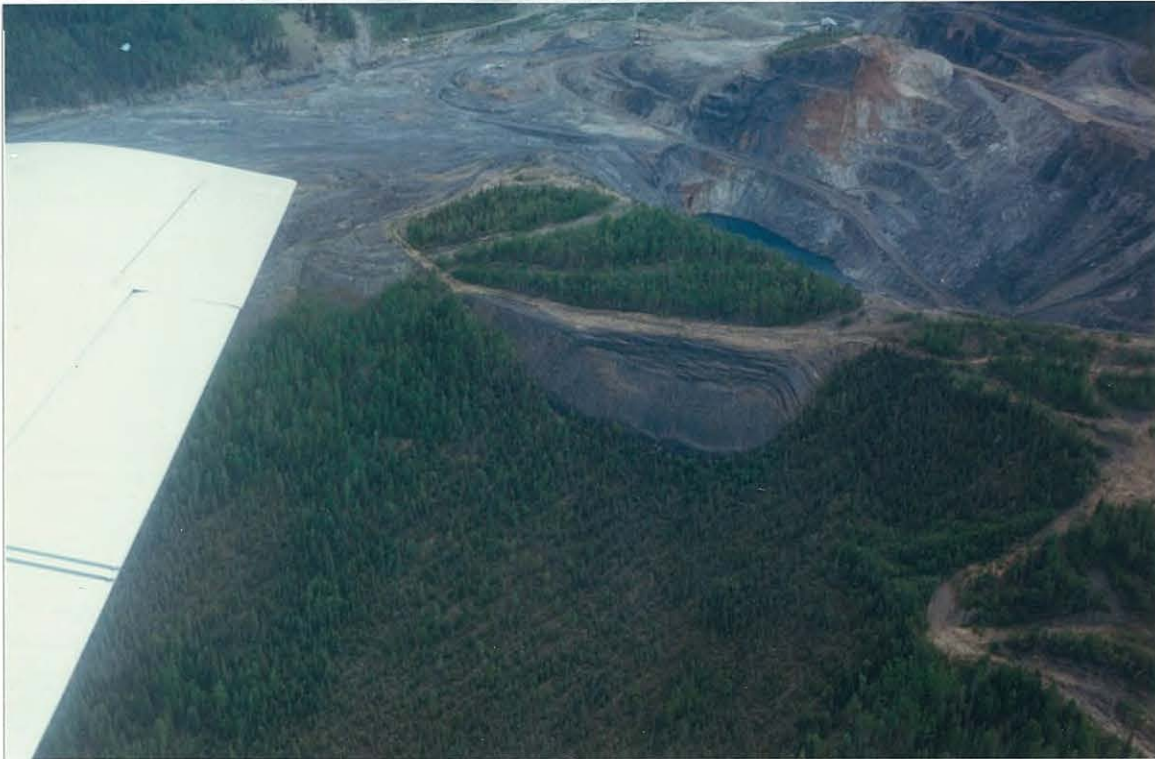
Photo 1: View of Porcupine Pit and a small unstable waste dump, looking east (June, 1983).

The open pits expose bedrock and Porcupine pit contains a lake (Photos 1 and 2). They have a local impact on the groundwater regime and permafrost table. The walls of the pits are unstable and in the long run, they will degrade to a rubble covering bedrock. The slope failures are confined to the pit areas with little or no impact on the surrounding ground.

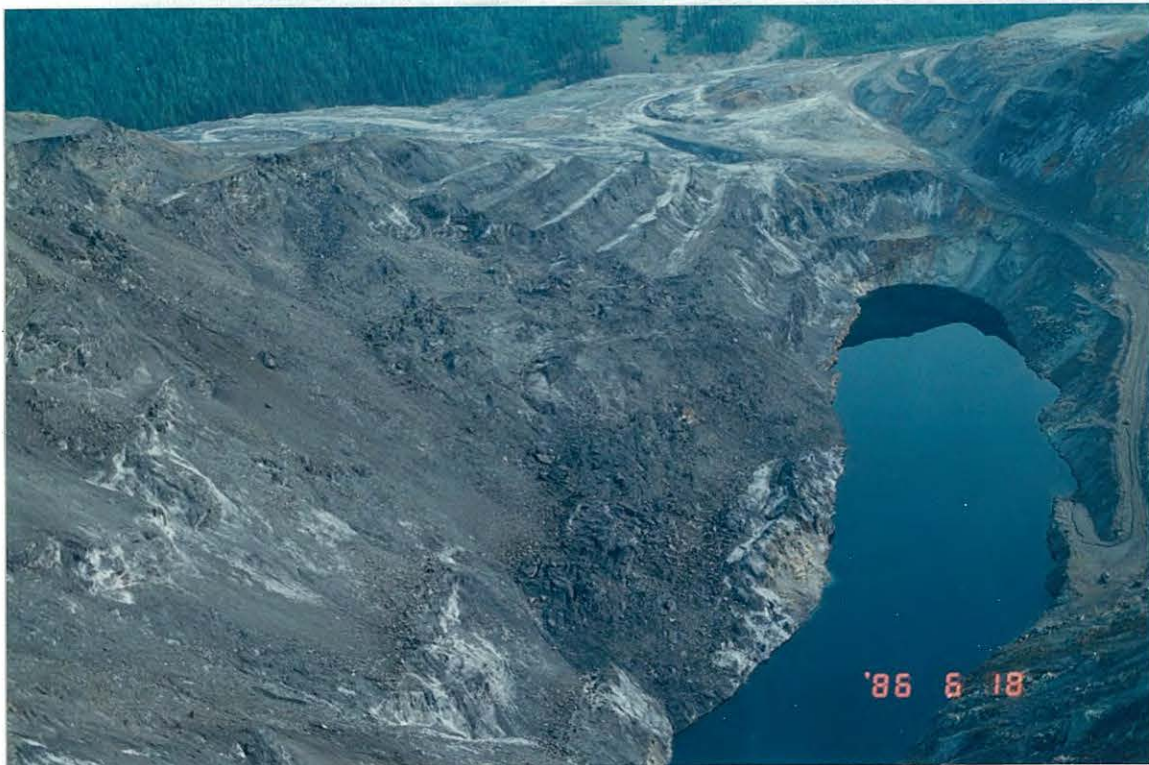
Photo 2: Porcupine Pit looking north. Note unstable west and south walls.

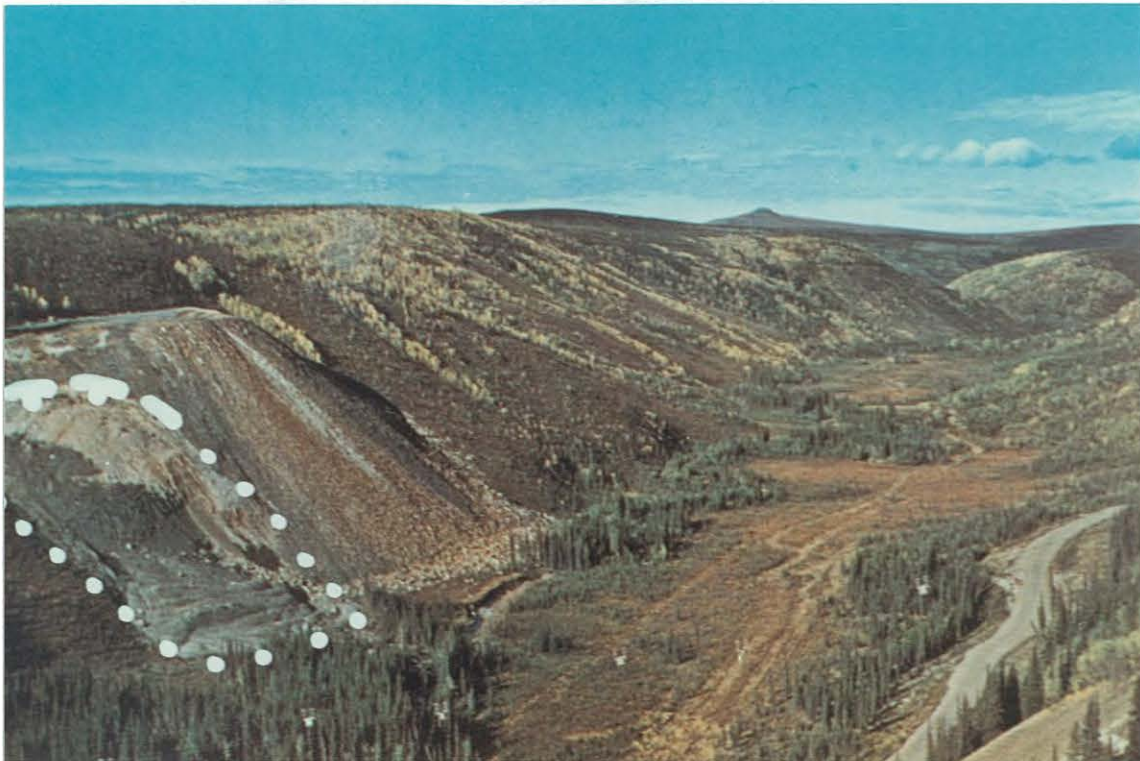
Photo 3: Clinton Creek and the waste dump, probably in 1970. Note slide on left side of the dump.

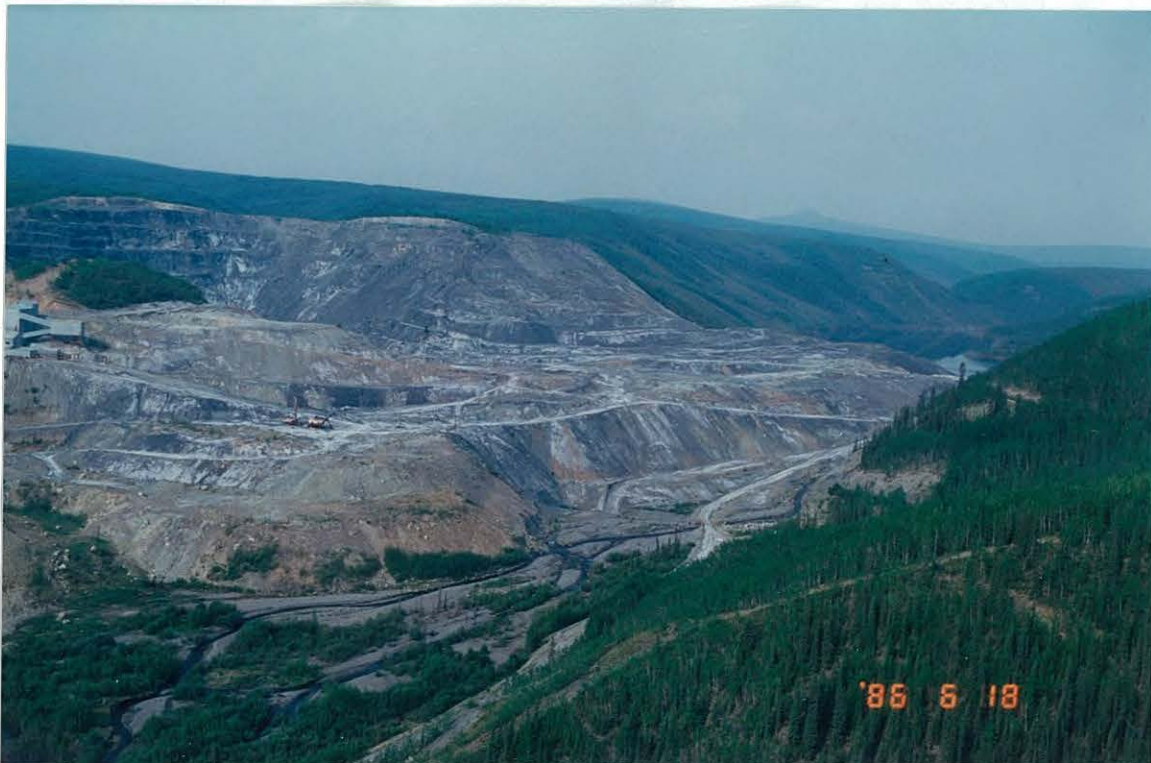
Photo 4: Clinton Creek valley and Porcupine Pit in 1986.

The major portion of overburden rock from the Porcupine pit was dumped over the slope which forms the south wall of the Clinton Creek valley. Originally, the valley floor was flat-bottomed with a width of about 240 m and Clinton Creek meandered within the valley bottom (Photo 3). As the toe of the dump reached the valley floor, it began to spread over the low shear strength, presumably ice-rich alluvial soils comprising the valley bottom. As more waste material was placed on the dump, the dump continued to spread until the entire valley bottom was blocked (Photo 4).

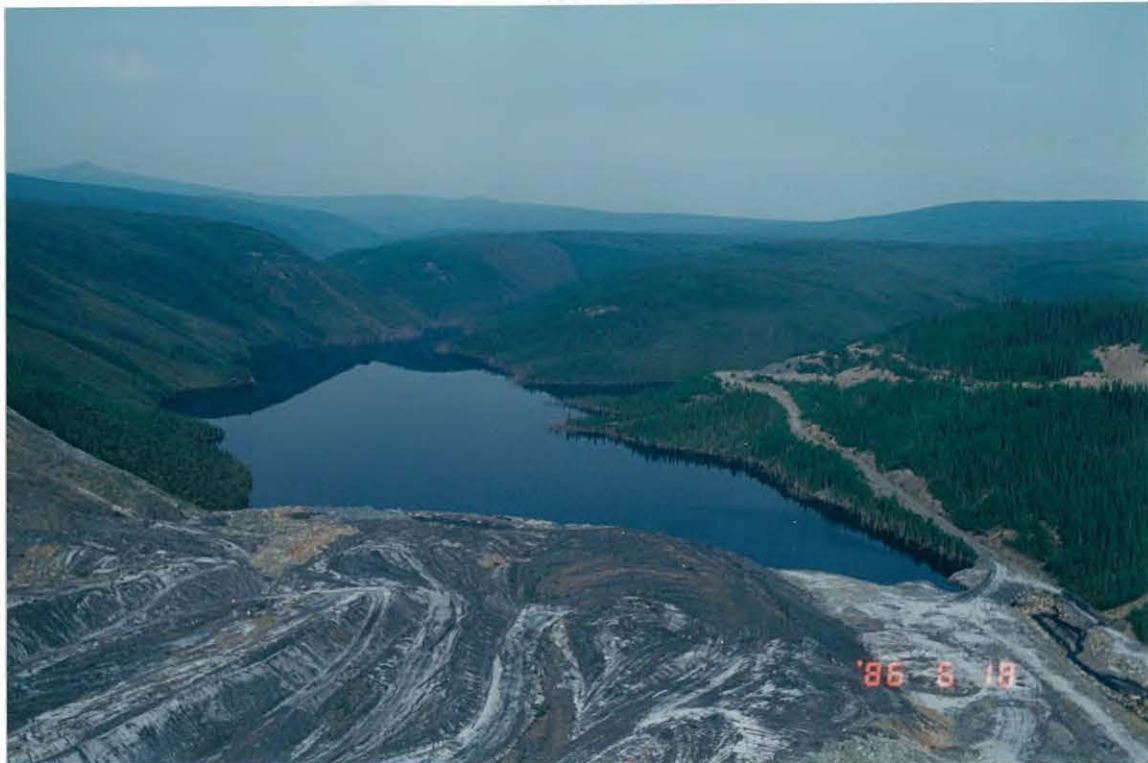
Photo 5: Hudgeon Lake and the upstream segment of the waste dump.

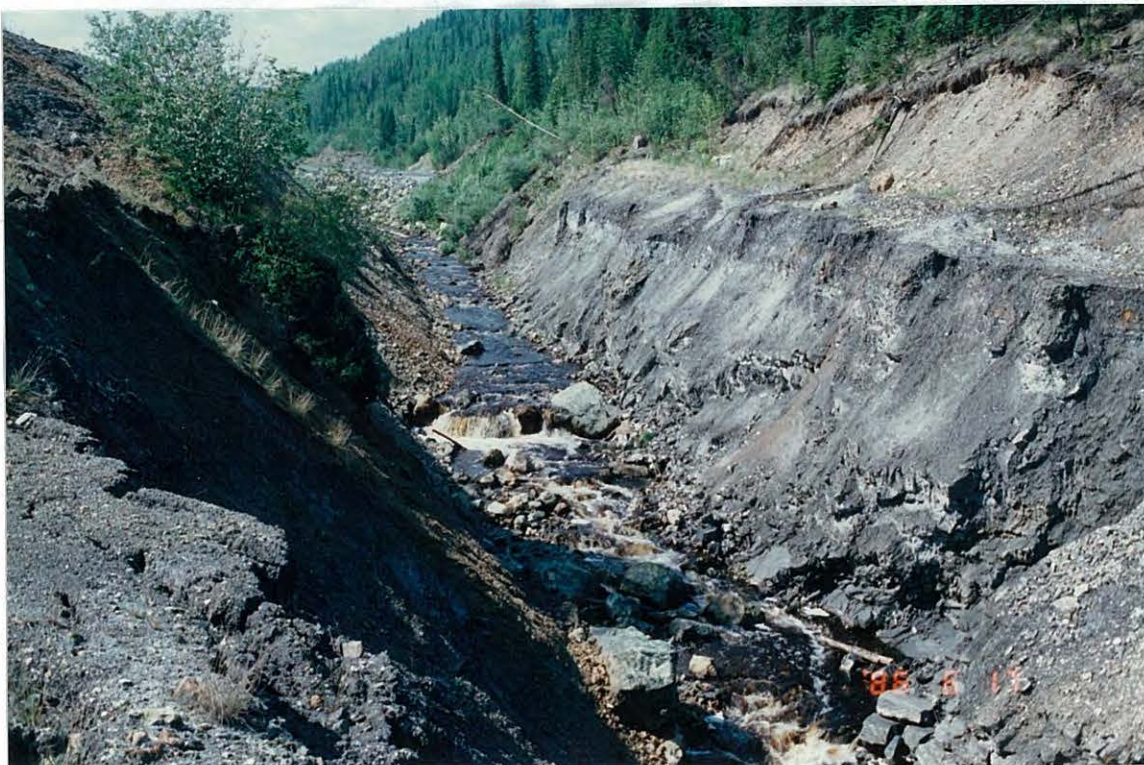
Photo 6: Clinton Creek channel squeezed between the north valley wall and unstable dump.

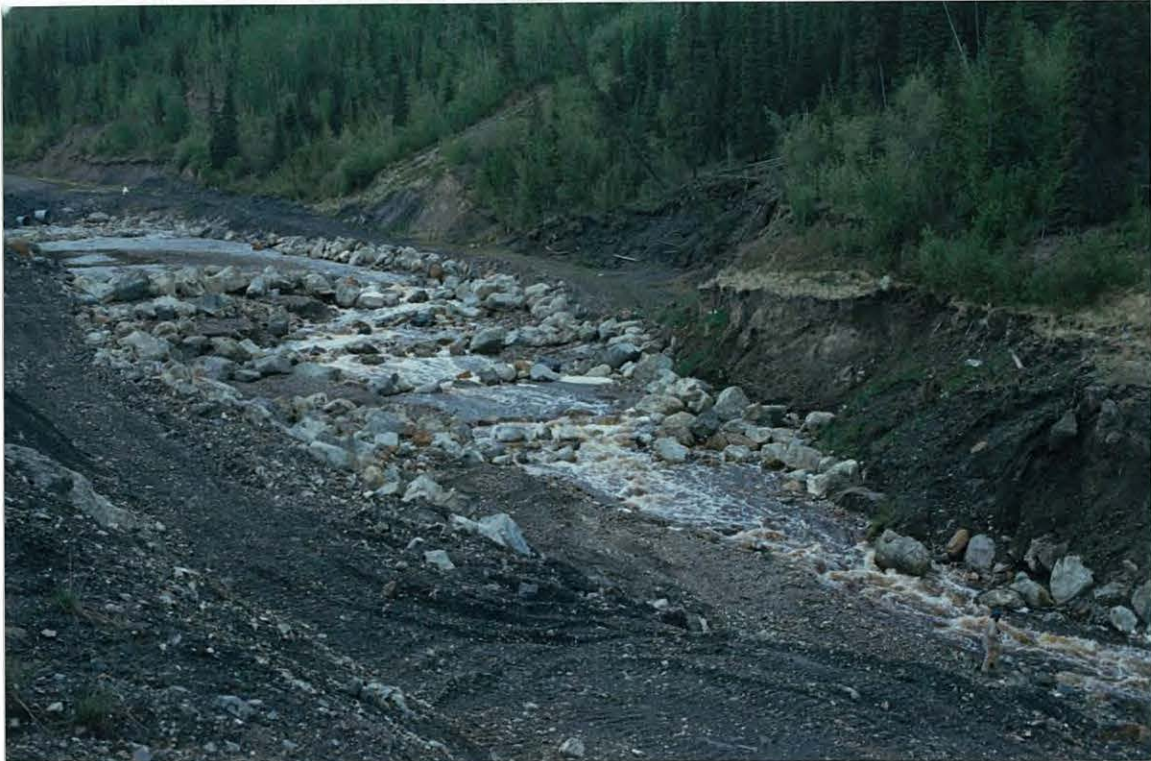
Photo 7: Clinton Creek at the outlet from Hudgeon Lake. Rock weirs constructed in 1981 were bypassed during the spring break-up in 1982.

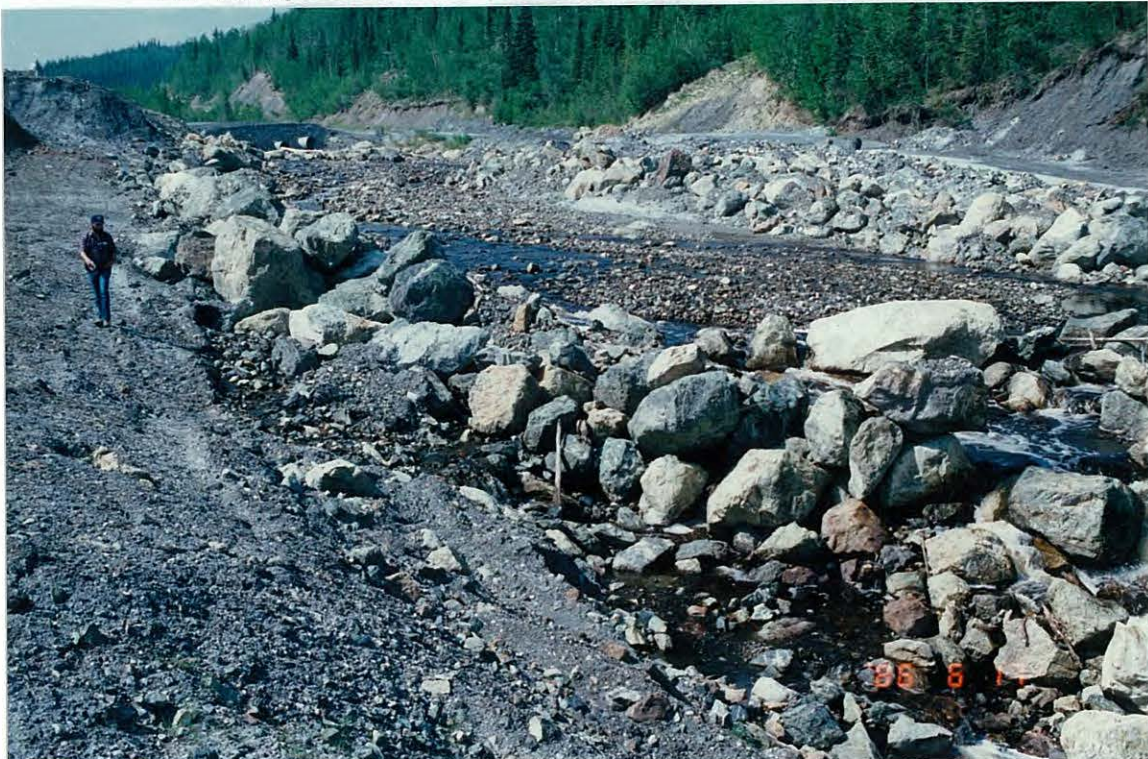
Photo 8: The rock-lined stream section (re-constructed in 1984) shows signs of erosion in 1986.

and undercut the north valley wall. This rock-lined section was modified and reconstructed in 1984 (Photo 8). The design included backfilling of the eroded channel and placing rip-rap along both banks of the channel. A rip-rap apron at the outlet culverts from Hudgeon Lake was also provided.

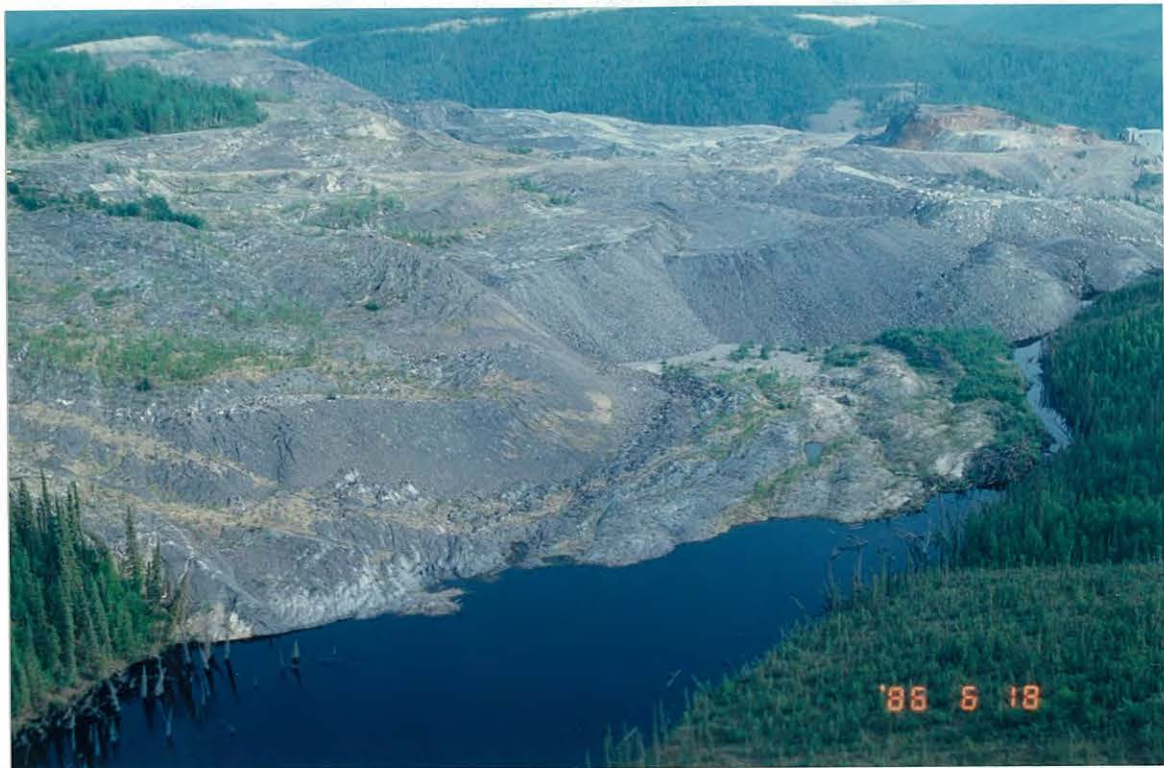
Photo 9: Porcupine Creek waste dump and valley blockage forming a small lake.

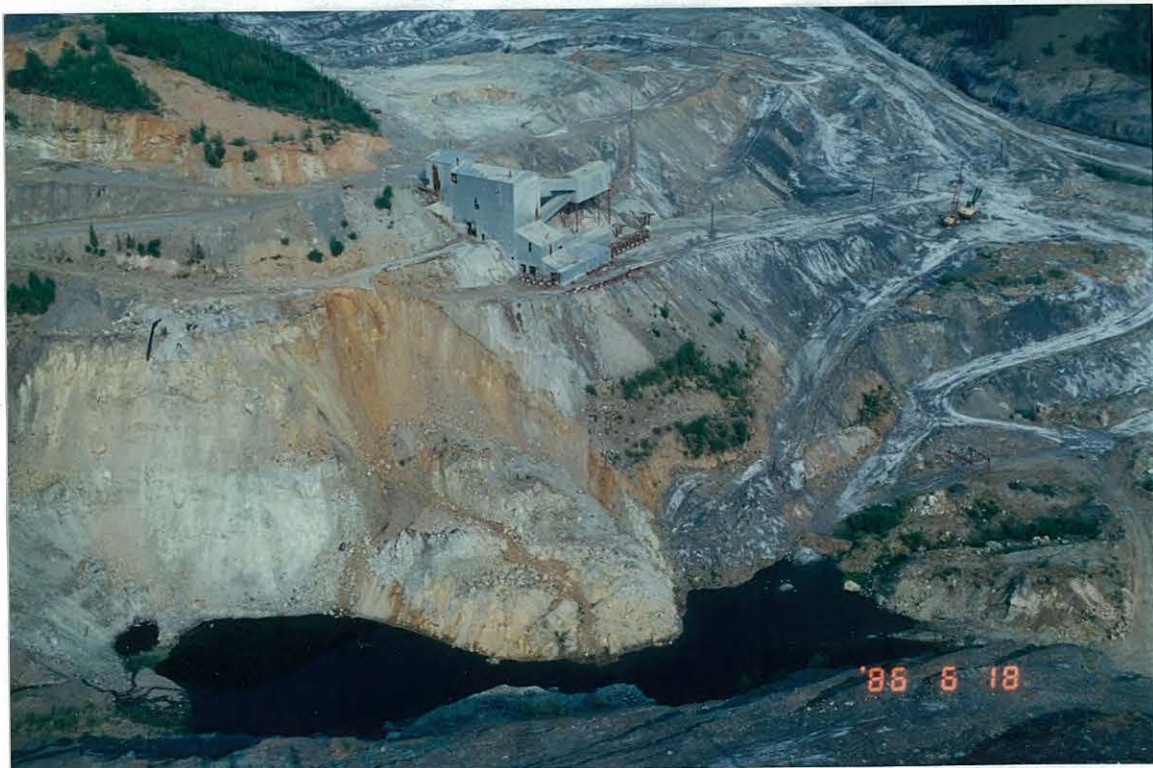
Photo 10: Slump in the vicinity of the crusher partially blocking the Porcupine Creek valley.

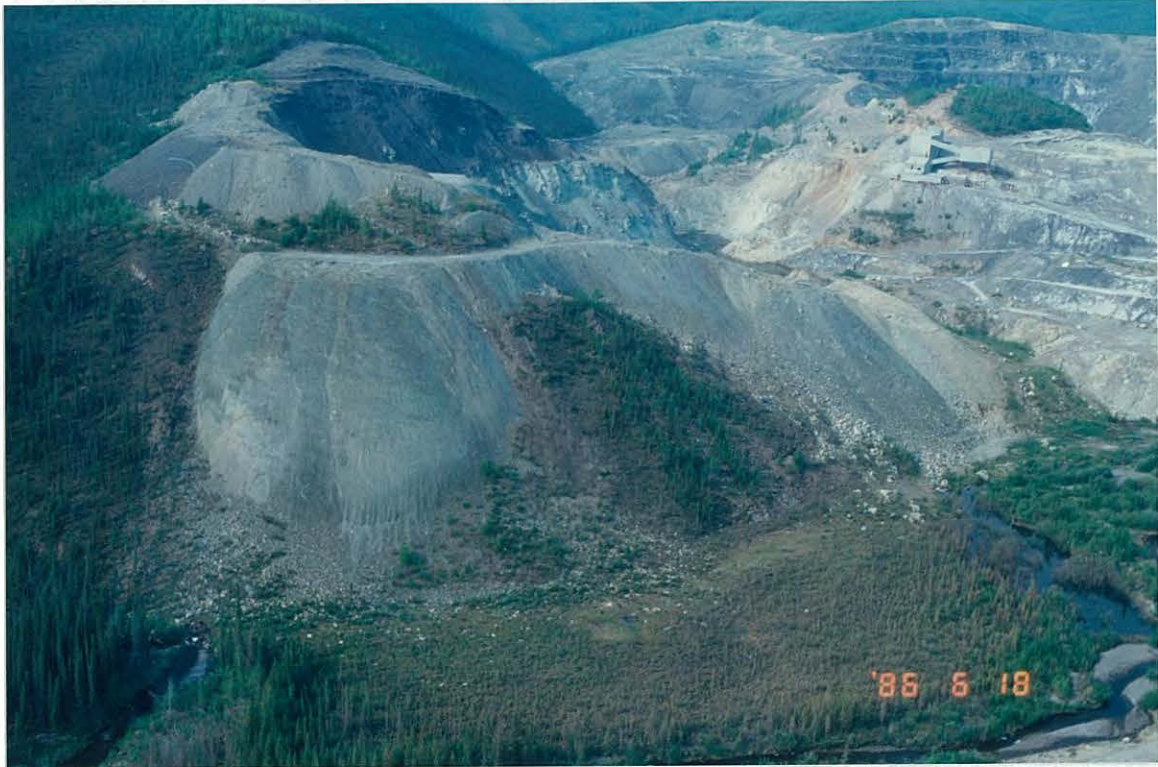
This dump, placed across the south valley wall of the Clinton Creek valley, is relatively small. The toe of the dump barely reaches the valley bottom. The face of the dump is bulging out - indicating incipient failure (Photo 11). The toe of the dump acts as a passive wedge against the driving force of the uppermost dump segment.

This dump will eventually fail, partially blocking the valley bottom. The failure will likely impact on the Clinton Creek channel.

Photo 11: Snowshoe Pit waste dump deposited over the Clinton Creek valley. The dump is unstable - note the bulging.

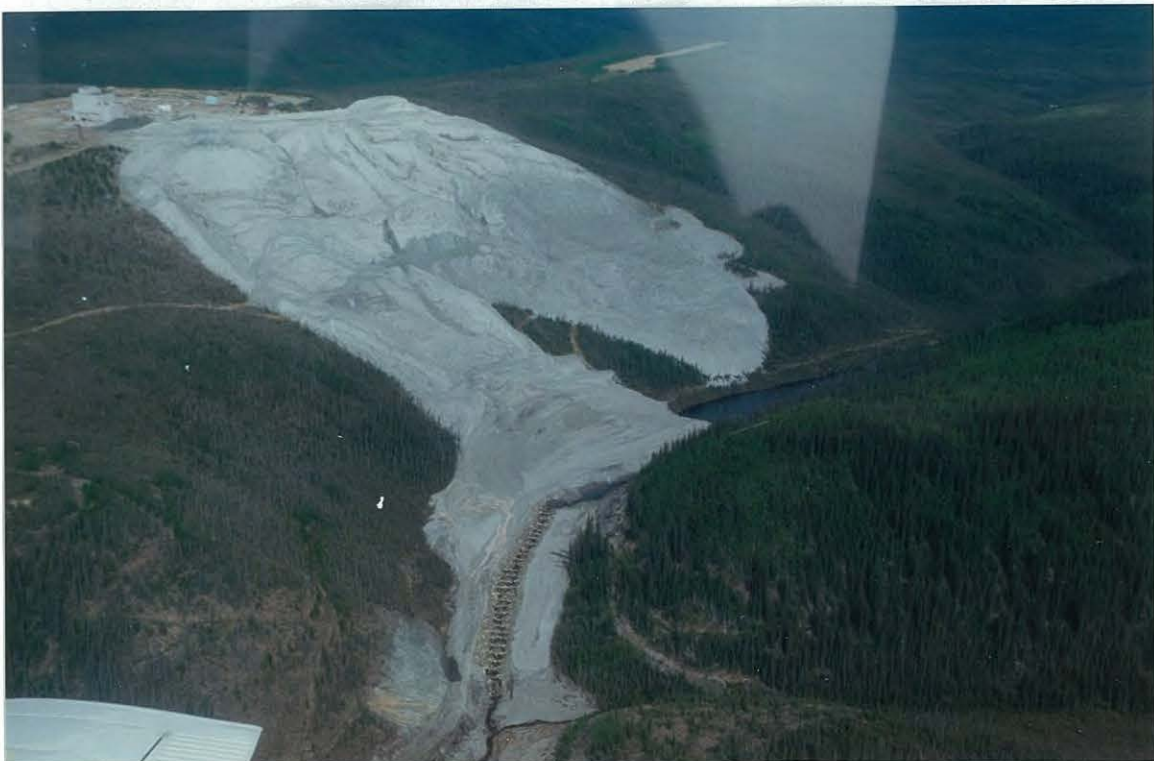
The tailings have been stacked in two piles, referred to as the north and south lobes. The south lobe was deposited from startup until 1974, when a failure of the tailings pile occurred and a segment of the pile moved downslope and blocked the valley bottom including the creek. Following the failure, tailings were placed on the north lobe until the mine shutdown in 1978. A rock-lined outfall channel has been constructed to control erosion and convey the creek across the valley blockage (Photo 12).

Photo 12: View of the Wolverine Creek tailings pile, looking north; June 1982.

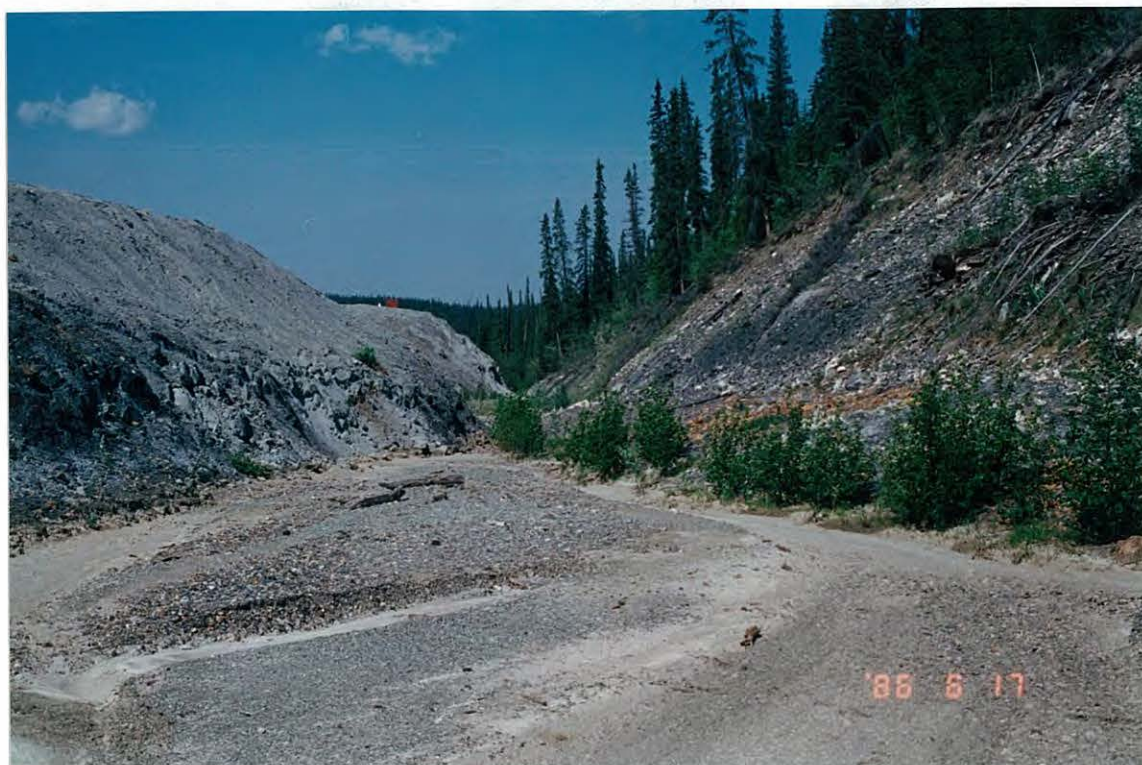
Photo 13: South lobe of the Wolverine Creek tailings pile blocked the outfall channel in June, 1986.
