# **Anvil Range Mining Complex: Rose Creek Tailings Deposit Assessment of Zinc Attenuation**

**2005/06 Task 22h(ii)**

**July 2006**

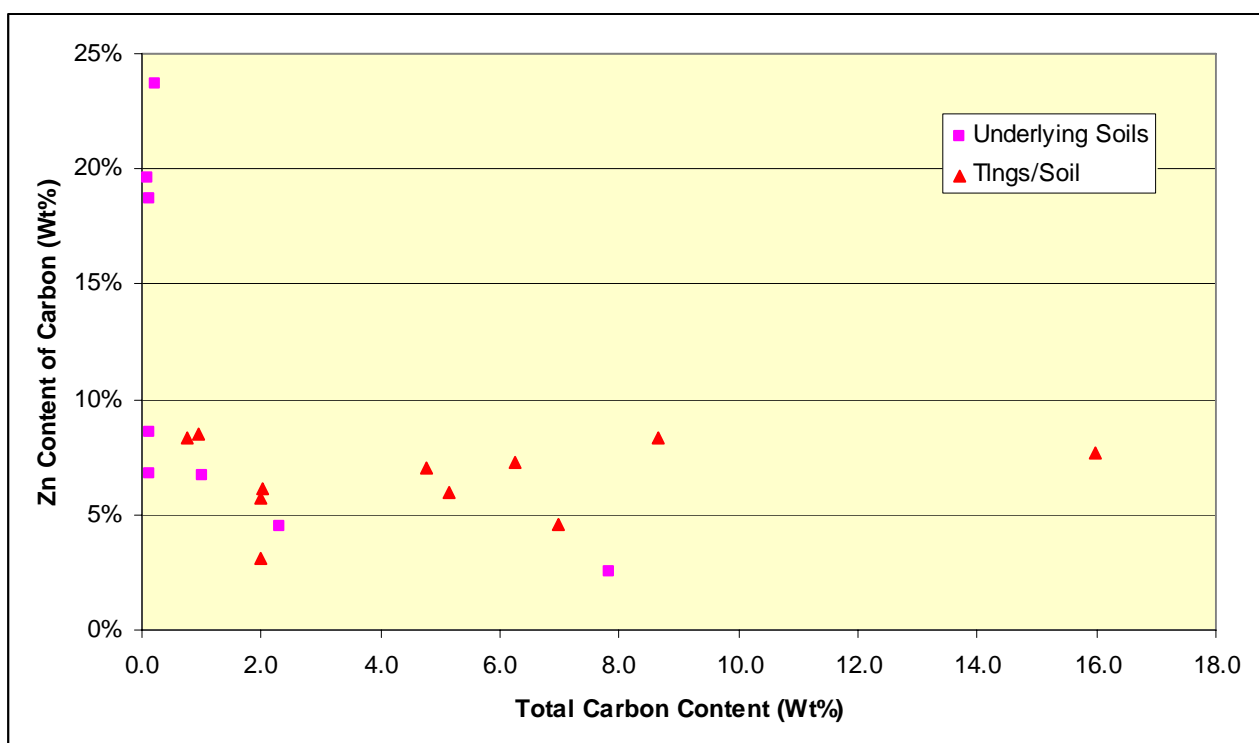
**Figure 3-5 Correlation between Calculated Mass Zn 'Free' and Total Carbon**

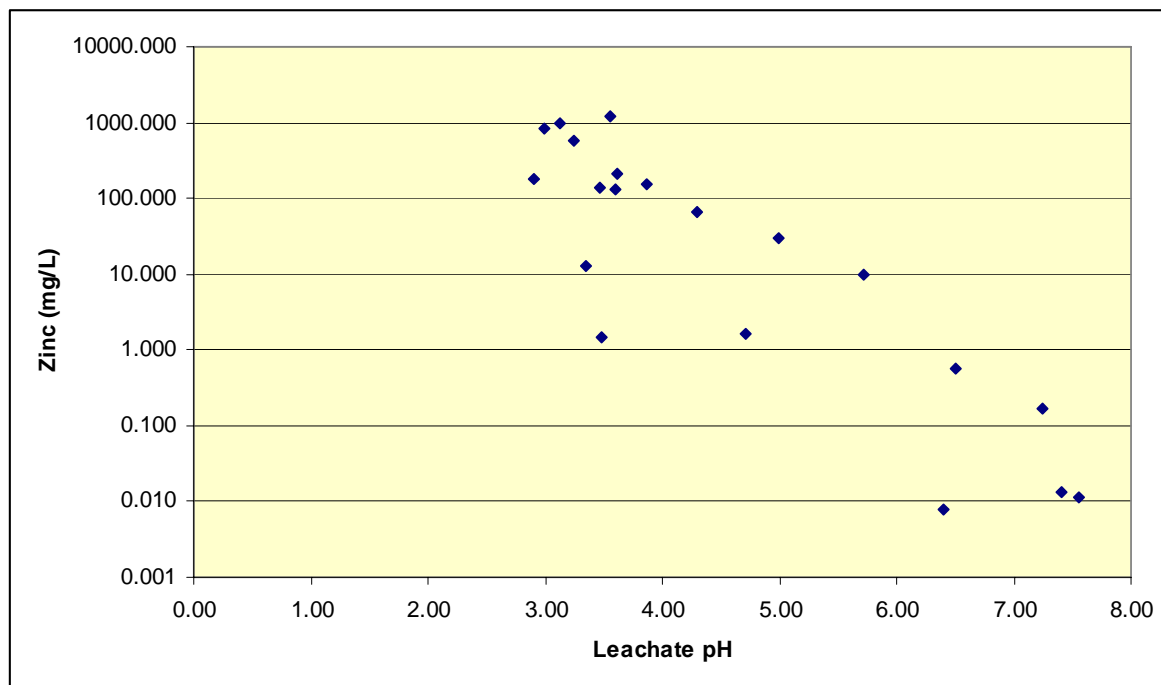
**Figure 3-7 Correlation between Zinc Concentrations and pH in Shake Flask Leachates**

The results for the leach extraction tests completed on the natural soils indicated a correlation between the zinc concentration in the leach extraction leachate and zinc content of the solids. However, it is also noted that there is a strong correlation between the zinc correlation and the leachate pH, as shown in Figure 3-7. Most of the samples had acidified, presumably as a result of the ingress of oxygen to the leach extraction tests (or during the initial sampling) leading to oxidation of dissolved ferrous iron resulting in the precipitation of ferric hydroxide. It is therefore not possible to determine whether the zinc release is occurring from the tailings that are present in the samples

(through oxidation, acidification), and/or being released from the organic carbon due to the declining pH.

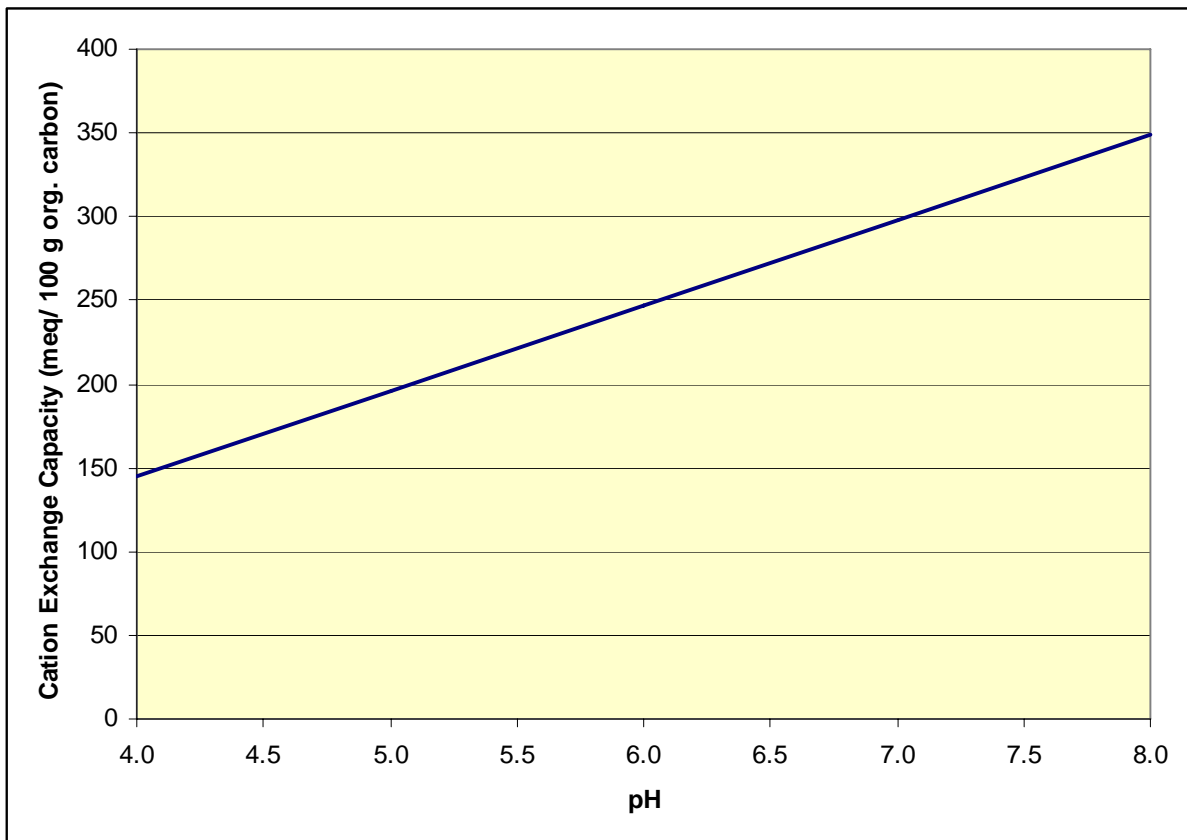
**Figure 3-8 pH Dependency of Cation Exchange Capacity of Soil Organic Carbon (Scheffer & Schachtschabel, 2002)**

Typical cation exchange capacities reported for soil organic carbon is in the range of 150 to 400 meq per 100 g organic carbon (Appelo and Postma, 1993). A pH-dependent estimate of cation exchange capacity for soil organic carbon (Scheffer & Schachtschabel, 2002) suggests a linear correlation as shown in Figure 3-8. At a neutral pH the cation exchange capacity is very similar to that calculated for the Rose Creek soil organic carbon presented herein. As shown in the figure, the exchange capacity decreases from about 300 to about 150 meq per 100 g organic carbon for a decrease in pH from 7 to 4.

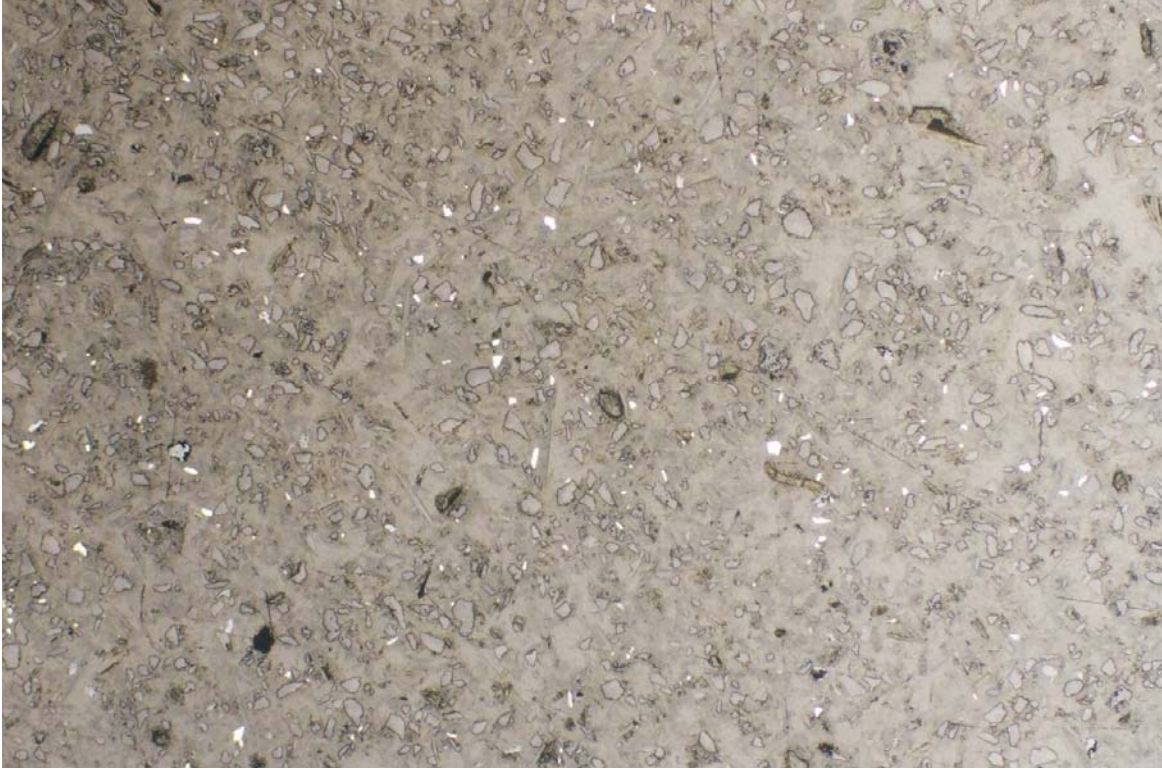
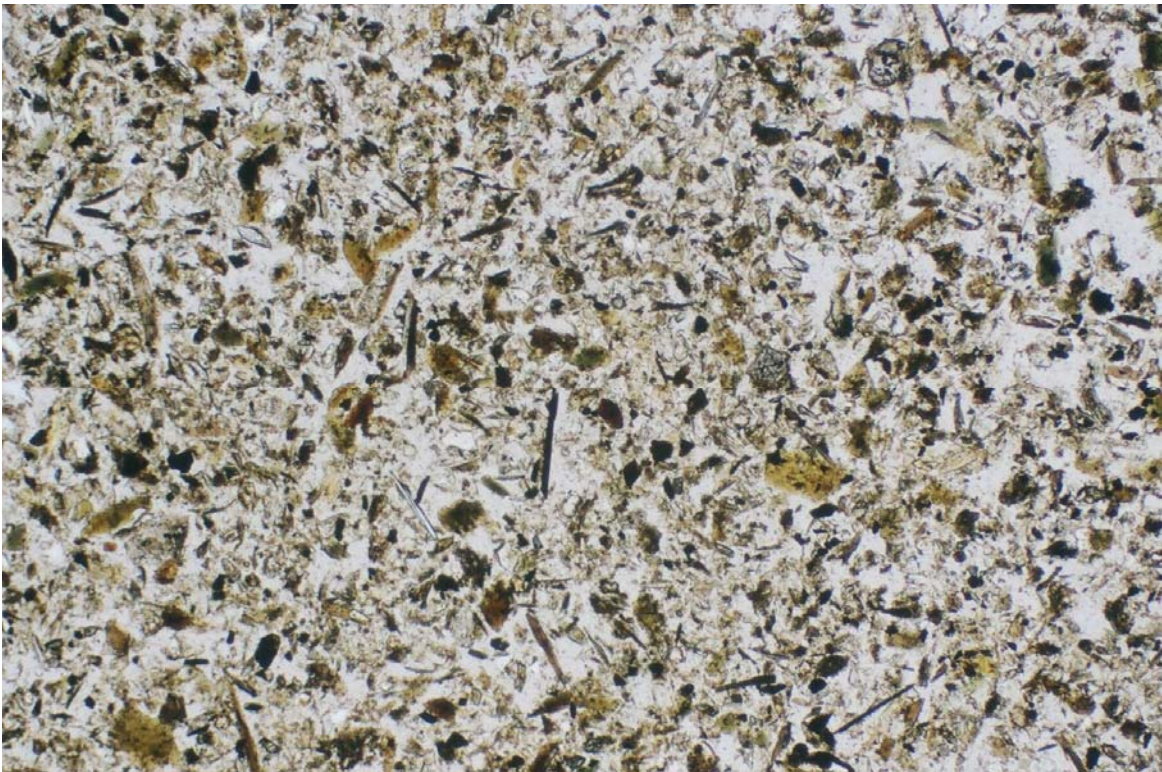
**Figure 1.** Overview of NA-05-02 in plain reflected light (top) and the same field in plain transmitted light (bottom), width of field 5.2 mm. The white grains in the upper photo are pyrite. The brownish and dark lath- or needle-like grains in the lower photo are biotite.

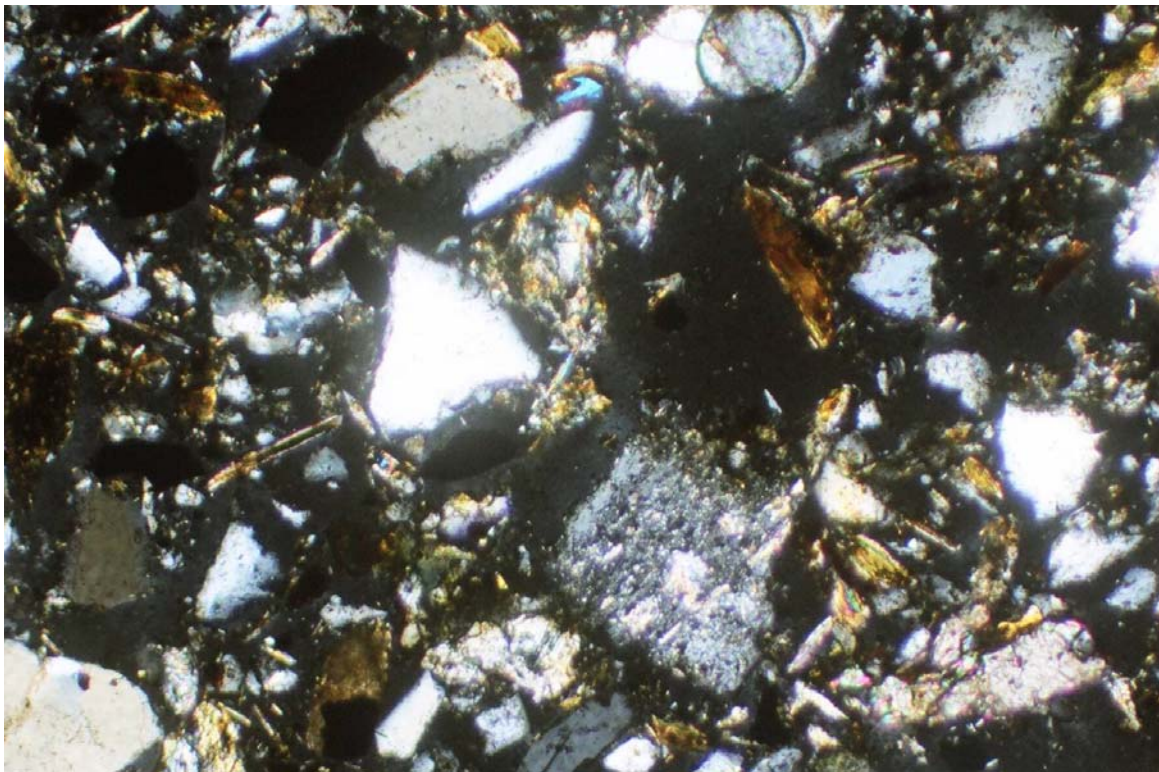
**Figure 2.** NA-05-02 in plain reflected light (top) and the same field in transmitted light with crossed polarizers (bottom), width of field 1.3 mm. The white grains in the upper photo are pyrite; labelled grains are **Ti** titanite, **Sid** siderite, **Ru** rutile, and **Sp** sphalerite. The white-to-grey rains in the lower photo are quartz and feldspar, and the brightly coloured shreds and laths are biotite.

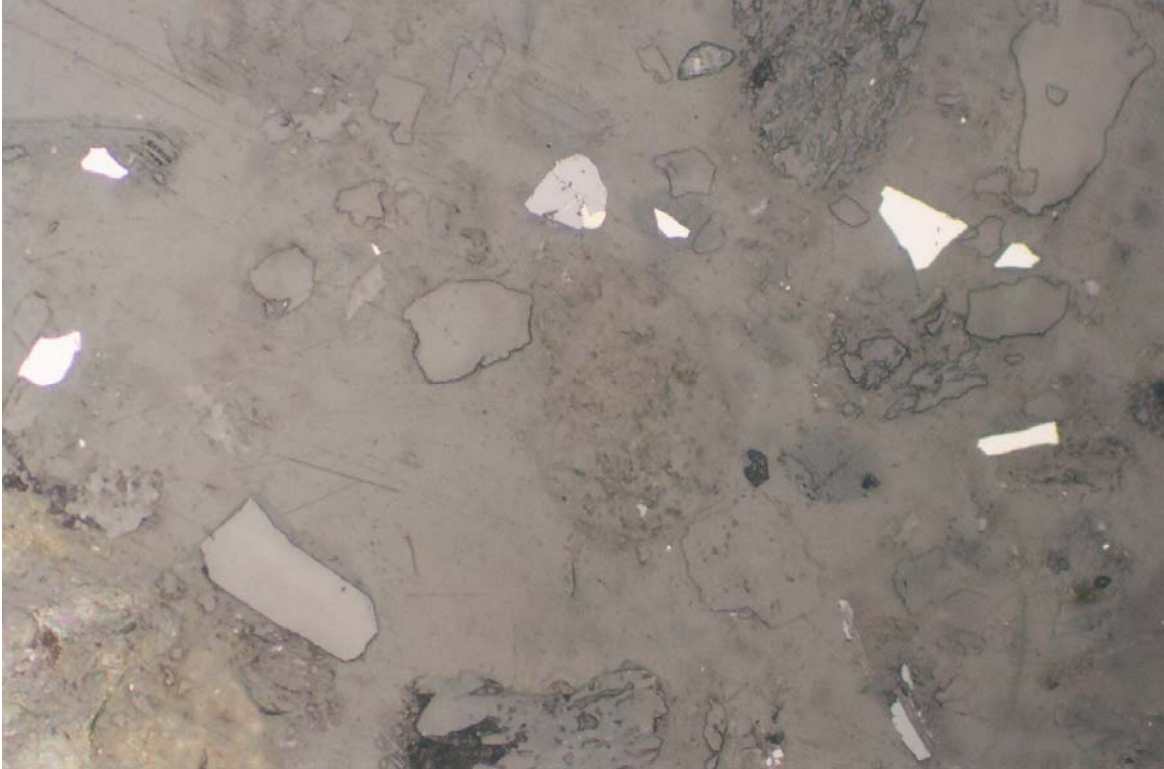
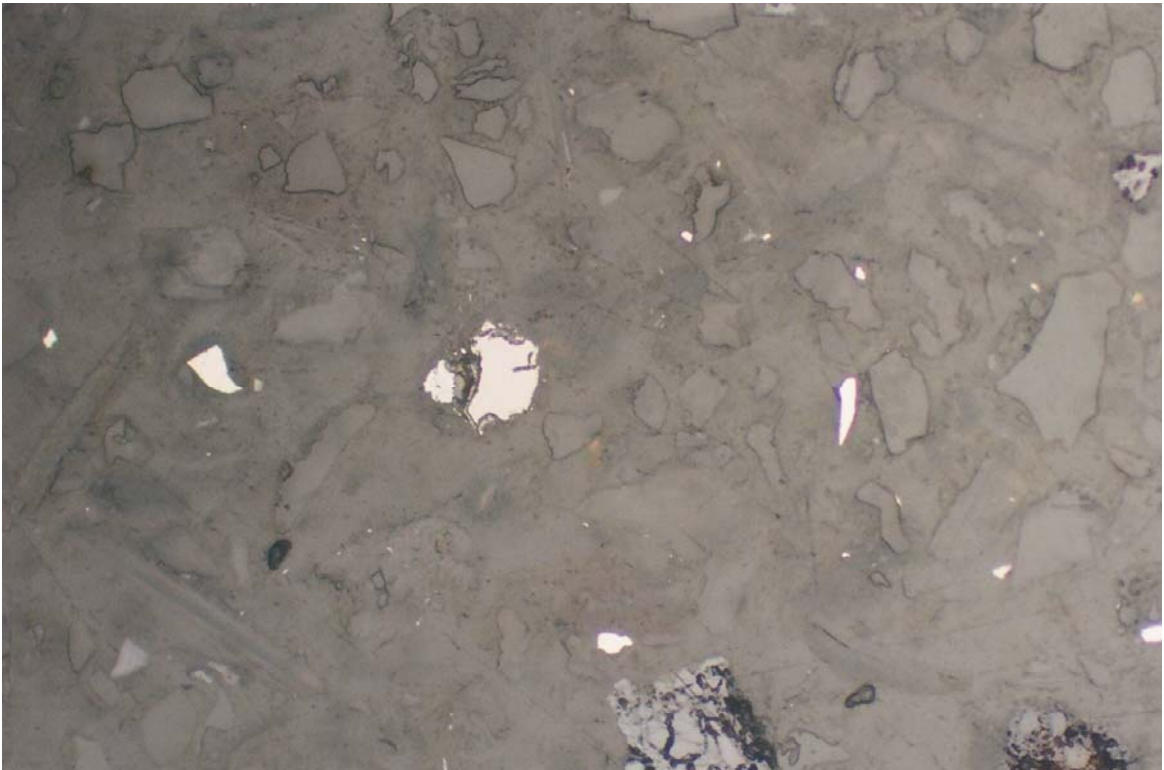
**Figure 3.** NA-05-02 in plain reflected light, width of field 0.625 mm. The white grains are pyrite, and in the upper photo, above centre is a grey grain of unaltered sphalerite with associated chalcopyrite. At the centre of the lower photo is pyrrhotite that has a narrow rim of Fe oxyhydroxide.

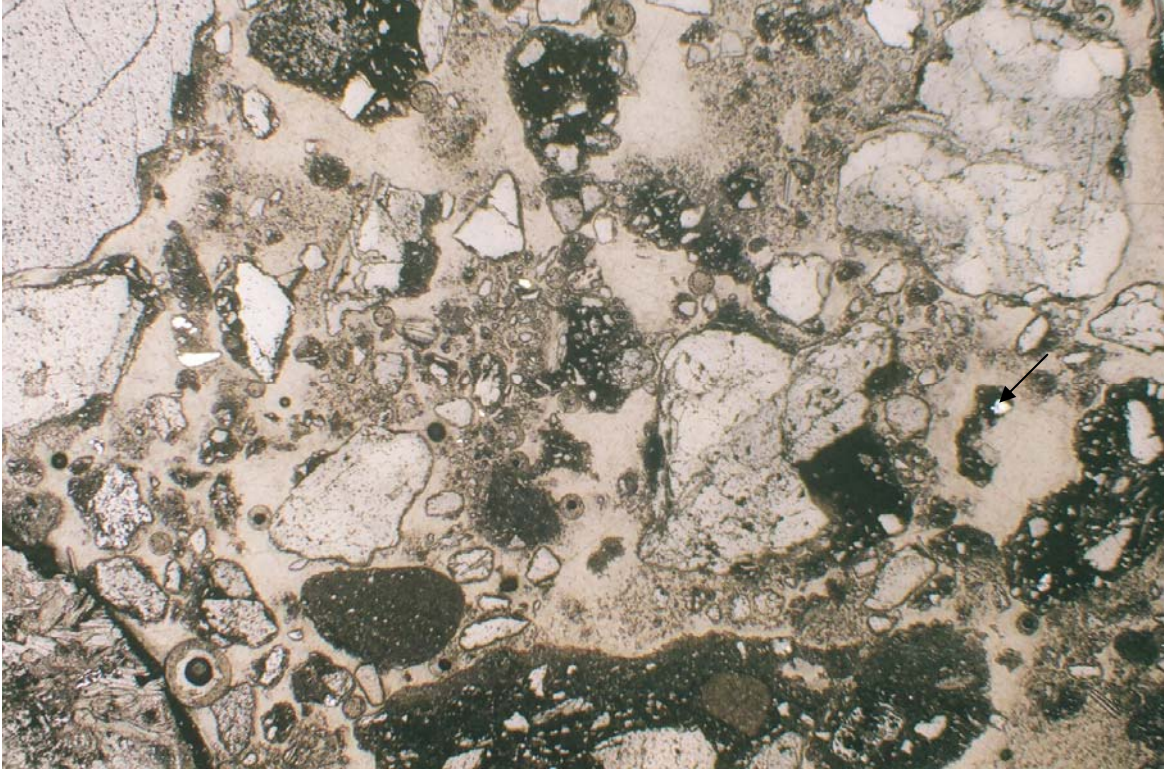
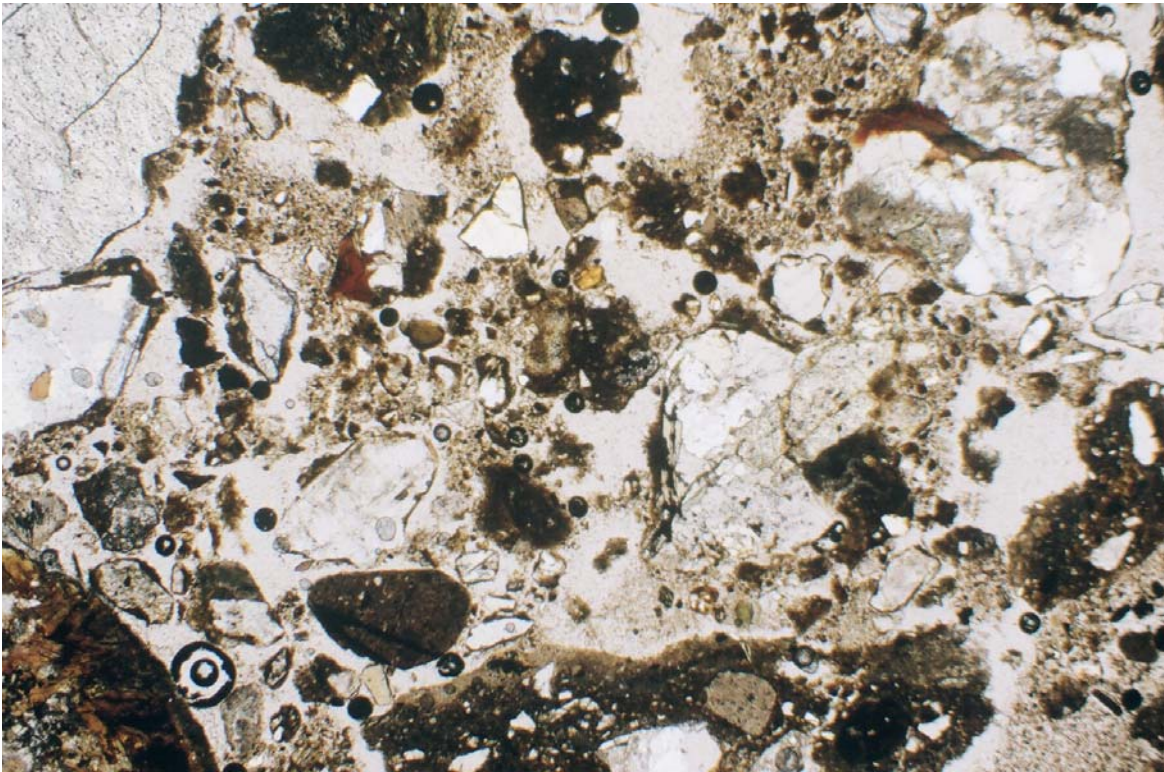
**Figure 4.** Overview of NA-05-03 in plain reflected light (top) and the same field in plain transmitted light (bottom), width of field 5.2 mm, showing the high proportion of lithic particles and the sparseness of sulfides (white grains). The arrow (upper photo, right) points to the pyrite of Figure 5 (upper photo). Much of the opacity is a polishing artifact, as is evident along the base of the lower photo.

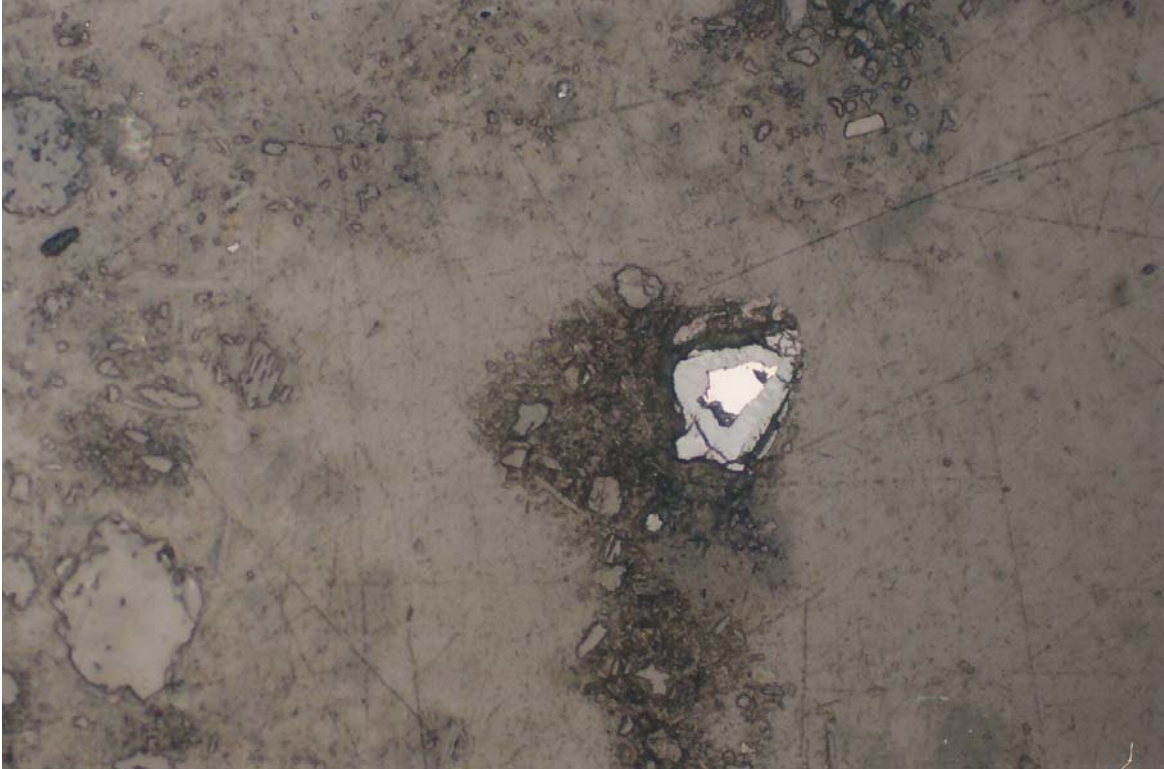
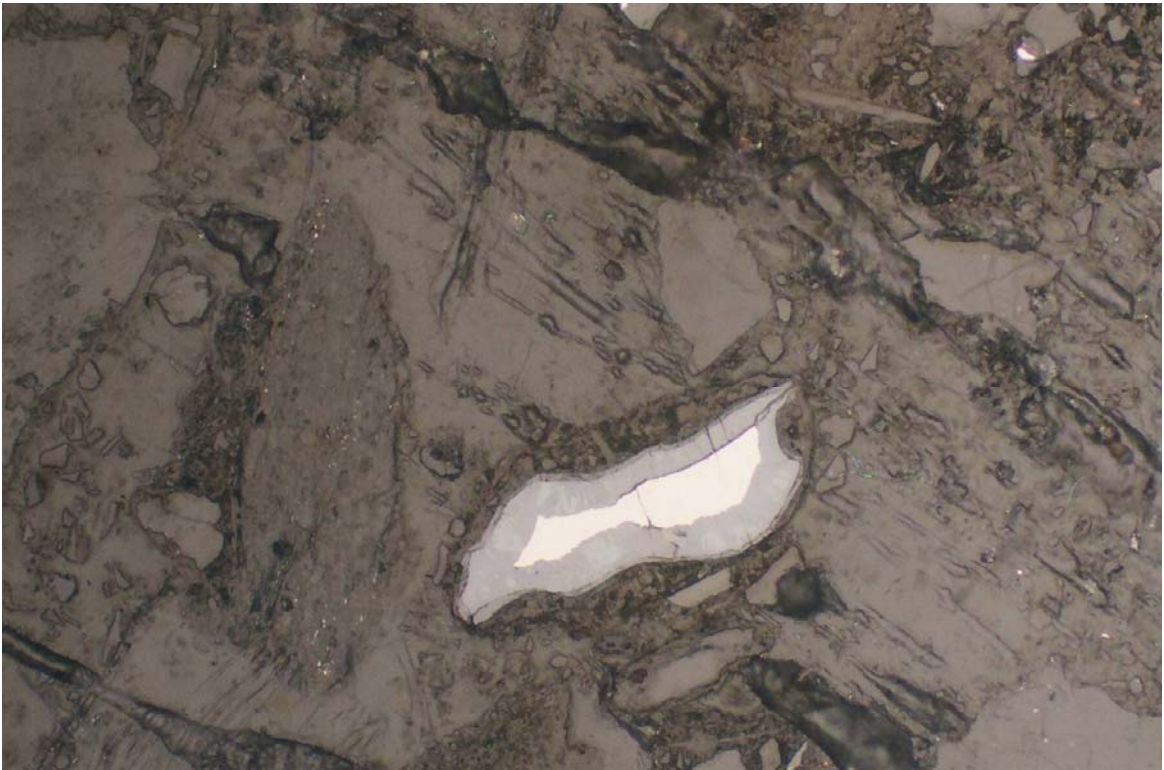
**Figure 5.** The two oxidized pyrite grains observed in NA-05-03, shown in reflected light, width of field 0.625 mm. A core of residual pyrite is enclosed within goethite-like Fe oxyhydroxide. EDS spectra of the rims on both grains gave similar results (Fig. 6).

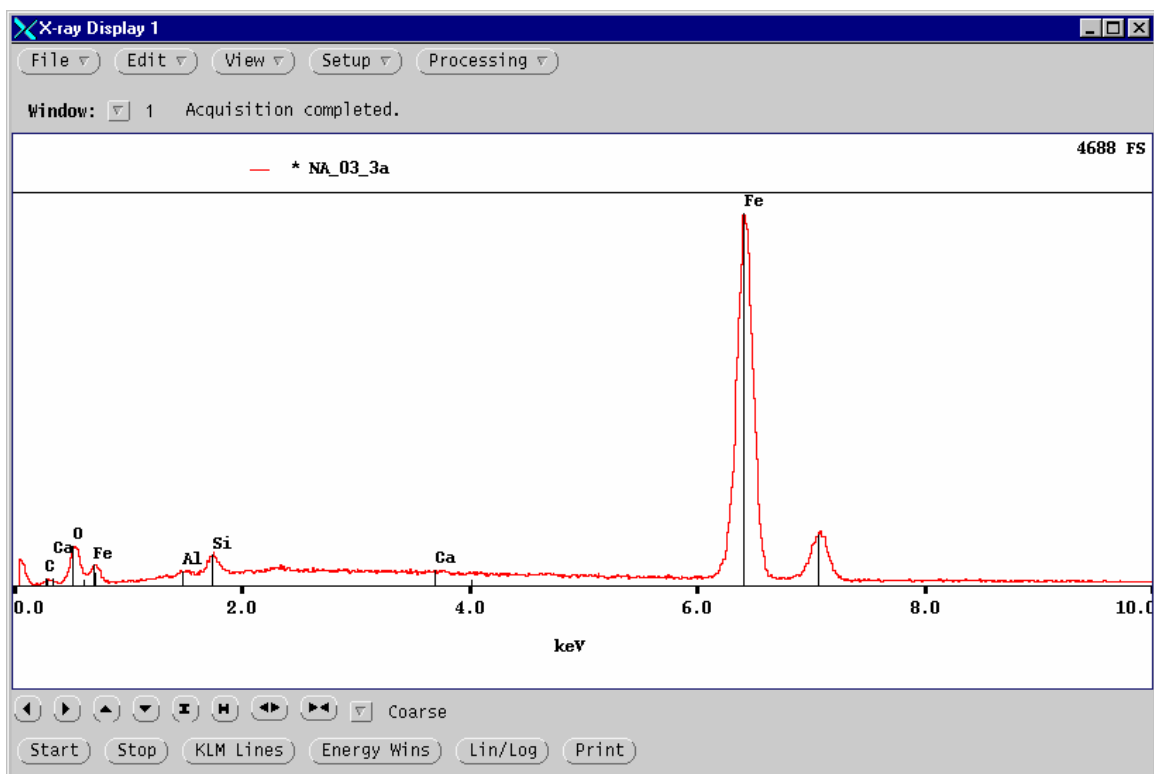
**Figure 6.** EDS spectrum of the Fe-oxyhydroxide rim shown in the lower photo of Figure 5. A similar spectrum was obtained for the rim in the upper photo.

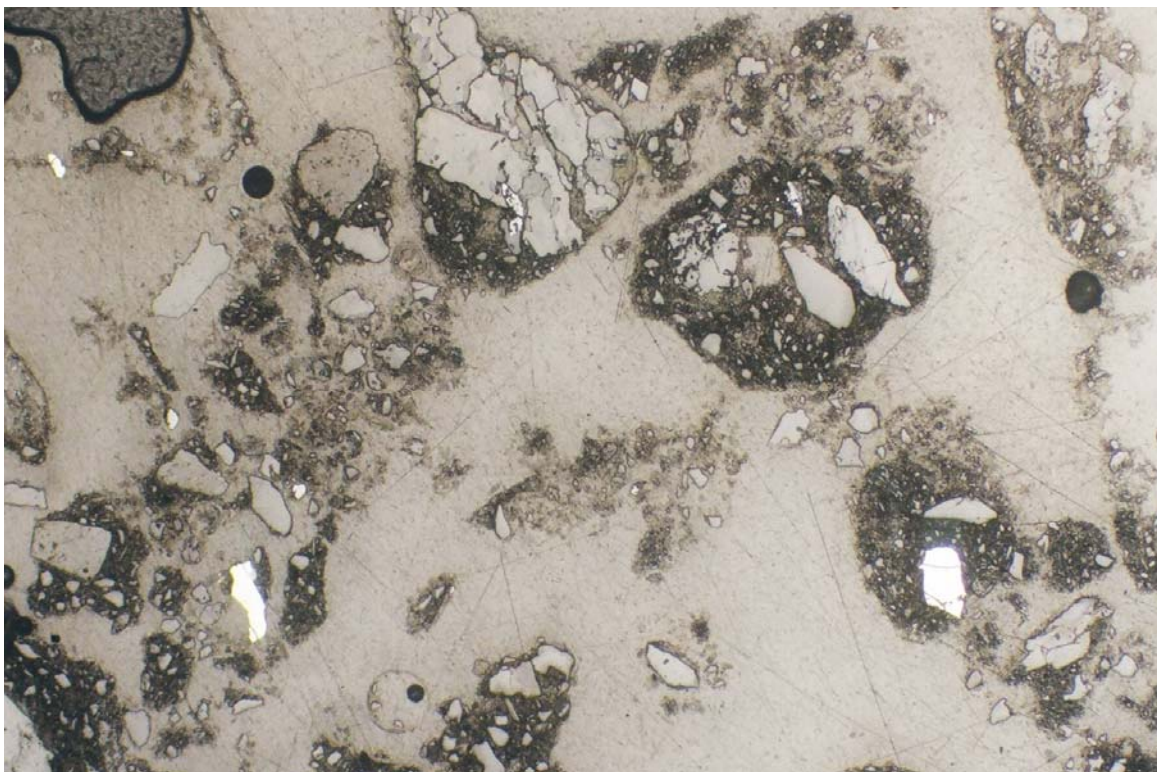
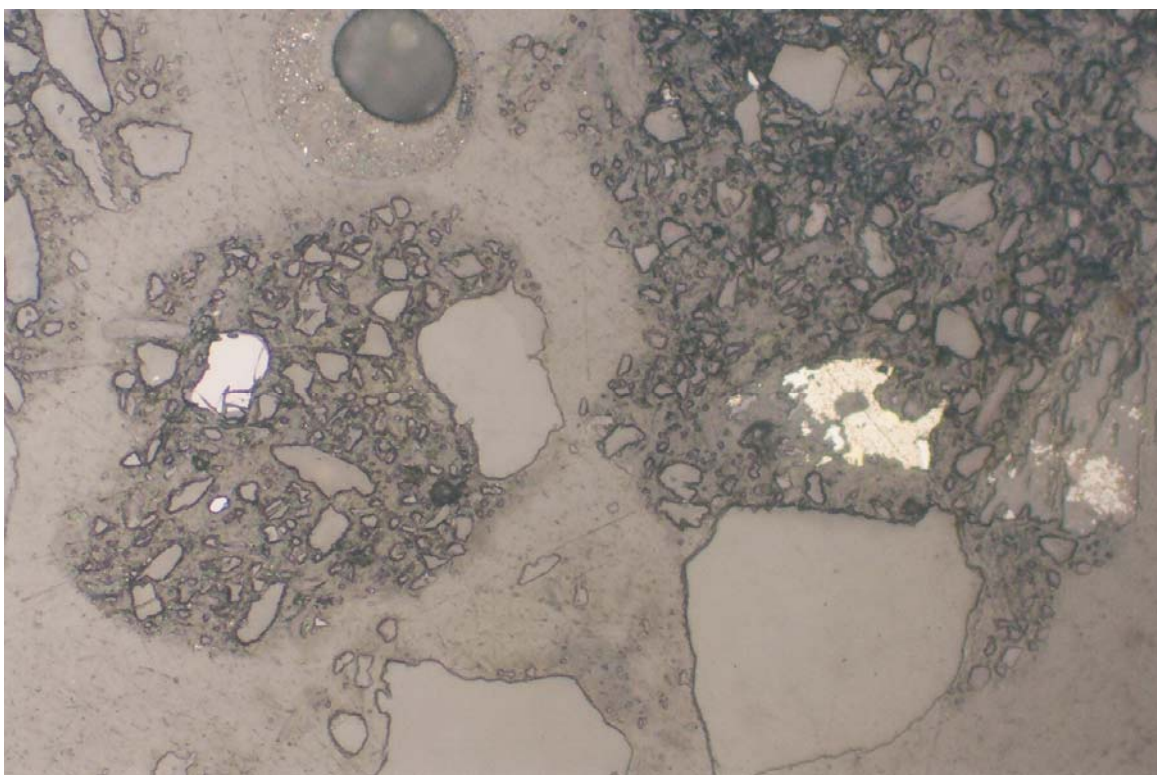
**Figure 7.** NA-05-05 (9-9.1) in plain reflected light. The upper photo (width of field 2.6 mm) shows the general character and two large grains of pyrite (white). A minute area of attached sphalerite is at the upper right of the pyrite grain on the left, and above the pyrite at mid-height are two light-grey, minute grains of ilmenite. The lower photo (width of field 0.625 mm) shows a large brownish grey grain of ilmenite on the left, and opposite on the right is roughly polished pyrite with peripheral, whiter grains of marcasite.

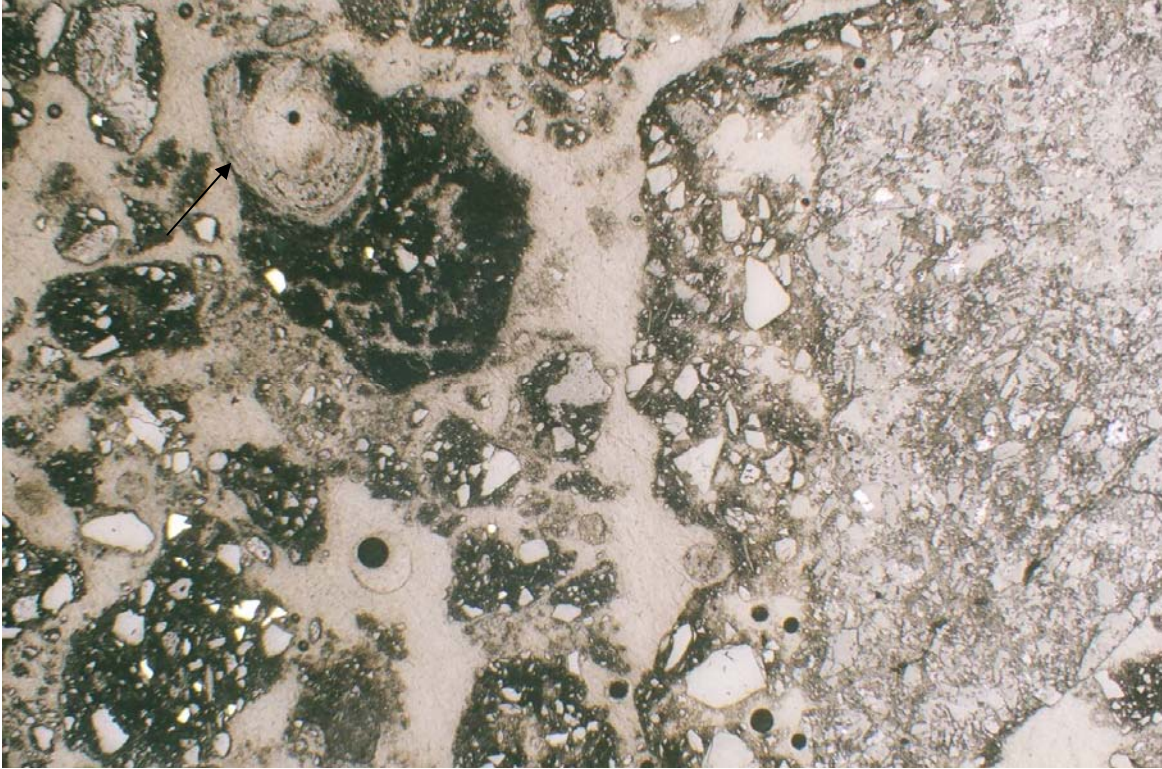
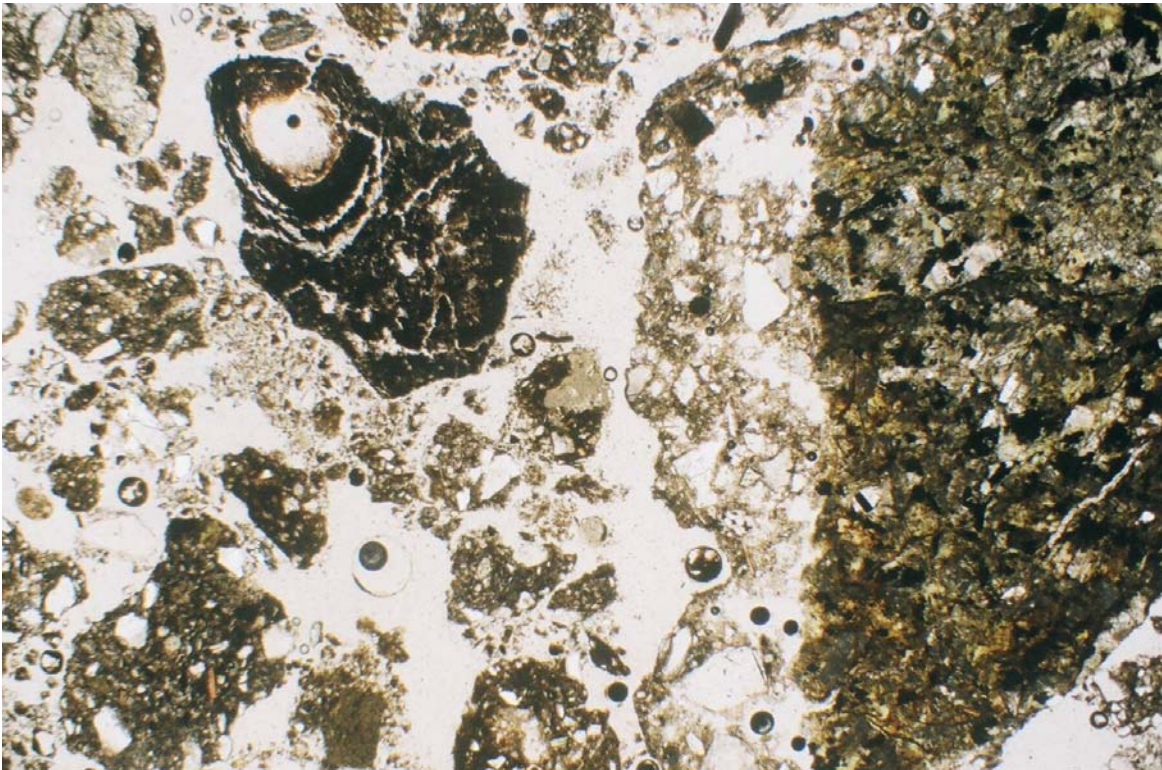
**Figure 8.** NA-05-05 (9–9.1) in plain reflected (top) and plain transmitted light (bottom), width of field 5.2 mm. The white grains are pyrite, and on the right is a large lithic particle. The arrow at the top left points to an annular particle of organic material for which EDS spectra are given in Figure 10.

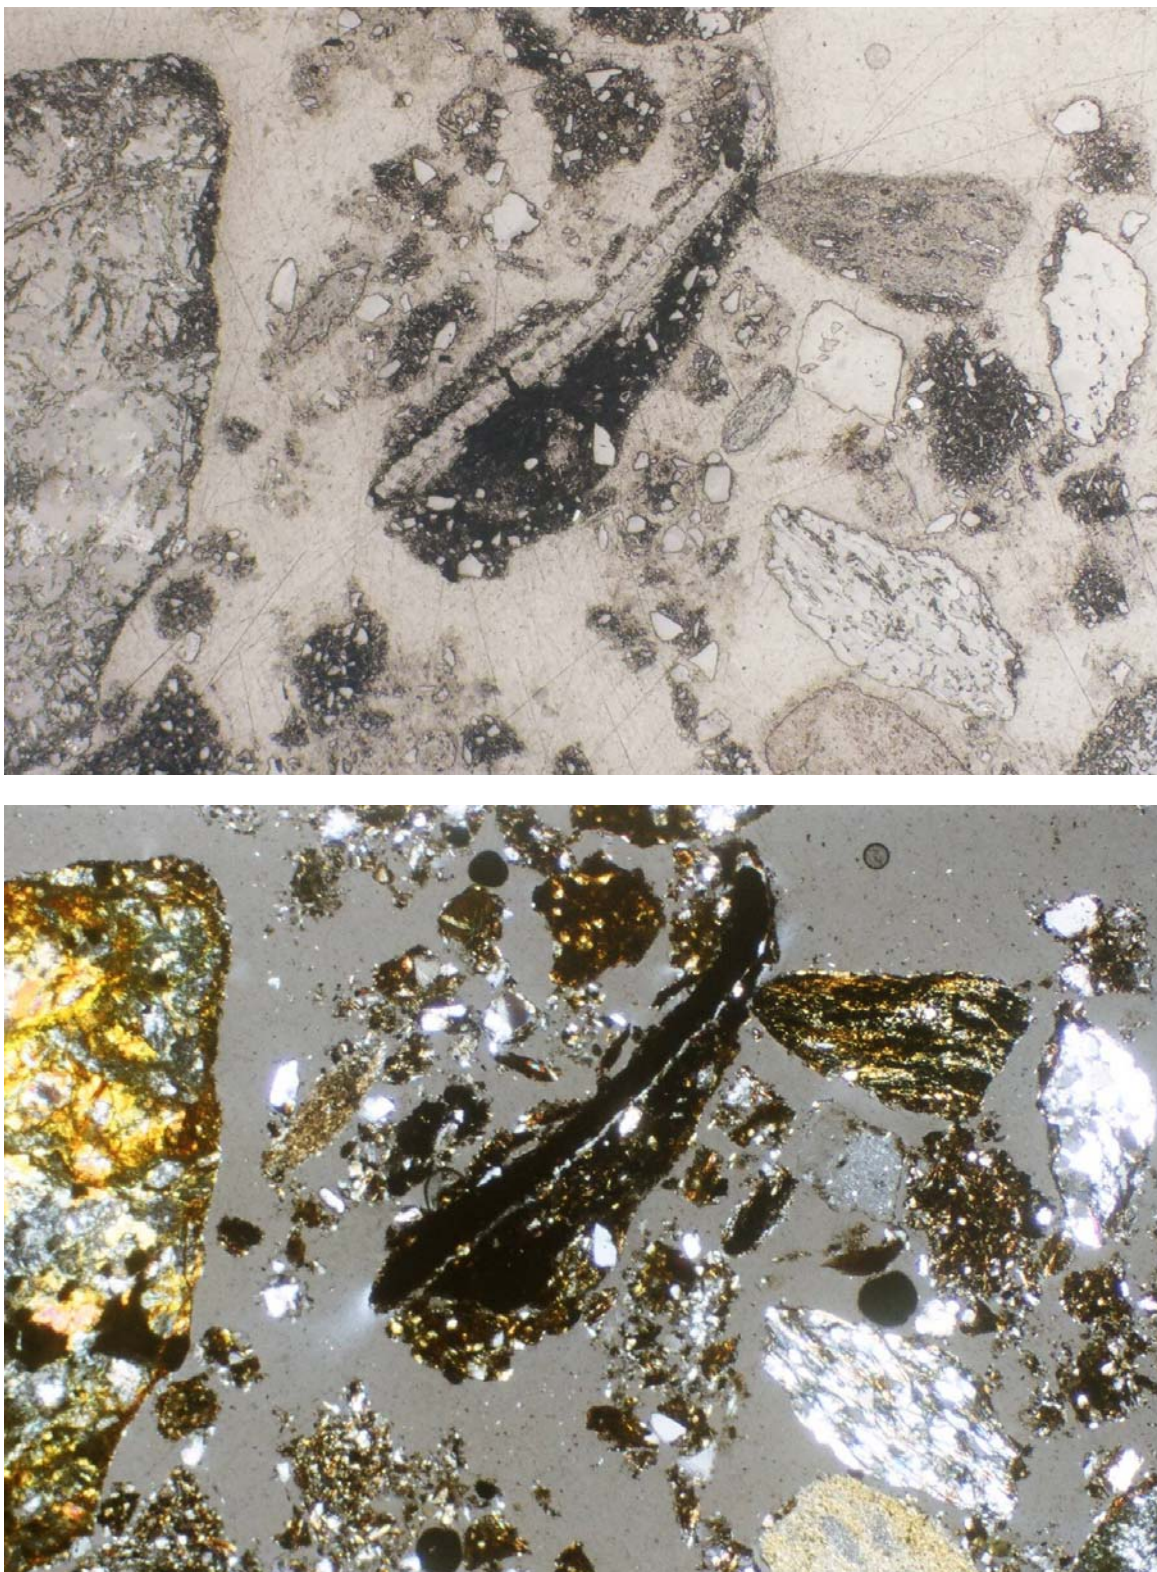
**Figure 9.** NA-05-05 (9-9.1) in plain reflected light (top) and in transmitted light with crossed polarizers (bottom), width of field 2.6 mm. At the centre is a cellular organic structure for which an EDS spectrum is given in Figure 11.

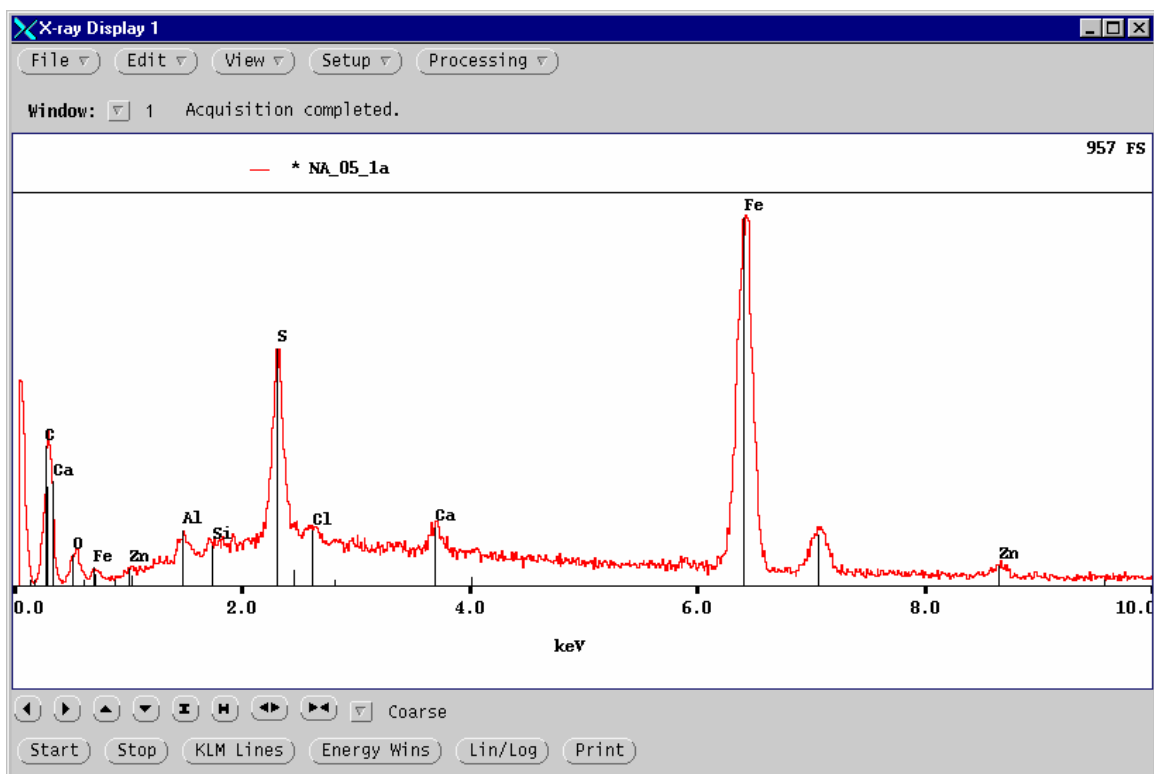
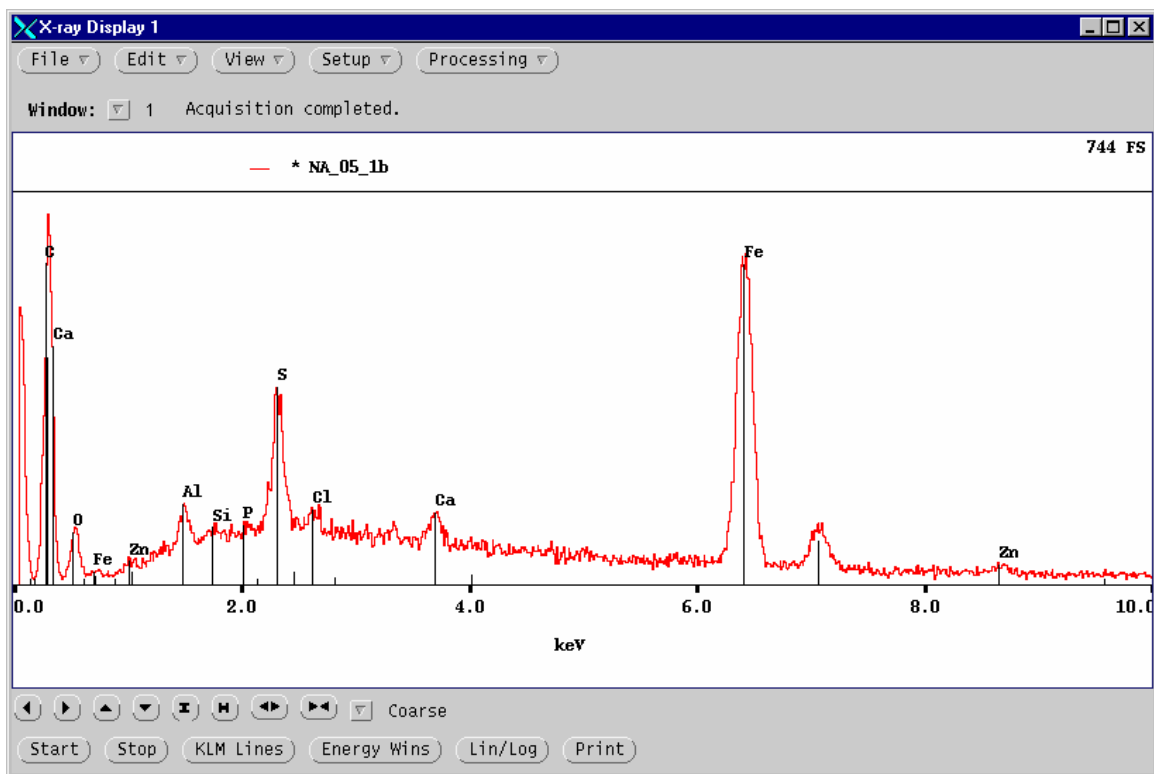
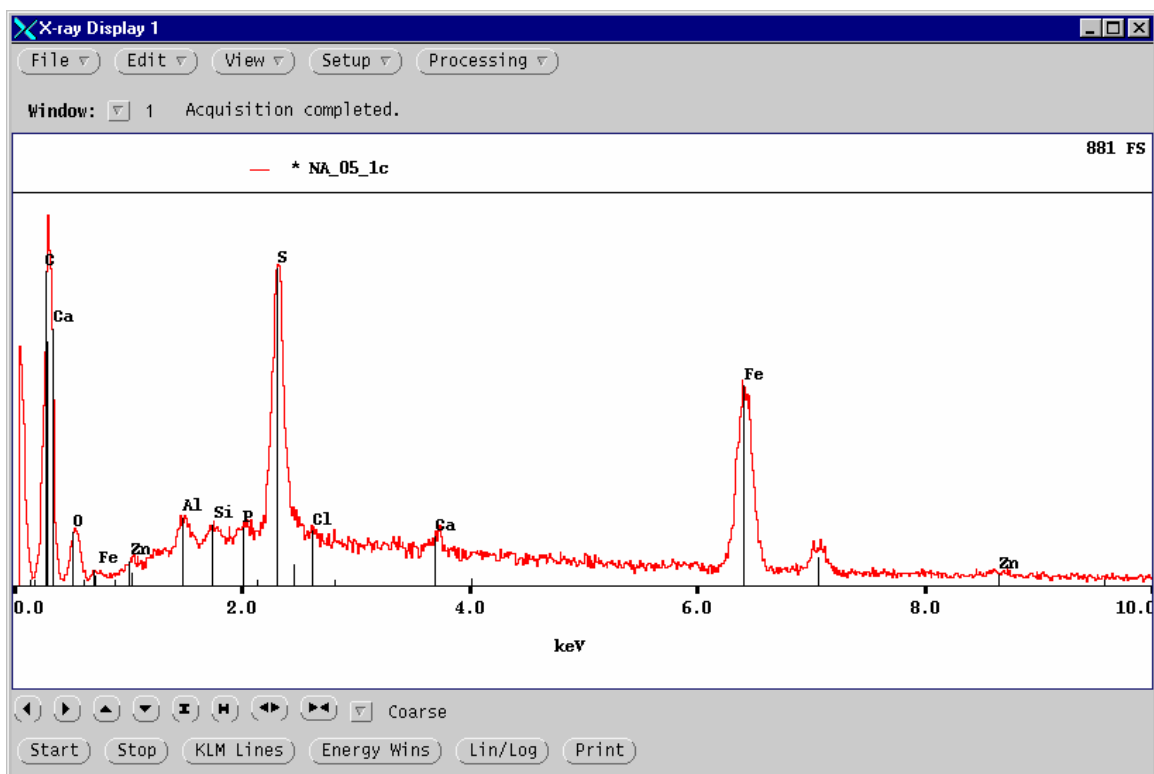
**Figure 10.** EDS spectra for the organic particle of Figure 8. The upper spectrum is for the outermost part of the structure, and the lower spectrum is about 20  $\mu\text{m}$  farther inward, toward the core. See also the next page.

**Figure 10** (cont'd). EDS spectrum for the core area, thus indicating that all of the analyzed points of the organic material are Zn-bearing, but the Zn content is highest in the outermost part of the structure.

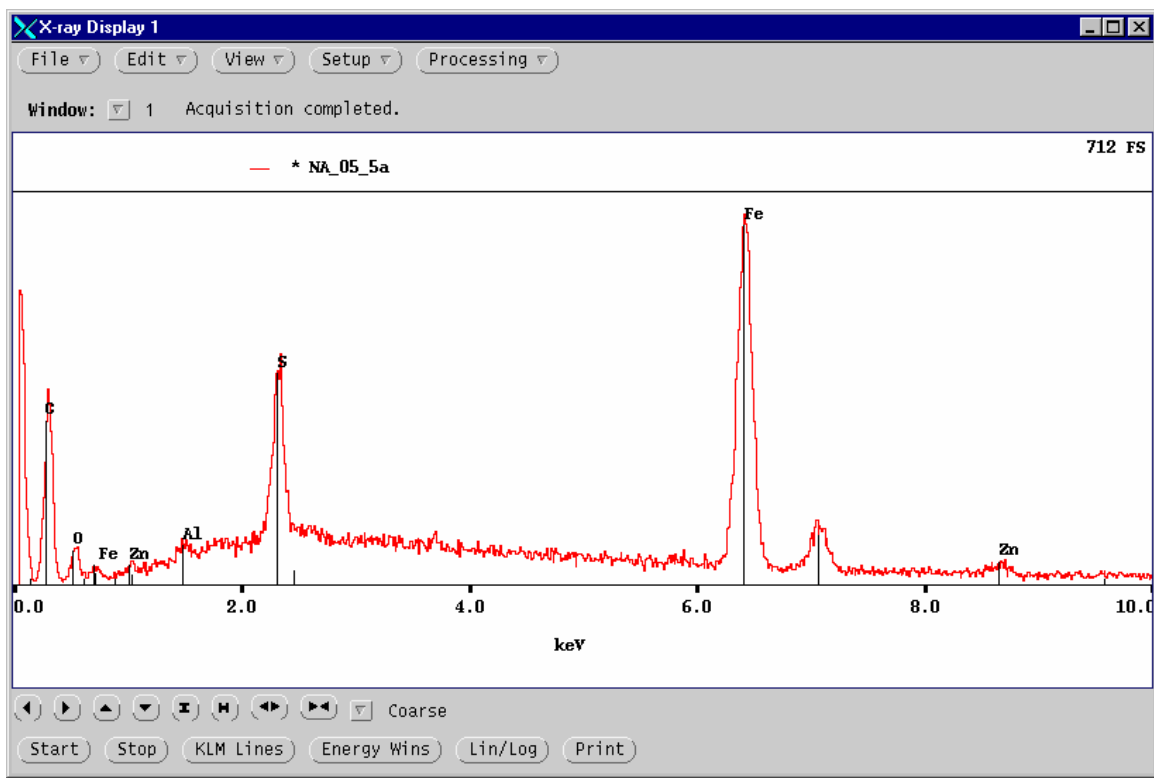
**Figure 11.** EDS spectrum of the organic structure shown in Figure 9.
