# **Anvil Range Mining Complex: Rose Creek Tailings Deposit Assessment of Zinc Attenuation**

**2005/06 Task 22h(ii)**

**July 2006**

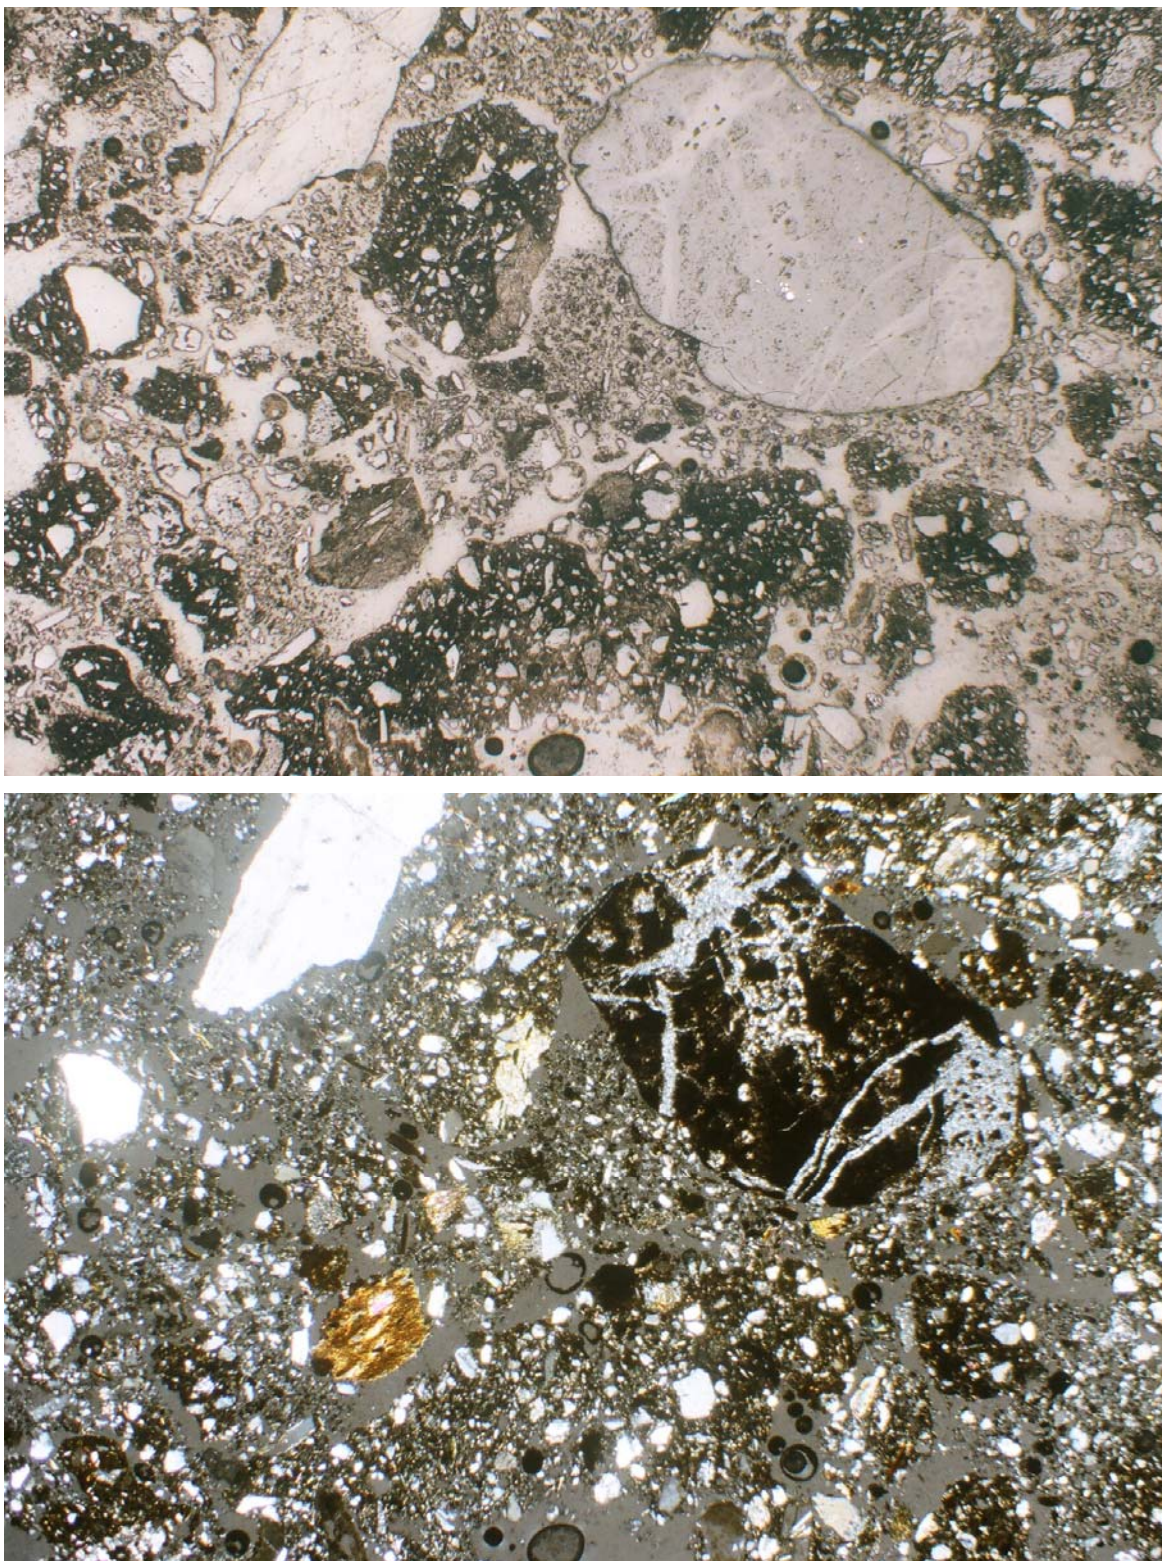
**Figure 12.** NA-05-05 (9.1–10.9) in plain reflected light (top) and in transmitted light with crossed polarizers (bottom), width of field 5.2 mm. At the upper right is a large cherty particle containing minute grains of pyrite (white), but the field is otherwise sulfide-barren.

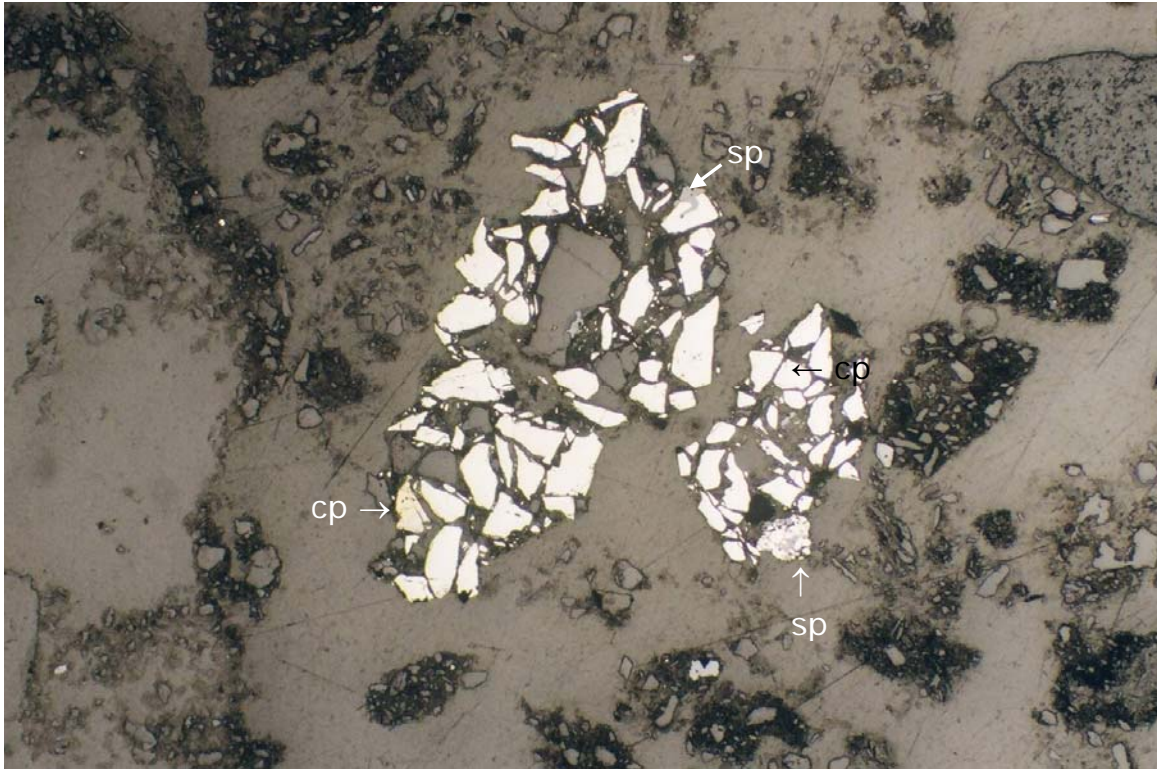
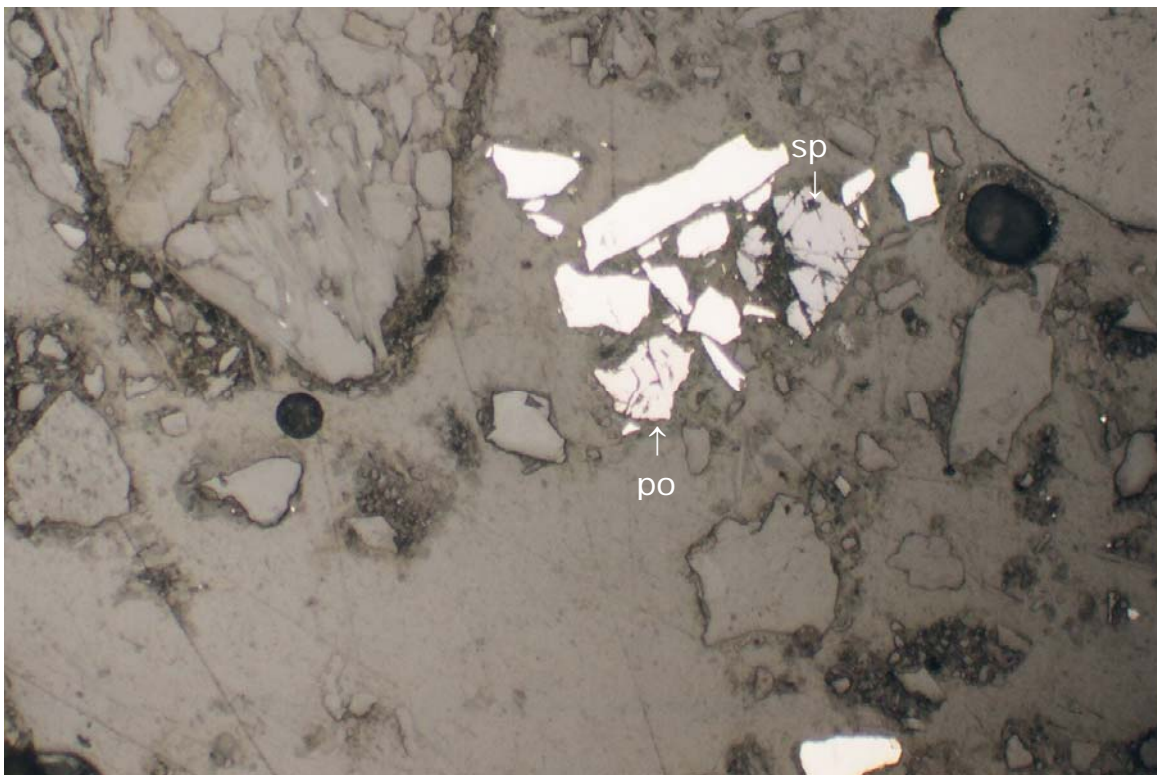
**Figure 13.** NA-05-06 in plain reflected light, width of field 2.6 mm (top) and 1.3 mm (bottom), showing clustered tailings sulfides, mainly pyrite. In the upper photo the arrows at 1 and 6 o'clock point to sphalerite (grey) intergrown with pyrite, and arrows at 3 and 8 o'clock point to chalcopyrite. The lower photo shows pyrite, pyrrhotite (at arrow), and grey sphalerite.

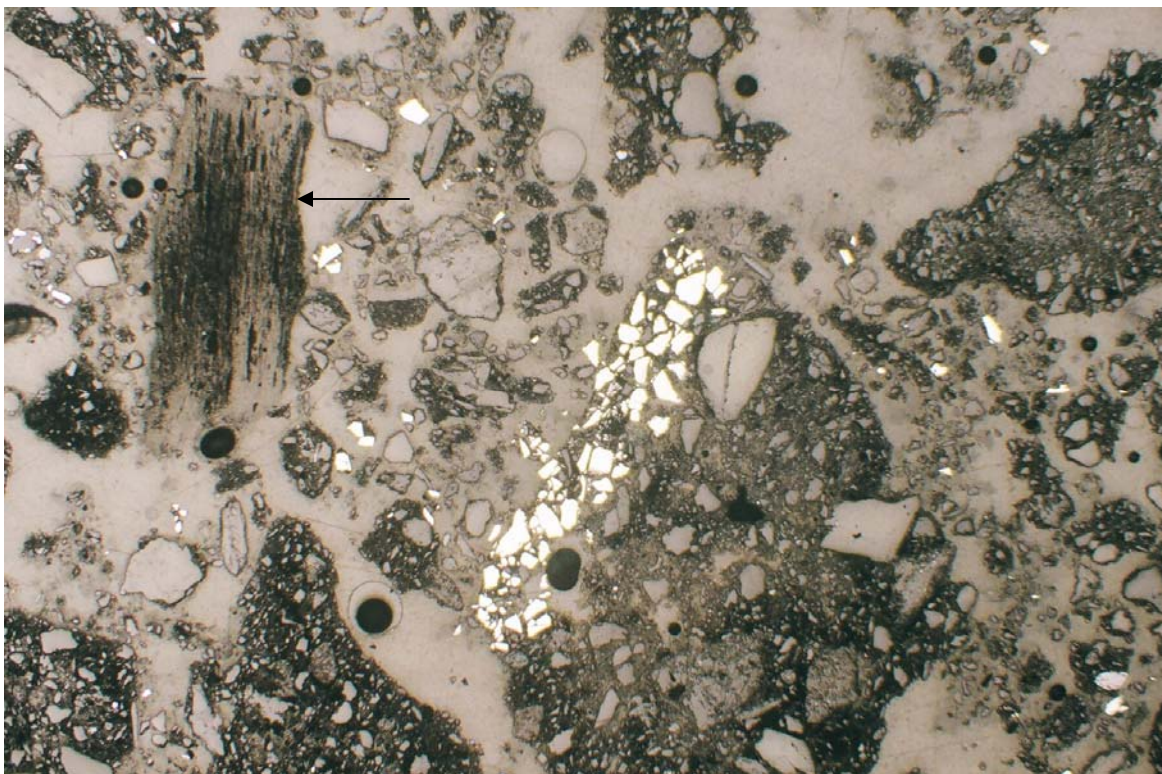
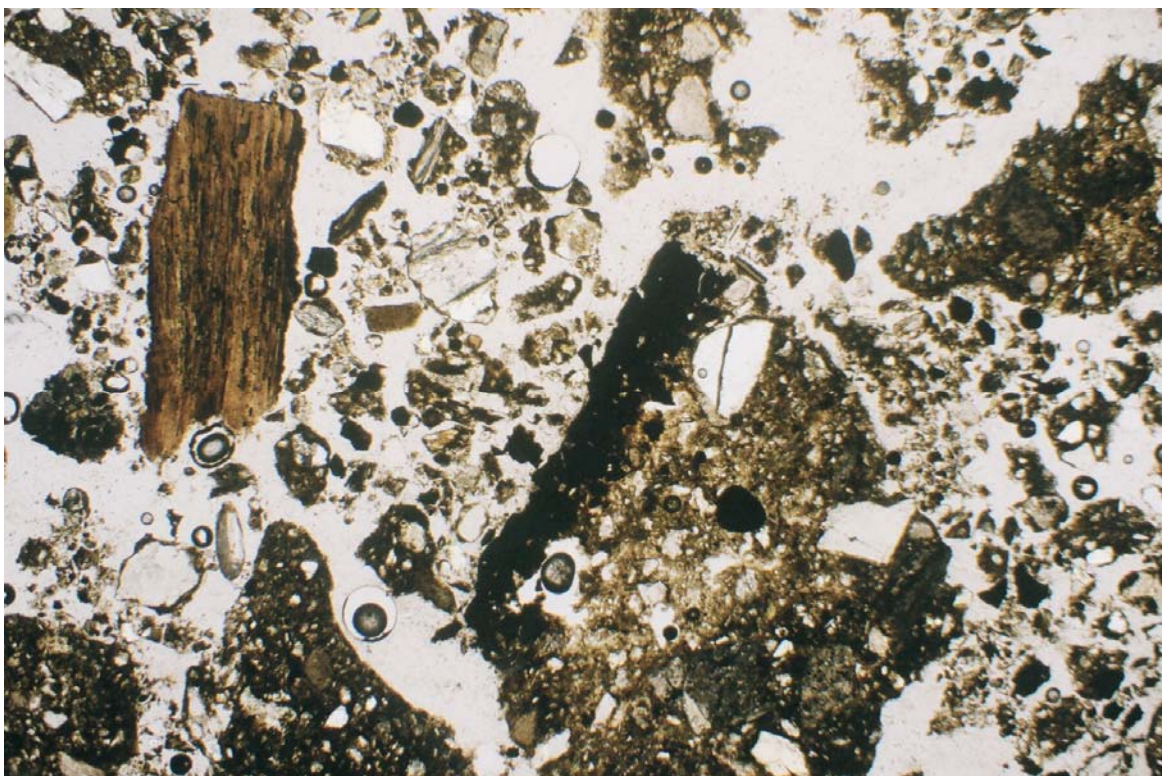
**Figure 14.** NA-05-06 in plain reflected light (top) and the same field in plain transmitted light (bottom), width of field 5.2 mm. The upper photo shows clustered and disseminated pyrite; the arrow at the left points to a large particle of organic material.

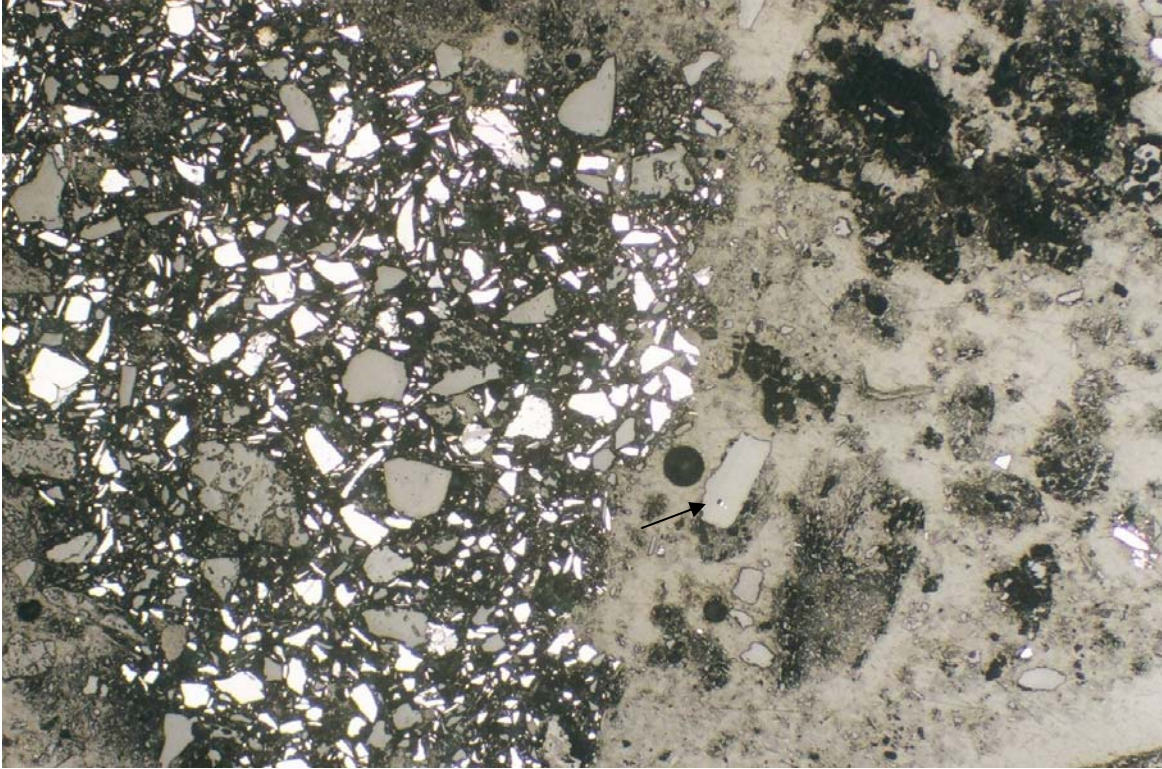
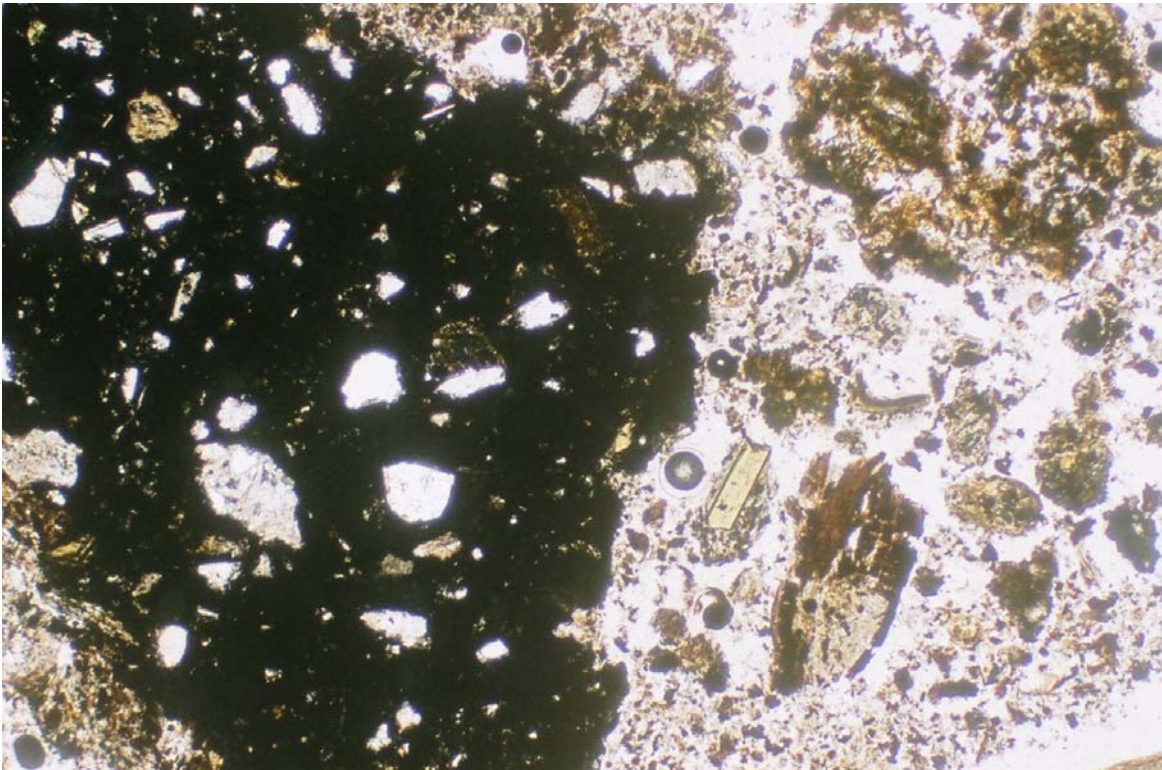
**Figure 15.** NA-05-07 in plain reflected light (top) and in plain transmitted light (bottom), width of field 2.6 mm. The clustered sulfide grains on the left are mainly pyrite, and the sulfide-poor area on the right is organic-rich. The arrow points to the reference prismatic grain shown in Figure 16.

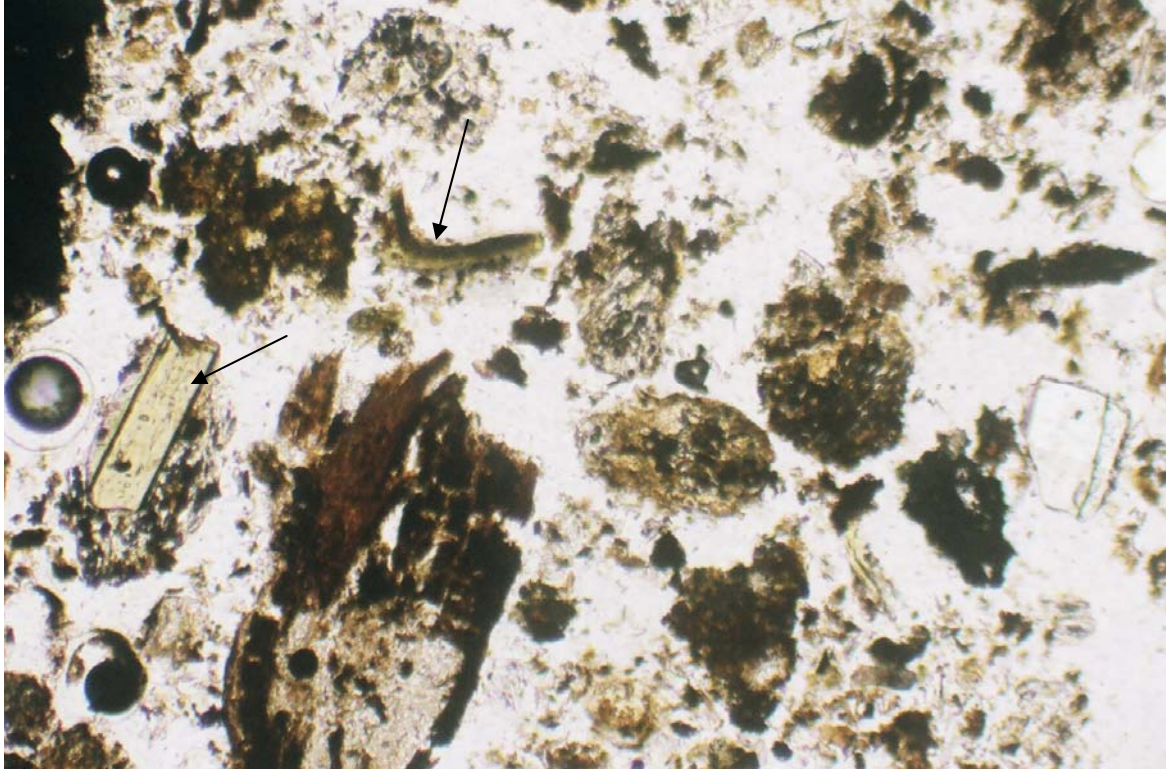
**Figure 16.** Enlargement of the right side of Figure 15, in plain transmitted light, width of field 1.3 mm. The arrows point to the reference prismatic grain (left) and to a mica grain, with both also indicated in the backscattered-electron (BSE) image. EDS spectra for **a** (at bottom), **b**, and **e** are shown in Figure 17.

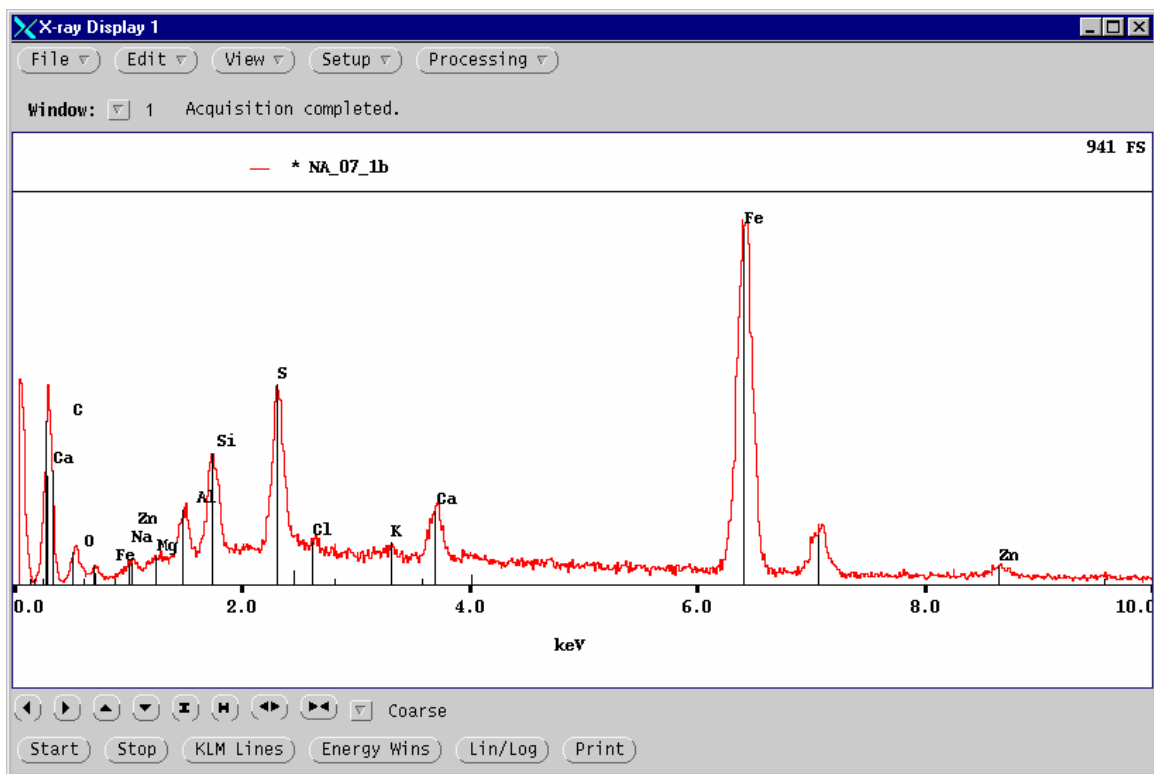
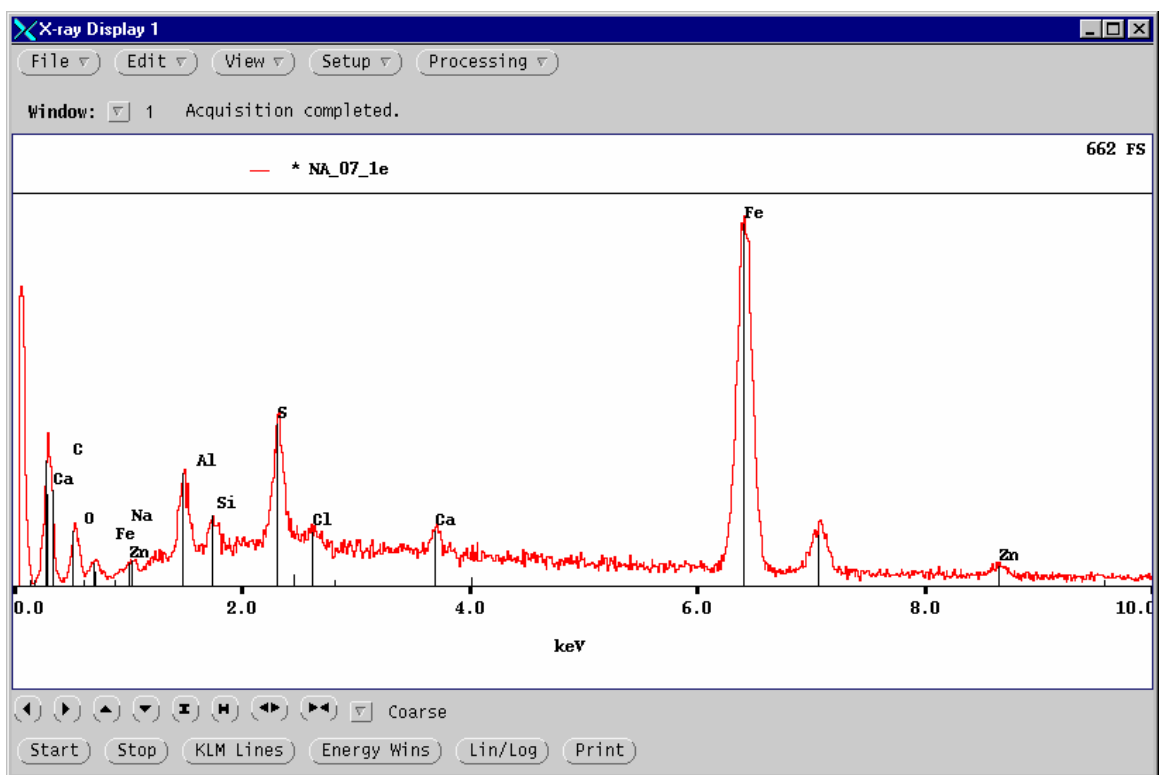
**Figure 17.** EDS spectra of areas **a**, **b**, and **e** shown in Figure 16.

**Figure 17** (cont'd). EDS spectrum of carbonaceous material at **e** in the BSE image of Figure 16.

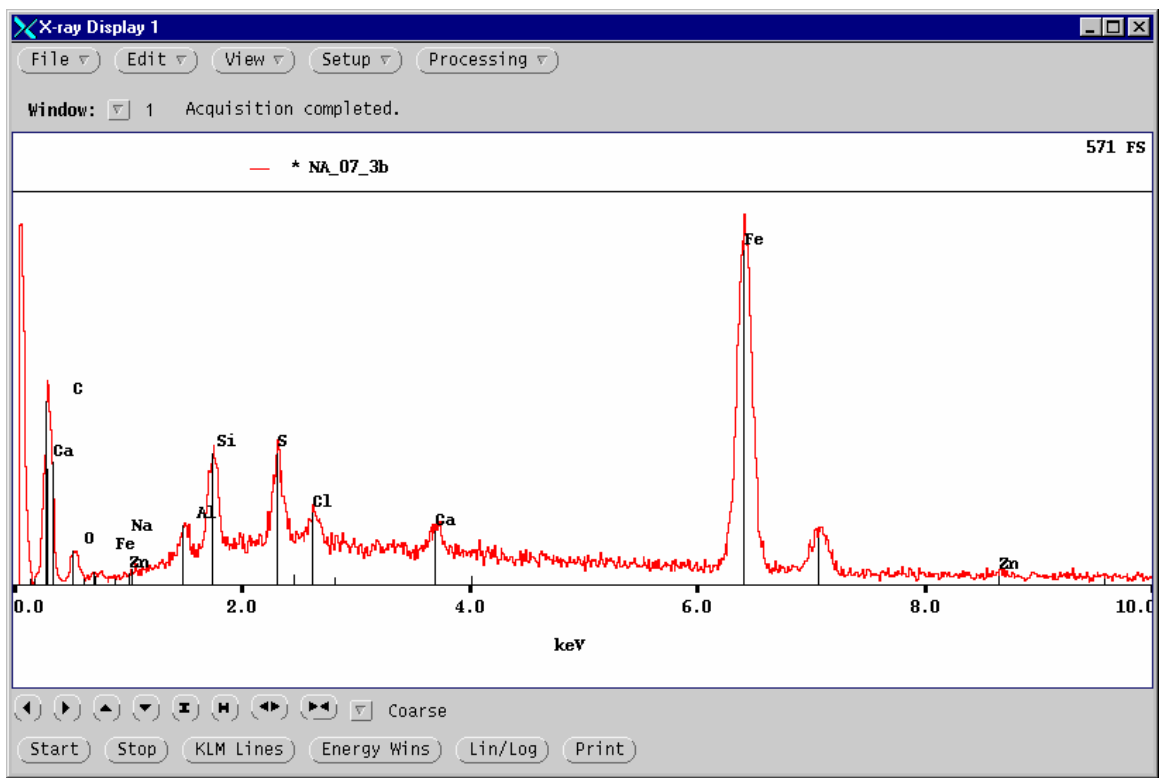
**Figure 18.** EDS spectrum of **b** shown in Figure 19.

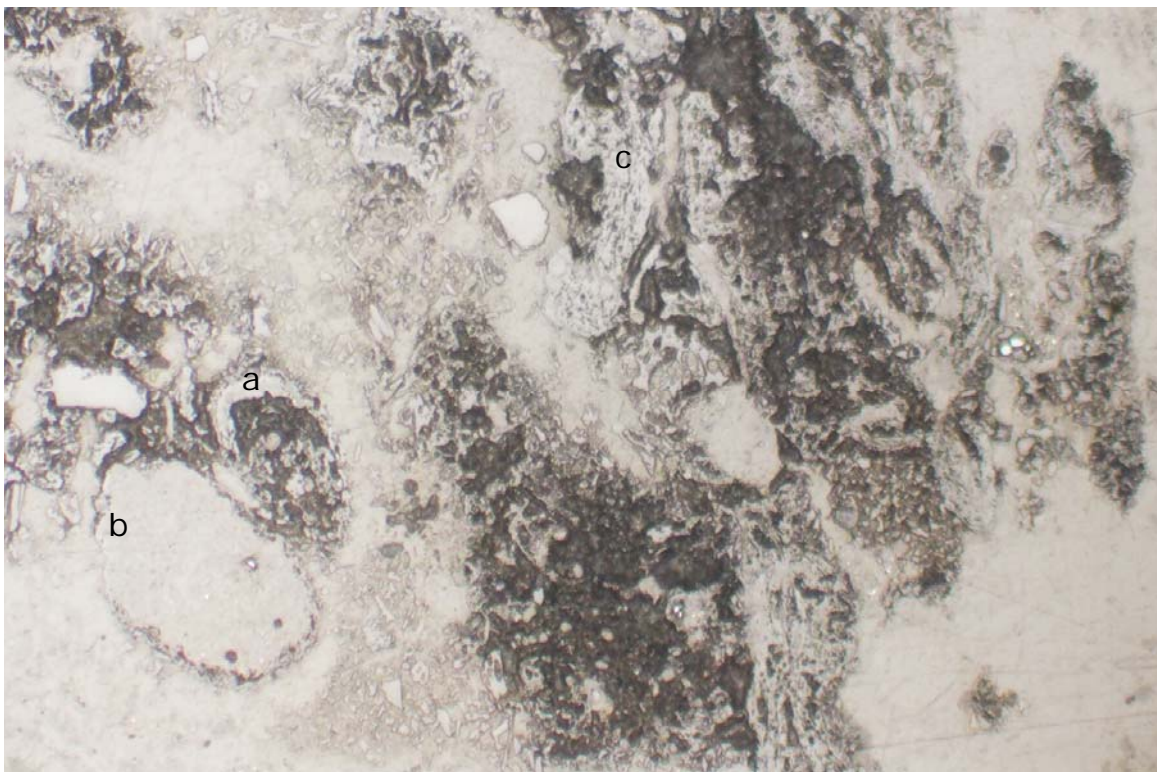
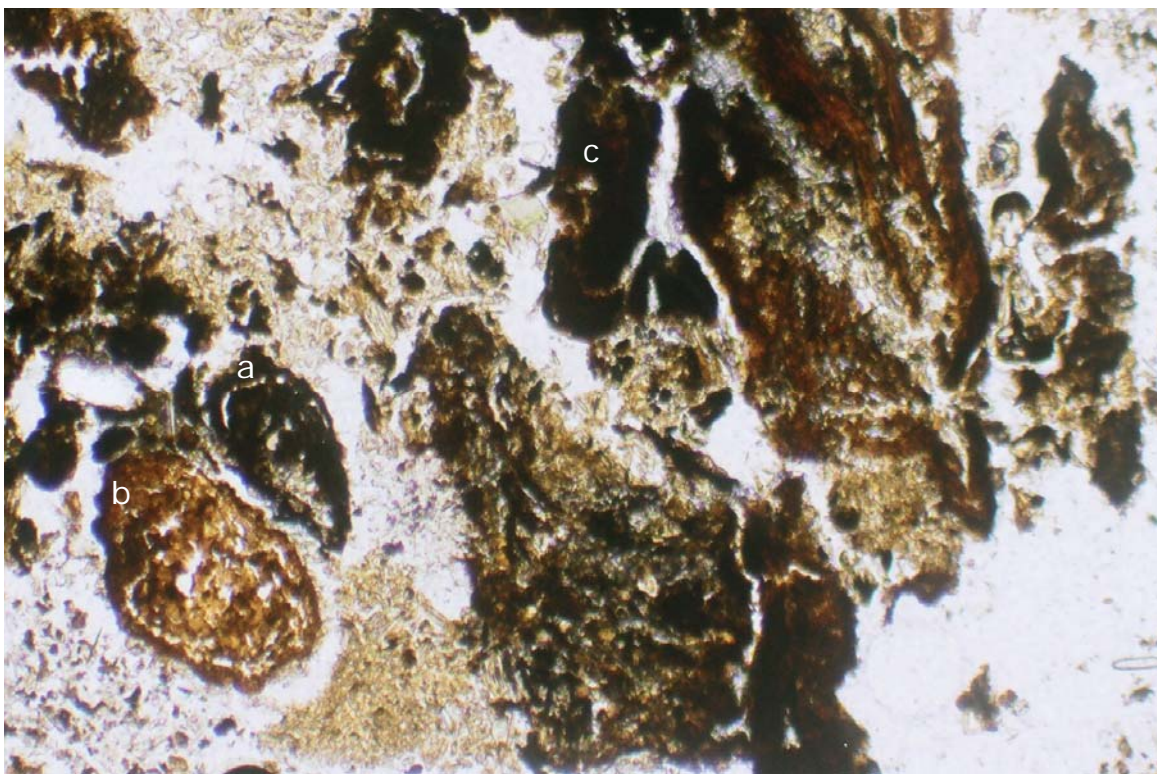
**Figure 19.** Carbonaceous area in NA-05-07 in plain reflected (top) and plain transmitted light (bottom), width of field 1.3 mm. The EDS spectrum of **a** showed the presence of low amounts of Zn, but **b** and **c** have higher Fe and barely detectable Zn whose presence was confirmed in an expanded-scale spectrum.

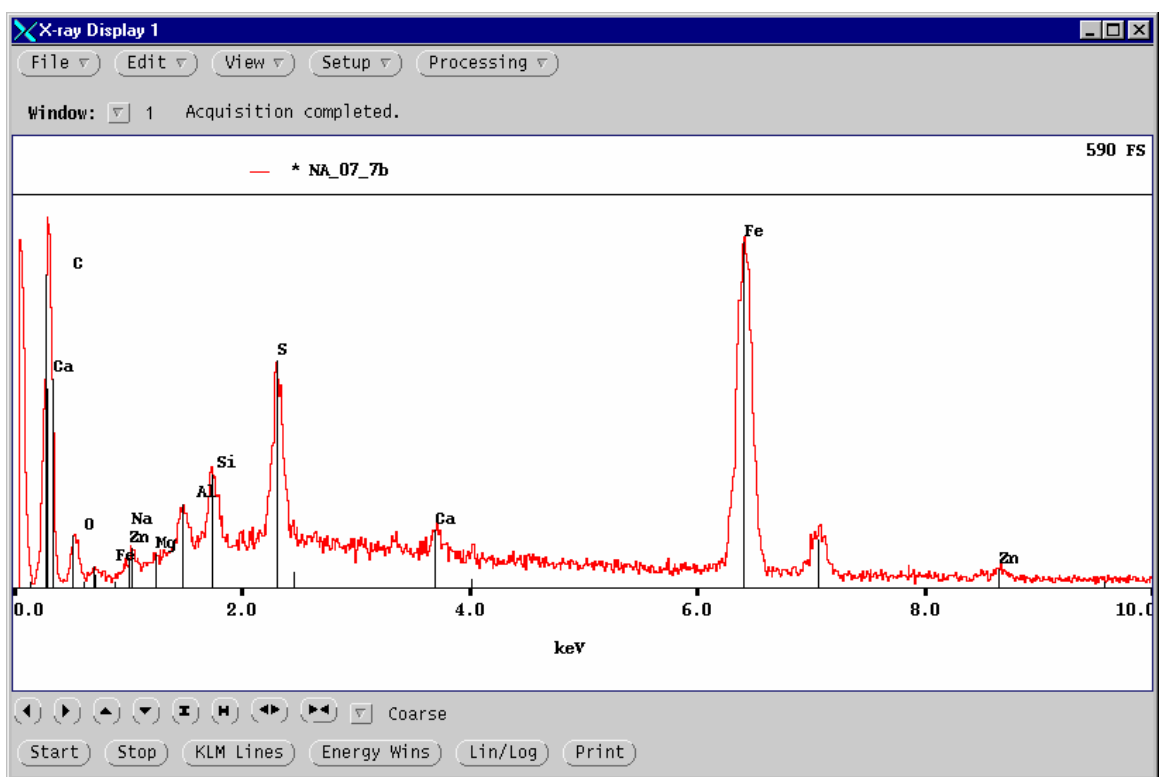
**Figure 20.** Cellular carbonaceous material in NA-05-07; plain reflected light, width of field 0.625 mm, and the corresponding EDS spectrum.

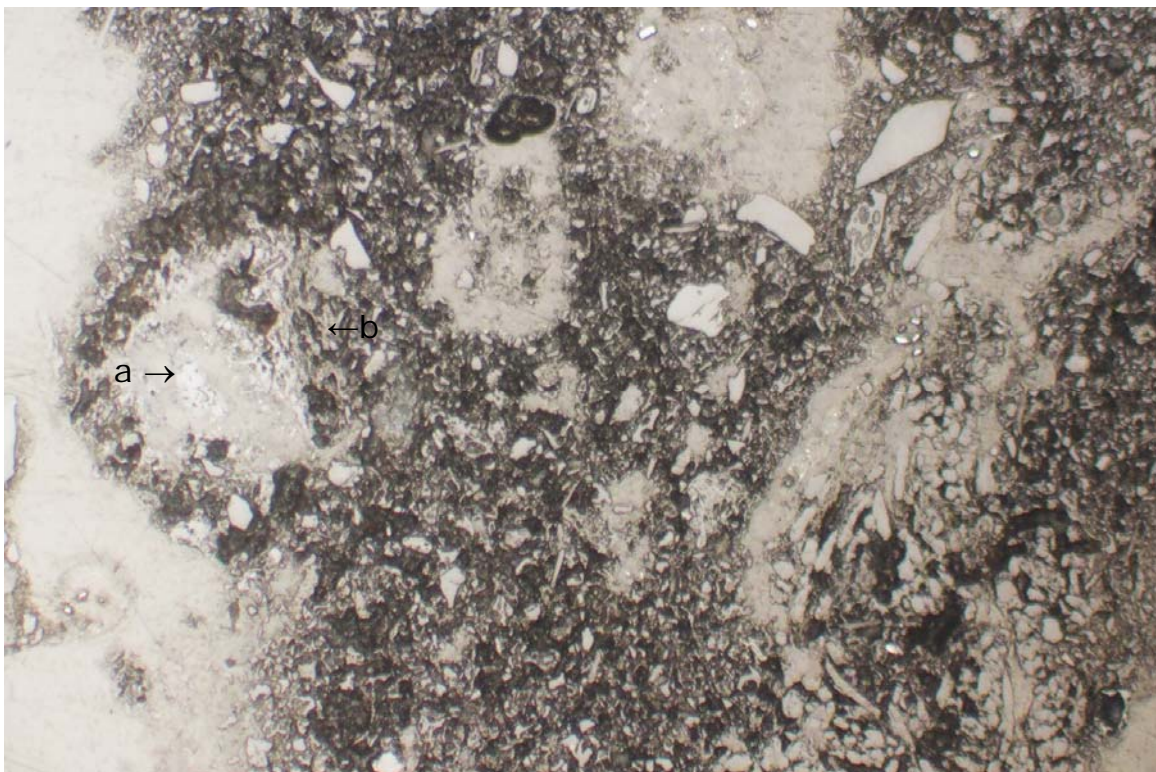
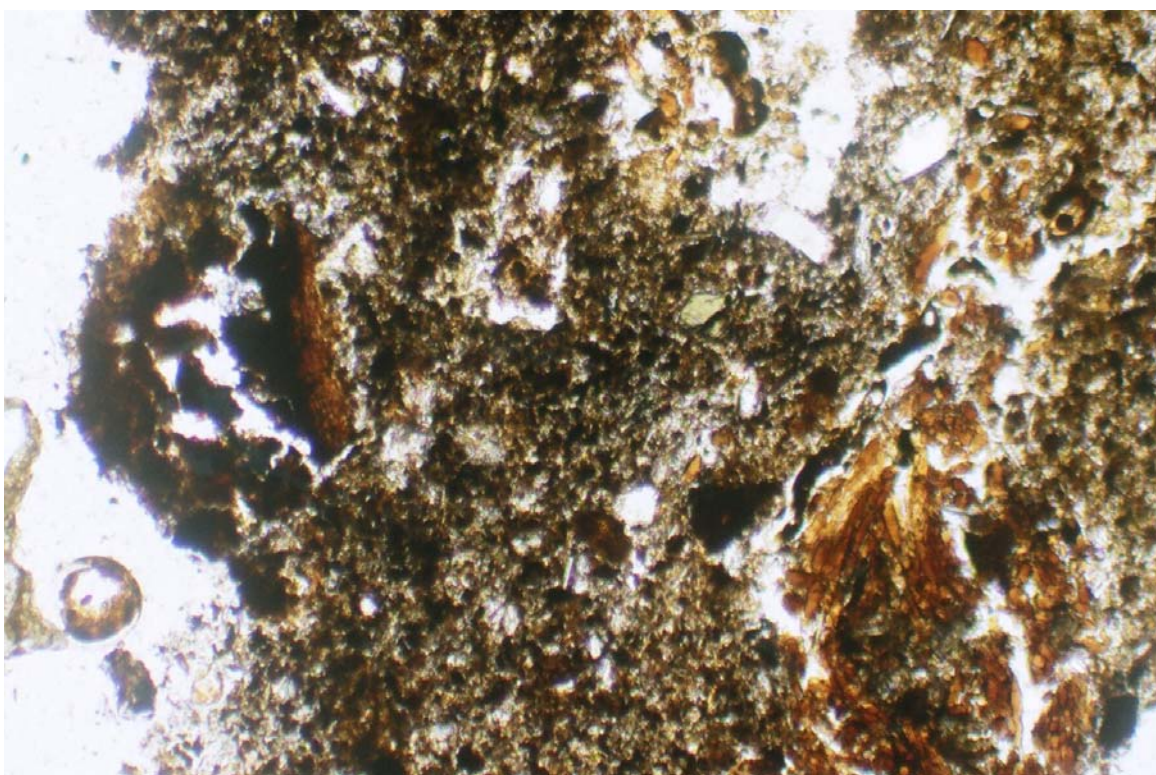
**Figure 21.** A-05-07 in plain reflected light (top) and in plain transmitted light (bottom), width of field 1.3 mm. Arrow **a** points to higher reflectance material that may represent the initial stage of development of secondary Fe oxyhydroxide; arrow **b** points to less extensively replaced carbonaceous material.

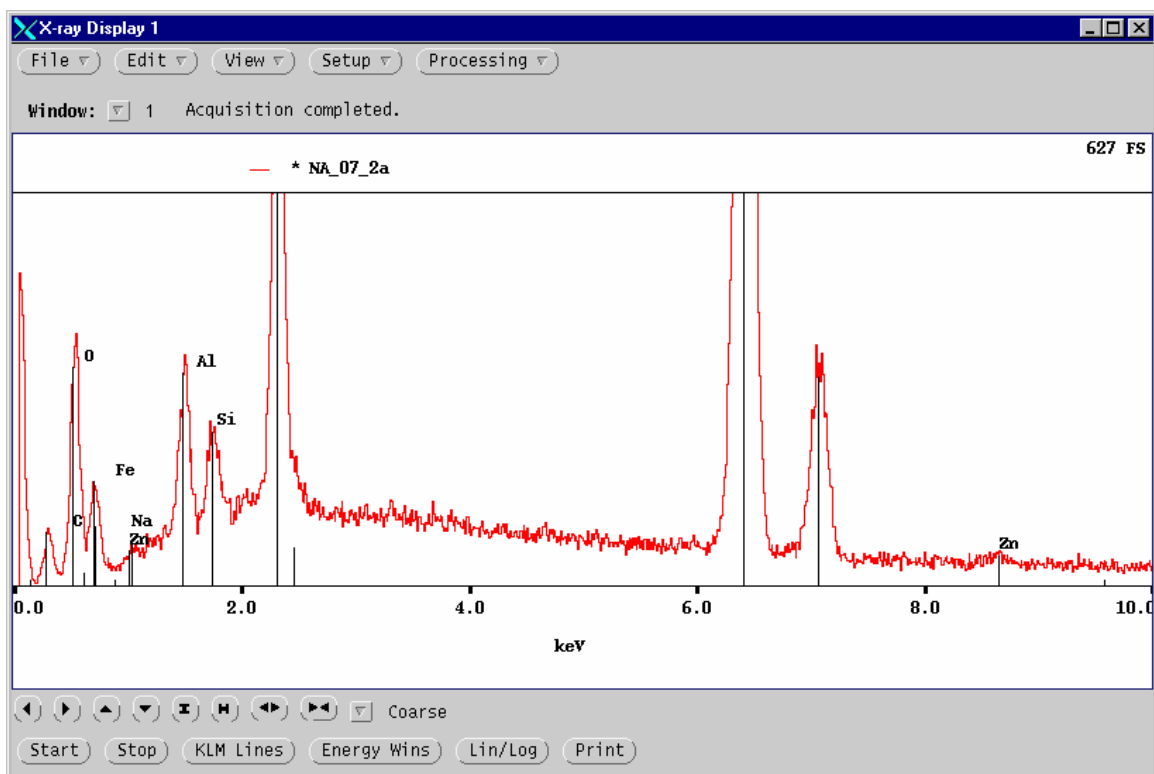
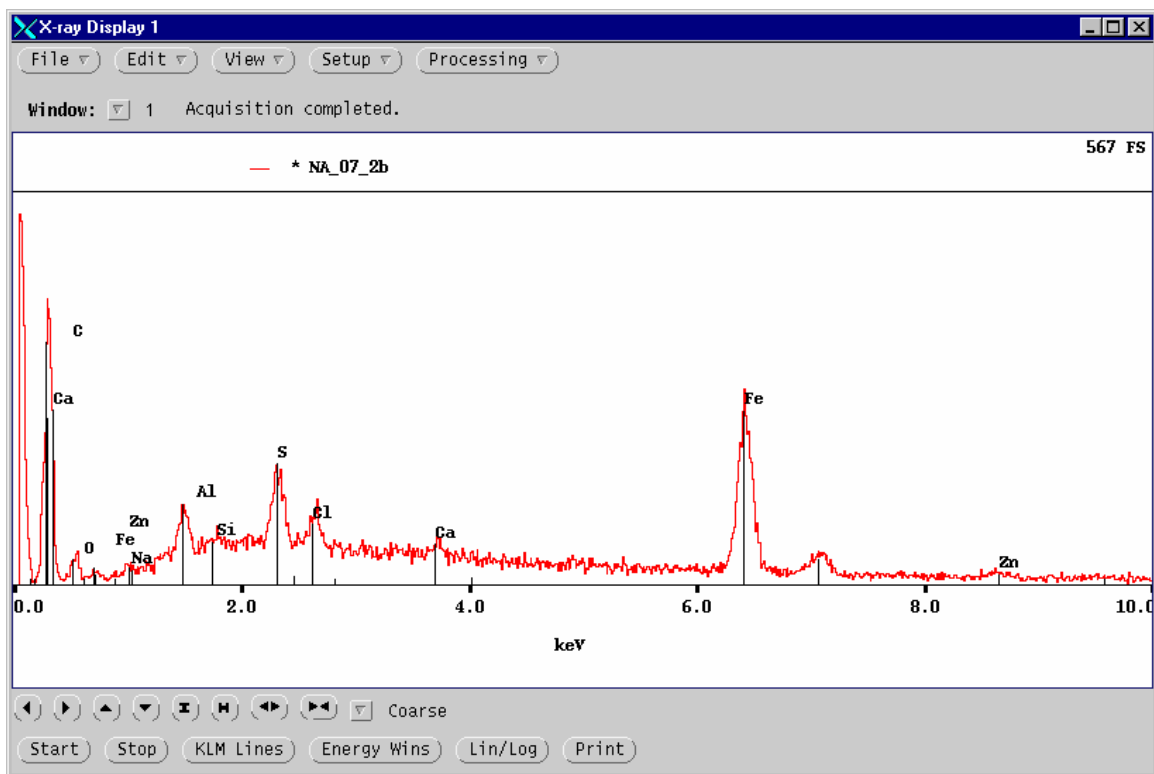
**Figure 22.** EDS spectra of **a** (upper spectrum) and **b** (lower spectrum) of Figure 21. The upper spectrum is at an expanded scale to show that Zn is present; the two off-scale highest peaks are for S (on the left) and Fe (on the right). The lower spectrum at standard scale is for **b**, which contains less S and Fe, but more Zn, than does **a**.

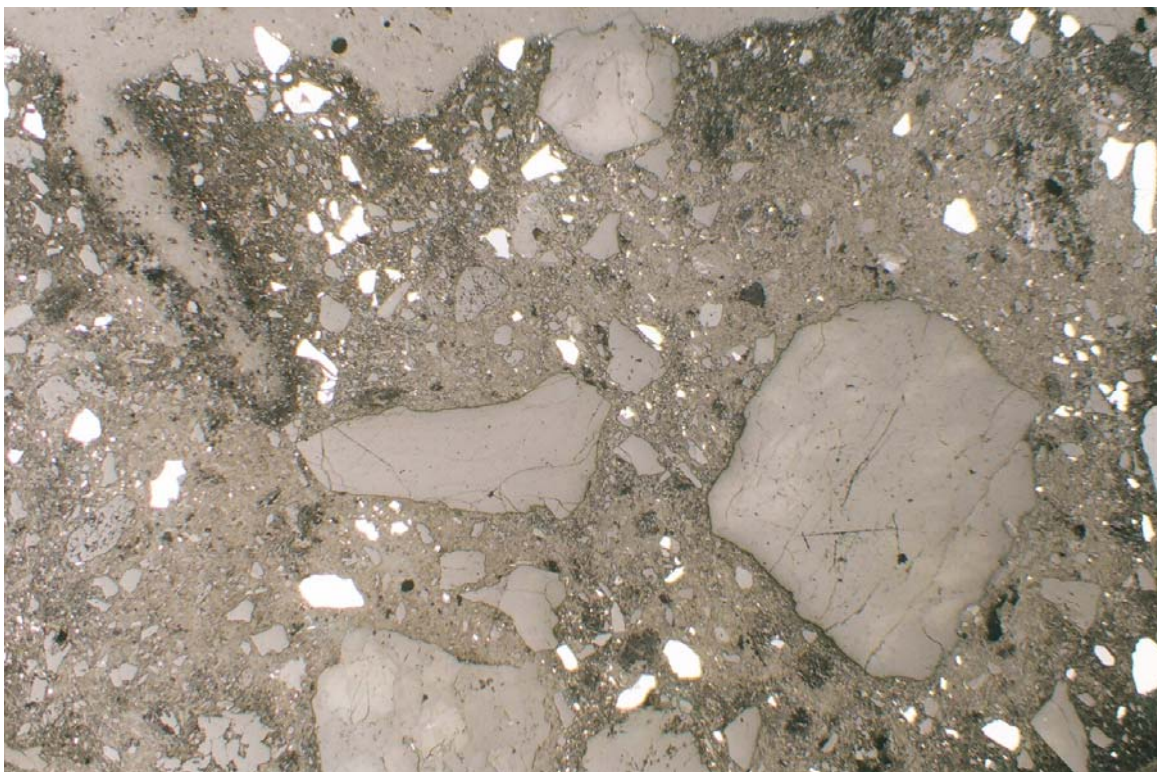
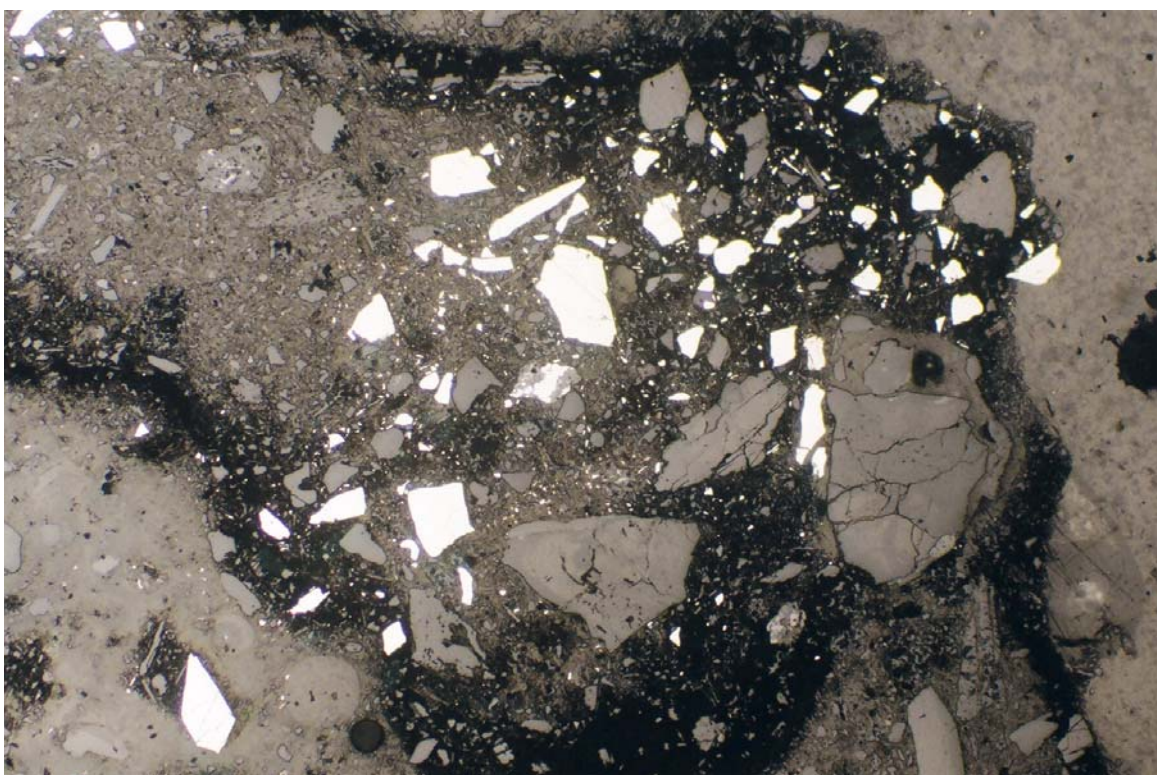
**Figure 23.** NA-05-08 in plain reflected light, width of field 5.2 mm (top) and 2.6 mm (bottom), showing the distribution of pyrite (white) and non-sulfide particles in the sample.

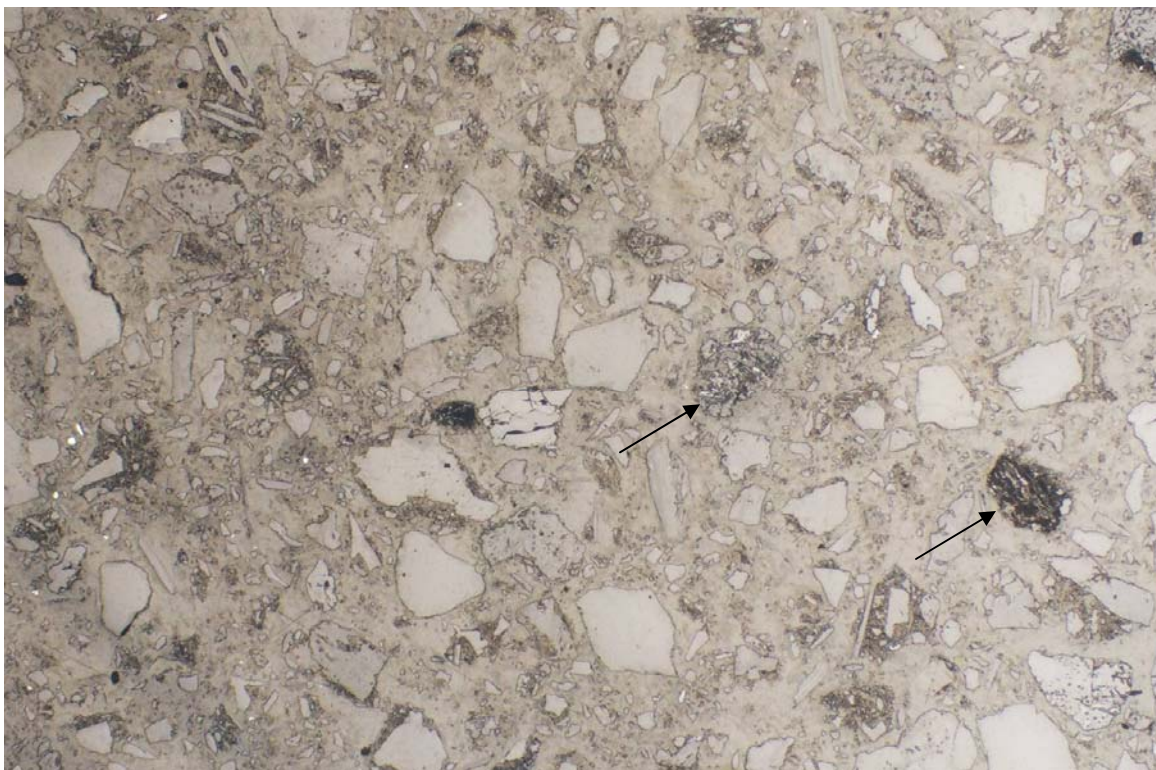
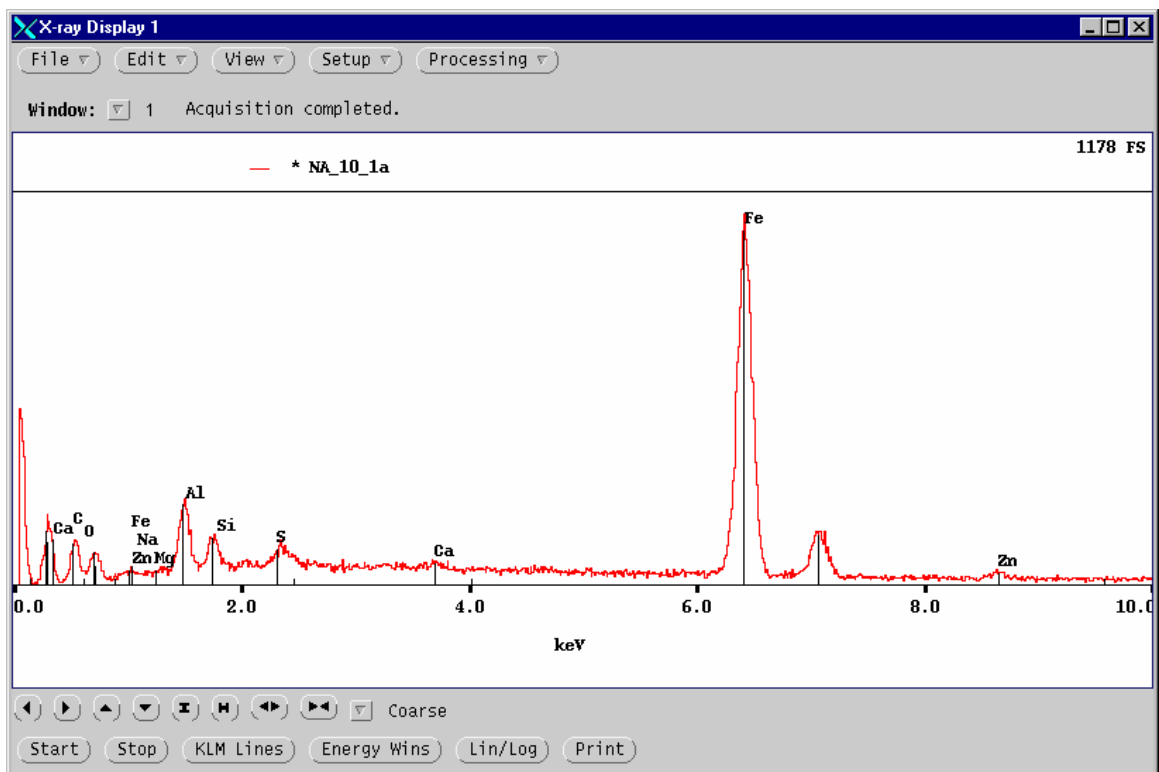
**Figure 25.** NA-05-10 in plain reflected light, width of field 2.6 mm. The EDS spectrum is for the particle on the right, which is Zn-bearing.
