# **Anvil Range Mining Complex: Rose Creek Tailings Deposit Assessment of Zinc Attenuation**

**2005/06 Task 22h(ii)**

**July 2006**

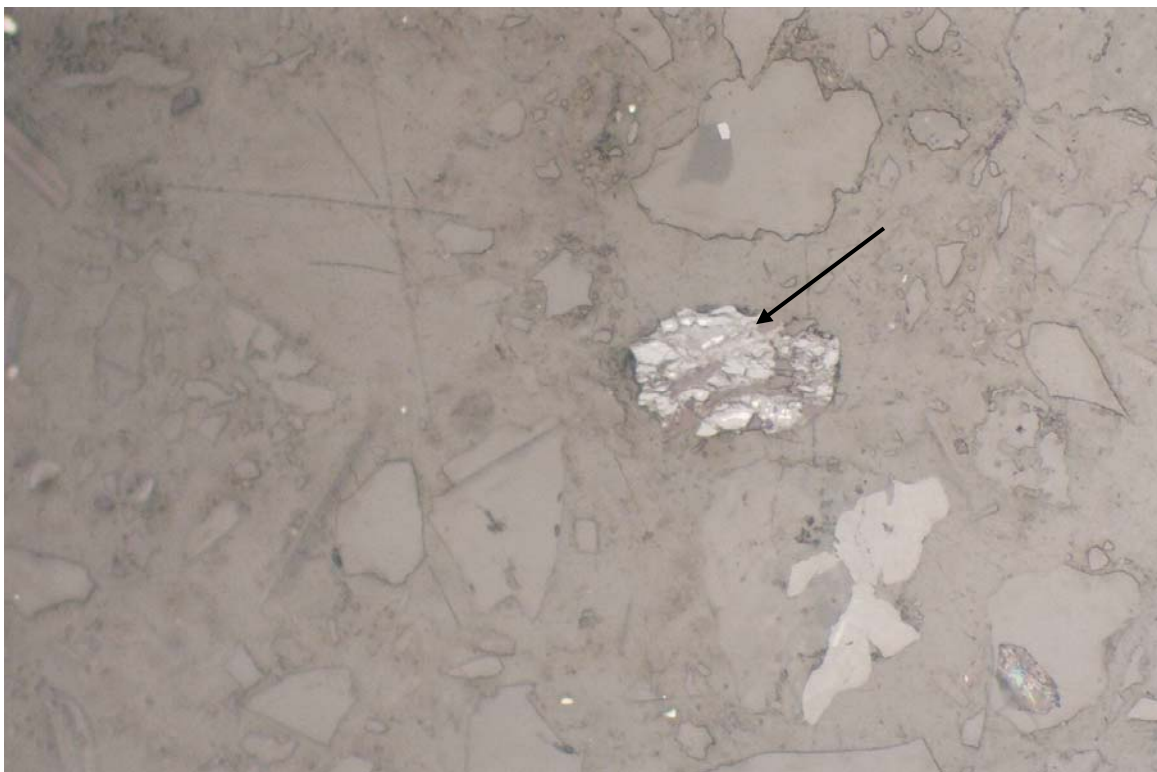
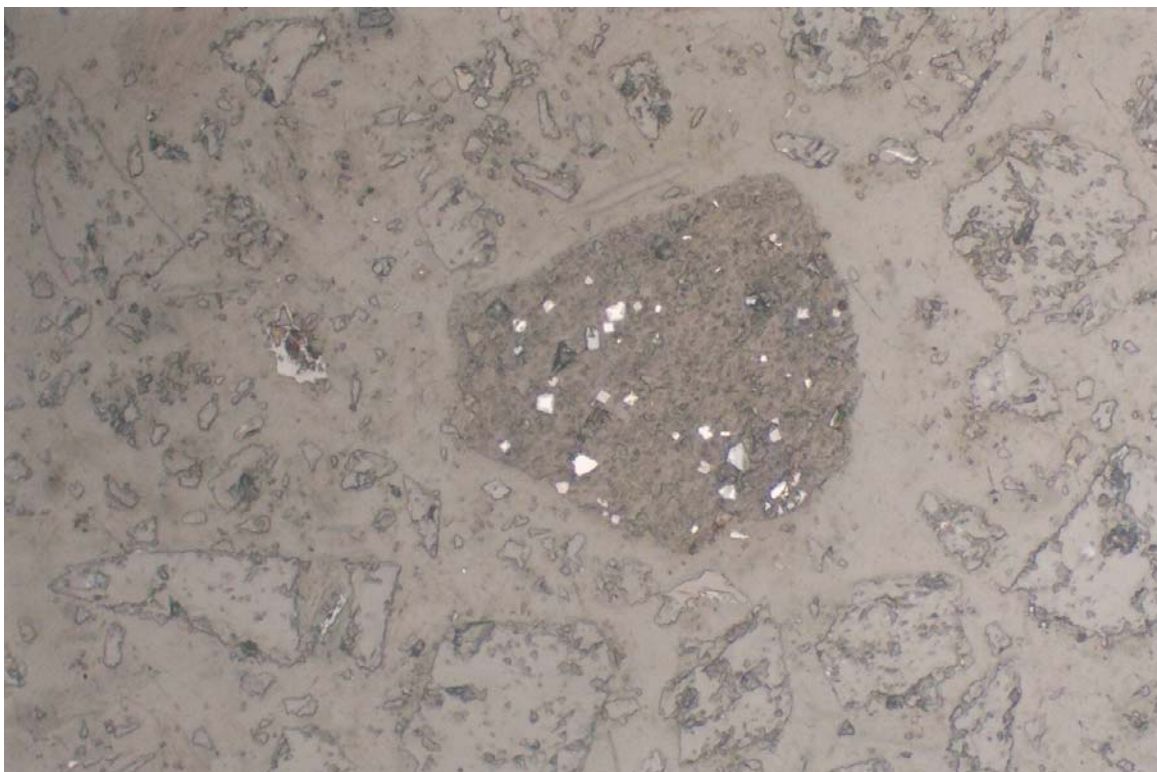
**Figure 26.** NA-05-10 in plain reflected light, width of field 0.625 mm. The upper photo shows a goethite-type particle containing whitish residual pyrite. The central clast in the lower photo contains white grains of pyrite, some of which have rims of Fe oxyhydroxide. The oxyhydroxides in both photos do not contain detectable Zn.

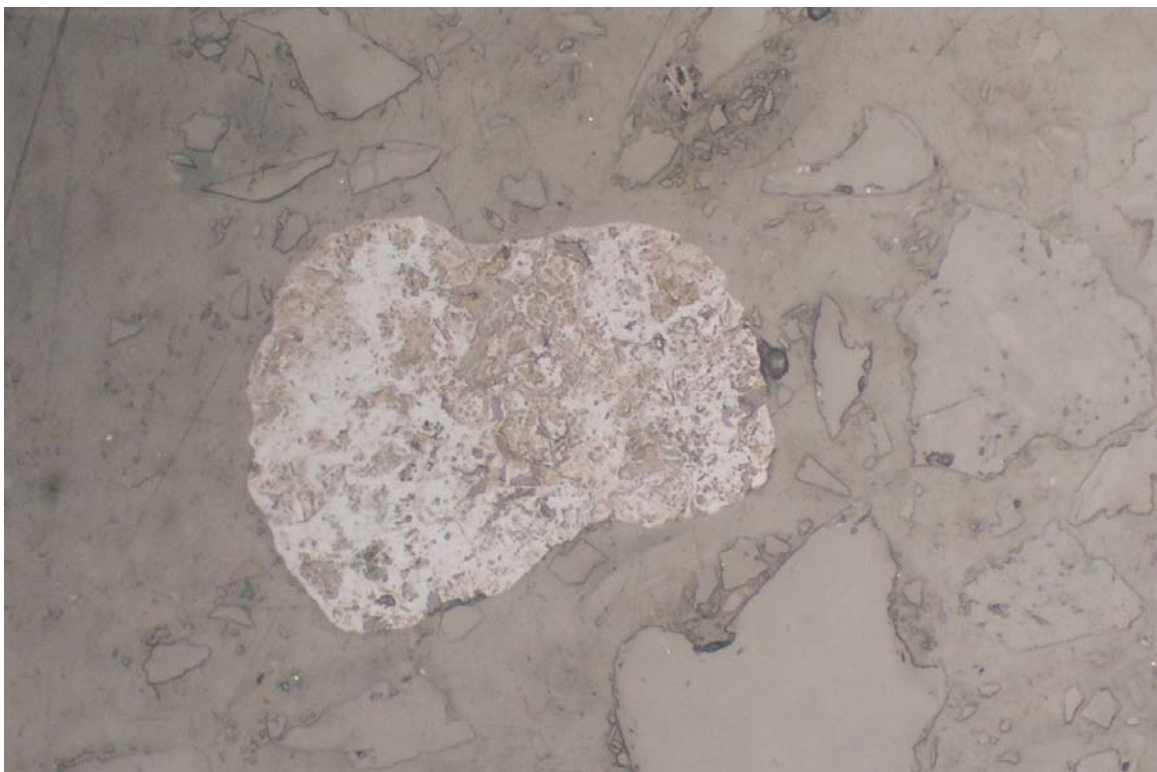
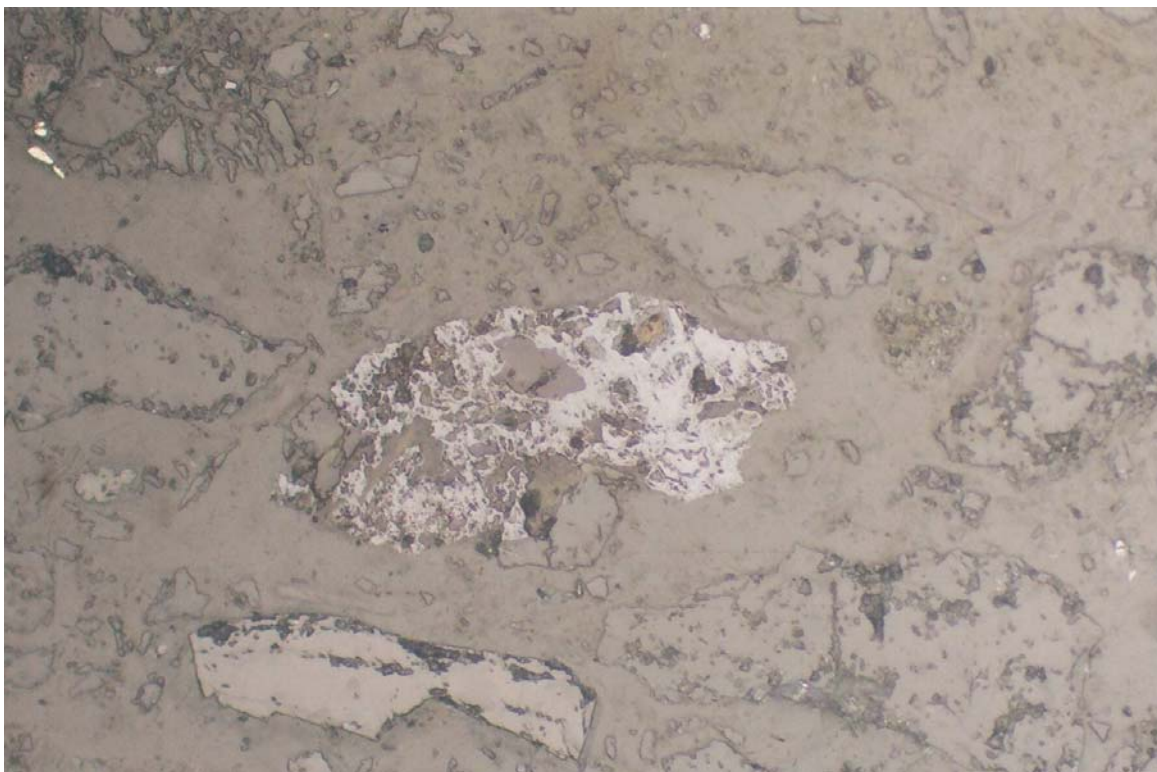
**Figure 27.** NA-05-10 in plain reflected light, width of field 0.625 mm, showing goethite-type particles that were probably deposited as oxyhydroxide clasts. Neither of the particles contains detectable Zn.

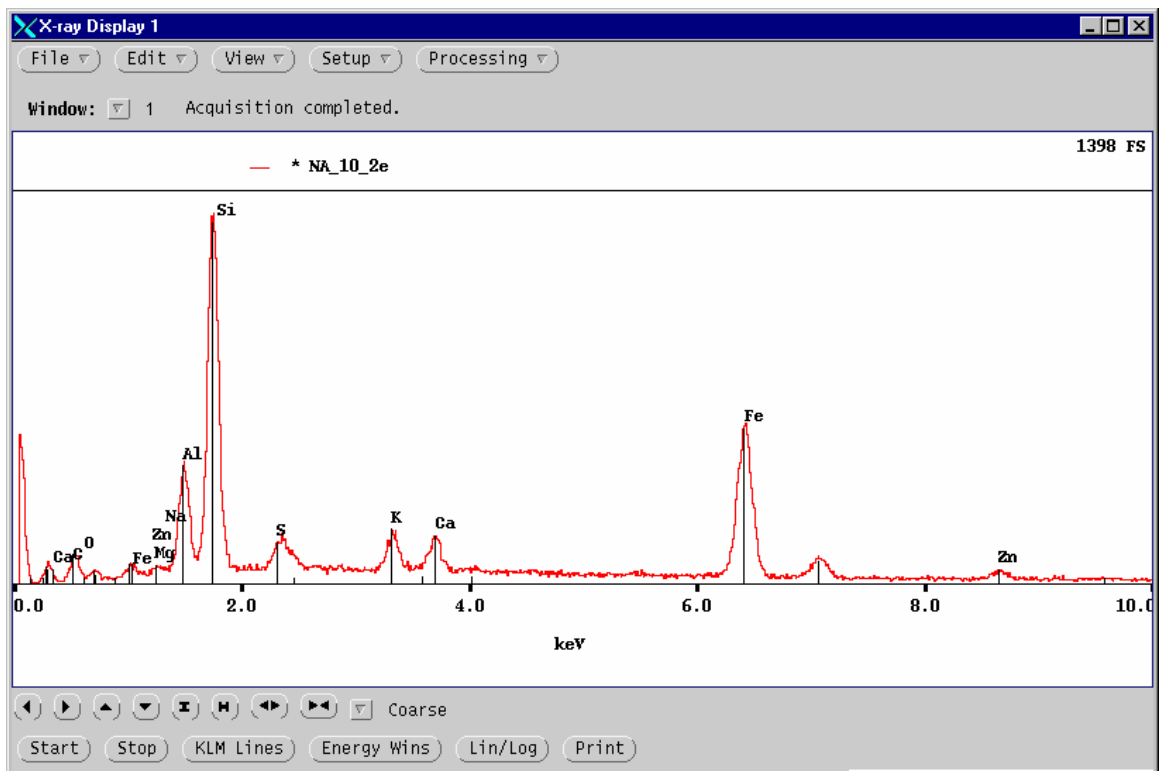
**Figure 28.** NA-05-10 in plain reflected light, width of field 0.625 mm. The arrow points to a ring-like zone of Fe-oxyhydroxide cementation within a particle that contains minute grains of unaltered pyrite (white). The EDS spectrum of the heterogeneous oxyhydroxide indicates that it is Zn-bearing.

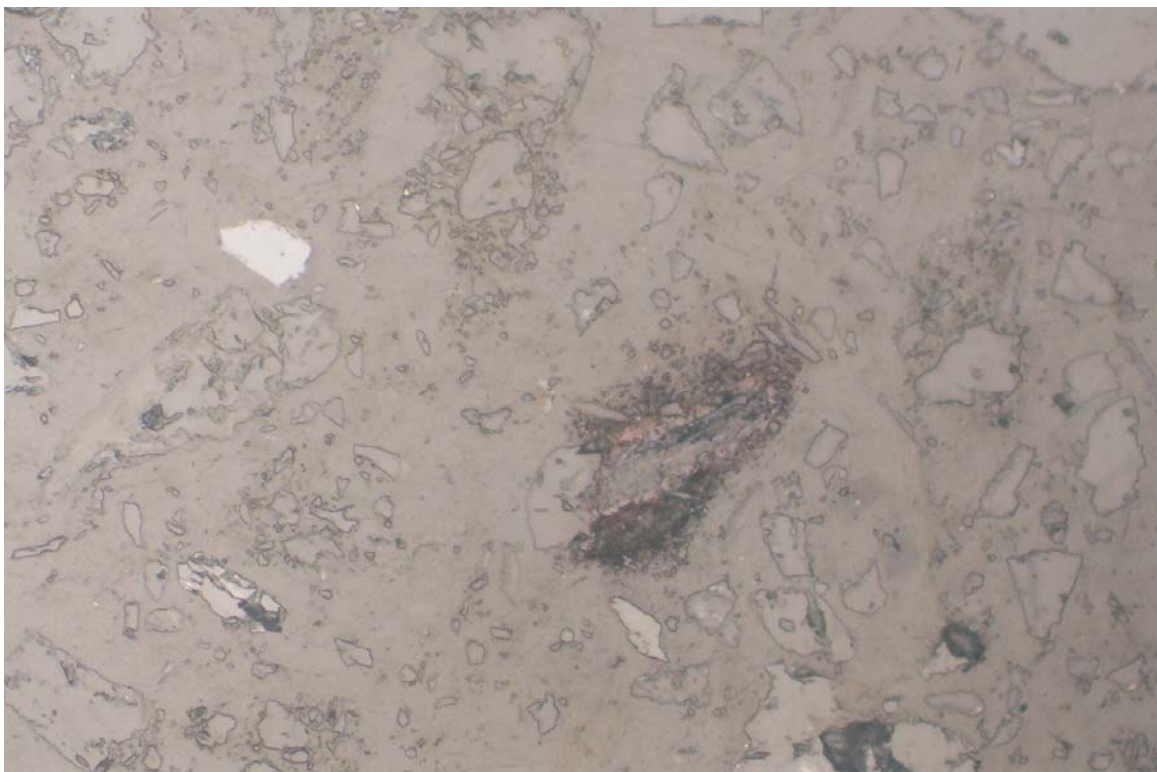
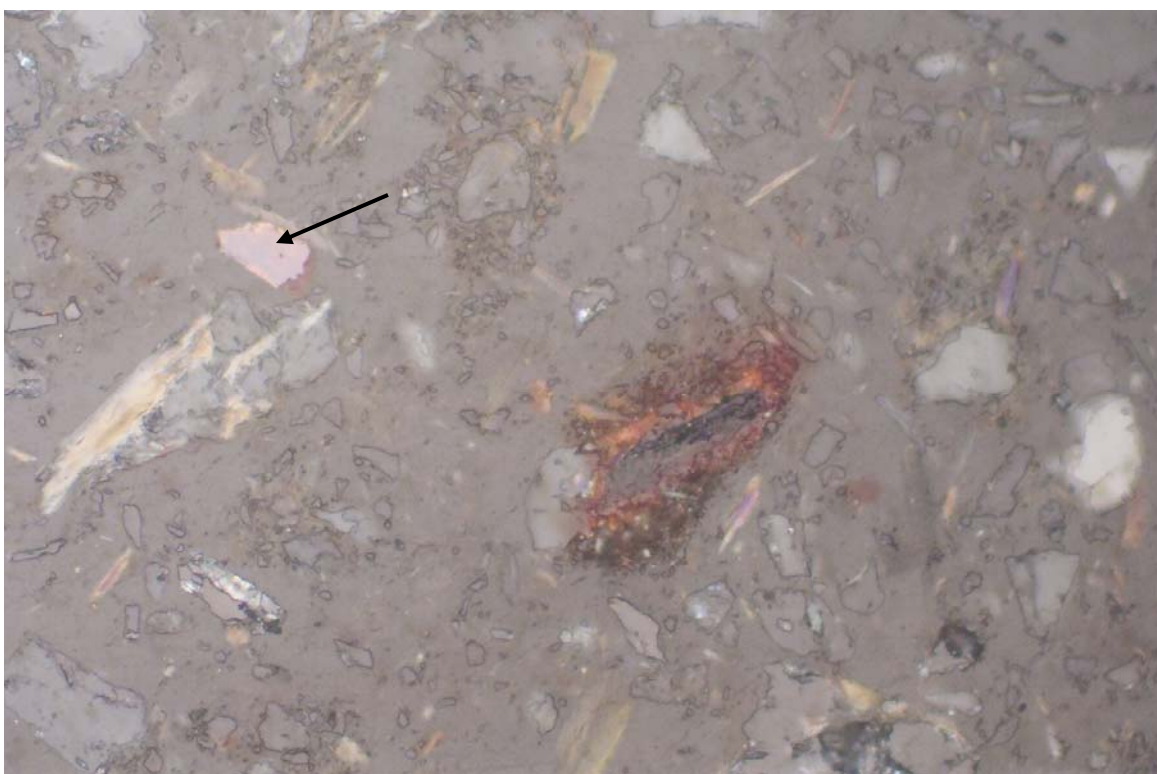
**Figure 29.** NA-05-10 in plain reflected light (top) and with almost crossed polarizers and internal reflection (bottom), width of field 0.625 mm, showing a heterogeneous oxyhydroxide particle (reddish internal reflection) for which the spectrum is in Figure 30. The smaller, homogeneous particle (arrow) is Zn-free.
