**Town of Faro Water Wells Investigation
Preliminary Results
Project #20a**

**Anvil Range Mining Corporation
(Interim Receivership)**

Gartner Lee Limited

**Re: 40-419 – Town of Faro Water Wells Investigation (Project #20a)
Preliminary Results – FINAL REPORT**

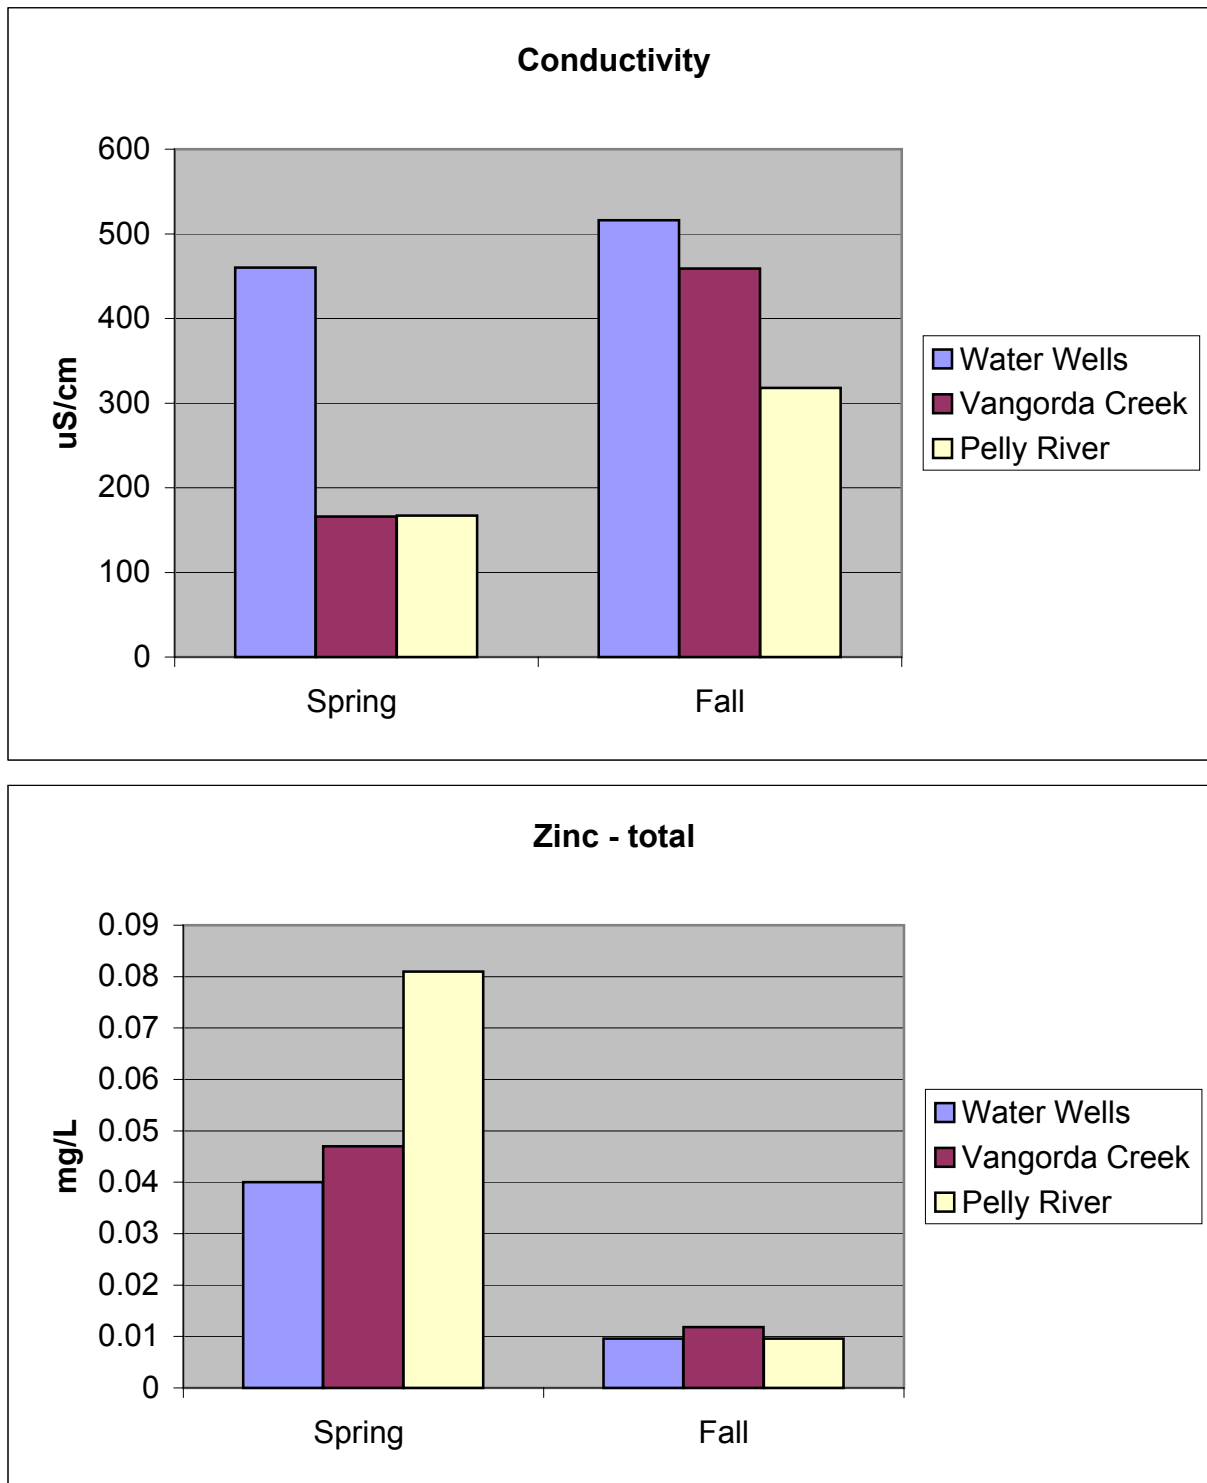
Figure 6: Comparison of Selected 2004 Water Quality Data

1. Data summarized in Tables 3 and 4
2. Results below detection limit are shown on plot at the detection limit

Figure 6 provides an illustrative comparison of water quality results for the Town of Faro water wells, Vangorda Creek, and the Pelly River. Based on the spring 2004 sample results, the town water well quality can be easily distinguished from Vangorda Creek and Pelly River based on the conductivity analysis (and related parameters such as hardness, alkalinity, sulphate, calcium, and magnesium). The fall 2004 results indicate less pronounced differences between water sources based on the same conductivity-related parameters. While zinc concentrations do not follow the same spatial or temporal pattern as the conductivity-related parameters, a relatively high degree of seasonal variability in zinc levels is apparent for each of the three sources.

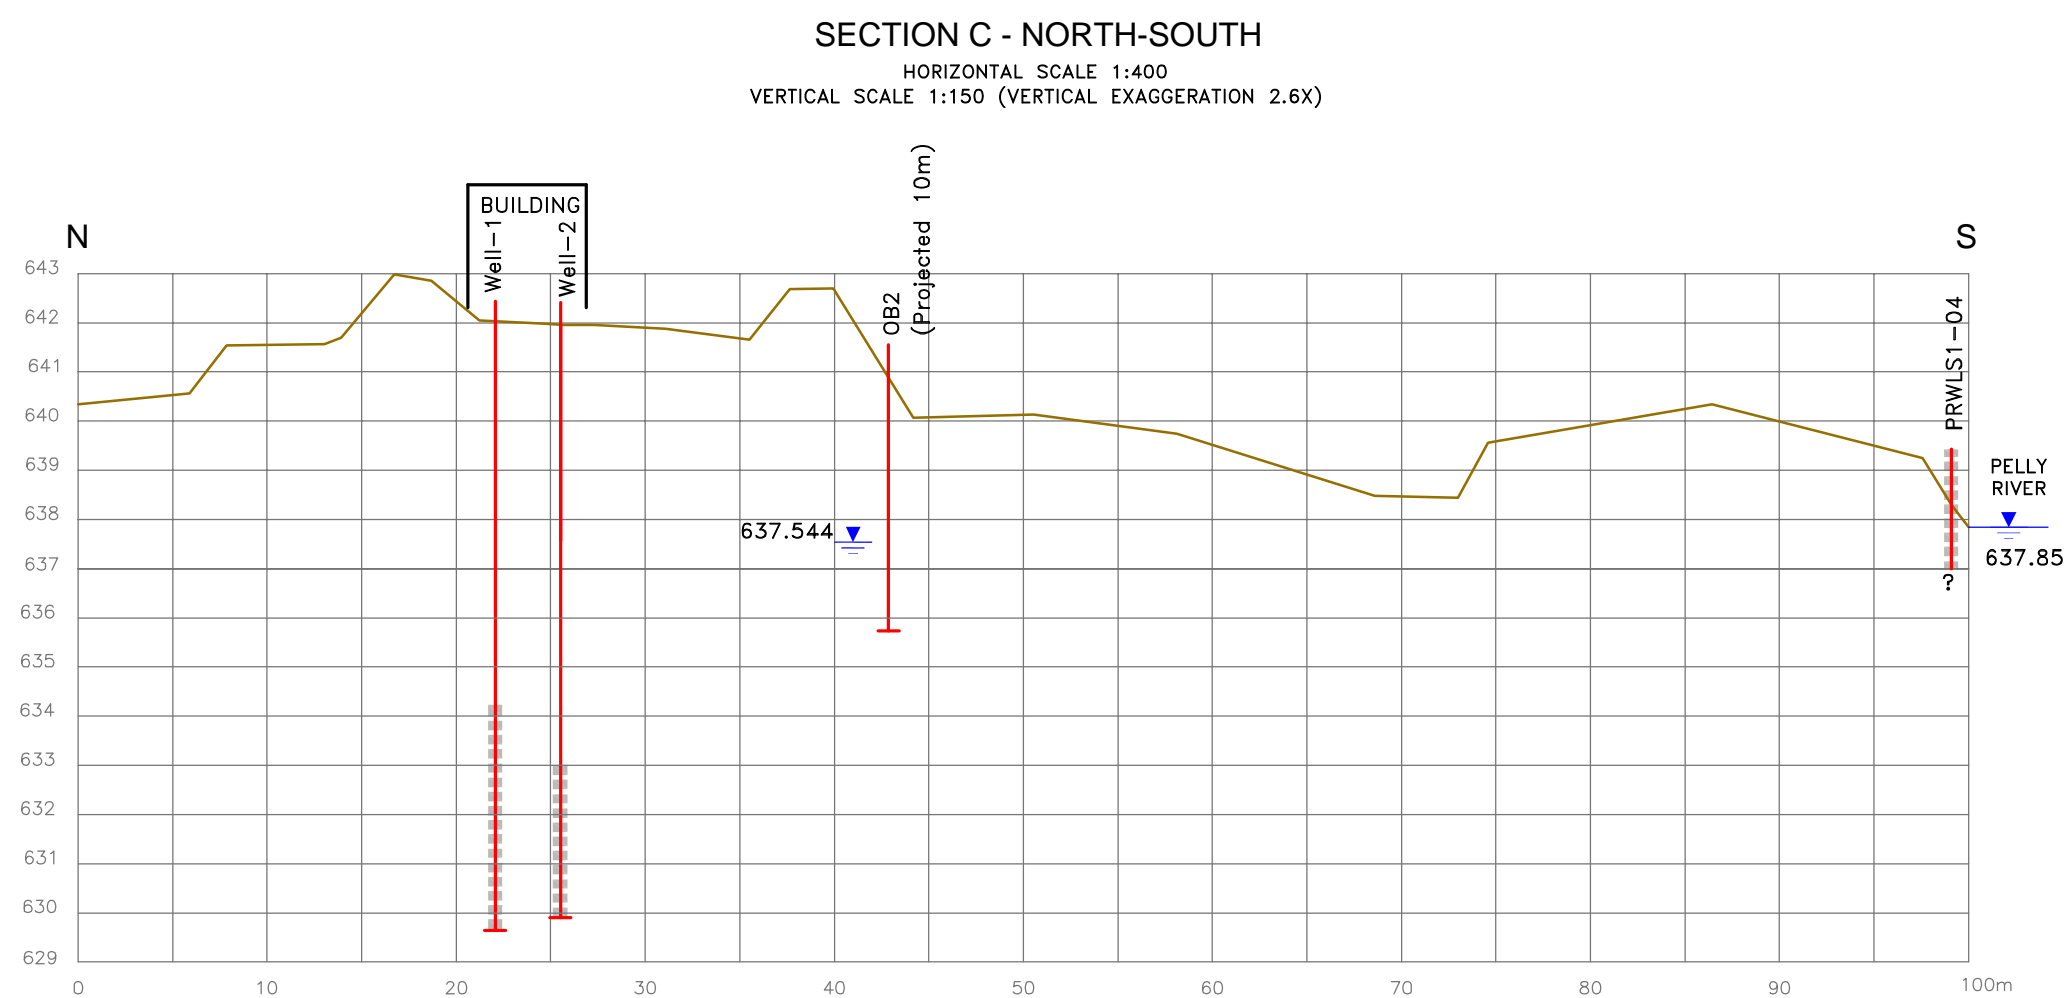
- LEGEND:**
- Ground Surface
 - Surface Water
 - VWLS1-04 Water Level Sensor
 - VCSG1 Stream Gauging Location
 - Water Level measured on October 2, 2004
 - Well
 - Screened Interval

As part of this preliminary hydrogeological assessment, a “snapshot” of water elevations collected on October 7th, 2004 has been compiled and incorporated with the results of the site elevation survey. For visual comparison, the information is presented in cross section form on Figure 7. (Please refer to Figures 2 and 3 for the locations and names of the cross sections).

The elevation data indicates that the water levels in observation wells OB2 and OB6 are lower than the nearest surface waterbodies to the wells (Pelly River and Vangorda Creek, respectively). This observation suggests that water from both of these surface sources may be providing recharge boundaries for the town production wells. At this time however, this single water elevation “snapshot” does not allow an assessment of what the relative contribution of each surface water source may be to the groundwater that is being pumped from the production wells. Additionally, because transient data has yet to be collected and analyzed, it is not possible at this time to determine if the gradients observed are related directly to the pumping activities or if pumping influences in the aquifer are even detected at the monitoring locations. The transient data collection process initiated during this phase of the project (i.e., the installation of water level and temperature sensors) will help establish this relationship and will help to assess possible correlations between the groundwater and surface flow systems.

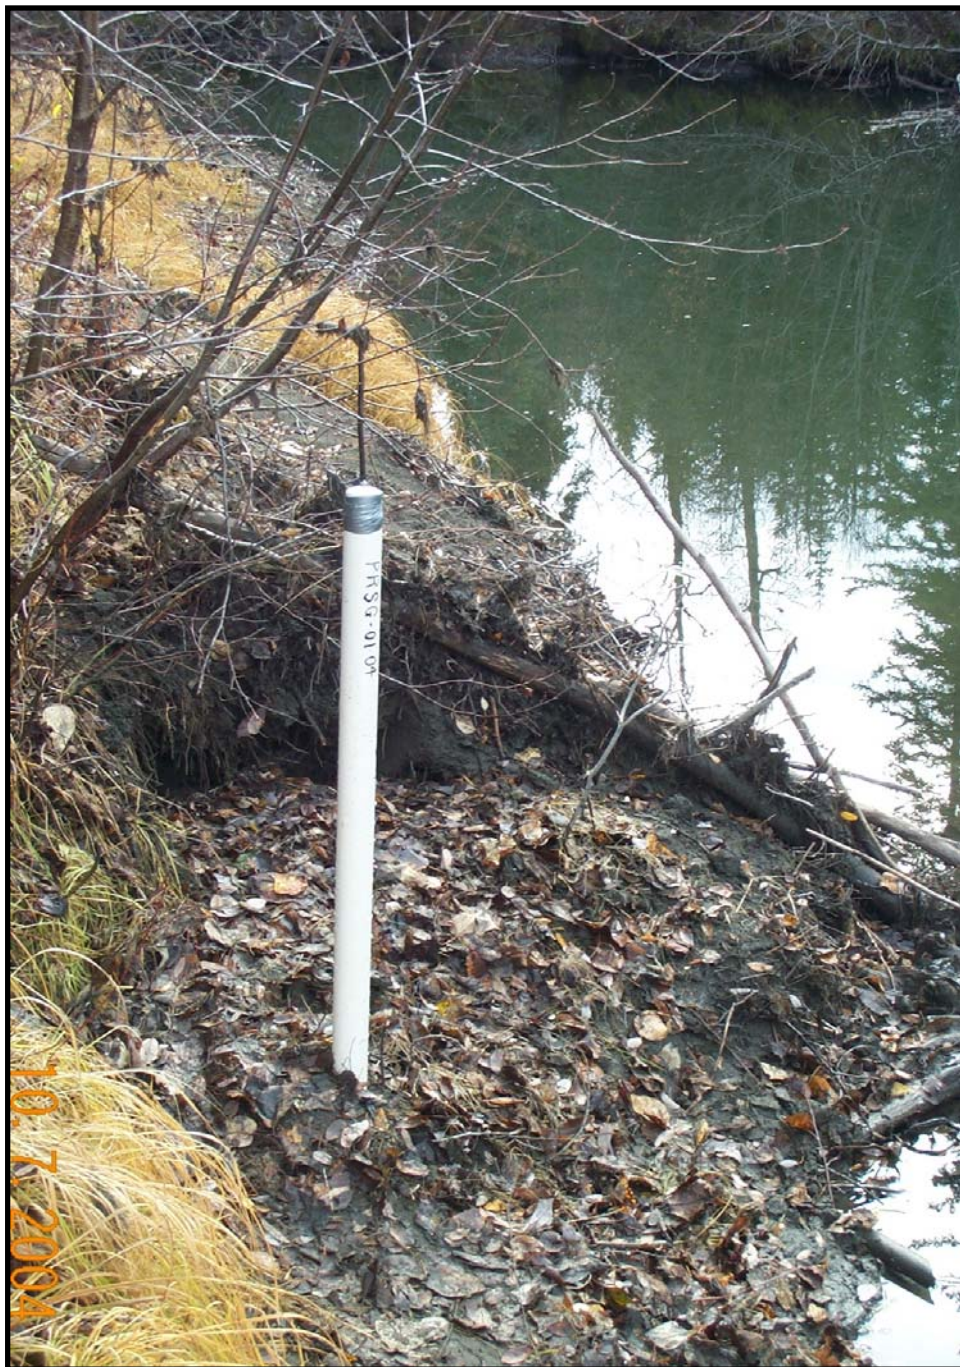
Photo of Staff Gauge constructed in permeable sediments adjacent to the Pelly River. A Level Logger sensor is hanging within the Staff Gauge collecting water elevations

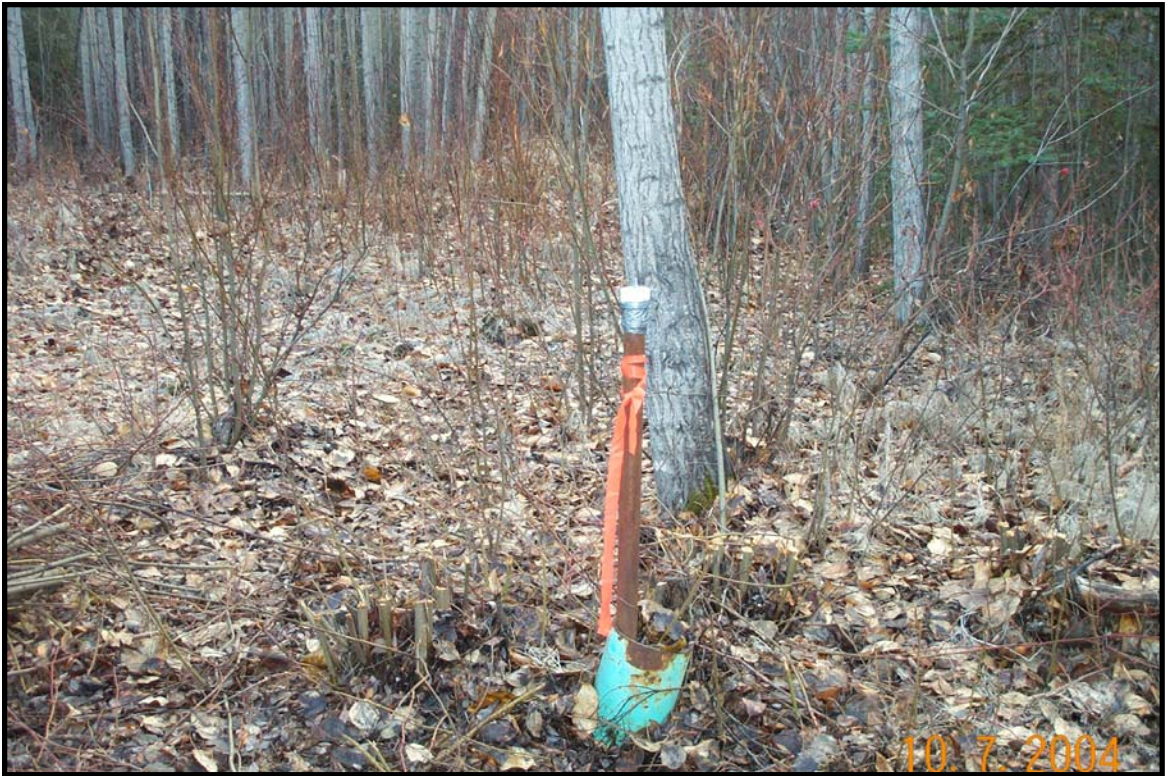
OB2 located just south west of Pump House #1. Note that a protective cap has been installed. A Level Logger sensor has been hung from inside the cap to collect groundwater elevation data.

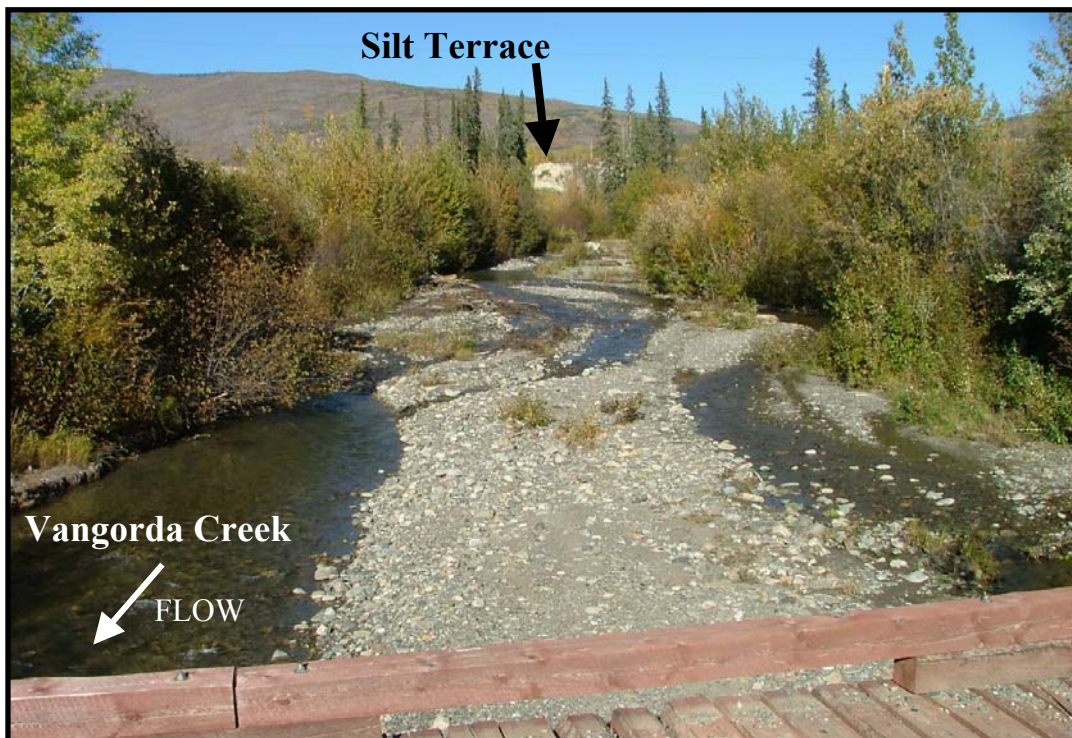
View looking north up Vangorda Creek from bridge. Note the silt terrace in the background upon which the Town of Faro is located.

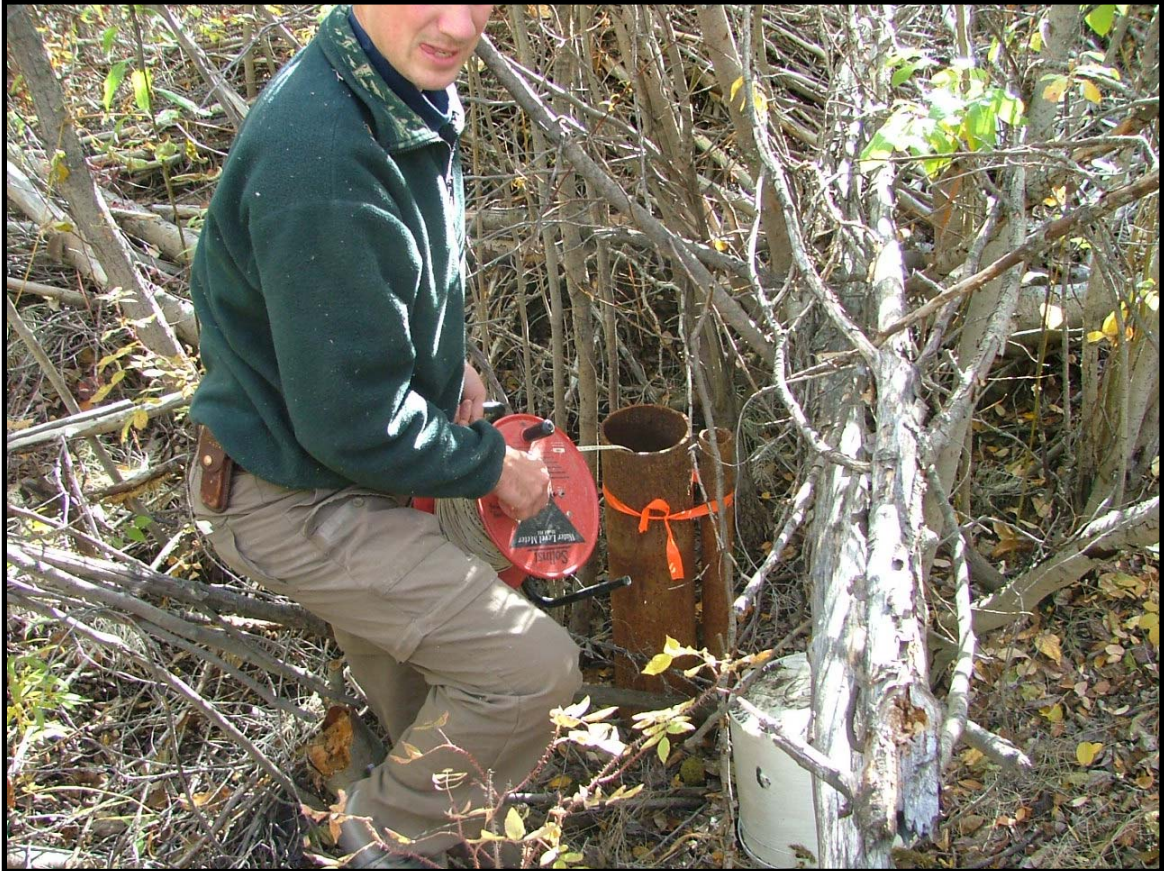
Photo of Forest Pearson (GLL) measuring the depth to groundwater water atOB6. Brush around wells has since been cleared and a PVC cap and Level Logger installed to collected groundwater elevation data at this location.

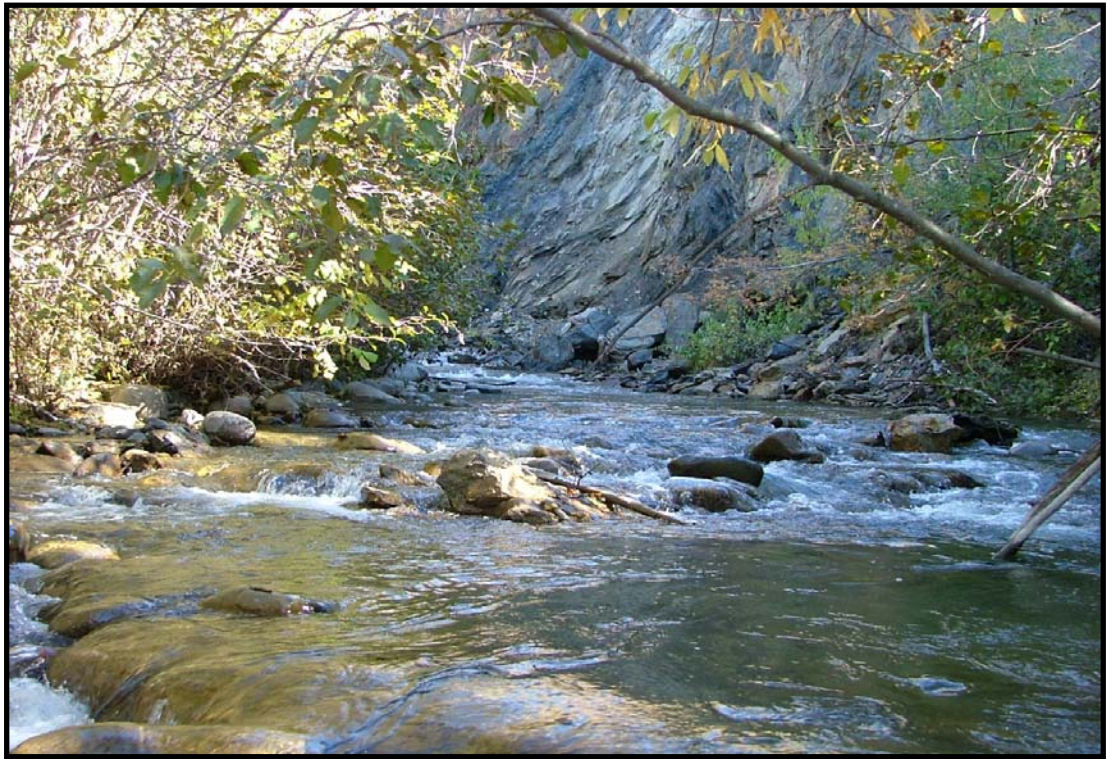
View of Vangorda Creek as it comes out of the Canyon onto the Vangorda Alluvial fan type deposits.

Vangorda Creek is a relatively small stream, two to three metres in width during normal conditions. Approximately 800 m from its confluence with the Pelly River, it exits a relatively narrow, high gradient canyon (Figure 3) and spills onto a moderate gradient (3%) alluvial fan for a distance of approximately 250 m. Downstream of this location, the creek gradient is reduced somewhat to approximately 1%. It is apparent from aerial photography (Figure 3) and previously published reports that the lower one-third of this 800 m reach has likely occupied different channels in the recent past. As reported in the Hydrogeological Consultants (1988) report, prior to 1968 Vangorda Creek flowed in a channel east of water supply wells #1 and #2 (approximately mid-way between these wells and the current location of water well #3). In later 1968 or early 1969, the lower Vangorda Creek watercourse changed to its current location approximately 100 m west of water wells #1 and #2.

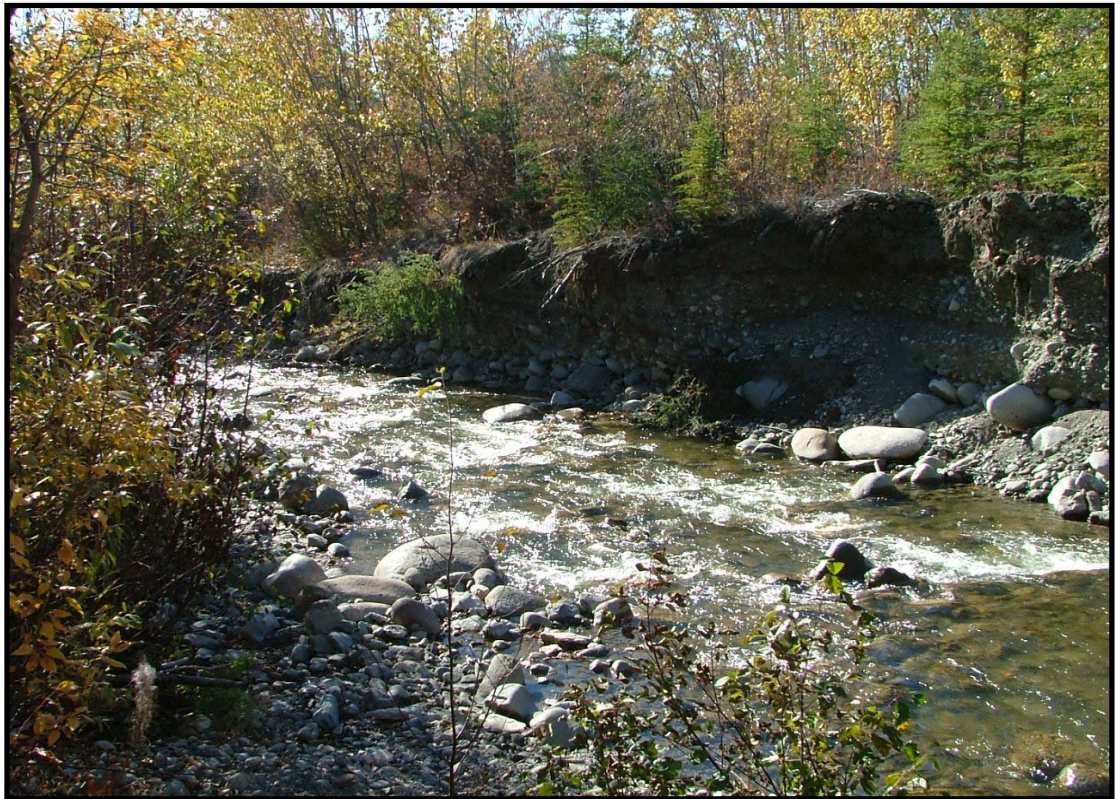
View of Vangorda Creek, just down stream (approx 20 m) of the photo location shown above. GS2 and a small foot bridge is just out of photo view to the right.
