VANGORDA PLATEAU DEVELOPMENT AS-BUILT CONSTRUCTION REPORT FOR LITTLE CREEK DAM

SRK REPORT 160636/1

MAY 1991

STEFFEN ROBERTSON AND KIRSTEN (B.C.) INC. 580 Hornby Street Vancouver, B.C. V6C 3B6 Canada

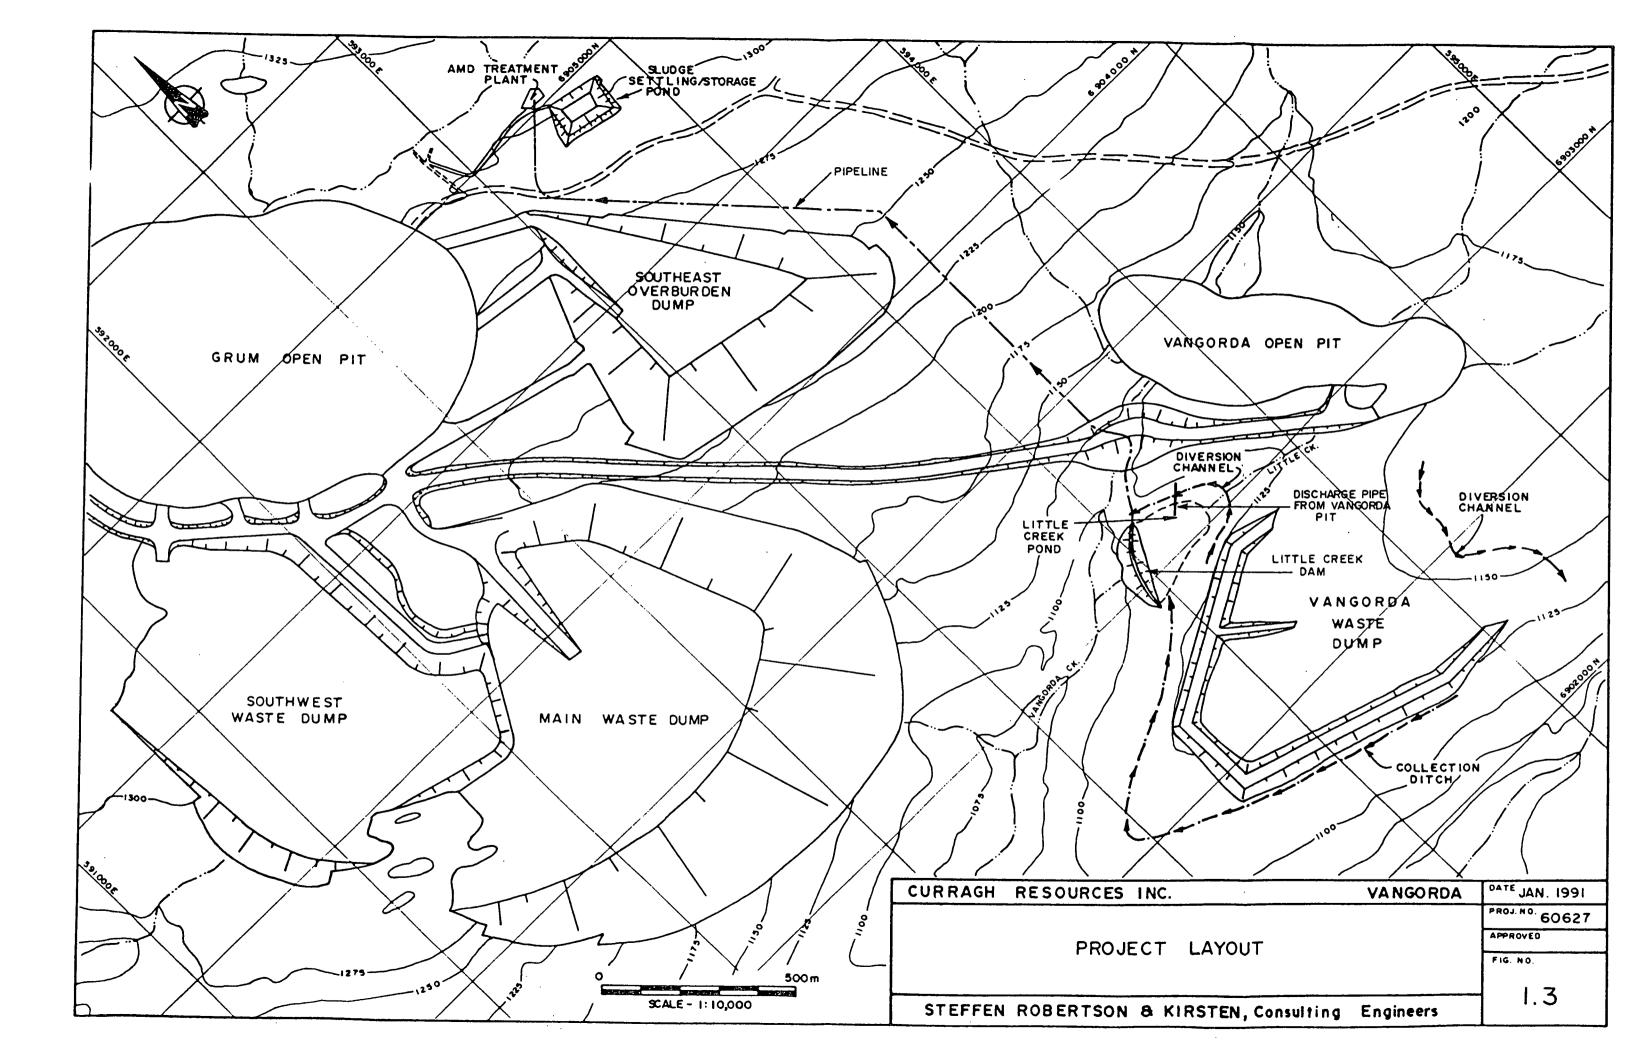
The main components of the collection and treatment system are shown on Figure 1.3. They comprise the following: a system of underdrains and ditches to collect seepage from the waste dump and direct it to an ARD collection facility (Little Creek Pond) located in a small valley with a creek which is referred to in this report as Little Creek; a pump and pipeline to direct to Little Creek Pond the seepage, runoff and precipitation which collects in the Vangorda open pit; a dam (Little Creek Dam), engineered to retain the ARD from the waste dump and the open pit, which forms part of the ARD collection facility; a wet well, pump house and pipeline system to direct the water in Little Creek Pond to a water treatment facility; and a water treatment facility to treat the ARD before it is released into Vangorda Creek.

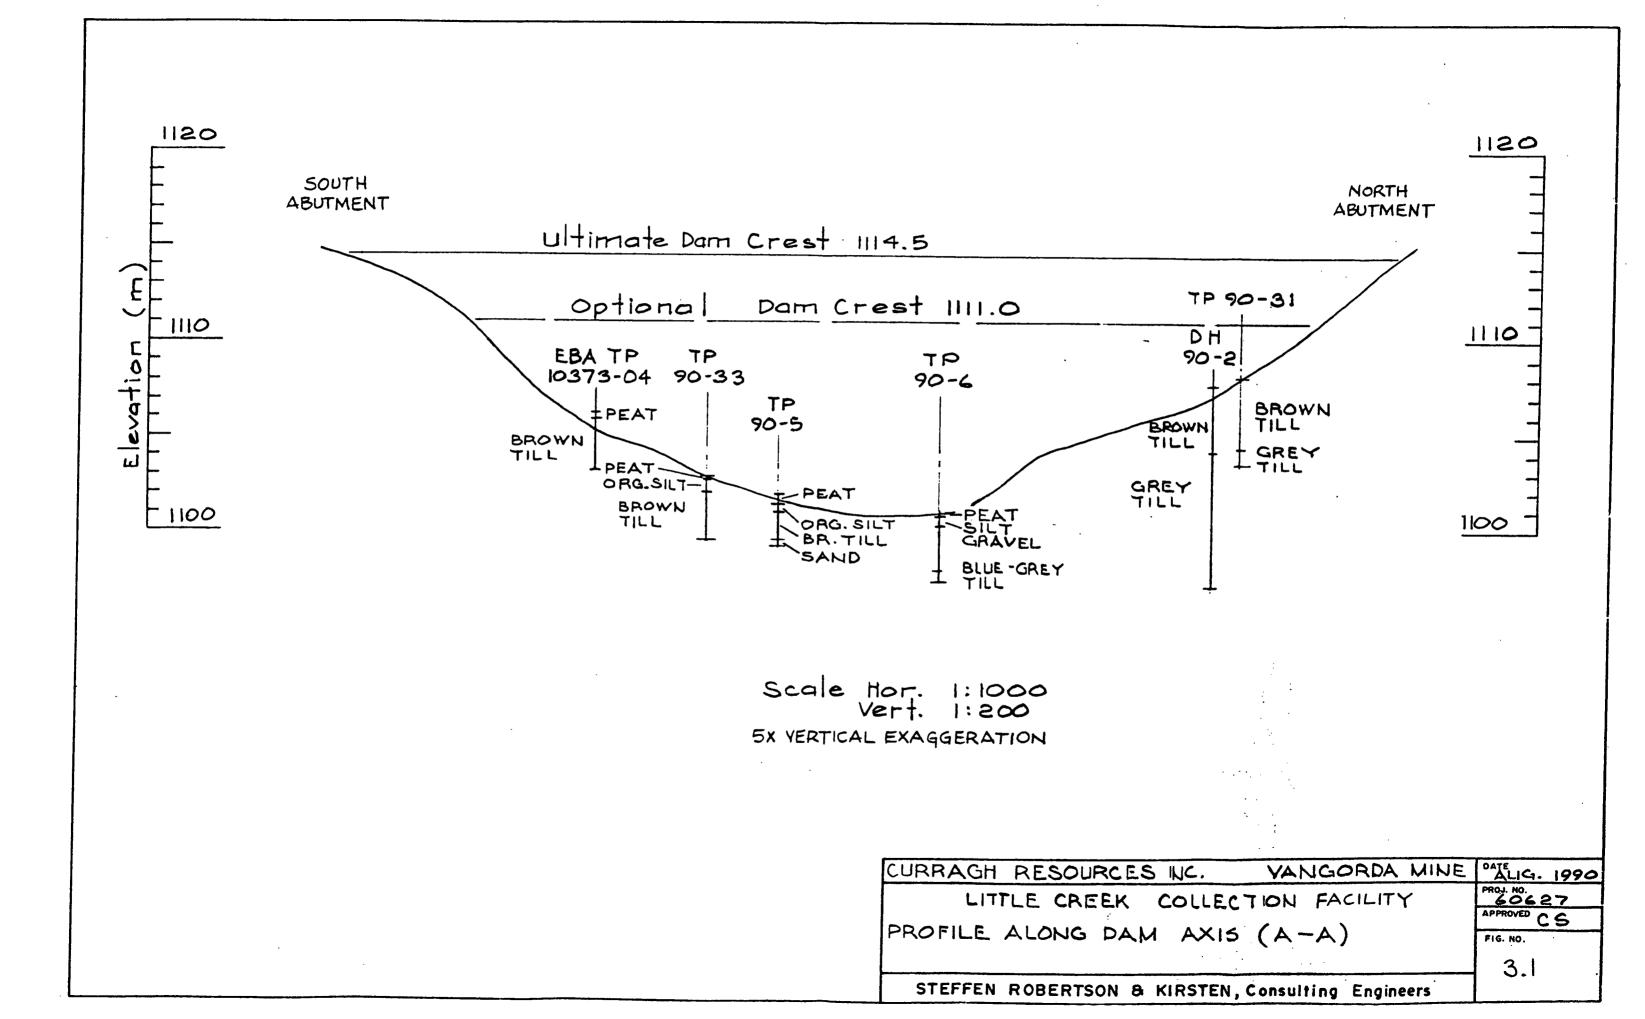
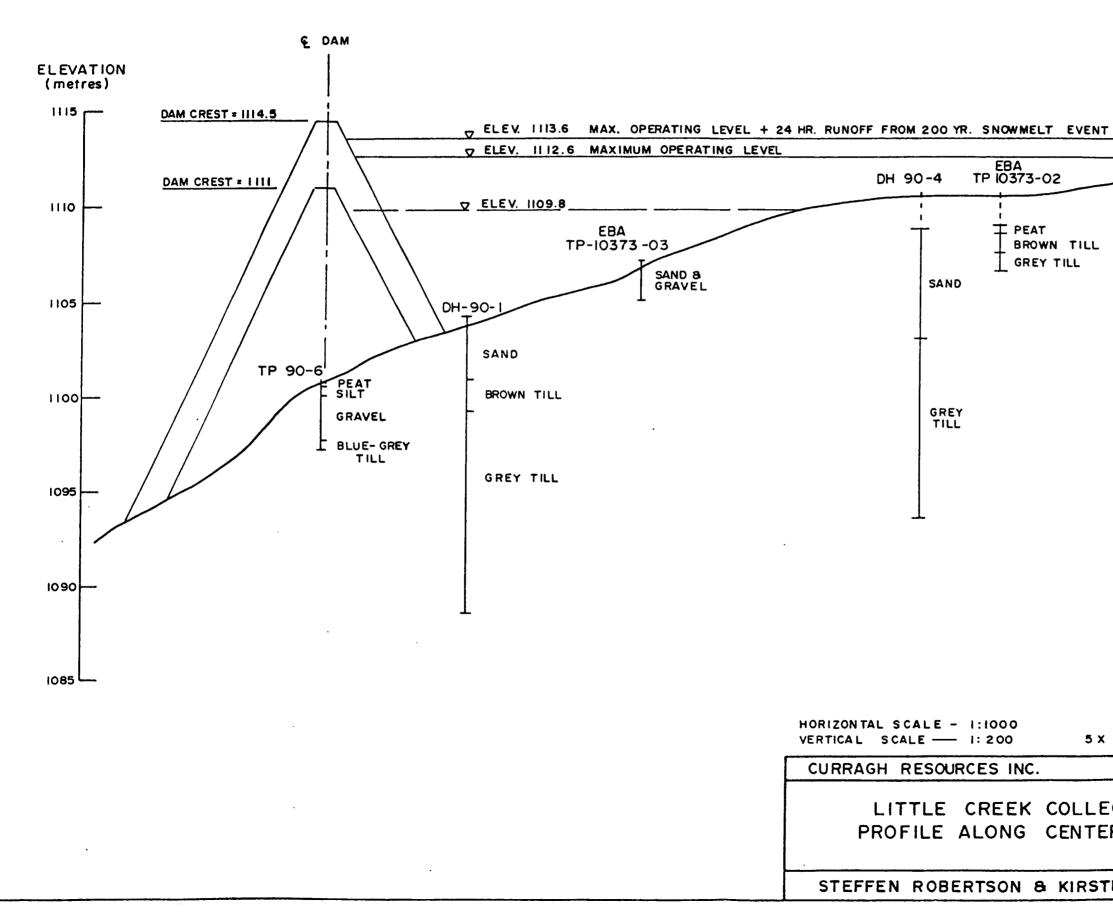
·	
-	
X VERTICAL EXAGGERATION	
X VERTICAL EXAGGERATION	
VANGORDA	DATE AUG. 1990
	PROJ NO
	PROJ. NO. 60627
ECTION FACILITY	APPROVED
ER OF VALLEY (B-B)	FIG. NO.
	FIG. NO.
	20
	3.2
STEN, Consulting Engineers

dam are shown on Figure 3.1 and 3.2 respectively. The results of the boreholes and test pits that have been completed in the vicinity of the collection pond indicate that the near-surface soils vary across the valley. On the left (south) side of the valley, the soils comprise up to 0.2 m of peat overlying approximately 0.5 m of soft organic silt overlying brown, moist, firm to very stiff sand (till) overlying a grey, firm to hard silt (till). In the valley bottom, there is approximately 3 m of gravelly sand overlying either brown, wet silt and sand (till) which in turn overlies grey silt and sand (till) or, alternatively, the gravelly sand overlies grey, moist, stiff silt and sand (till). There is evidence to suggest that in the valley bottom, the gravelly sand may be interlayered with the brown sand (till). On the right (north) side of the valley, there is approximately 4 m of brown, moist, firm to stiff sand (till) overlying grey, hard silt (till). No bedrock was encountered during the investigation.

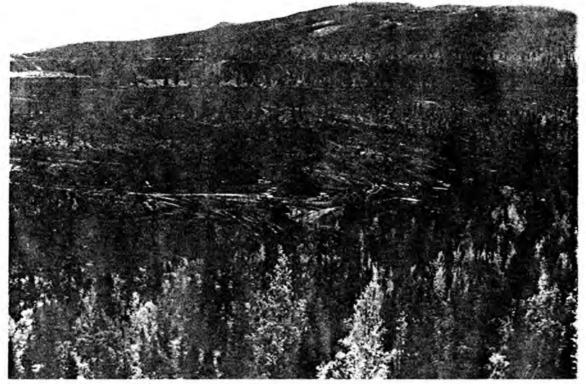
PLATE 1:

Sept. 12/90. View from the main haul road of the cleared footprint of the dam. Brownish soil in foreground of footprint is native sand and gravel; greyish soil in background of footprint is the native till. The flat embankment extending across the plate is the north limb of the starter dyke for the Vangorda waste dump.

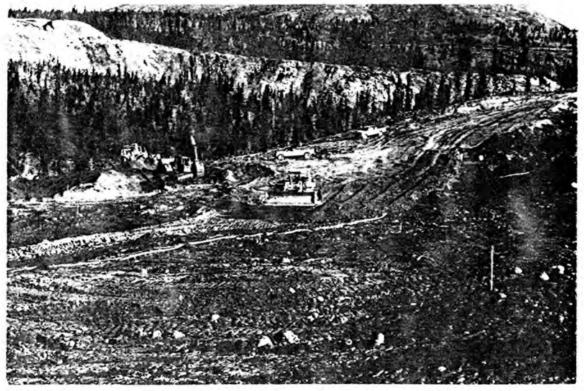
PLATE 2:

Sept. 13/90. Opposite view to Plate 1, from the south abutment of the dam. Excavation of the cutoff by the backhoe is underway and the area in valley bottom between the cutoff trench and the upstream toe of the dam is being covered with till from the stripping of Vangorda open pit.

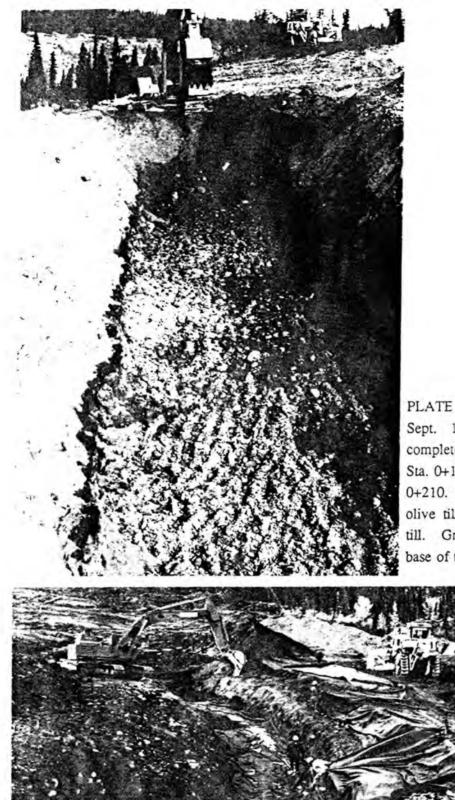
Sept. 13/90. Northward view of completed cutoff trench between Sta. 0+180 (in foreground) and Sta. 0+210. Brown sand and gravel overlies olive till which, in turn, overlies grey till. Groundwater is evident near the base of the sand and gravel.

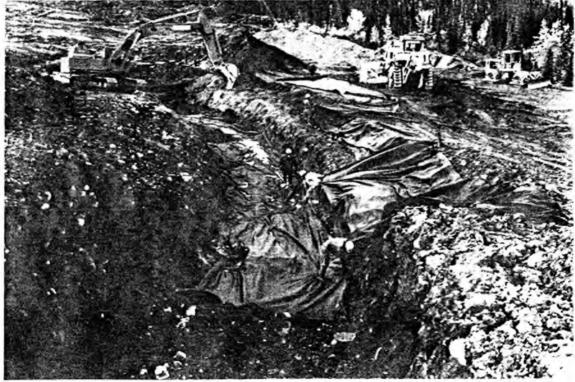
PLATE 4:

Sept. 14/90. Excavation of the cutoff trench between Sta. 0+180 and 0+235 is complete and filter fabric is being placed on the base and against the downstream face of the trench.

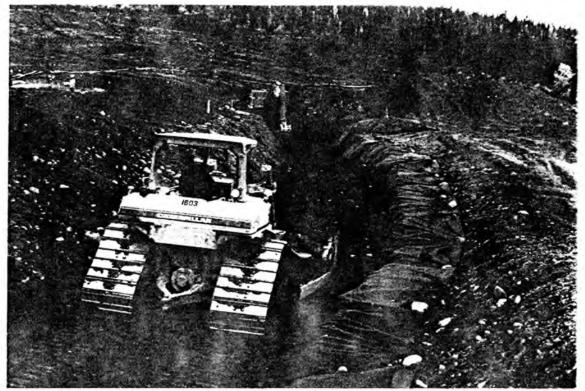
PLATE 5:

Sept. 14/90. The cutoff trench is then backfilled in thin lifts which are placed initially by the backhoe and then tracked down with a dozer in preparation for compaction.

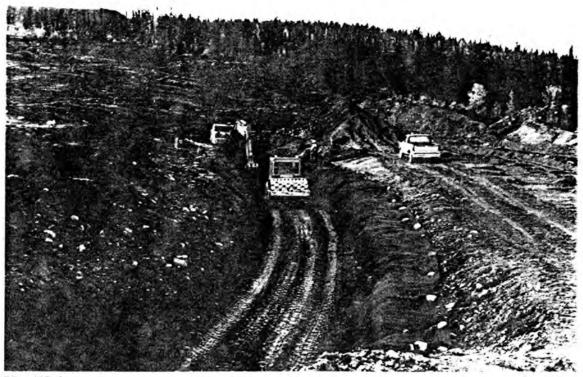
PLATE 6: Sept. 14/90. Each lift is compacted with 5 cycles of a Dynapac compactor.

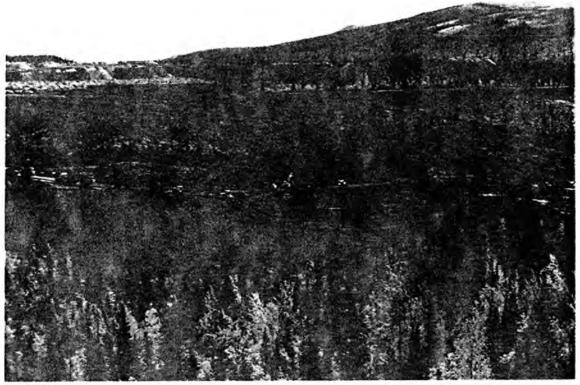
PLATE 7:

Sept. 15/90. View from the main haul road showing the scrapers hauling till. The brownish zone in the foreground of the footprint is the local sand and gravel which has been redistributed to develop part of the blanket drain and the downstream toe of the dam.

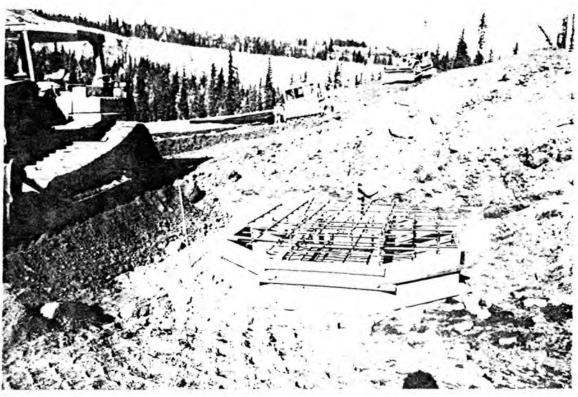
PLATE 8:

Sept. 17/90. Formwork for the base of the wet well in place on in situ sand and gravel. In background, filter fabric is partially in place over the blanket drain on the north side of the valley.

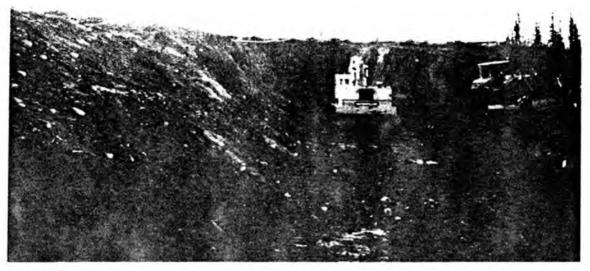
PLATE 9:

A zone of permafrost was completely removed from the footprint of the dam at the south abutment. The zone was excavated to a depth of two metres below original ground surface at Station 0+070 and to a depth of seven metres at the south abutment of the dam. The entire dam footprint between Stations 0+020 and 0+070 was excavated during excavation of the cut-off trench.

The entire permafrost zone was excavated because it was considered unsatisfactory as a foundation material. Any disturbance or stripping of the top layer would cause the ice to thaw, leaving the soil with a near liquid consistency and little or no strength.

Sept. 29/90. Excavation of up to 7 m of permafrost from the footprint of the south abutment, between Sta. 0+020 and 0+070.

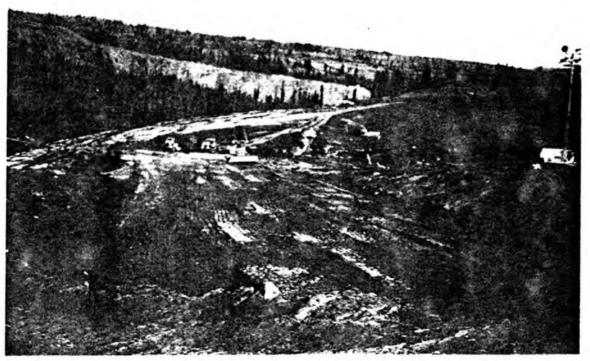
PLATE 10:

Sept. 30/90. Backfilling in thin compacted lifts of the area between Sta. 0+020 and 0+070 where the zone of permafrost was excavated.

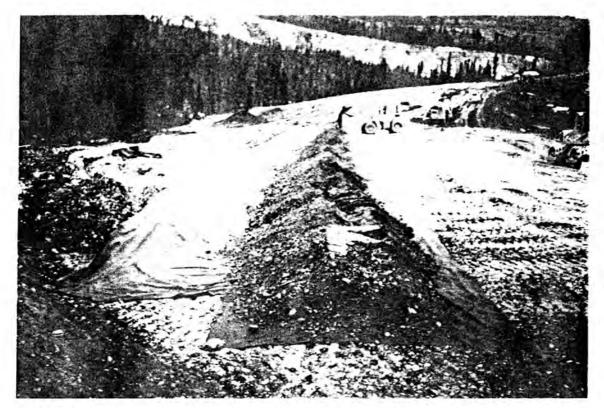
PLATE 11: Oct. 1/90. View northwards from Sta. 0+040 at the construction of finger drain "L1."

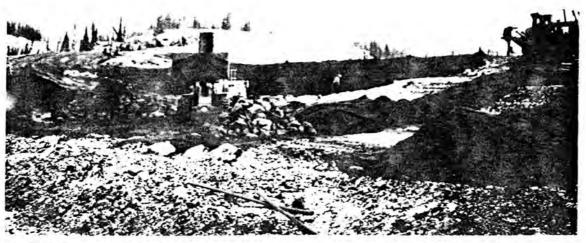
PLATE 12:

Oct. 3/90. Covering finger drains "T1" and "T2" with filter fabric and constructing the rock drain at the end of "T1."

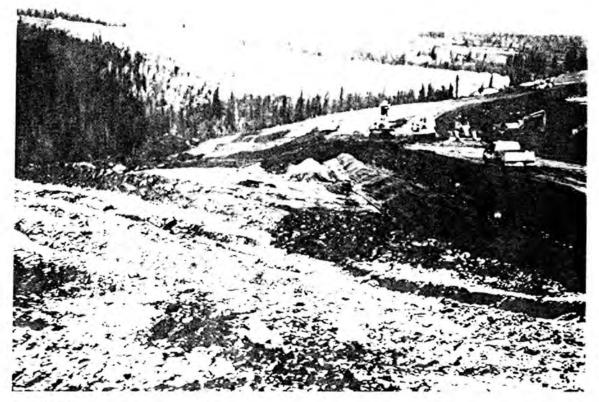
PLATE 13: Oct. 3/90. Placement of till over top of the finger drains on the south side of the dam footprint.

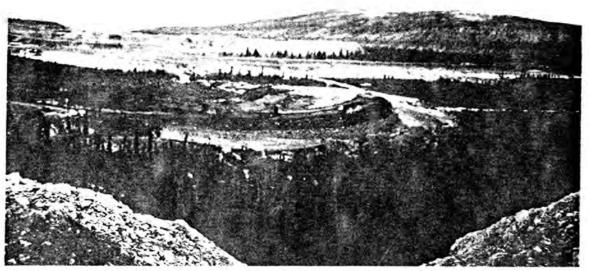
PLATE 14: Oct. 8/90. View from the main haul road. Crest of the dam is at Elev. 1112.

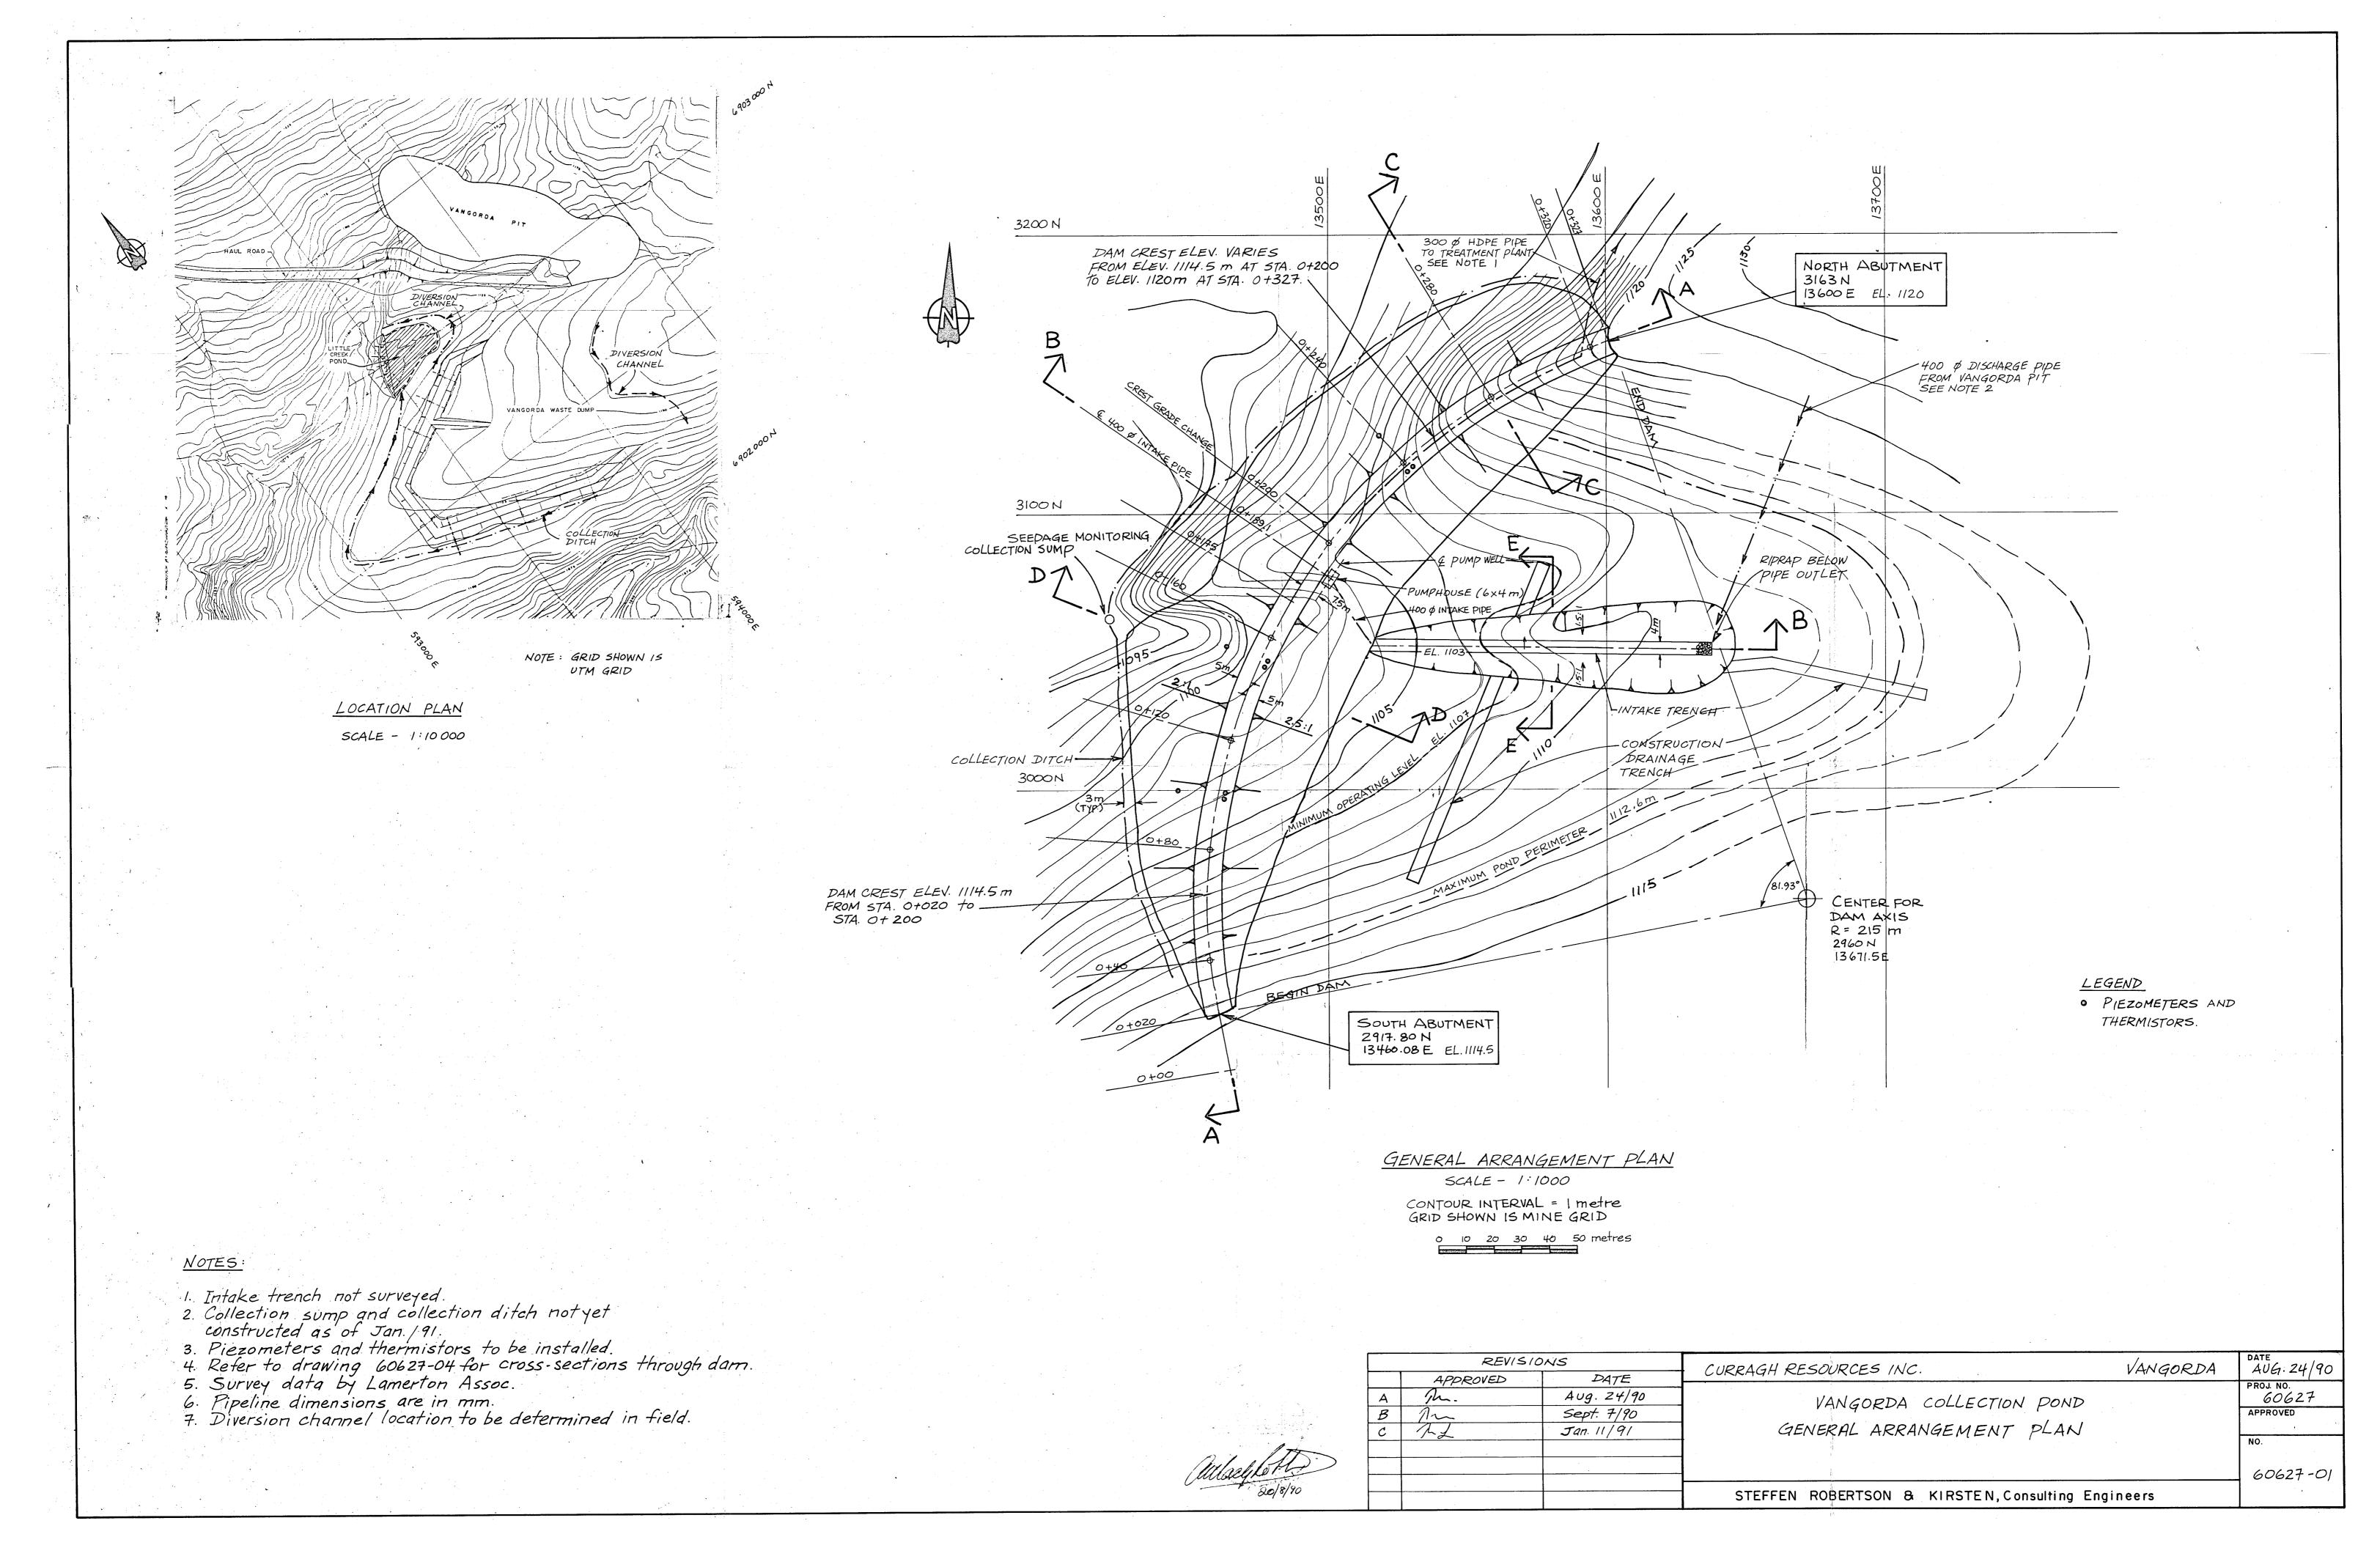
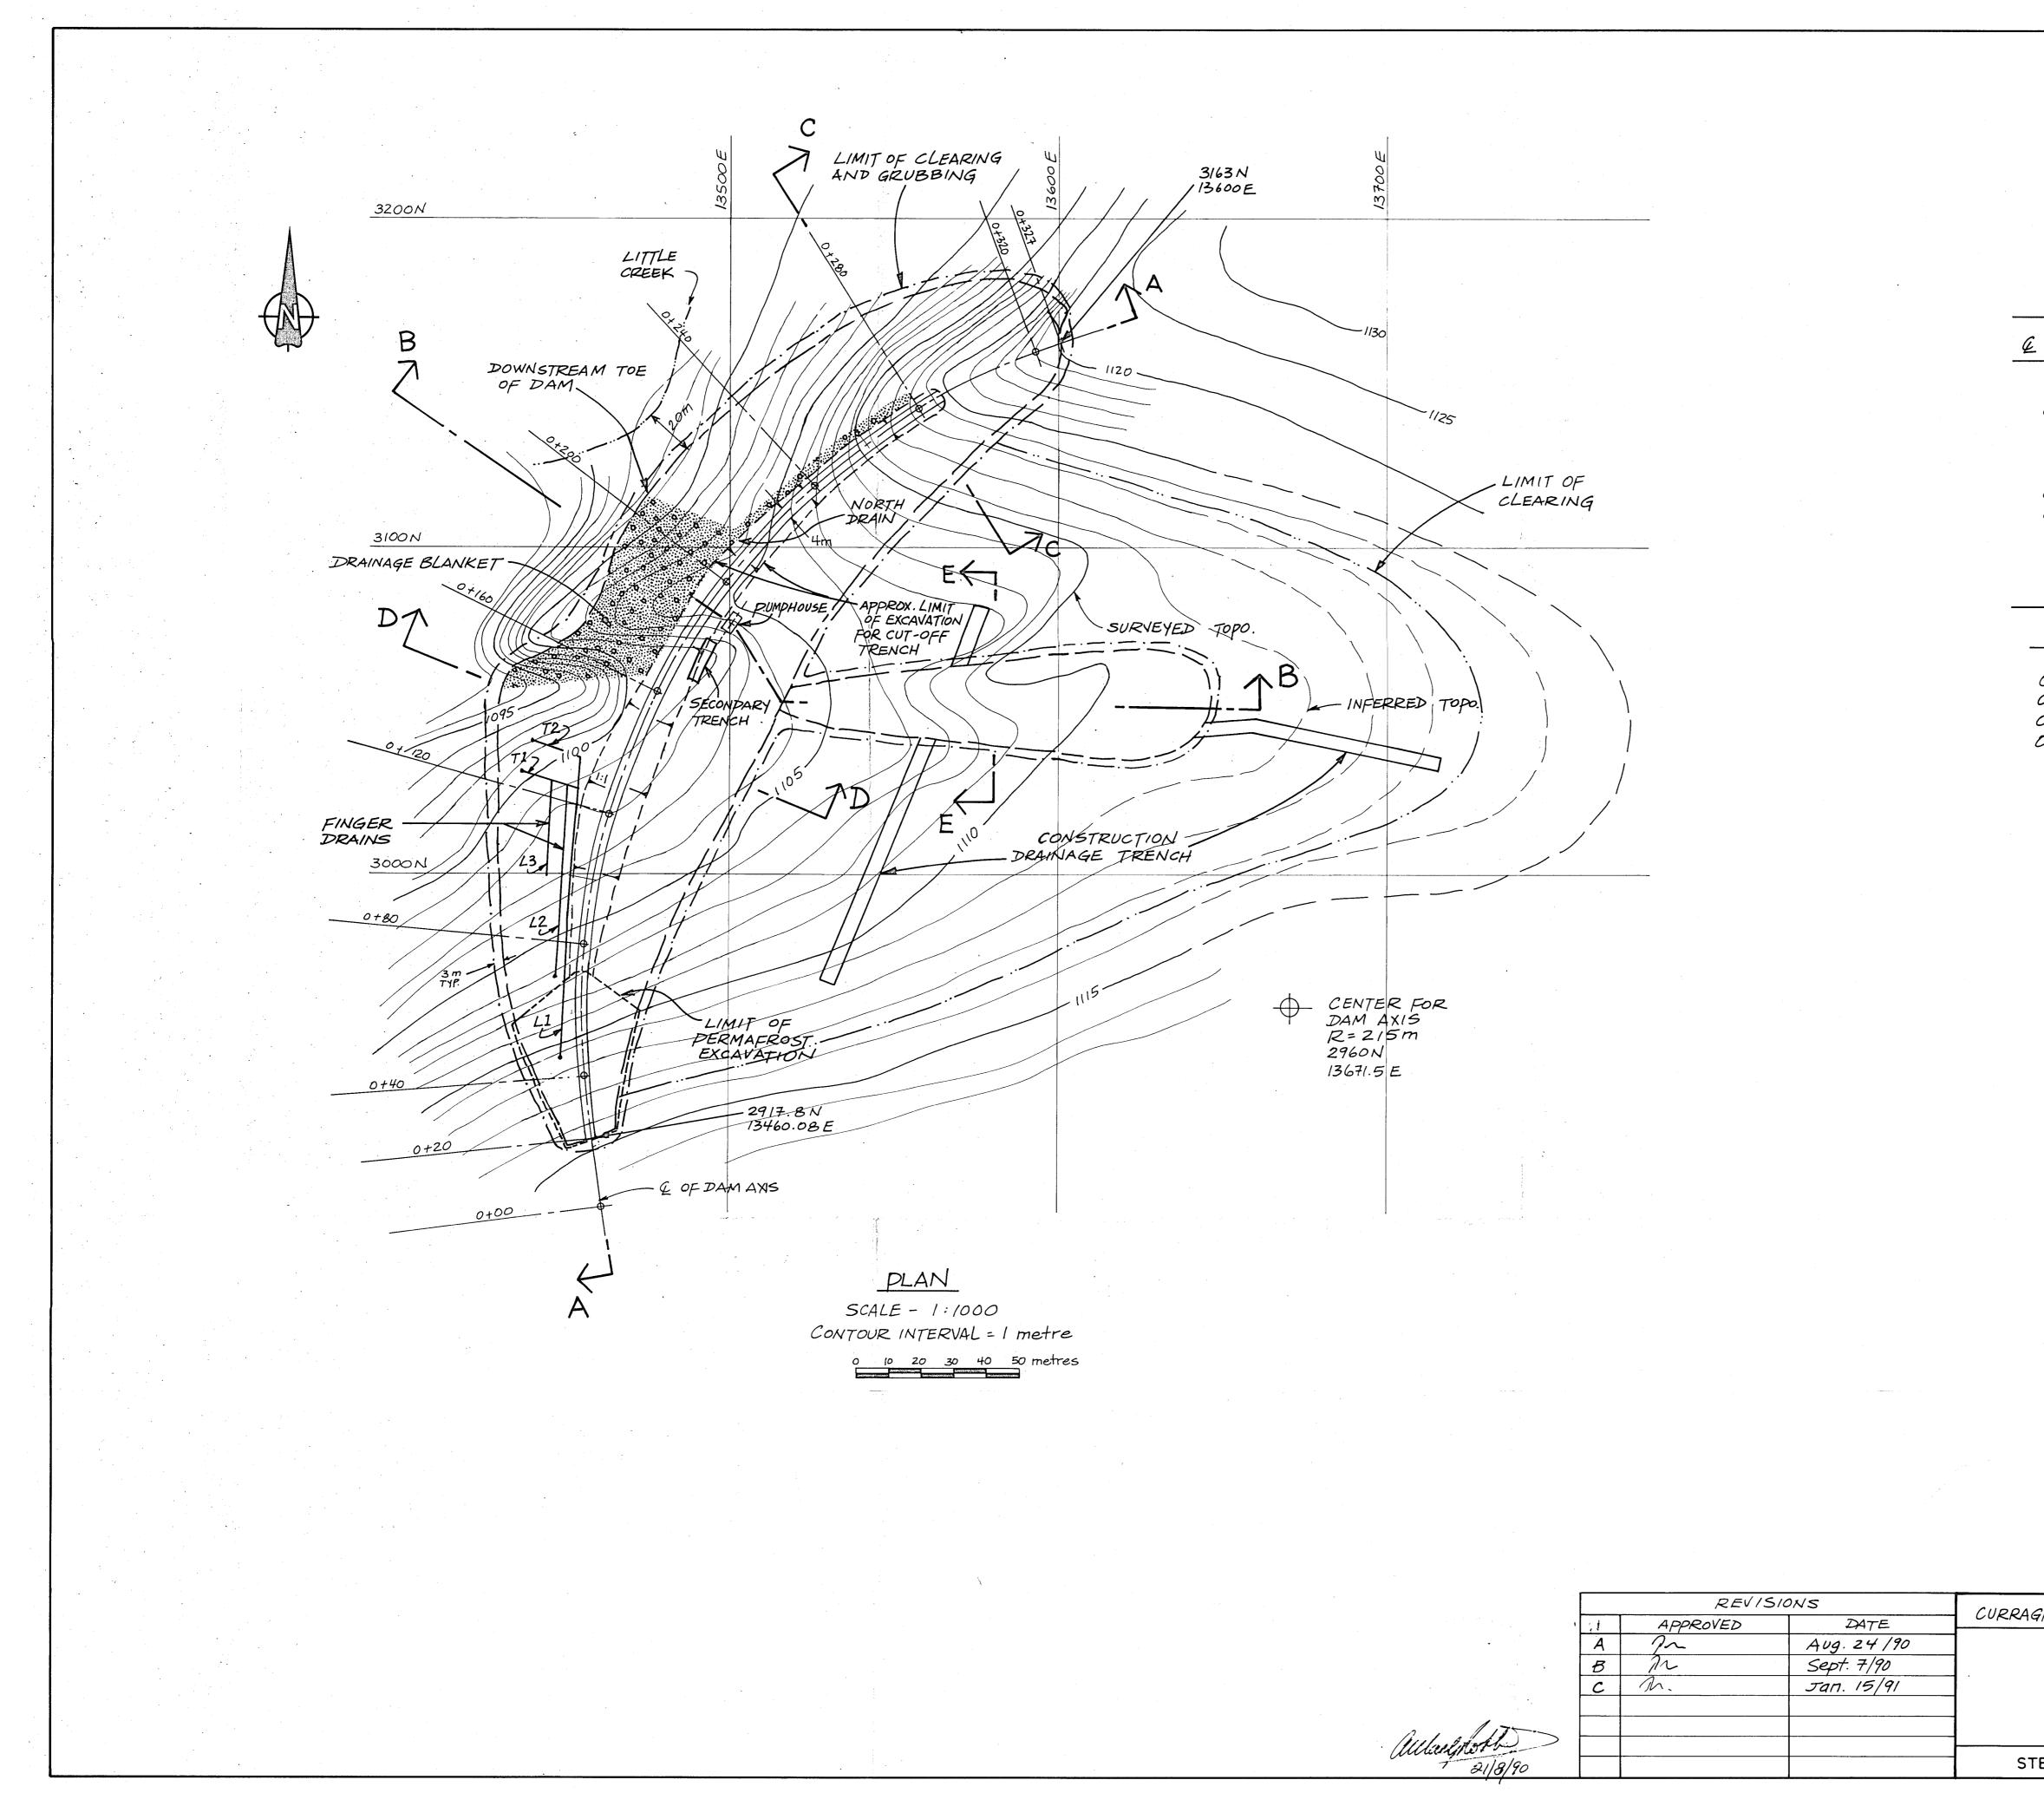
a
GH RESOURCES INC.	VANGORDA	DATE AUG. 24/90
VANGORDA COLLECTION POND LAYOUTS FOR CUT-OFF TRENCH EXCAVATION		PROJ. NO. 60627
		APPROVED
AND DRAINAGE BLANKET		NO.
		60627-02
EFFEN ROBERTSON & KIRSTEN, Consulting	Engineers

AS-BUILT COORDINATES OF DAM

AS-BUILT STATION	NORTHING	EASTING
0+080 0+120 0+160 0+200 0+240 0+280 0+320	2977.48 3016.19 3052.89 3085.38 3114.07 3135.26 3152.23	13458.14 13466.47 13481.05 13500.95 13528.14 13561.46 13597.99

STA.	ELEV.	NORTHING	EASTING
0+070	//03.5	2967.7	13457.1
0+080	//00.9	2976.5	13457.2
0+100	1098.B	2995.6	13459.8
0+120	1097.6	3018.6	13457.2
