Victoria Creek Fish Overwintering Study, Mount Nansen Project

EDI ENVIRONMENTAL DYNAMICS INC.

PROJECT # 11-Y-0344
DATE JULY 19, 2012

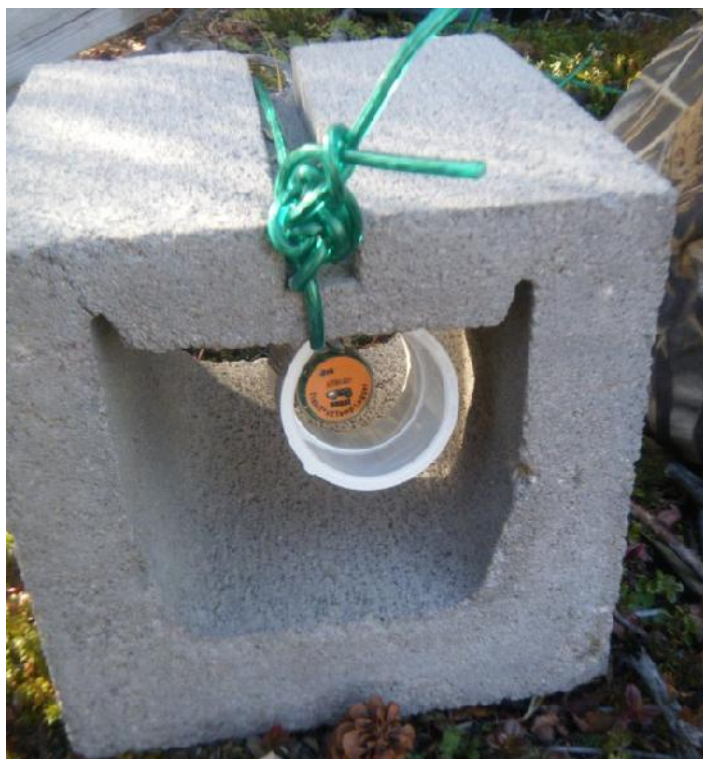
Hobo TidBit temperature loggers were installed at each station (Photo 1). Loggers were attached within a cement cinderblock which was anchored to a secure point on shore using plastic-coated wire. Loggers were set to collect data every 30 minutes. Stations were flagged and the location marked on a GPS.

Photo 1. Temperature logger installation on Victoria Creek (September 13, 2011).

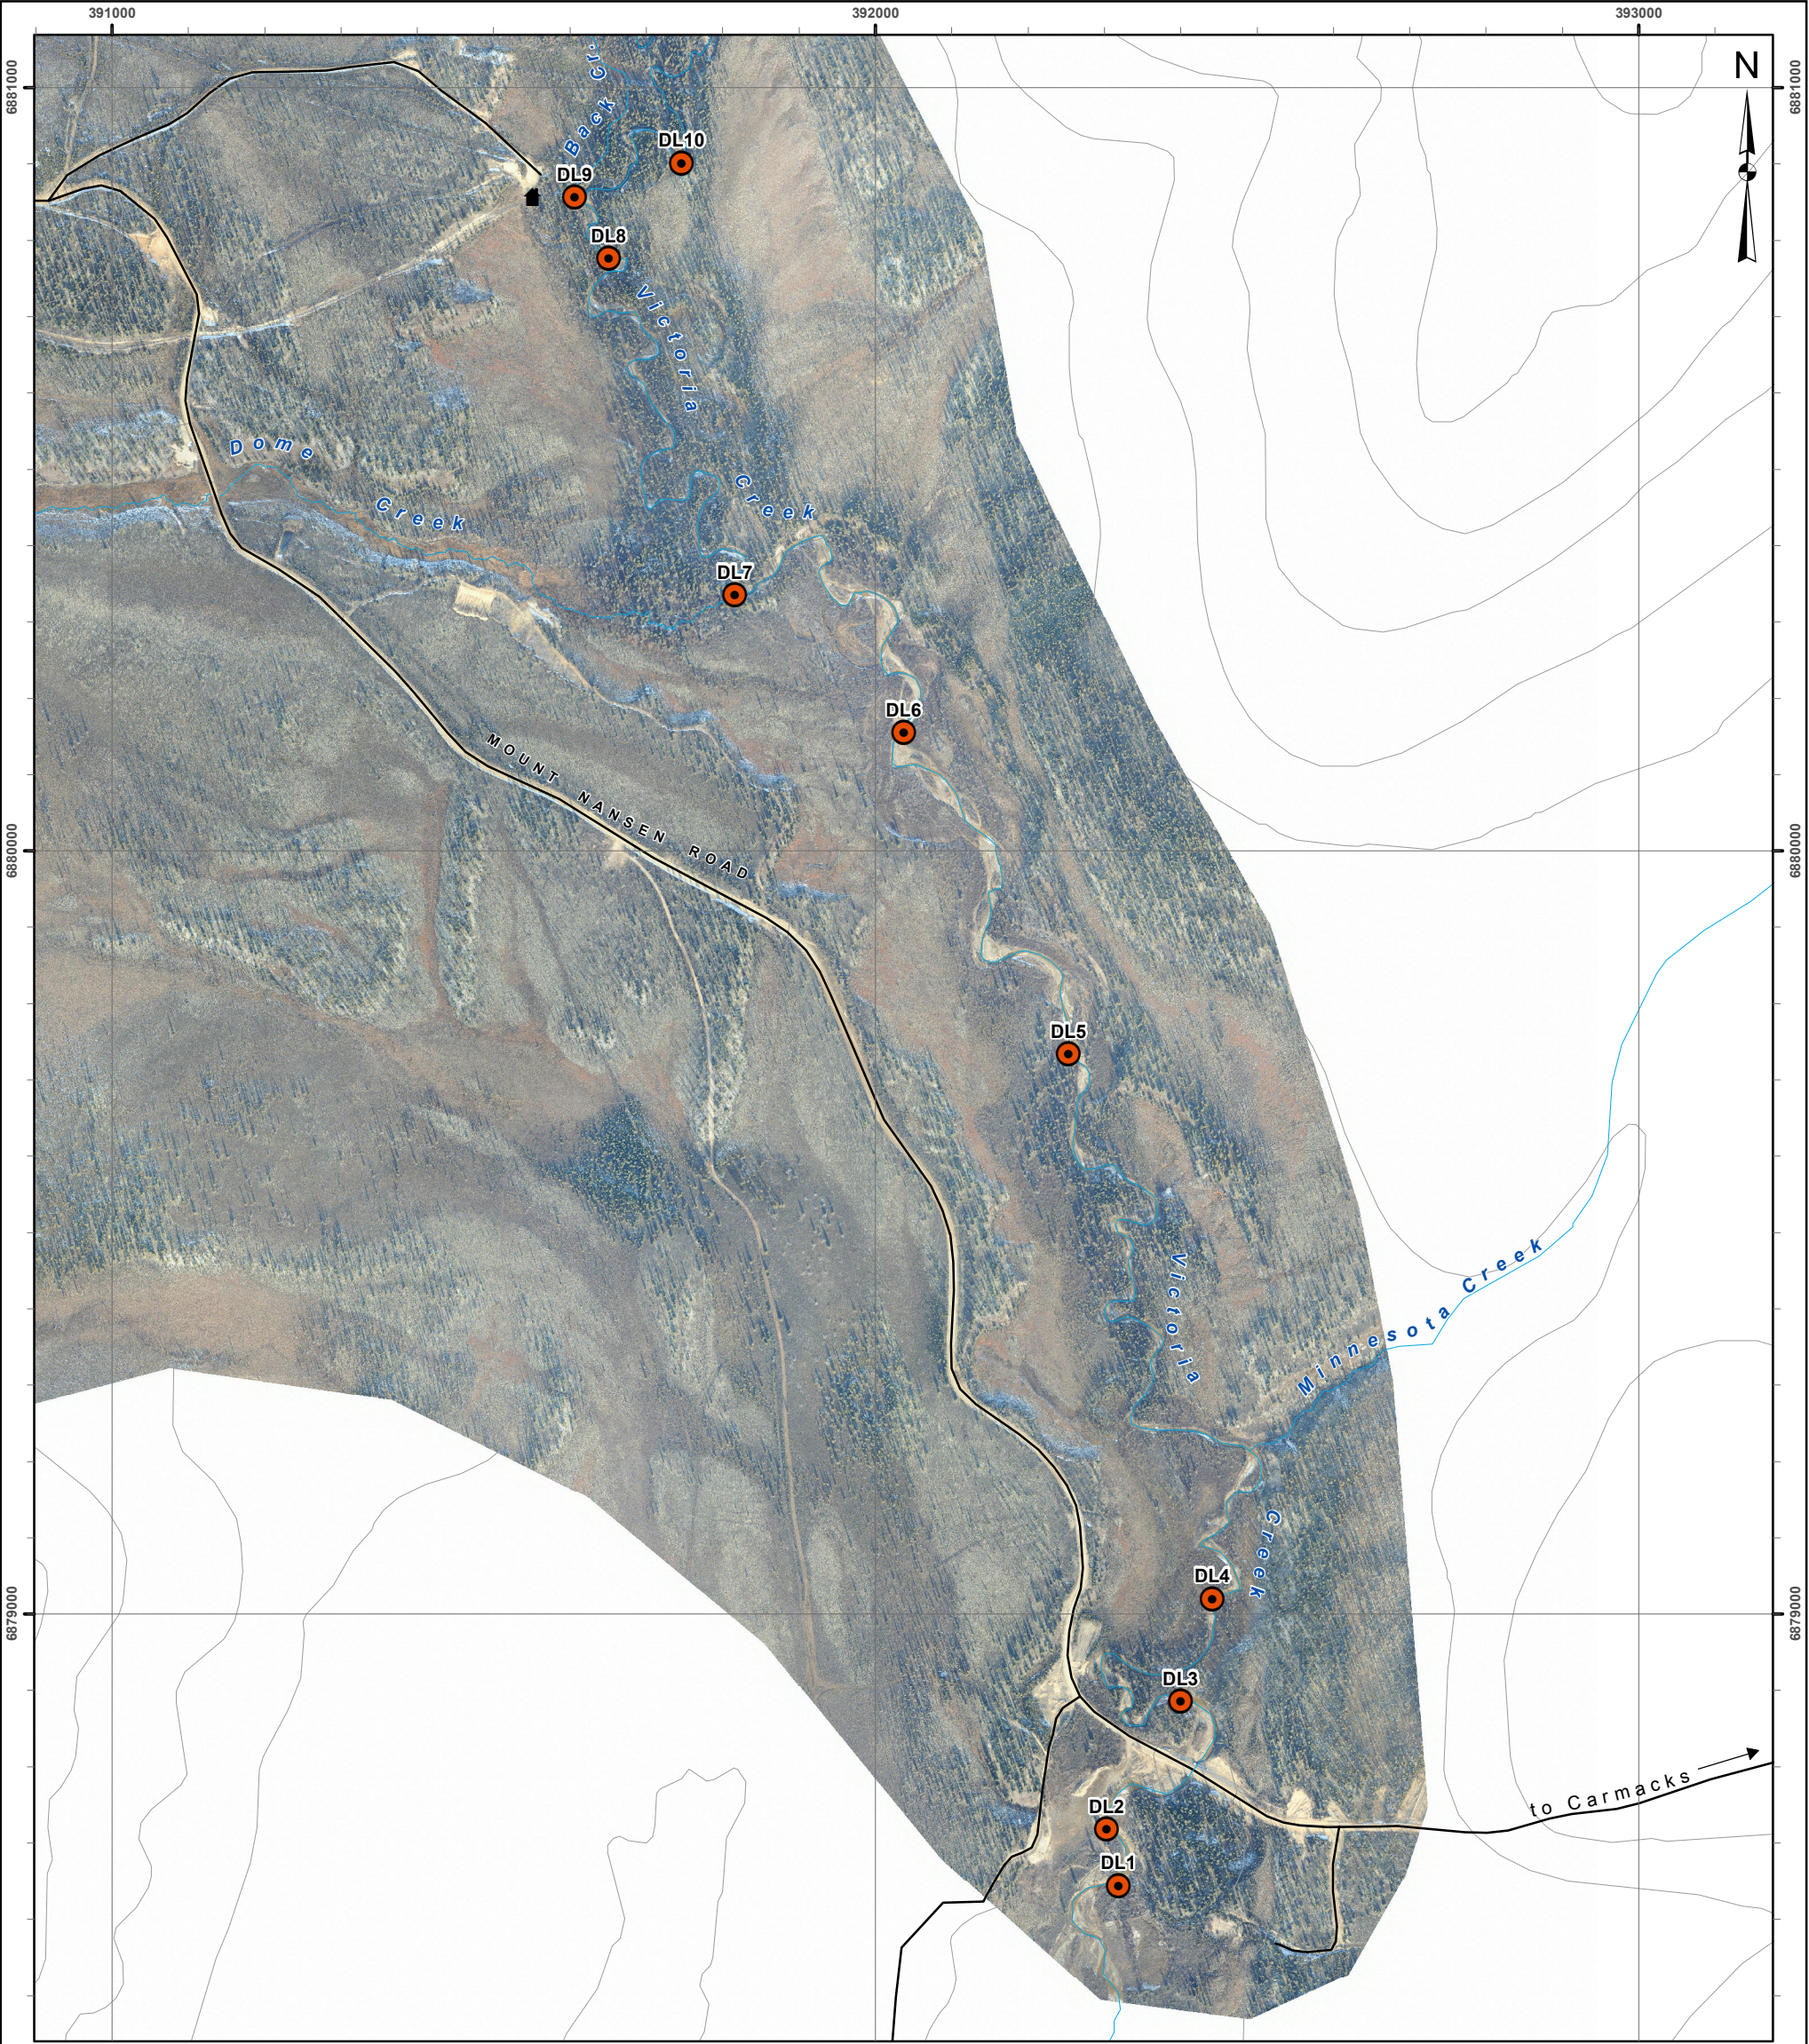
Drawn: LG	Checked: MP / MM	Date: 7/17/2012	FIGURE 1
--------------	---------------------	-----------------	----------

EDI conducted an initial fish and fish habitat reconnaissance on September 13-14, 2011 to document deep pools with overwintering potential, as well as potential groundwater sources and fall congregations of Arctic grayling. During this assessment, ten monitoring stations were established along the creek in deep pools with the greatest overwintering potential (Figure 1). Areas with good cover, such as large woody debris were also incorporated into station selection. The overwintering study area extended approximately 250 m upstream of the confluence of Back Creek and 250 m downstream of the Mount Nansen Road crossing (Figure 1). This covers approximately 4.2 km of stream.

**Overview Map of Victoria Creek
Overwintering Fish Monitoring Stations,
Mount Nansen Site.**

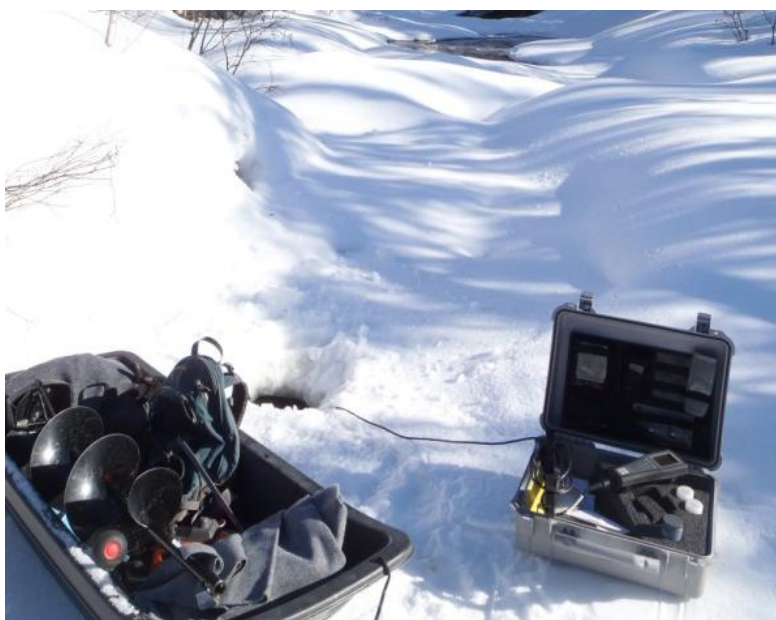
Temperature logger data was supplemented with surveys completed in mid and late winter. During each survey, field biologists walked the creek to document open water areas and general ice conditions. Each monitoring station was visited to measure water depth beneath the ice, ice thickness, dissolved oxygen (DO) and water temperature using a YSI Pro Plus multi-metre (Photo 2).

Photo 2. Measuring winter DO levels on Victoria Creek (April 5, 2012).

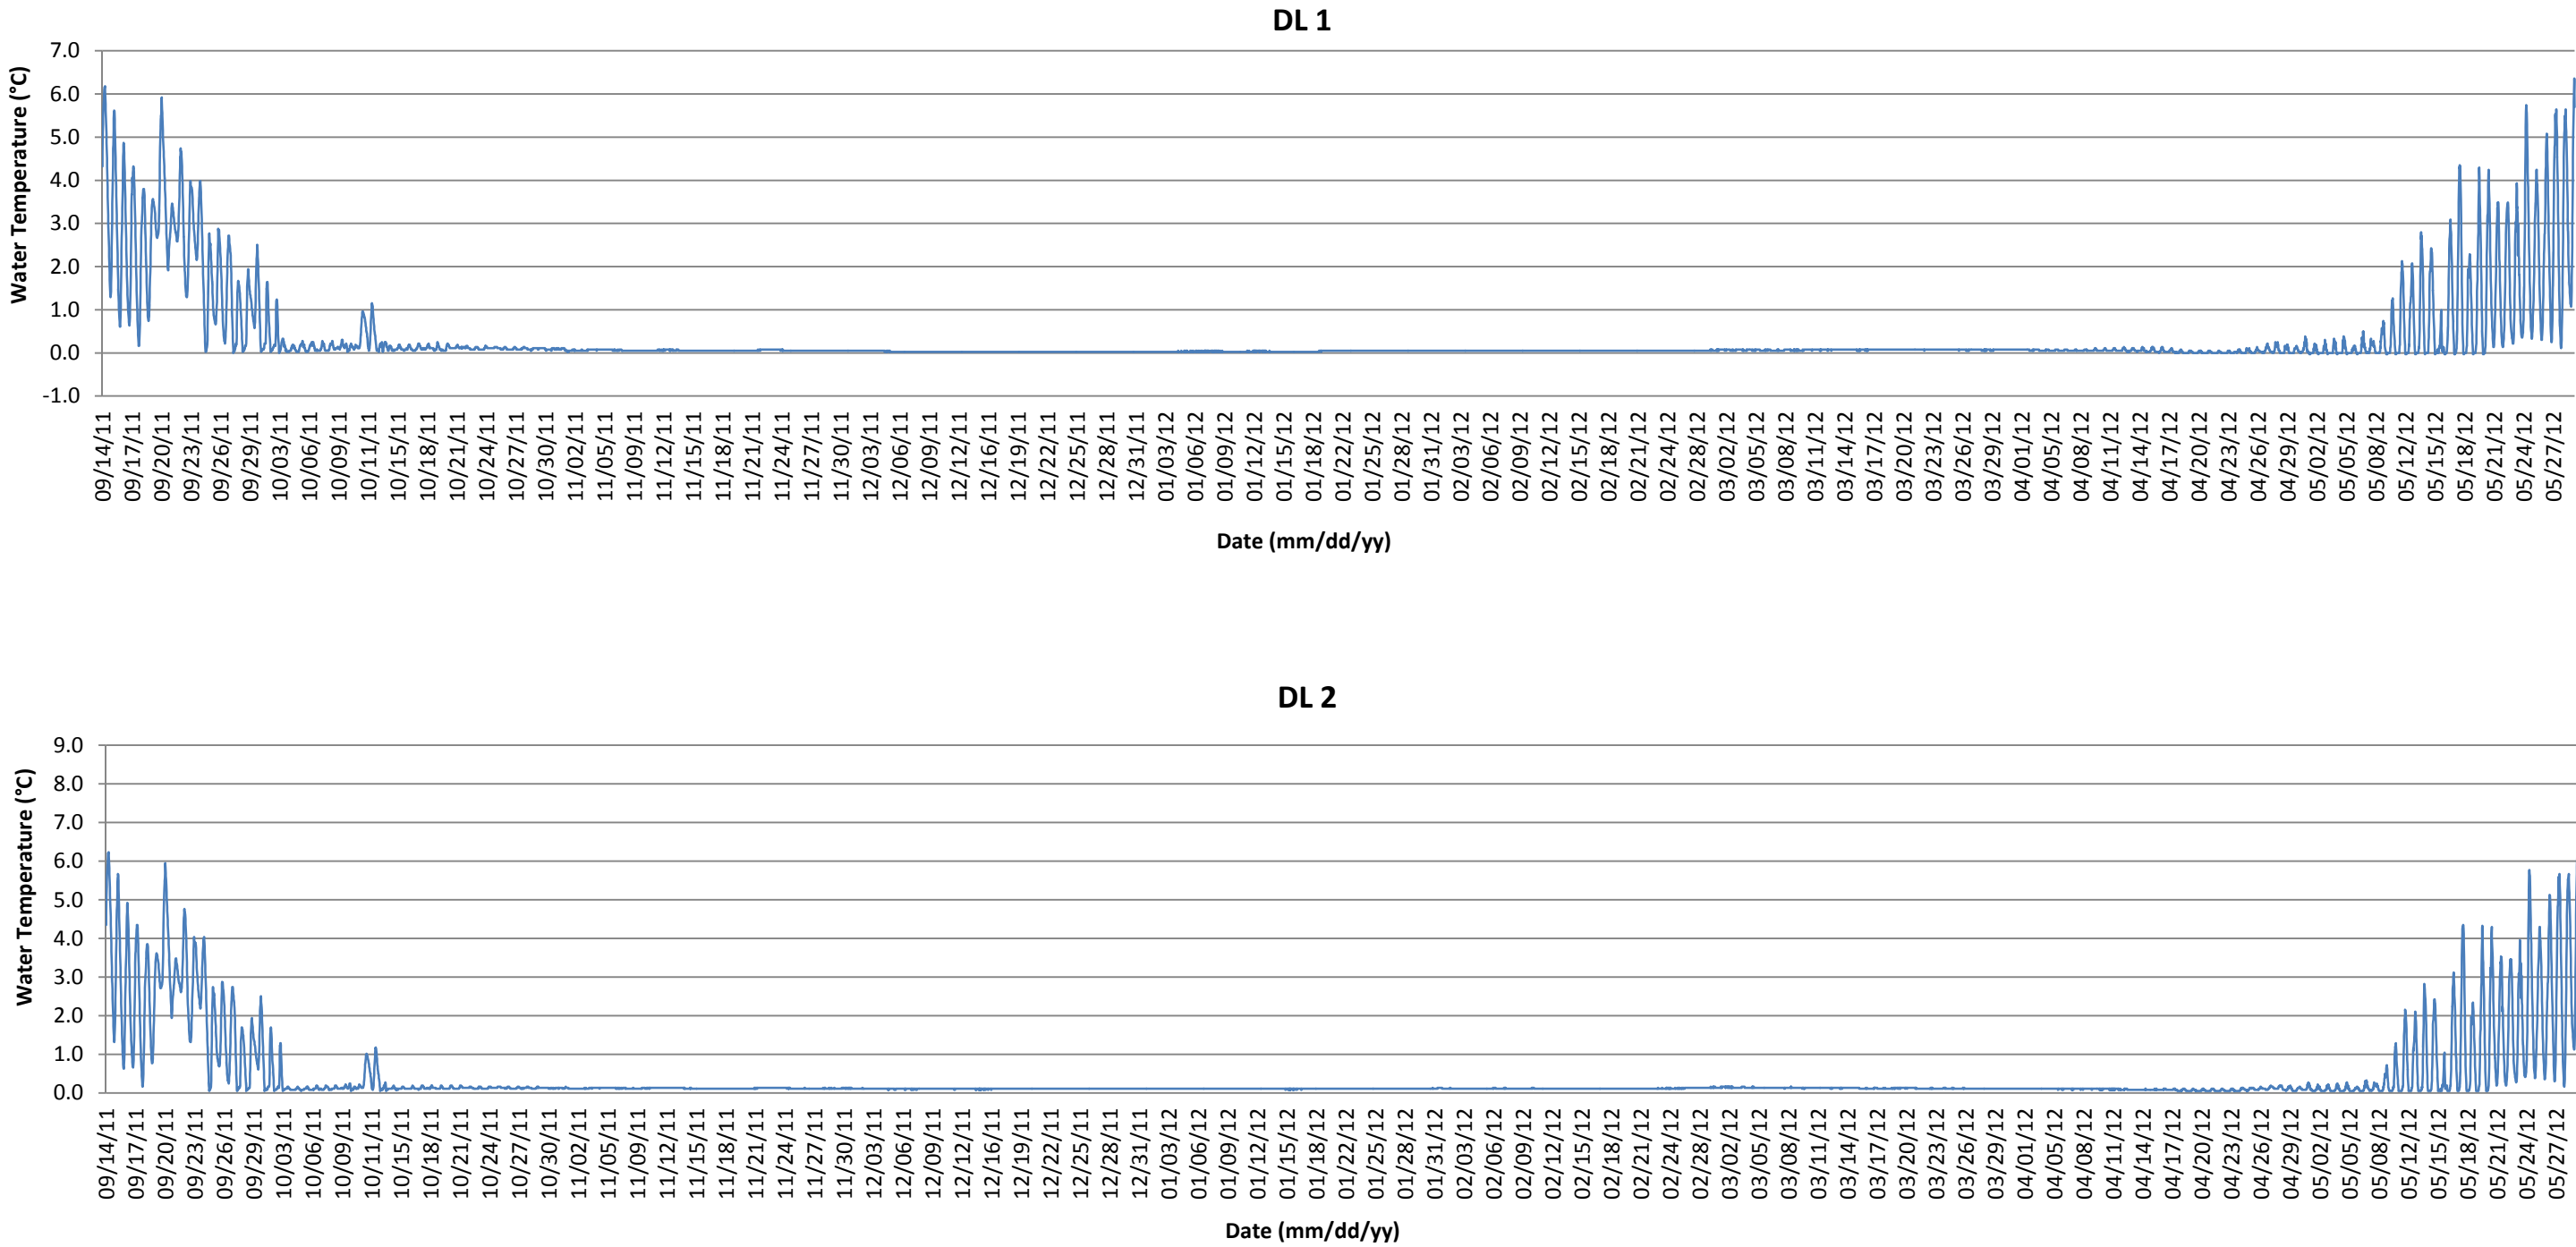
Figure 2. Water temperature record from September 2011 to May 2012 for Stations DL 1 and DL 2.

Temperature loggers recorded data every 30 minutes from September 13-14, 2011 to May 29-30, 2012 (Table 2). The average water temperature at DL 2 was the warmest on record through the logging period, followed by DL 8 (0.38 °C and 0.36 °C, respectively; Table 2). Water temperatures at both of these stations stayed above zero degrees throughout the winter. Conversely, the DL 3 and DL 4 stations had the lowest average water temperatures over the logging period (both 0.21 °C; Table 2) and dropped to a minimum temperature of - 0.12 °C.

In general, at most stations water temperatures dropped to near zero degrees at the end of September or mid-October (Figure 2 to Figure 6). Some sites stayed around zero degrees for the winter (DL 3, 4, 5), with many others fluctuating just above zero (DL 1, 2, 6, 7, 8, 9, 10). In the spring, water temperatures generally started increasing around May 10, 2012 for most sites (Figure 2 to Figure 6). The exceptions were DL 5 and DL 6 which started warming earlier around May 1, 2012 (Figure 4) and DL 8 and DL 9 which had an early warming period around April 14, 2012 (Figure 5 and Figure 6). Note in the fall of 2011, these sites also had a more gradual temperature decline towards zero degrees as winter approached.

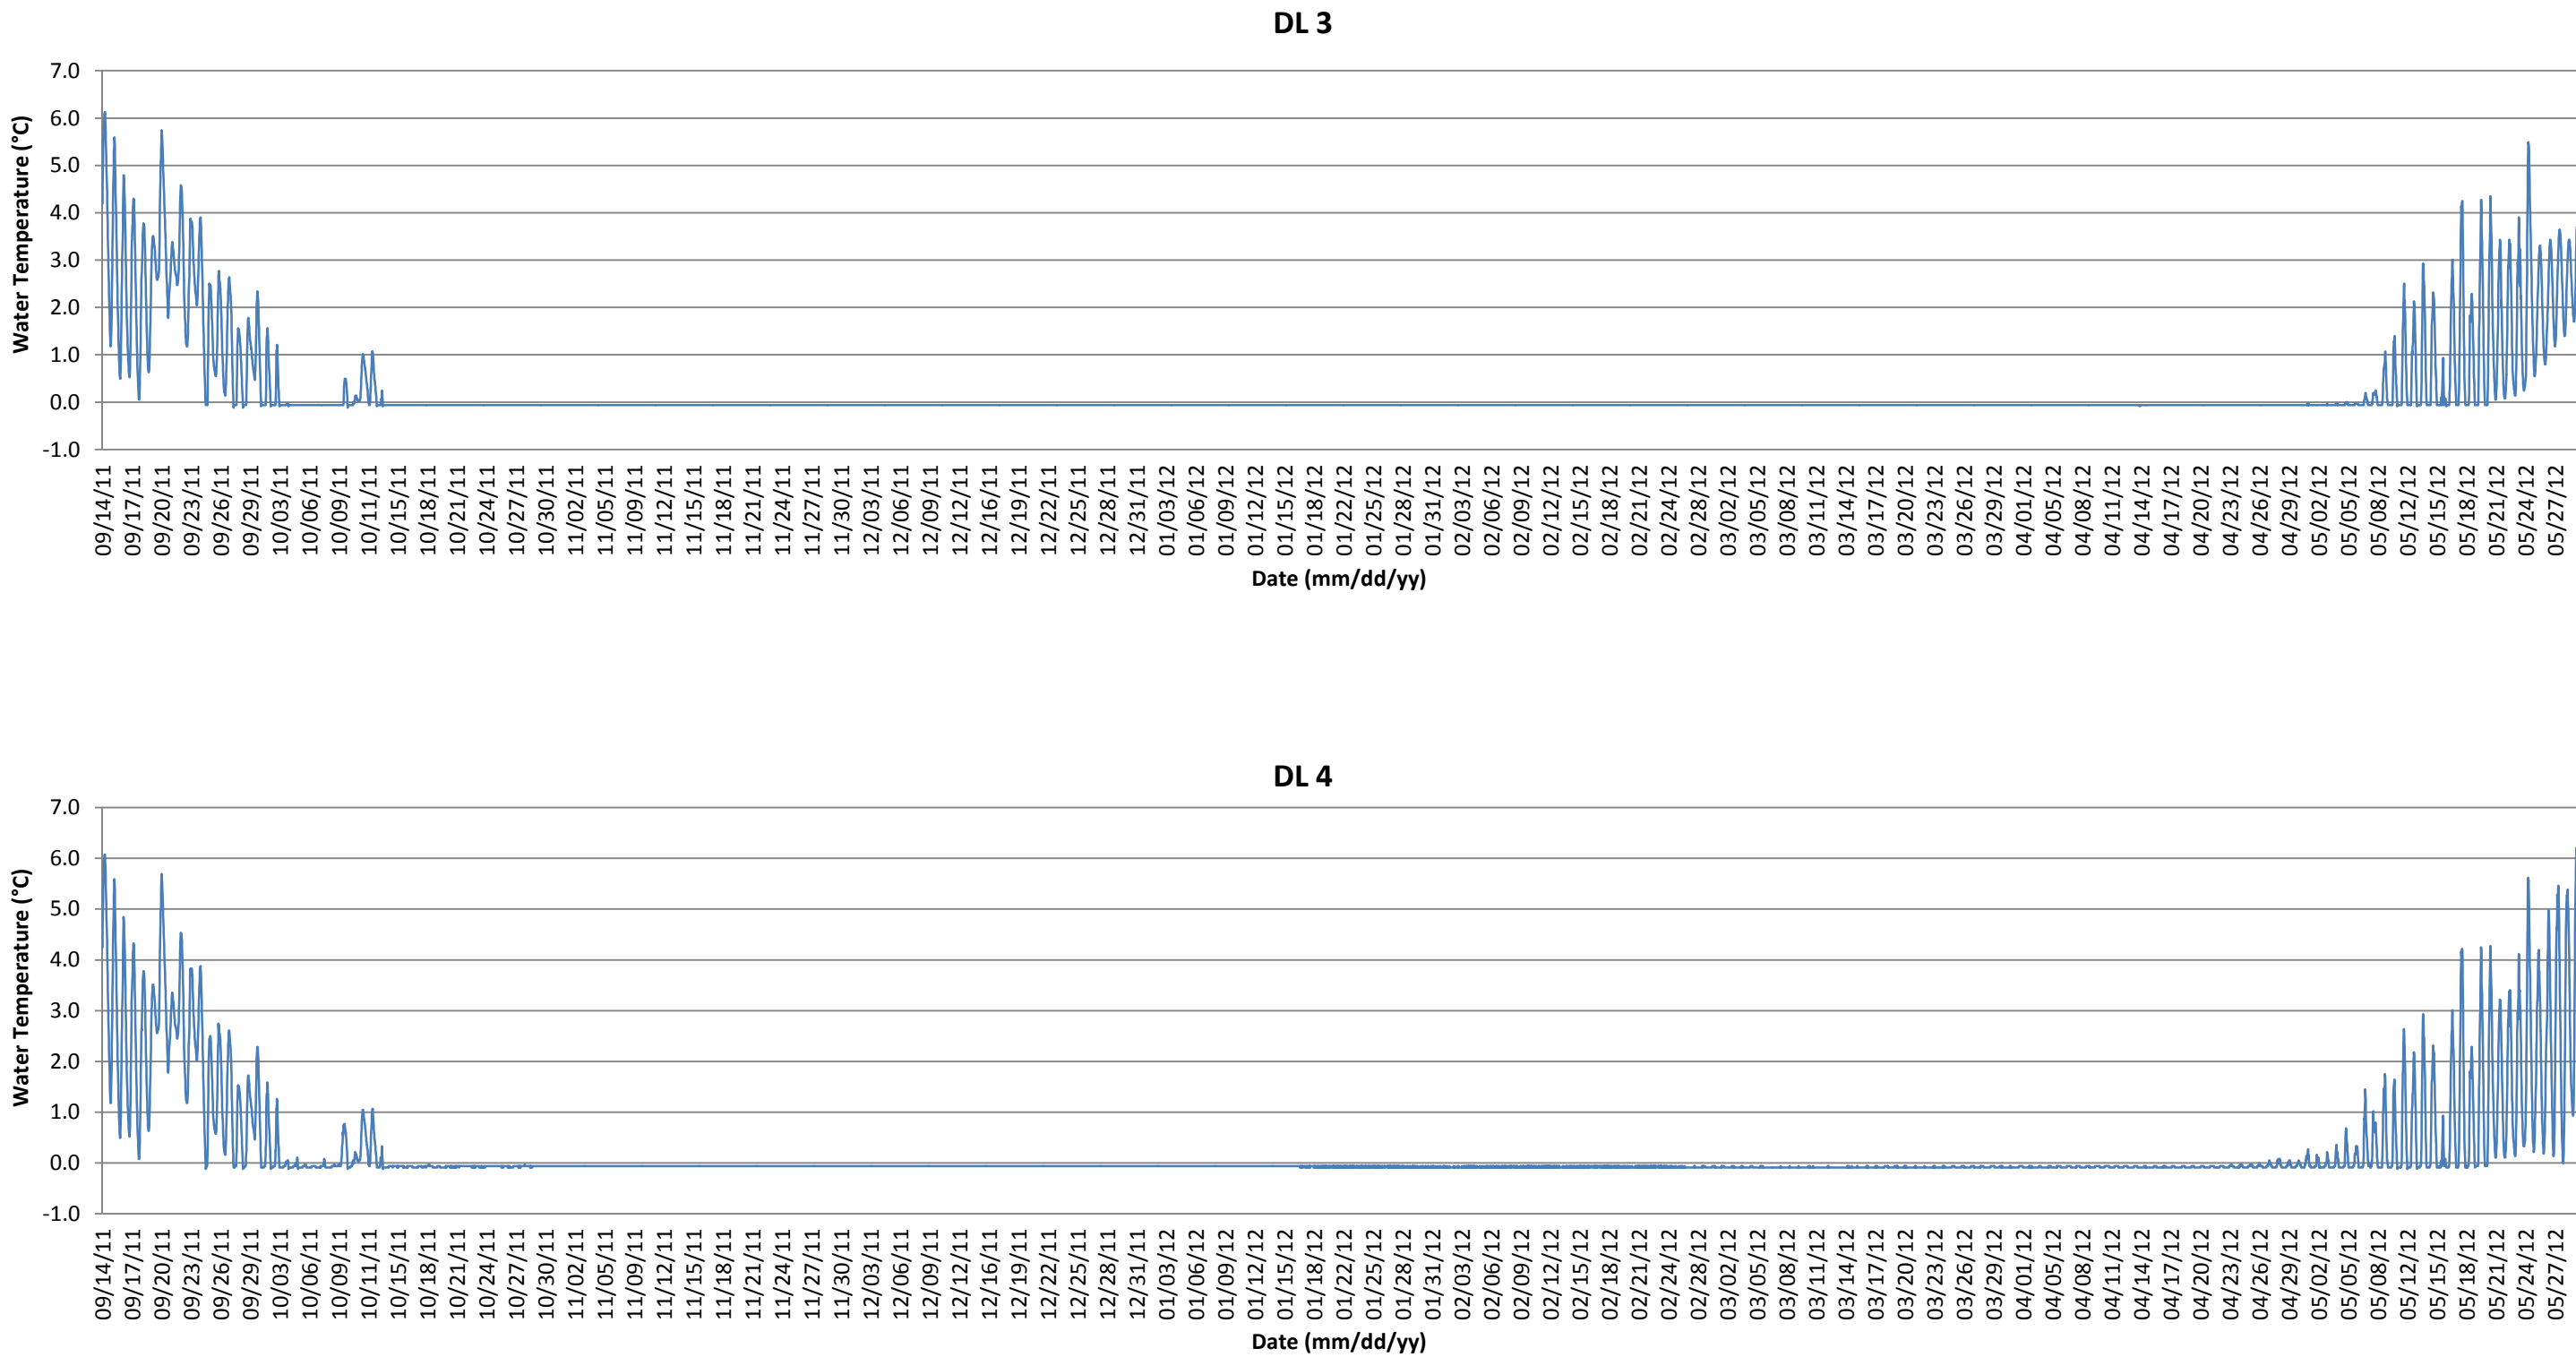
Figure 3. Water temperature record from September 2011 to May 2012 for Stations DL 3 and DL 4.

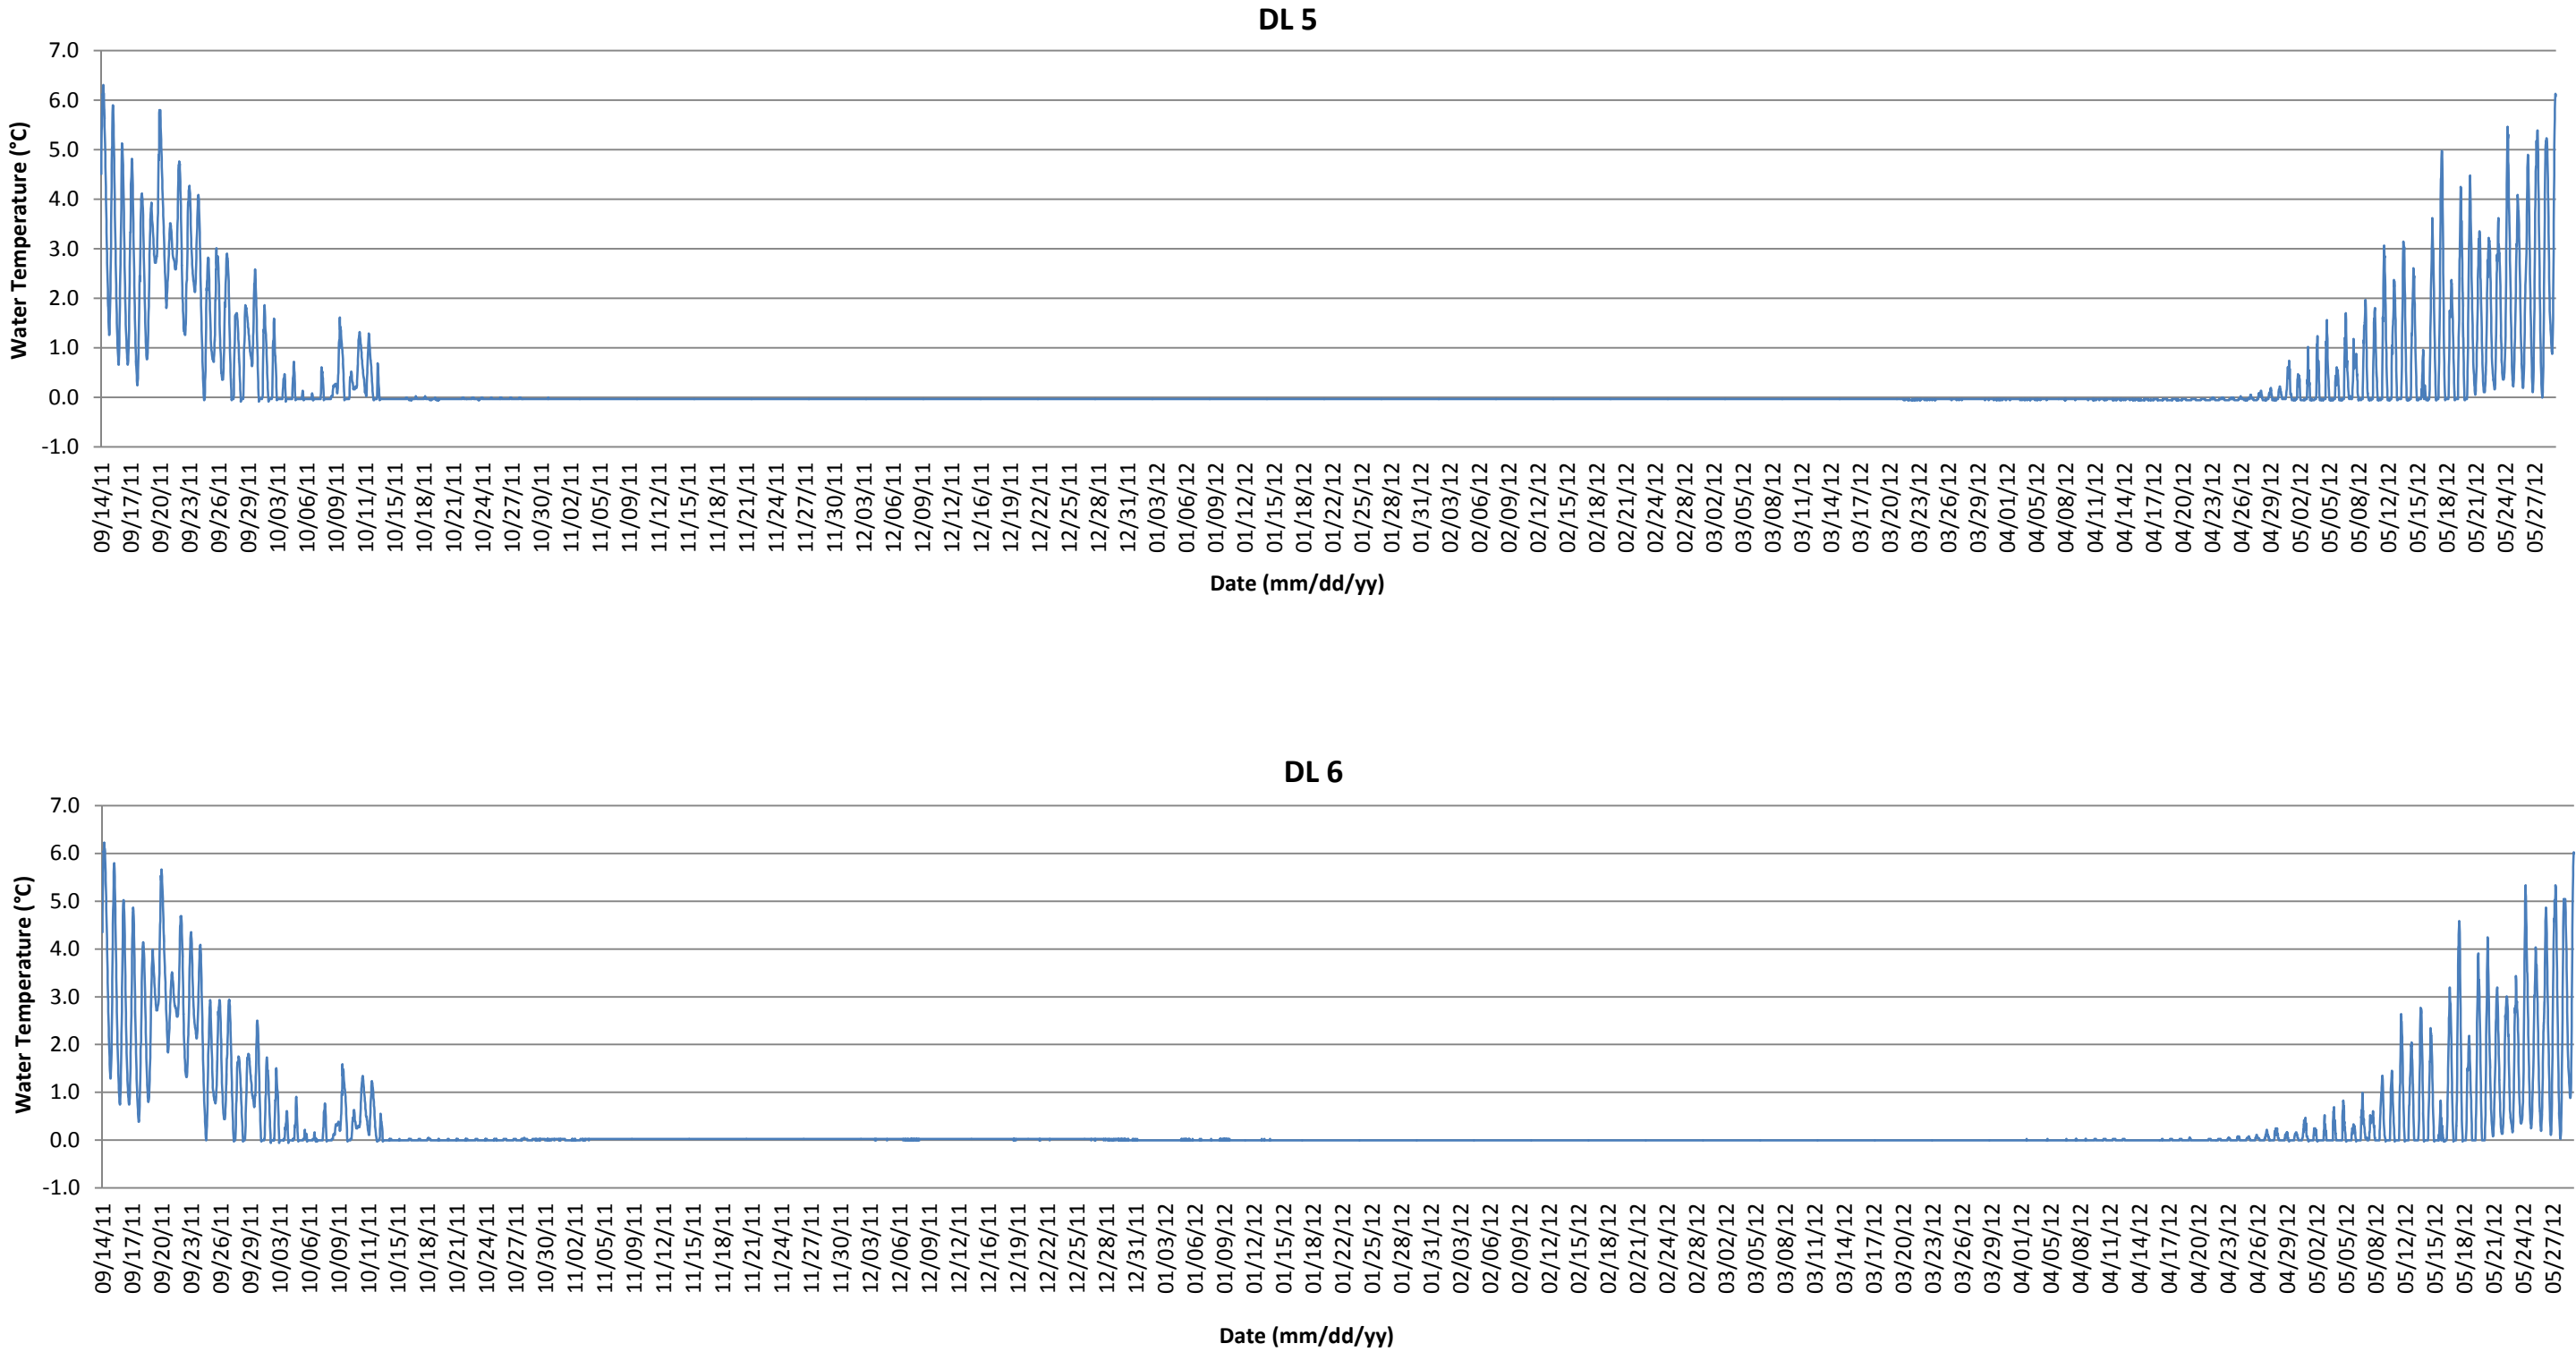
Figure 4. Water temperature record from September 2011 to May 2012 for Stations DL 5 and DL 6.

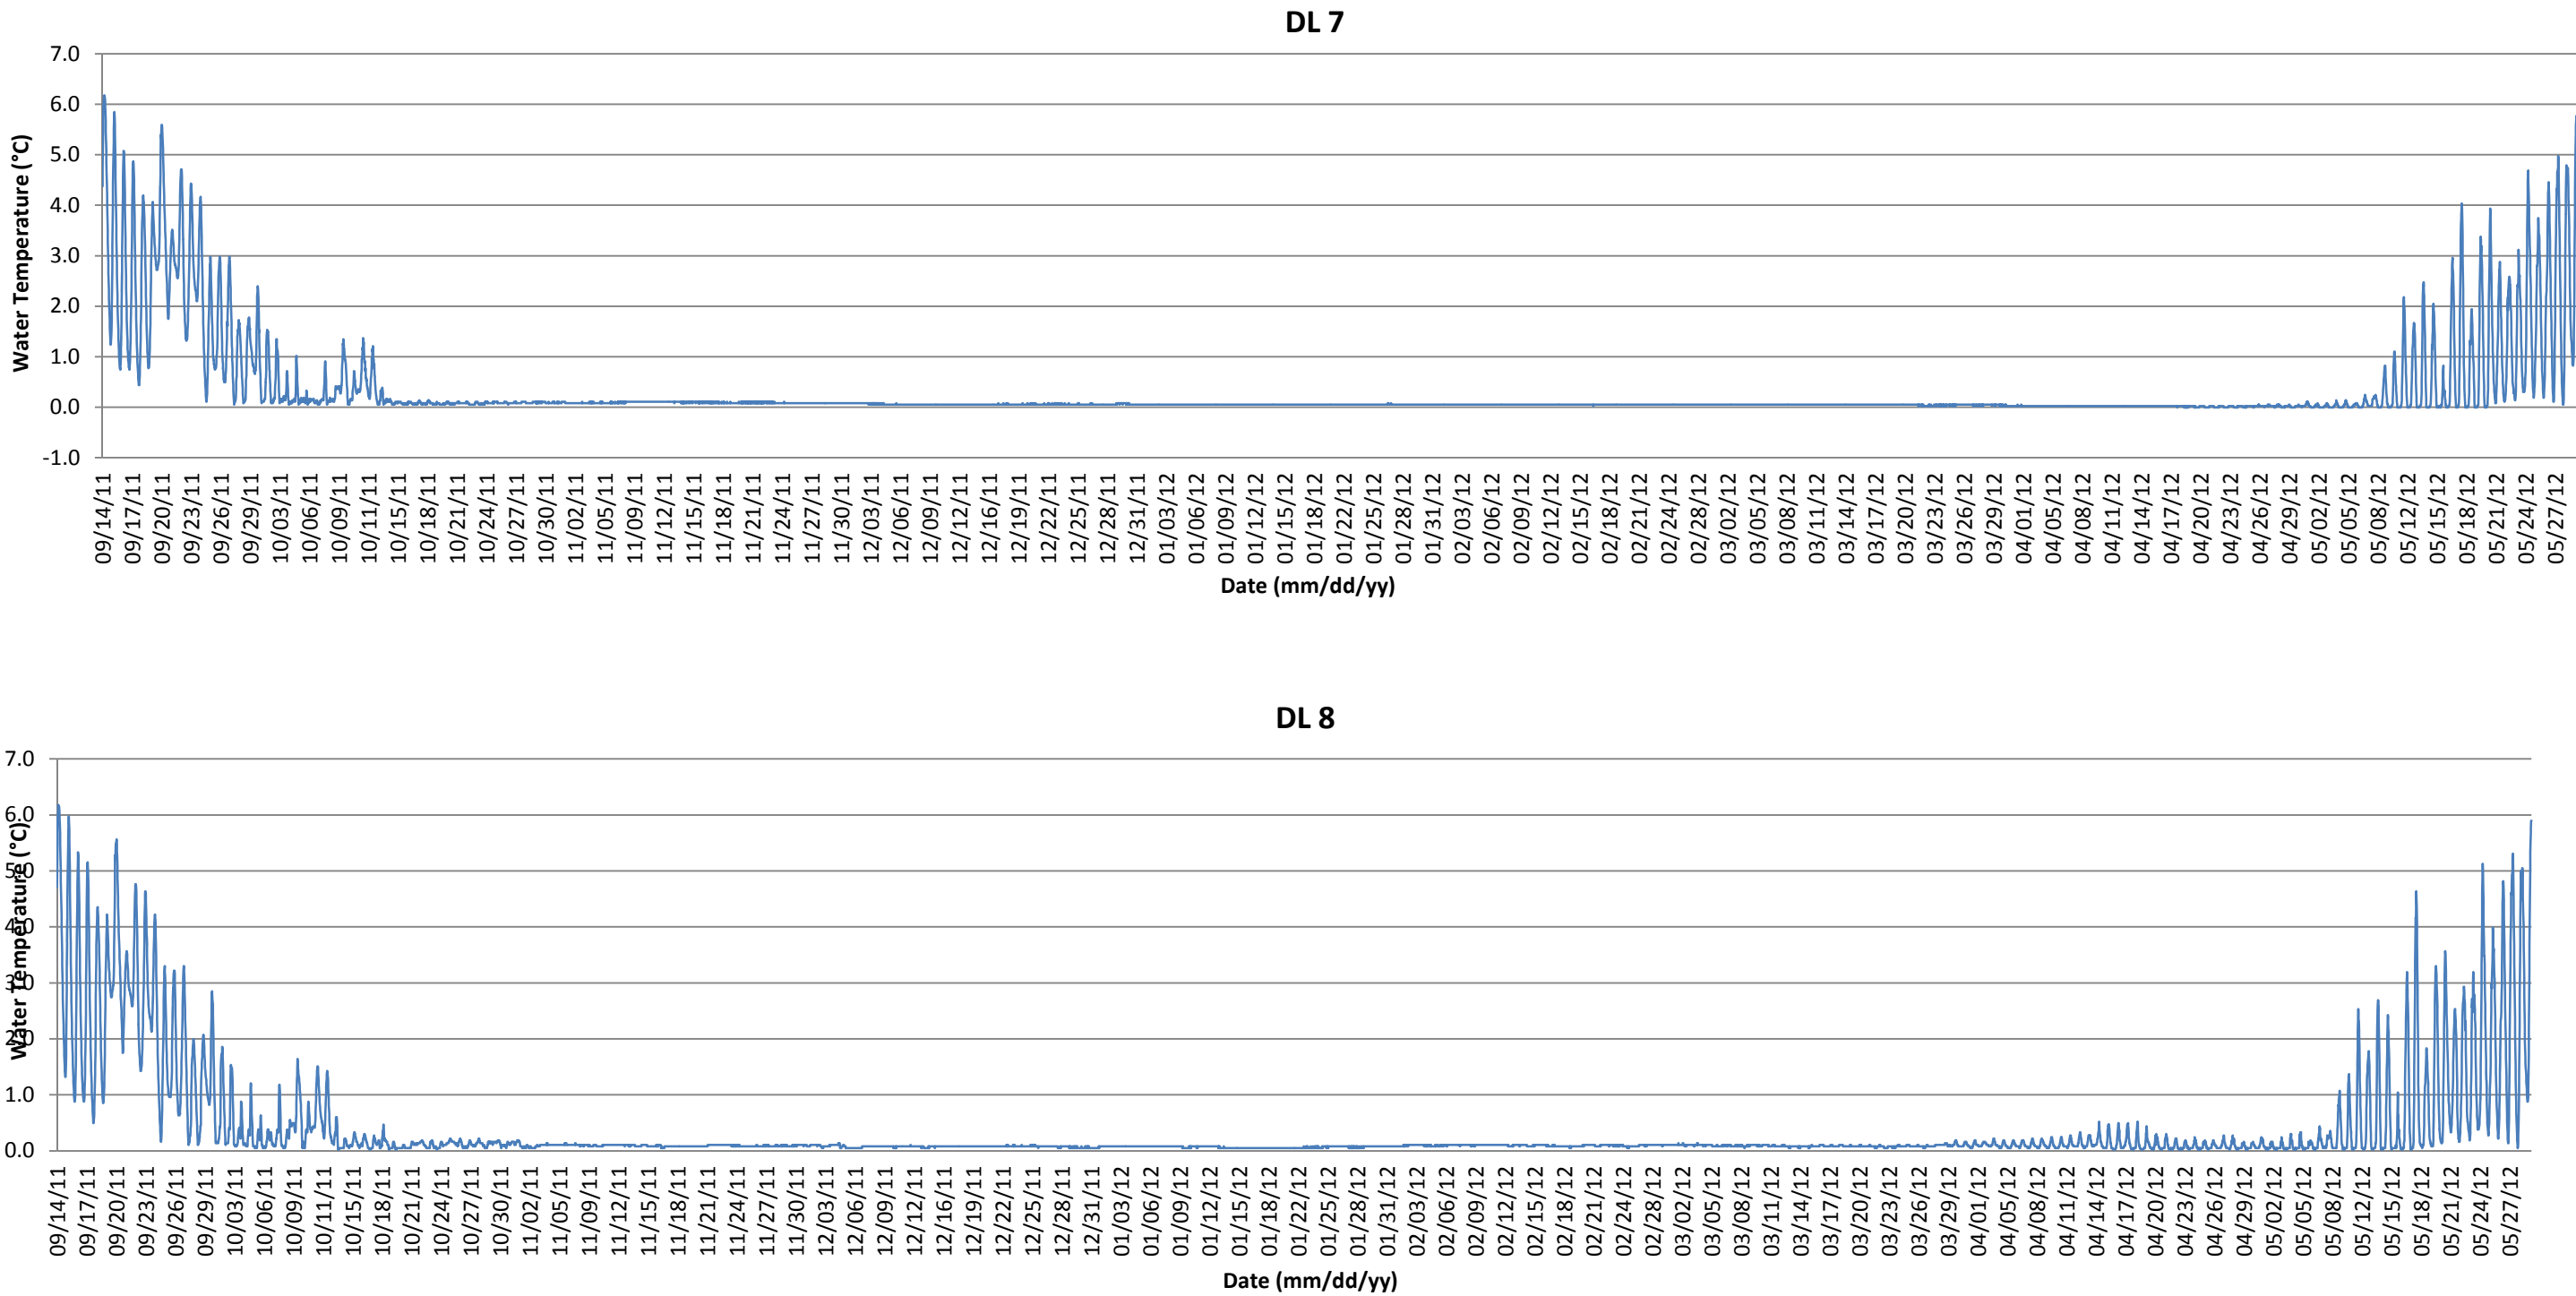
Figure 5. Water temperature record from September 2011 to May 2012 for Stations DL 7 and DL 8.

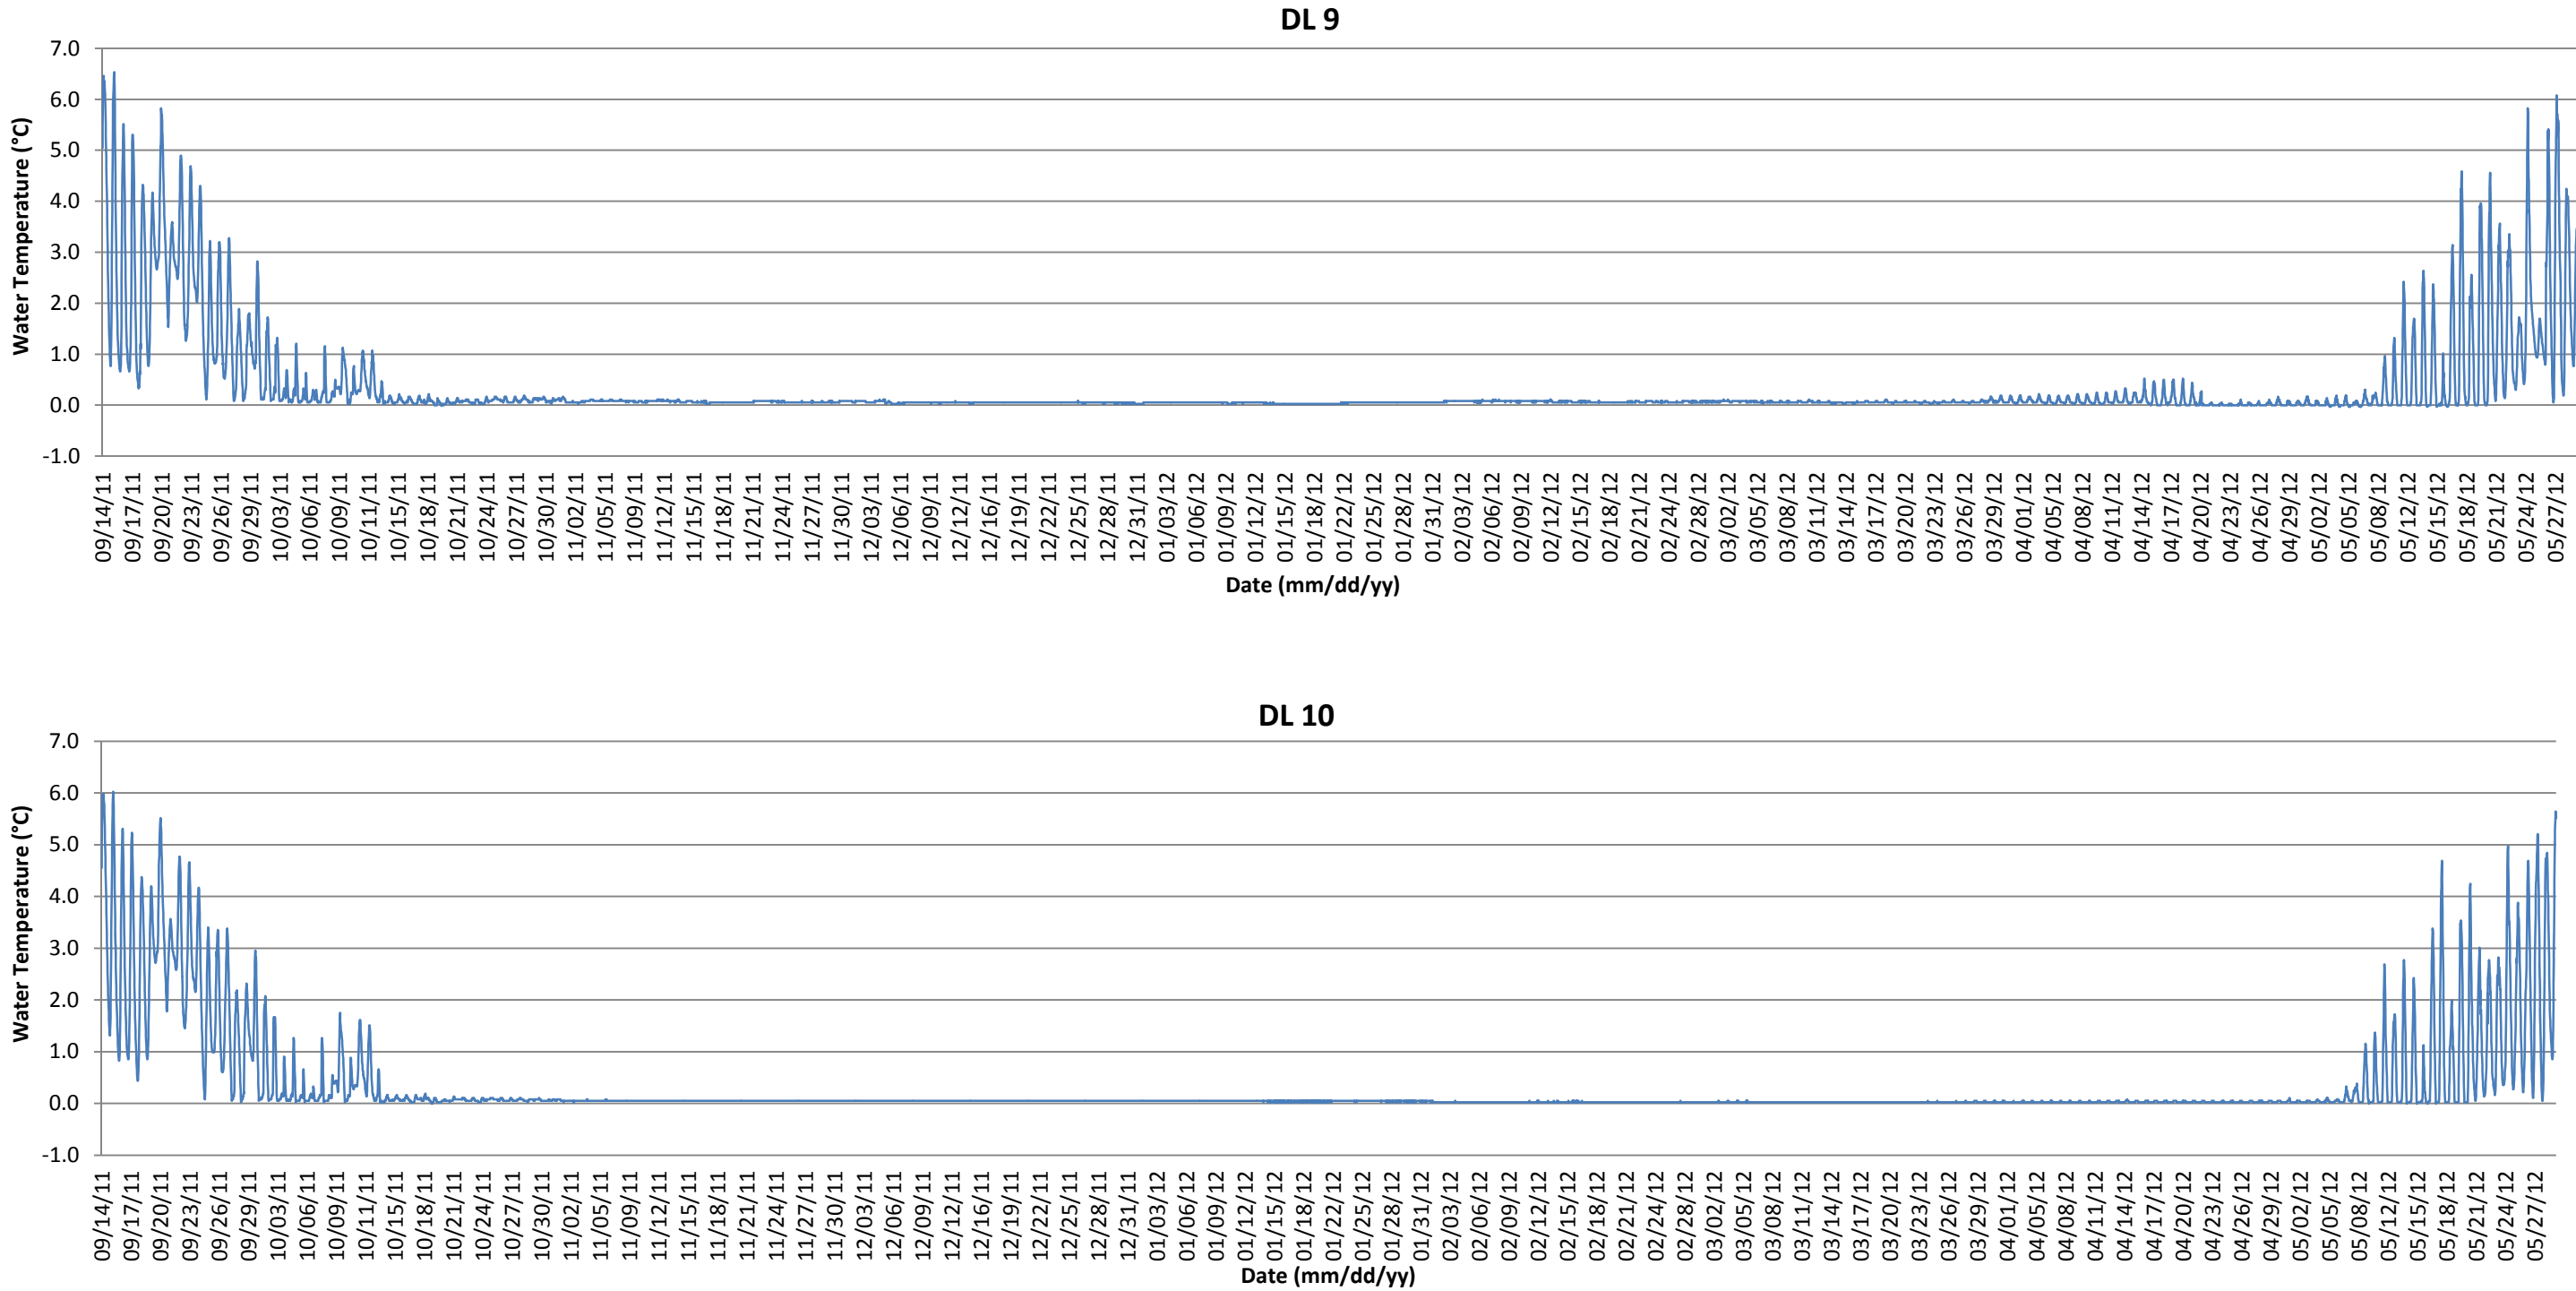
Figure 6. Water temperature record from September 2011 to May 2012 for Stations DL 9 and DL 10.
