Victoria Creek Fish Overwintering Study, Mount Nansen Project

EDI ENVIRONMENTAL DYNAMICS INC.

PROJECT # 11-Y-0344
DATE JULY 19, 2012

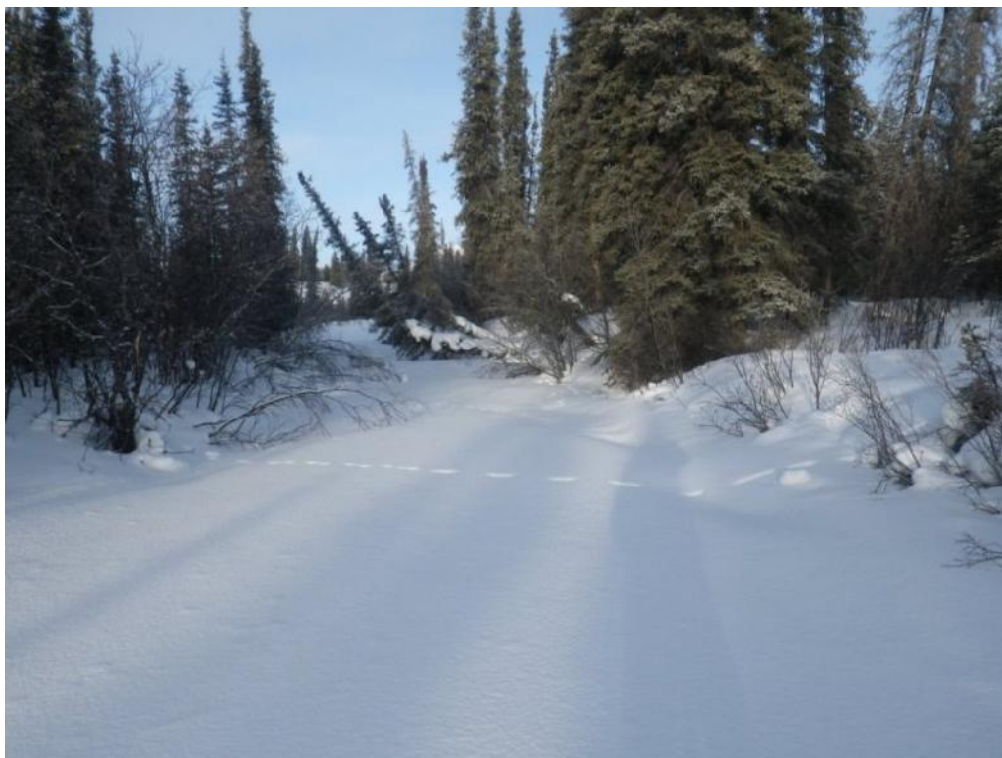
Between DL 4 and DL 5 there were sections of thin ice evident through depressions in the snow (Photo 3). These were concentrated just upstream of the confluence with Minnesota Creek. Between DL 5 and DL 6 there were no open water areas, except for some depressions in the snow where ice was thinner. This pattern continued upstream towards DL 7 and DL 8. There were open water areas just downstream from DL 8, as well as between DL 9 and DL 10 during both surveys (Photo 4). Results are displayed spatially on Figure 7 and Figure 8. More details on open water conditions during the surveys are found in Appendix B.

Photo 3. Thin ice depressions along Victoria Creek (February 2012).

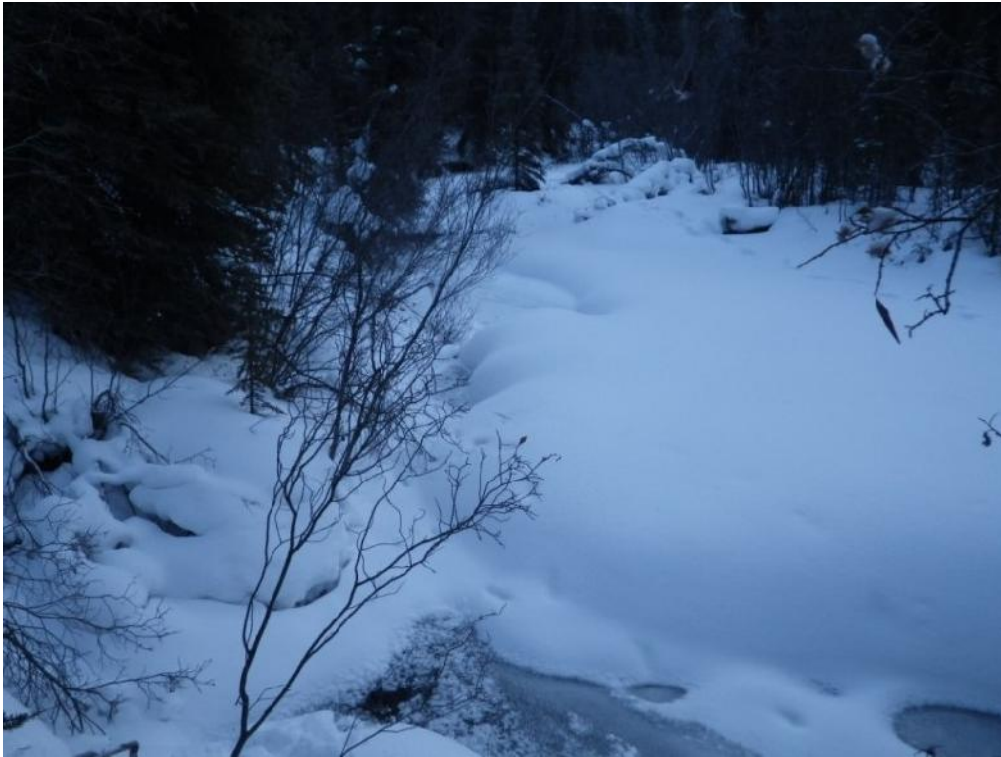
Photo 4. Areas on Victoria Creek with thin ice and open water (February 2012).

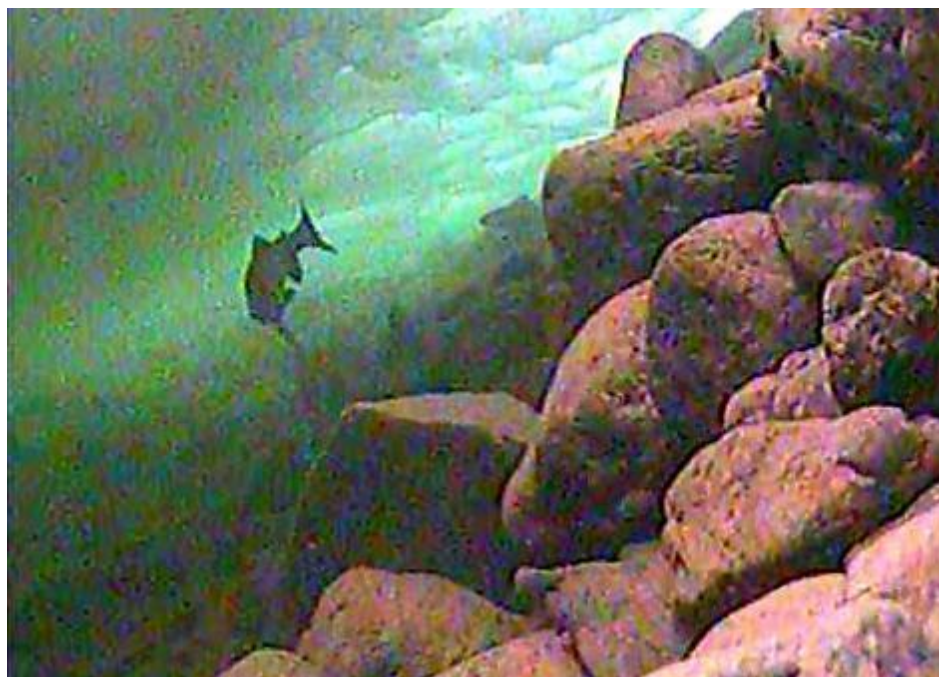
Photo 5. Underwater video recording snapshot of Arctic grayling at DL 6 (April 2012).

observed at one time during video monitoring, so that individuals were not counted multiple times. The time spent on video monitoring depended on viewing conditions and how soon fish were observed. Sampling effort was prolonged until fish were observed or up to 27 minutes; when fish were observed, sampling effort would generally continue until observers had a good sense of how many individual fish were present. No video monitoring could be undertaken at Station DL 3 as thick overflow ice had buried the station. Photos 5 to 7 provide an example of the video footage acquired.

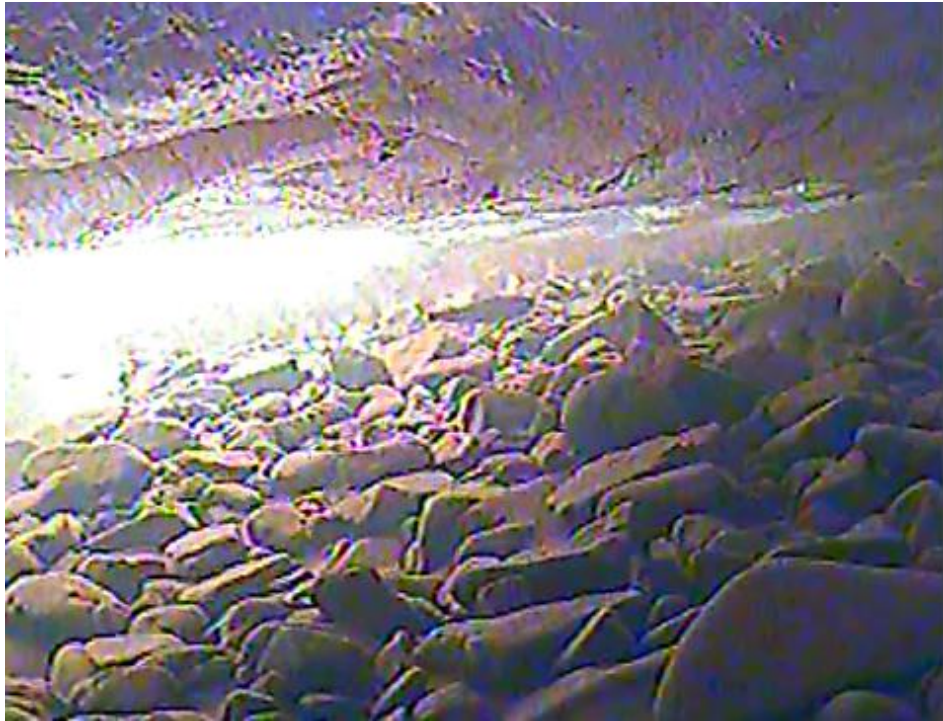
Photo 6. Underwater video recording snapshot of one Arctic grayling at DL 4 (upper centre of photo; April 2012).

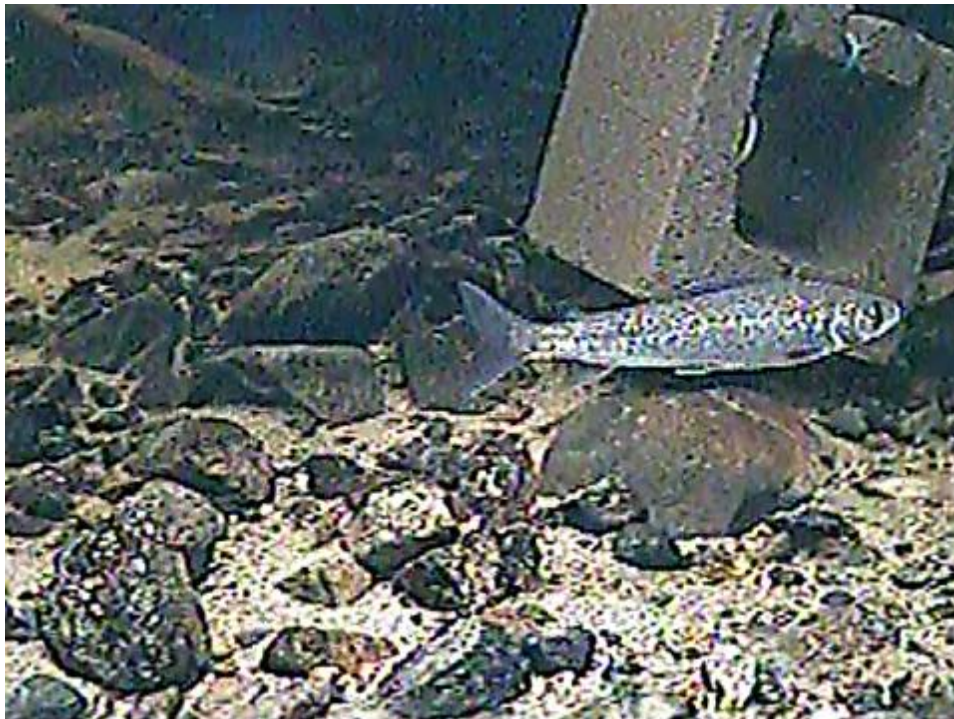
Photo 7. Underwater video recording snapshot of one Arctic grayling at DL 9 – Back Creek confluence (April 2012).

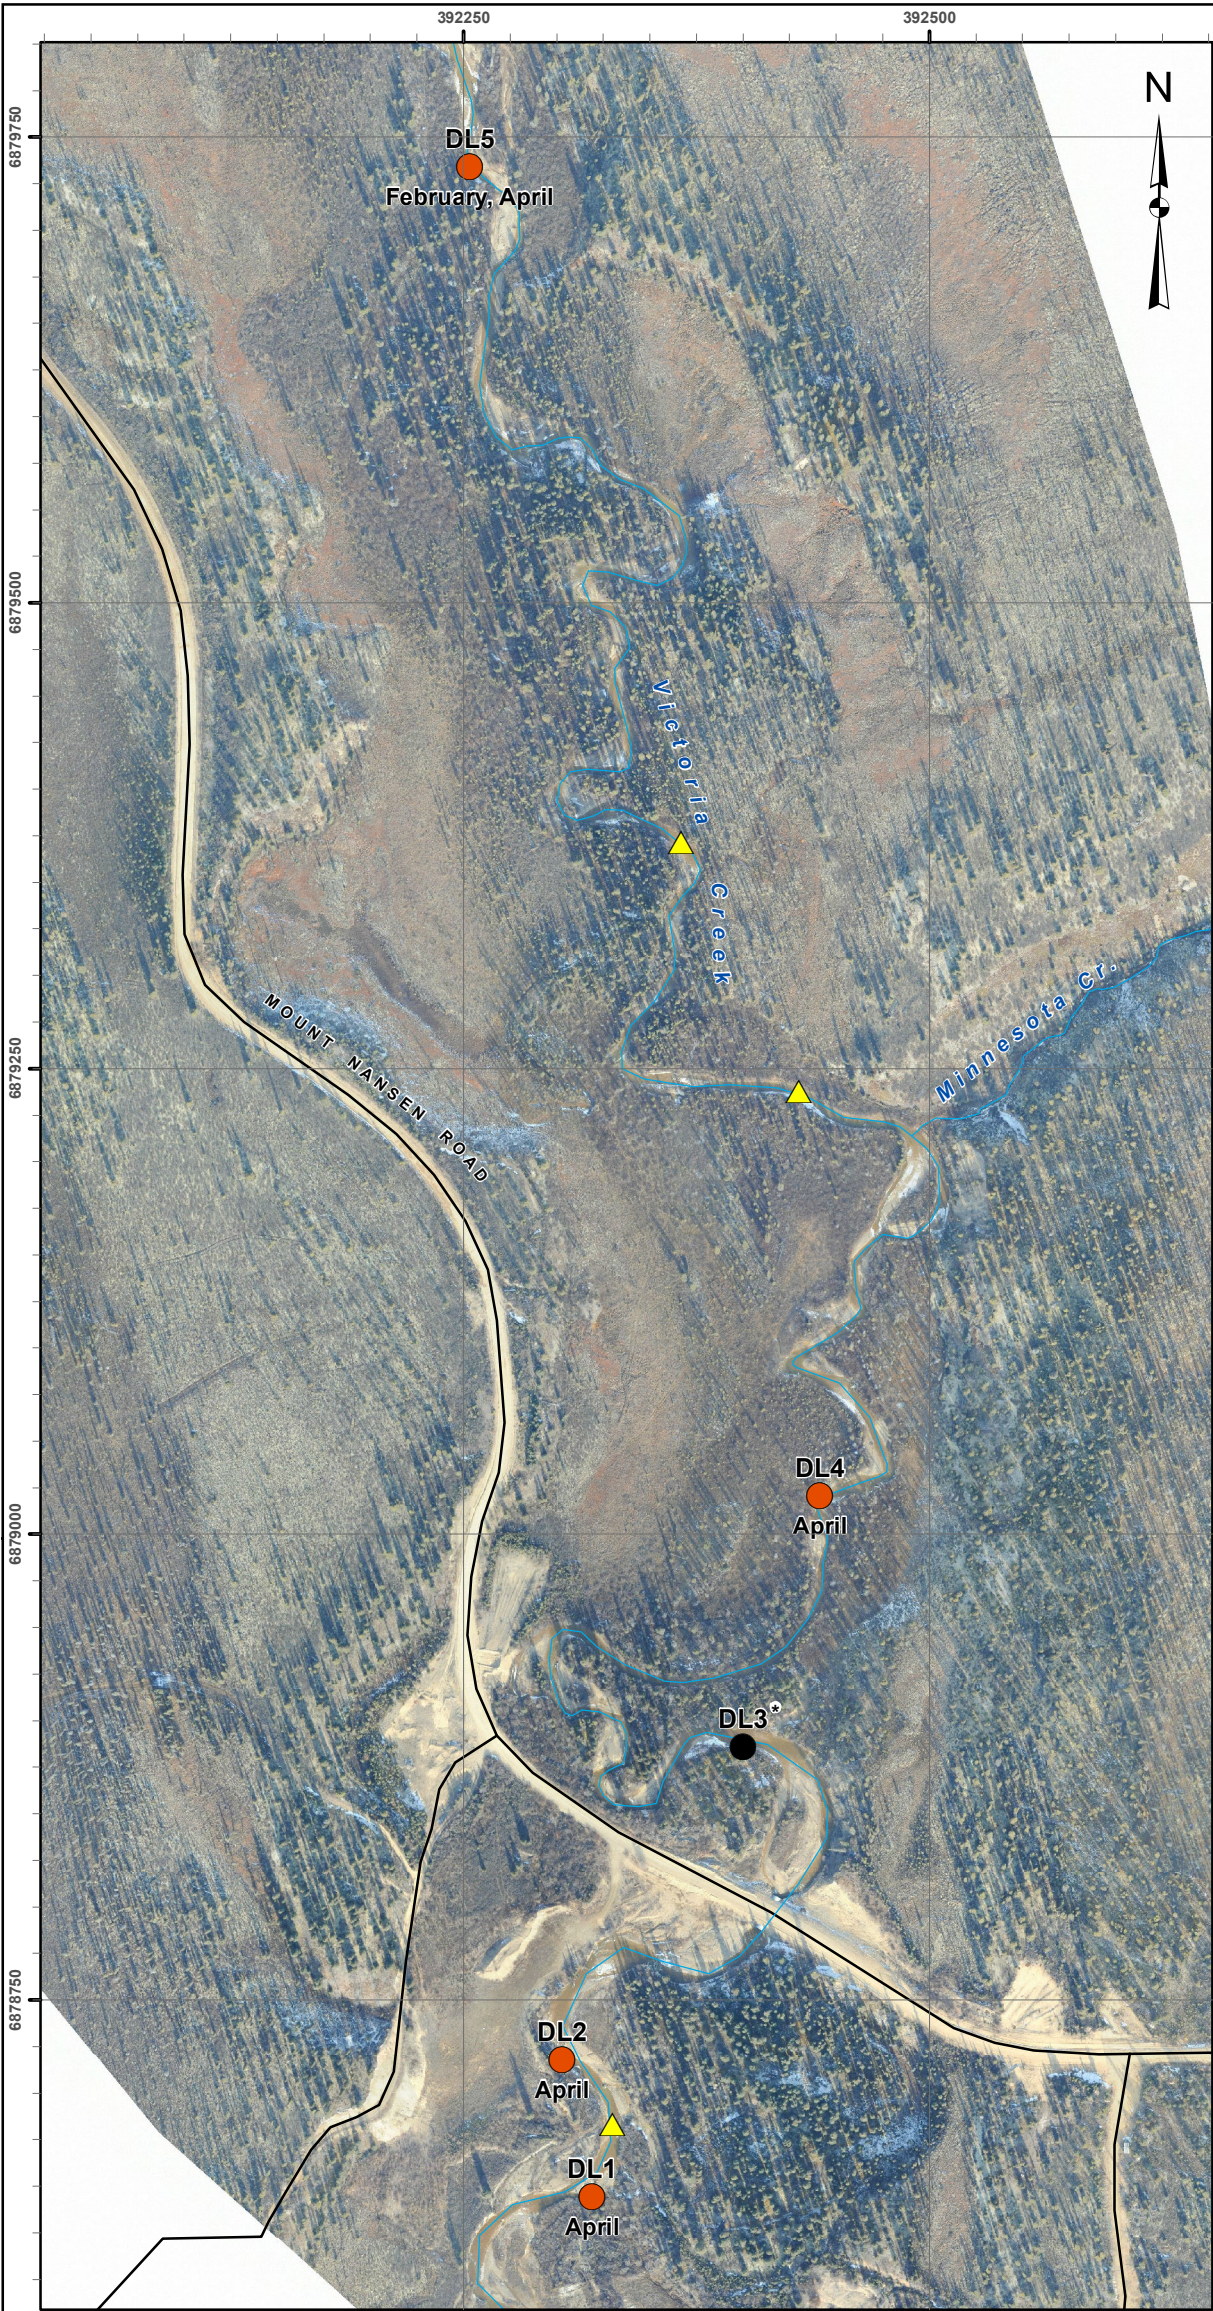
Drawn: LG	Checked: MP / MM	Date: 7/17/2012	FIGURE 7
--------------	---------------------	-----------------	----------

Winter Fish Observations and Open Water Areas on Victoria Creek (Lower Section).

Fish presence was successfully documented using underwater video monitoring and recording during both winter surveys. During the mid-winter survey, fish were identified at four out of ten stations, from the mid to upper sections of the study area (Table 5; Figure 7; Figure 8). During the late-winter survey, fish were identified at seven out of ten stations, including some of the more downstream stations (Table 5; Figure 7; Figure 8).

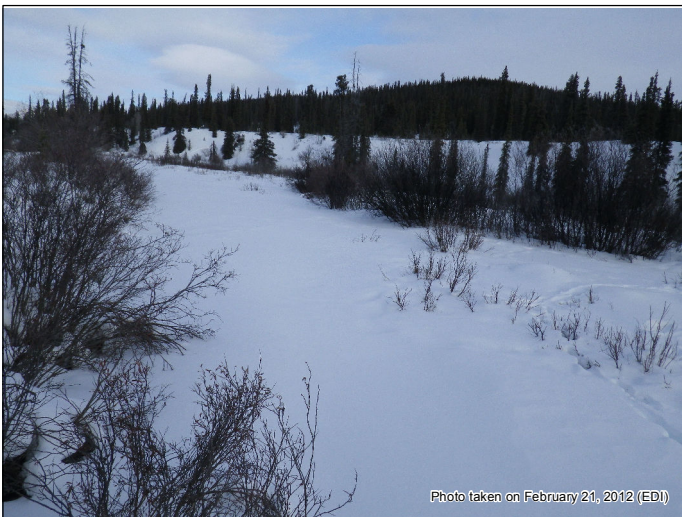
DL5: Upstream view from the monitoring station.

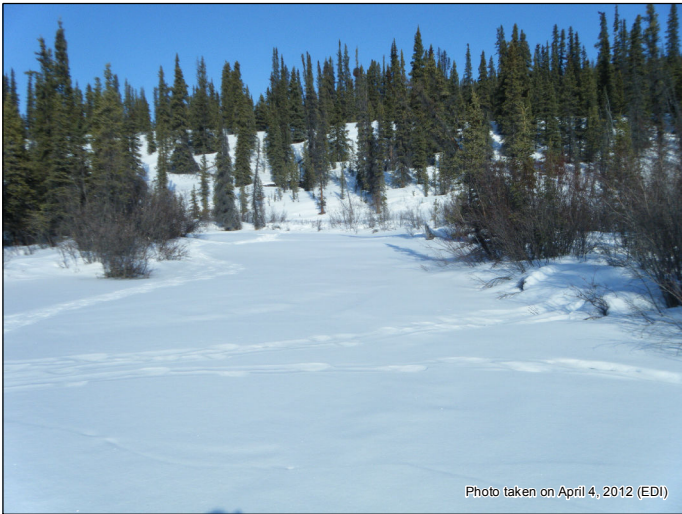
DL4: Upstream view from the monitoring station.

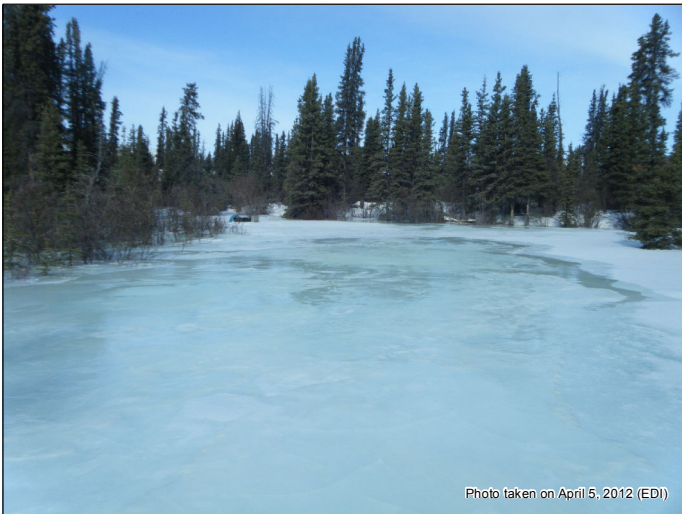
DL3: Upstream view of overflow conditions.

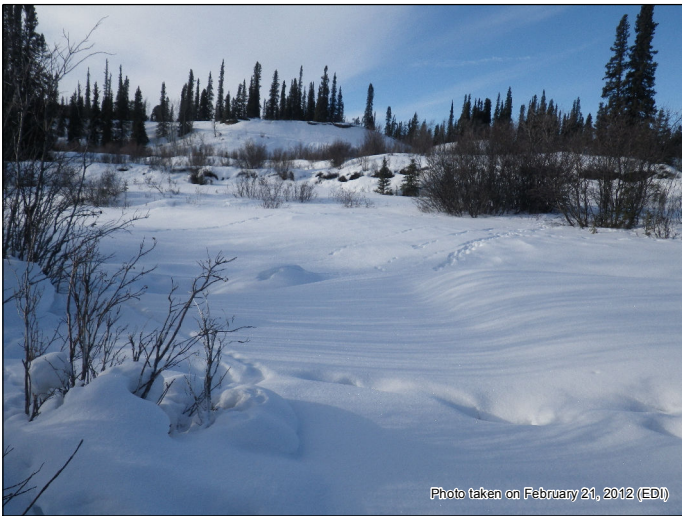
DL1: View looking downstream of the monitoring station.

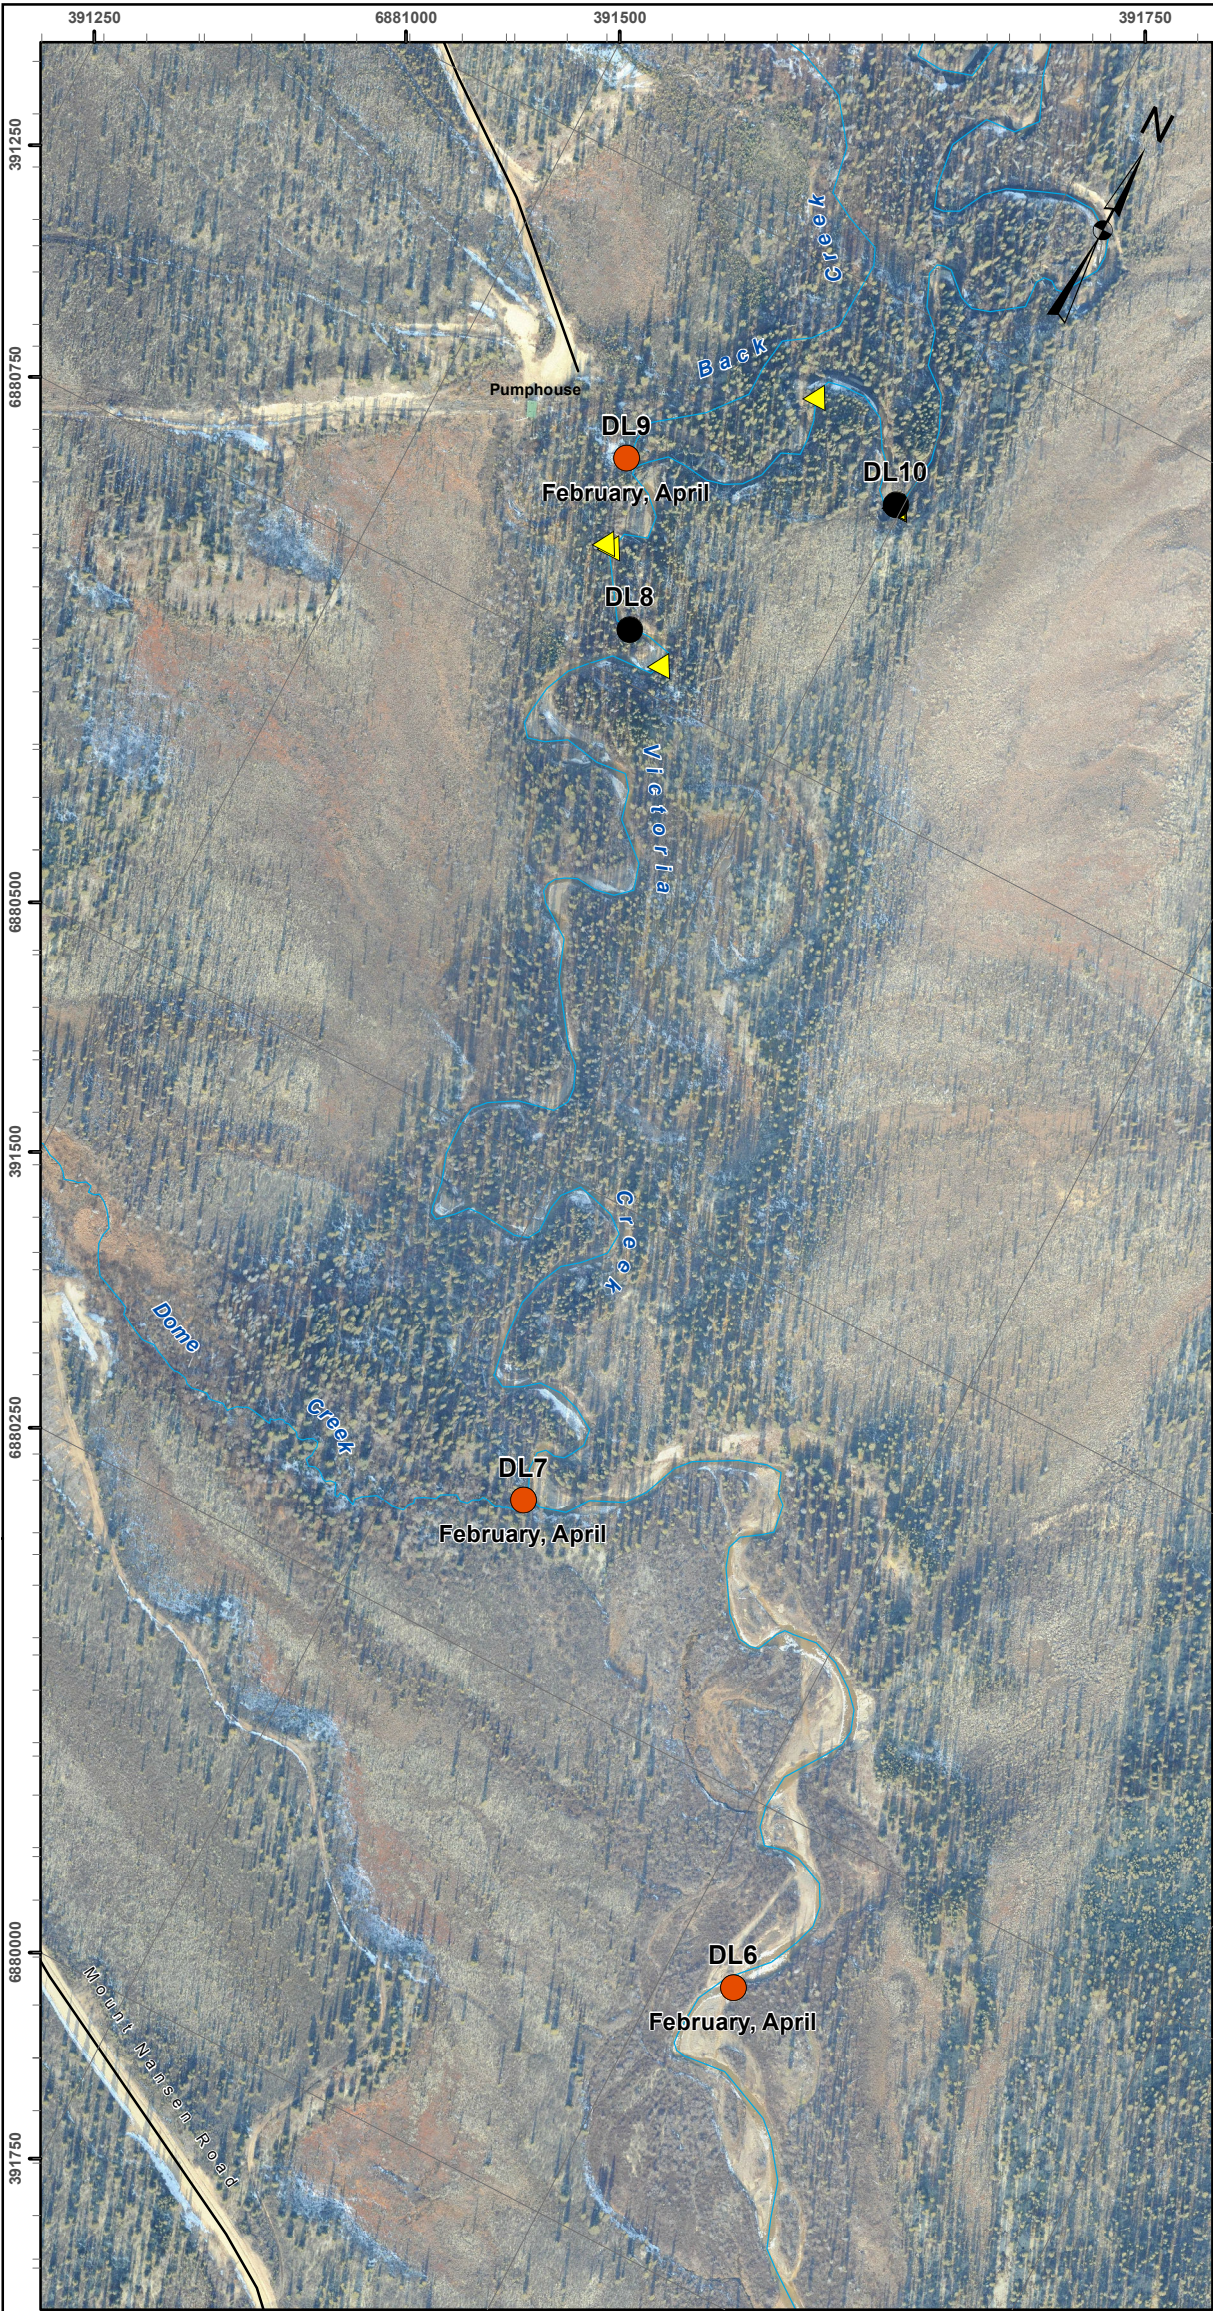
FIGURE 8

Winter Fish Observations and Open Water Areas on Victoria Creek (Upper Section).

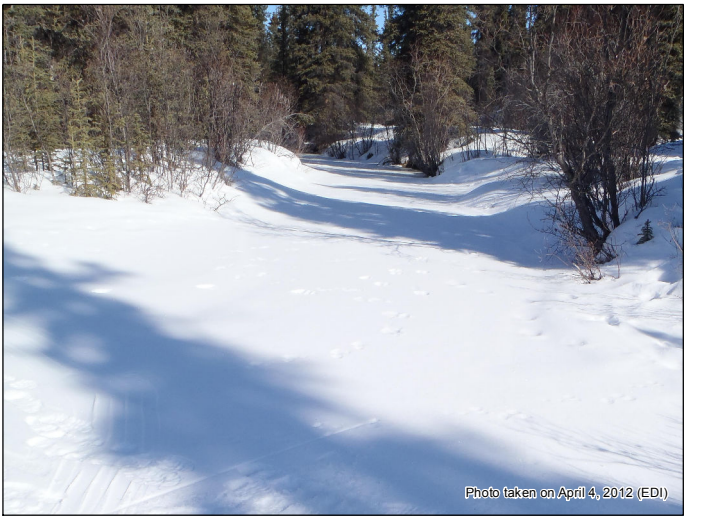
DL10: Upstream view from the monitoring station.

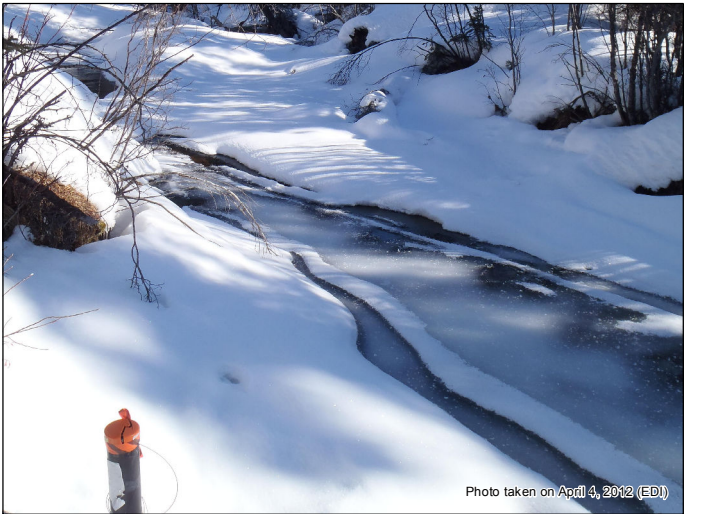
DL9: Thin ice upstream from the monitoring station.

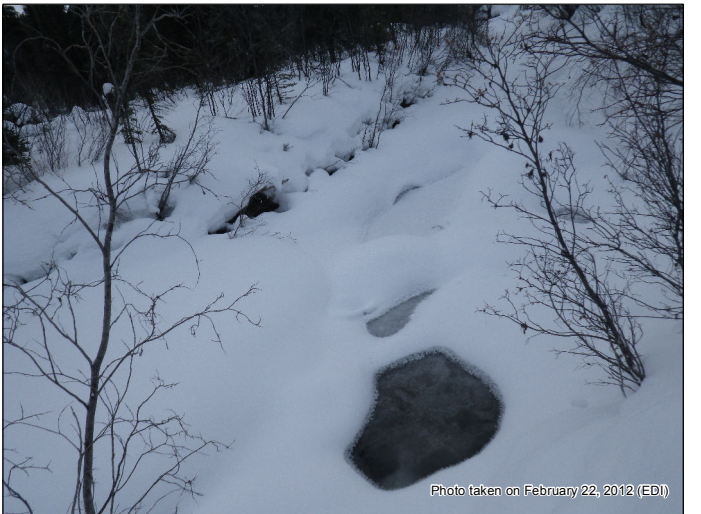
DL8: Downstream view of open water conditions.

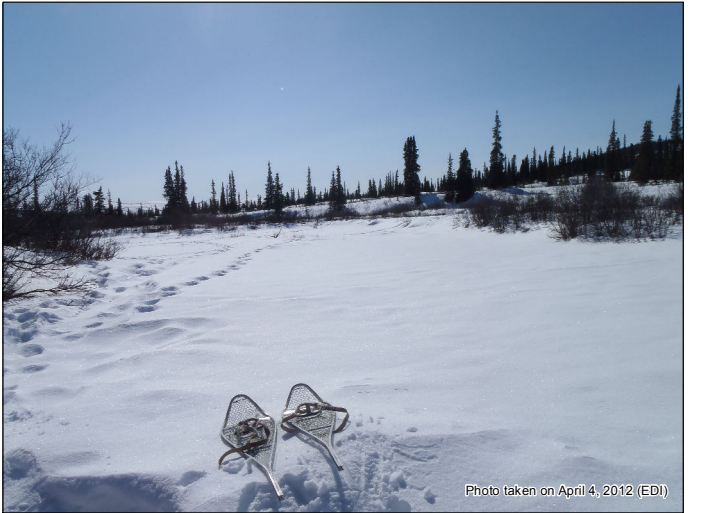
DL6: View looking downstream of the monitoring station.

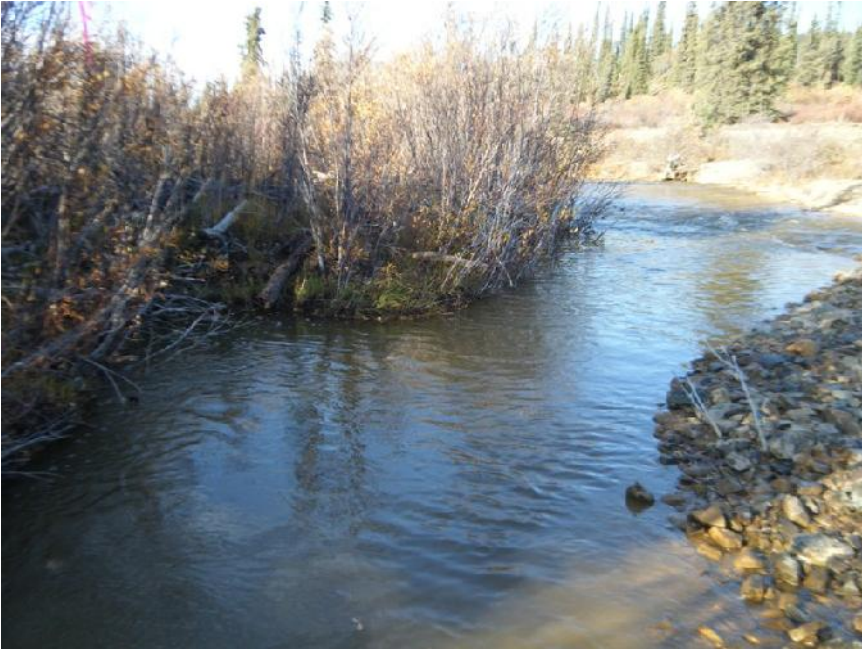
Station DL1	Description

<ul style="list-style-type: none">- Deep pool (110 cm) in a side channel- Overhanging vegetation (willow)- Small woody debris- Cobble substrate
Station DL2	Description

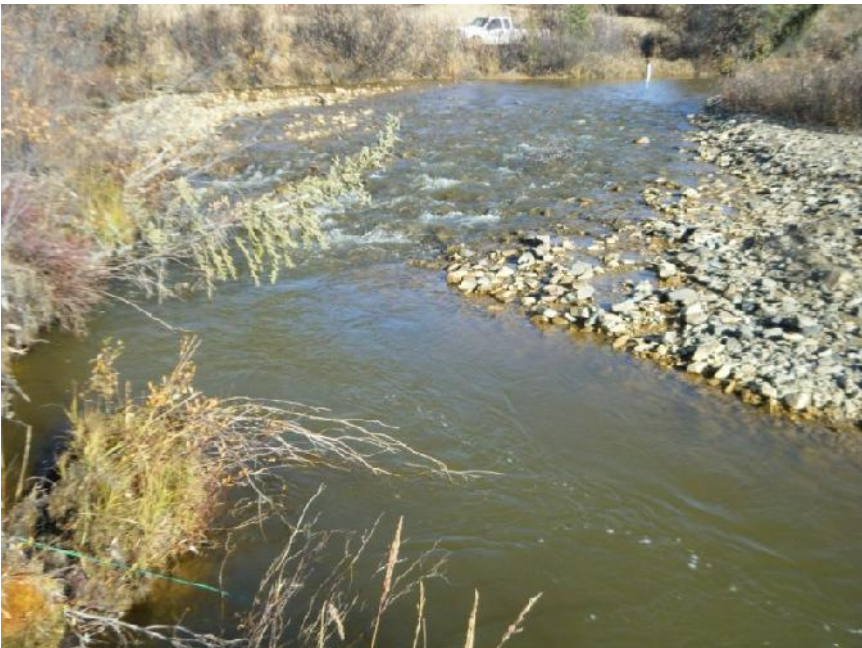
<ul style="list-style-type: none">- Upstream from Station 1, but downstream from the Victoria at Road hydrology site- Back eddy pool (<100 cm) with good cover (large woody debris, submerged willow)- Located in bend in creek with riffle section upstream- Cobble, gravel and fines substrate

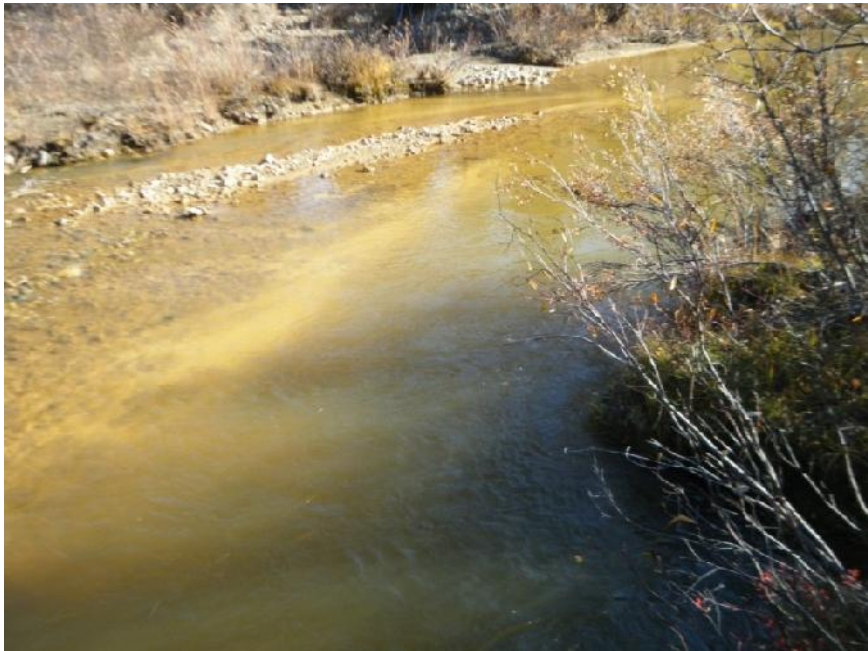
Station DL3	Description

<ul style="list-style-type: none">- Back eddy pool upstream from road culvert- Depth <100 cm- Overhanging willow cover- Substrate is large gravel and fines
Station DL4	Description

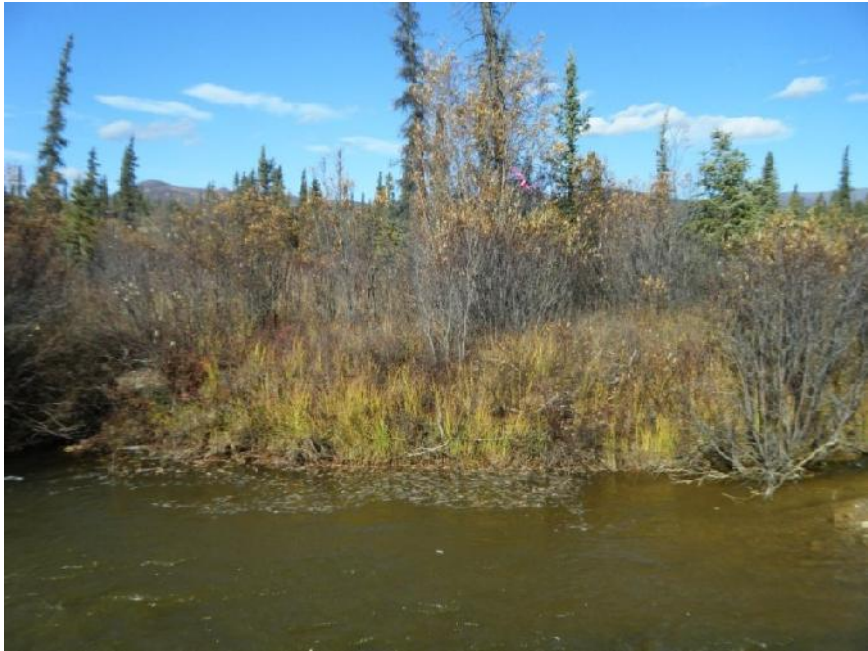
<ul style="list-style-type: none">- Large back eddy pool, very deep >100 cm- In a bend in creek, below a riffle section- 145 m upstream from DL3- Mostly cobble substrate

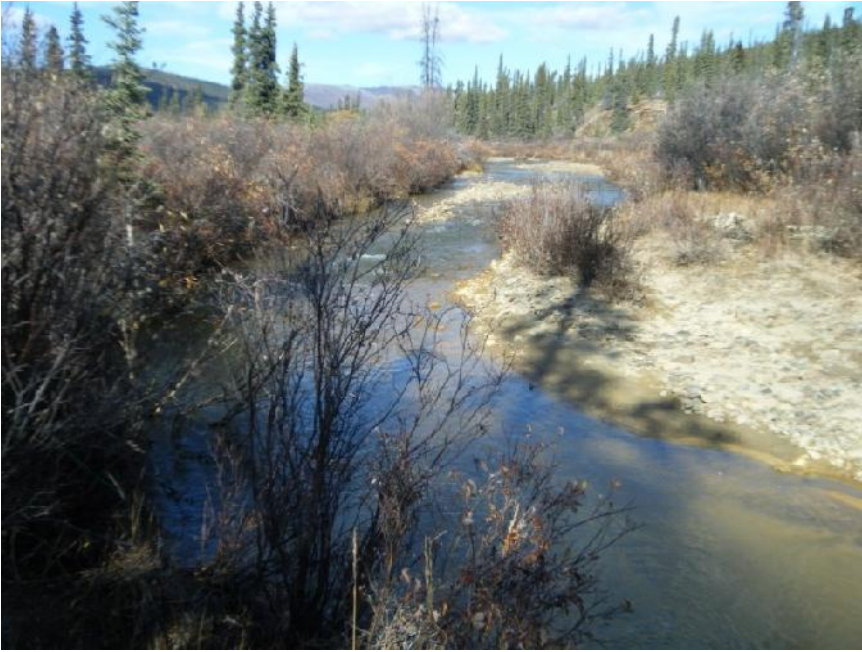
Station DL5	Description

<ul style="list-style-type: none"> - 700 m upstream from DL4 - Road is about 100 m away - Deep pool (90 cm) at bend in creek, with riffle section upstream - Overhanging willow cover and small woody debris - Cobble mixed with fines, some small boulders
Station DL6	Description

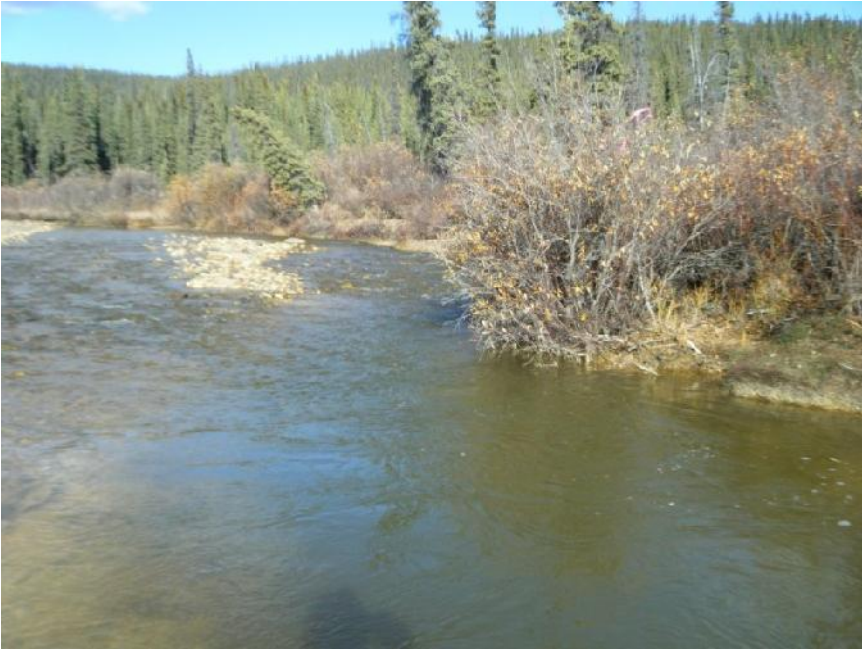
<ul style="list-style-type: none"> - Deep pool, >110 cm depth - Riffle section upstream - Some overhanging willow cover - Large and small cobble mixed with fines and gravel

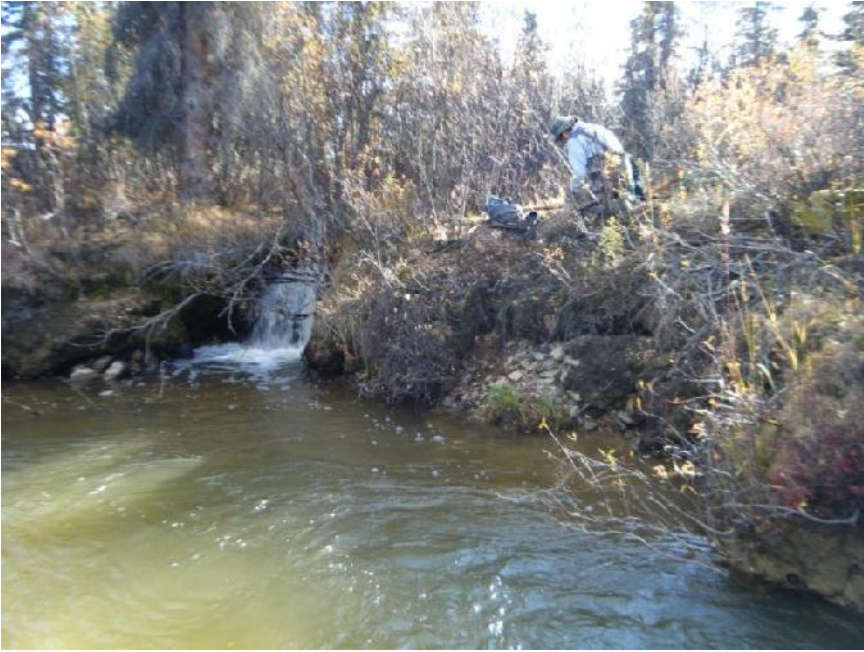
Station DL7	Description

<ul style="list-style-type: none"> - At Dome Creek confluence, upstream from falls - 468 m d/s from DL8 - Deep pool (80 cm) at bend in creek - Overhanging willow cover - Large woody debris near pool – good cover for fish - Substrate mostly cobble and large gravel
Station DL8	Description

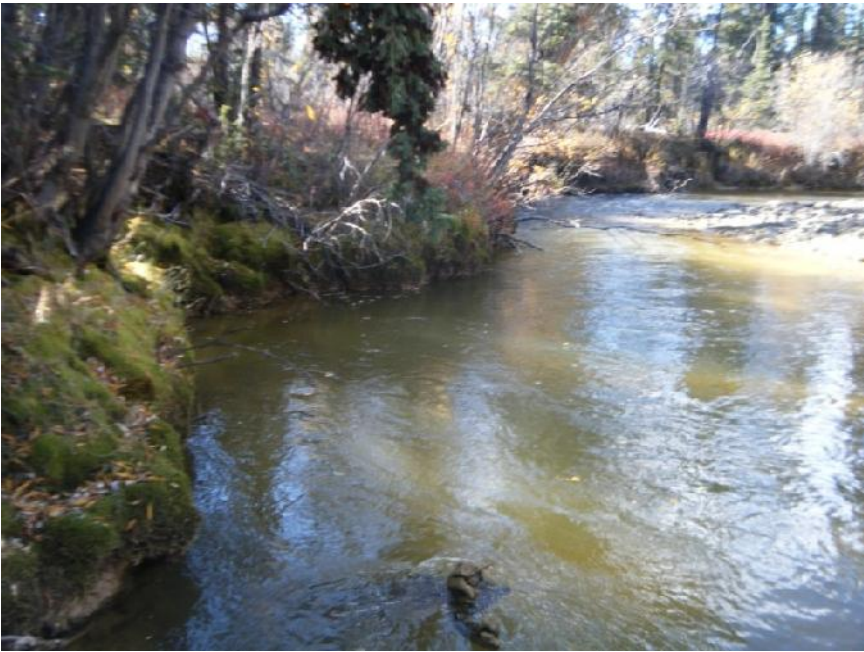
<ul style="list-style-type: none"> - Downstream of Back Creek confluence (90 m) - Pool is 0.90 cm depth - Lots of shade spruce and willow - Large woody debris near pool – good cover for fish - Small and large cobble with fines

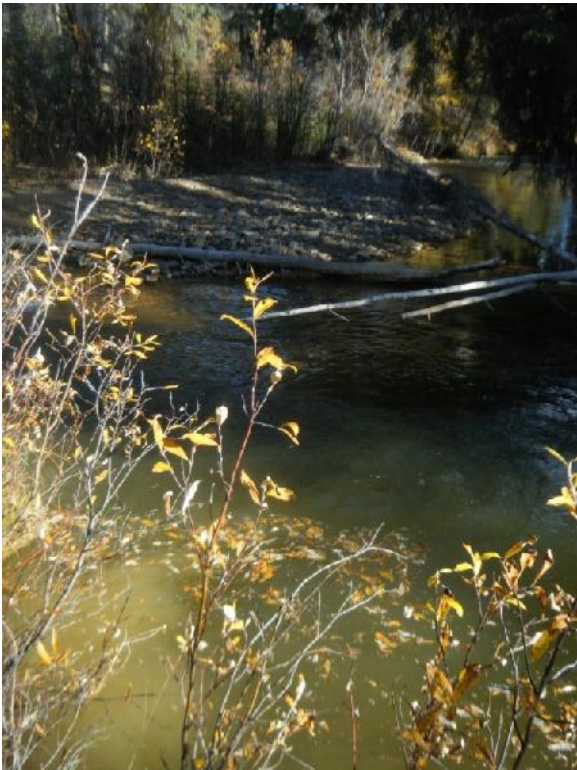
Station DL9	Description

<ul style="list-style-type: none"> - 90 m u/s from DL8, at confluence of Back Creek - Very deep pool (>120 cm) - Riffle section upstream near Upper Victoria water quality site - Small cobble and gravel with sand
Station DL10	Description

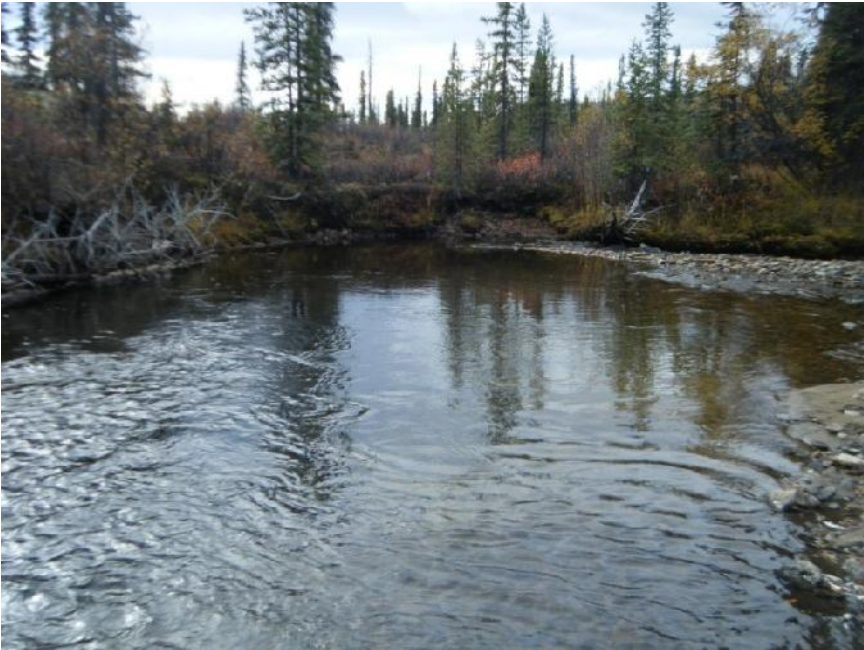
<ul style="list-style-type: none"> - Very deep pool, 125 cm depth - Large woody debris in stream - Gravel and small cobble substrate with sand
