**VEGETATIVE REHABILITATION OF WHITEHORSE
COPPER MINE TAILINGS**

REPORT NUMBER 3

D. B. CRAIG, Ph. D., P. Eng.

August 4, 1996

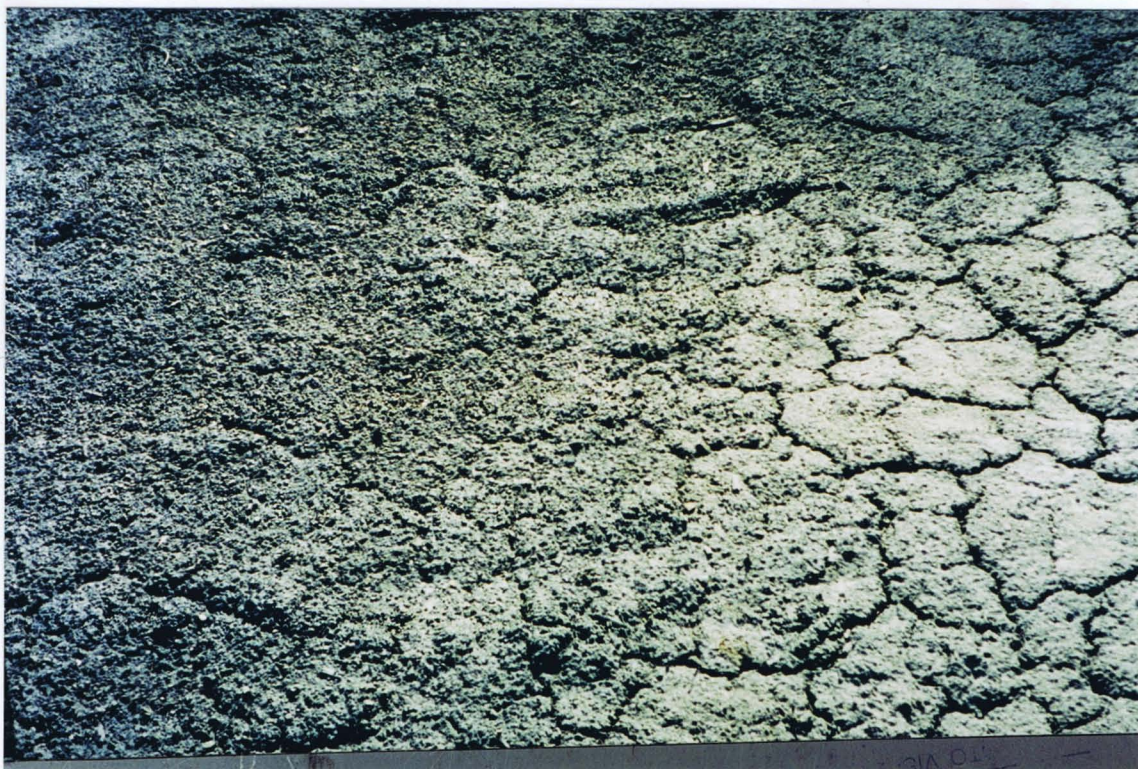
This plot is regarded as the control plot with respect to organic material. No organic enhancement was provided. In spite of tilling, fertilizing, seeding and irrigating there was zero growth on this plot. By spring 1995, compaction was such that these tailings appeared to be the same as in the spring of 1994, before any reclamation efforts had been started. Crusted evaporites developed, (possibly exacerbated by irrigation), gullies on the slope and cracks, many centimeters in length, formed similar to those in evaporite zones outside the reclamation site. Irrigation water drained down the cracks. (Photograph 1) pH was 9.4 (very high) although E.C. was still acceptable at 1.3.

Photograph # 1: Cracks in Plot 2 (Control) and fewer cracks in Plot 3 (Sawdust)

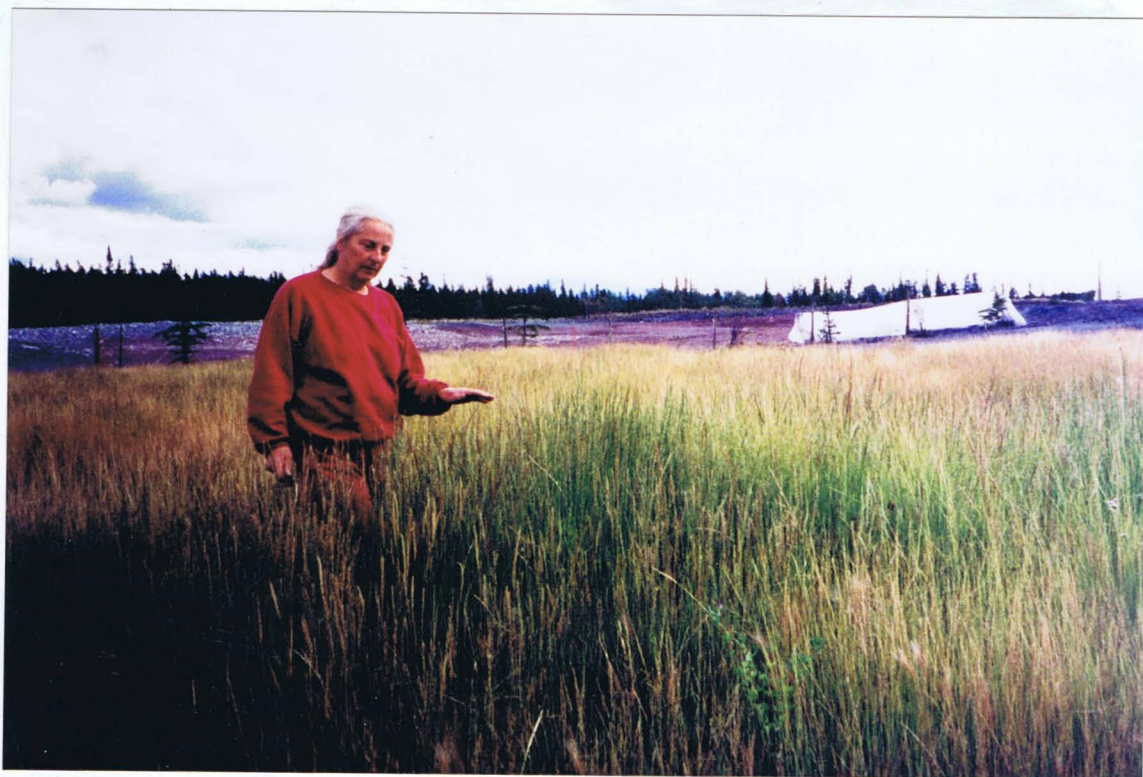
Photograph # 3: Plot 5A dense growth to 80 centimeters.

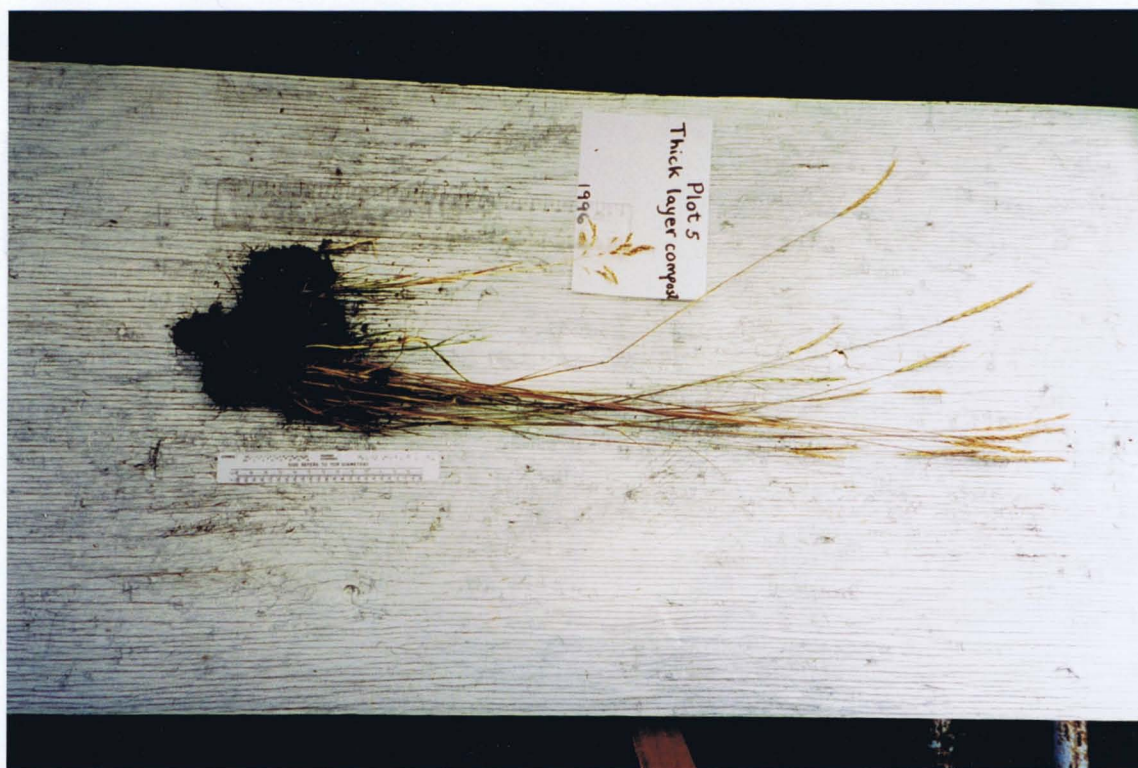
Photograph # 4: Plot 5A robust root system.

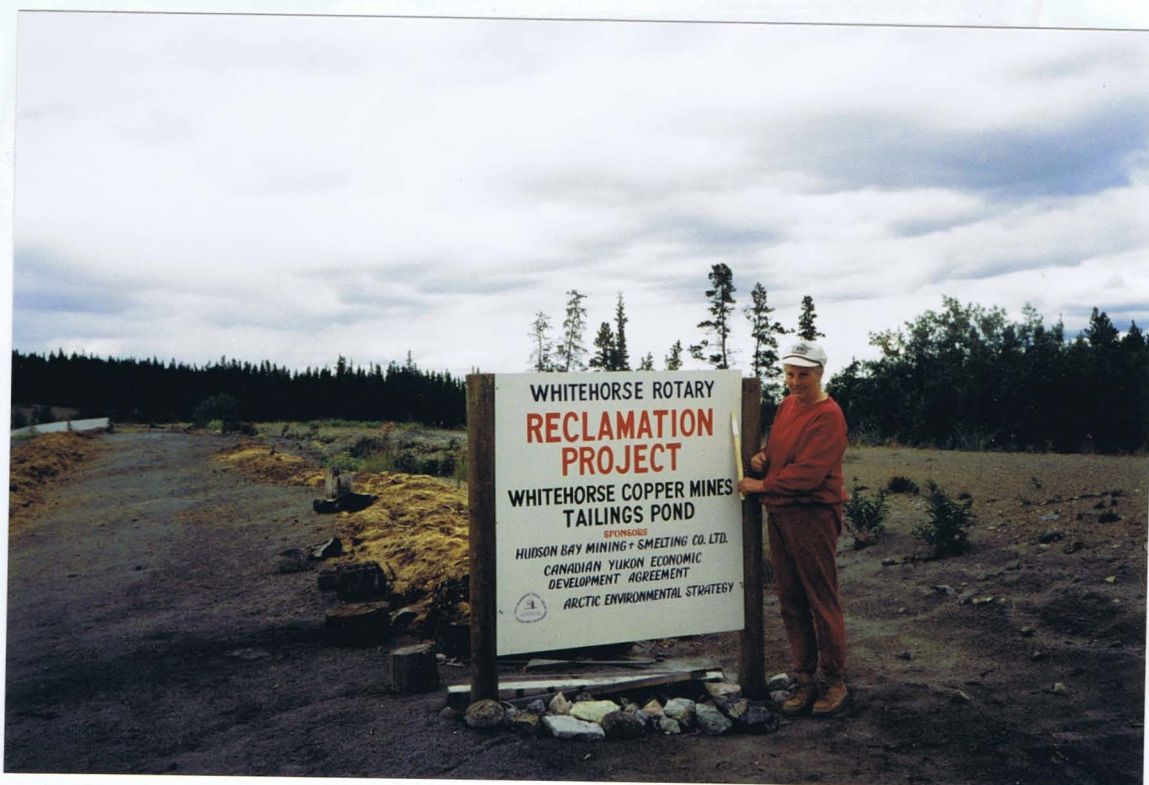
Photograph # 5: Sign and windrow.

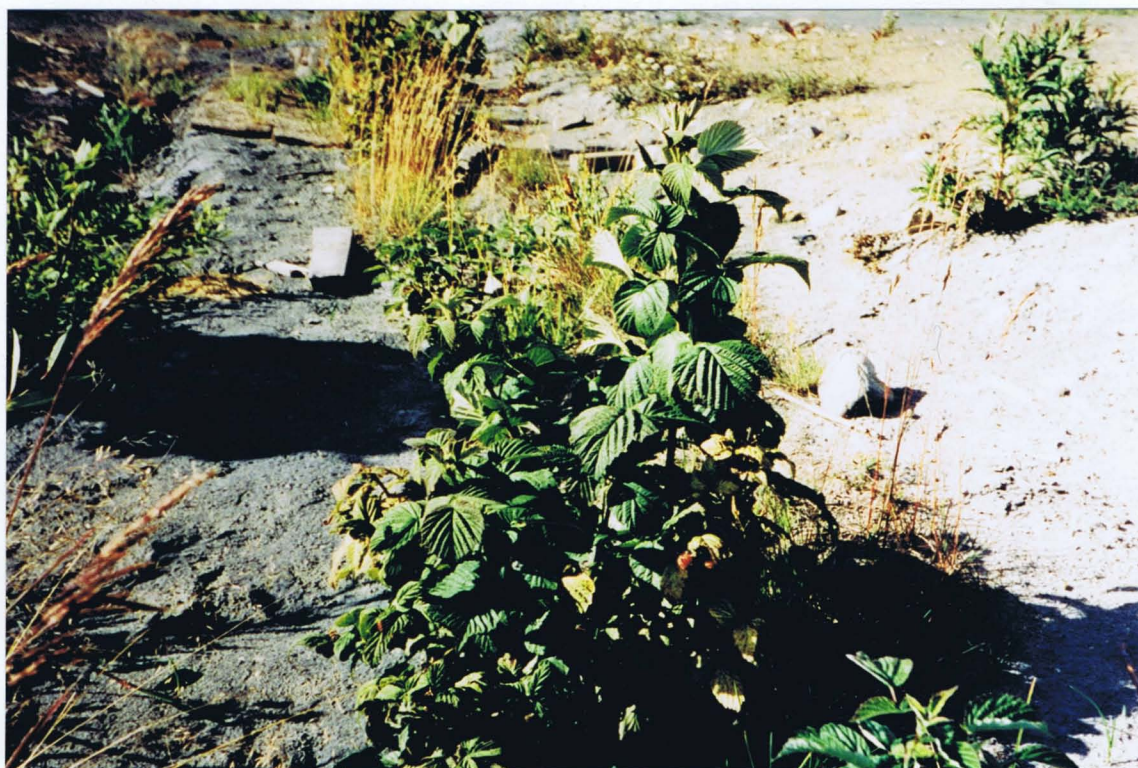
Photograph # 6: Plant growth in trench.

- g. A trench system, both for wind protection, snow catchment and ground moisture should be tried.
- h. Food scraps should probably be avoided as any inadvertent fat, meat or dairy products may lure bears or other wild animals, an illegal activity. Bear have been seen nearby on occasions but have not scavenged at this site. Animals, both microscopic to large mammals, are an important part of this revegetation project.

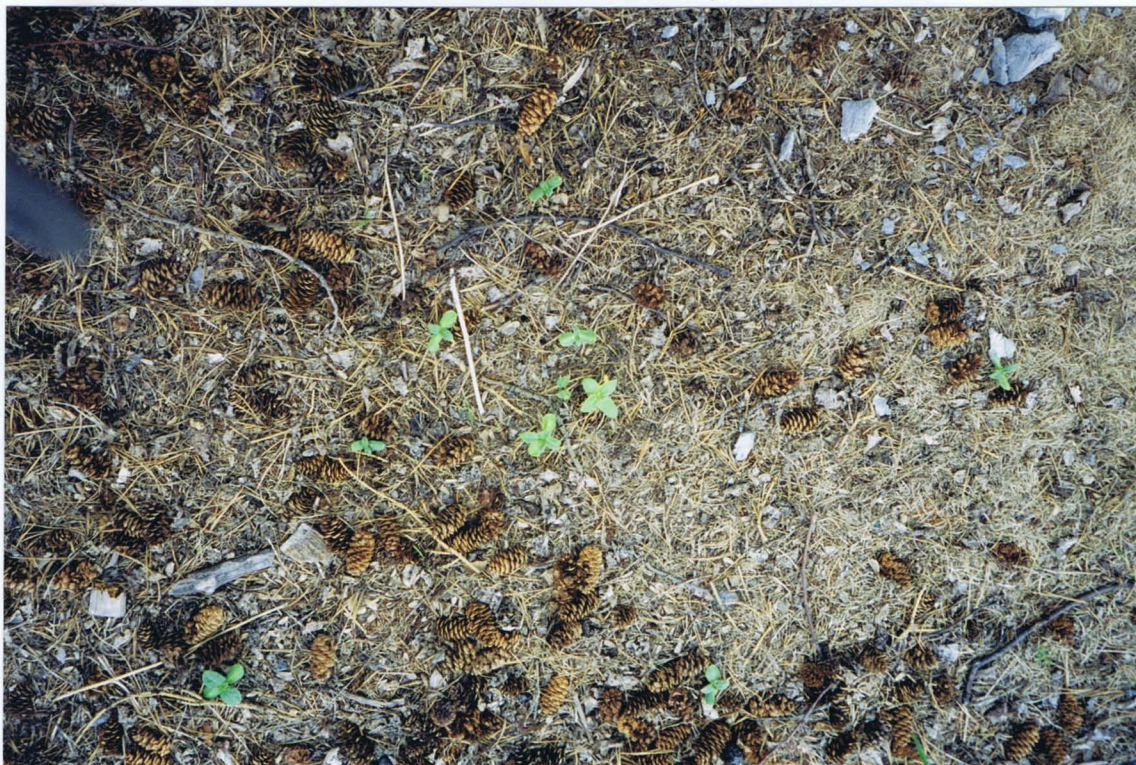
Photograph # 7: Sunflower germination in springtime rakings.
