# Preliminary description and slope stability analyses of the 2008 Little Salmon Lake and 2007 Mt. Steele landslides, Yukon

Brideau, M.-A., Stead, D., Lipovsky, P., Jaboyedoff, M., Hopkinson, C., Demuth, M., Barlow, J., Evans, S. and Delaney, K., 2010. Preliminary description and slope stability analyses of the 2008 Little Salmon Lake and 2007 Mt. Steele landslides, Yukon. *In: Yukon Exploration and Geology 2009*, K.E. MacFarlane, L.H. Weston and L.R. Blackburn (eds.), Yukon Geological Survey, p. 119-133.

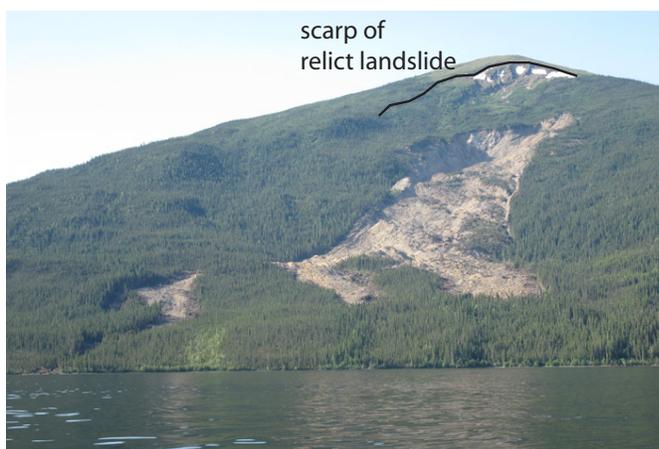
**Figure 2.** View of the Little Salmon Lake landslide.

The former landslide debris was reactivated in a large debris flow/avalanche some time between August 22 and 28, 2008 following a period of higher than normal precipitation. The 2008 reactivation involved little additional material from the headscarp. Instead, bedrock slump blocks and colluvial surficial materials located below the headscarp were mobilized in the debris flow, travelling a horizontal distance of 2050 m and descending 515 m in elevation into Little Salmon Lake, *i.e.*, a  $\Delta H/L$  ratio of 0.25. A conservative estimate of the volume of material involved is on the order of  $1 \text{ Mm}^3$ , assuming a

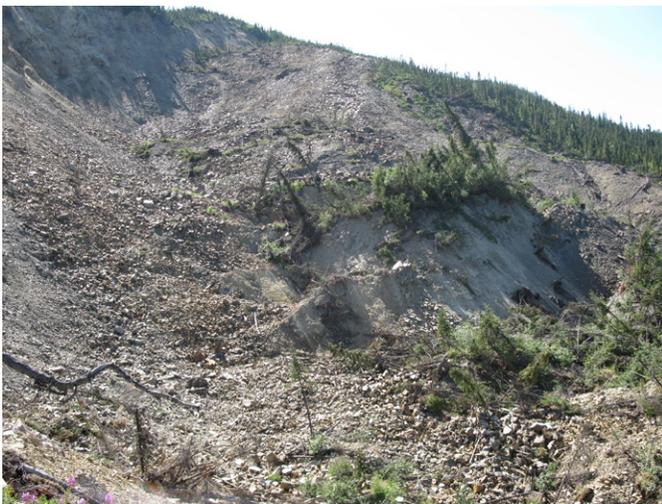
**Figure 3.** Slumped block of broken bedrock in the upper section of the landslide deposit.

The upper part of the landslide deposit consists of tens of large slump blocks, most of which are still vegetated (Fig. 3). The slumped blocks have dimensions on the order of 10 x 10 x 20 m (height x length x width). Two sag ponds were observed behind slumped blocks on the western upper portion of the deposit. Hundreds of conical mounds of distinctly variable colour and varying in height from 0.3 m to 10 m (Fig. 4) comprise the central and lower sections of the deposit. A great majority of the mounds are composed of disintegrated bedrock of unimodal lithology, including yellow quartzite, grey schist and dark grey graphitic schist while others are composed

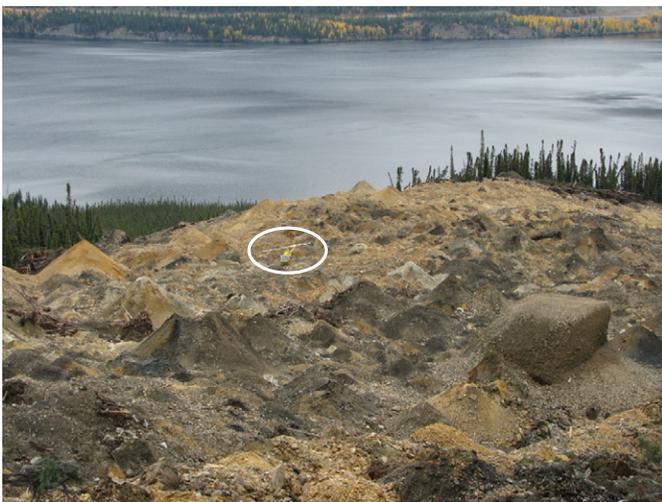
**Figure 4.** Conical mounds in the central and lower portion of the landslide deposit. Helicopter circled for scale.

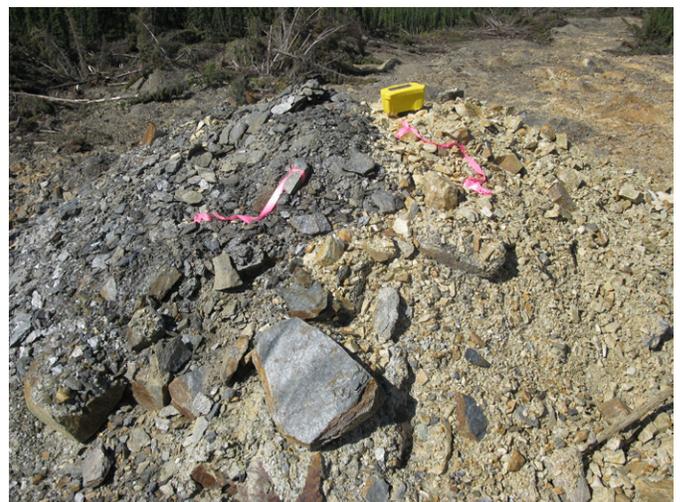
**Figure 5.** Conical mound with bi-modal lithologies (graphitic schist and quartzite).

of brown gravel-size surficial material. Where the material in the mounds is derived from two lithologies, the contact between them is sharp (Fig. 5). Some mounds have a thin layer of tephra at their pinnacle. The materials comprising the mounds are generally clast-supported, although occasionally consist of exclusively fine-grained clay-rich material. The clasts primarily consist of medium gravel to small cobbles, with occasional larger cobbles up to 50 cm. The average slope angle of the conical features is between 35° and 37° (Fig. 6a). These values correlate with the angle of repose of gravel which is reported to be between 35° and 40°. Field assessment of the density categories for the conical landforms revealed that they could be excavated with a shovel (S2 and S3) while some needed a pick for excavation (S4) (classification from BC Ministry of Forests, 2002; Fig. 6b).

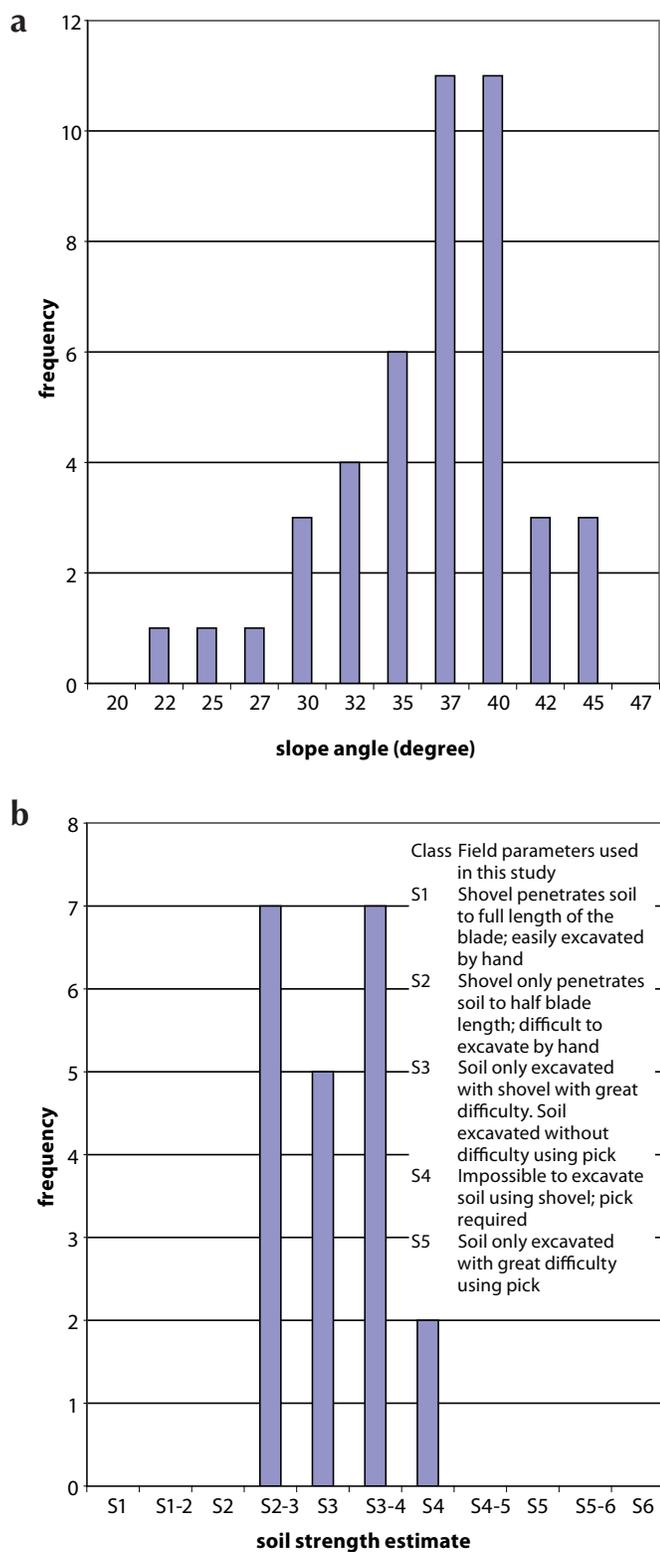
**Figure 6.** (a) Histogram of the slope angle of the sides of the conical mounds, (b) Material strength categories of the conical mounds.

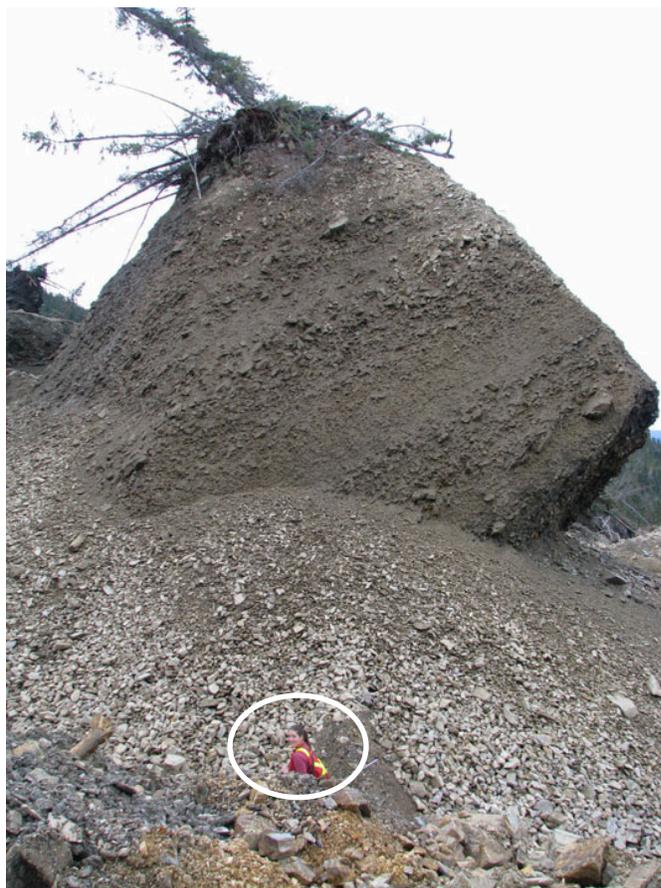
**Figure 7.** Frozen angular block of surficial material observed in 2008 in the landslide debris. Person circled for scale.

Ten conical mounds (of varying sizes) were excavated to 0.5 m depth during the week of July 5, 2009 and no ice was observed in them at that time. Soil temperatures were measured (using a household-grade thermometer) at a depth of 0.5 m in these mounds and were found to be 8°C while the ambient air temperature was 23°C. A solid ice lens approximately 10 cm thick was, however, identified in a fractured bedrock slump block found in the upper part of the deposit (Fig. 8).

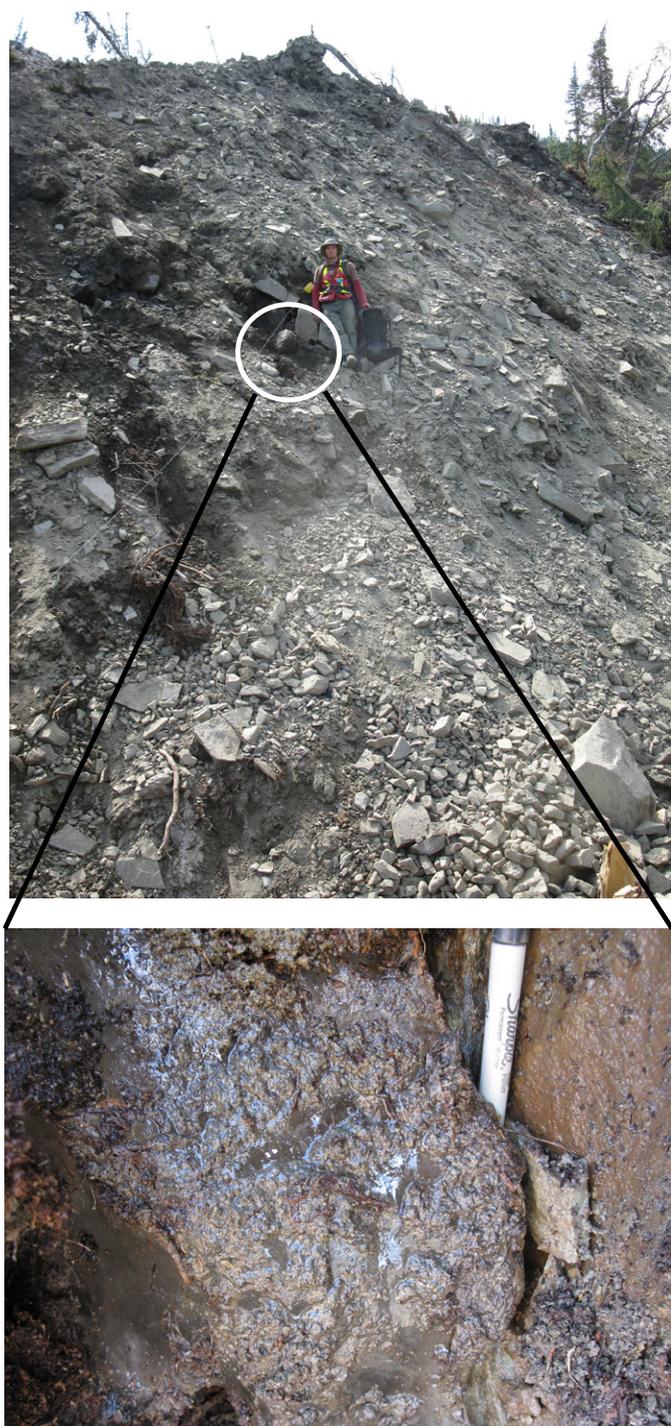
**Figure 8.** Ice lens observed at the front of a slumped block of highly broken-up schist.

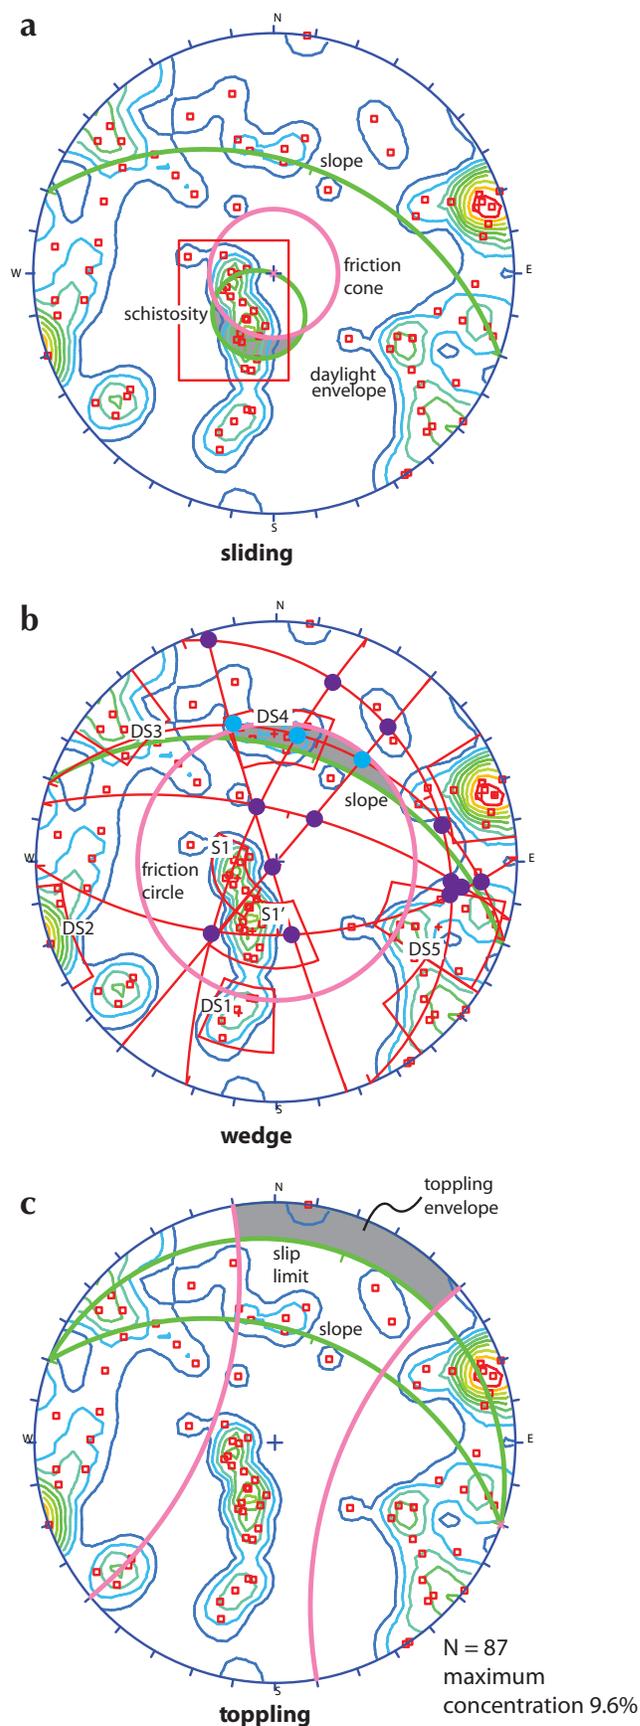
**Figure 10.** Summary of the kinematic analysis performed on the poles to the discontinuities measured in the sidescarp of the Little Salmon Lake landslide. (a) sliding, (b) wedge, (c) toppling failure mechanism (lower hemisphere projection, equal angle stereonet).

A limited number ( $N = 87$ ) of discontinuity (foliation and joints) orientation measurements were acquired in the sidescarp of the landslide and used to conduct a kinematic analysis. A kinematic analysis is a geometric test, which uses for the average slope orientation an assumed discontinuity friction angle and the discontinuity measurements to assess the feasibility of simple failure mechanisms (Fig. 10). The stereographic techniques used to kinematically assess the feasibility of the planar, wedge and toppling failure mechanisms are outlined in Wyllie and Mah, 2004. Poles (Figs. 10a and 10c) or intersection of planes (Fig. 10b) which fall within the shaded area of the stereonet indicate a feasible failure mechanism. The results suggest that planar sliding (Fig. 10a) and wedge failures (Fig. 10b) are feasible with an assumed  $40^\circ$  slope angle and a  $30^\circ$  friction angle (angle at which a block would slide along an inclined plane) along the discontinuity surfaces. Only one discontinuity falls within the toppling envelope (Fig. 10c).

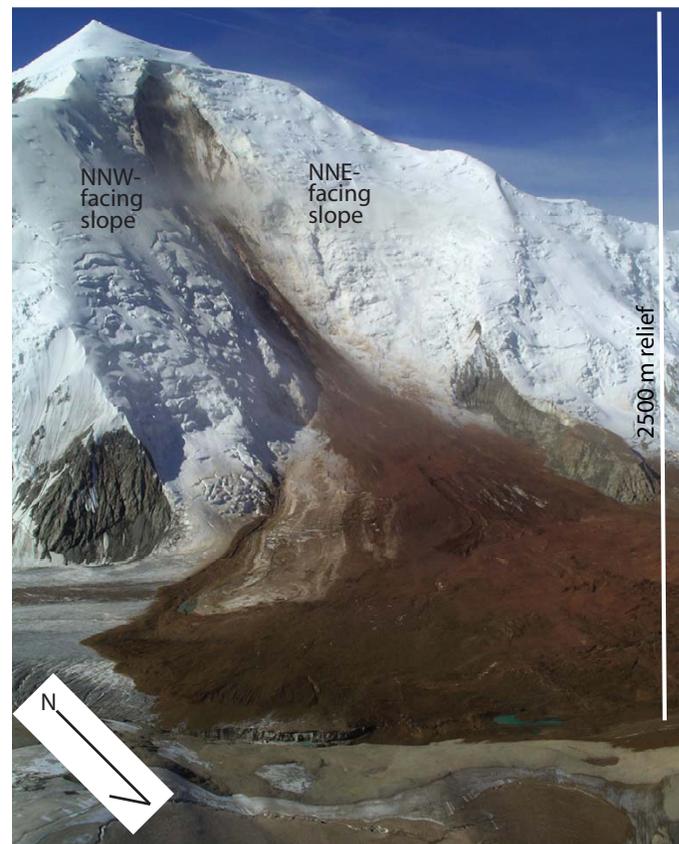
**Figure 12.** View of the Mount Steele rock and ice avalanche.

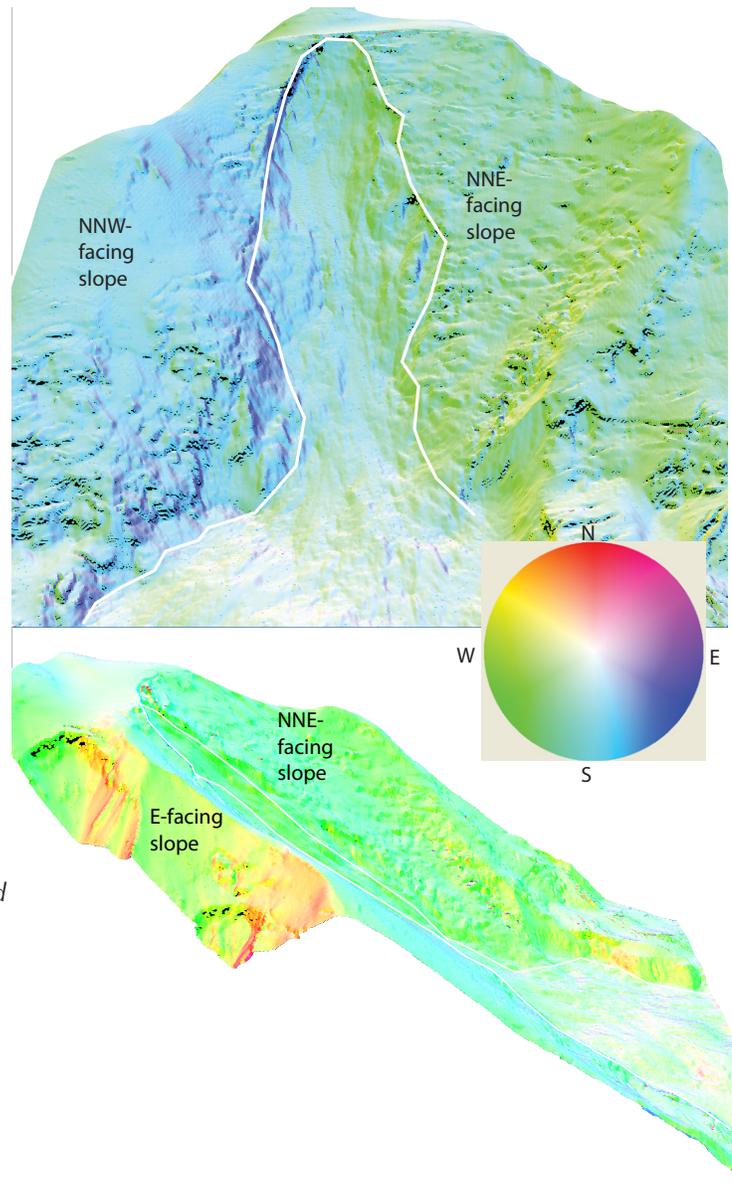
**Figure 13.** COLTOP-3D rendered view where the digital elevation model is coloured as a function of the dip and dip direction of each cell. The inset stereonet provides the colour coding for the surfaces.

bedding, persistent joints and/or faults. These zones of constant orientation are manually identified by the user. COLTOP-3D has been previously used on several rock slope stability case studies (Derron *et al.*, 2005; Pedrazzini *et al.*, 2008; Jaboyedoff *et al.*, 2009; Metzger *et al.*, 2009). Due to the extensive ice cover in the study area, surface orientations could only be obtained from the initiation zone of the landslide and from the east-facing rock wall in the gully that the landslides followed (Fig. 13).

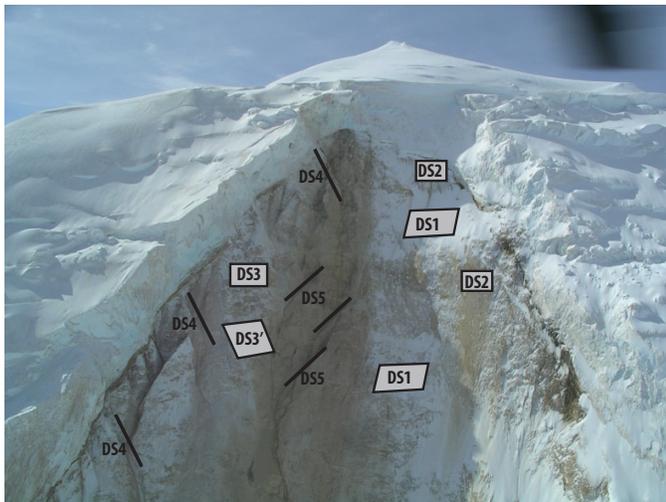
**Figure 14.** Headscarp of the Mount Steele rock and ice avalanche with the identified discontinuities annotated.

Three discontinuity sets (DS1, DS2, DS3) were identified in the landslide scarp using COLTOP-3D (Fig. 14). They correspond to the discontinuities identified by Lipovsky *et al.* (2008a). DS3 may have a subset with a steeper dip, which is shown as DS3' in Figure 14. Two other discontinuity sets (DS4 and DS5) were also noted in

photographs of the headscarp but are dipping into the slope and therefore cannot be resolved in the landslide scar using COLTOP-3D. Upon further investigation of the east-facing gully wall using the LiDAR-derived DEM of Mount Steele, two more surfaces were recognized having orientations consistent with the planes (DS4 and DS5) highlighted in the photograph (Fig. 14).

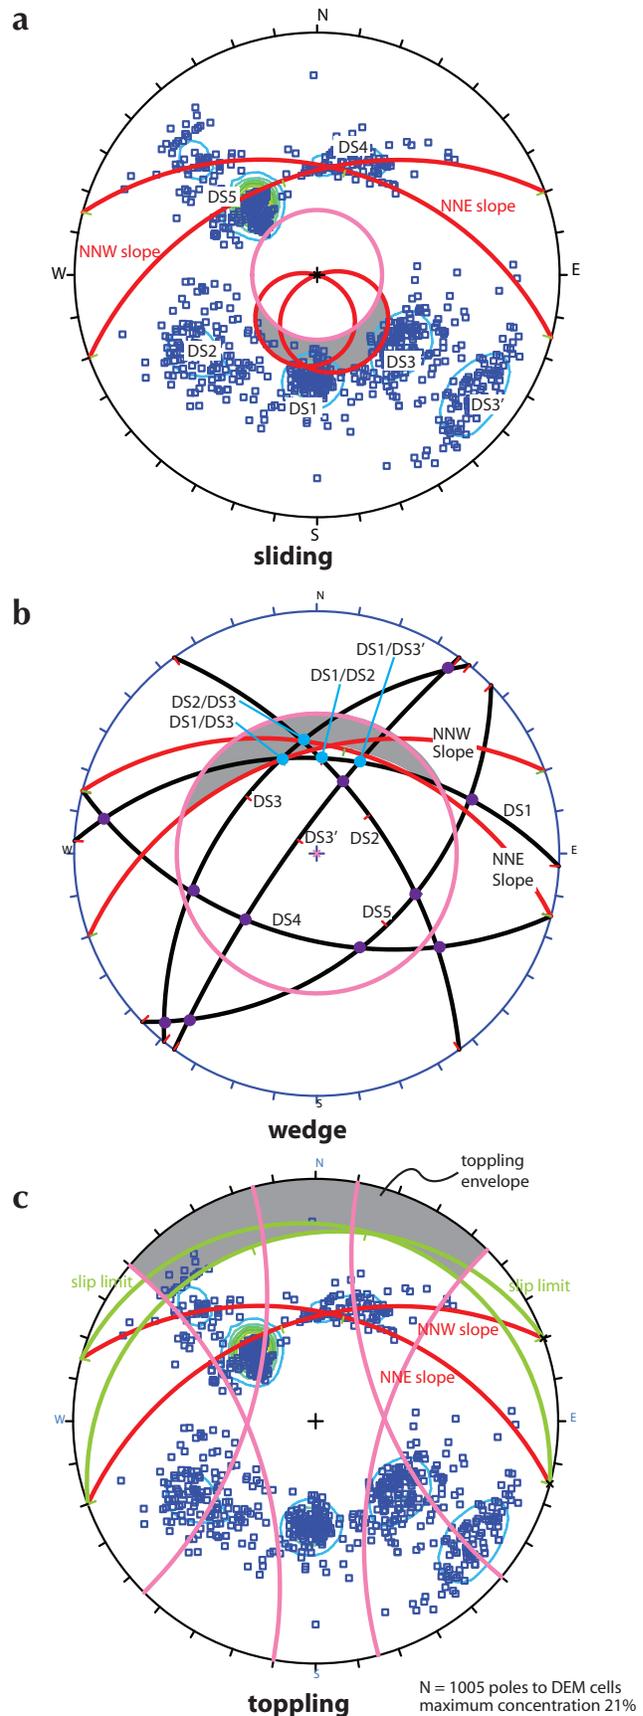
**Figure 15.** Summary of the Mount Steele kinematic analysis performed on the poles to the surfaces obtained using COLTOP-3D. (a) sliding, (b) wedge, (c) toppling failure mechanism (lower hemisphere projection, equal angle stereonet).

A preliminary kinematic analysis was performed using a friction angle of 30° along the discontinuity surfaces. Since the failure occurred in a broad gully, two slope surfaces were considered in this analysis. The pre-failure topography was approximated by projecting the orientation of the slope on either side of the landslide source zone into the existing landslide scar. Two such surfaces were defined using COLTOP-3D: a north-northeast wall with dip/direction 42°/018° and a north-northwest wall with dip/direction 45°/340°. The kinematic analysis revealed that sliding failure was feasible on DS1 in the north-northeast wall (Fig. 15a) as suggested by Lipovsky *et al.* (2008a) and that sliding was only marginally feasible on DS1 and DS3 in the north-northwest wall. Wedge failures were feasible along

intersections between DS1 and DS3 and DS2 and DS3 in the north-northwest wall; they were only marginally feasible along the intersections between DS1 and DS3' and between DS2 and DS3 in the north-northeast wall and between DS1 and DS2 in the north-northwest wall (Fig. 15b). Toppling was shown to be marginally feasible along discontinuity orientations which represent outliers to DS5 in the north-northwest wall (Fig. 15c).

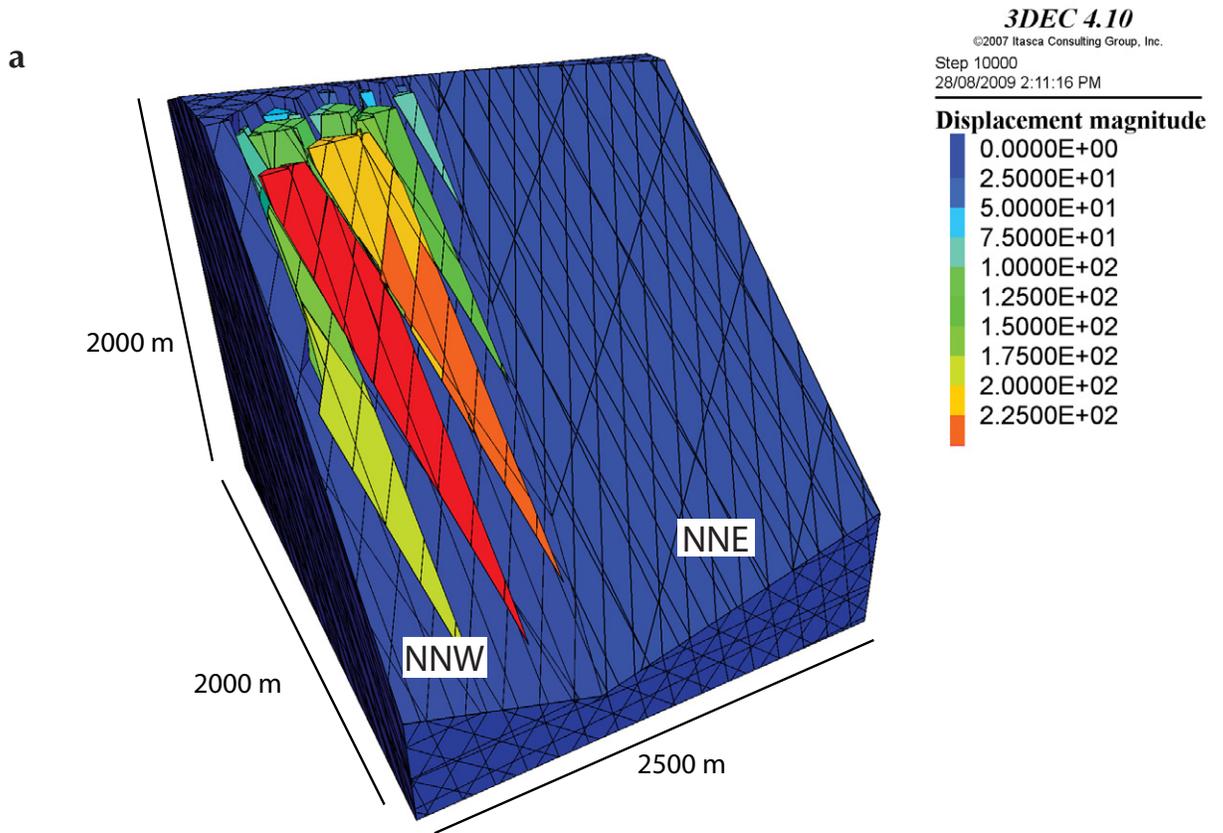
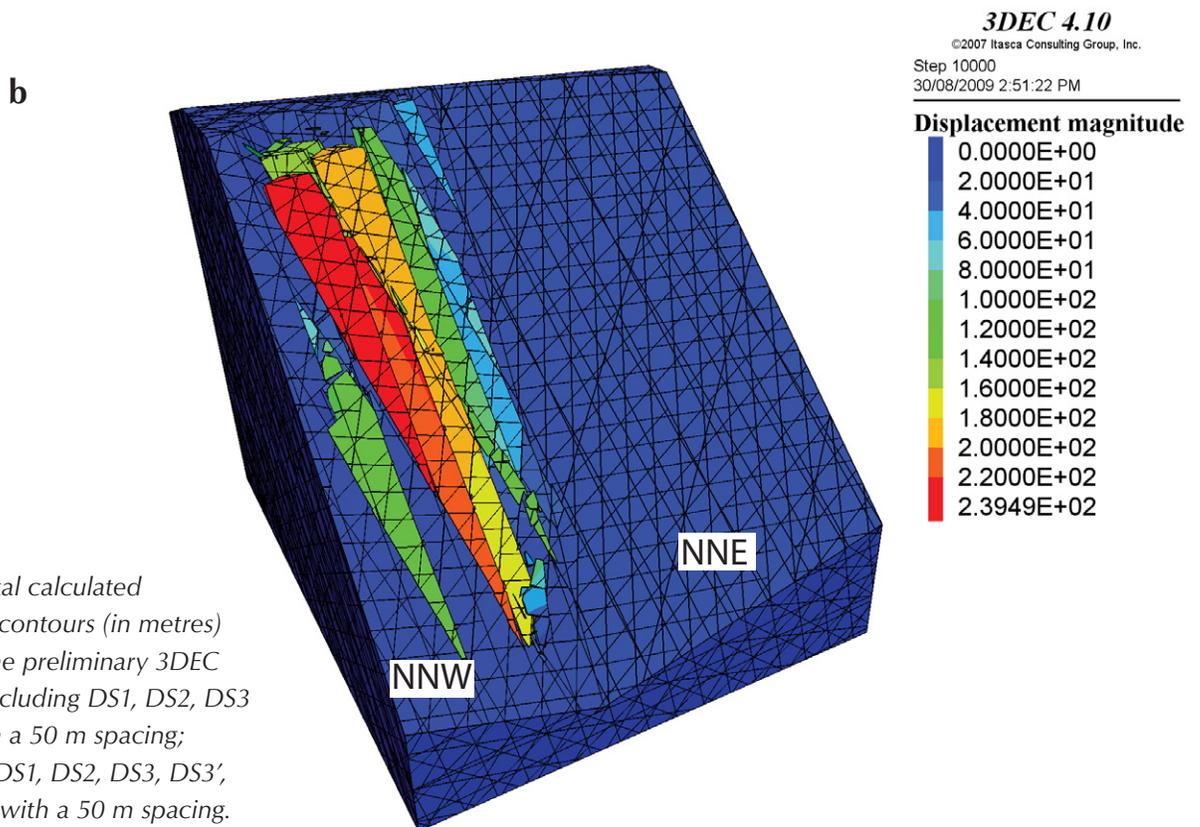
**Figure 16.** Total calculated displacement contours (in metres) obtained in the preliminary 3DEC models; **(a)** including DS1, DS2, DS3 and DS3' with a 50 m spacing; **(b)** including DS1, DS2, DS3, DS3', DS4 and DS5 with a 50 m spacing.

3DEC (Itasca, 2008) is a three-dimensional distinct element code which represents a rock mass as a collection of blocks bounded by planes (*i.e.*, discontinuities). The constitutive model (rigid, elastic, elasto-plastic), the strength of the material inside the blocks and the shear and tensile strength along the surfaces bounding the blocks can be specified by the user. 3DEC allows for large displacement and rotation of the modelled blocks. More information about 3DEC can be obtained in Cundall (1988) and Hart *et al.* (1988). Preliminary 3DEC models were constructed using rigid blocks and an assumed 30° friction angle along all discontinuities. The geometry of the north face of Mount Steele was modelled as two planes (north-northeast and north-northwest walls) approximating the pre-failure topography of the broad gully as previously described. The spacing of all discontinuity sets in these preliminary models was assumed to be 75 m. The first model assumed that only DS1, DS2, DS3 and DS3' were present, which resulted in a large failure on the north-northwest-facing slope (Fig. 16a). The second model incorporated all six identified discontinuity sets (DS1, DS2, DS3, DS3', DS4 and DS5). As in the previous model a large failure was modelled on the north-northwest-facing slope (Fig. 16b). The results demonstrate that DS1, DS2, DS3 and DS3' play an important role in the stability of the models while DS4 and DS5 appear to be less important. The rock slope failures in both models appear to be restricted to the north-northwest-facing slope.
